Interim Reclamation Inspection

Operator: Atlas Resources

Location ID: 314139

API: 095-06231

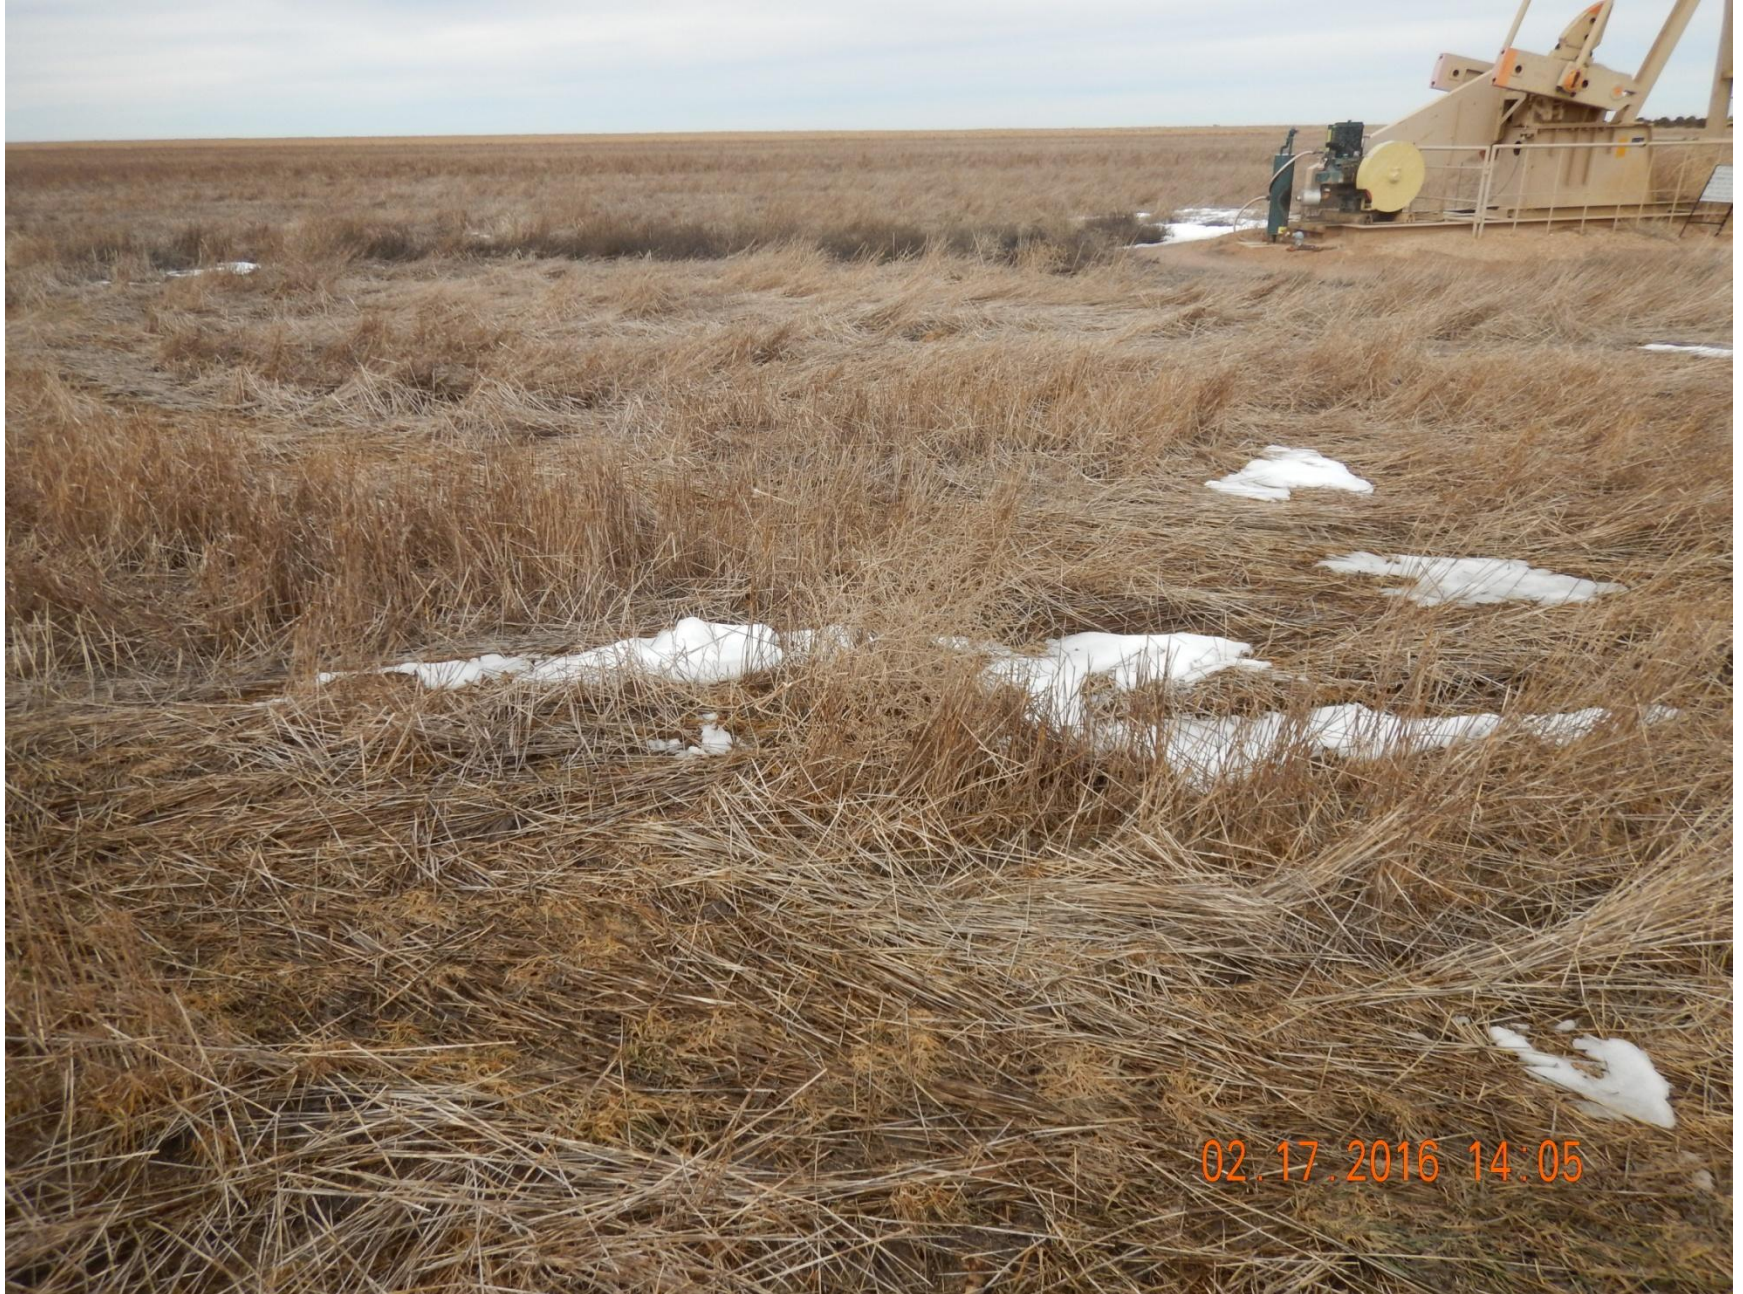
Figure 11: Photo taken from the southwest corner of location, facing north. Photo shows vegetation on interim area, and project area.

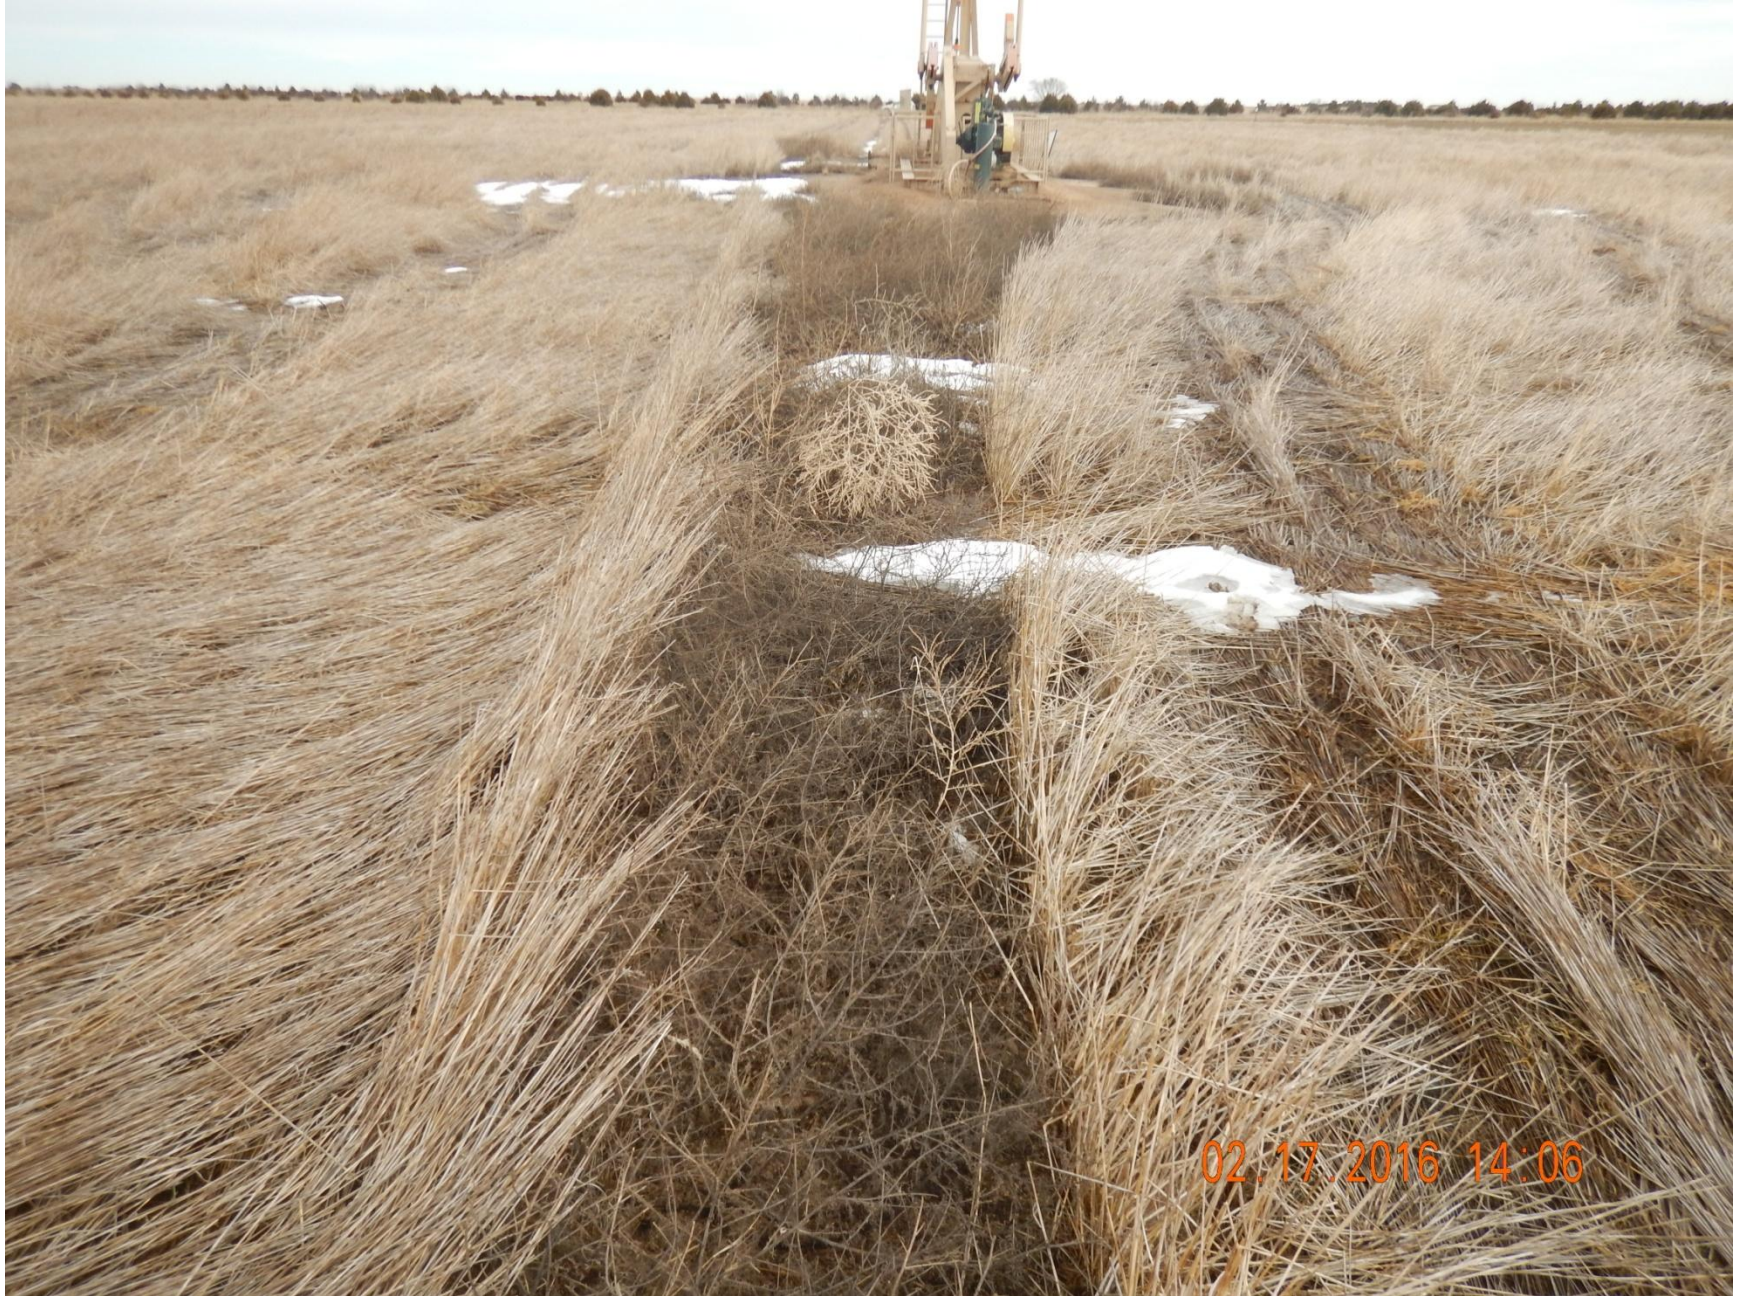
Figure 12: Photo taken from the west end of location, facing east. Photo shows vegetation on interim area, and project area.

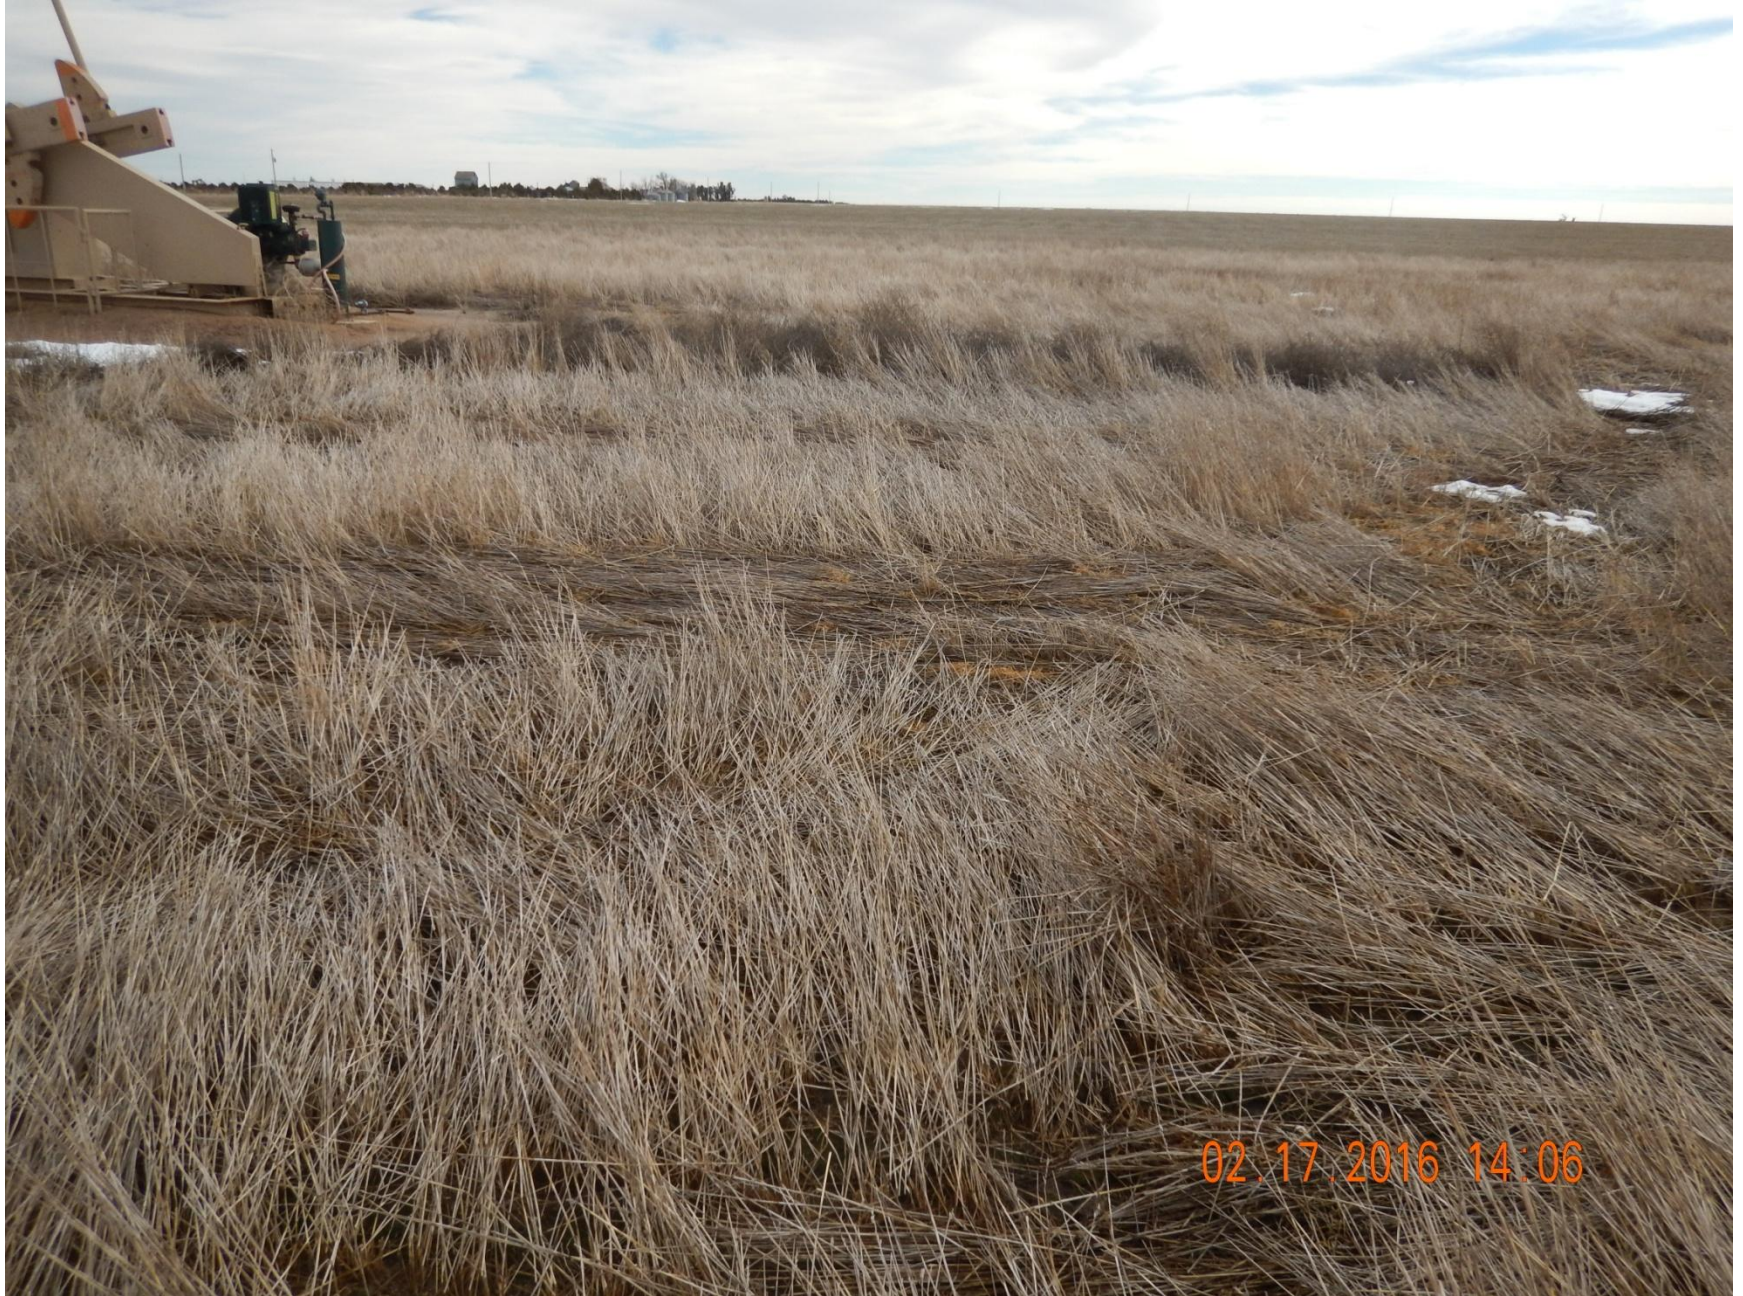
Figure 13: Photo taken the northwest end of project area, facing south. Photo shows vegetation on interim area, and project area.

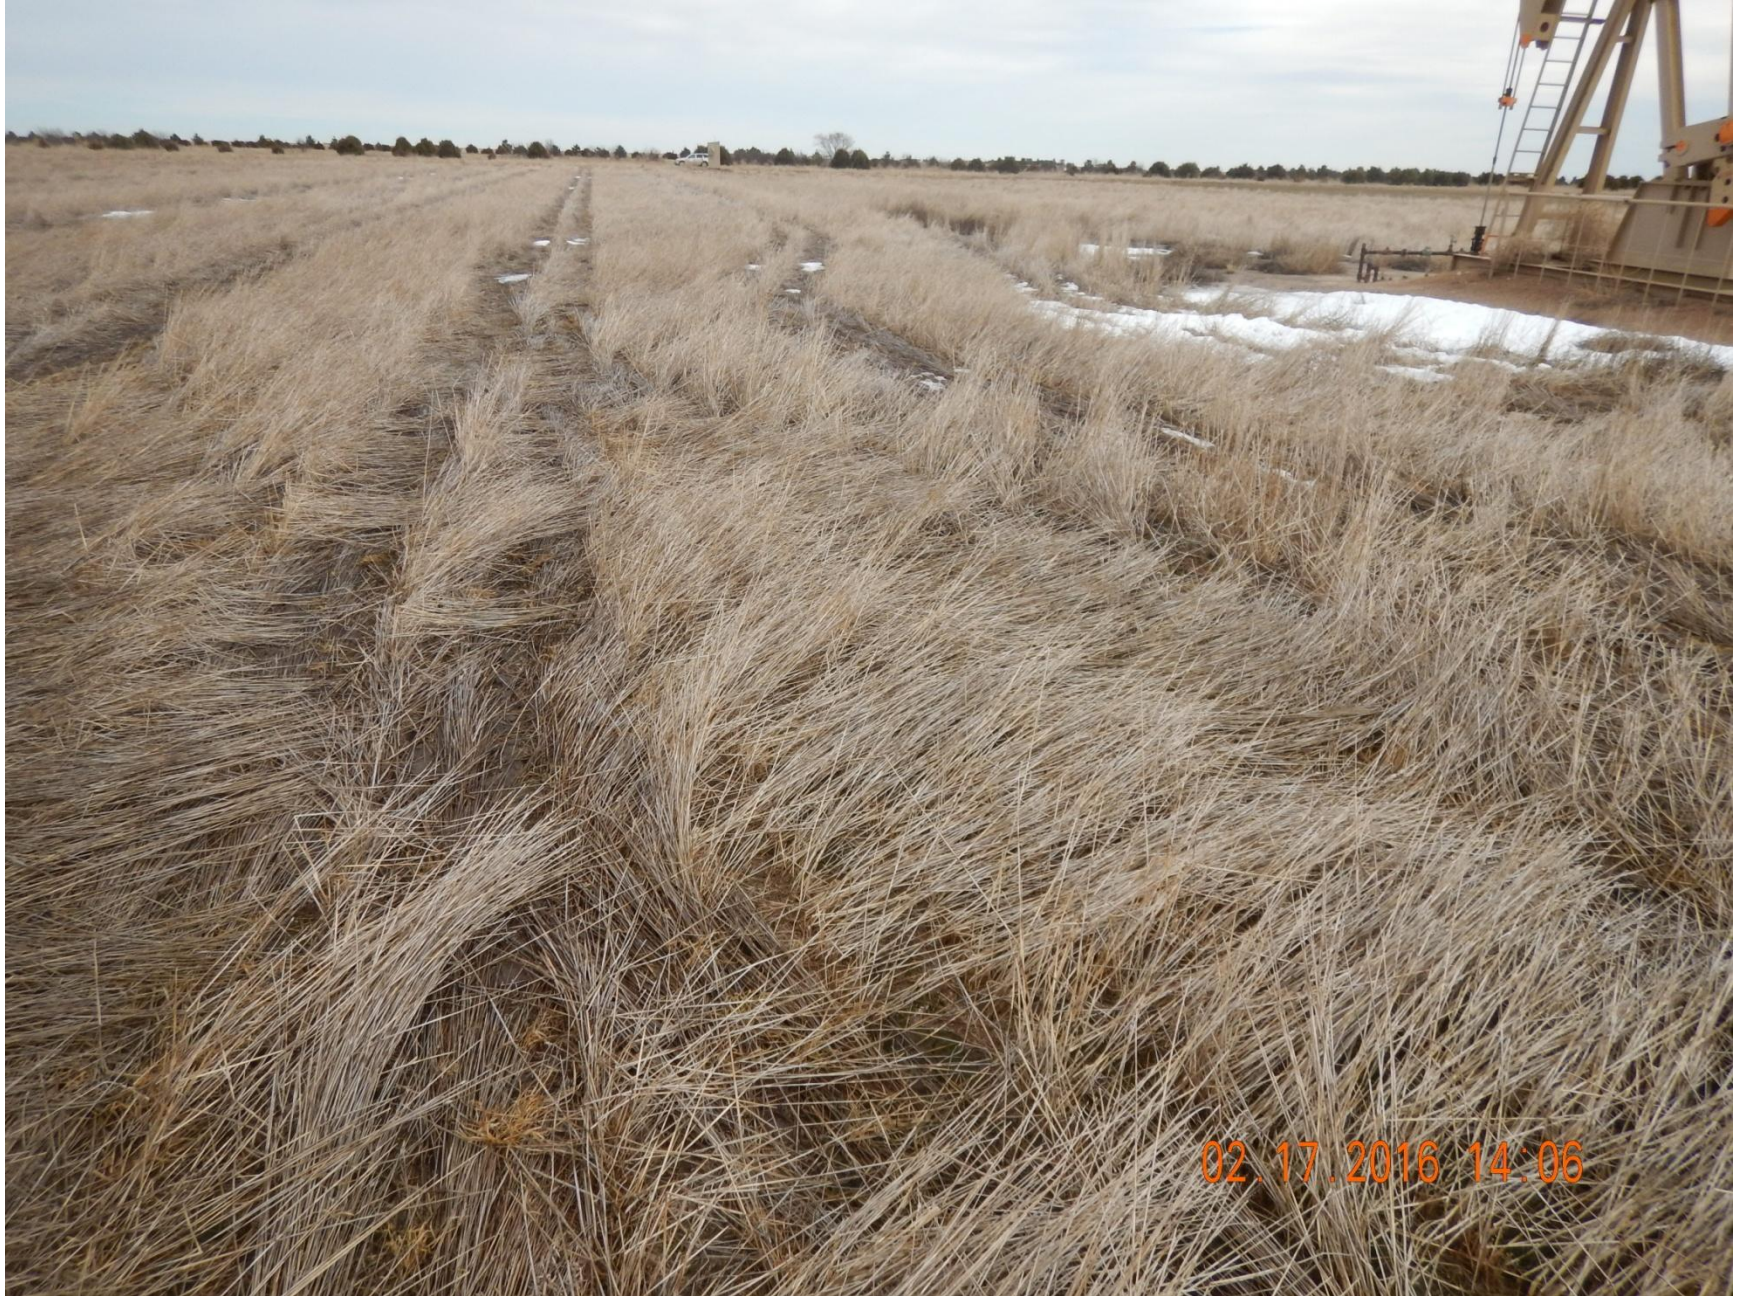
Figure 14: Photo taken the northwest end of project area, facing east. Photo shows vegetation on interim area, and project area.

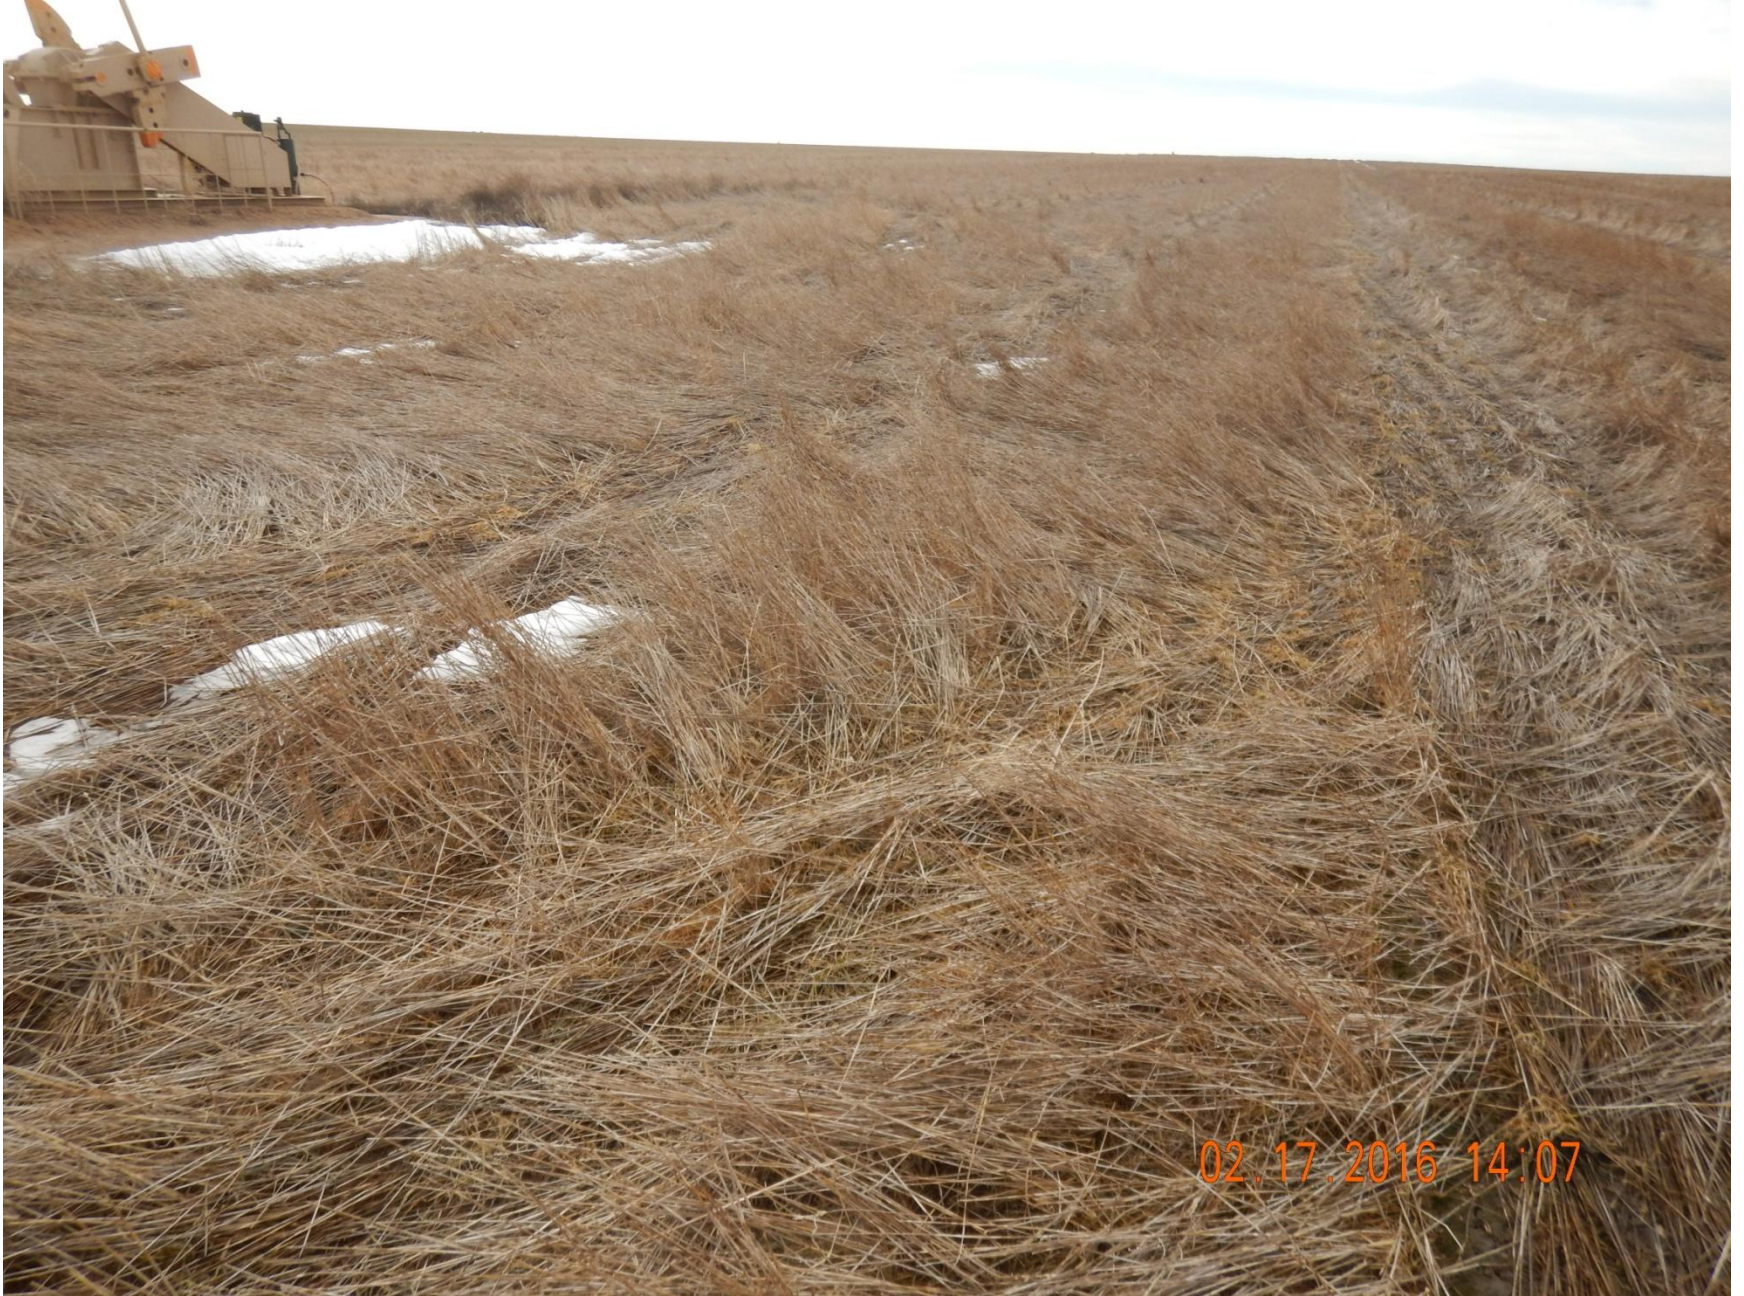
Figure 15: Photo taken northeast of project area, facing west. Photo shows vegetation on interim area, and project area.

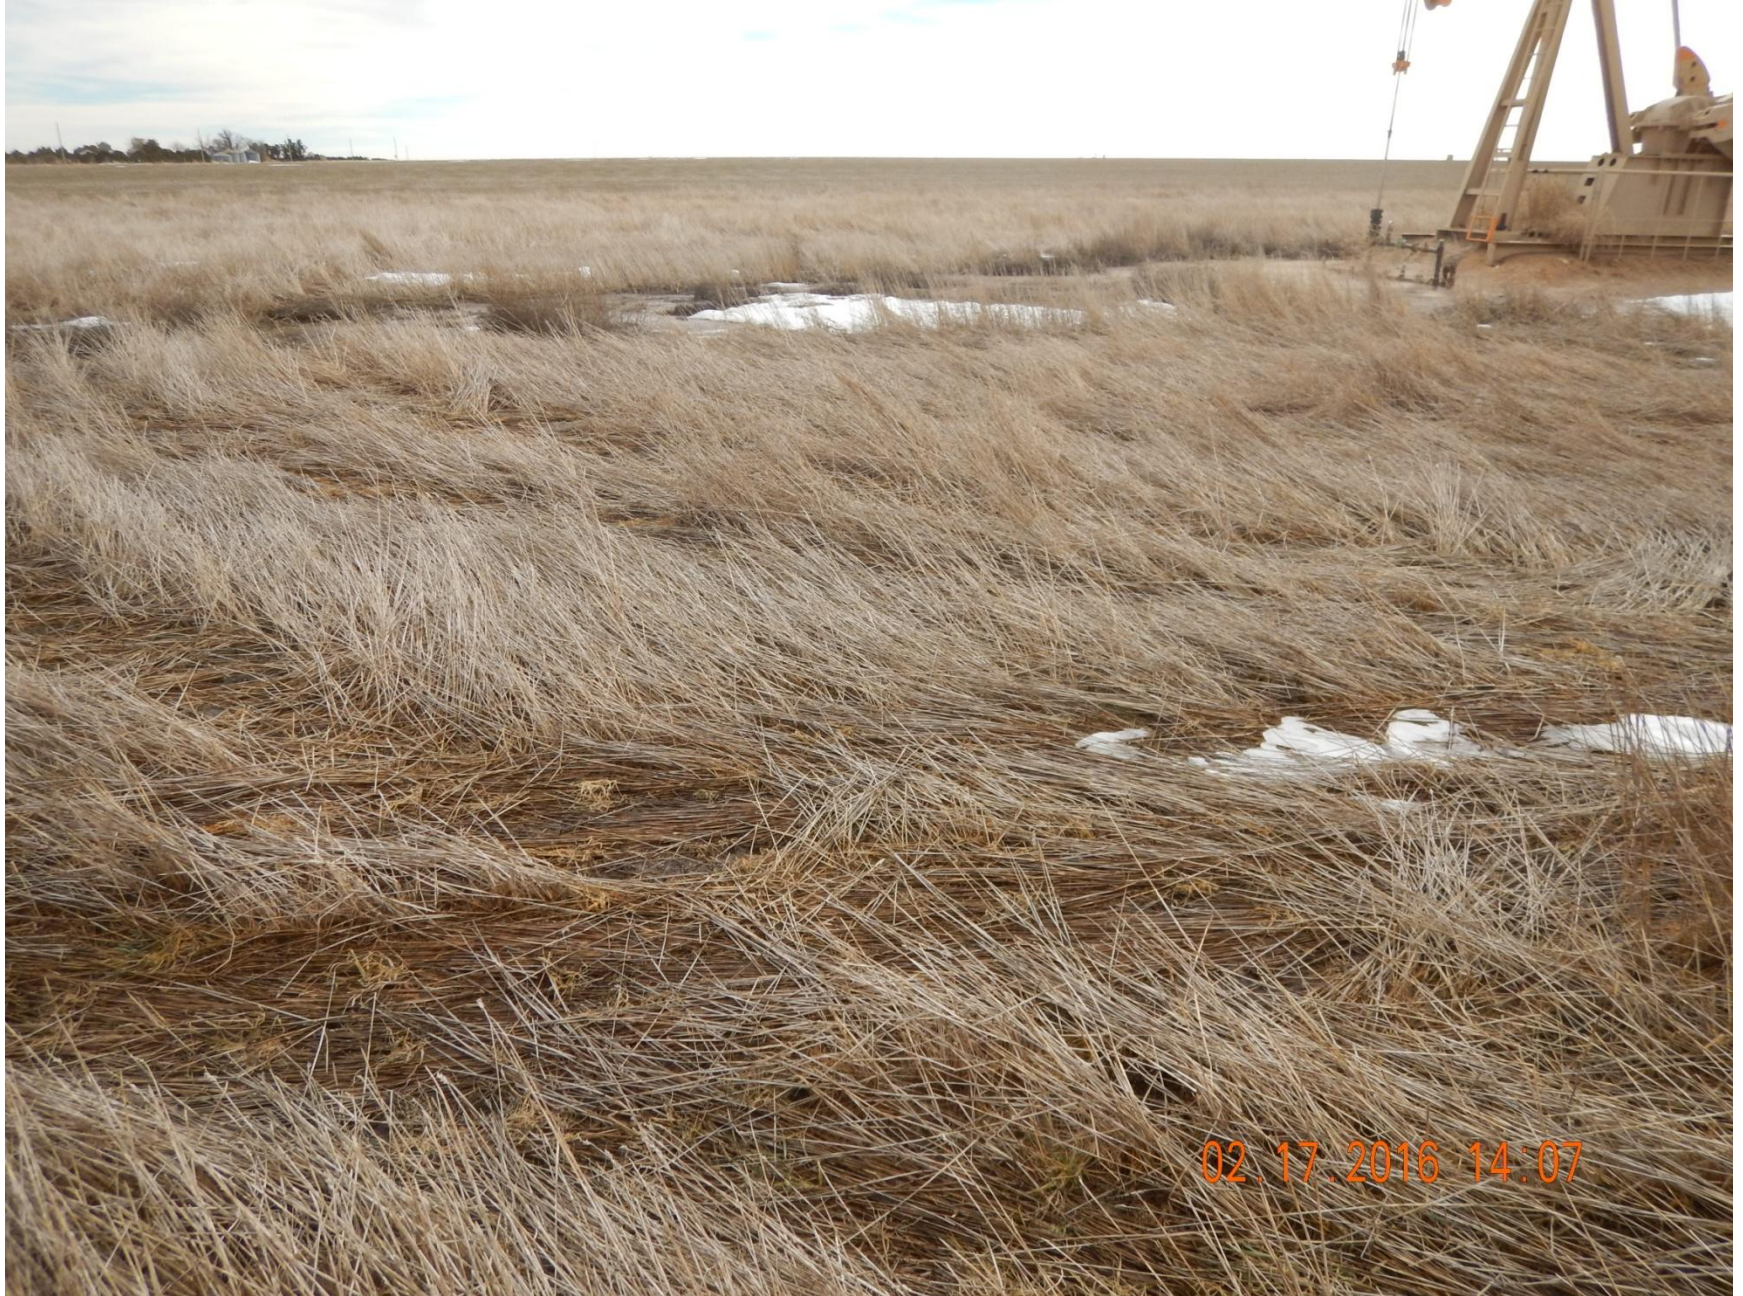
Figure 16: Photo taken northeast of project area, facing south. Photo shows vegetation on interim area, and project area.

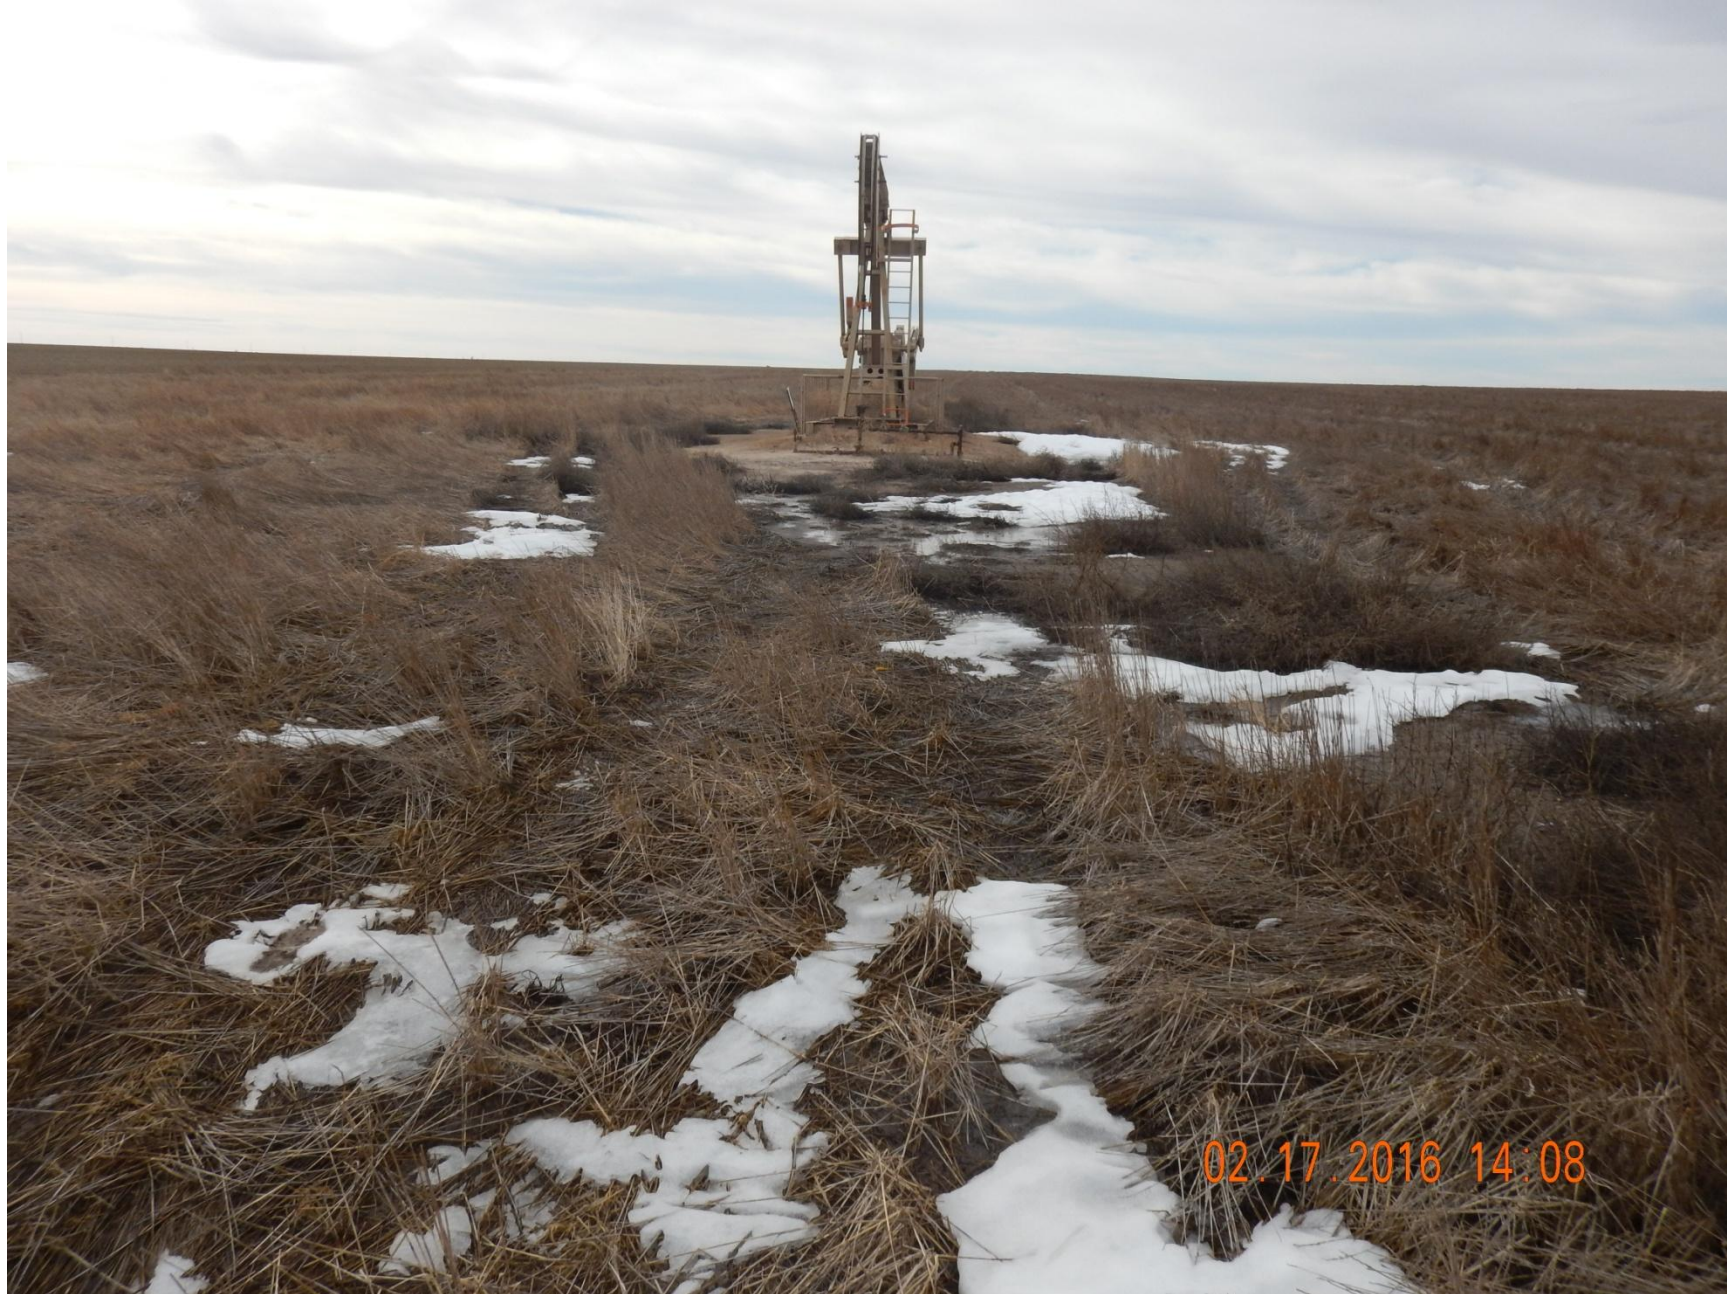
Figure 17: Photo taken east of well location, facing west. Photo shows vegetation on interim area, and project area.
