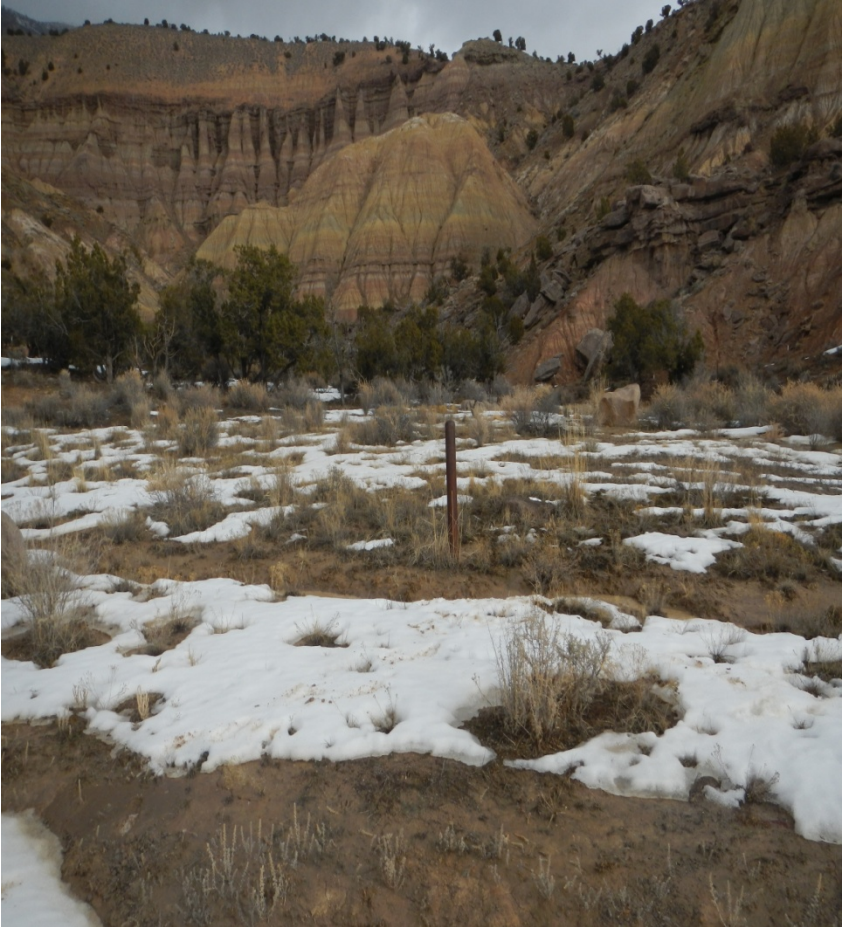
Photo#1:
Overview of Location to North

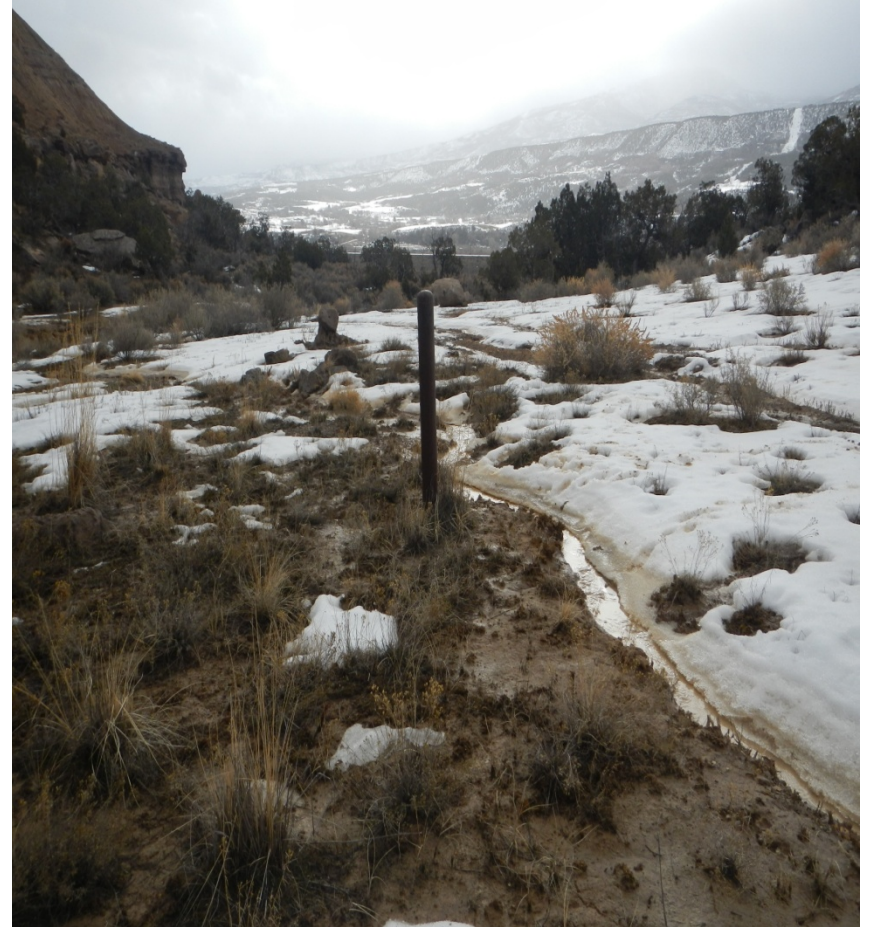
Photo#2:
Overview of Location to East

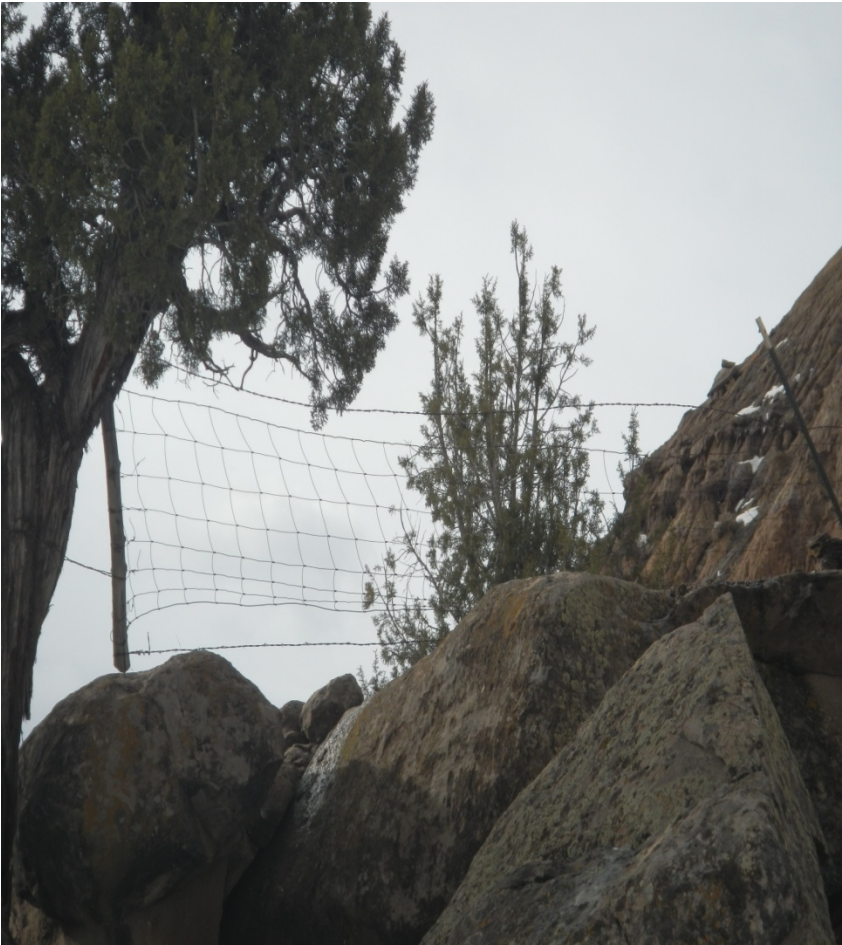
Photo#3:

Point where Net fencing begins at SE corner of Location.

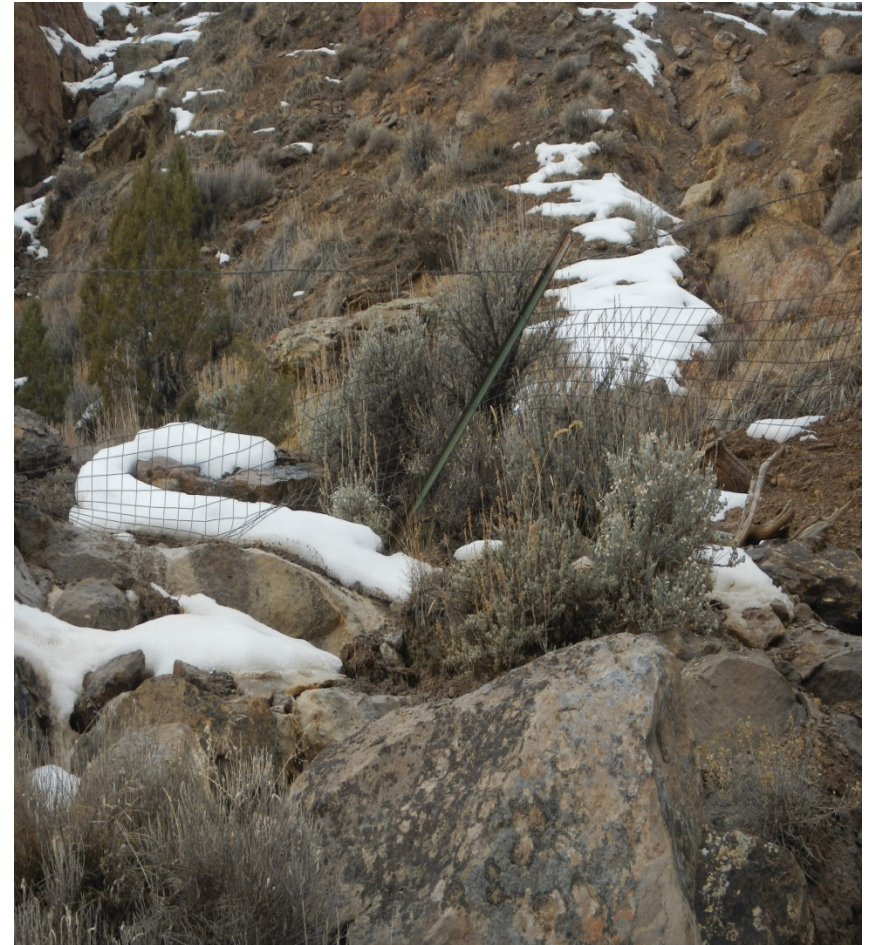
Photo#4:

Net Fencing encircles Location on three Sides.

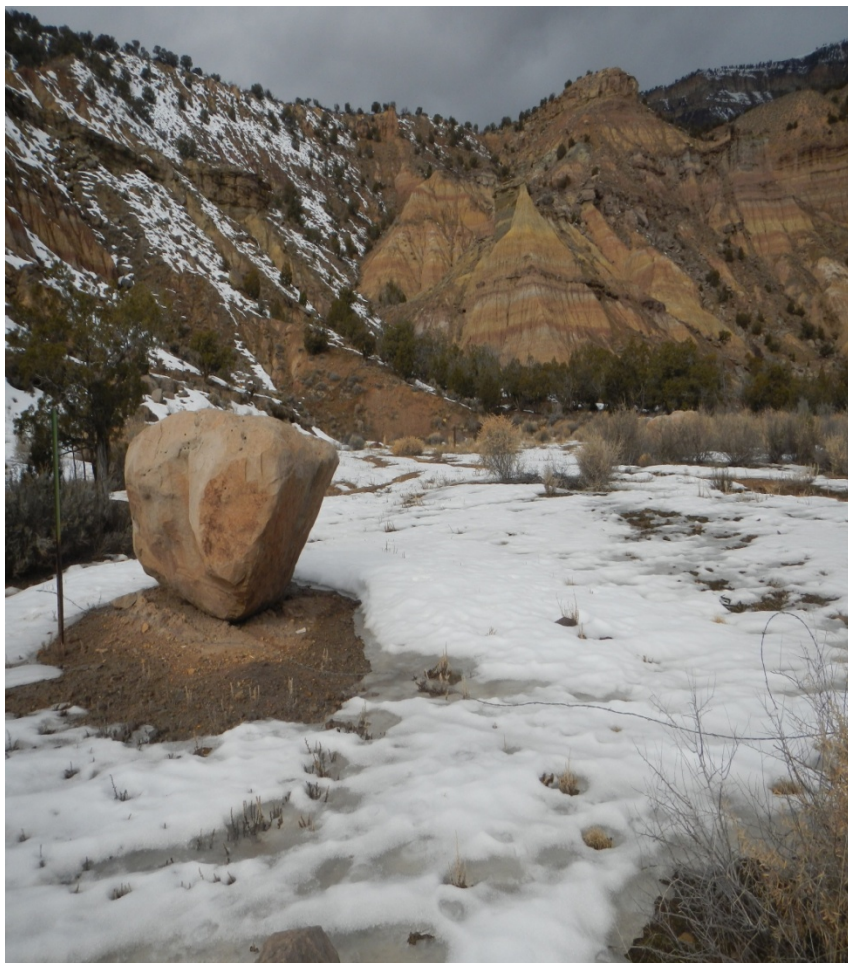
Photo#5:

Entrance to Location, downed Barbed wire fence.

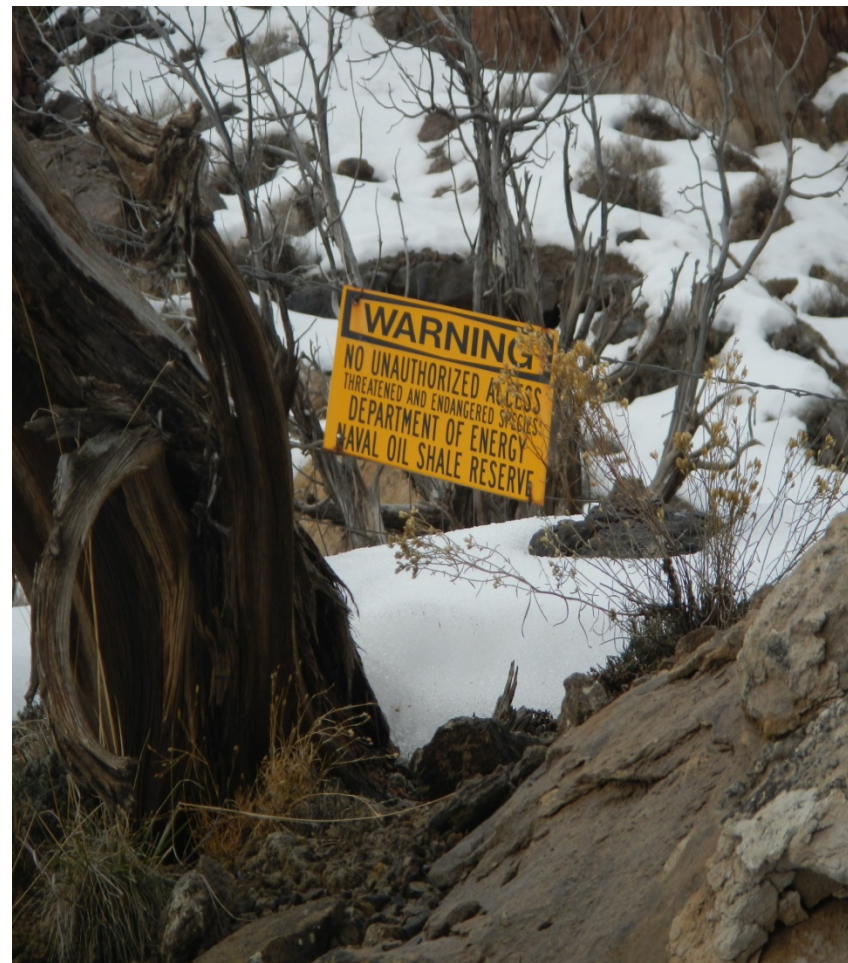
Photo#6:

Lease Location Sign.
