Construction and Stormwater Inspection

2/22/2016

Operator: Grand Mesa Operating

Location ID: 443491

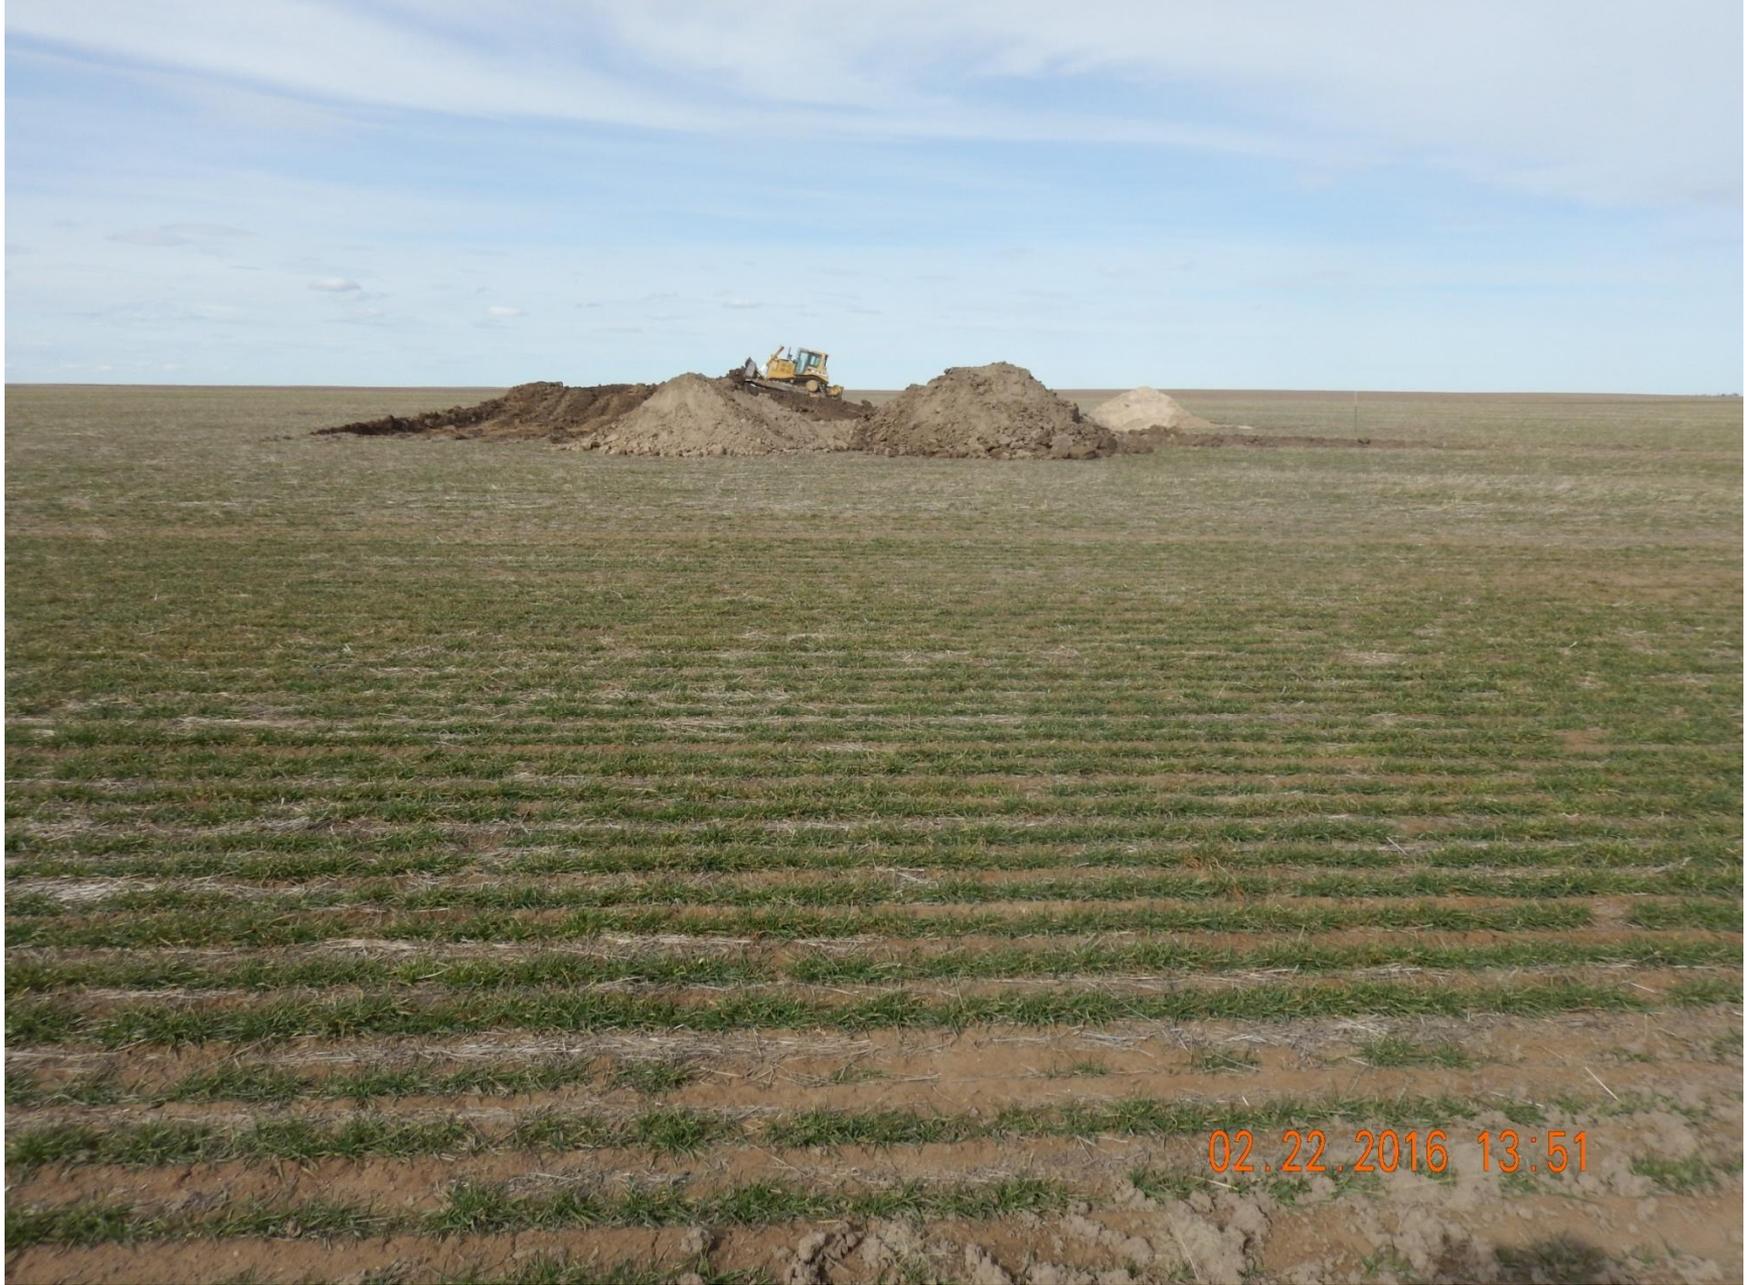
Figure 1: Photo taken from access road, south of location facing north. Photo of construction in process. Note stormwater and sediment control BMPs not in place.

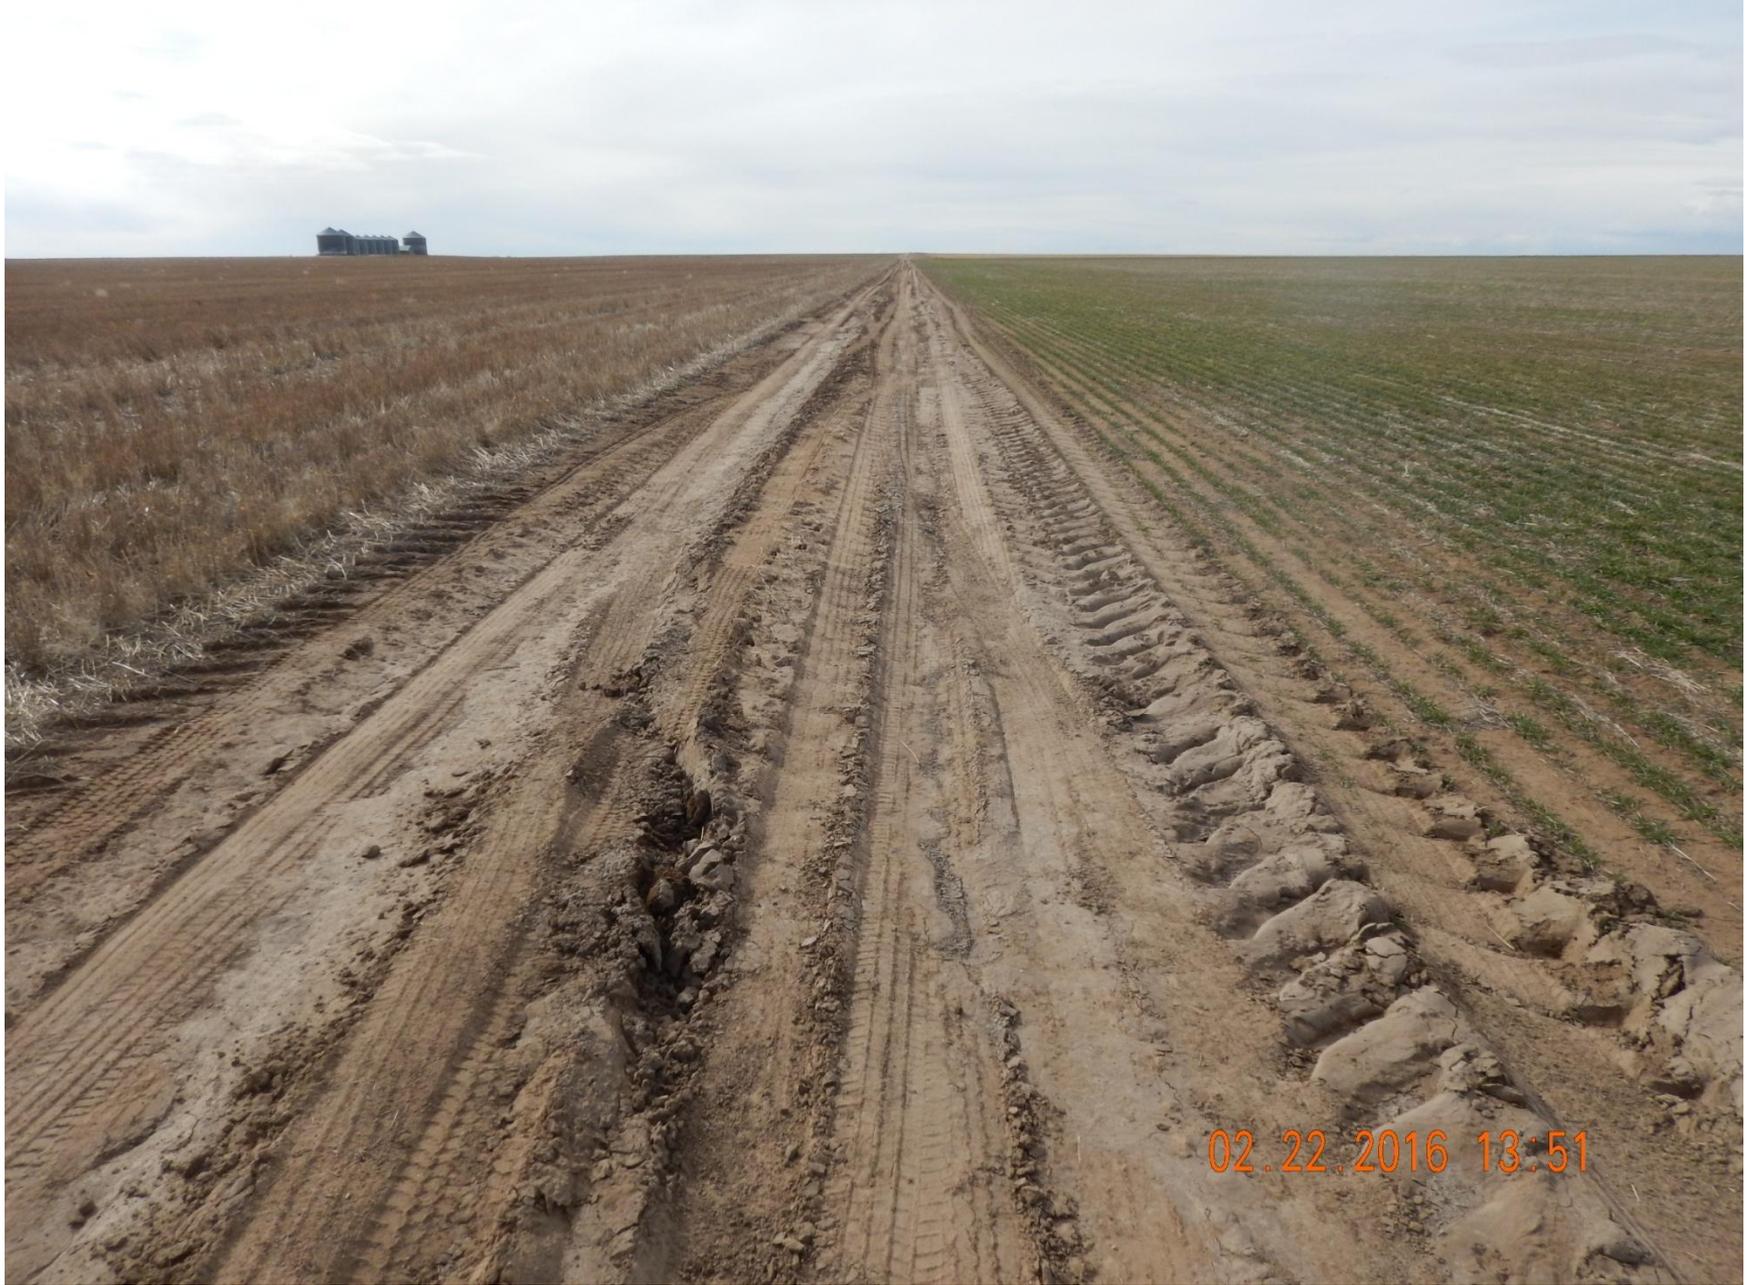
Figure 2: Photo taken from access road, south of location facing west. Photo of access road.

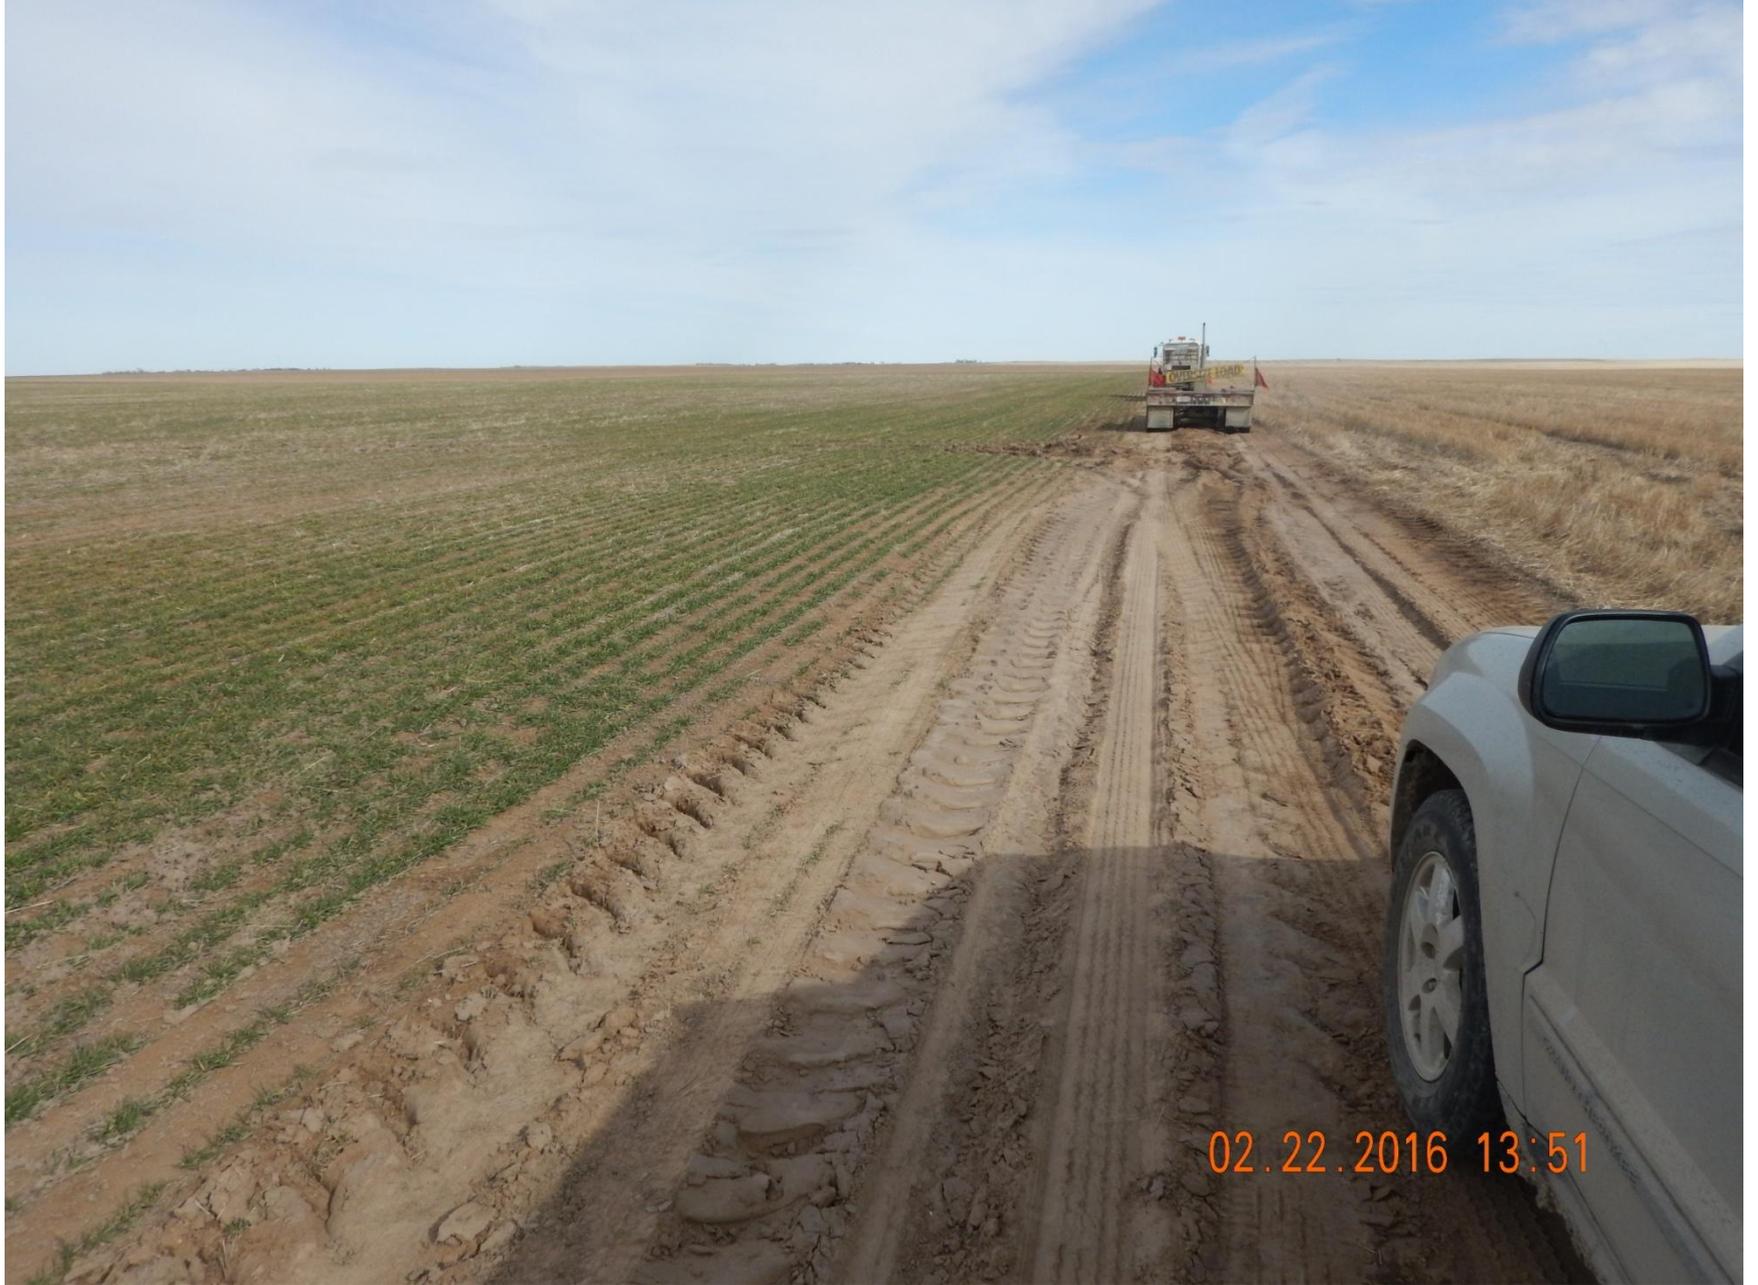
Figure 3: Photo taken from access road, south of location facing east. Photo of access road.

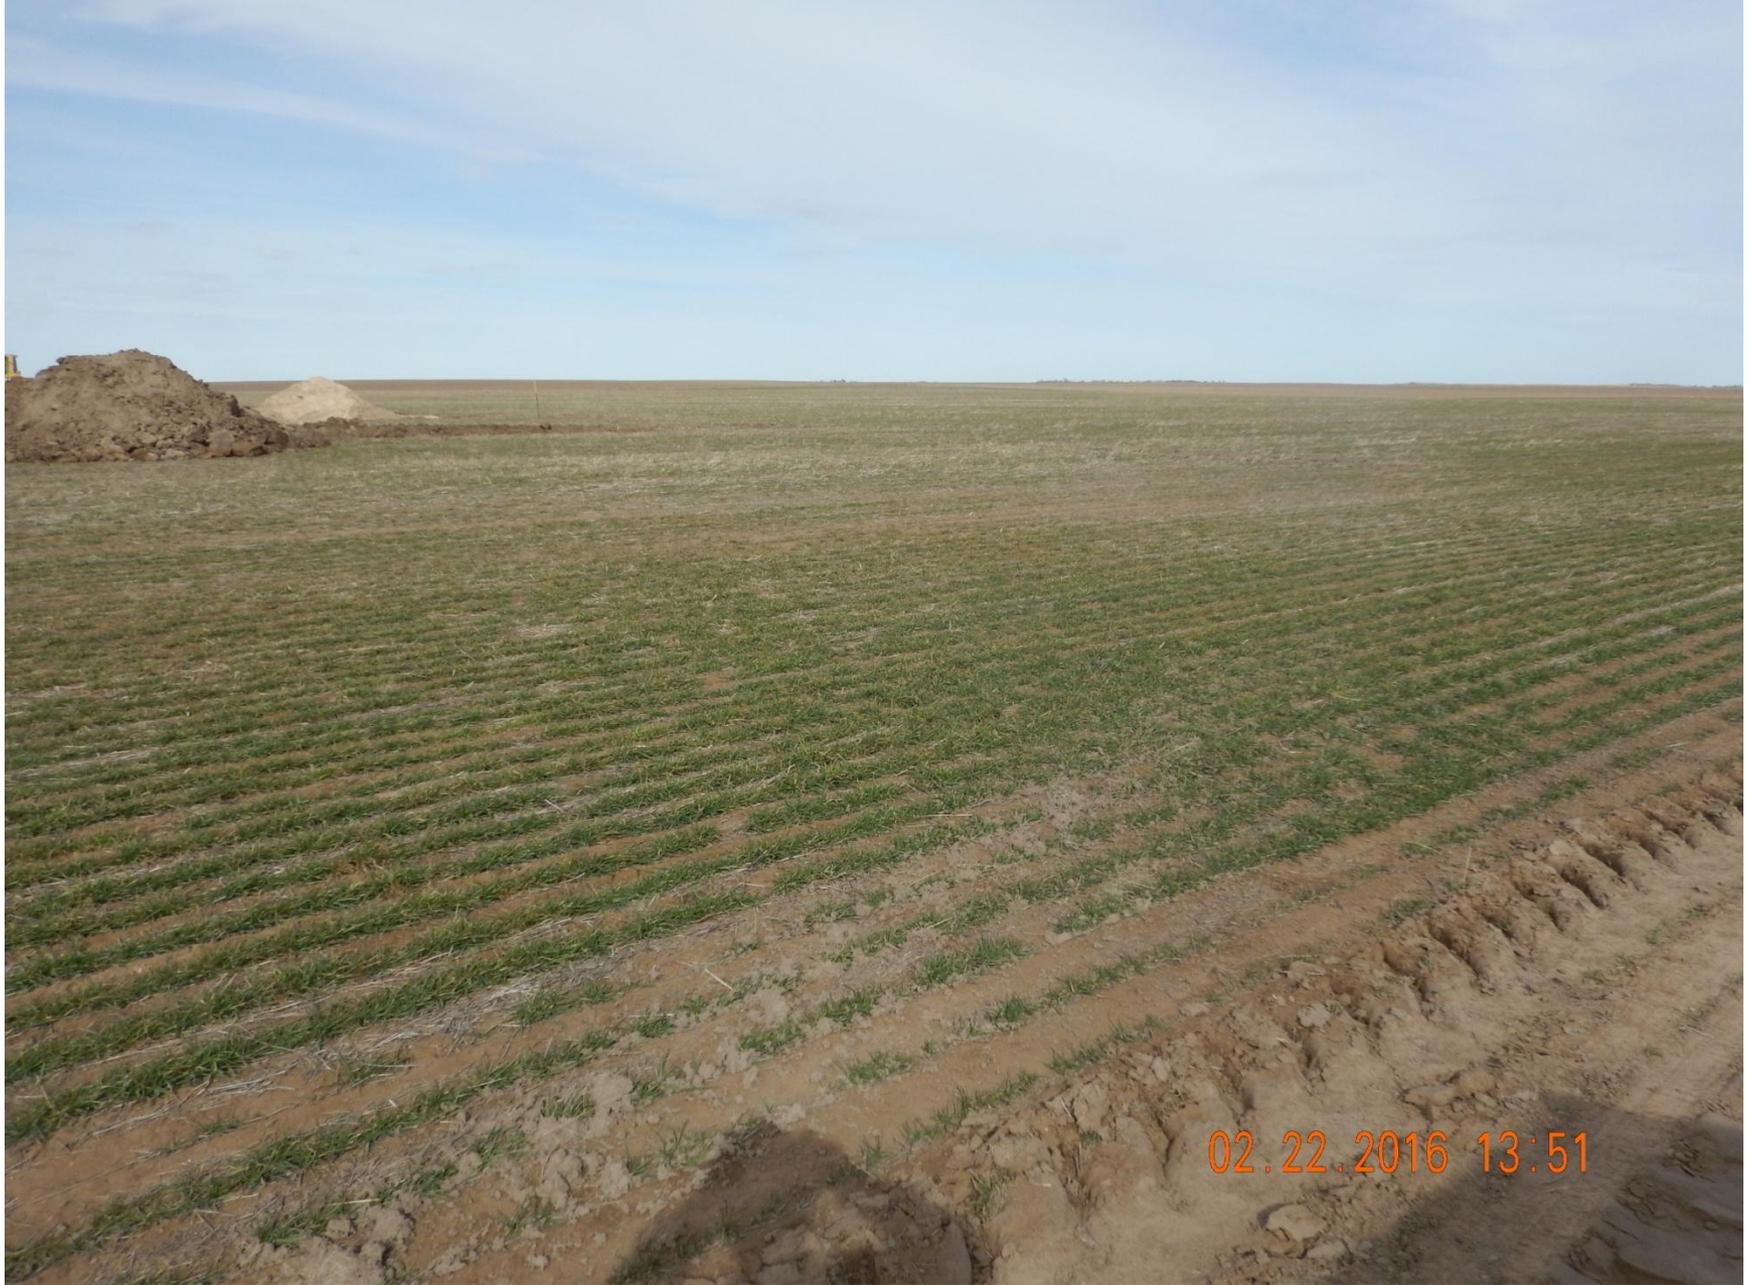
Figure 4: Photo taken from access road, south of location facing northeast. Photo of location.

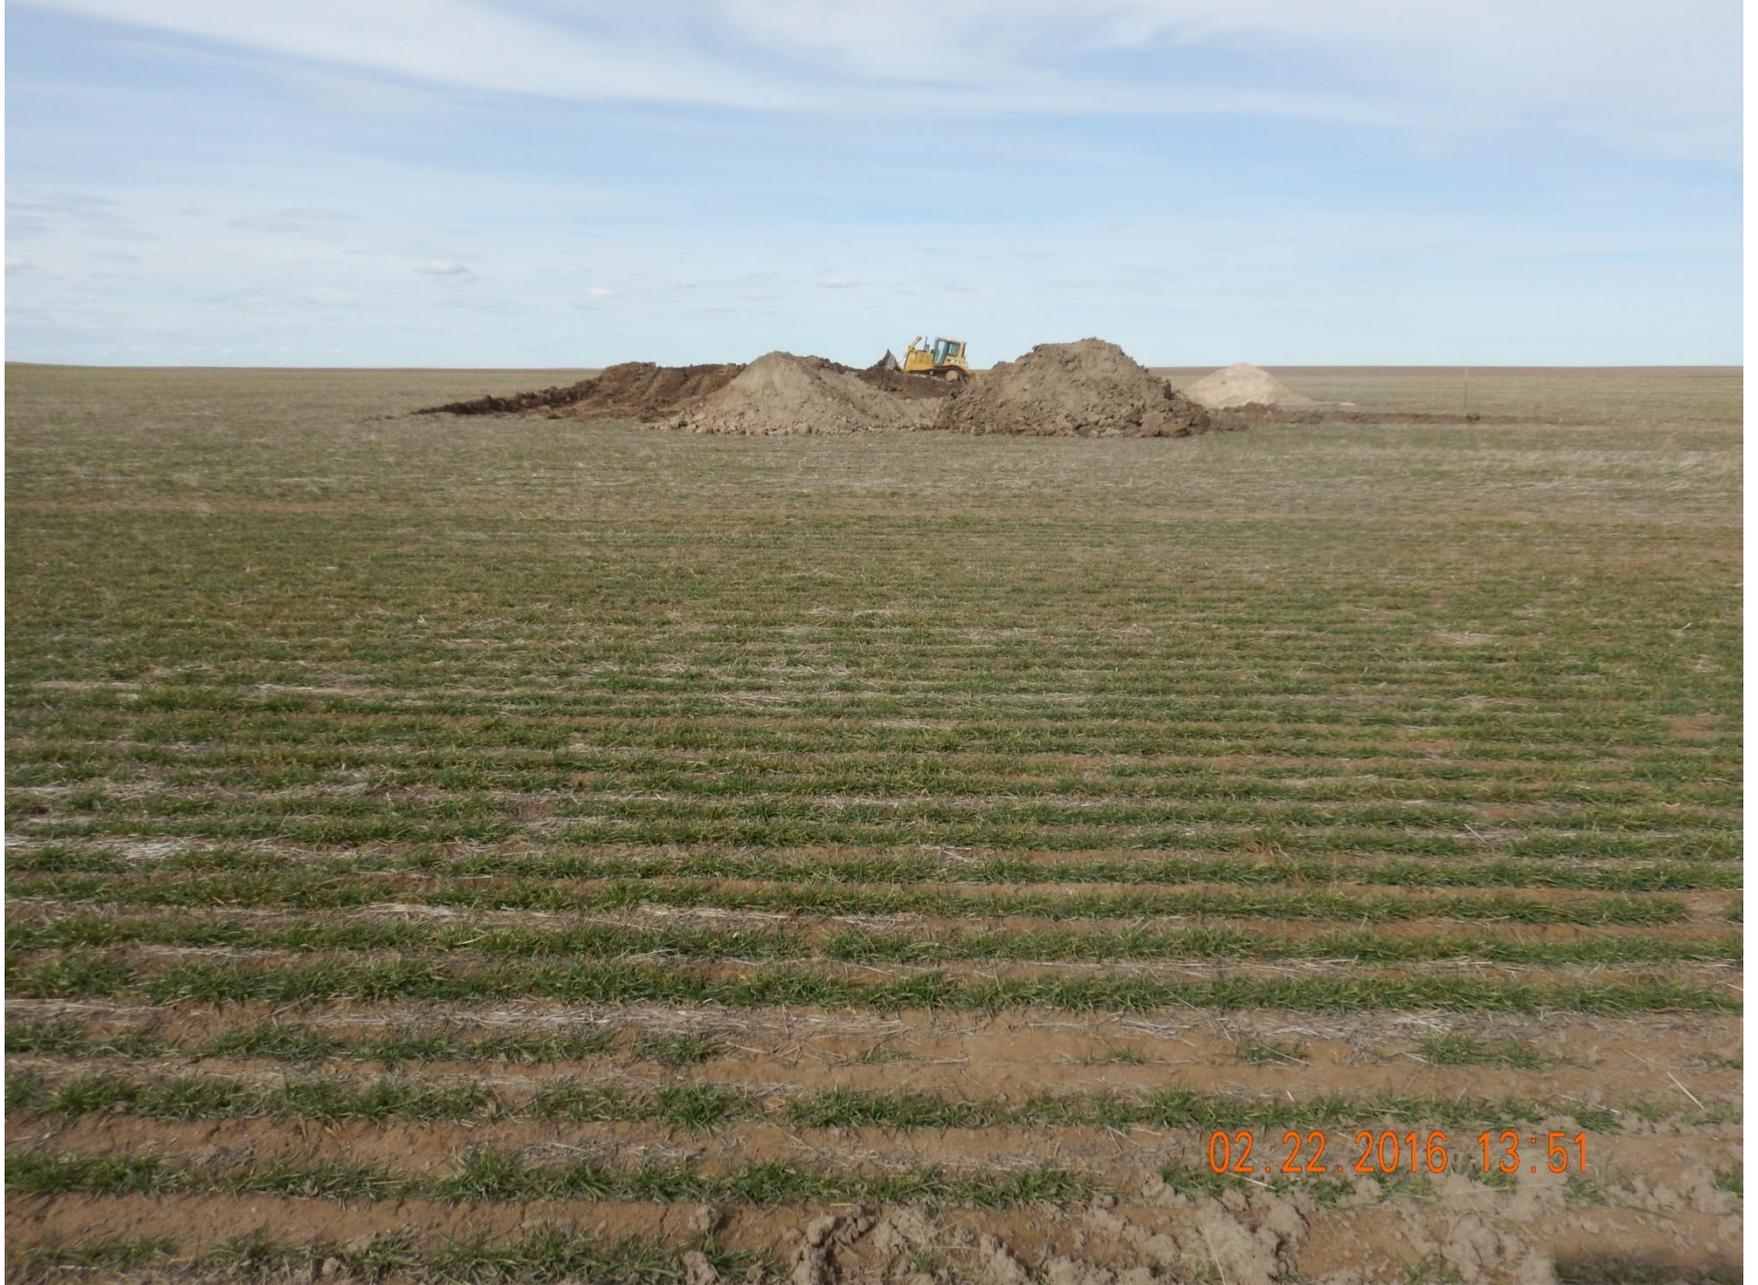
Figure 5: Photo taken from access road, south of location facing north. Photo of location.

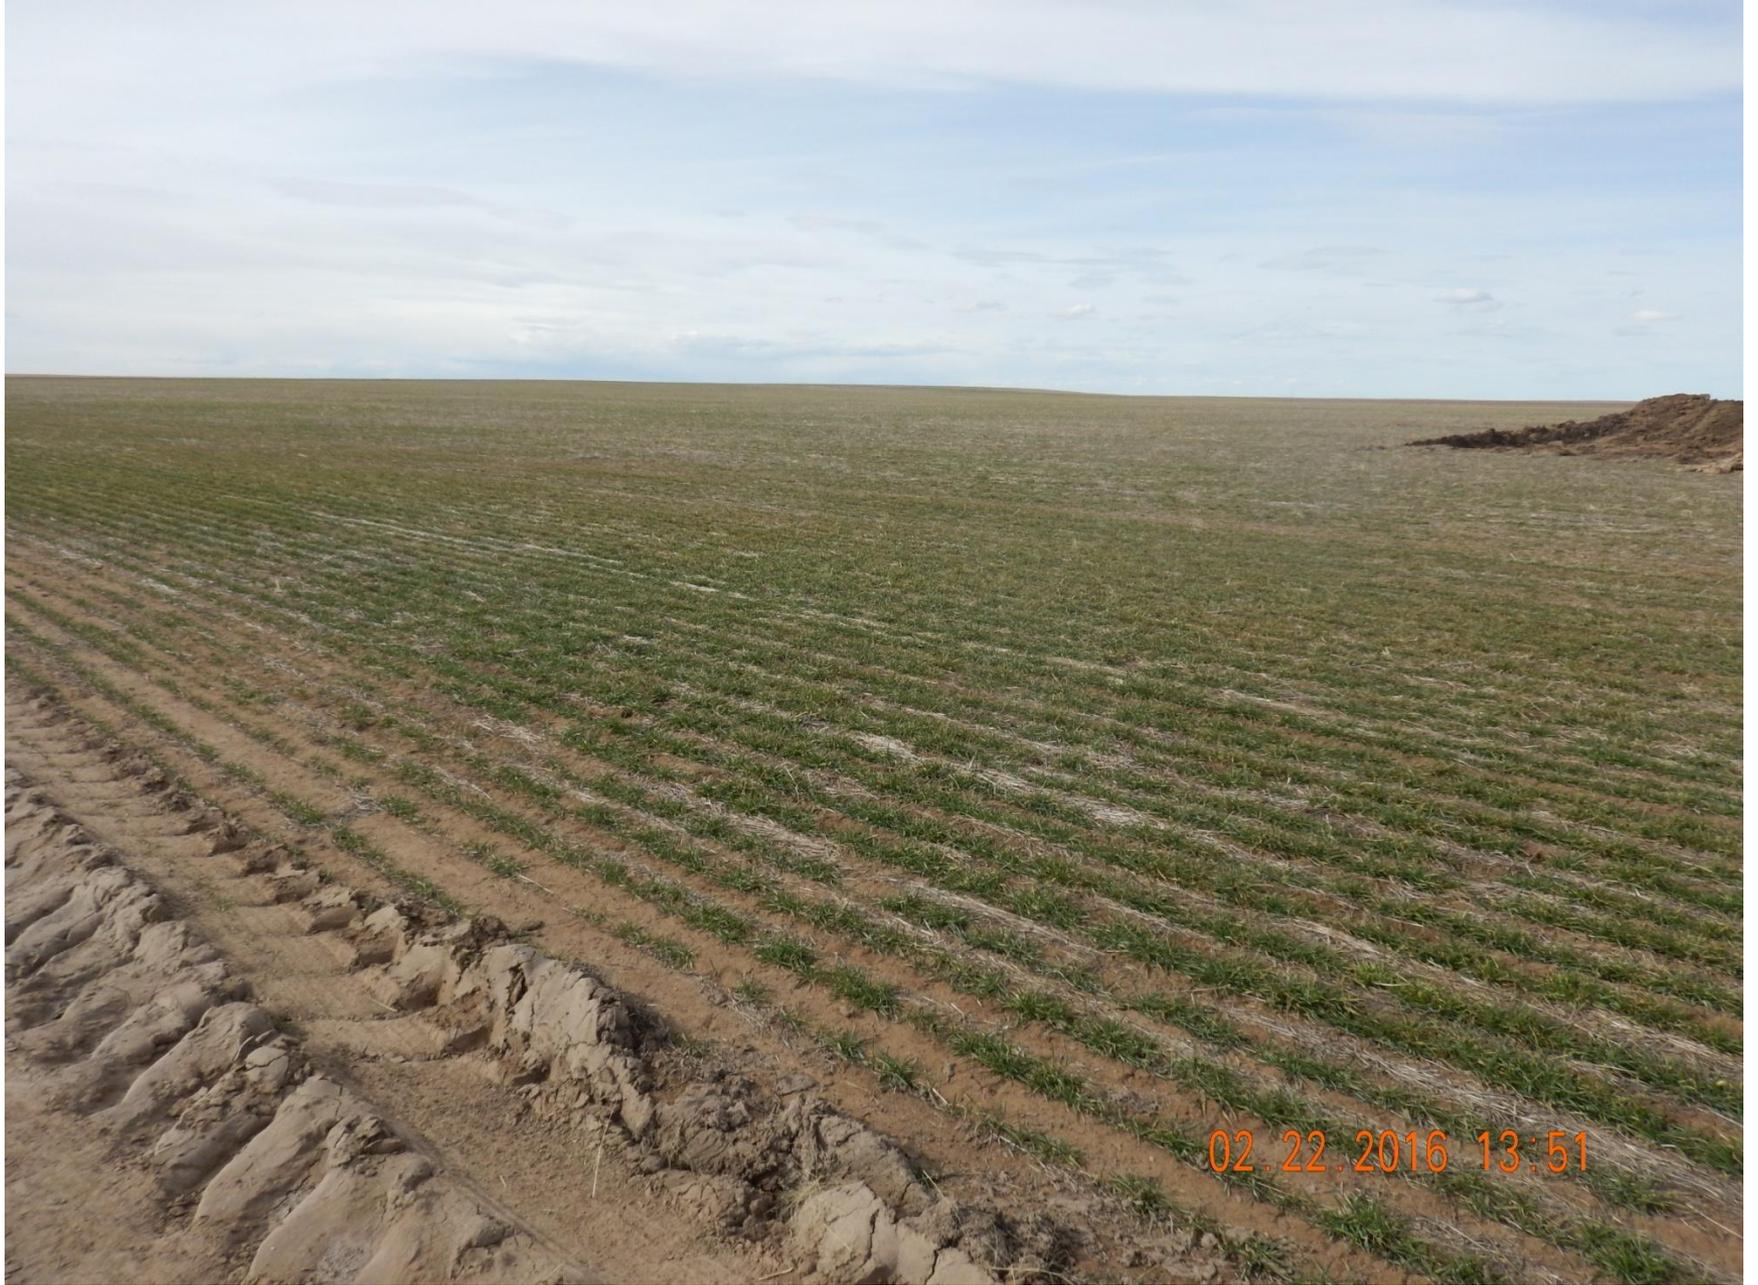
Figure 6: Photo taken from access road, south of location facing northwest. Photo of location.

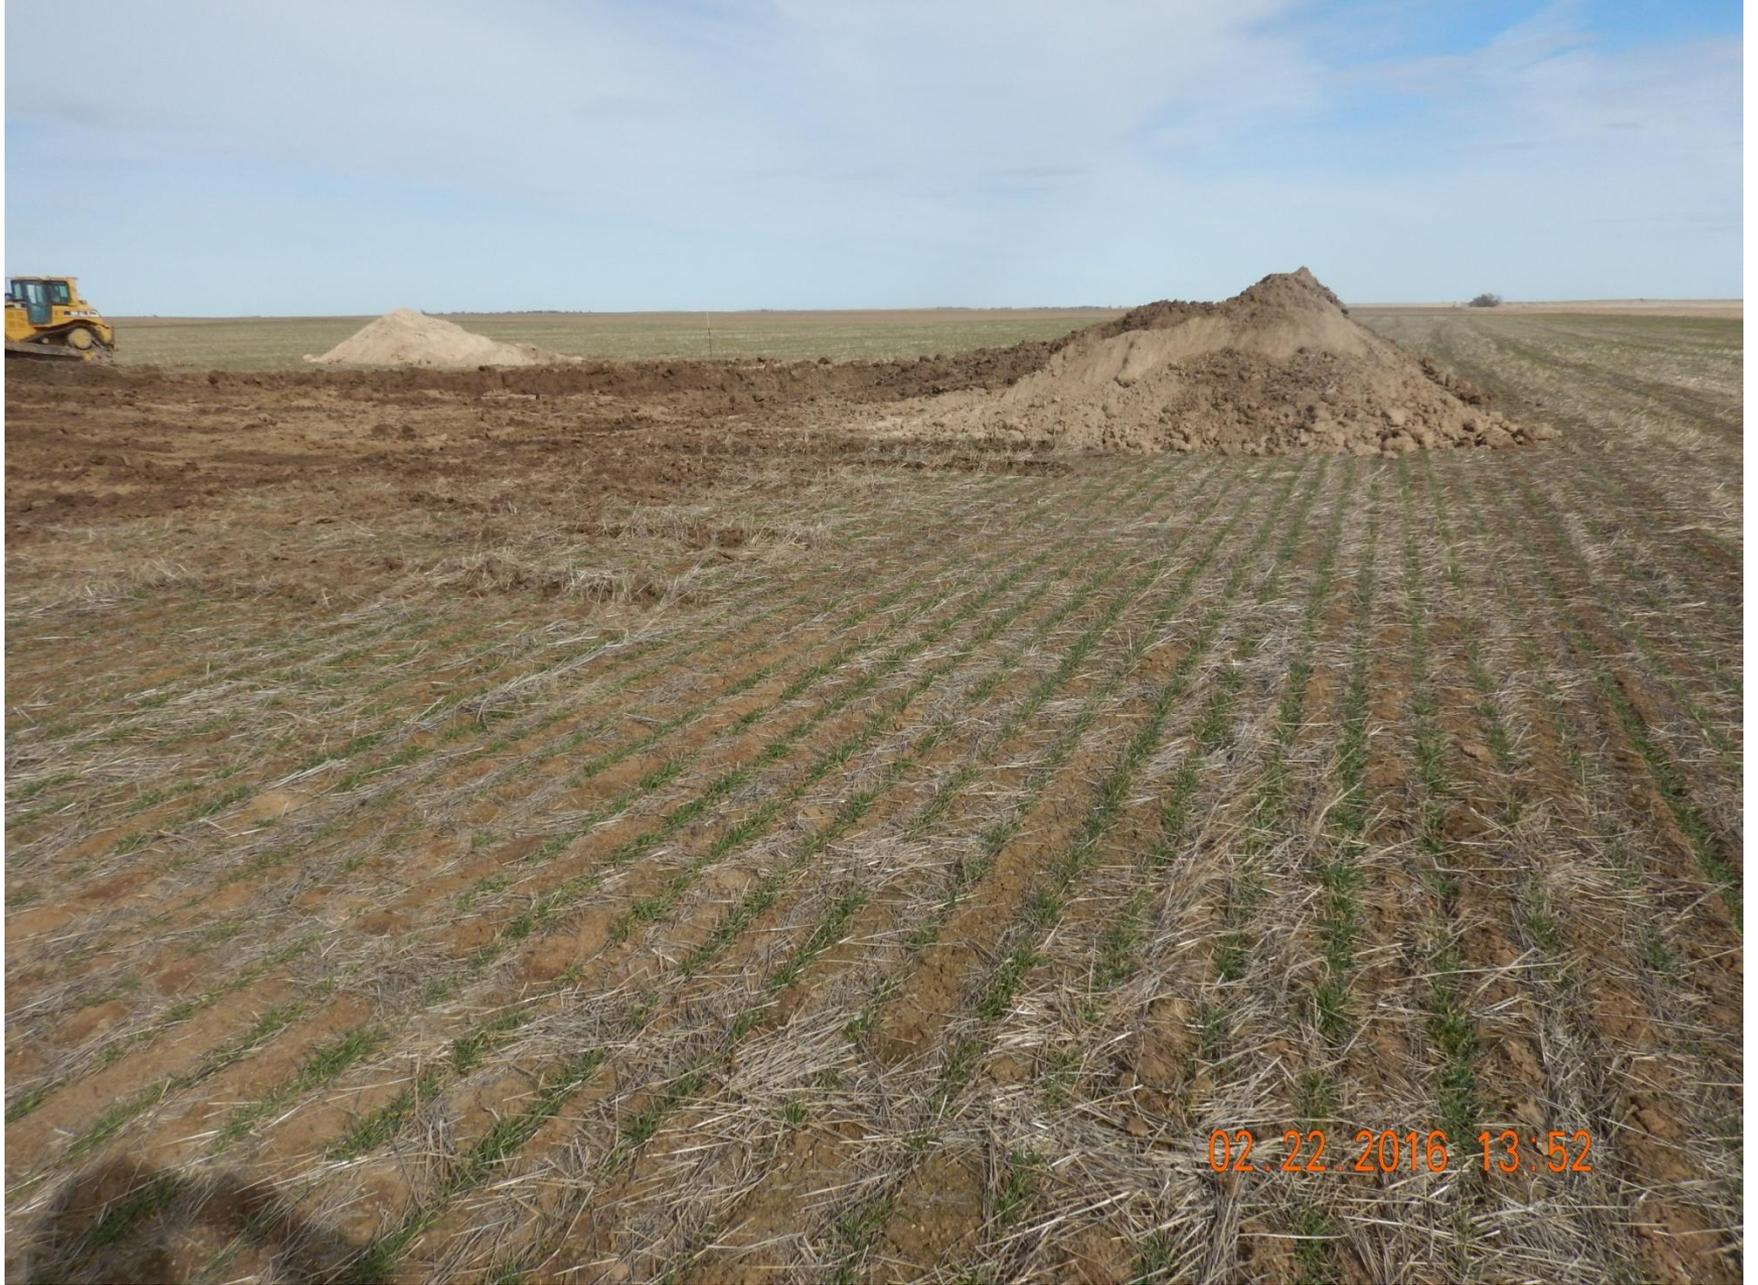
Figure 7: Photo taken from the southwest corner of location, facing east. Photo shows perimeter stormwater and sediment controls have not been installed.

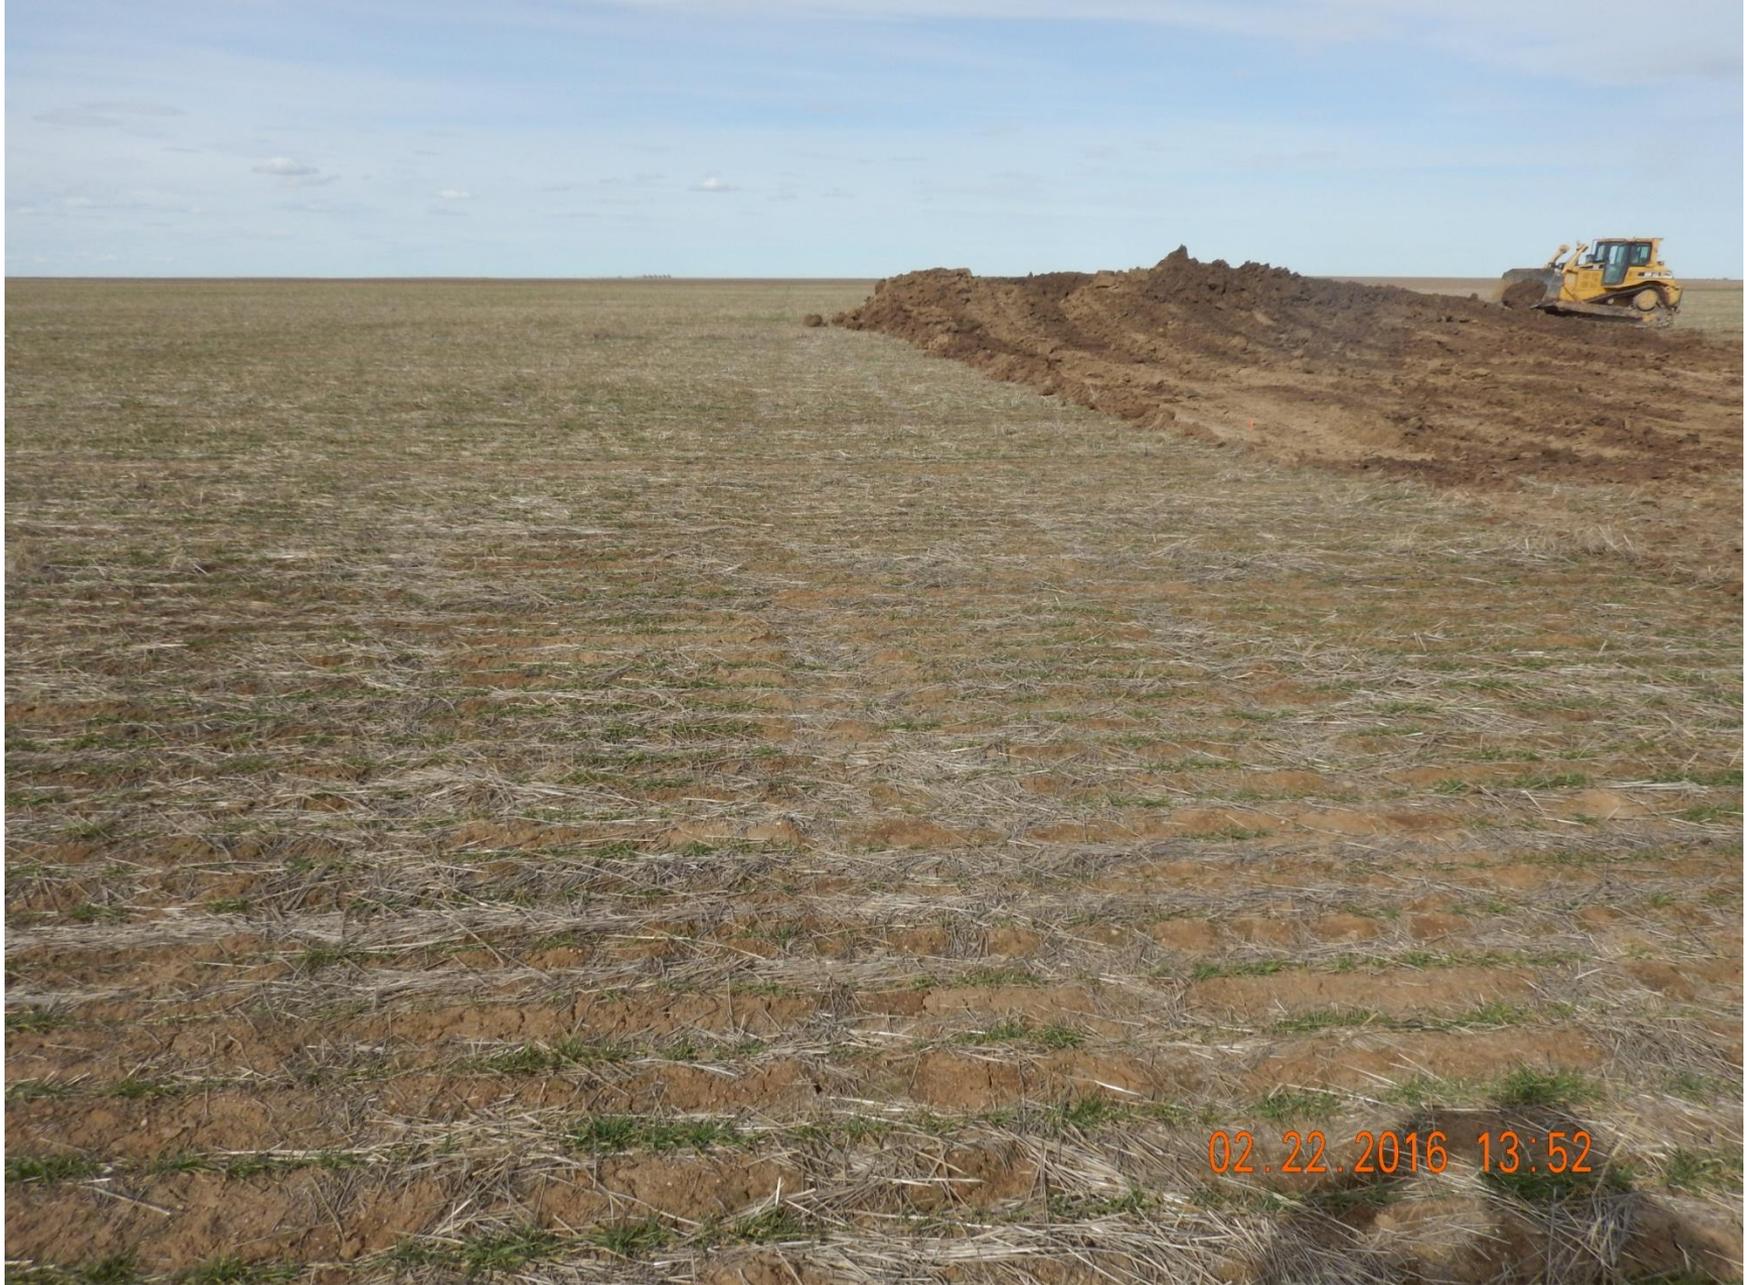
Figure 8: Photo taken from the southwest corner of location, facing north. Photo shows perimeter stormwater and sediment controls have not been installed.

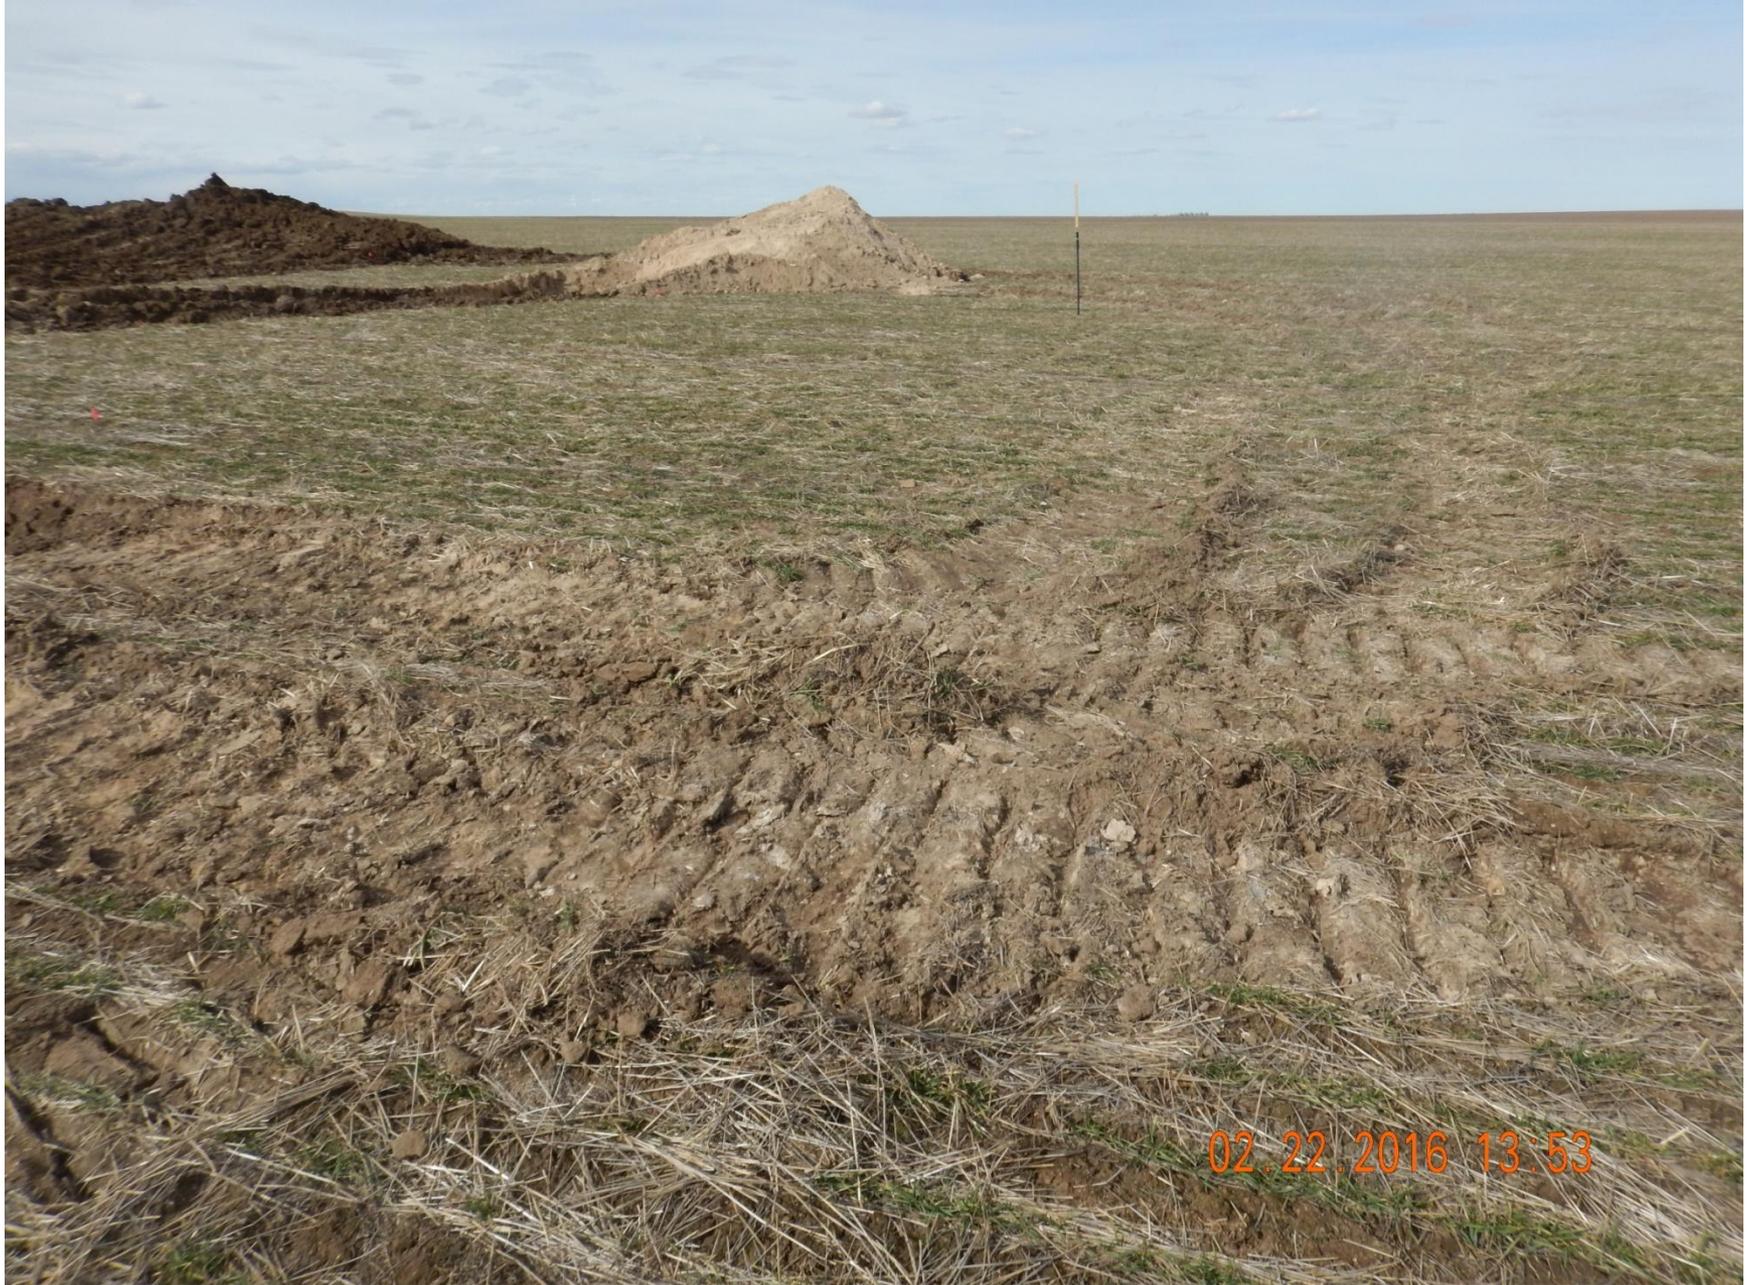
Figure 9: Photo taken from the southeast corner of location, facing north. Photo shows perimeter stormwater and sediment controls have not been installed.

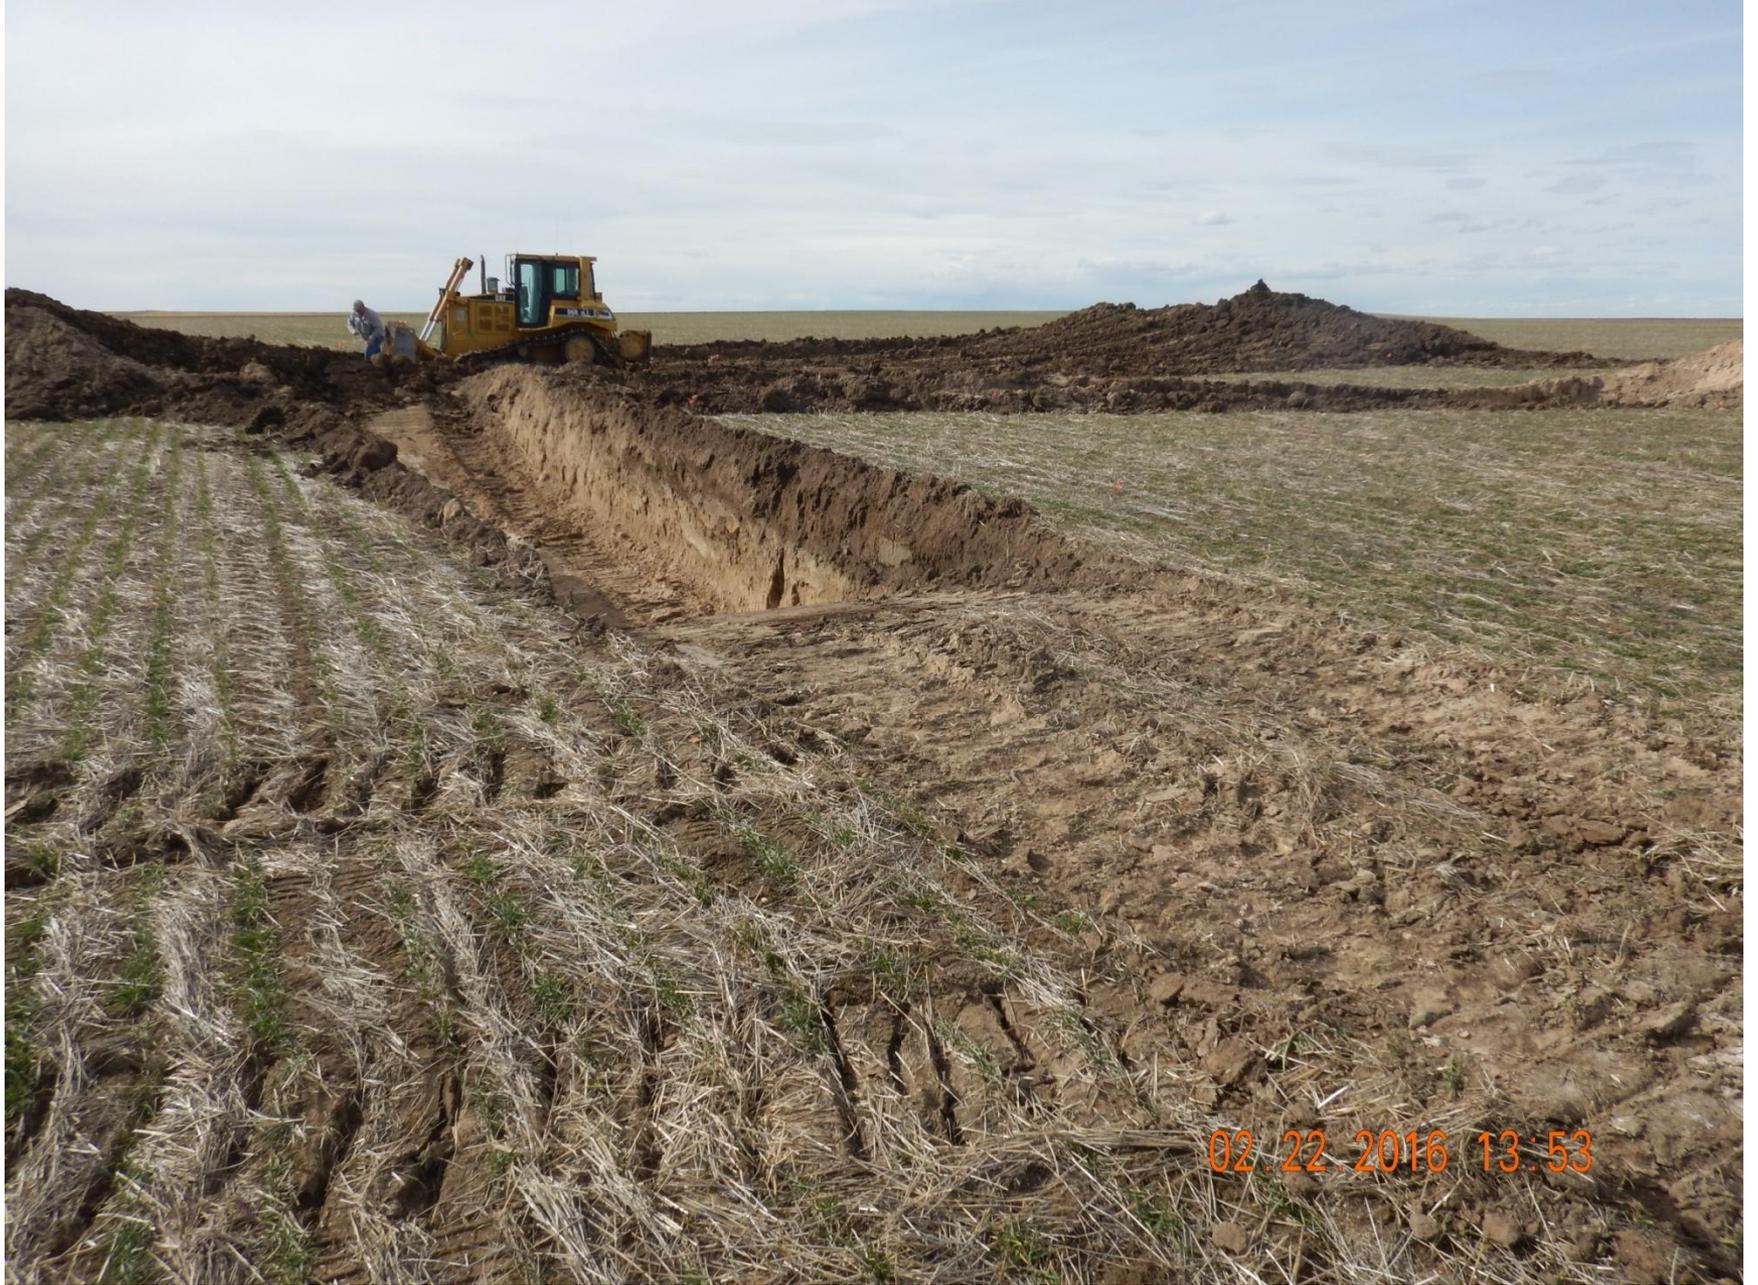
Figure 10: Photo taken from the southeast corner of location, facing west. Photo shows perimeter stormwater and sediment controls have not been installed.
