Construction and Stormwater Inspection

2/22/2016

Operator: Grand Mesa Operating

Location ID: 443491

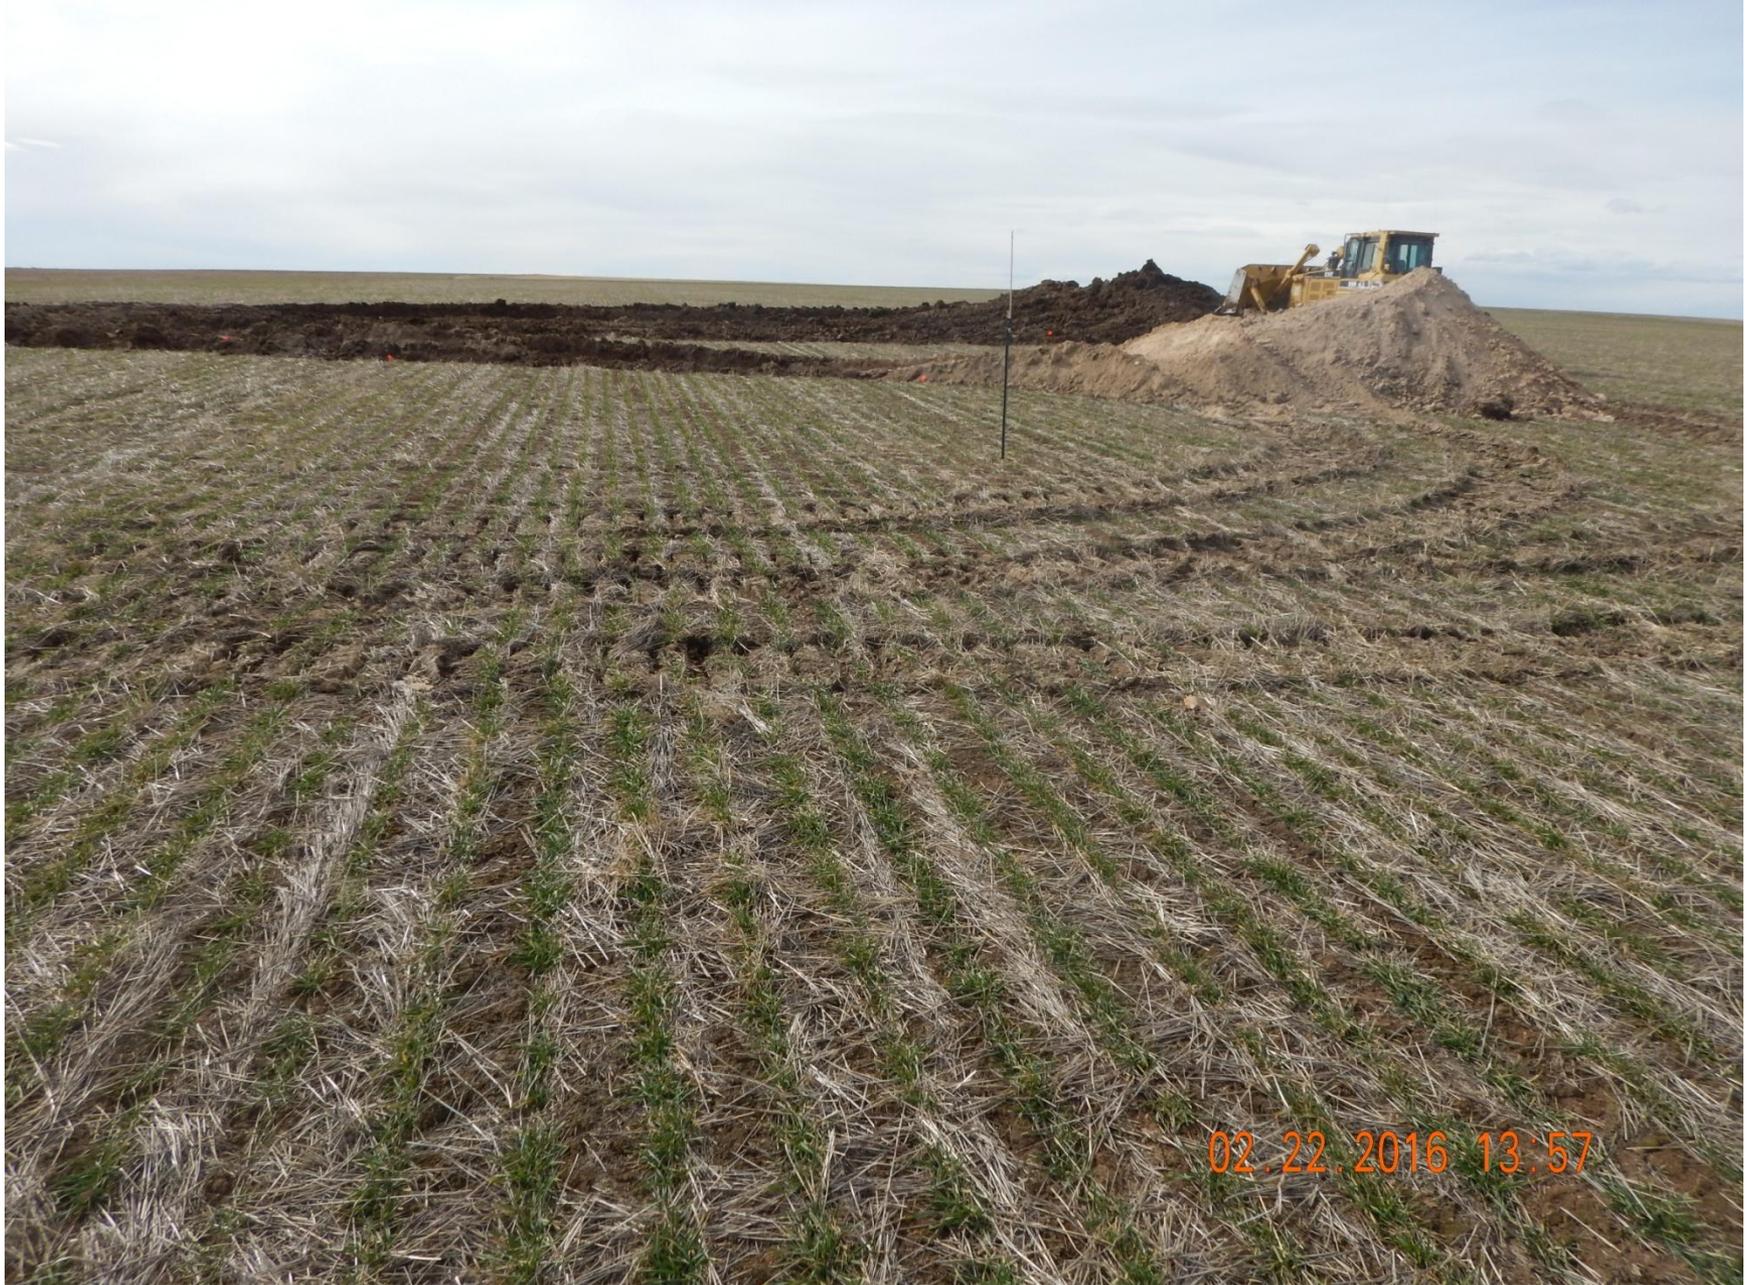
Figure 11: Photo taken from the east end of location, facing west. Photo shows perimeter stormwater and sediment controls have not been installed.

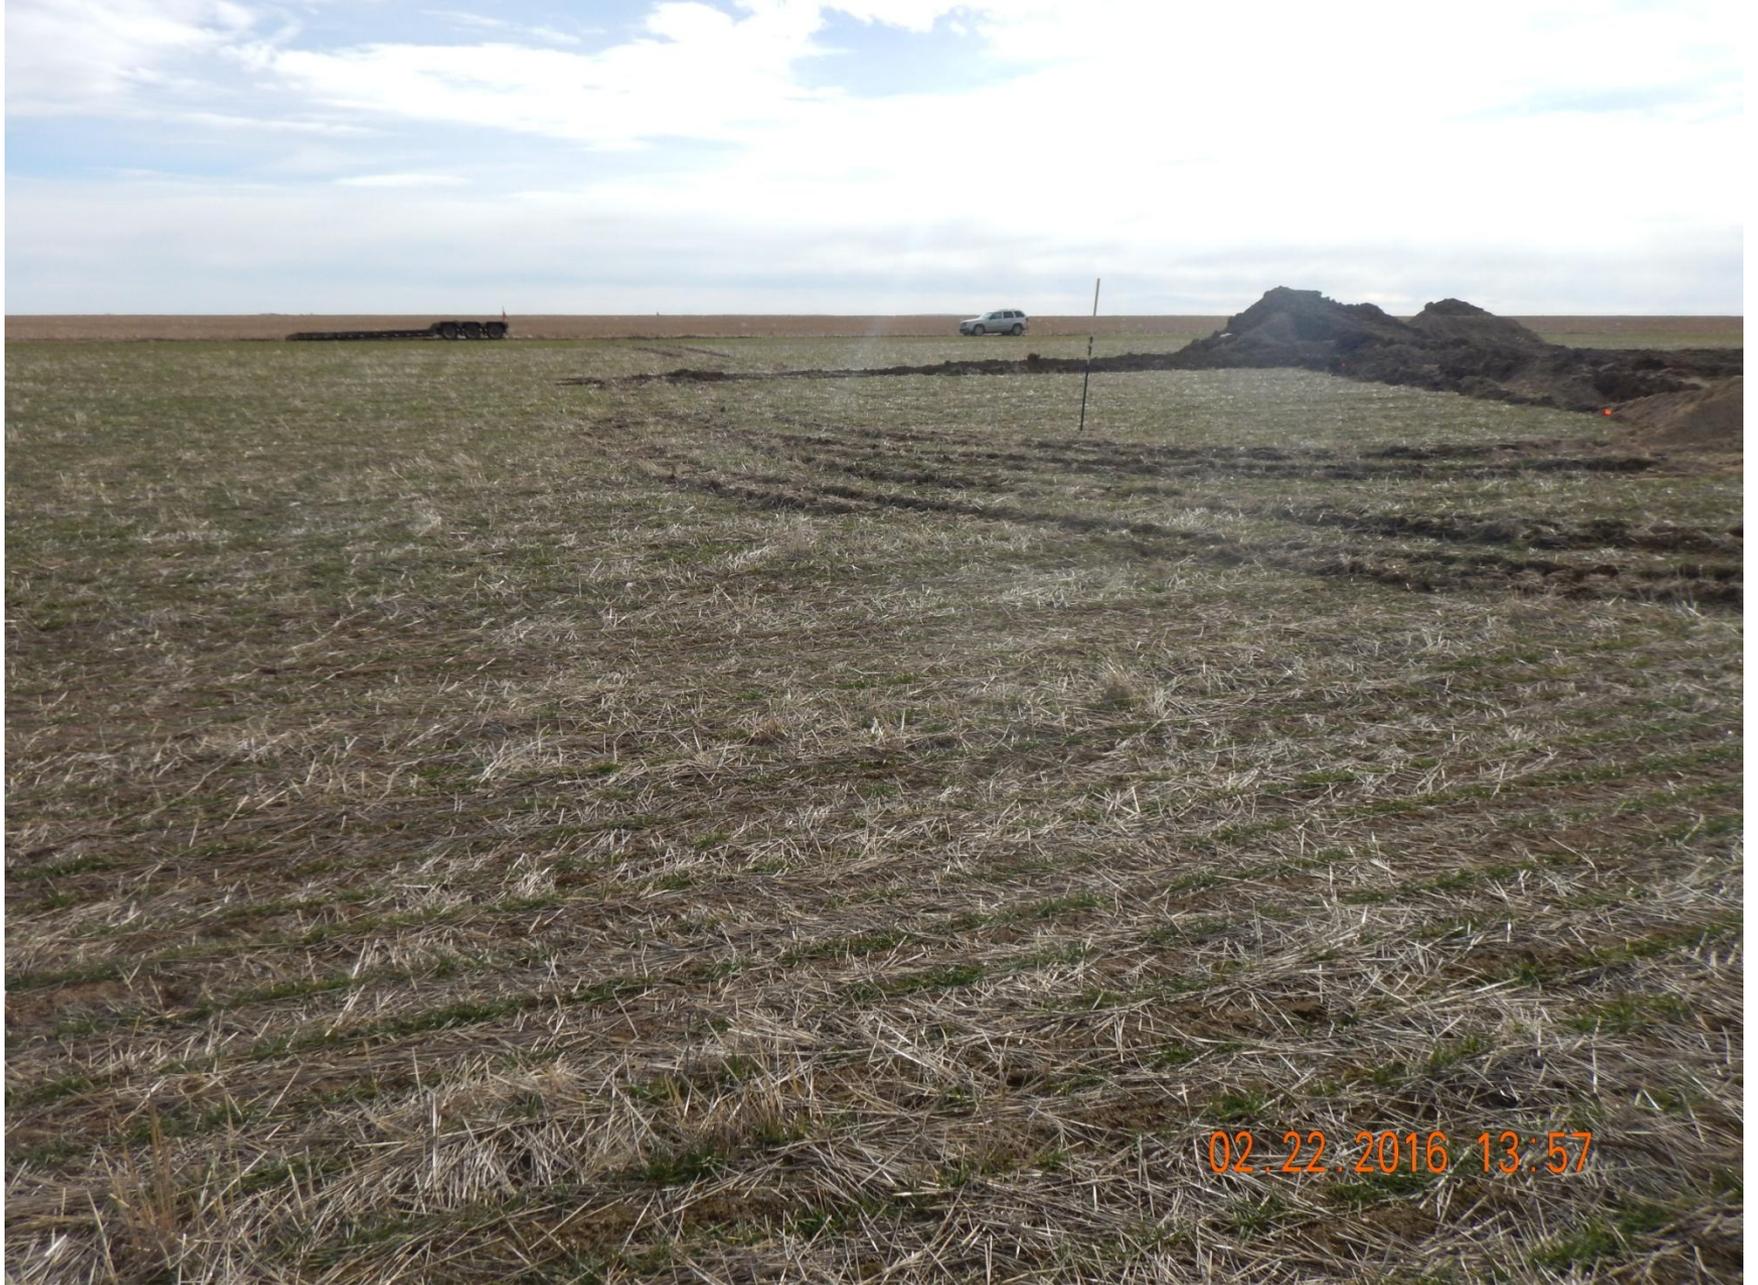
Figure 12: Photo taken from the northeast corner of location, facing south. Photo shows perimeter stormwater and sediment controls have not been installed.

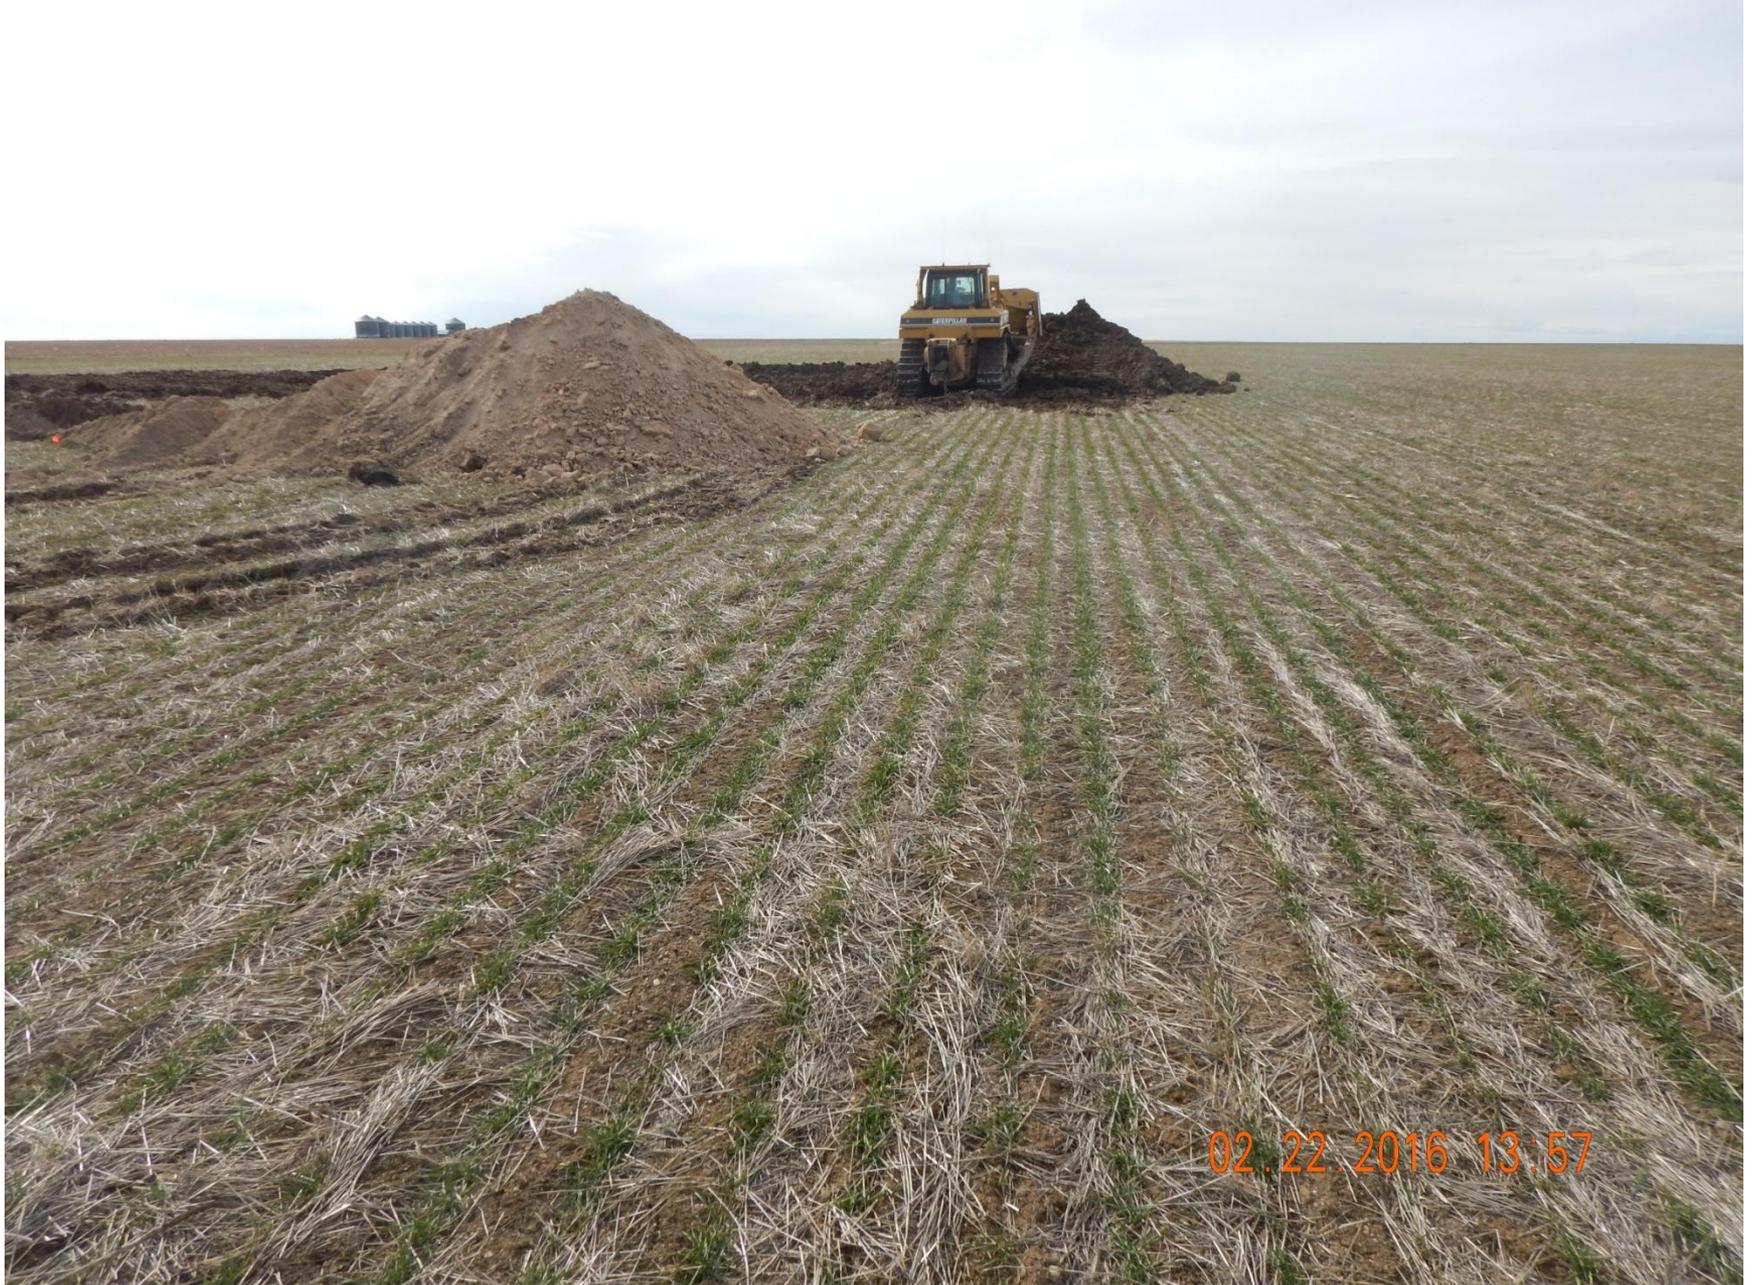
Figure 13: Photo taken from the northeast corner of location, facing west. Photo shows perimeter stormwater and sediment controls have not been installed.

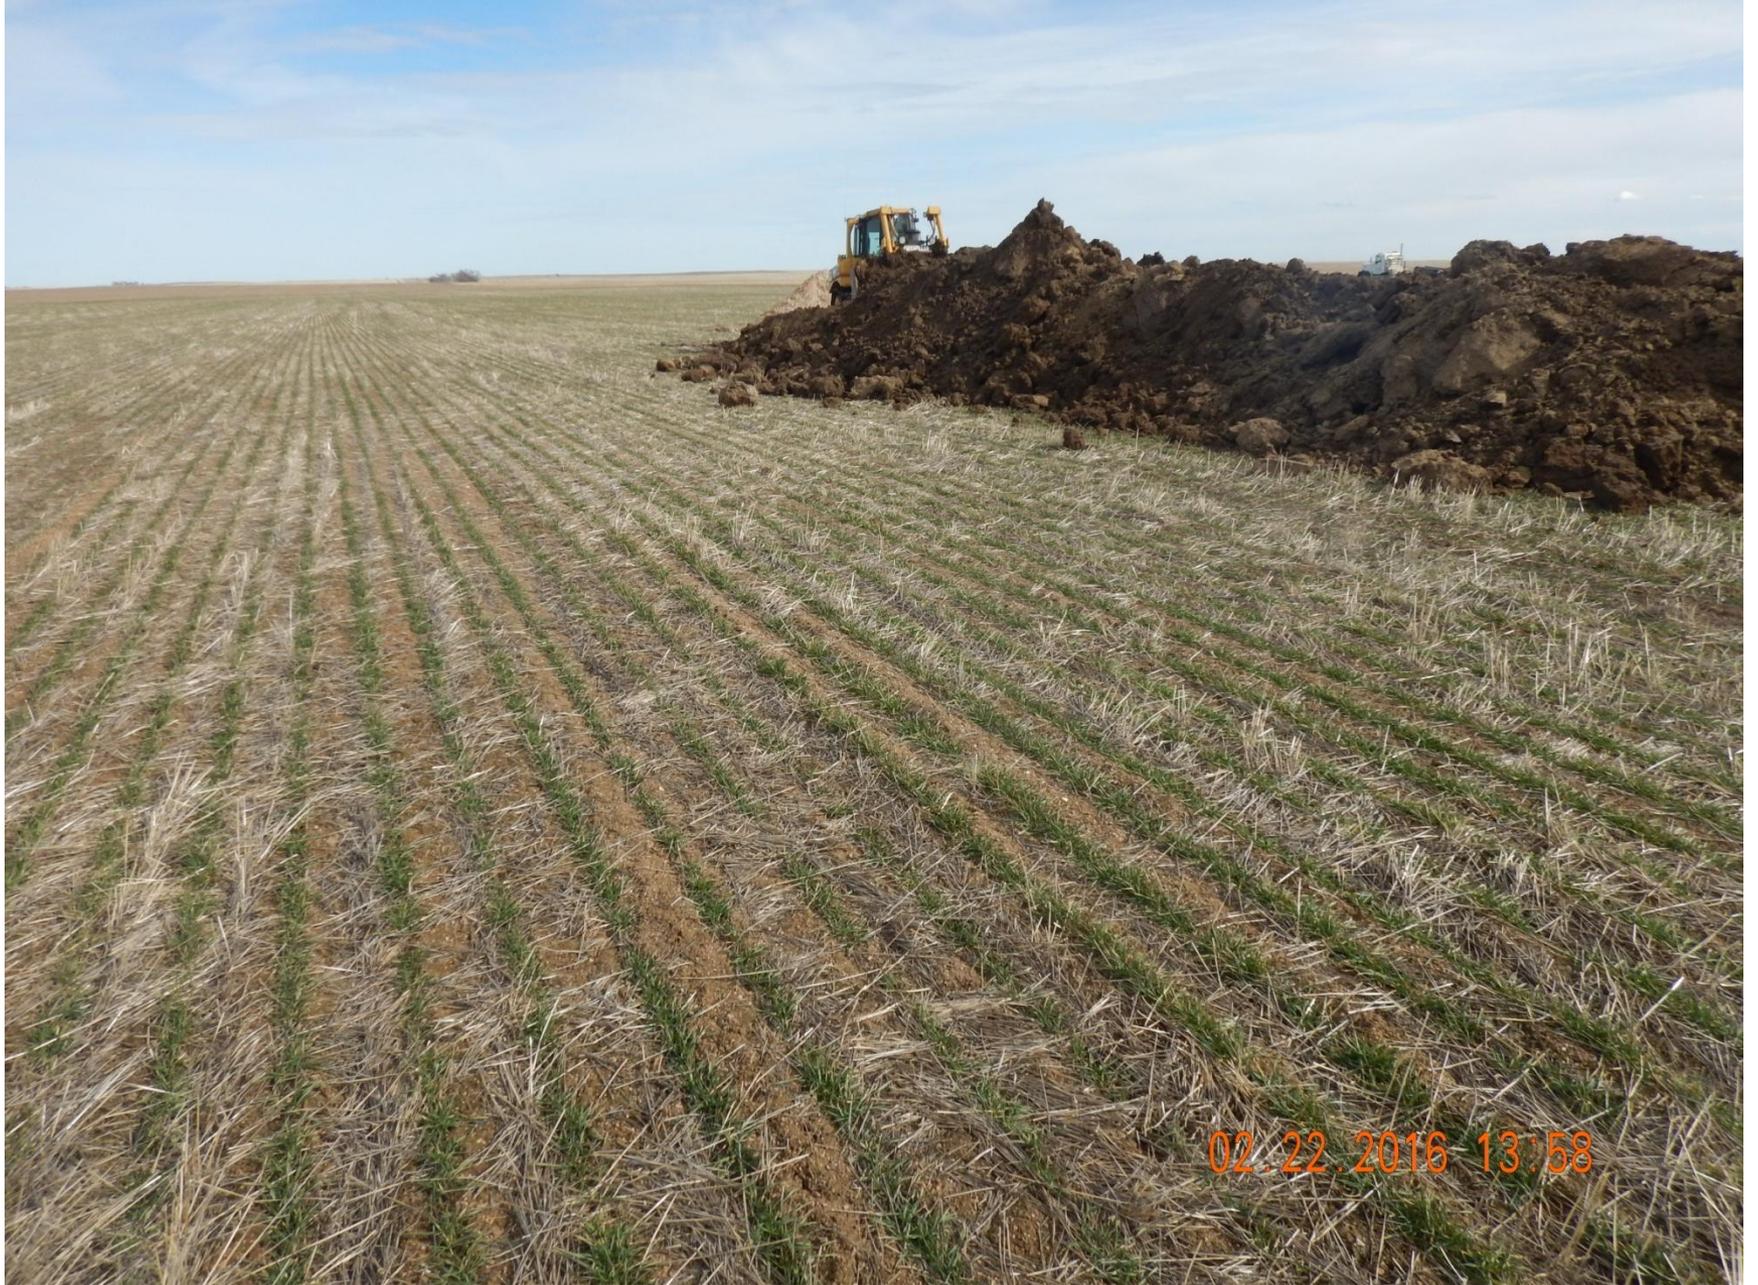
Figure 14: Photo taken from the northwest corner of location, facing east. Photo shows perimeter stormwater and sediment controls have not been installed.

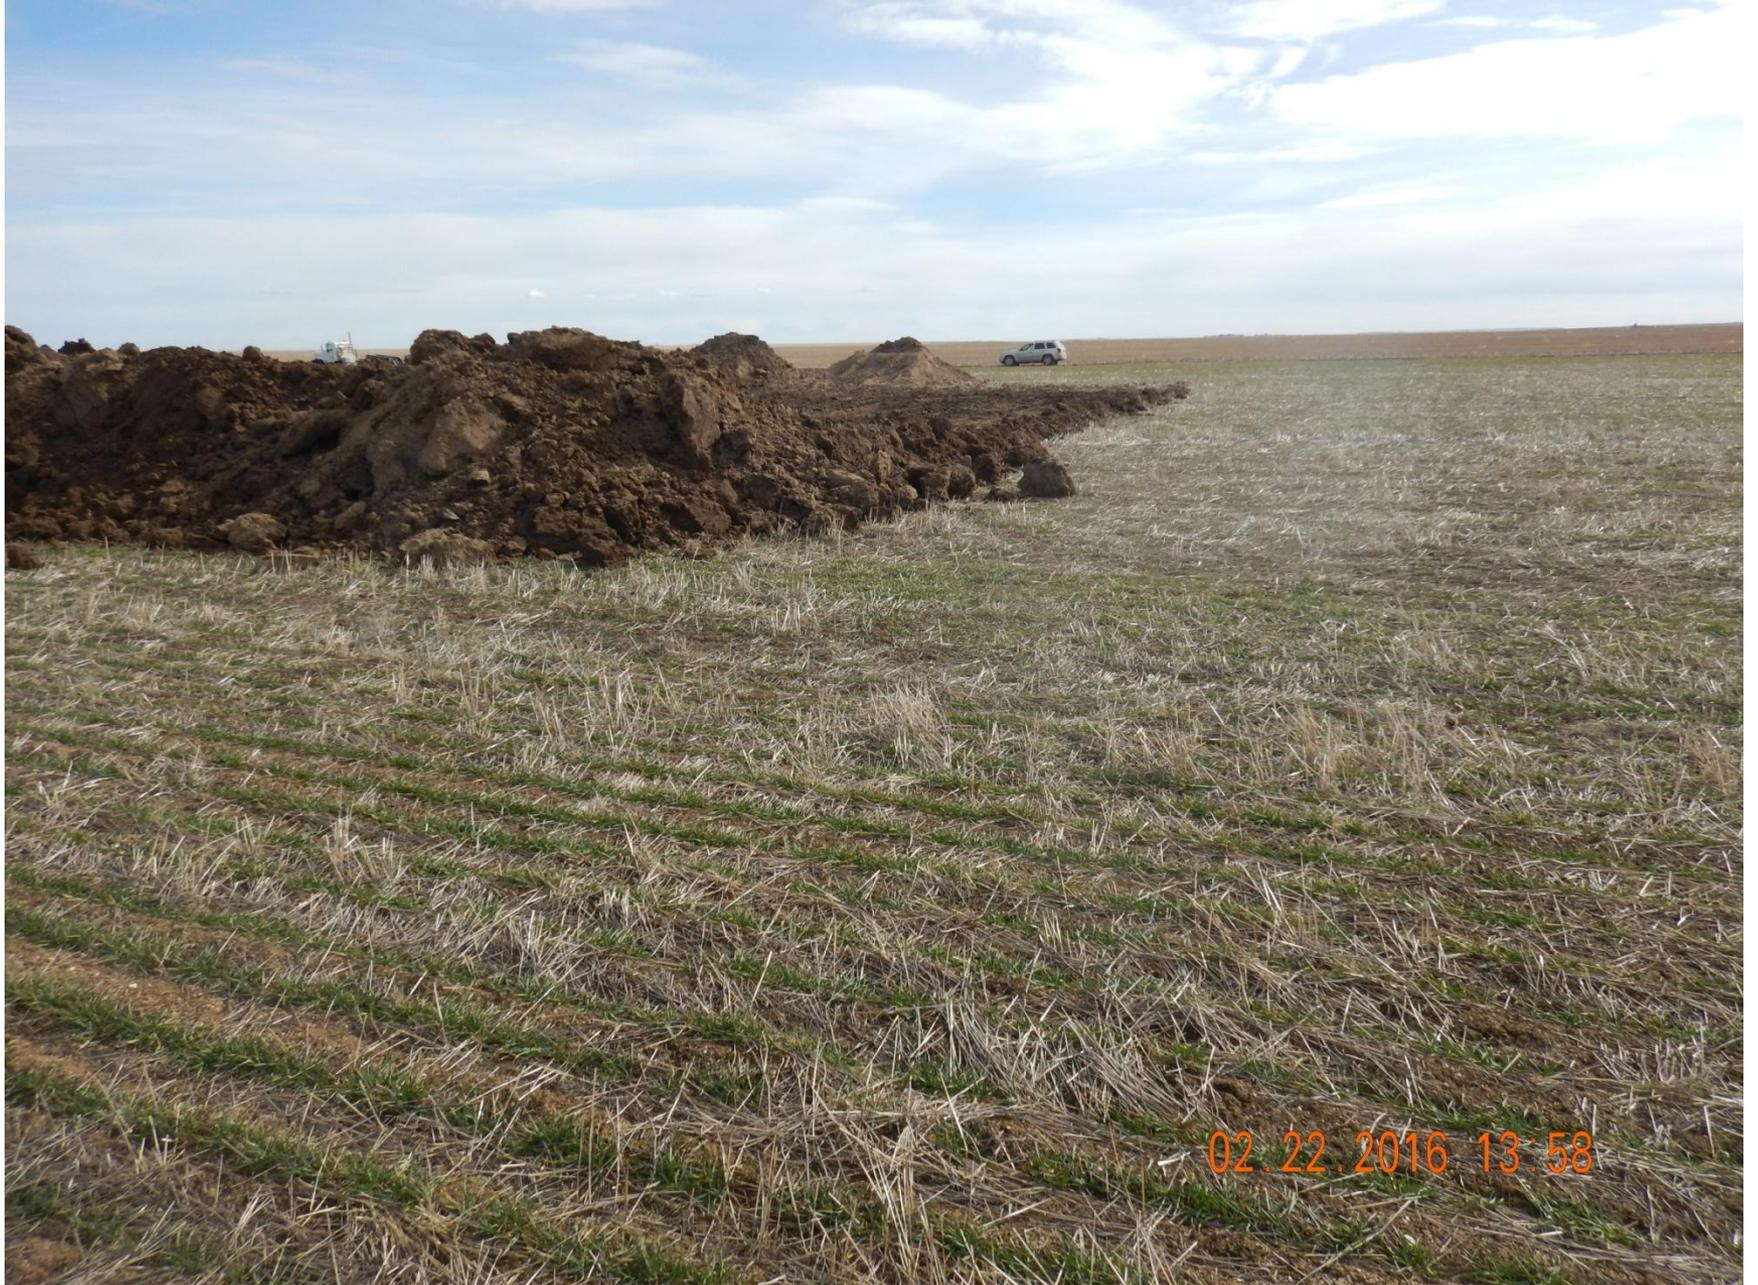
Figure 15: Photo taken from the northwest corner of location, facing south. Photo shows perimeter stormwater and sediment controls have not been installed.

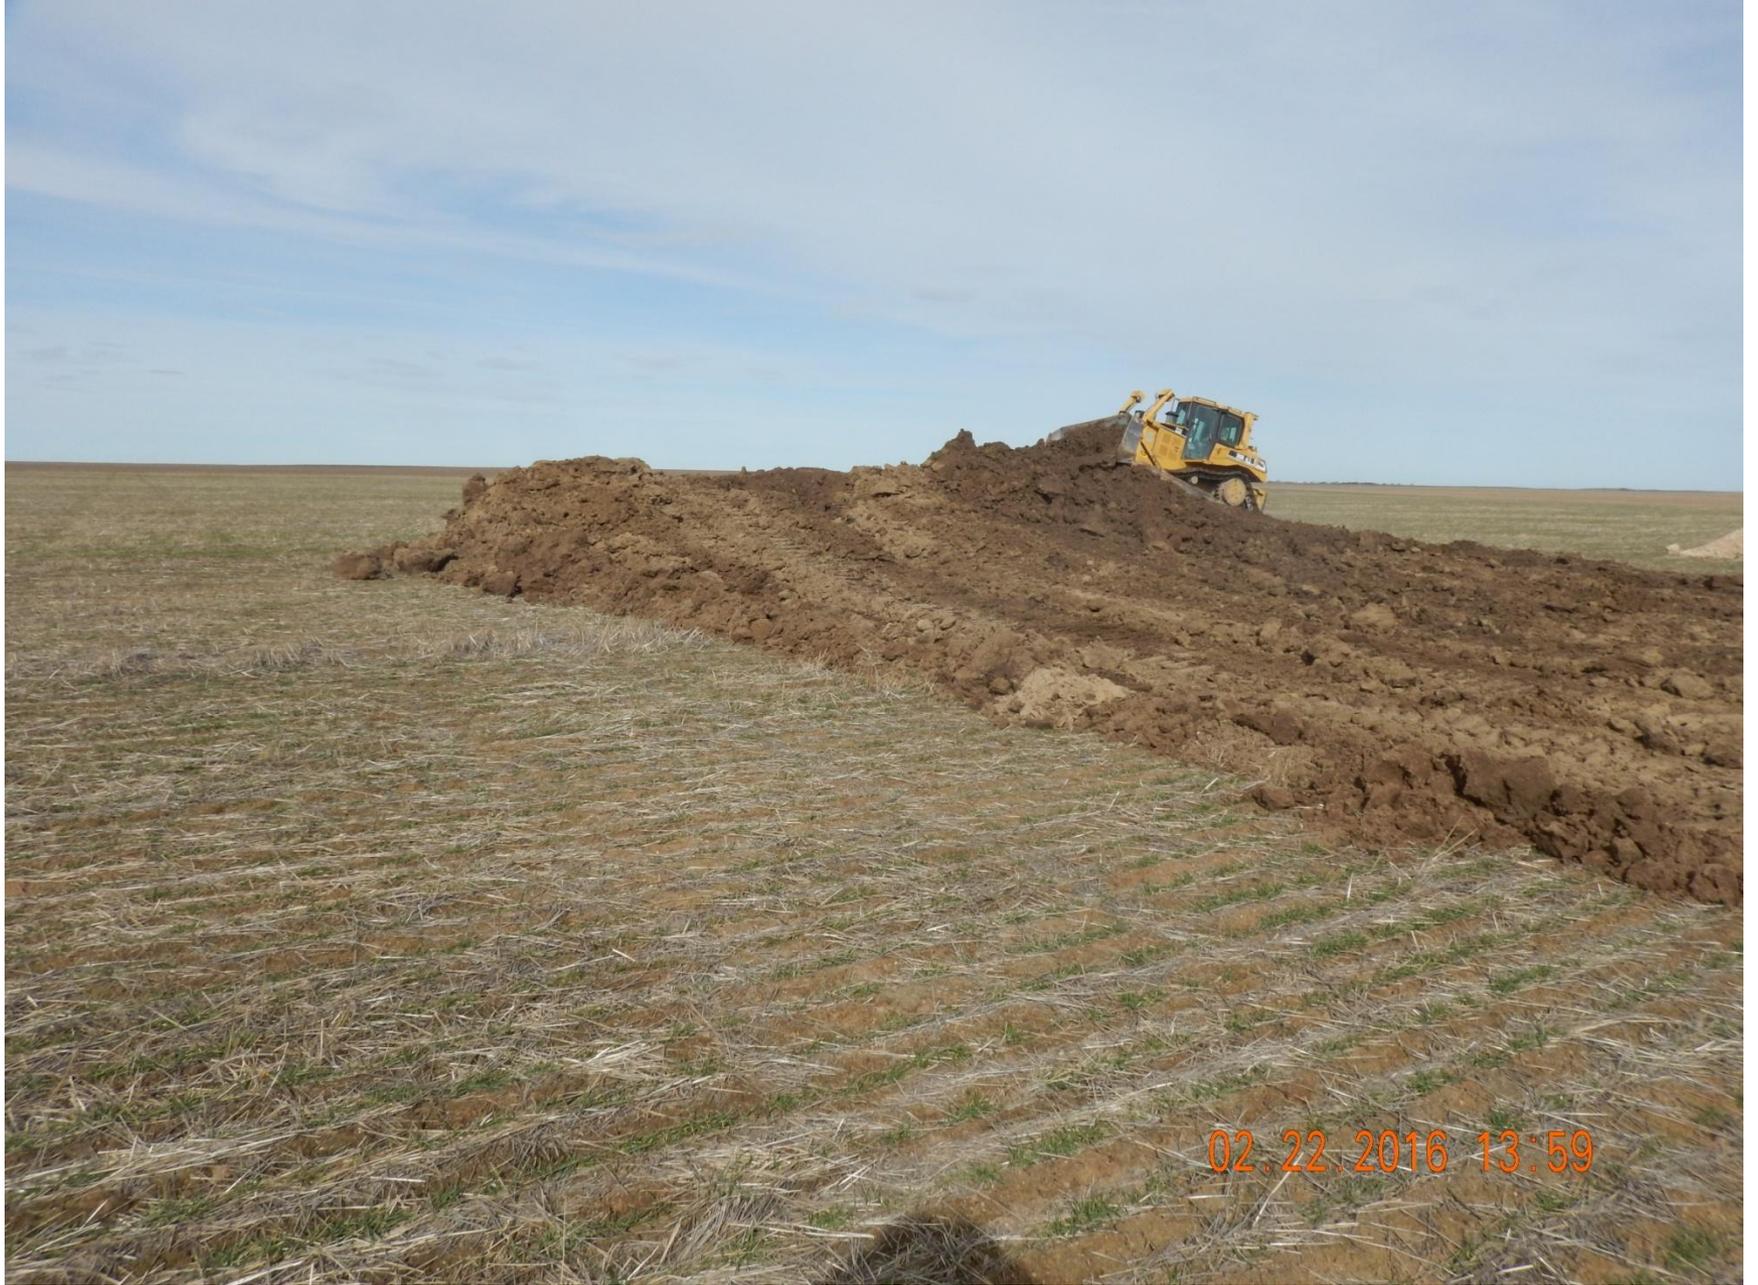
Figure 7: Photo taken from the west end of the location, facing northeast. Photo shows perimeter stormwater and sediment controls have not been installed.
