Field Inspection Photos  
2/23/16  
Berry Energy  
099-06872

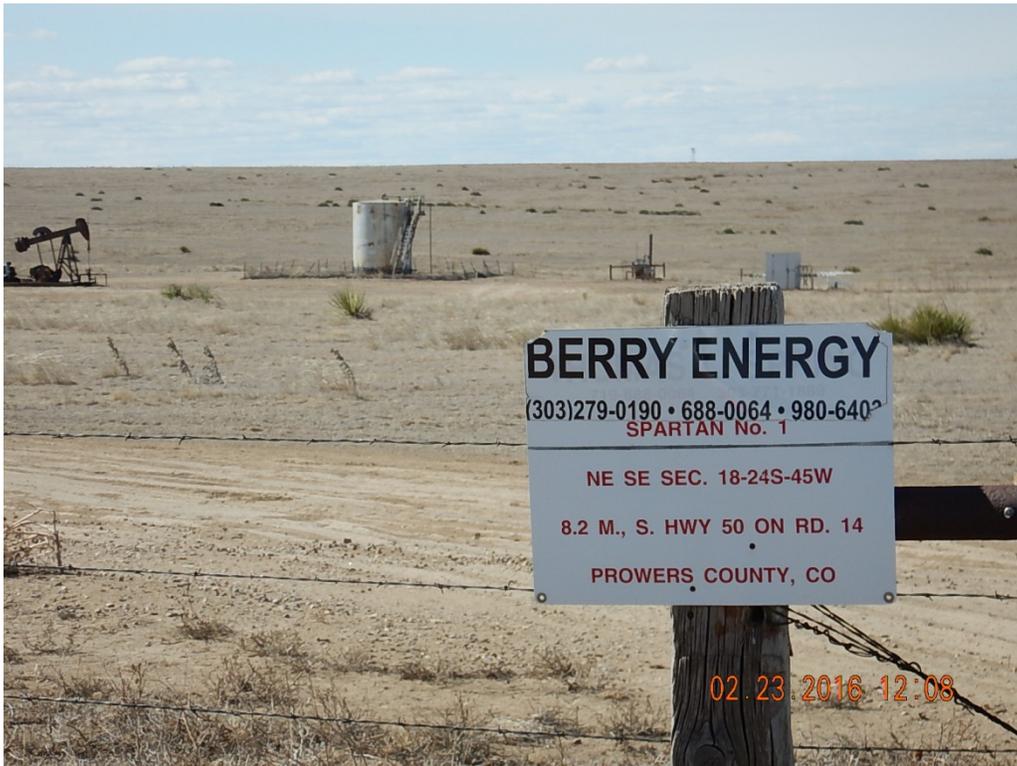
Figure 1 – Lease sign.

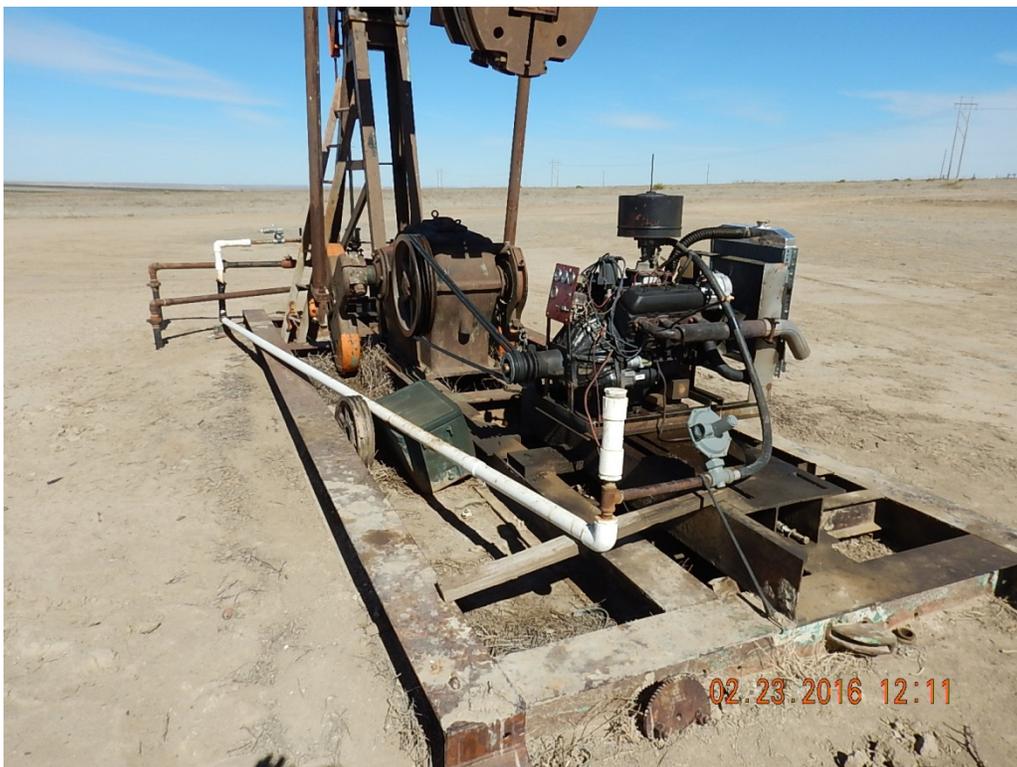
Figure 2 – Improperly stored materials and stained soil have been removed.

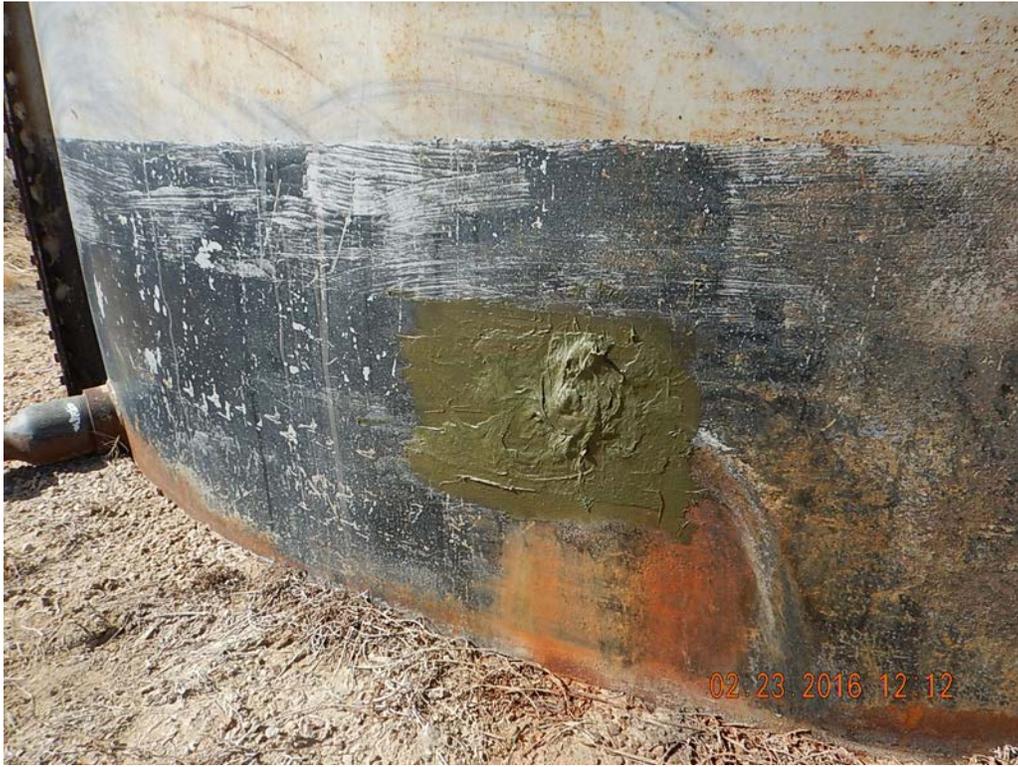
Figure 3 – Leak in produced water tank has been repaired and stained soil removed.
