Final Reclamation Inspection

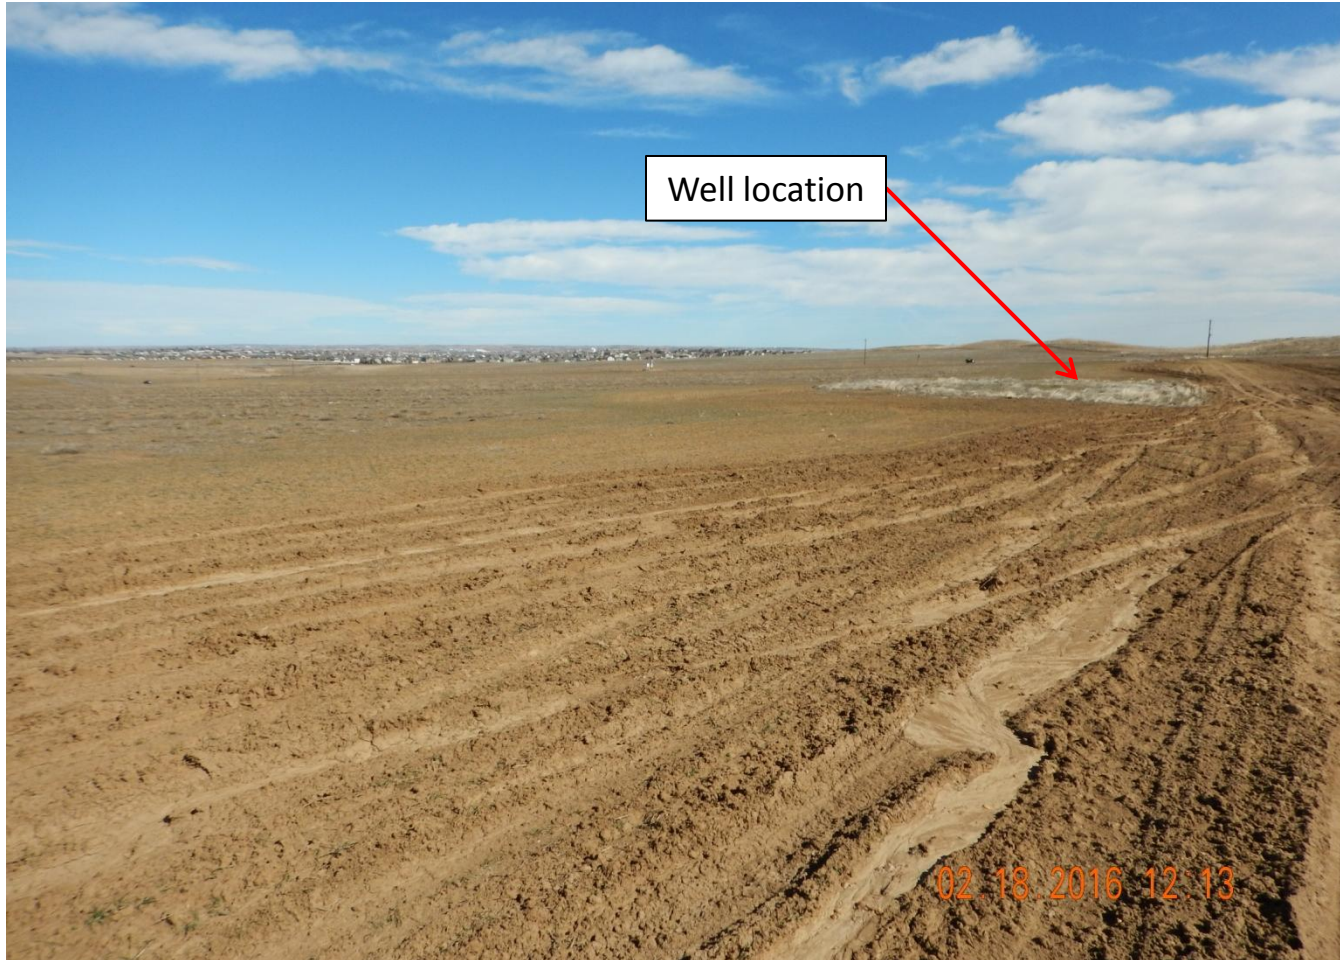
Photo 1. Photo taken west of location, facing East. Apparent evidence of well location in agricultural field.

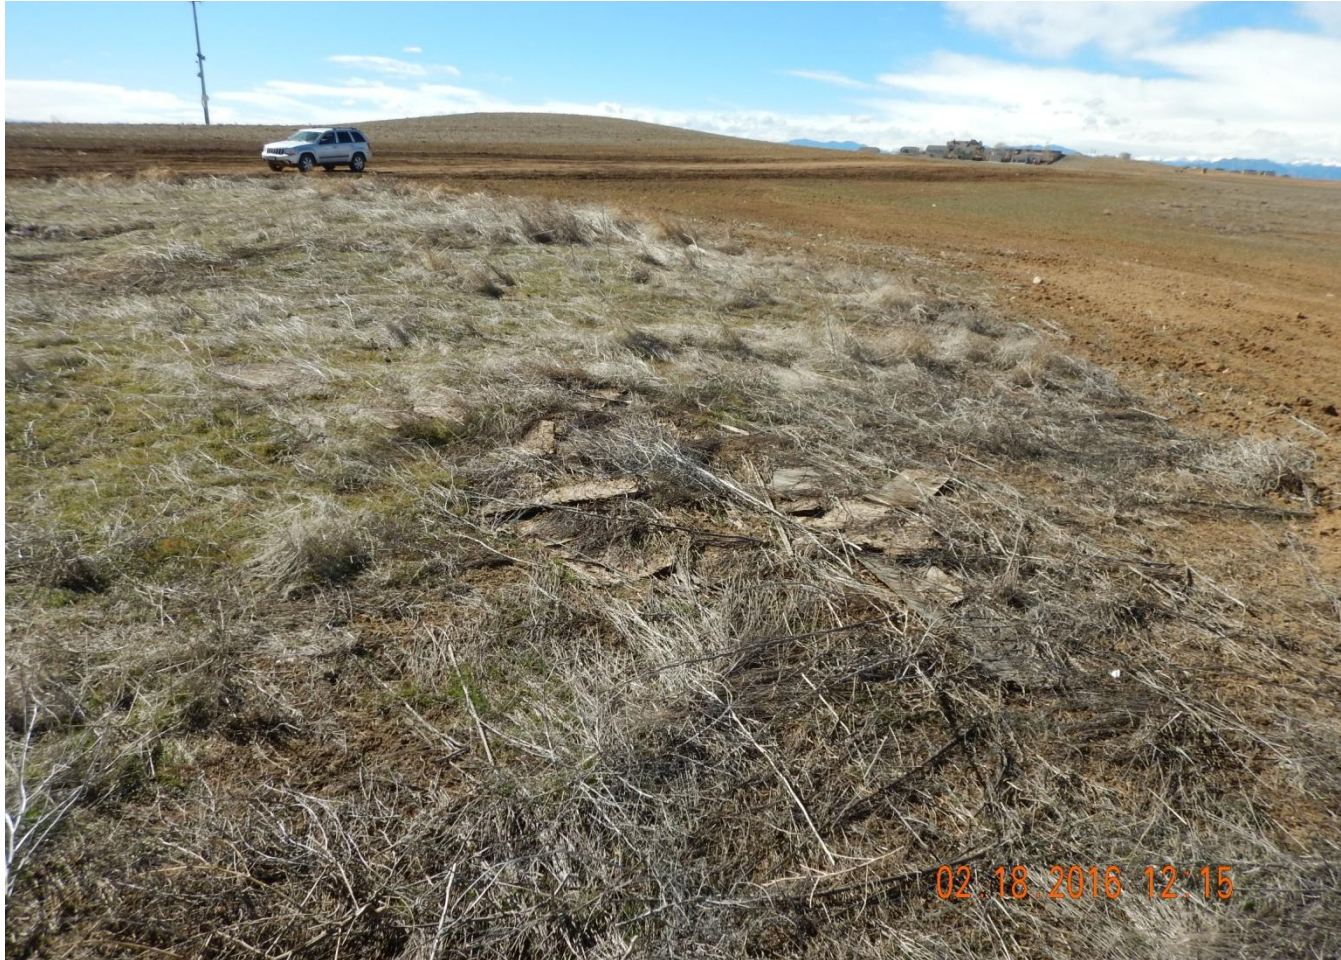
Photo 2. Photo taken from north well location, facing Southwest. Well location not properly reclaimed-not recontoured and waste material left behind.

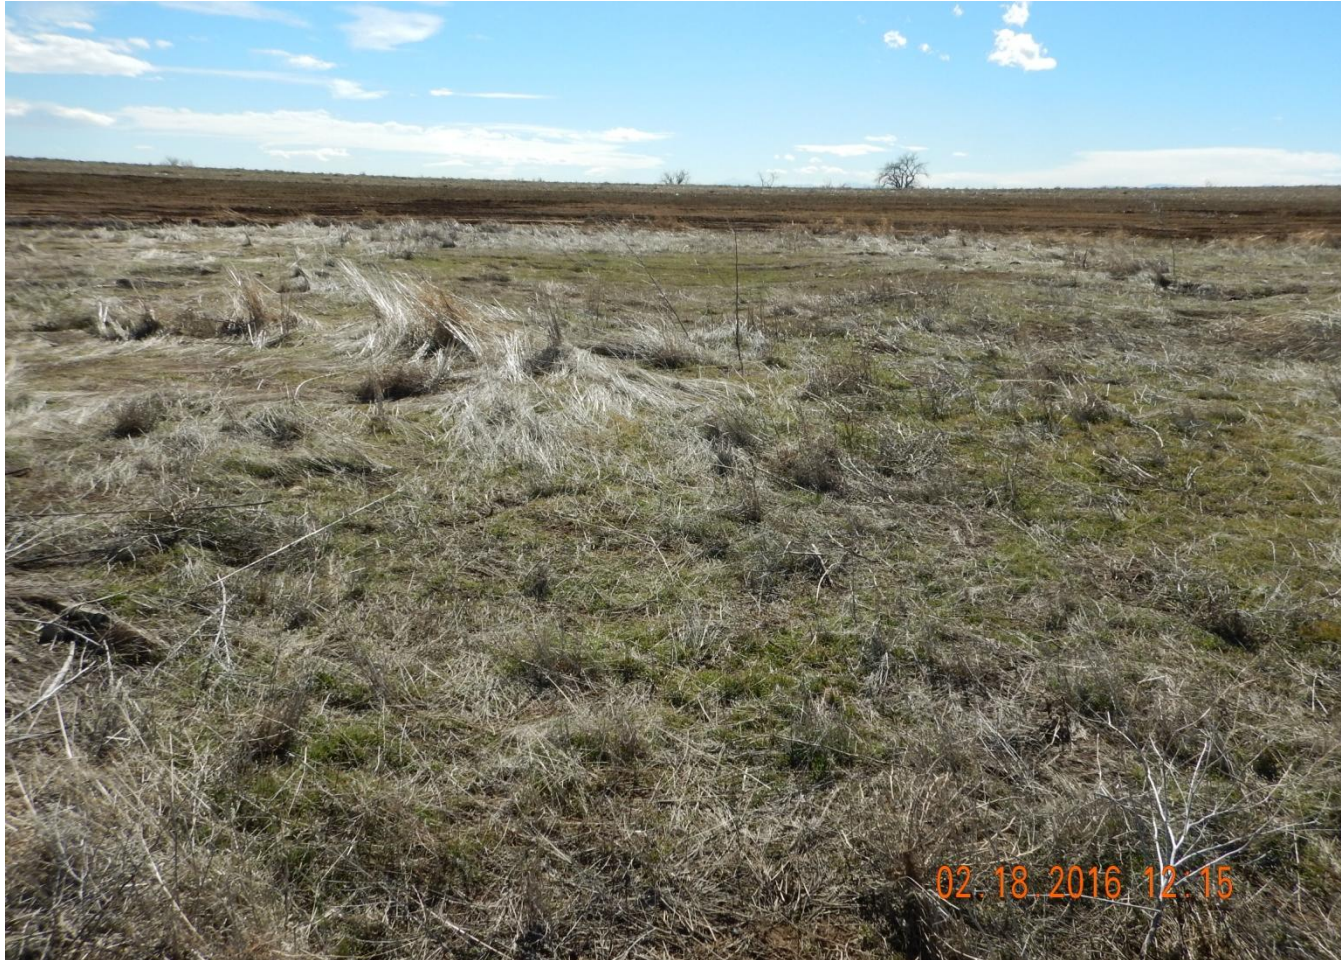
Photo 3. Photo taken from north well location, facing South. Well location not properly reclaimed-not recontoured and waste material left behind.

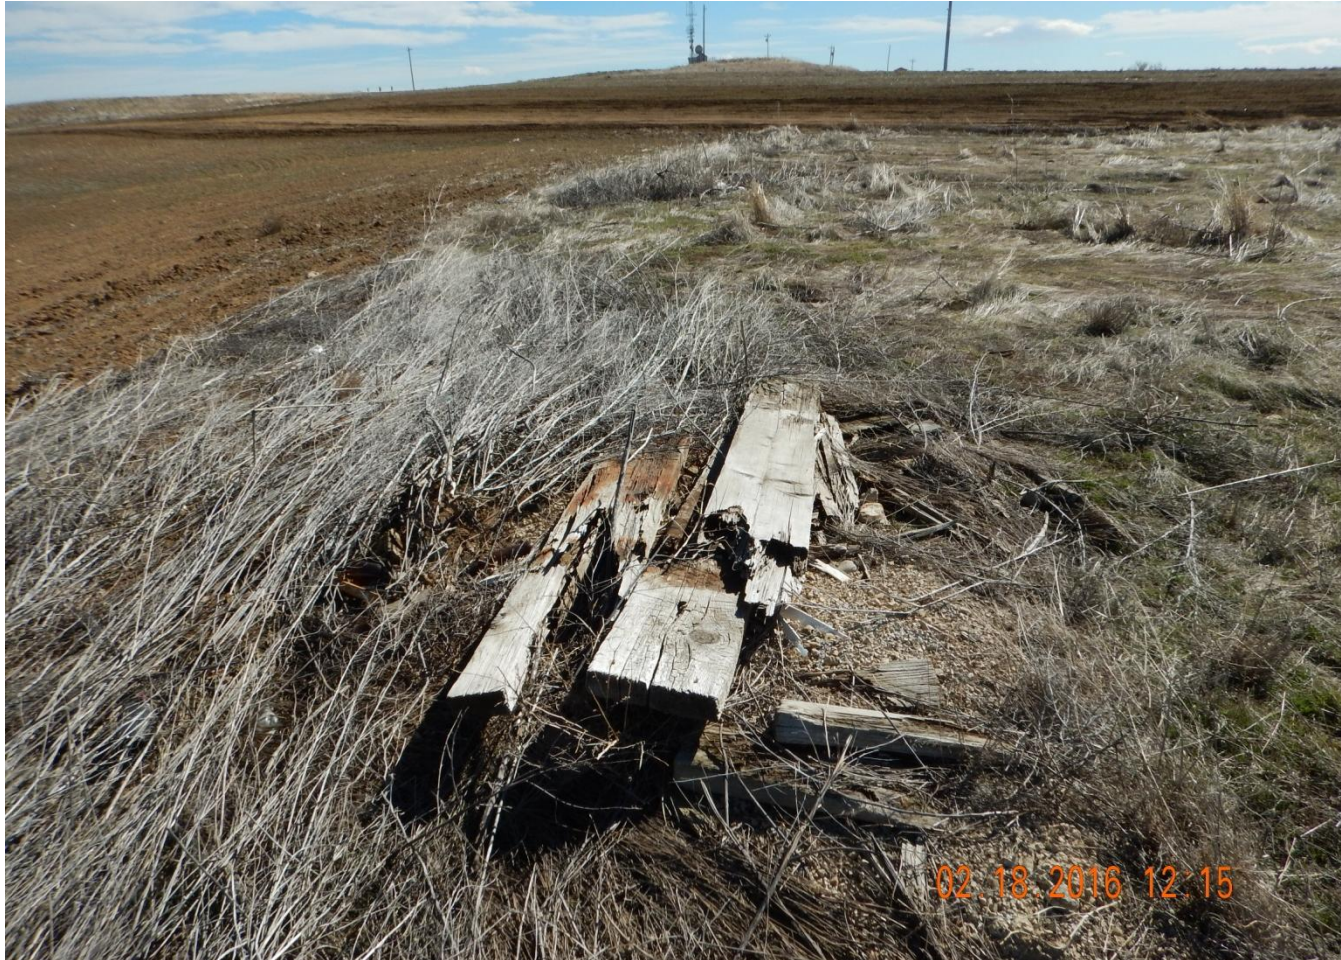
Photo 4. Photo taken from north well location, facing East. Well location not properly reclaimed-not recontoured and waste material left behind.

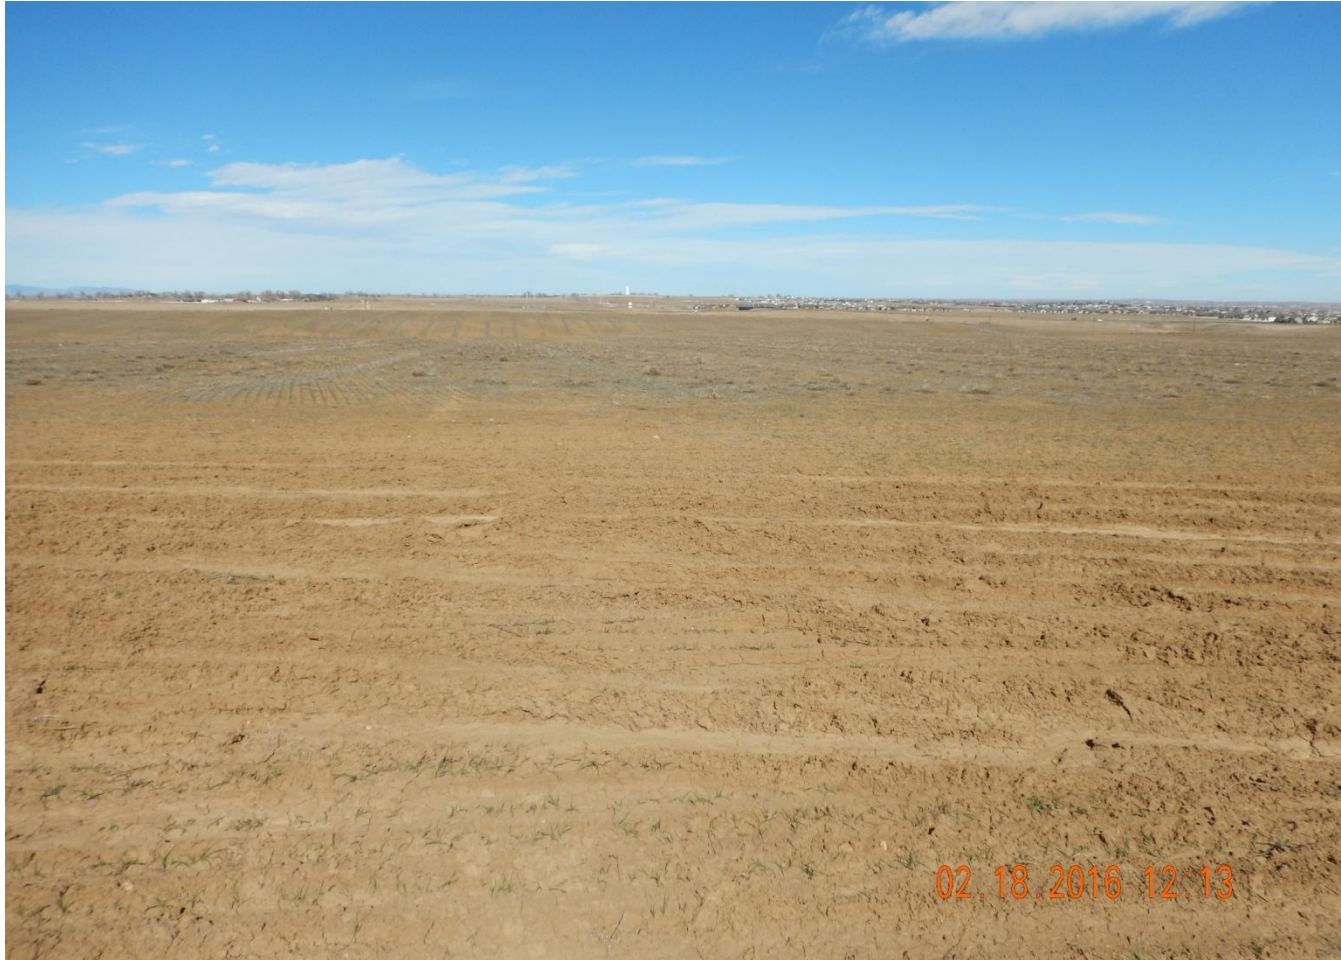
Photo 5. Photo taken west of location, facing North. Demonstrates current land use and reference photo.
