Field Inspection Photos  
2/17/16  
Prowers Gas Gathering  
Facility 444661

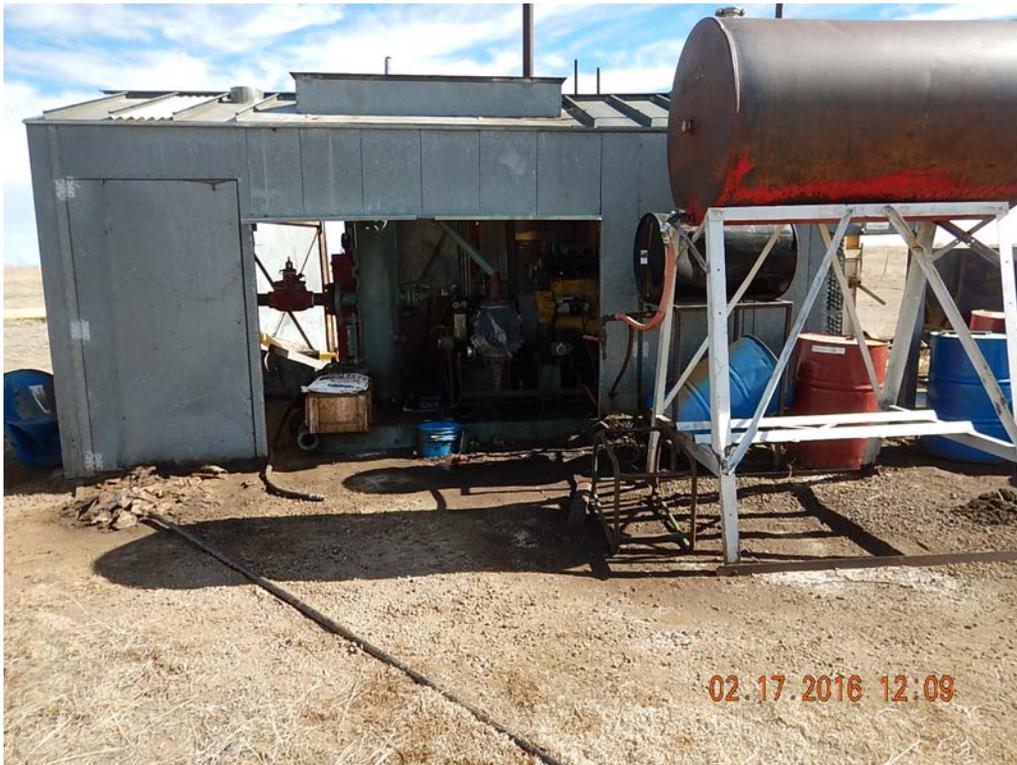
Figure 1 – West side of facility

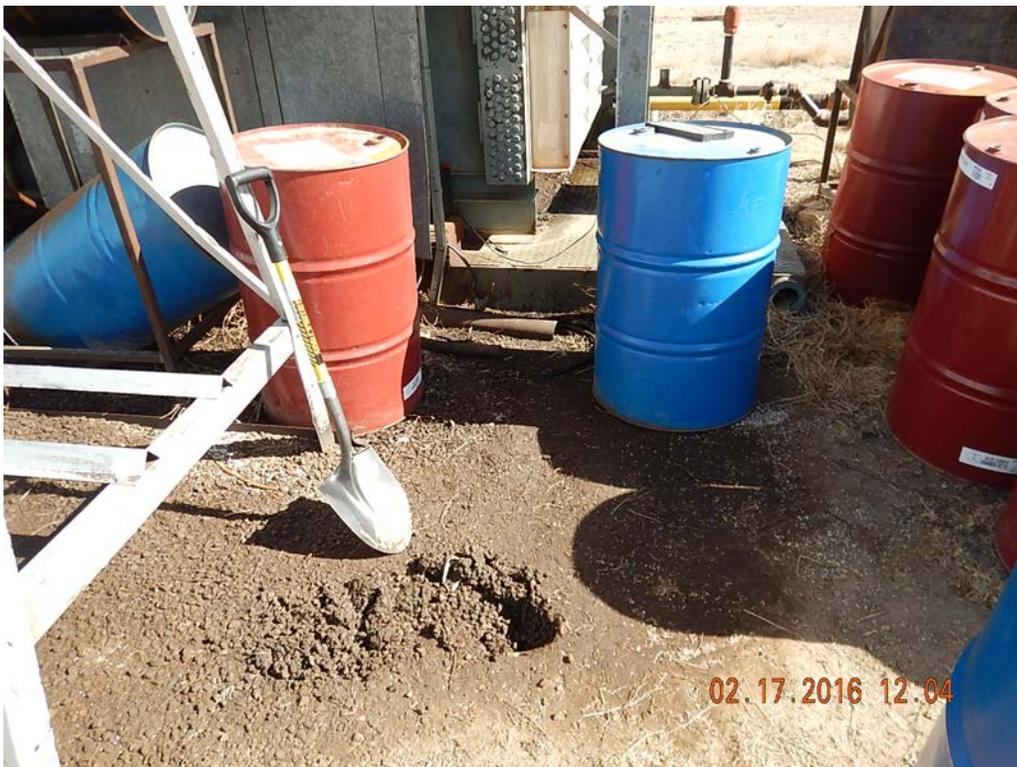
Figure 2 – Soil stained six to eight inches deep.

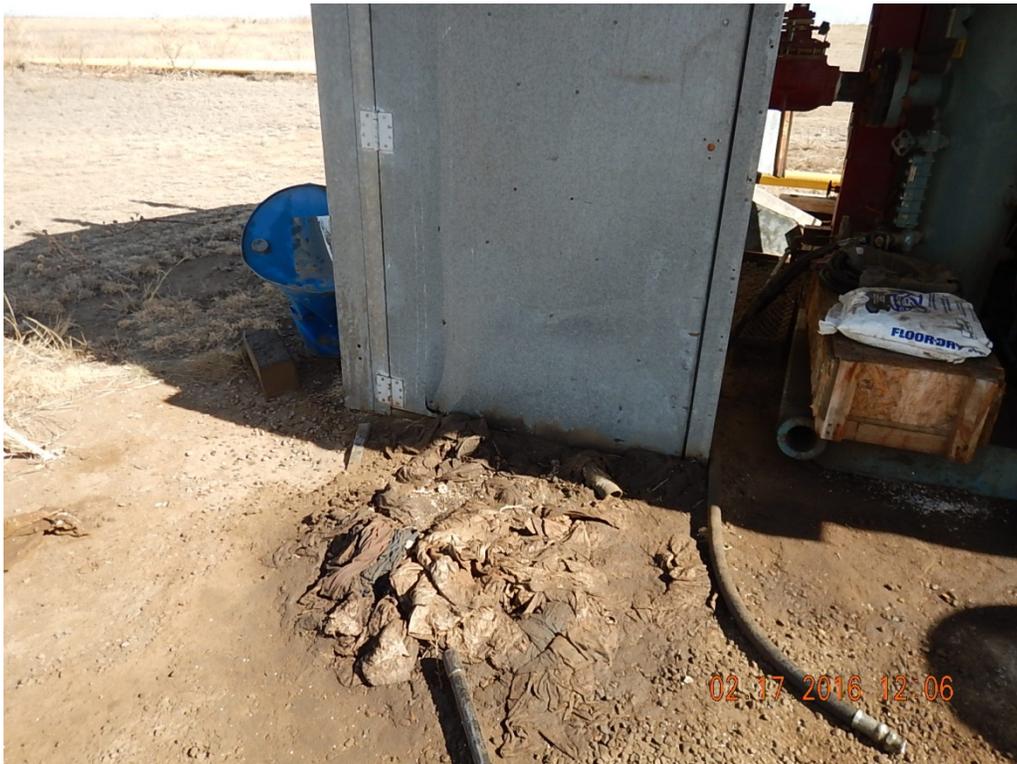
Figure 3 – Oily rags discarded on northwest corner of compressor.

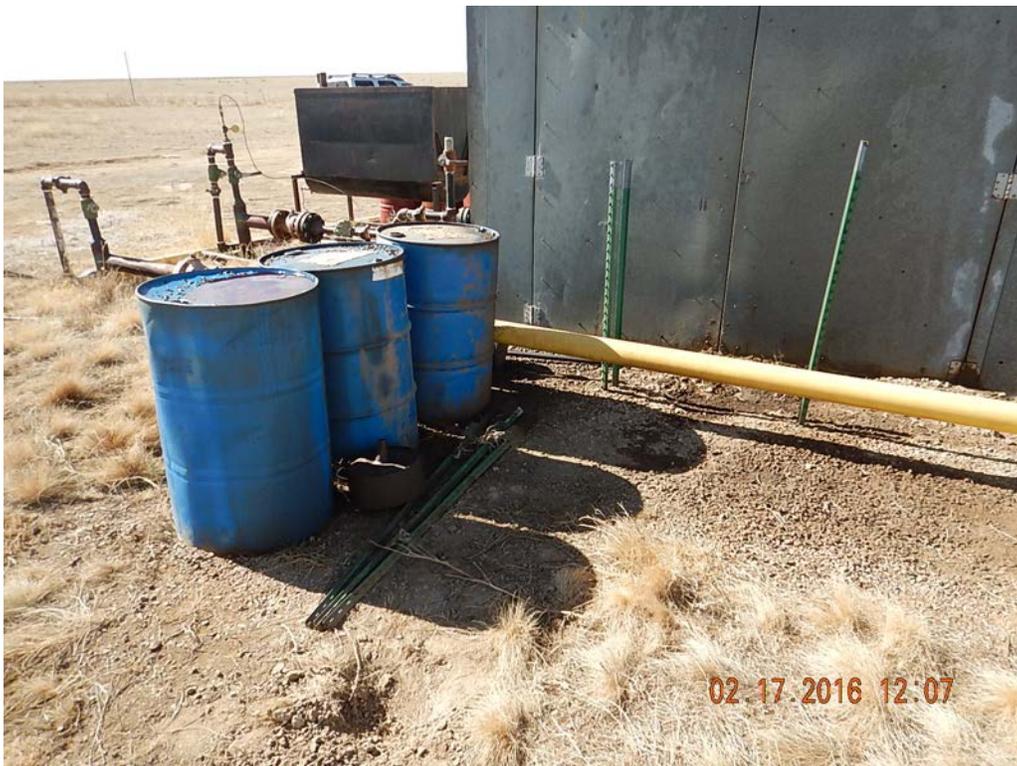
Figure 4 – Barrels leaking and stained soil on east side of compressor.

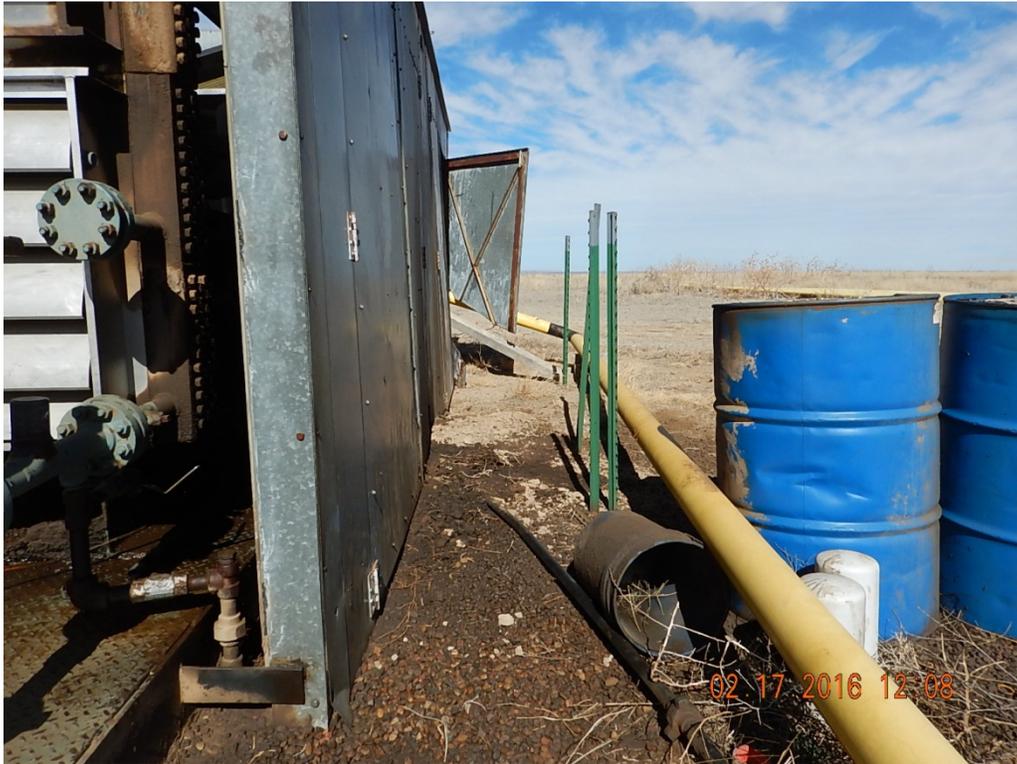
Figure 5 – Stained soil on east side of compressor.

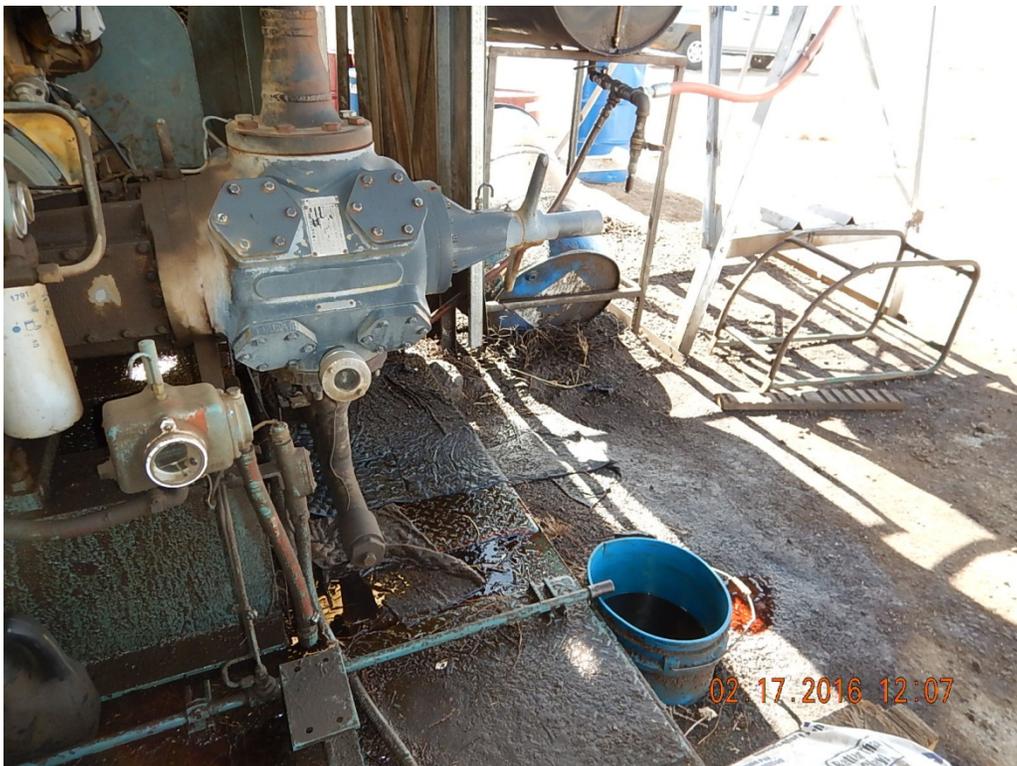
Figure 6 – Compressor leaking oil on west side of facility.

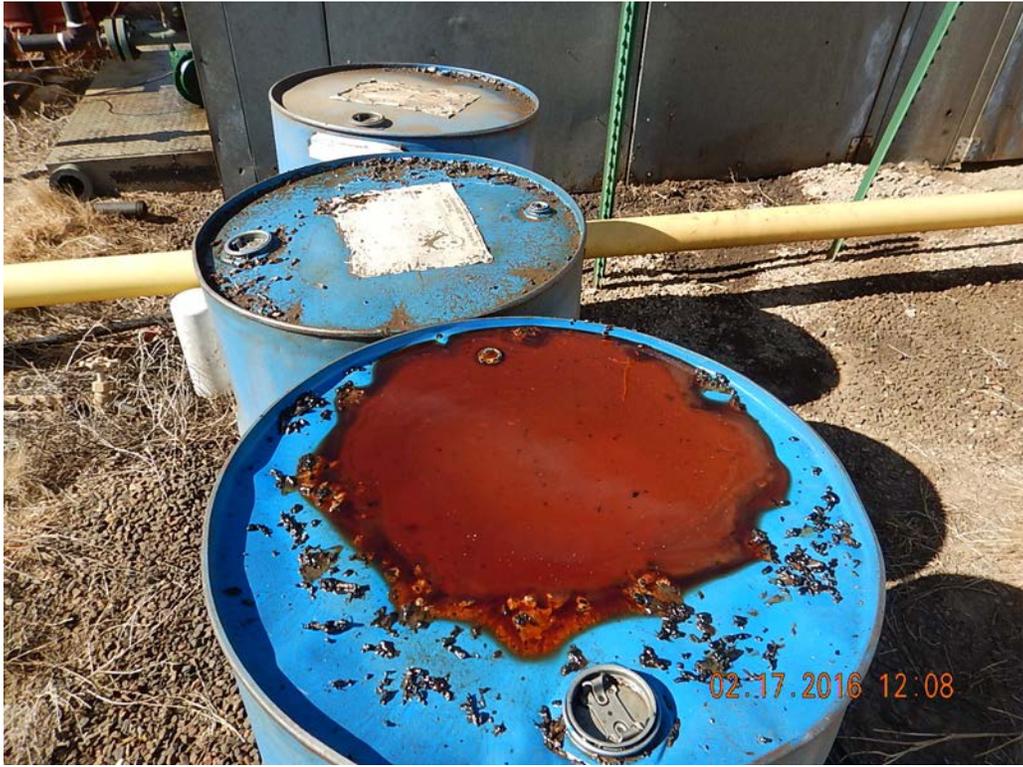
Figure 7 – Leaking barrels of motor oil stored on site.
