Field Inspection Photos
2/23/16
Prowers Gas Gathering
Facility 444661

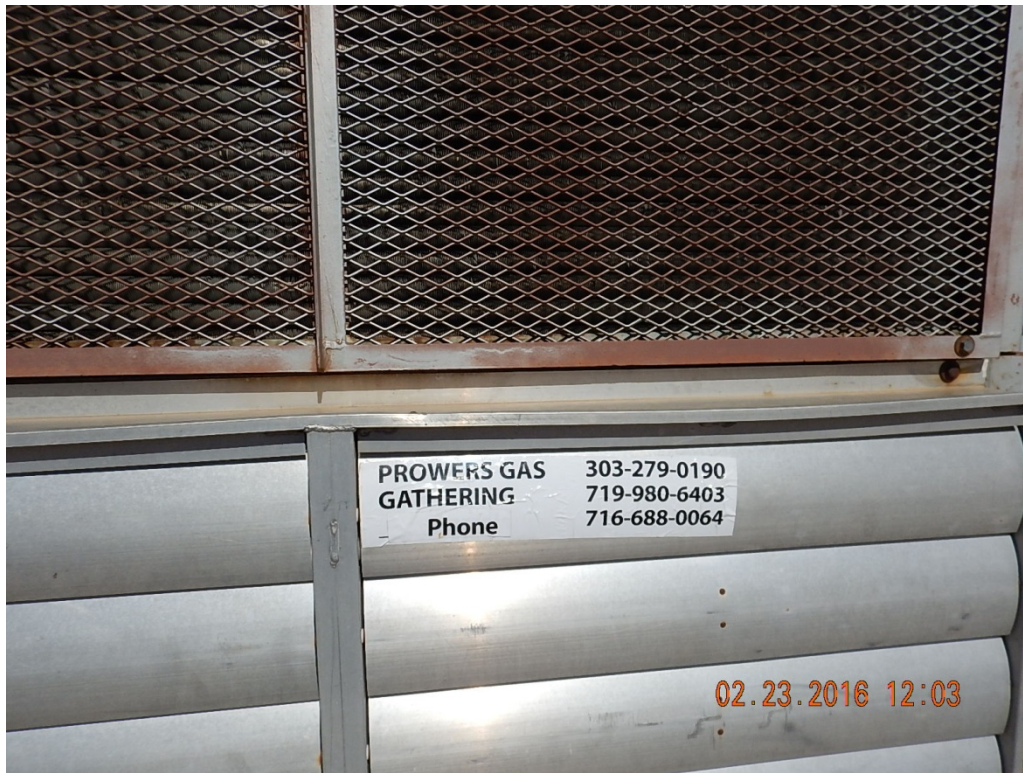
Figure 1 – Ownership and contact information has been posted.

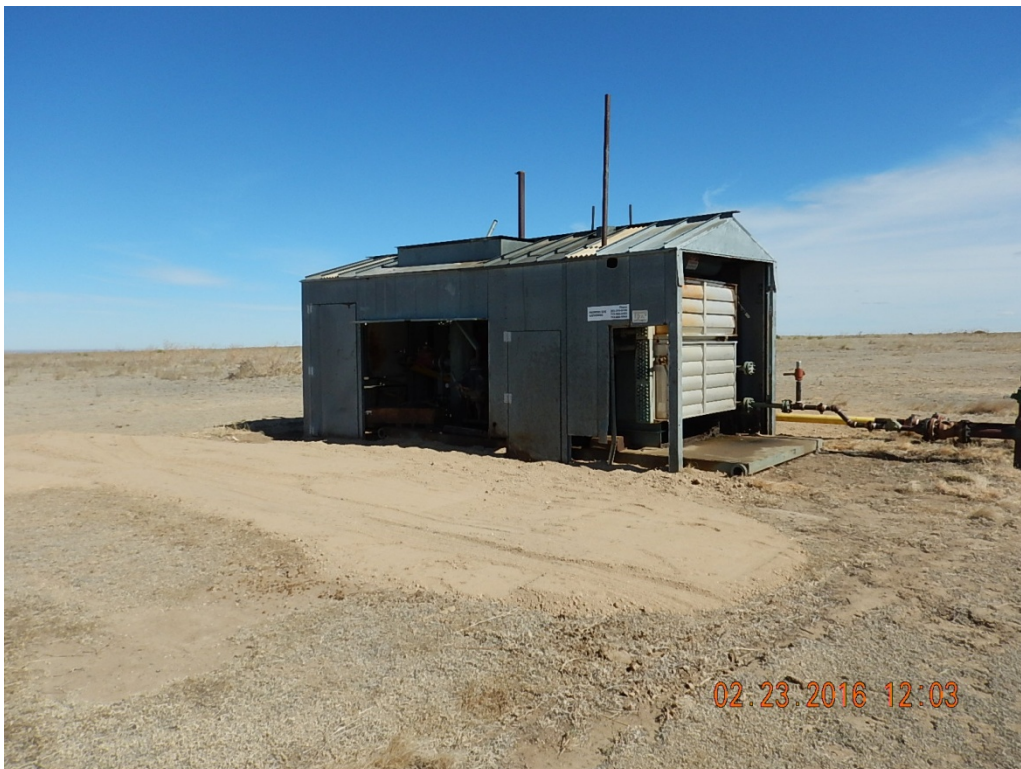
Figure 2 – Looking northeast. Barrels of motor oil have been removed and stained soil excavated.
