Interim Reclamation Inspection

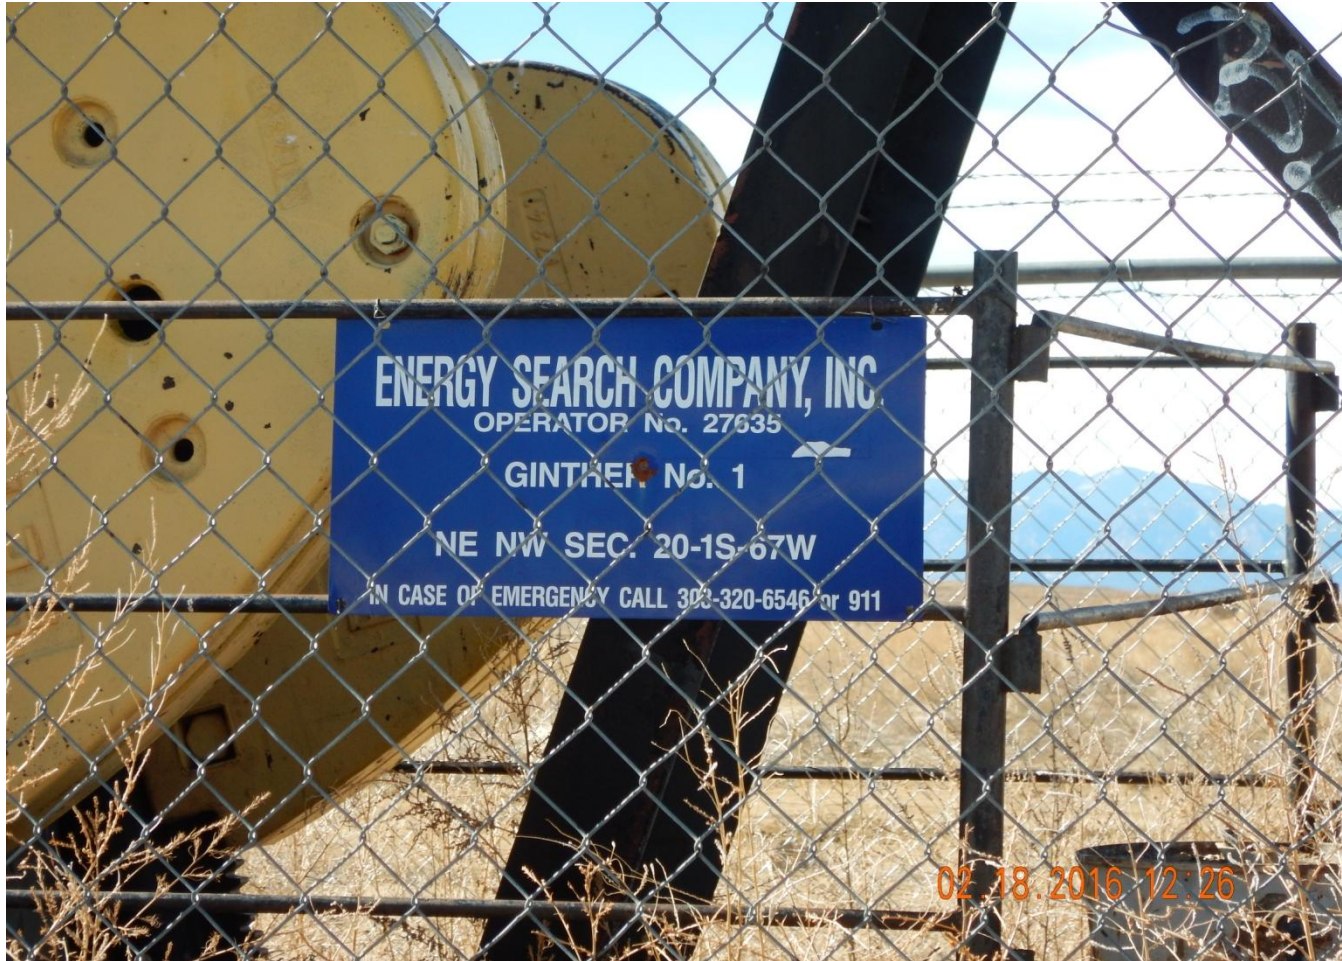
Photo 1. Photo of well sign.

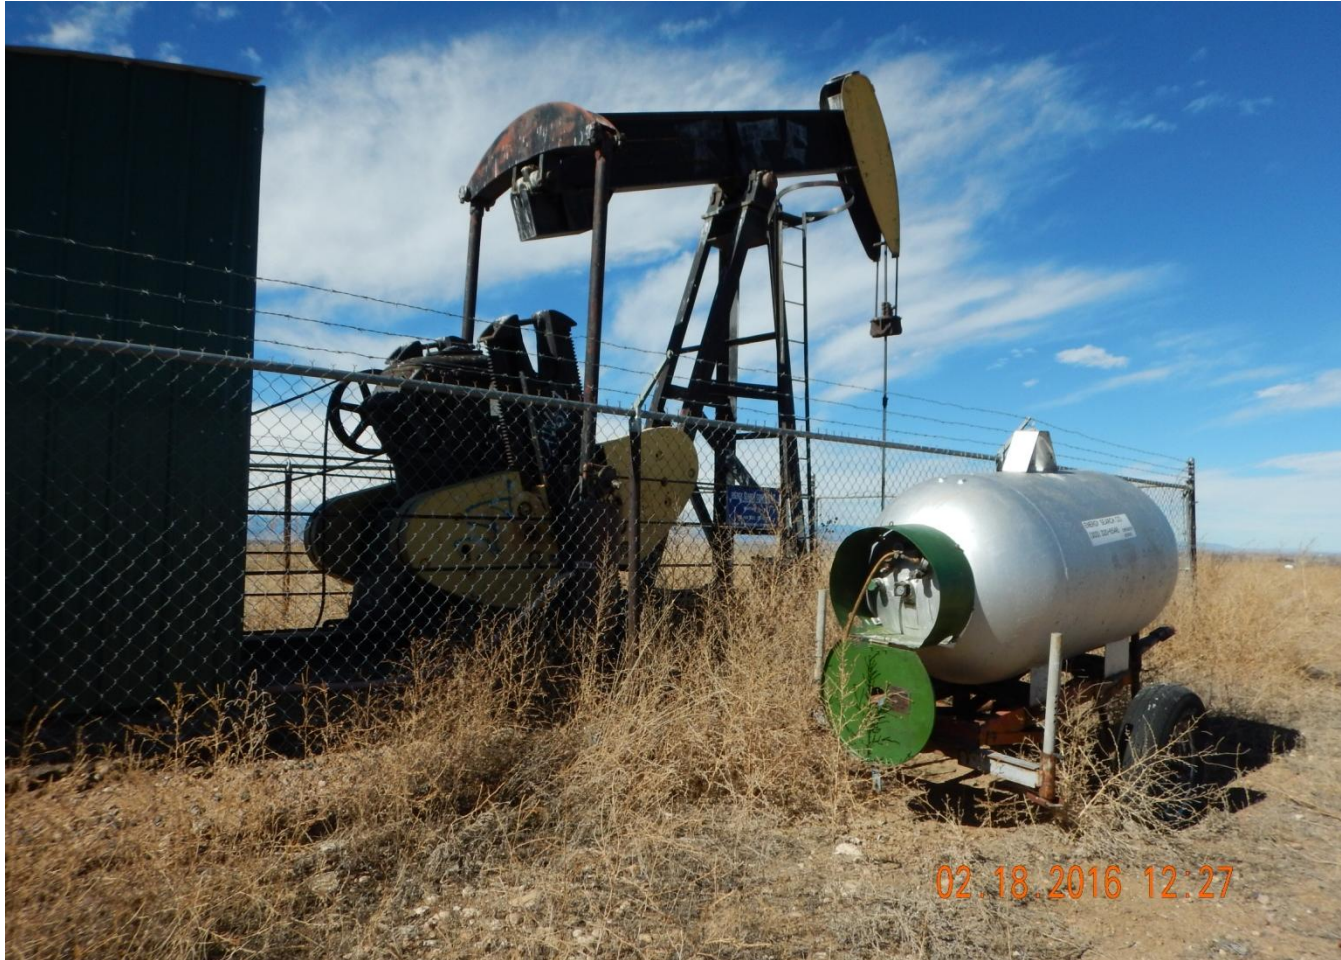
Photo 2. Photo taken from east location, facing West. Need to remove weeds around all operating oil and gas equipment on location.

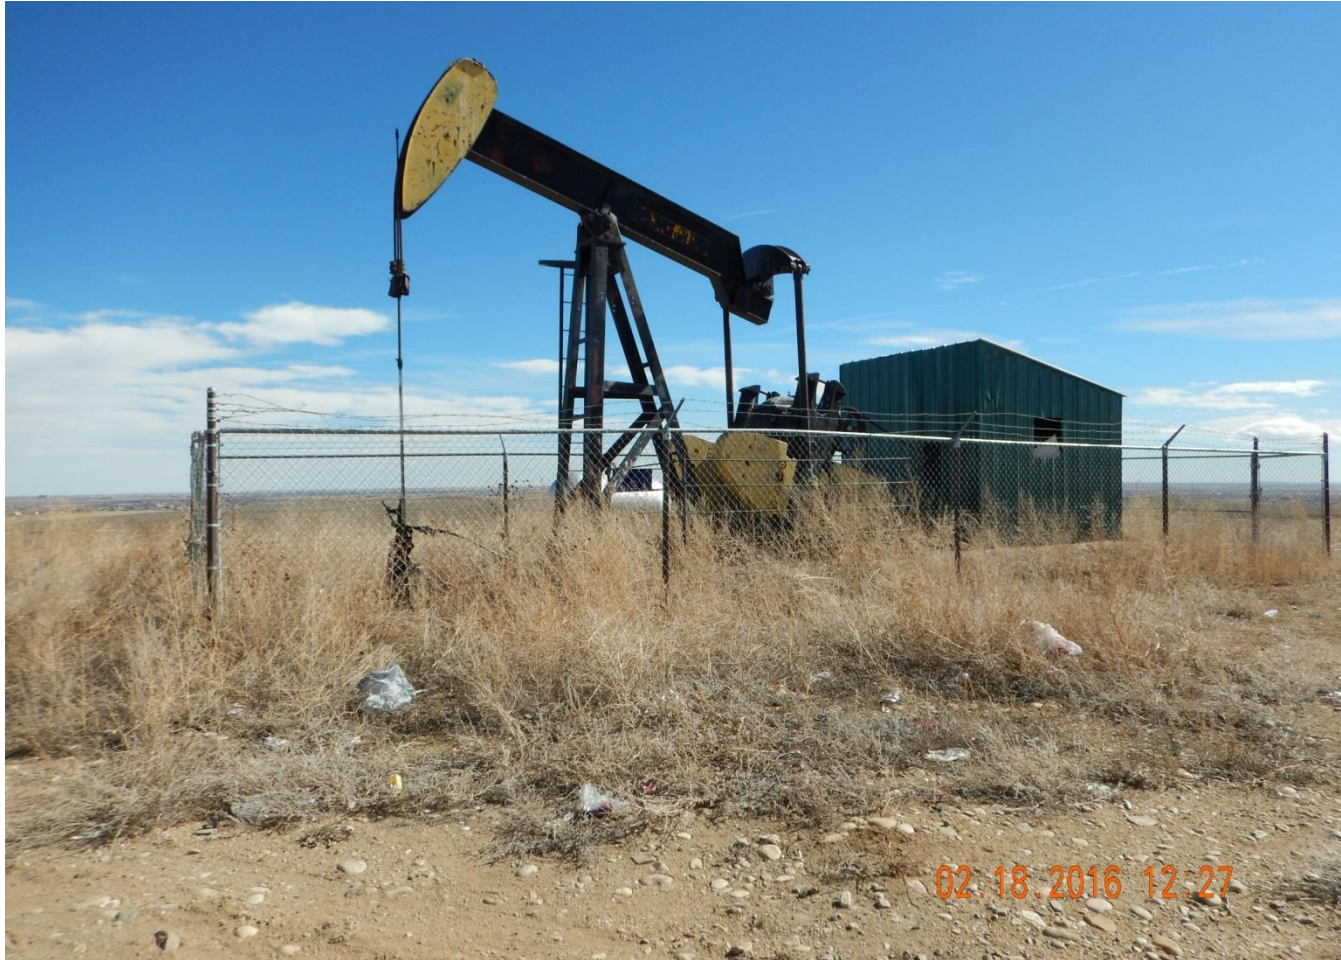
Photo 3. Photo taken from west location, facing East. Need to remove weeds around all operating oil and gas equipment on location.
