Final Reclamation Inspection

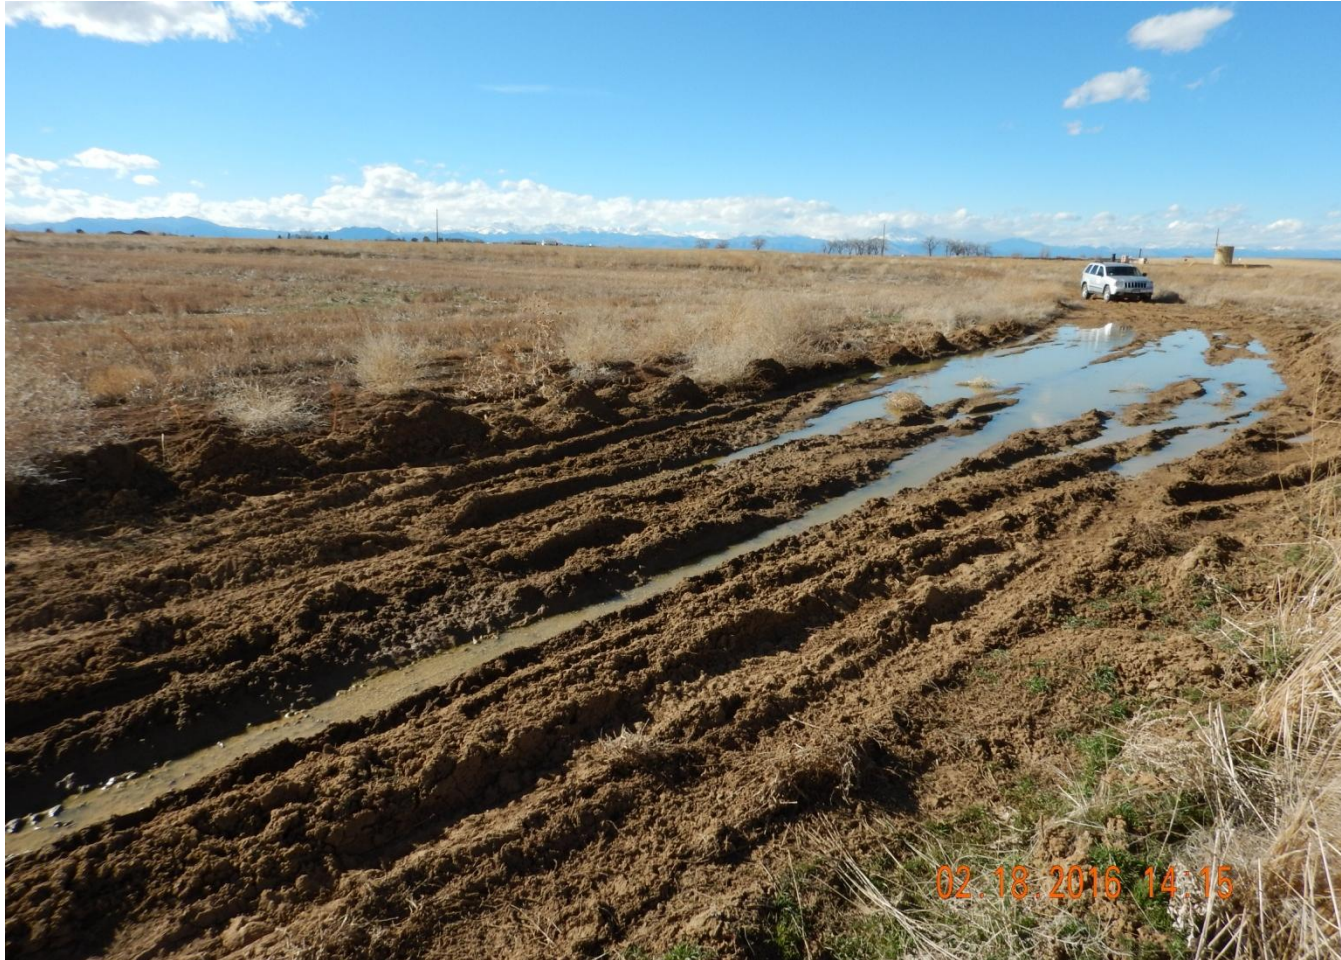
Photo 1. Photo taken from center of location, facing West. Access road traveling through location. Uncertain what this access road is being used for.

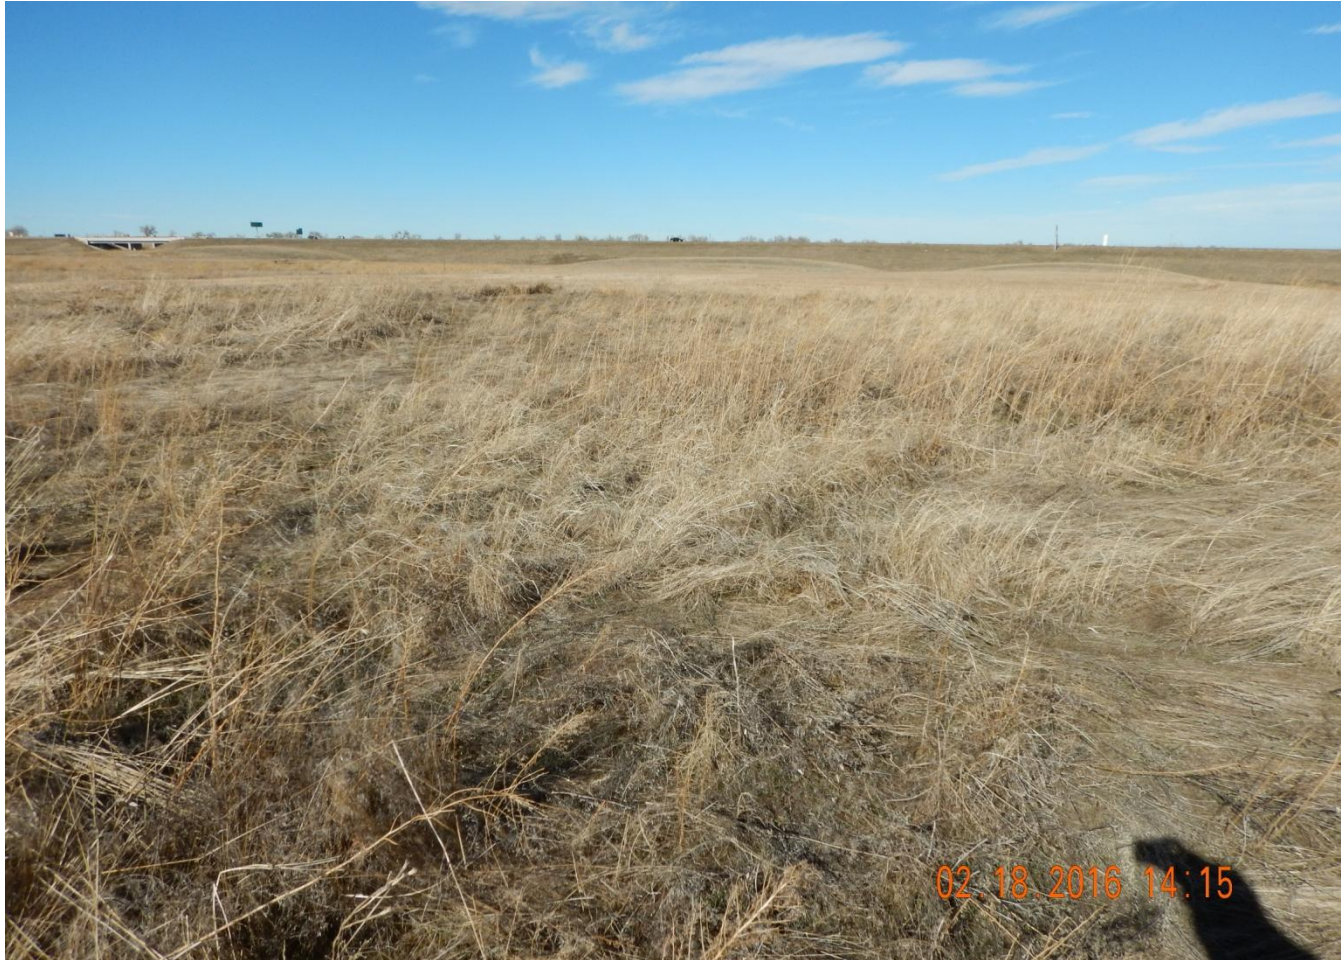
Photo 2. Photo taken from center of location, facing North. Appears to have perennial growth in some areas of the location.

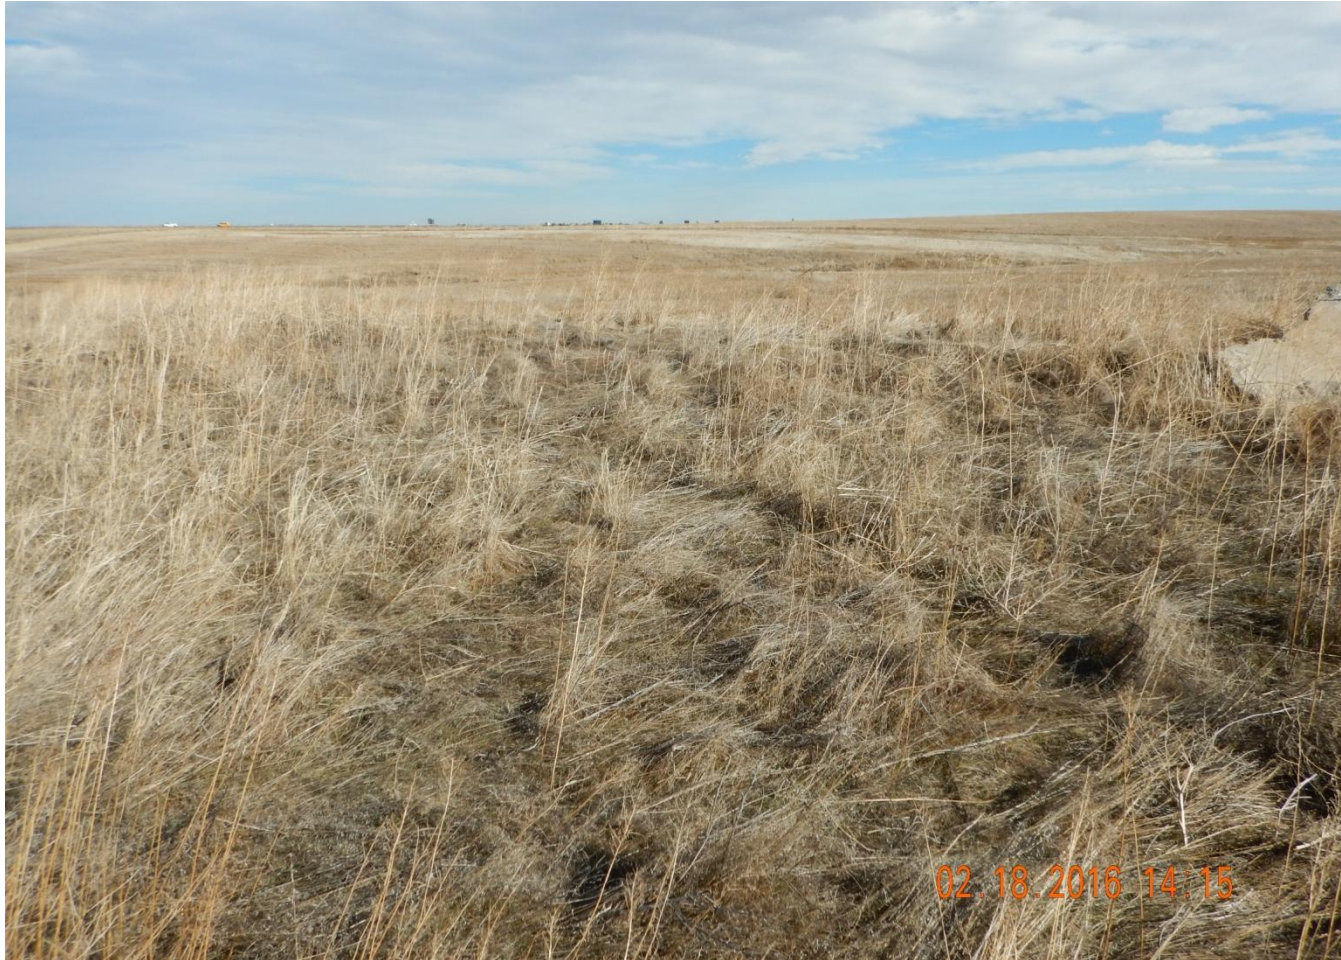
Photo 3. Photo taken from center of location, facing East. Appears to have perennial growth in some areas of the location.

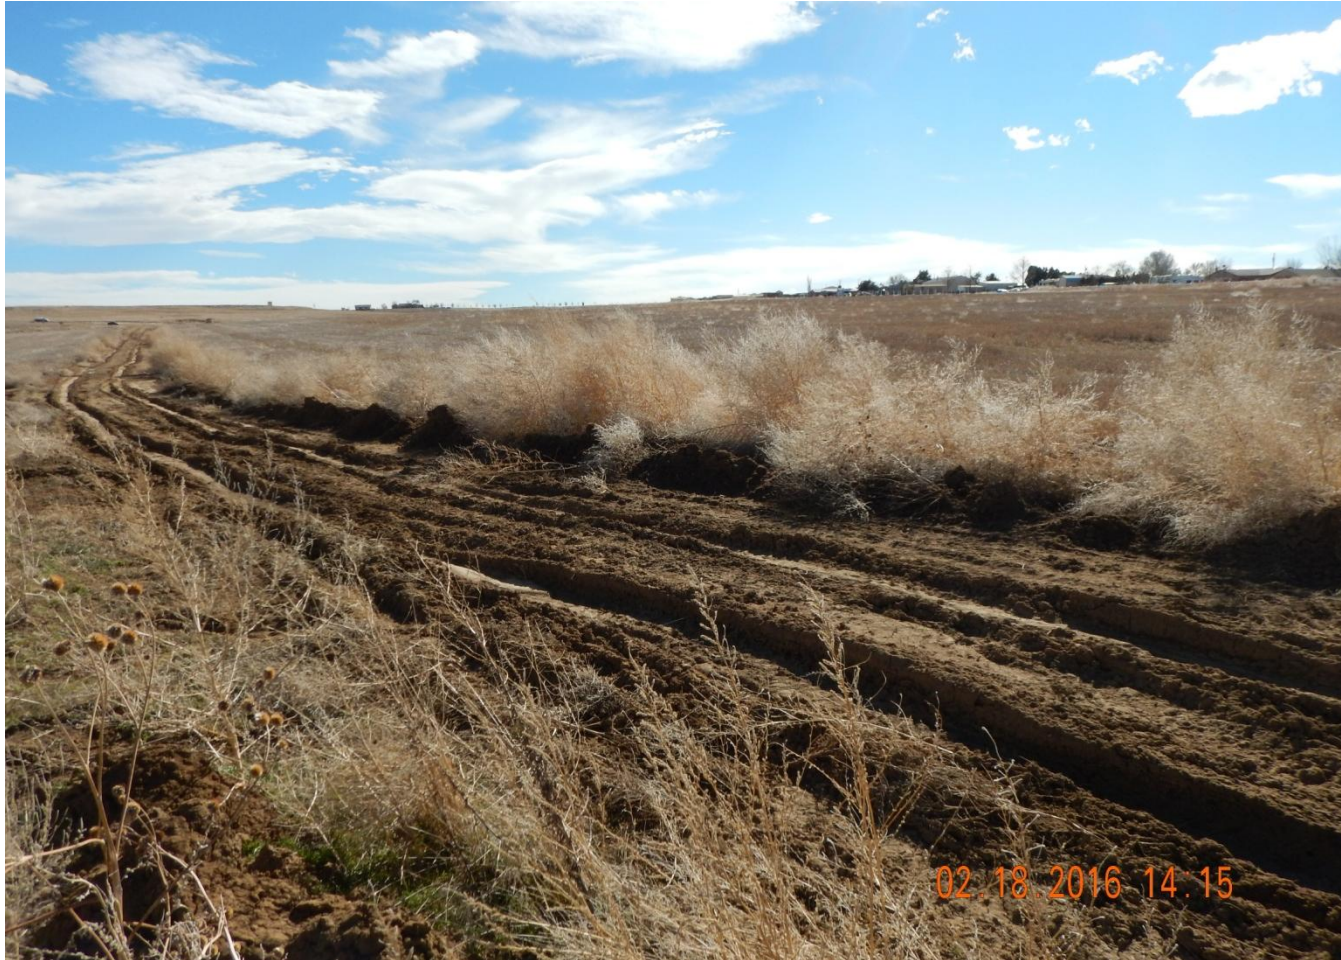
Photo 4. Photo taken from center of location, facing South. Access road traveling through location. Uncertain what this access road is being used for.

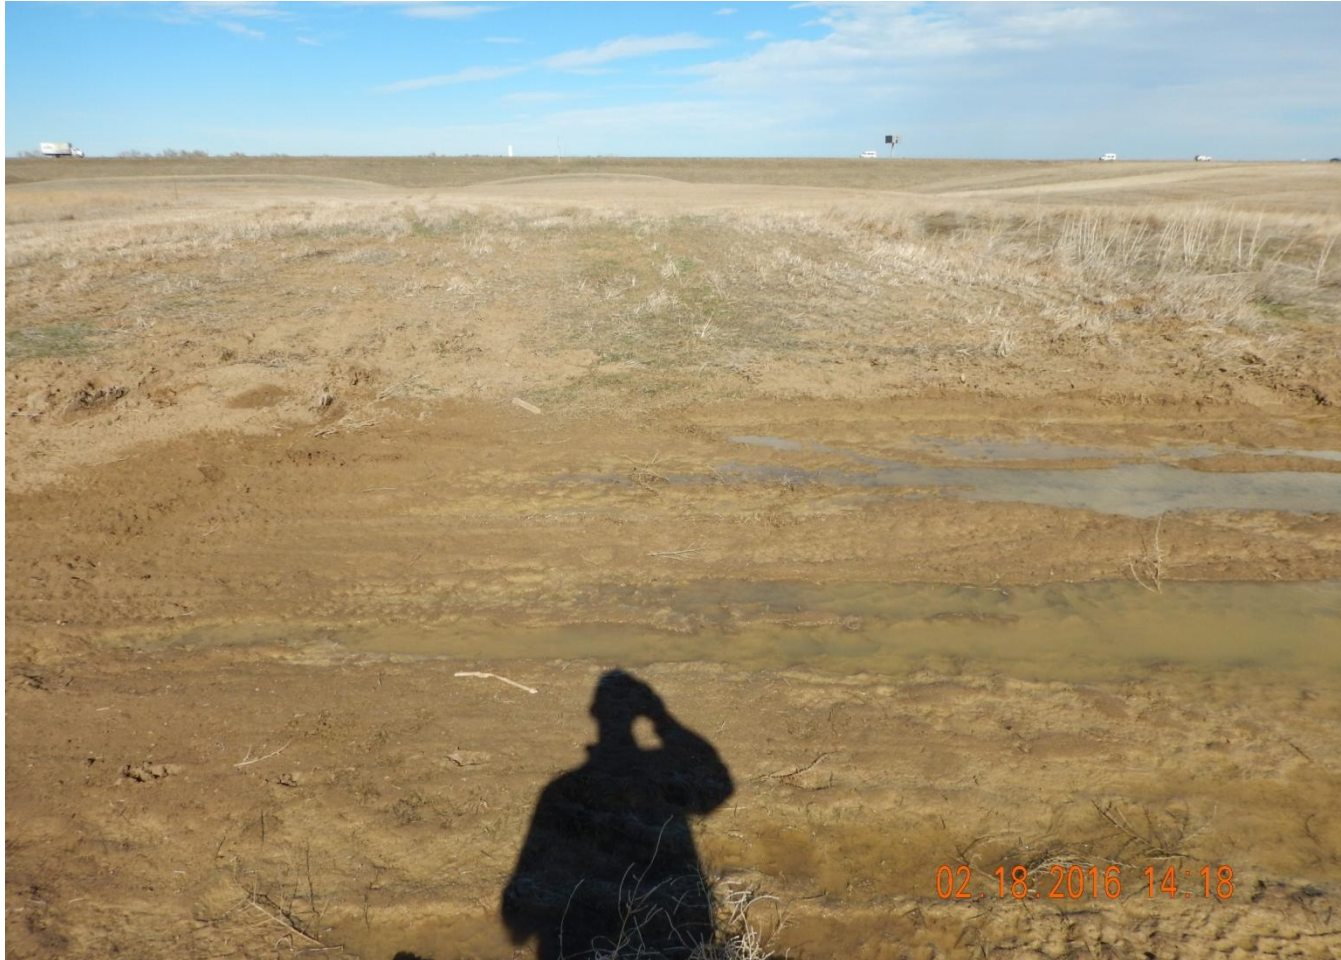
Photo 5. Photo taken from west location, facing East. Appears to lack vegetative growth in some areas of the location.

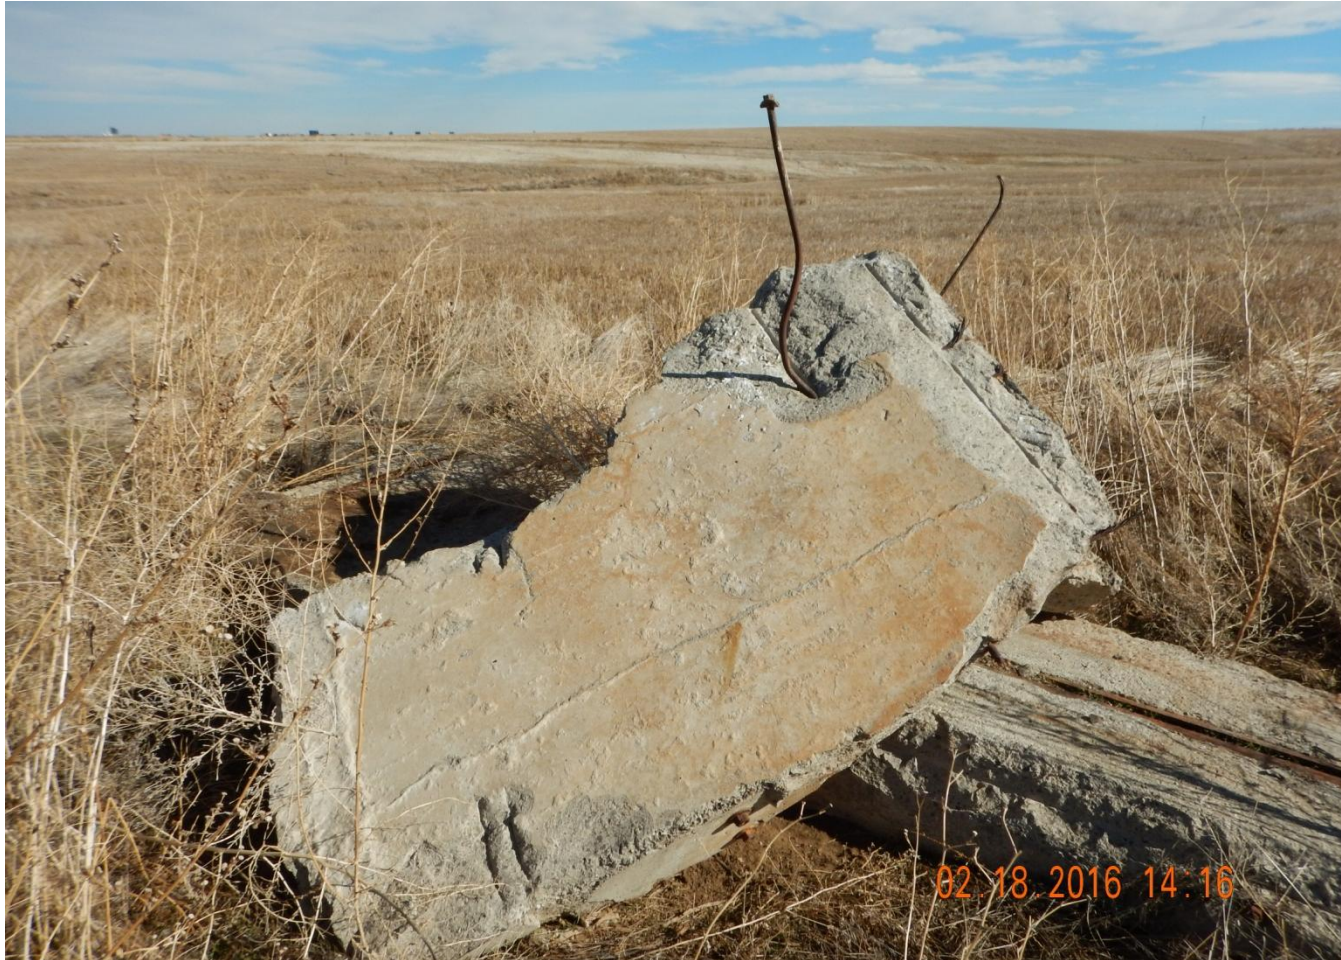
Photo 6. Photo taken from center of location. Waste material left behind.
