Construction Inspection

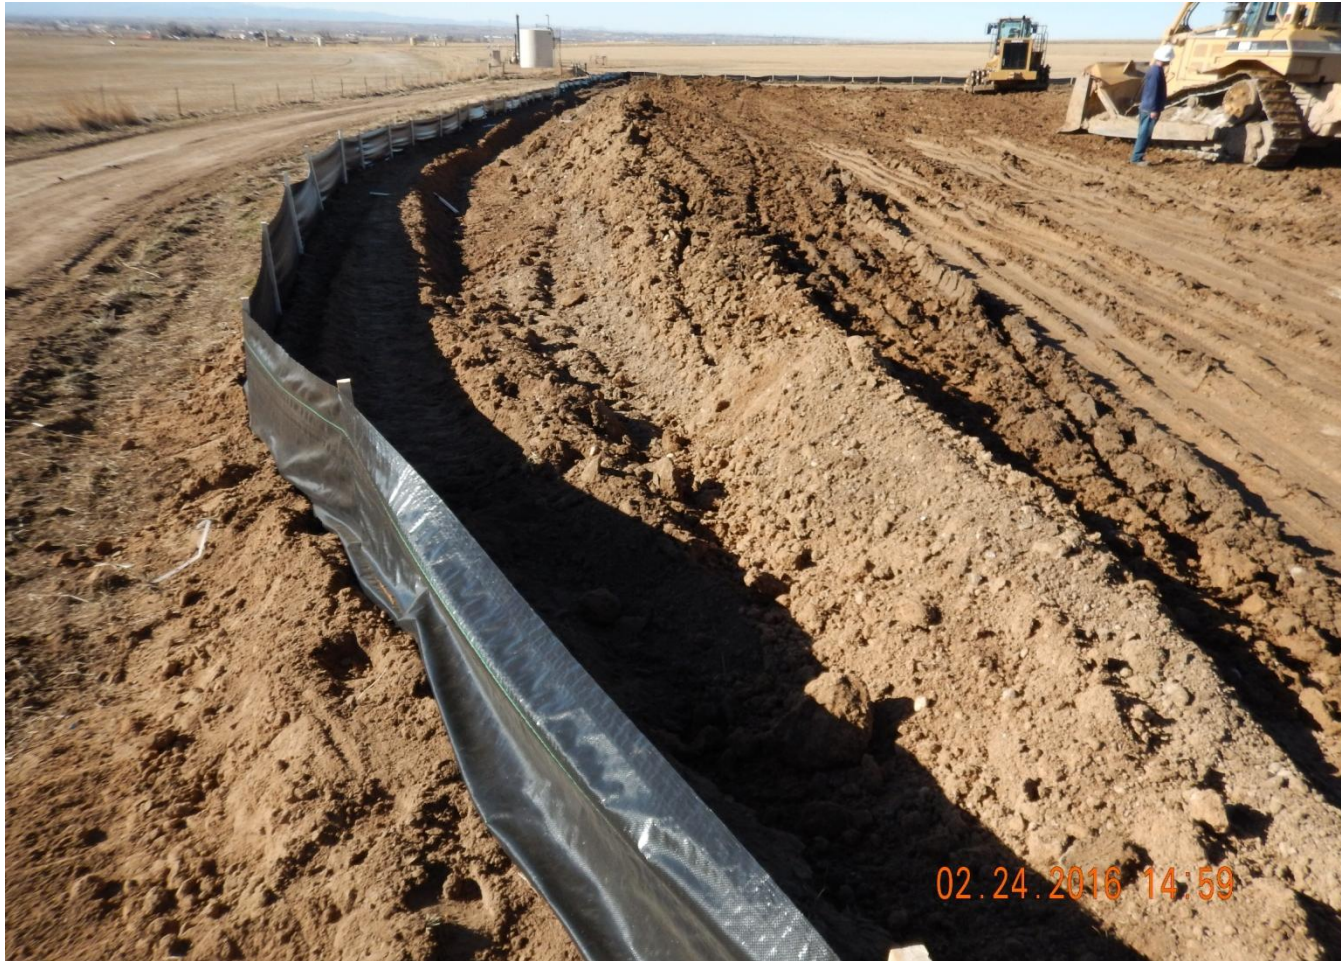
Photo 1. Photo taken from southwest location, facing North. Stormwater and sediment control BMPs installed in center of photo.

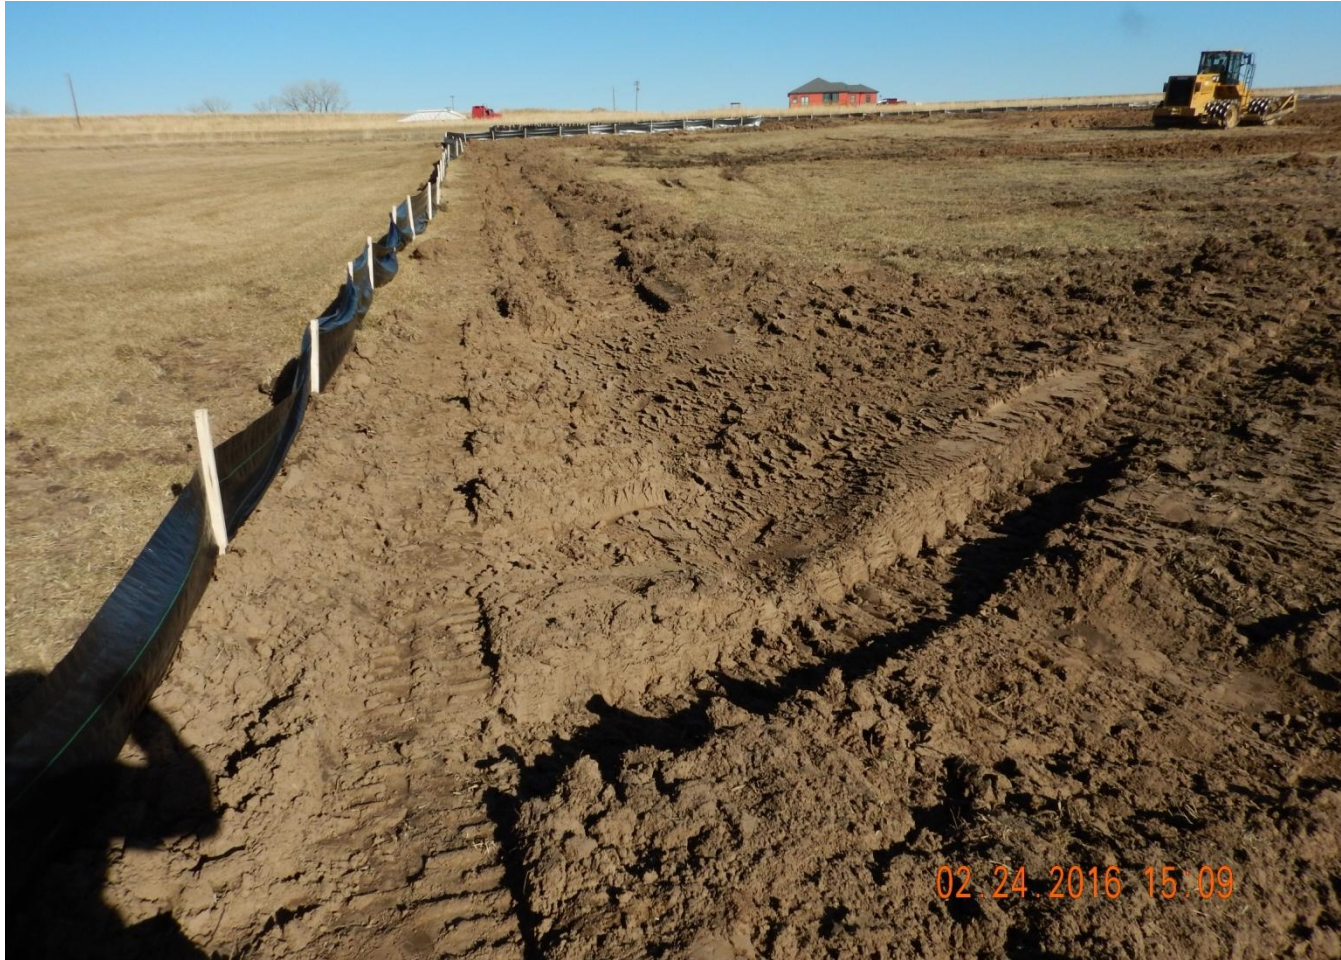
Photo 2. Photo taken from northwest location, facing East. Stormwater and sediment control BMPs installed in center of photo.

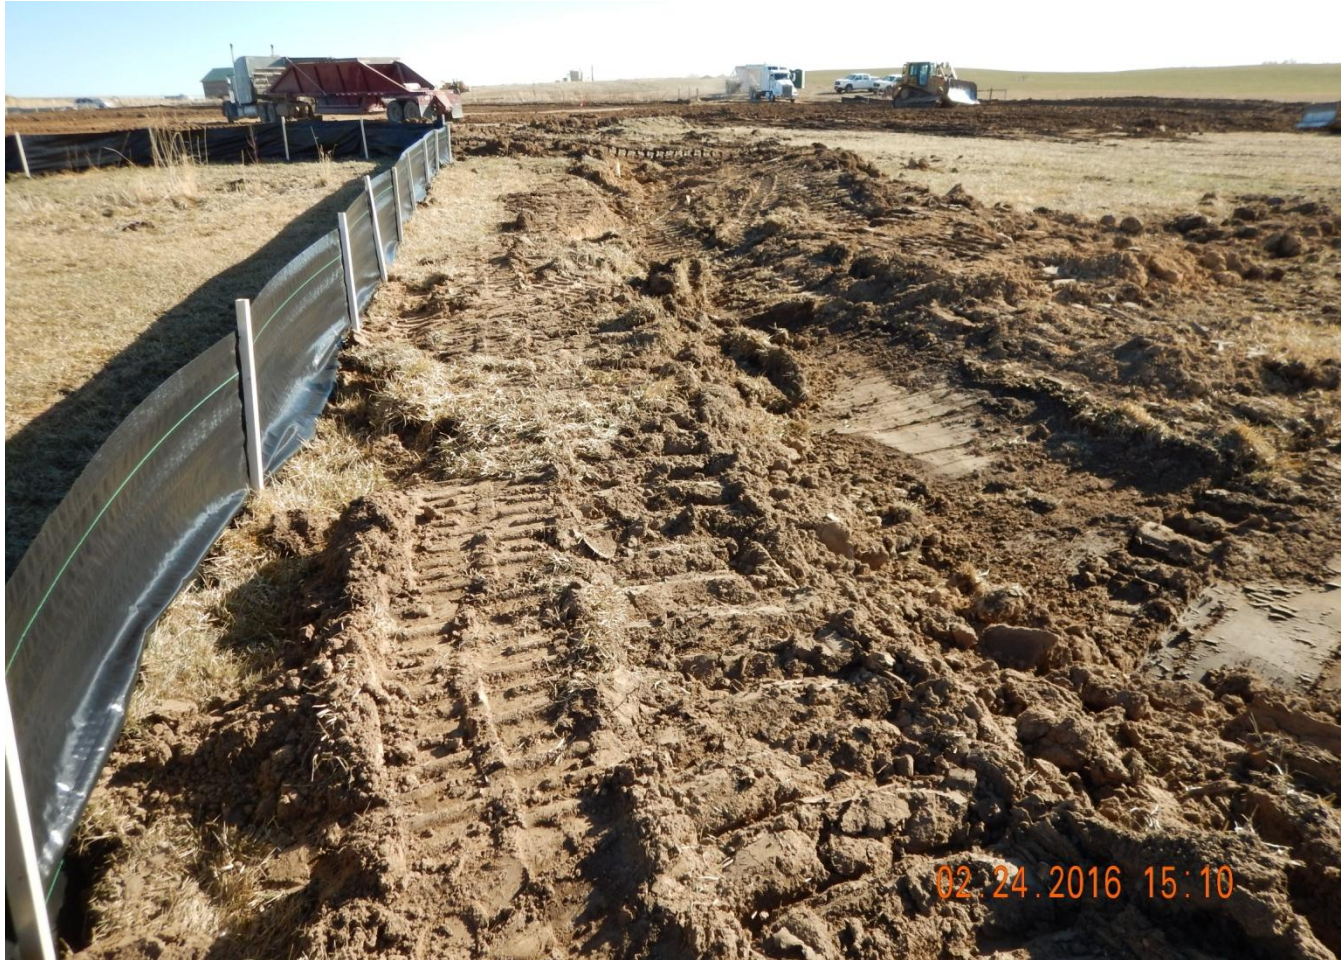
Photo 3. Photo taken from north-central location, facing South. Stormwater and sediment control BMPs installed in center of photo.

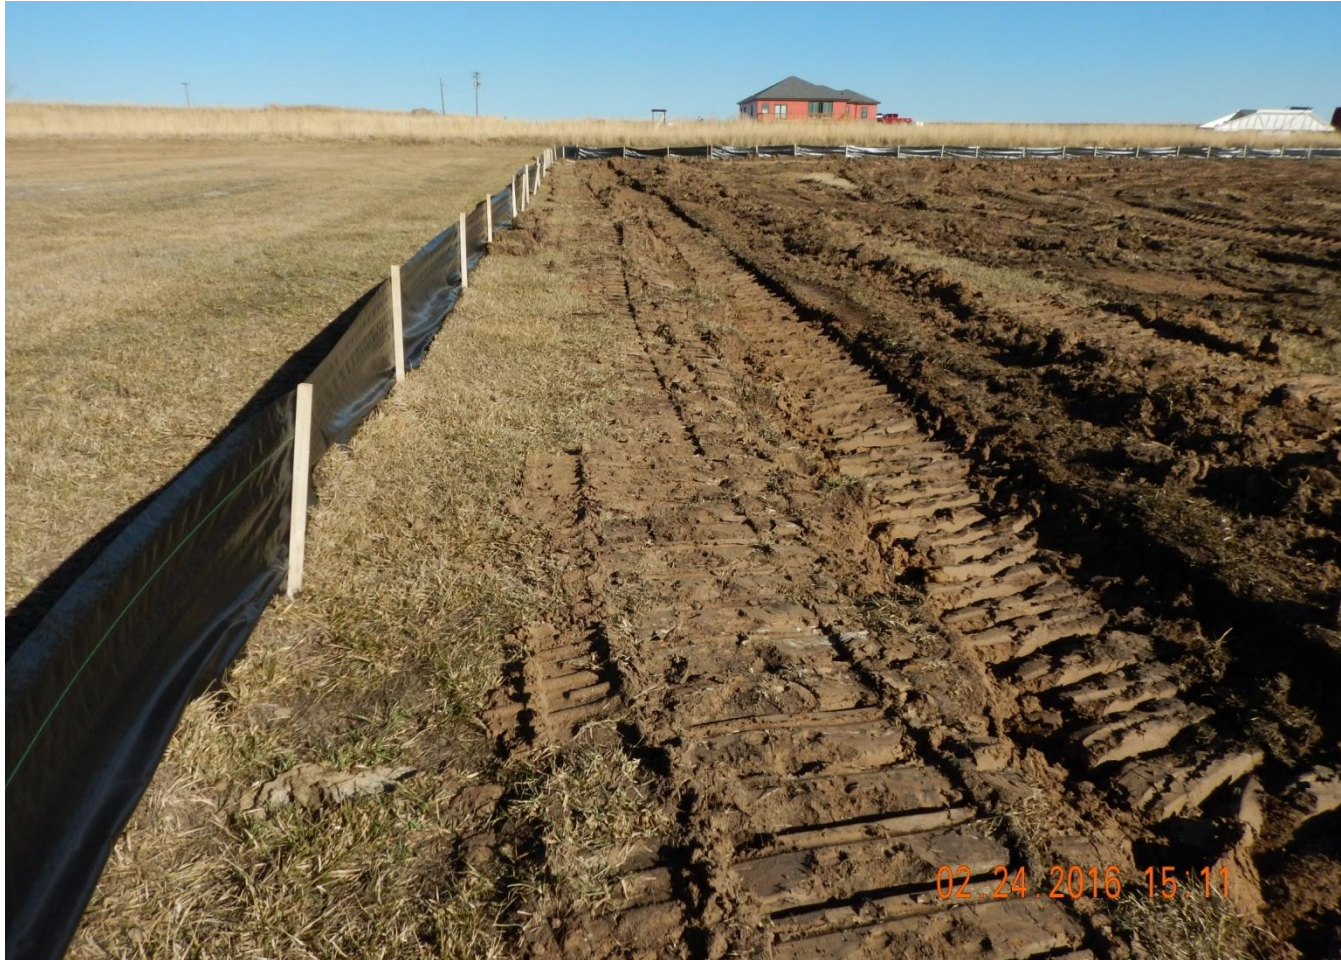
Photo 4. Photo taken from north-central location, facing East. Stormwater and sediment control BMPs installed in center of photo.

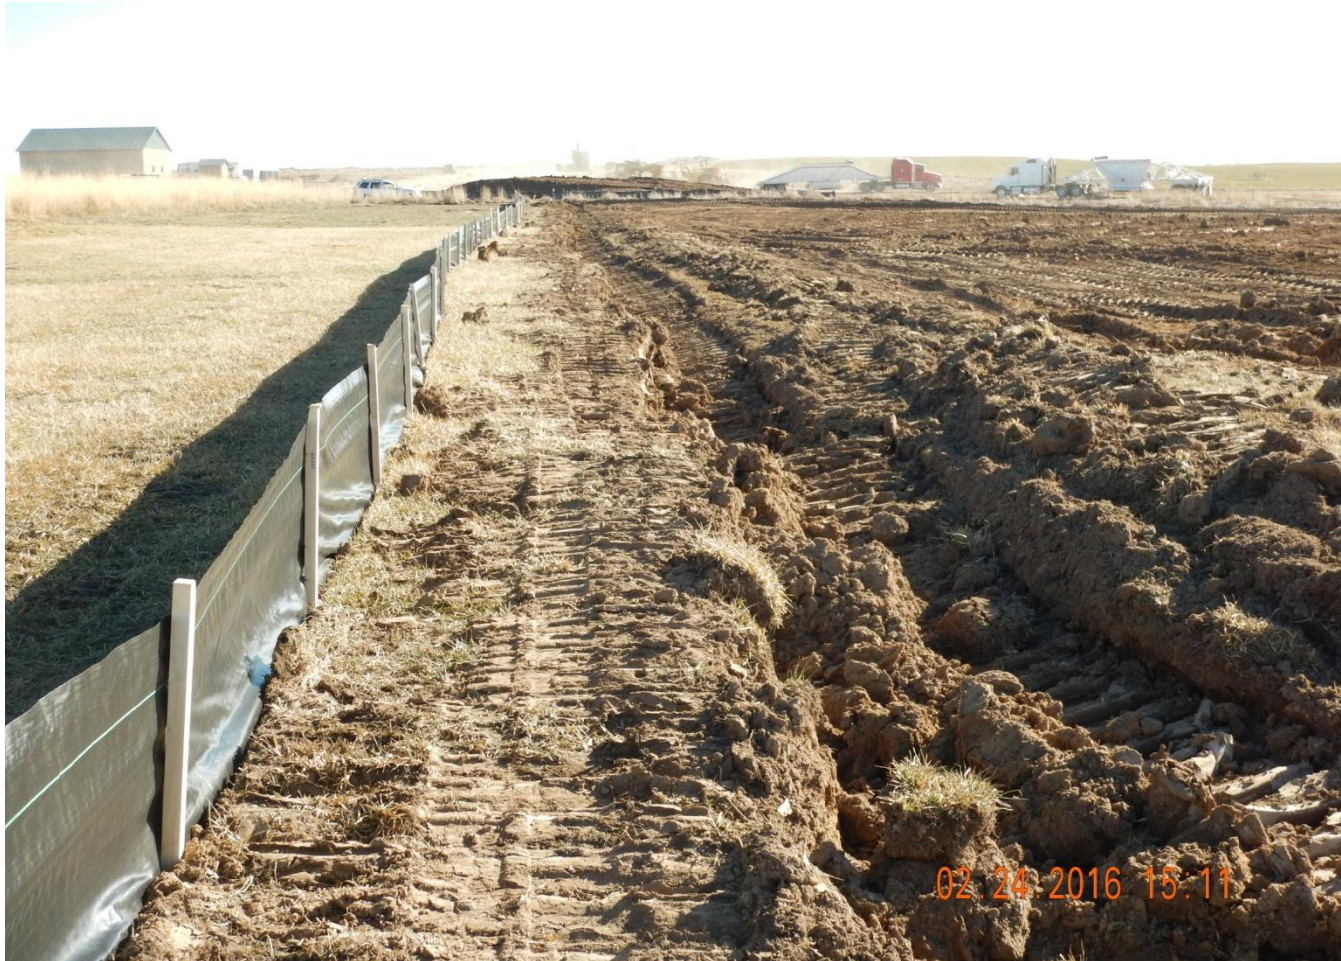
Photo 5. Photo taken from northeast location, facing South. Stormwater and sediment control BMPs installed in center of photo.

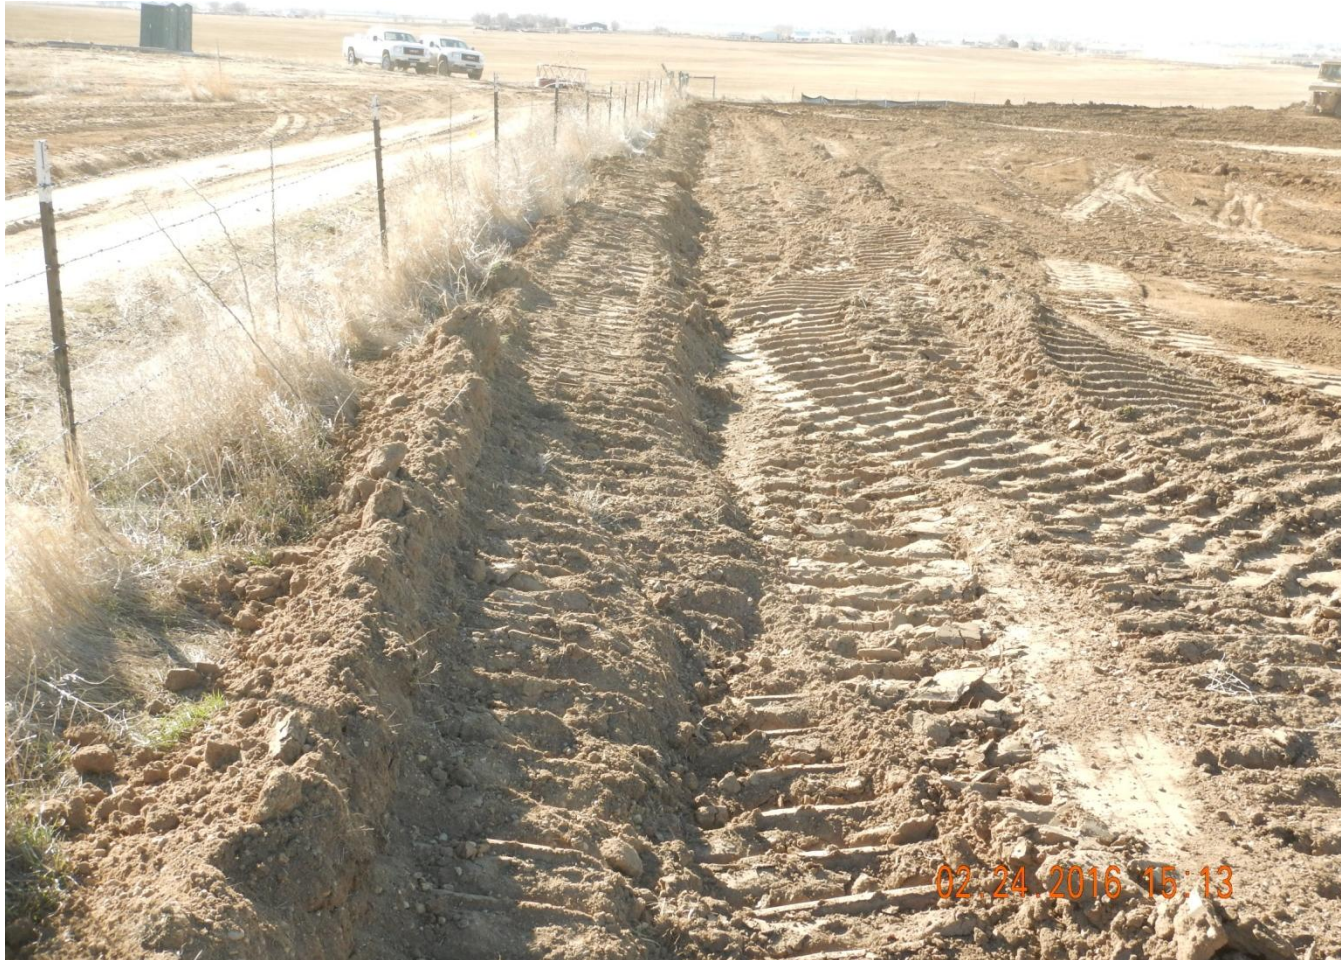
Photo 6. Photo taken from southeast location, facing West. Stormwater and sediment control BMPs installed in center of photo.

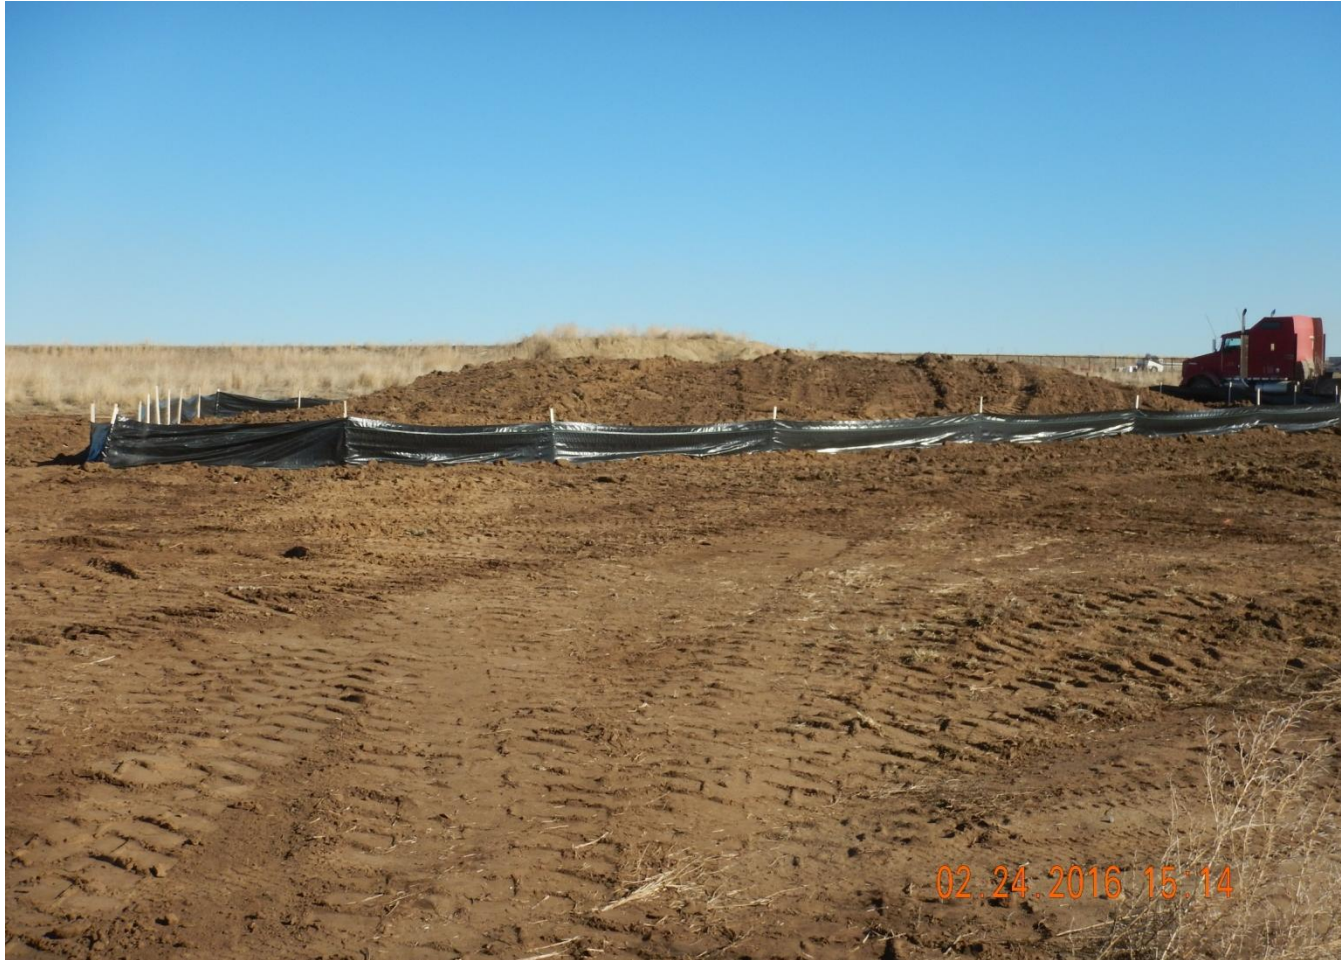
Photo 7. Photo taken from south of well location, facing East. Topsoil stockpile moved south of well location about 30 meters. Sediment control BMPs installed around topsoil stockpile.

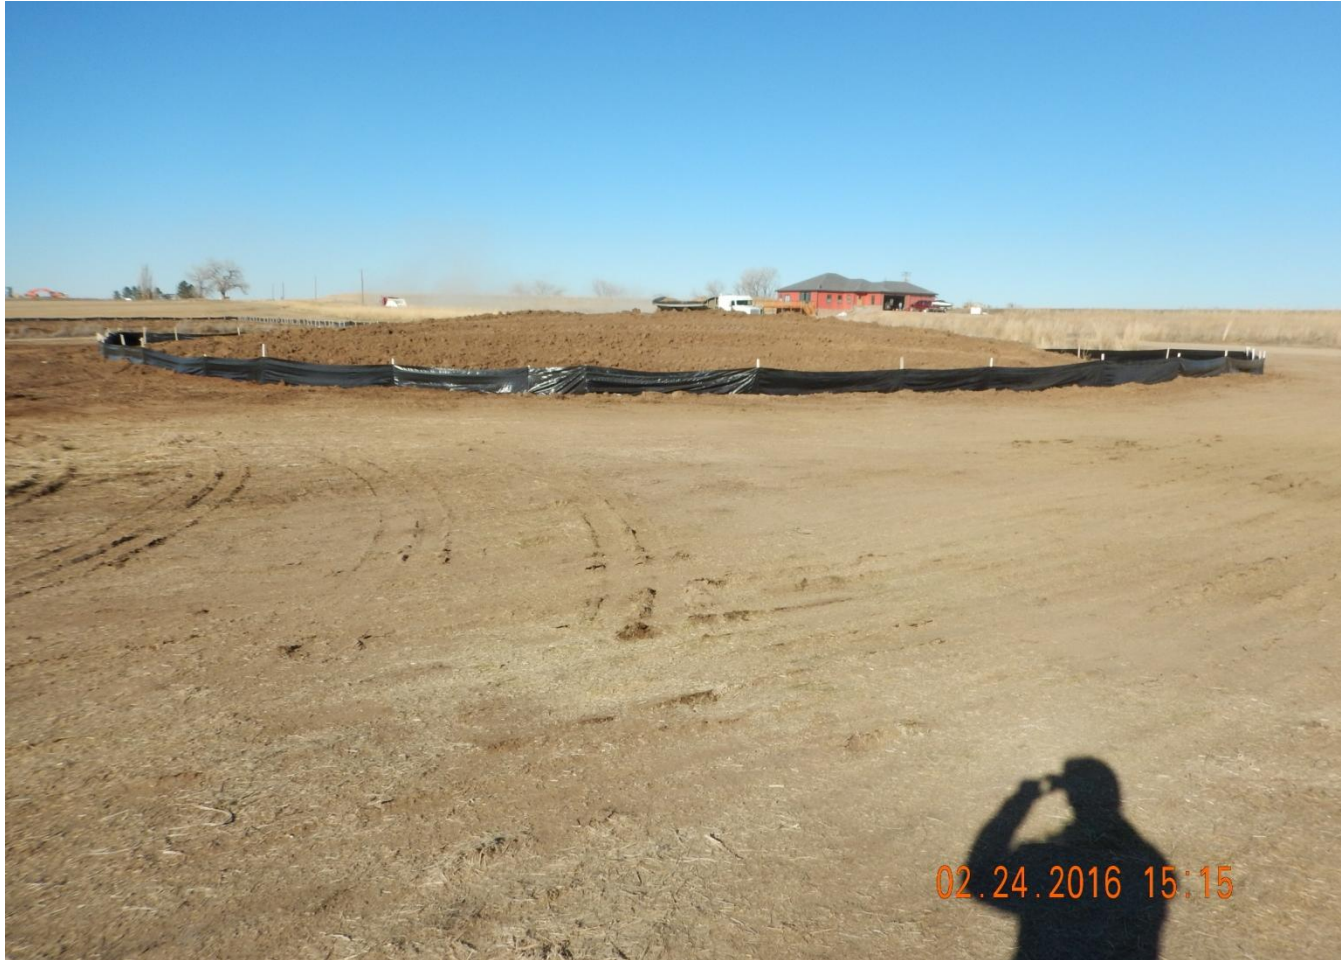
Photo 8. Photo taken from south of well location, facing North. Topsoil stockpile moved south of well location about 30 meters. Sediment control BMPs installed around topsoil stockpile.
