February 25, 2016

Inspection Photos WPX Loc# 335070

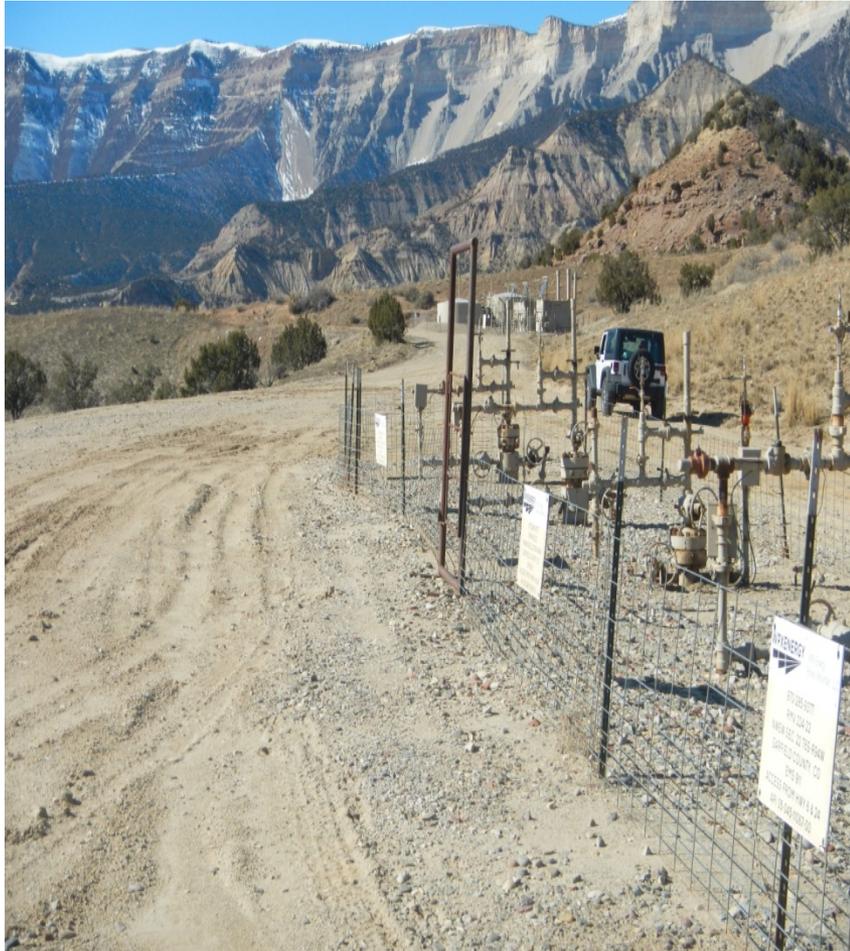
Photo#1:

View West over Location

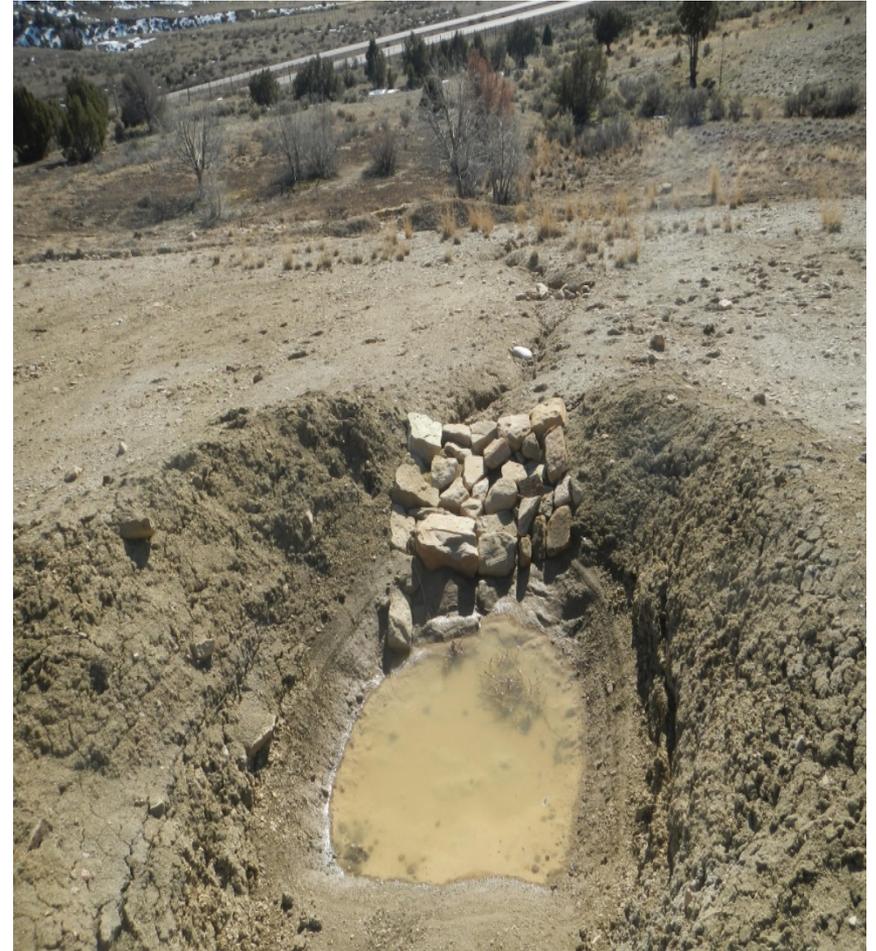
Photo#2:

View Down slope over sediment trap, South to base of Fill Slope

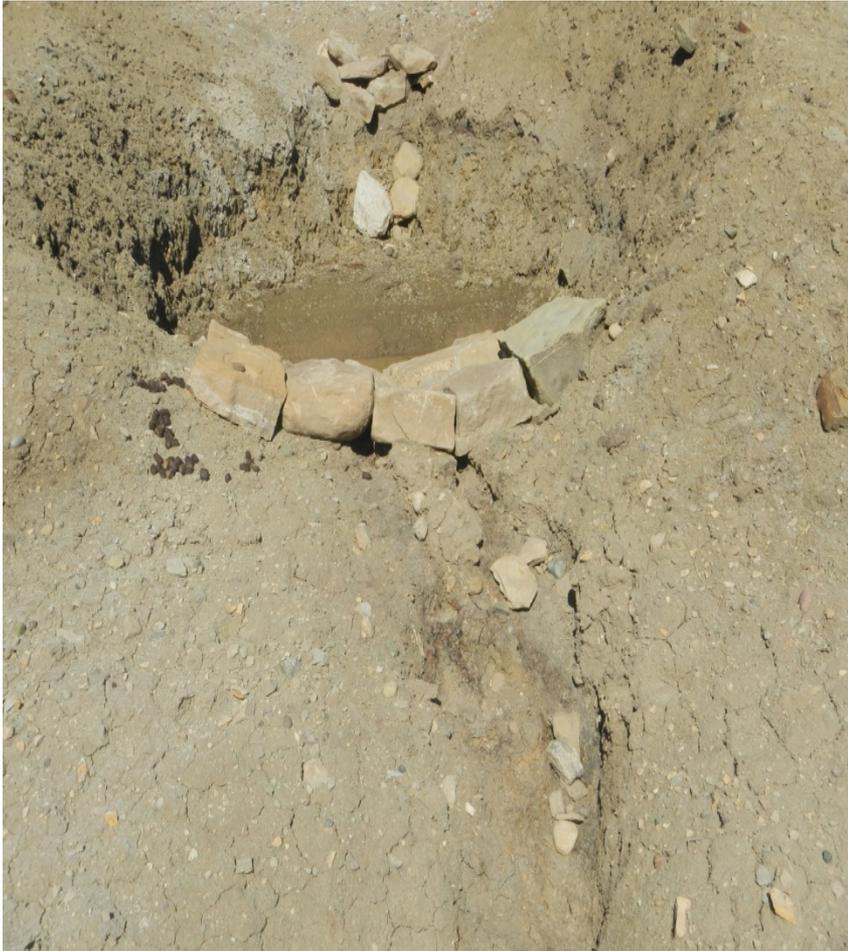
Photo#3:
Sediment Trap, water cutting under Rock

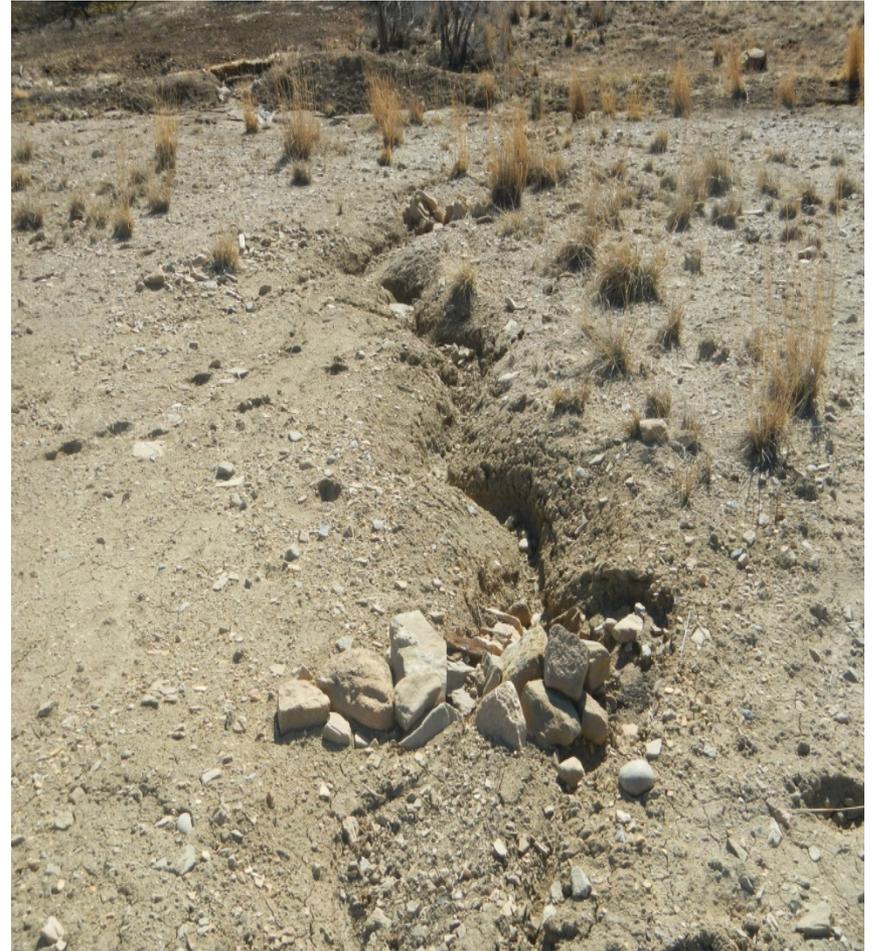
Photo#4:
Channel forming from water exiting Sed Trap

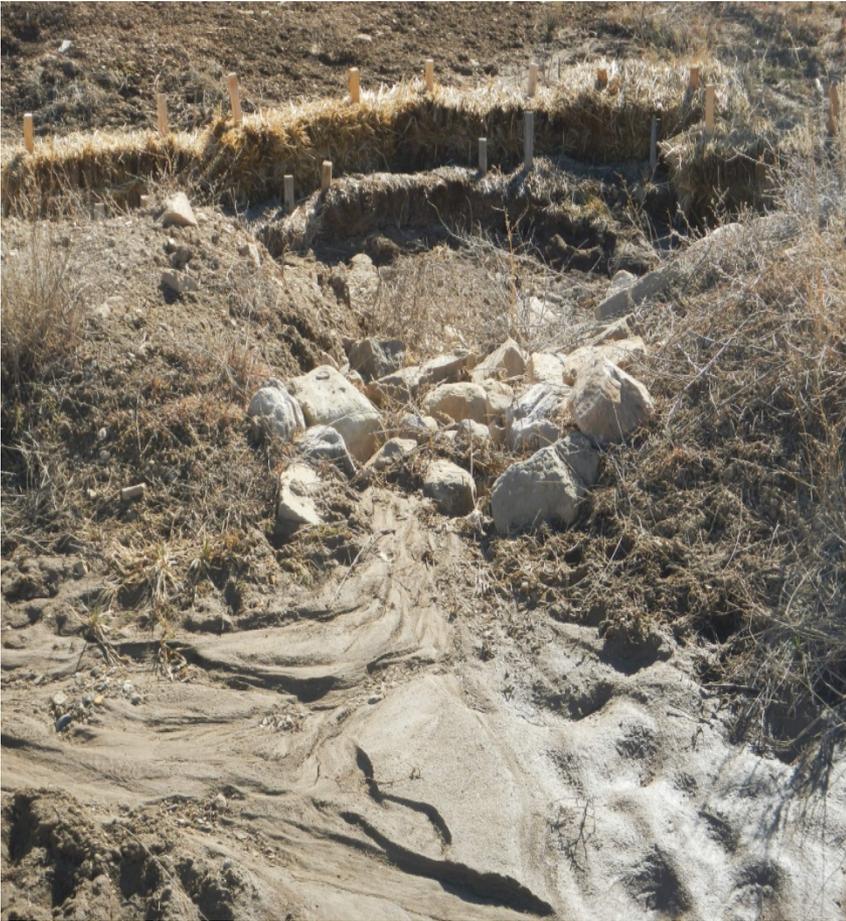
Photo#5:

View of BMPs at base of Fill Slope at South edge of Location

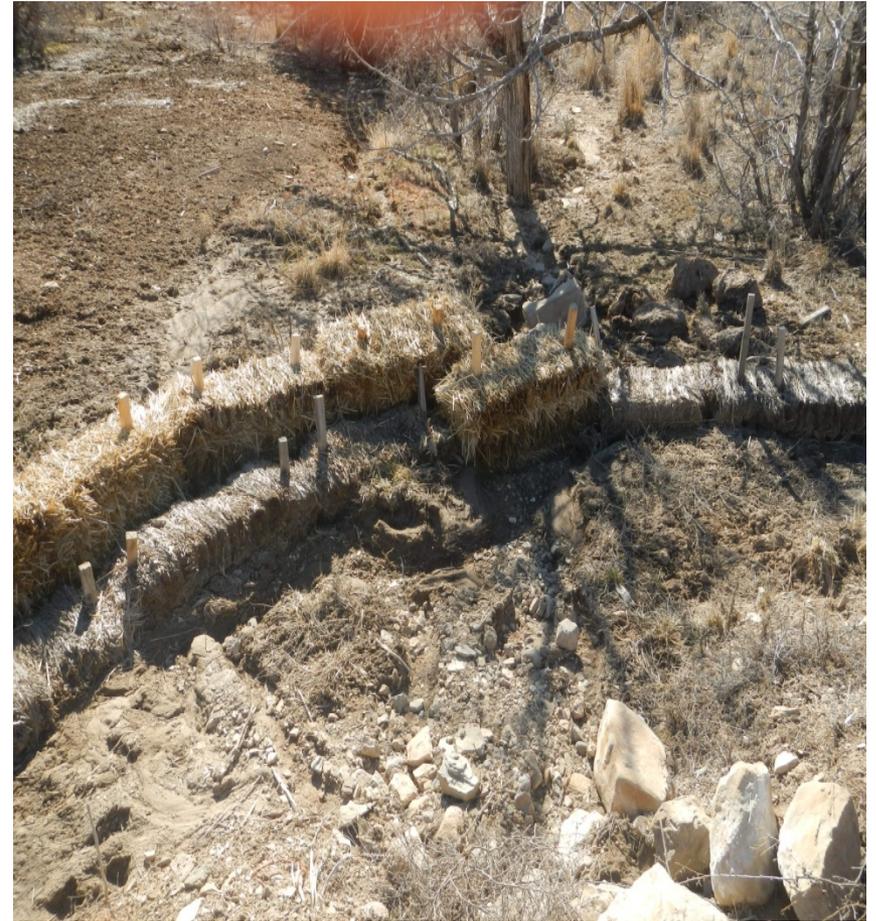
Photo#6:

View of BMPs at base of Fill Slope at South edge of Location

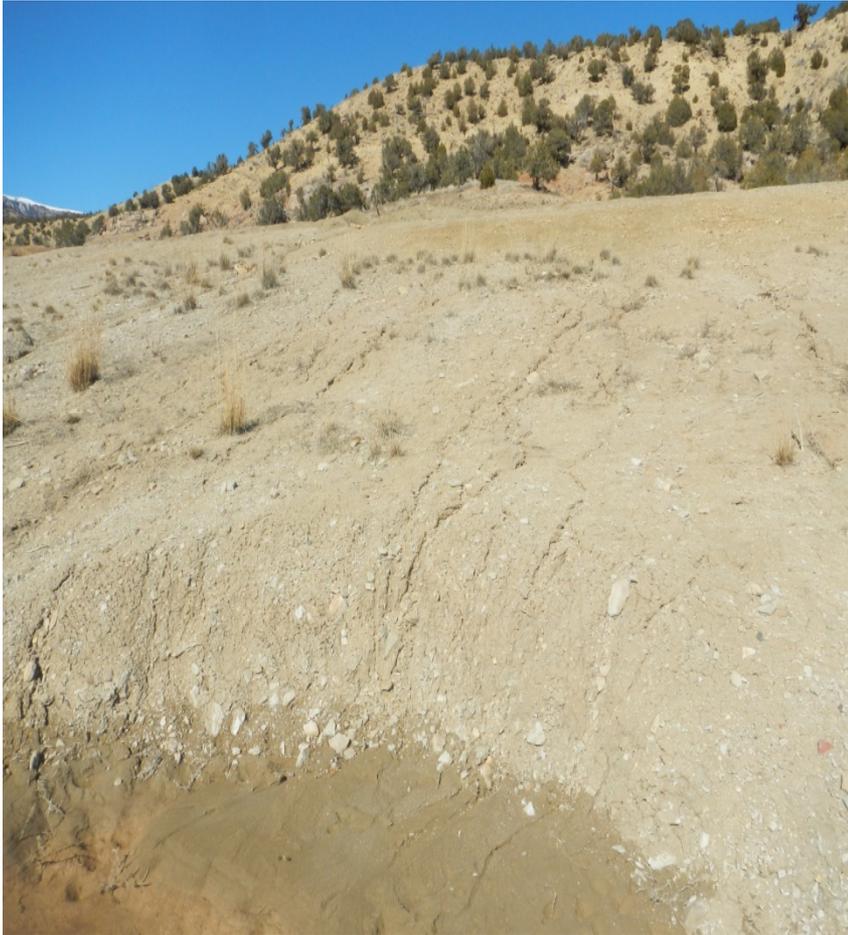
Photo#7:

Rill erosion commencing on Fill Slope.

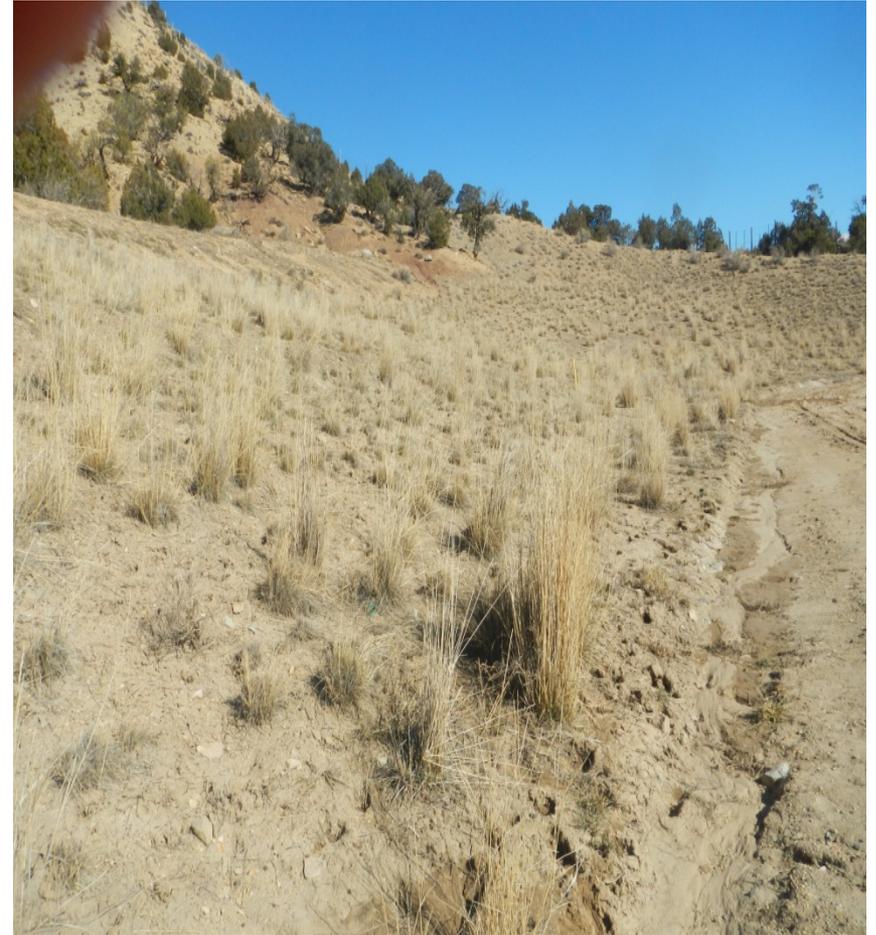
Photo#8:

Fill Slope well stabilized, NE side of Location
