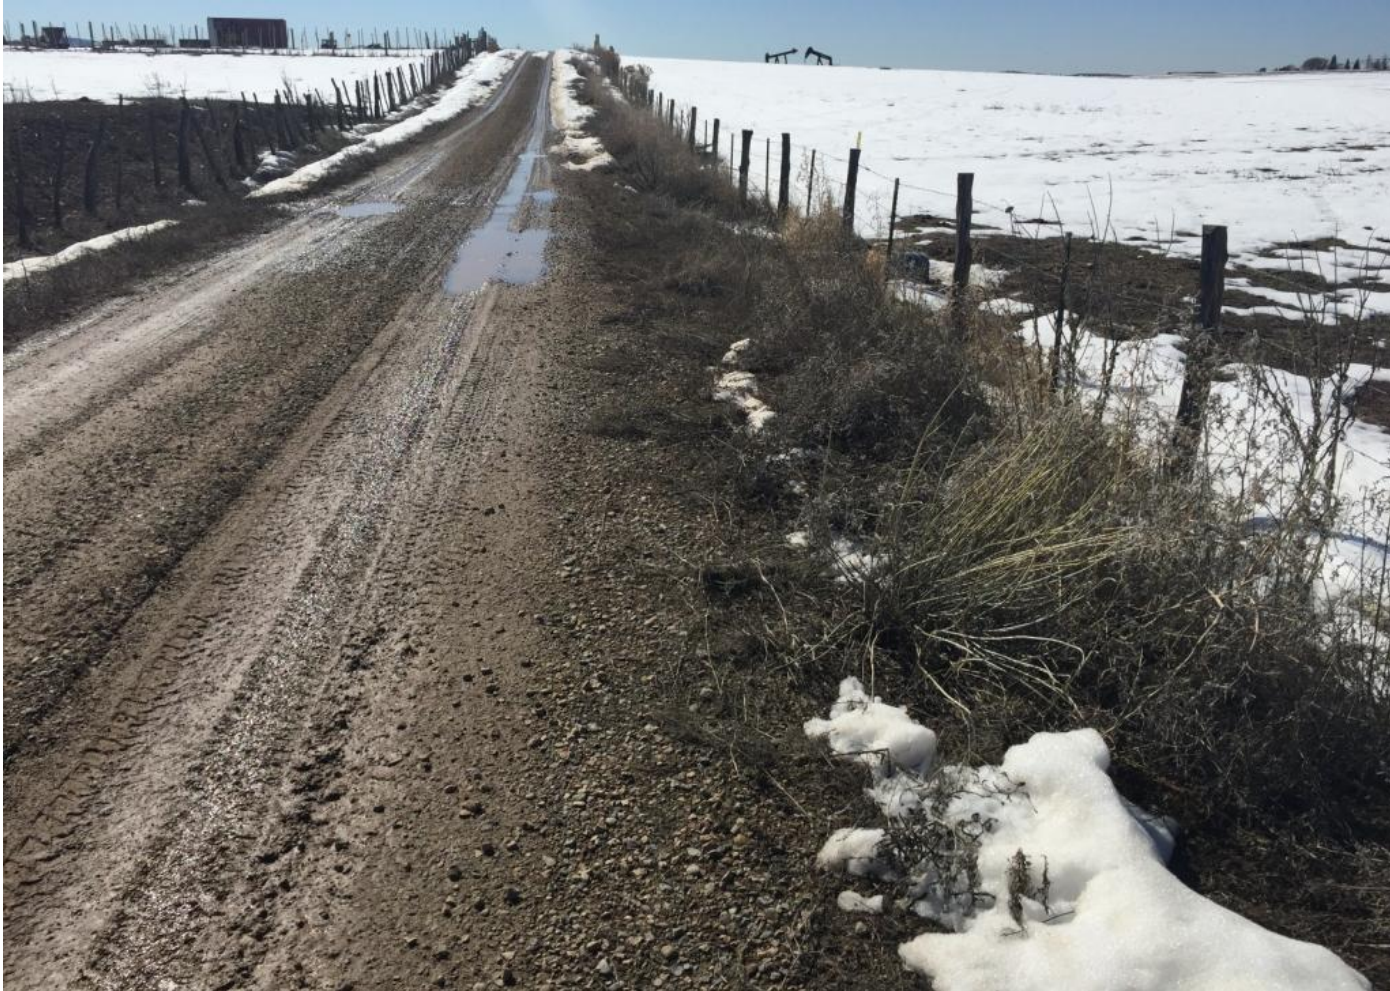
Photo 1. View of the access road facing southward. Roadsides are weedy and musk thistle (*Carduus nutans*) is present and needs control.

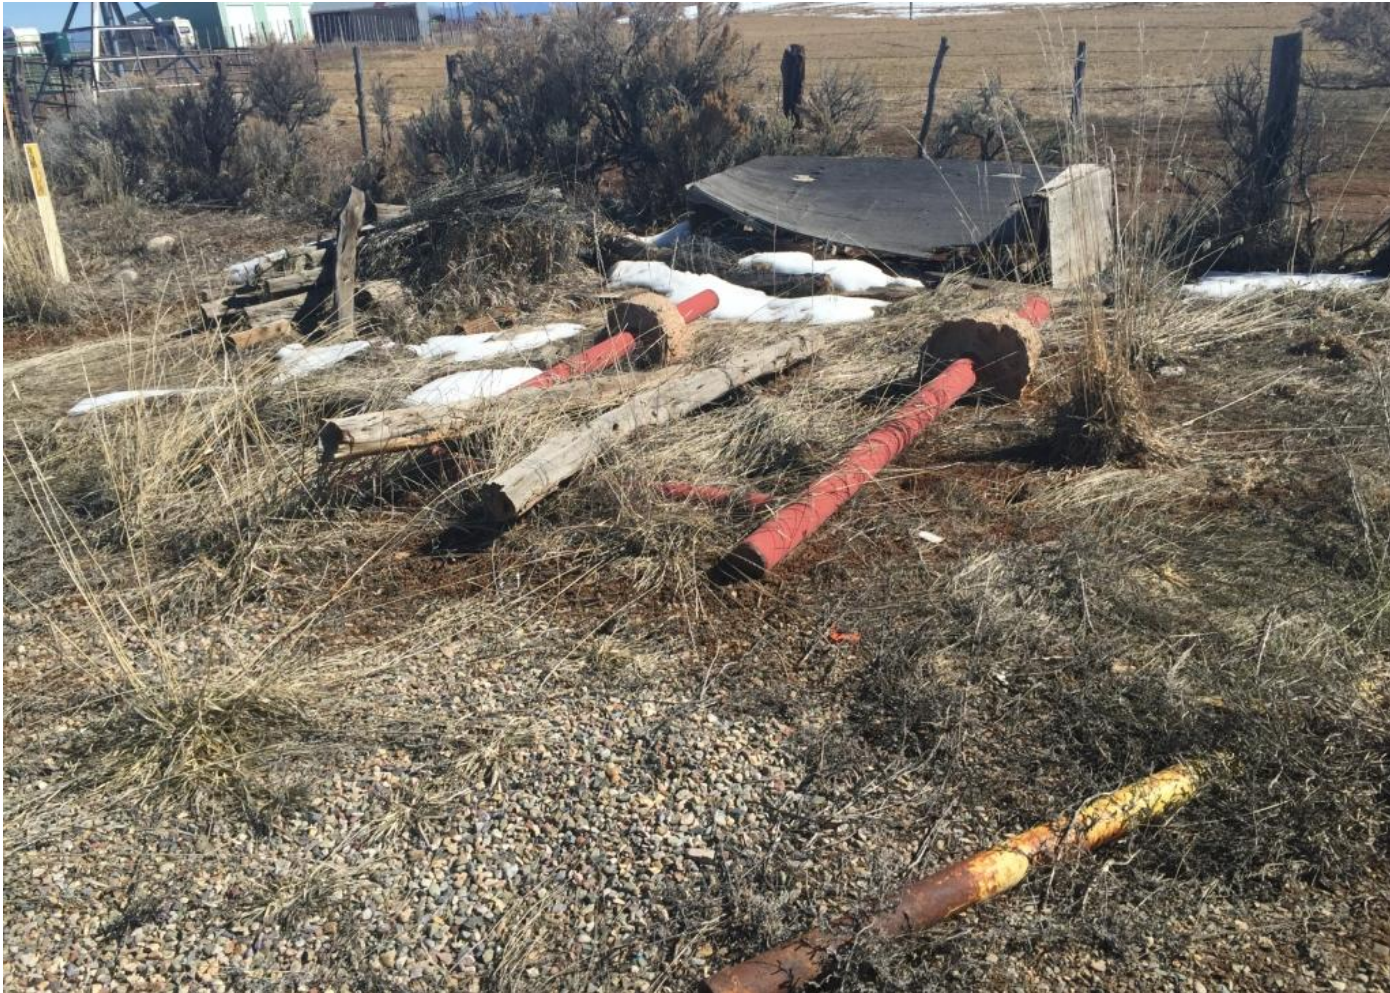
Photo 2. View of fencing debris in the northeastern portion of the project area.

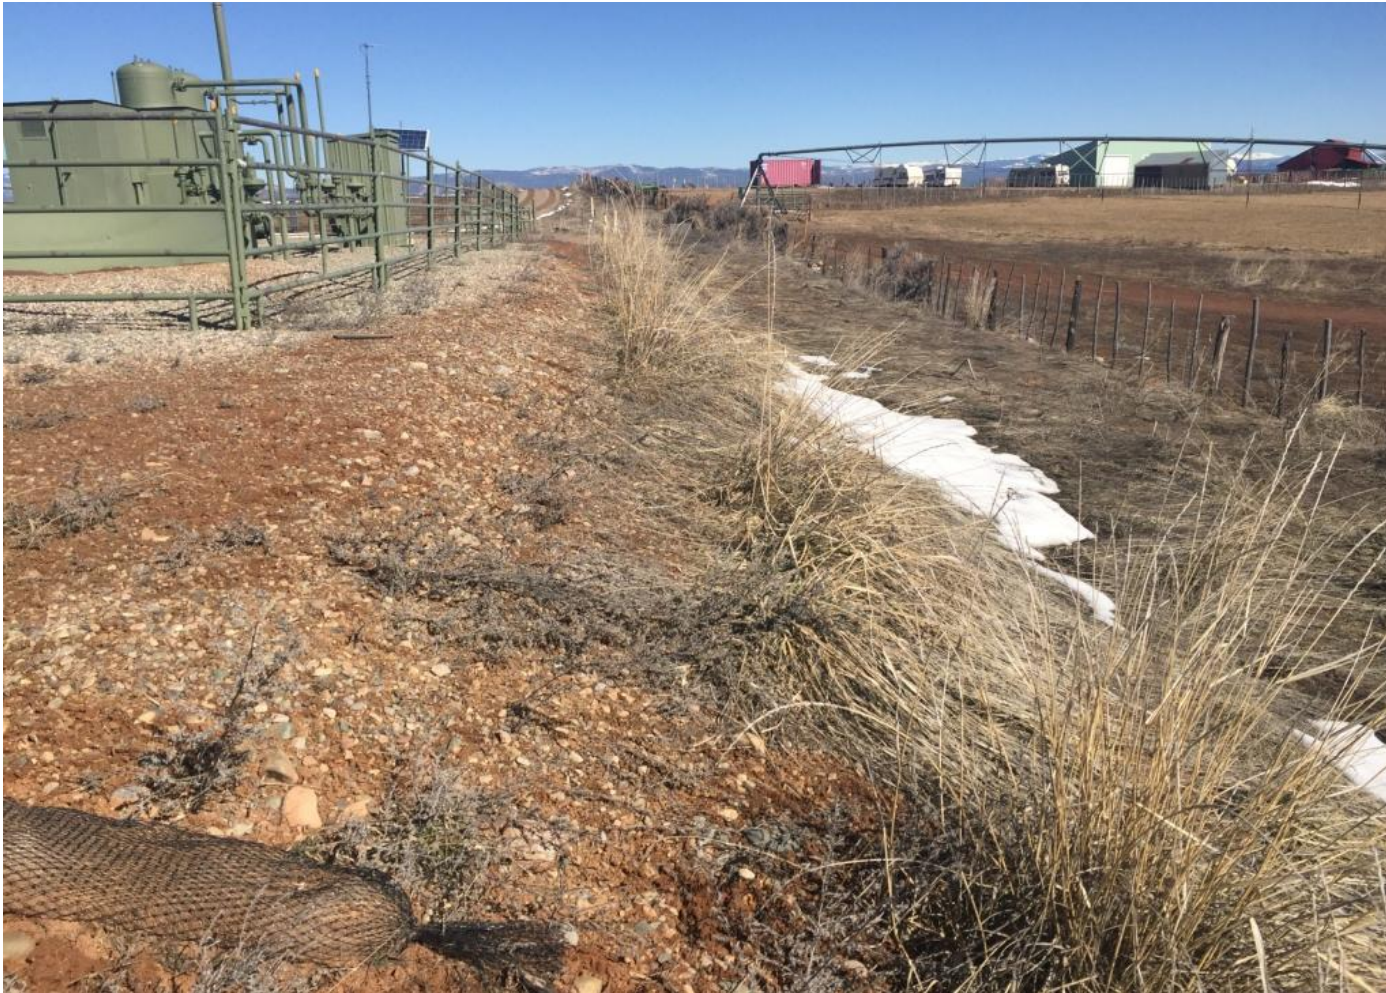
Photo 3. View of the eastern portion of the project area from the southeastern corner facing northward. Revegetation is comprised of re-seed and weedy species such as intermediate wheatgrass (*Thinopyron intermedium*) and Russian thistle (*Salsola tragus*).

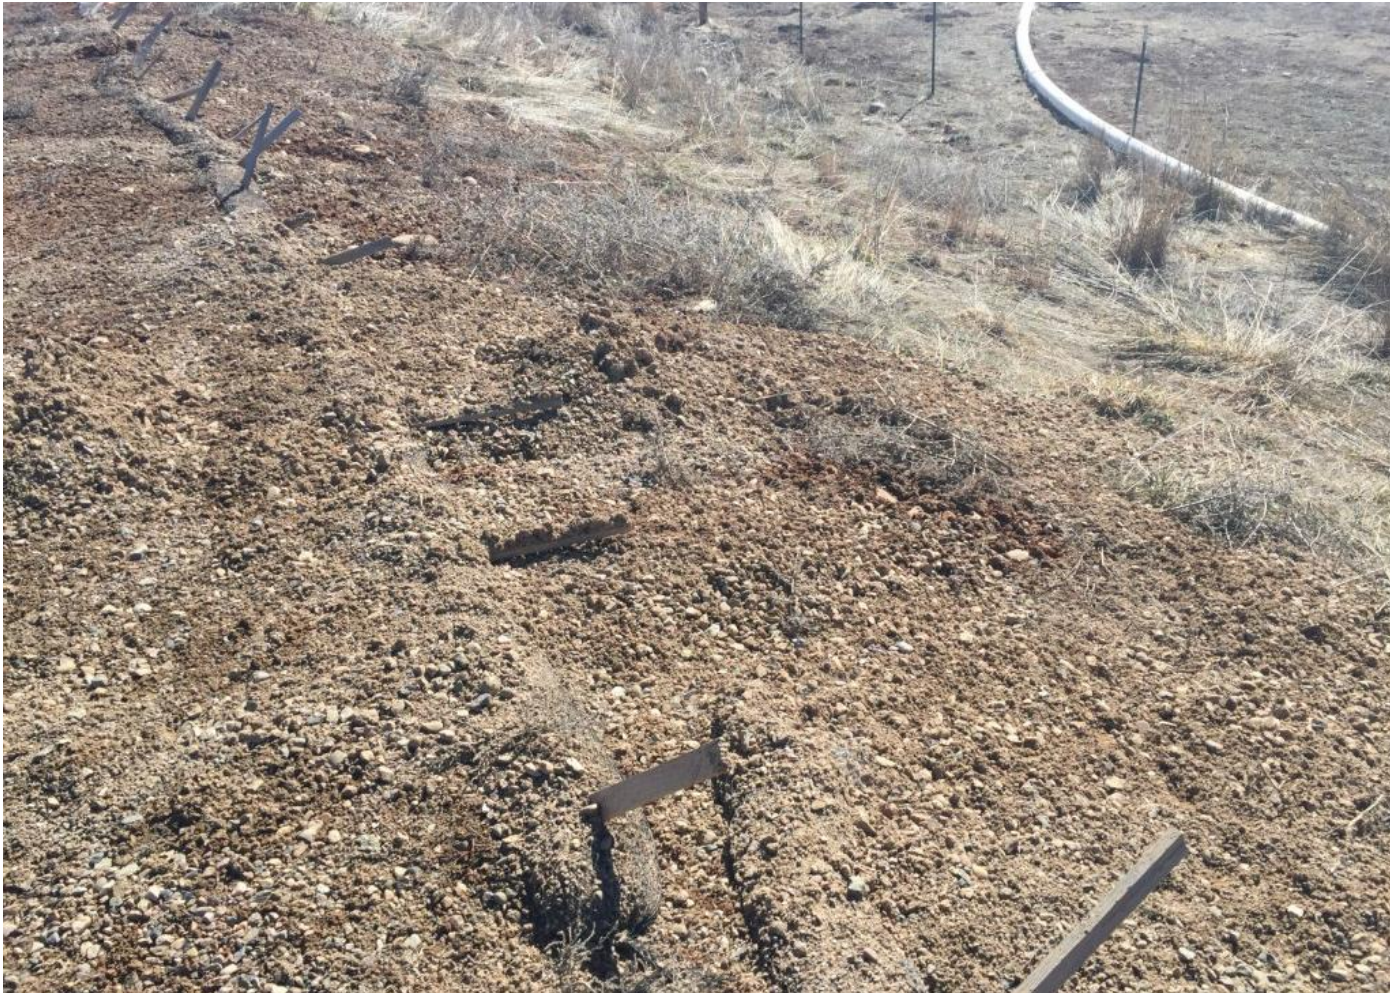
Photo 6. View of fresh disturbance in the southern portion of the project area. This area needs monitoring may need revegetation in fall 2016 if it doesn't revegetate during the 2016 growing season.

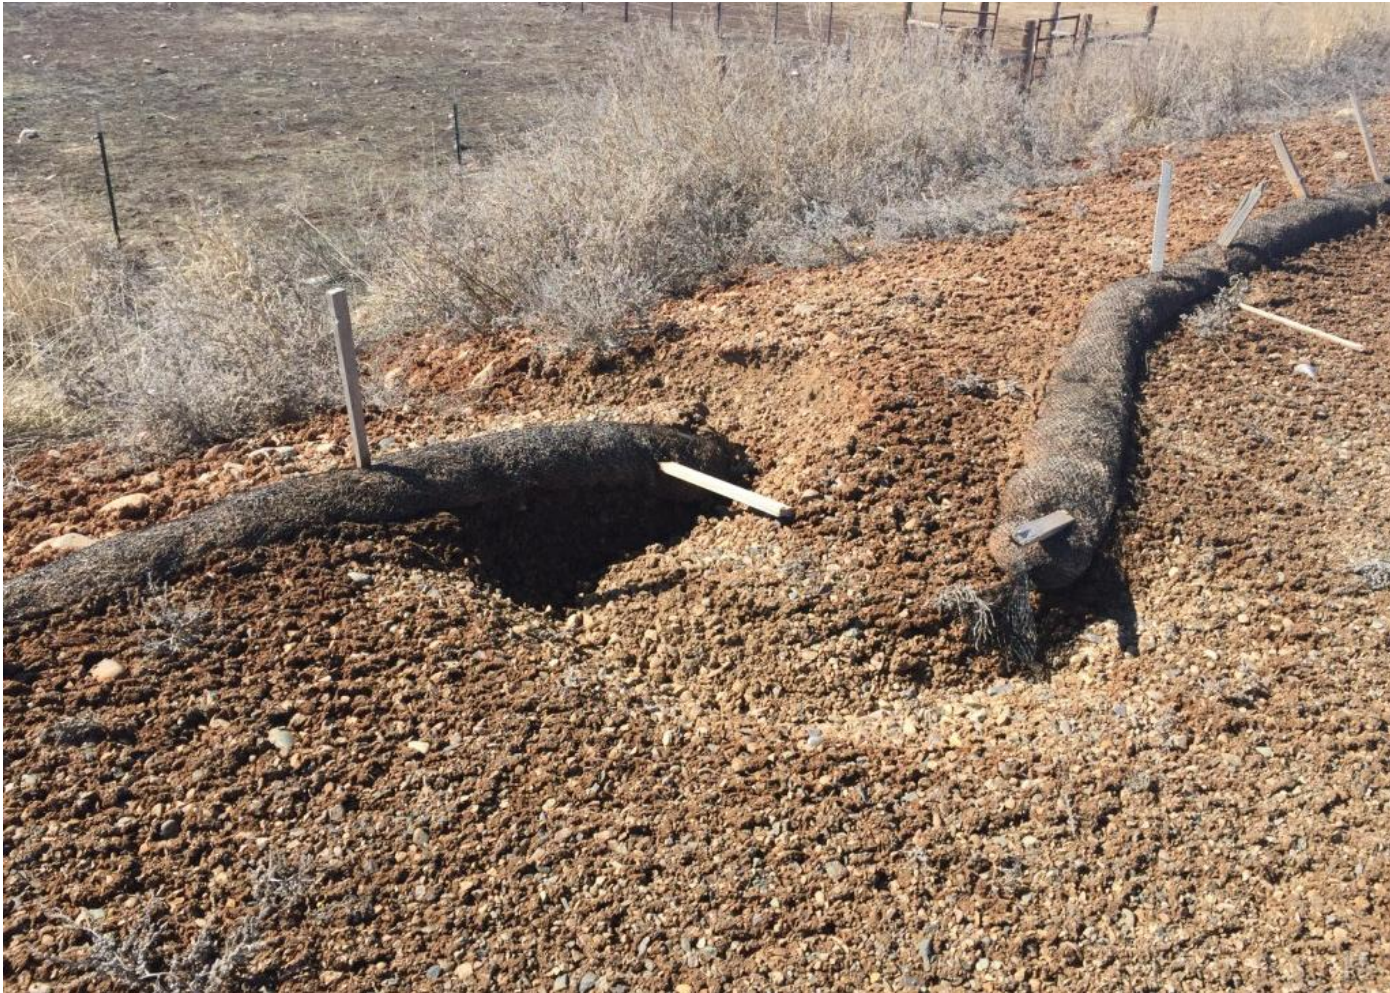
Photo 7. View of stormwater erosion that is occurring in the southern portion of the project area. Wattles need to be repaired and new BMPs may need to be installed.
