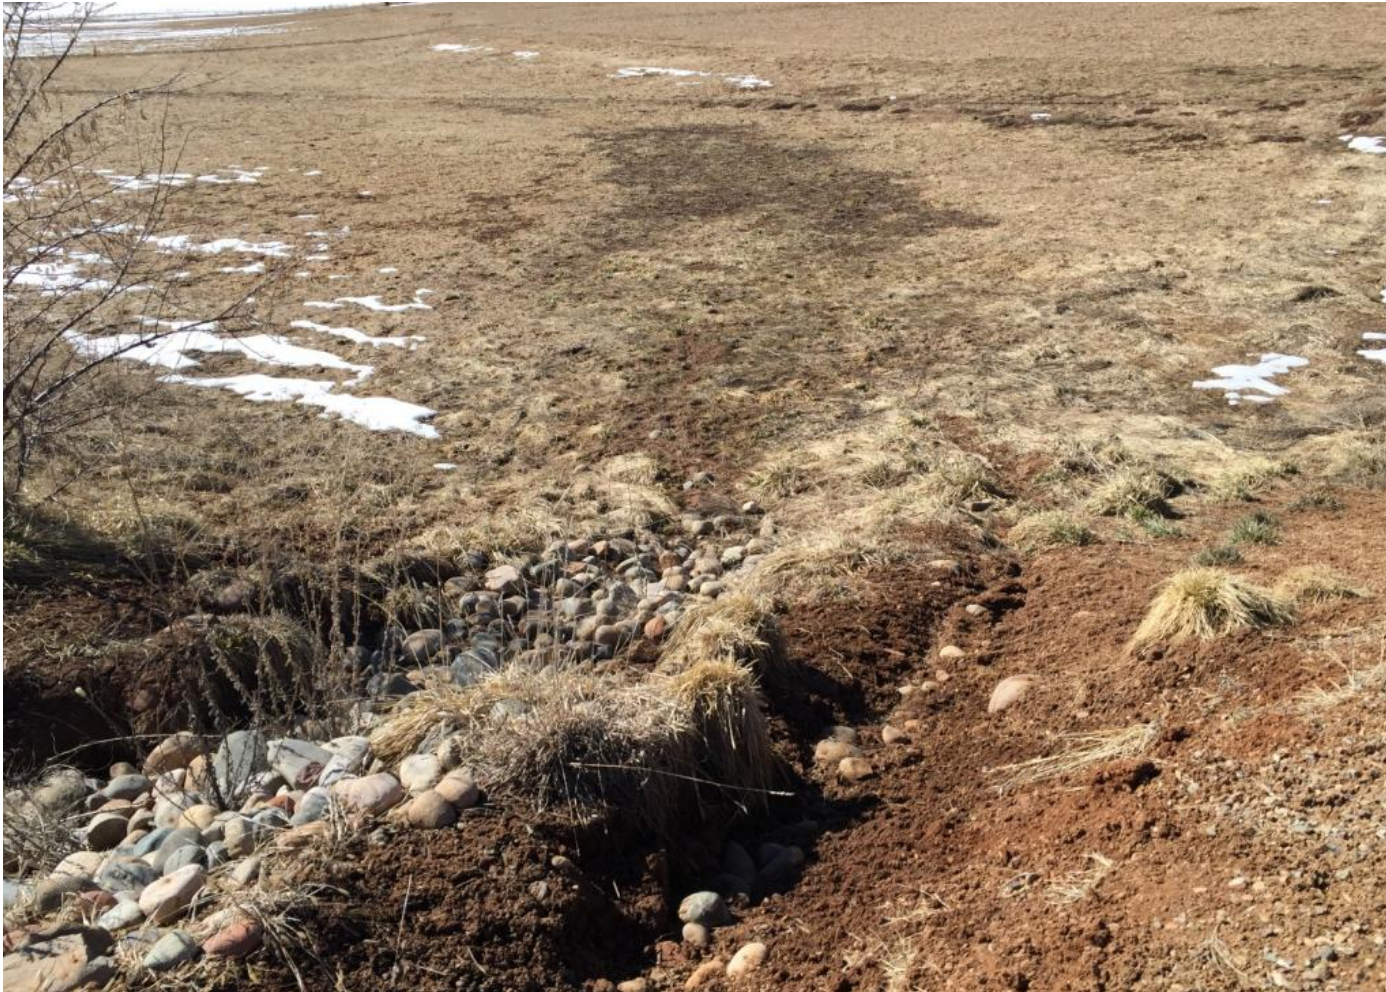
Photo 1. View of stormwater erosion occurring at the well pad entrance, south of the access road. It is unclear if cobble lined channel was recently stabilized or if it needs additional stabilization. The channel on the right does not appear stabilized and needs BMPs.

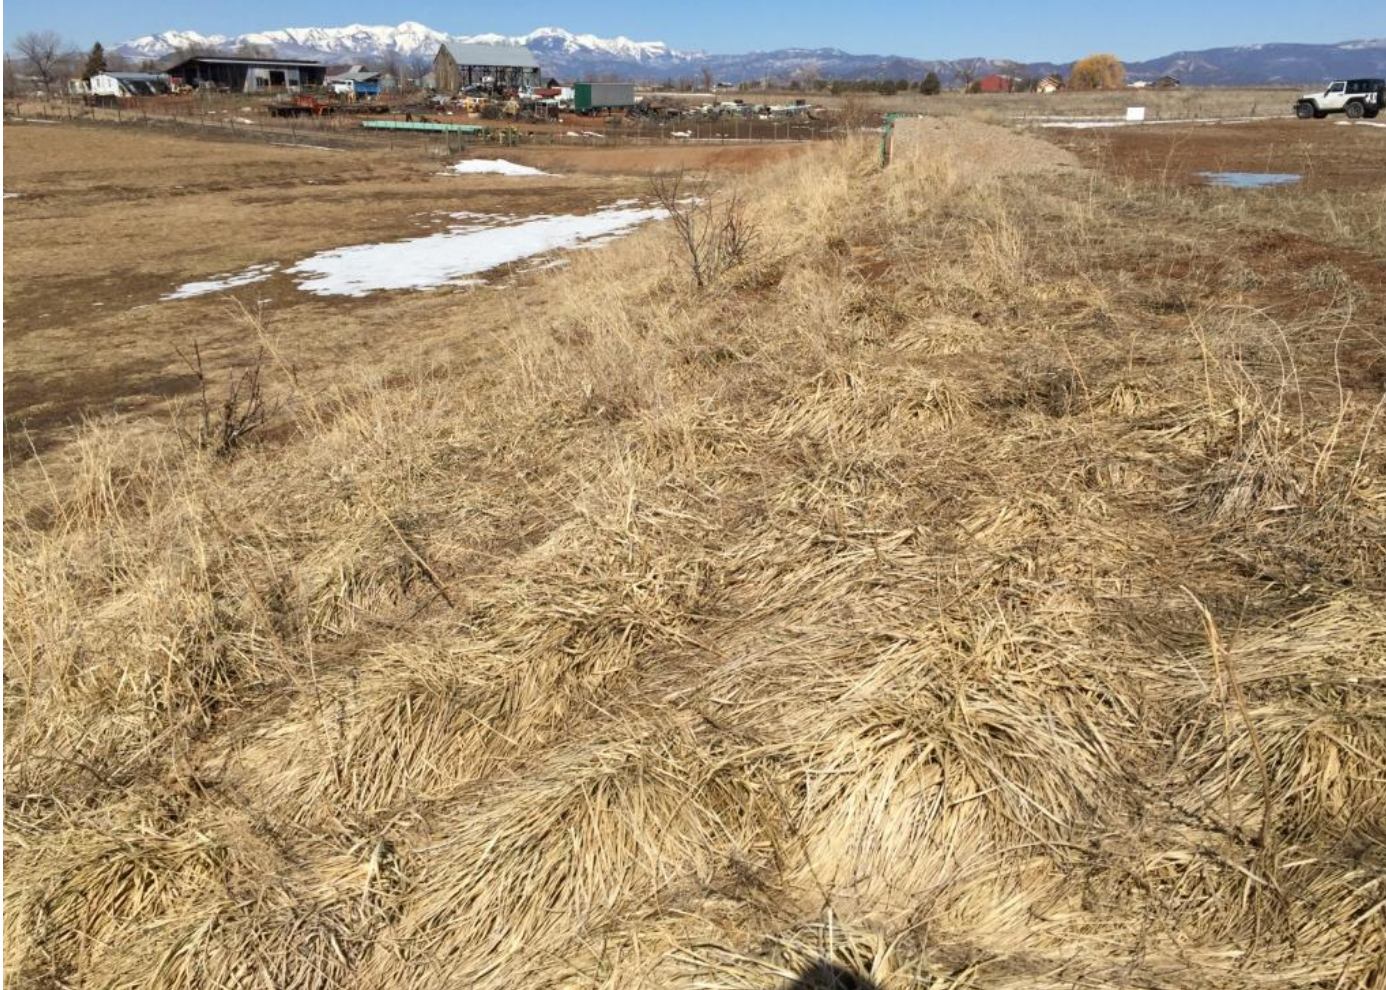
Photo 3. View of the western portion of the project area from the southwestern corner facing northward. Revegetation is progressing here with intermediate wheatgrass (*Thinopyron intermedium*) and dropseed (*Sporobolus* sp.) as well as weeds such as chicory (*Cichorium intybus*) and kochia (*Kochia scoparia*).

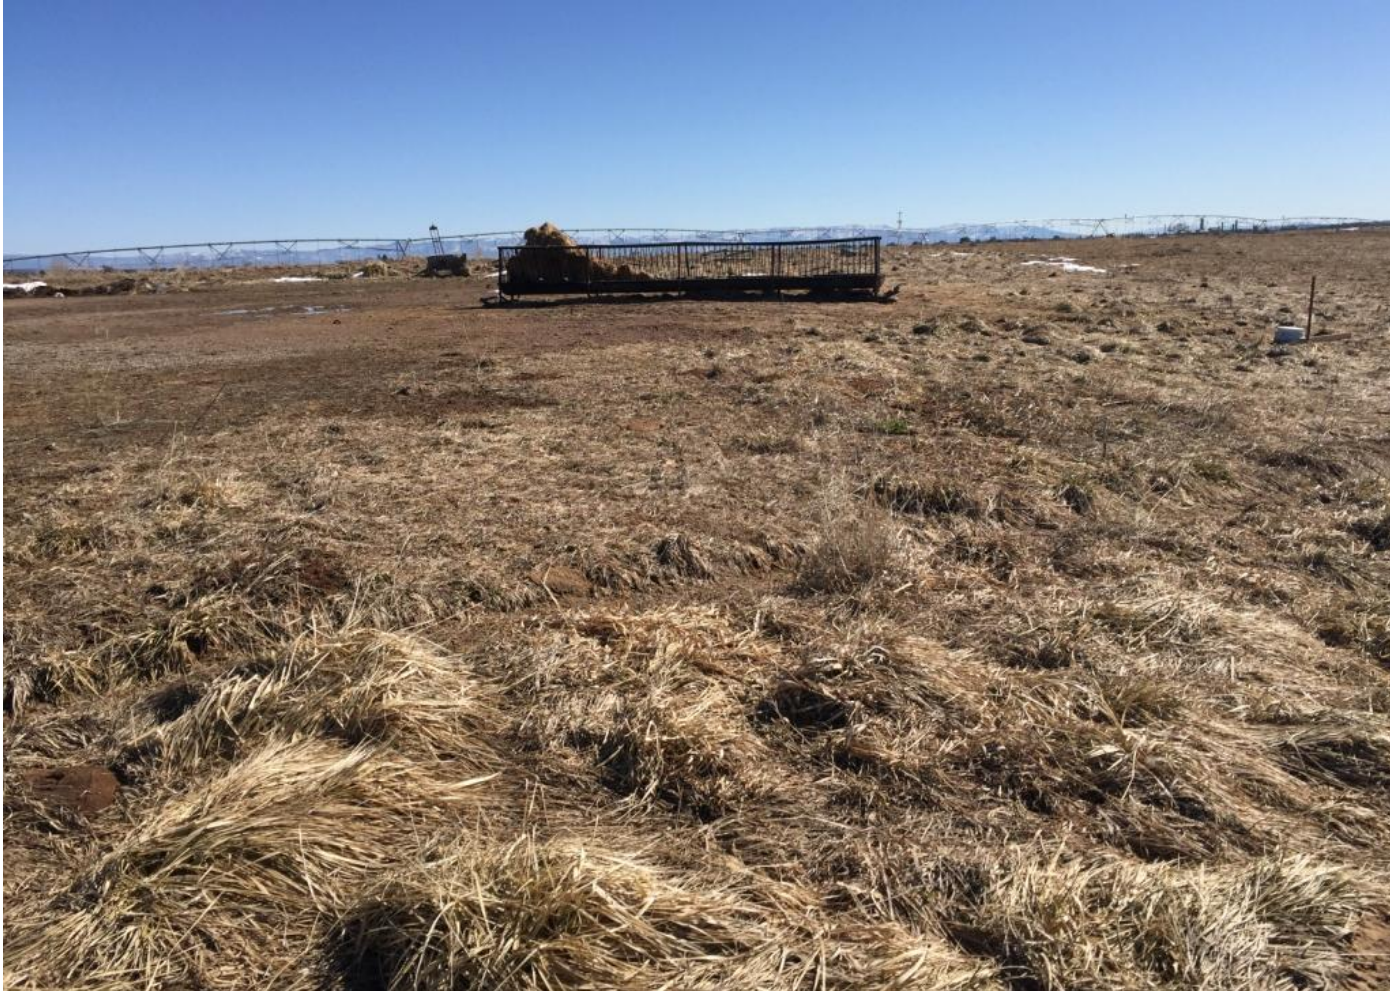
Photo 5. View of the southern portion of the project area from the southwestern corner facing eastward. Salt licks and cattle feeding trough are present.
