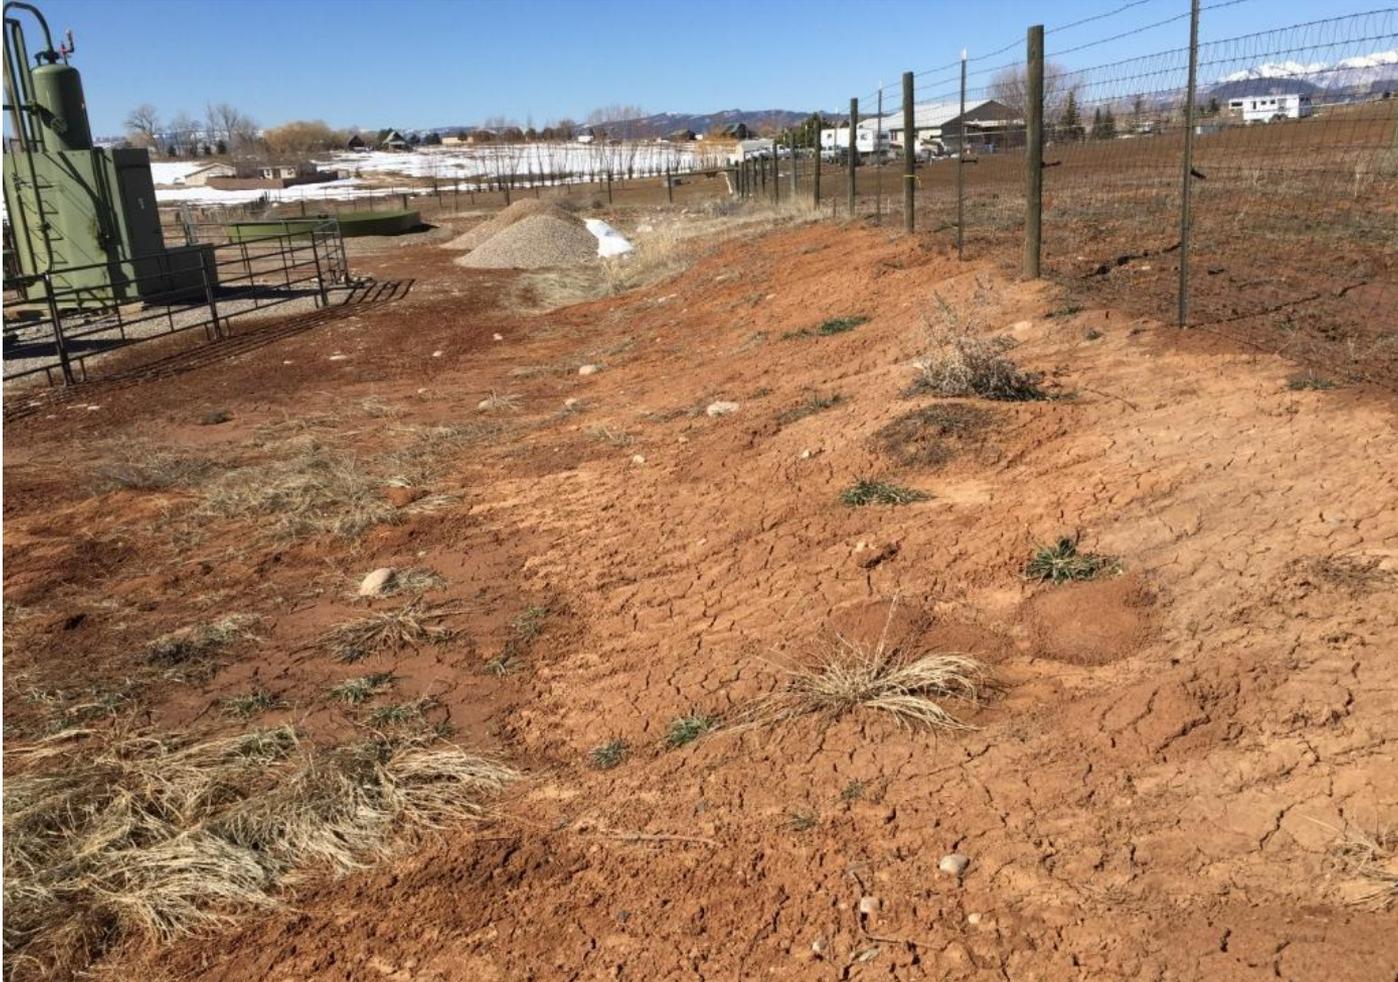
Photo 1. View of the northern portion of the project area from the northeastern corner facing westward. Poor revegetation along slopes needs to be monitored and re-seeded in fall 2016 if it is not progressing during the 2016 growing season.

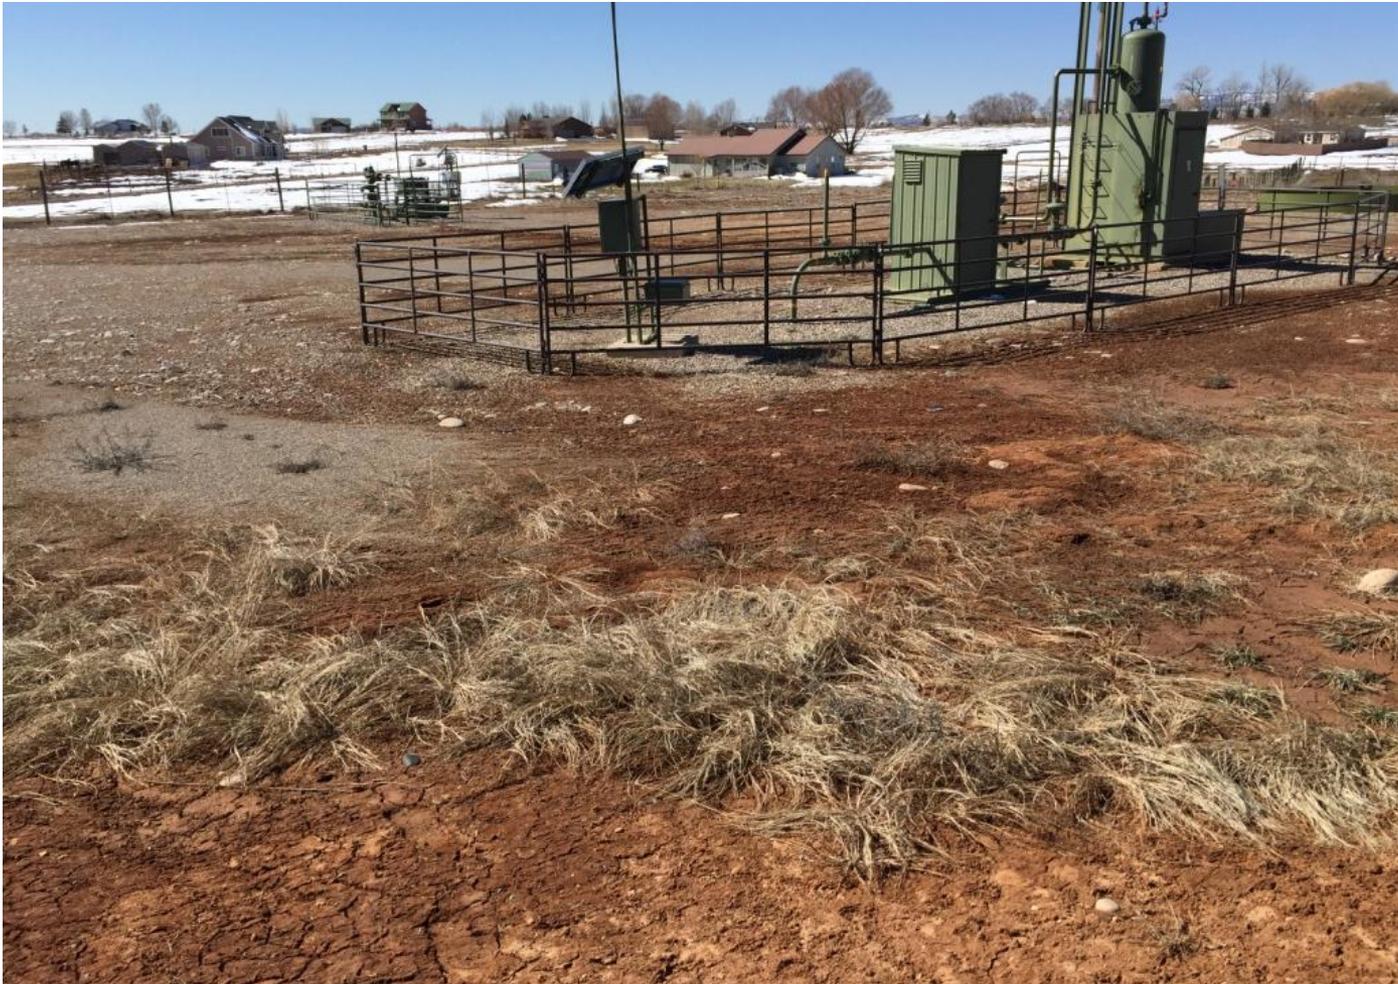
Photo 2. View of the project area from the northeastern corner facing center. Sand dropseed (*Sporobolus* sp.) is growing at the bottom of the cut slope.

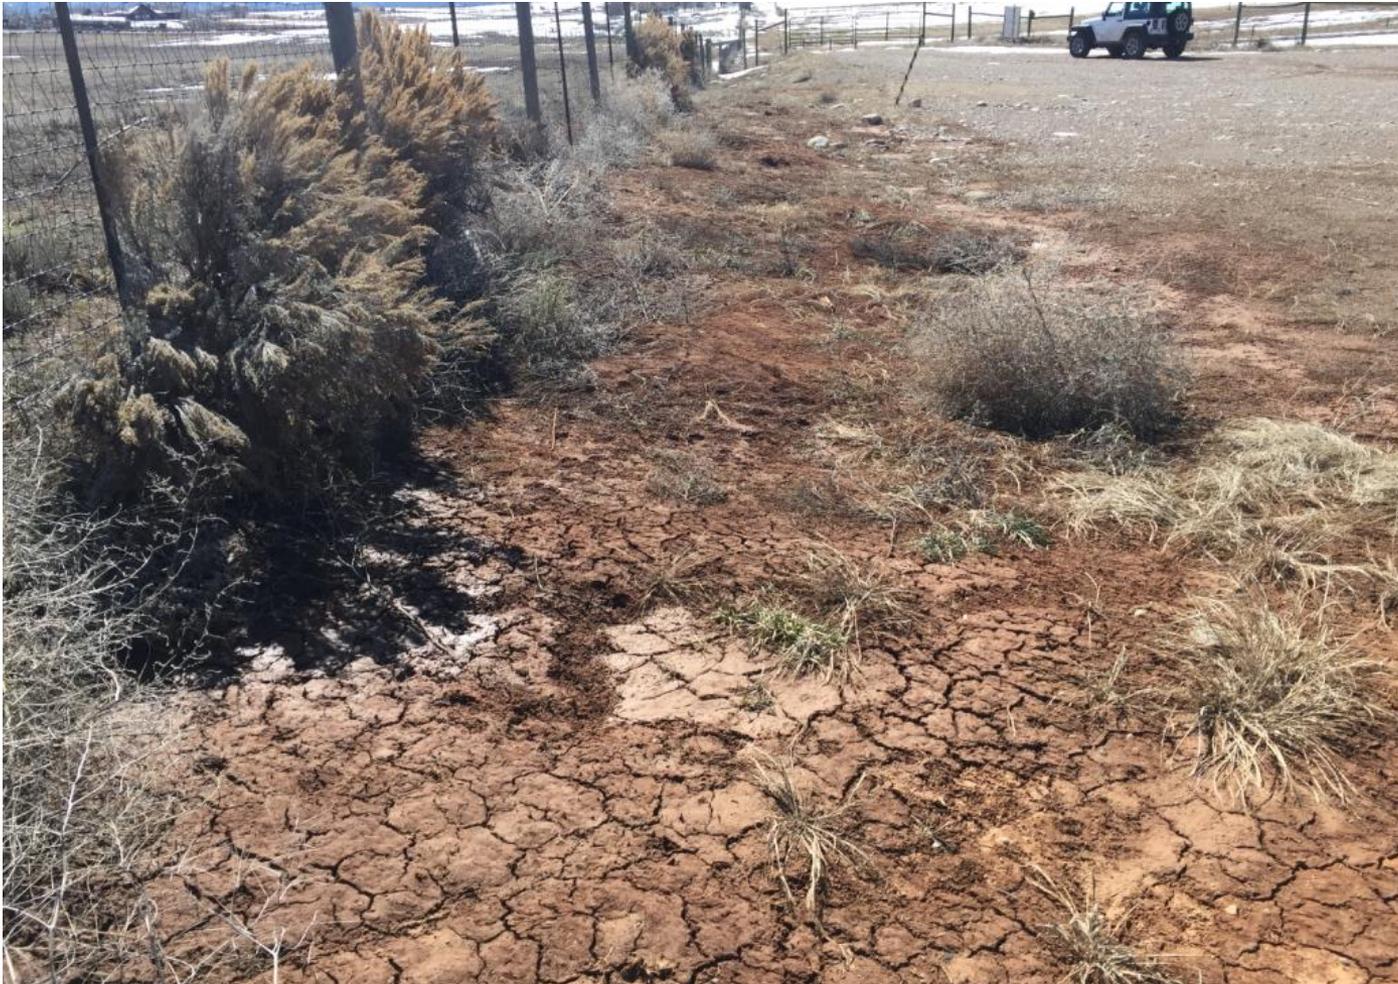
Photo 3. View of the eastern portion of the project area from the northeastern corner facing southward. Poor revegetation here, may need re-seeding in fall 2016 if it is not progressing.

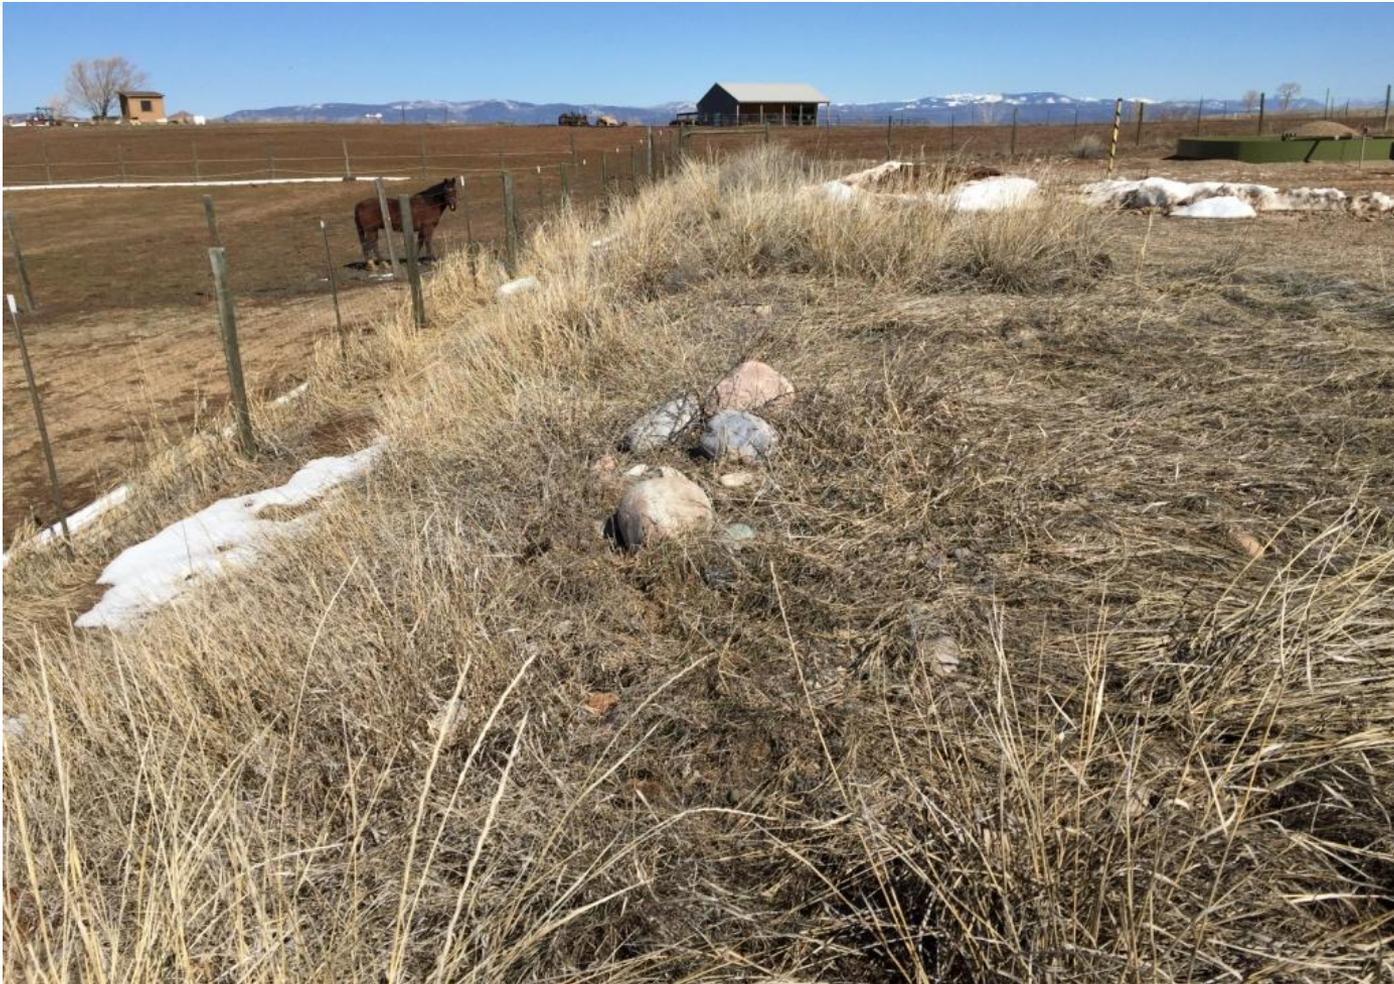
Photo 4. View of the western portion of the project area from the southwestern corner facing northward. Revegetation is progressing here with intermediate wheatgrass (*Thinopyron intermedium*), soft brome (*Bromus inermis*), and crested wheatgrass (*Agropyron cristatum*).

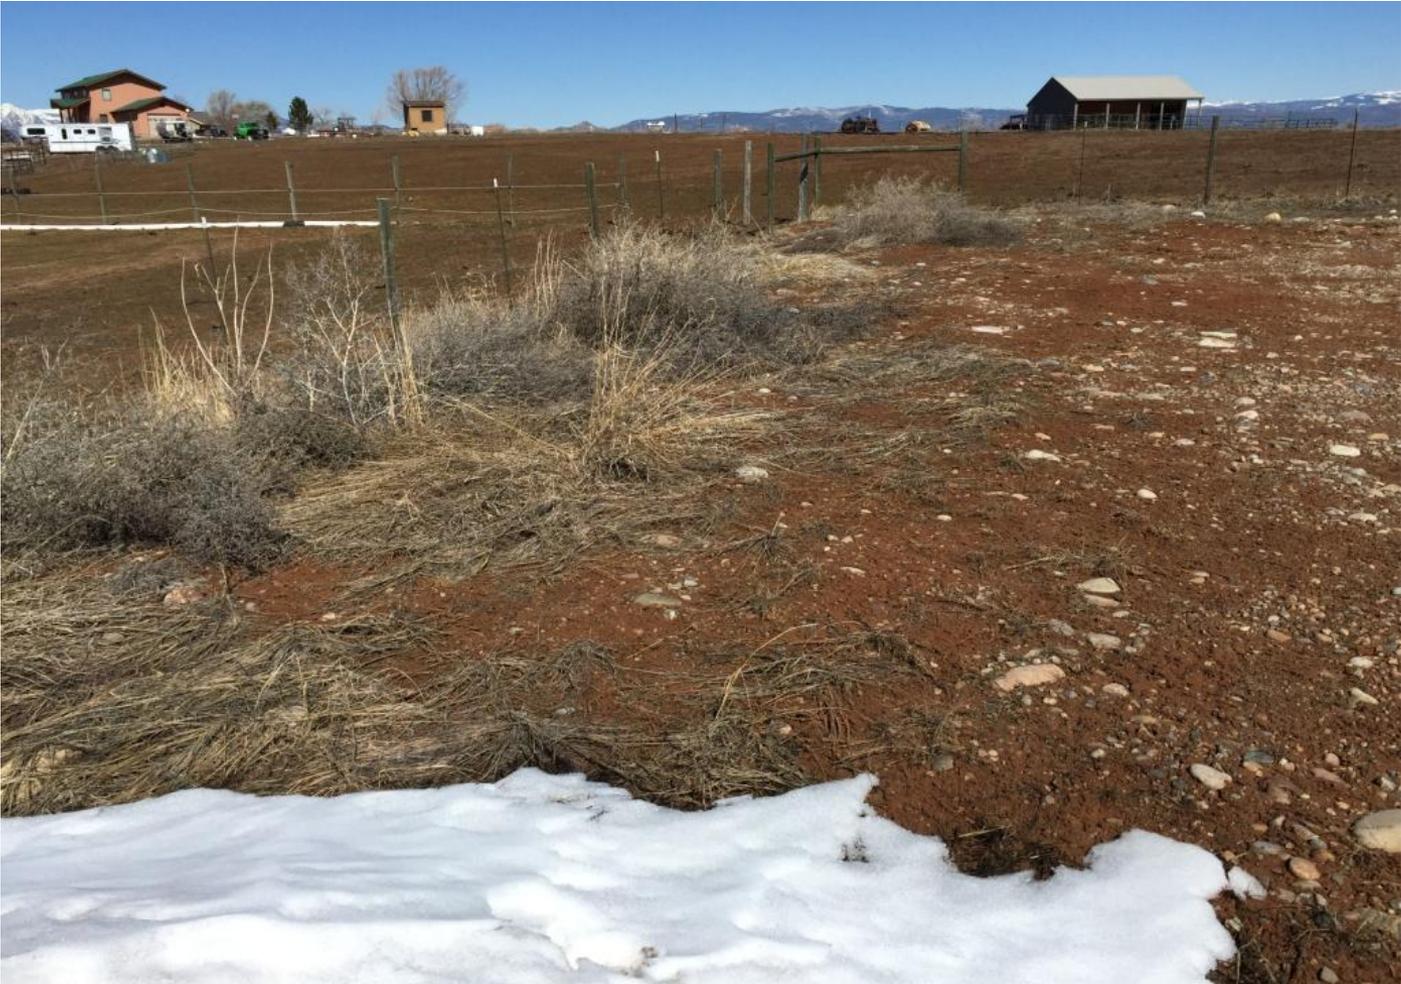
Photo 5. View of kochia (*Kochia scoparia*) debris in the western portion of the project area that needs to be removed.
