Final Reclamation Inspection

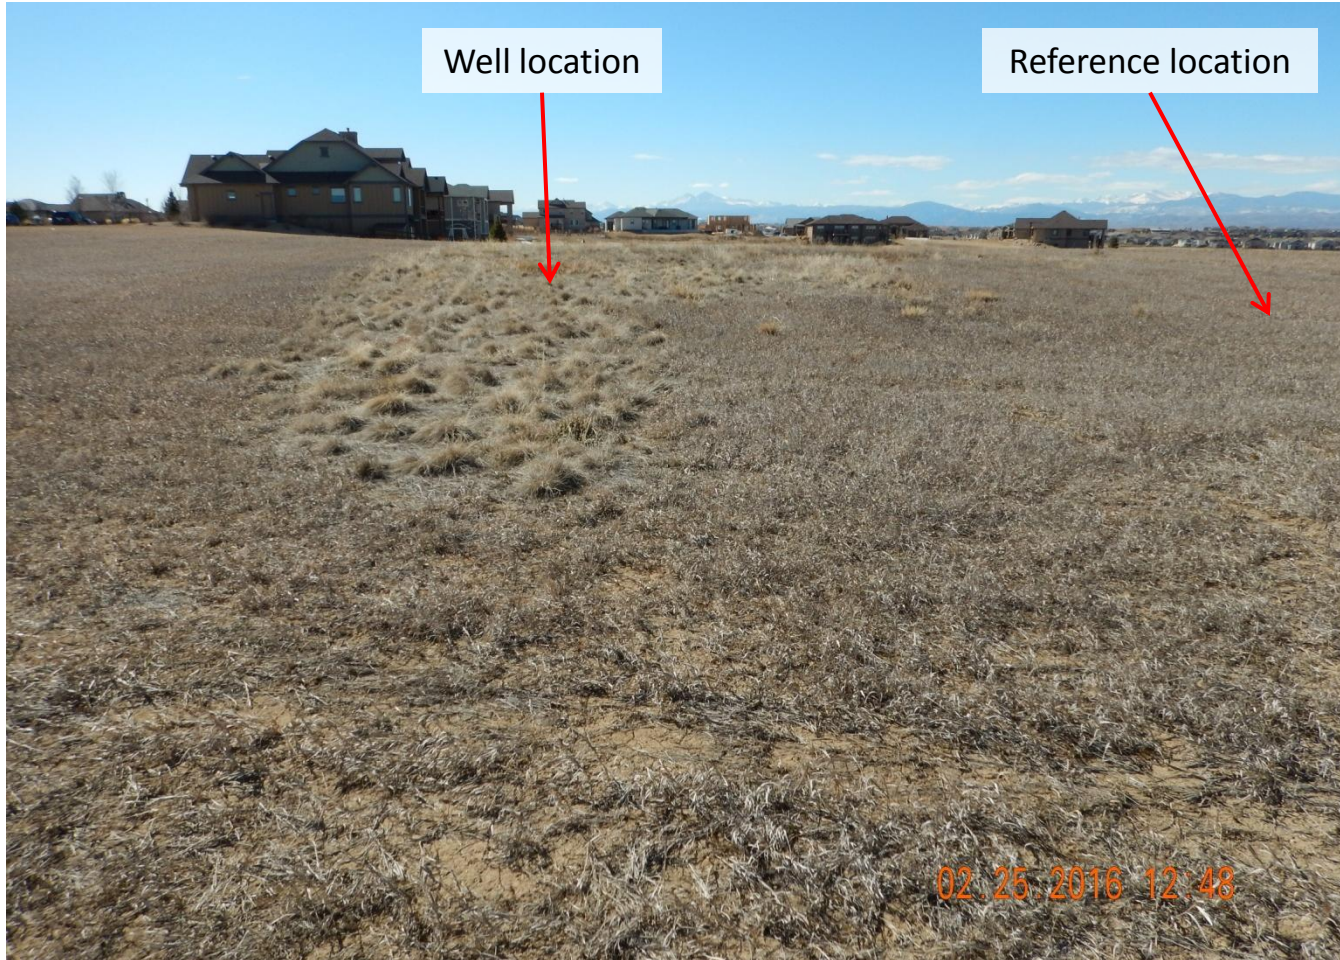
Photo 1. Photo taken east of location, facing West. Evidence of well pad. Location lacks vegetative growth- not representative of the reference area, gravel not removed, and waste material on location.

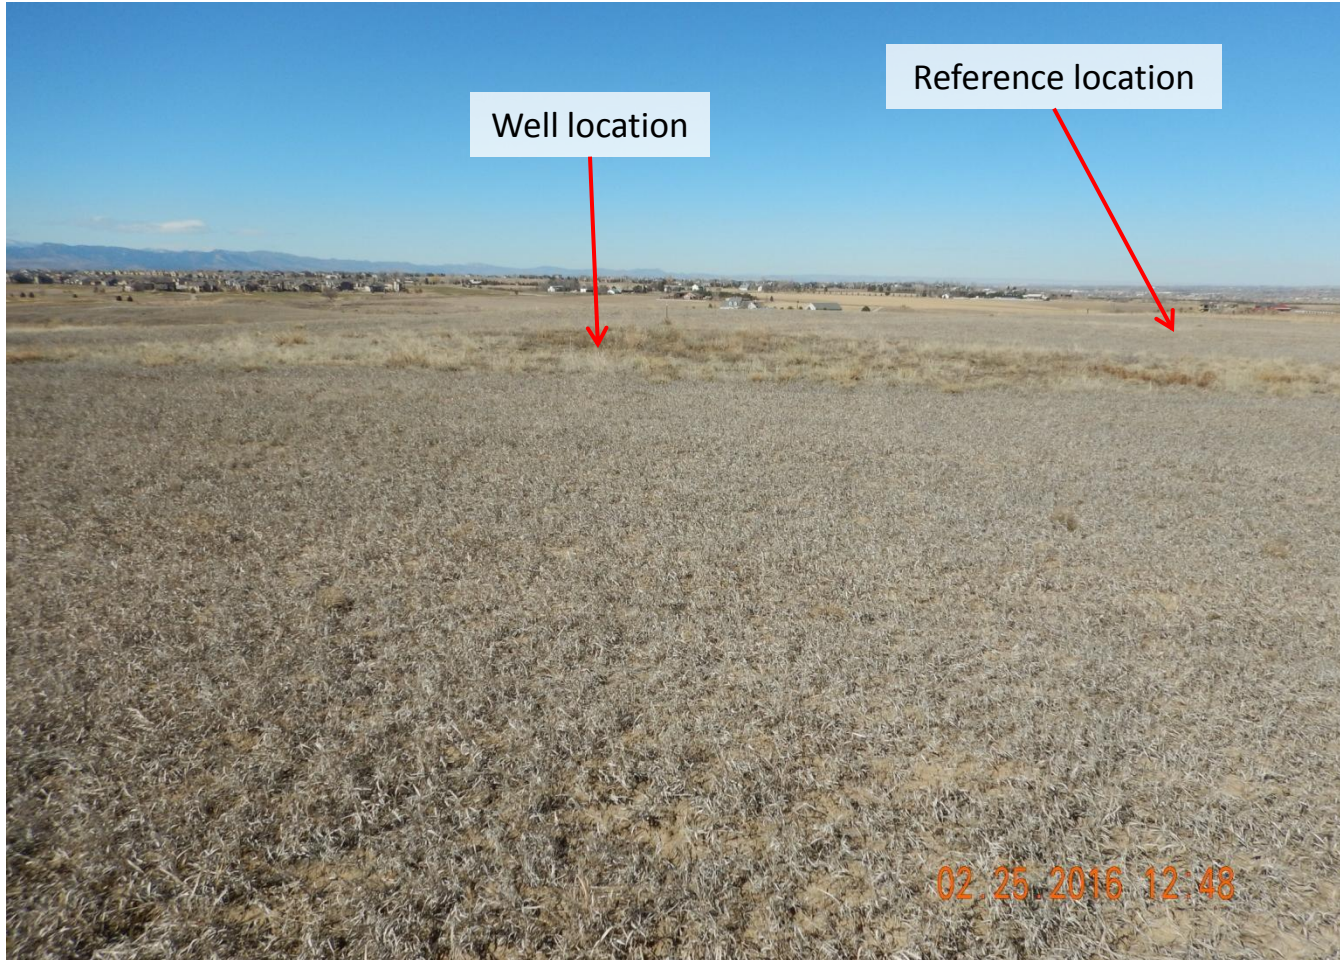
Photo 2. Photo taken south of location, facing North. Evidence of well pad. Location lacks vegetative growth- not representative of the reference area, gravel not removed, and waste material on location.

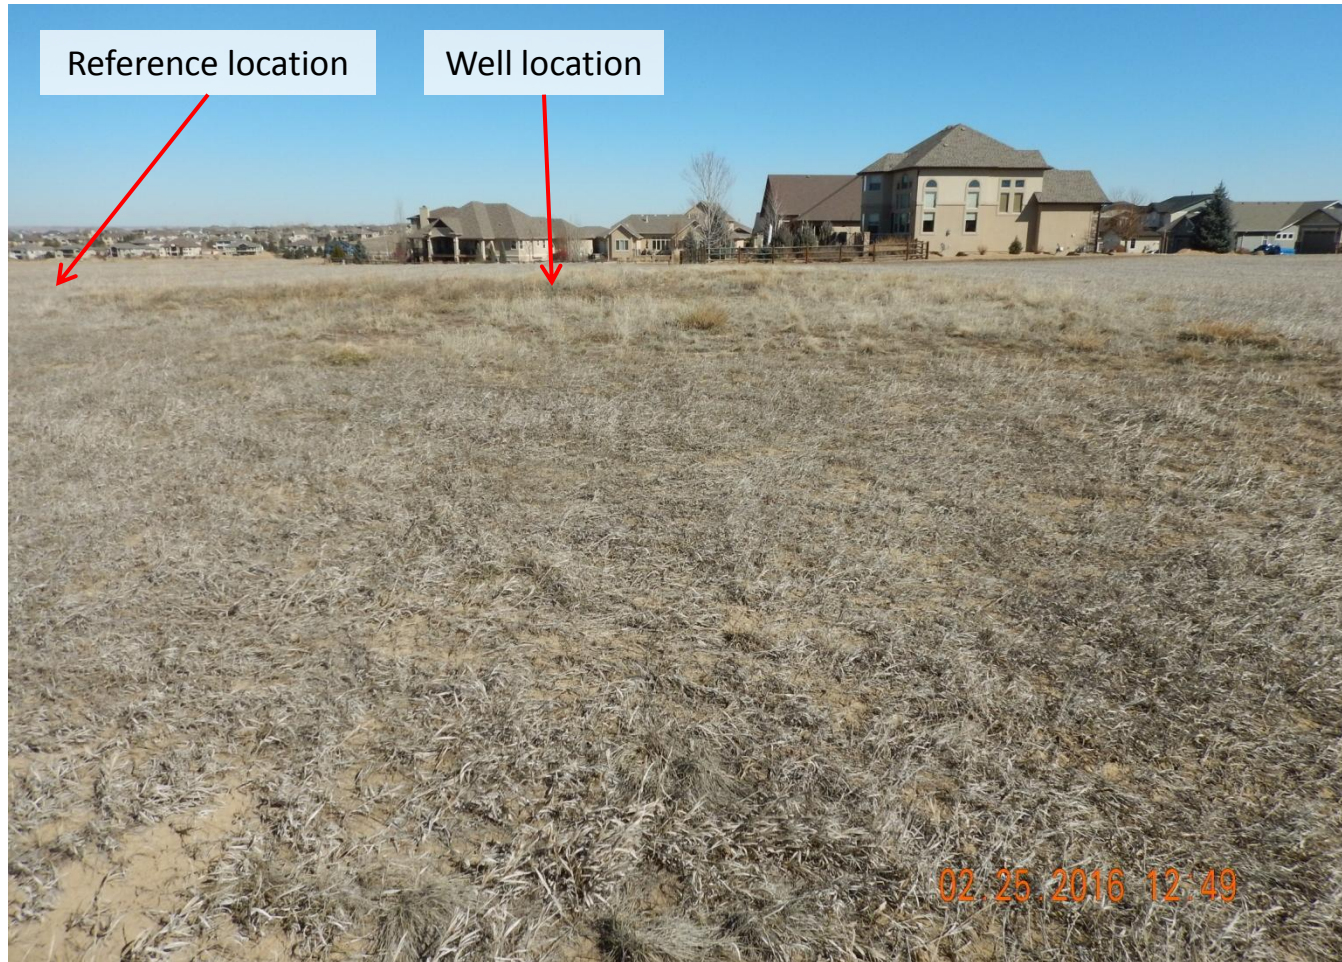
Photo 3. Photo taken west of location, facing East. Evidence of well pad. Location lacks vegetative growth- not representative of the reference area, gravel not removed, and waste material on location.

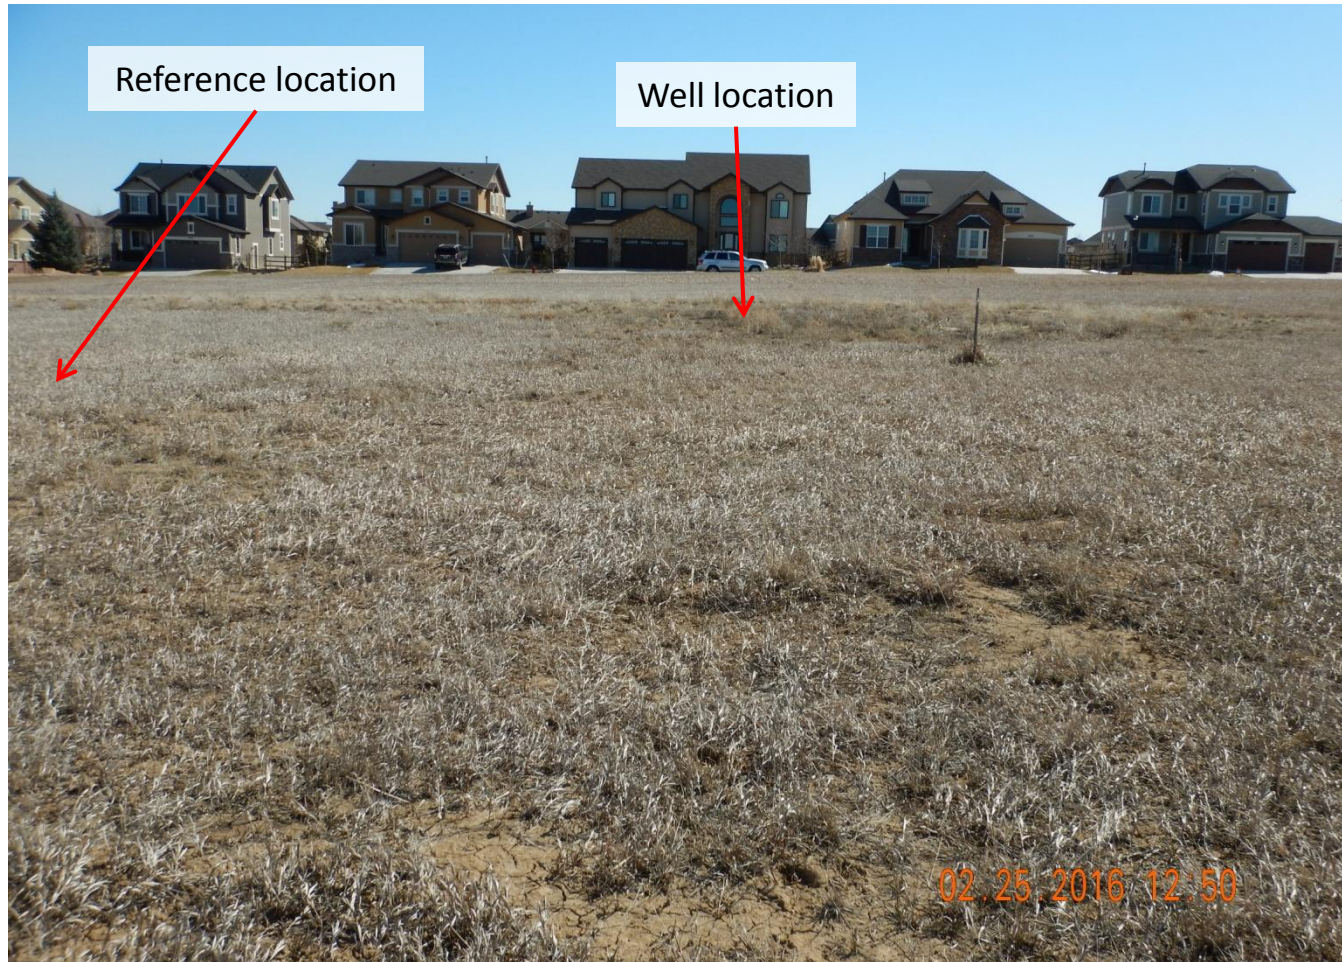
Photo 4. Photo taken north of location, facing South. Evidence of well pad. Location lacks vegetative growth- not representative of the reference area, gravel not removed, and waste material on location.

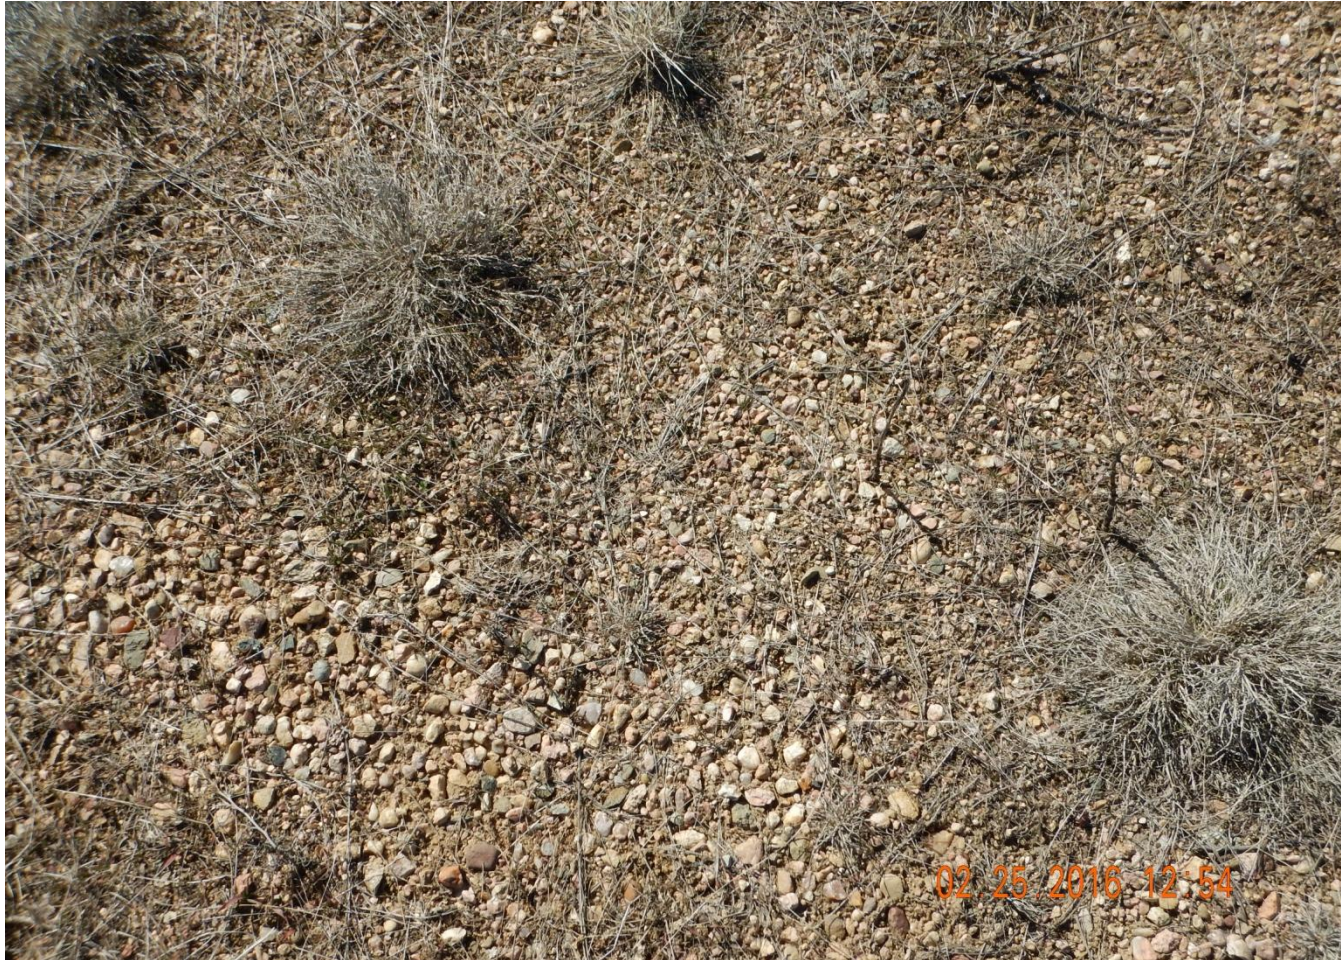
Photo 5. Photo taken from central well location illustrating the lack of vegetative growth and gravel not removed.

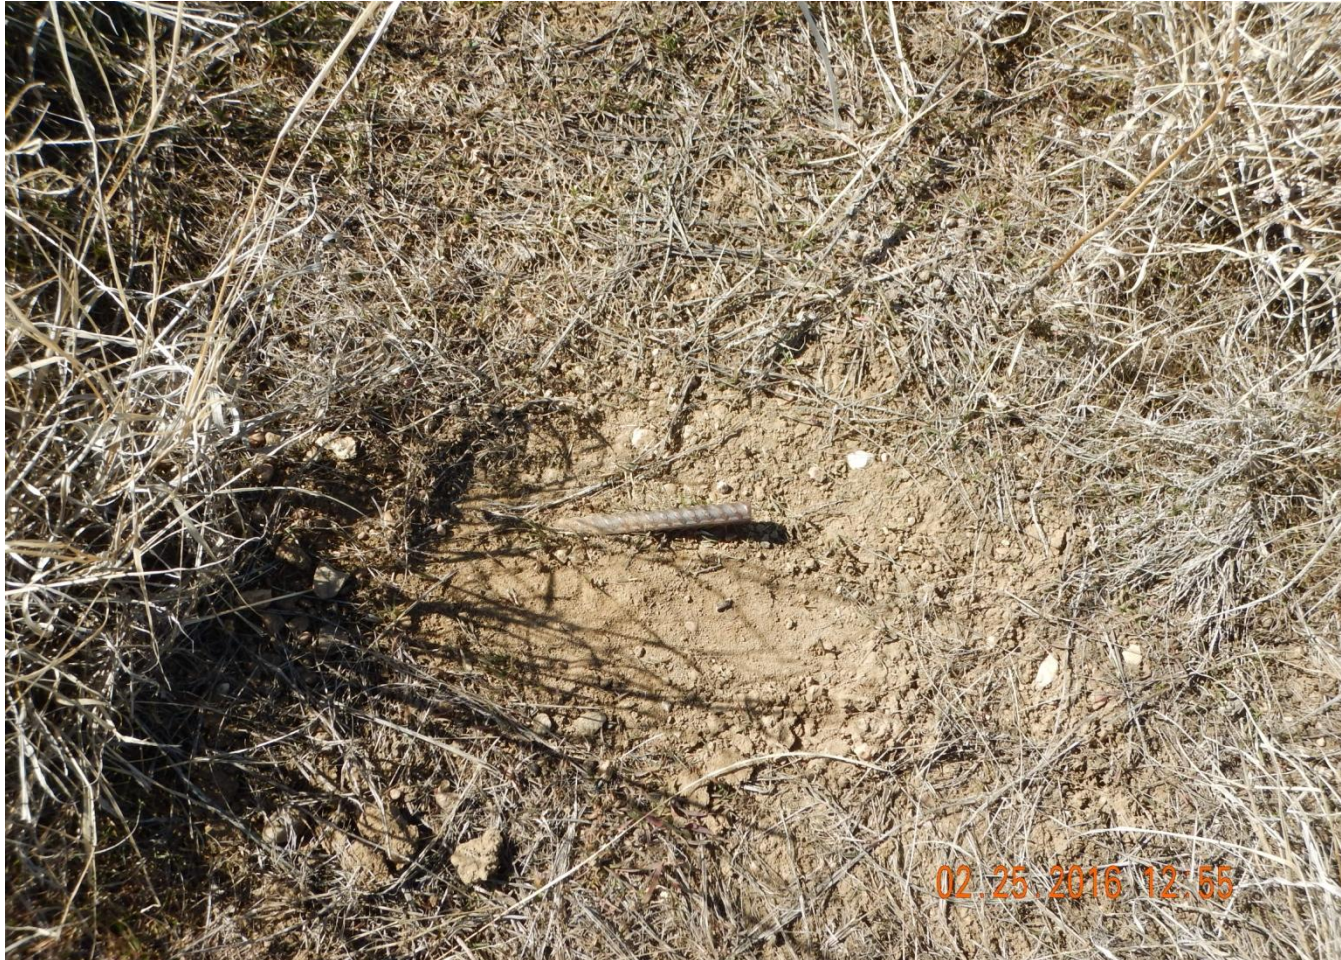
Photo 6. Photo taken from well location illustrating waste material (rebar) left behind.

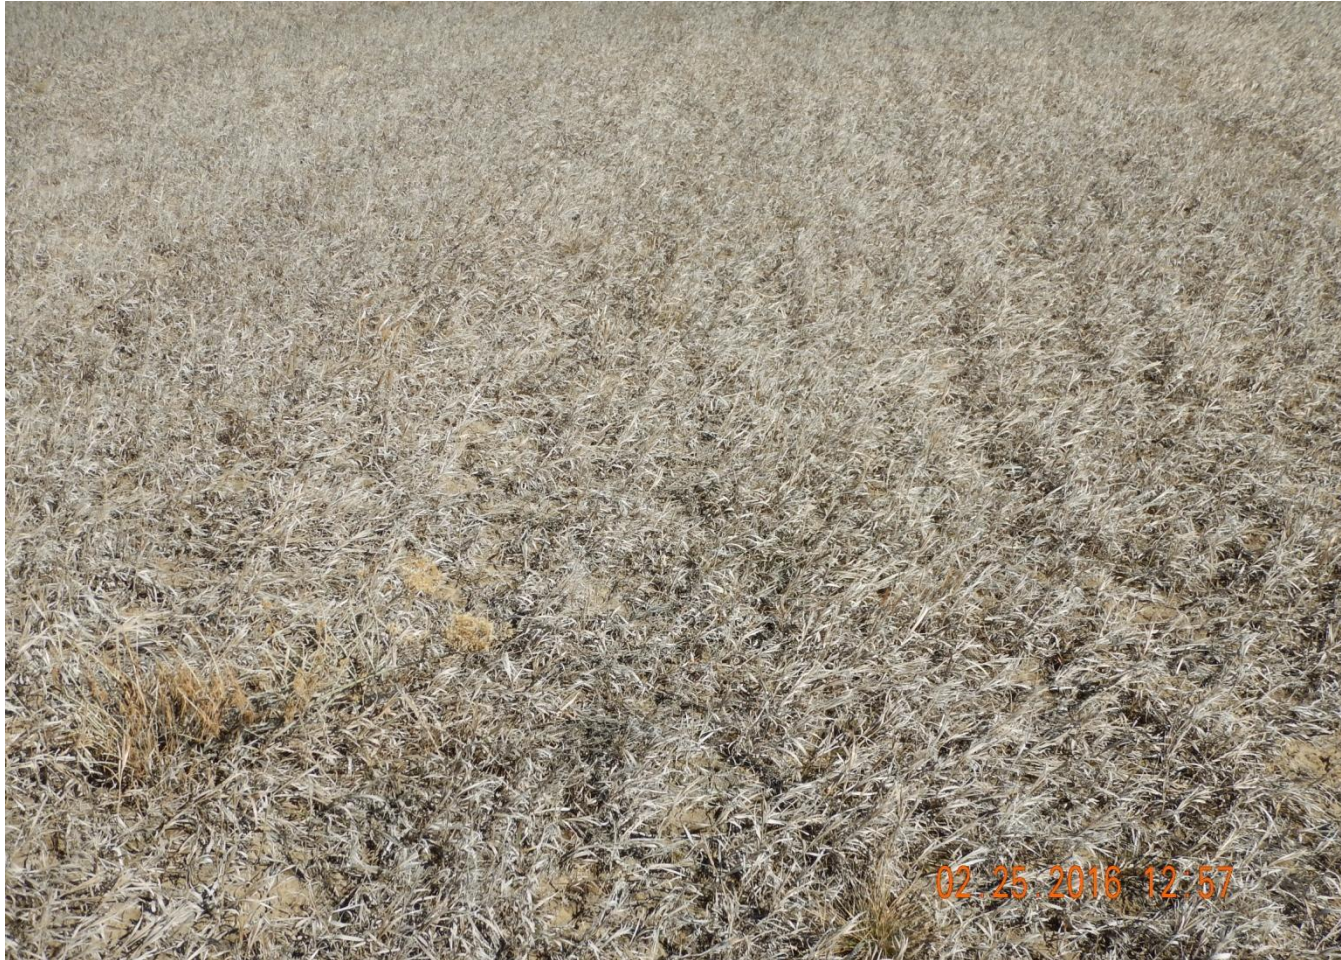
Photo 7. Reference photo taken approximately 30 meter northwest of location illustrating vegetative growth.

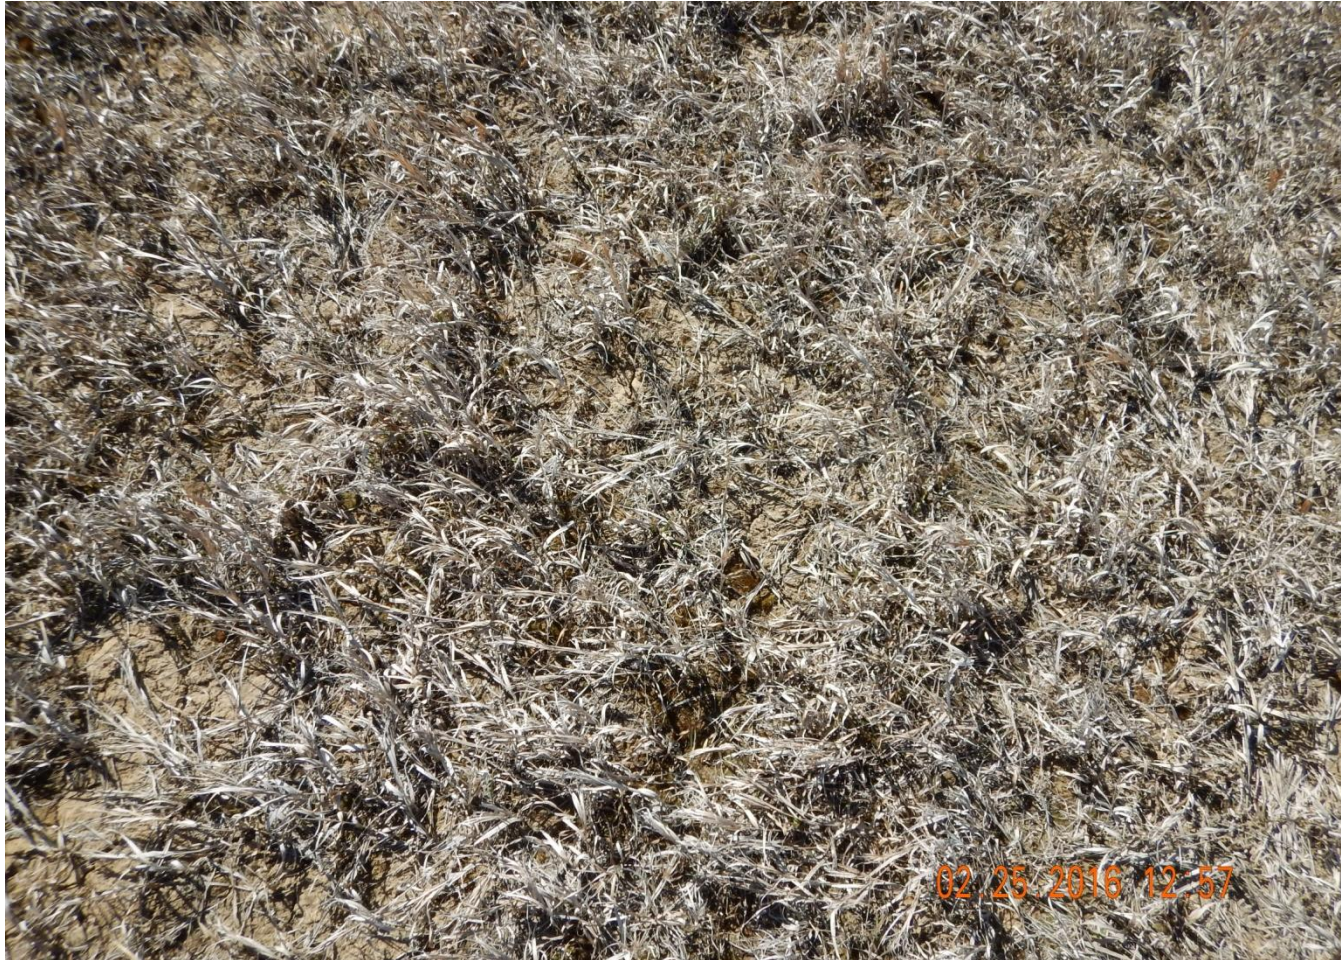
Photo 8. Close up reference photo taken approximately 30 meter northwest of location.
