# Stormwater Inspection

2/26/2016

Operator: Western Operating

Location ID: 435387

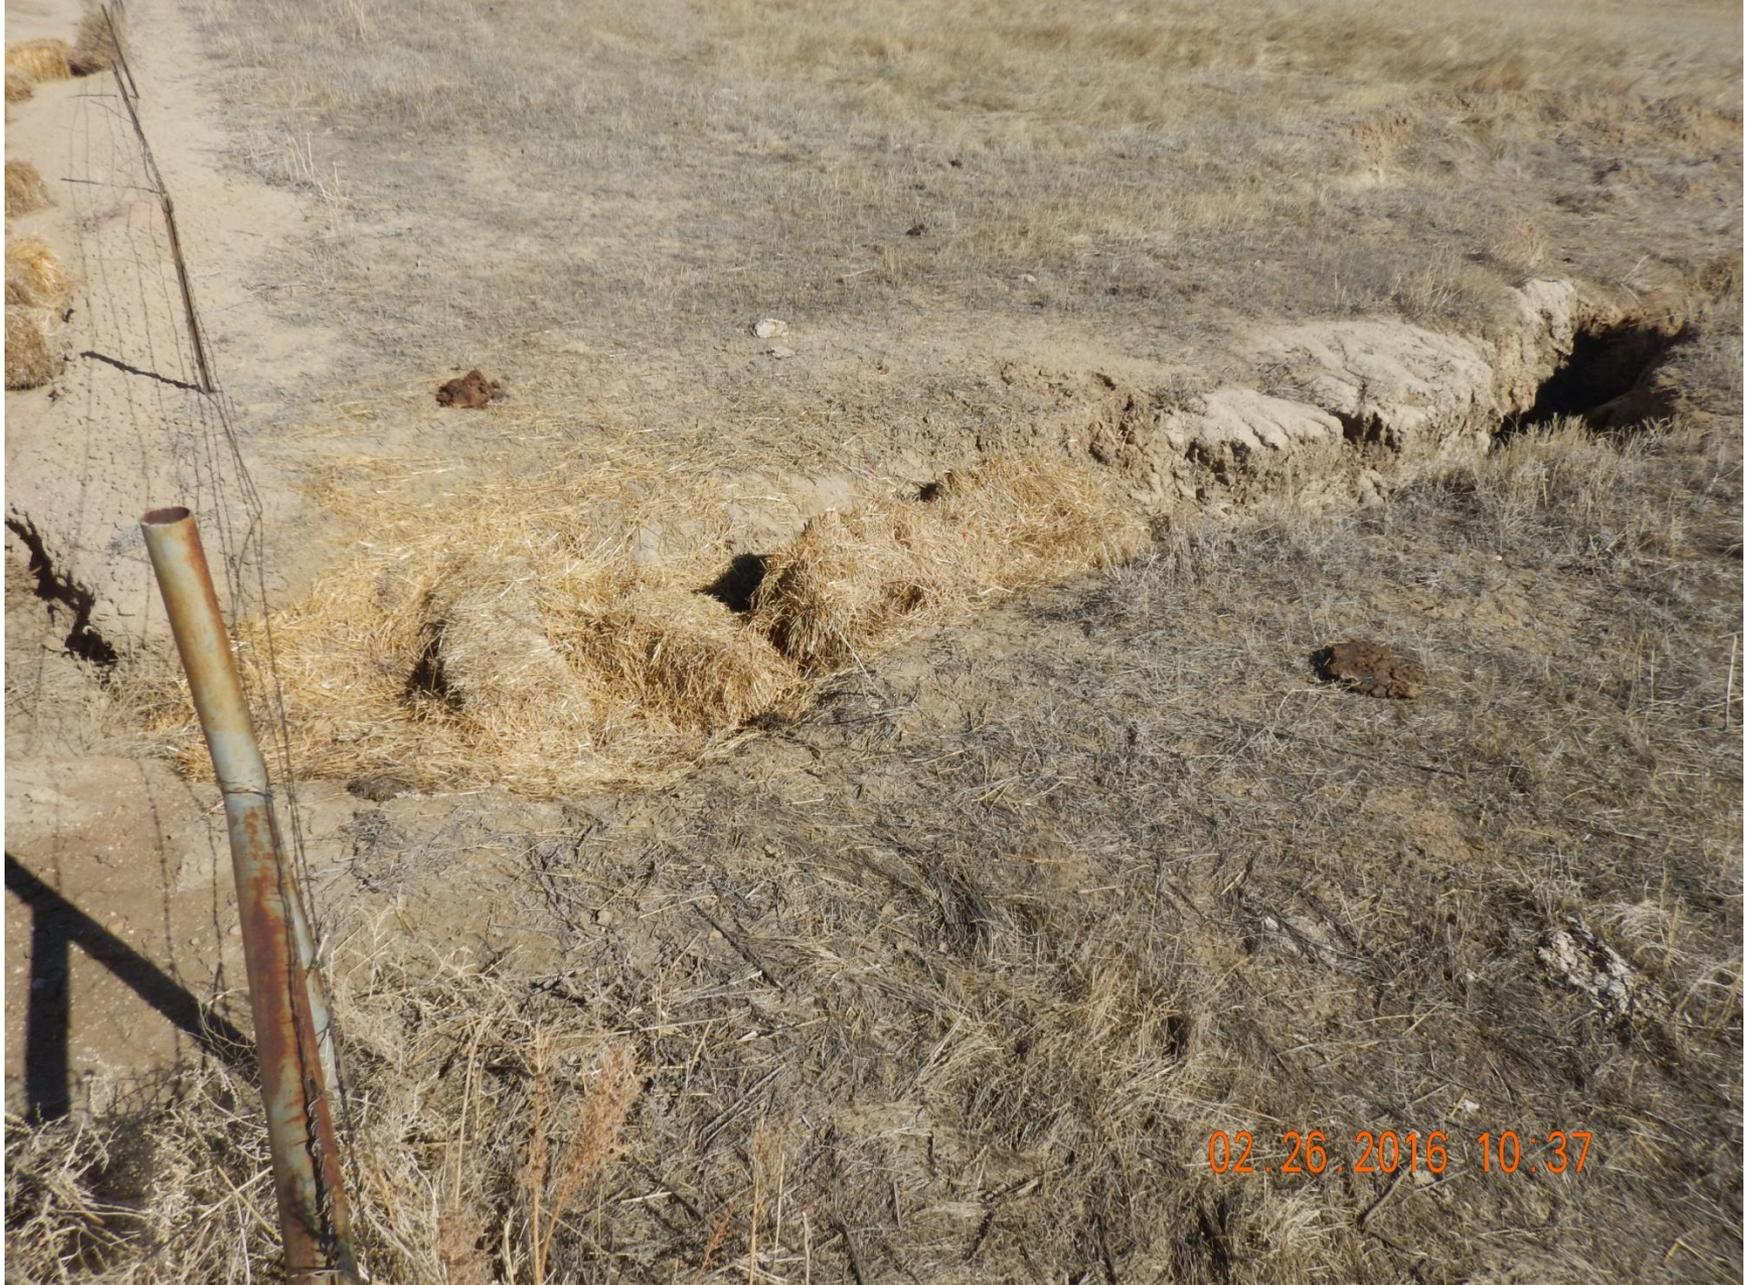
**Figure 1:** Photo taken from east end of location. Photo of gully forming off location and hay bales used as a stormwater control method. Note that stormwater control method used for gully erosion is inadequate and unsatisfactory.

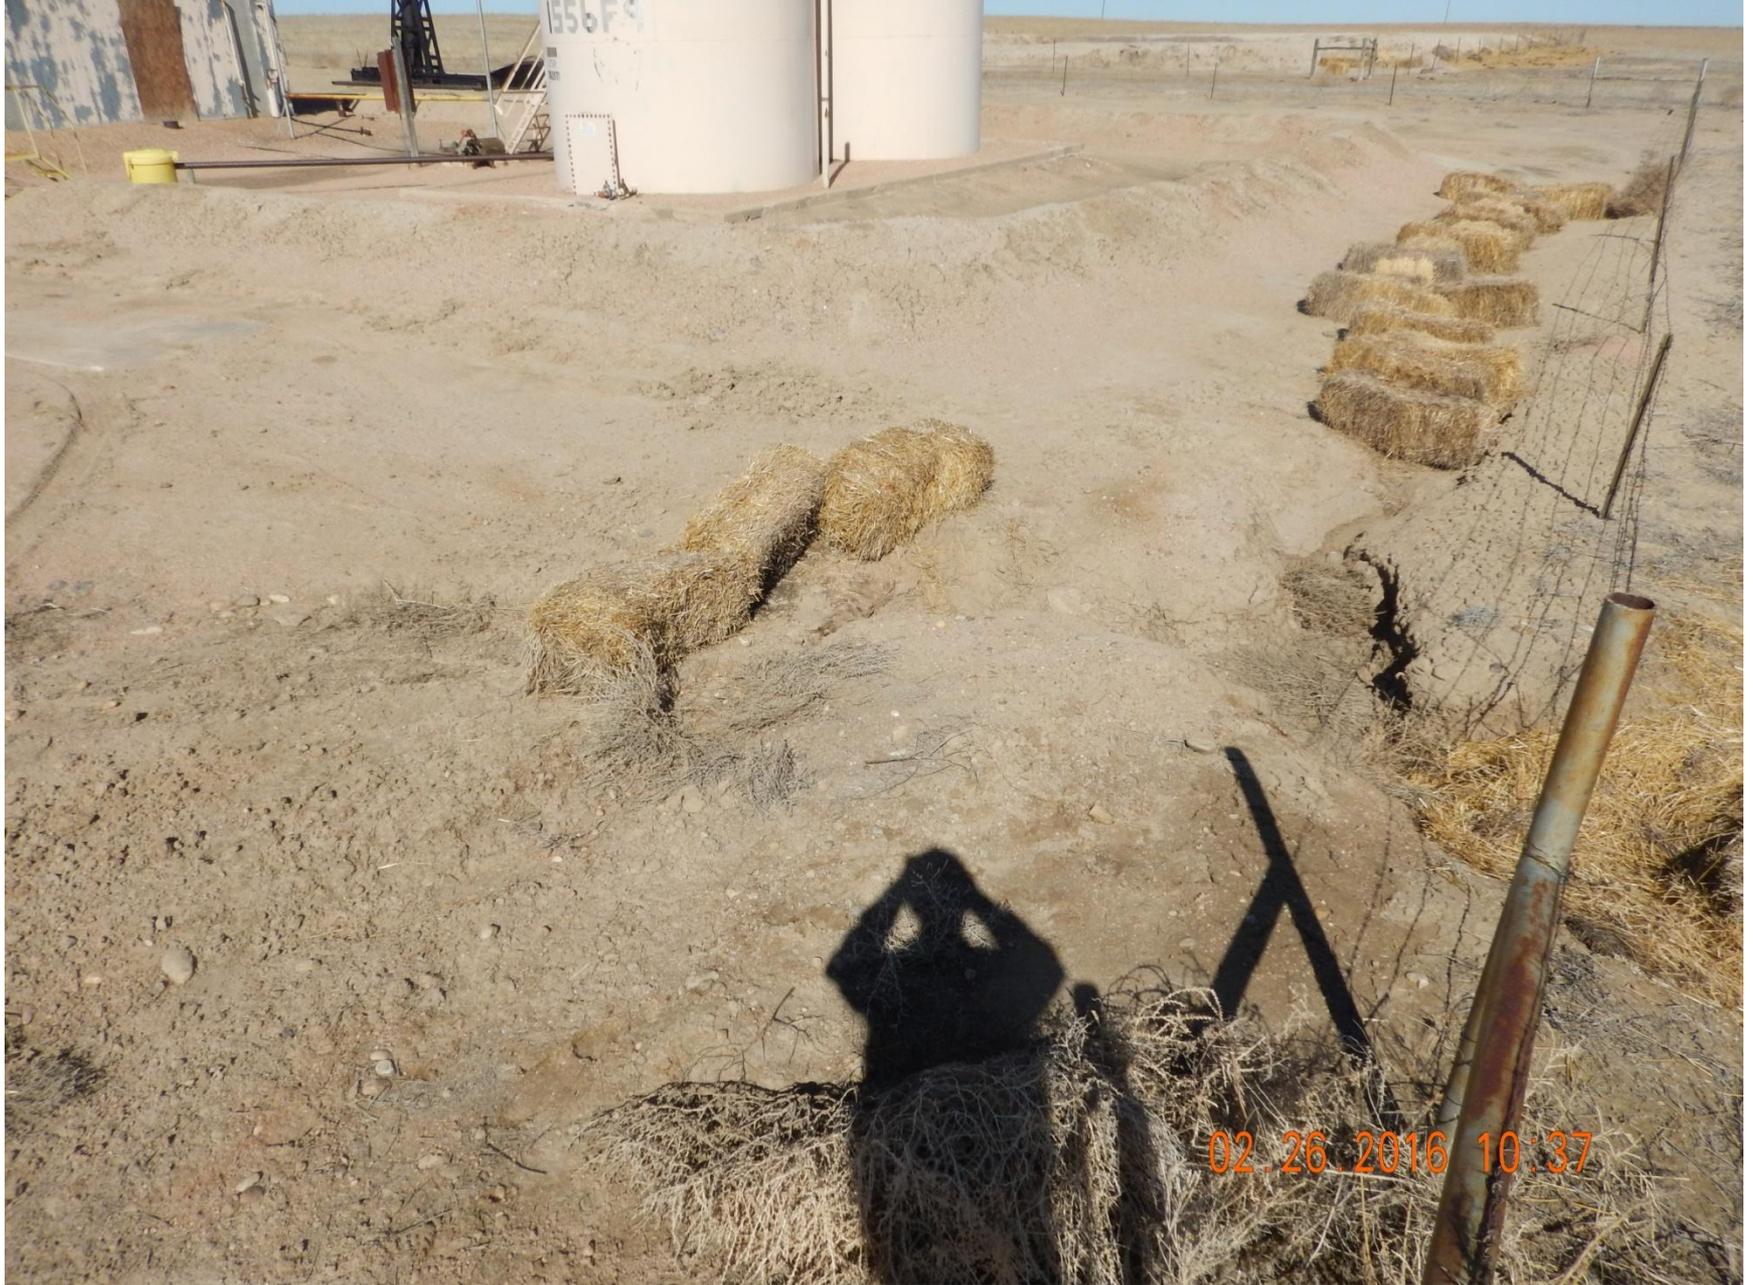
**Figure 2:** Photo taken from east end of location facing northwest. Photo of gully formation on location and hay bales used as a stormwater control. Note that stormwater control method used is inadequate and improperly installed.

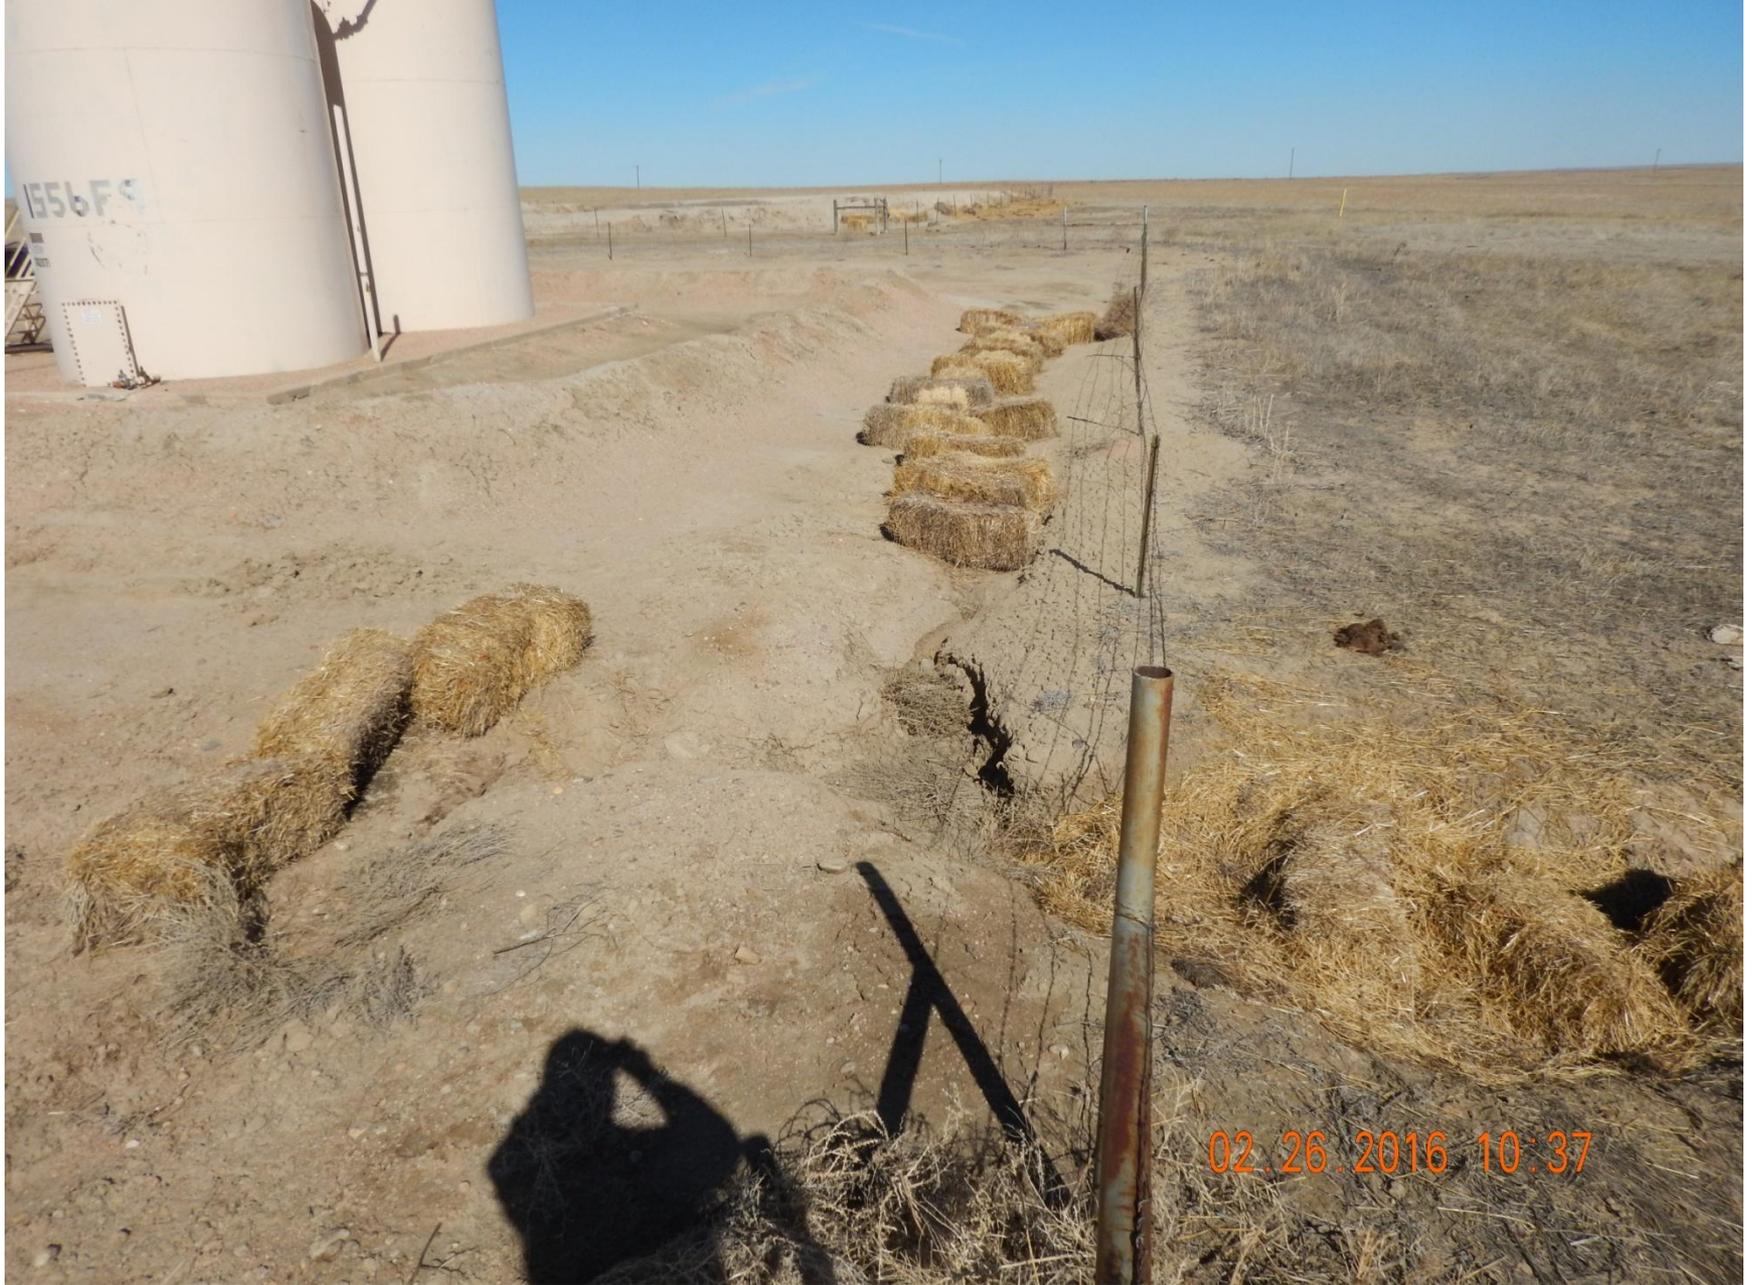
**Figure 3:** Photo taken from east end of location, facing north. Photo of gully formation on and off location, and hay bales used as a stormwater control. Note stormwater controls used are inadequate and improperly installed.

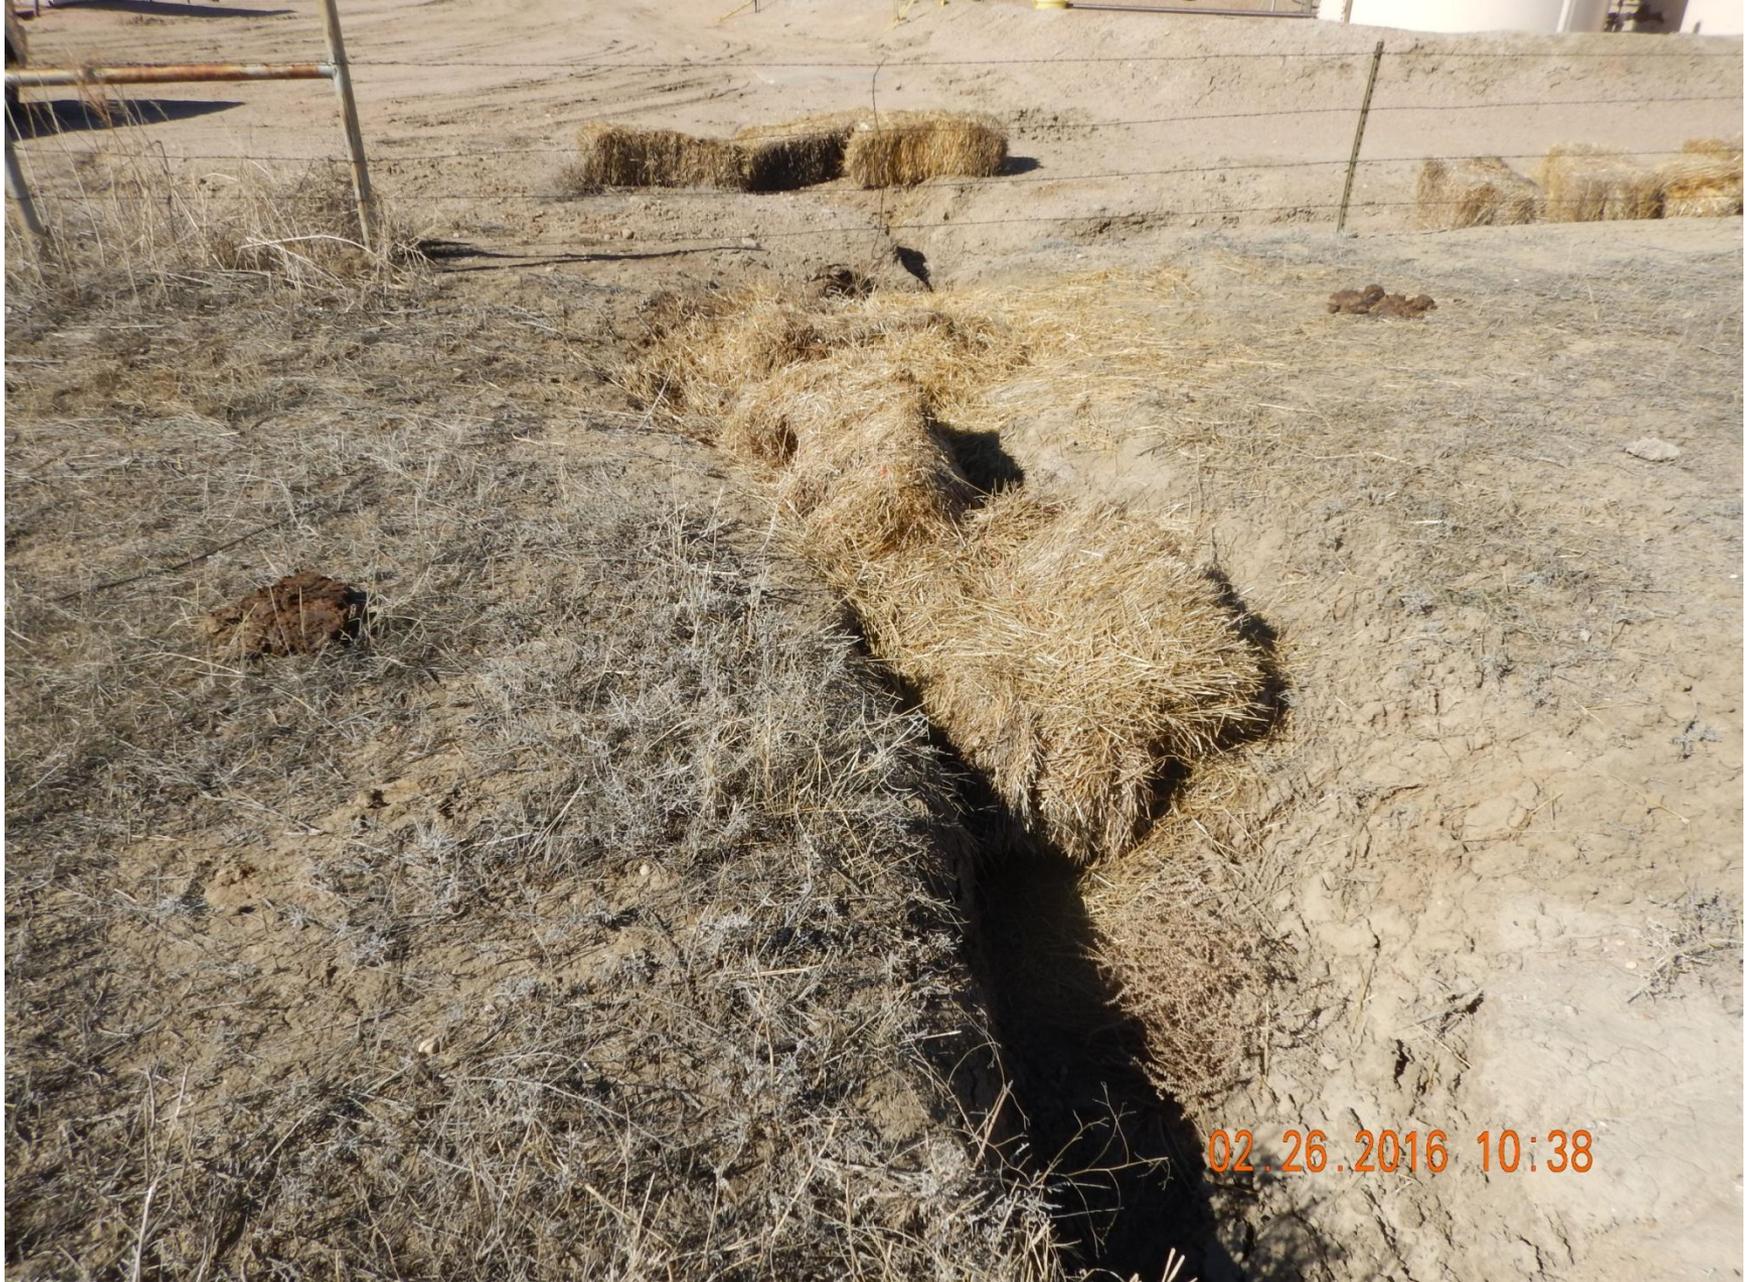
**Figure 4:** Photo taken east of location, facing west. Photo of gully forming off location and hay bales used as a stormwater control. Note that stormwater control method used for gully erosion is inadequate and unsatisfactory.

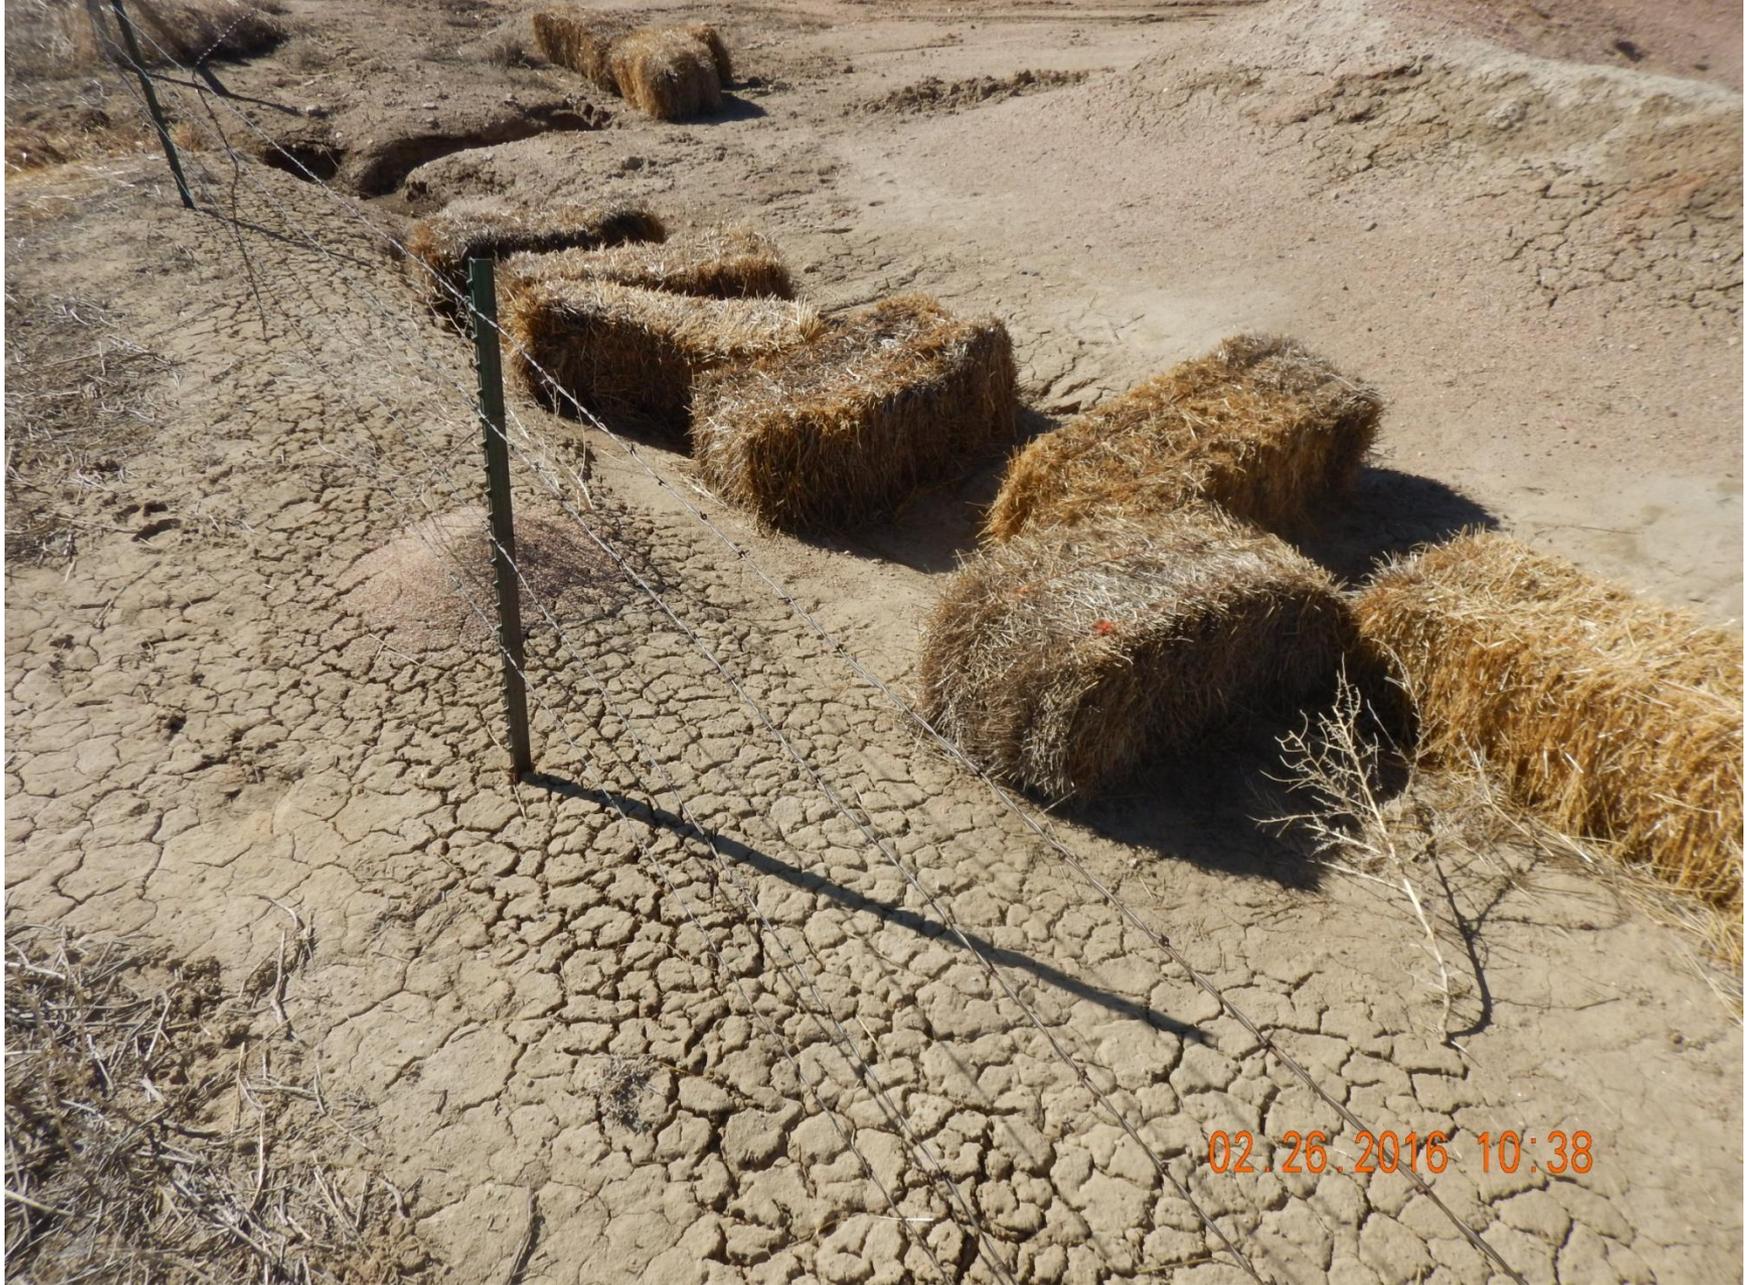
**Figure 5:** Photo taken from east end of location, facing southwest. Photo of erosion on location, and hay bales used as a stormwater control method. Note stormwater controls used are improperly installed.

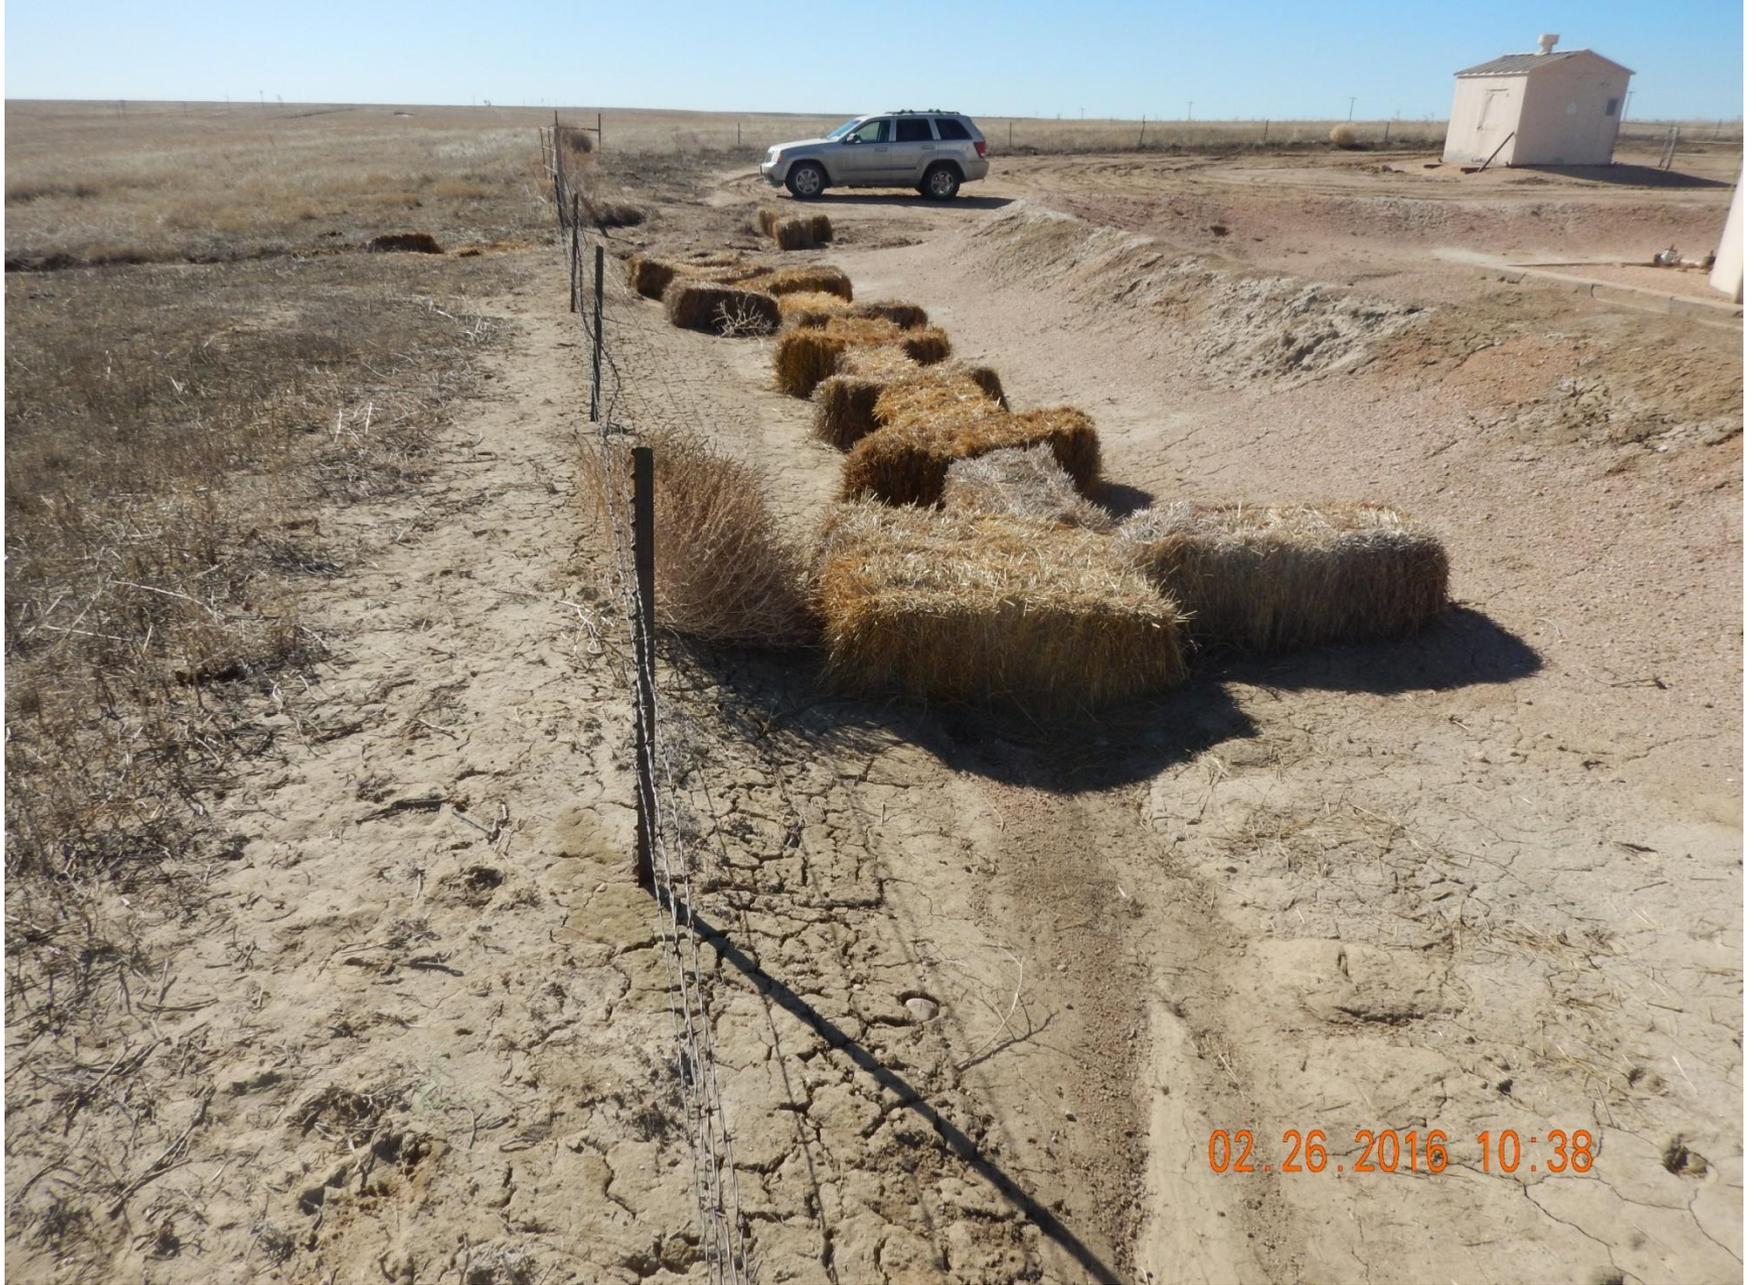
**Figure 6:** Photo taken from east end of location, facing south. Photo of erosion on location, and hay bales used as a stormwater control method. Note stormwater controls used are improperly installed.

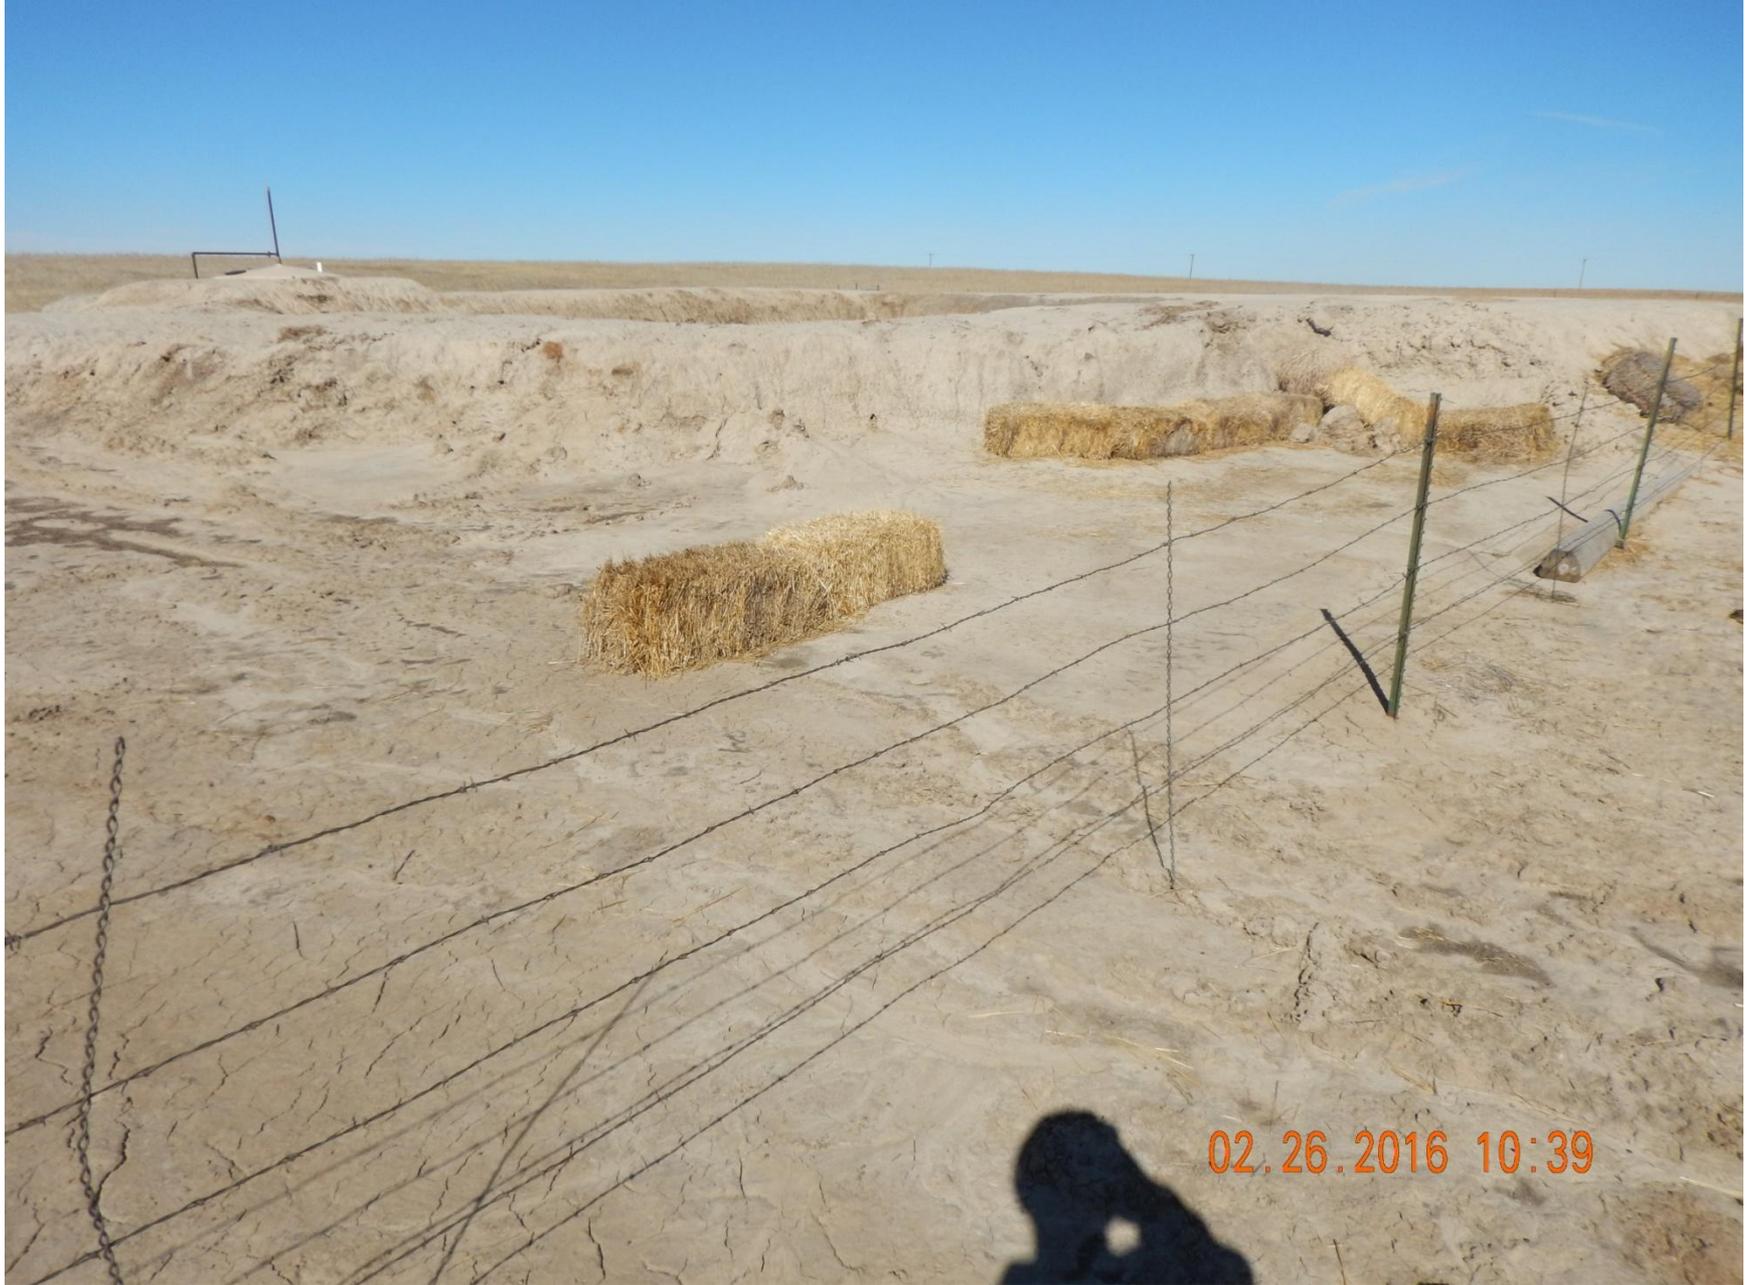
**Figure 7:** Photo taken from the southeast end of pit, facing northwest. Photo of erosion on pit, and hay bales used as a stormwater control. Note stormwater controls used are improperly installed.

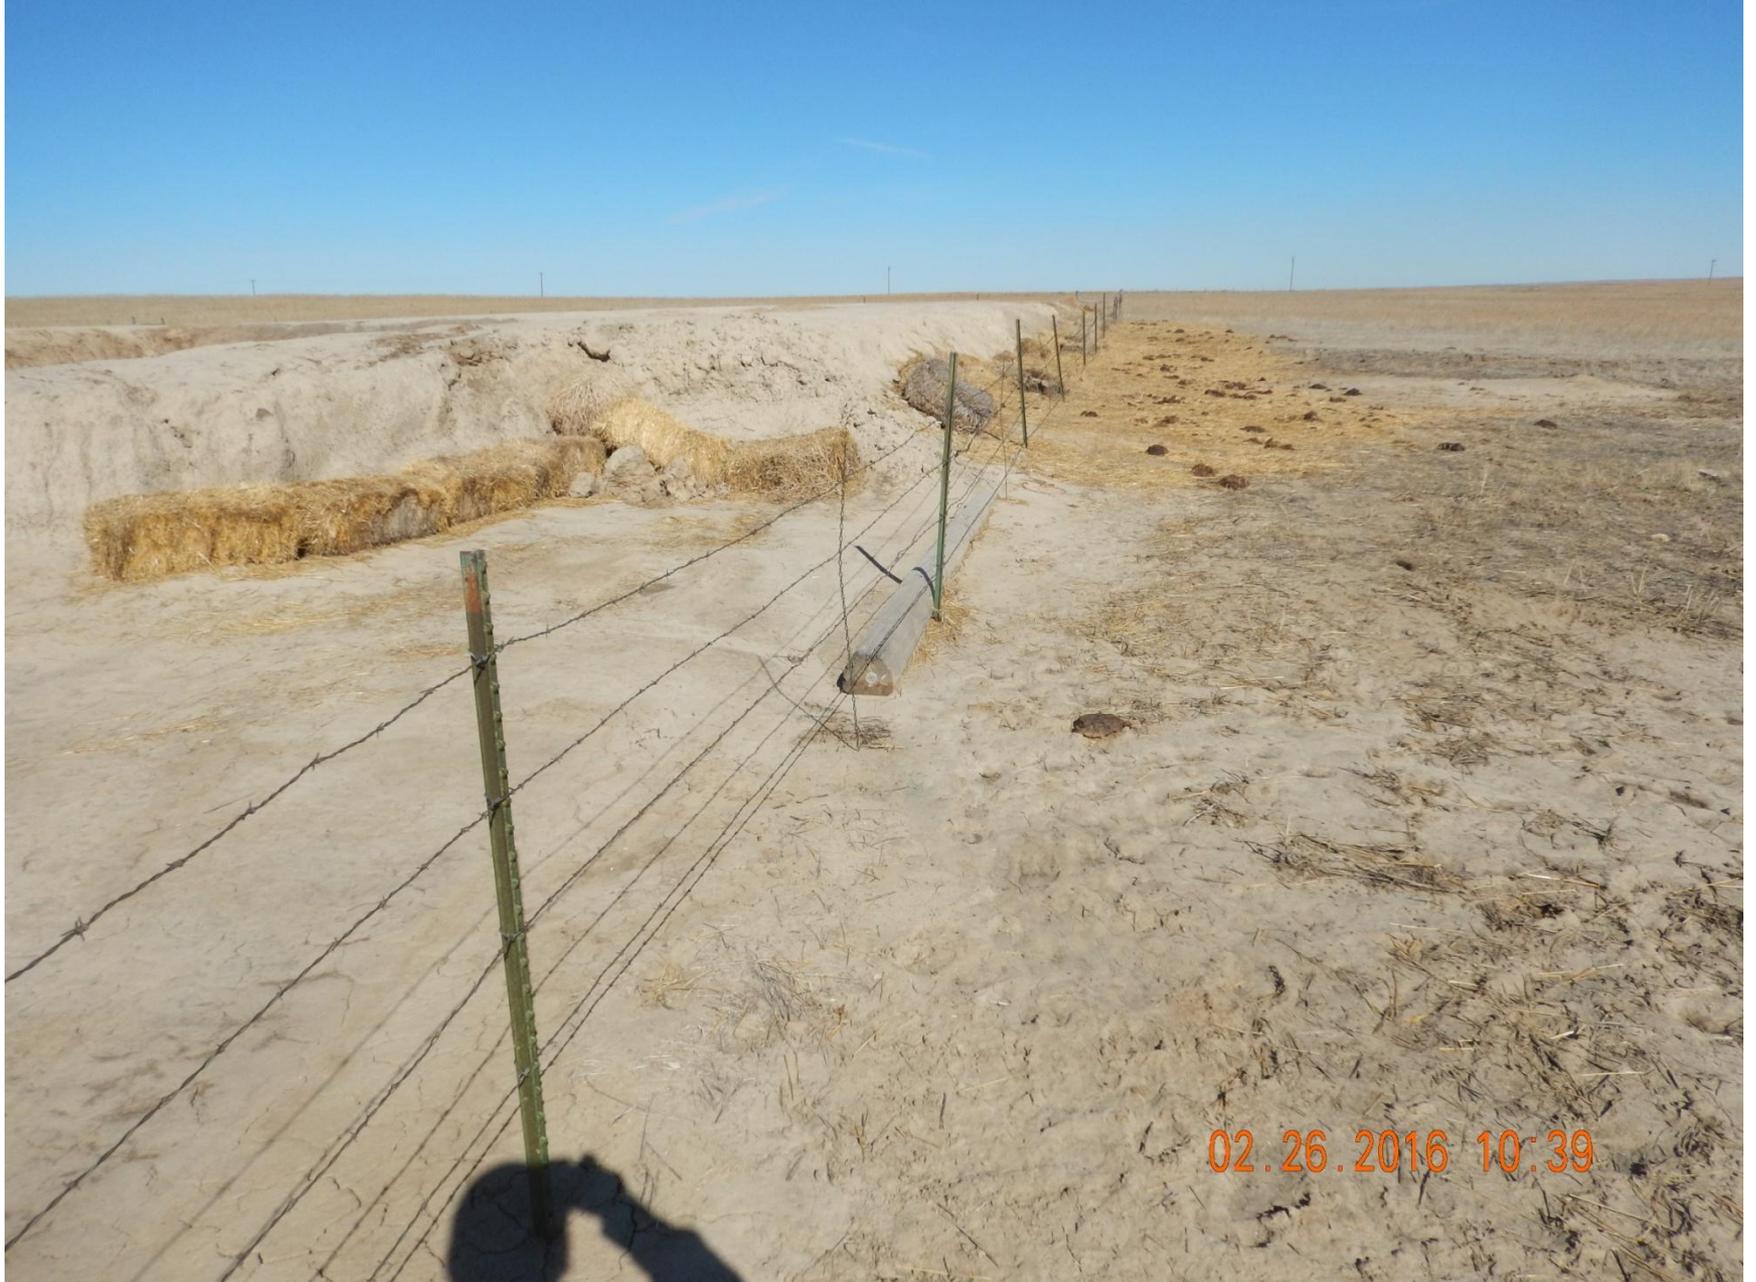
**Figure 8:** Photo taken from the southeast end of pit, facing northwest. Photo of erosion on pit, and hay bales used as a stormwater control. Note stormwater controls used are improperly installed and have not been maintained.

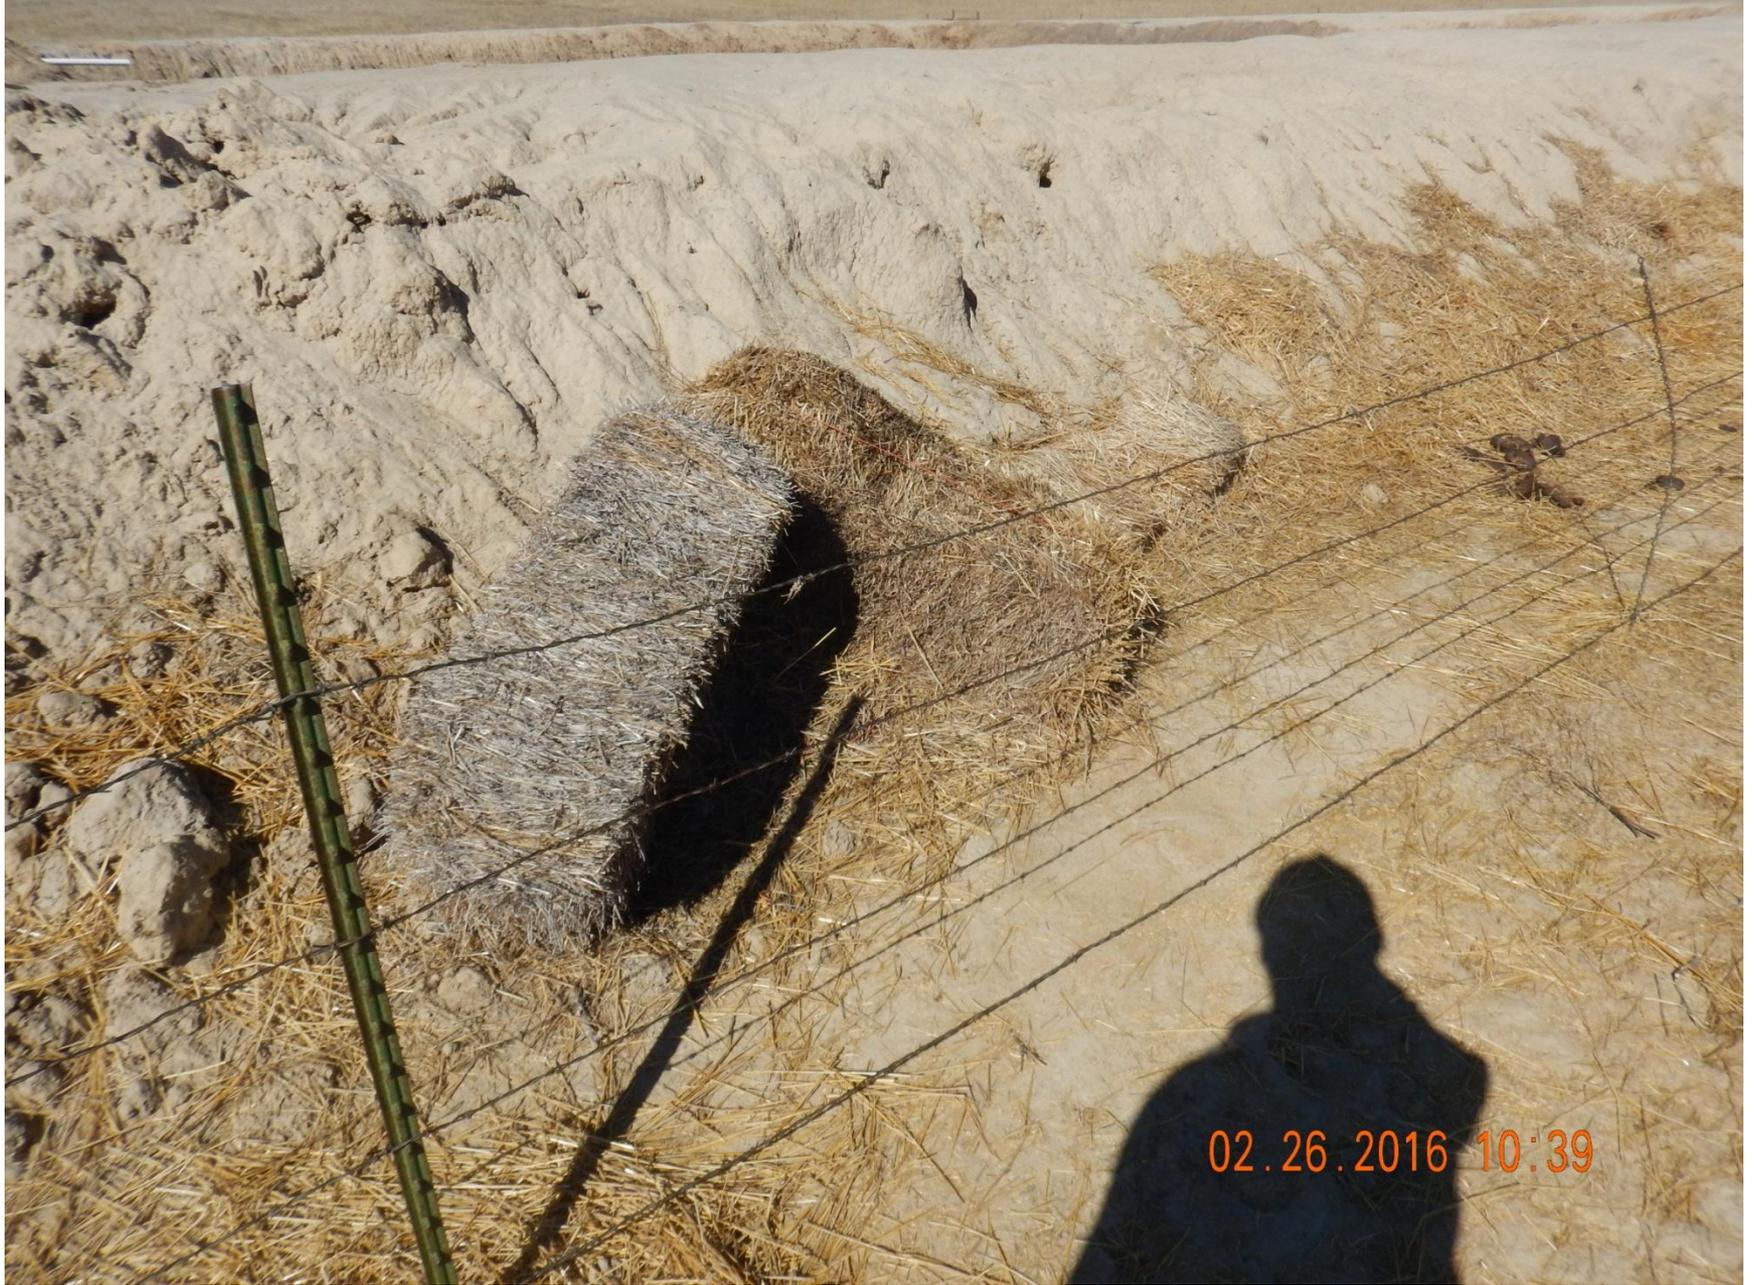
**Figure 9:** Photo taken from the southeast end of pit, facing northwest. Photo of erosion on pit, and hay bales used as a stormwater control. Note stormwater controls used are improperly installed and have not been maintained.

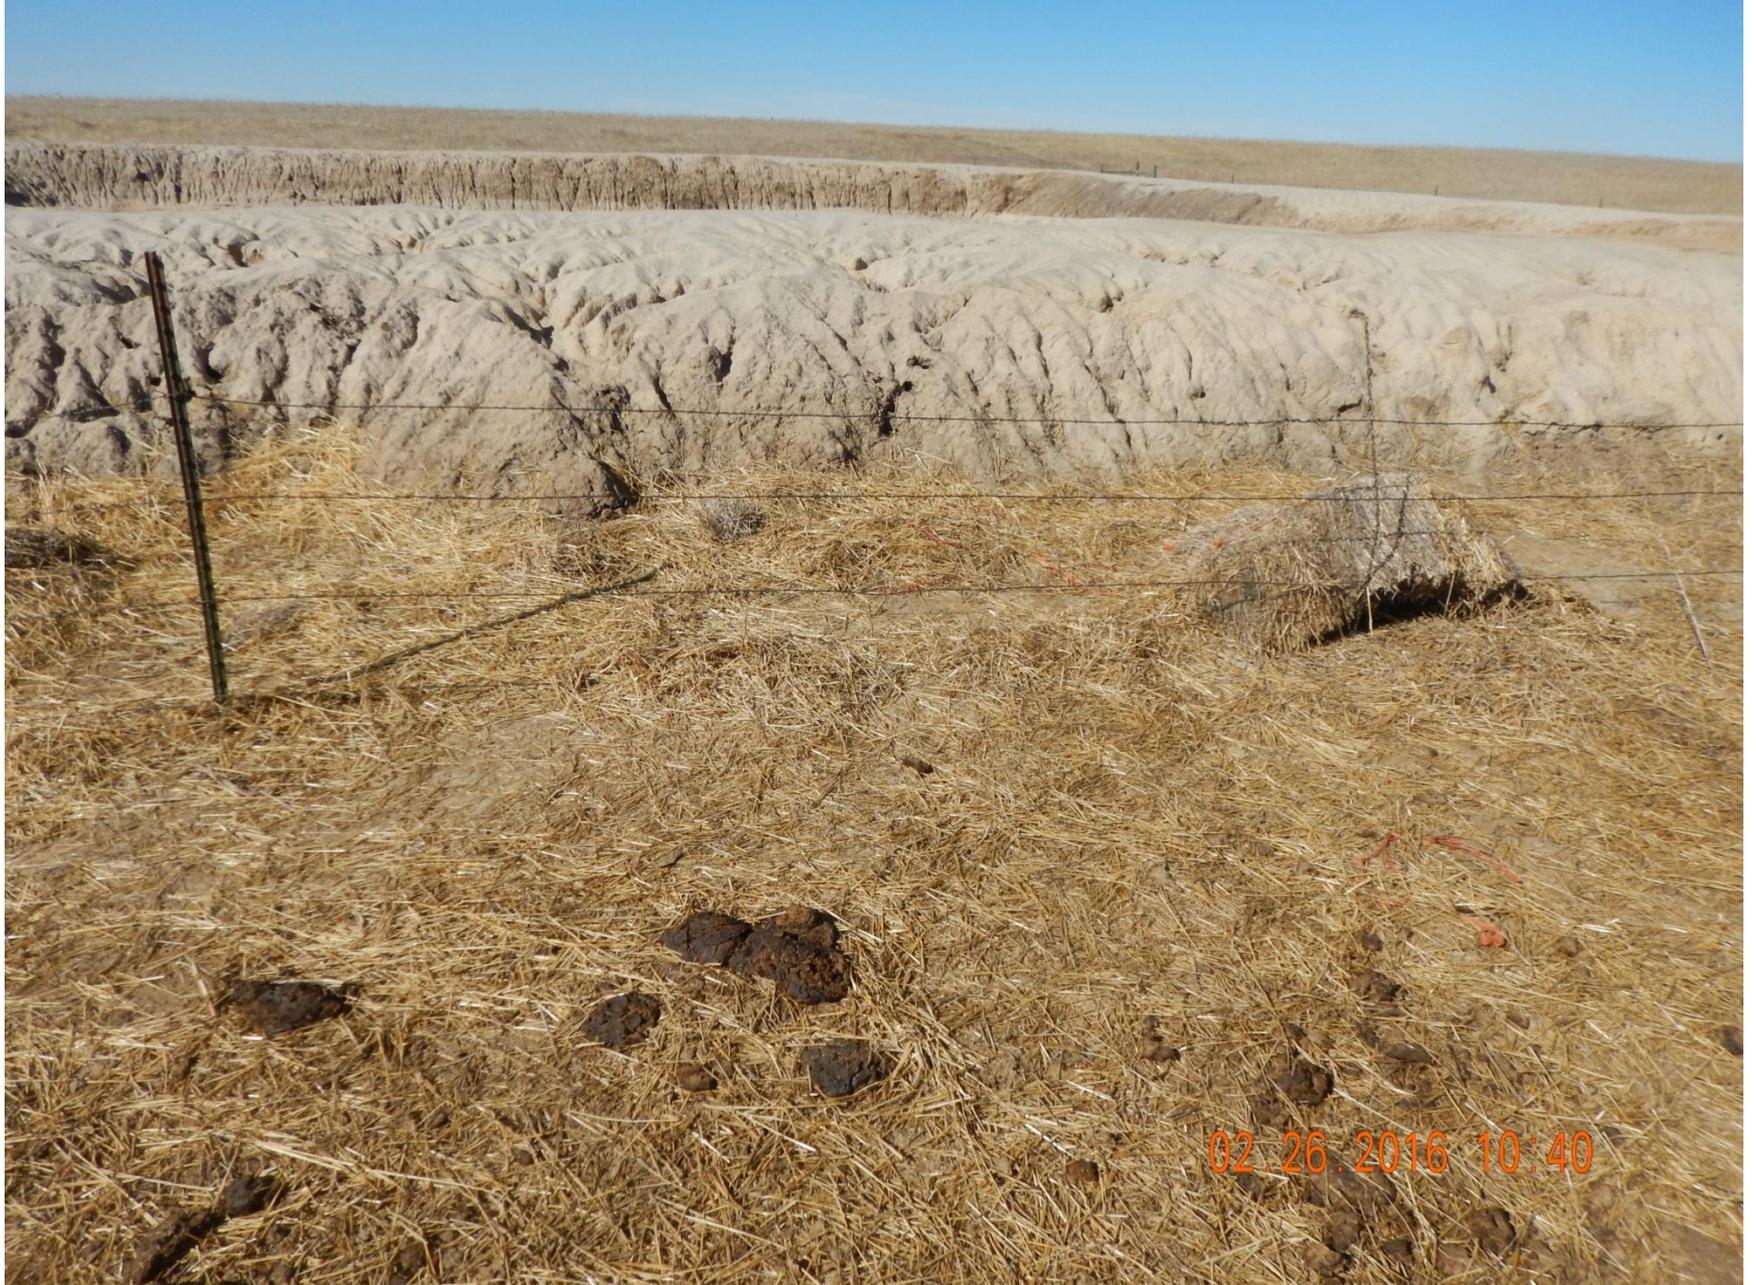
**Figure 10:** Photo taken from the east end of pit, facing west. Photo of erosion on pit, and hay bales used as a stormwater control. Note stormwater controls used are improperly installed and have not been maintained.
