# Stormwater Inspection

2/26/2016

Operator: Western Operating

Location ID: 435387

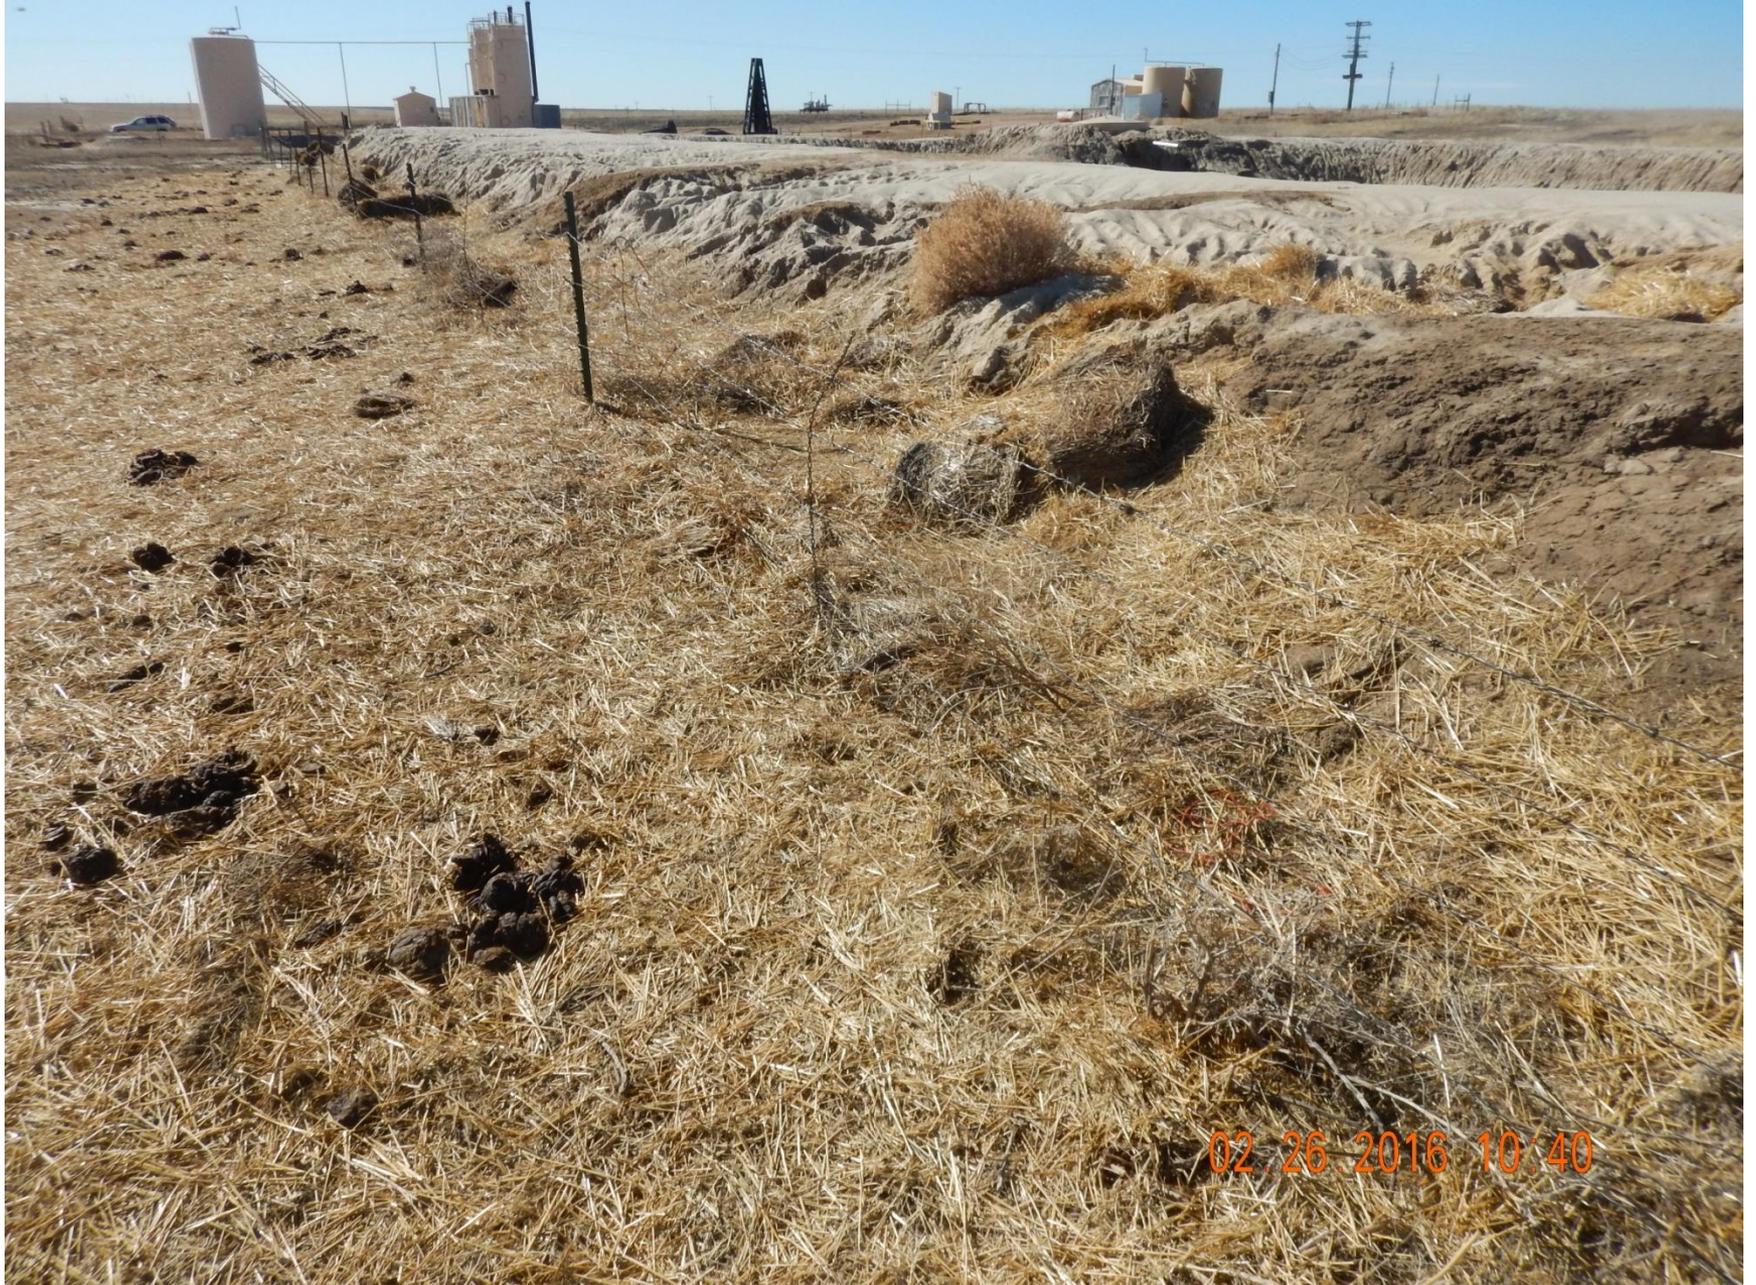
**Figure 11:** Photo taken from the northeast end of pit, facing south. Photo of erosion on pit, and hay bales used as a stormwater control. Note stormwater controls used are improperly installed and have not been maintained.

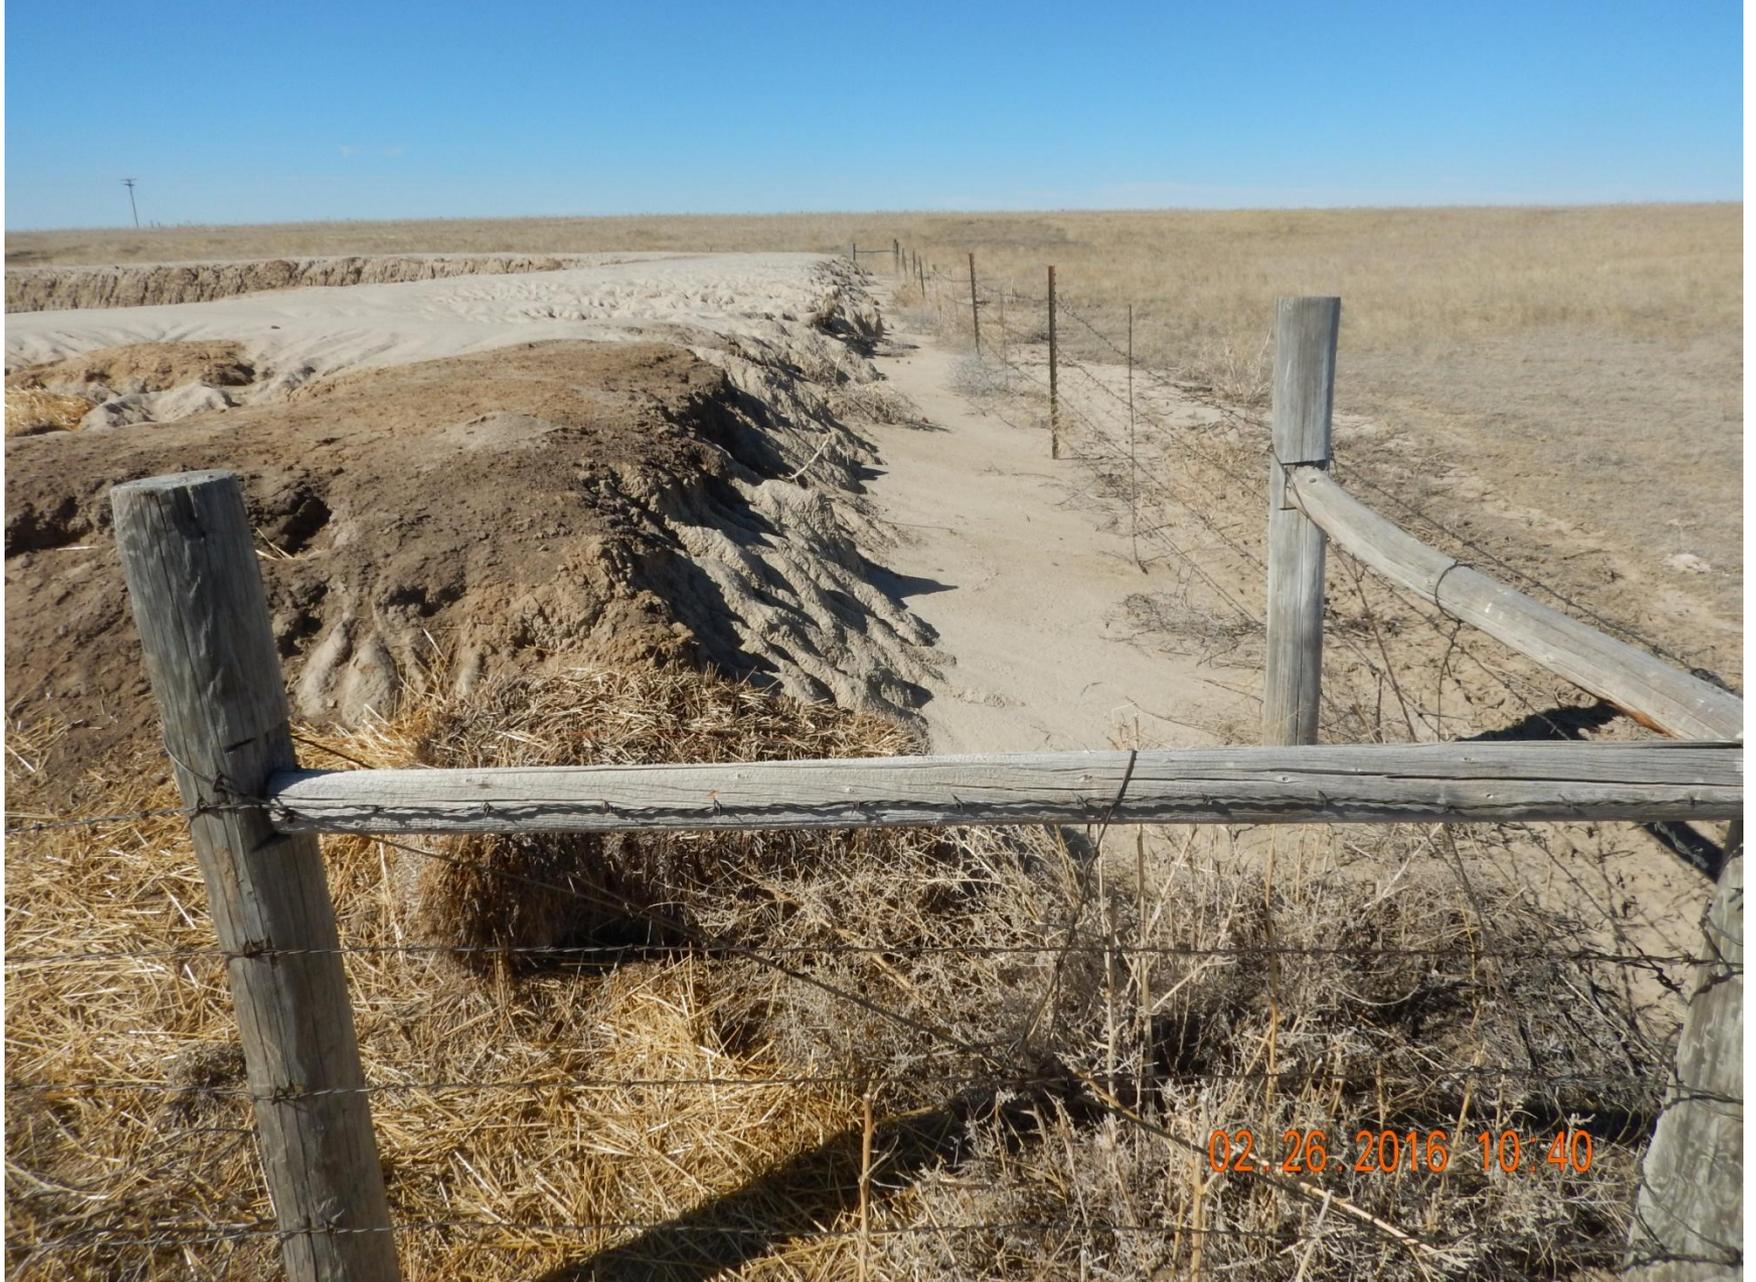
**Figure 12:** Photo taken from the northeast end of pit, facing west. Photo of erosion on pit, and hay bales used as a stormwater control. Note stormwater controls used are improperly installed and have not been maintained. Stormwater controls have not been installed on the northern end of the pit.

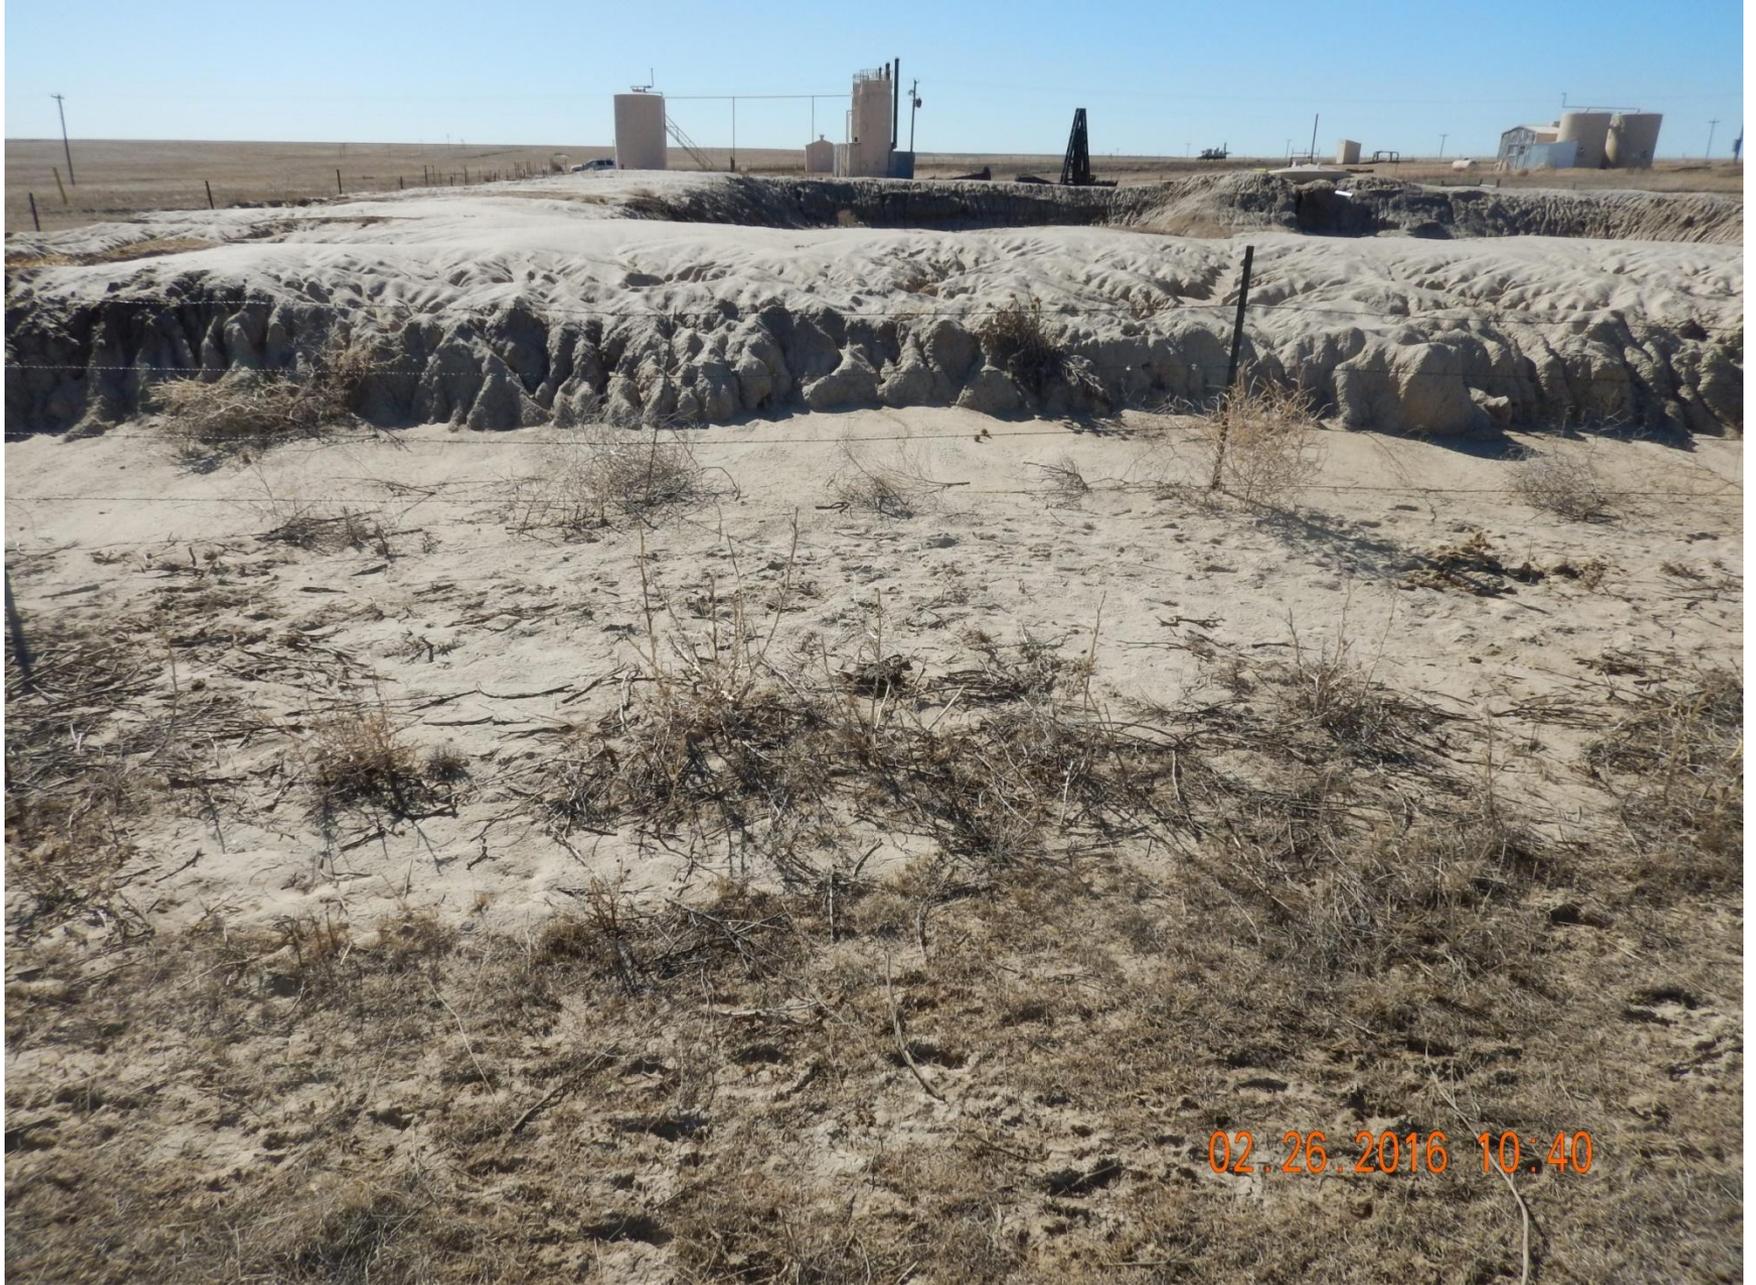
**Figure 13:** Photo taken from the north end of pit, facing south. Photo of erosion on pit. Note stormwater controls have not been installed on the northern end of the pit.

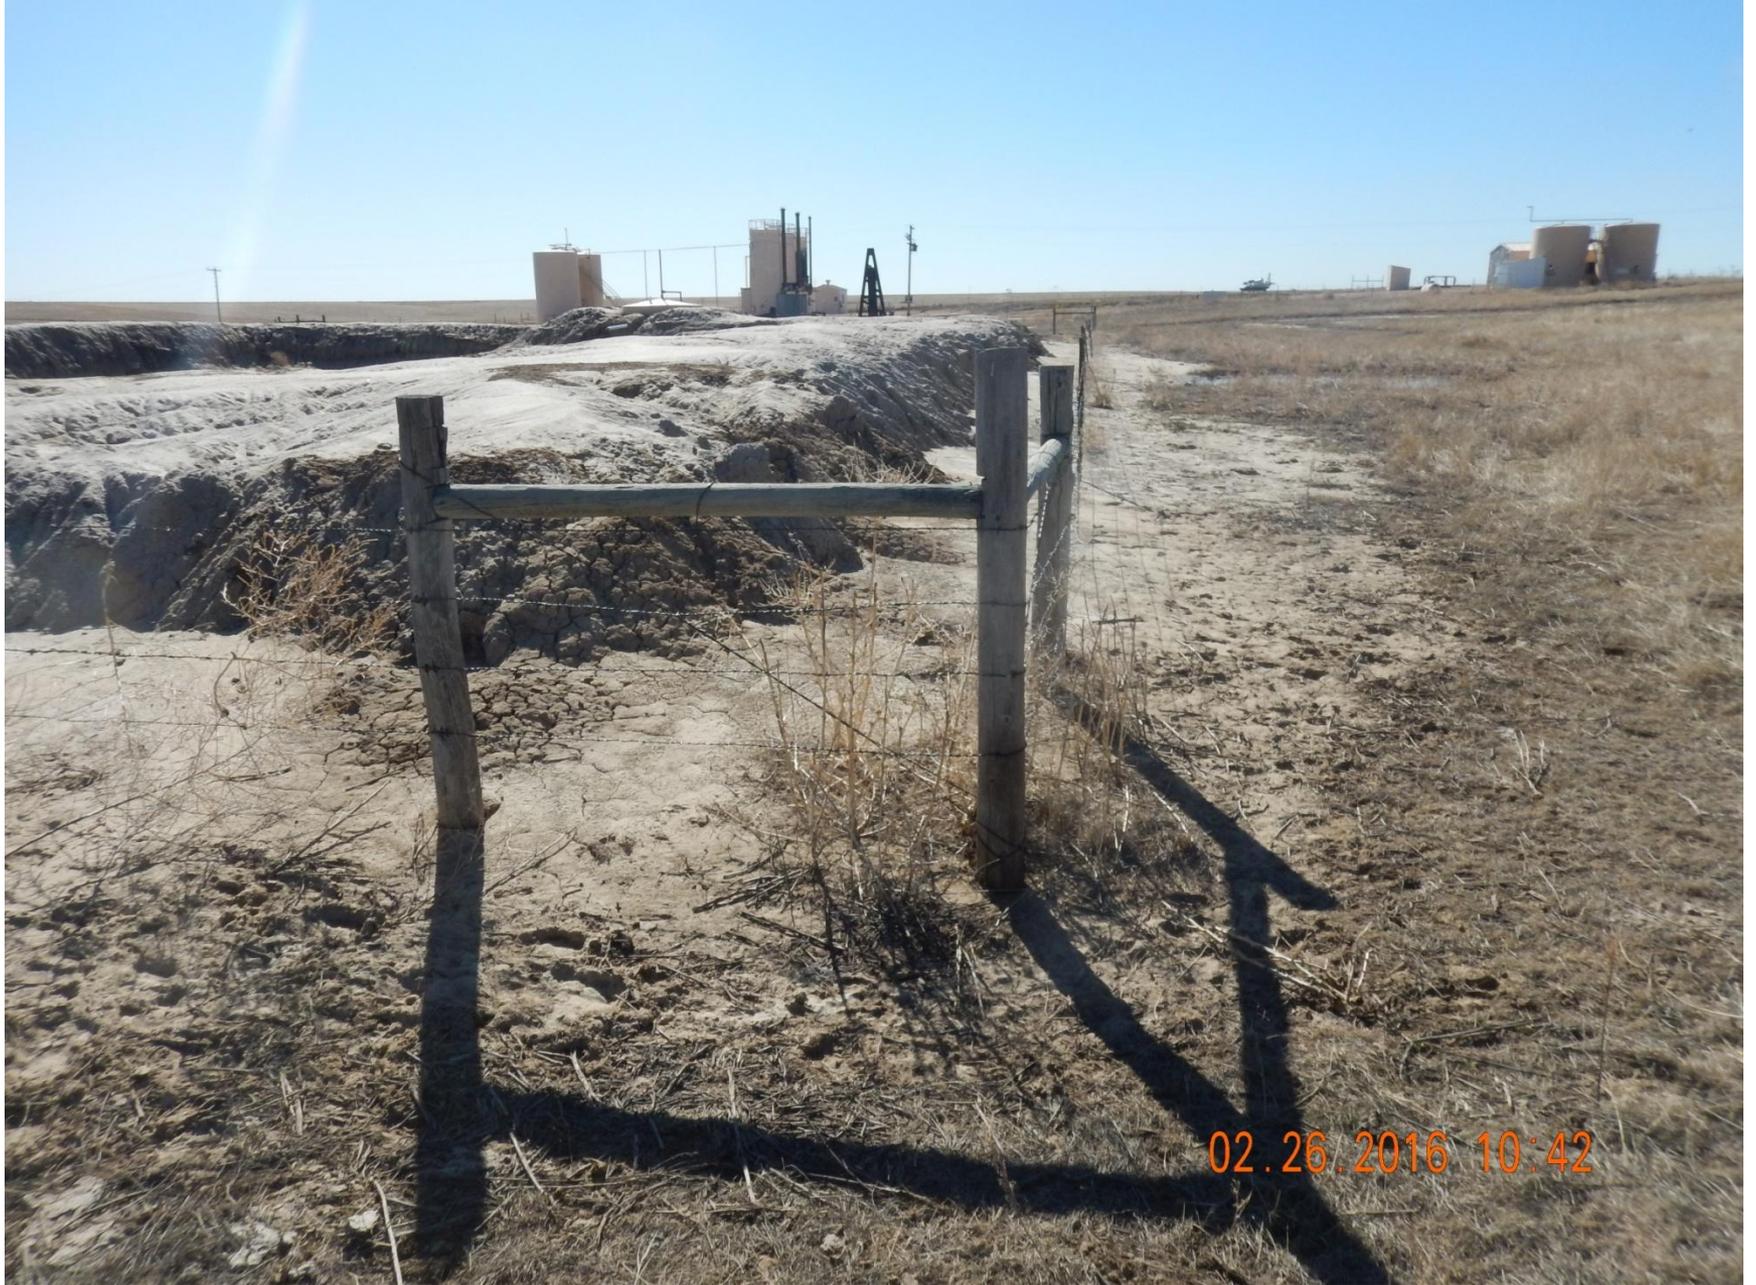
**Figure 14:** Photo taken from the northwest end of pit, facing south. Photo of erosion on pit. Note stormwater controls have not been installed on the northern and western end of the pit.

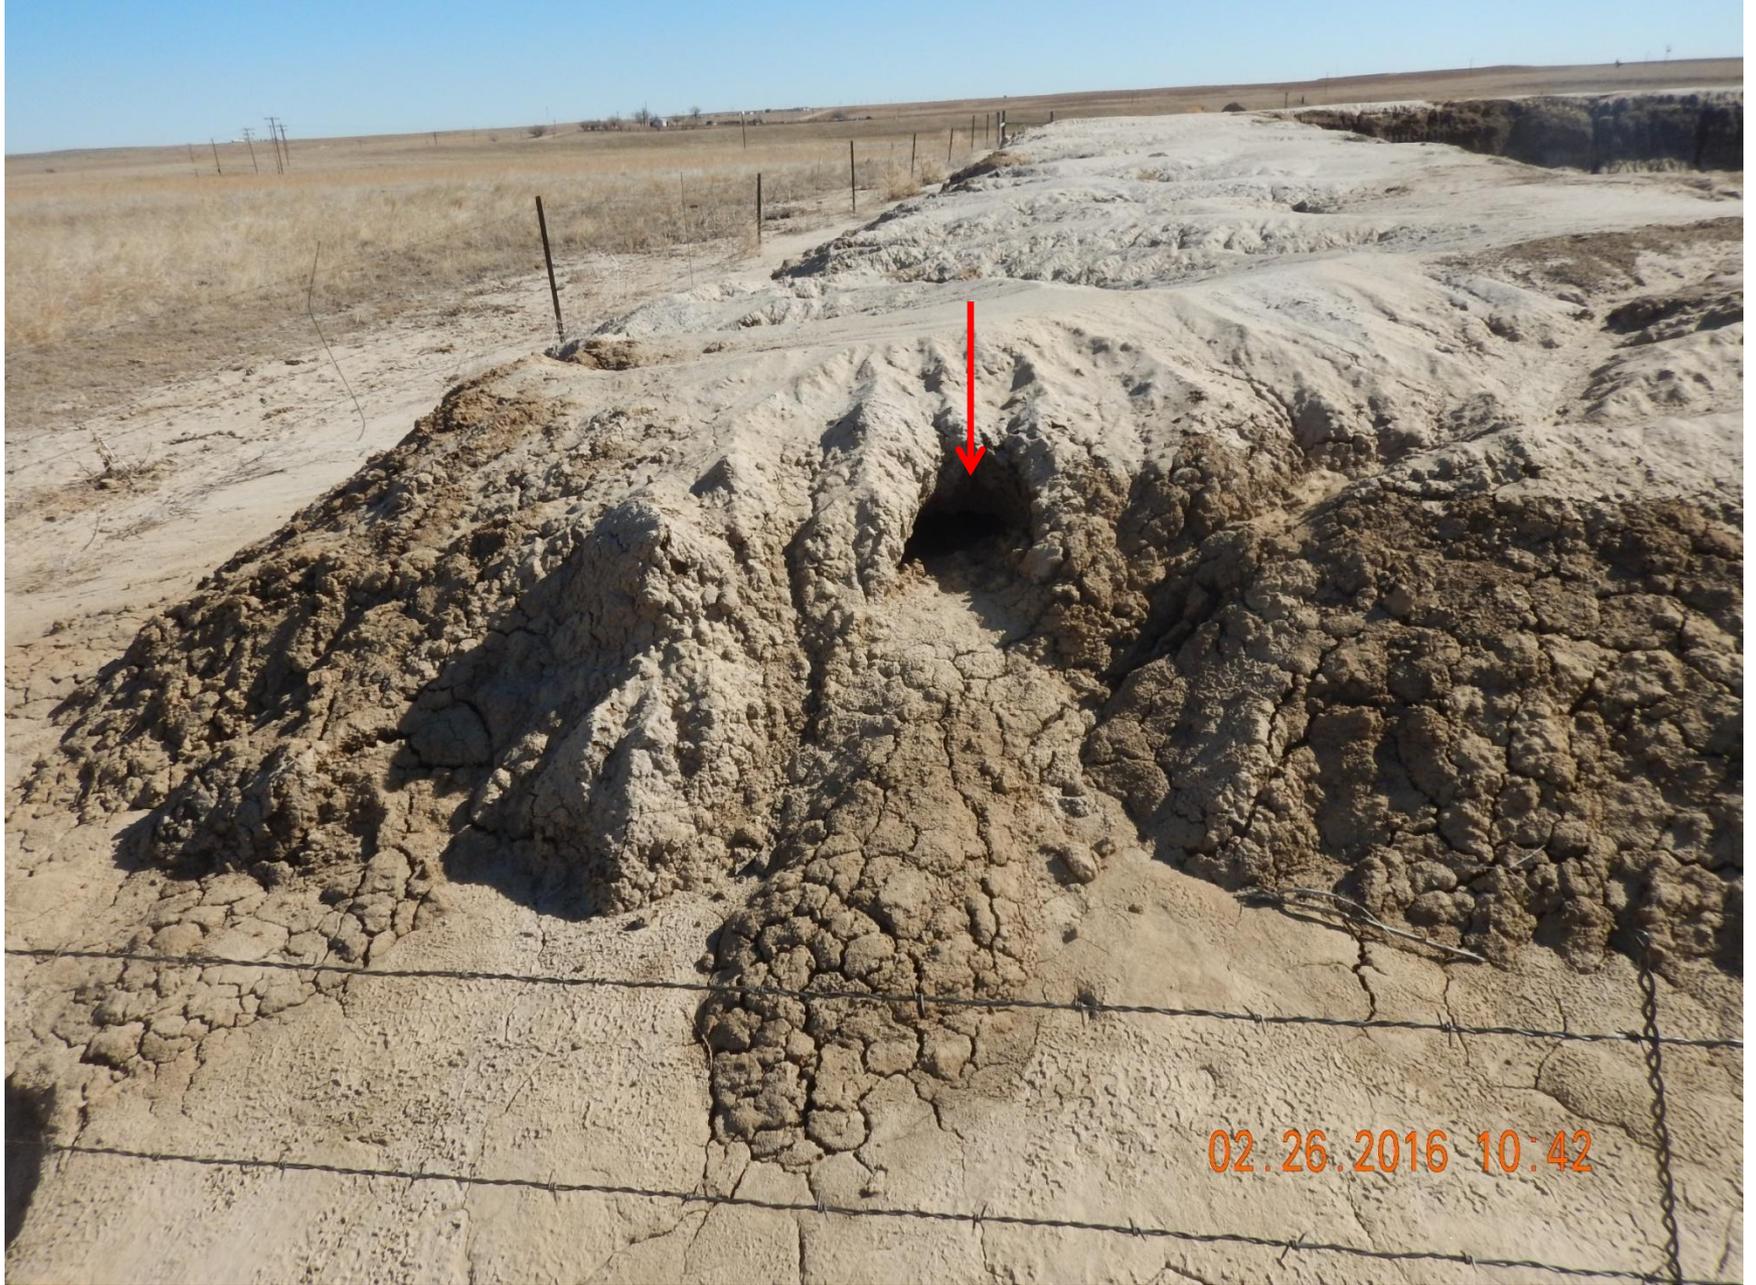
**Figure 15:** Photo taken from the northwest end of pit, facing east. Photo shows burrowing activities by wildlife taking place in pit wall.

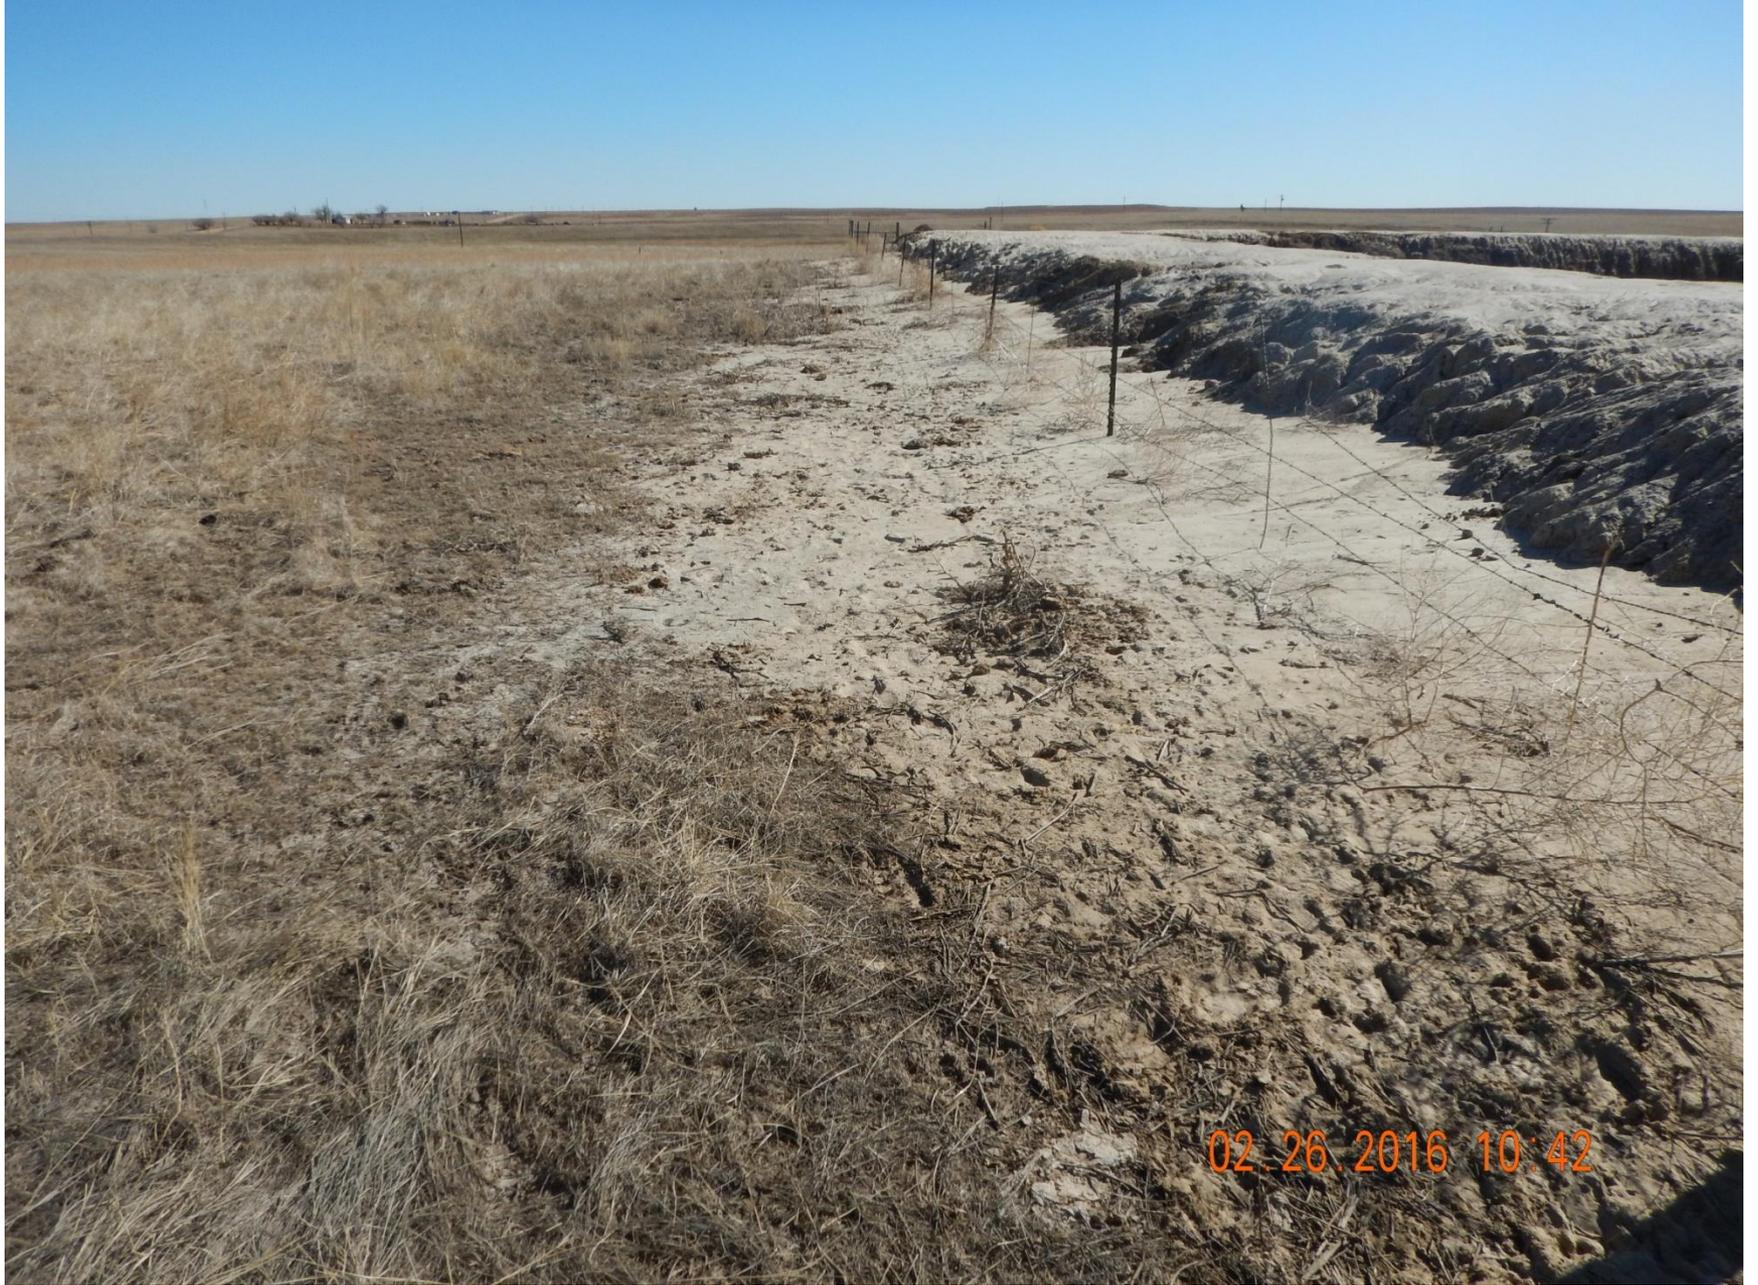
**Figure 16:** Photo taken from the northwest end of pit, facing west. Photo of erosion on pit. Note stormwater controls have not been installed on the northern end of the pit.

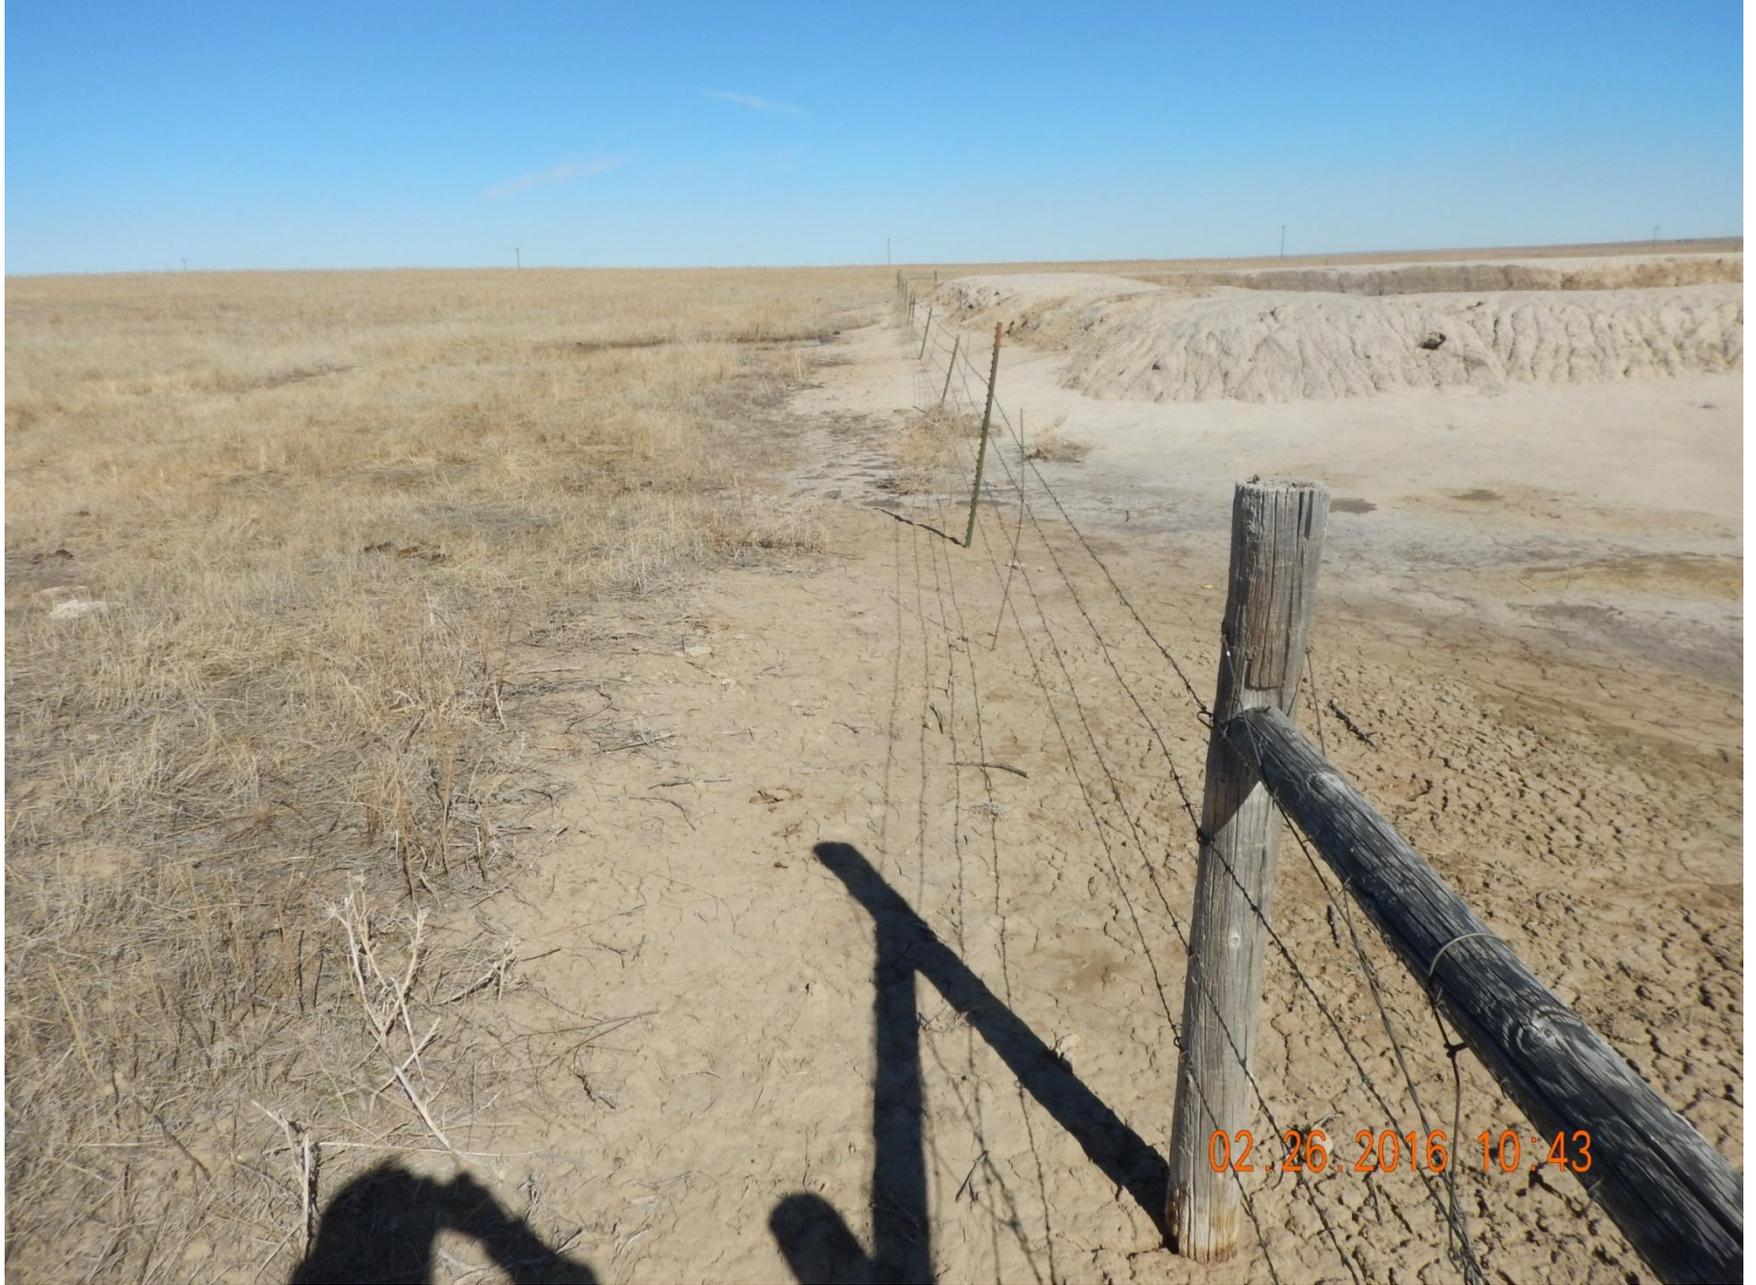
**Figure 16:** Photo taken from the southwest end of pit, facing north. Photo of erosion on pit. Note stormwater controls have not been installed on the western end of the pit.

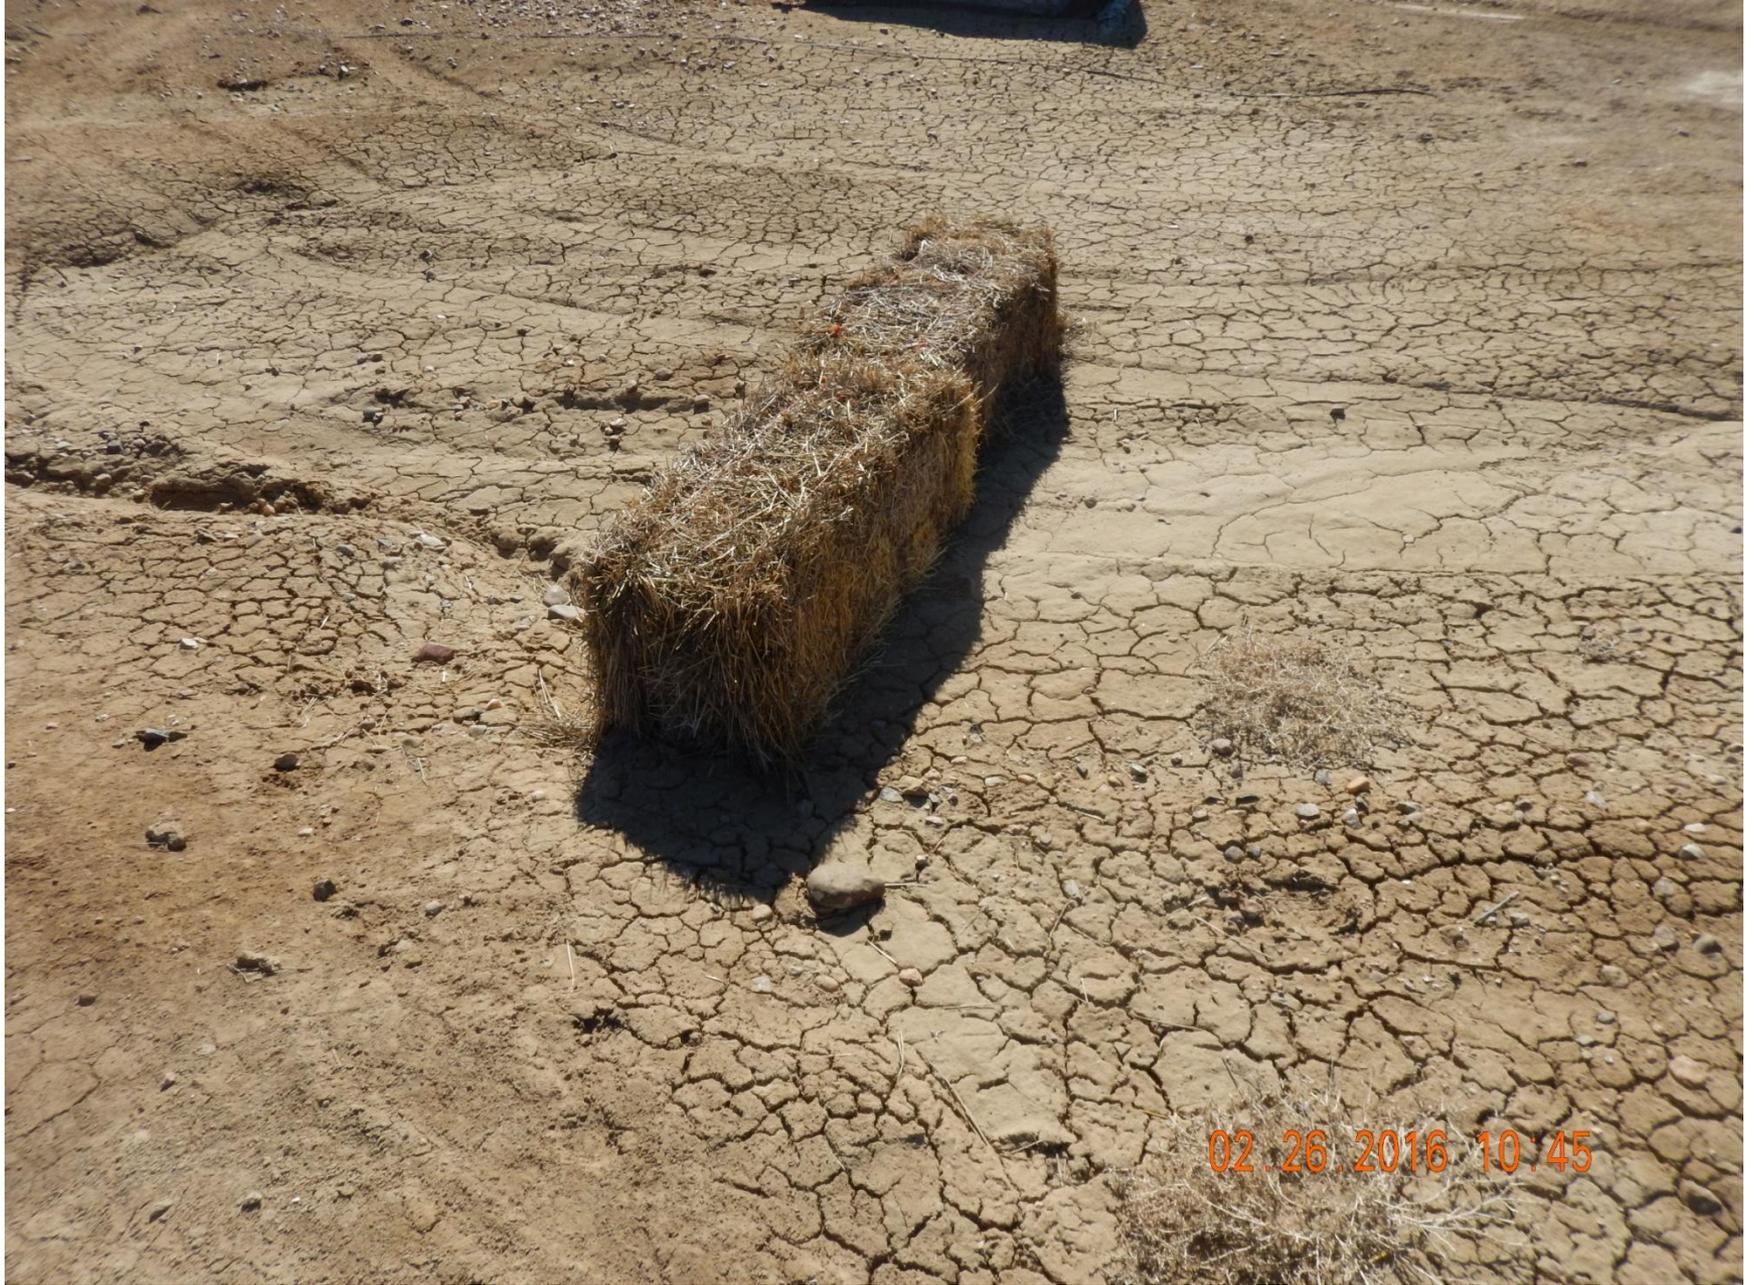
**Figure 18:** Photo taken from the east end of location. Photo of erosion on location, and hay bales used as a stormwater control method. Note stormwater controls used are improperly installed.

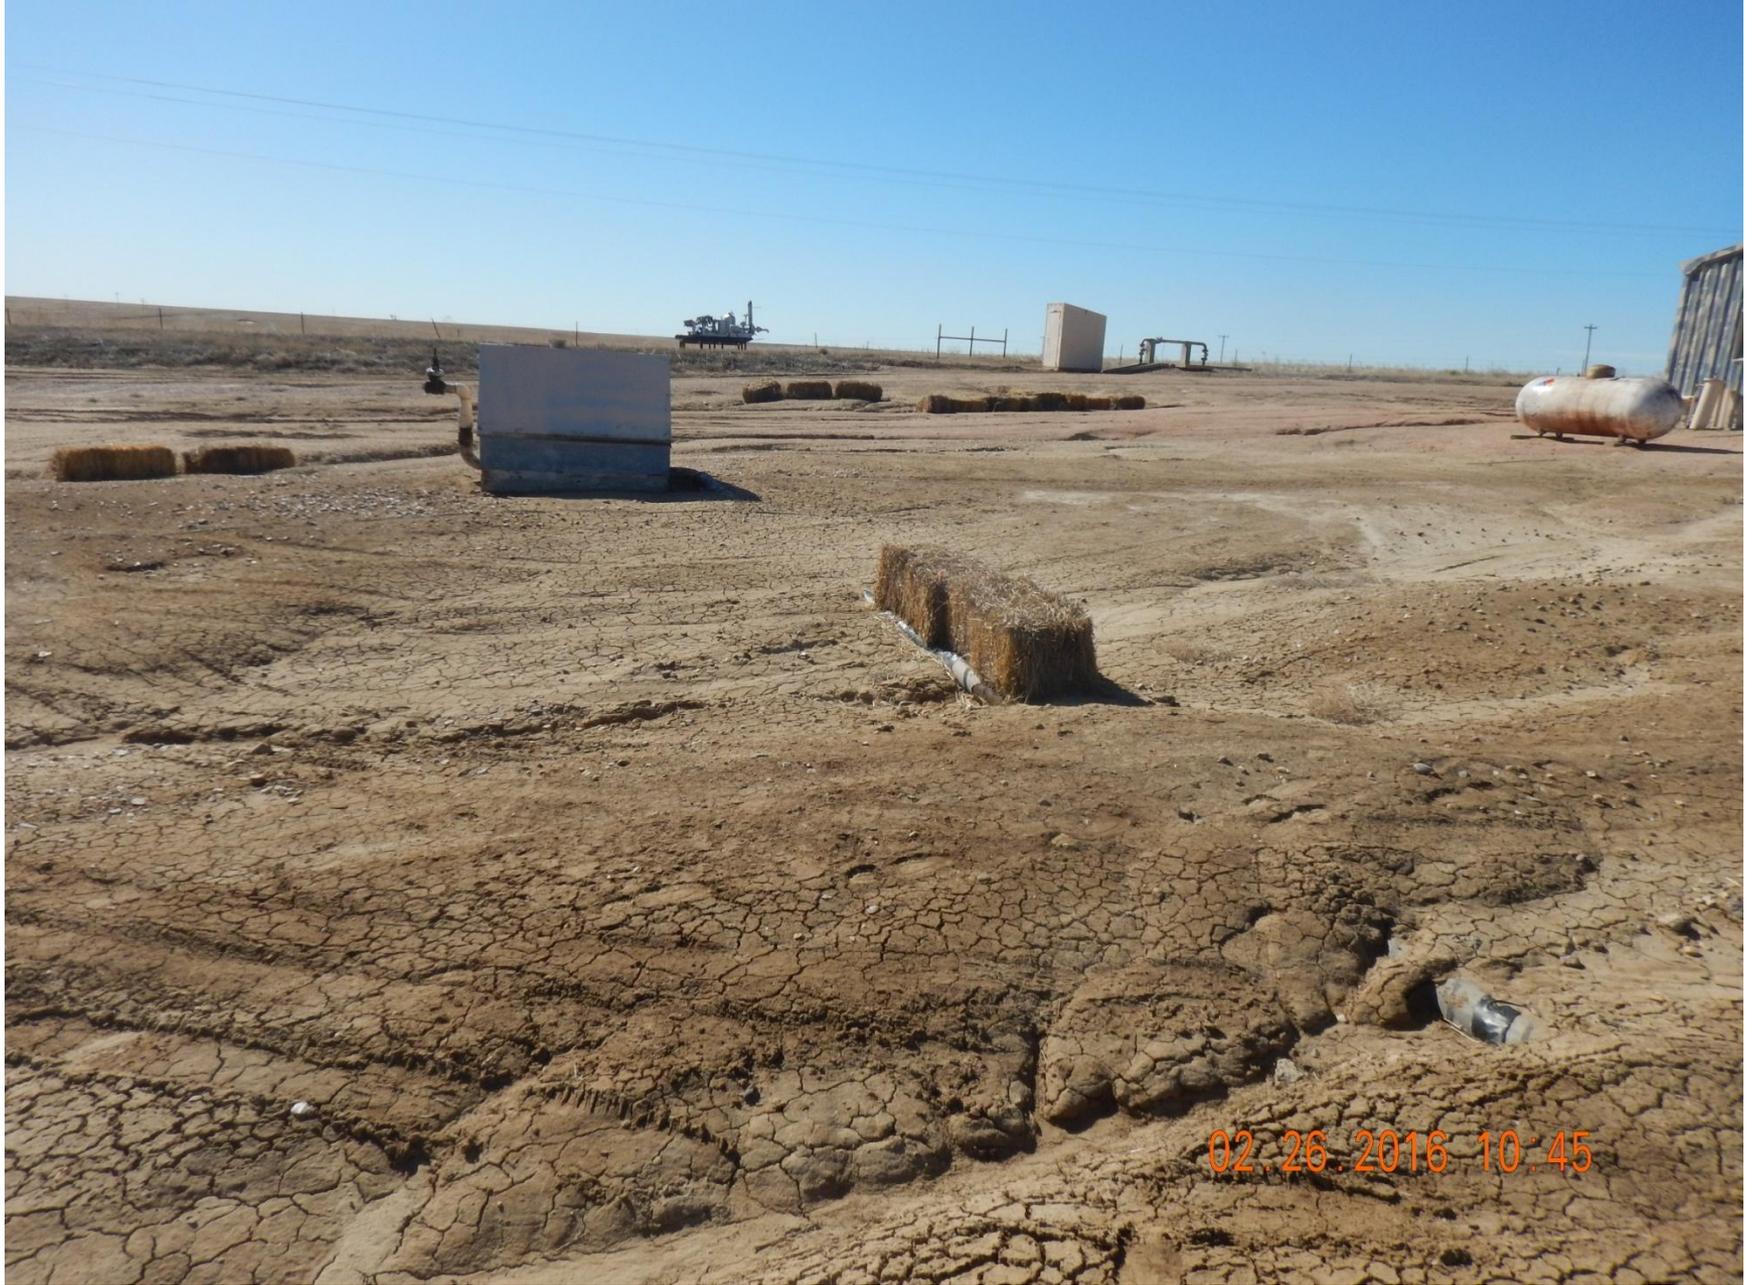
**Figure 19:** Photo taken from north end of location facing south. Photo of erosion on location, and hay bales used as a stormwater control method. Note stormwater controls used are improperly installed.

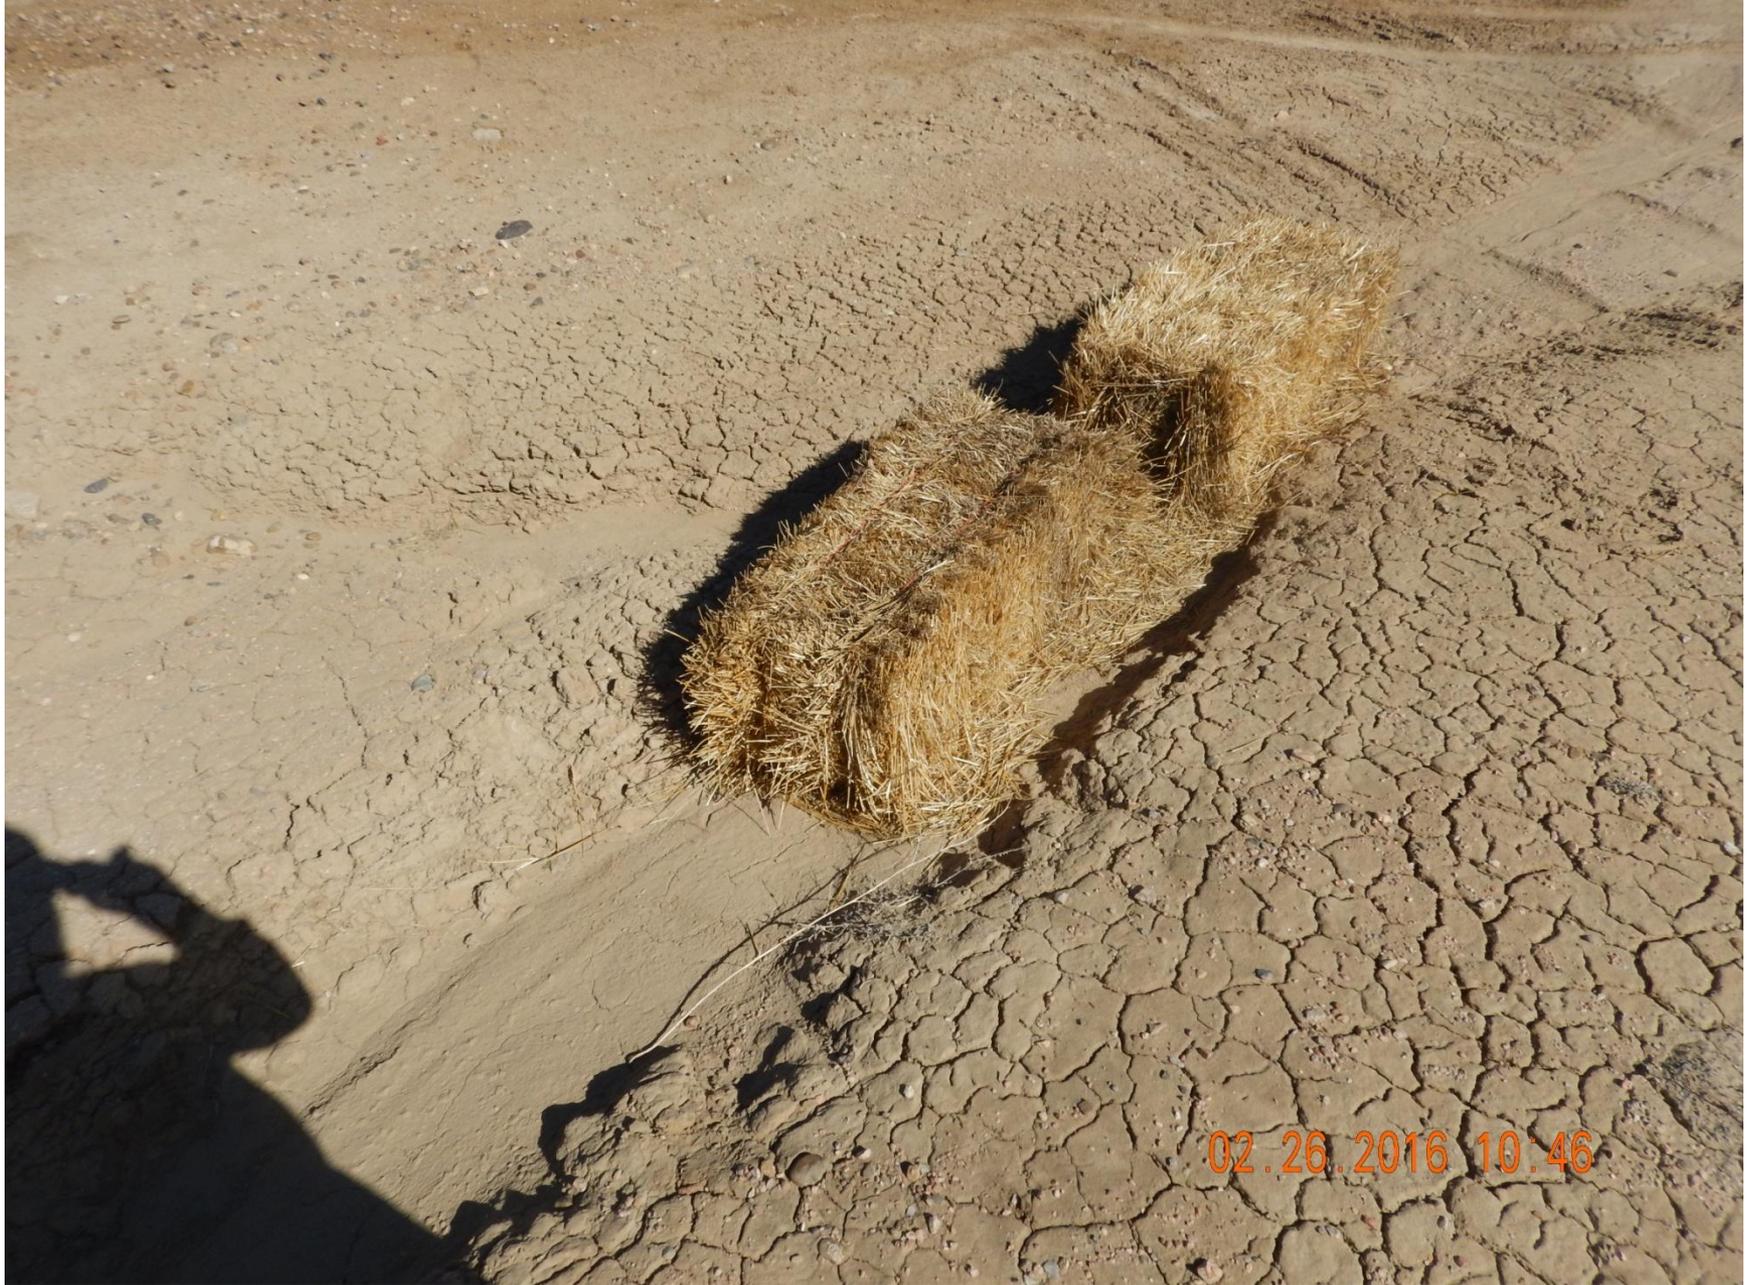
**Figure 20:** Photo taken from south end of location. Photo of erosion on location, and hay bales used as a stormwater control method. Note stormwater controls used are improperly installed .
