# Stormwater Inspection

2/26/2016

Operator: Western Operating

Location ID: 435387

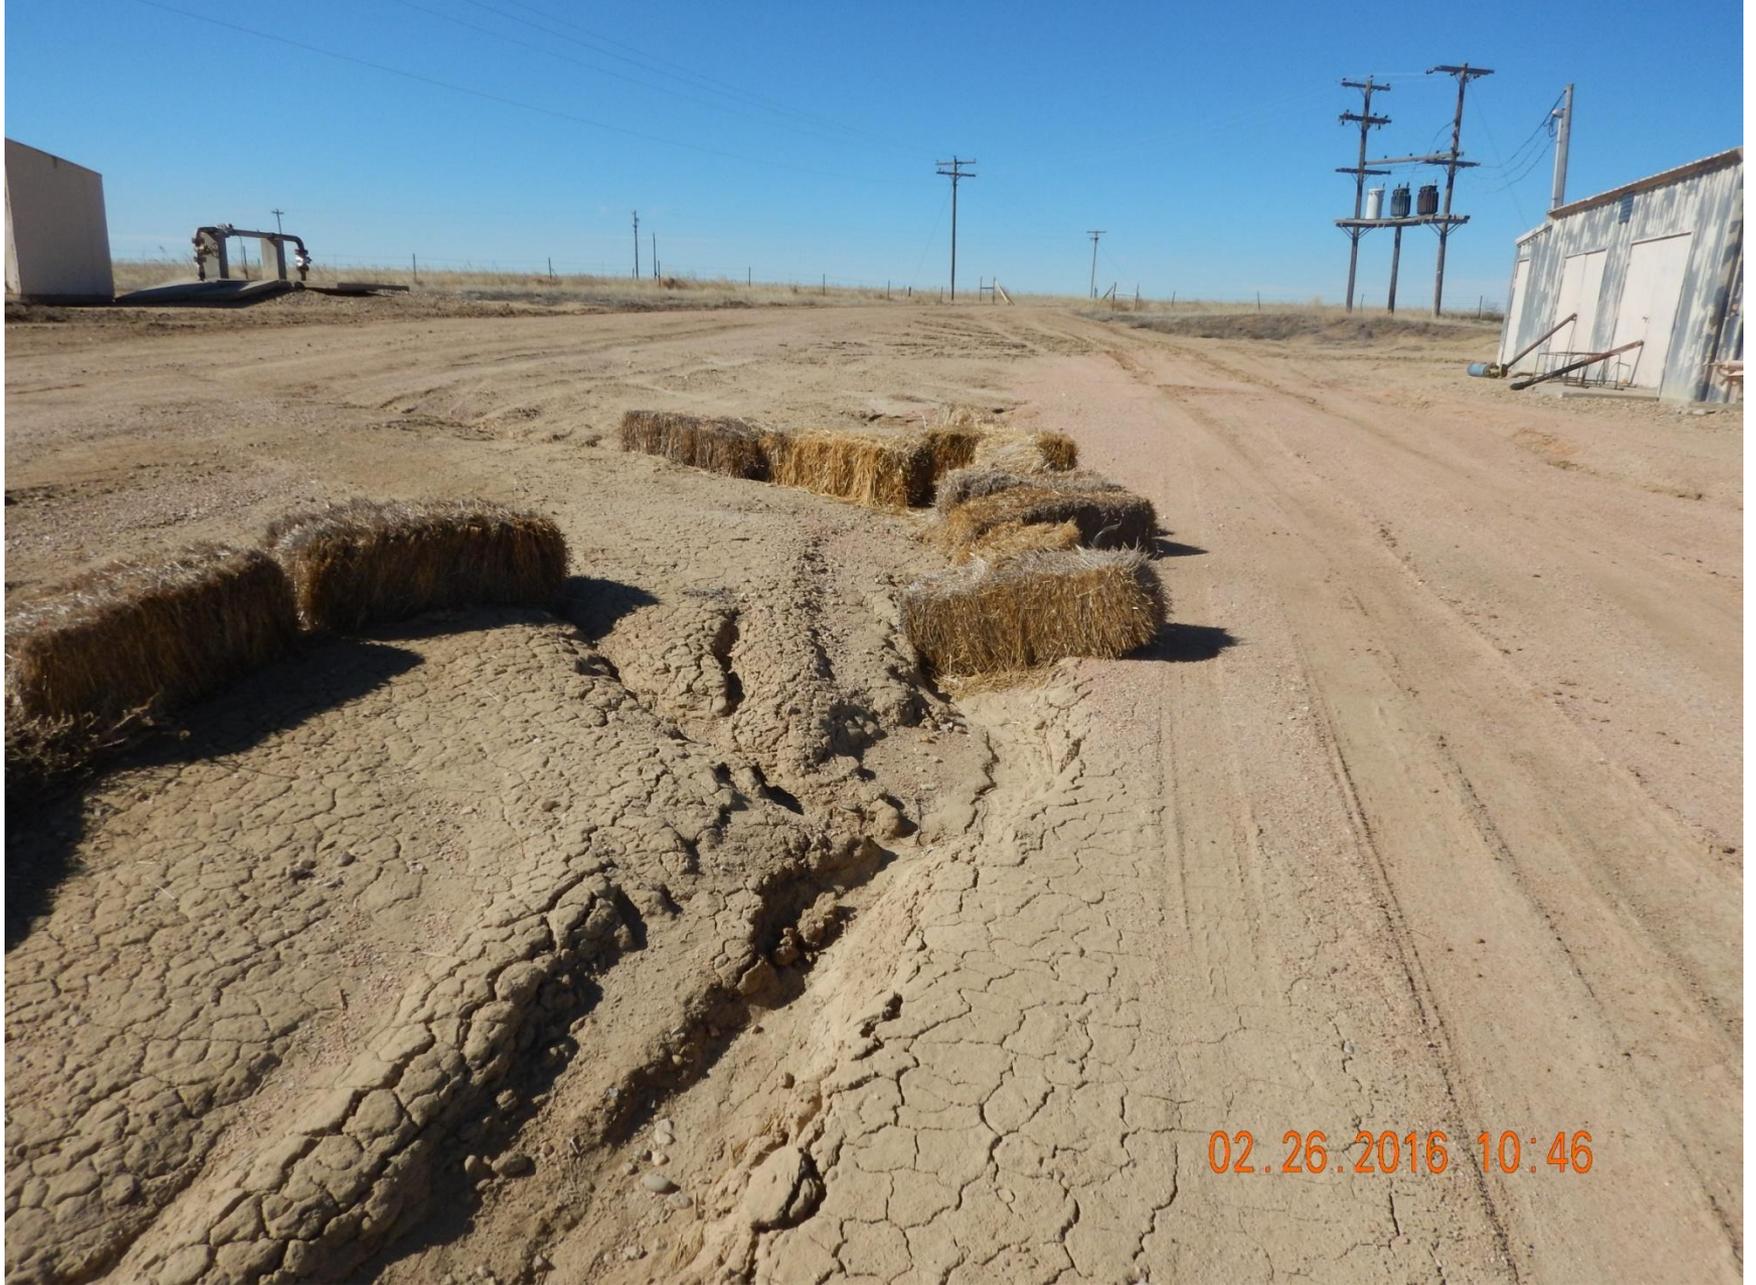
**Figure 21:** Photo taken from south end of location, facing west. Photo of erosion on location, and hay bales used as a stormwater control method. Note stormwater controls used are improperly installed.

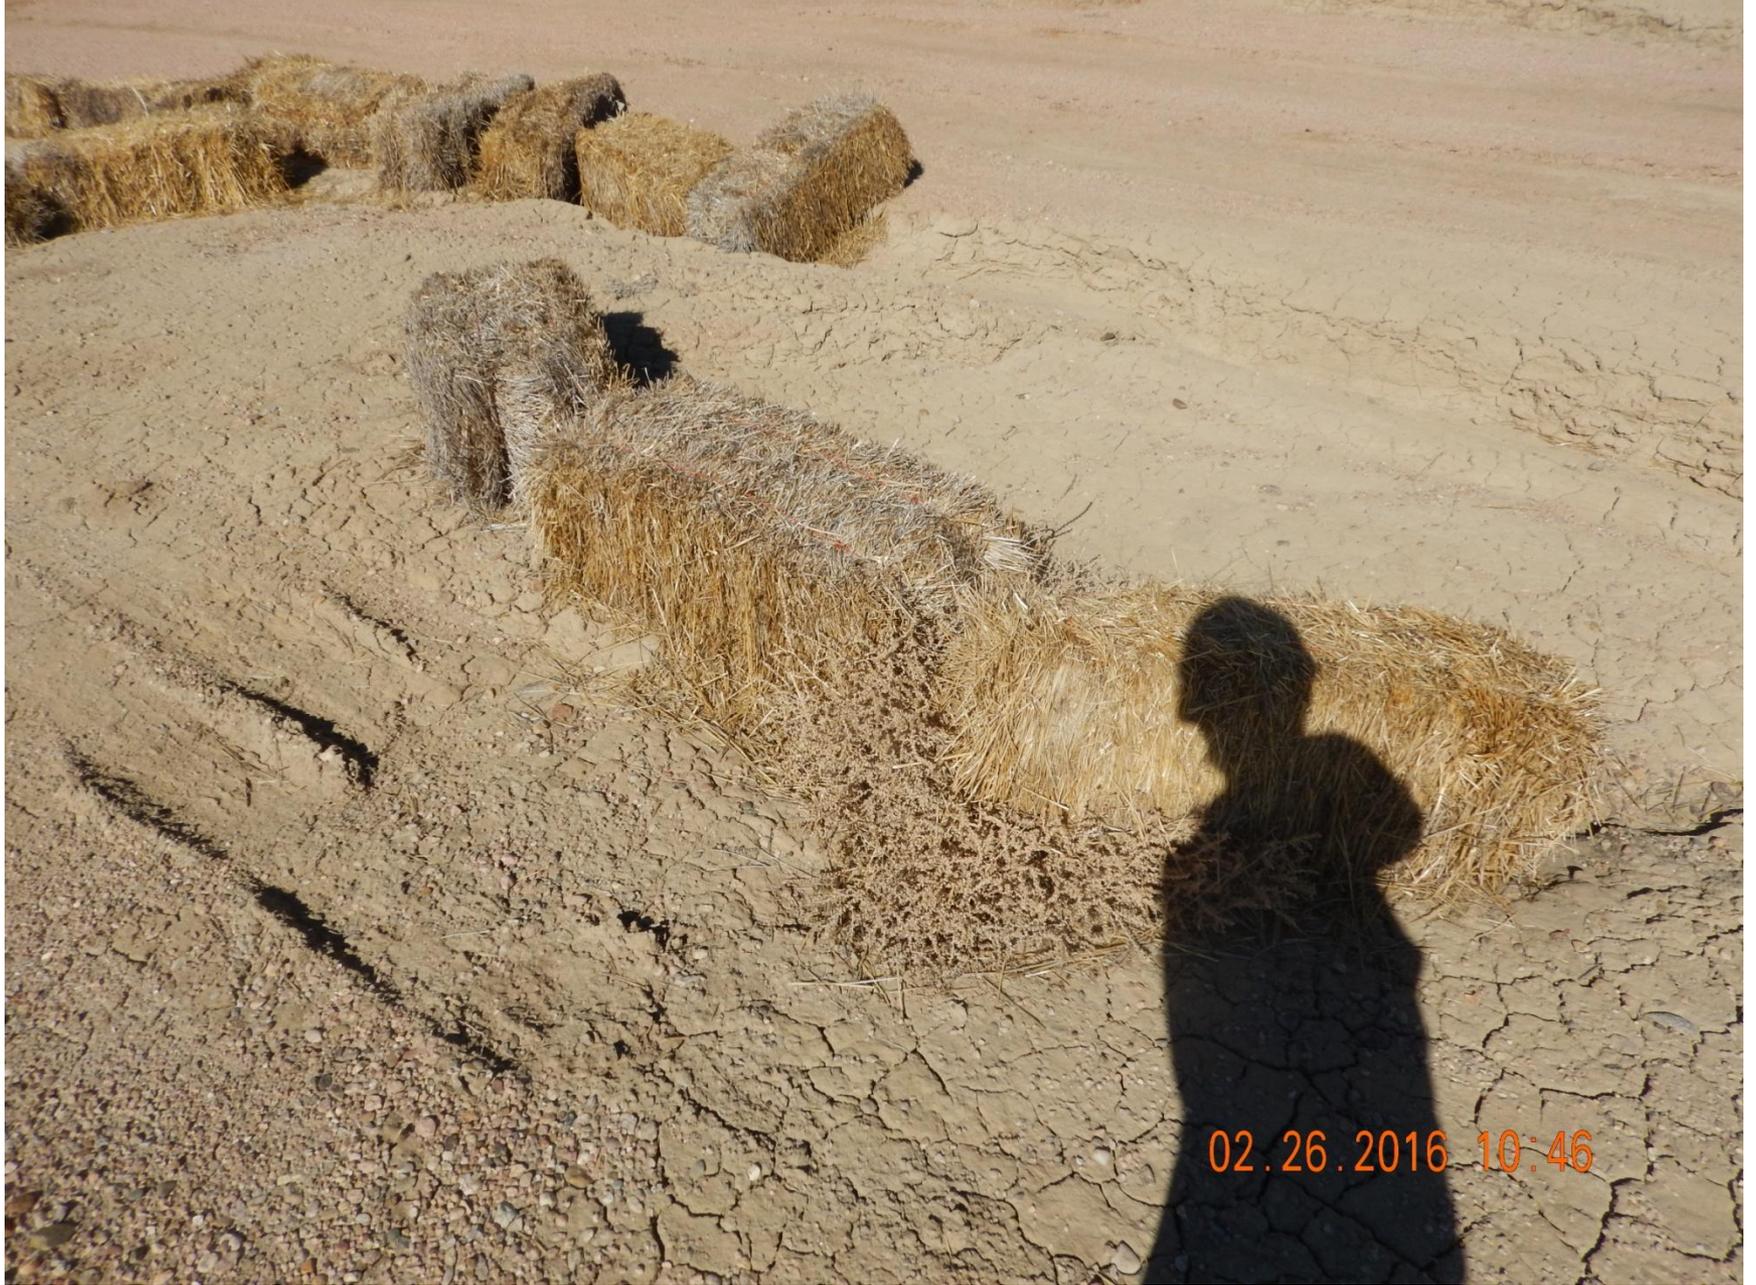
**Figure 22:** Photo taken from south end of location. Photo of erosion on location, and hay bales used as a stormwater control method. Note stormwater controls used are improperly installed.

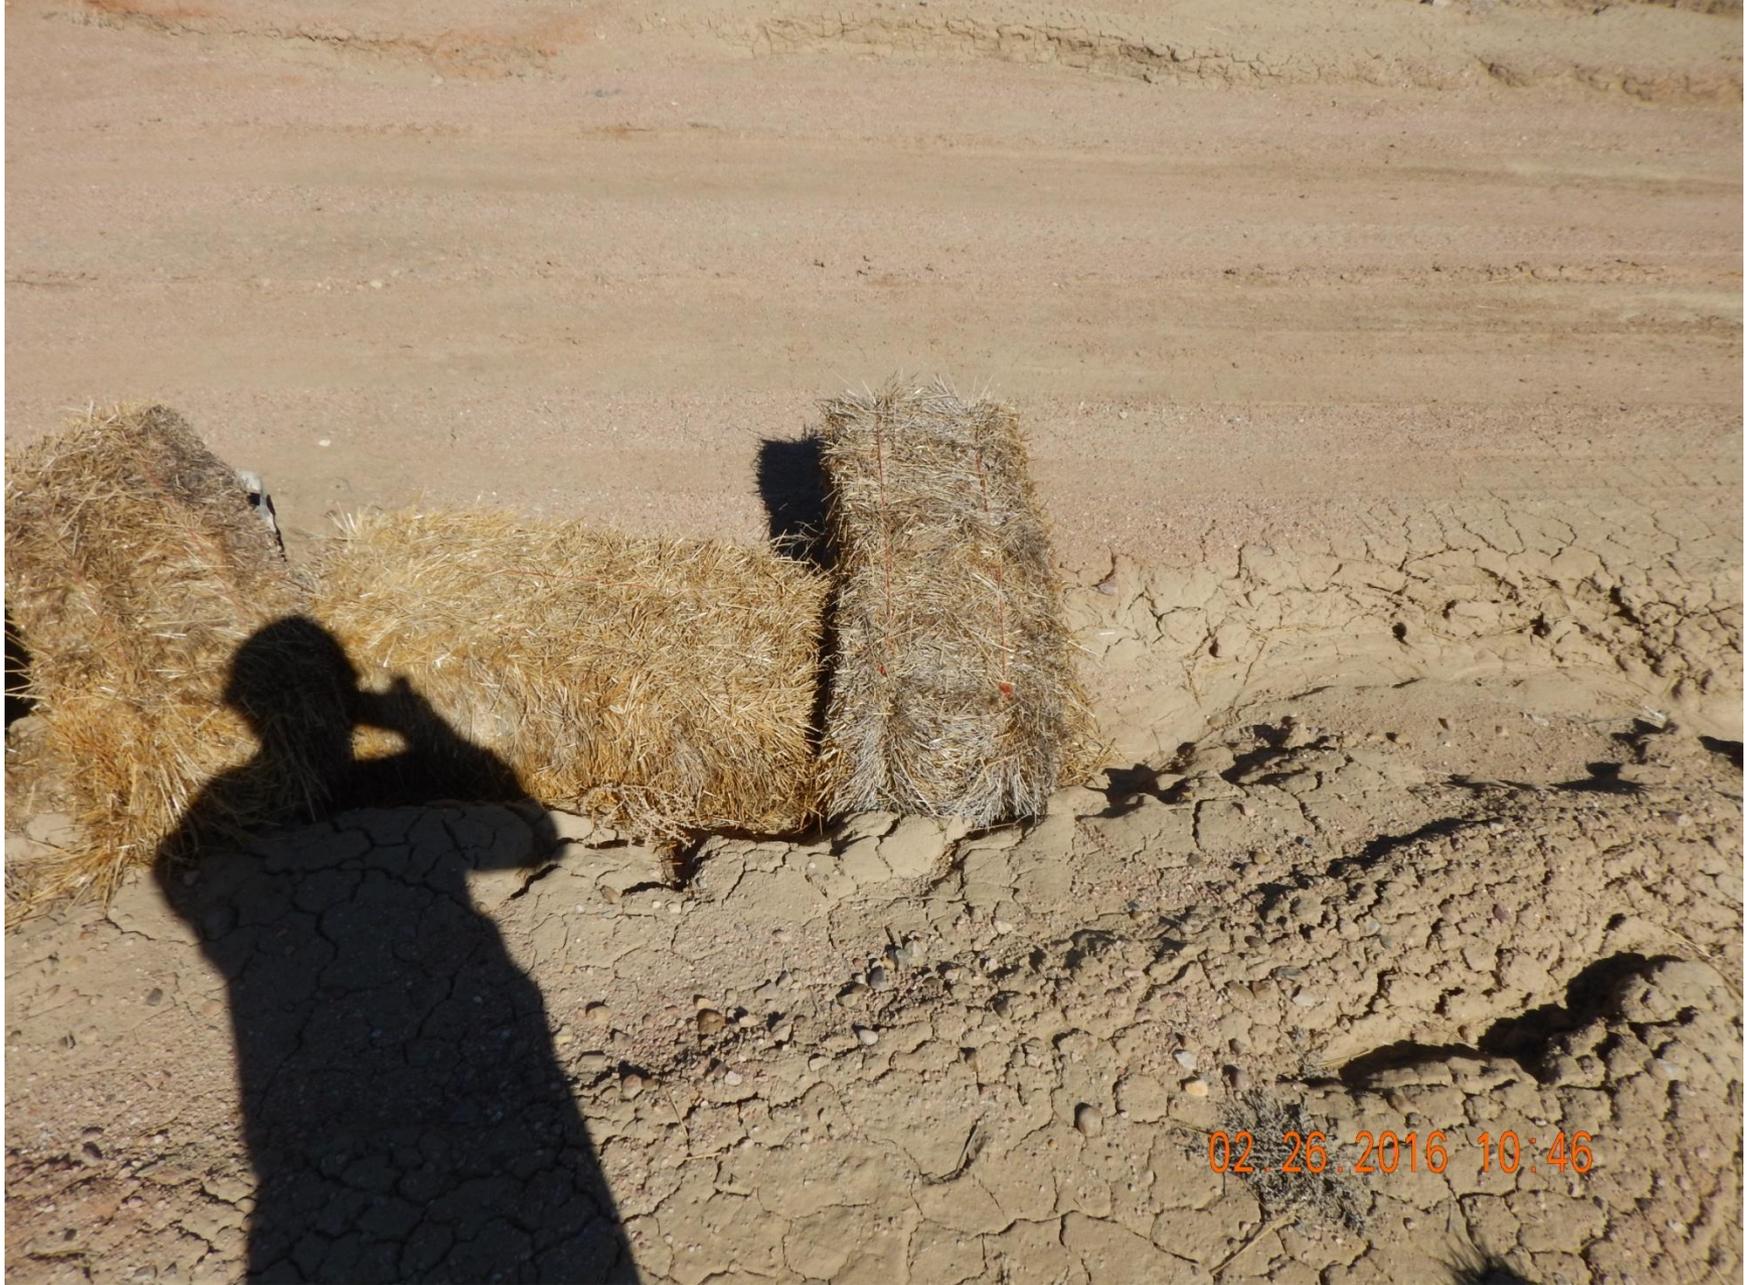
**Figure 23:** Photo taken from south end of location. Photo of erosion on location, and hay bales used as a stormwater control method. Note stormwater controls used are improperly installed.

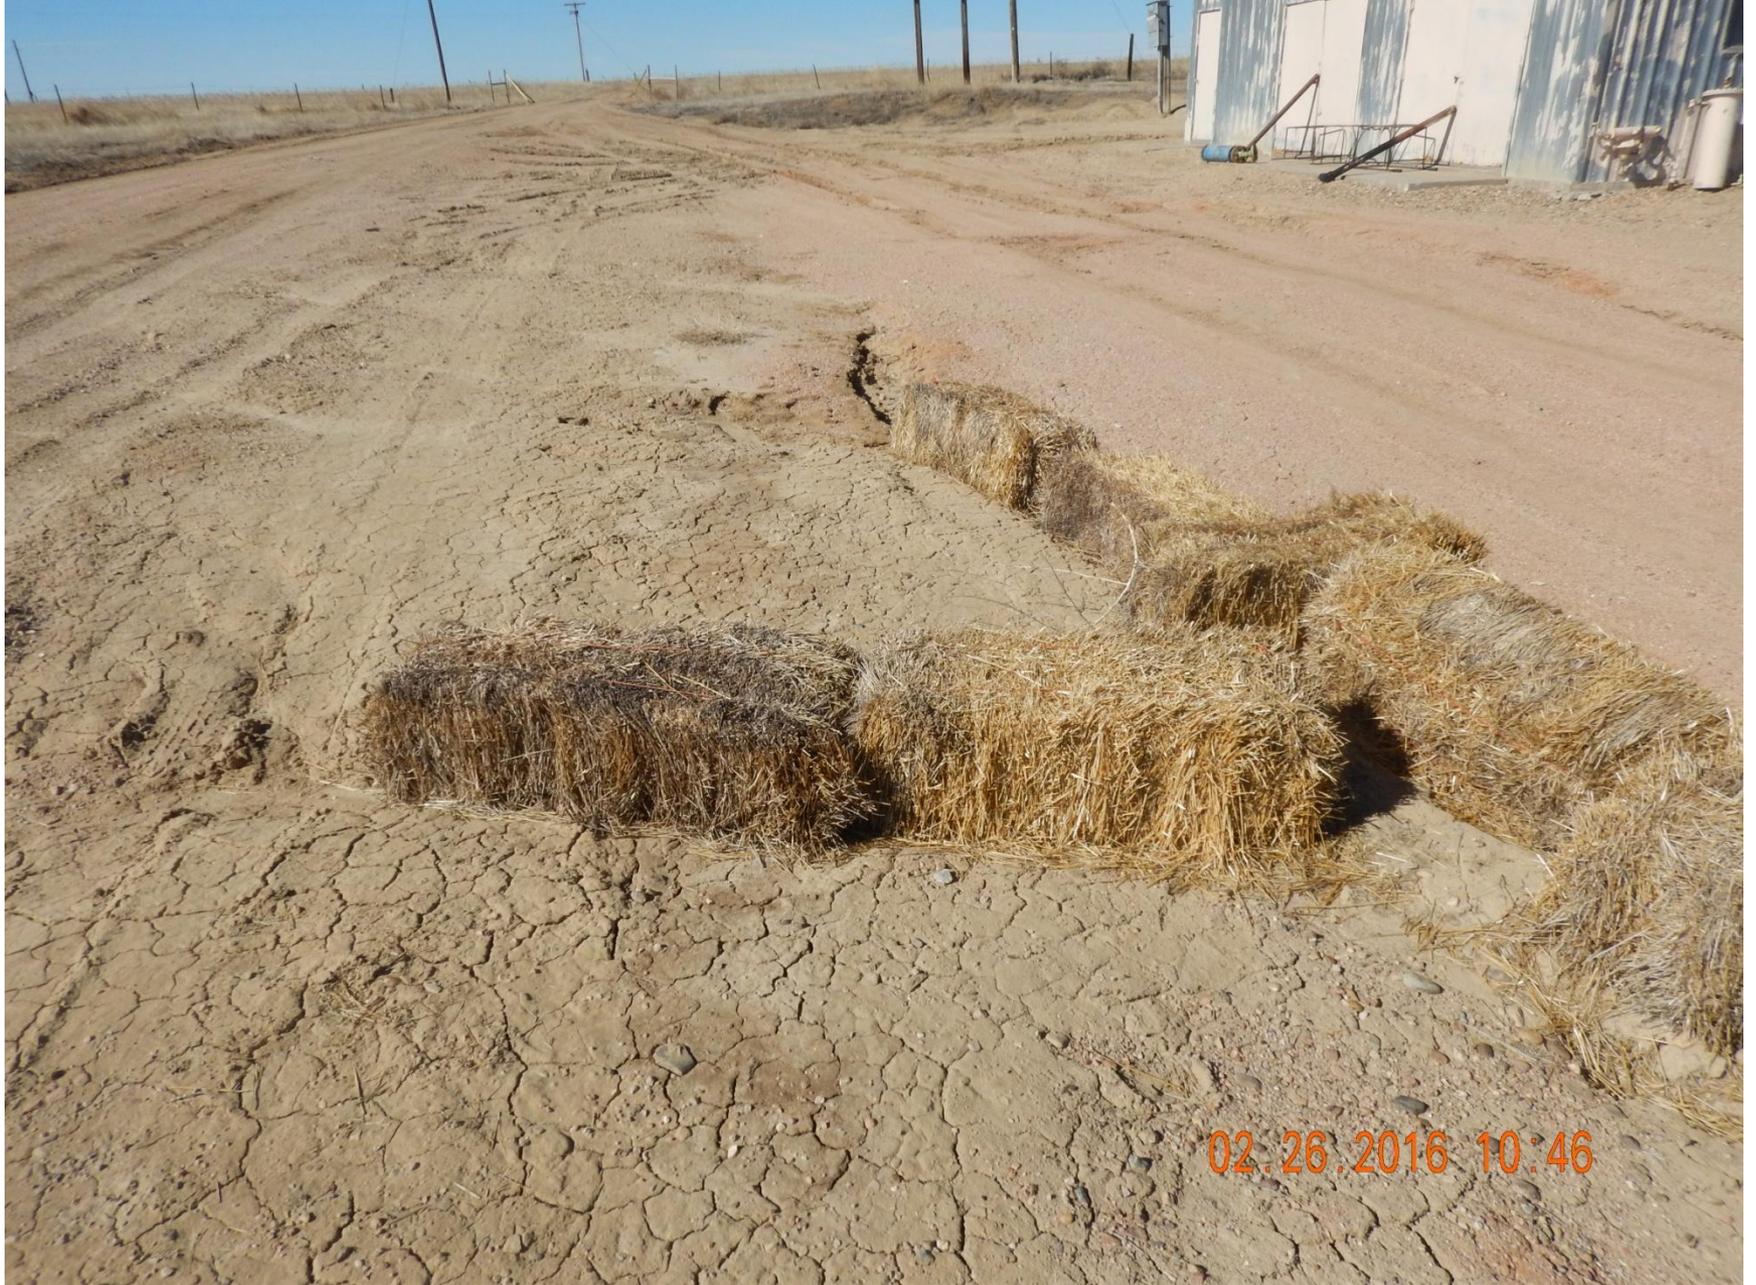
**Figure 24:** Photo taken from south end of location, facing west. Photo of erosion on location, and hay bales used as a stormwater control method. Note stormwater controls used are improperly installed.

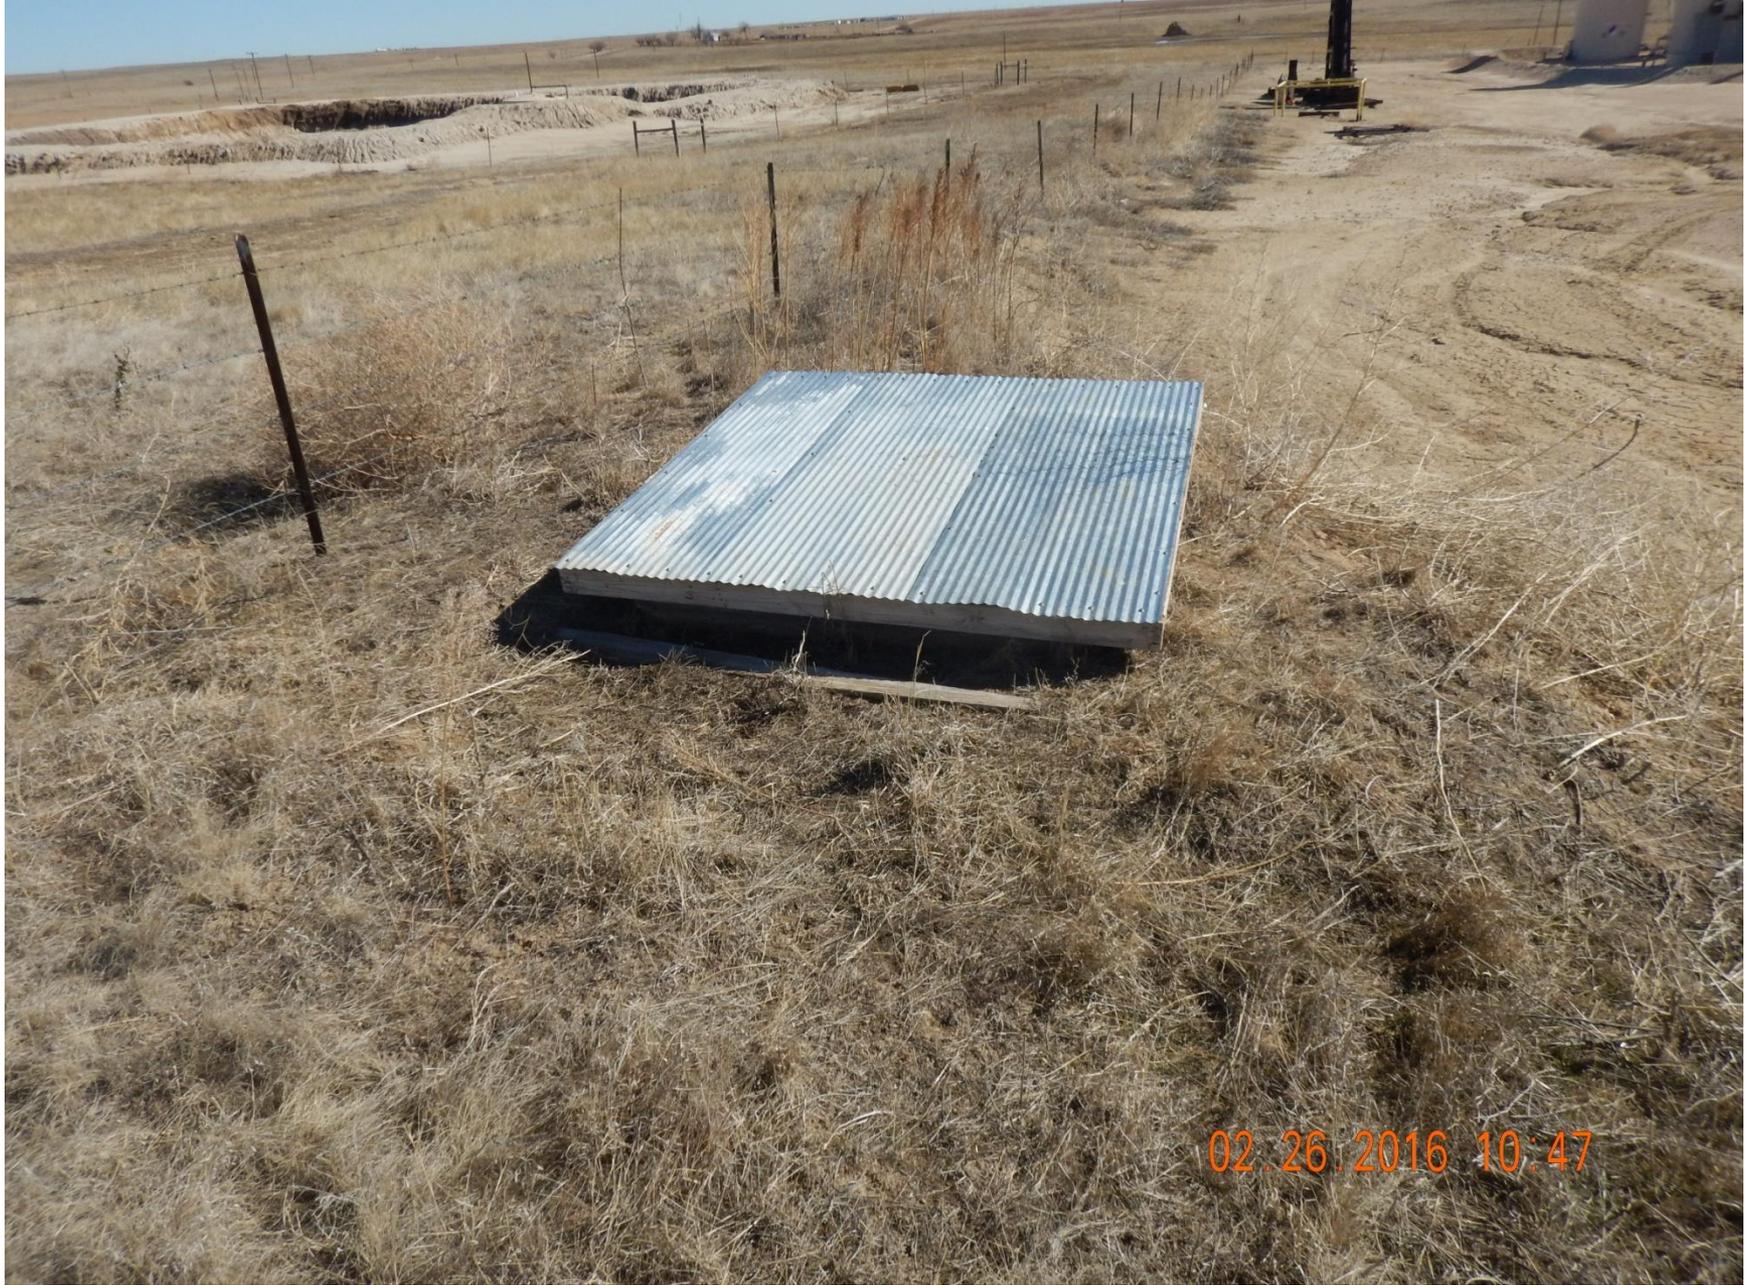
**Figure 25:** Photo taken from southwest end of location, facing east. Photo shows door to box-framed subsurface structure has been repaired.
