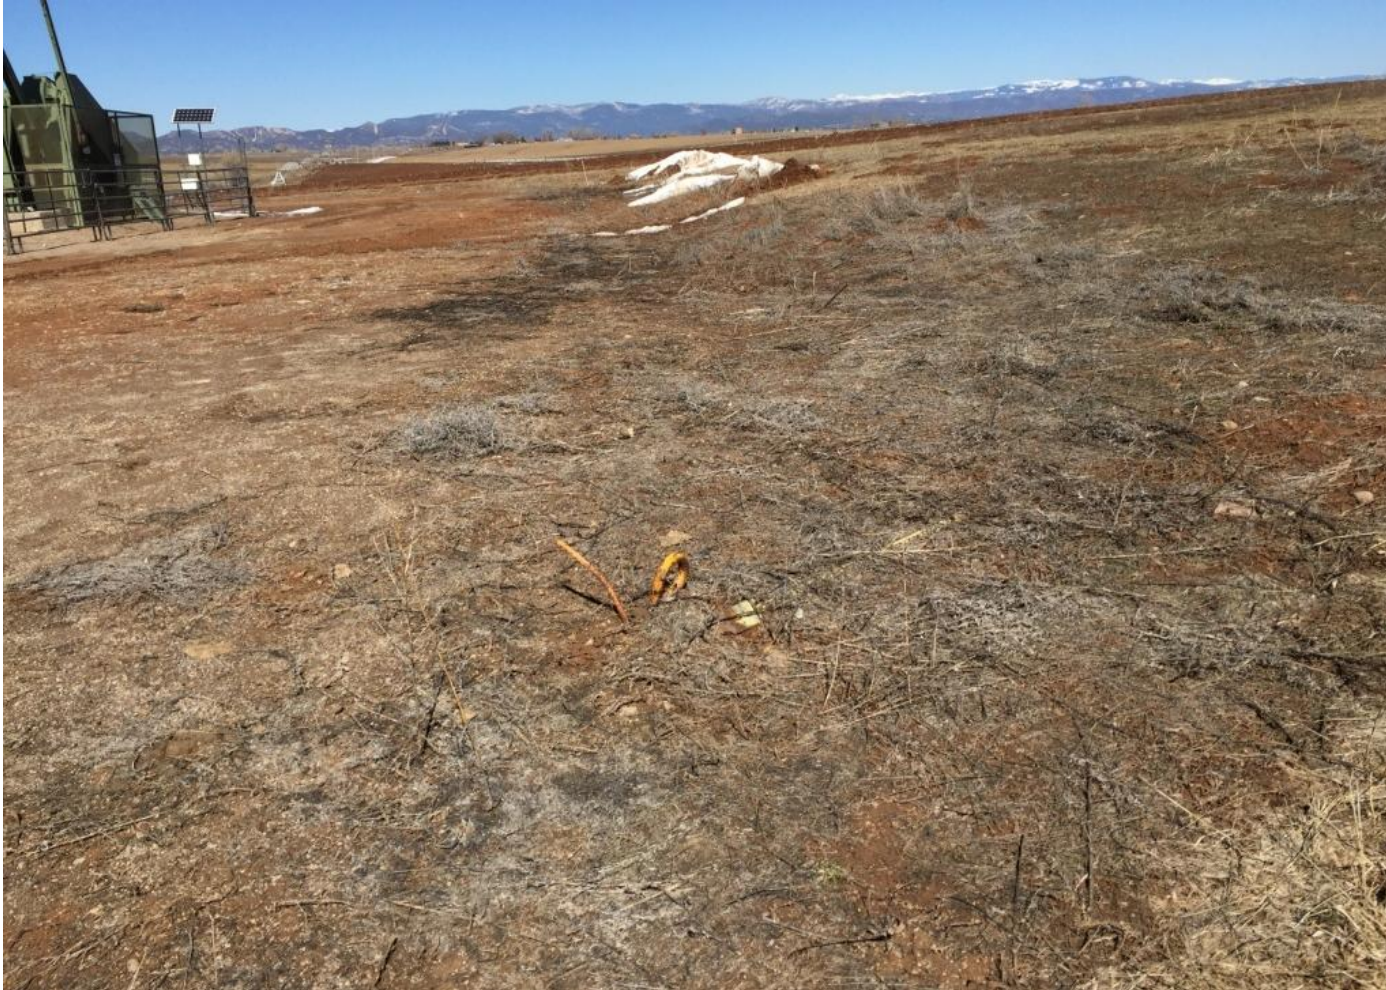
Photo 1. View of the eastern portion of the project area from the southeastern corner facing northward. Rig anchor is needs to be marked.

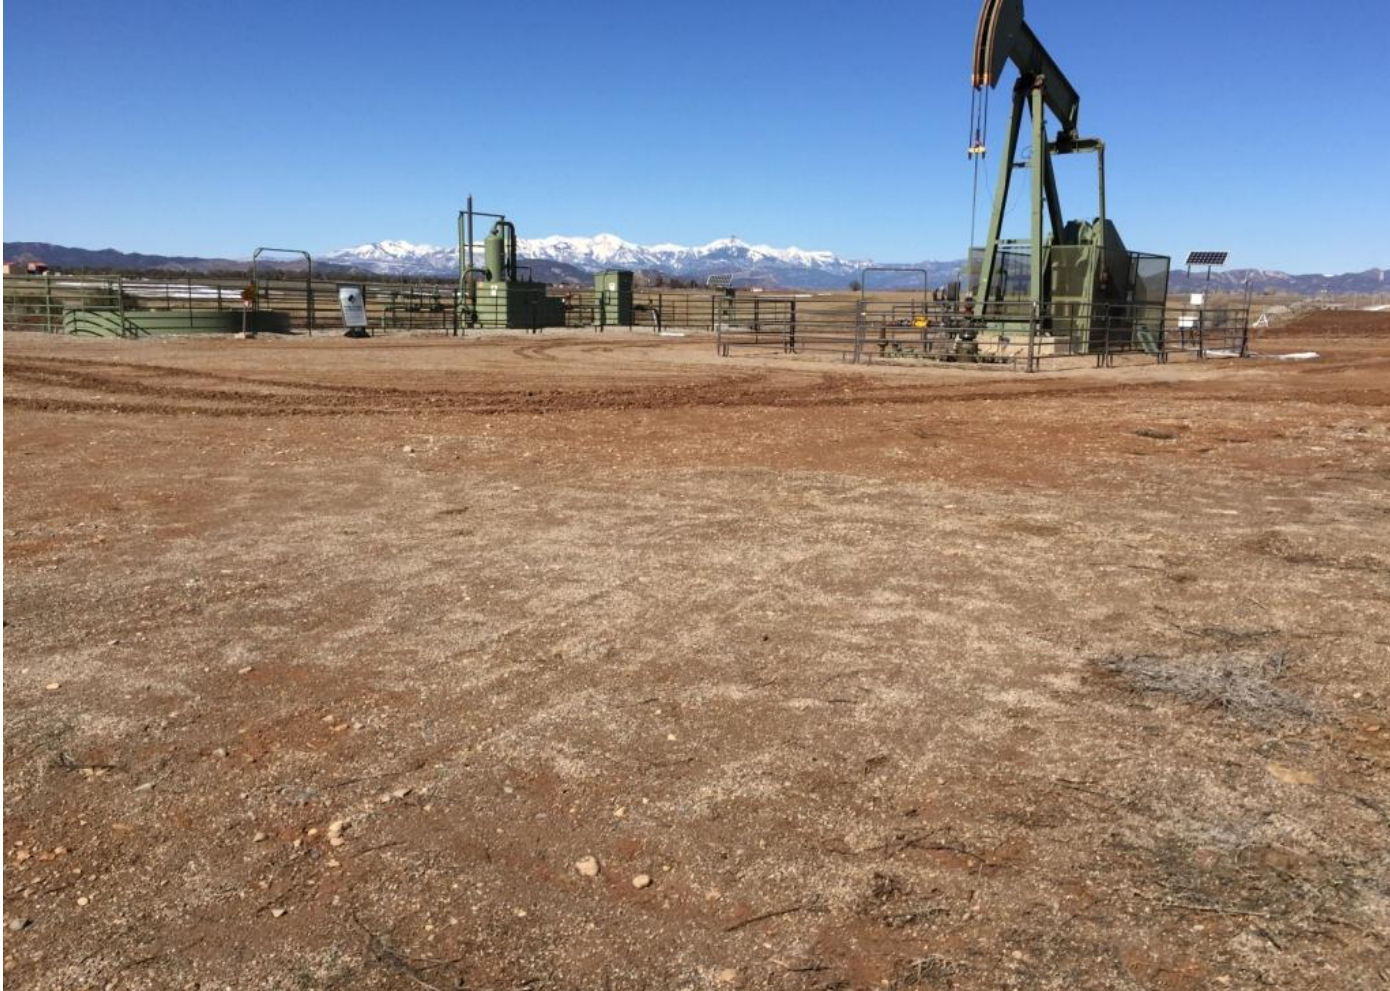
Photo 2. View of the project area from the southeastern corner facing center.

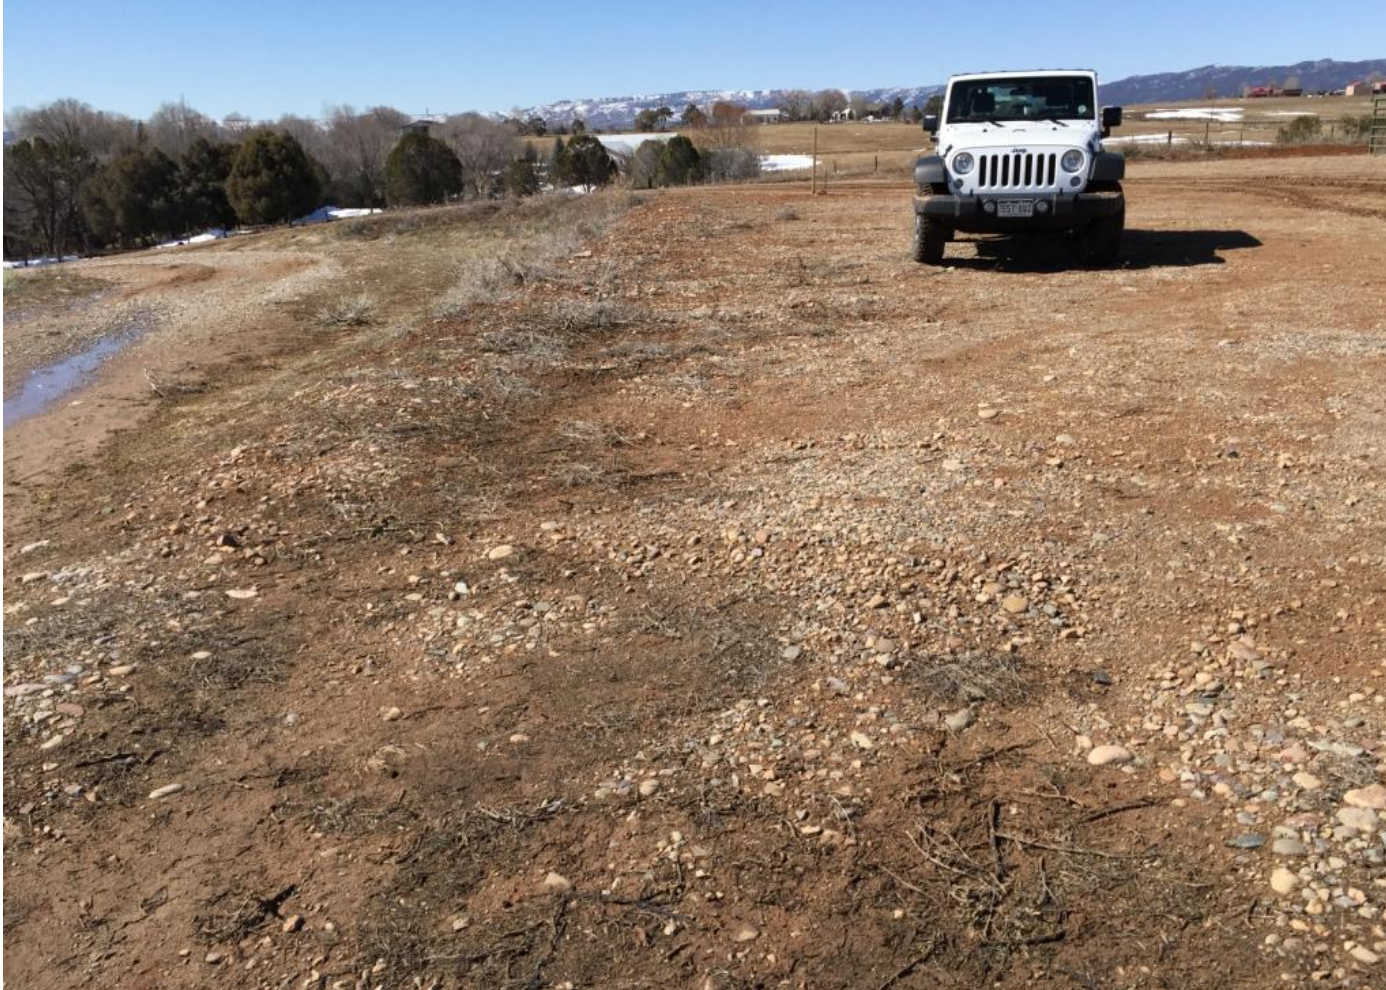
Photo 3. View of the southern portion of the project area from the southeastern corner facing westward.

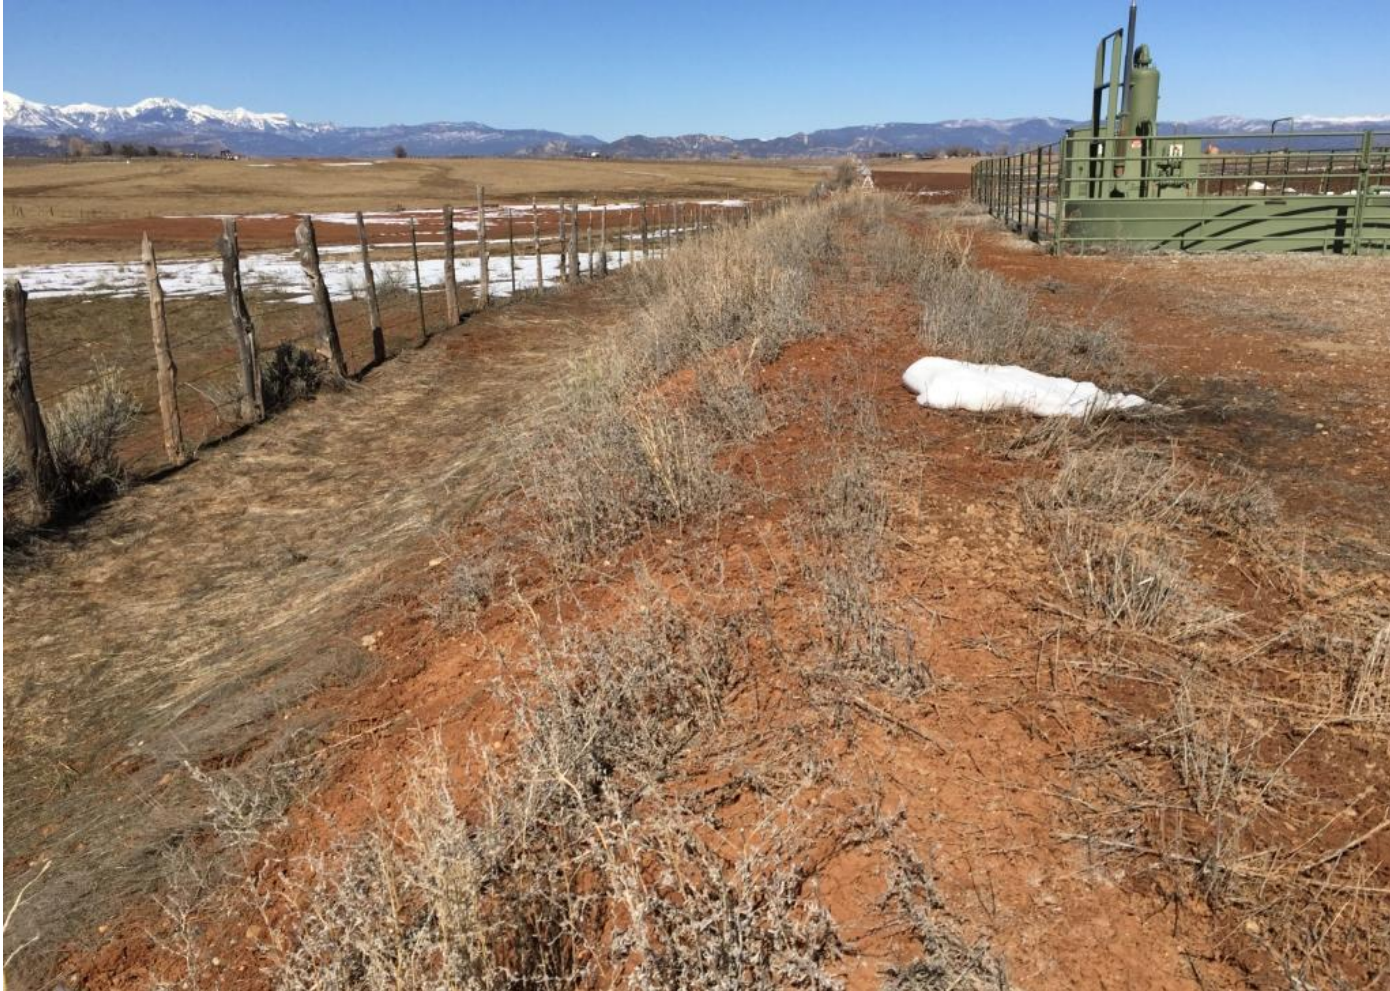
Photo 4. View of the western portion of the project area from the southwestern corner facing northward. Kochia (*Kochia scoparia*) needs to be monitored and controlled if it is discouraging revegetation or is growing near project facilities.
