## Interim Reclamation Inspection

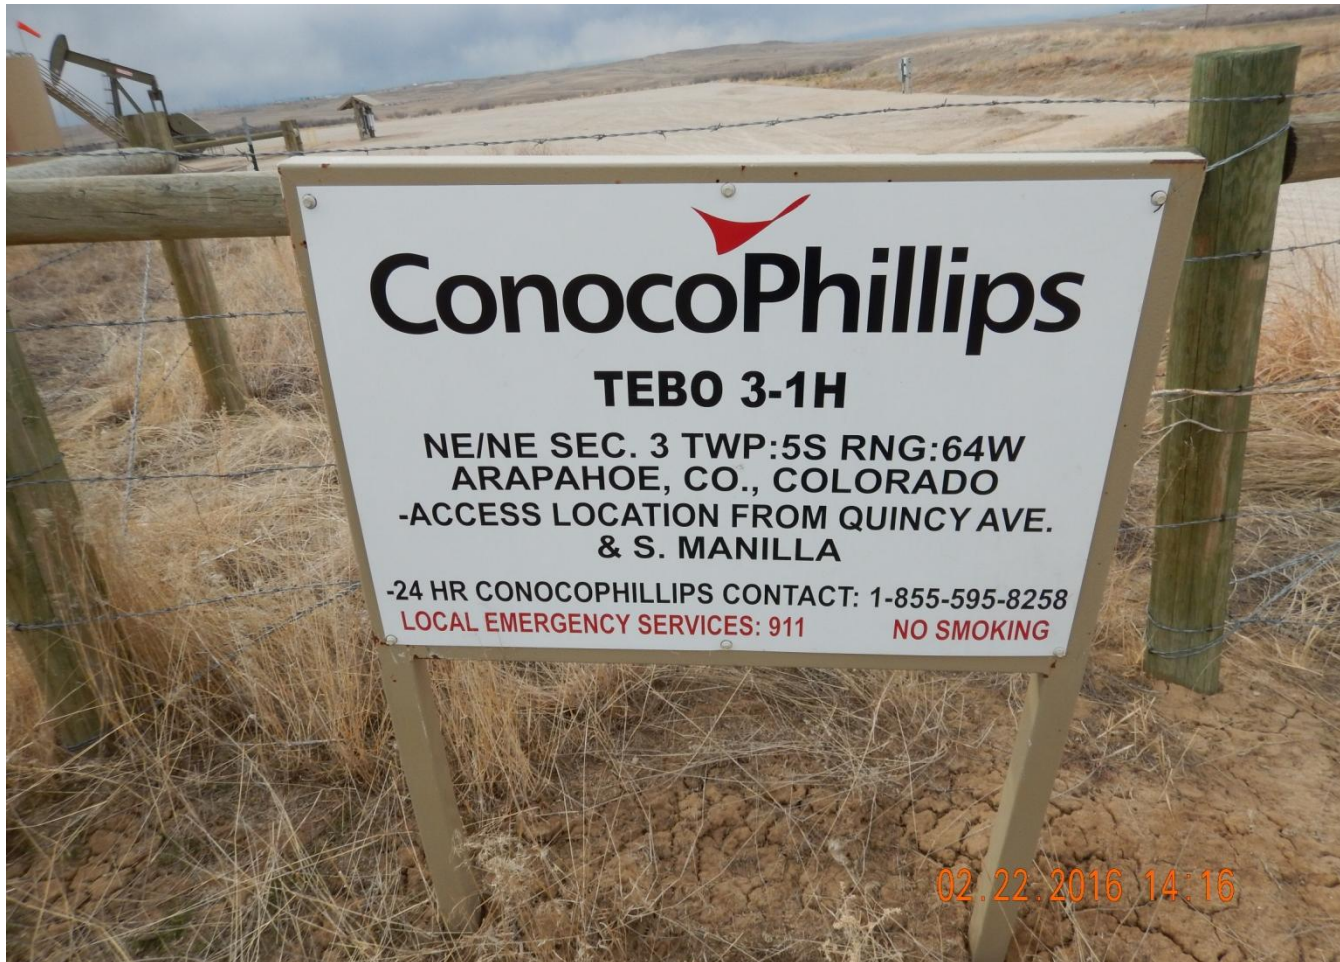
**Photo 1.** Photo taken of well sign at location entrance.

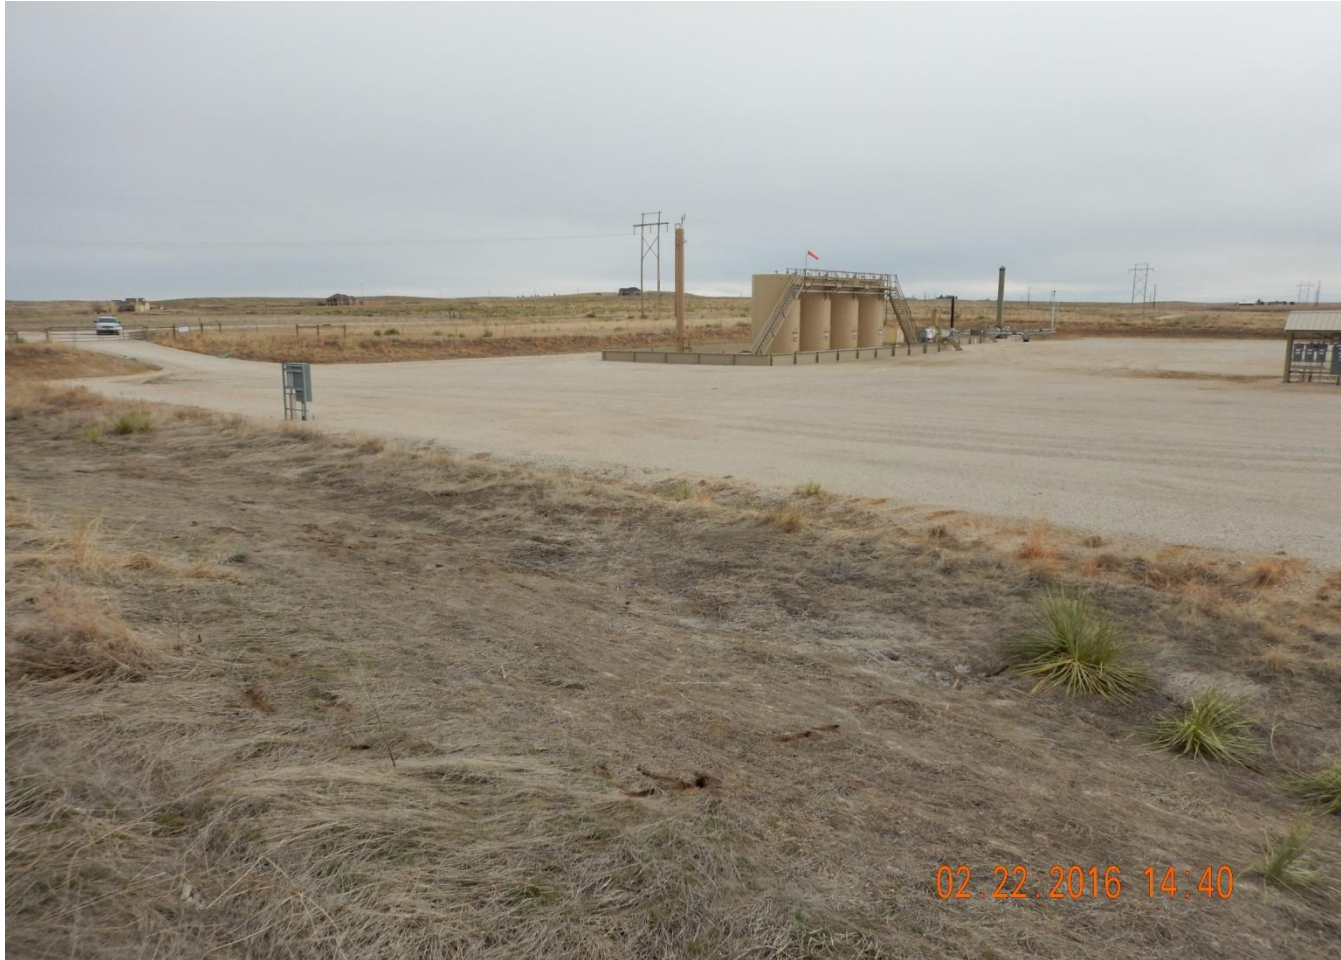
**Photo 2.** Photo taken from northern location, facing Southeast. Areas no longer in use have not been minimized per Rule 1003.

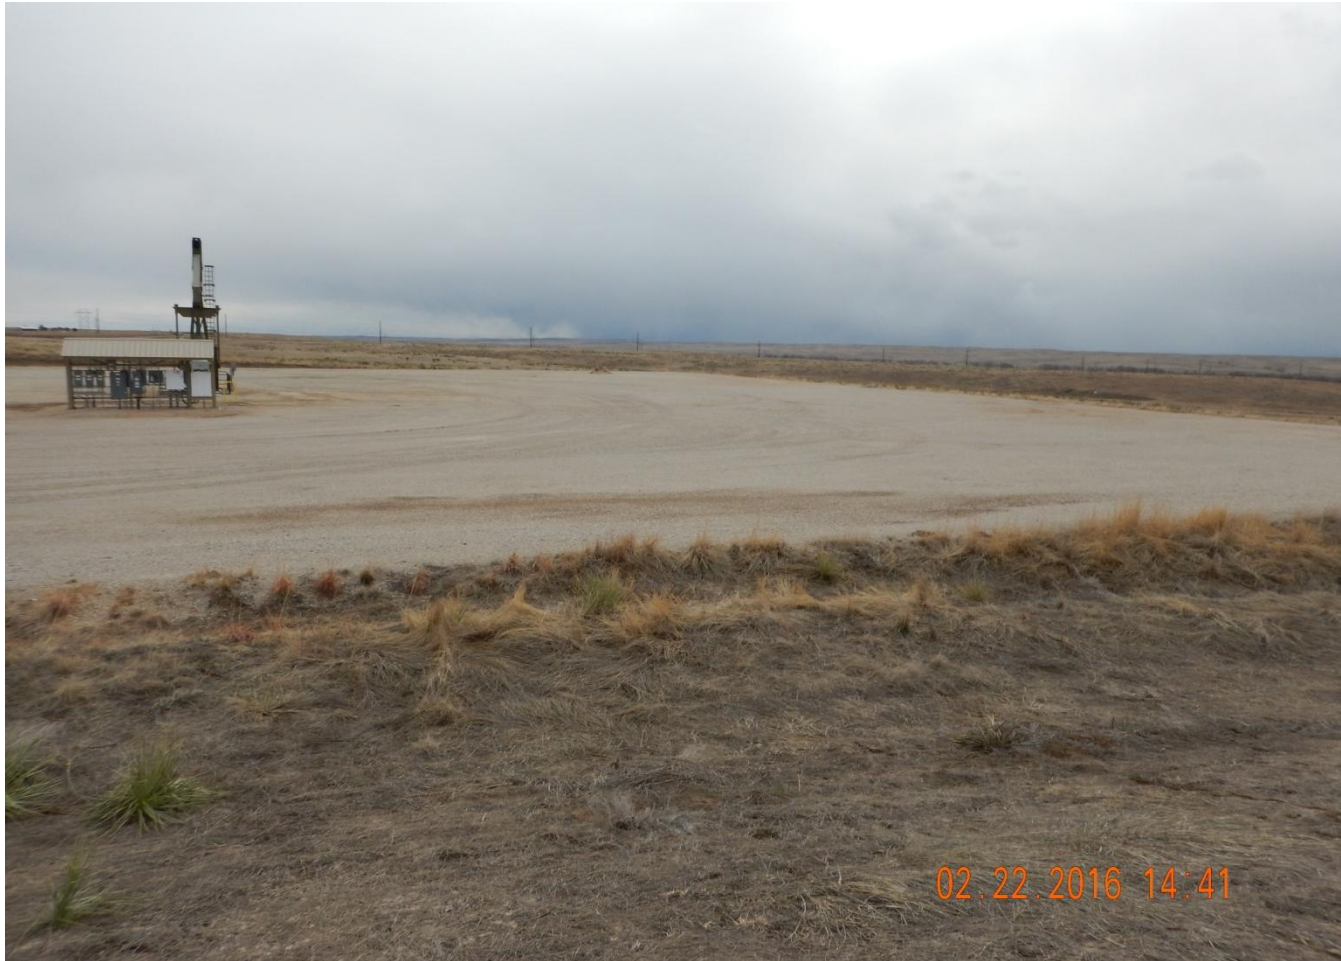
**Photo 3.** Photo taken from northern location, facing Southwest. Areas no longer in use have not been minimized per Rule 1003.

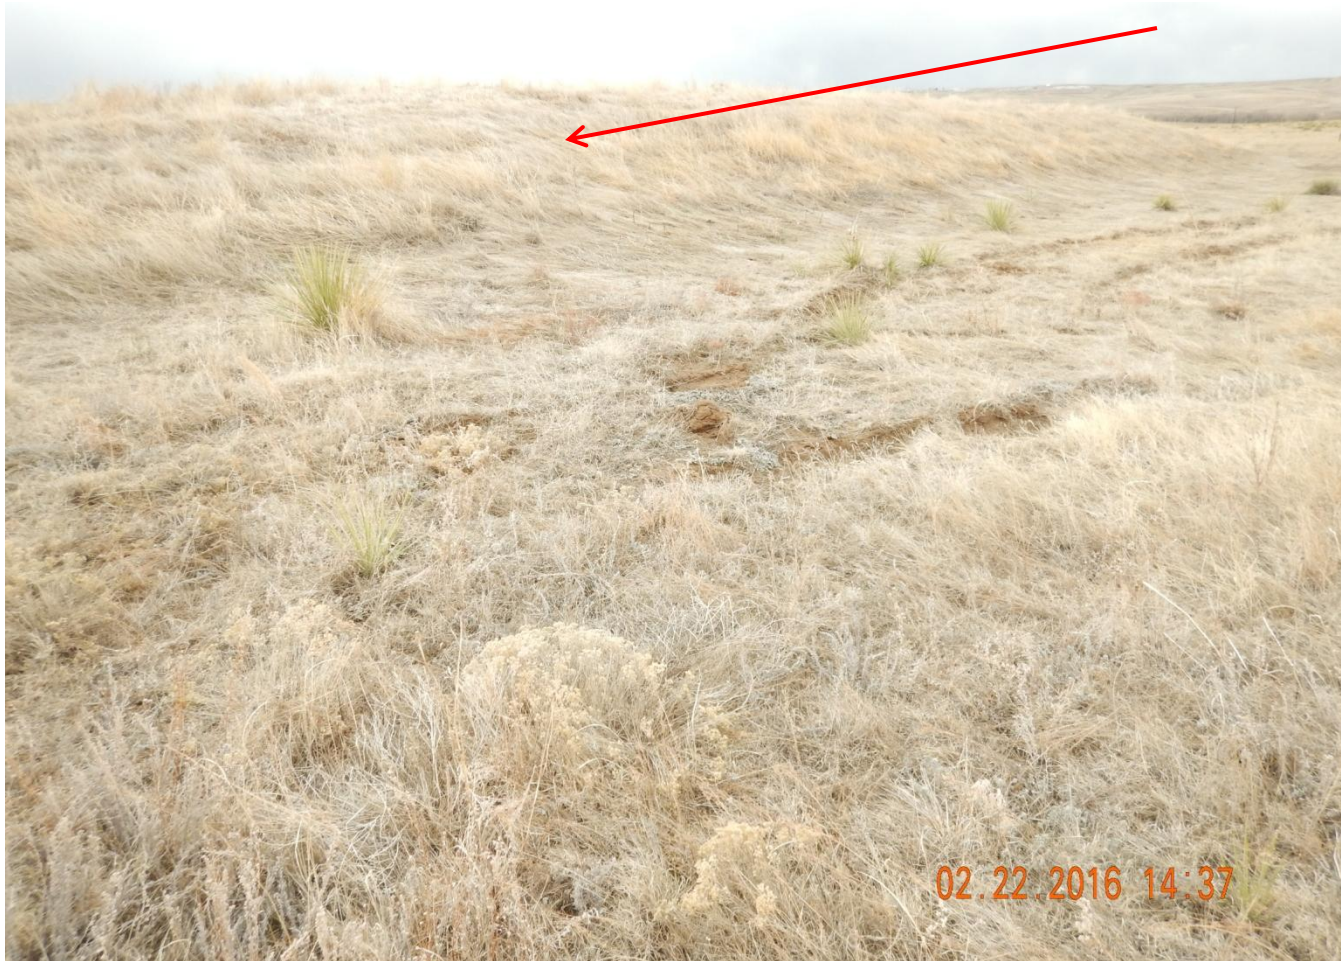
**Photo 4.** Photo taken from the northern location, facing North towards topsoil stockpile.

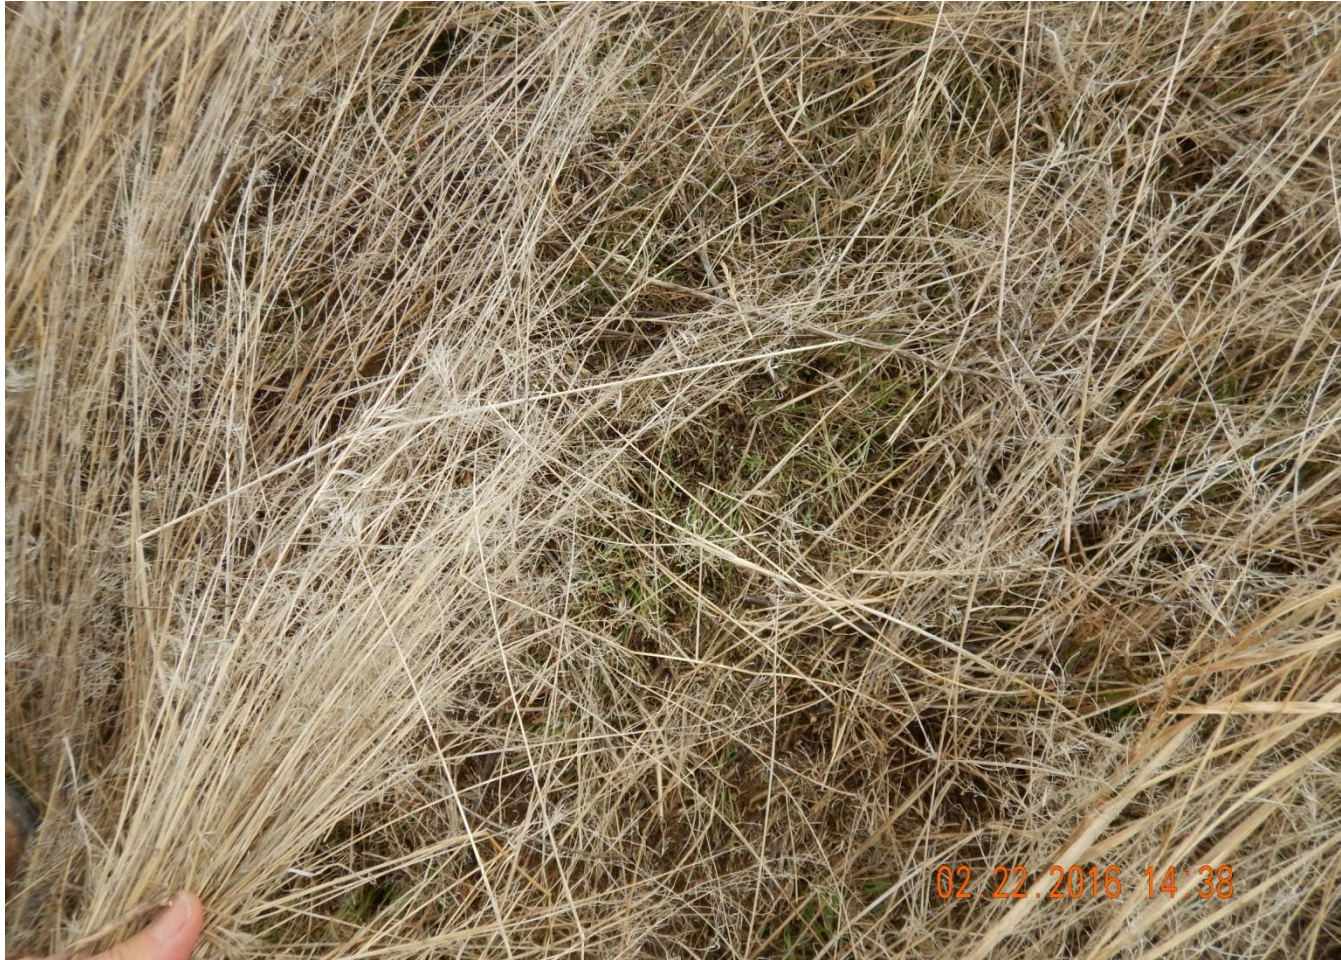
**Photo 5.** Photo taken of the dominant cheatgrass (*Bromus tectorum*) vegetative growth on the topsoil stockpile. Cheatgrass is a Colorado List C noxious weed species. Need to prevent weed establishment on the topsoil stockpile per Rule 1002. Need to reseed topsoil stockpile with native species that are included in the reference area.

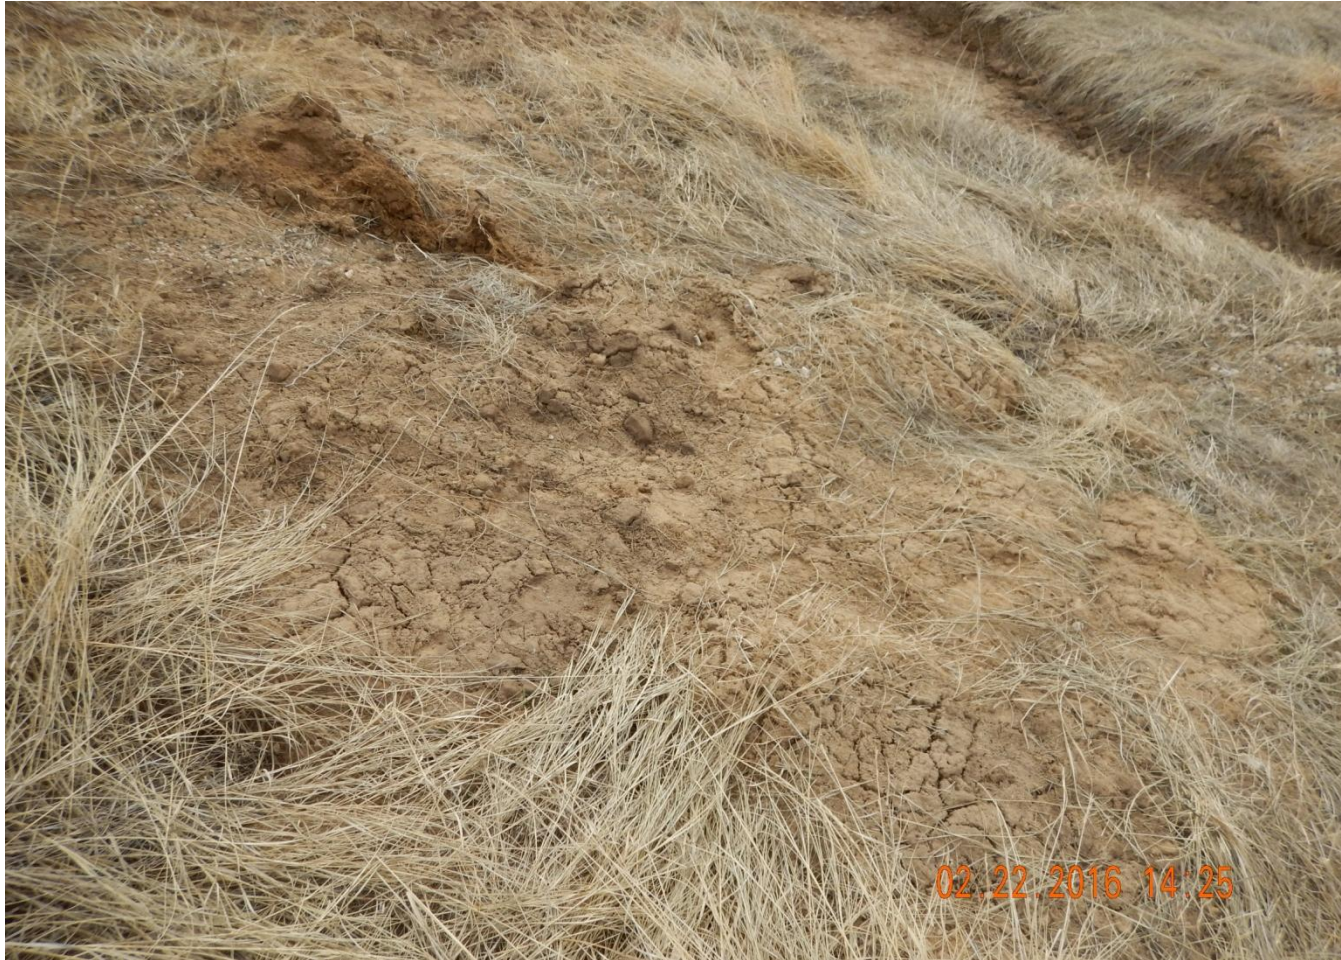
**Photo 6.** Photo taken from the western location, facing South. Interim reclamation area needs to be stabilized to minimize erosion while vegetative growth establishes. Erosion is occurring along portions of the western interim reclamation area.

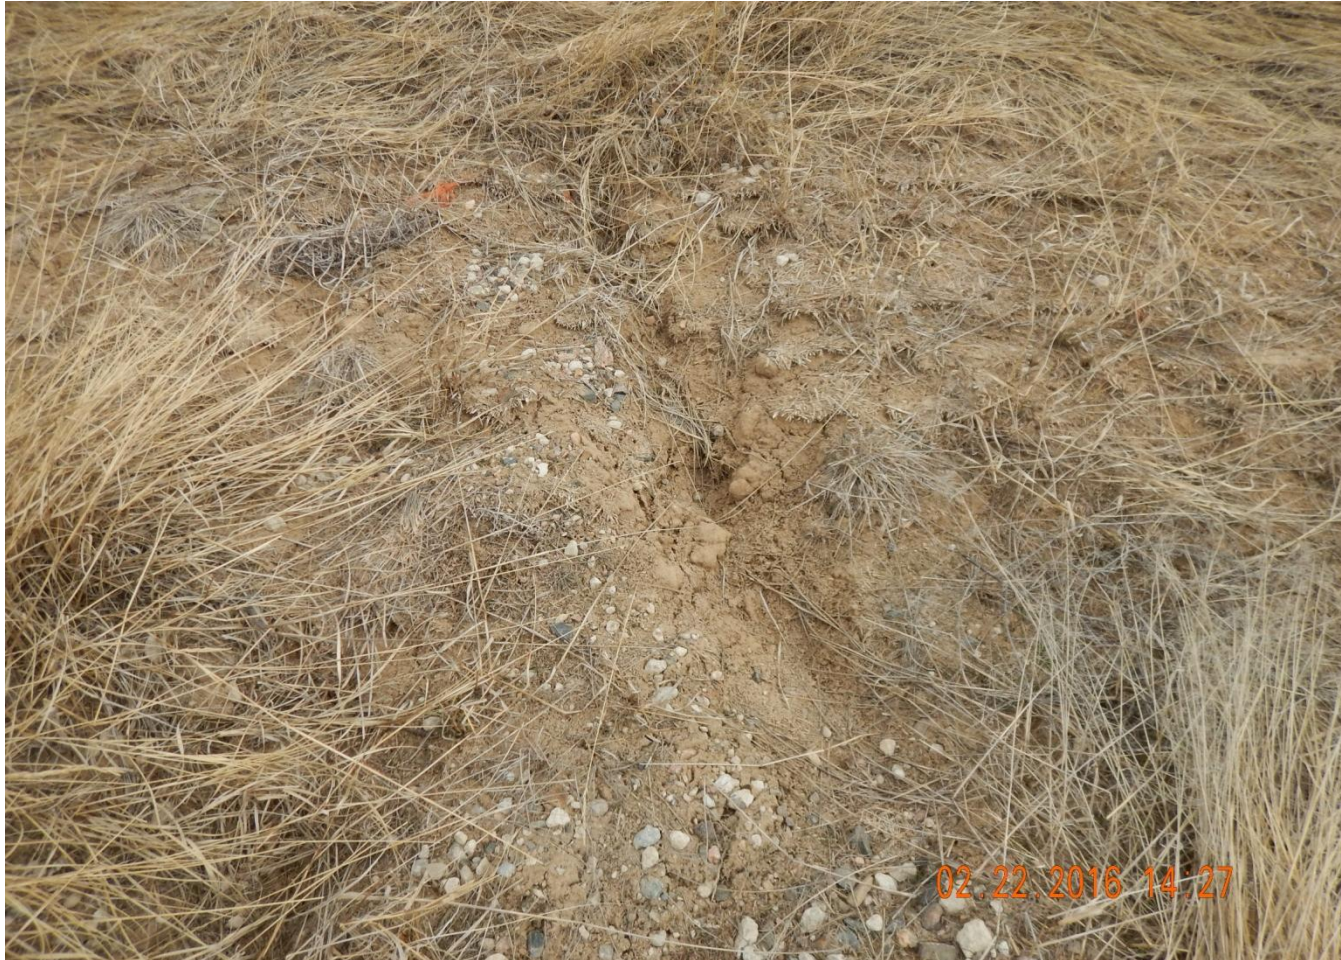
**Photo 7.** Photo taken from the western location, facing South. Interim reclamation area needs to be stabilized to minimize erosion while vegetative growth establishes. Erosion is occurring along portions of the western interim reclamation area.

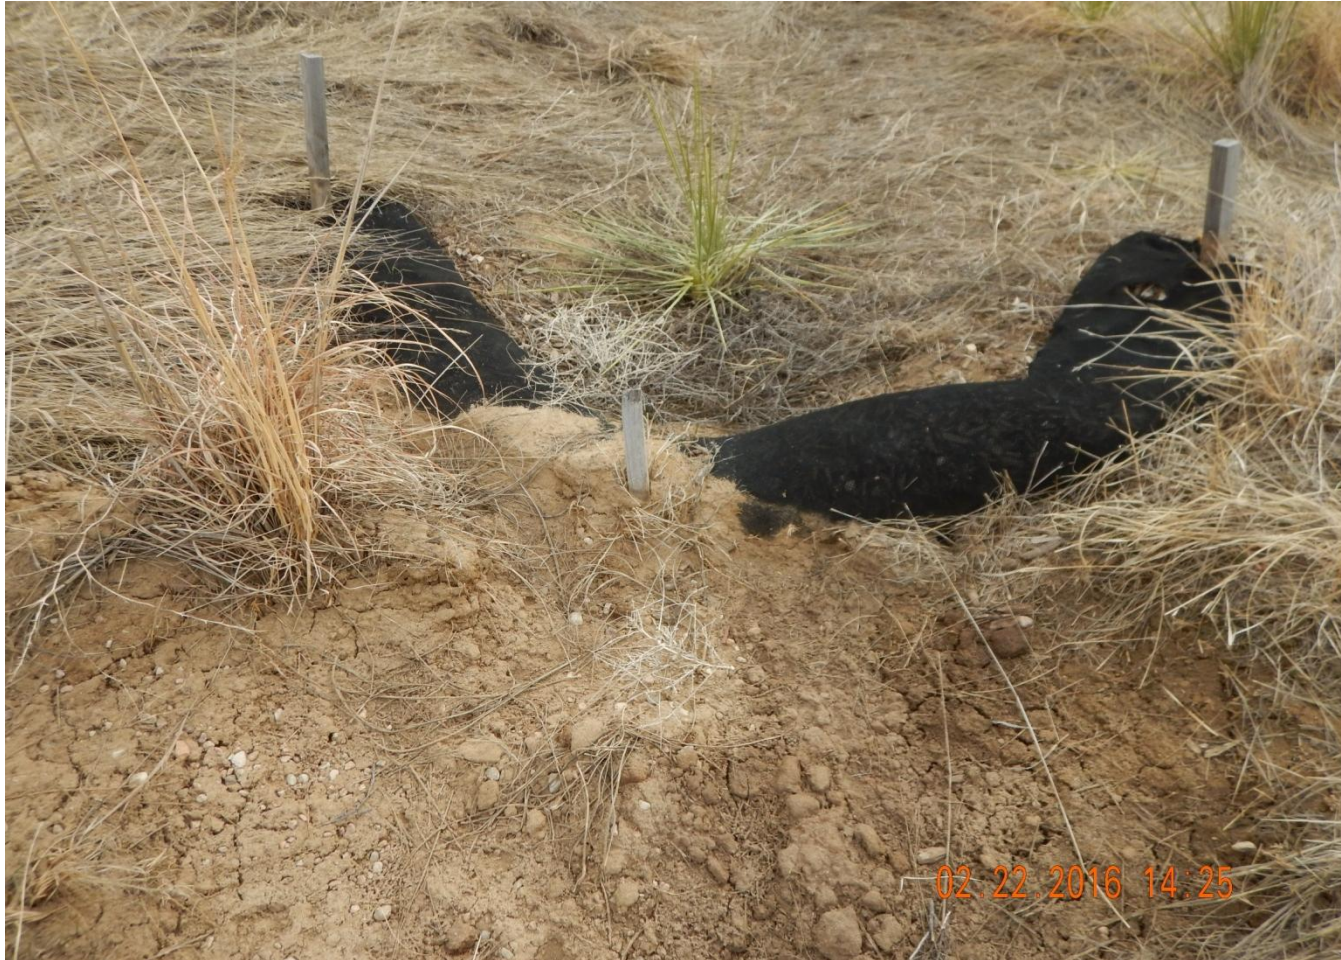
**Photo 8.** Photo taken from the western location, facing South. Stormwater and sediment BMPs need to be maintained to ensure controls are functioning properly.

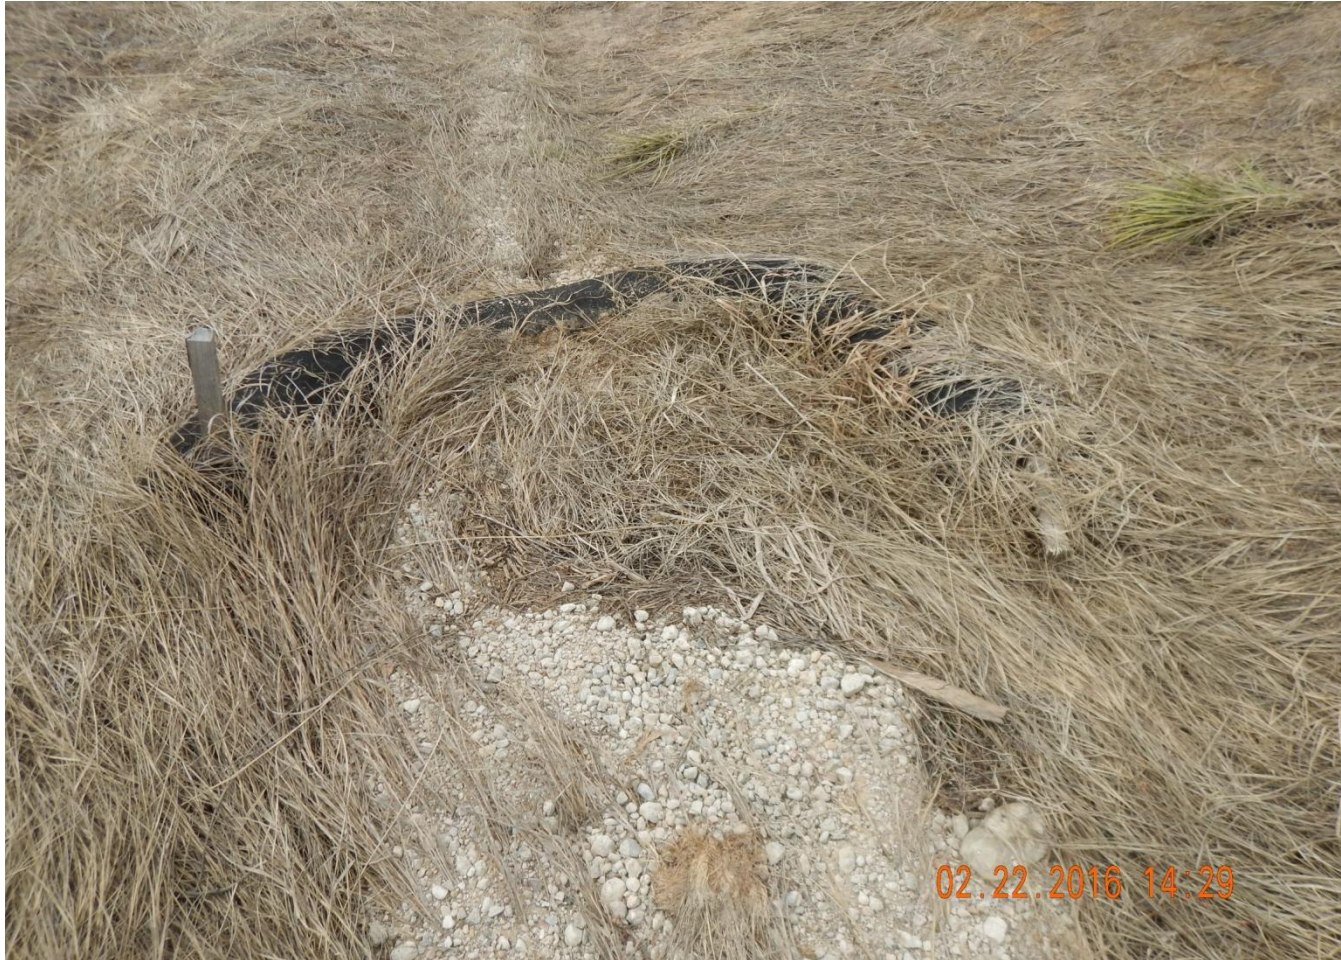
**Photo 9.** Photo taken from the western location, facing South. Stormwater and sediment BMPs need to be maintained to ensure controls are functioning properly. Wattle is full of sediment and debris.

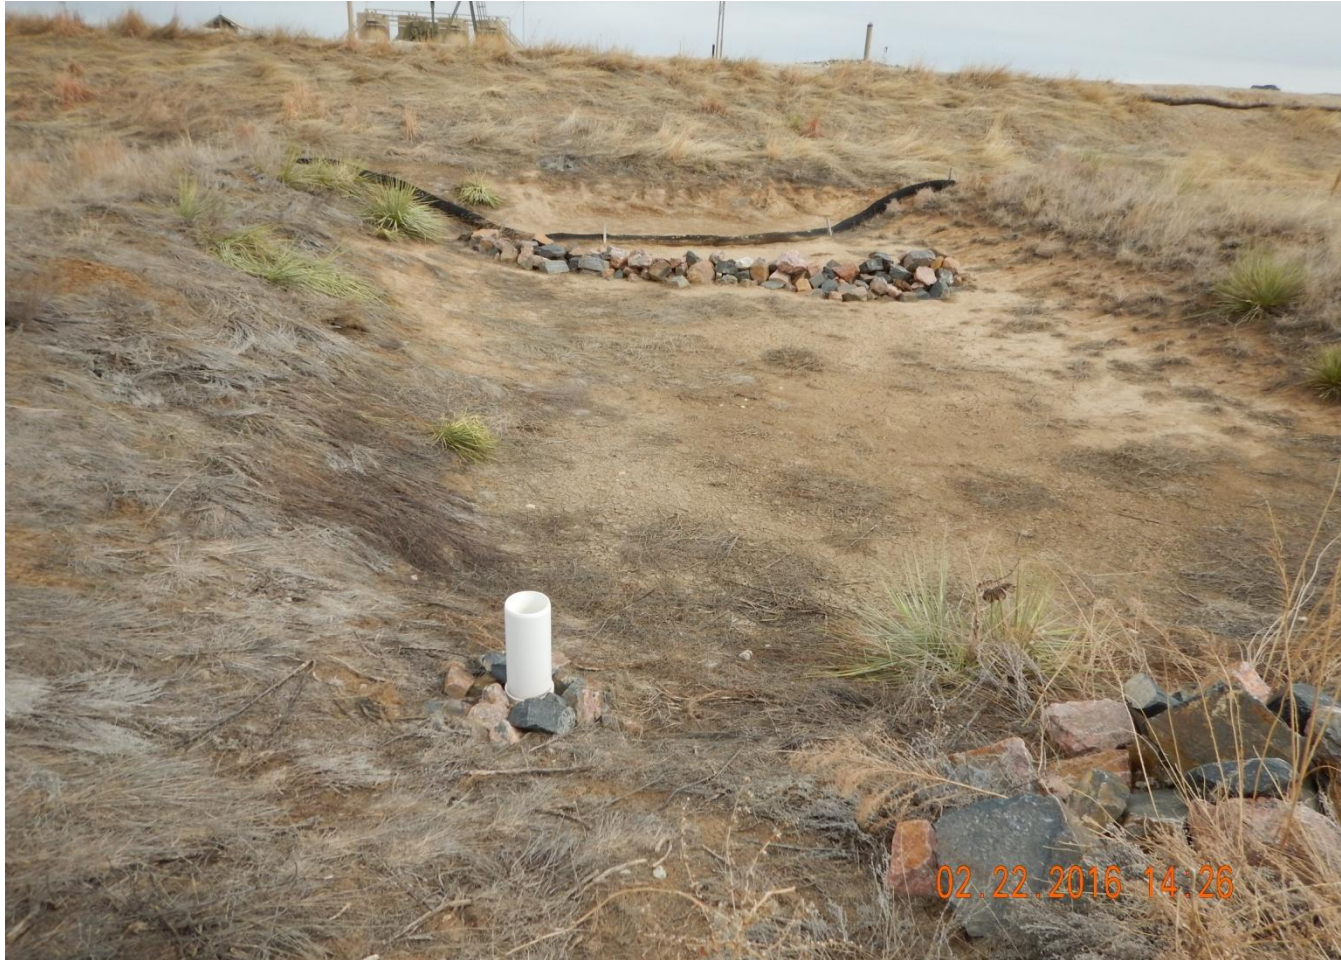
**Photo 10.** Photo taken from the western sediment trap location, facing East. Sediment trap was designed and installed correctly.

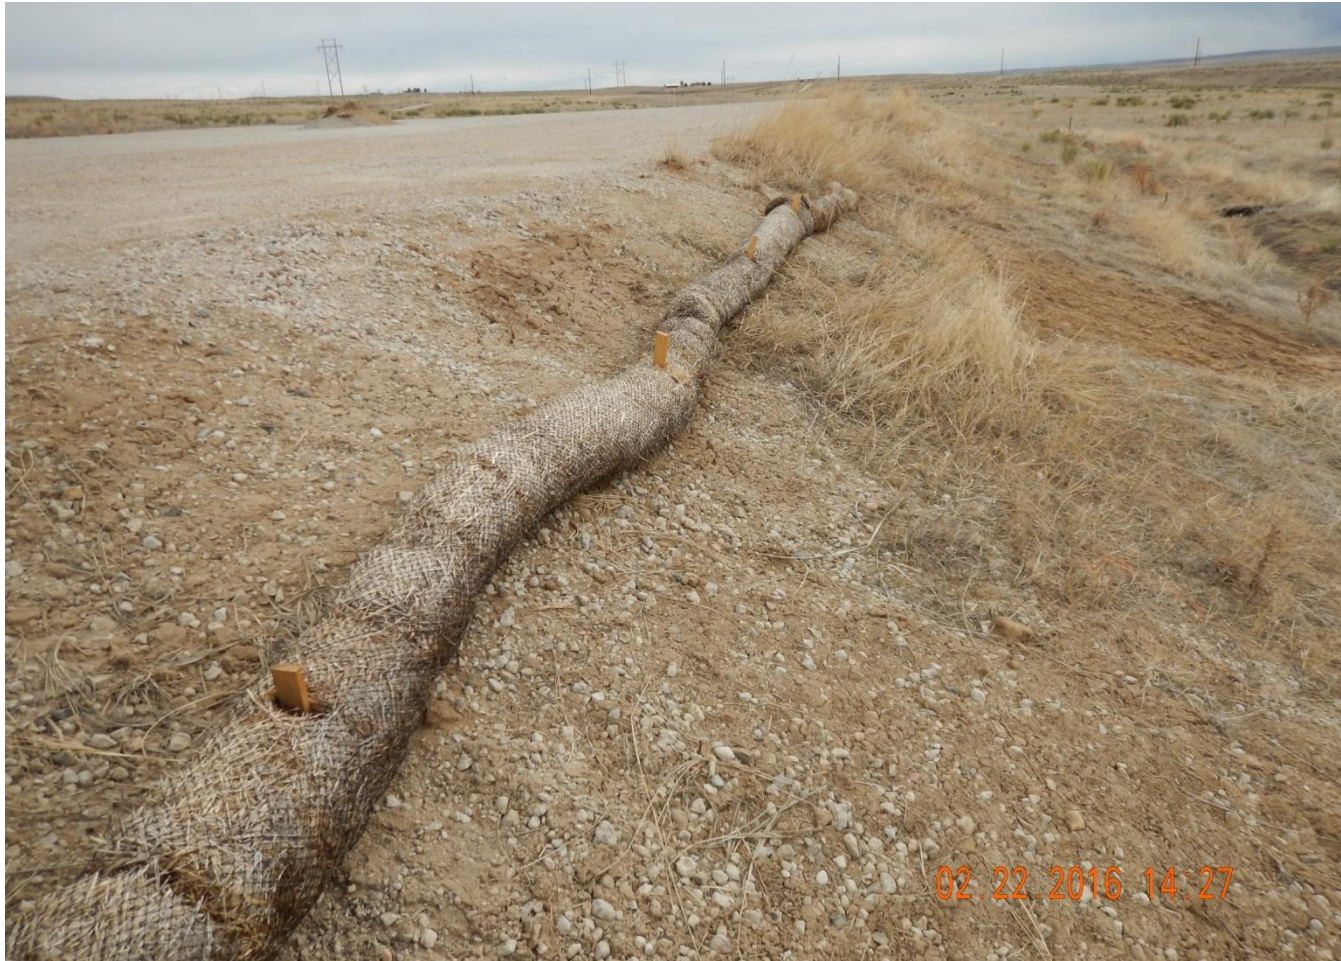
**Photo 11.** Photo taken from the western location, facing North. Wattle not properly installed. Gravel and sediment washing underneath wattle. Interim reclamation area needs to be reseeded and stabilized to minimize erosion while vegetative growth establishes.

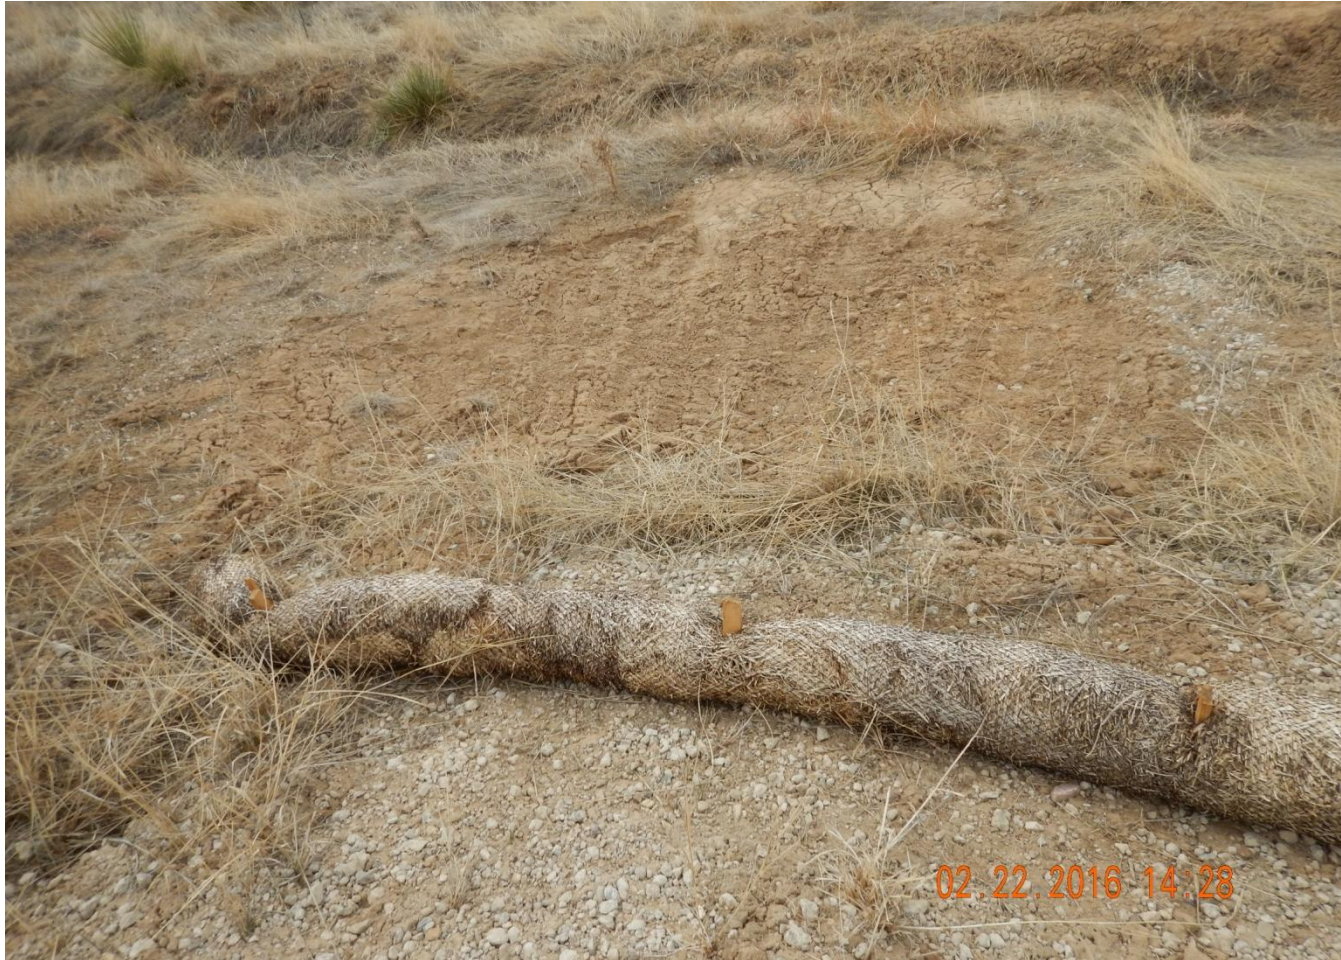
**Photo 12.** Photo taken from the western location, facing West. Wattle not properly installed. Gravel and sediment washing underneath wattle. Interim reclamation area needs to be stabilized to minimize erosion while vegetative growth establishes.

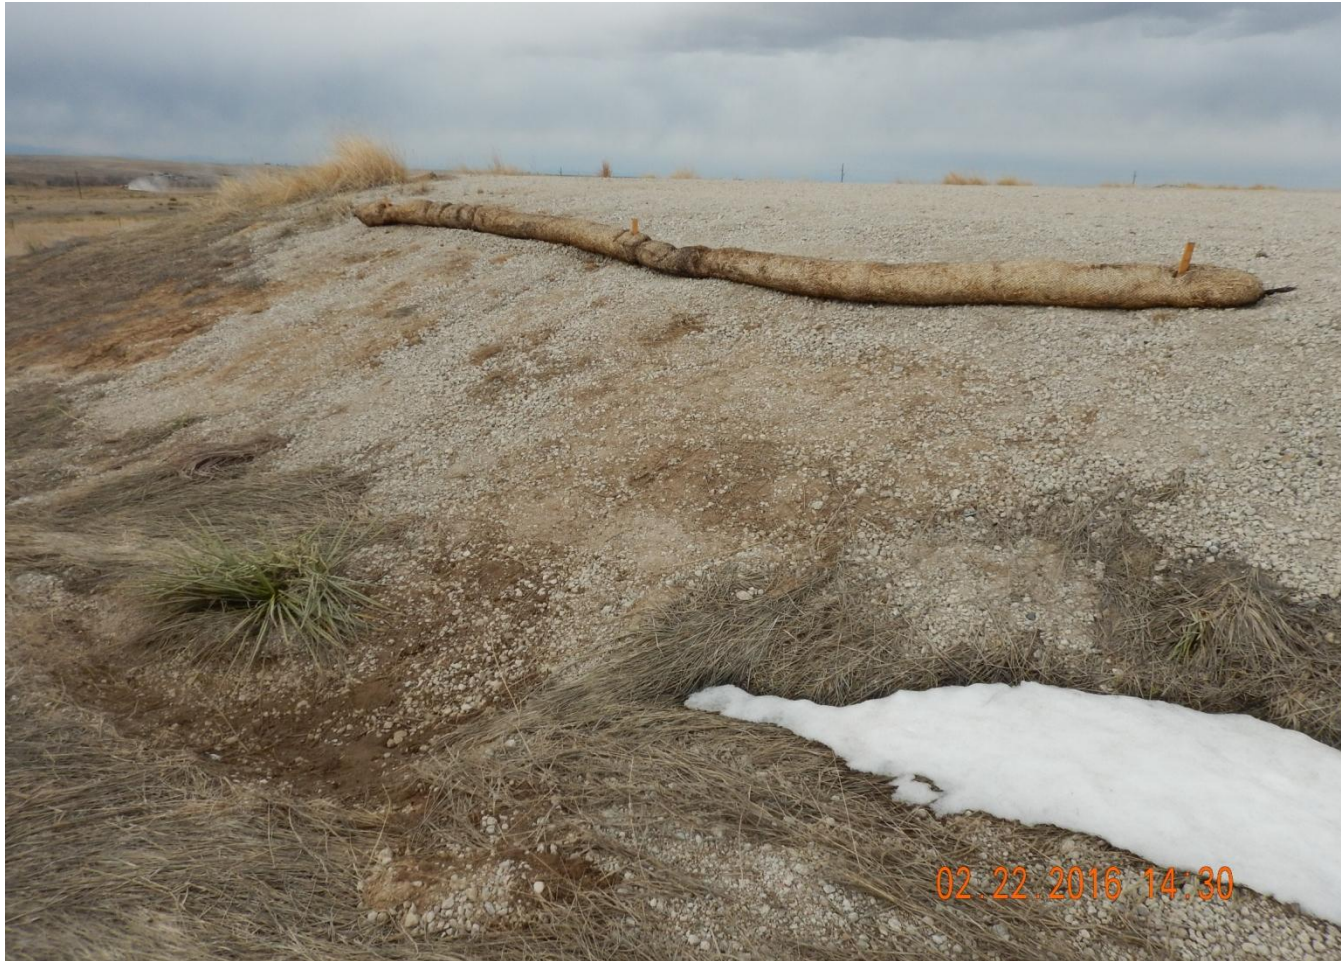
**Photo 13.** Photo taken from the southwest location, facing North. Wattle not properly installed. Gravel and sediment washing underneath wattle. Interim reclamation area needs to be reseeded and stabilized to minimize erosion while vegetative growth establishes.

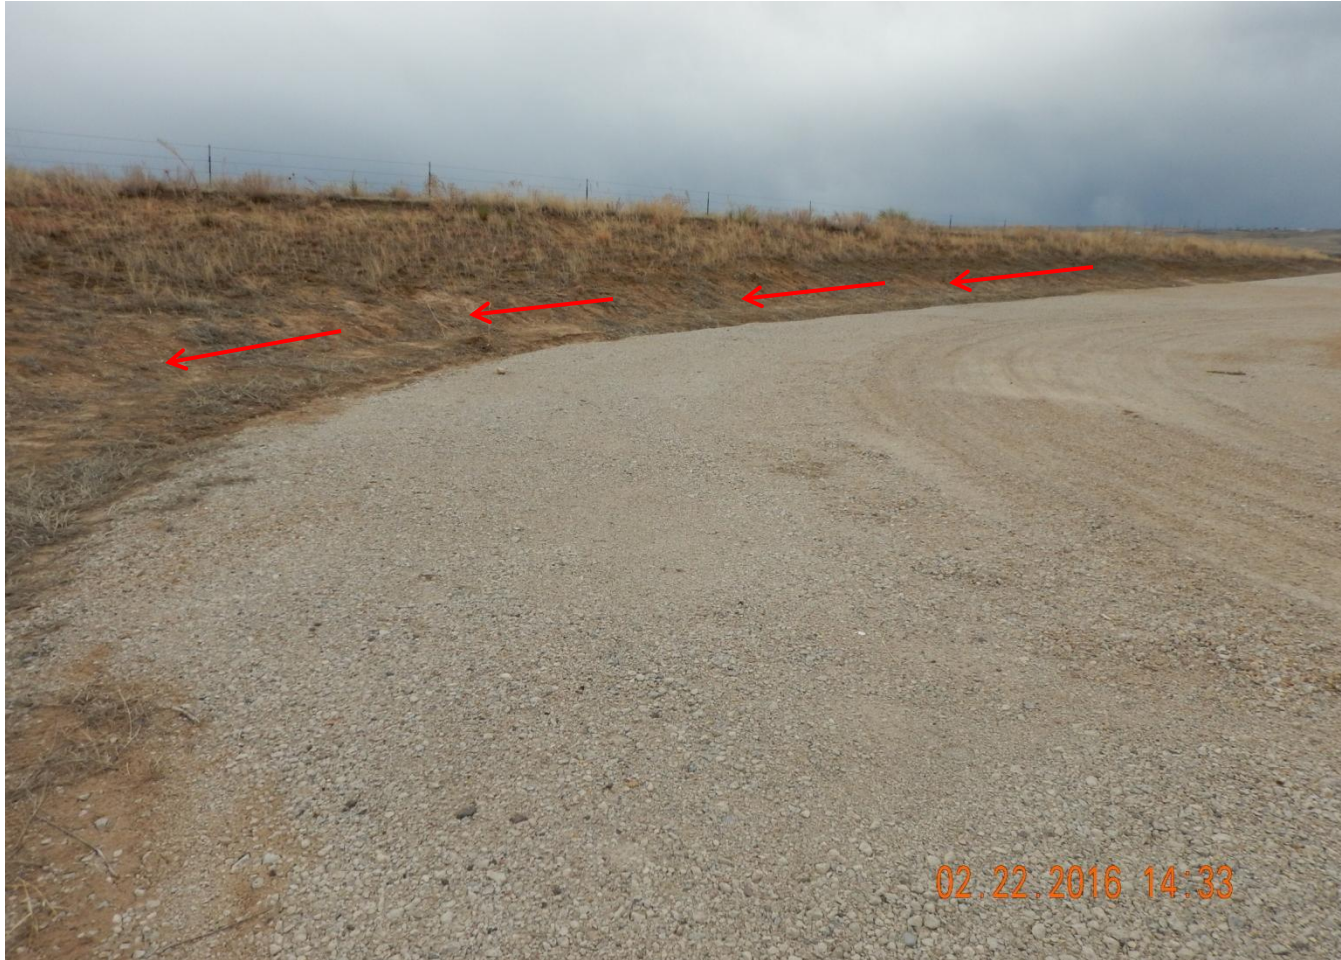
**Photo 14.** Photo taken from the southeast location, facing South. Cut slope needs to be stabilized with vegetation.

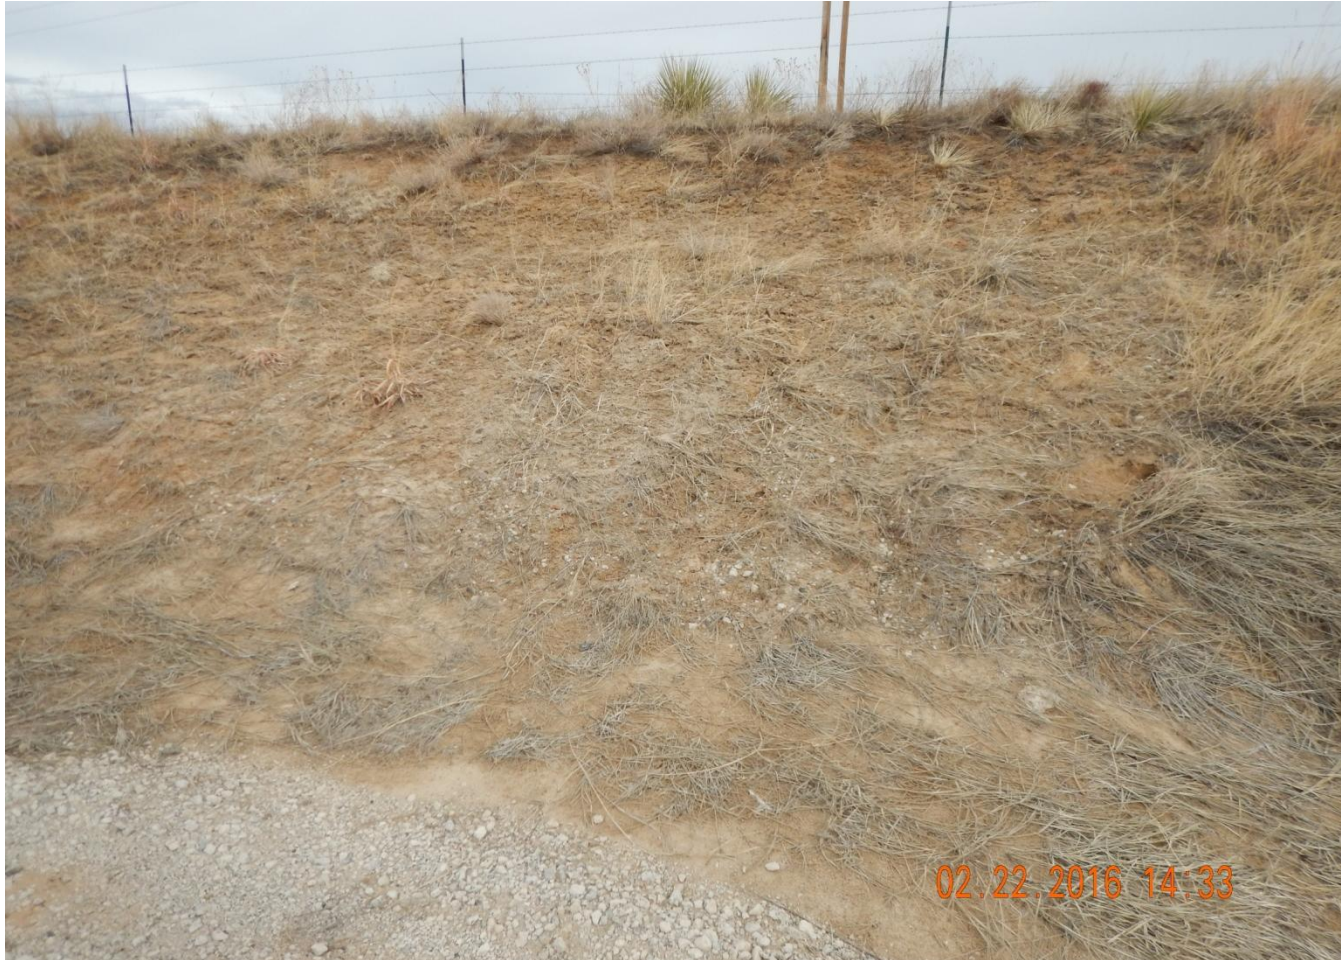
**Photo 15.** Photo taken from the southeast location, facing East. Cut slope needs to be stabilized with vegetation.

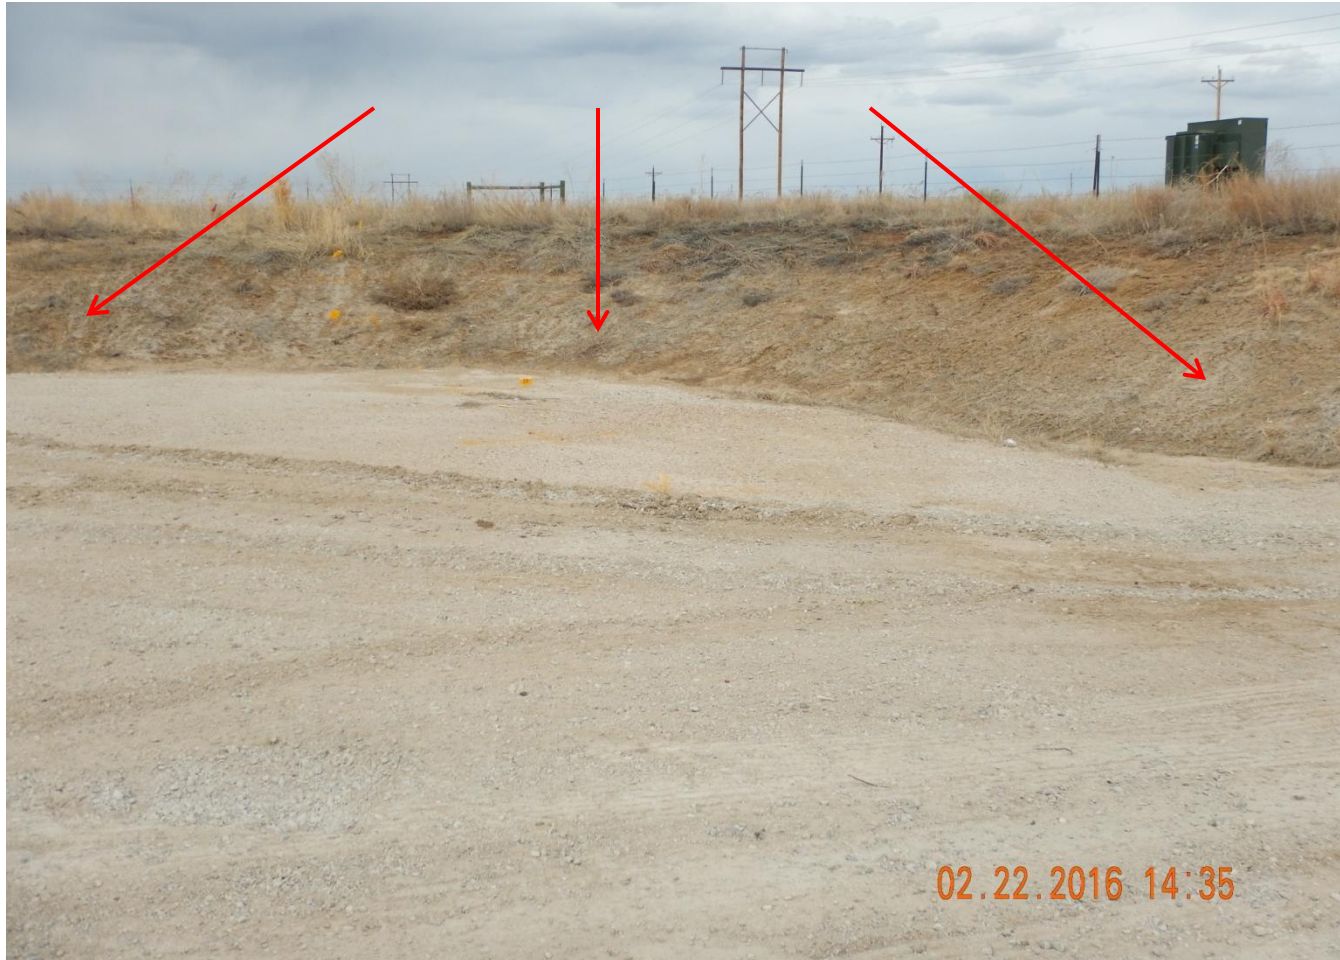
**Photo 16.** Photo taken from the southeast location, facing Northeast. Cut slope needs to be stabilized with vegetation.

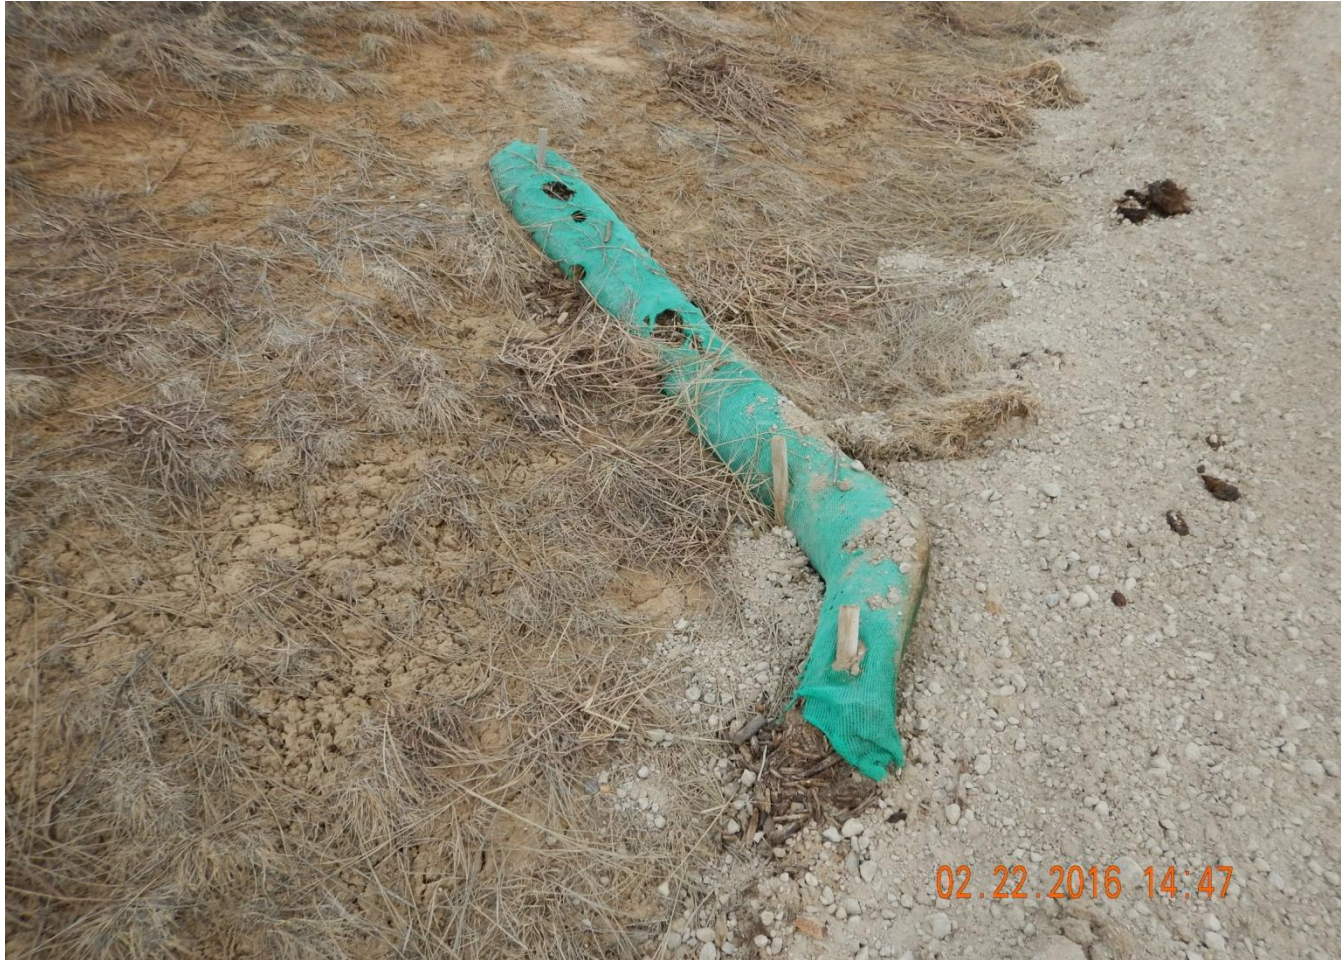
**Photo 17.** Photo taken from the entrance of the location, facing towards north wattle. Stormwater and sediment BMPs need to be maintained to controls are functioning properly. Wattle needs to be replaced.
