## Interim Reclamation Inspection

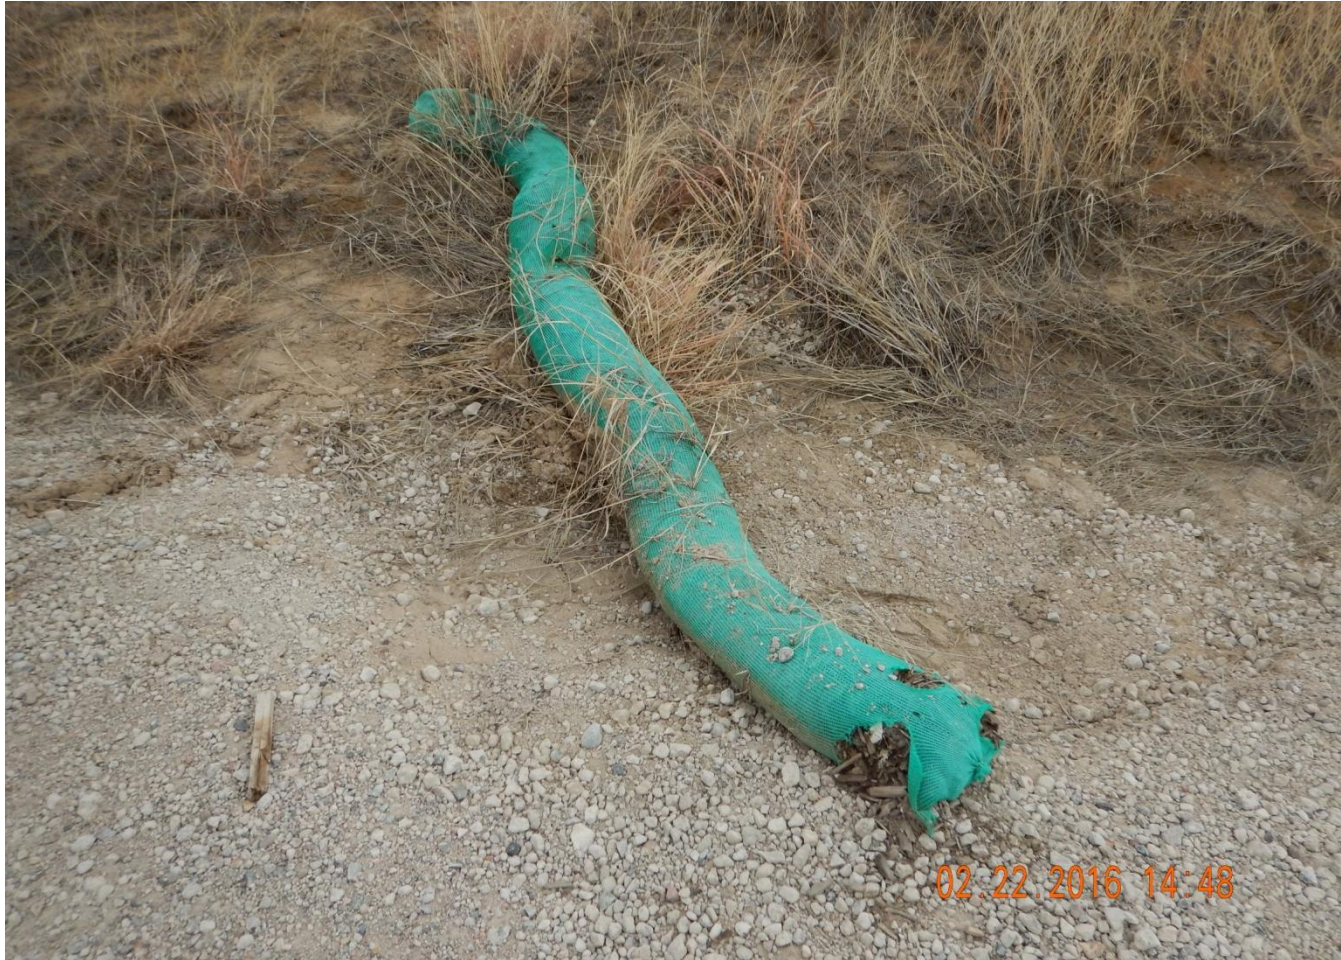
**Photo 18.** Photo taken from the entrance of the location, facing towards south wattle. Stormwater and sediment BMPs need to be maintained to ensure controls are functioning properly. Wattle needs to be replaced.

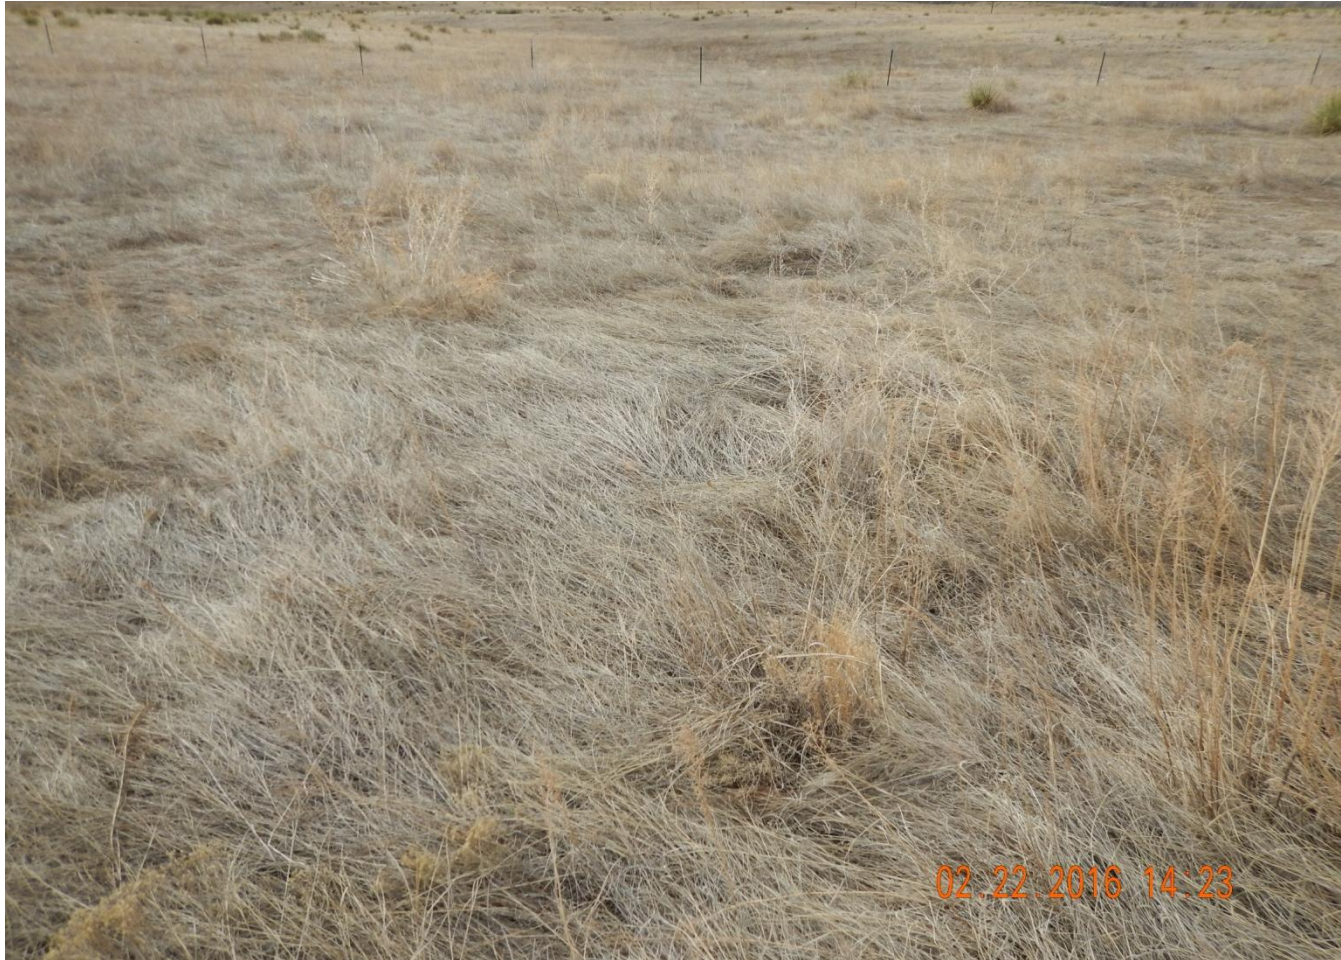
**Photo 19.** Photo taken from the northern location, facing Northwest. Photo illustrates native reference vegetative growth that should be reflective throughout the interim reclamation area and topsoil stockpile.
