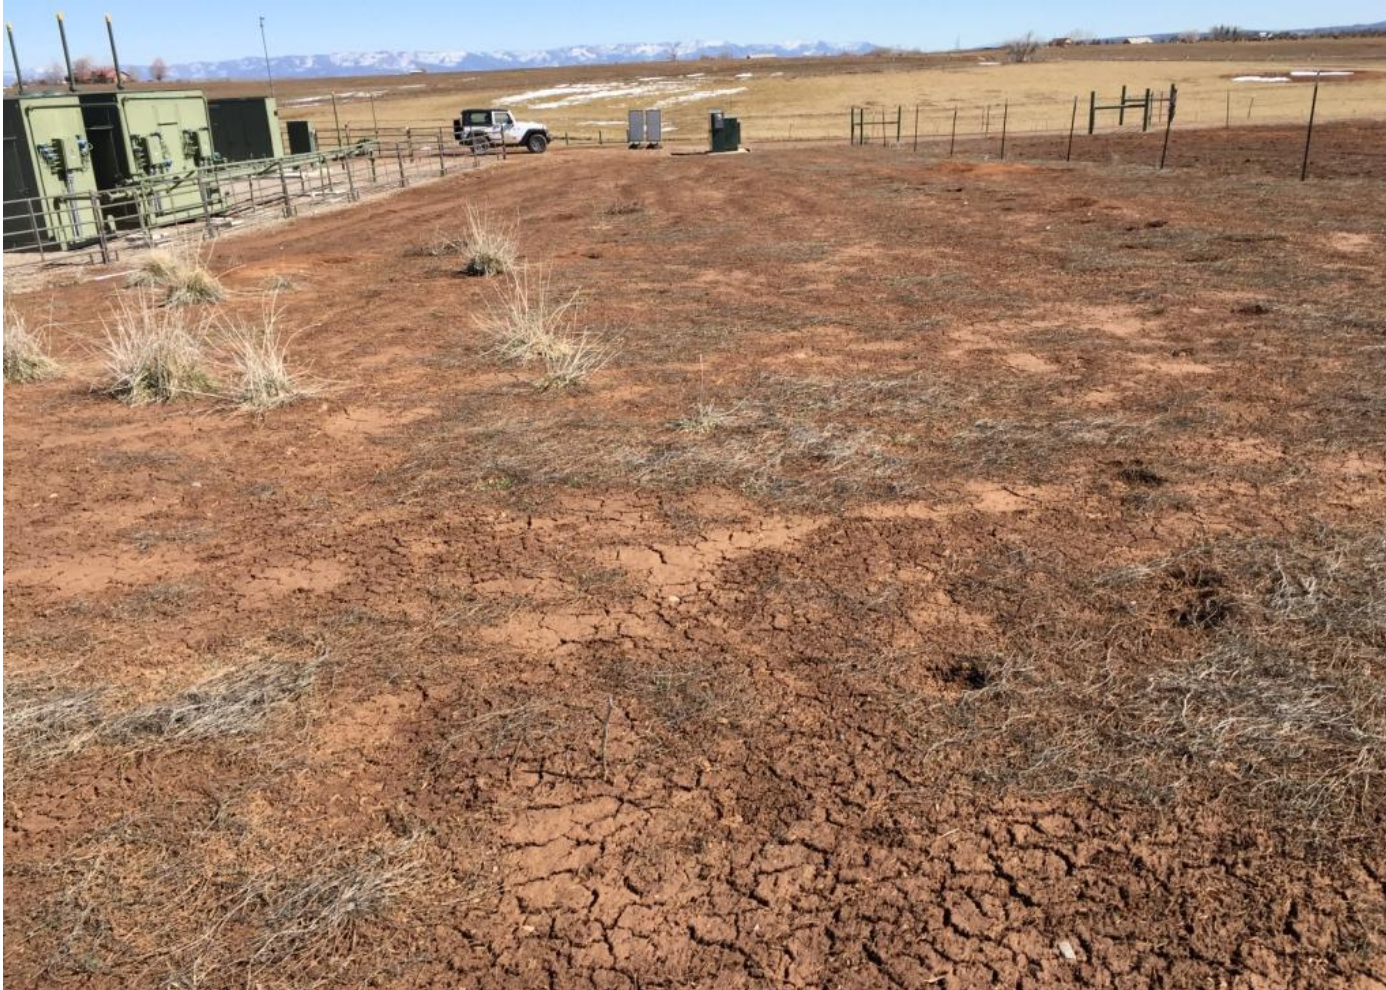
Photo 1. View of the southern portion of the project area from the southwestern corner facing eastward. Revegetation is sparse with only a few scattered intermediate wheatgrass (*Thinopyron intermedium*).

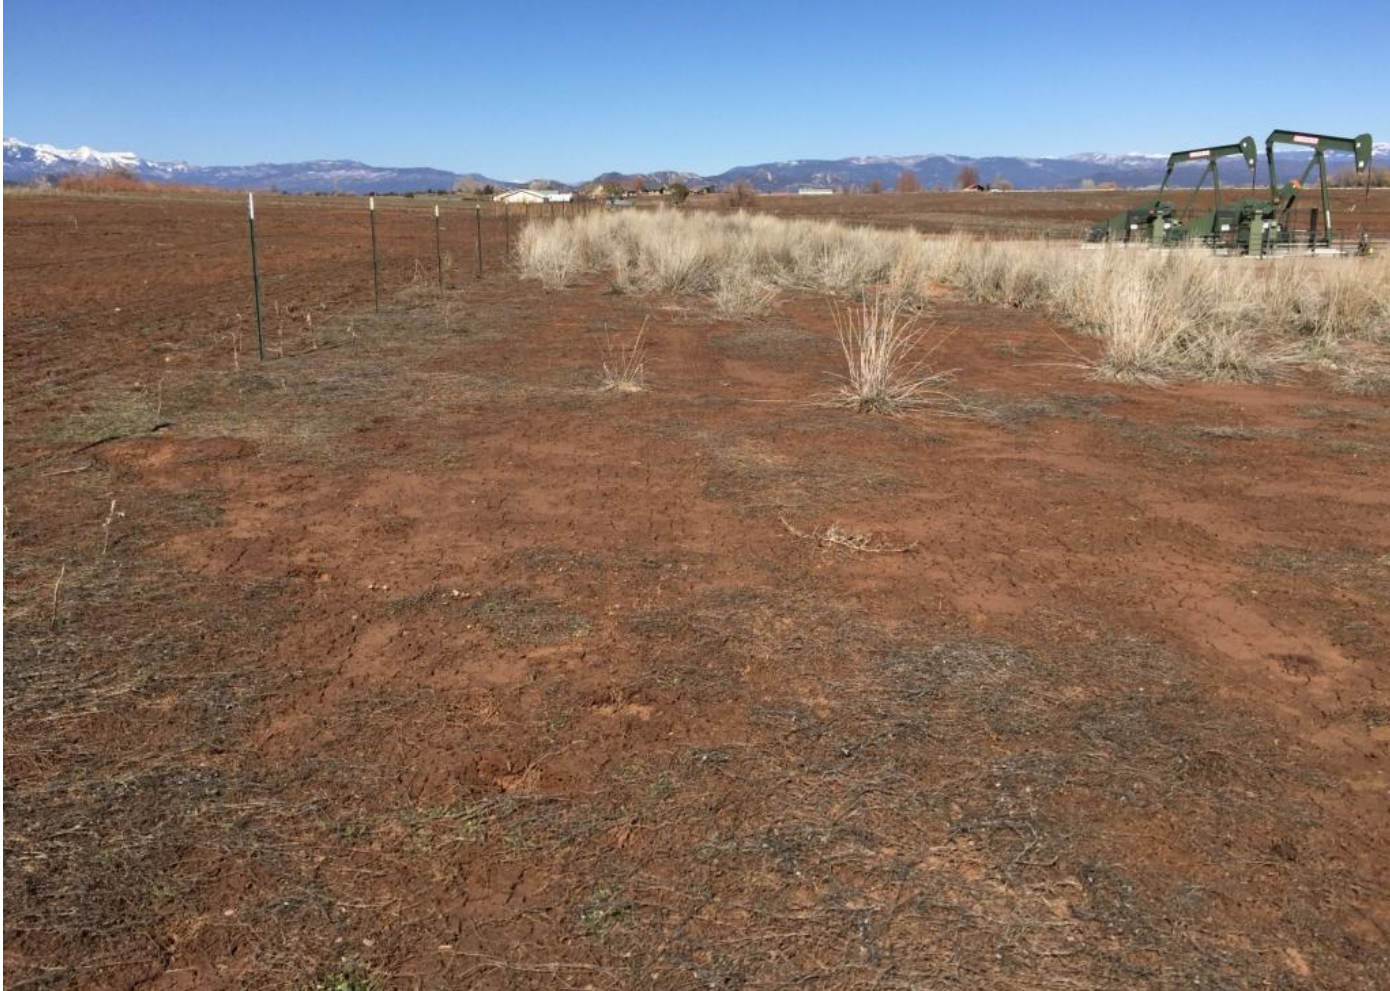
Photo 2. View of the western portion of the project area from the southwestern corner facing northward. There is a patch of intermediate wheatgrass in the western portion of the interim reclamation area shown in the mid-ground.

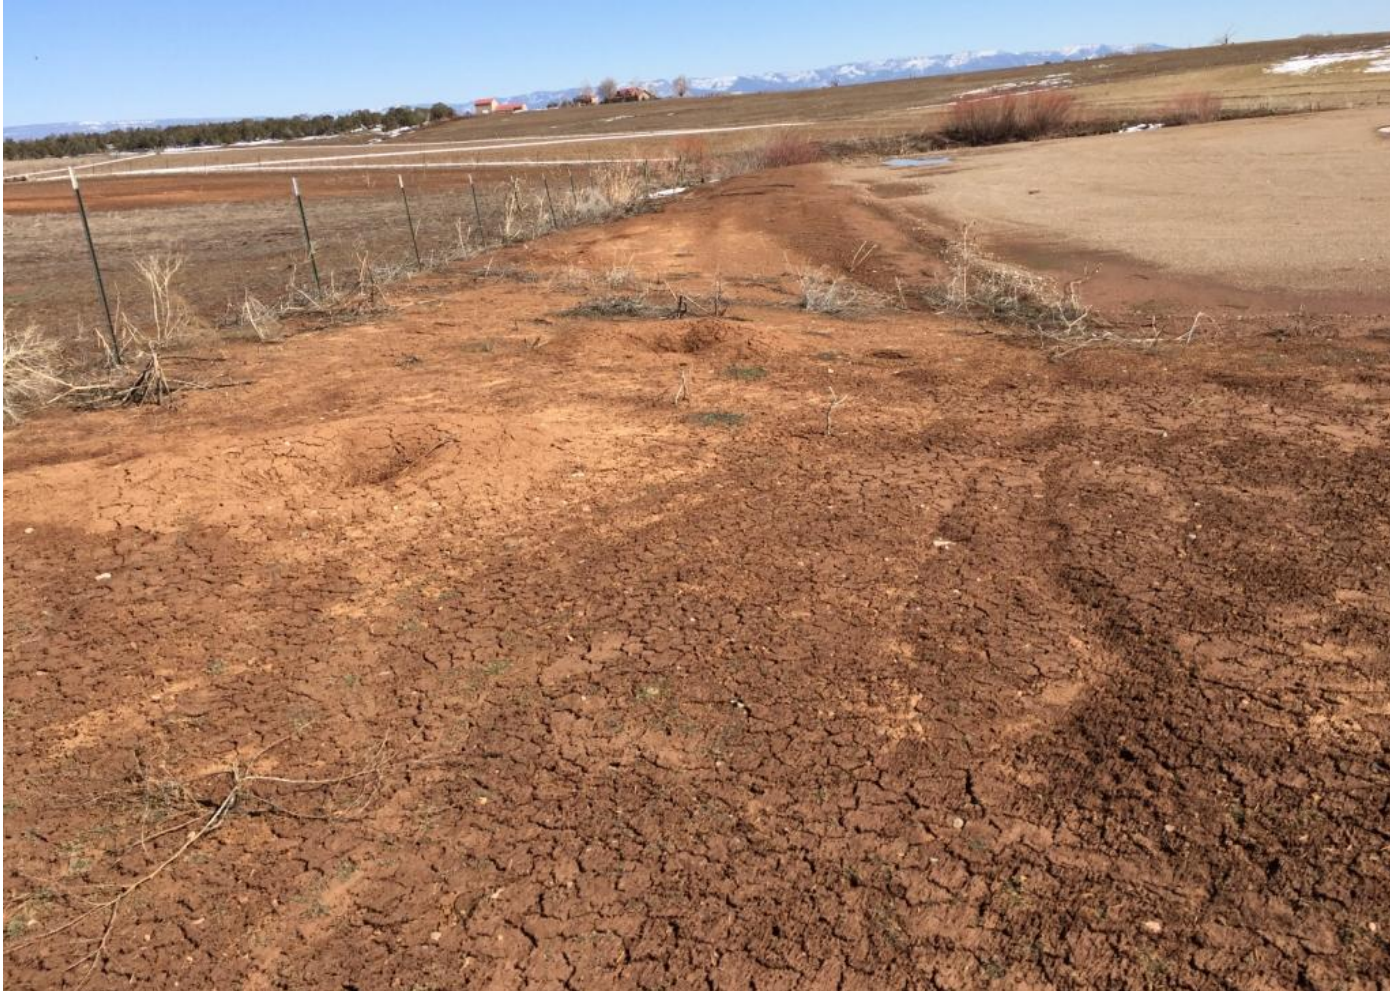
Photo 3. View of the northern portion of the project area from the northwestern corner facing eastward. There is very little vegetation established here.

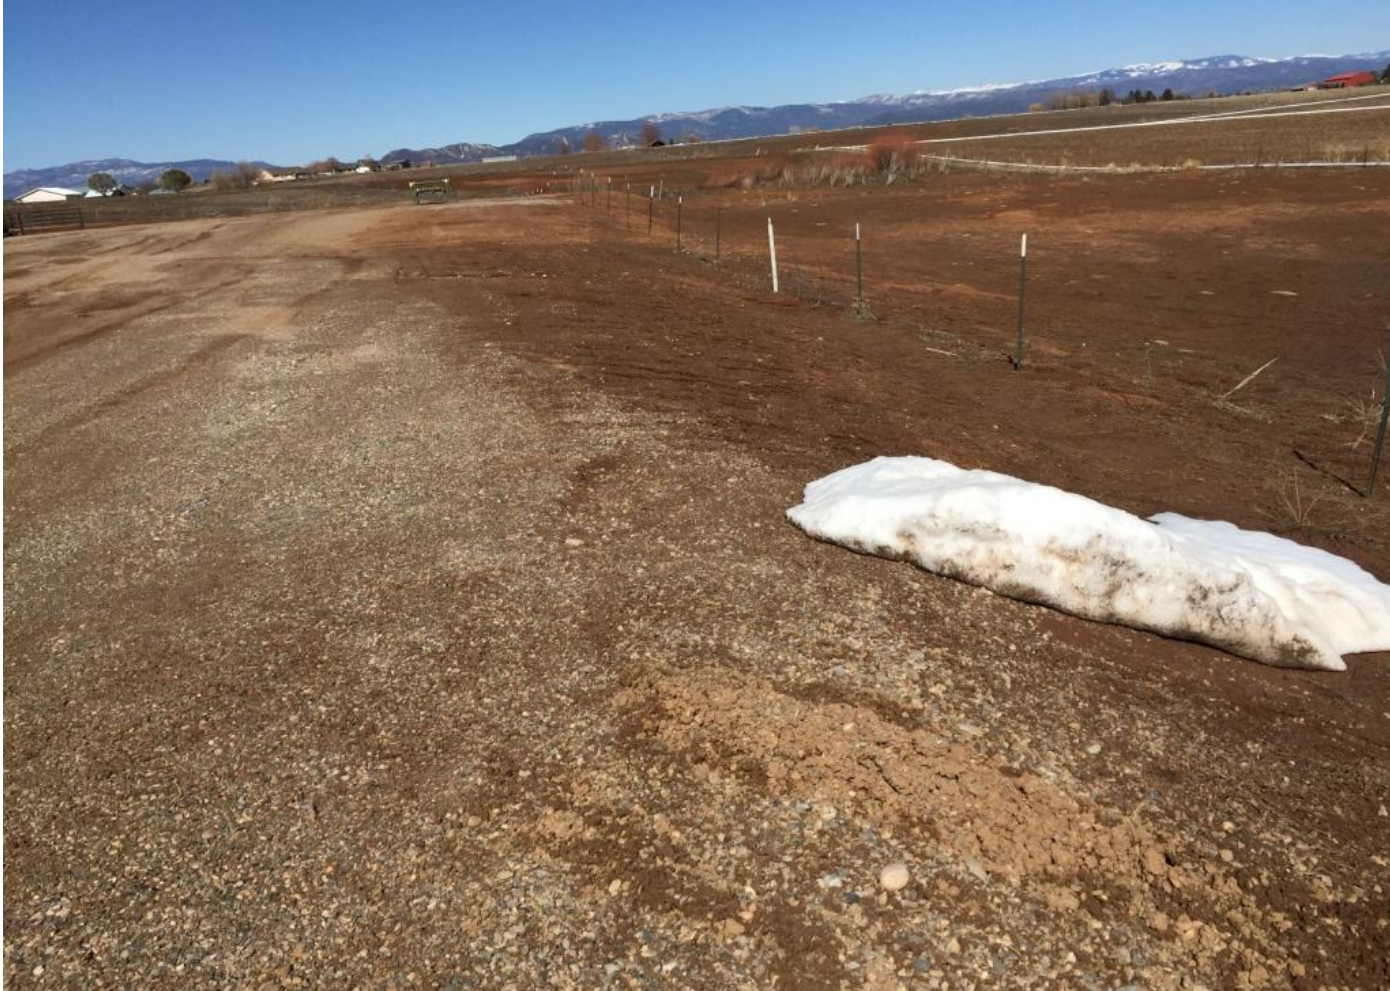
Photo 5. View of the eastern portion of the project area from the northwestern corner facing eastward. There is little to no desirable vegetation established here.

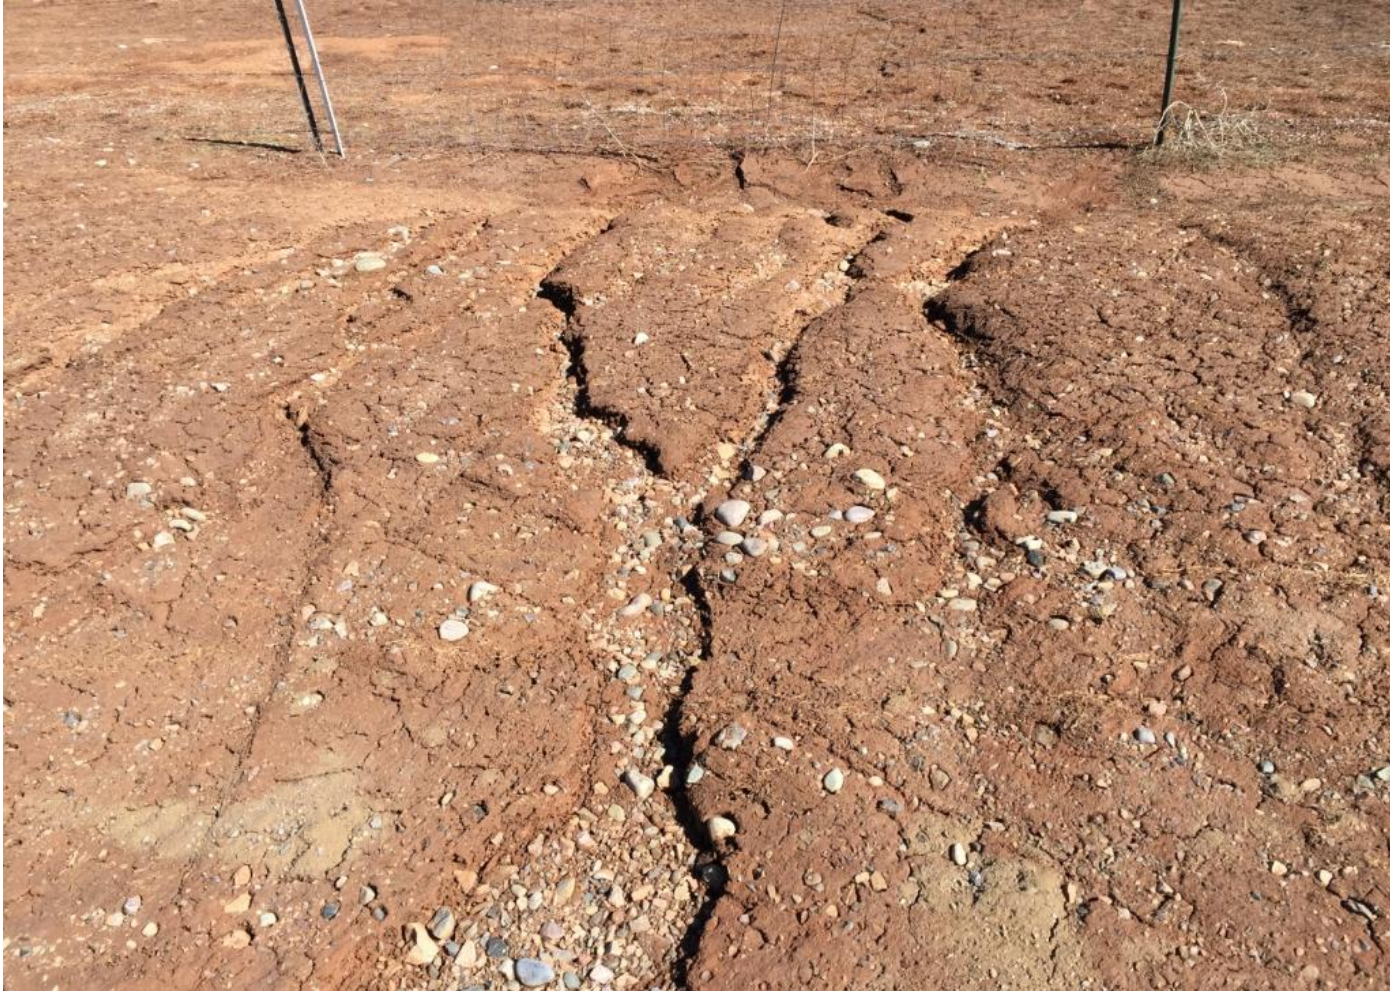
Photo 6. View of rill erosion occurring within the un-vegetated eastern portion of the interim reclamation area.

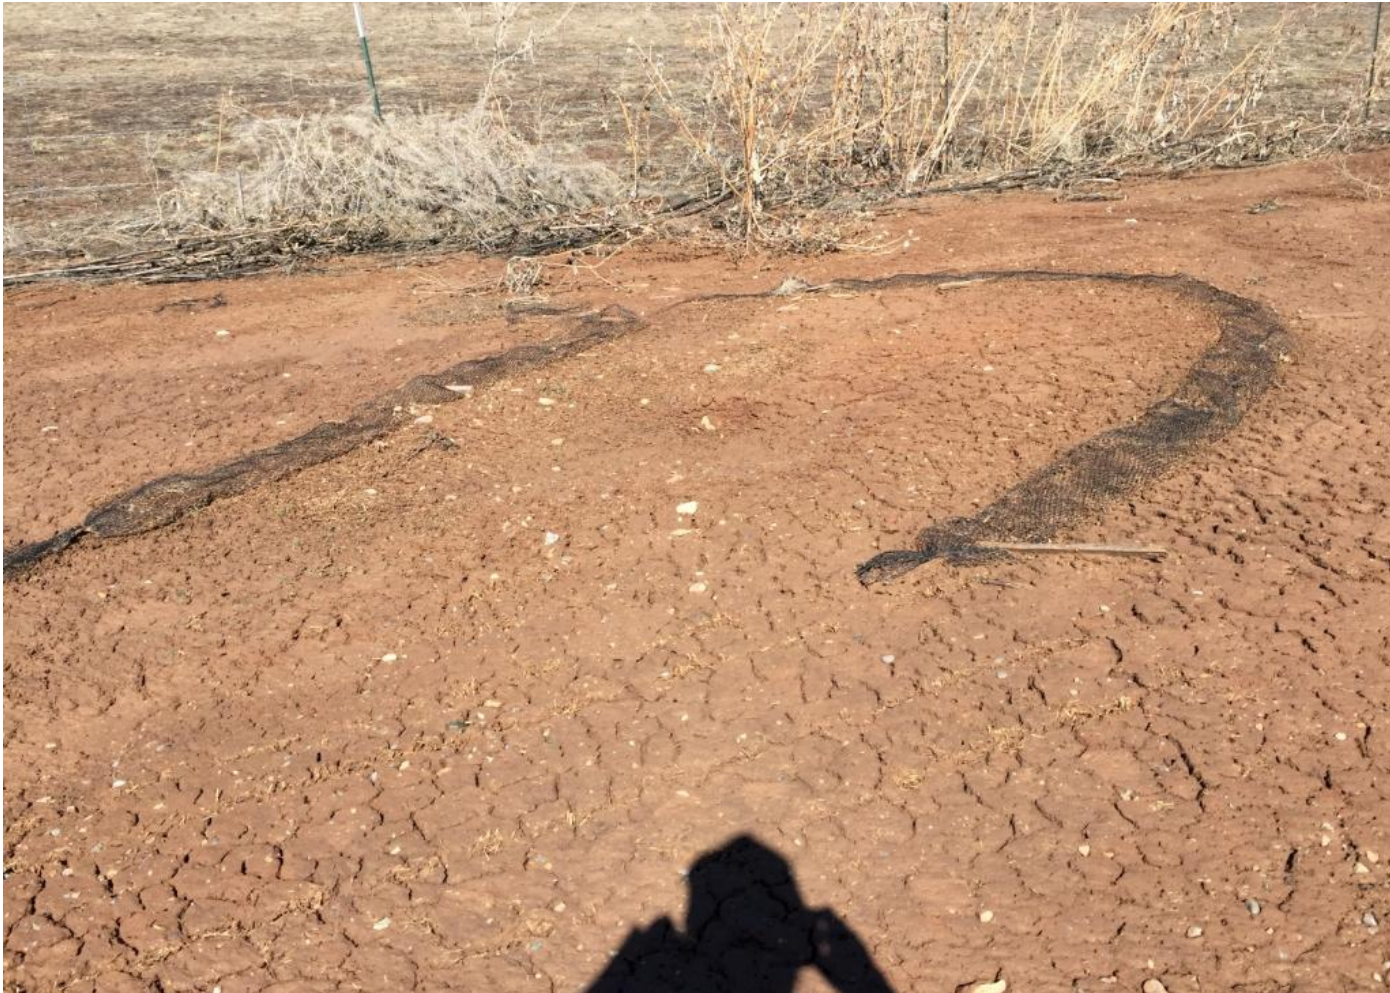
Photo 7. View of straw wattle in northeasterly portion of interim reclamation area that is flattened and does not appear to be functioning.

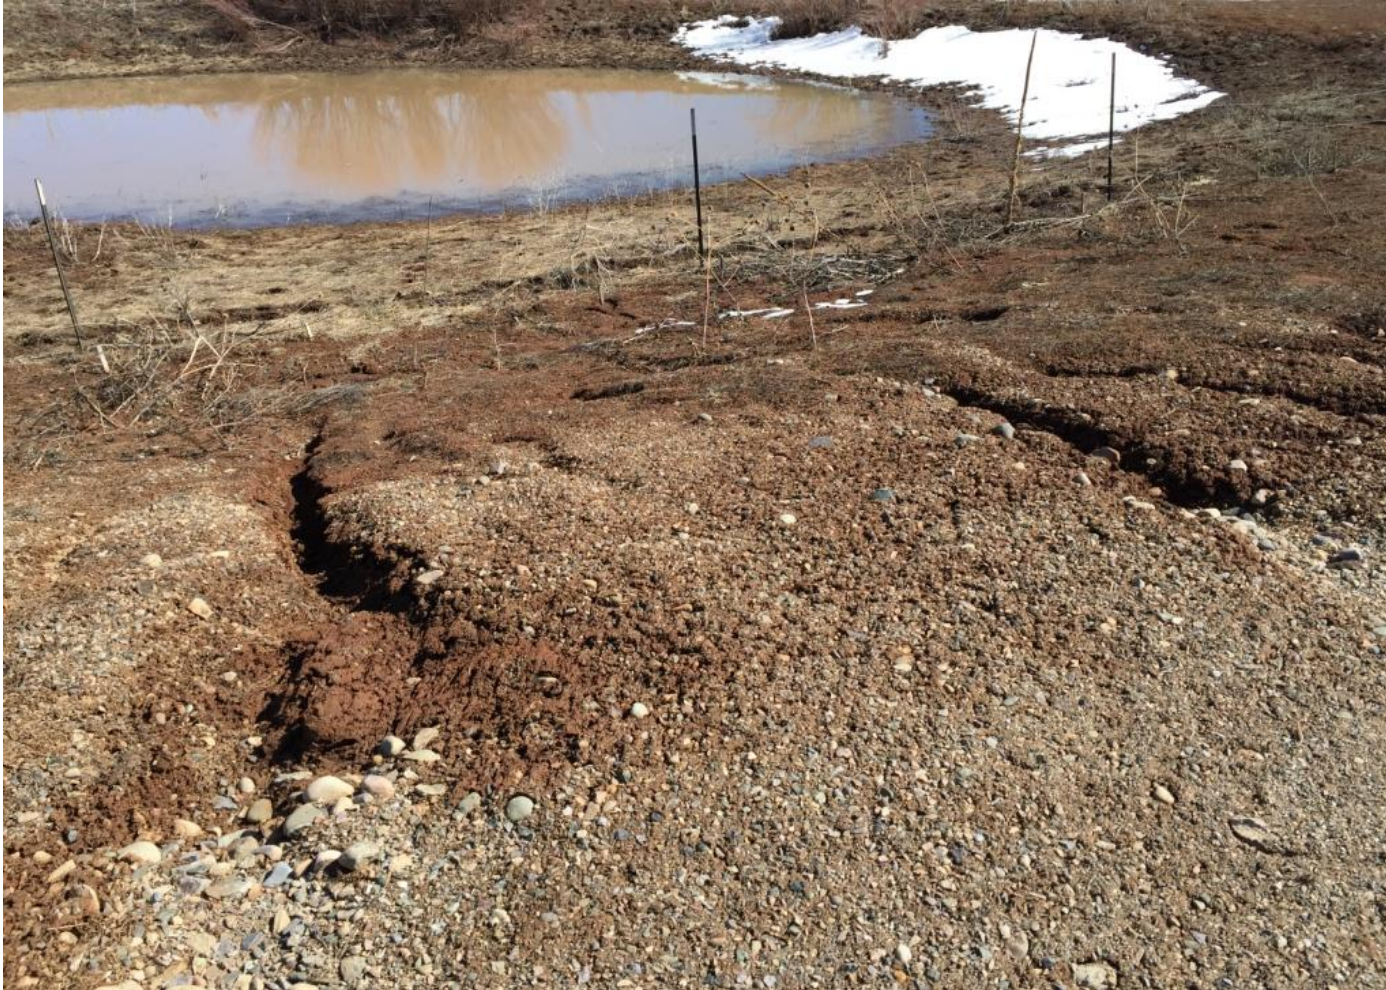
Photo 8. View of erosional channels in the northeastern portion of the interim reclamation area flowing toward a cattle pond. Stormwater BMPs are needed to stabilize soils and filter flows in this area.

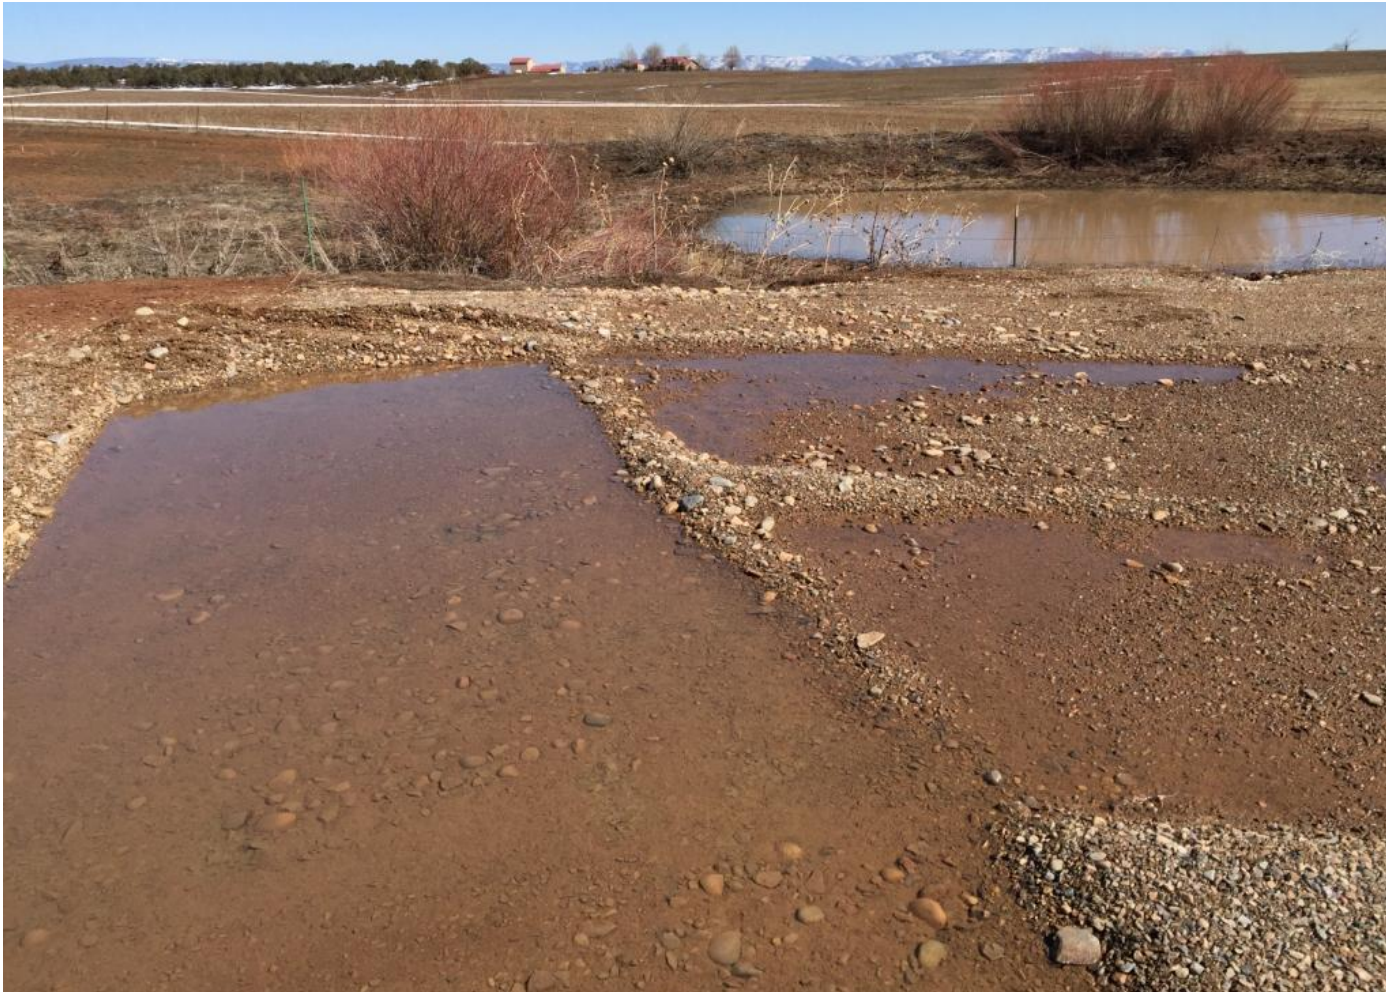
Photo 9. View of area in northeastern corner of the well pad where it appear to have been excavated to approximately 4 inches deep and water is ponding. If this is intended to be a stormwater BMP it is not sufficient as erosional channels shown in Photo 8 are downslope from this area.
