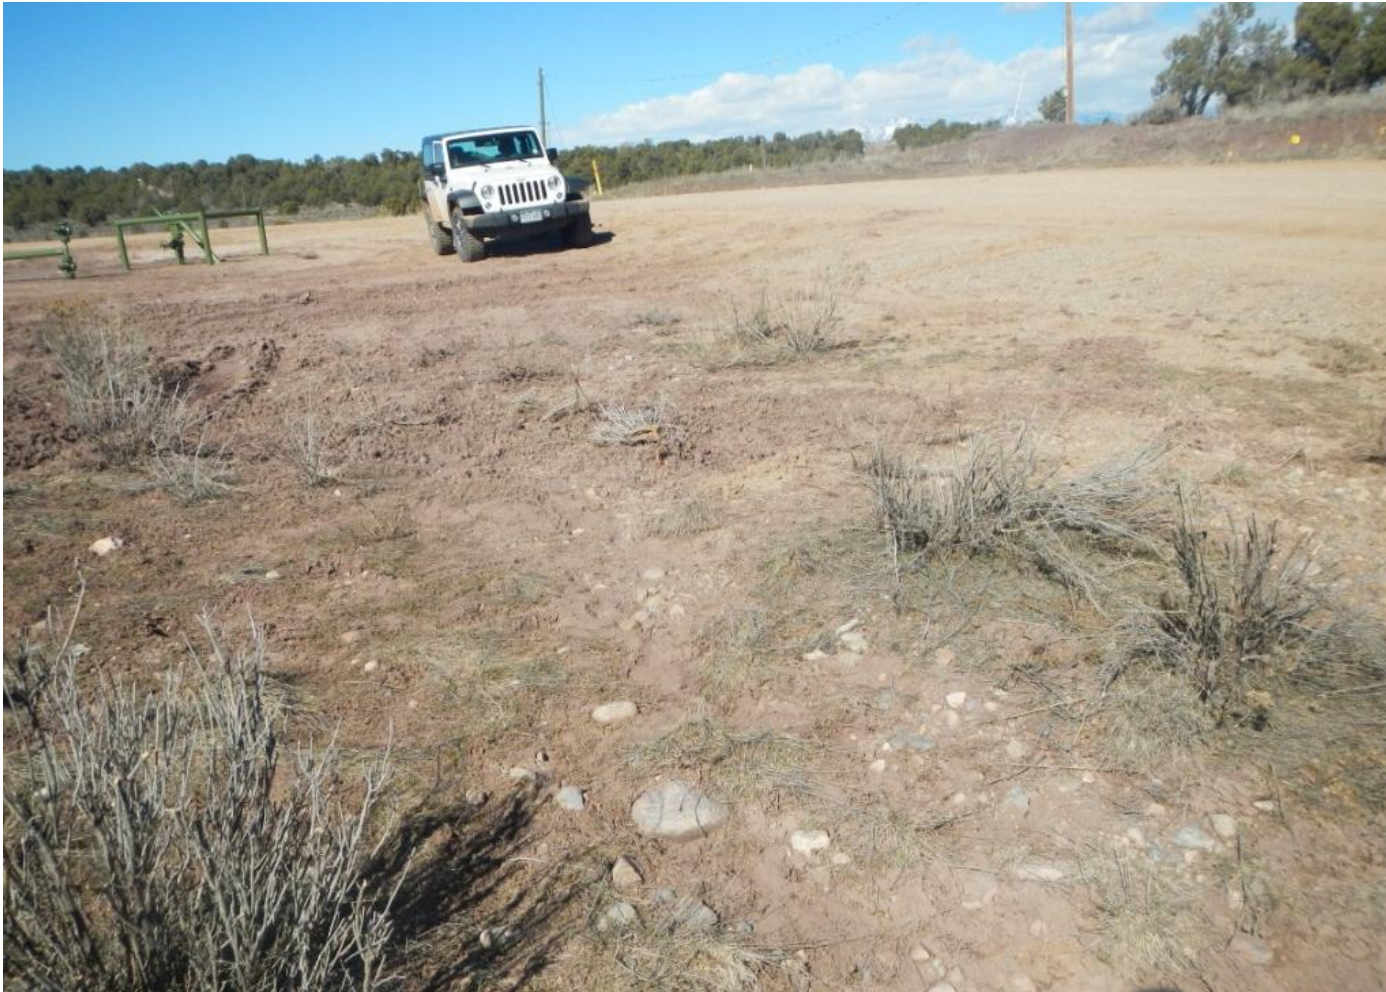
Photo 1. View of the eastern portion of the project area from the southeastern corner facing northward. It appears that stormwater flows exit the southeastern corner and flow southward. This area should be monitored and BMPs applied if needed.

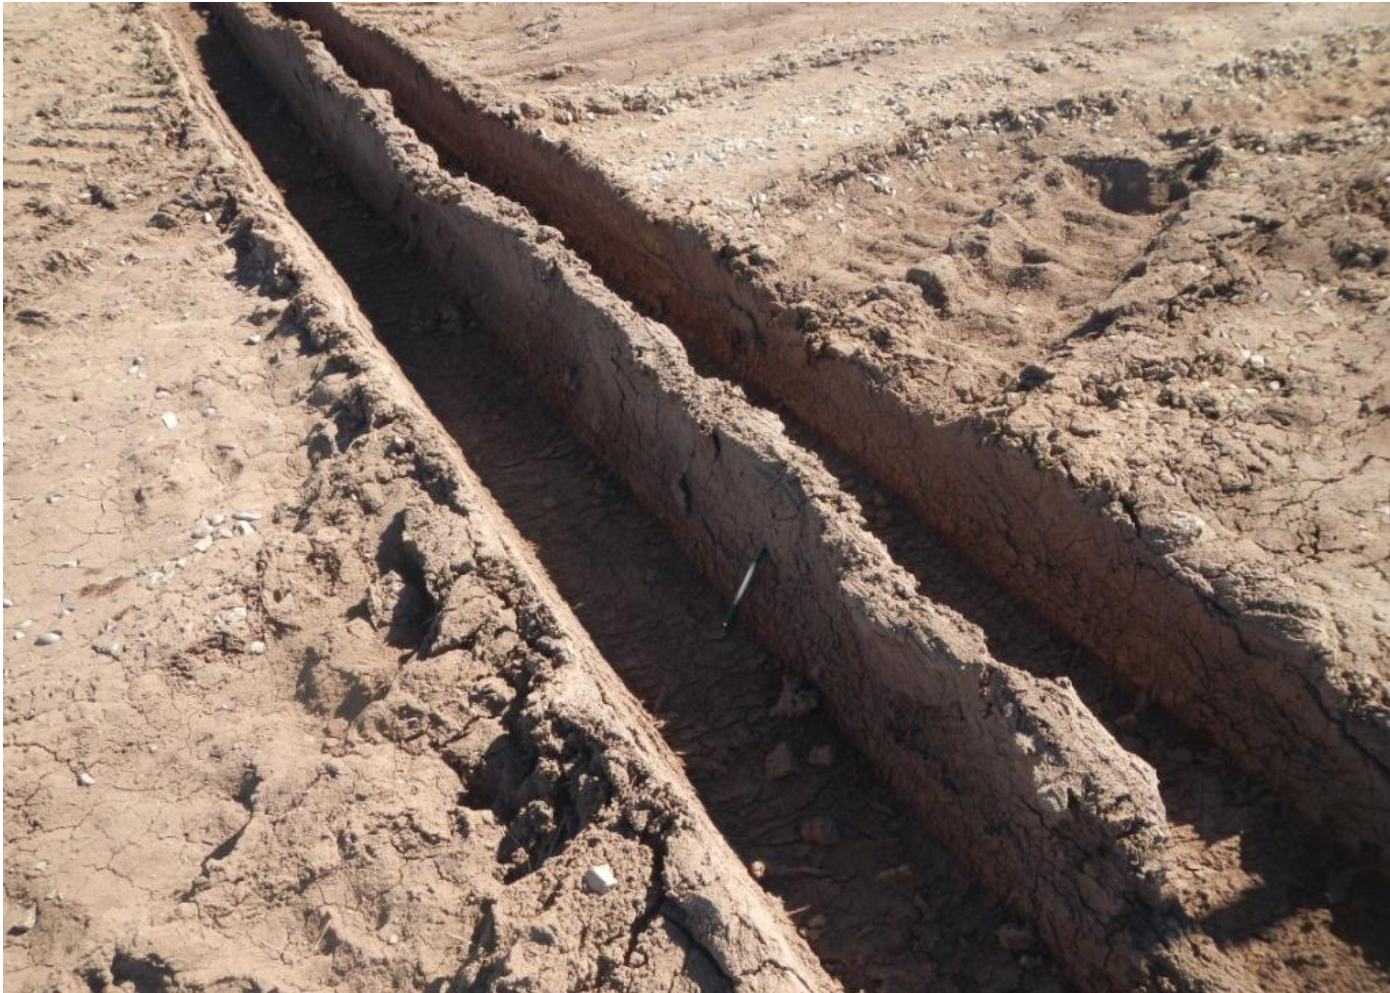
Photo 2. View of ruts in the well pad approximately 20 inches deep. The well pad surface needs better stabilization.

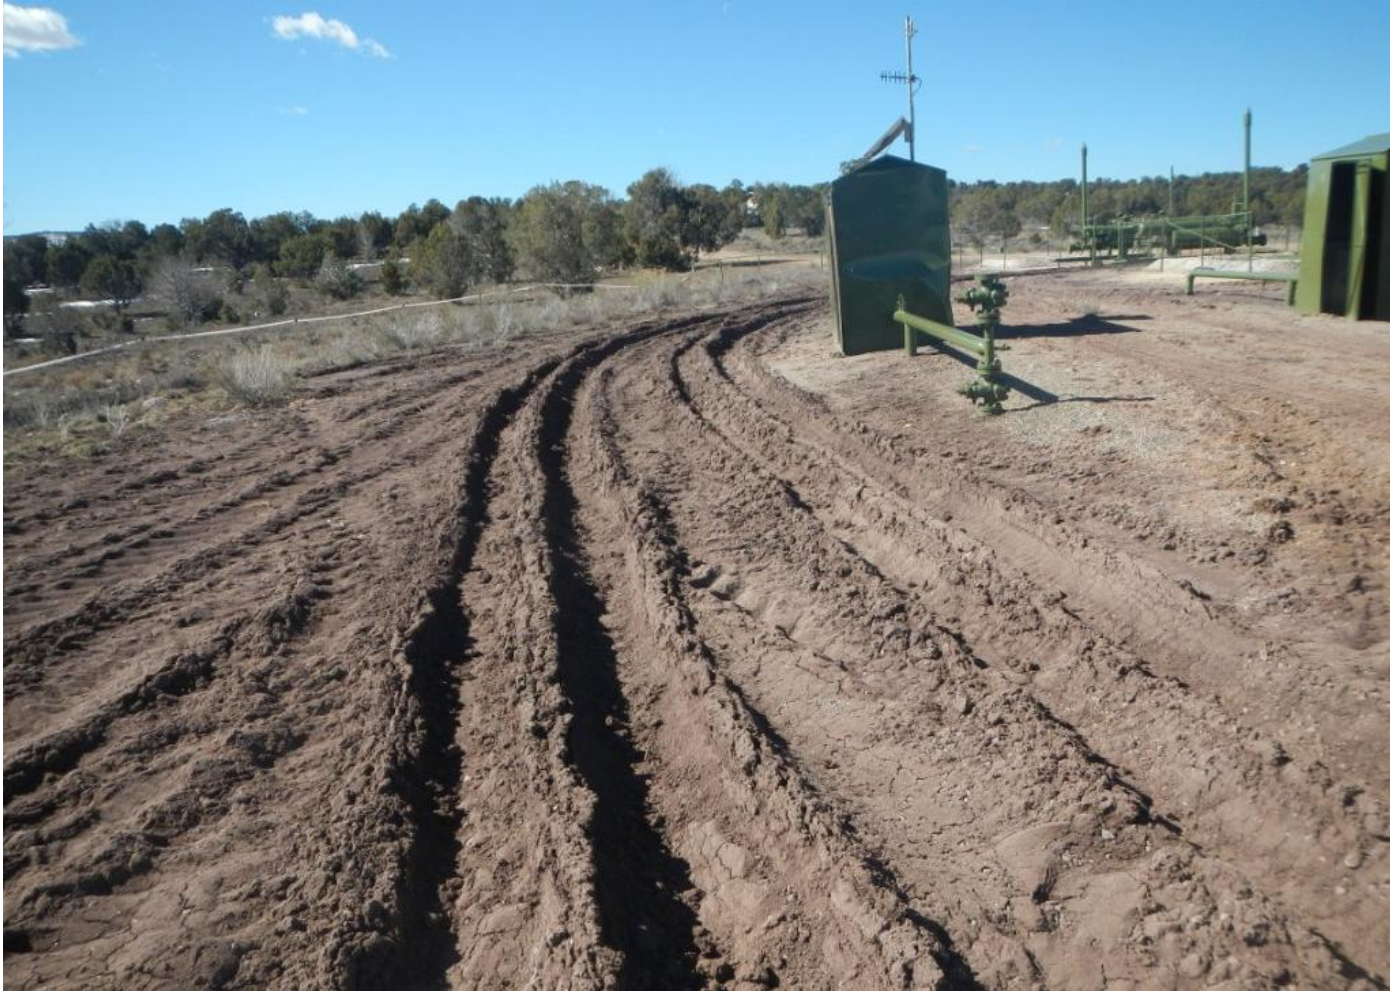
Photo 3. Another view of rutting within the project area. This needs to be stabilized.

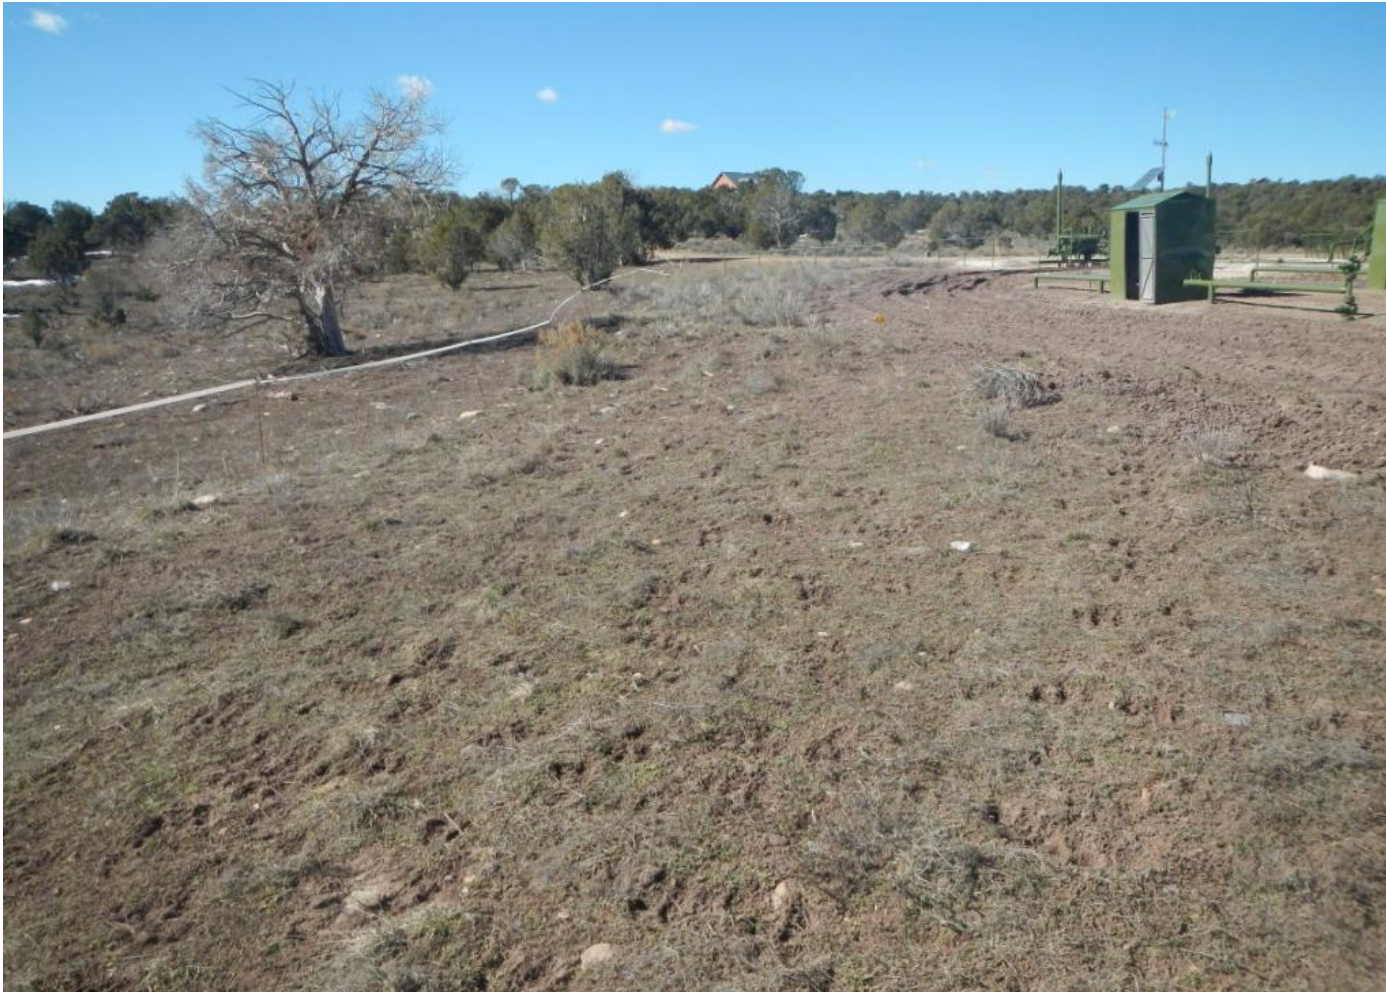
Photo 4. View of the southern portion of the project area from the southeastern corner facing westward. Grasses such as Indian ricegrass (*Achnatherum hymenoides*), squirreltail (*Elymus elymoides*), and western wheatgrass (*Pascopyrum smithii*) are established here.
