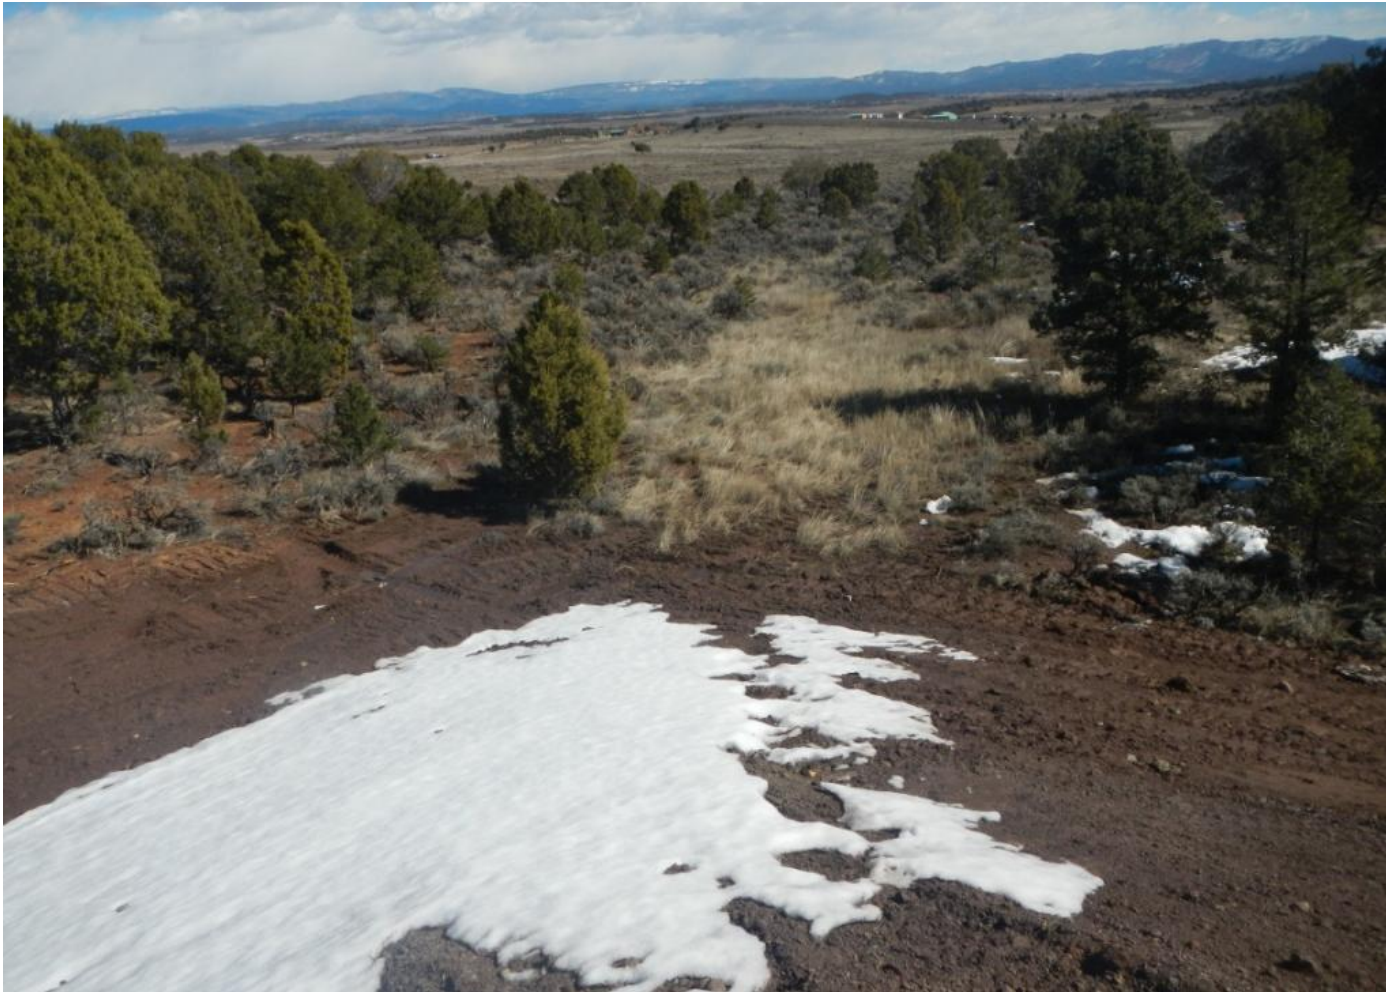
Photo 1. View of snow melting on unprotected slope above a grassy swale in the northeastern portion of the project area. Stormwater BMPs are needed here.

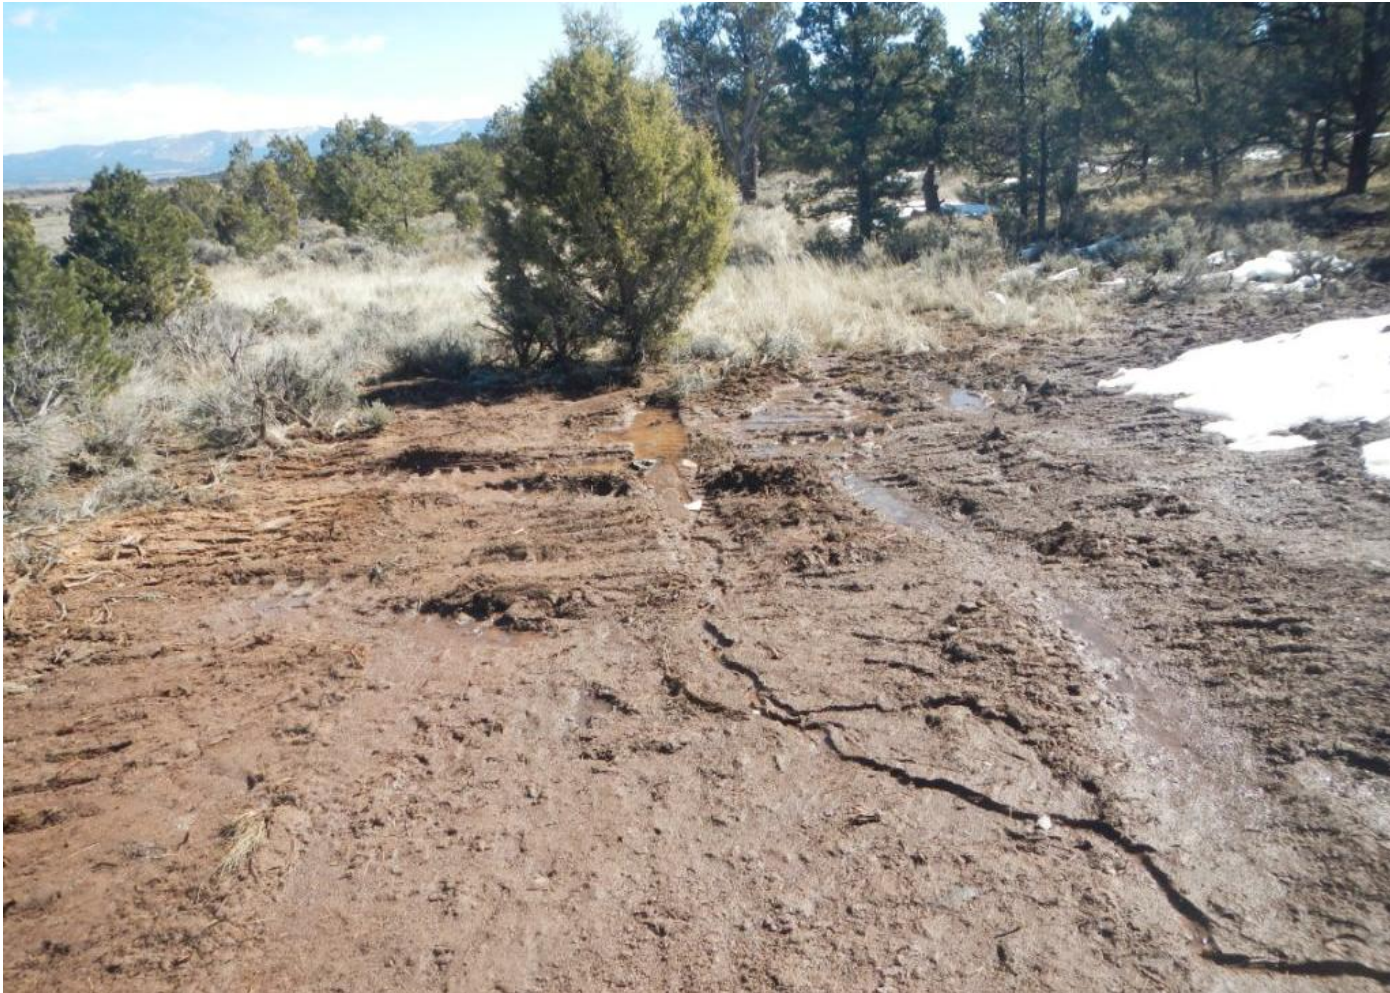
Photo 2. Another view of stormwater erosion occurring where sediment is being carried offsite into the grassy swale shown in Photo 1.

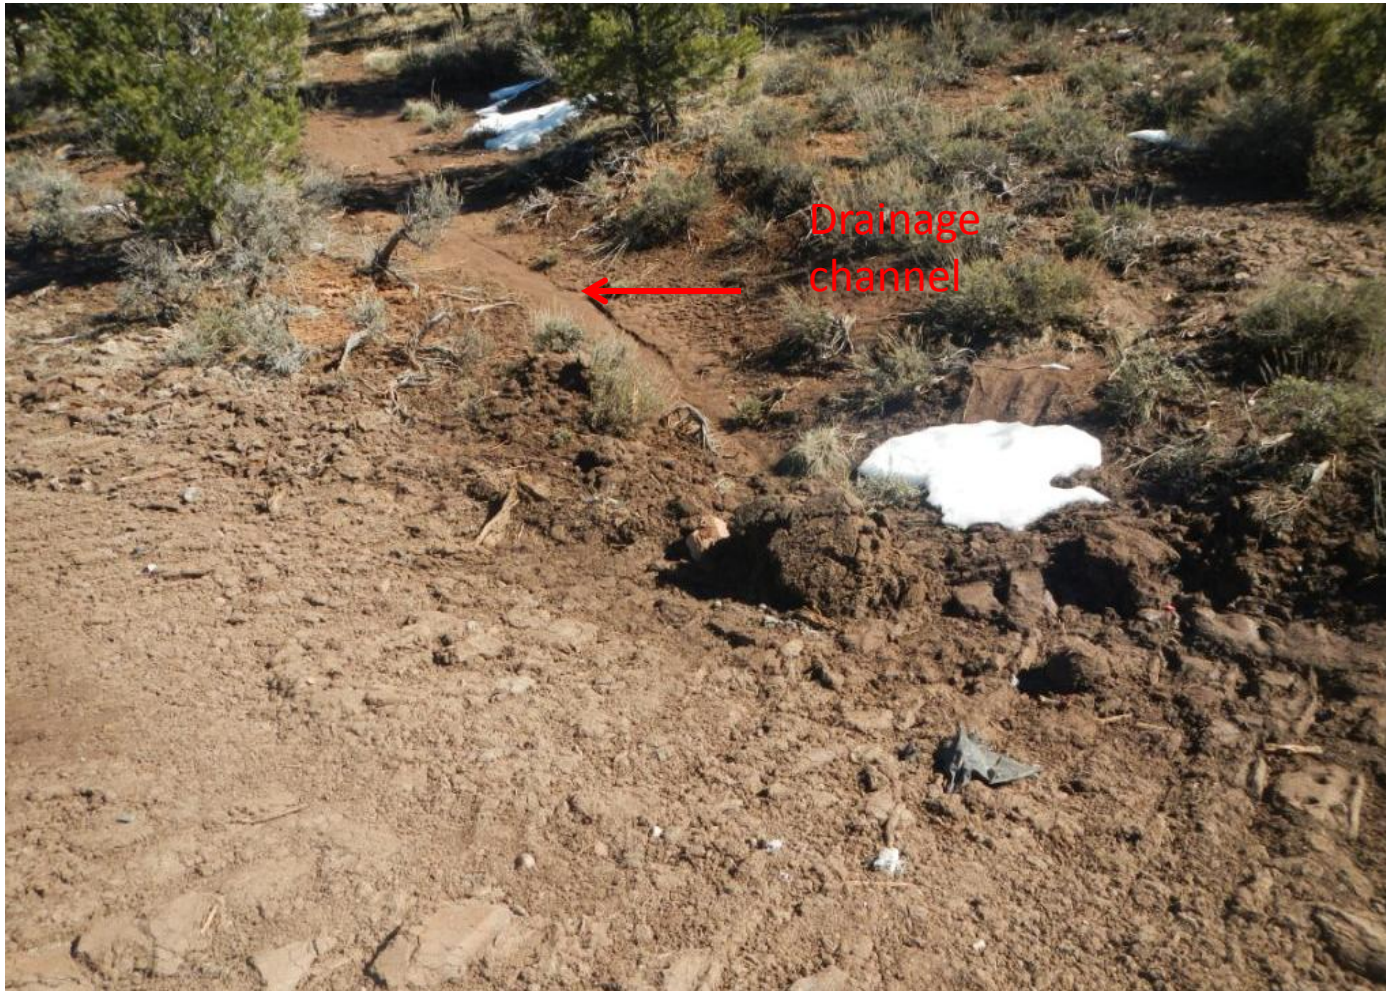
Photo 3. View of a drainage channel that was filled during construction in the eastern portion of the project area. No stormwater BMPs are present on the fill slopes in the foreground to prevent runoff into the channel.

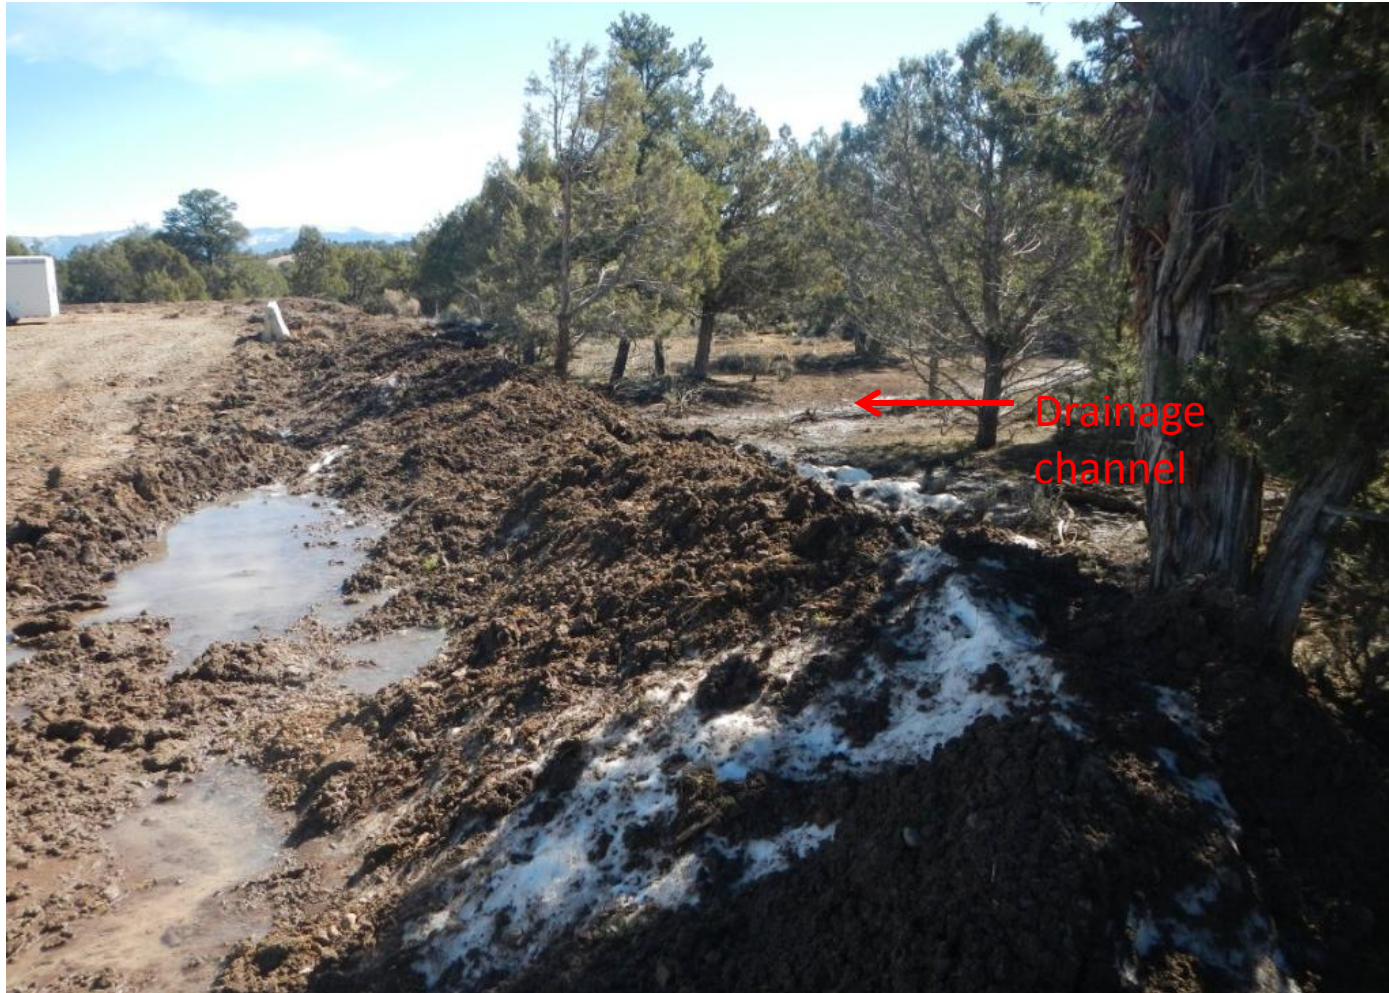
Photo 4. View of a drainage channel that was filled during construction in the southern portion of the project area from the southwestern corner facing eastward. No stormwater BMPs are present on the fill slopes to prevent runoff into the channel or along the southern edge.

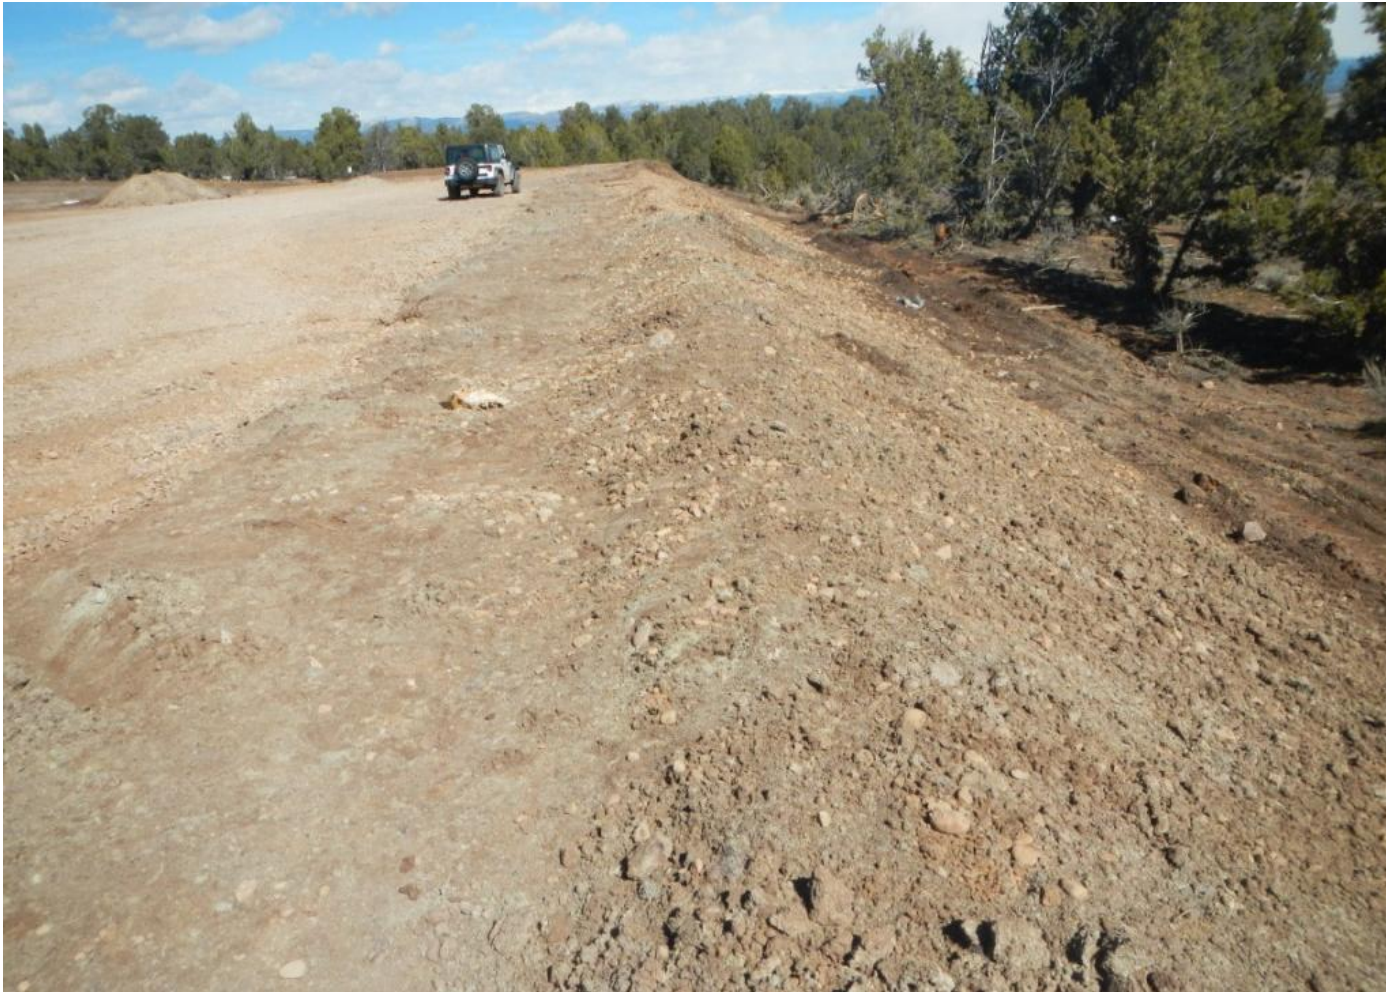
Photo 5. View of the eastern edge of the project area from the southeastern corner facing northward. Fill slopes are not stabilized and need additional stabilization measures.

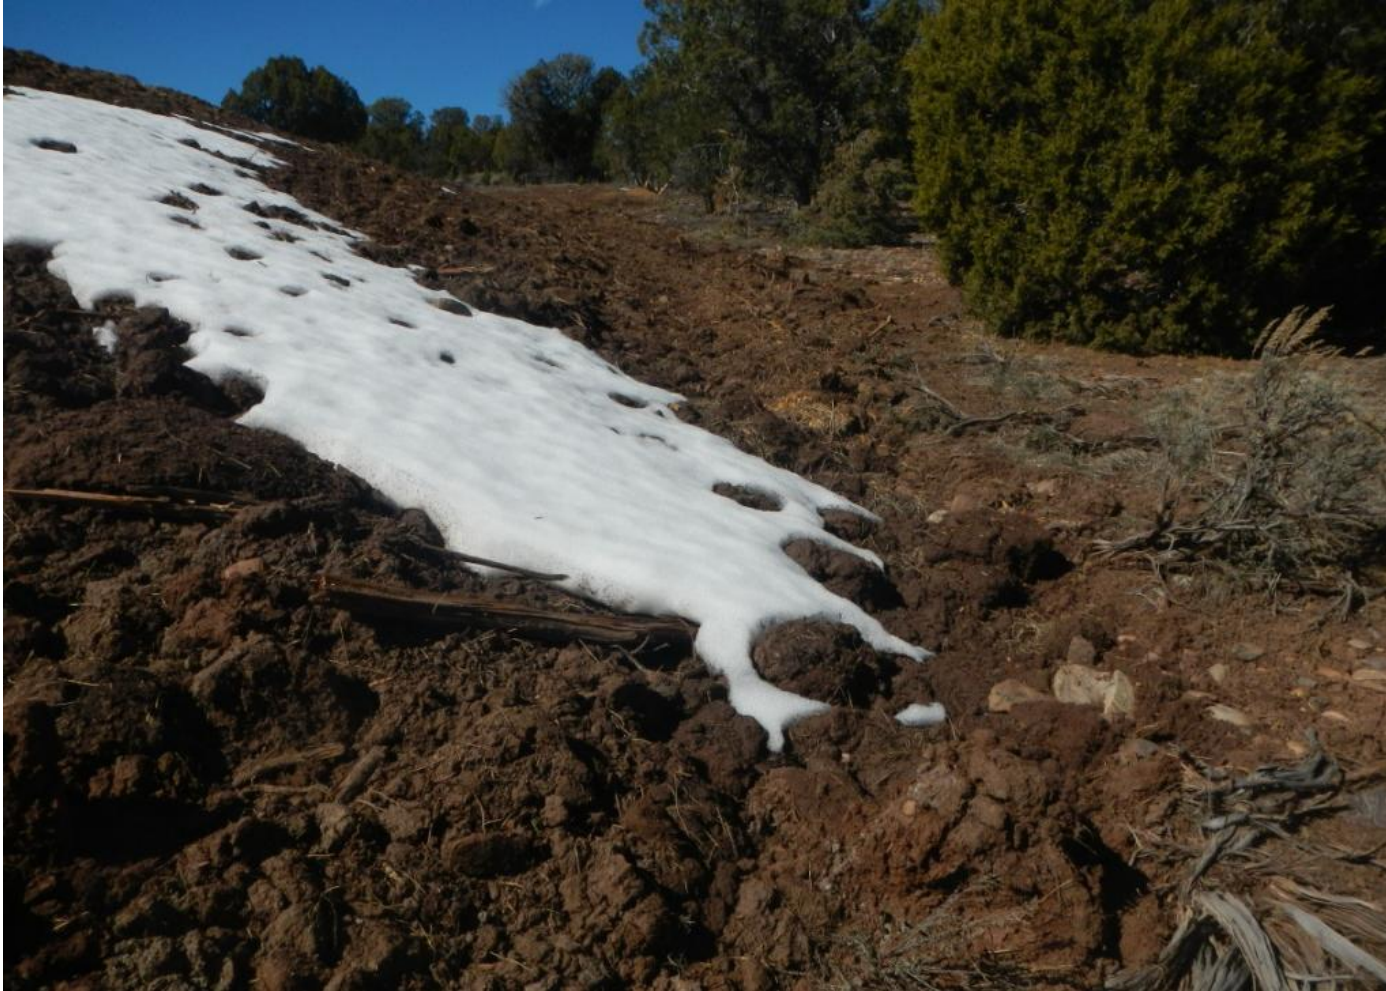
Photo 6. View of the topsoil stockpile in the northeastern corner of the project area. Topsoil stockpile is not stabilized as no BMPs to filter snowmelt or stormwater runoff have been applied.

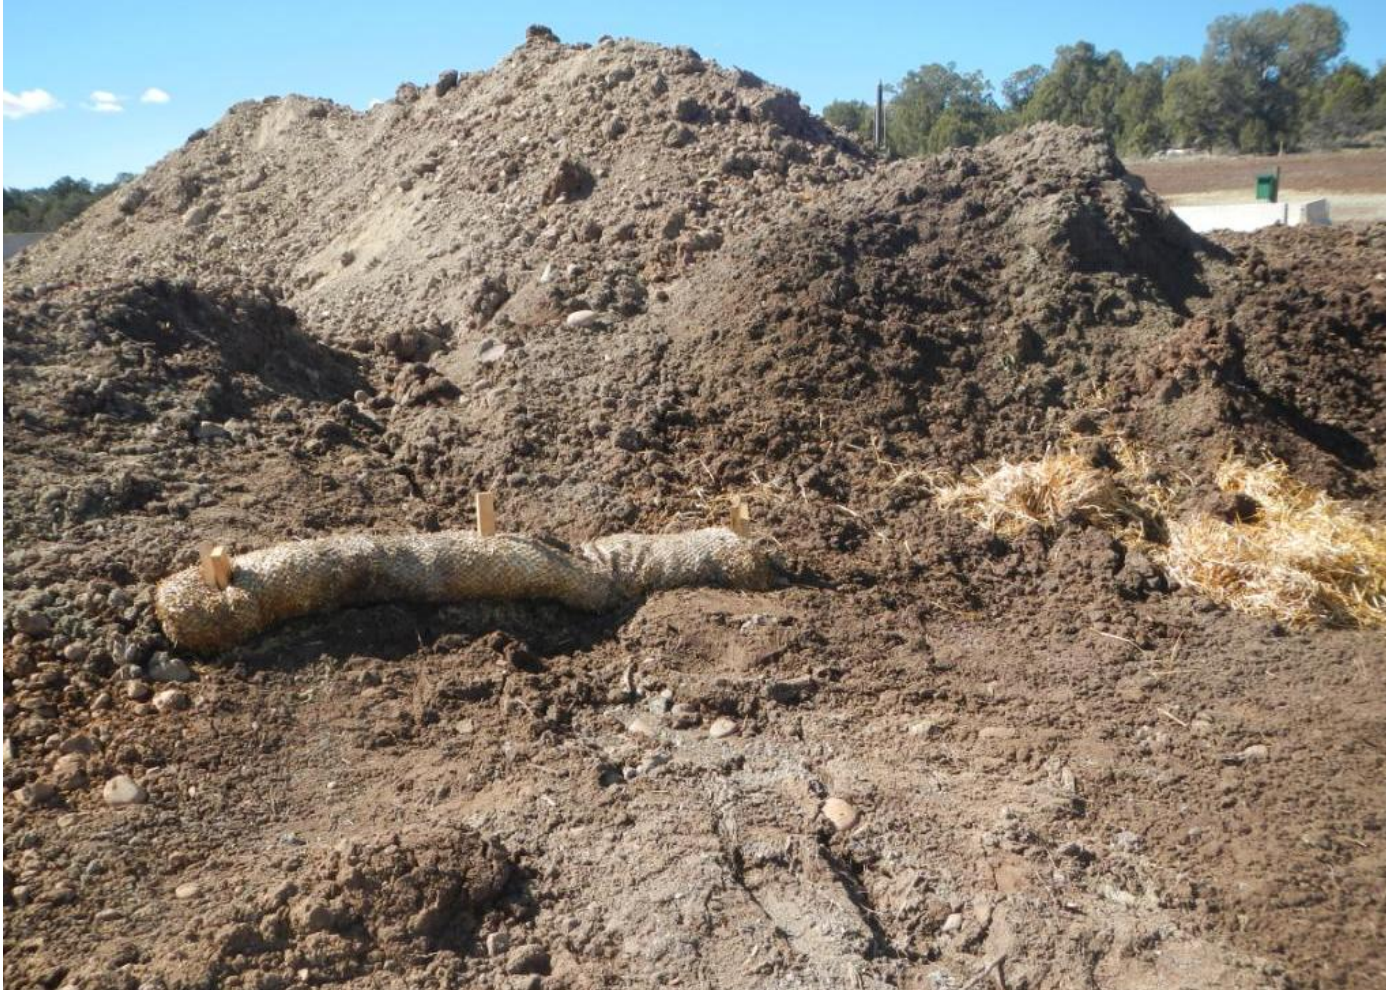
Photo 7. View of one of only two straw wattles in the project area. Wattle is in disrepair and does not appear to be functioning properly.

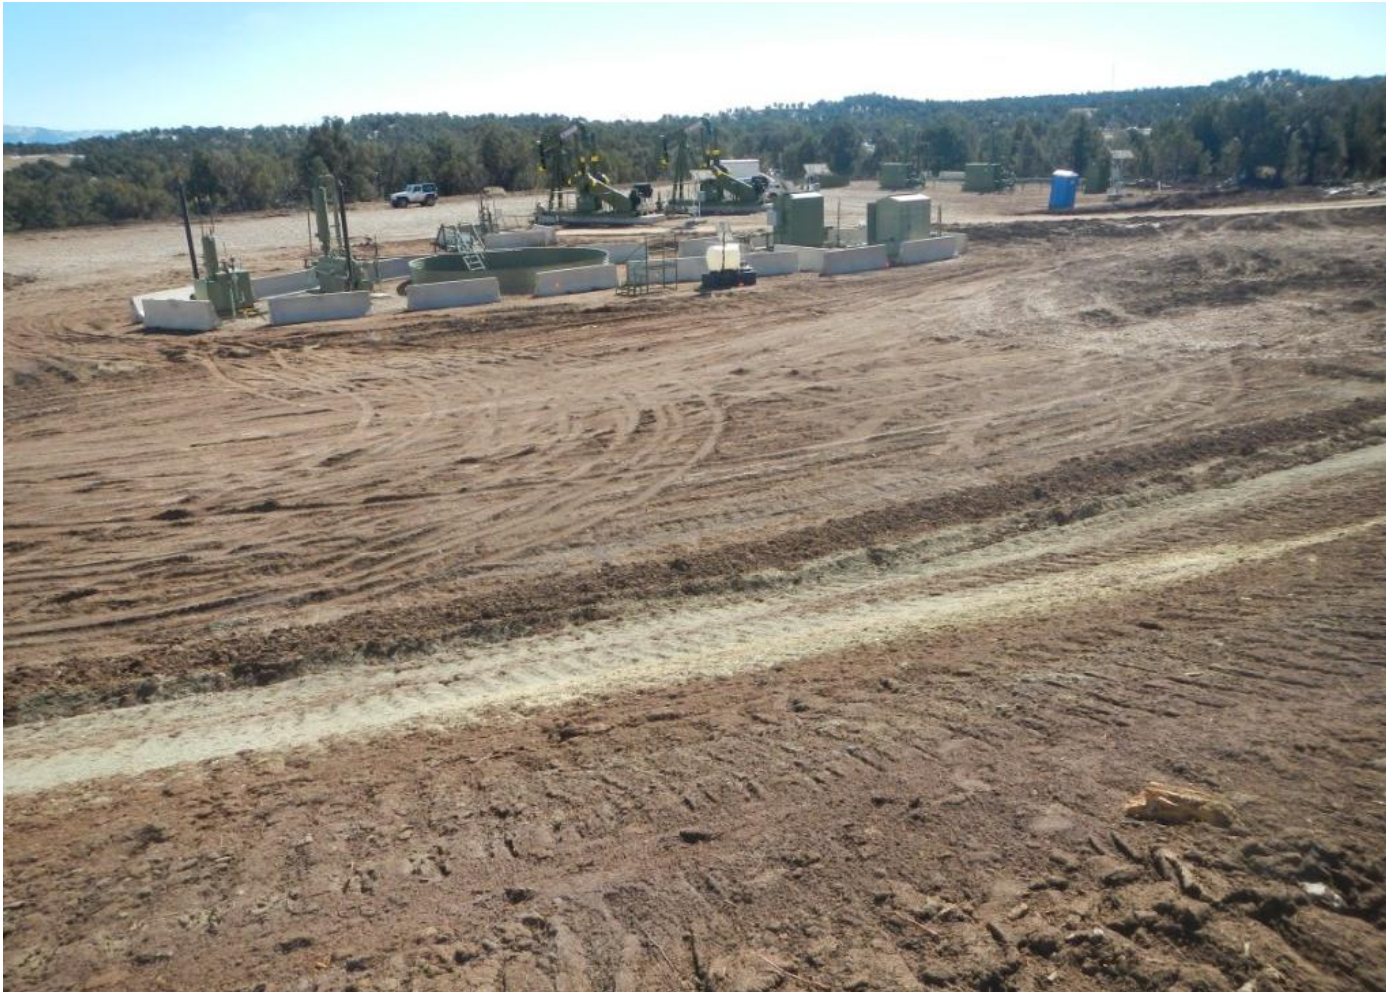
Photo 8. View of the project area from the northeastern corner facing center. It is expected that all areas except for those needed for production operations will be reclaimed in a timely manner according to the 1003 interim reclamation rules.

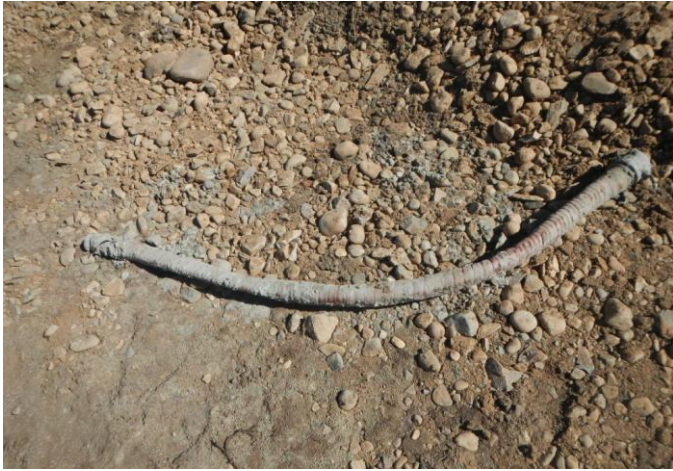
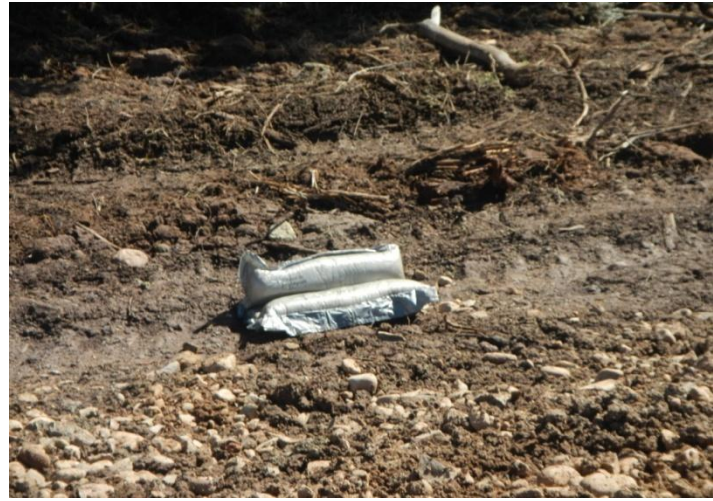
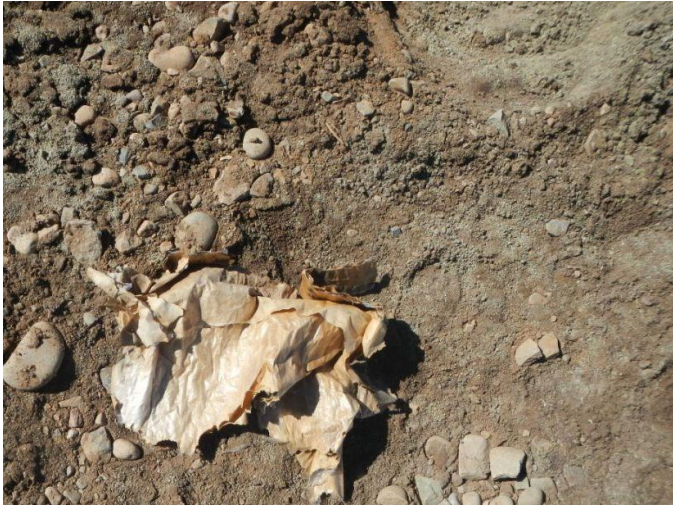
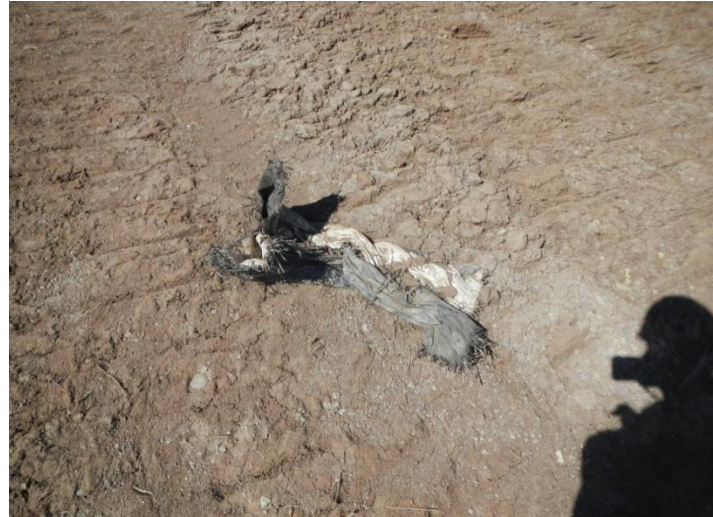
Photos 9-12. View of several pieces of junk and debris scattered around the project area.
