Inspection Photos
3/3/16
Facility #261309
State of Colorado AS 42-36V

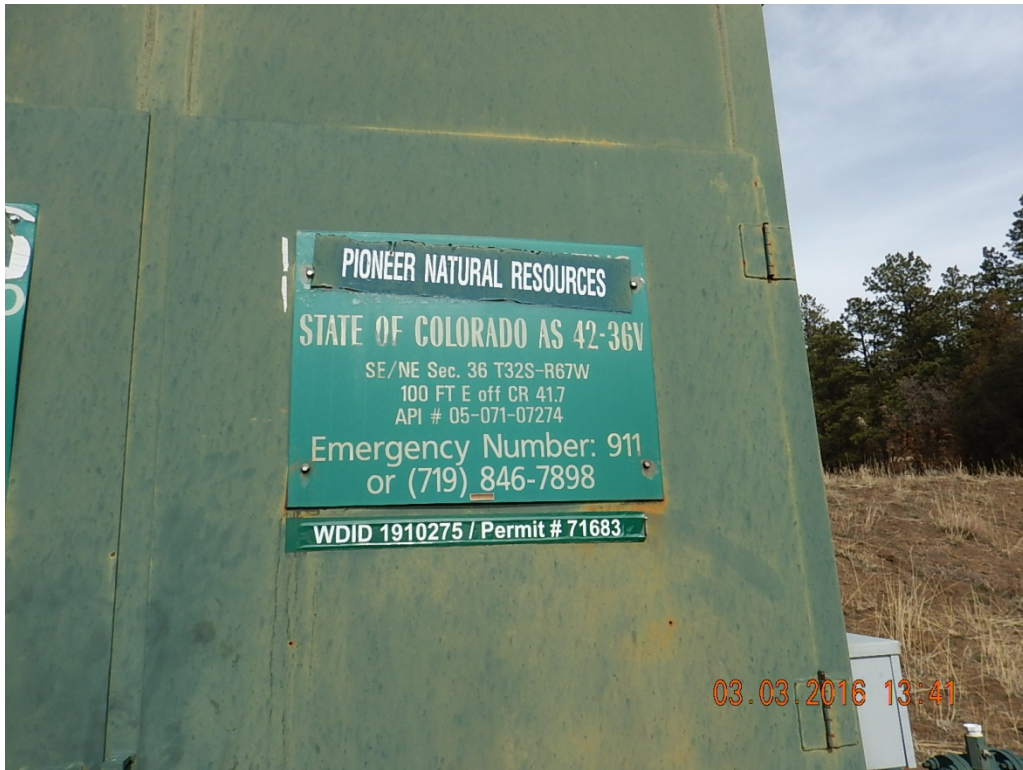
Figure 1 – Lease sign.

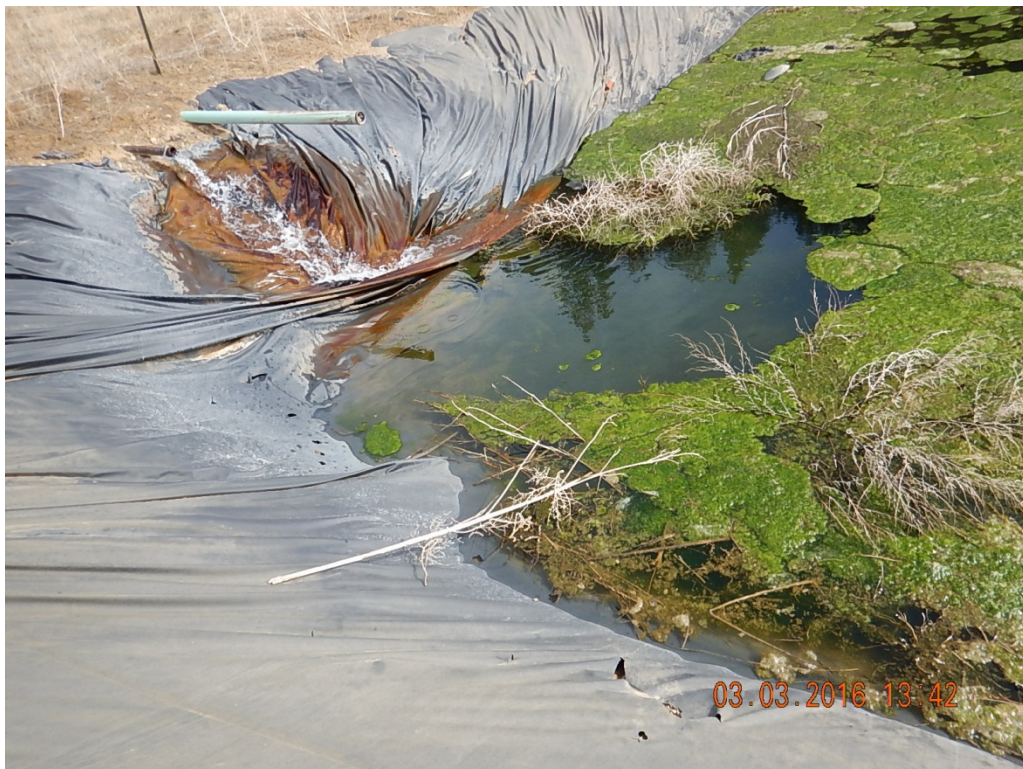
Figure 2 – Water intake on northwest corner of pit. Liner is torn above water level.

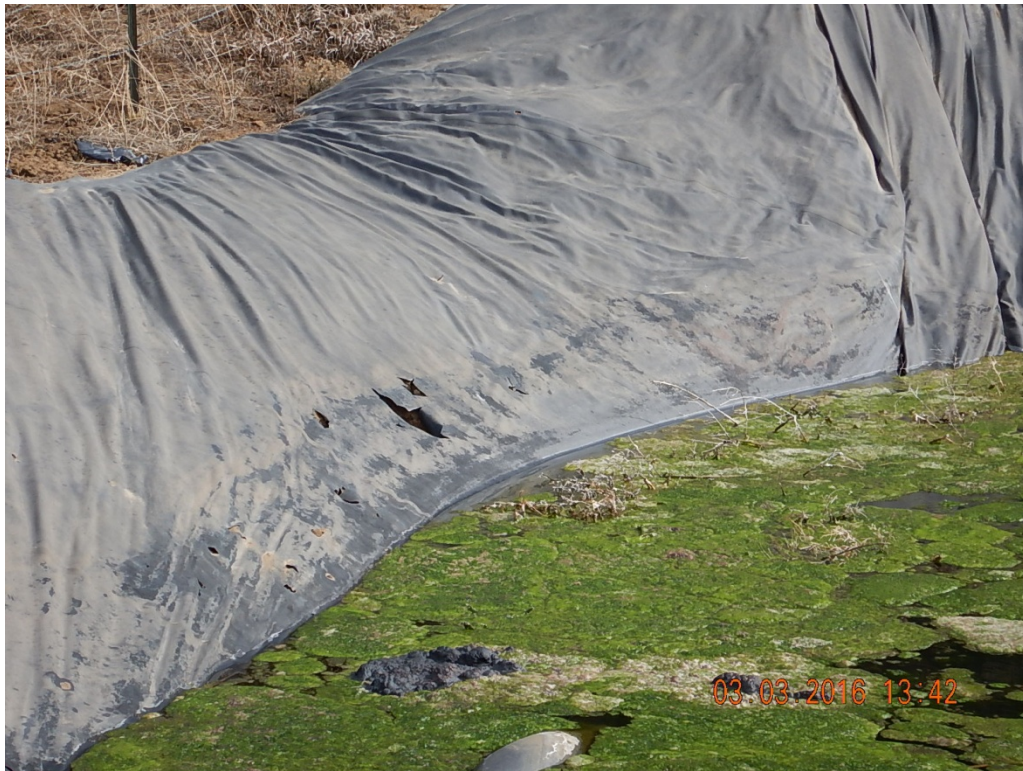
Figure 3 – Torn liner on northeast pit wall.

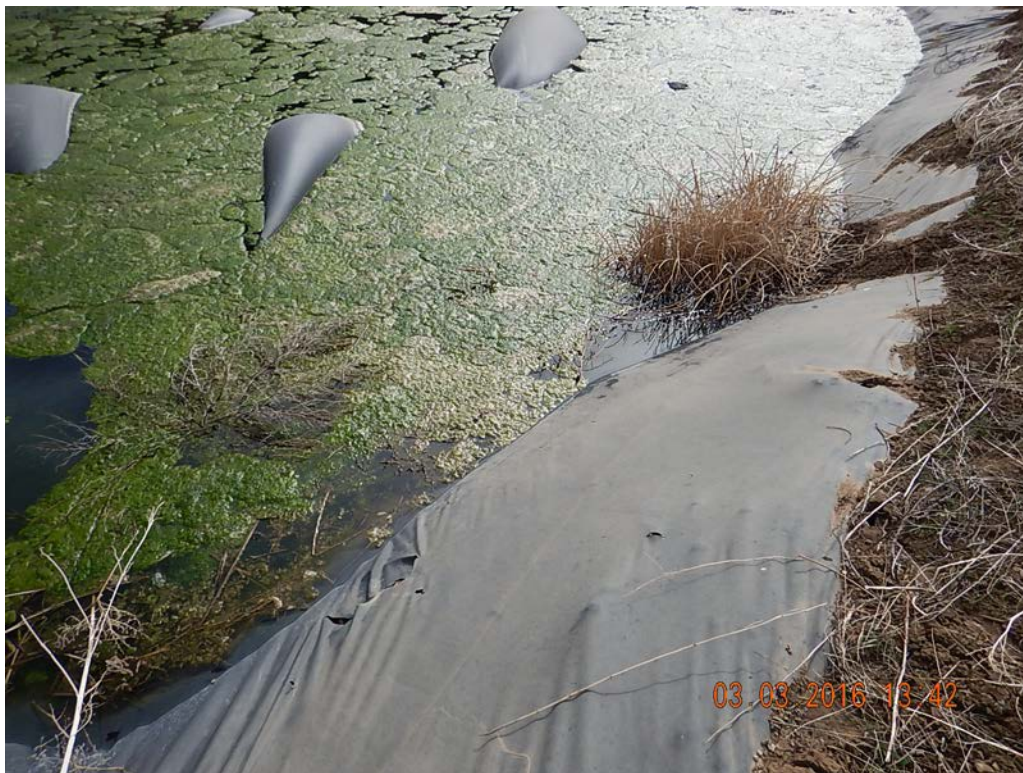
Figure 4 – Torn liner on northwest pit wall.

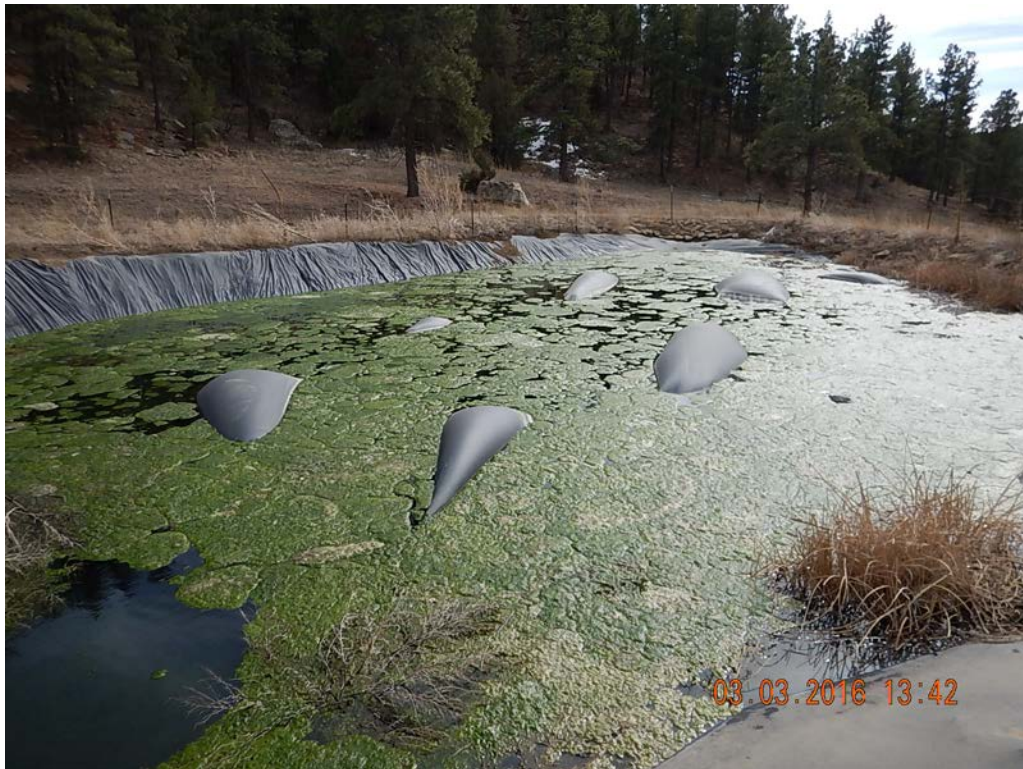
Figure 5 – Bubbles in pit liner and vegetation growing in pit.

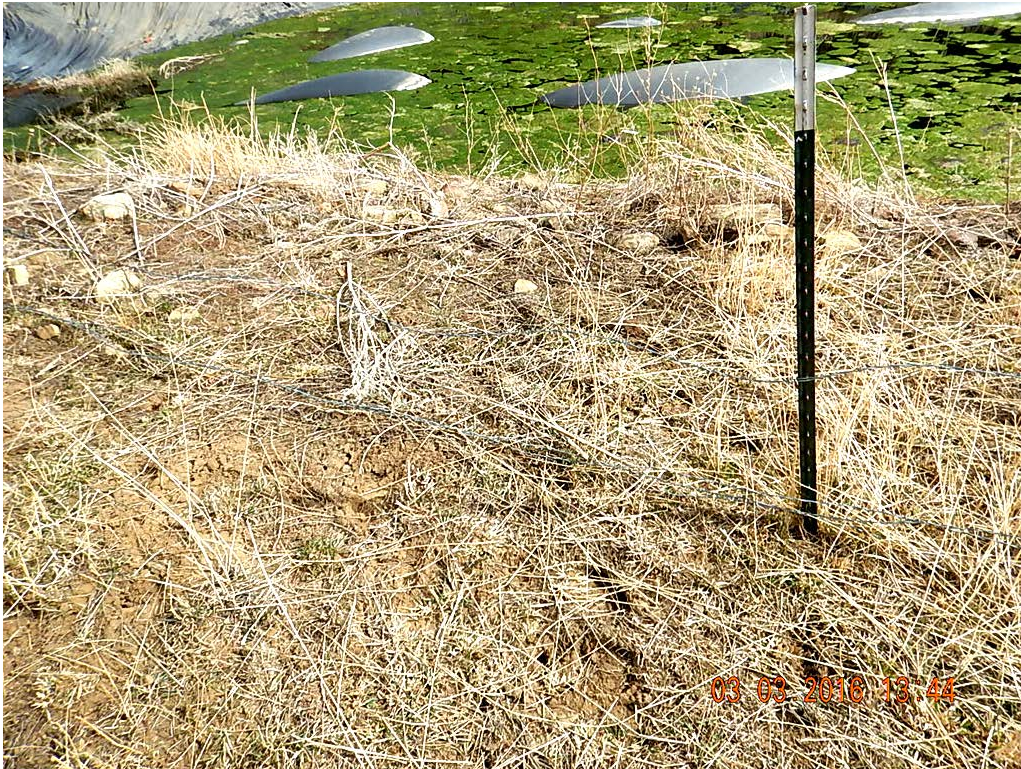
Figure 7 – Fencing is in disrepair.
