Interim Reclamation Inspection

3/3/2016

Operator: Whiting Oil and Gas

Location ID: 434267

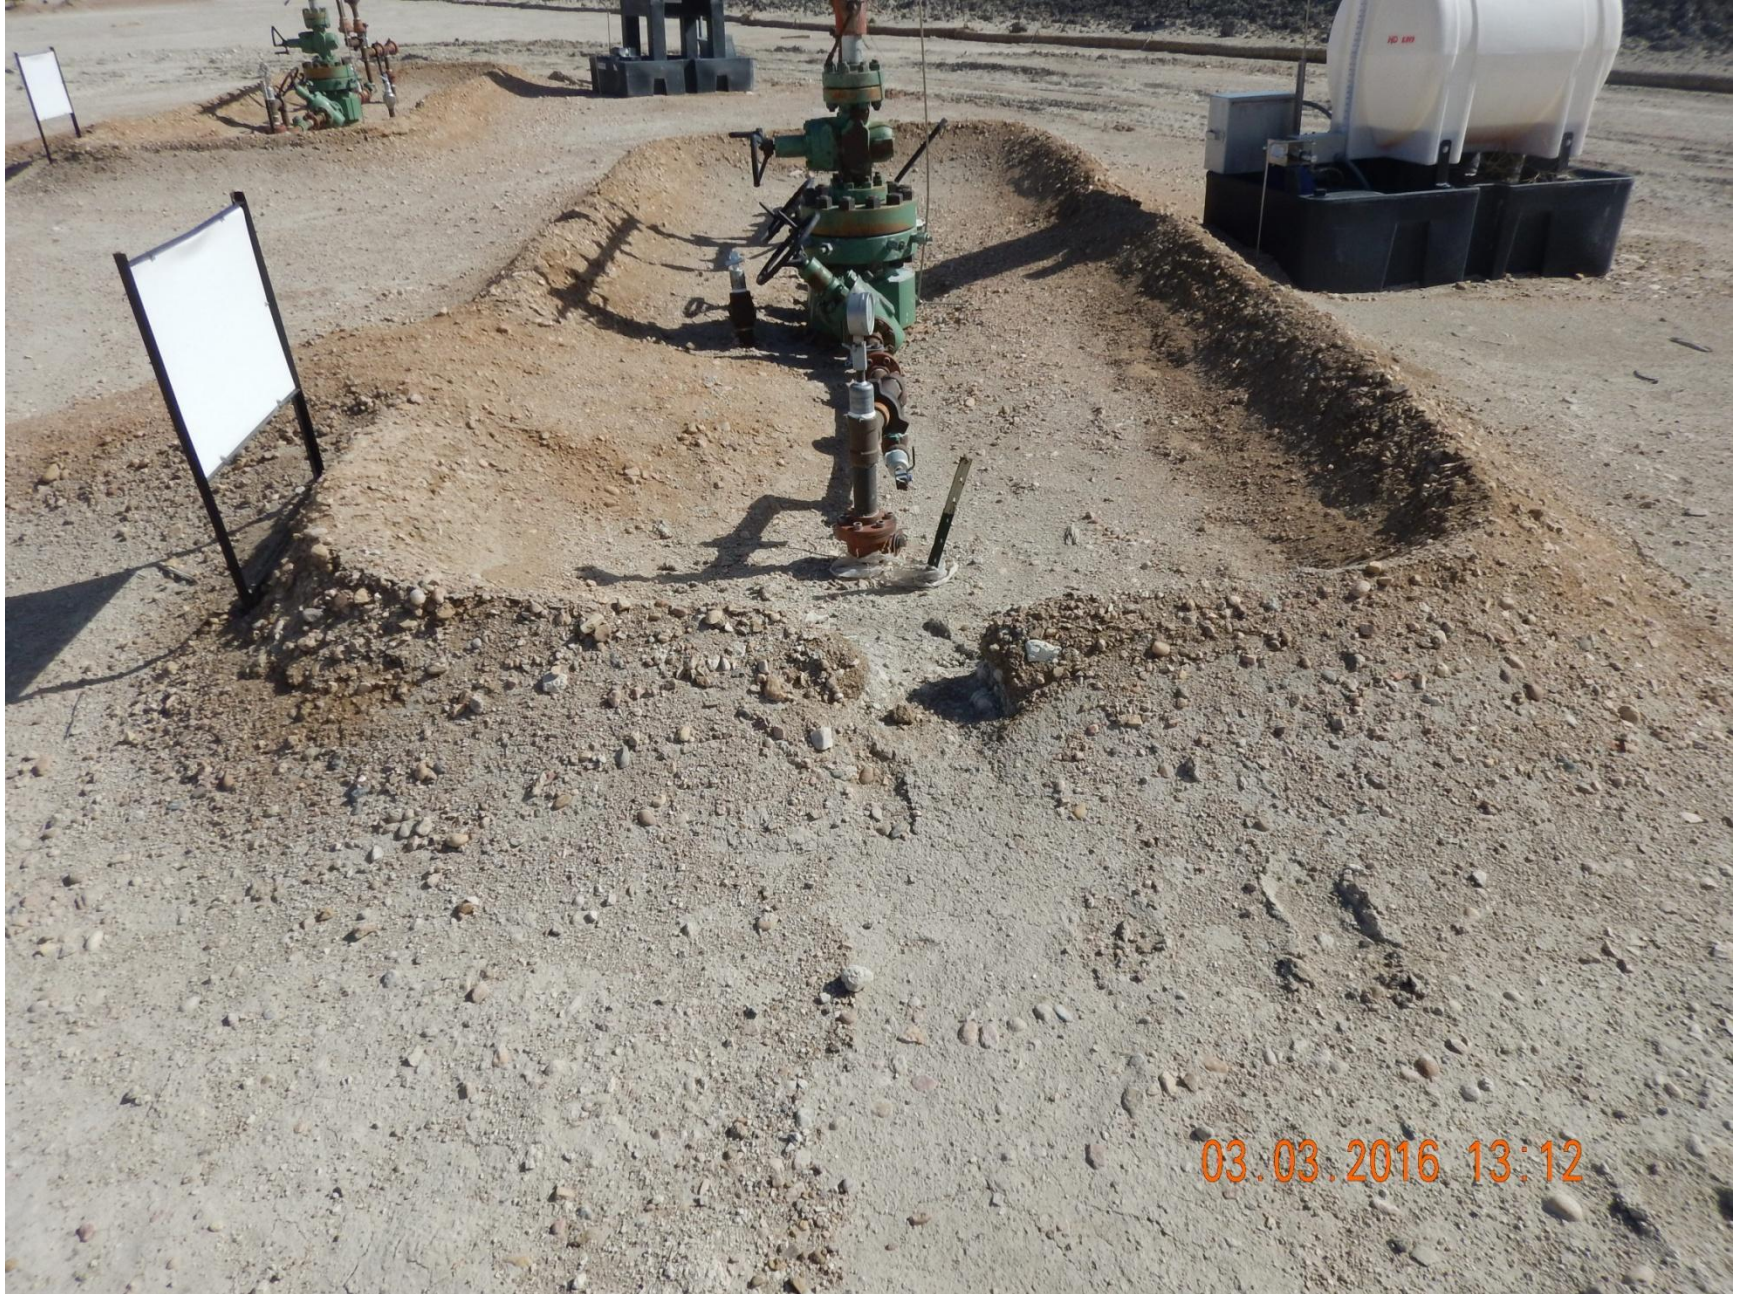
Figure 8: Photo taken from well #123-38060. Photo shows containment berm around well head in disrepair.

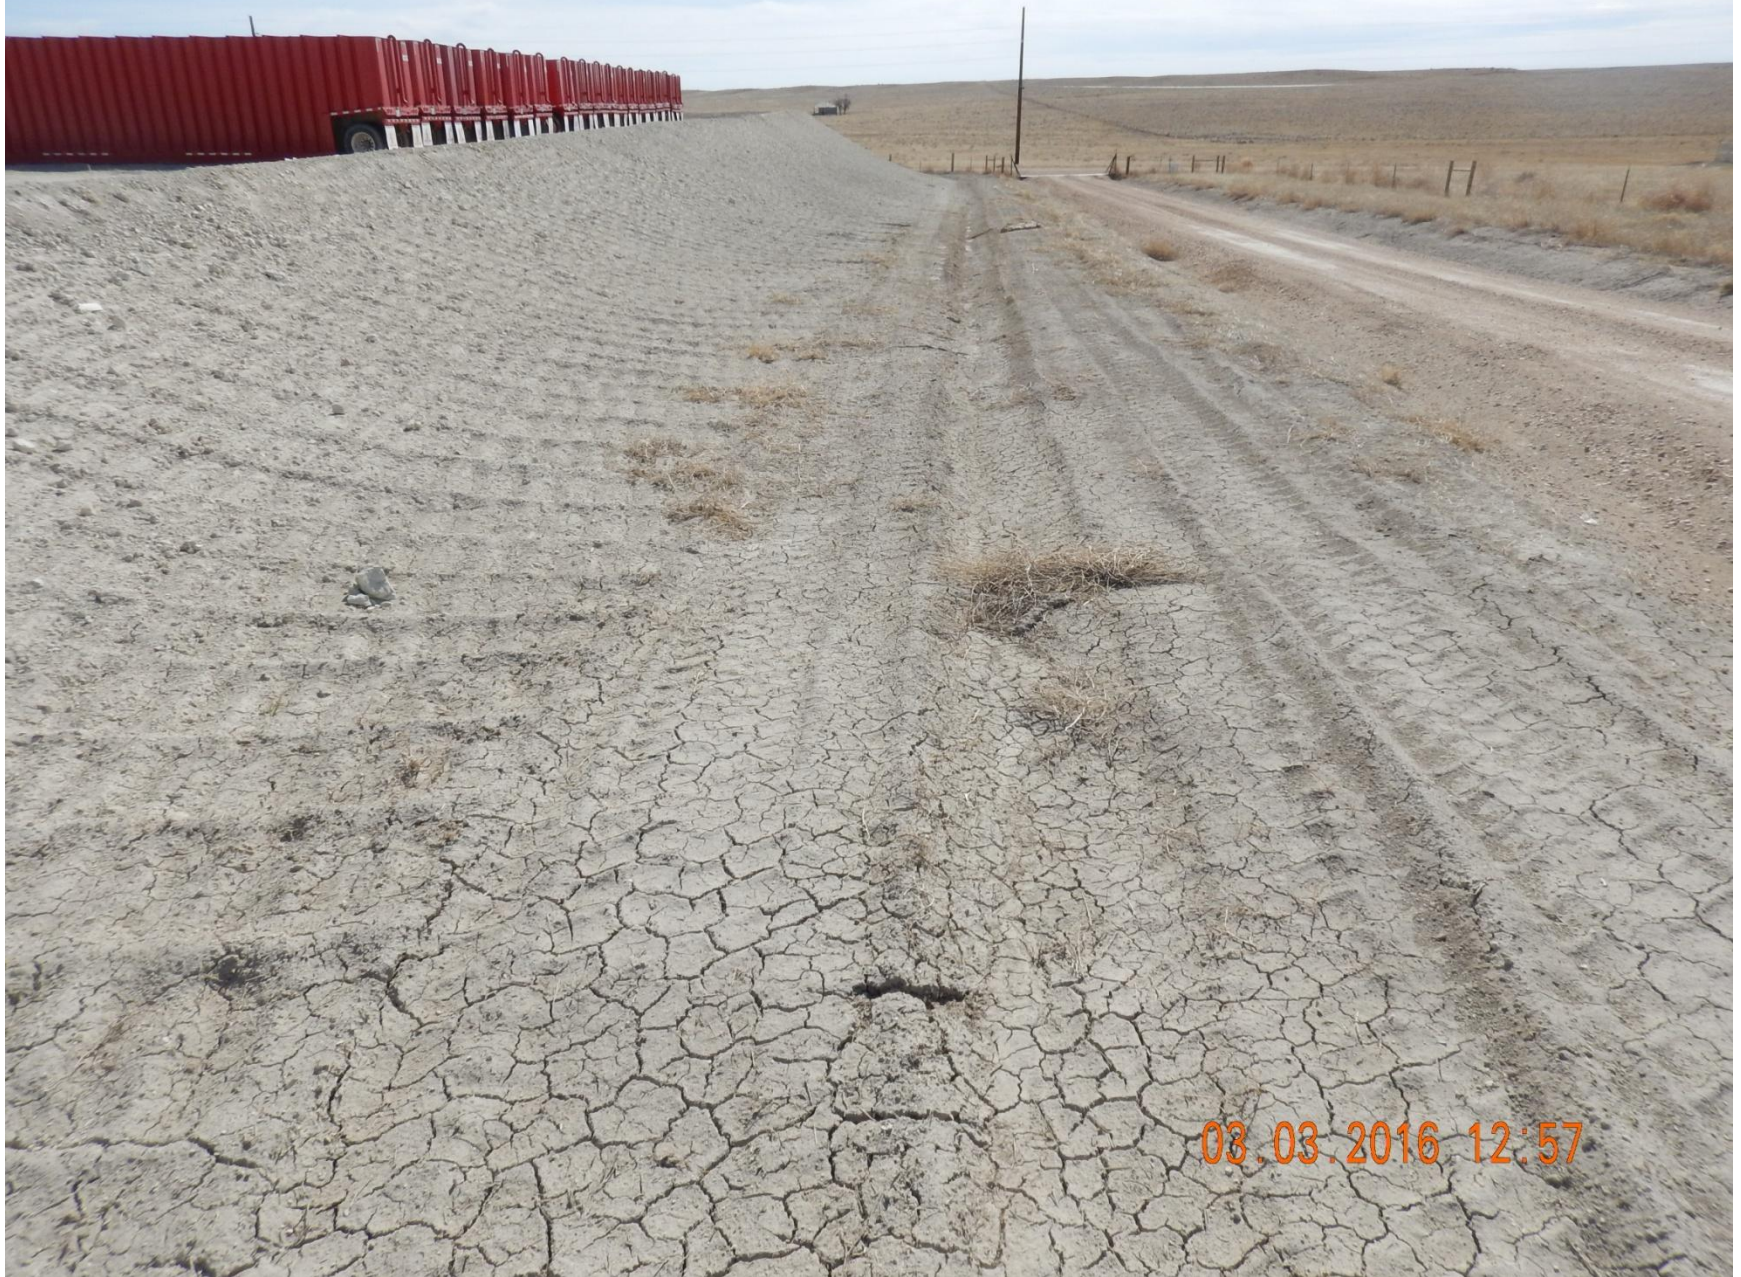
Figure 11: Photo taken from the west end of the location, facing south. Photo shows vehicle tracking on the slope of the pad, and a stormwater and sediment control BMP ditch.

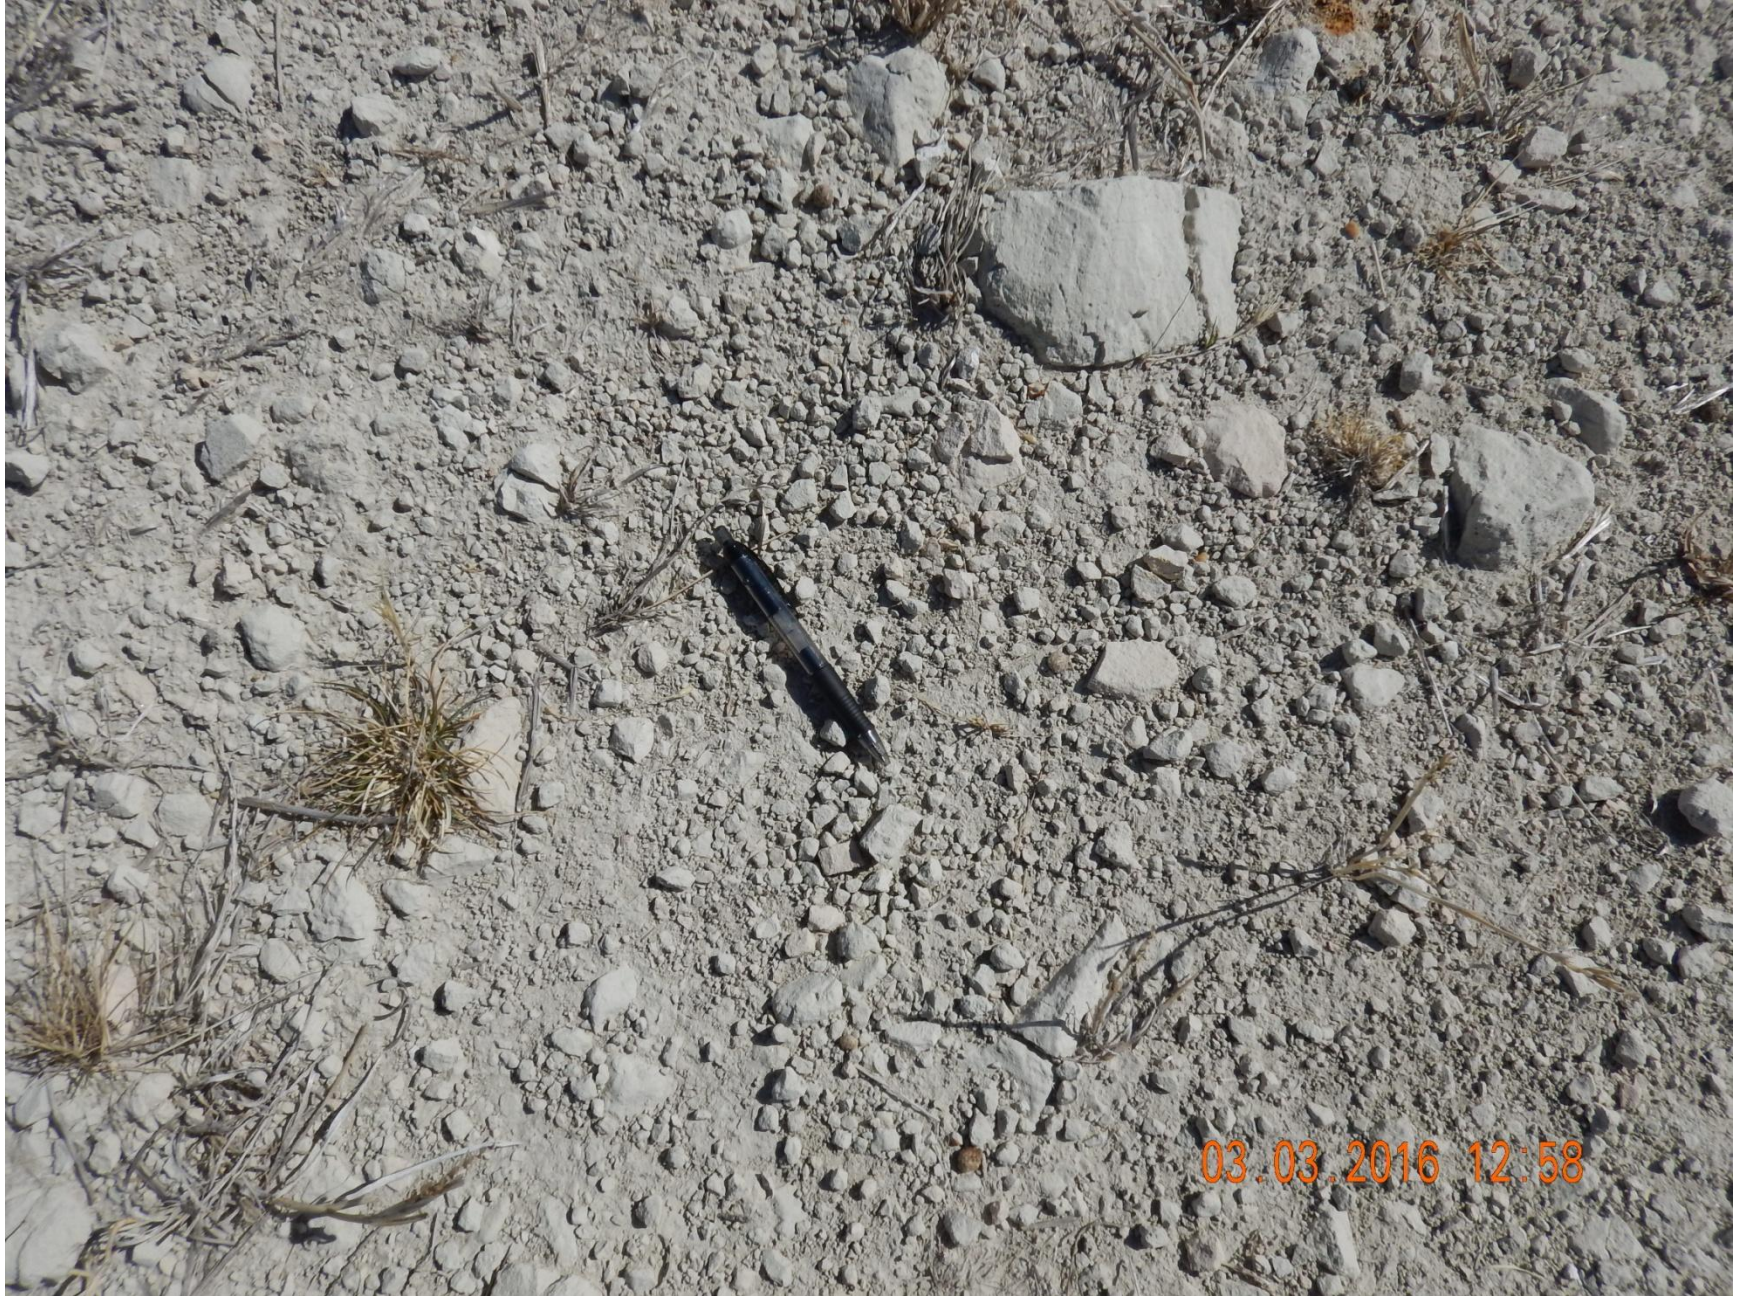
Figure 12: Photo taken from berm on the northwest end of the location. Photo shows coarse soil.

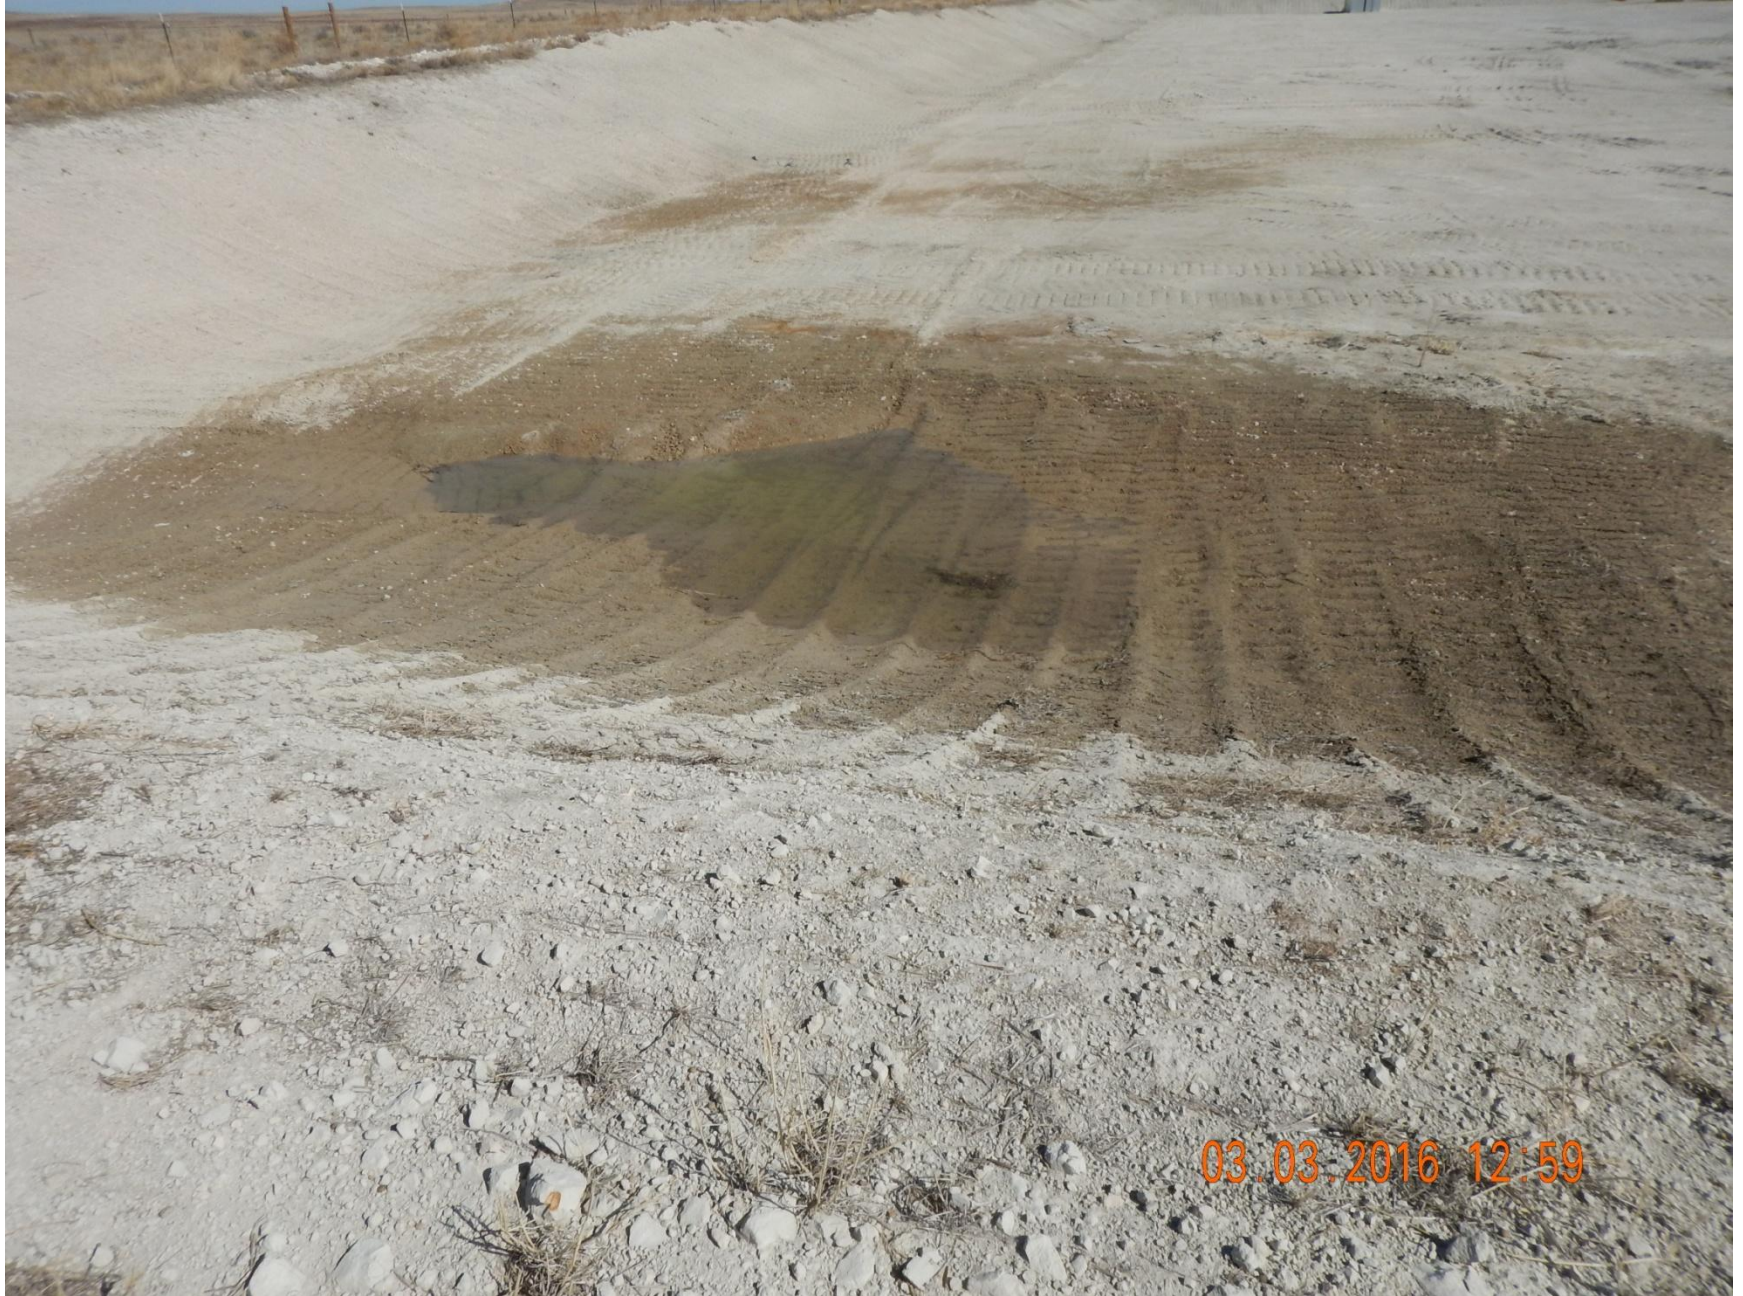
Figure 13: Photo taken from the northwest end of the location, facing east. Photo show water pooling in the northwest corner of the project area.

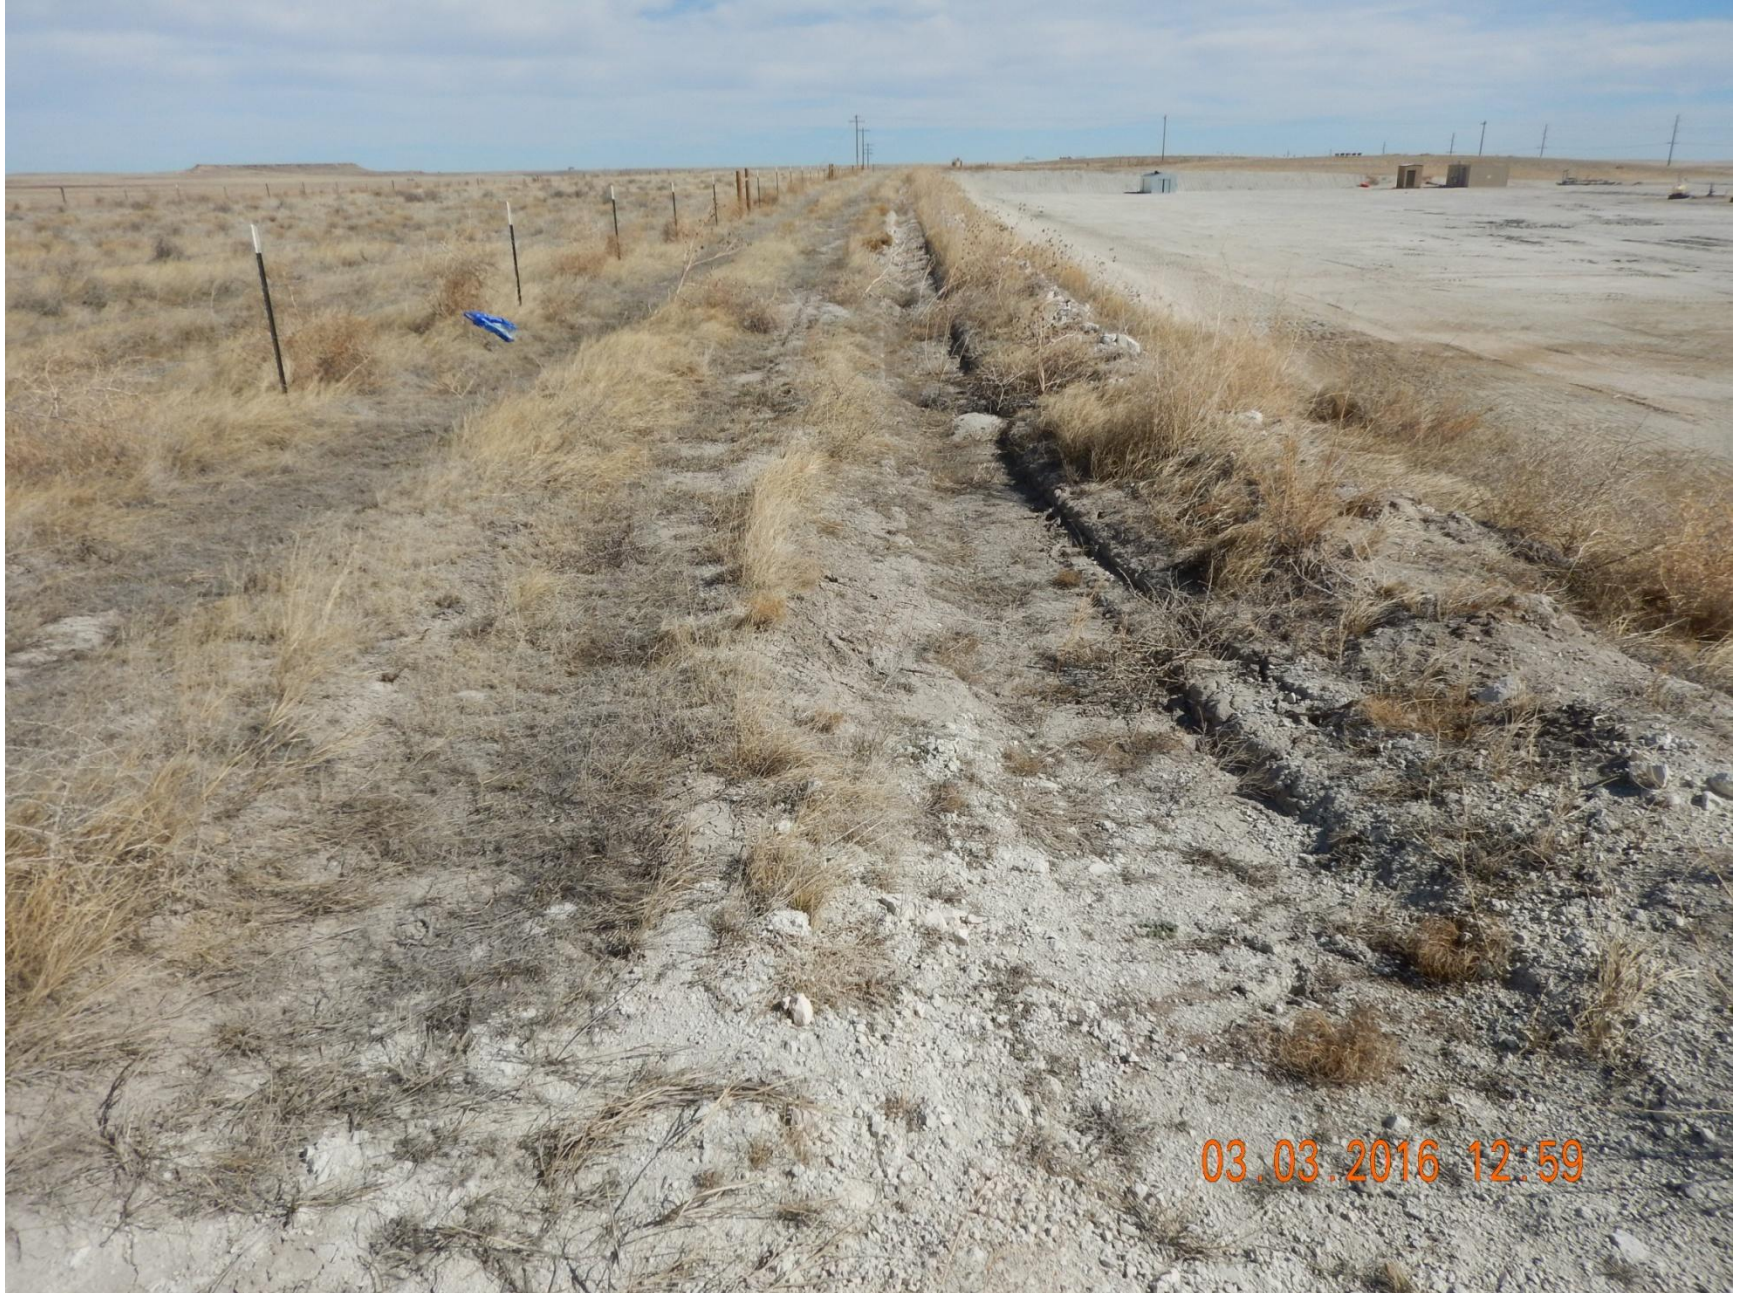
Figure 16: Photo taken from the northwest end of location, facing east. Phot shows stormwater and sediment control BMP ditch used on the north end of the location.

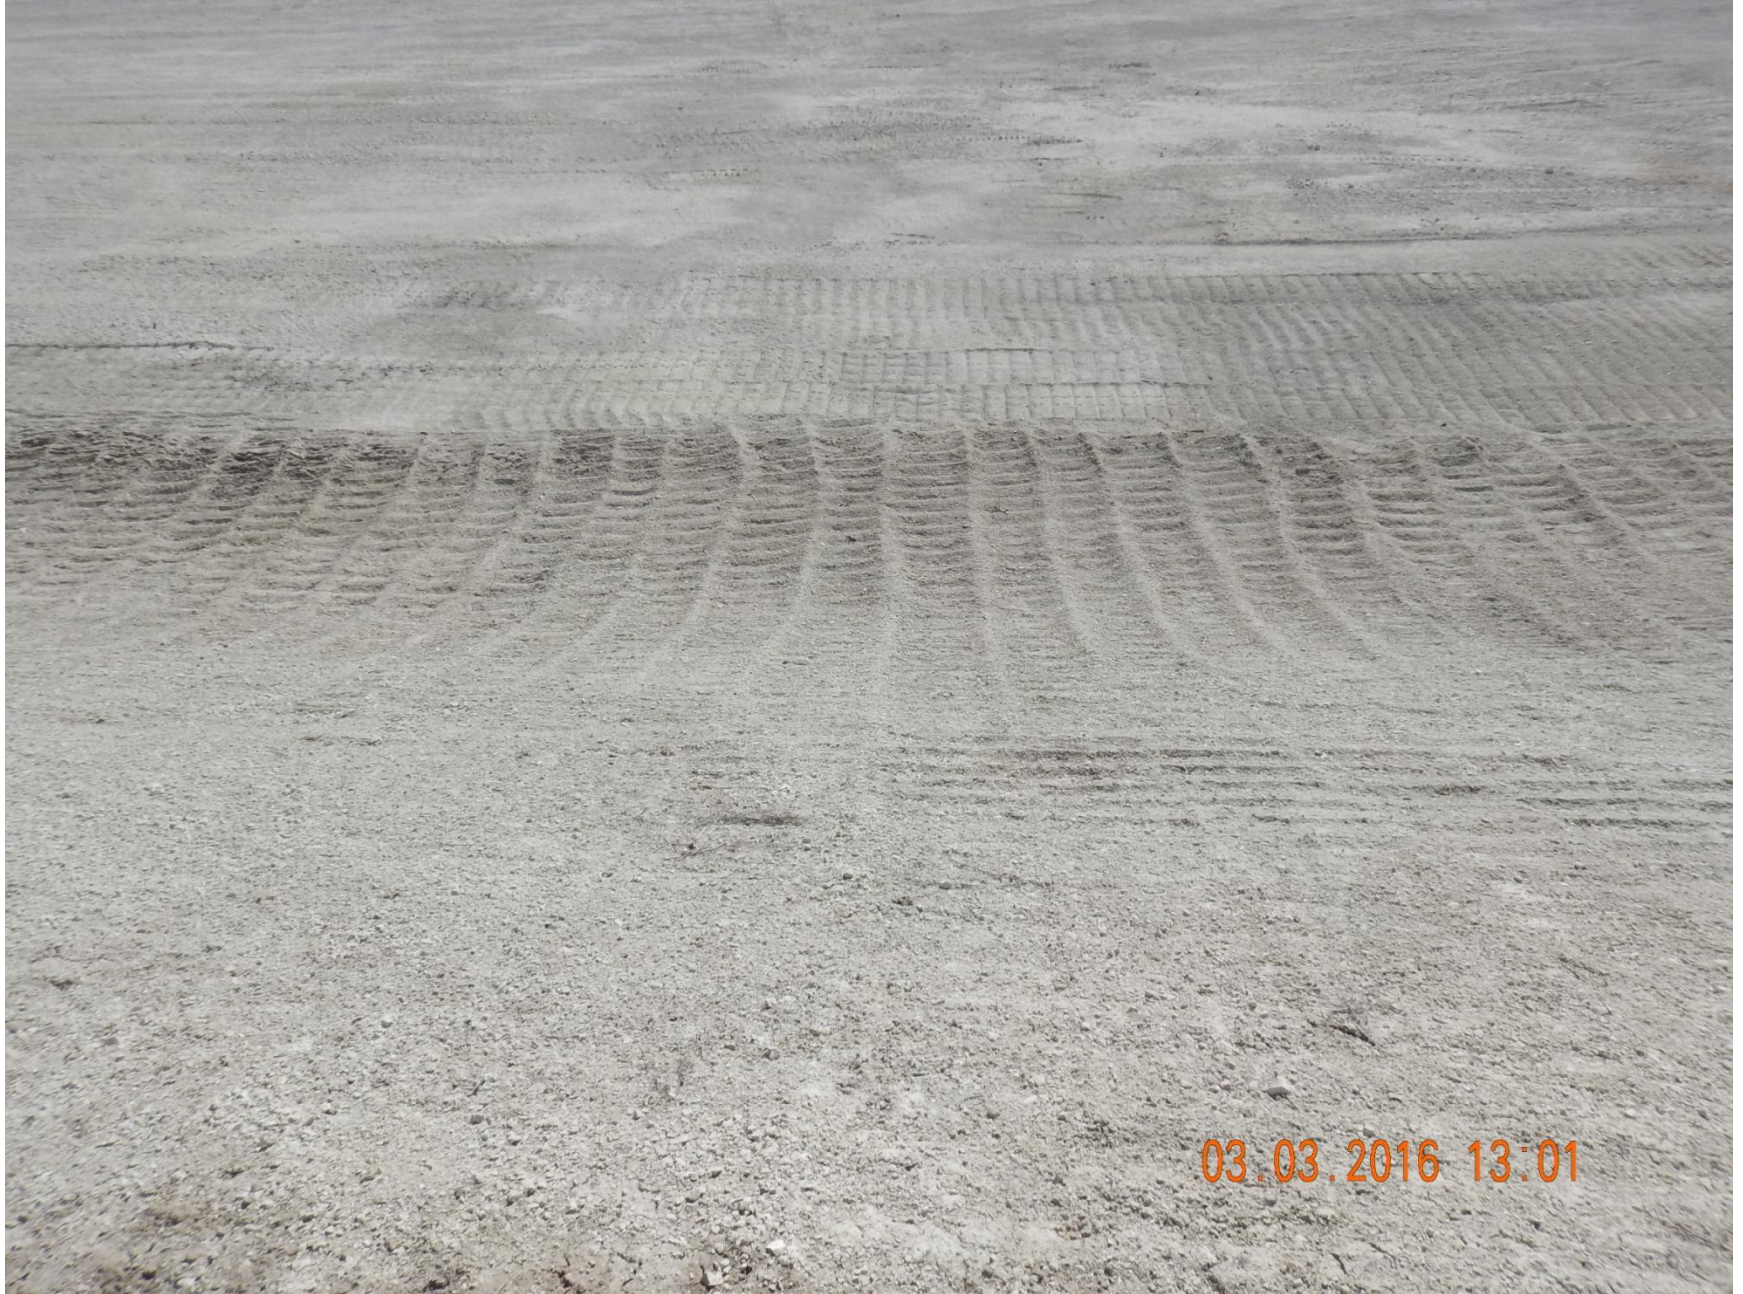
Figure 17: Photo taken from the north end of the location, facing south. Photo shows vehicle tracking used as a stormwater and sediment control BMP on the slope.

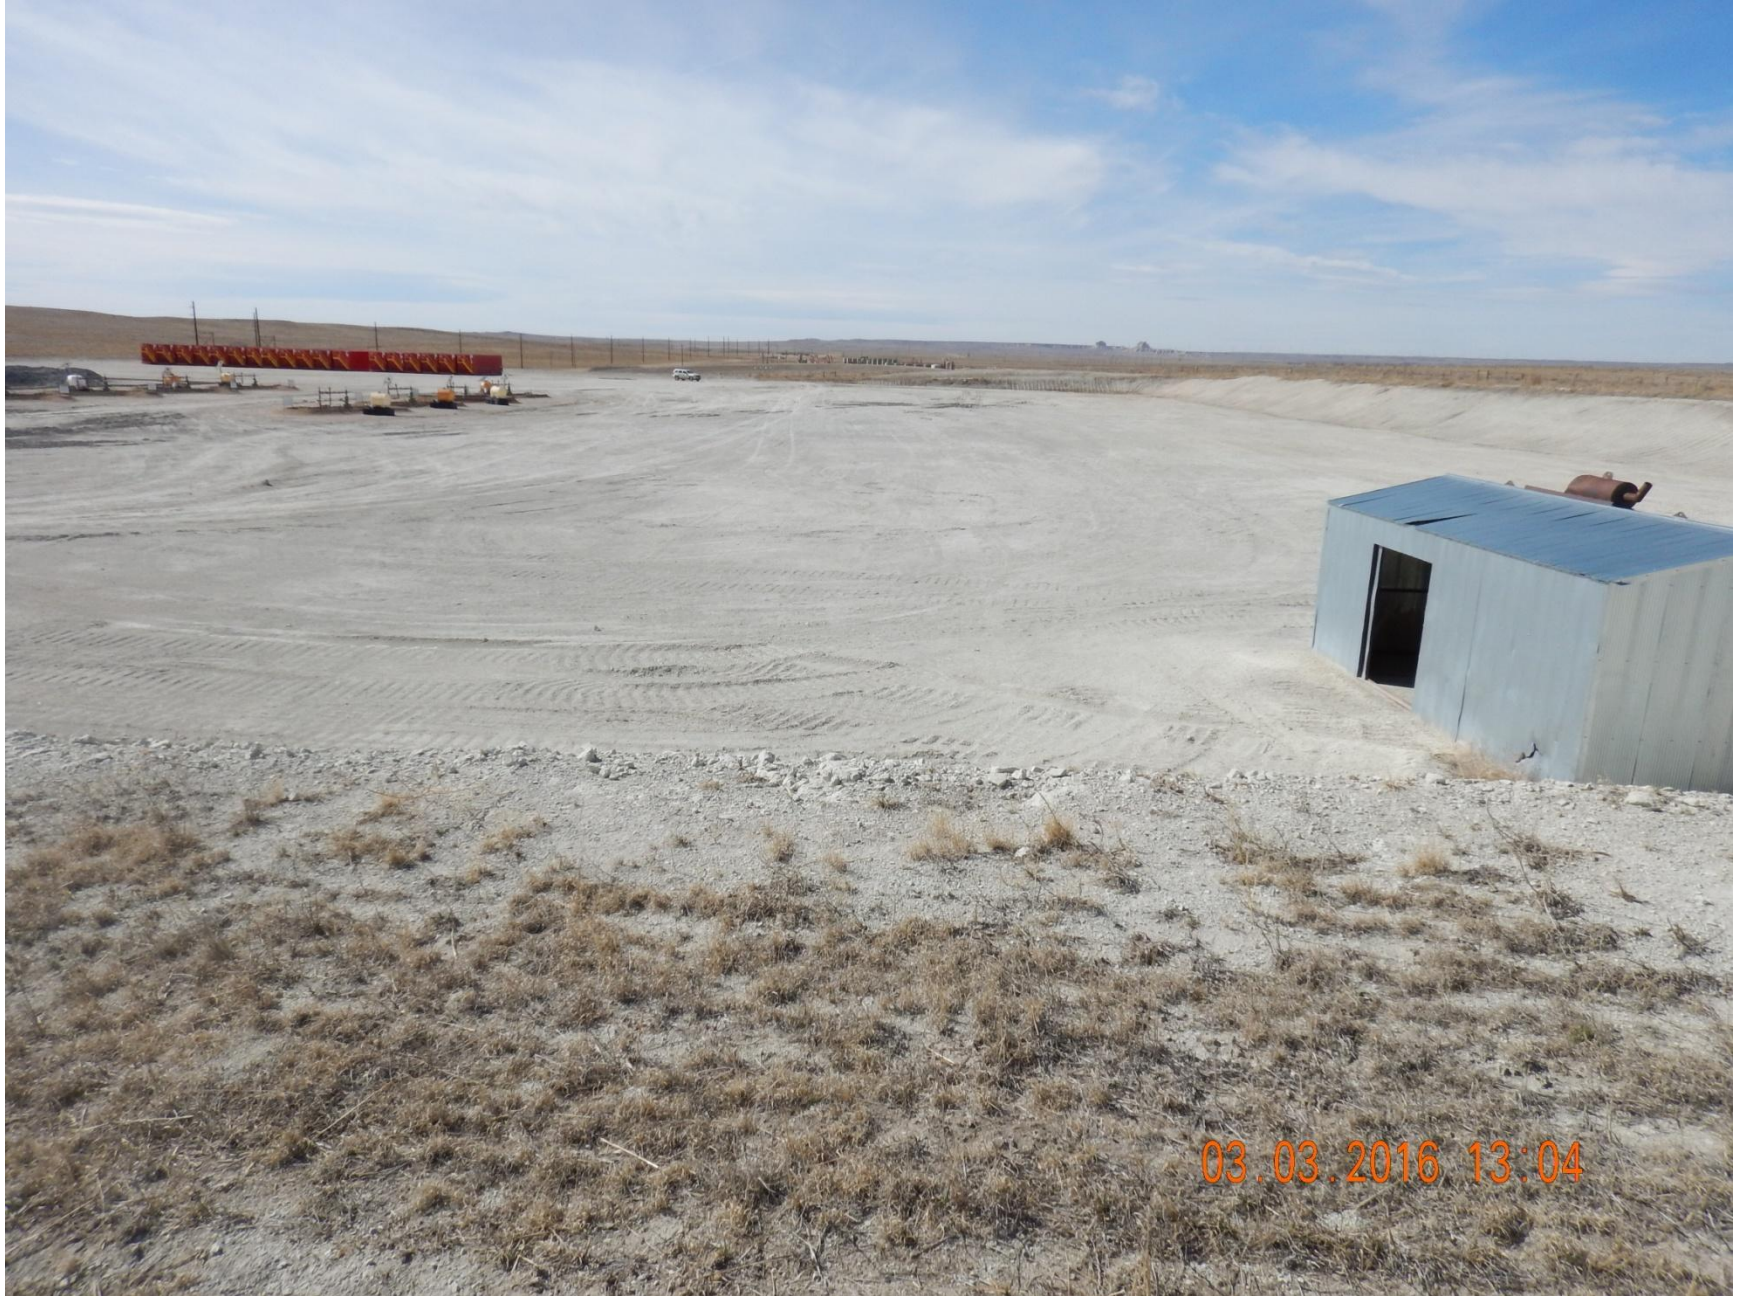
Figure 20: Photo taken from the east end of the location, facing west. Note large areas on the north end of the location do not appear to be necessary for production.

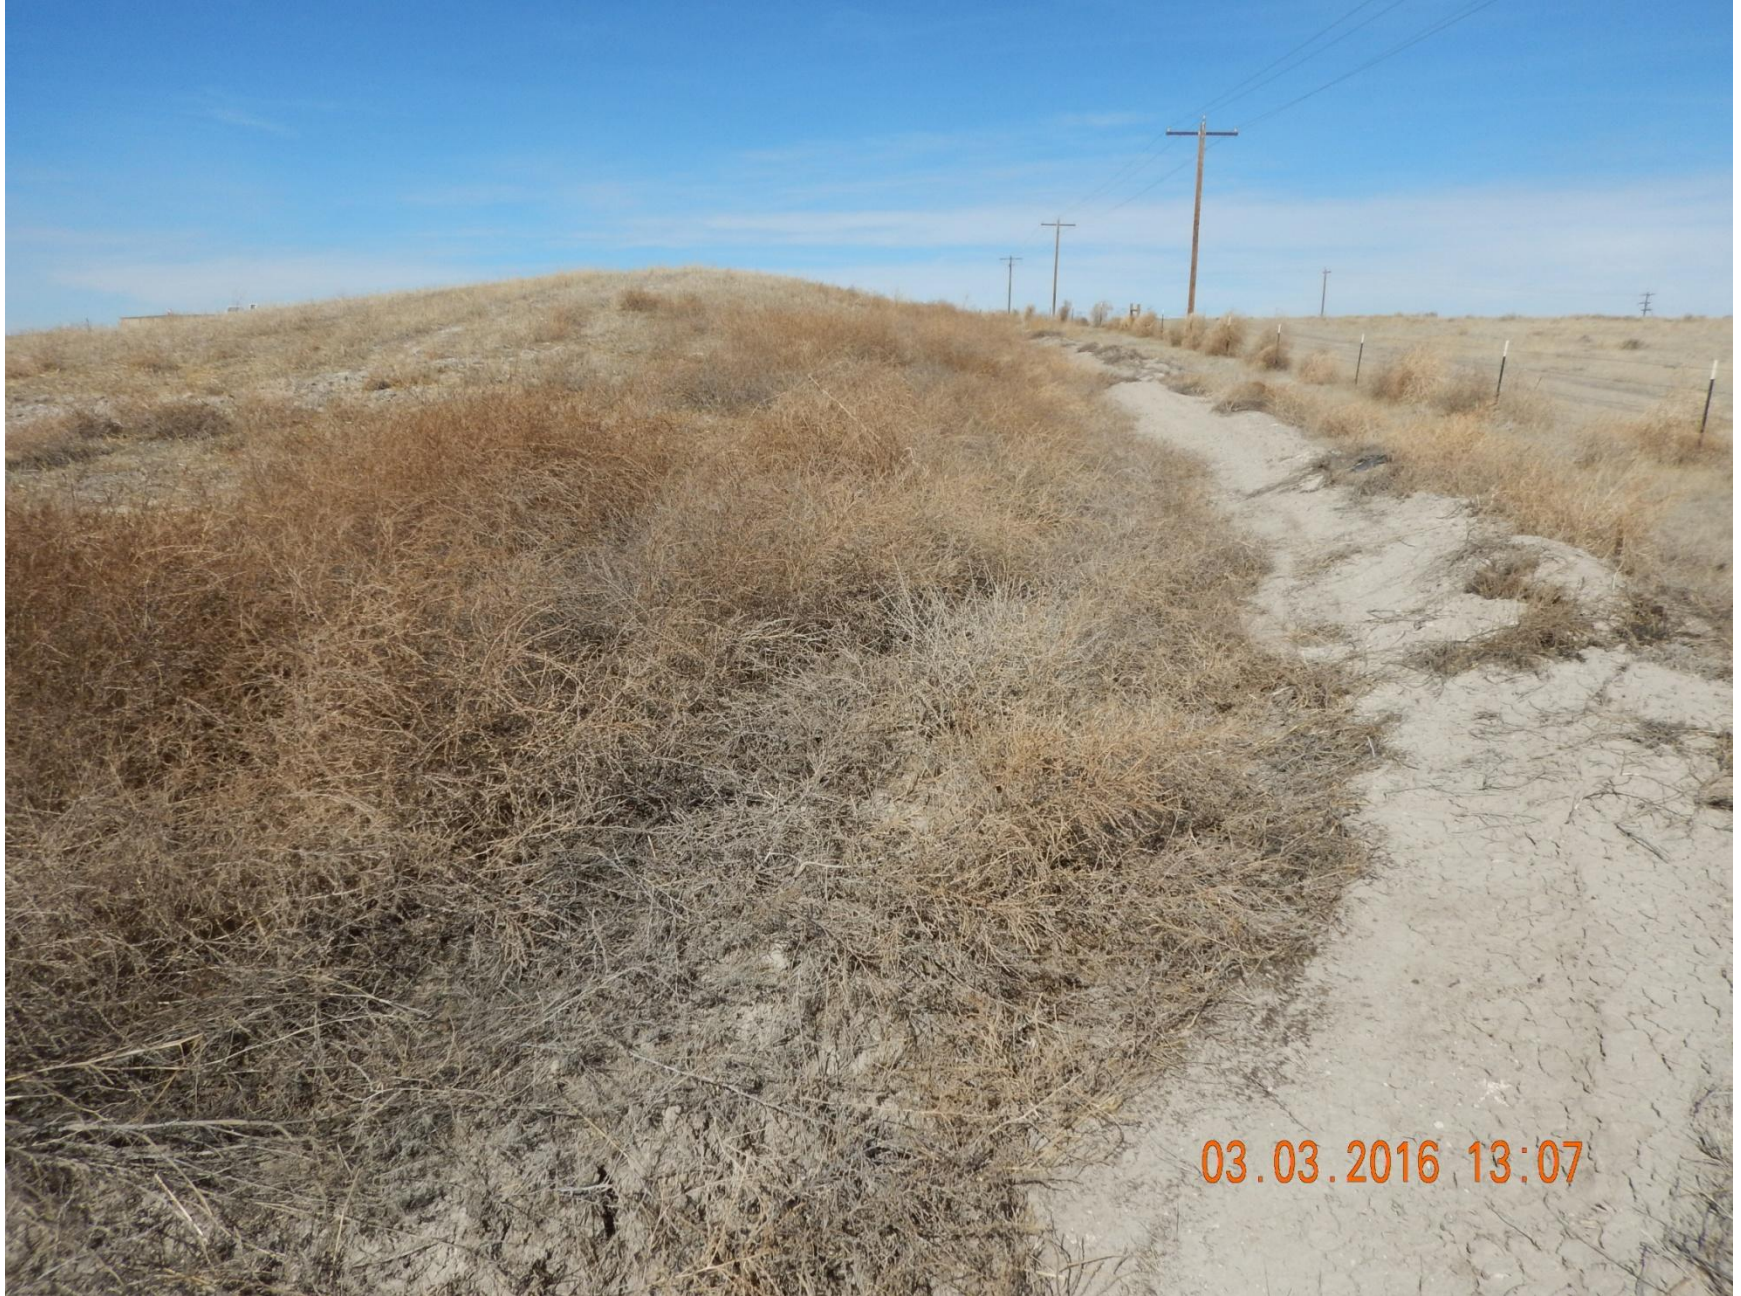
Figure 23: Photo taken from the southeast corner of the interim area, facing north. Photo shows stormwater and sediment control ditch. Note vegetation on interim area predominantly undesirable weedy vegetation.

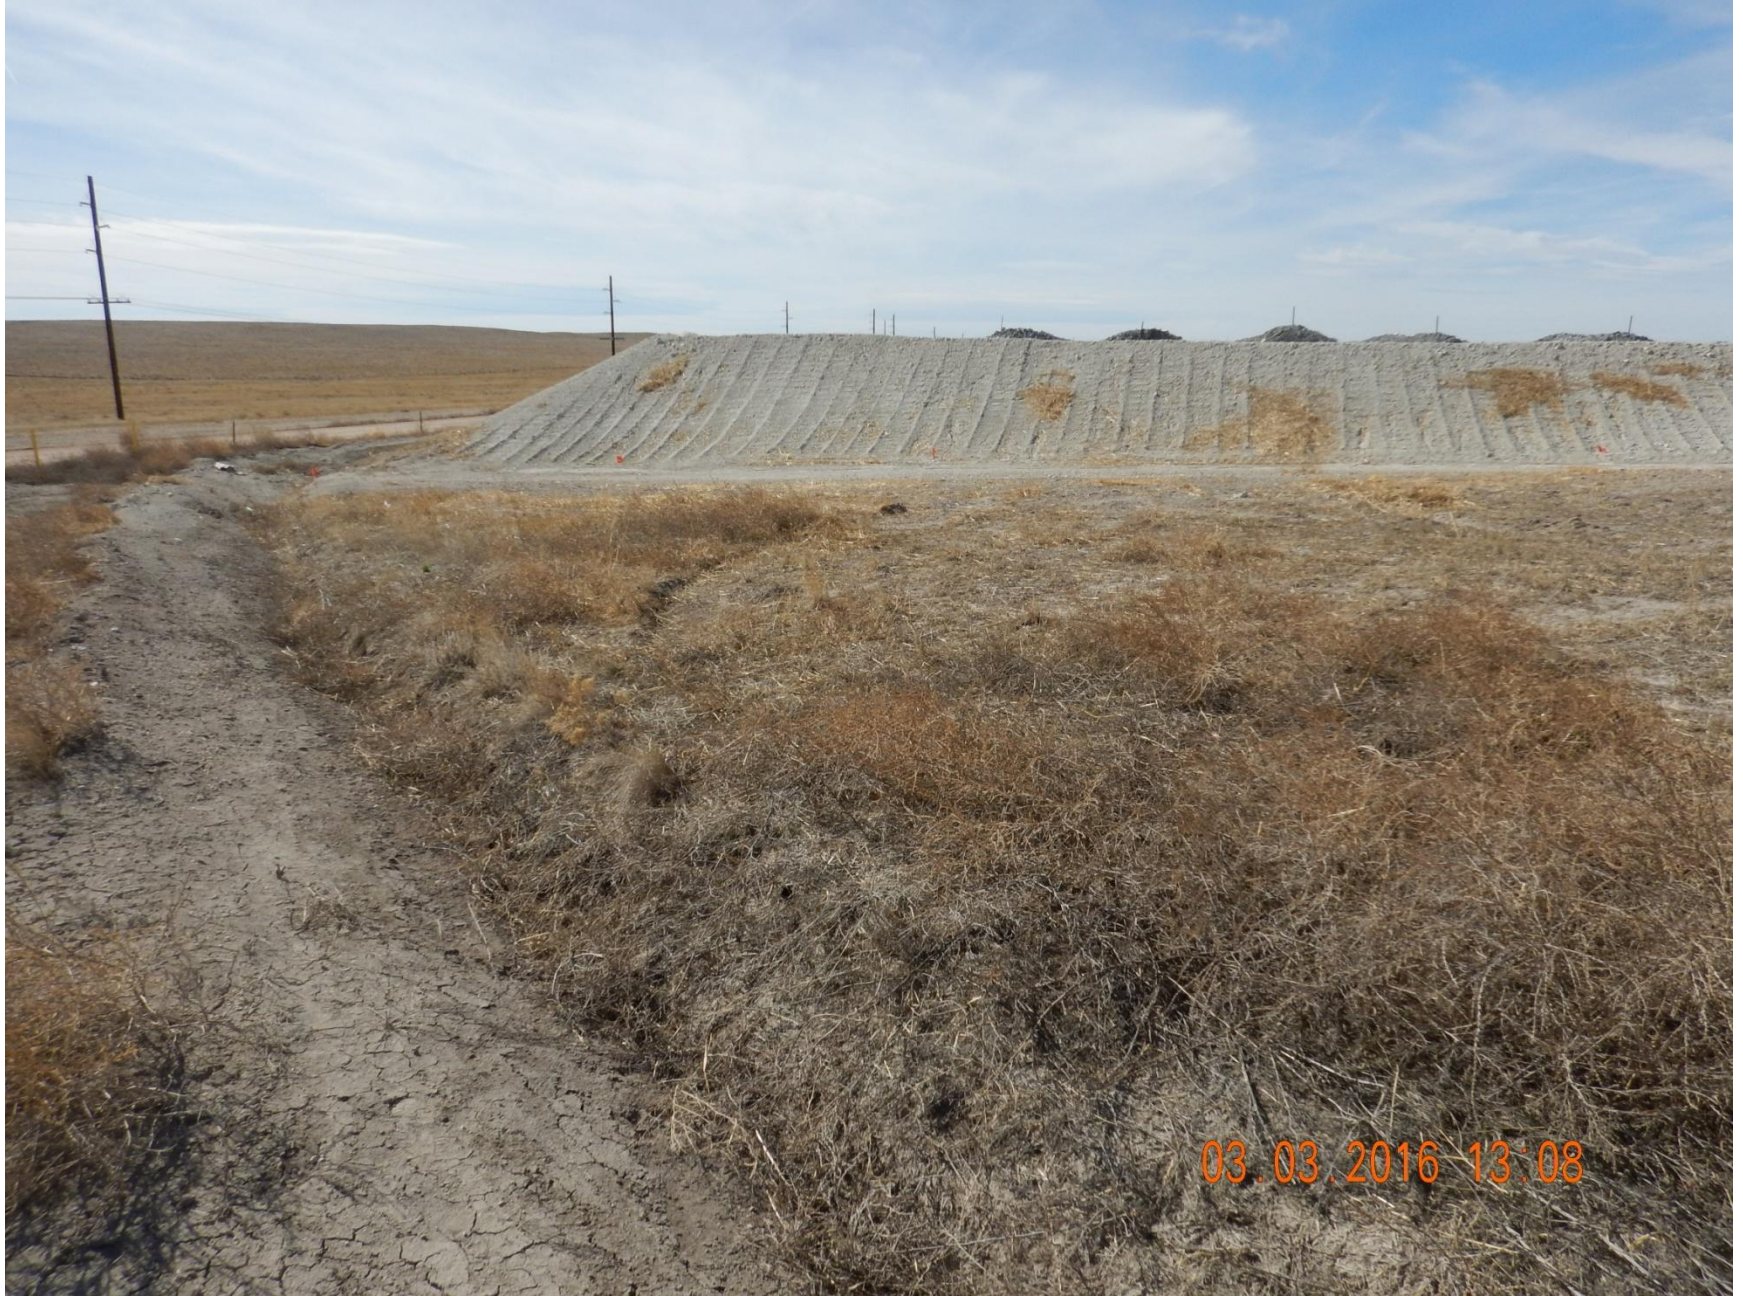
Figure 24: Photo taken from the southeast corner of the interim area, facing west. Photo shows stormwater and sediment control ditch, and slope at the project area. Note vegetation on interim area predominantly undesirable weedy vegetation.

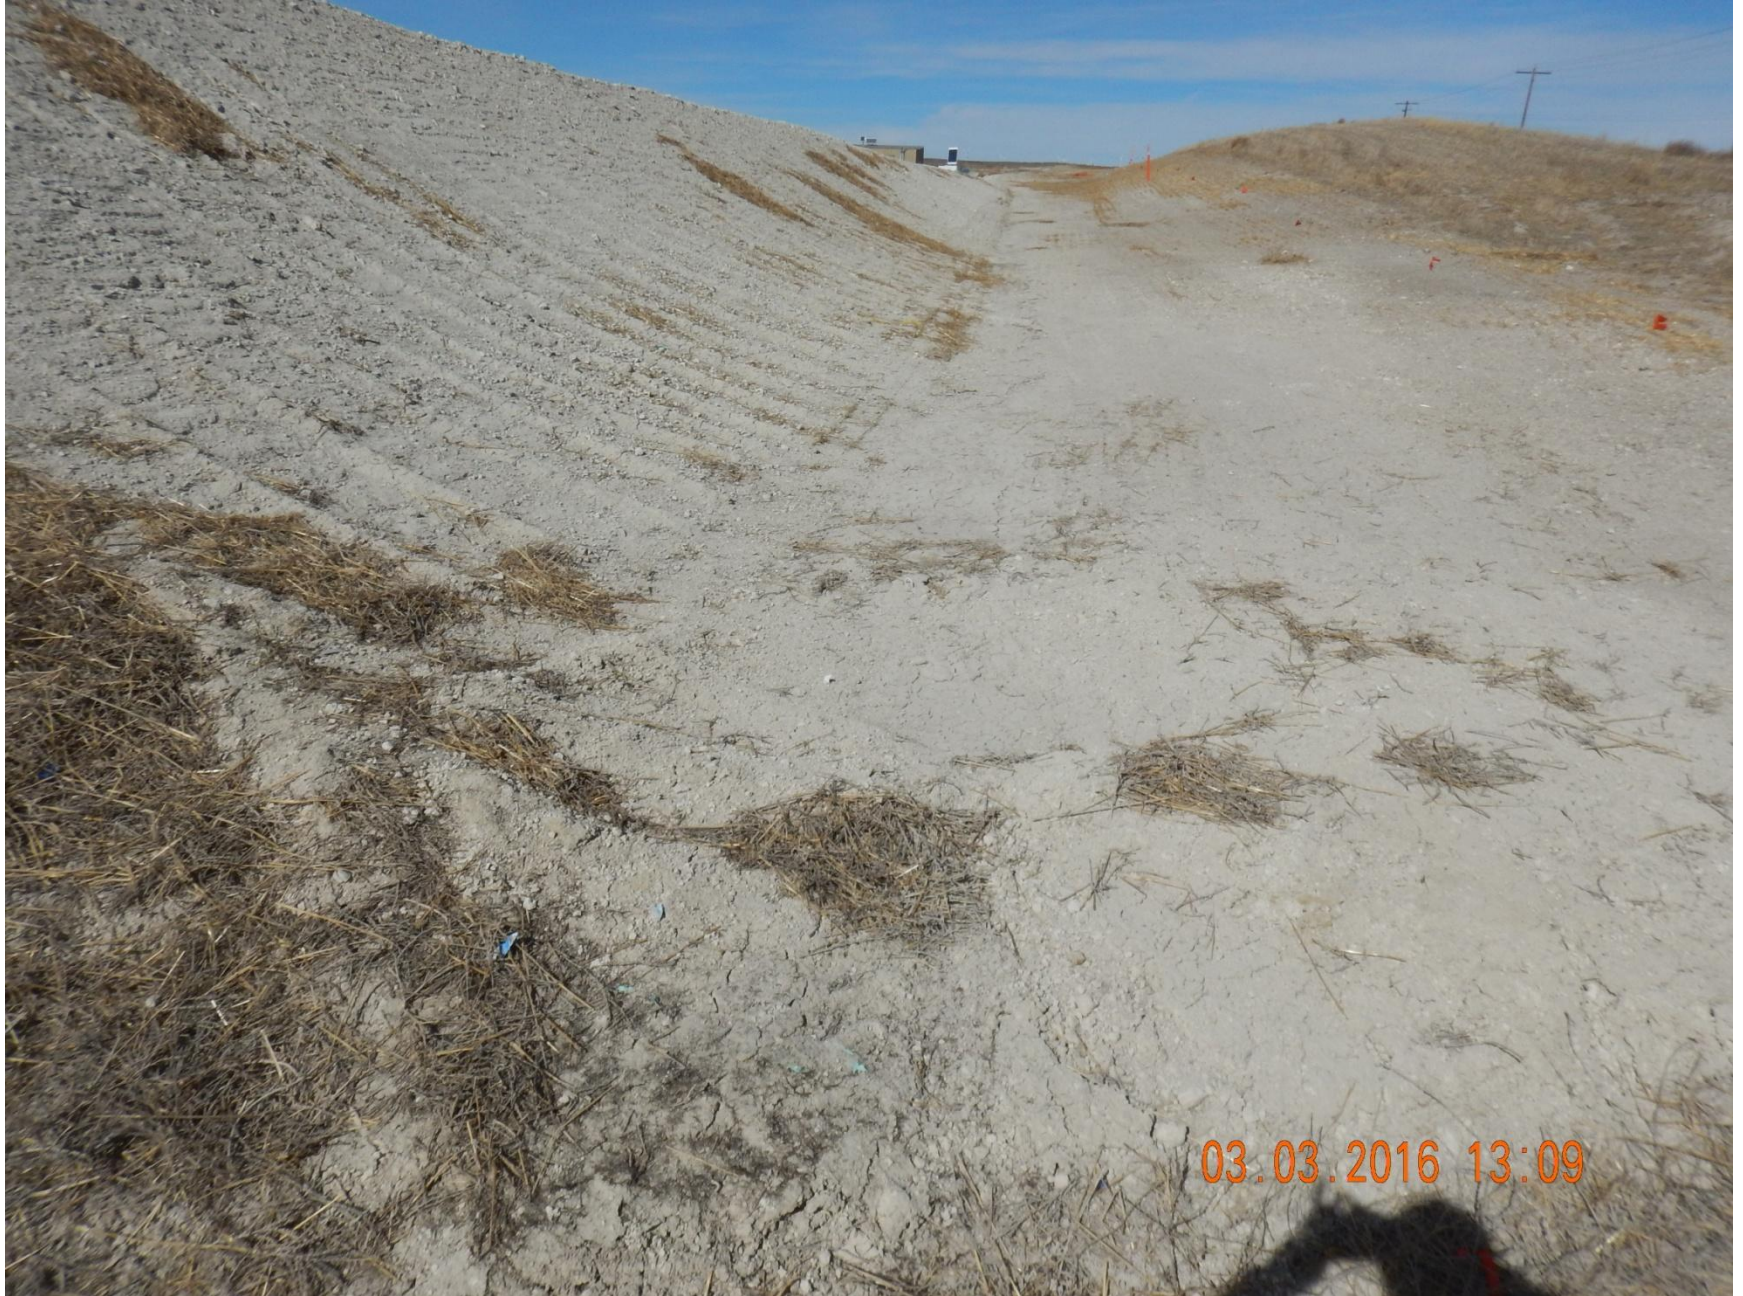
Figure 25: Photo taken from the southeast end of the project area, facing north. Photo shows slope, and vehicle tracking used as a stormwater and sediment control BMP.
