Interim Reclamation Inspection

3/3/2016

Operator: Whiting Oil and Gas

Location ID: 434267

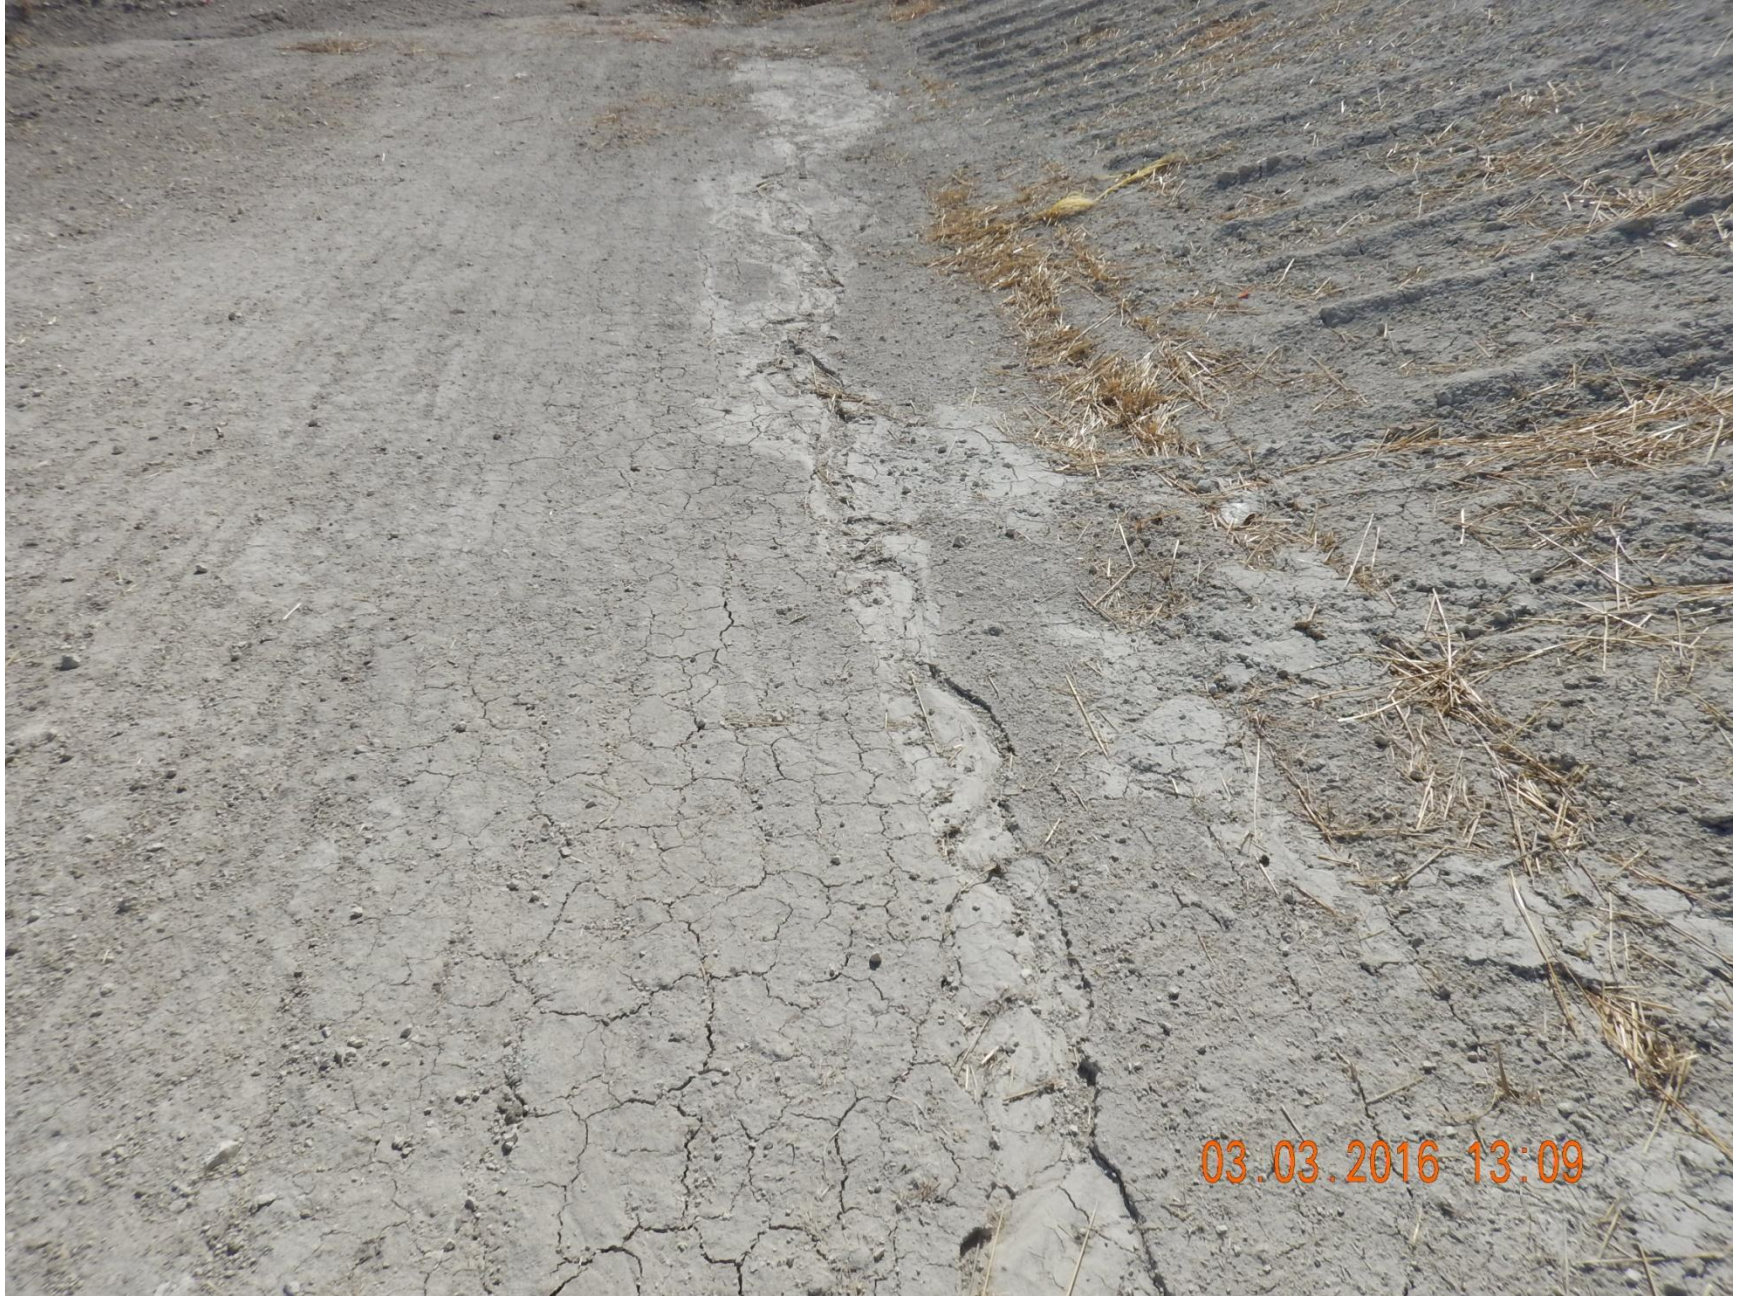
Figure 26: Photo taken at the toe of the slope on the east end of the project area, facing south. Photo shows erosion and water movement patterns.

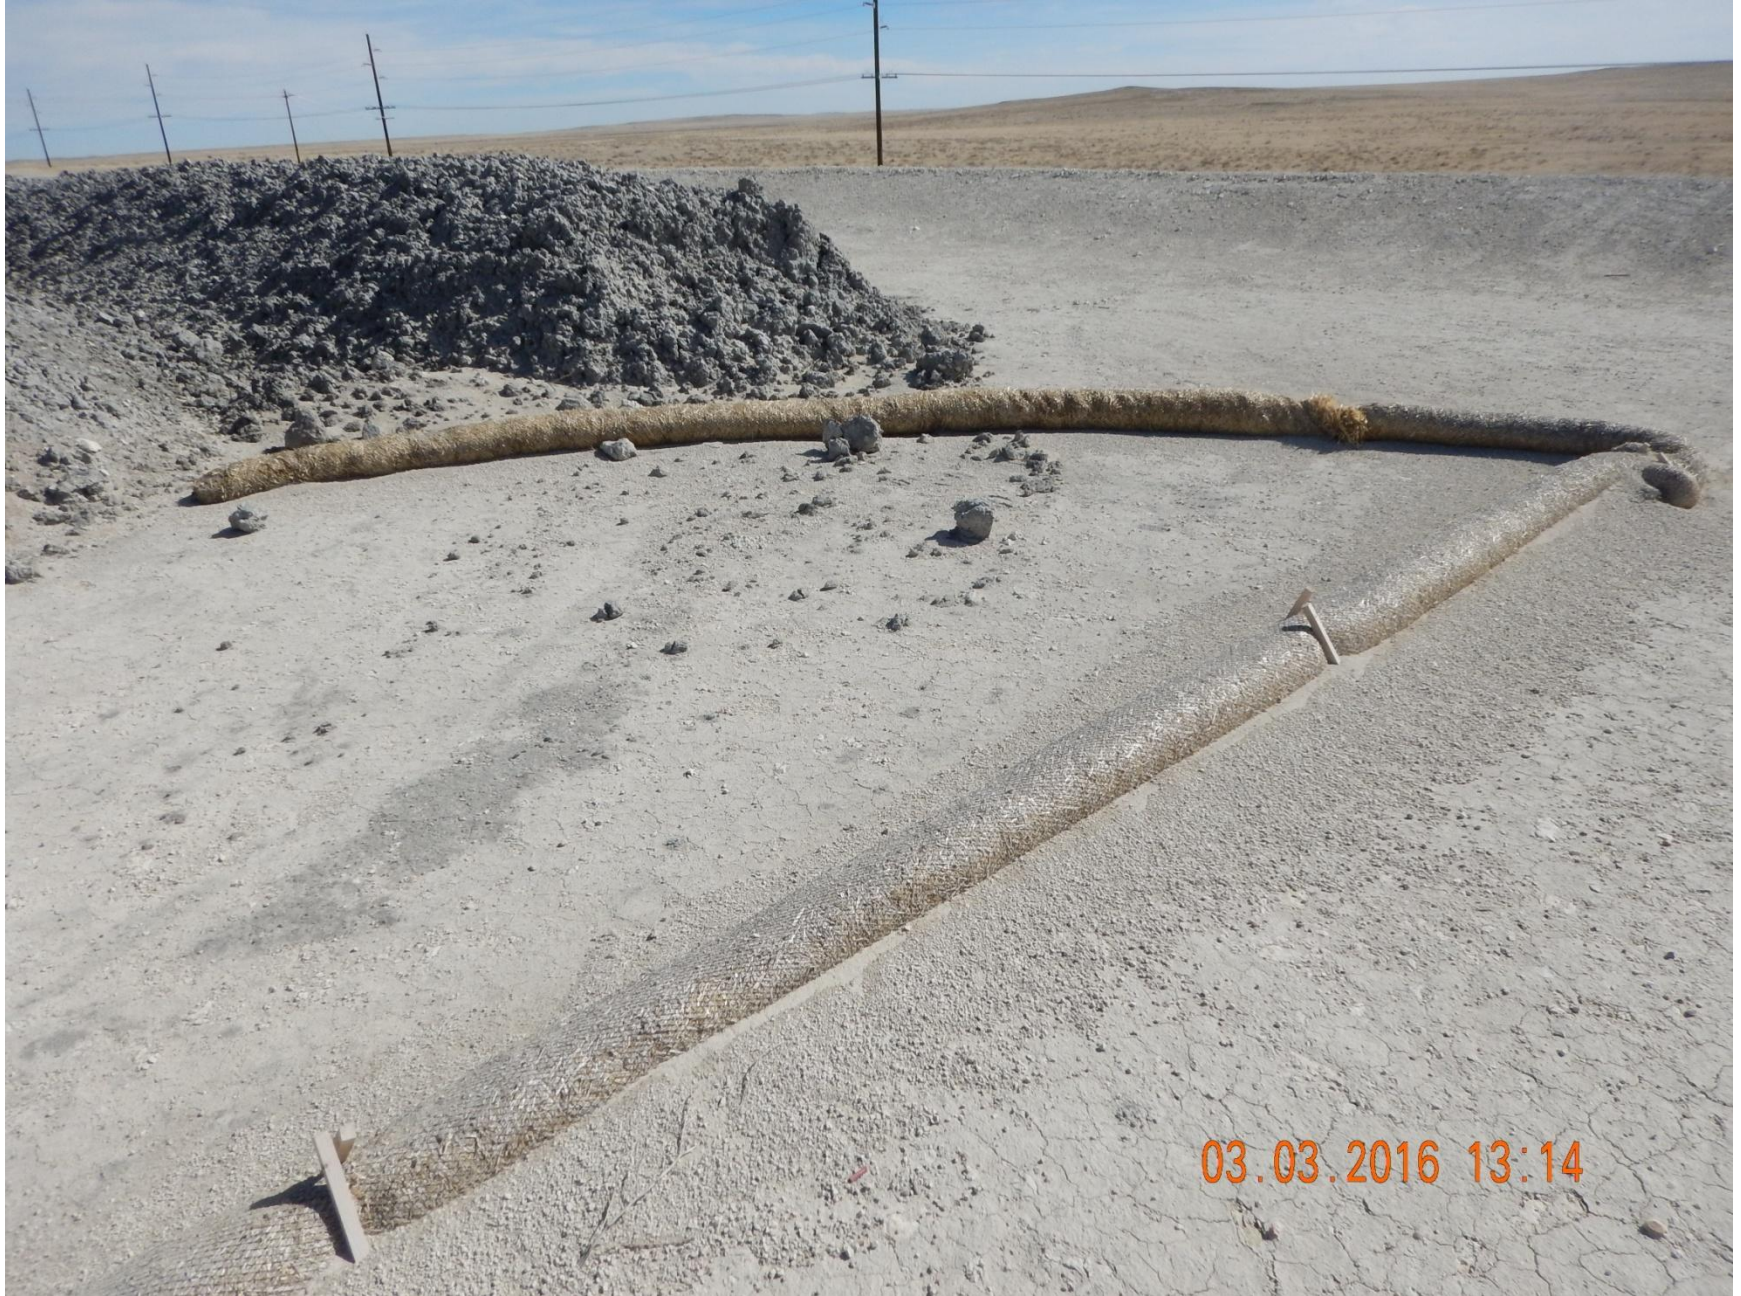
Figure 29: Photo taken from the southern end of the location, facing south. Photo shows straw wattles used as a stormwater and sediment control BMP around drill cuttings in disrepair.

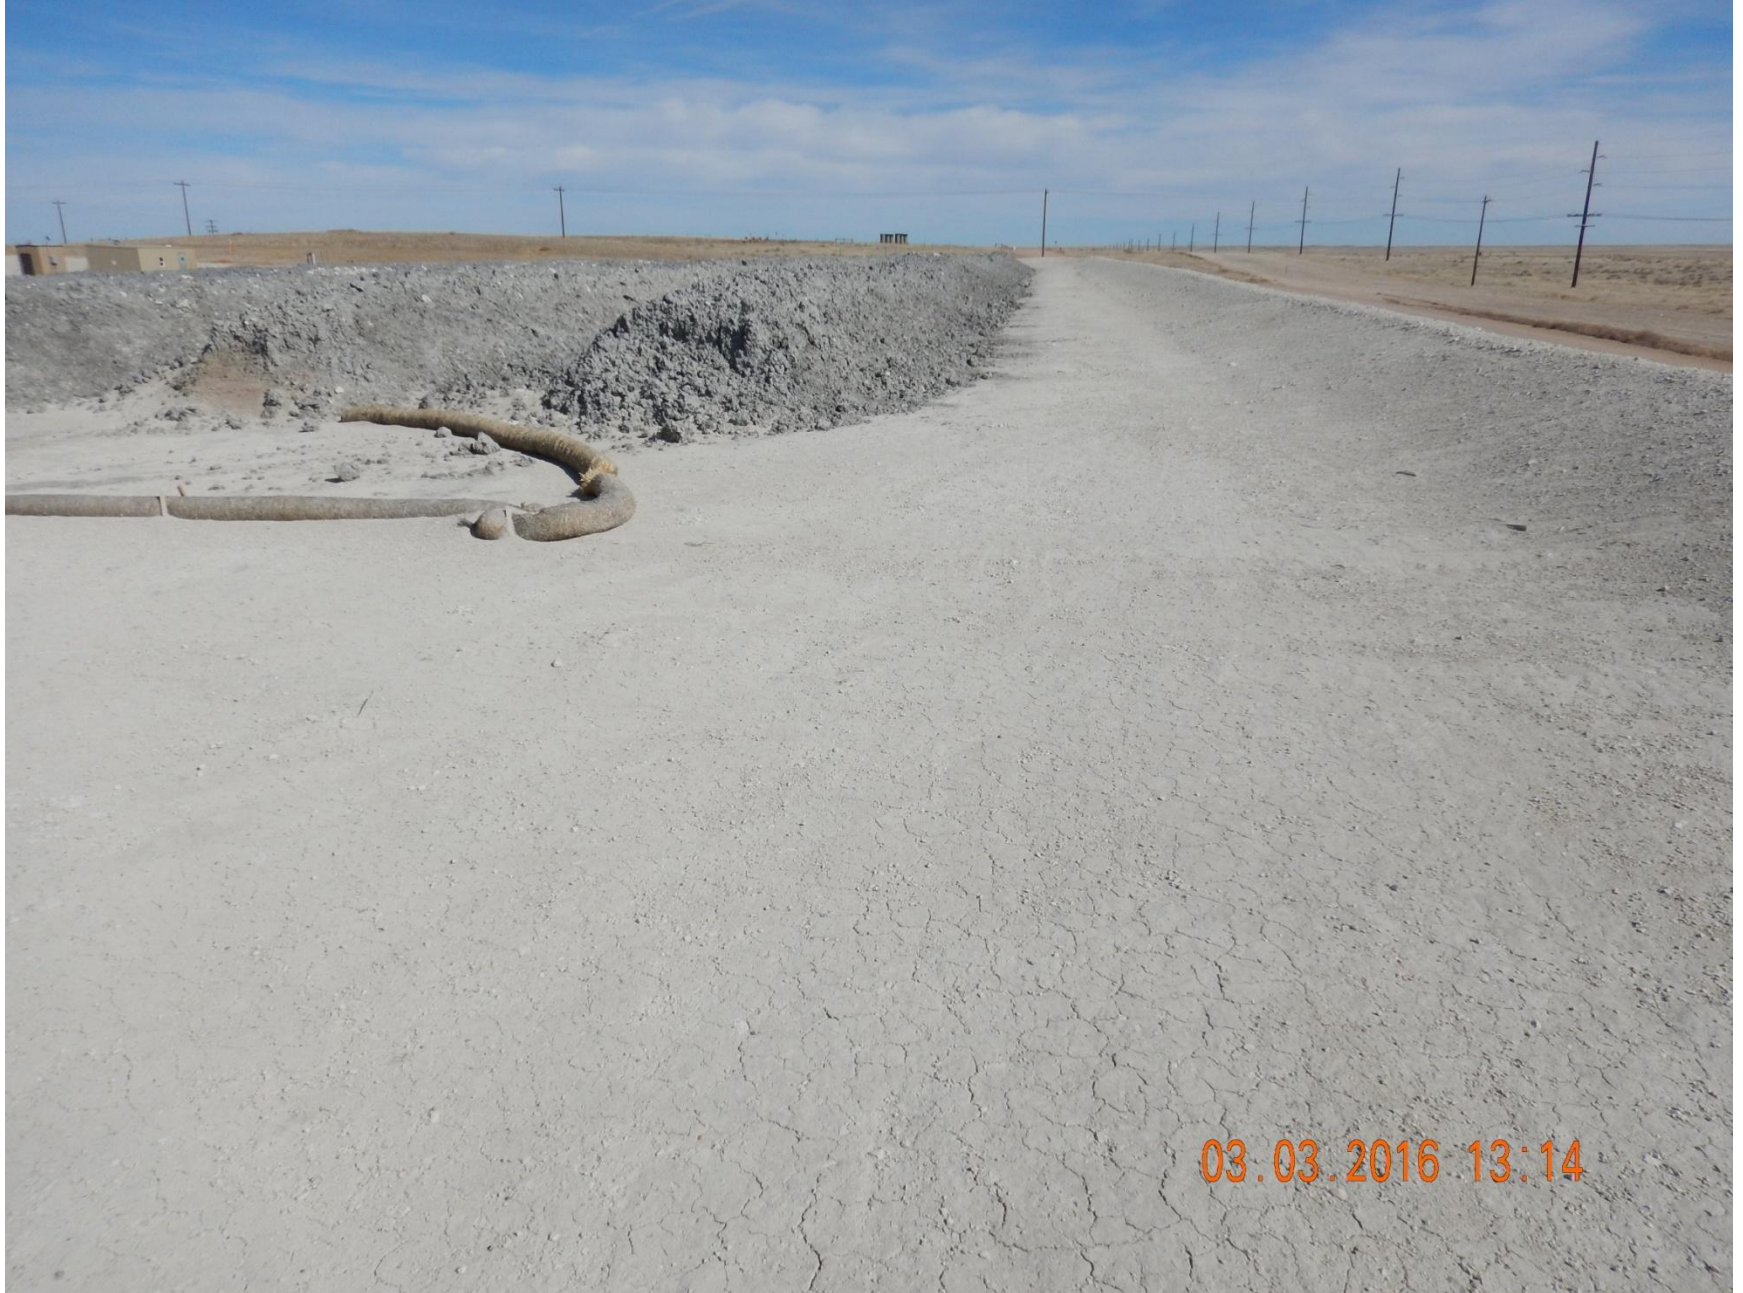
Figure 30: Photo taken from the southern end of the location, facing east. Photo shows straw wattles used as a stormwater and sediment control BMP around drill cuttings in disrepair.

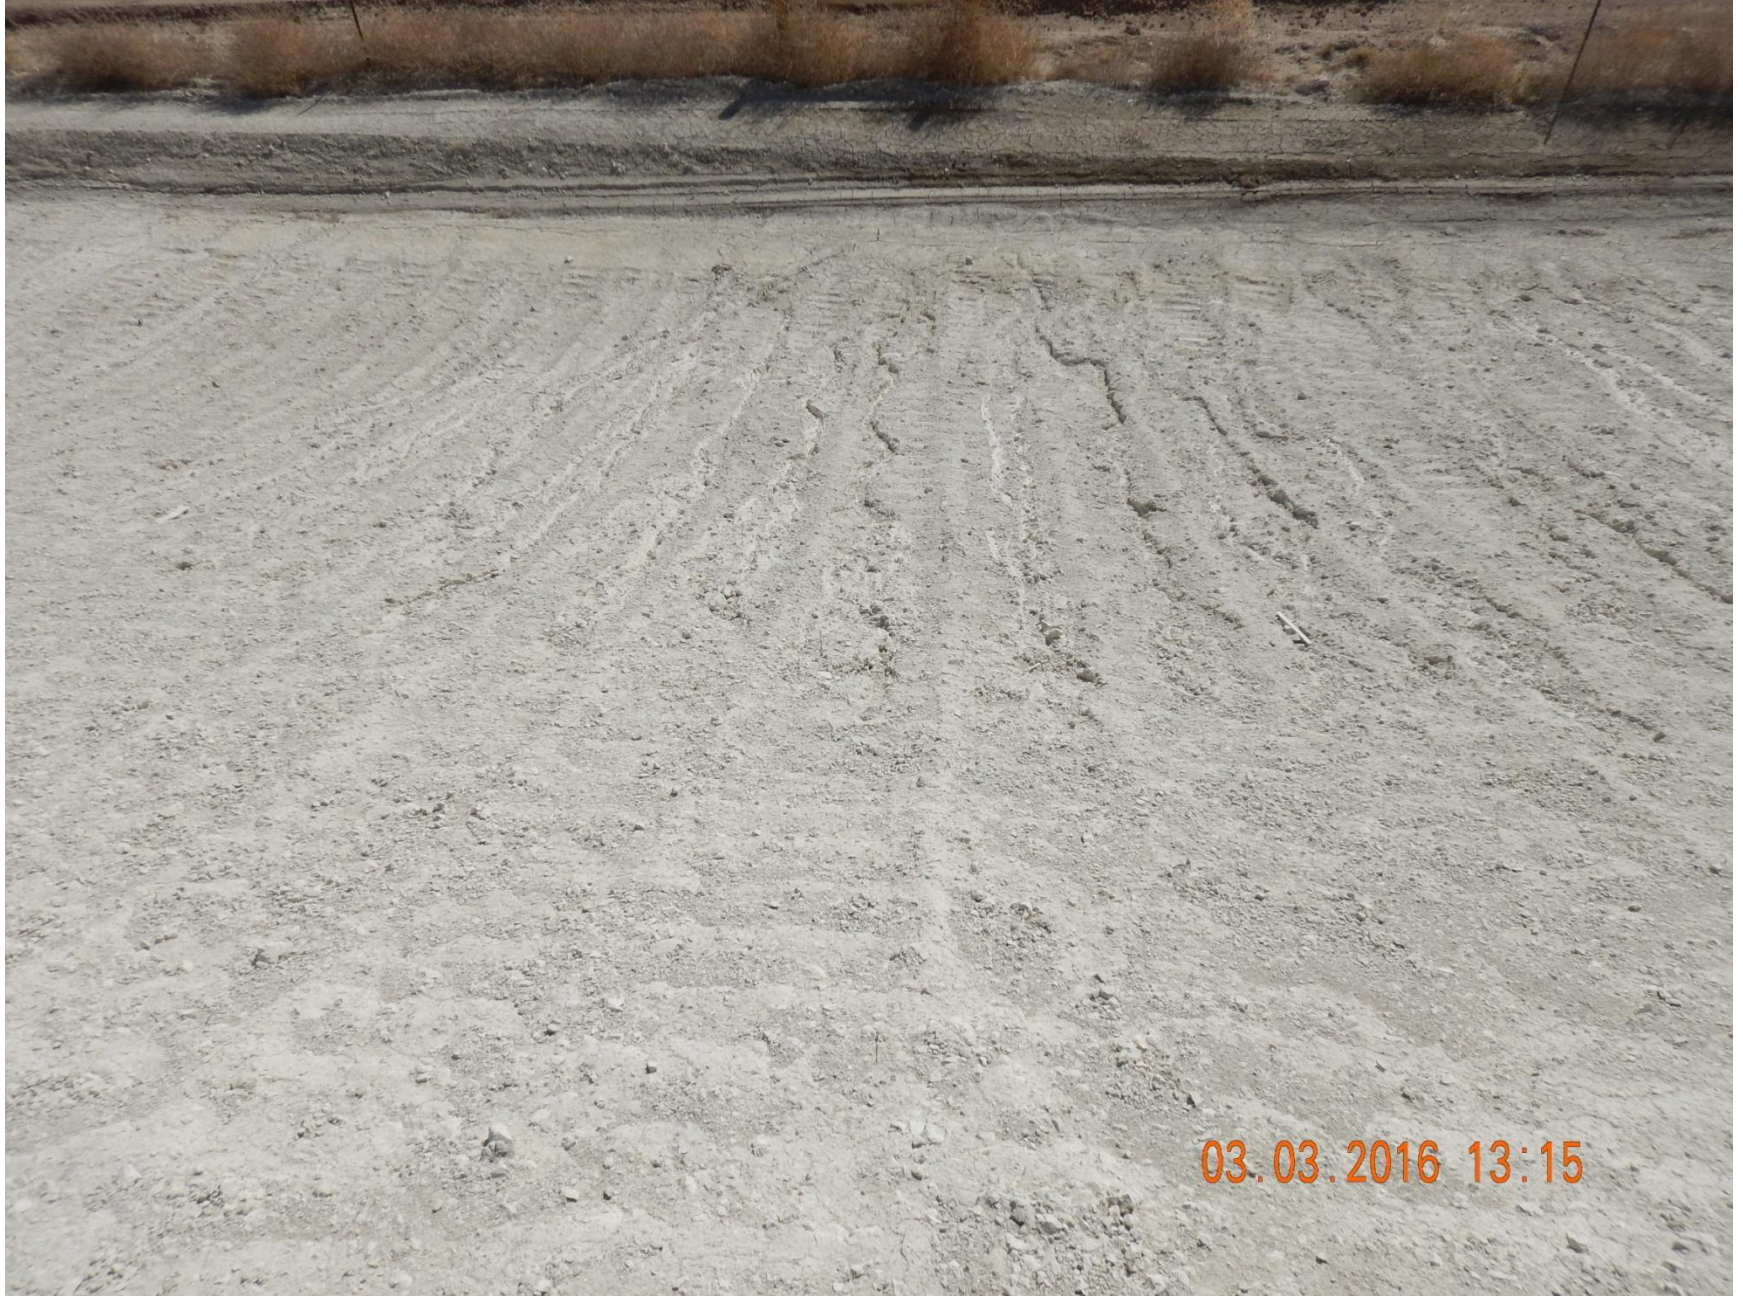
Figure 31: Photo taken from the south end of the location, facing south. Photo shows rill erosion beginning to form on the slope.

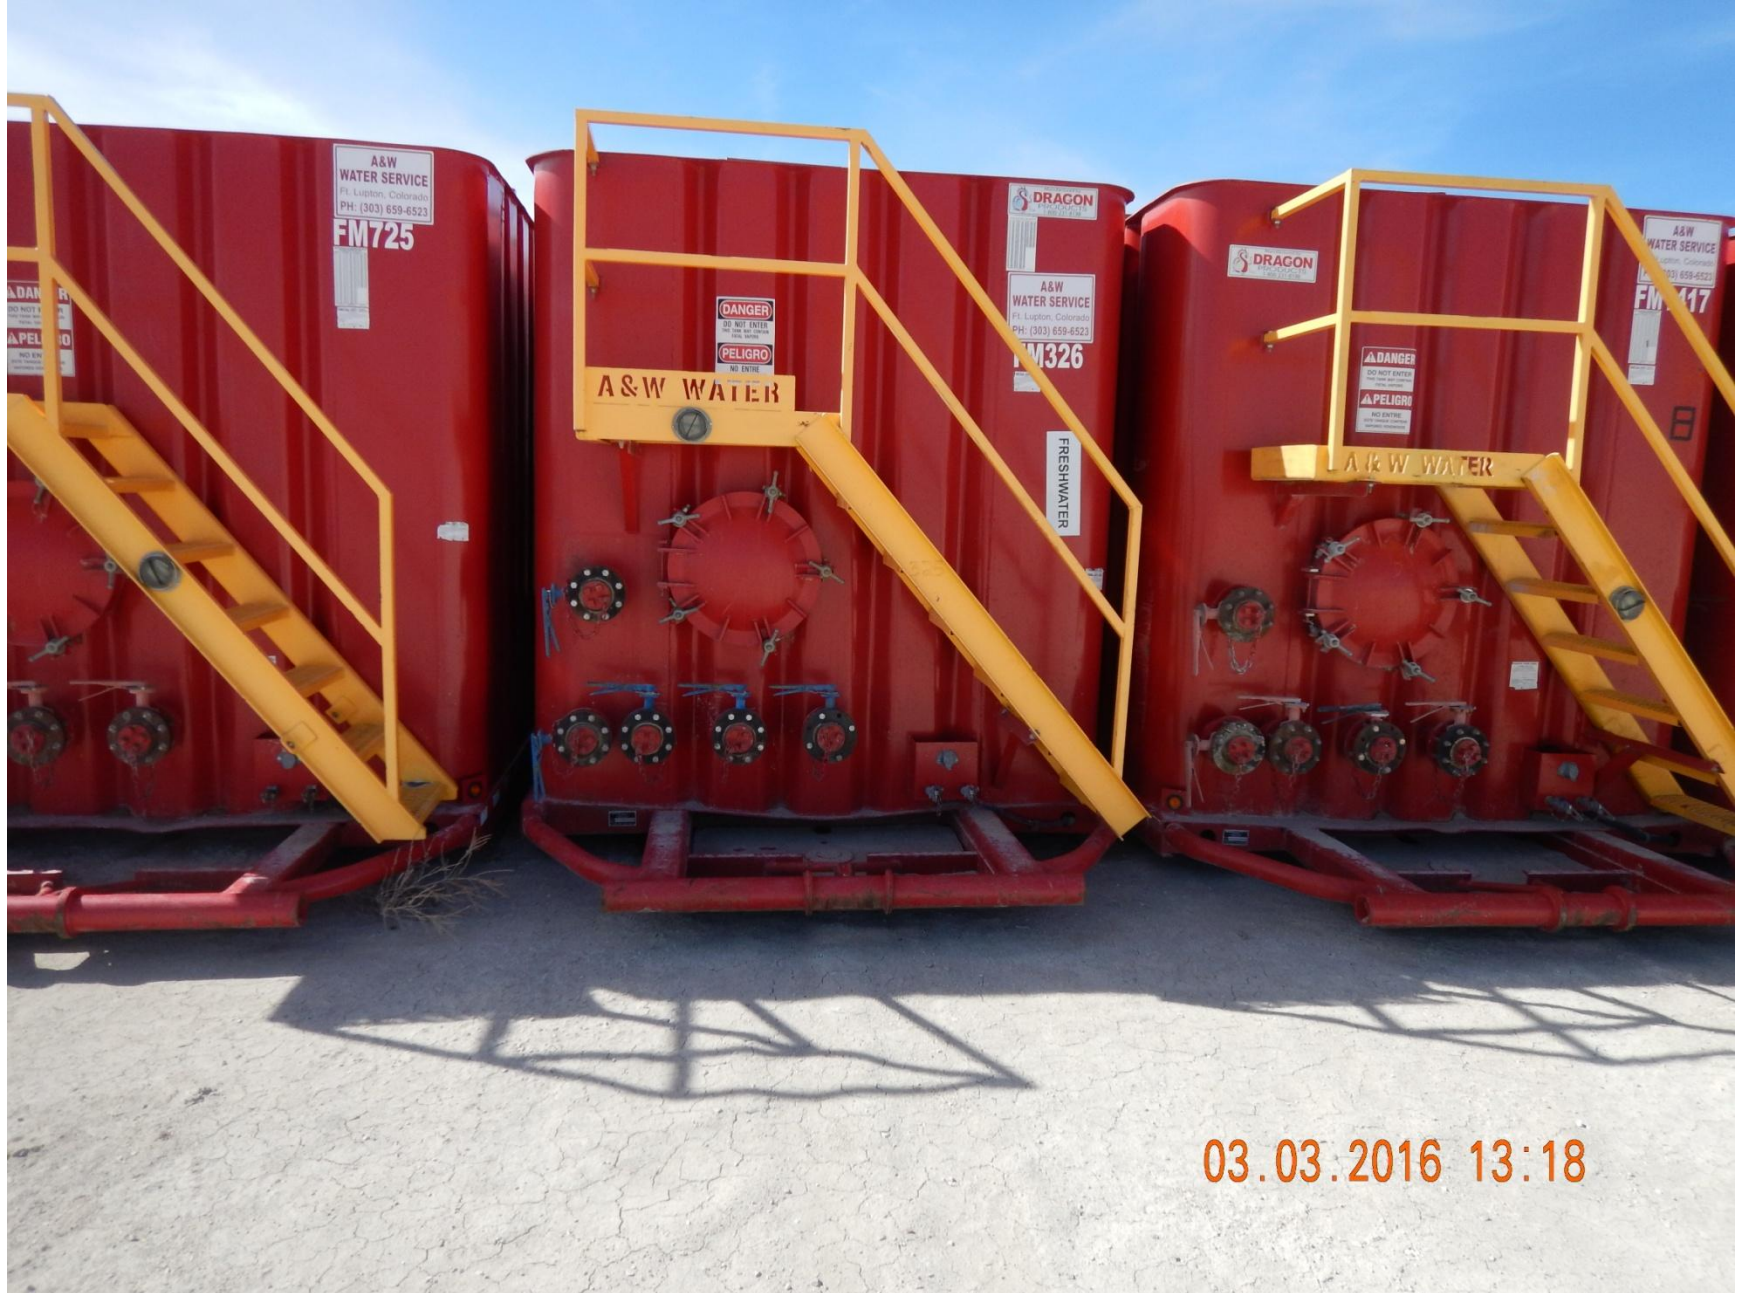
Figure 32: Photo taken from the western end of the project area, facing west. Photo shows tanks labeled as “freshwater” stored on location.

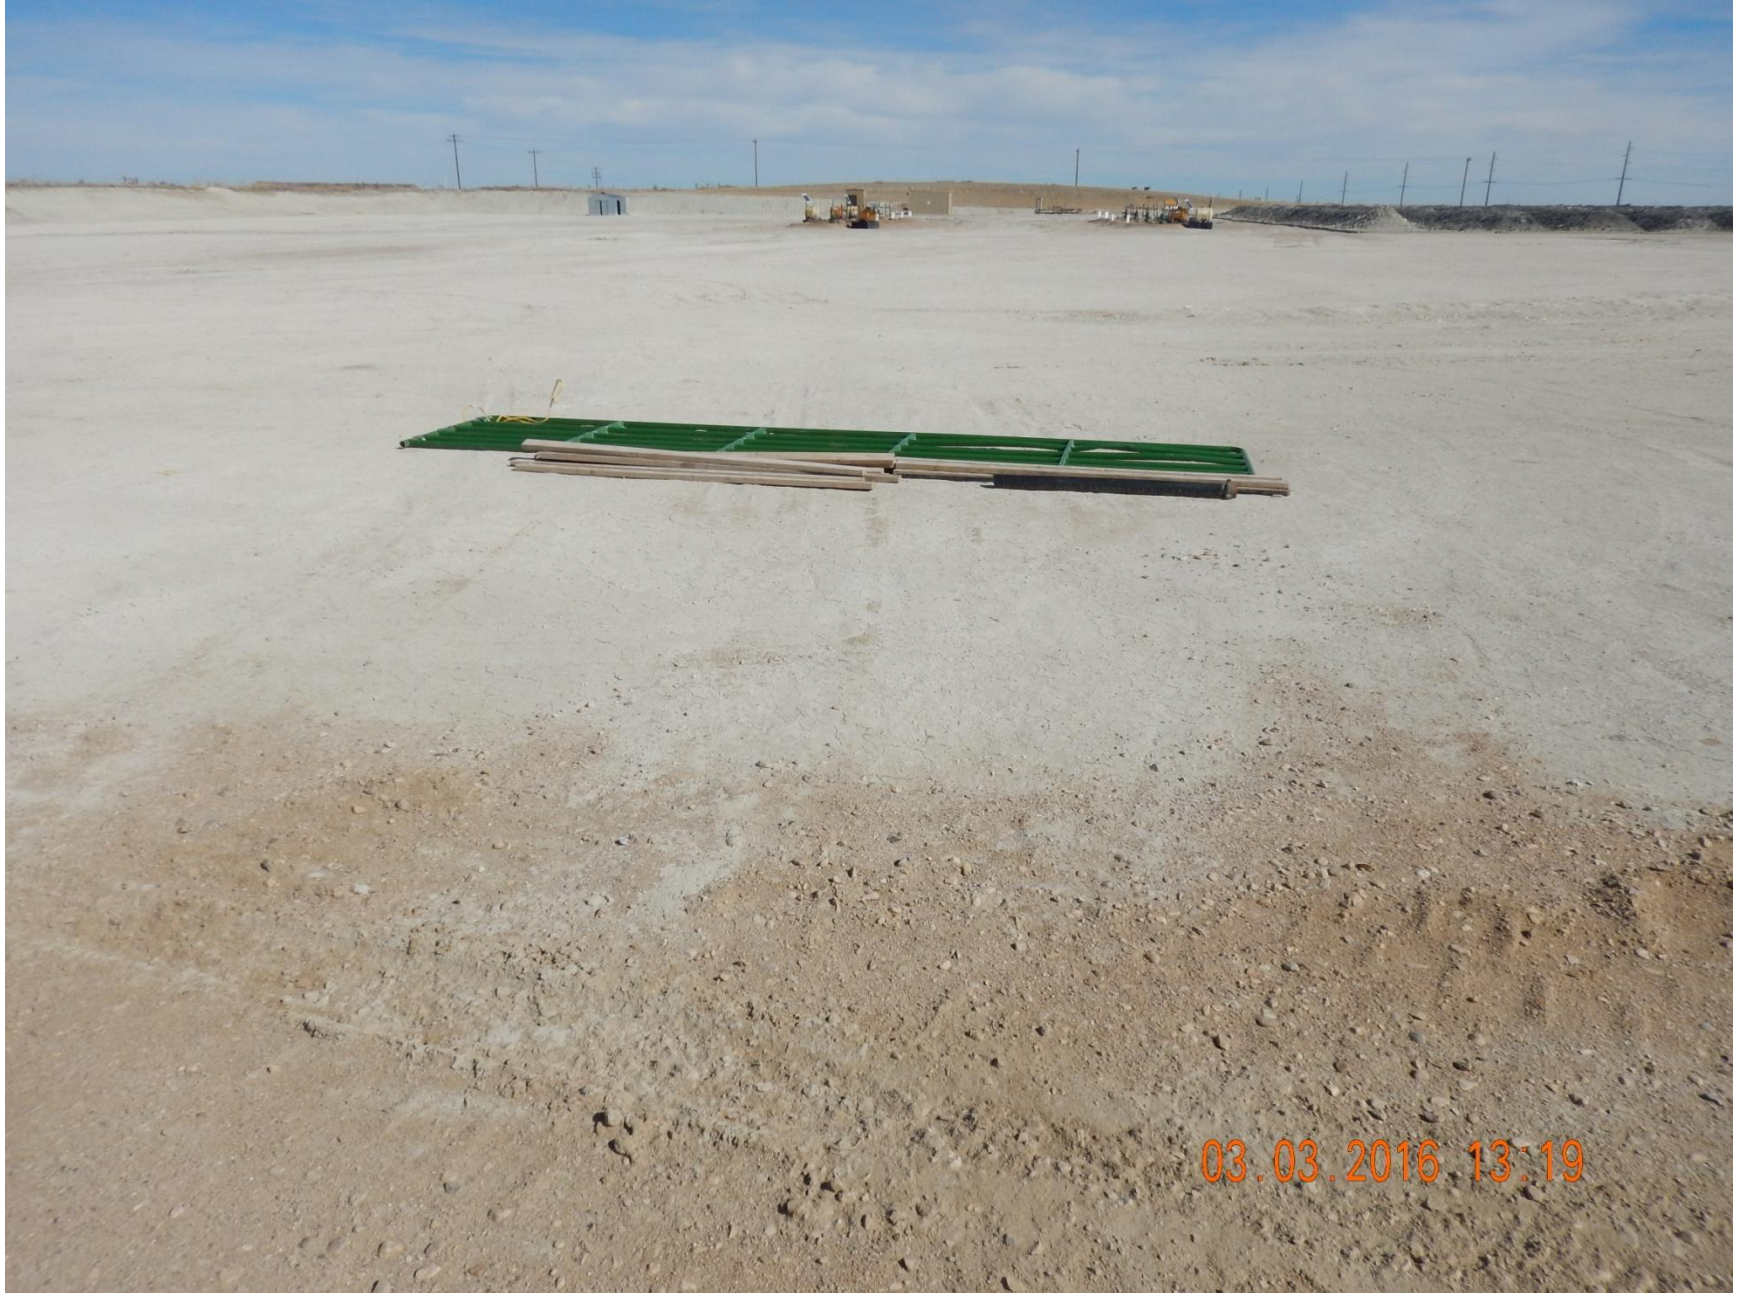
Figure 35: Photo taken from the western end of the project area, facing east. Photo of a green panel/gate stored on location.

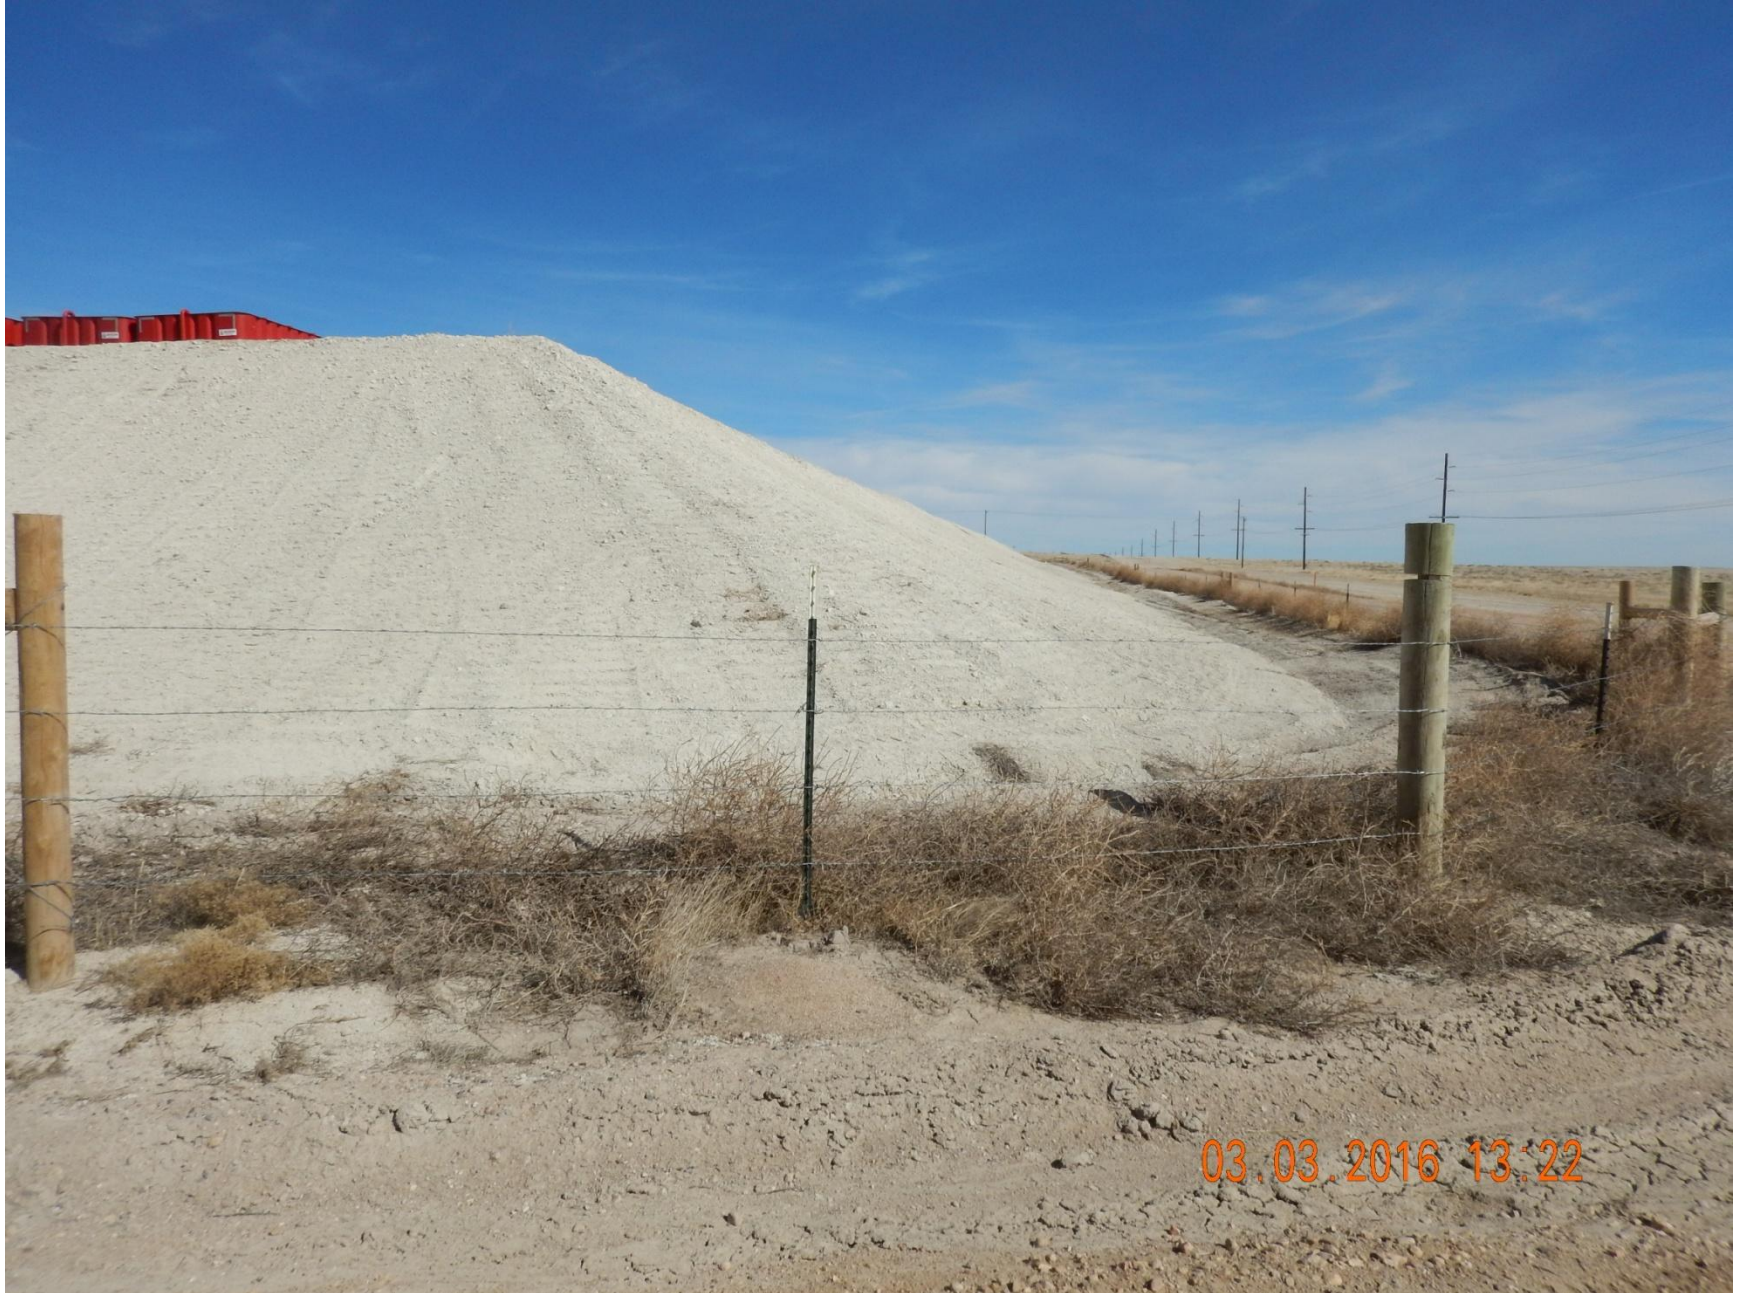
Figure 36: Photo taken from the southwest corner of the location, facing east. Photo shows the steep grade of the slope on the interim area.

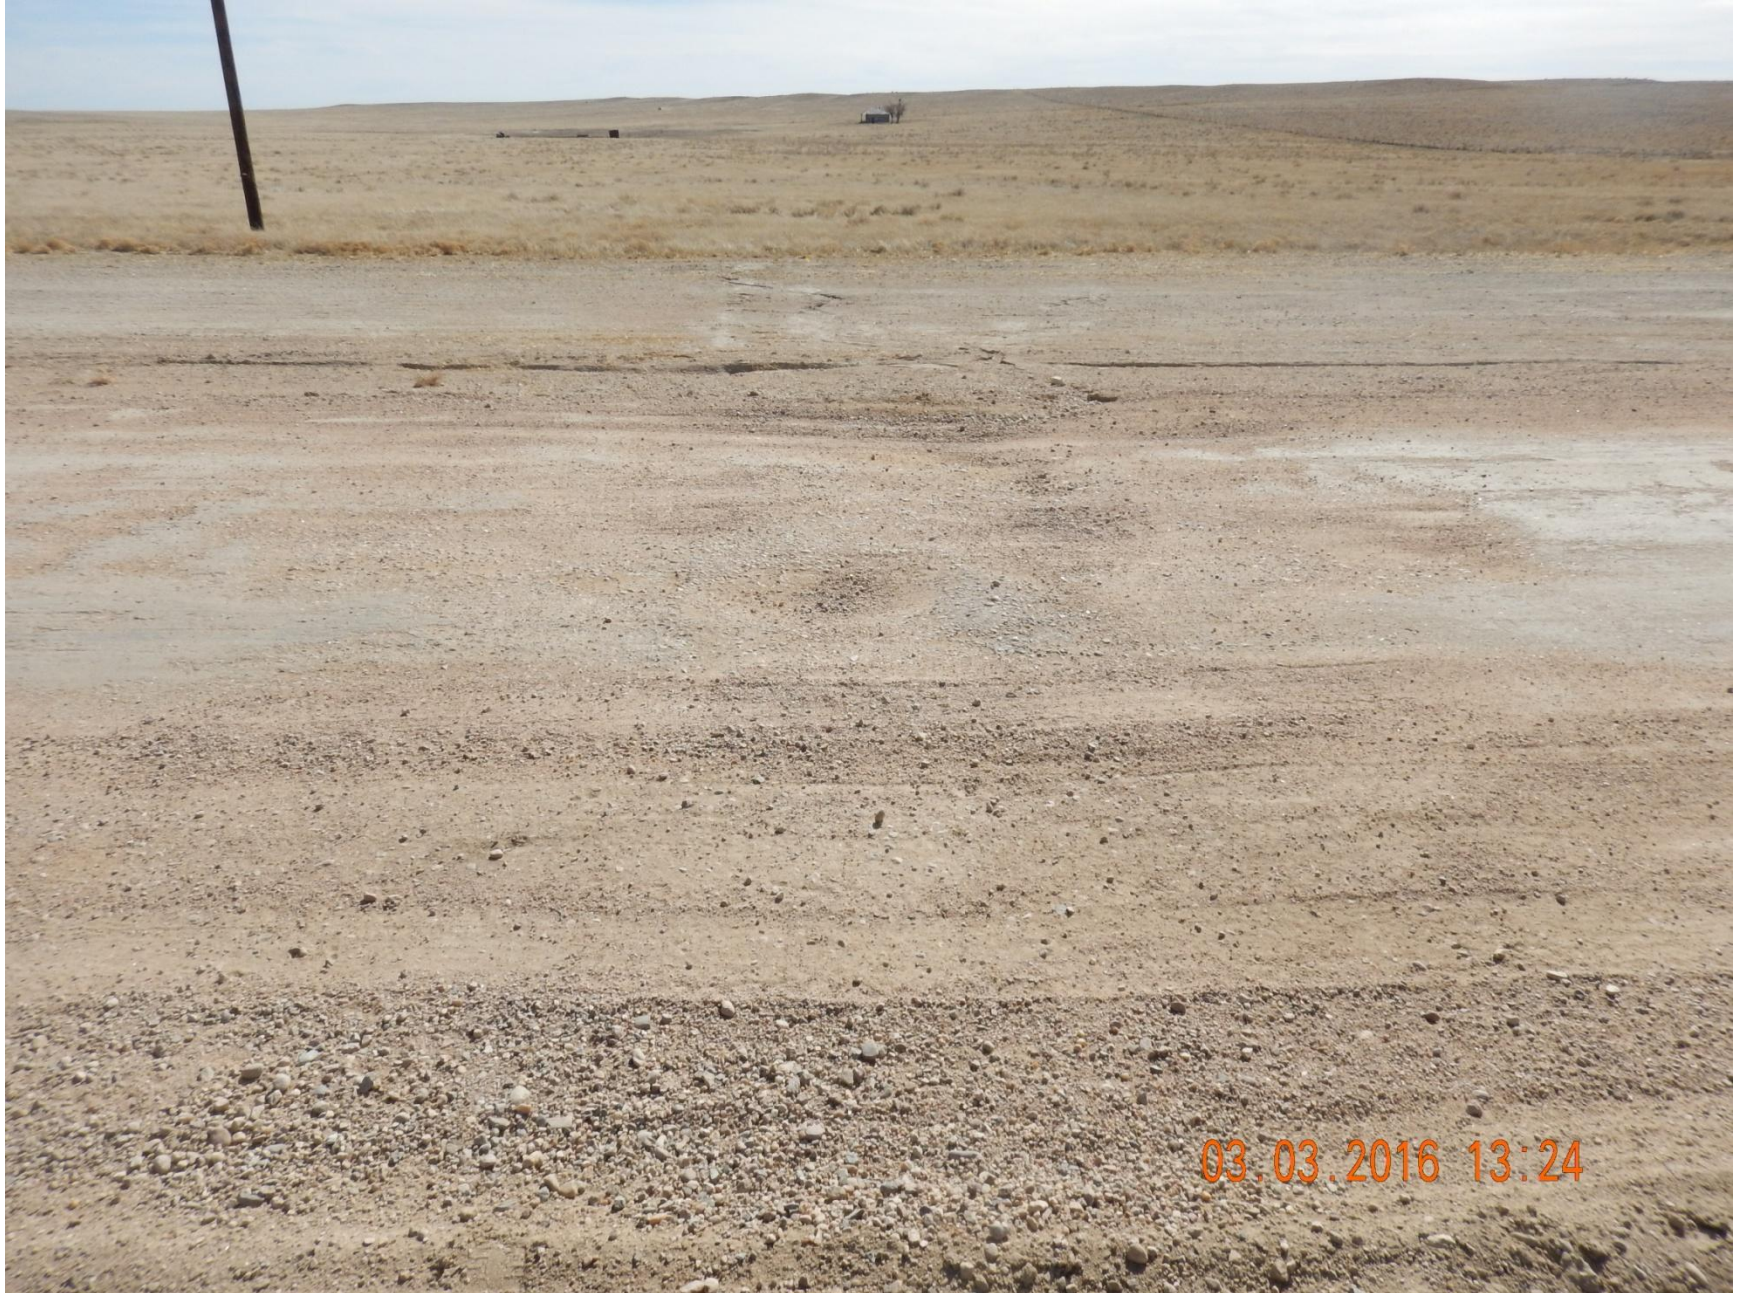
Figure 37: Photo taken from the access road that runs east/west, south of the location, facing south. Photo shows stormwater erosion running off road, over a pipeline reclamation project, and onto adjacent lands.

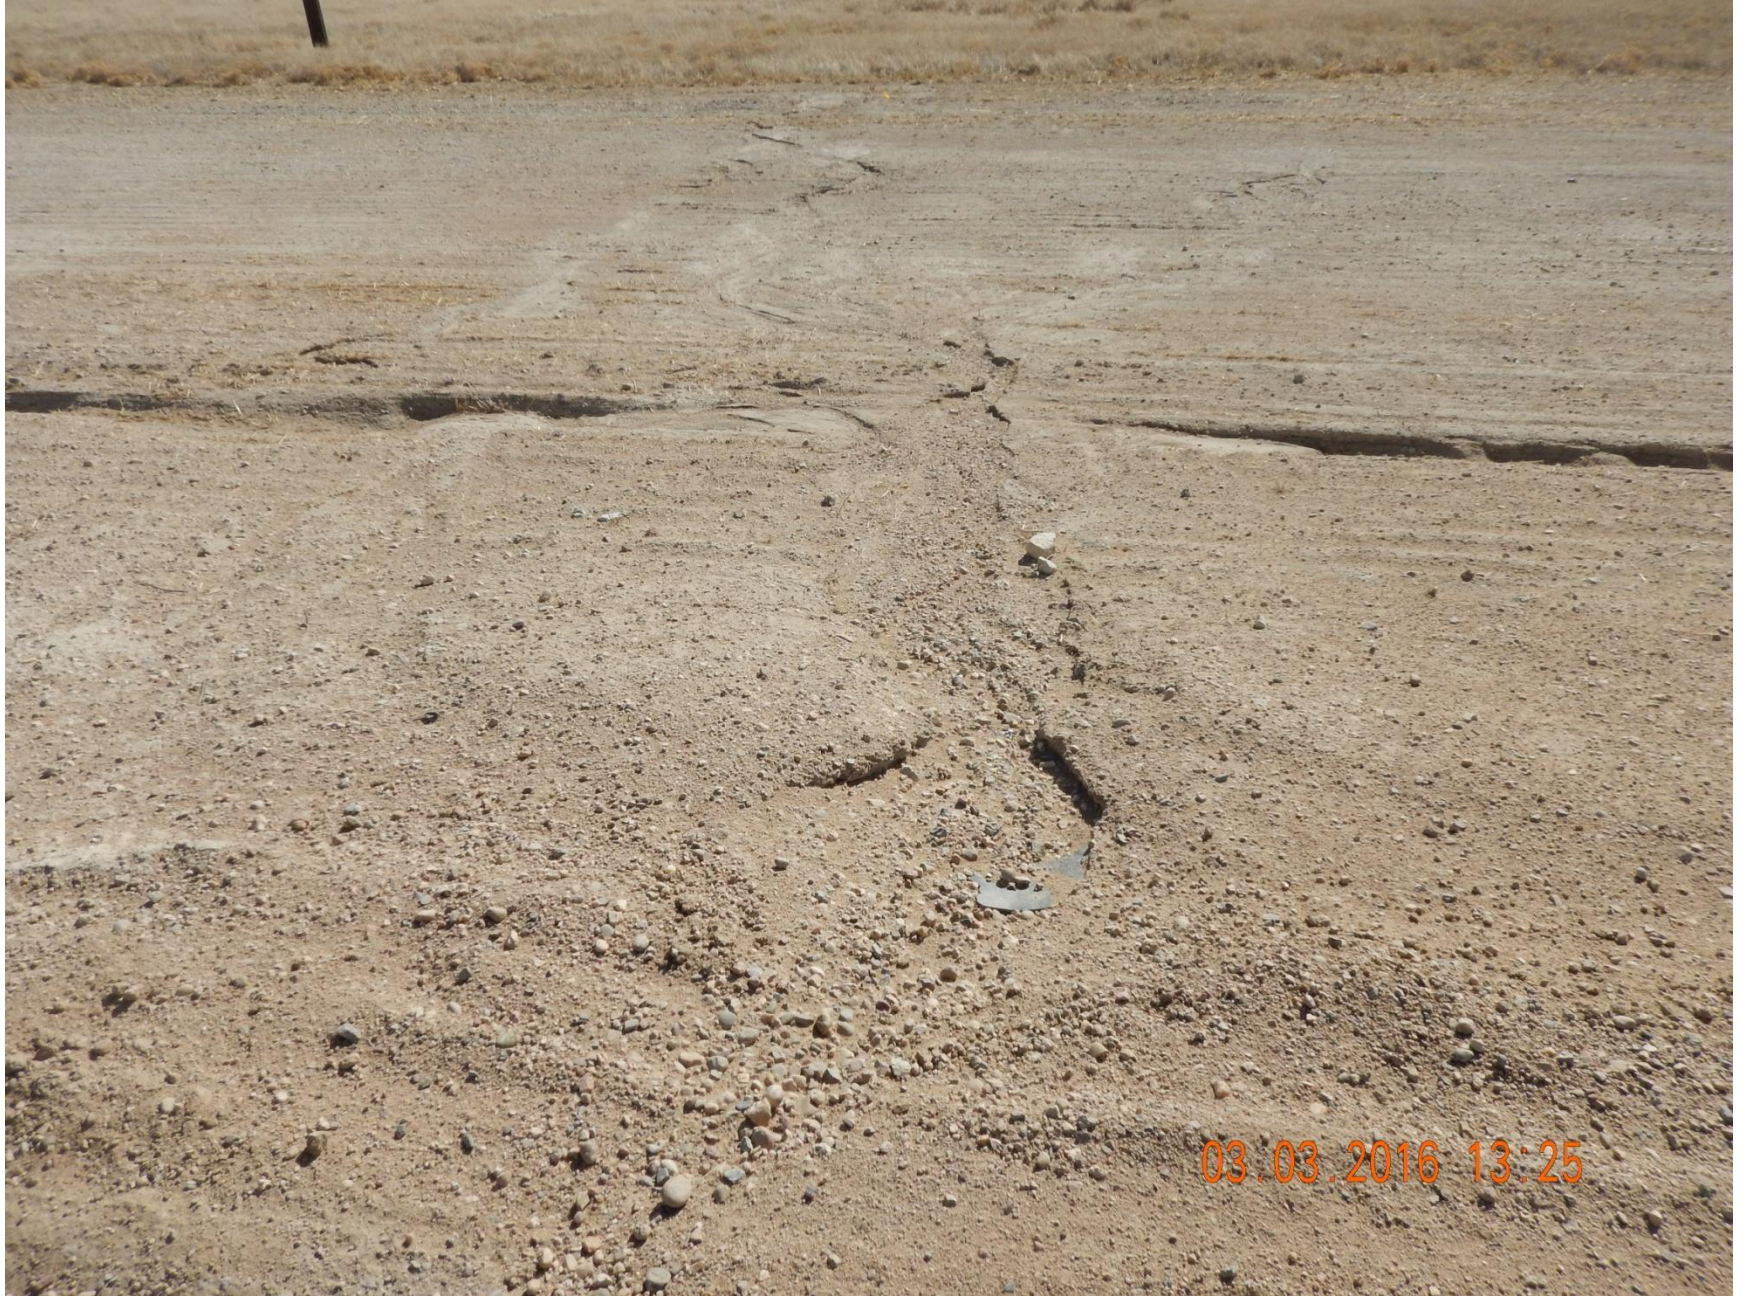
Figure 38: Photo taken from the access road that runs east/west, south of the location, facing south. Photo shows stormwater erosion running off road, over a pipeline reclamation project, and onto adjacent lands.

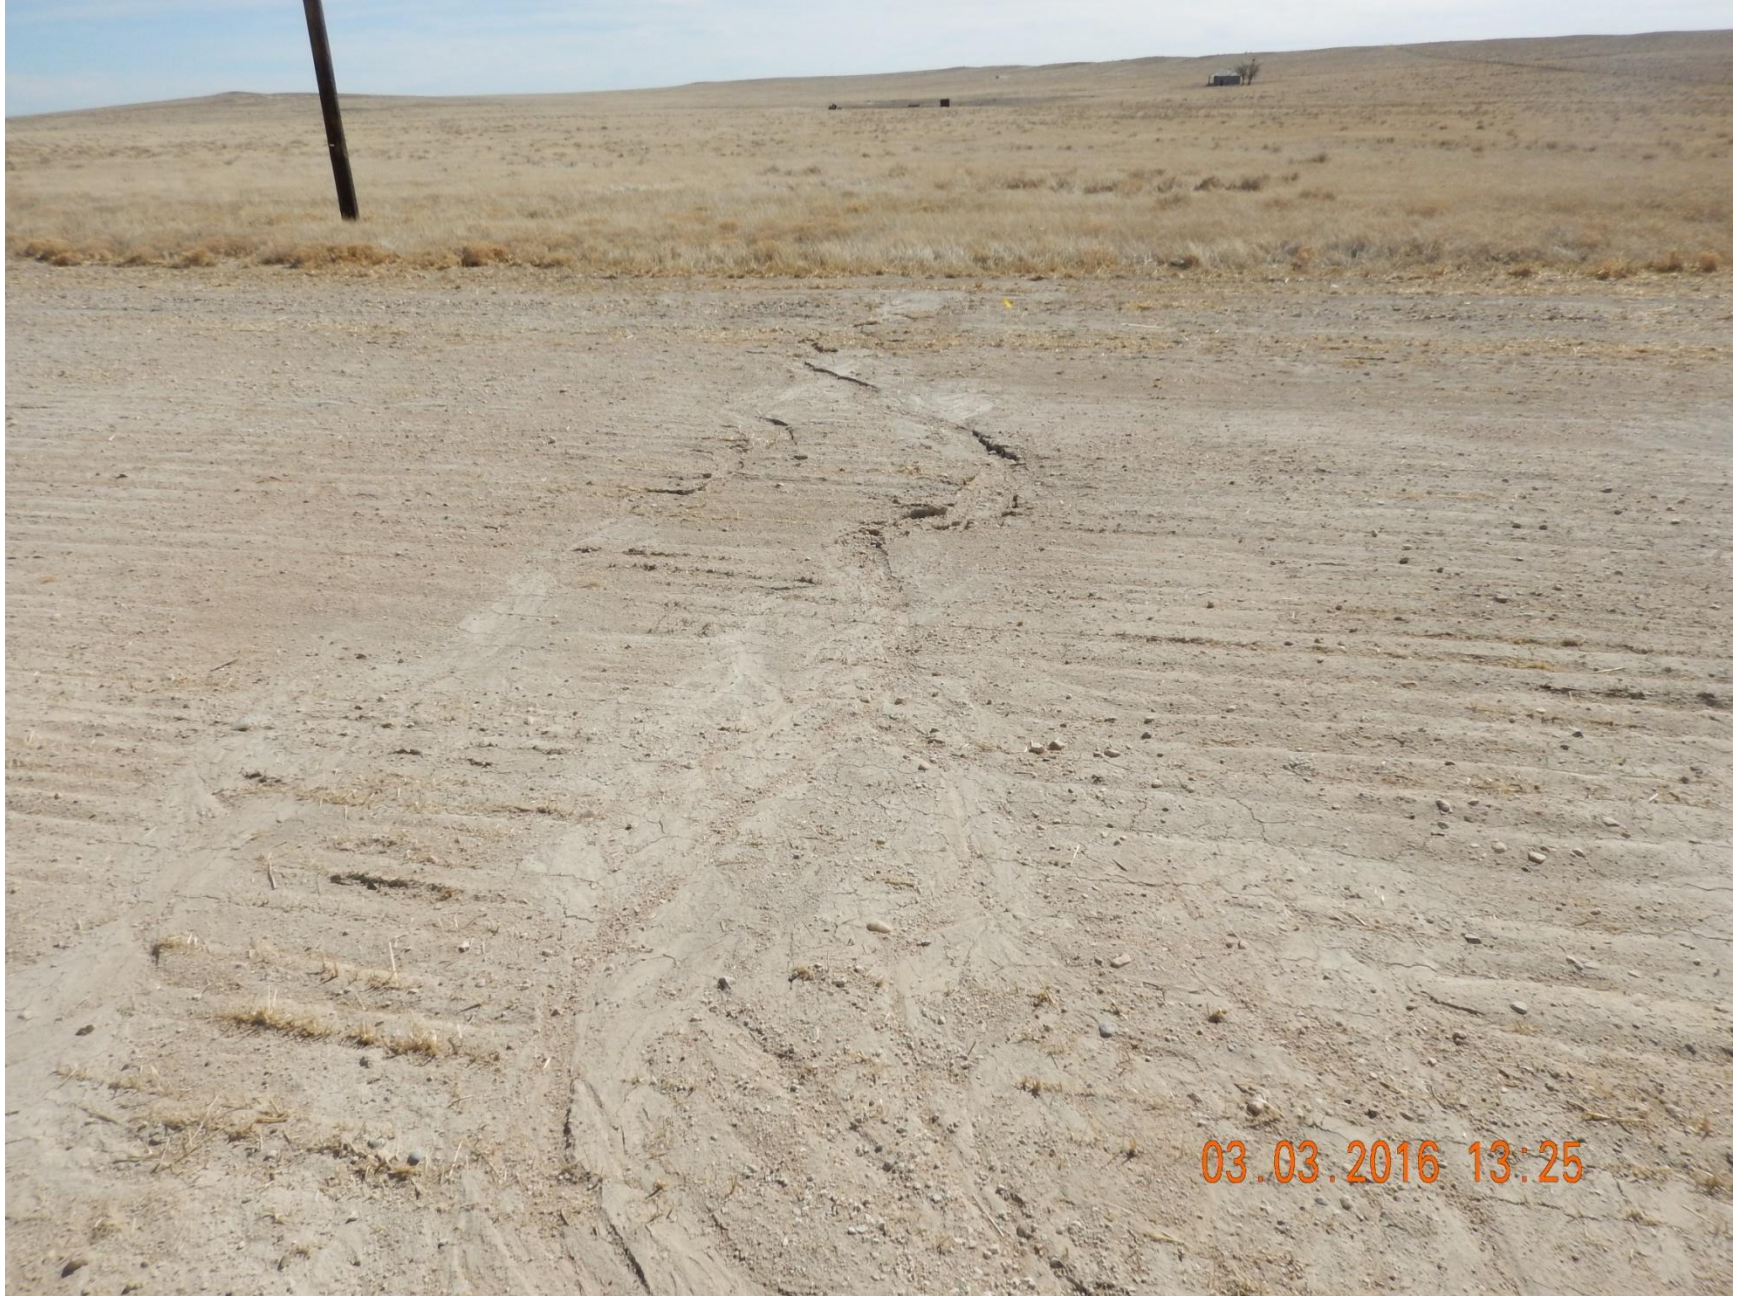
Figure 39: Photo taken from pipeline, south of the location, facing south. Photo shows stormwater erosion runoff from road, over a pipeline reclamation project, and onto adjacent lands.
