Interim Reclamation Inspection

3/3/2016

Operator: Whiting Oil and Gas

Location ID: 434267

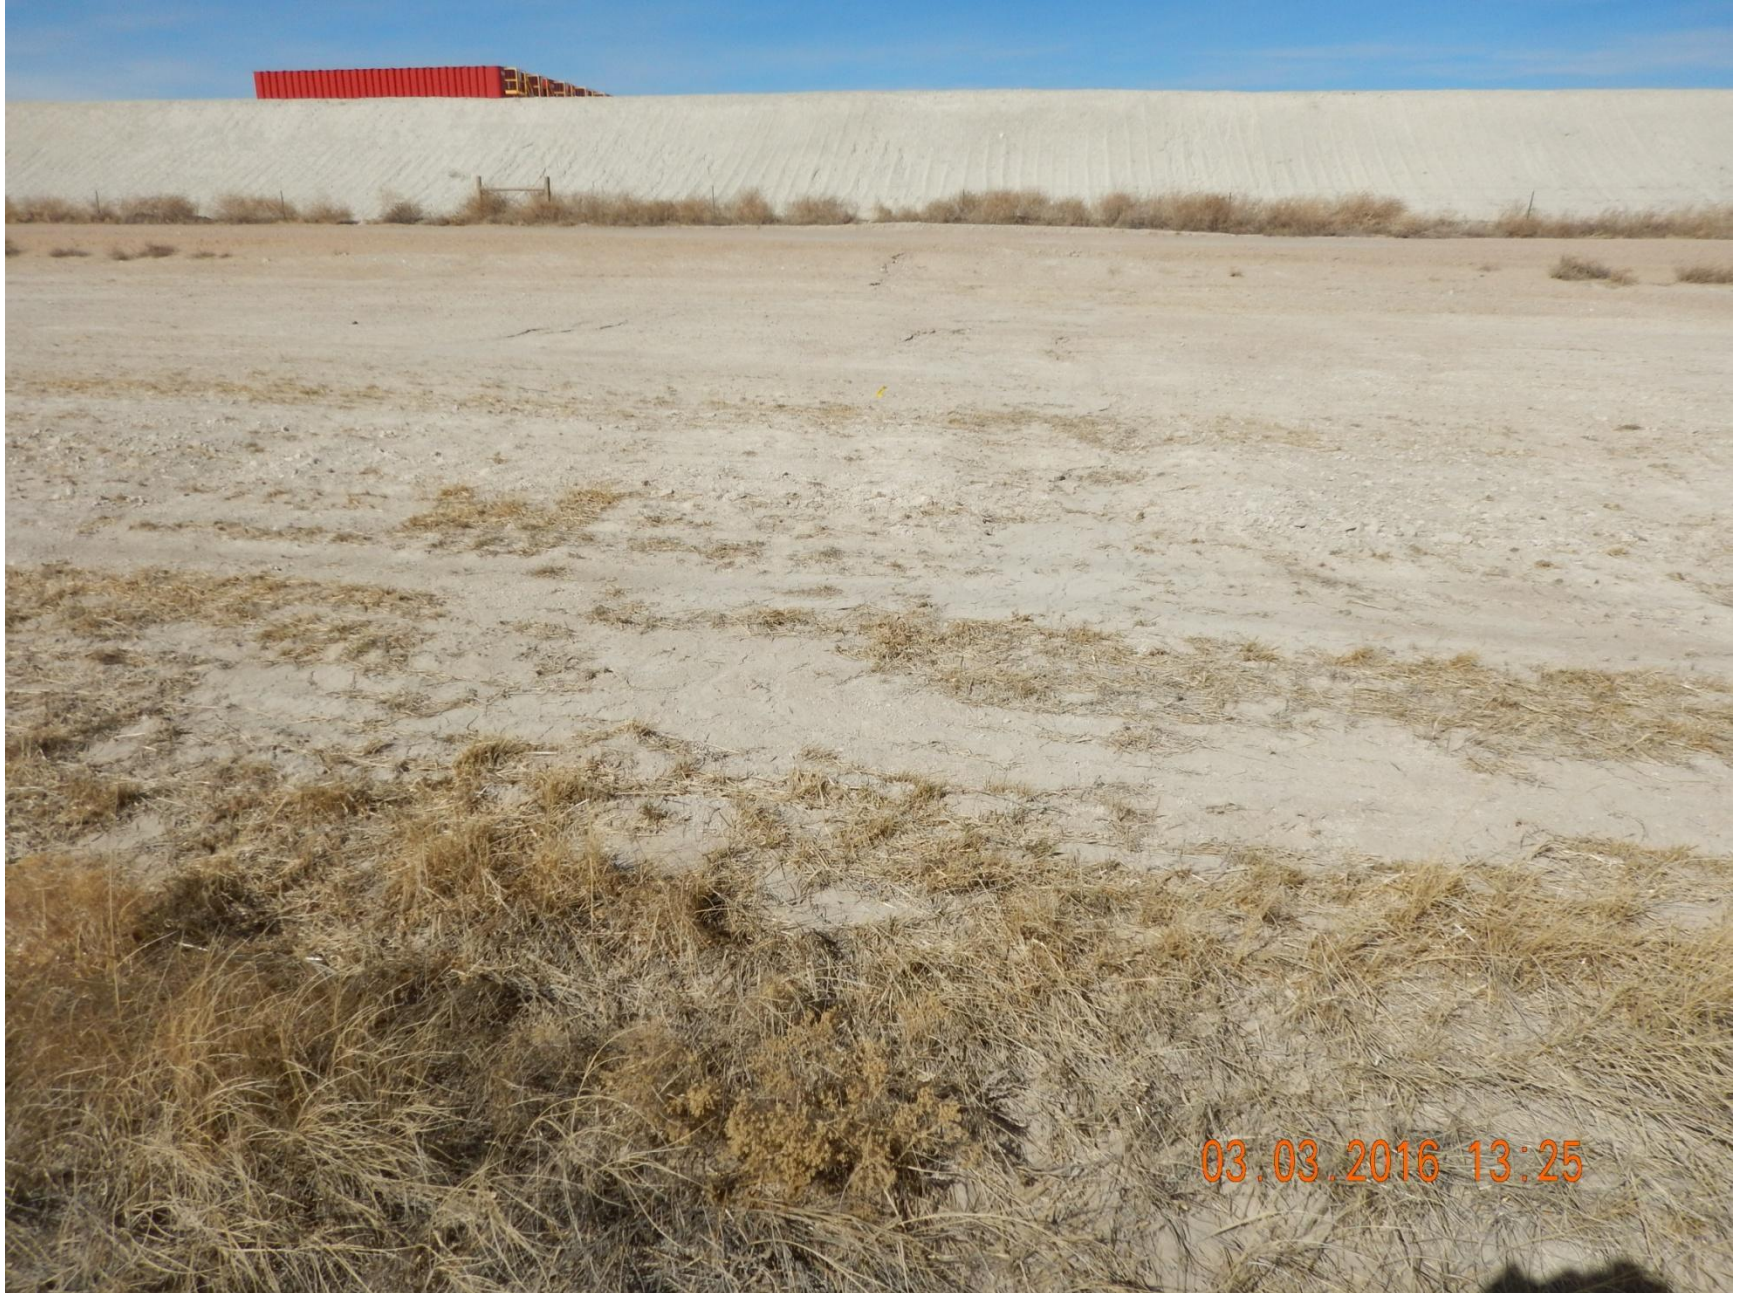
Figure 40: Photo taken from south of pipeline, facing north towards location. Photo shows stormwater erosion runoff from road, over a pipeline reclamation project, and onto adjacent lands.

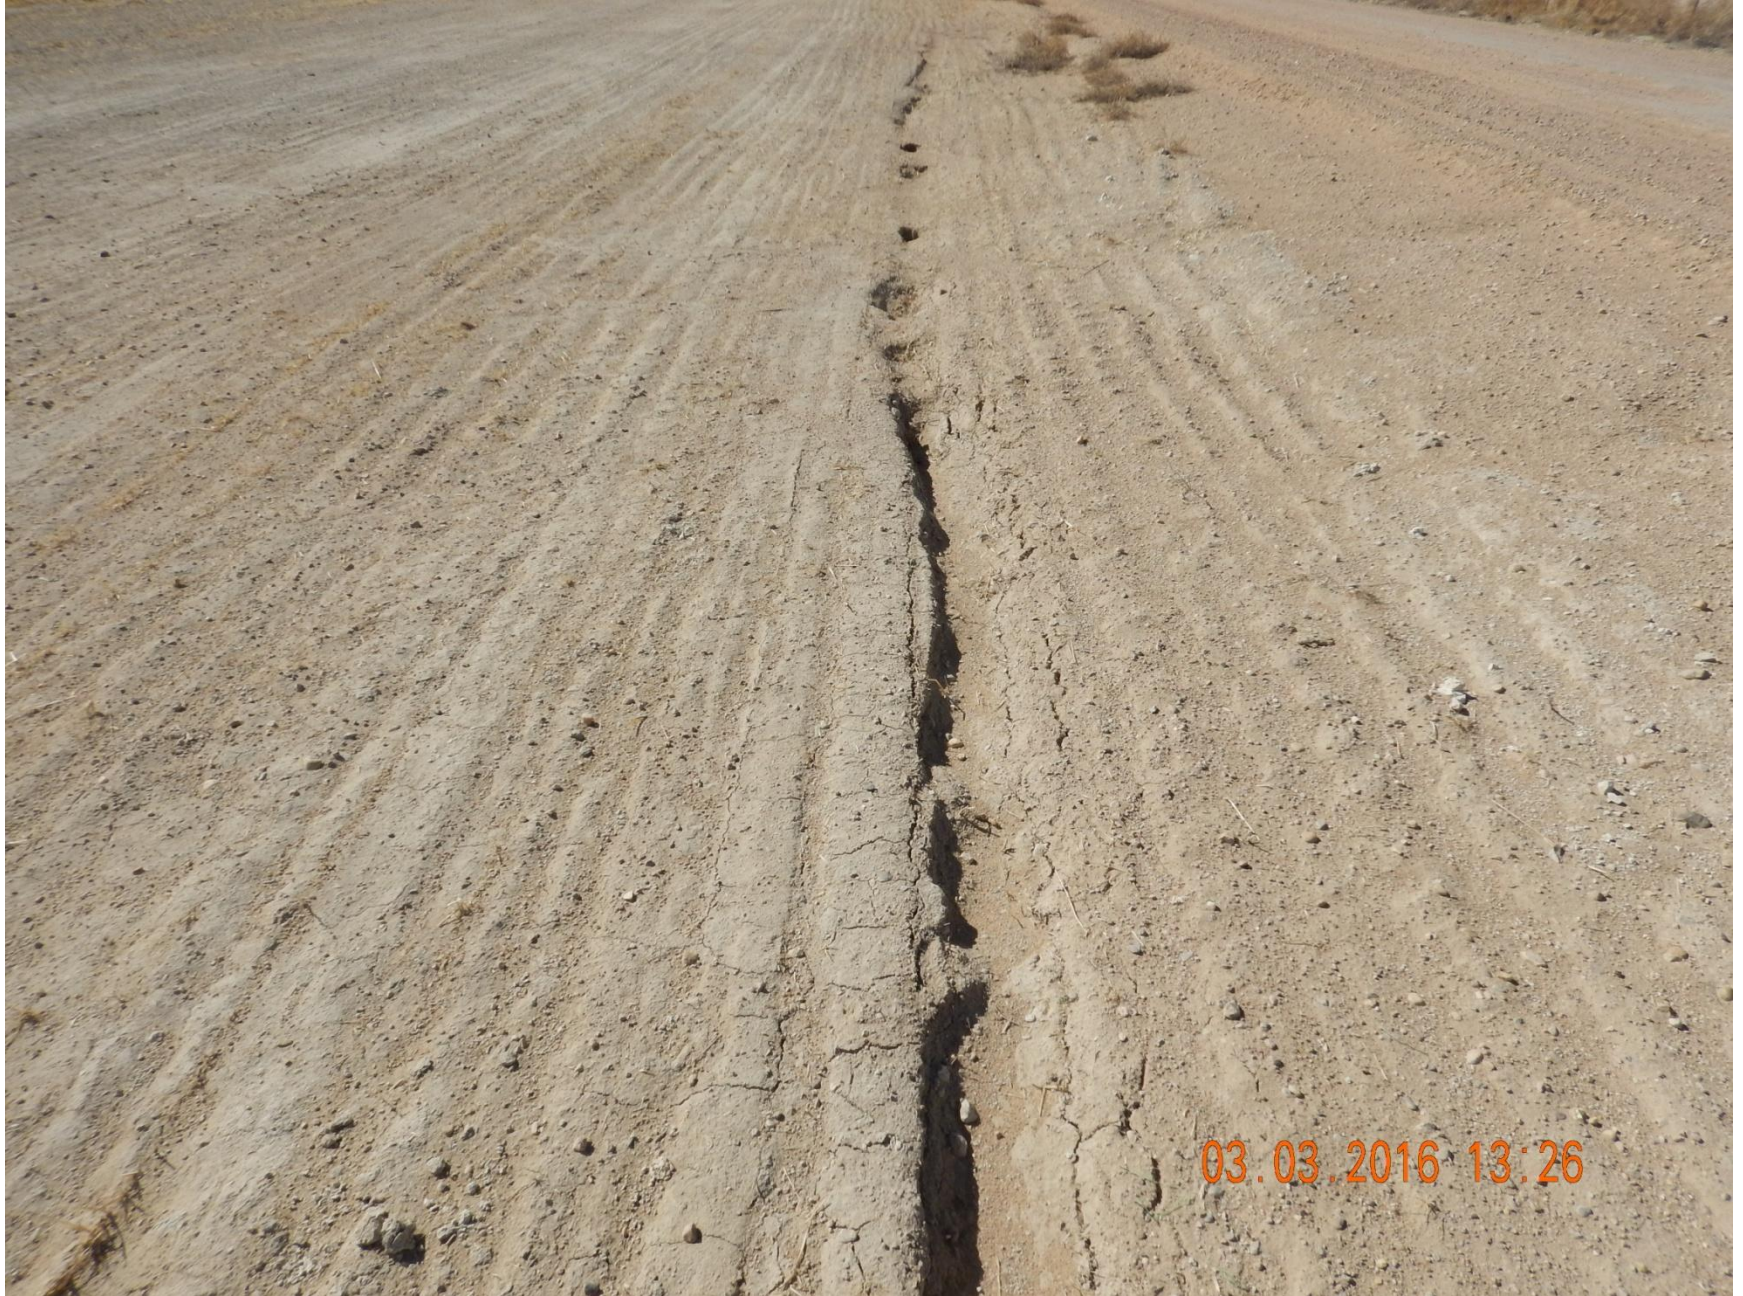
Figure 41: Photo taken from pipeline reclamation project, south of location facing west. Photo shows either subsidence or stormwater erosion occurring on pipeline.

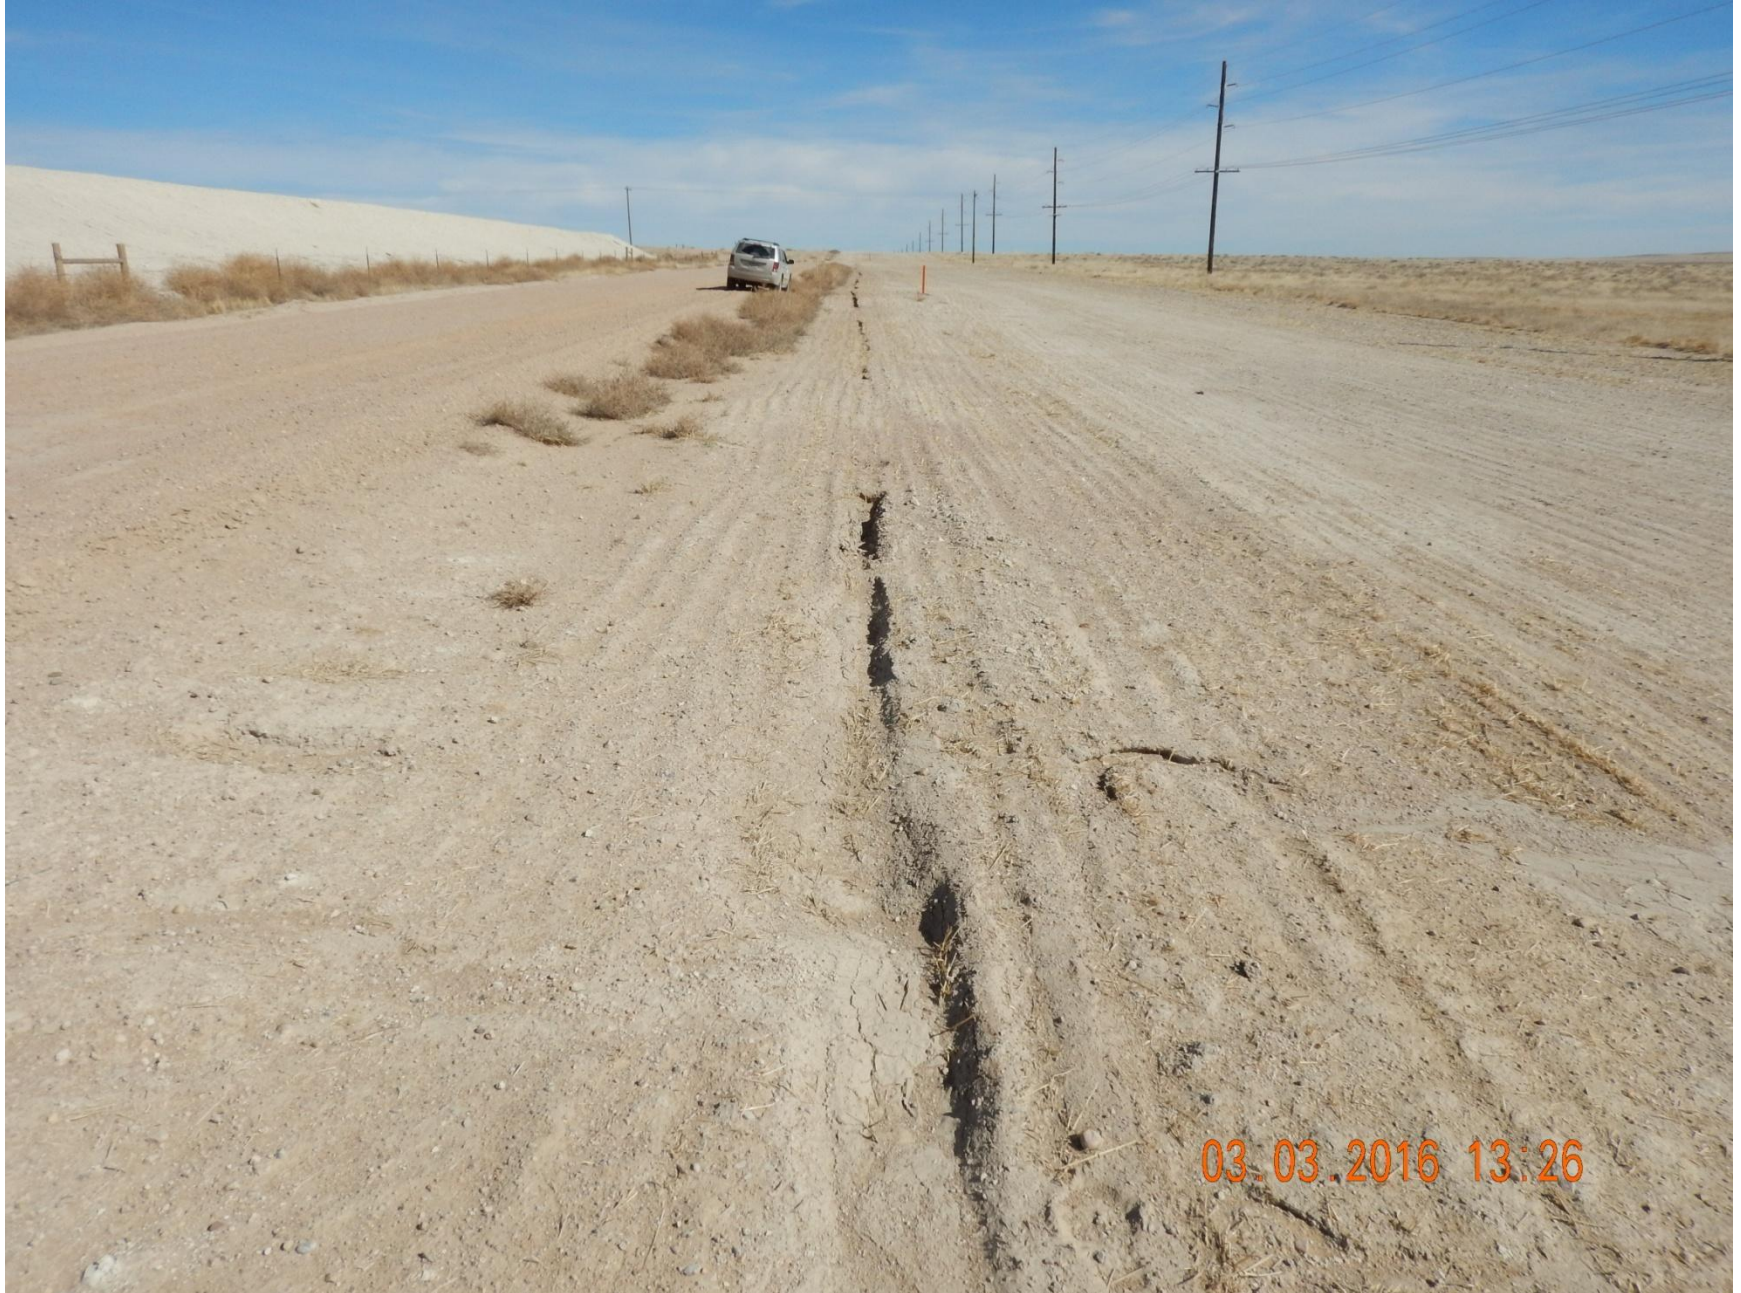
Figure 42: Photo taken from pipeline reclamation project, south of location facing east. Photo shows either subsidence or stormwater erosion occurring on pipeline. Photo also shows stormwater erosion runoff from access road.

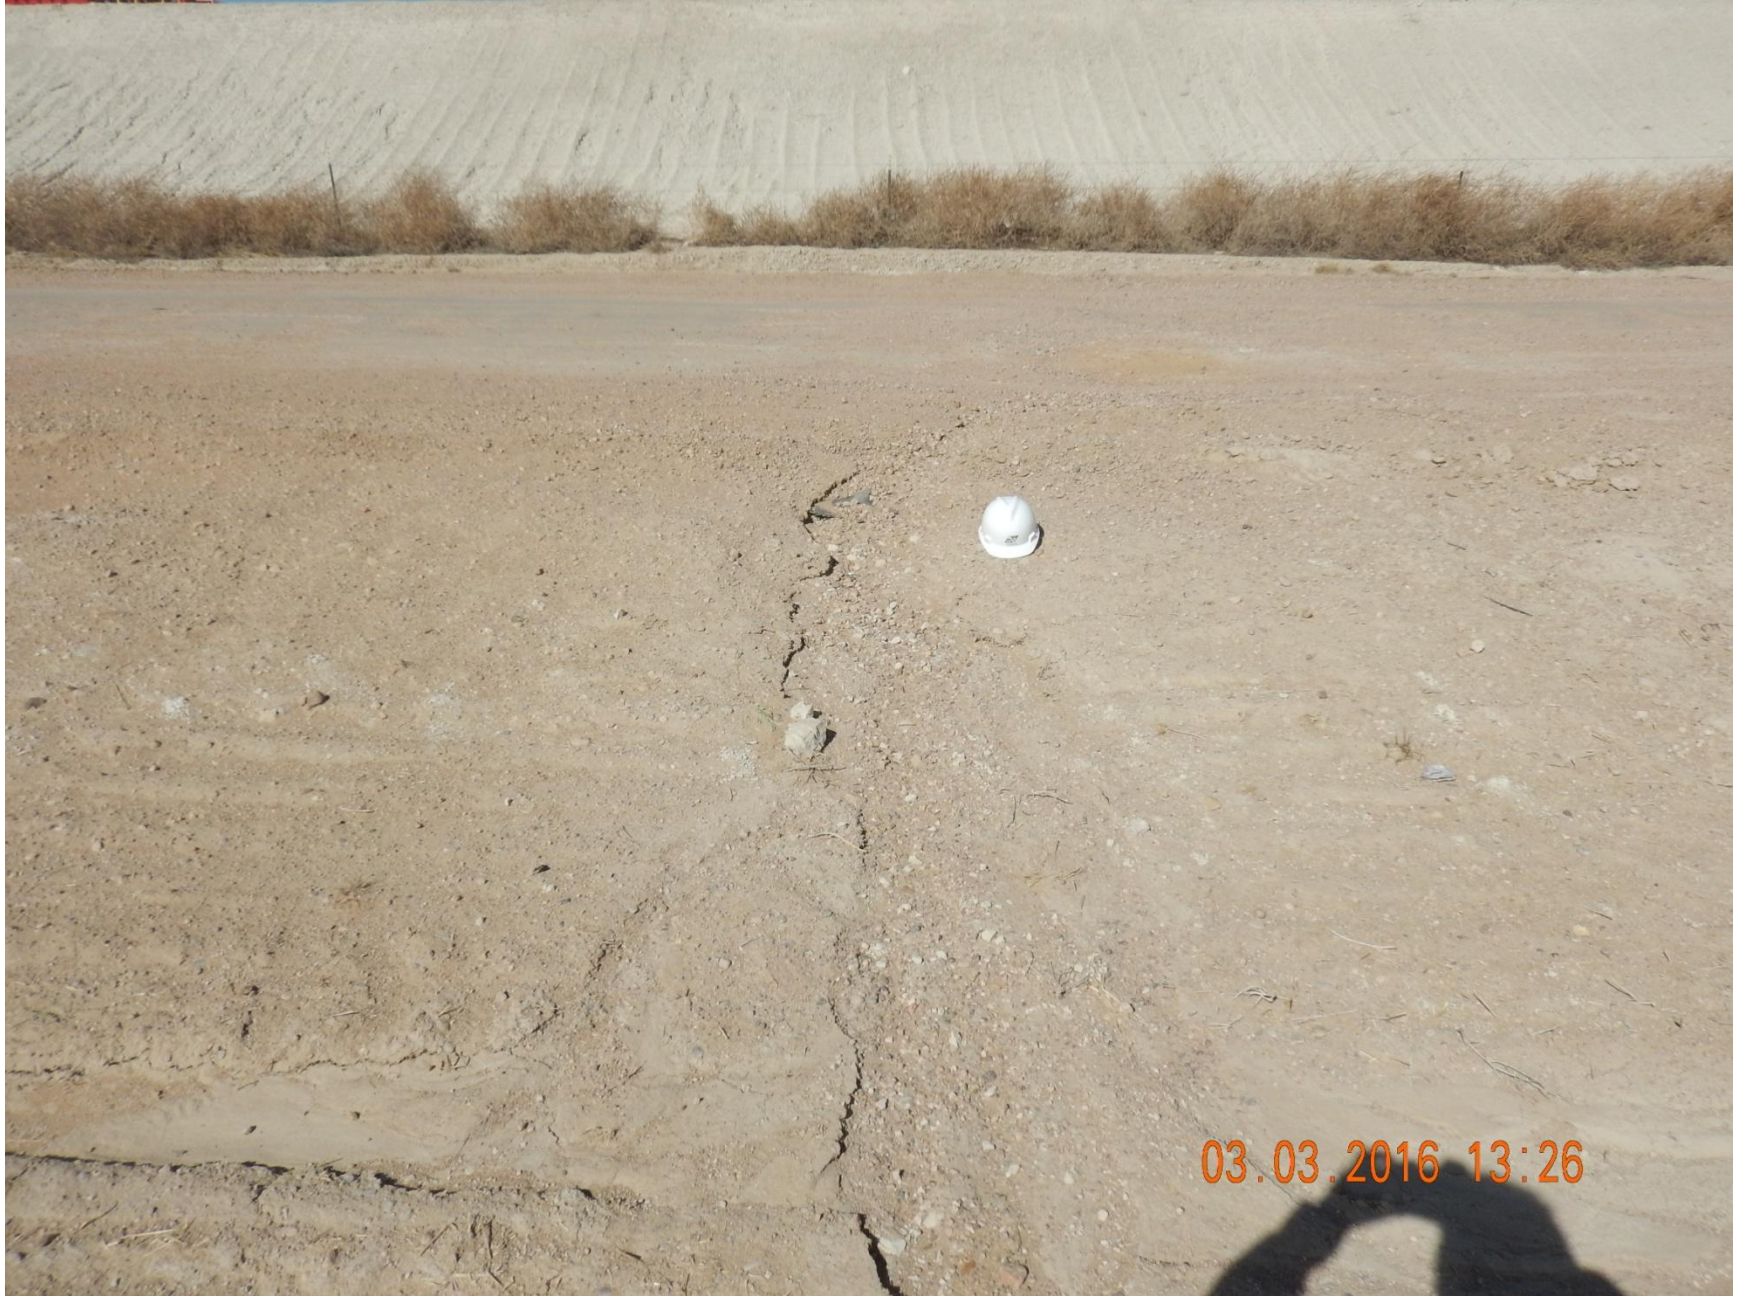
Figure 43: Photo taken from pipeline reclamation project, south of location. Photo shows stormwater erosion runoff from the access road.

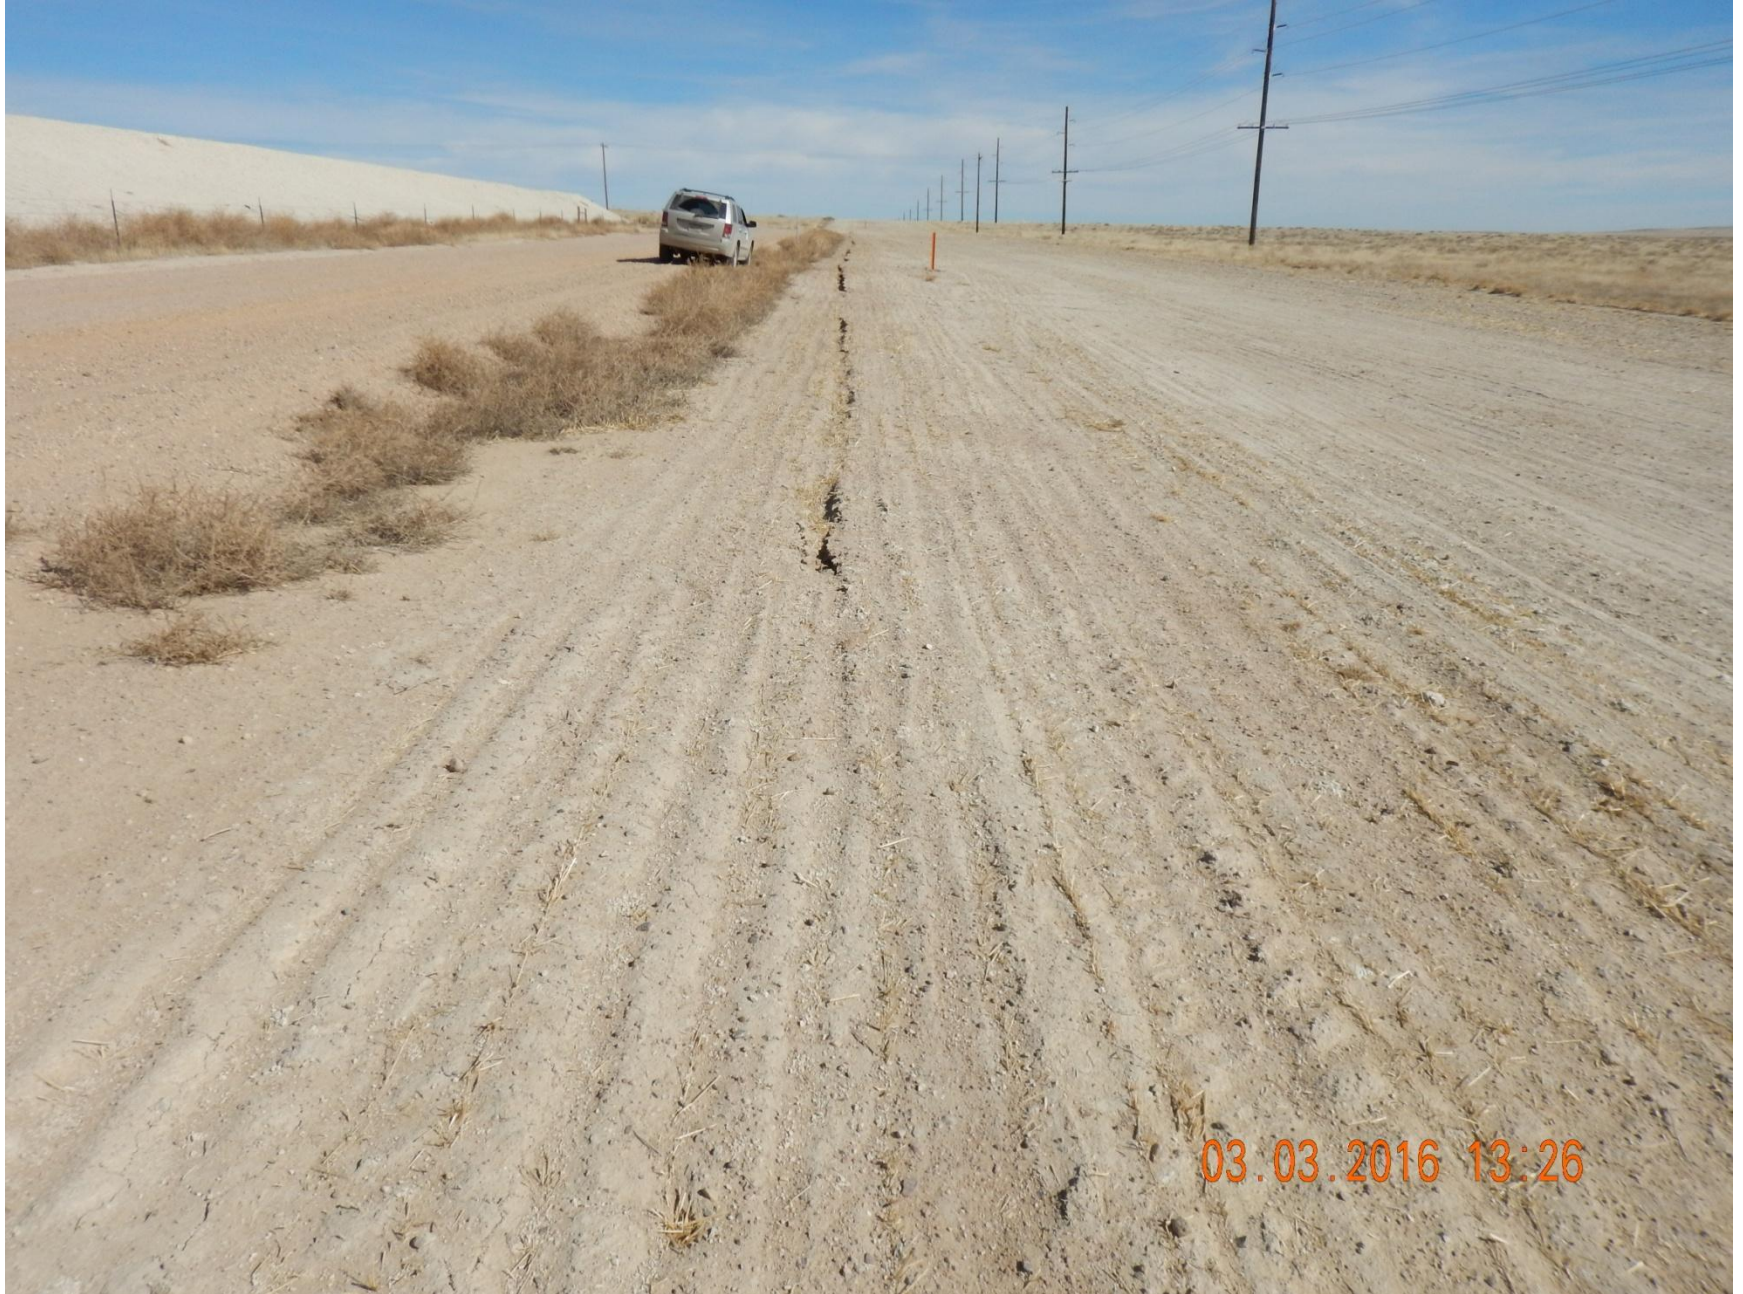
Figure 44: Photo taken from pipeline reclamation project, south of location facing east. Photo shows either subsidence or stormwater erosion occurring on pipeline.

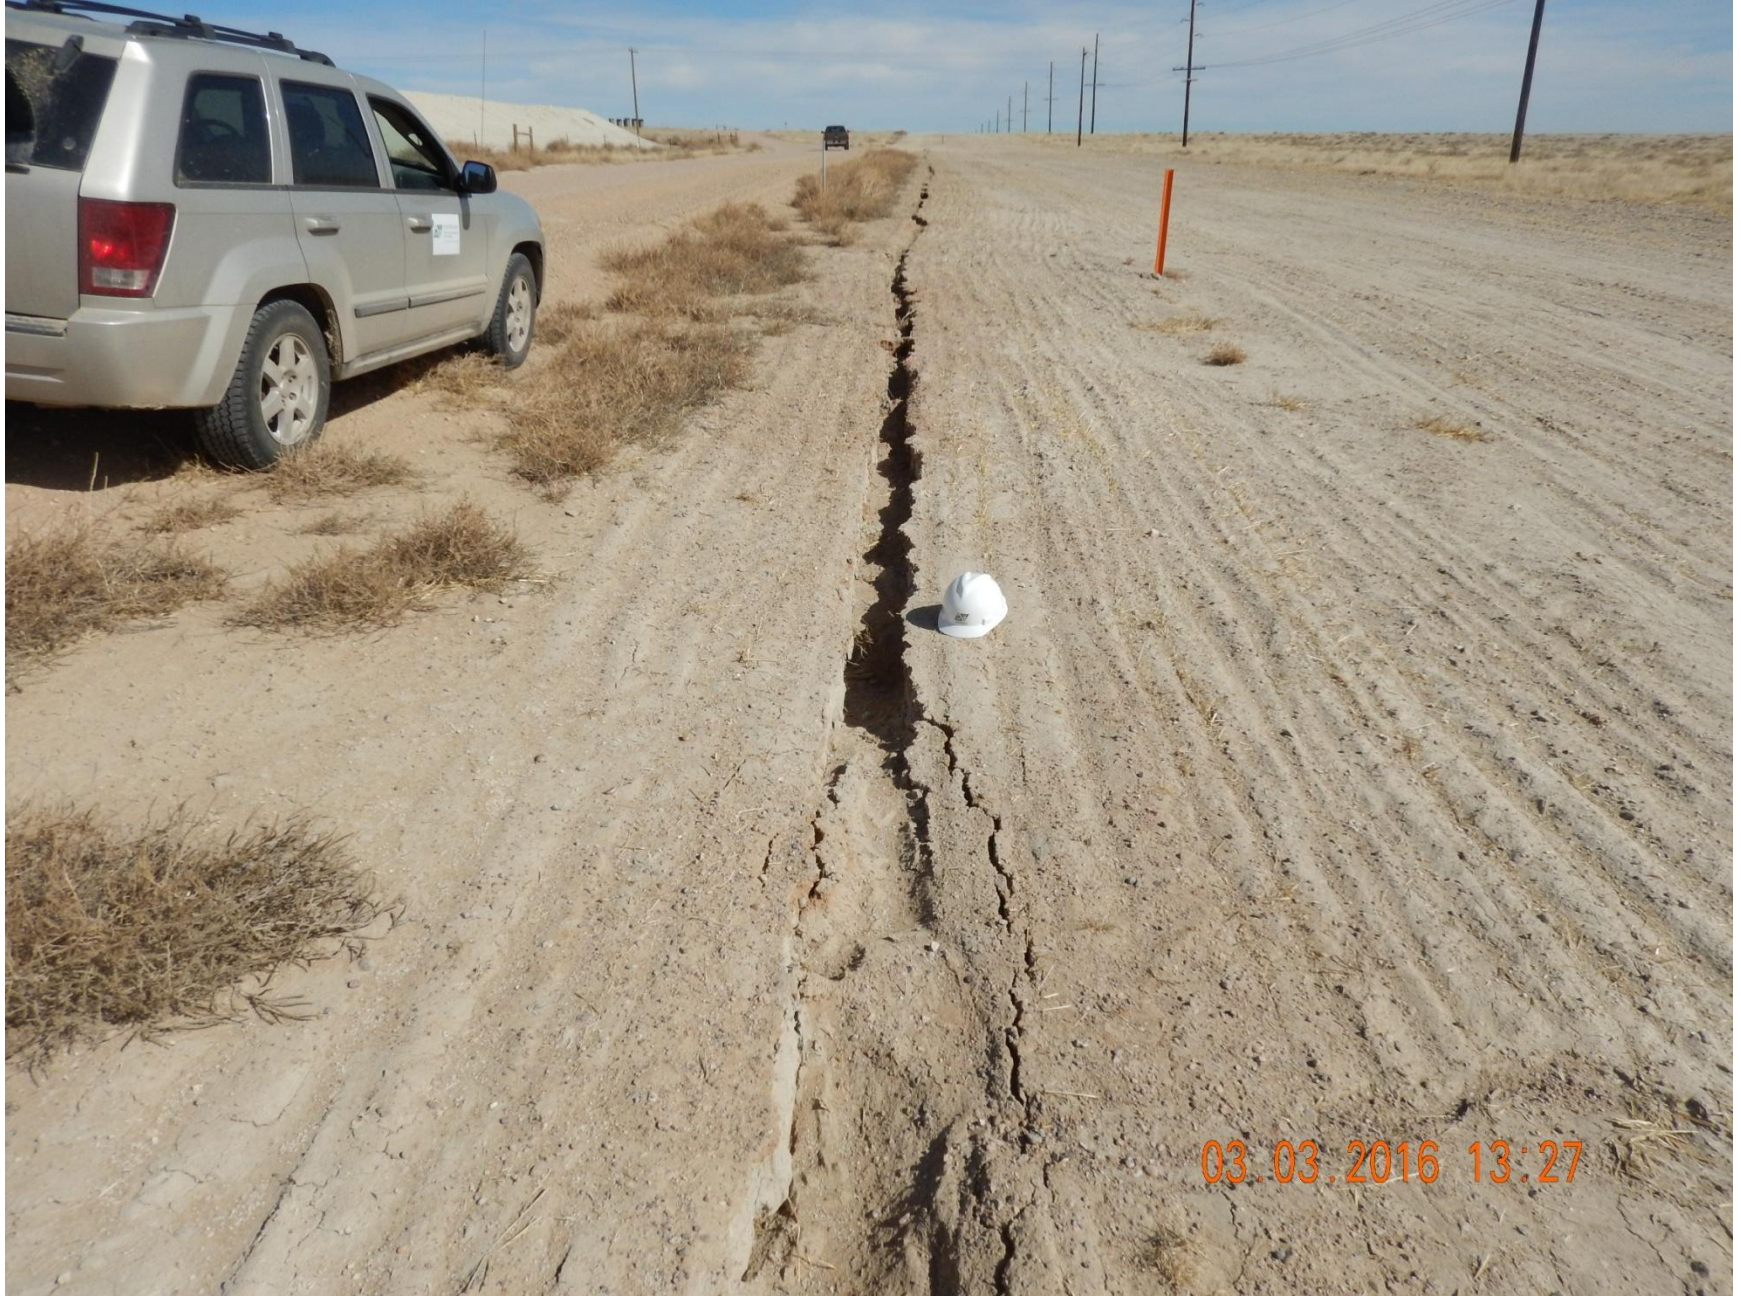
Figure 45: Photo taken from pipeline reclamation project, south of location facing east. Photo shows either subsidence or stormwater erosion occurring on pipeline.

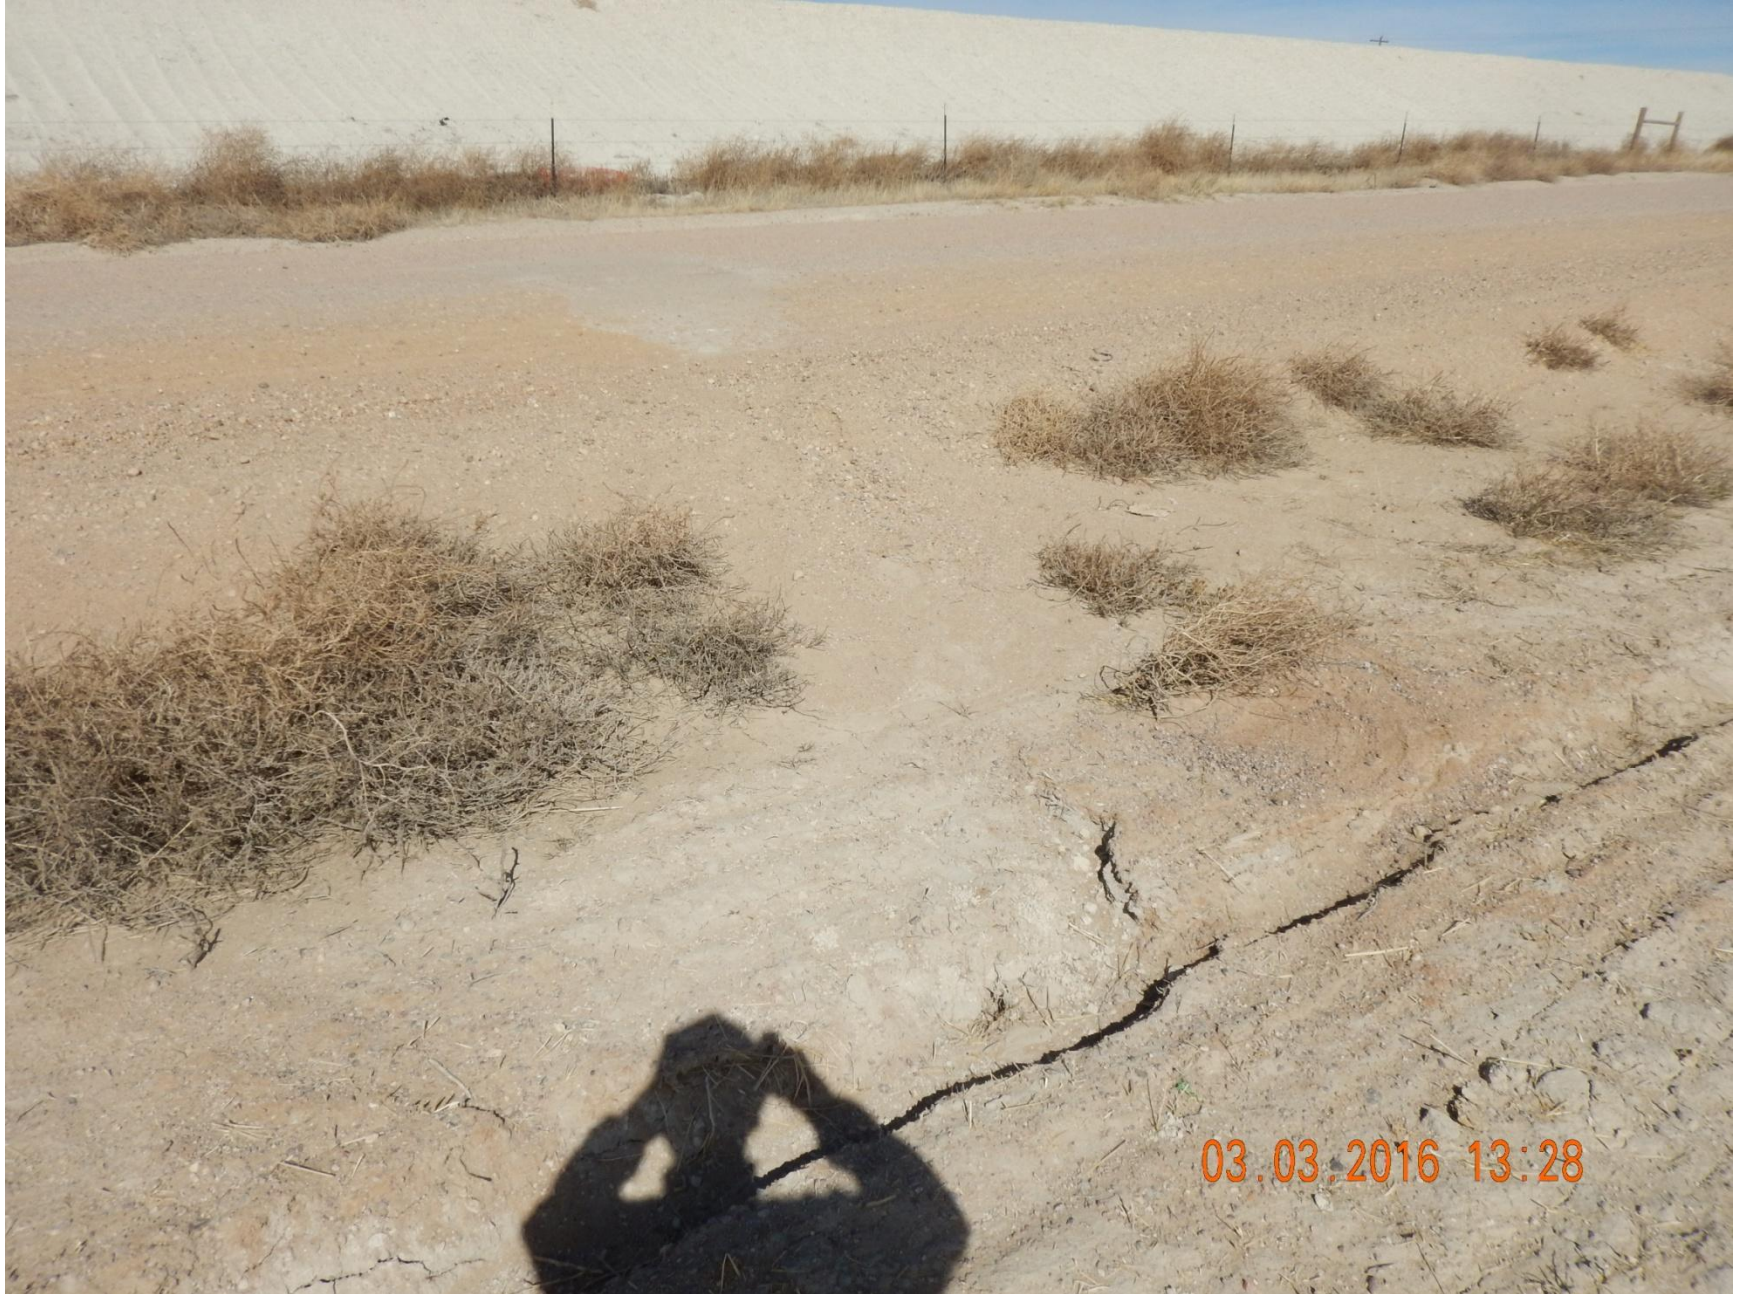
Figure 46: Photo taken from pipeline reclamation project, south of location facing east. Photo shows stormwater runoff from access road causing erosion on pipeline reclamation project.

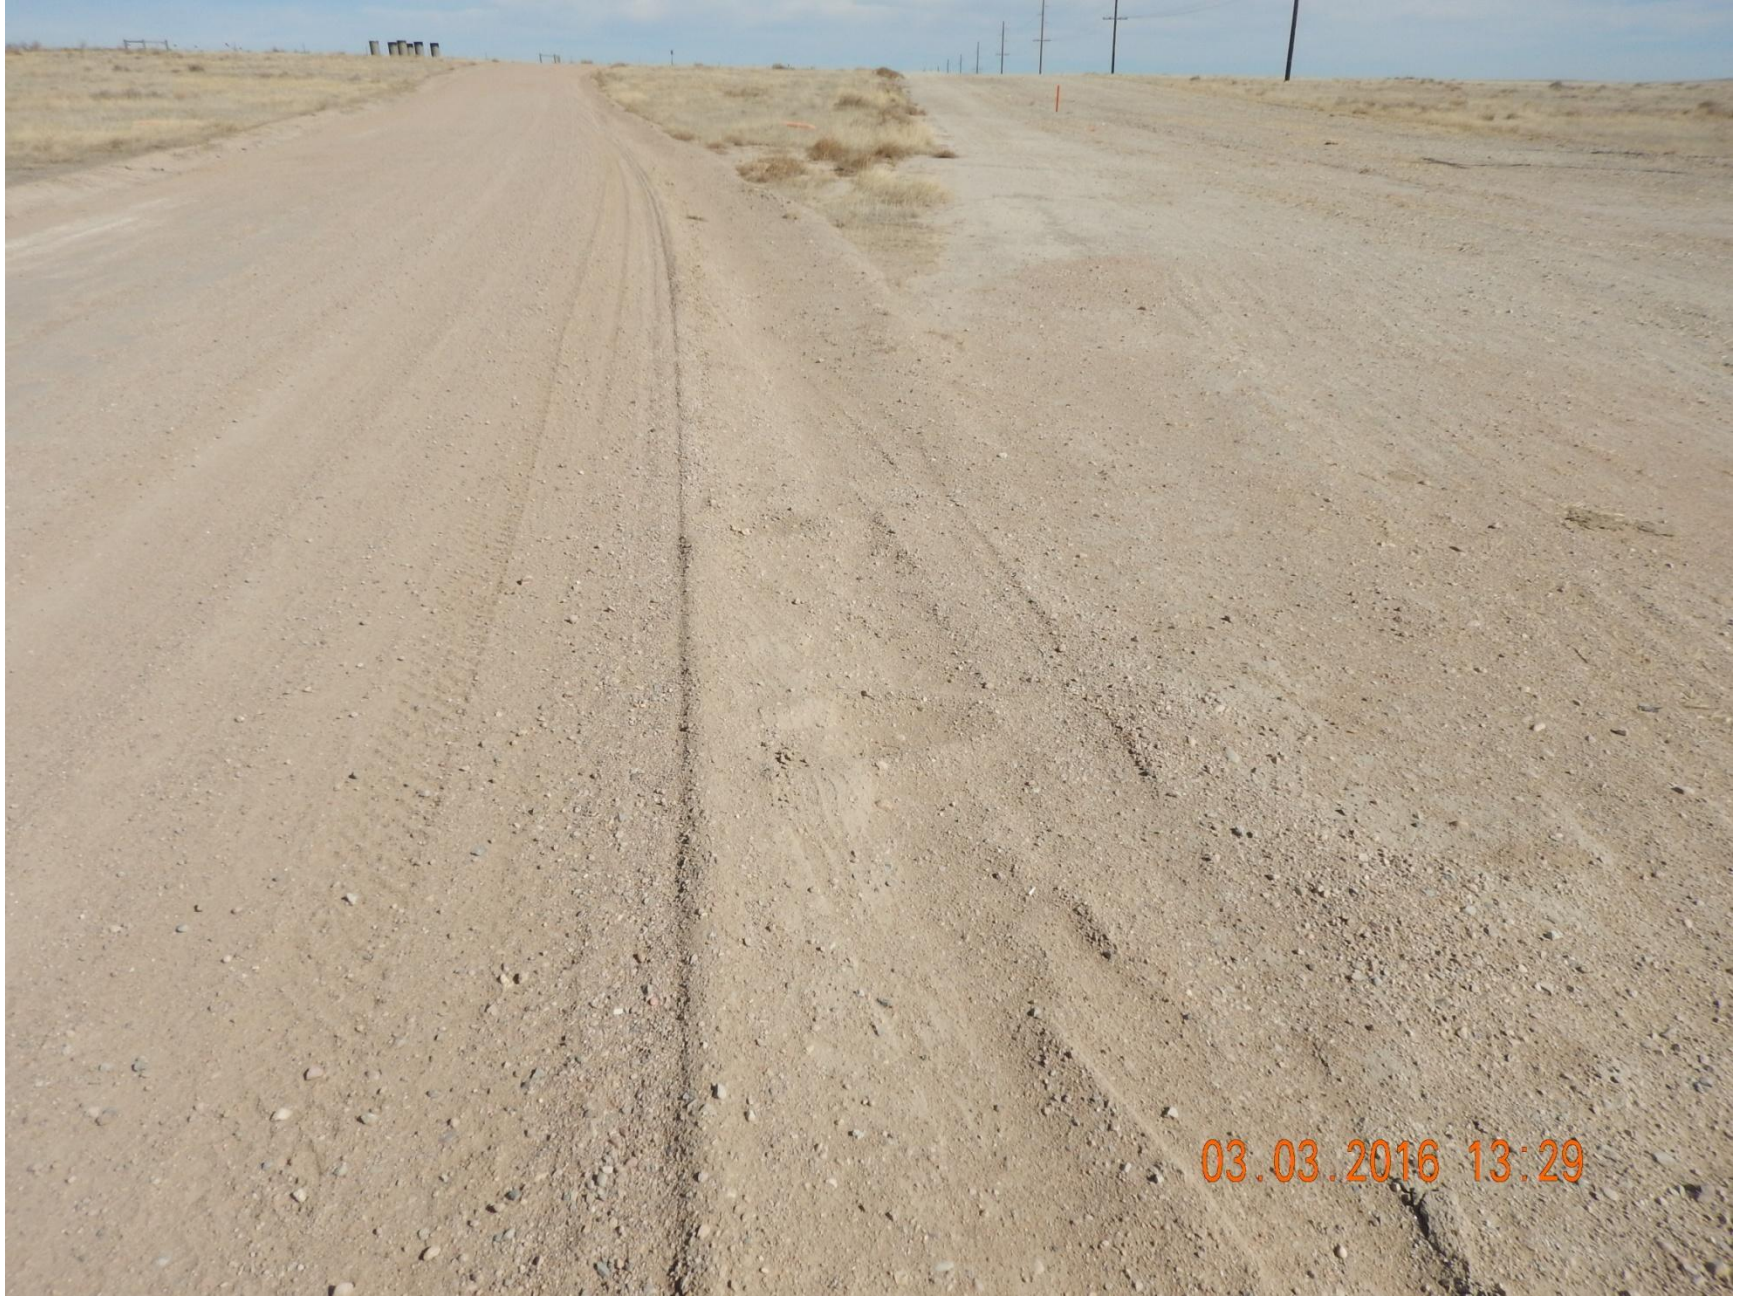
Figure 47: Photo taken from access road, southeast of location facing east. Photo shows stormwater ditch on access road leading to pipeline reclamation project.

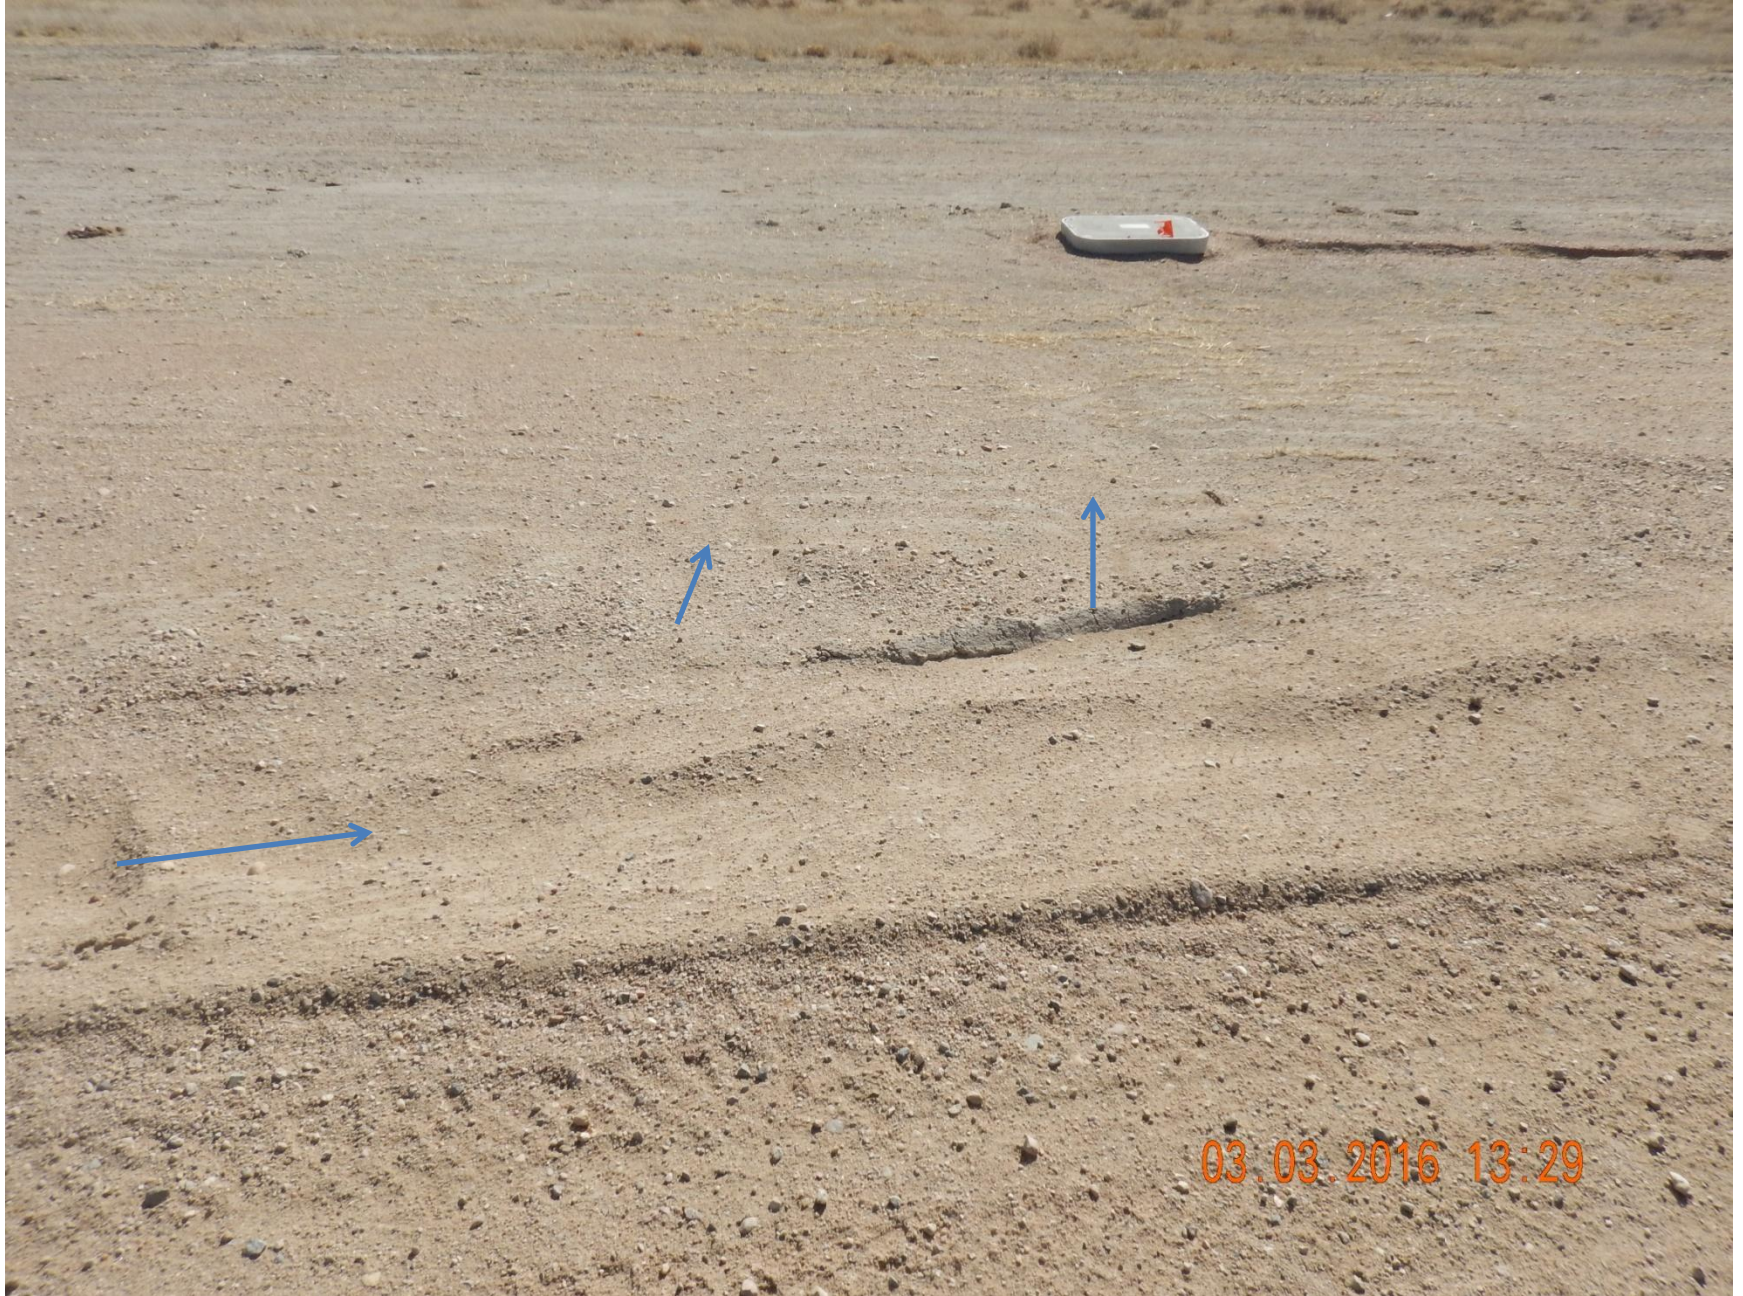
Figure 48: Photo taken from access road, southeast of location facing south. Photo shows stormwater ditch on access road leading to pipeline reclamation project.

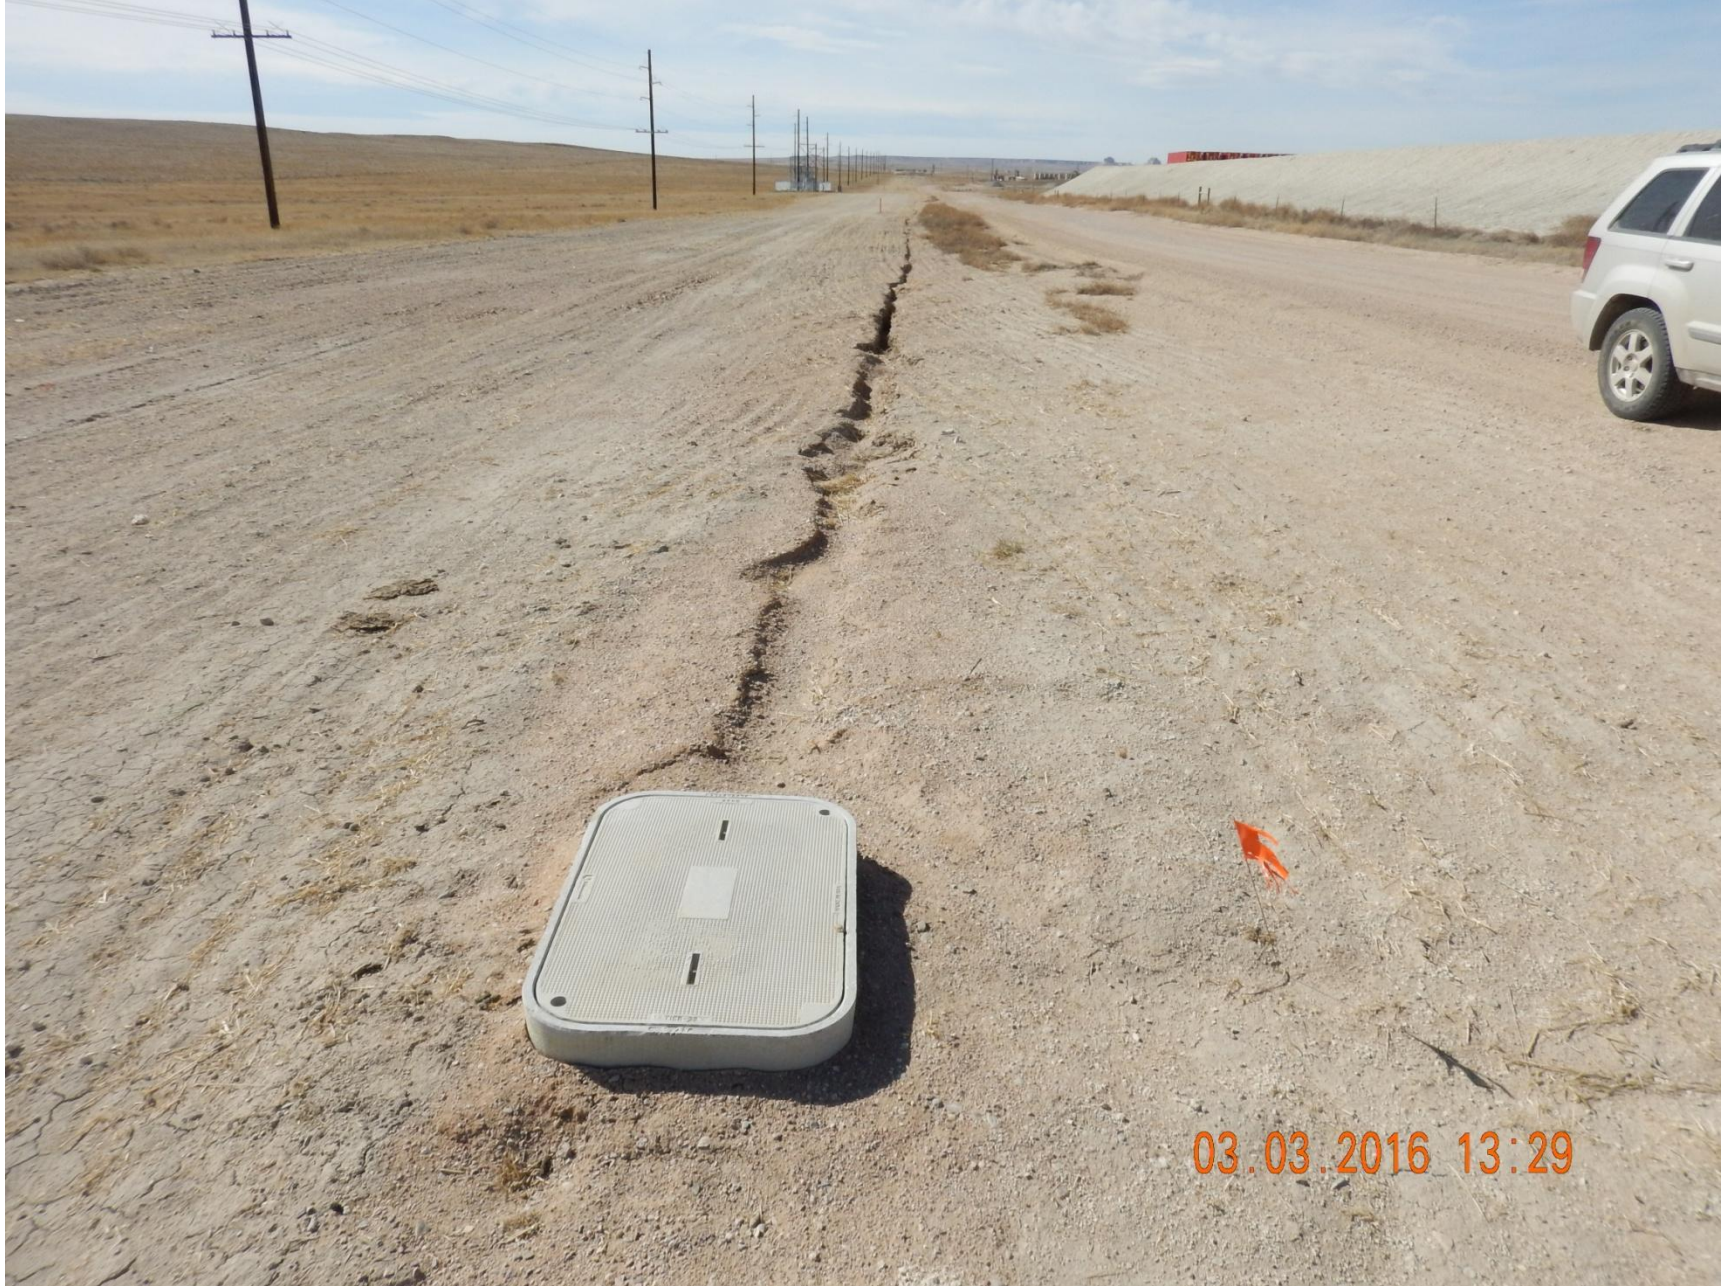
Figure 49: Photo taken from pipeline reclamation project, southeast of location facing west. Photo shows either subsidence or stormwater erosion occurring on pipeline.
