Interim Reclamation Inspection

3/3/2016

Operator: Whiting Oil and Gas

Location ID: 434267

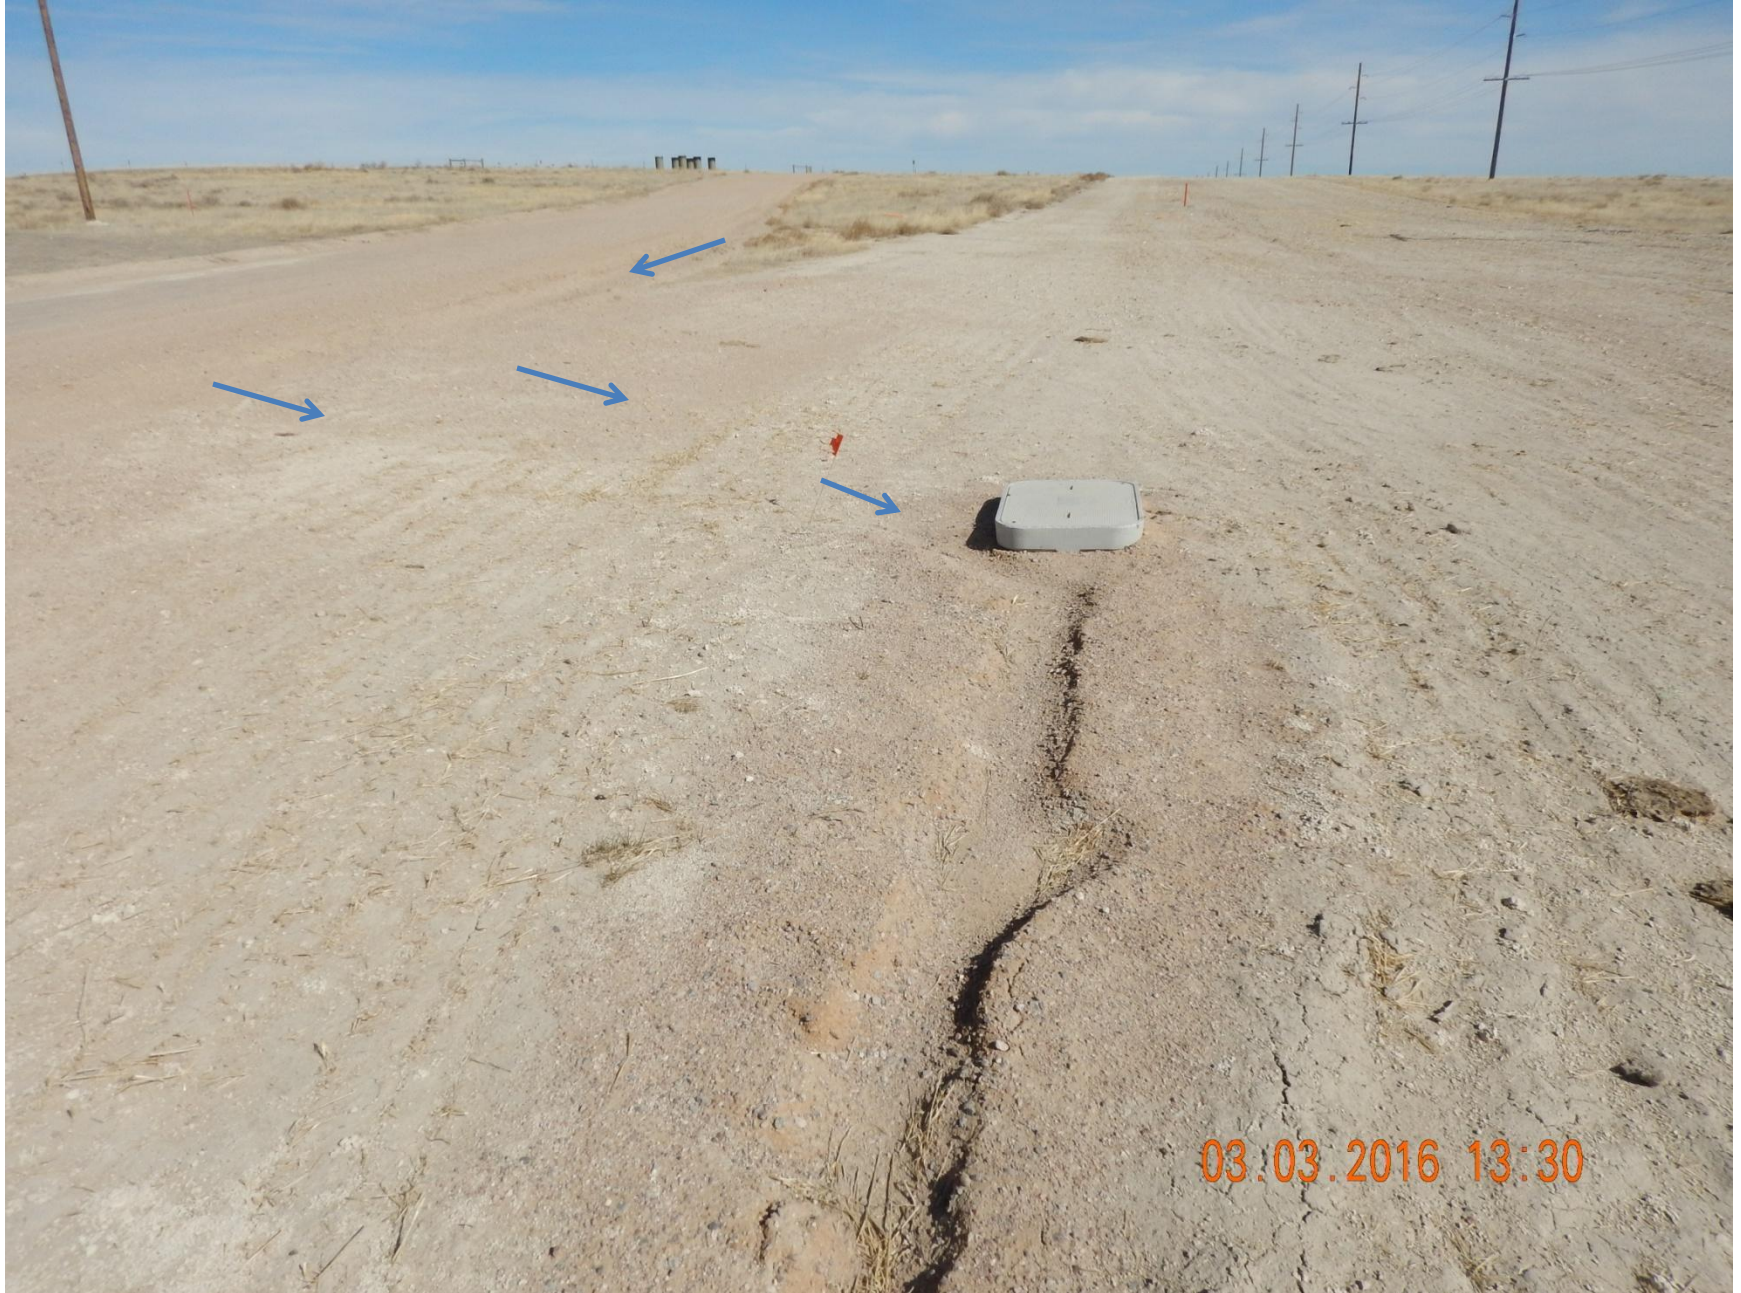
Figure 50: Photo taken from pipeline reclamation project, south of location facing east. Photo shows either subsidence or stormwater erosion occurring on pipeline. Note stormwater movement patterns off access road ditch leading into reclamation project.

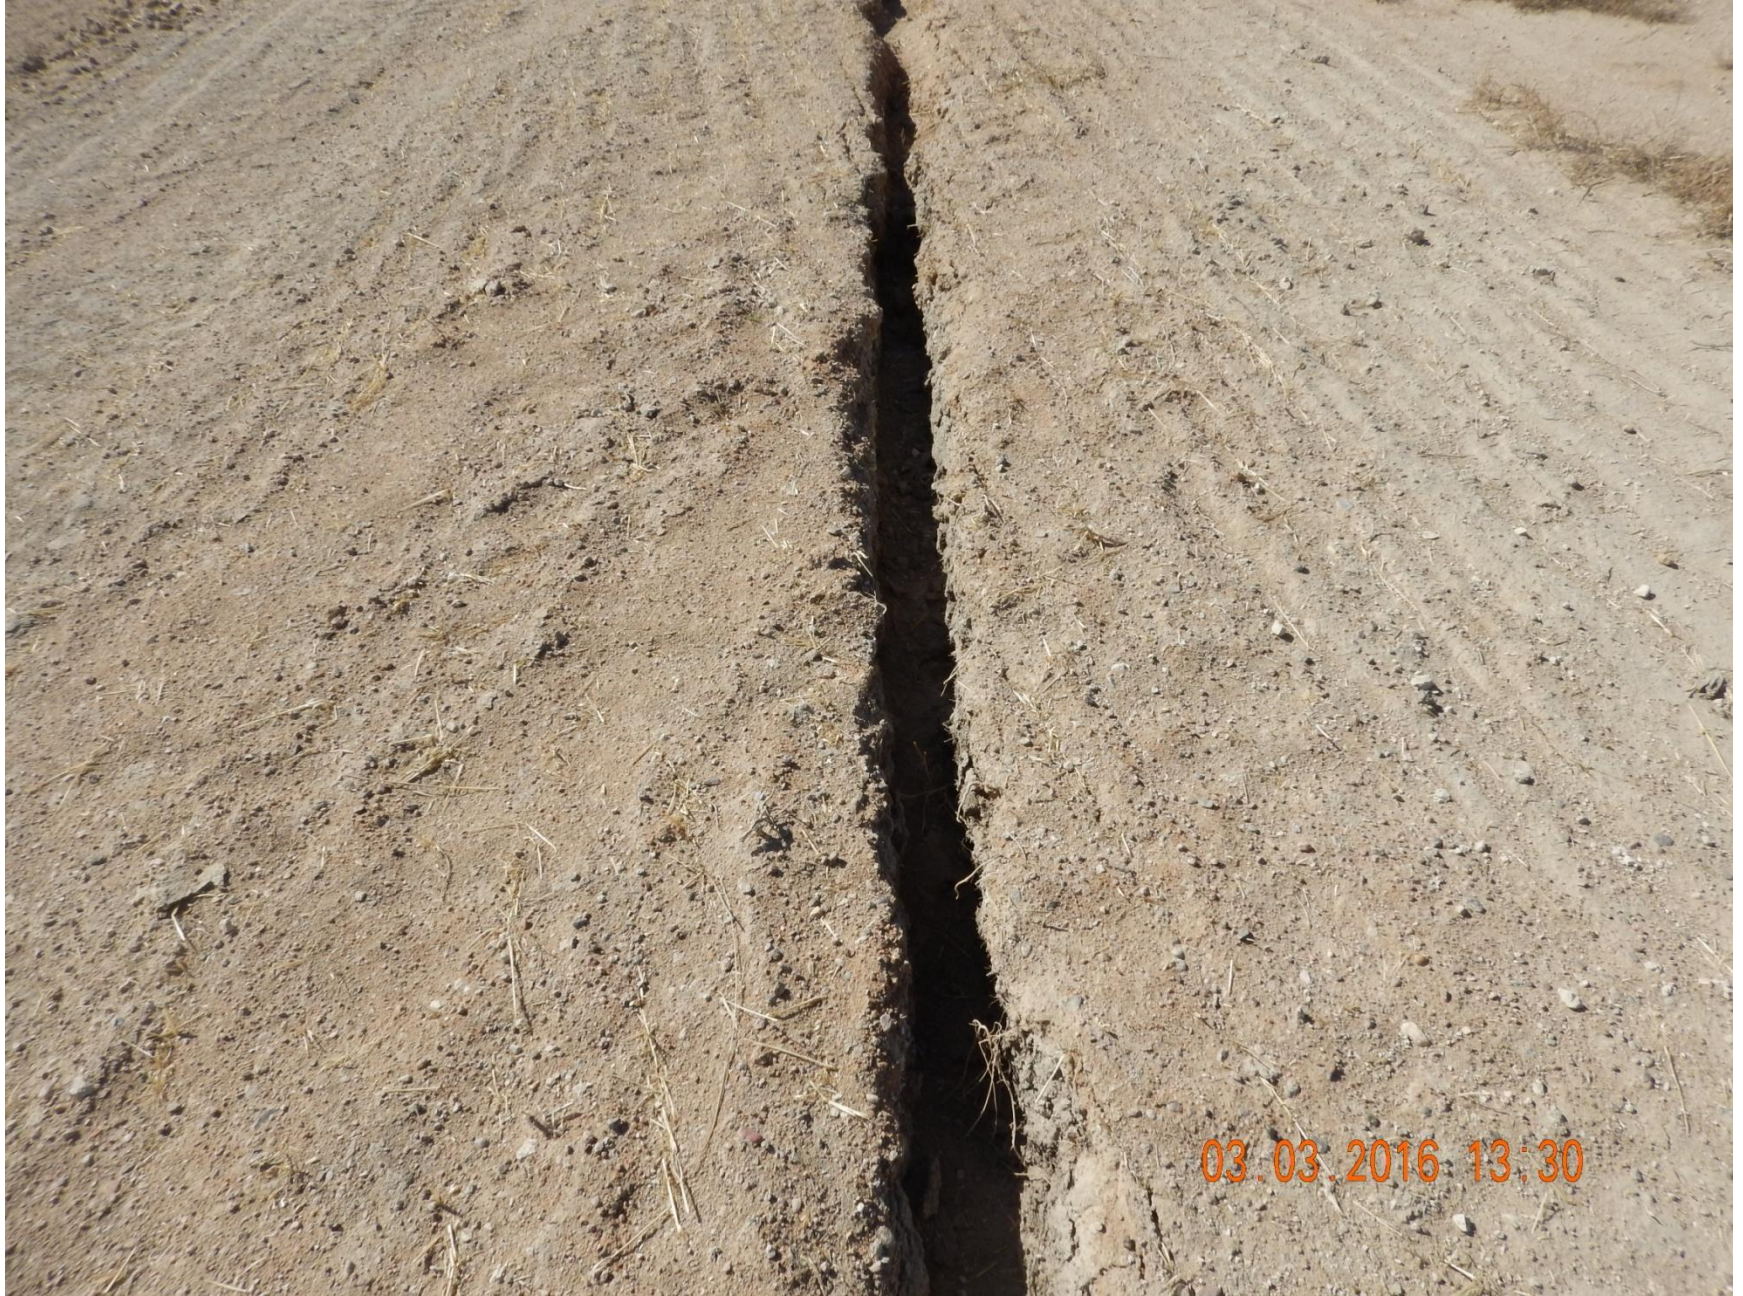
Figure 51: Photo taken from pipeline reclamation project, southeast of location facing west. Photo shows either subsidence or stormwater erosion occurring on pipeline.

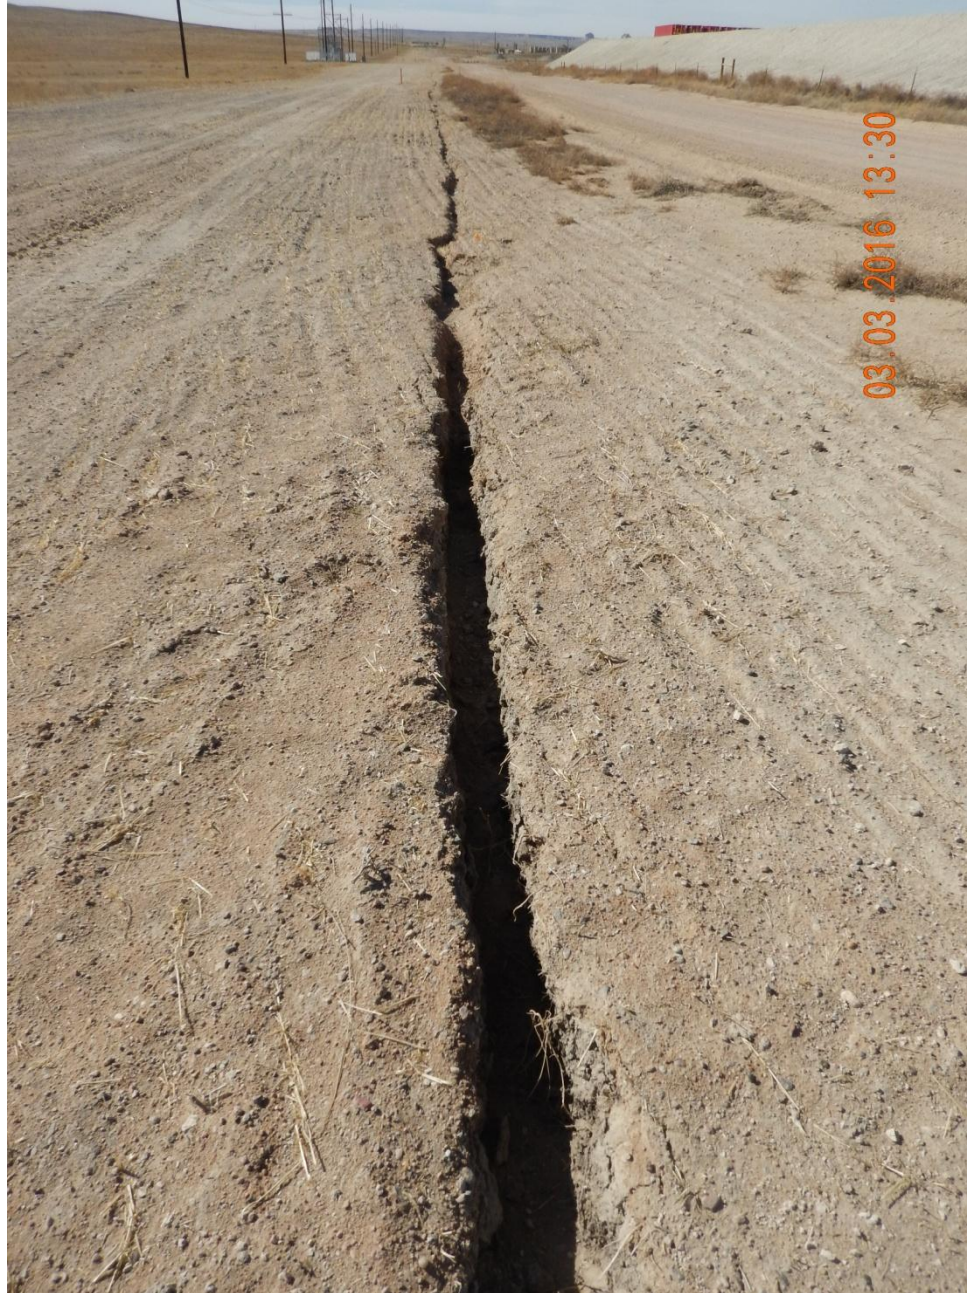
Figure 52: Photo taken from pipeline reclamation project, southeast of location facing west. Photo shows either subsidence or stormwater erosion occurring on pipeline.
