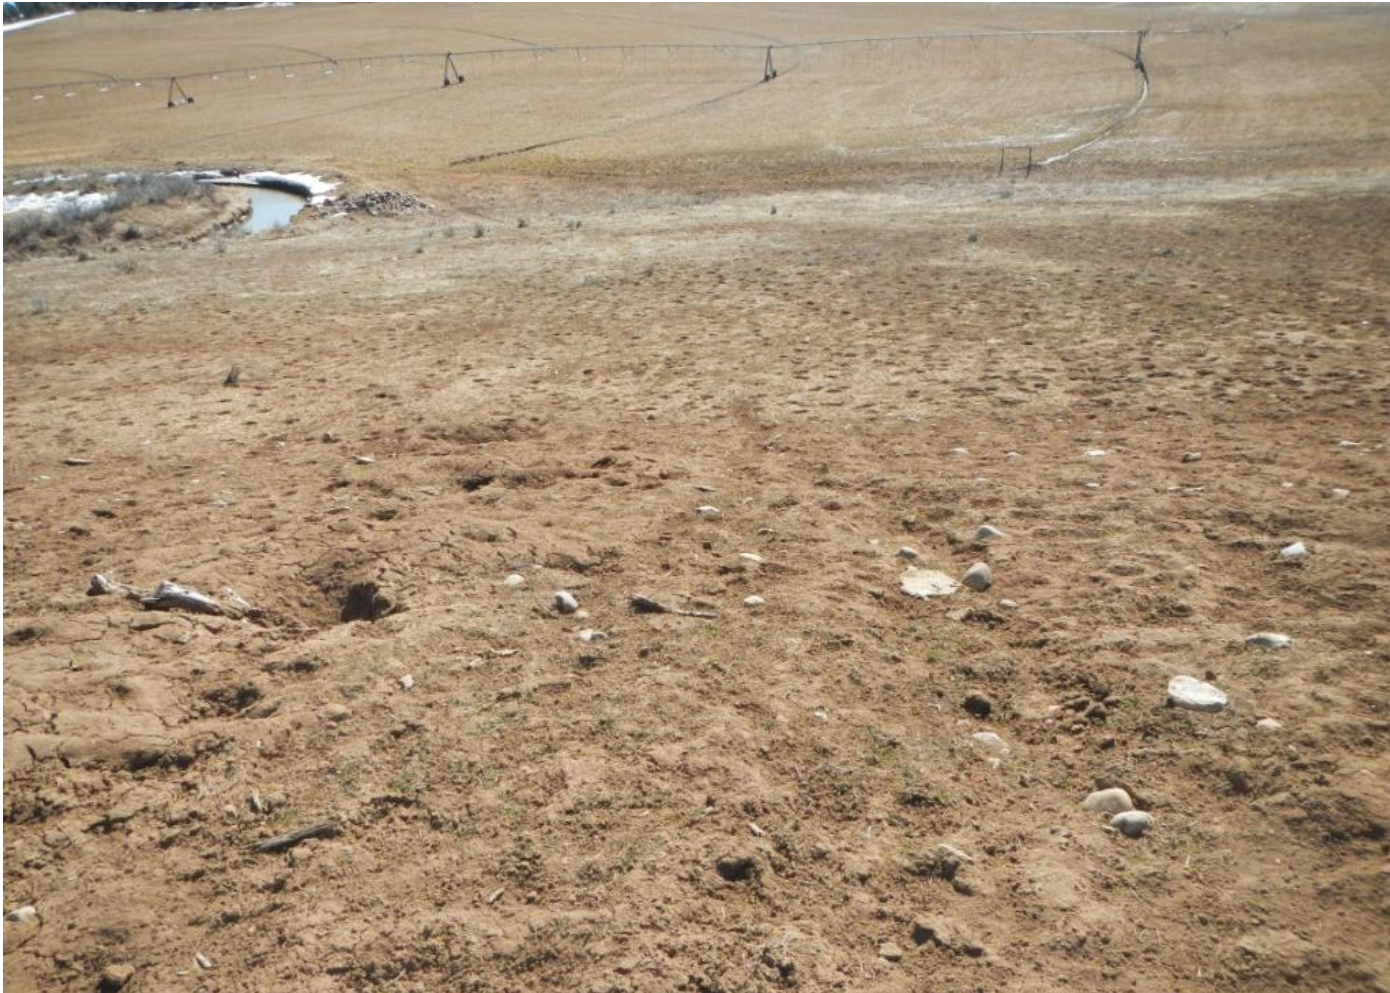
Photo 1. View of rills in southern slope eroding toward an irrigation canal southeast of the project area.

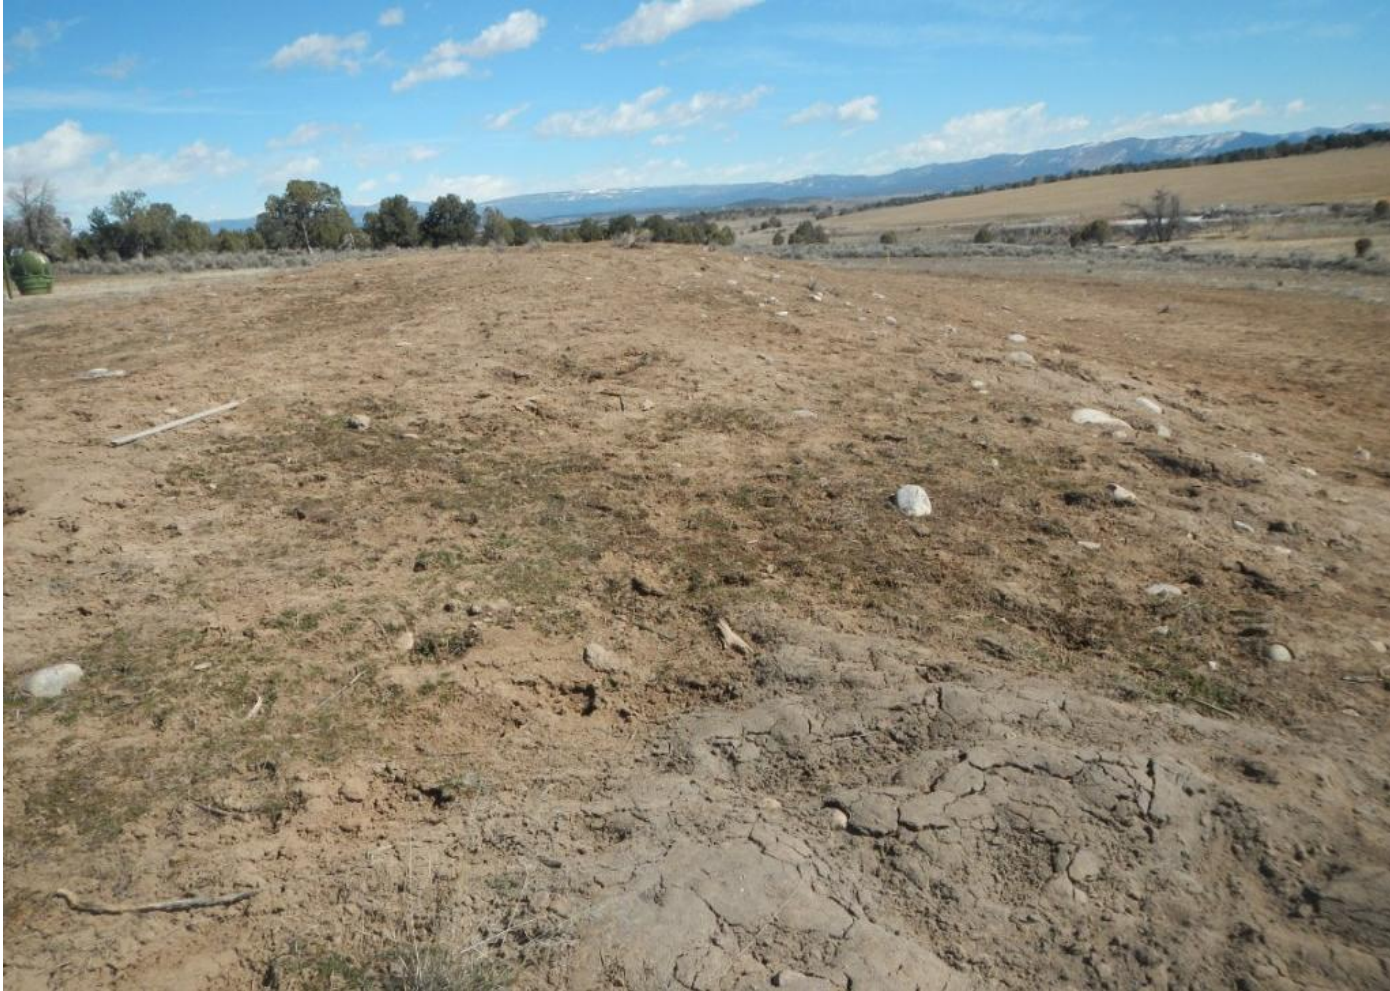
Photo 2. View of the southern portion of the project area from the southwestern corner facing eastward. Poor revegetation observed on this slope needs to be monitored and re-seeded in 2016 if vegetative cover is not increasing.

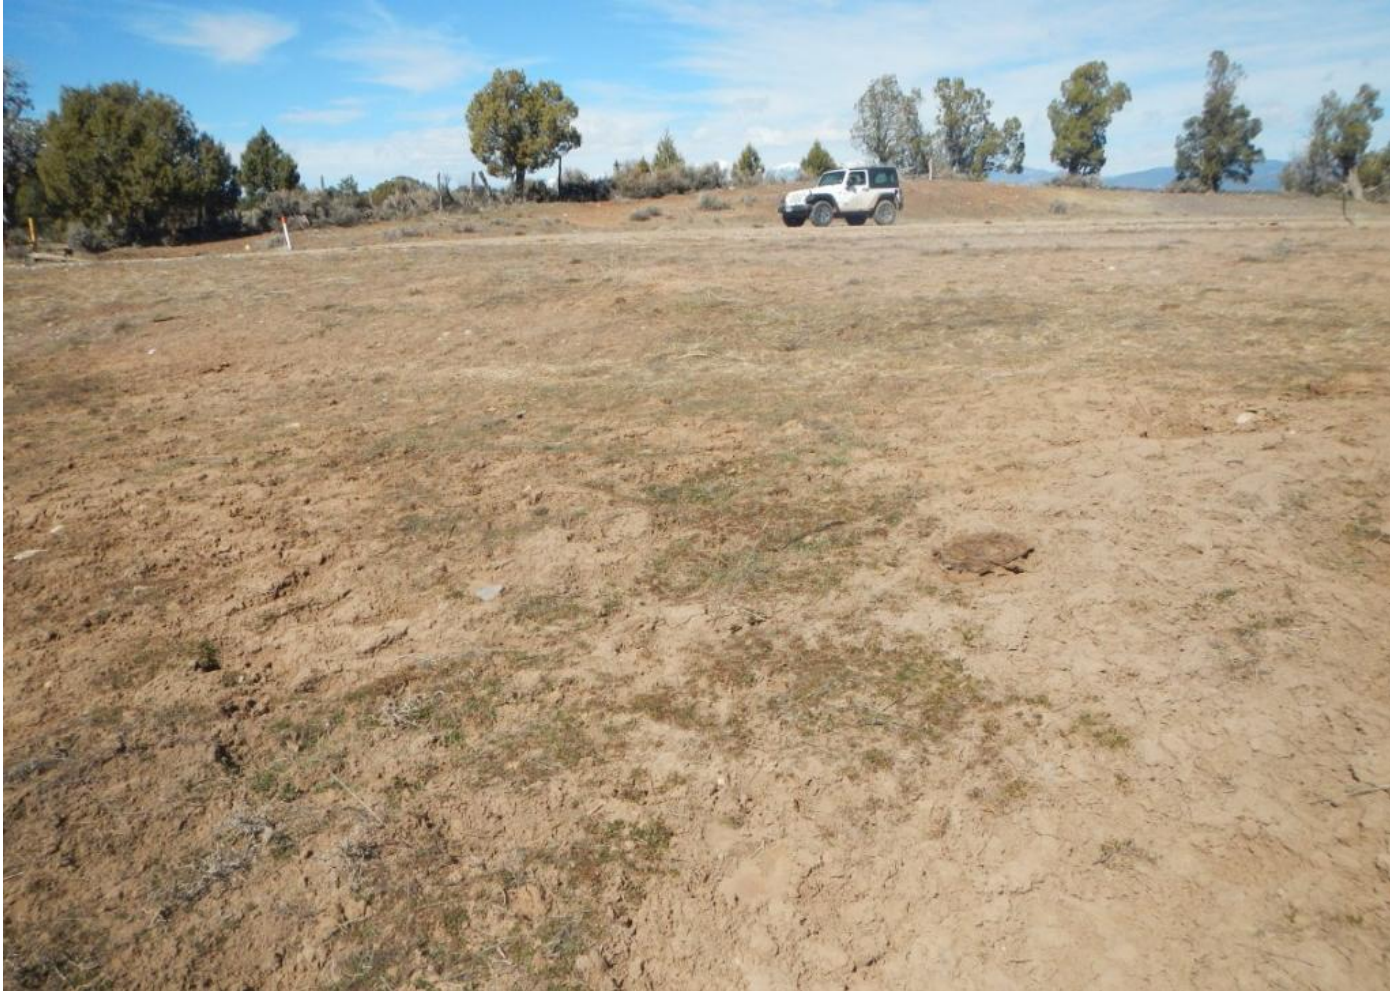
Photo 3. View of the western portion of the project area from the southwestern corner facing northward.

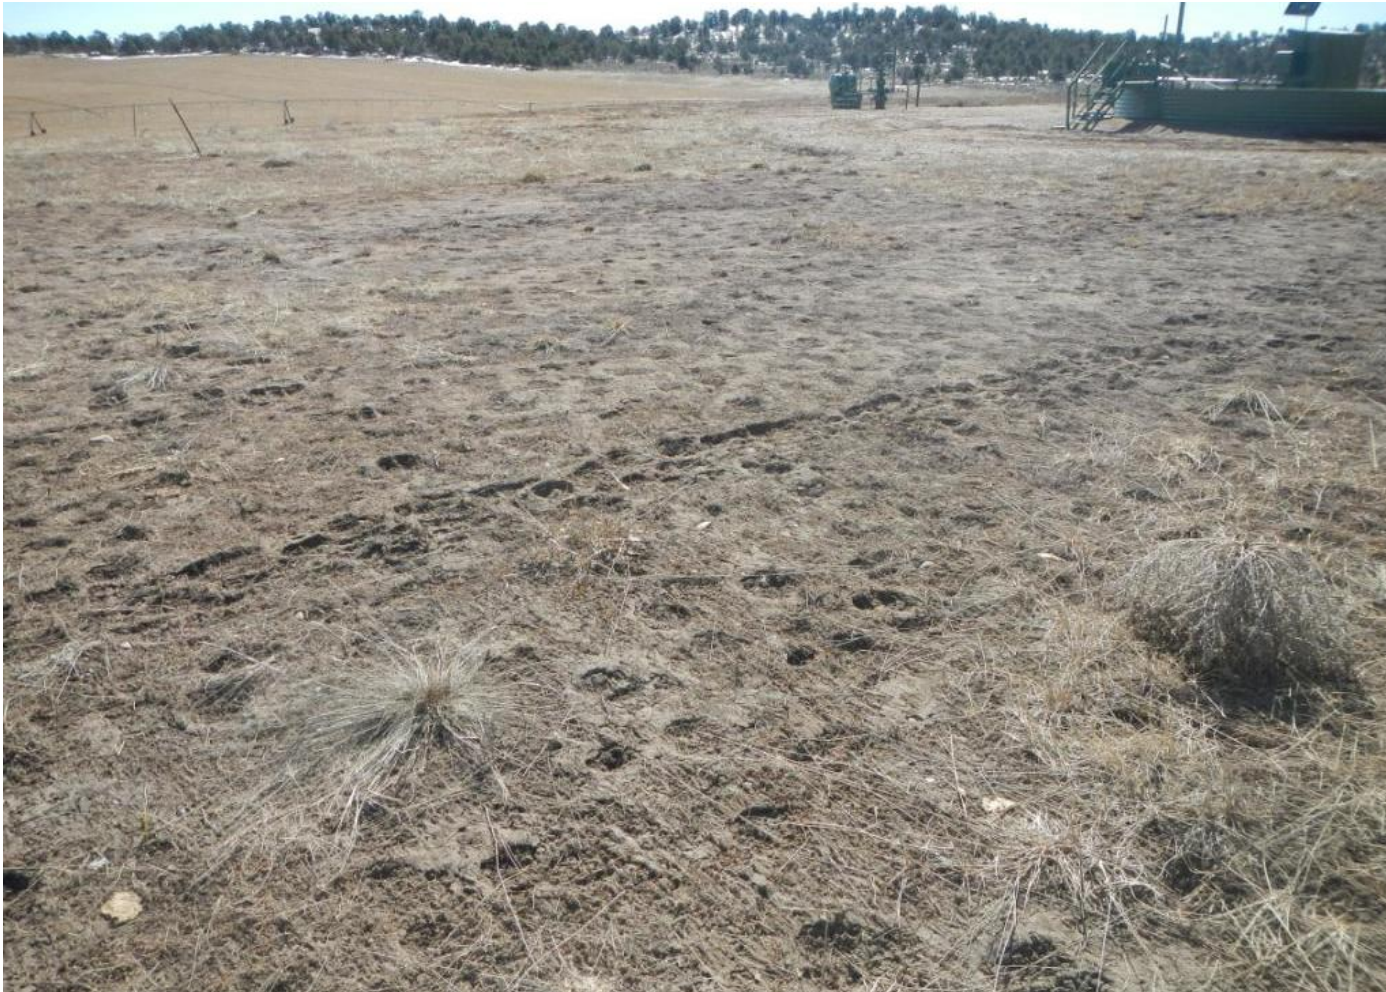
Photo 4. View of the eastern portion of the project area from the northeastern corner facing southward. Revegetation appears to be heavily grazed and should be monitored and re-seeded if vegetation is not increasing in fall 2016.

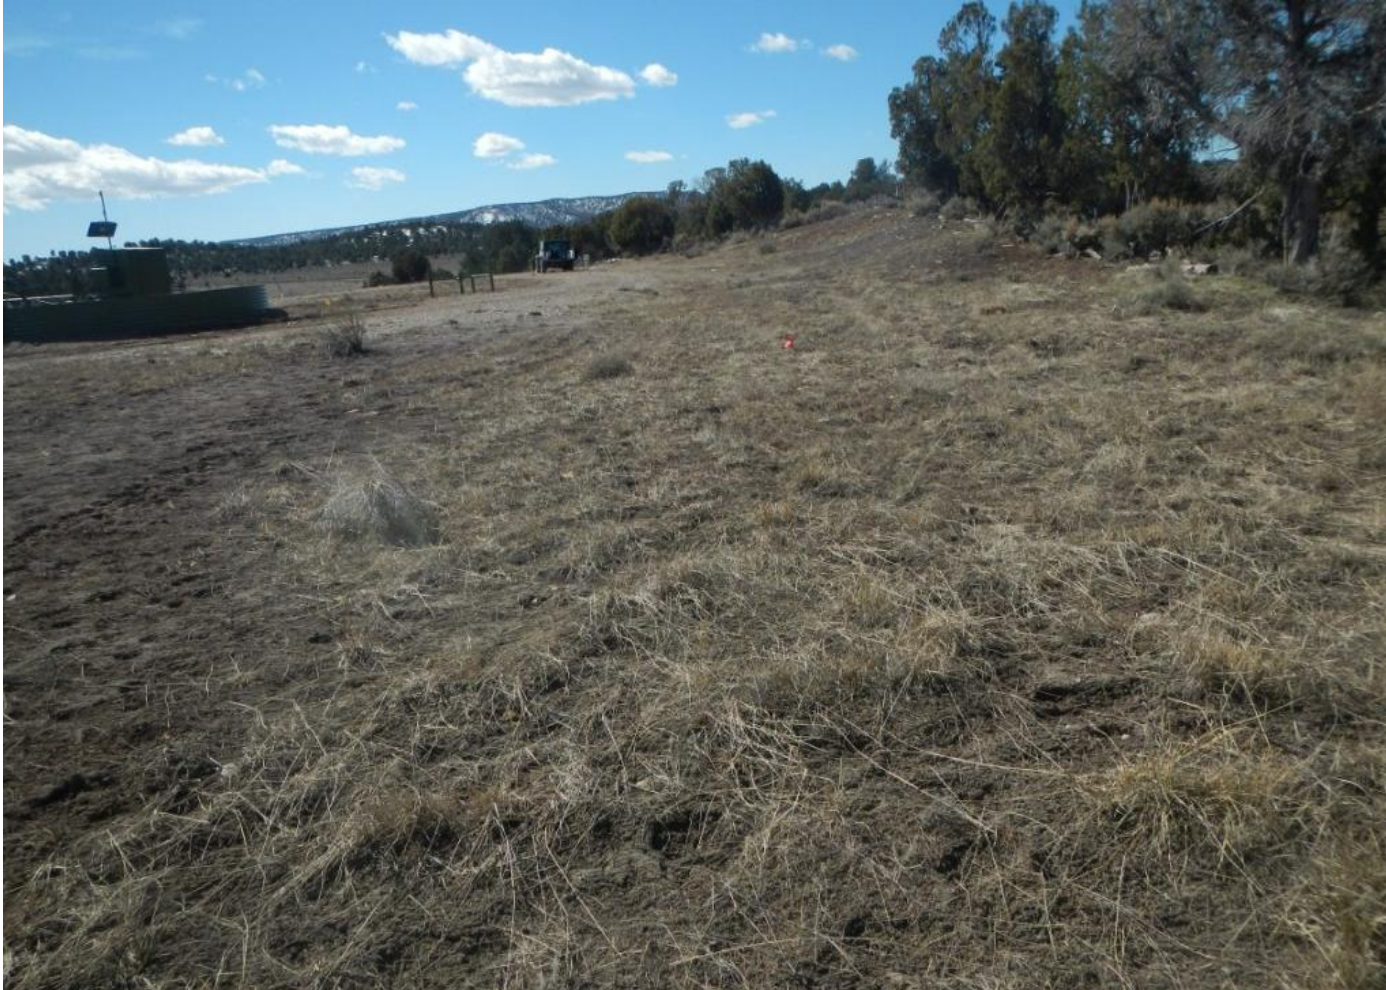
Photo 5 View of the northern portion of the project area from the northeastern corner facing westward. Grasses such as Indian ricegrass (*Achnatherum hymenoides*) and western wheatgrass (*Pascopyron smithii*) are growing here.

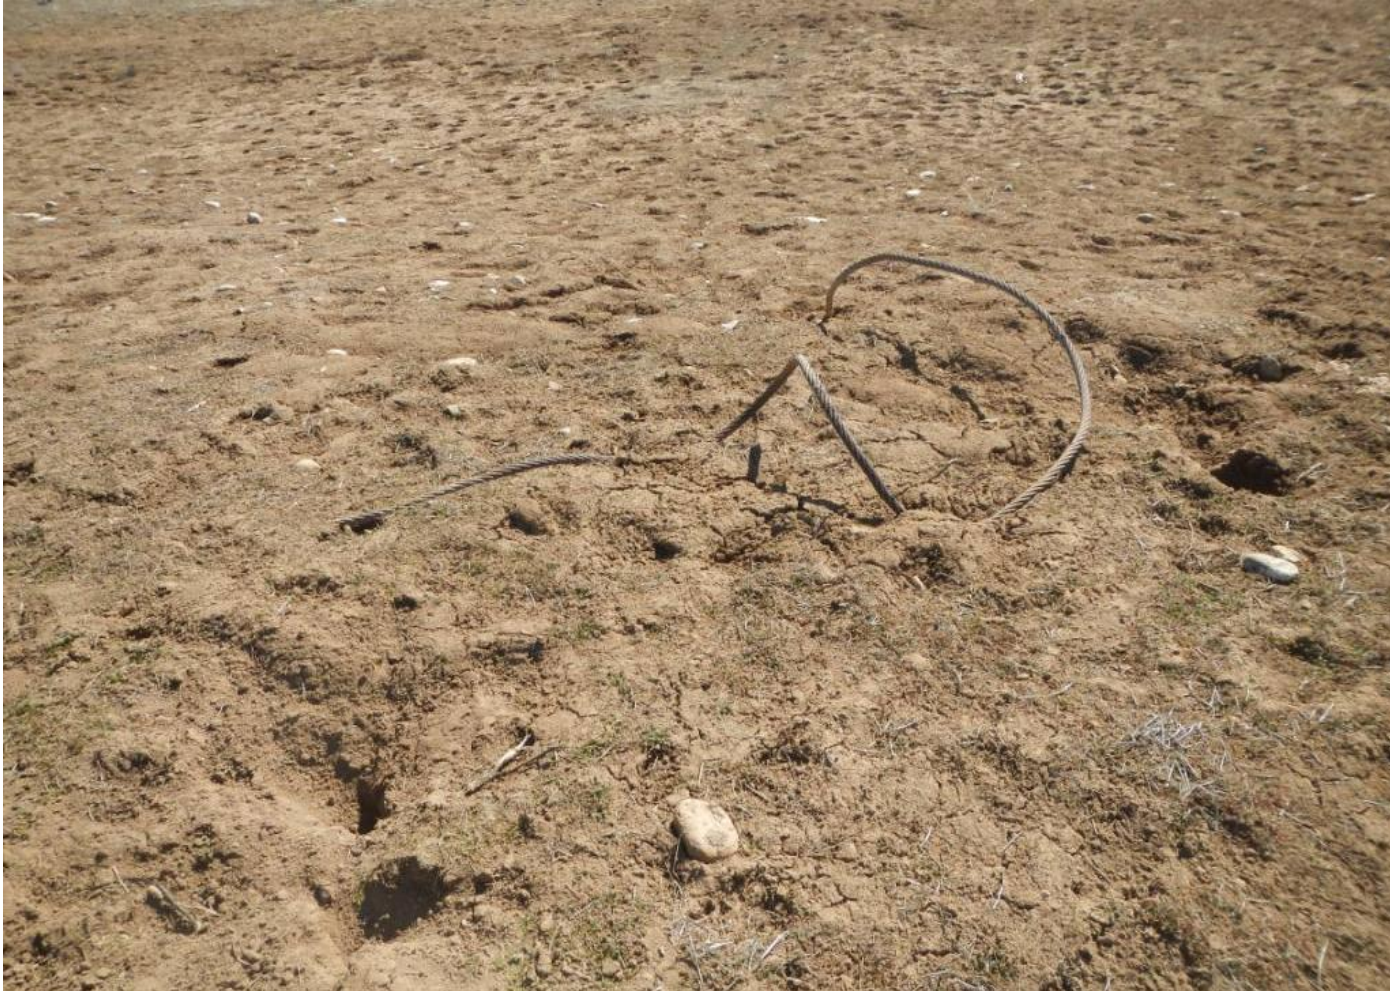
Photo 6. View of rig anchor cable in the southern portion of the project area. This needs to be removed.

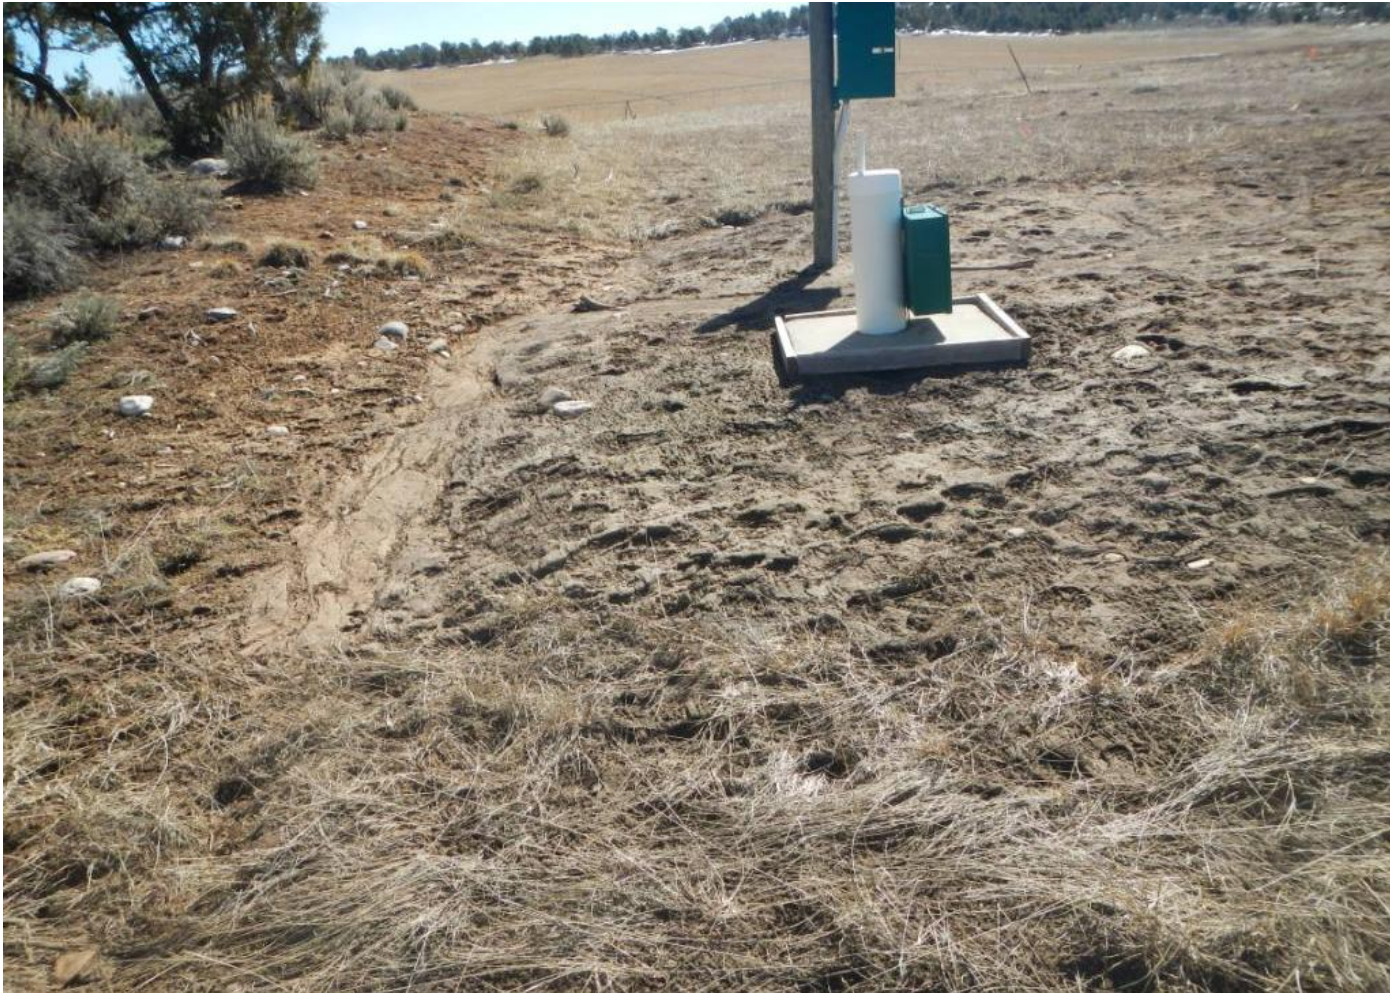
Photo 7. View of area in the northeastern corner of the project area where stormwater flows off of the well pad and is eroding the slope northeast of the project area, shown in Photo 8.

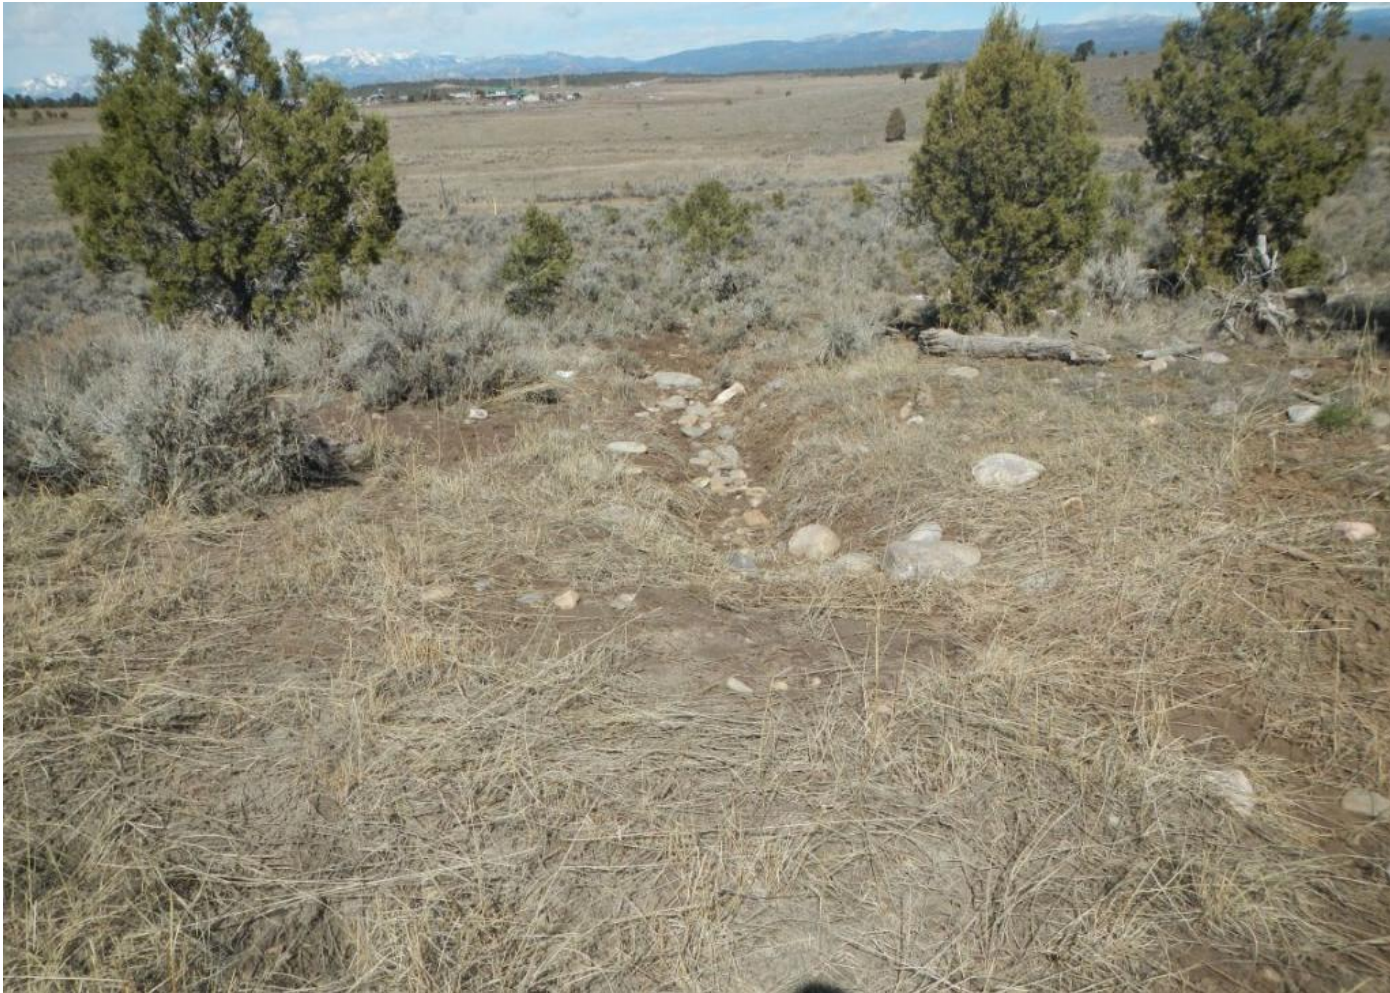
Photo 8. View of stormwater erosion downstream from Photo 7, where stormwater flows are eroding a channel northeast of the project area. Channel is approximately 2 feet wide and 1 foot deep.
