Antelope Farms #1-24 March 1, 2016 Environmental Inspection – S. Arauza

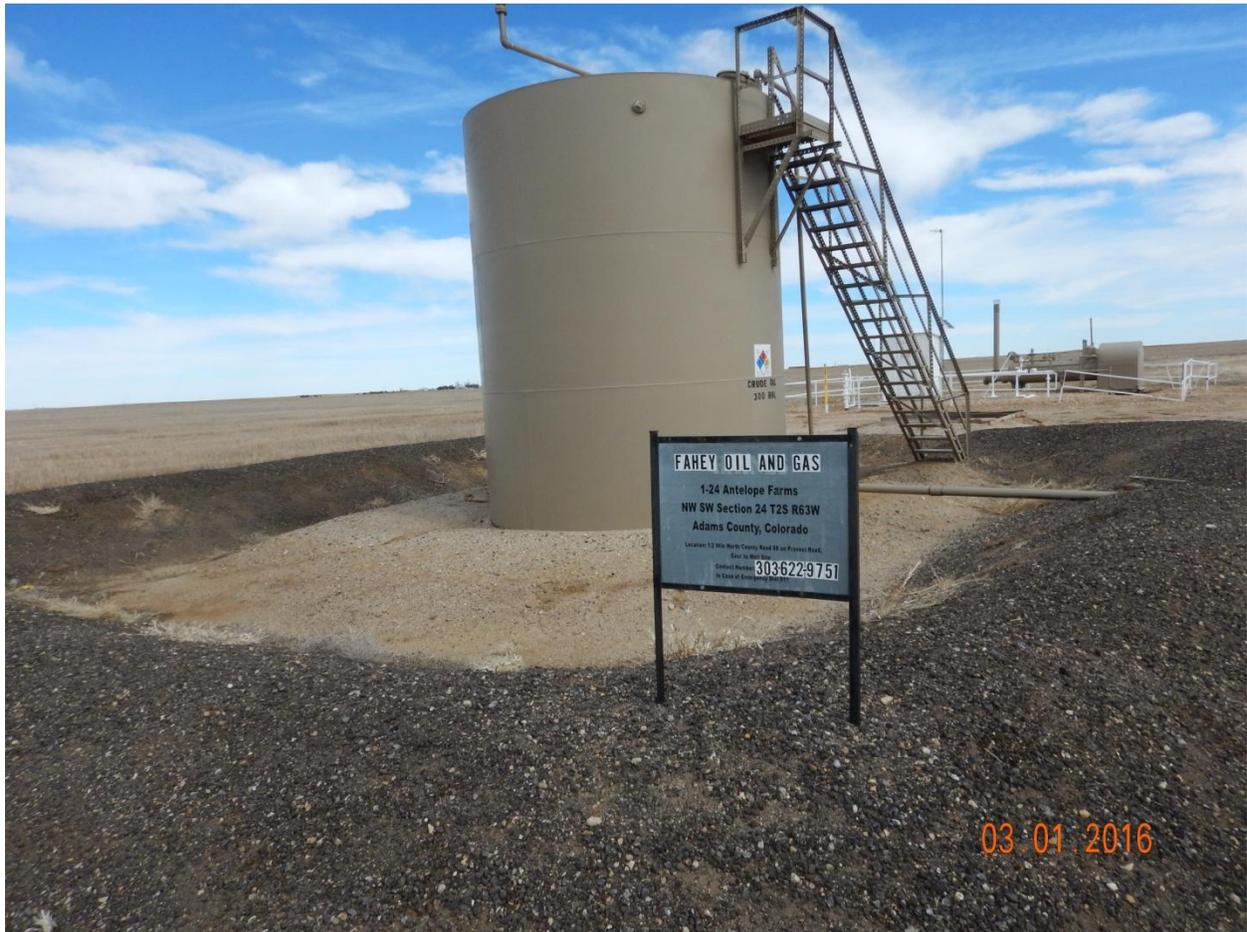
Figure 1 - Tank sign and tank.

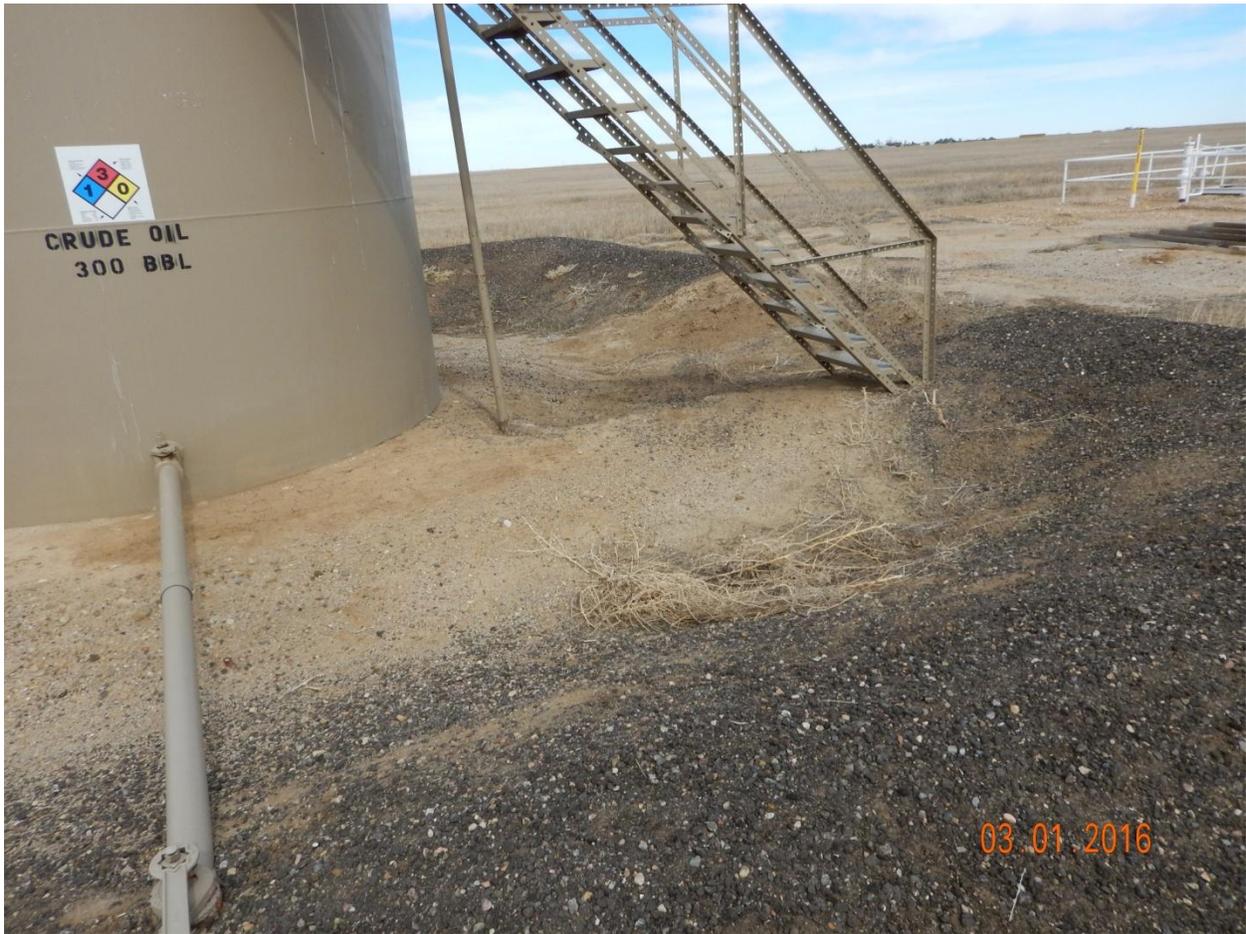
Figure 2 – Vegetation growth inside of tank battery berm.

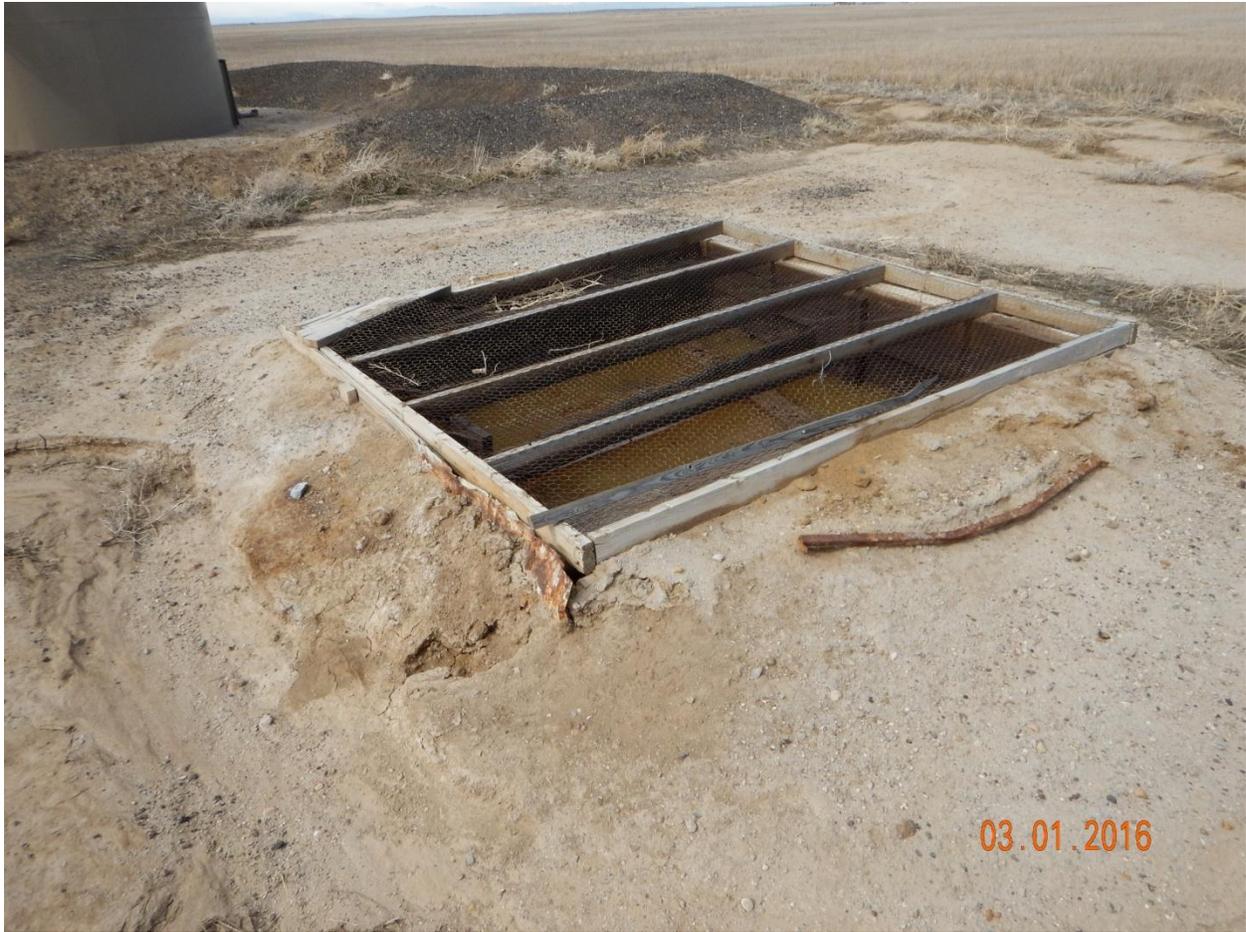
Figure 3 – Stained soil, maintenance issues, and gaps in wildlife protection at skim pit.

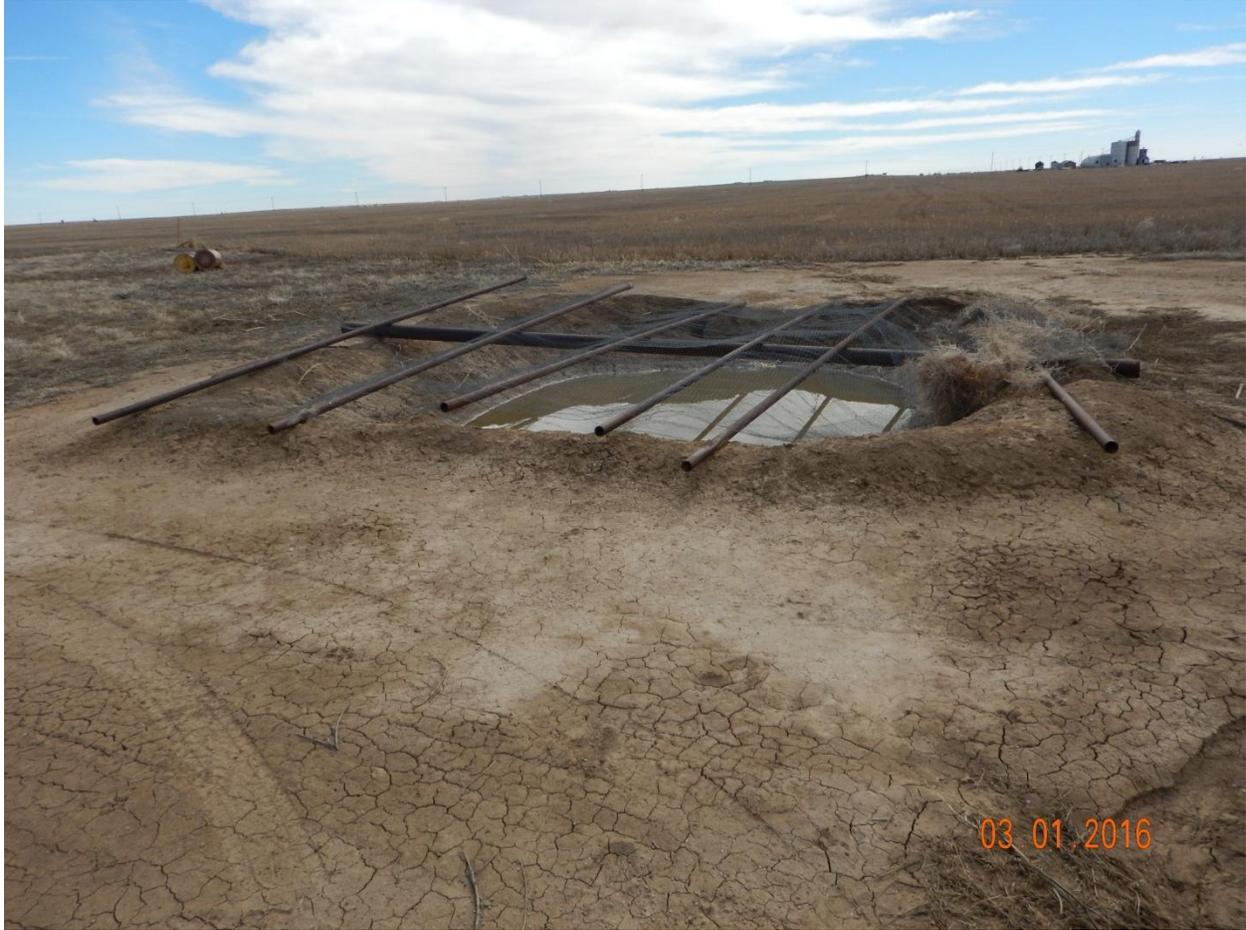
Figure 4 - View of produced water pit from northwest corner. Note sagging wildlife protection mesh and tumbleweeds encroaching on pit from the west.

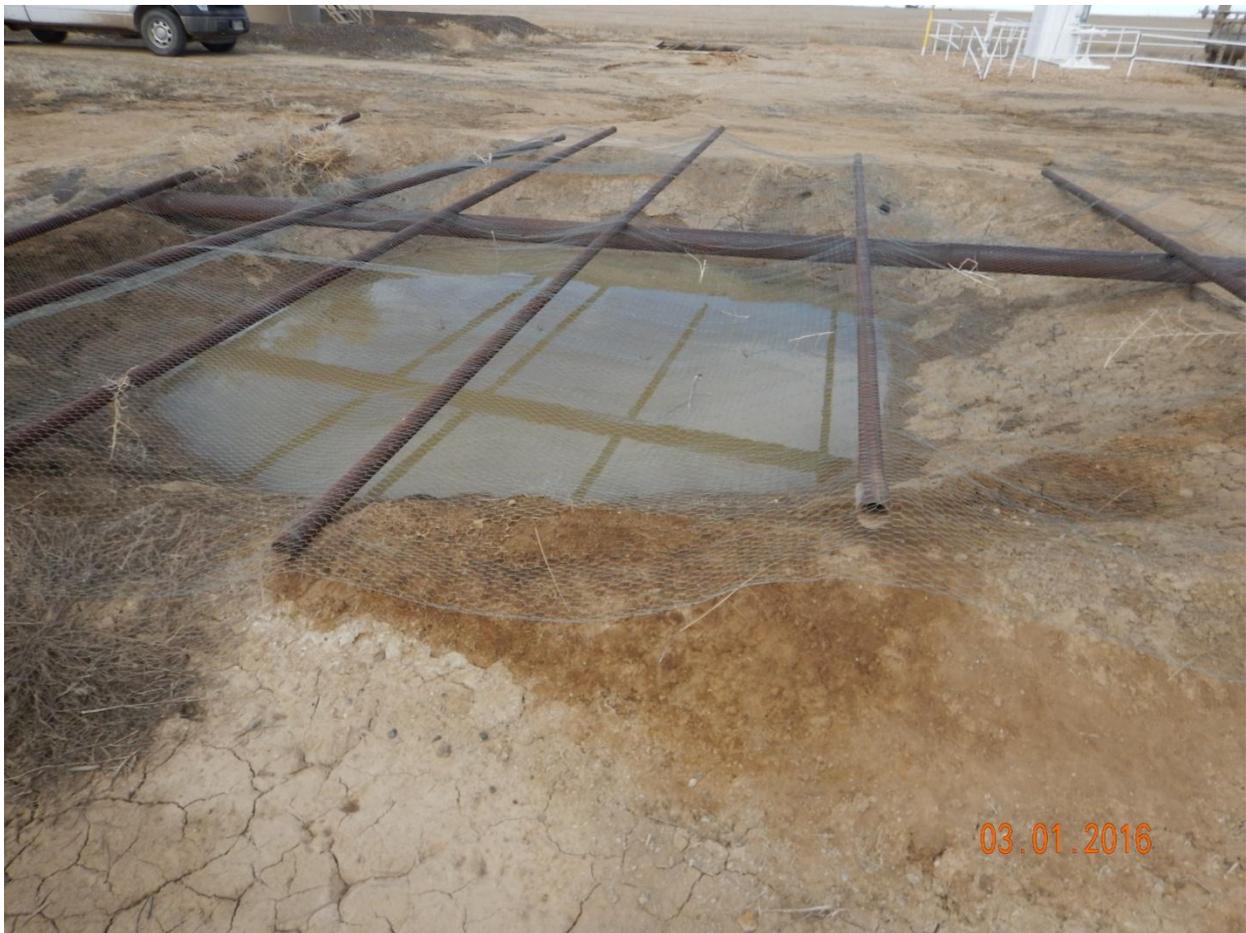
Figure 5 - Oil-stained soil at southeast corner of produced water pit. Note burrows in NE corner of pit.

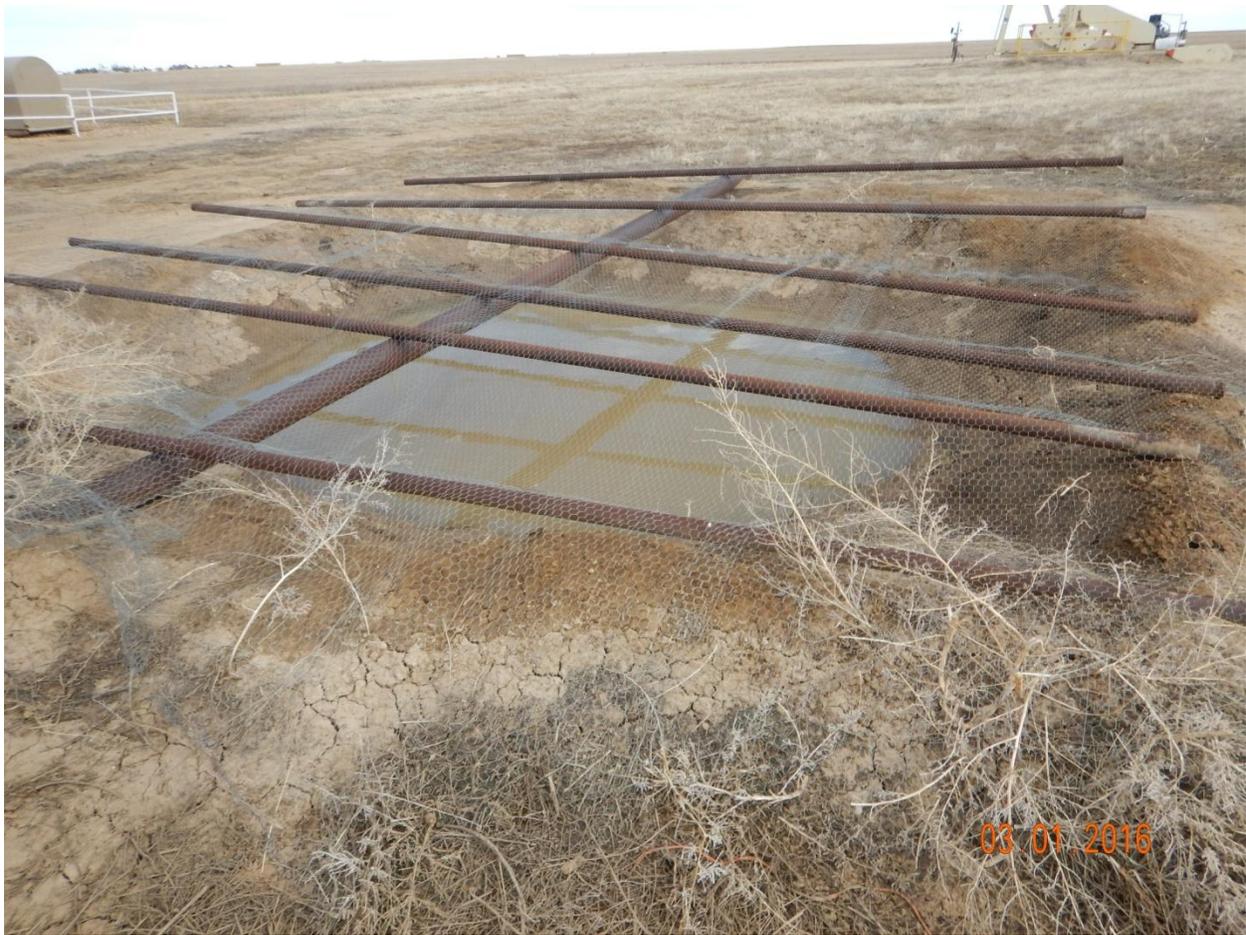
Figure 6 – Oil-stained soil inside of pit (along south and west walls), vegetation growth and wind-blown weeds accumulating outside of pit along west wall.
