COGCC March 1, 2016 Environmental Inspection of Ann Walker #2 – S. Arauza

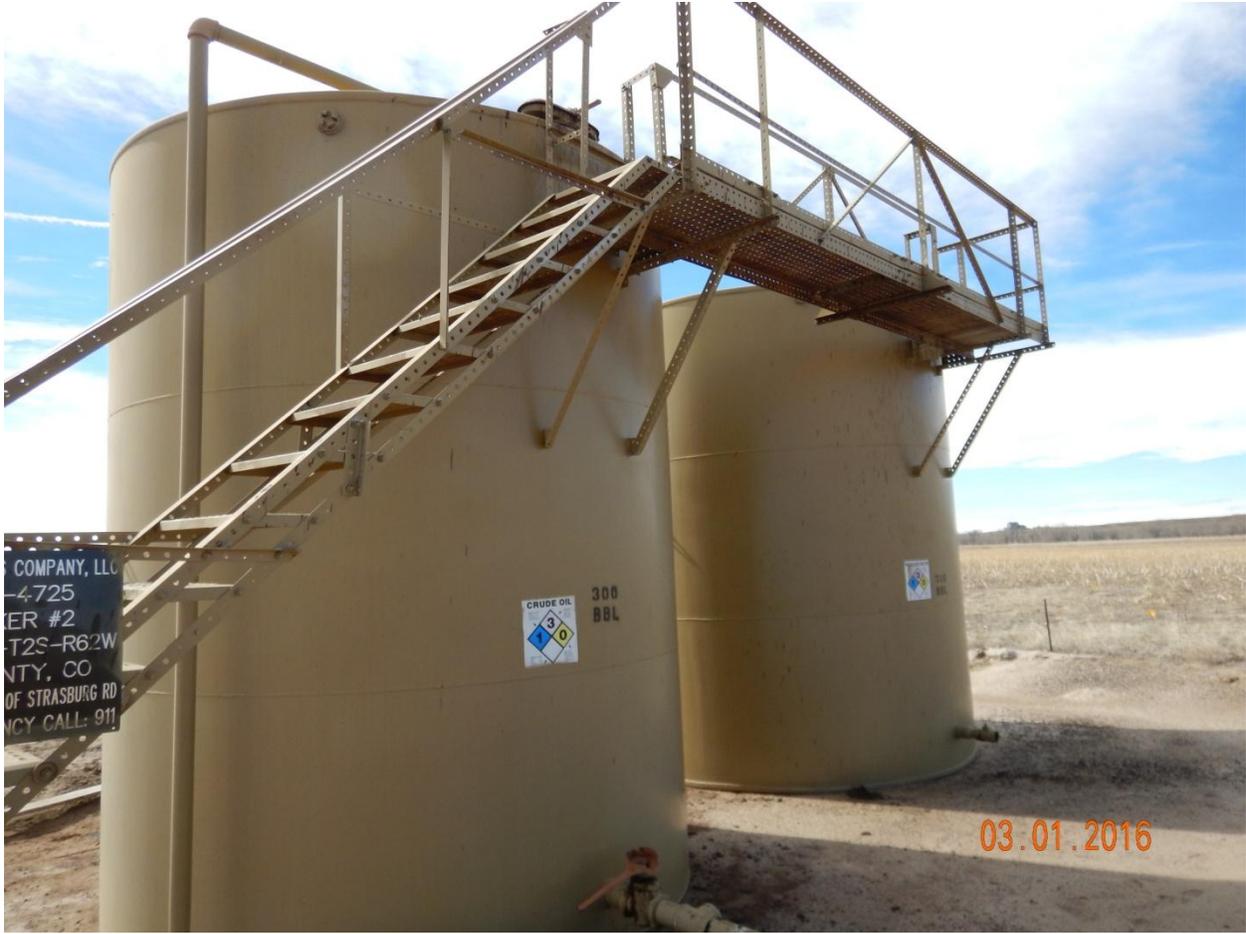
Figure 2 - Ann Walker #2 Tank Battery.

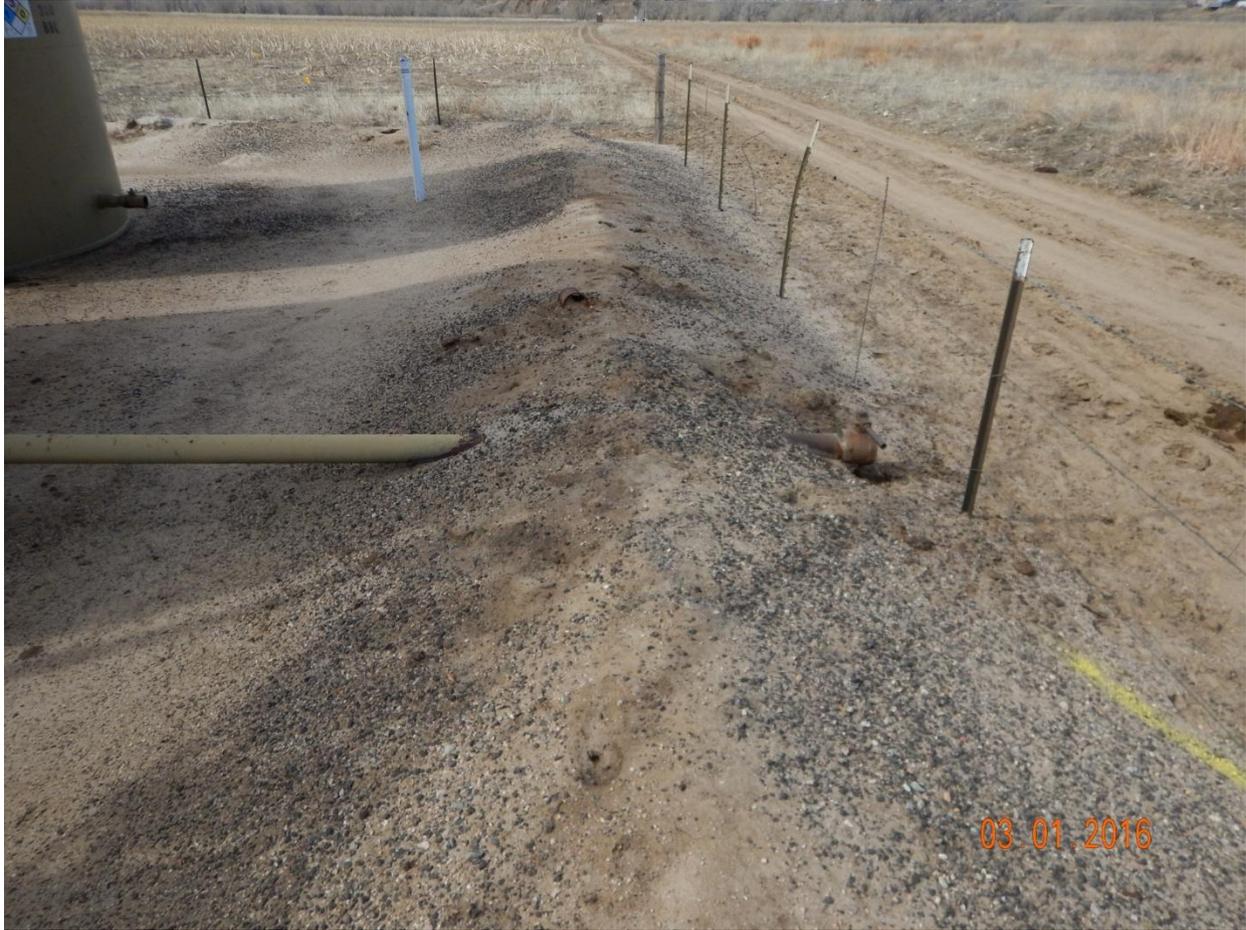
Figure 3 – Localized oily waste inside of tank battery berm.

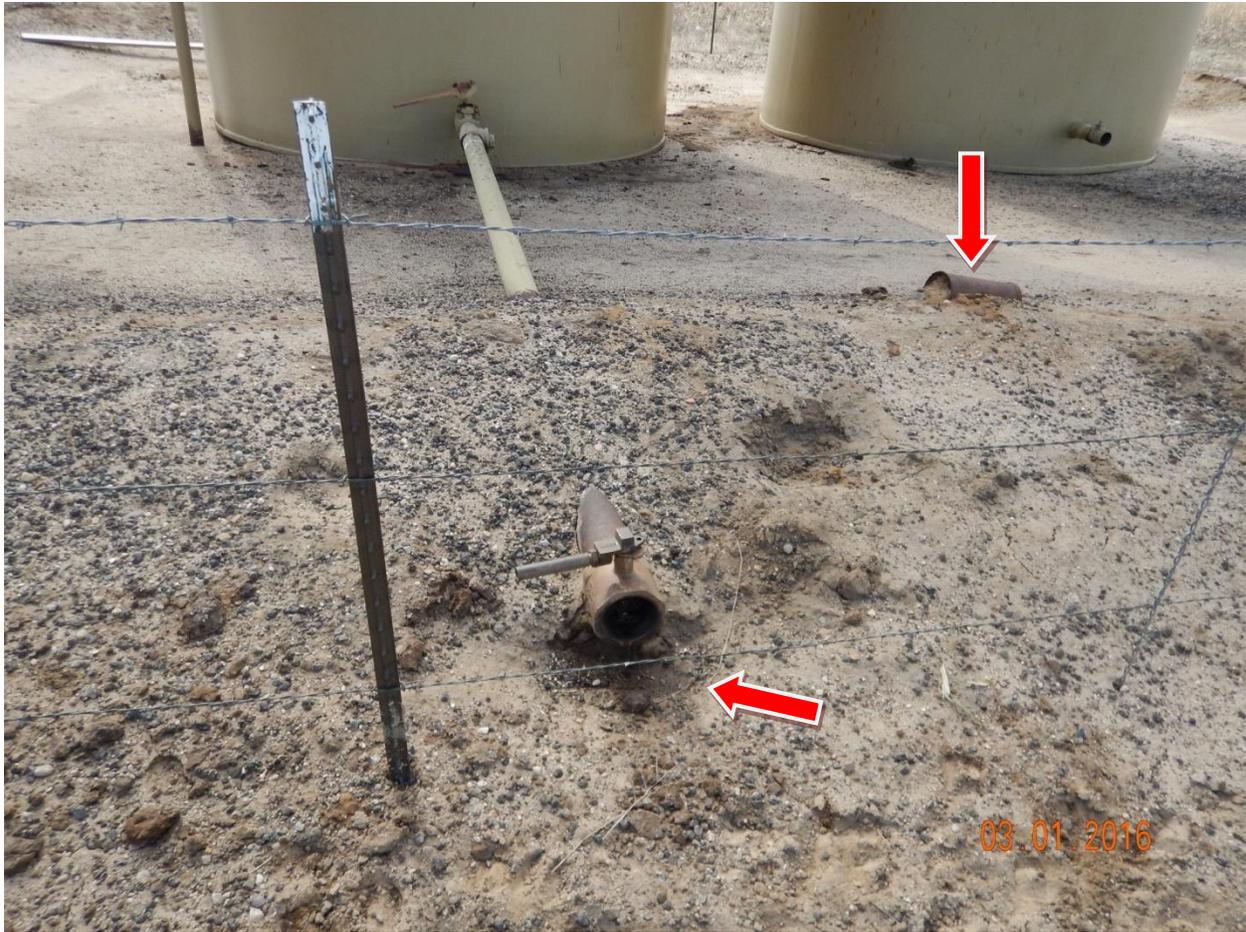
Figure 4 - Oil-stained soil at tank loadout and inside of containment berm, note unused equipment/trash present behind berm.

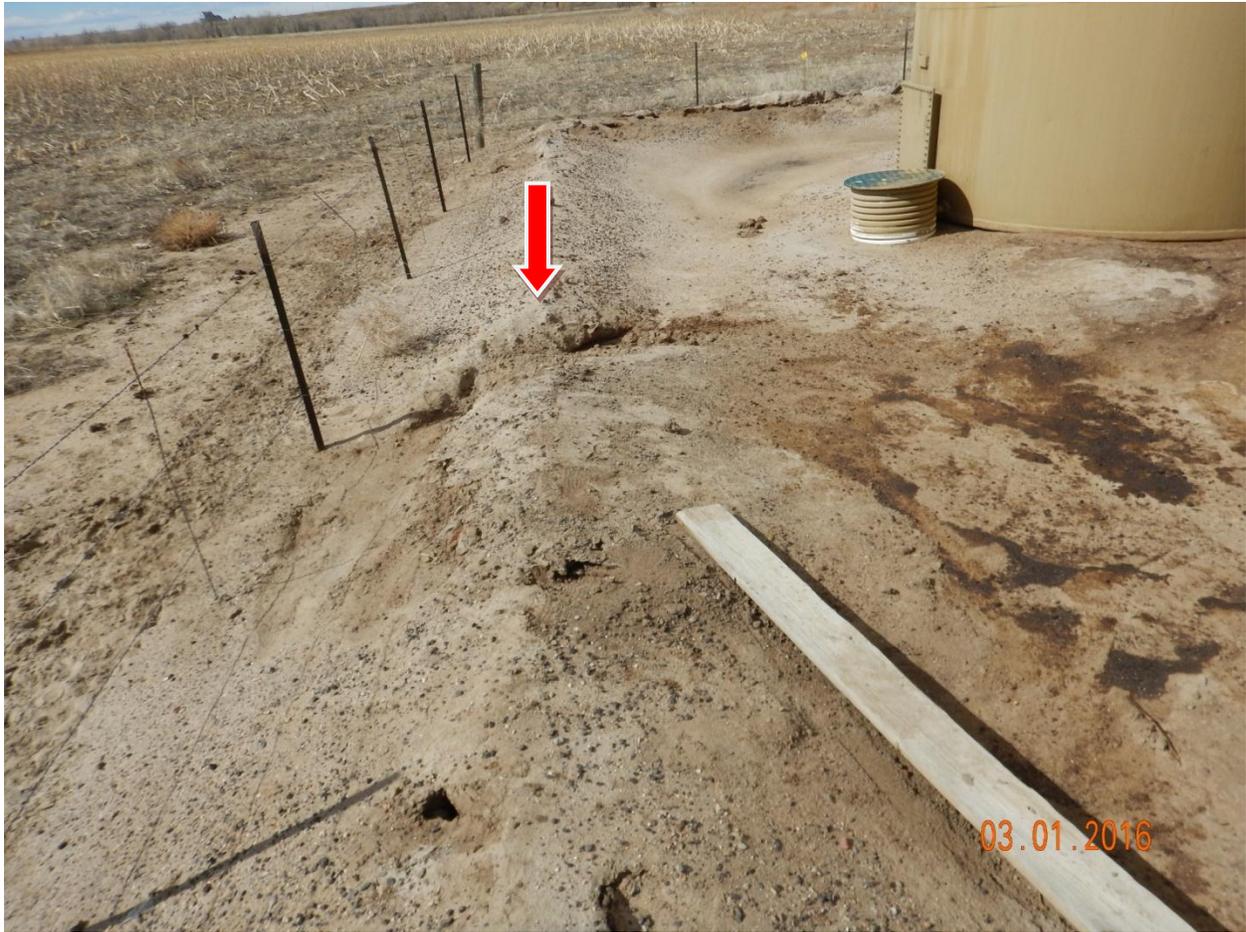
Figure 5 - Oil stained soil inside of tank battery and gap in berm.

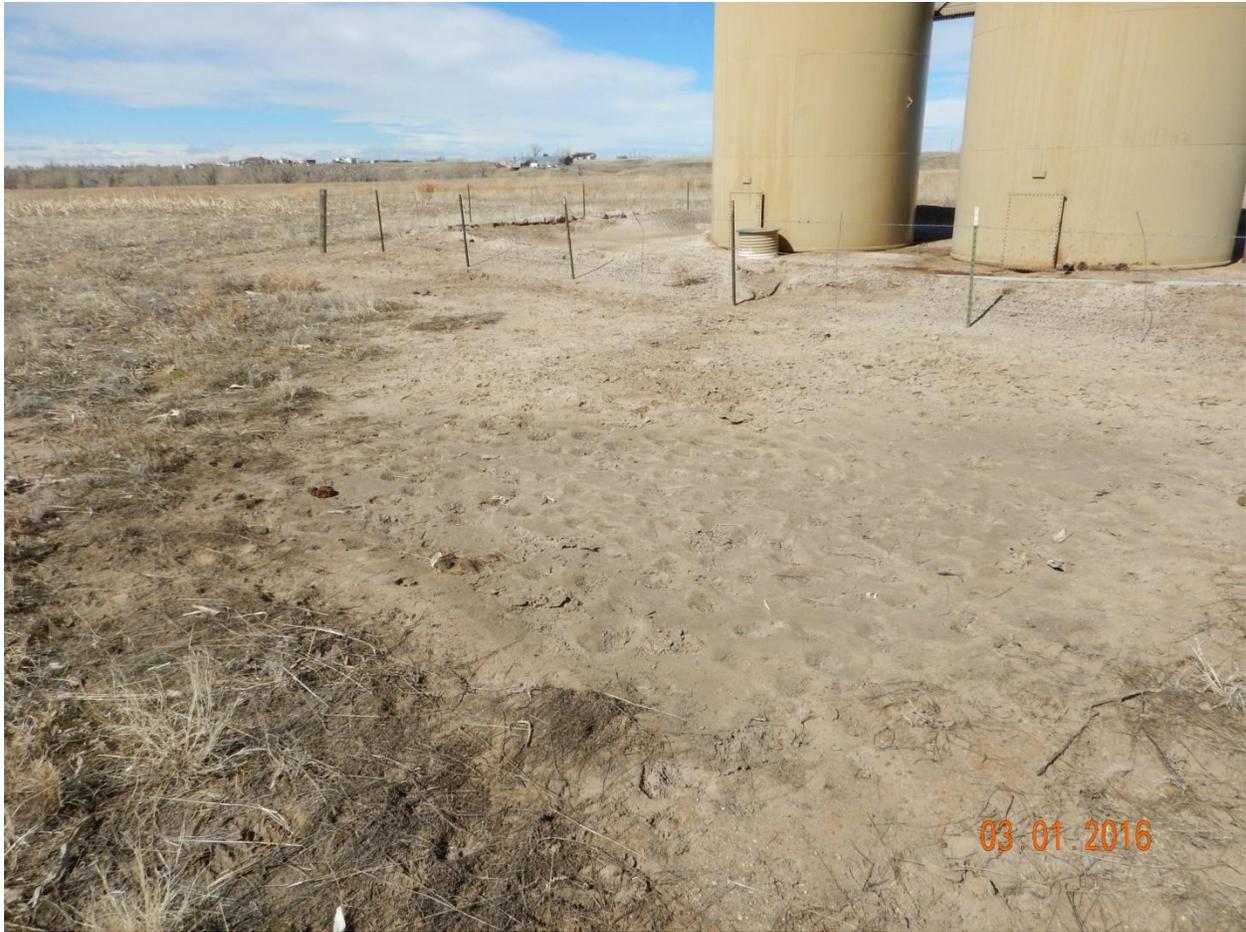
Figure 6 – Absence of vegetation south of tank battery and gap in berm.

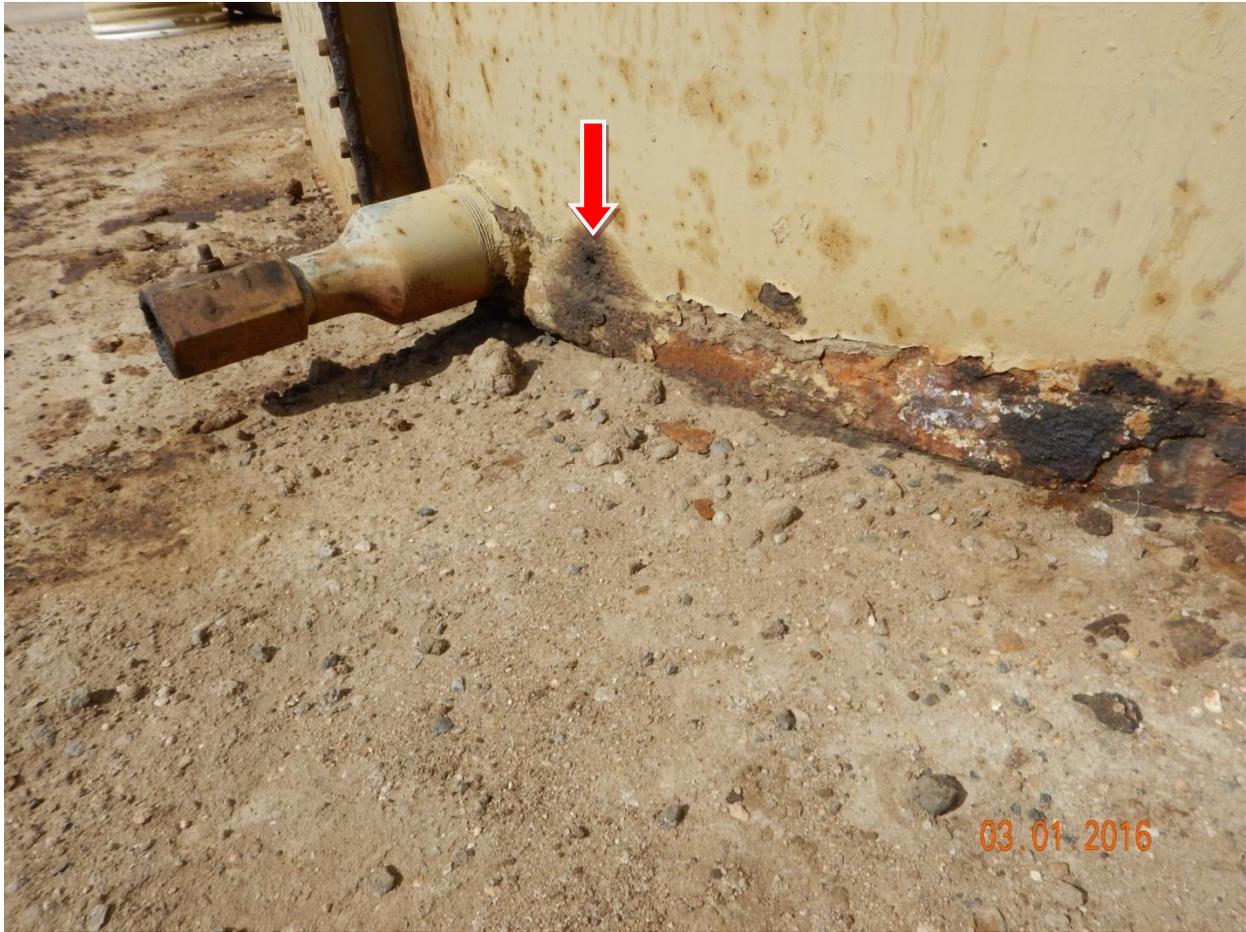
Figure 7 - Oil-stained soil, corrosion, and small hole in crude oil AST.

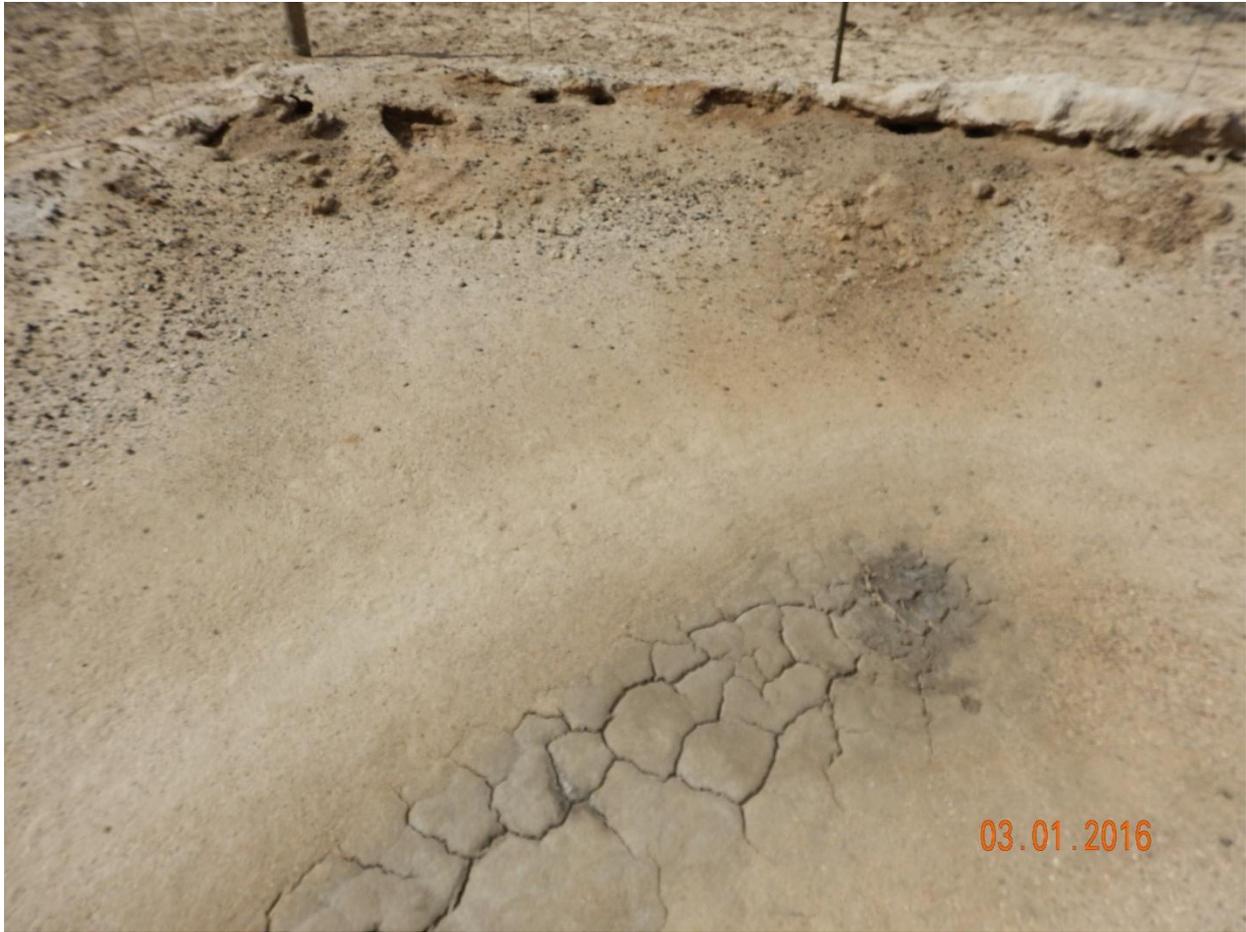
Figure 8 – Berm in need of repair.

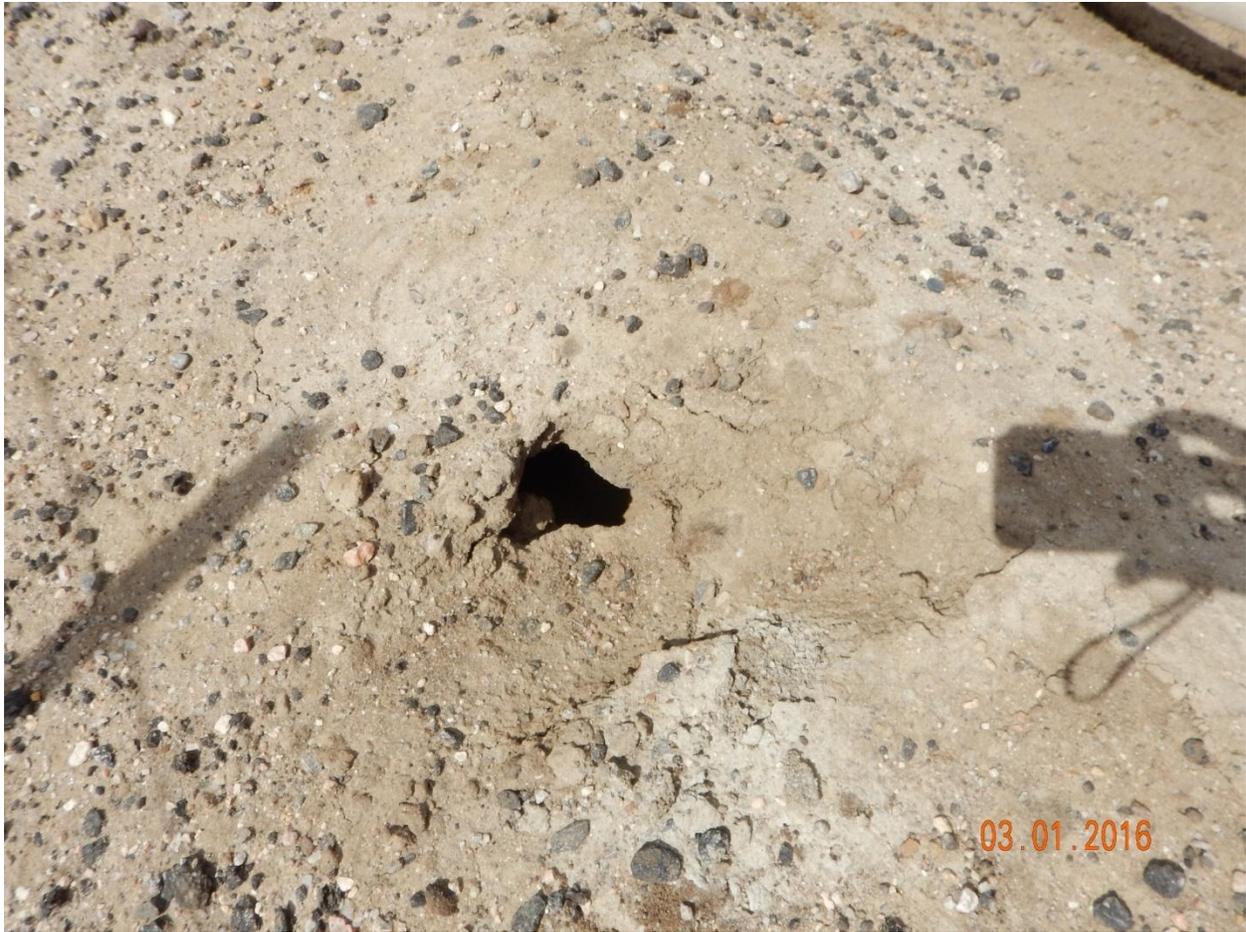
Figure 9 - Burrow observed in tank battery berm.

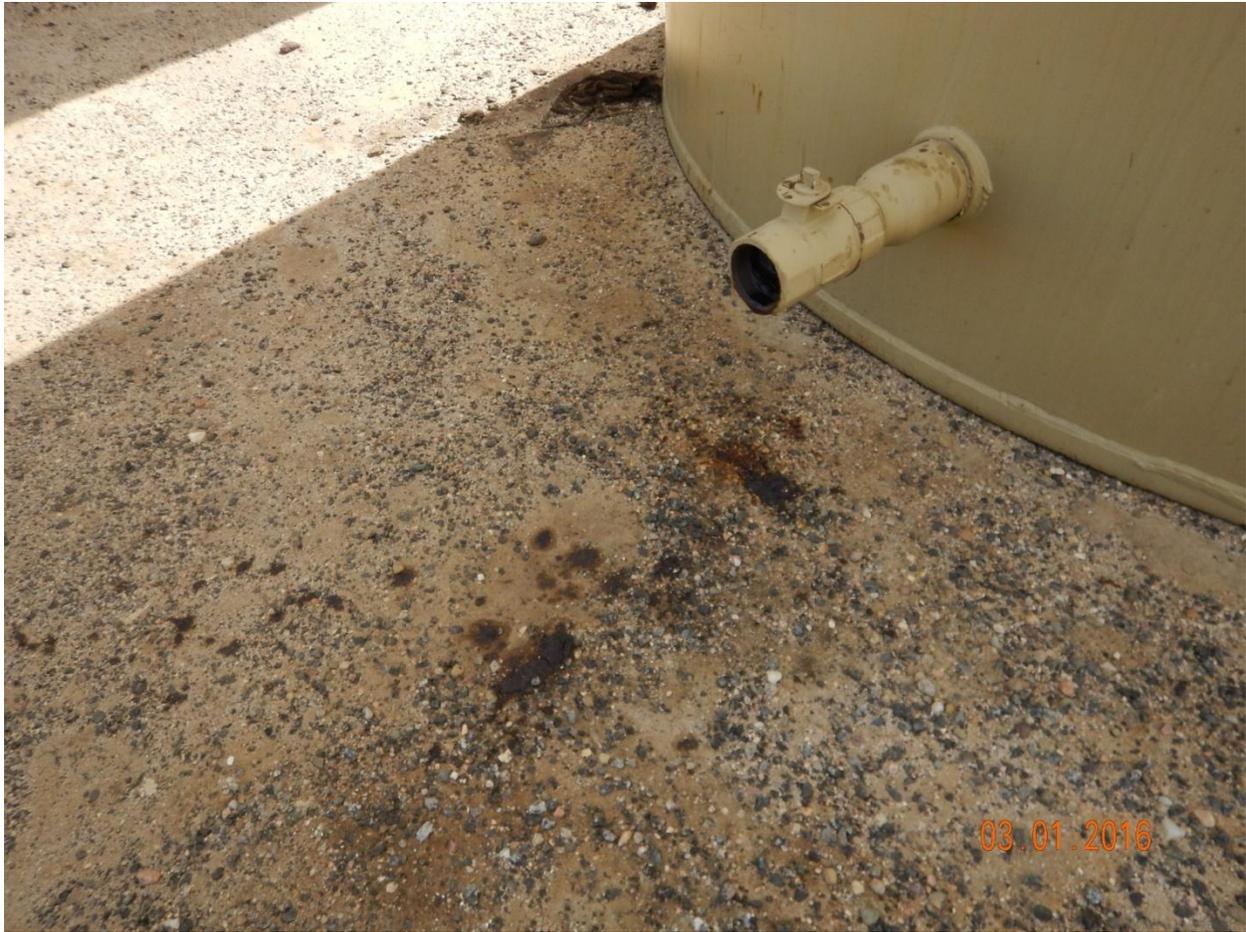
Figure 10 - Oil-stained soil north of production water tank.

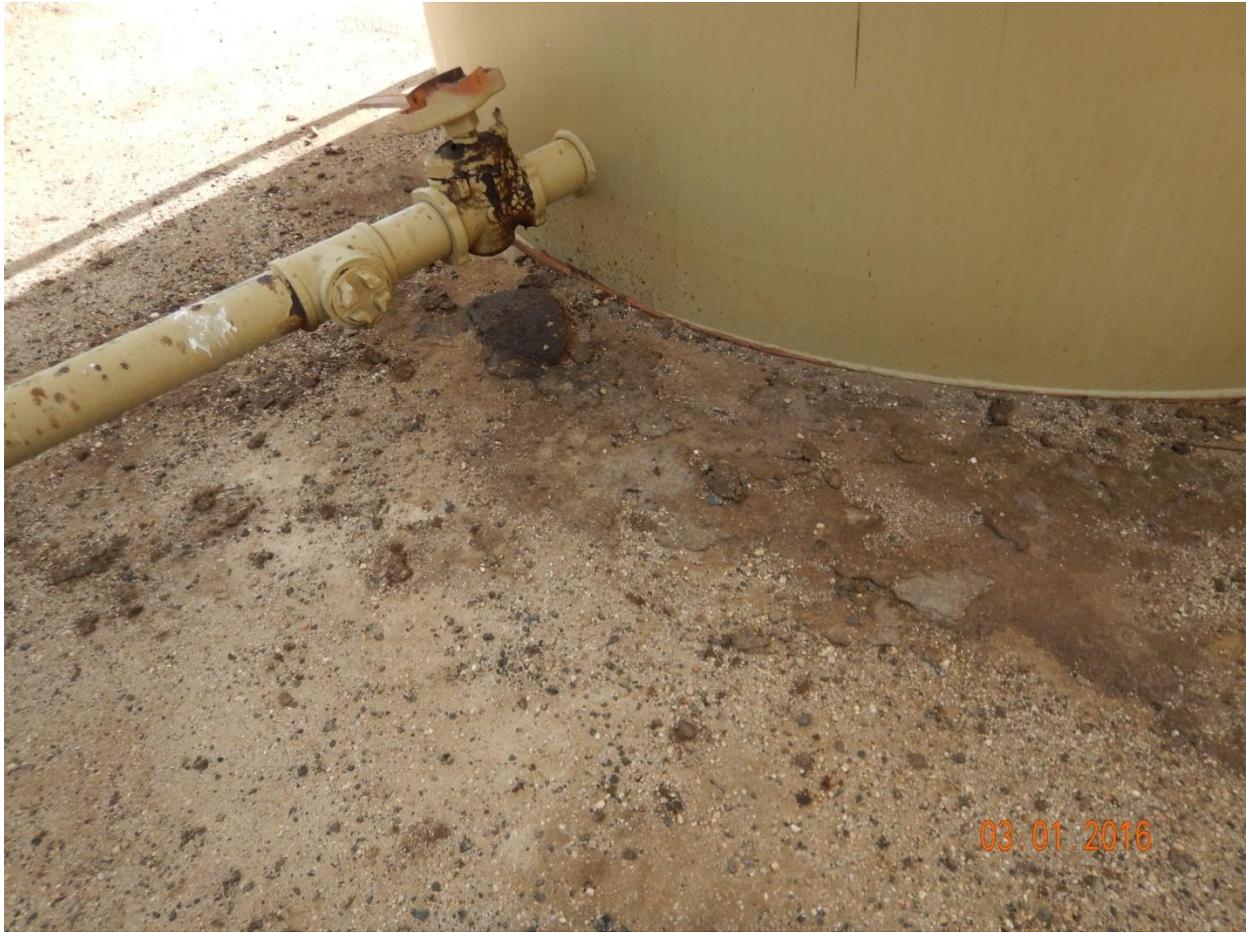
Figure 11 - Oil-stained soil beneath leaking valve on crude oil AST.

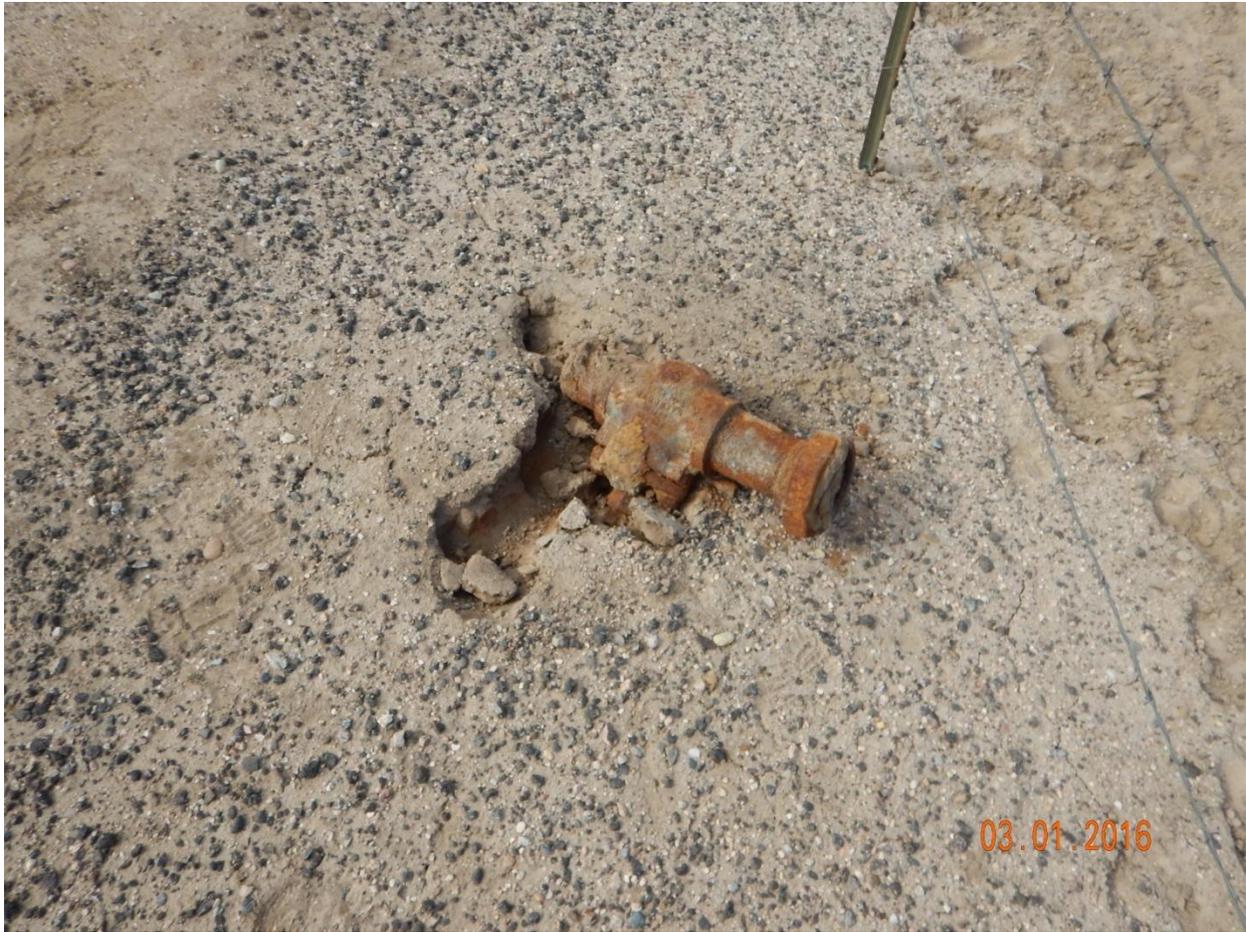
Figure 12 - Unused equipment/trash at tank battery.

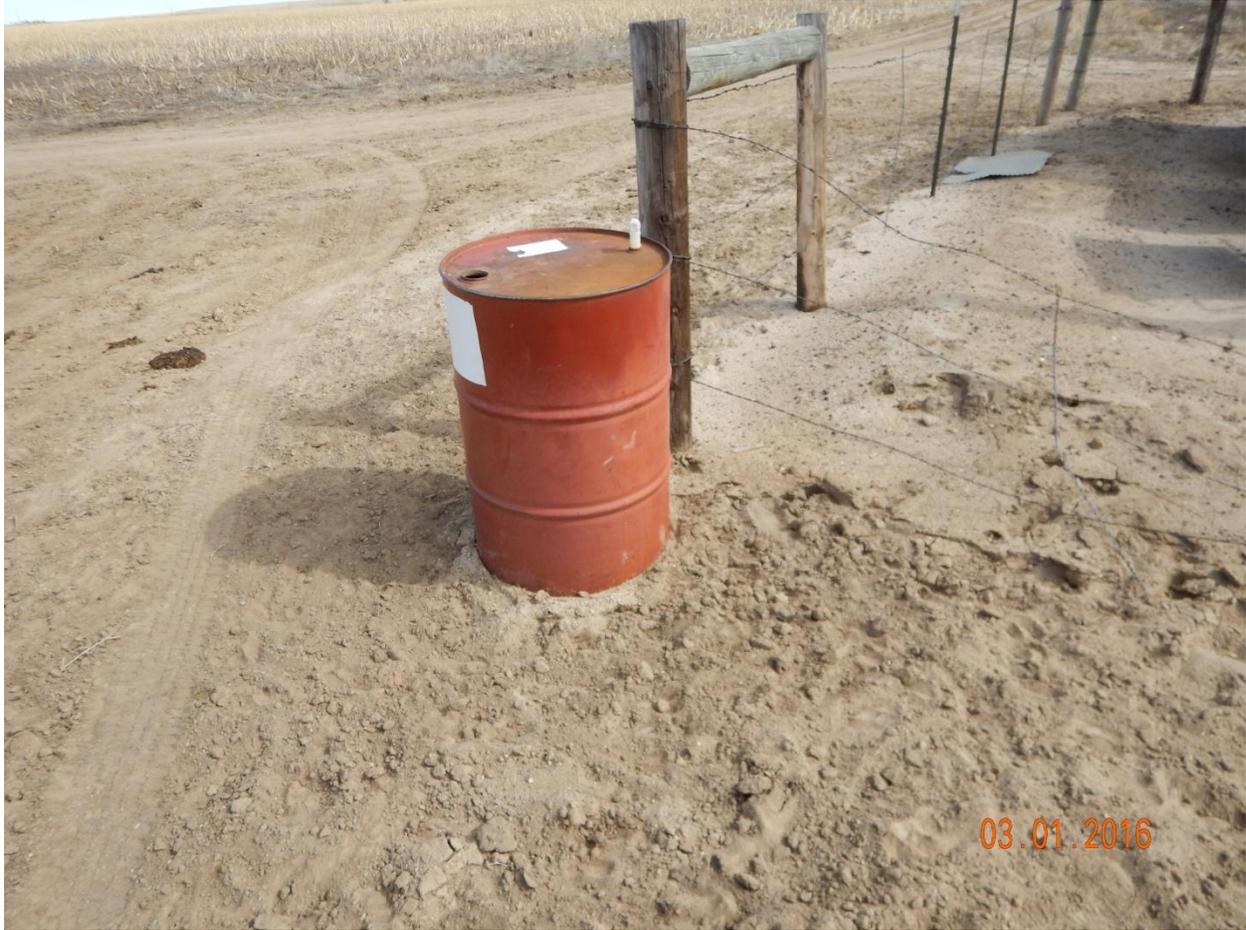
Figure 13 - 55-gallon drum outside of separator shed lacking secondary containment.

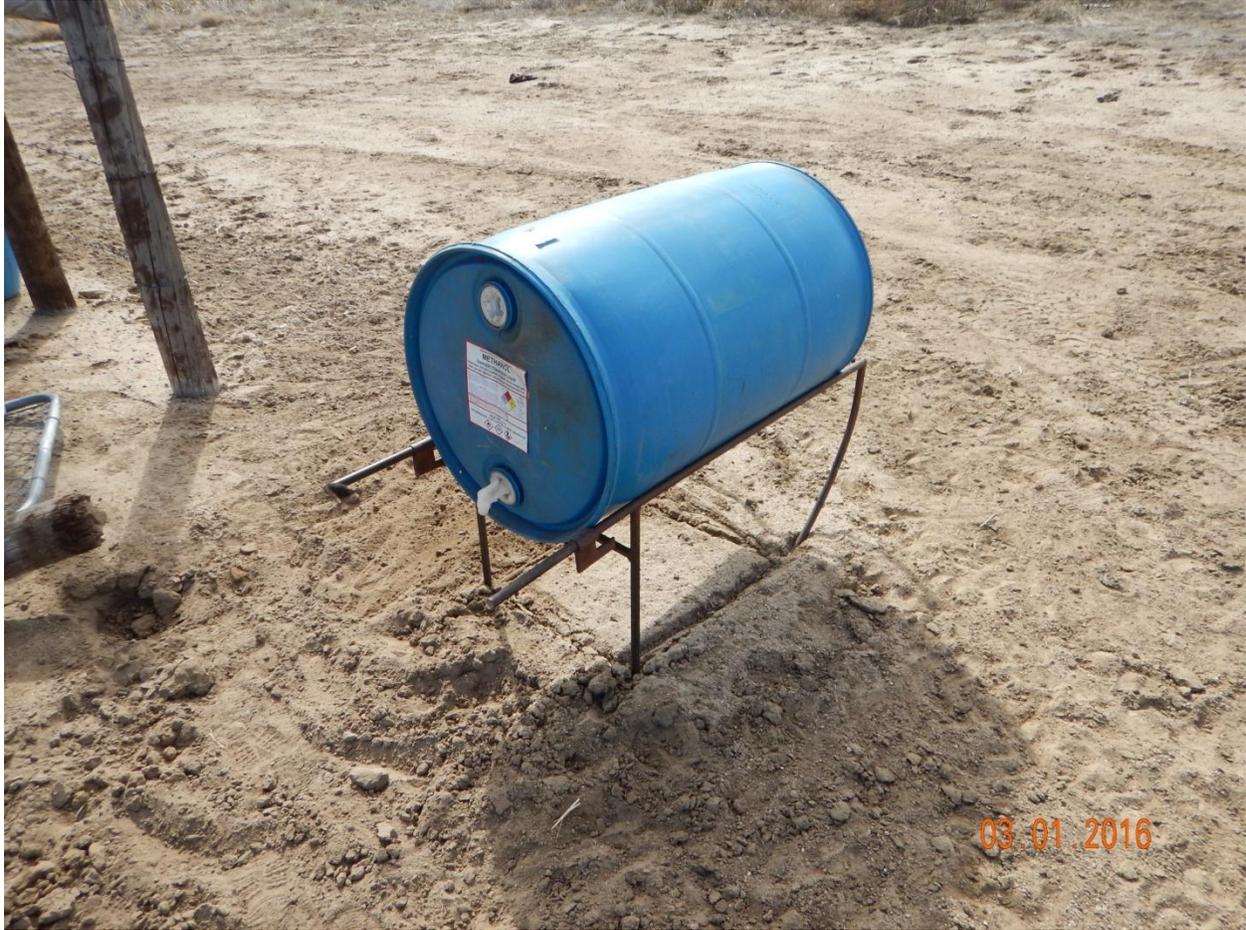
Figure 14 - 55-gallon drum outside of separator shed lacking secondary containment.

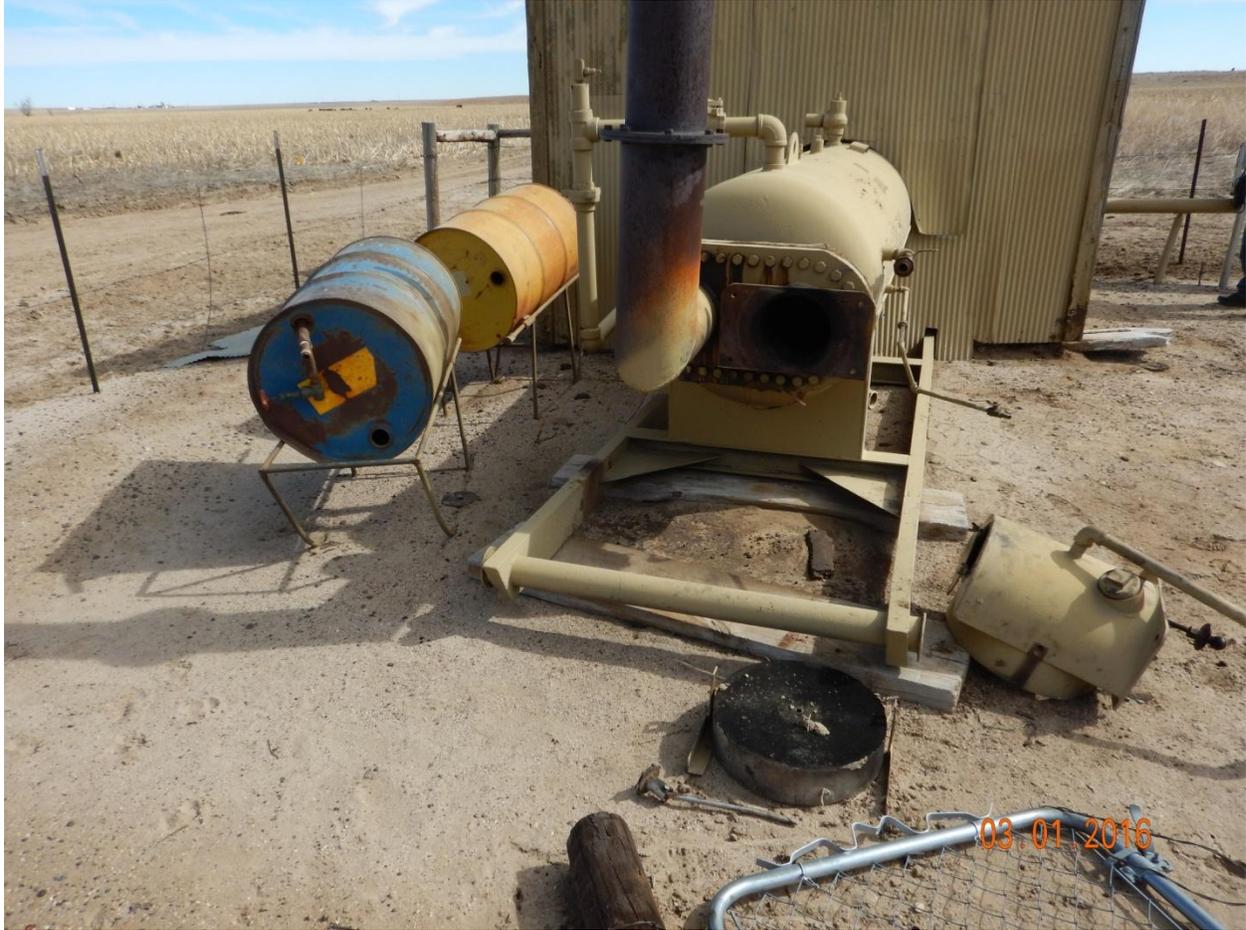
Figure 15 - Partially-dismantled separator with unused equipment and storage drums lacking secondary containment at separator shed.

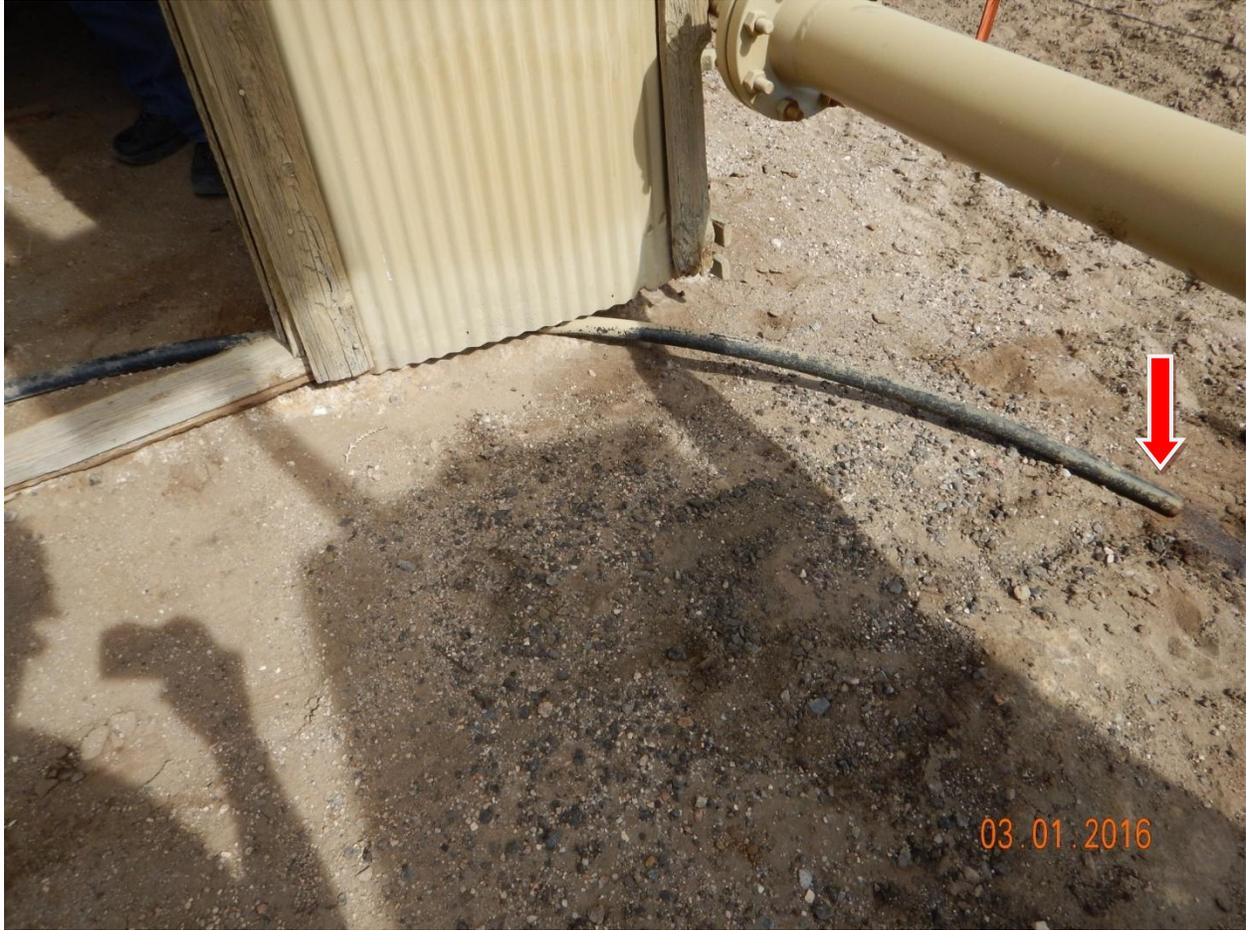
Figure 16 - Oil-stained soil at southeast corner of separator shed, note line being used to drain E&P waste from inside of shed.
