Interim Reclamation Inspection

Operator: Whiting Oil and Gas

Location ID: 433999

Weld County, CO

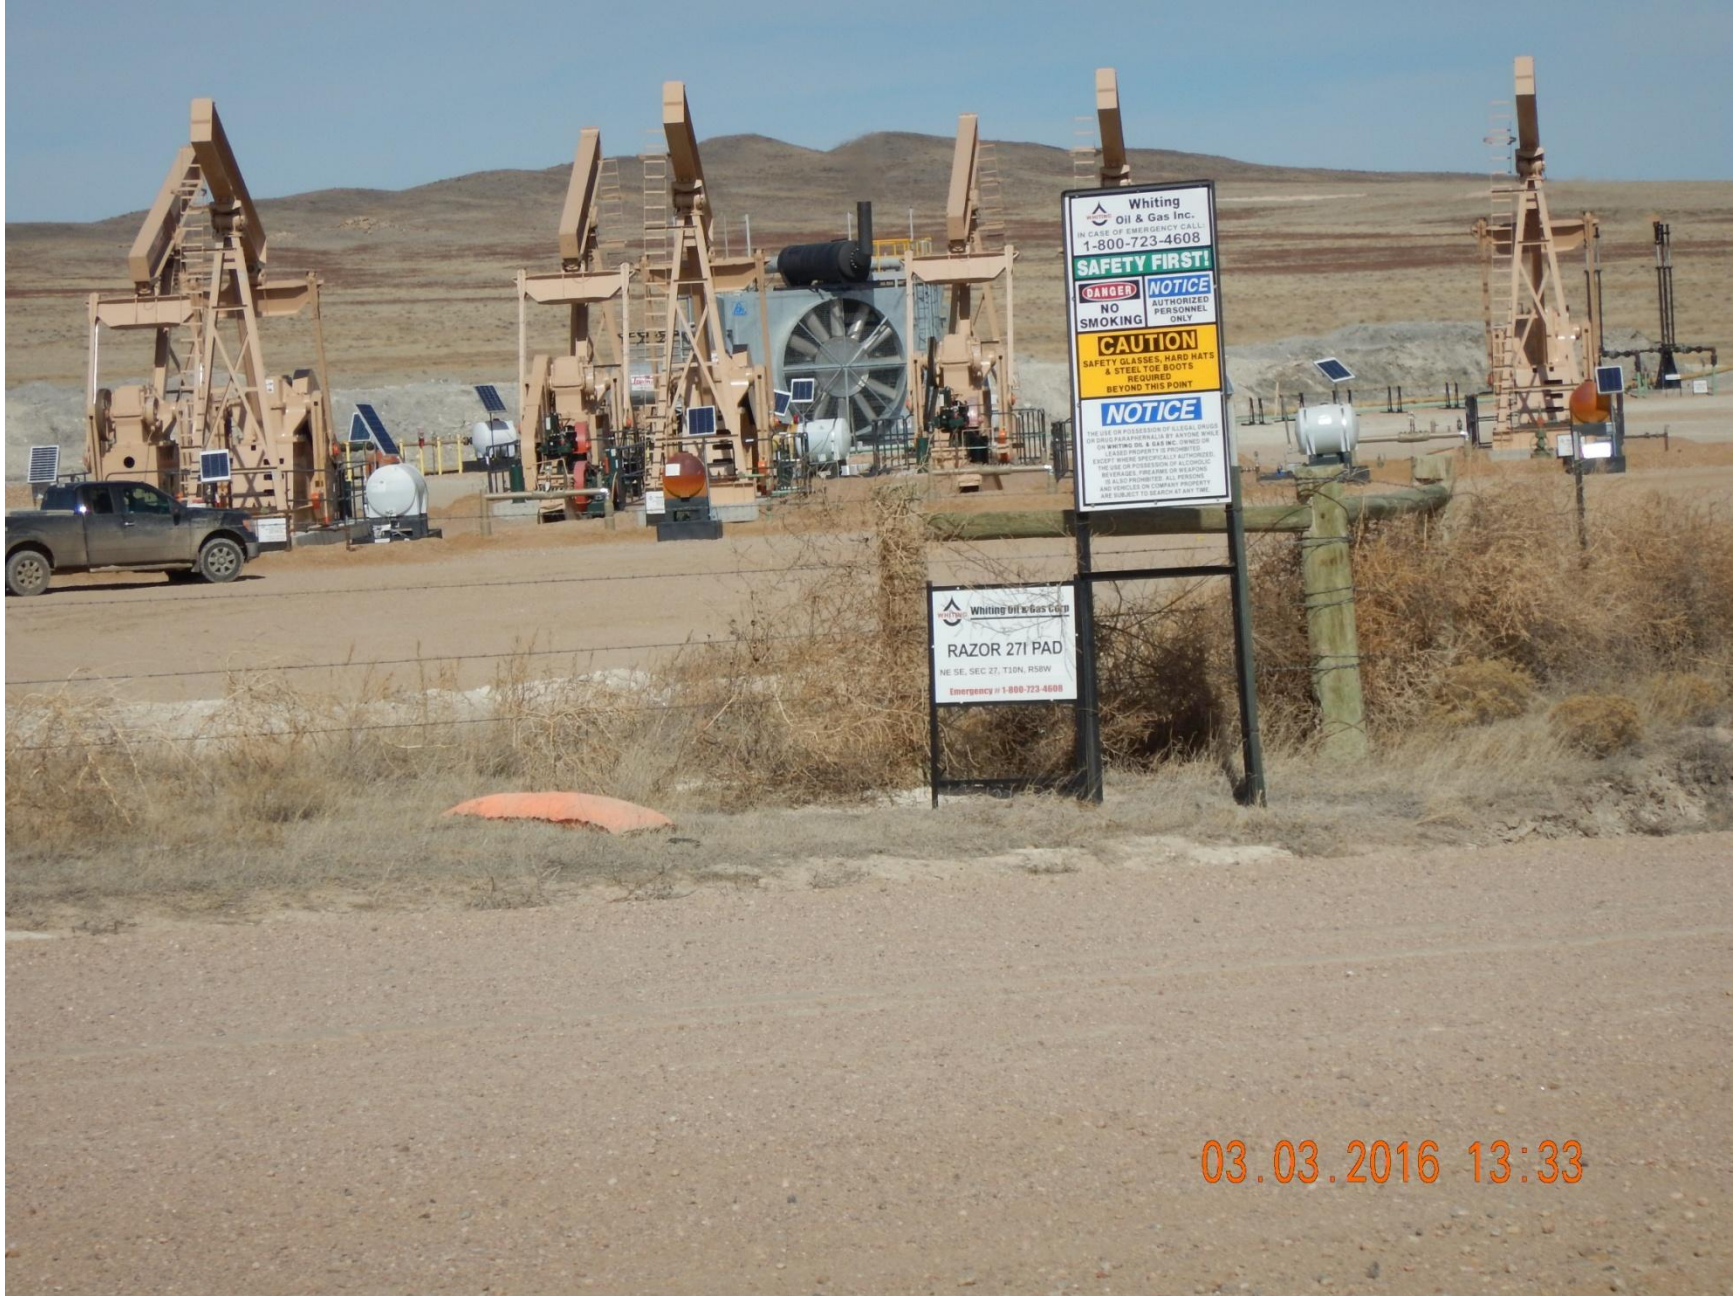
Figure 1: Photo taken from access road, south of location, facing north. Photo shows location sign.

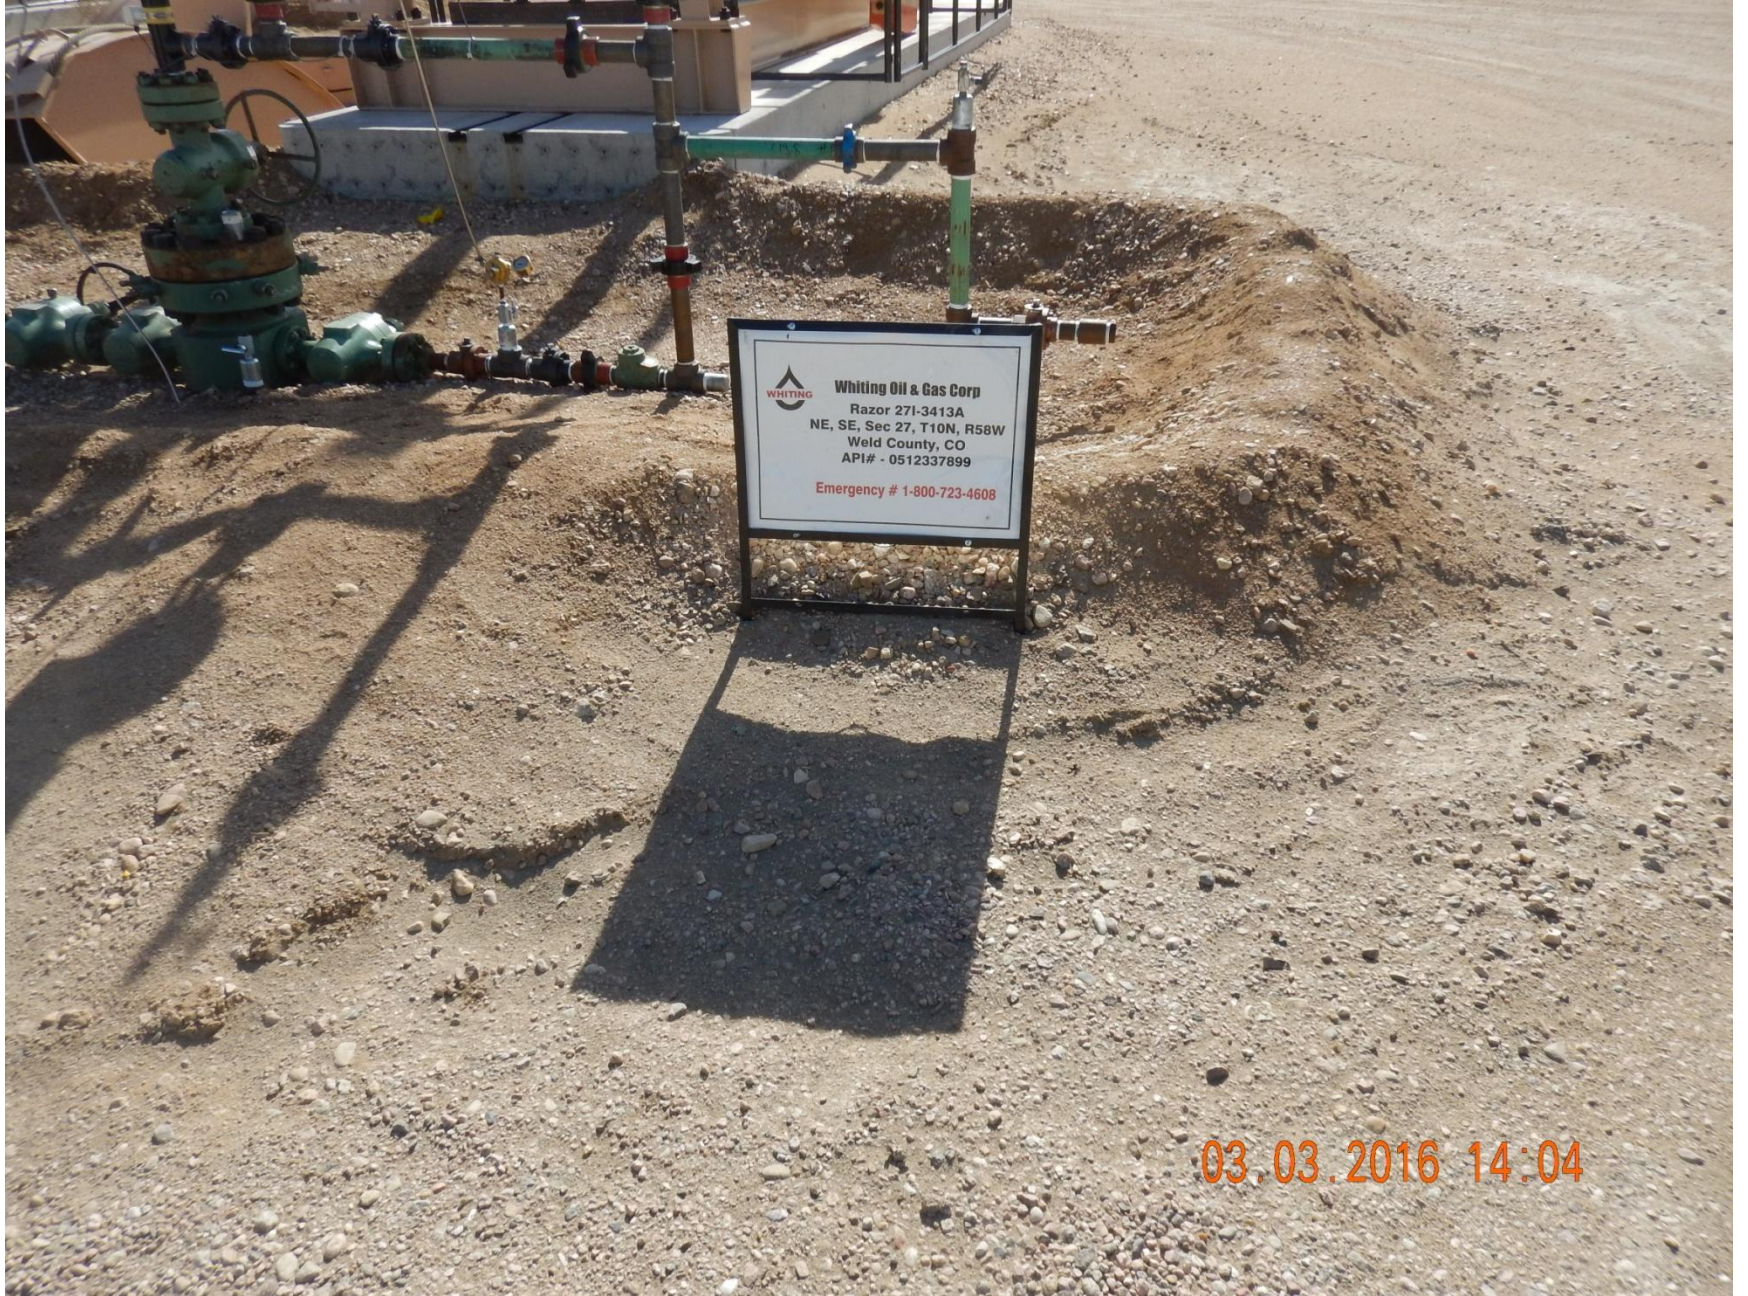
Figure 2: Photo of well #123-37899

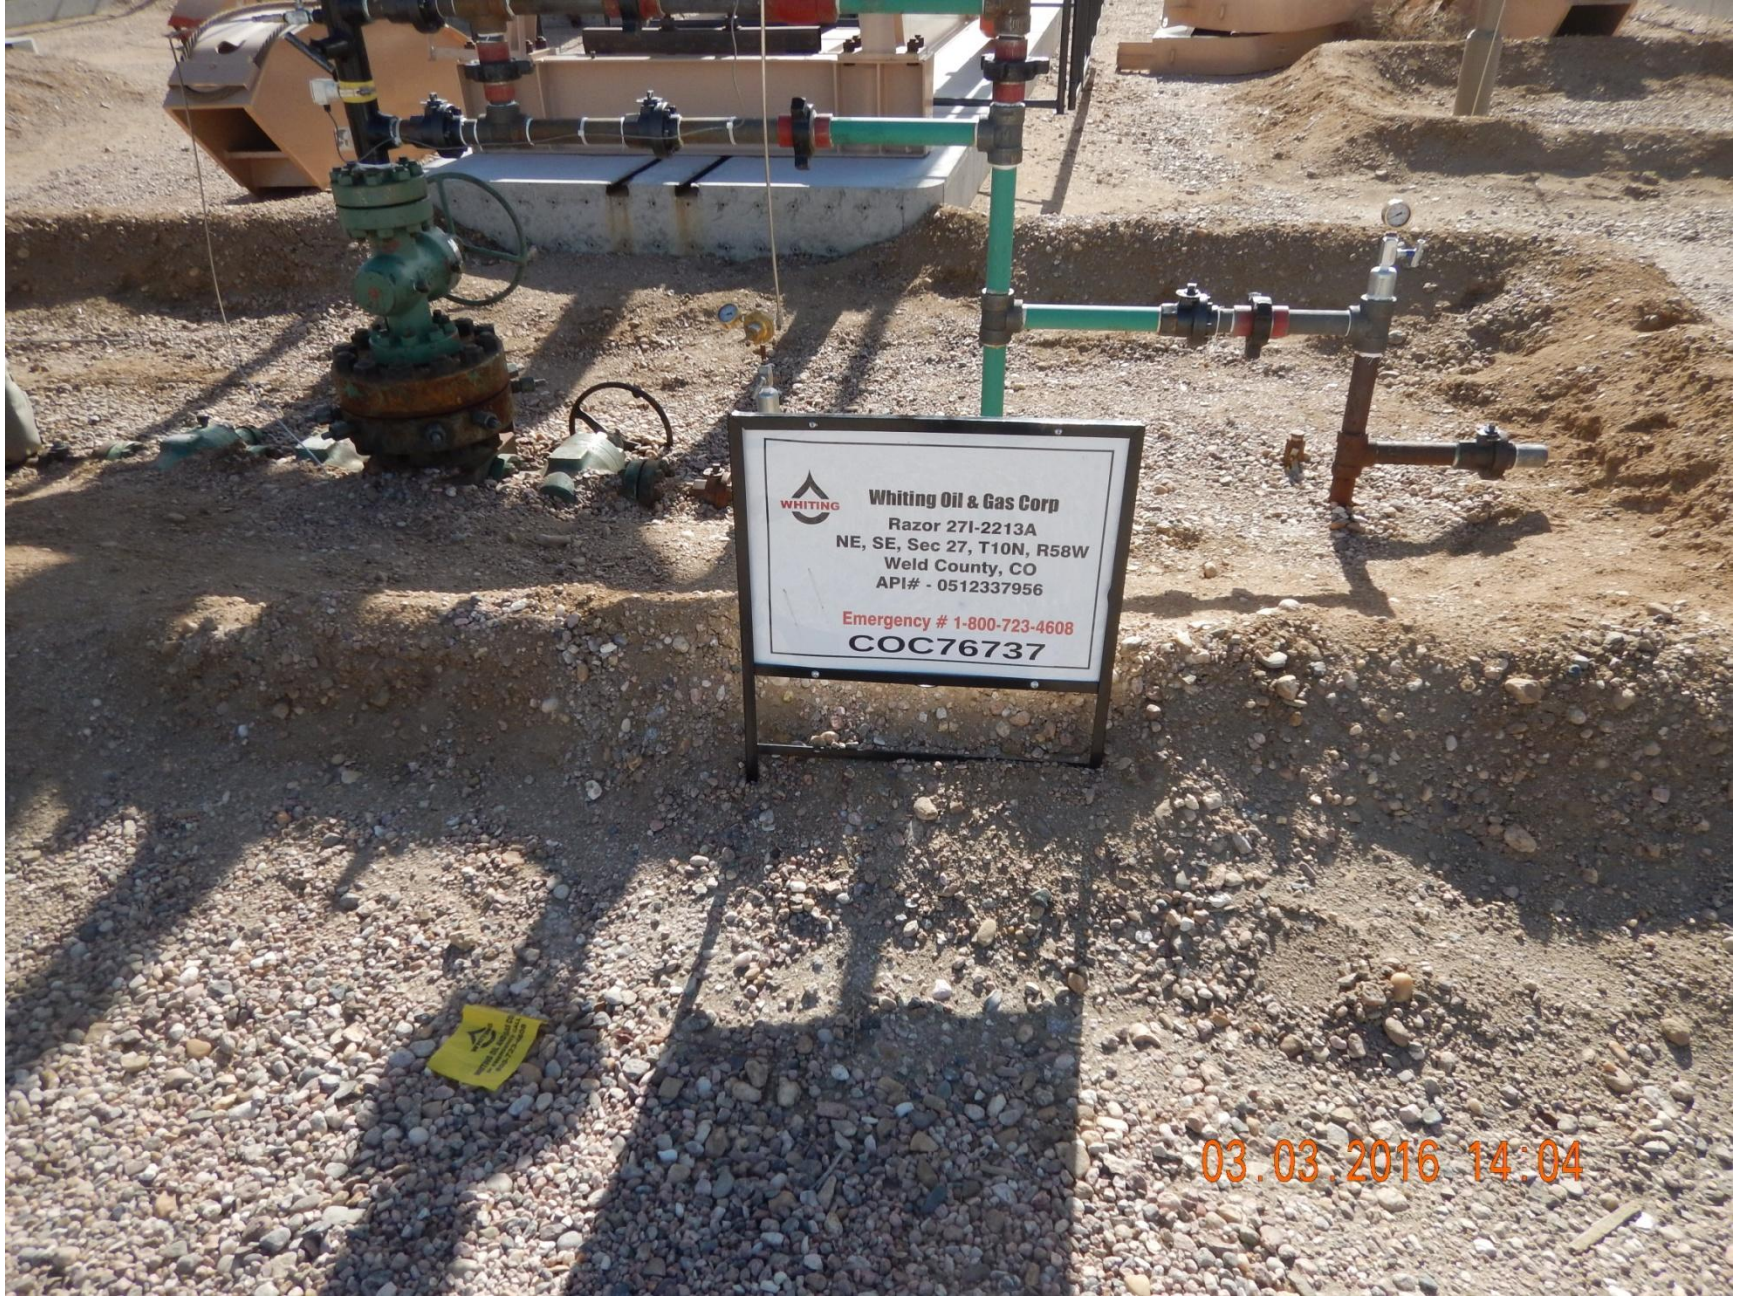
Figure 3: Photo of well #123-37956.

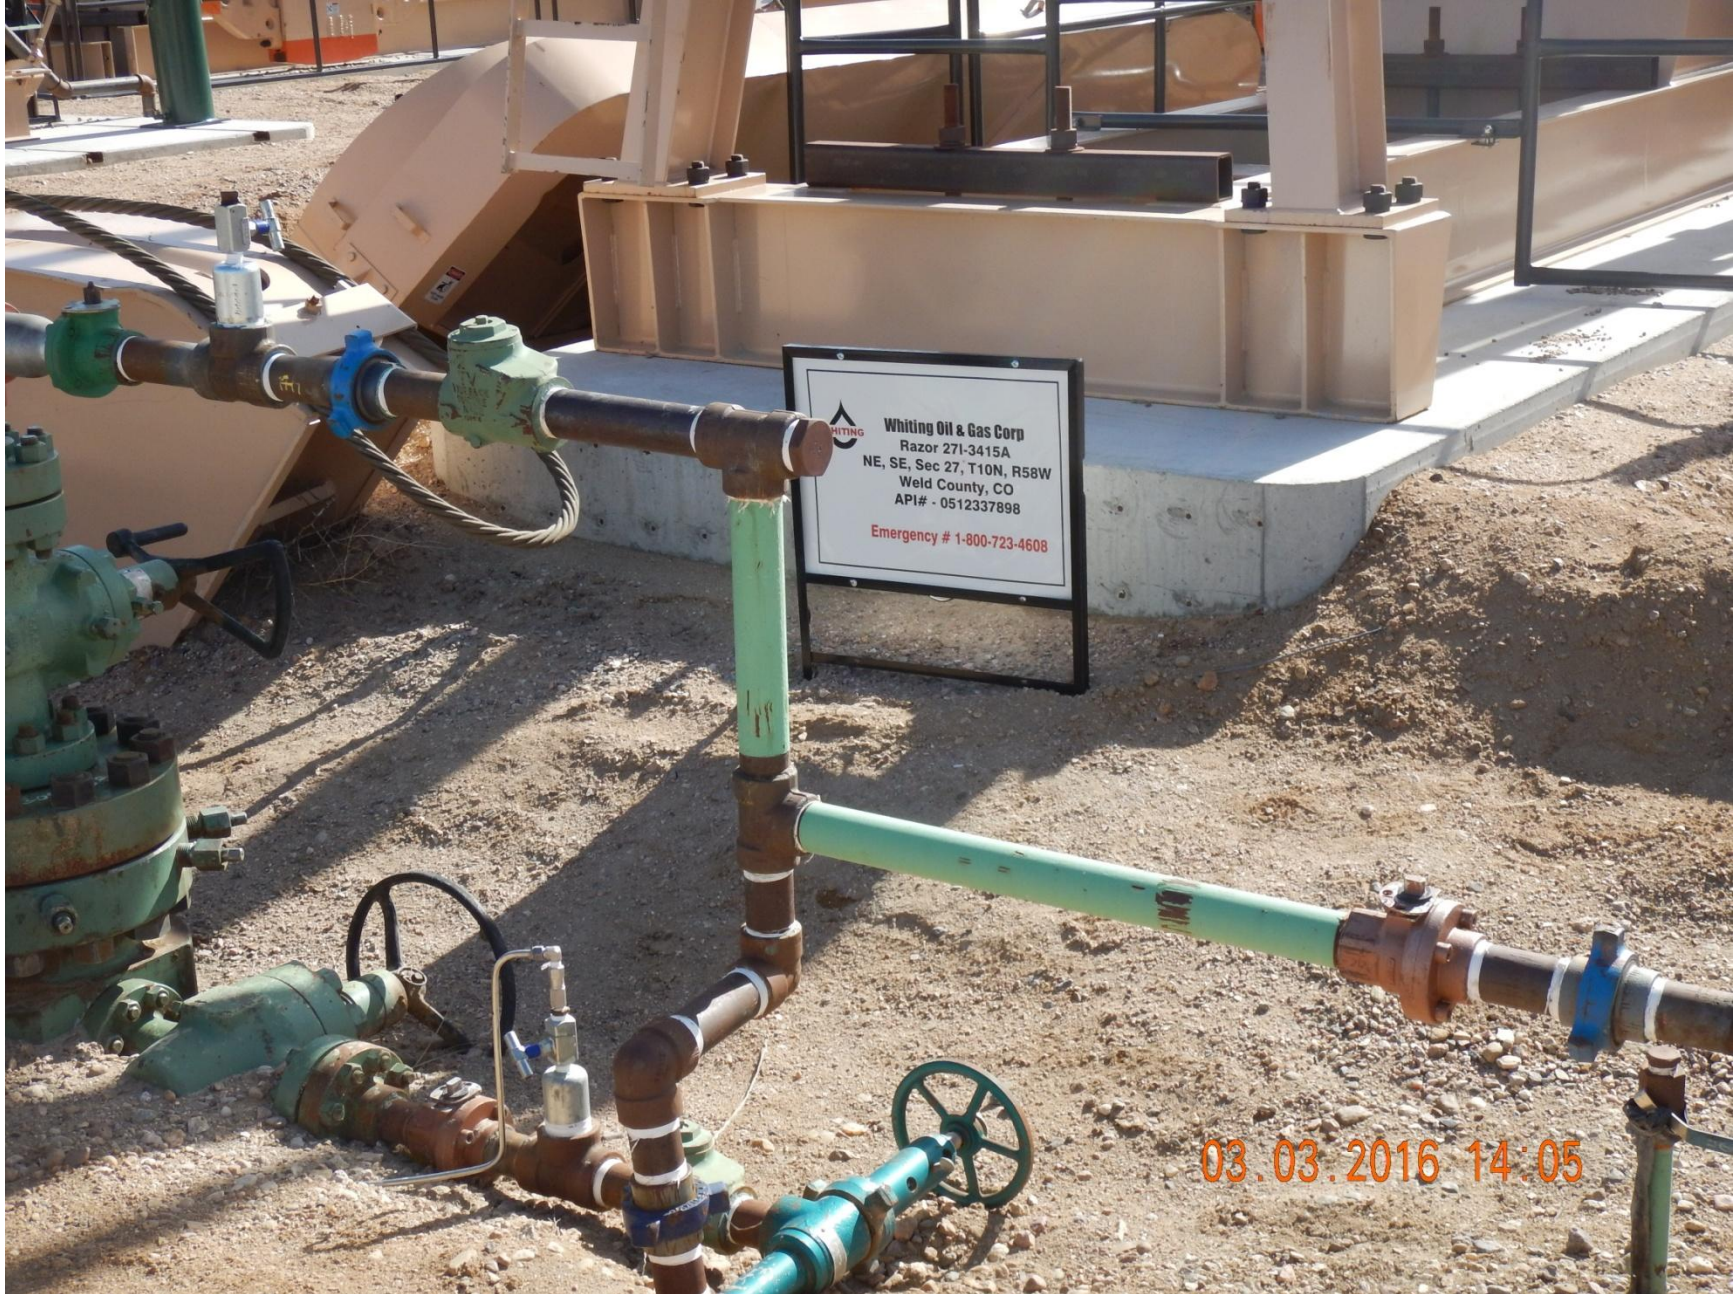
Figure 4: Photo of well #123-37898.

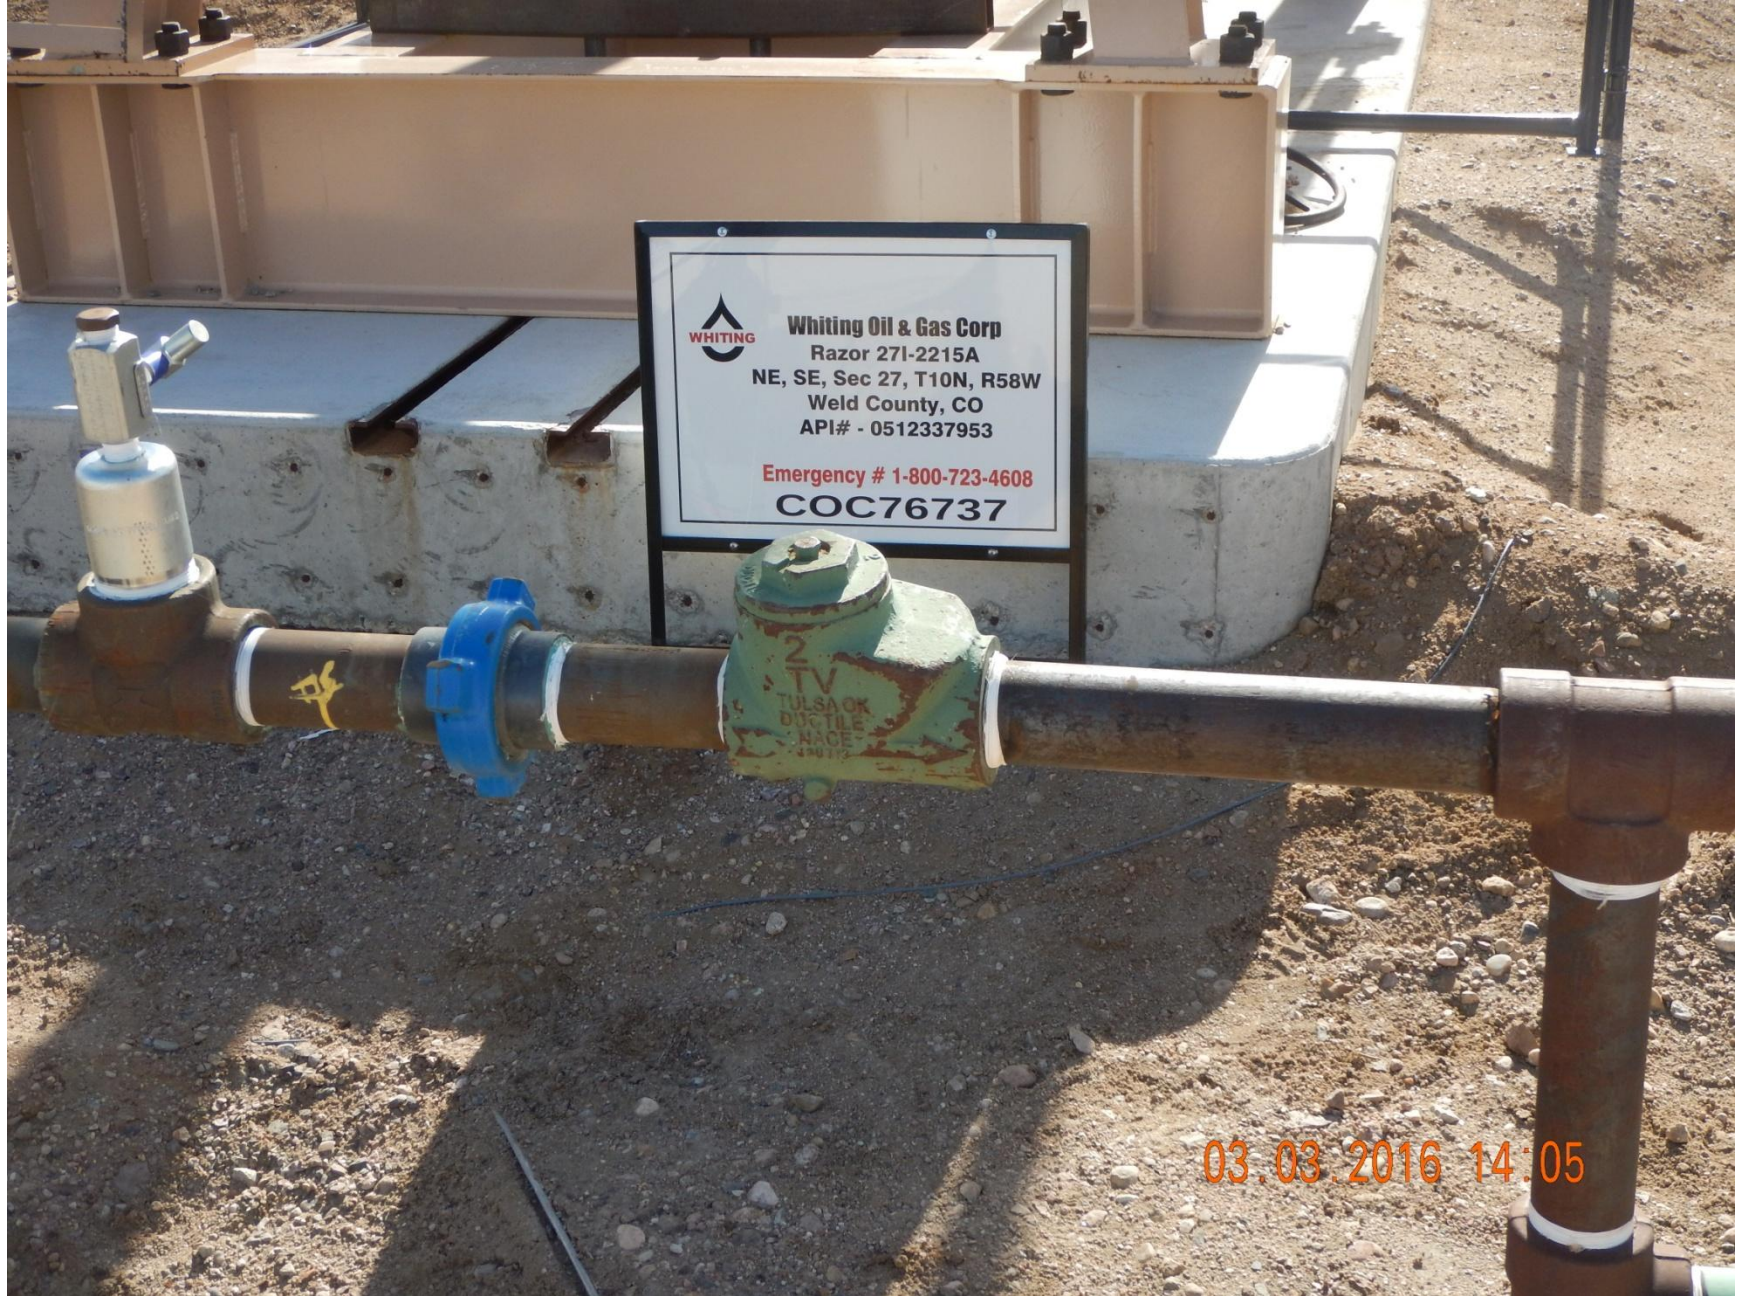
Figure 5: Photo of well #123-37953

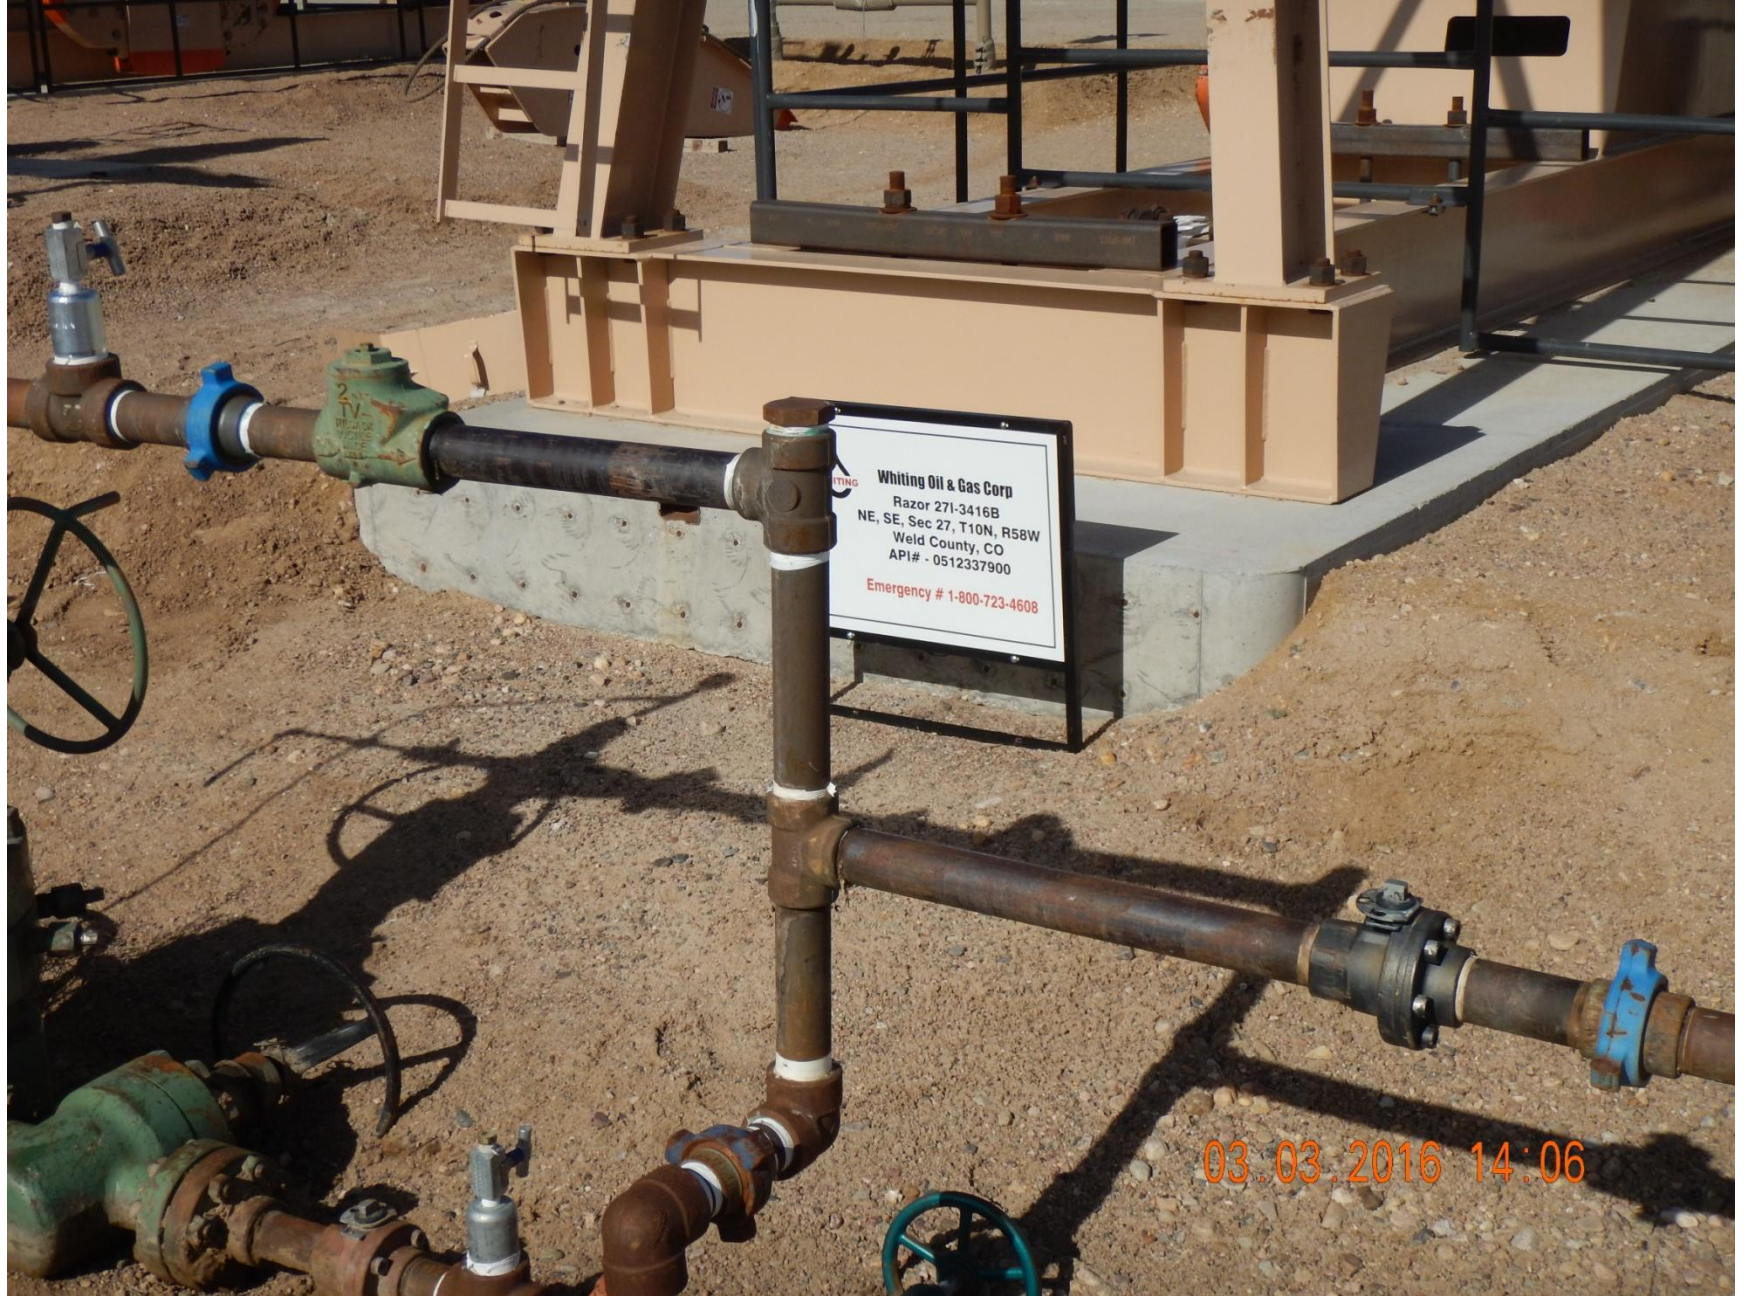
Figure 6: Photo of well #123-37900

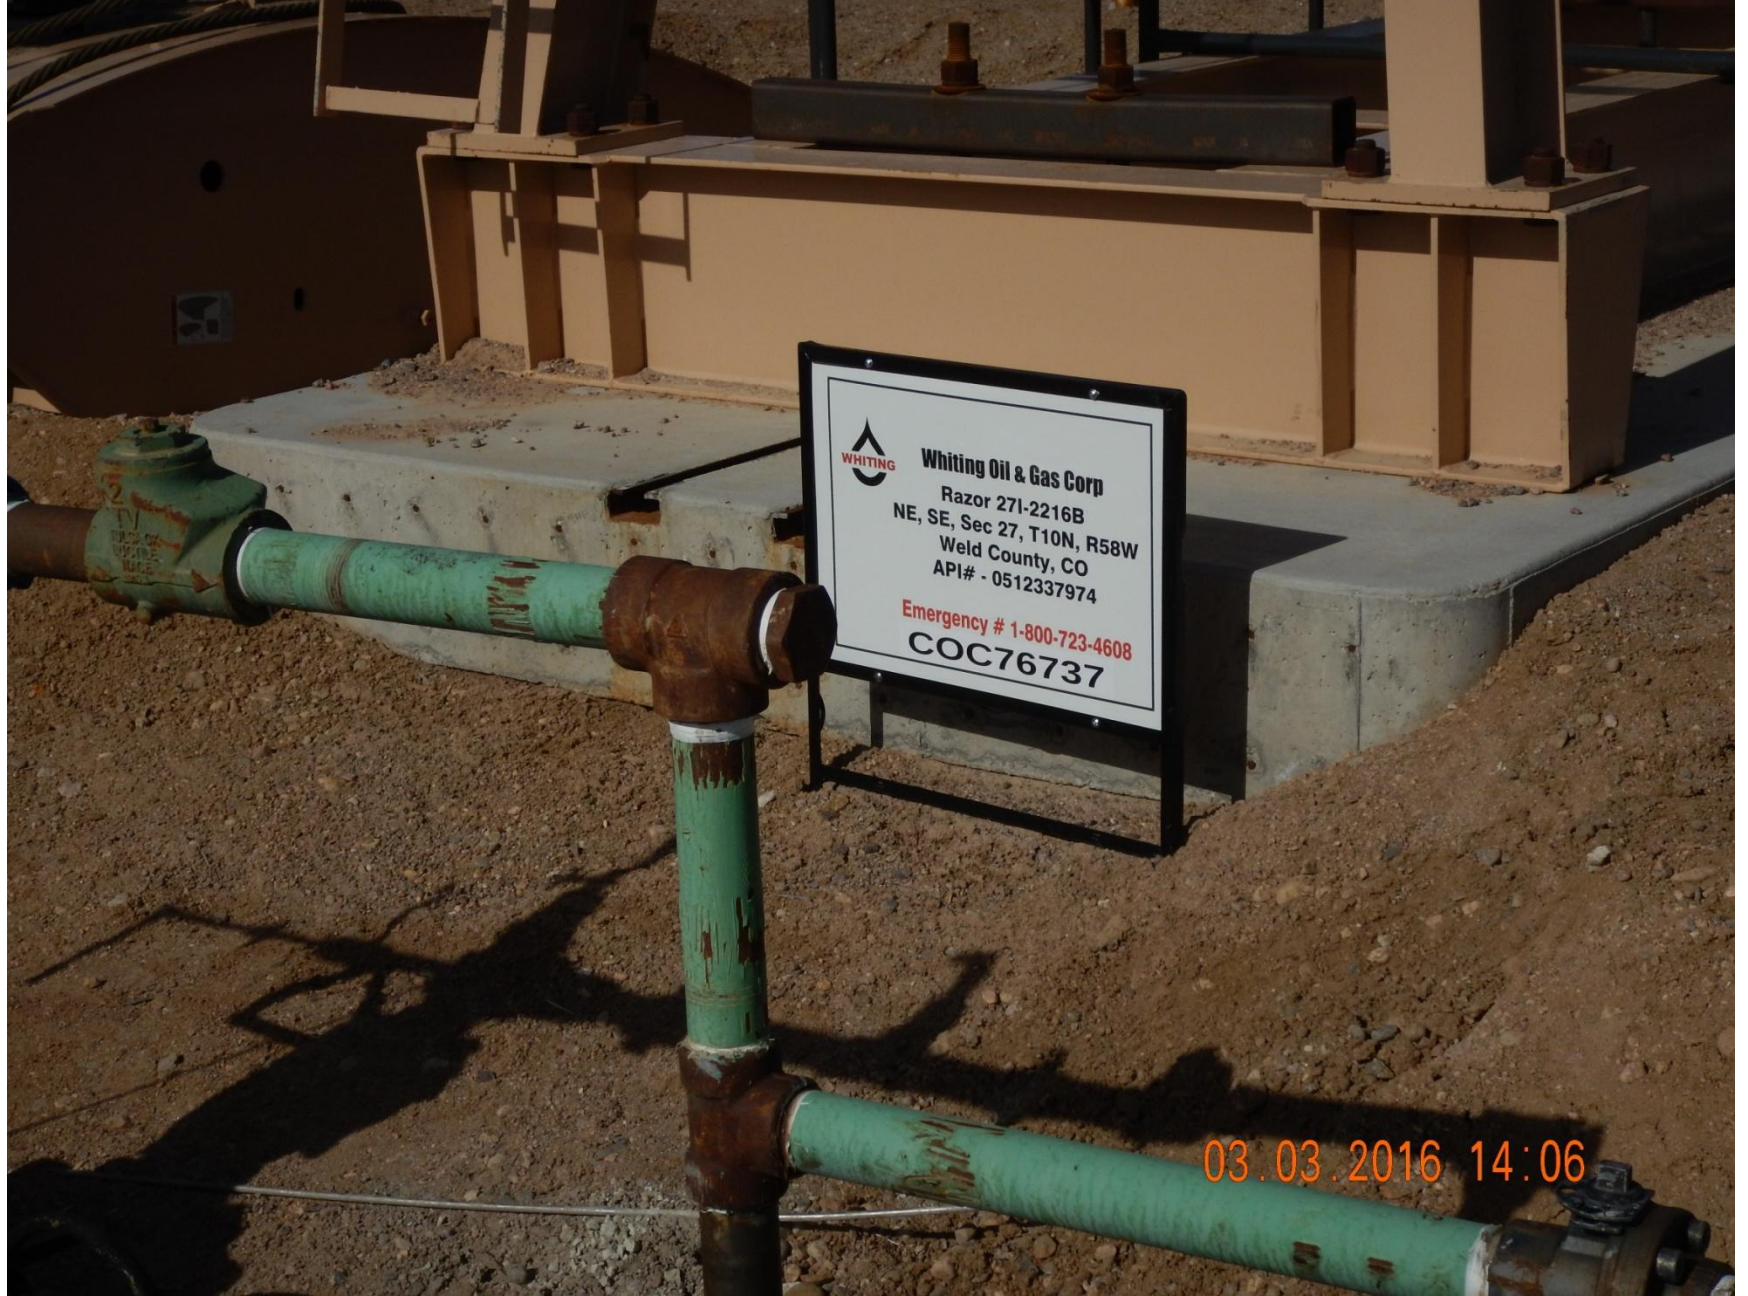
Figure 7: Photo of well #123-37974

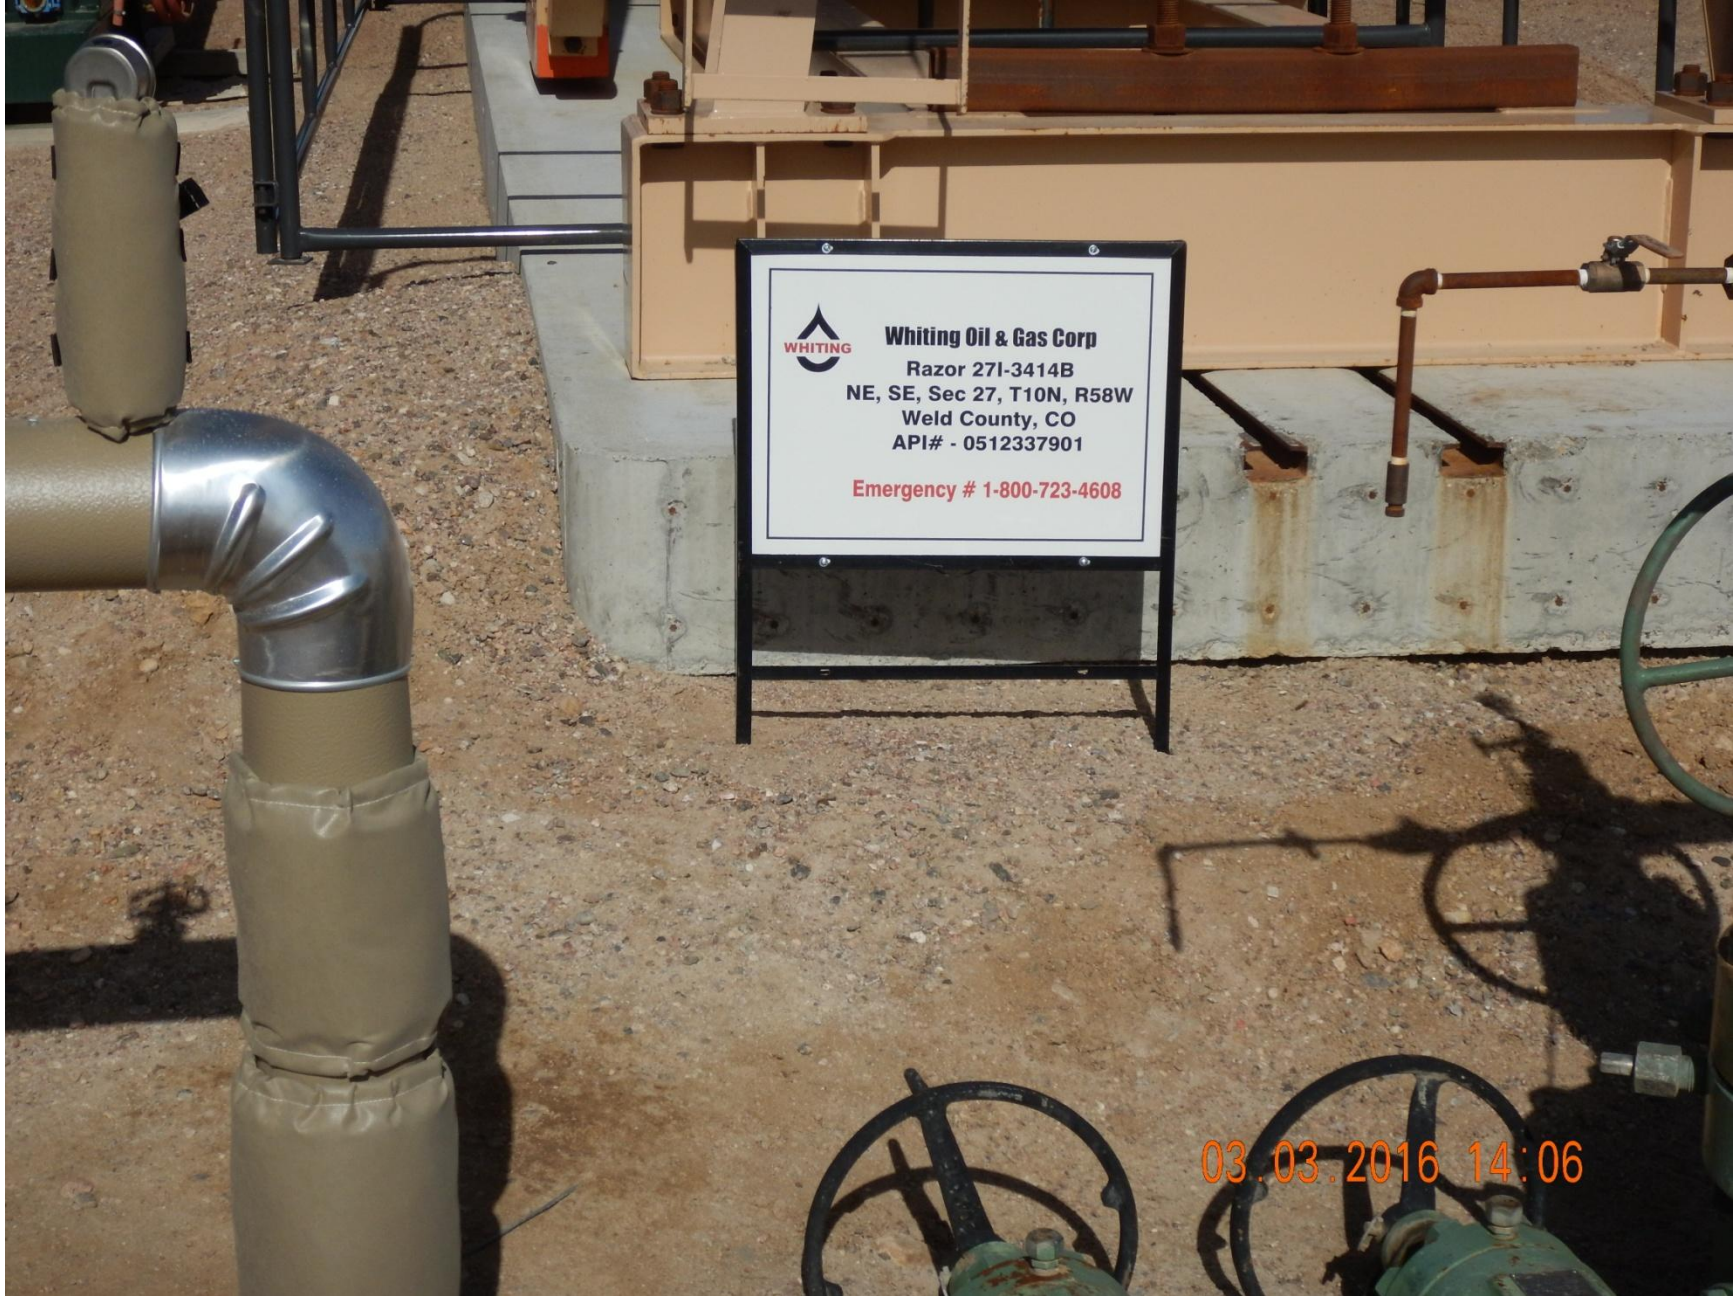
Figure 8: Photo of well #123-37901

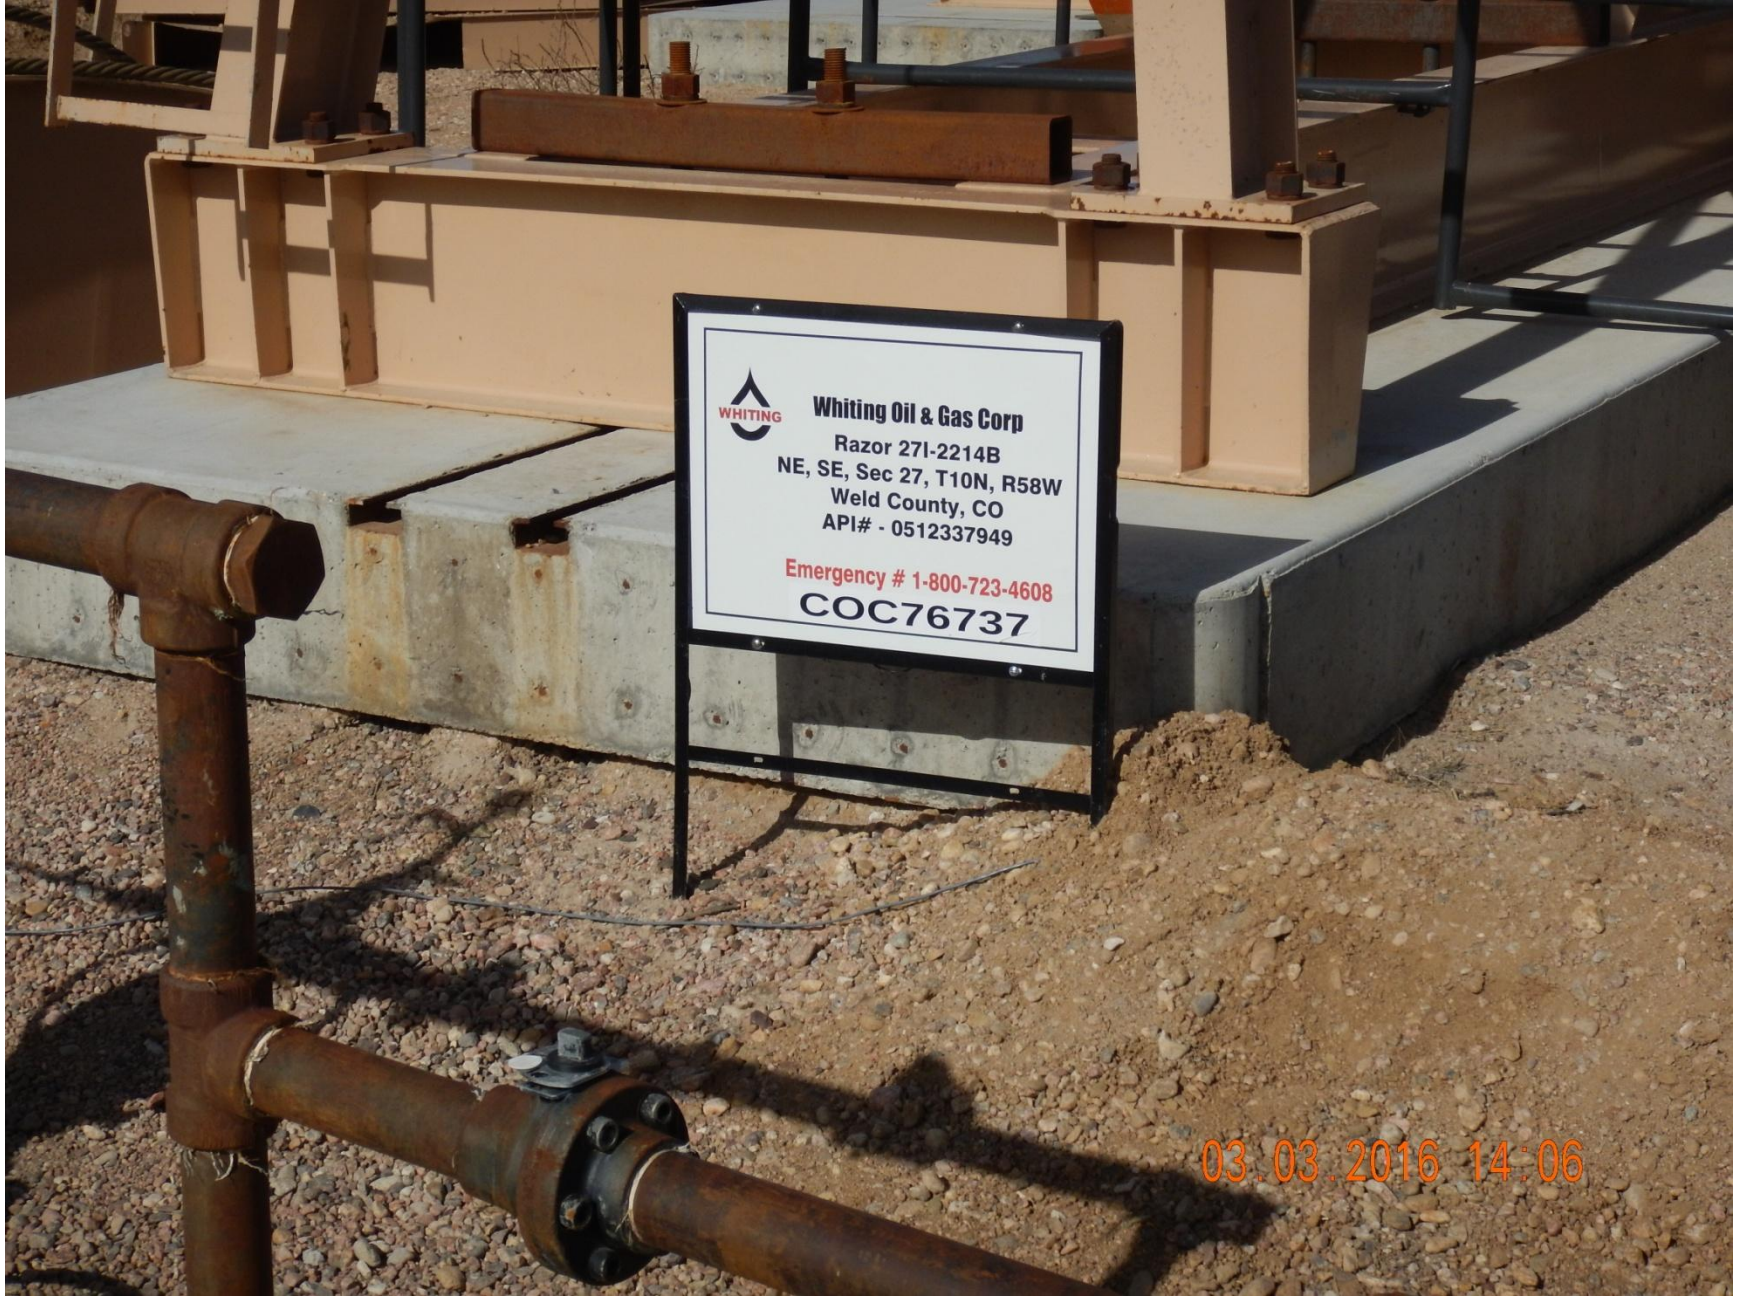
Figure 9: Photo of well #123-37949.

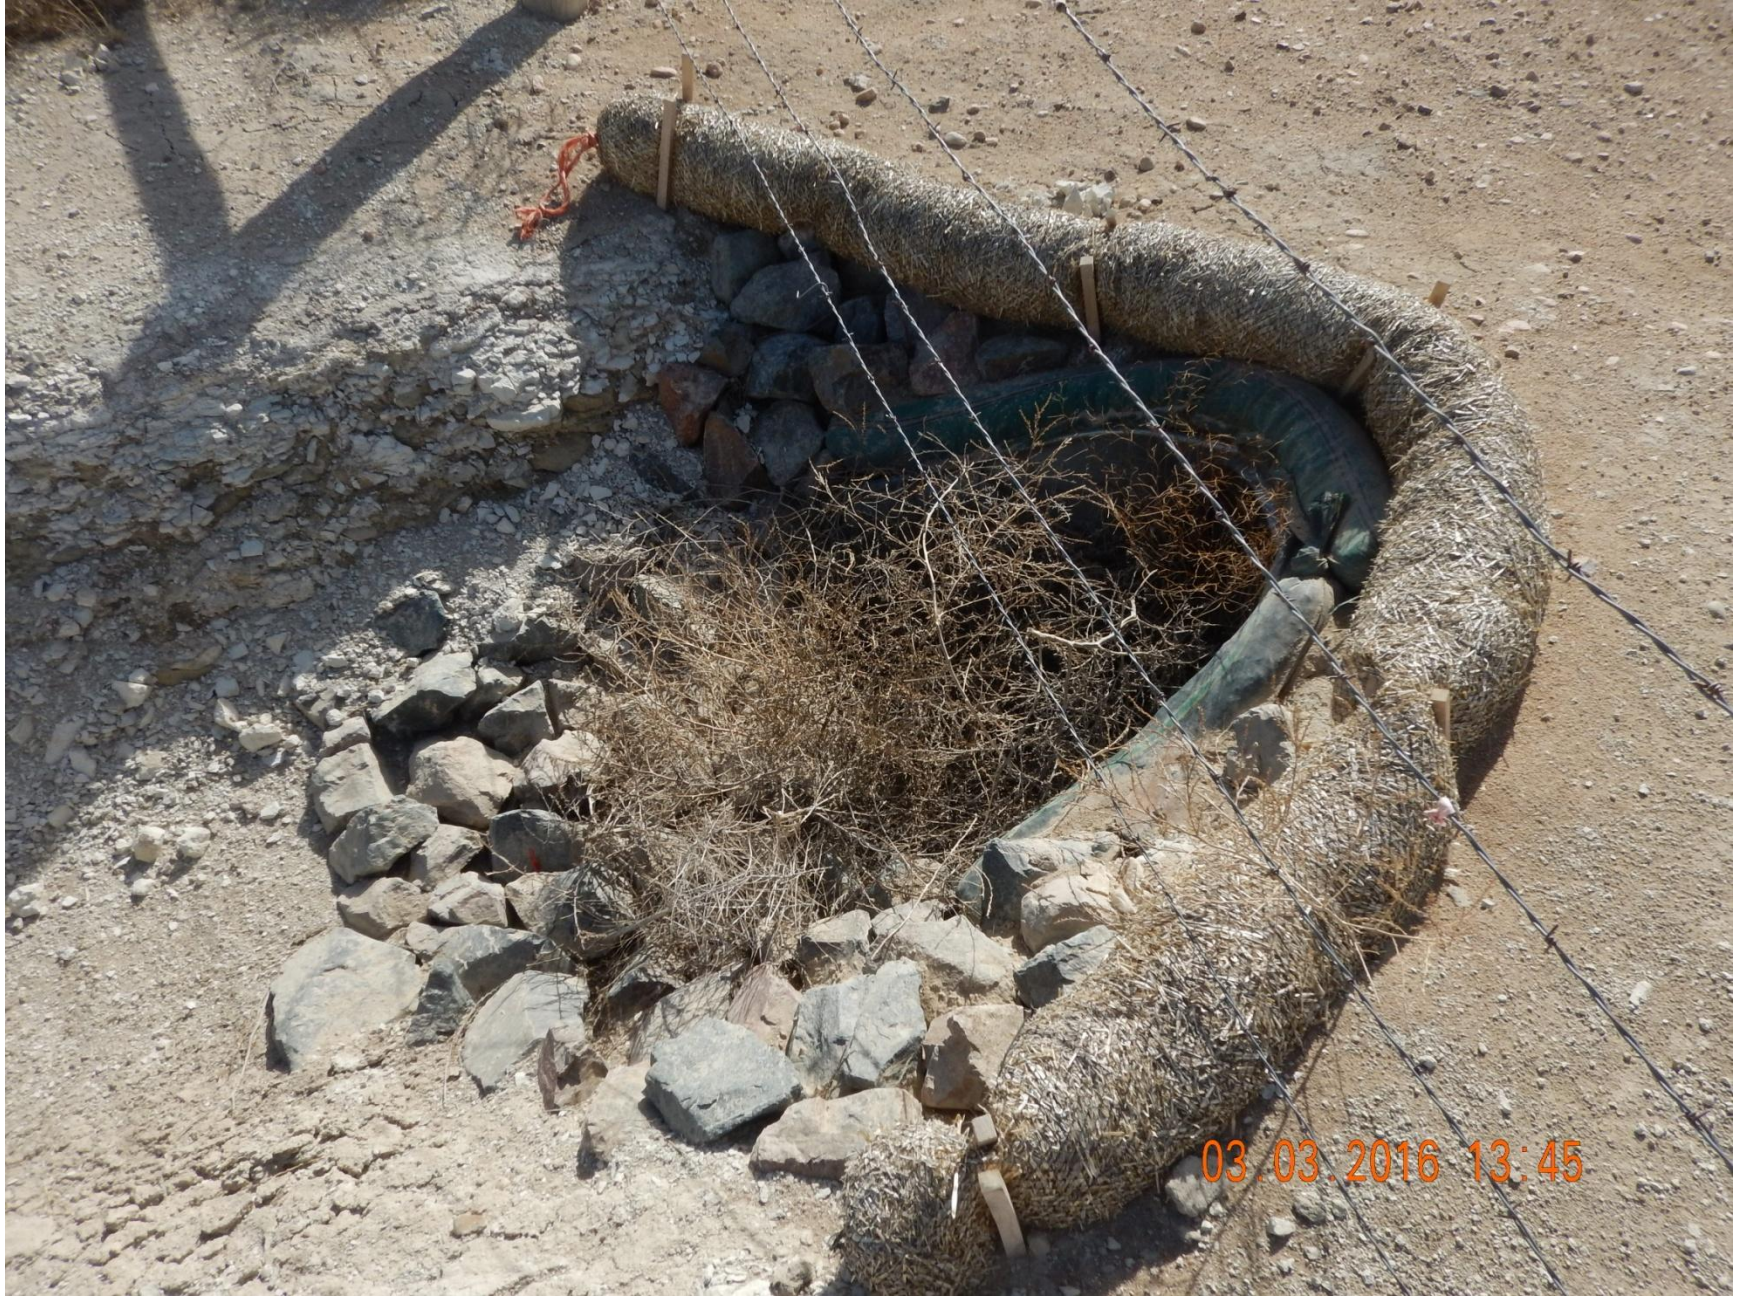
Figure 10: Photo taken from the access road at the south end of the location. Photo of culvert and stormwater and sediment control BMPs
