Interim Reclamation Inspection

Operator: Whiting Oil and Gas

Location ID: 433999

Weld County, CO

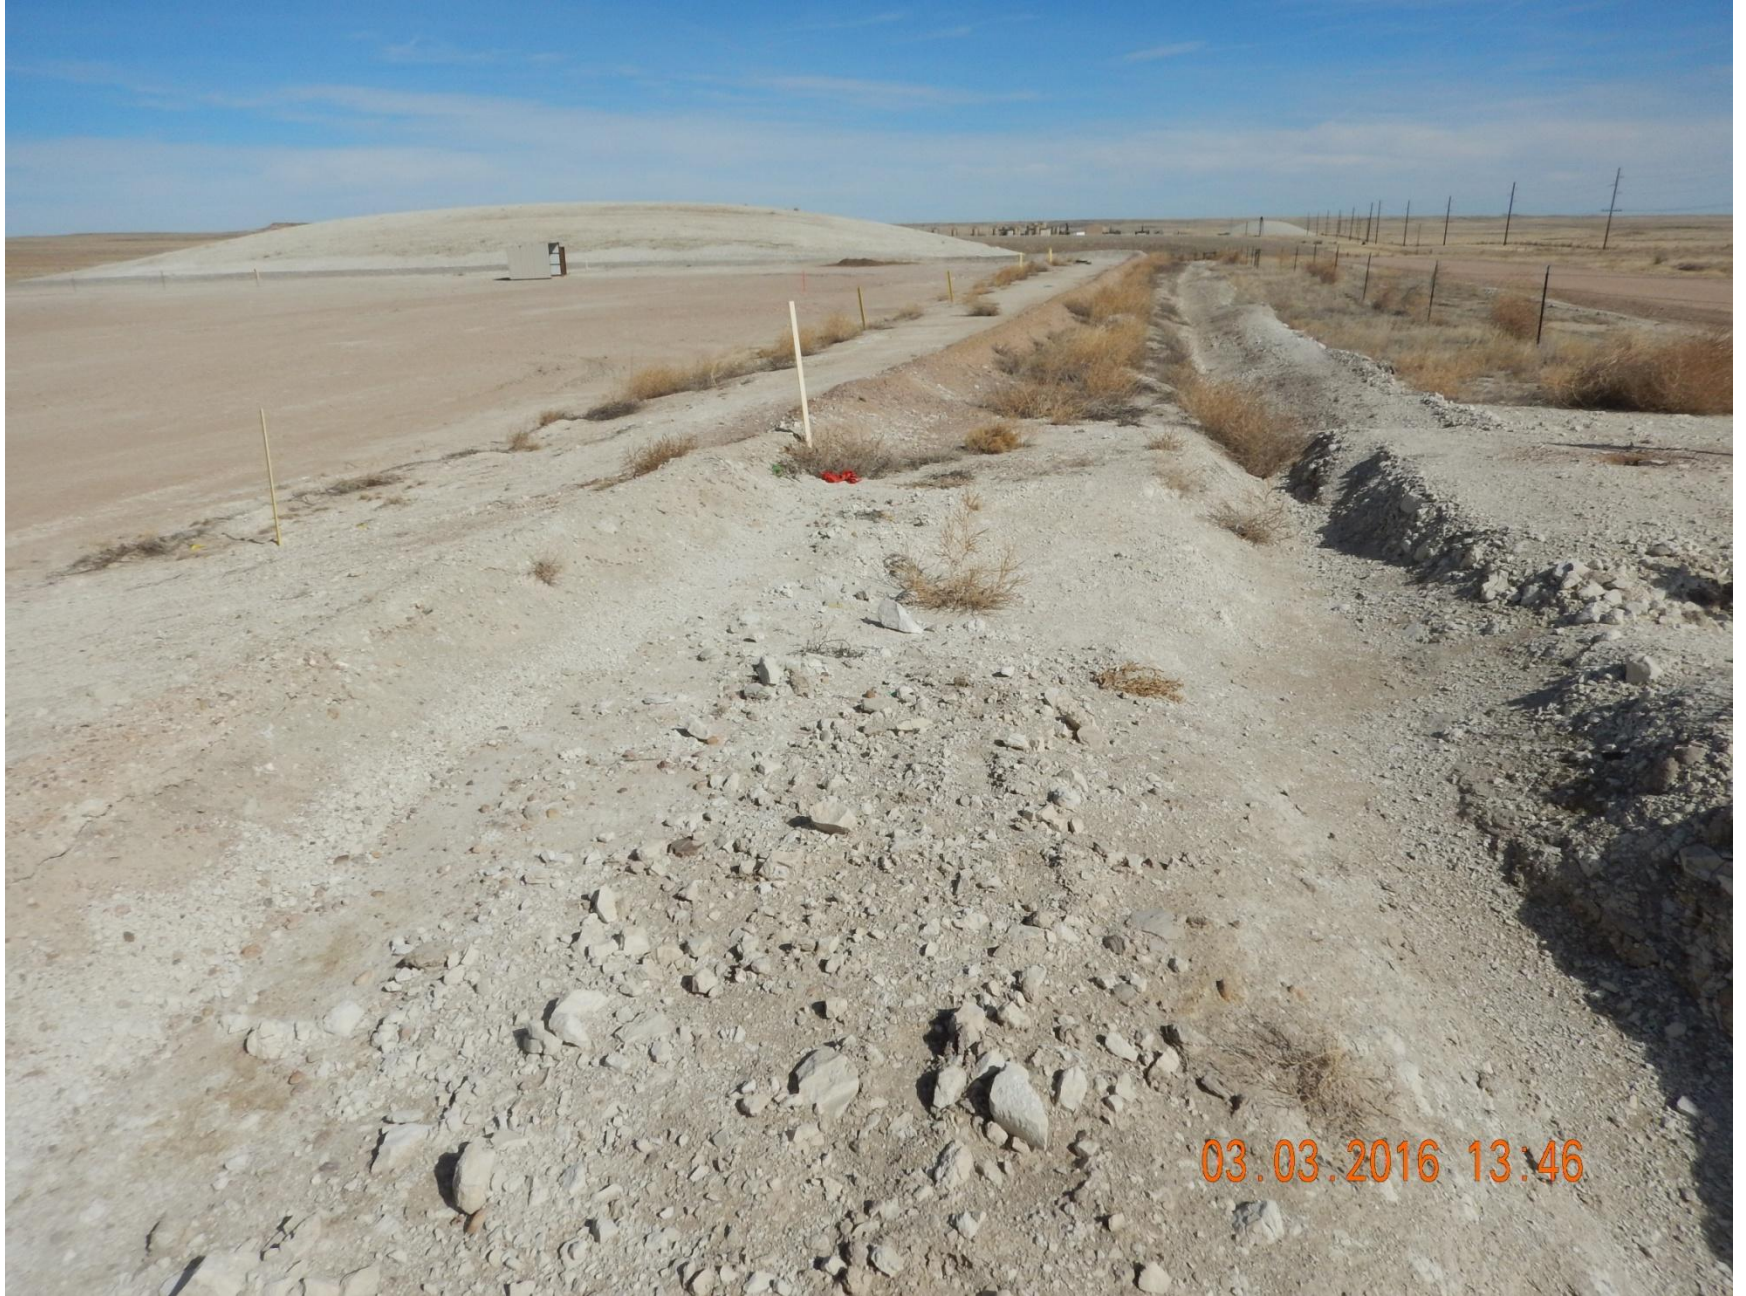
Figure 11: Photo taken from the access road on the south end of the location, facing east. Photo shows project area, and stormwater control ditch on the southern perimeter of the location.

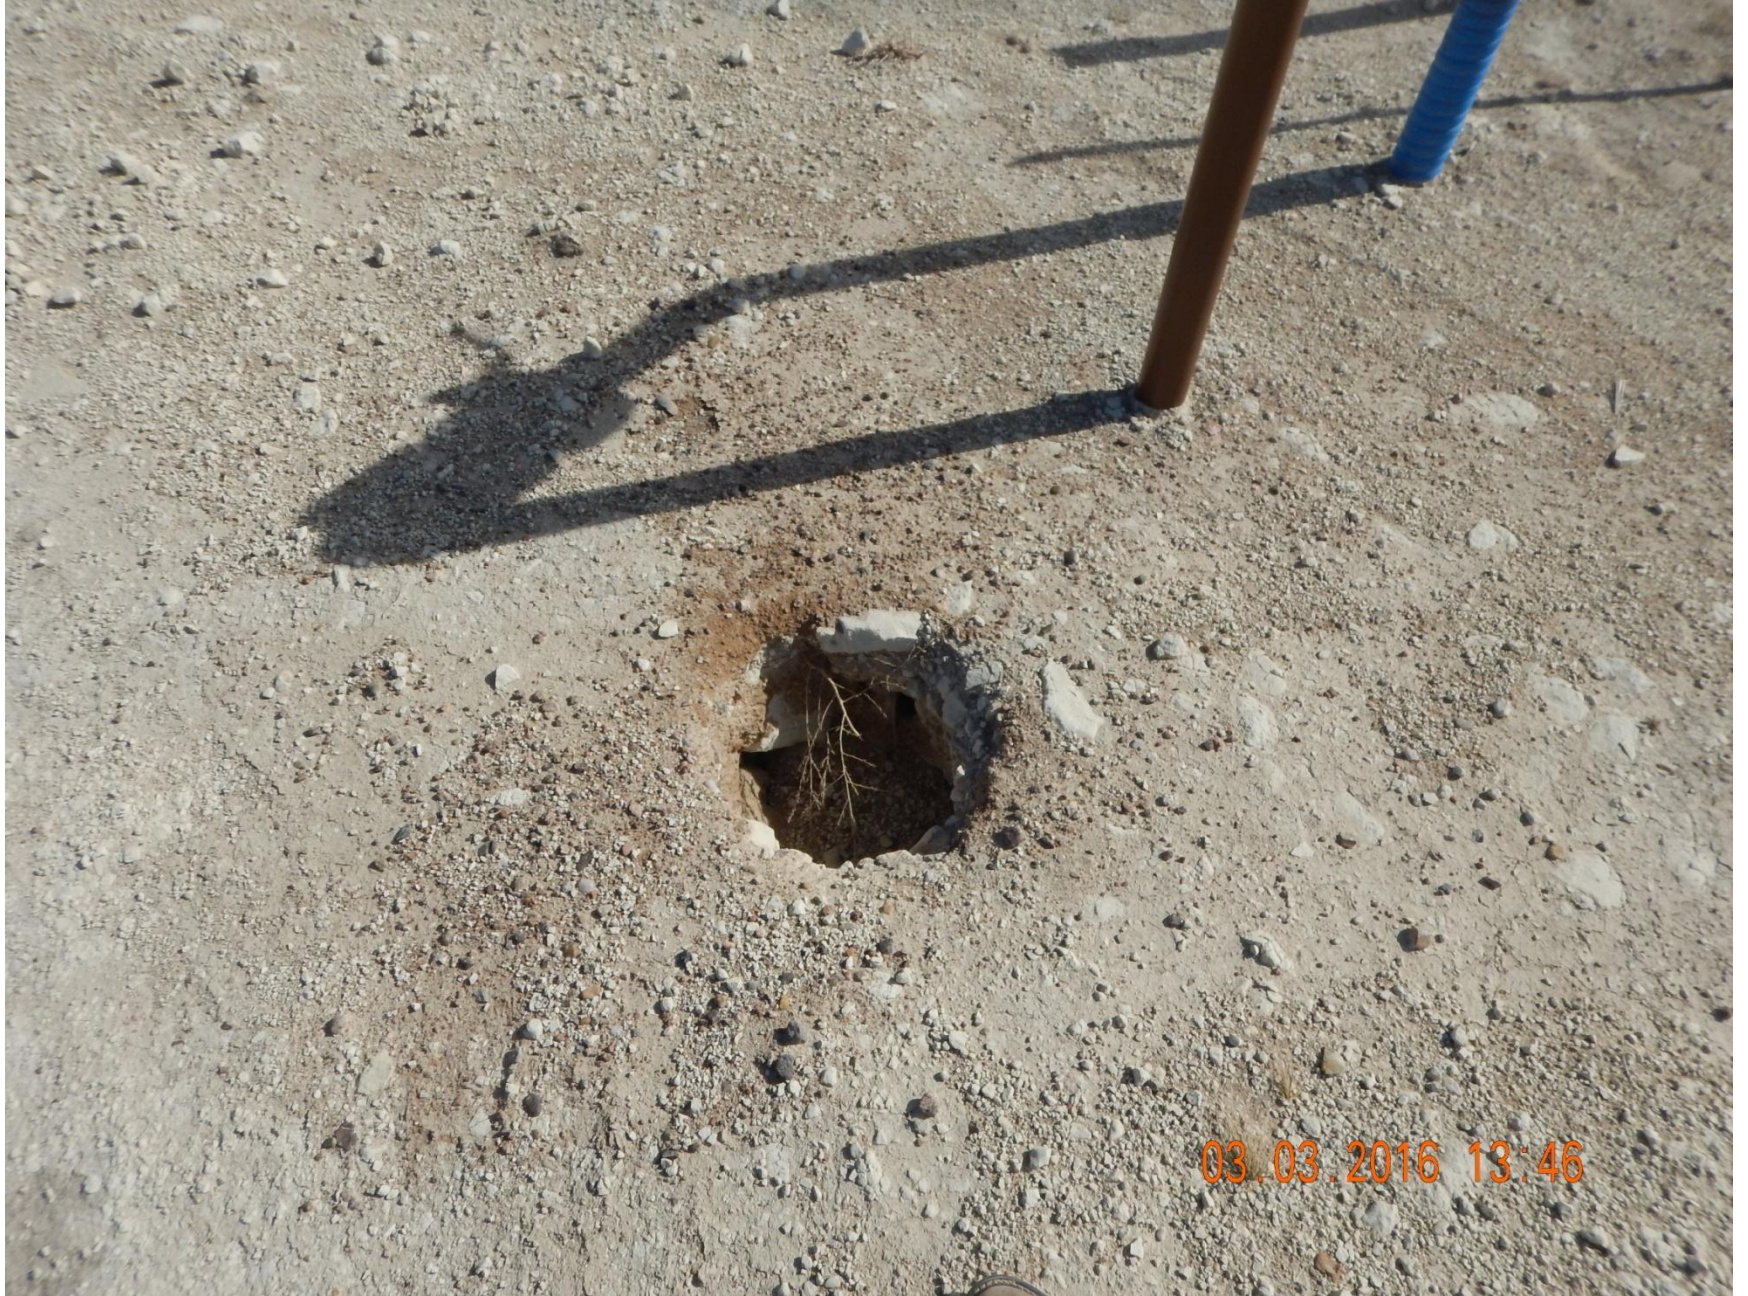
Figure 12: Photo taken from pipe adjacent to the access road on the south end of the location. Photo of exposed hole due to either subsidence or wildlife.

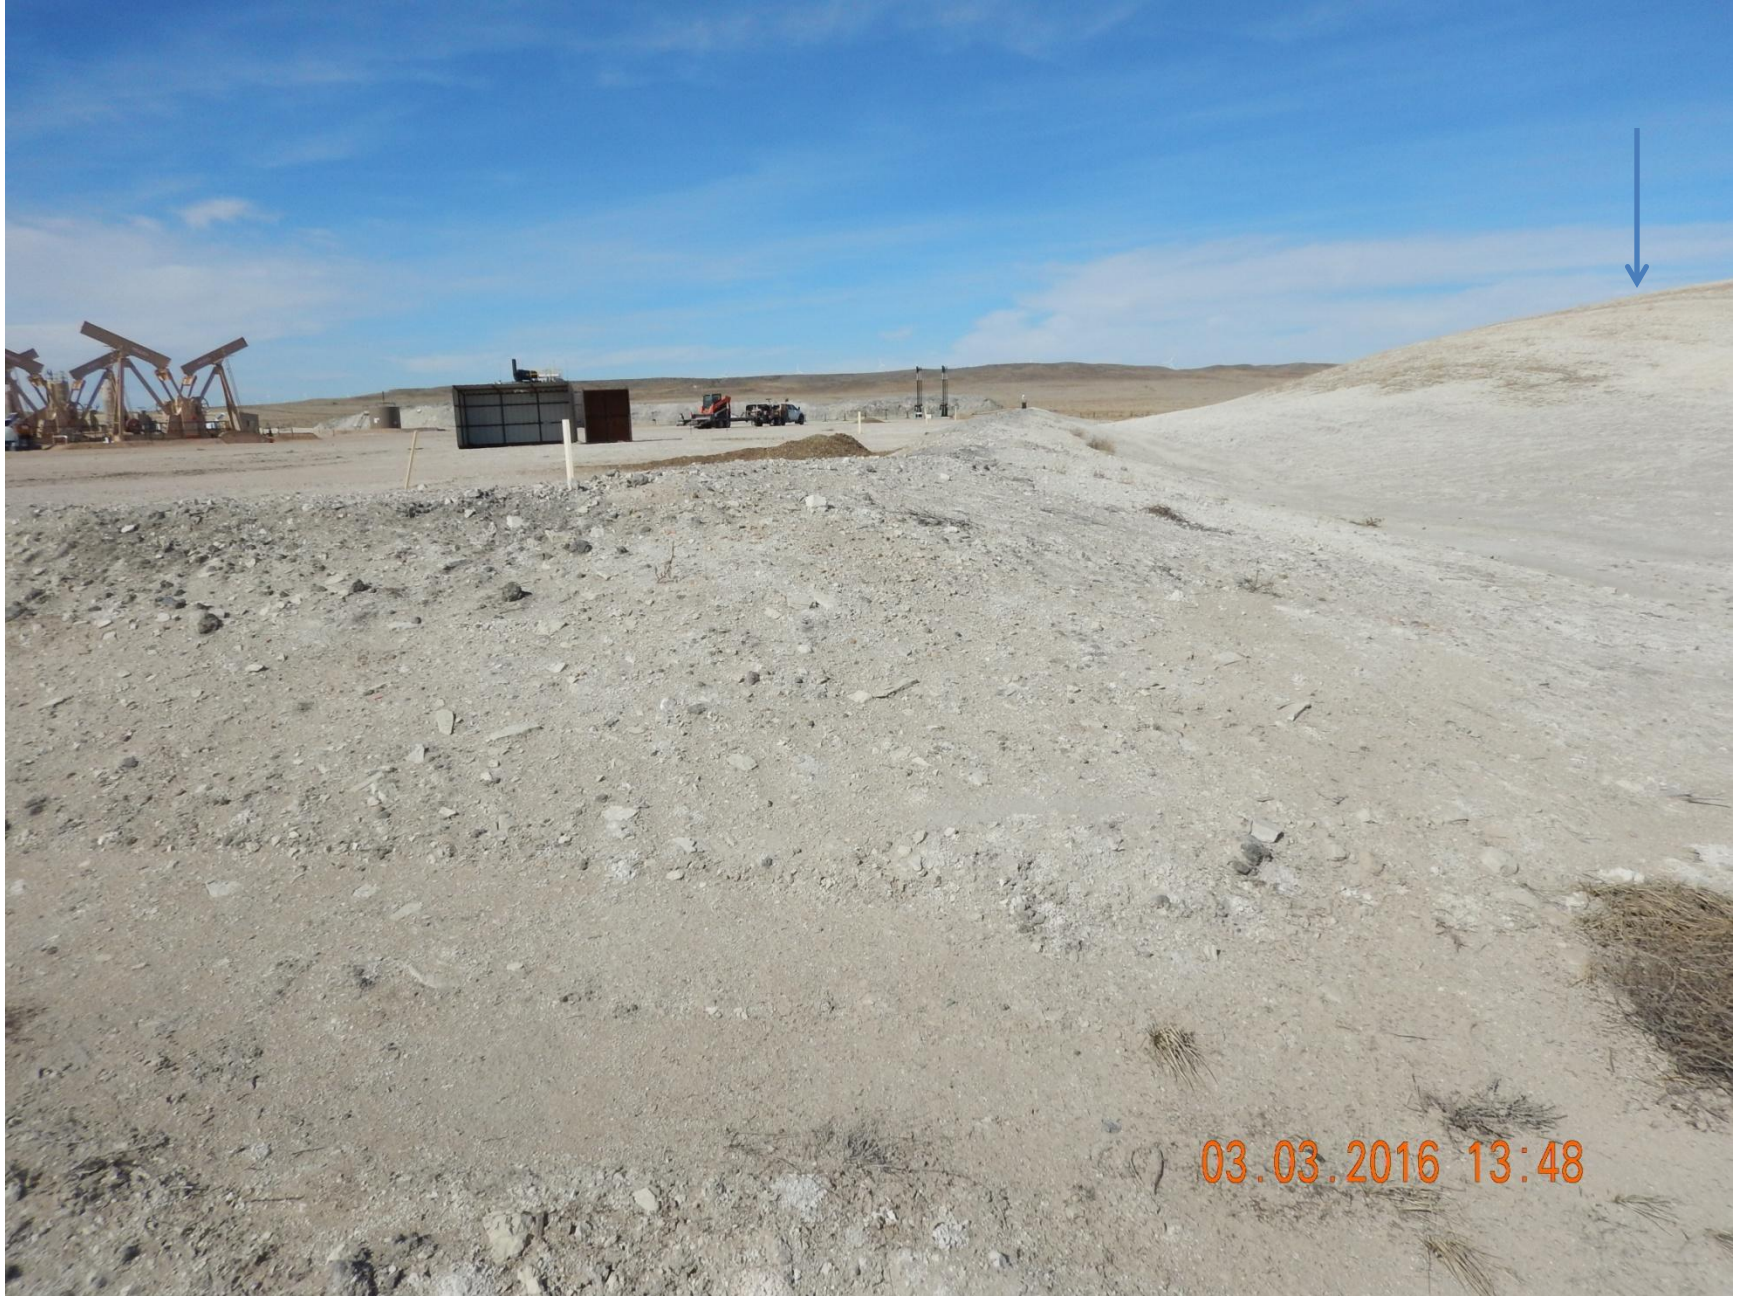
Figure 13: Photo taken from the southeast corner of the project area facing north. Photo shows project and interim areas. Spoils stockpile berm to the right of photo.

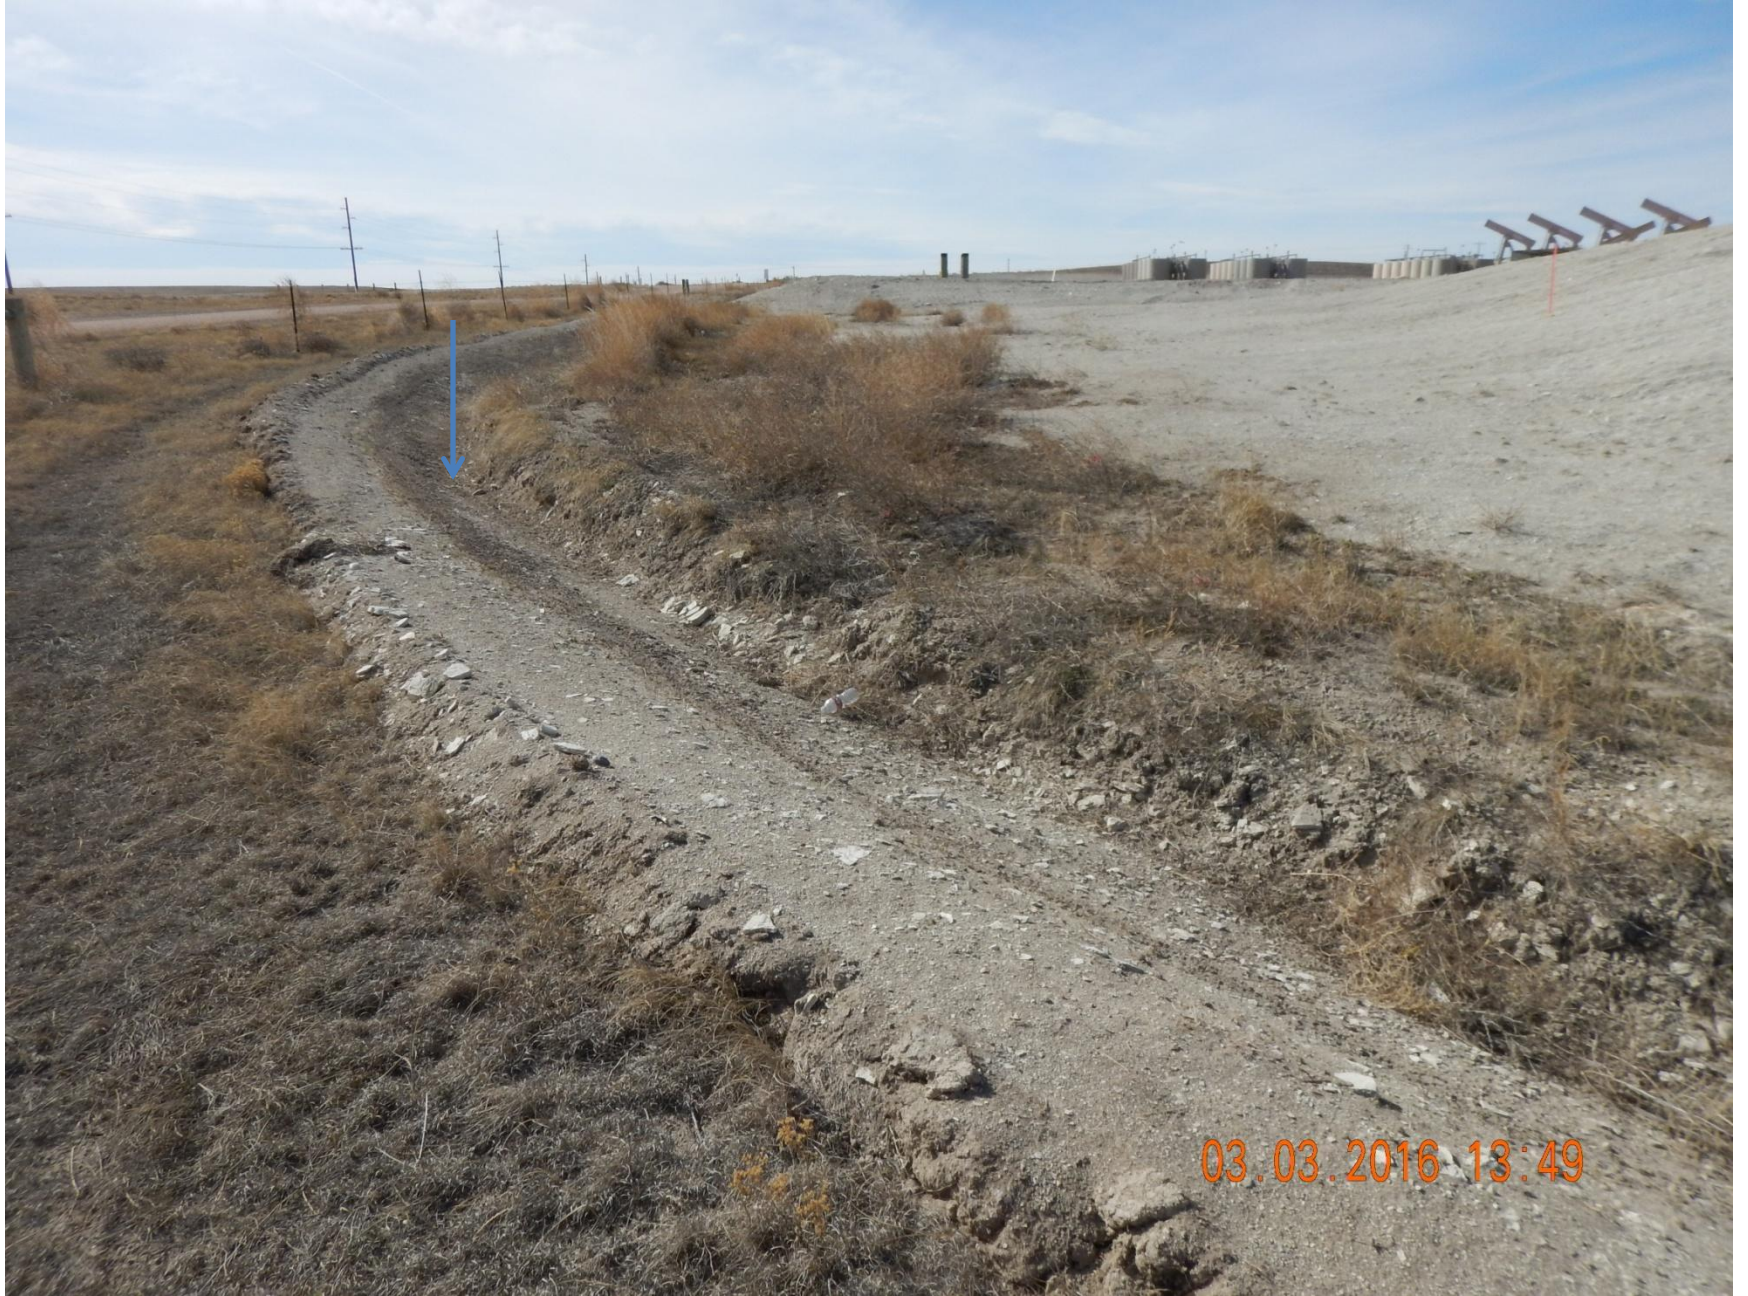
Figure 14: Photo taken from the southeast corner of the interim area facing west. Photo shows stormwater diversion ditch.

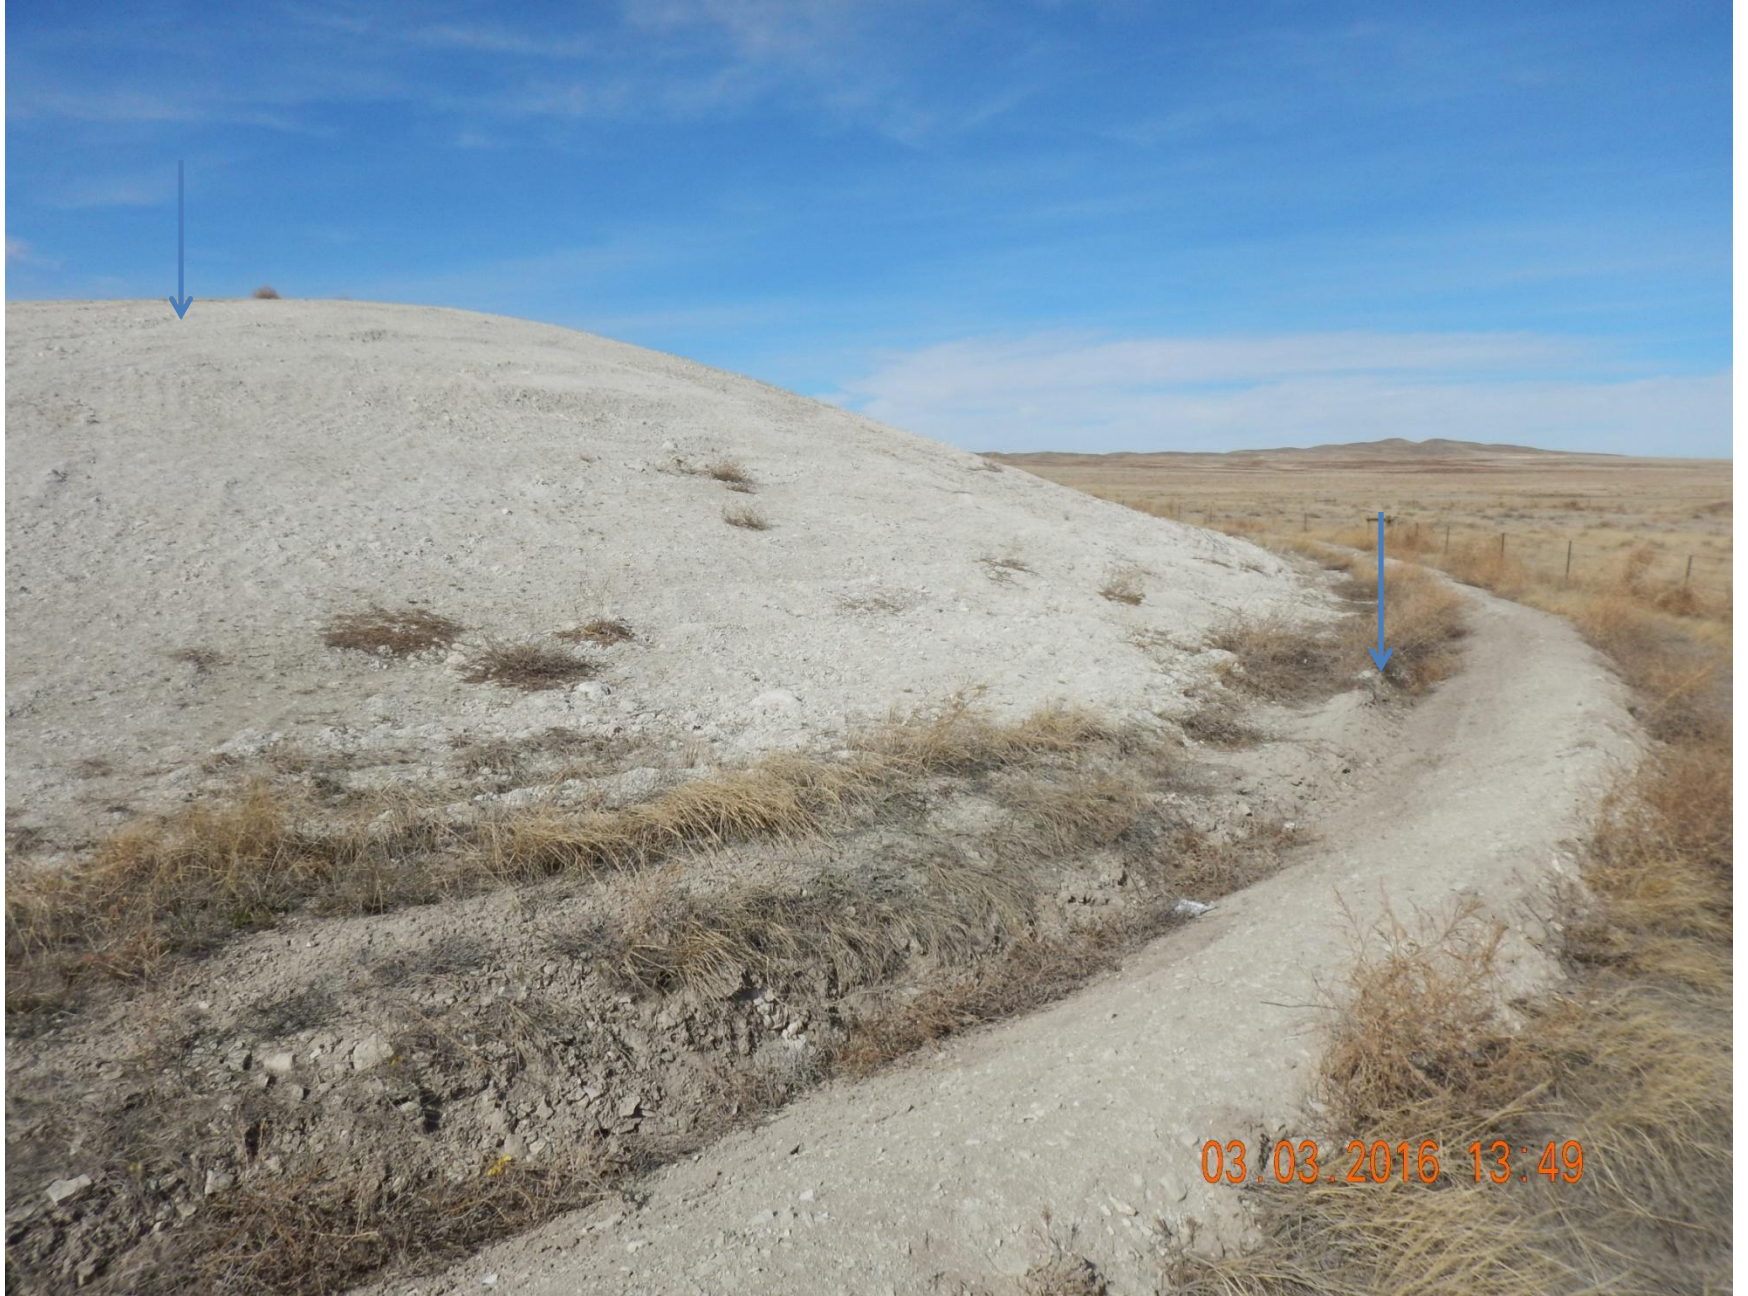
Figure 15: Photo taken from the southeast corner of the interim area facing northeast. Photo shows stormwater diversion ditch, and spoils stockpile berm.

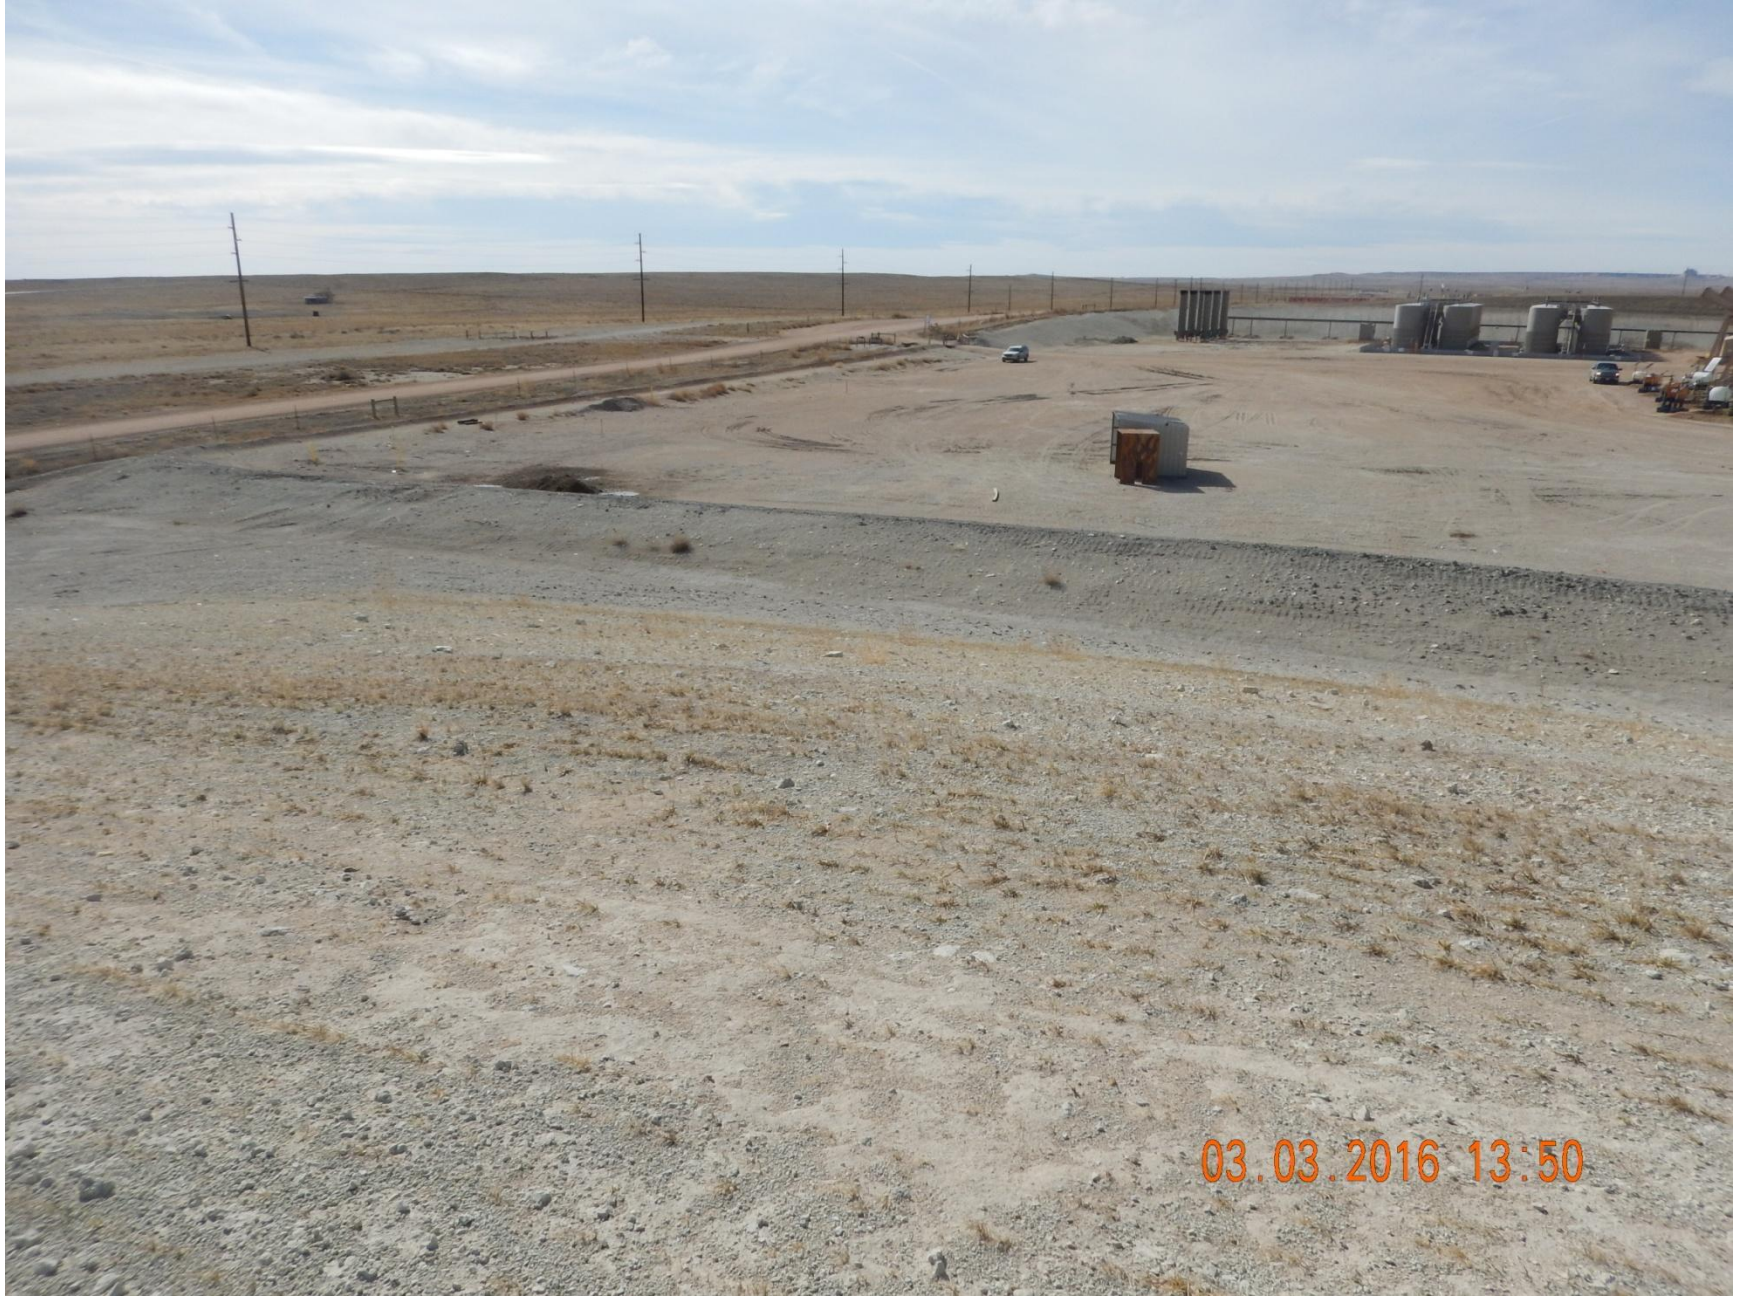
Figure 16: Photo taken from the spoils stockpile berm on the east end of the location, facing west. Photo shows interim and project areas.

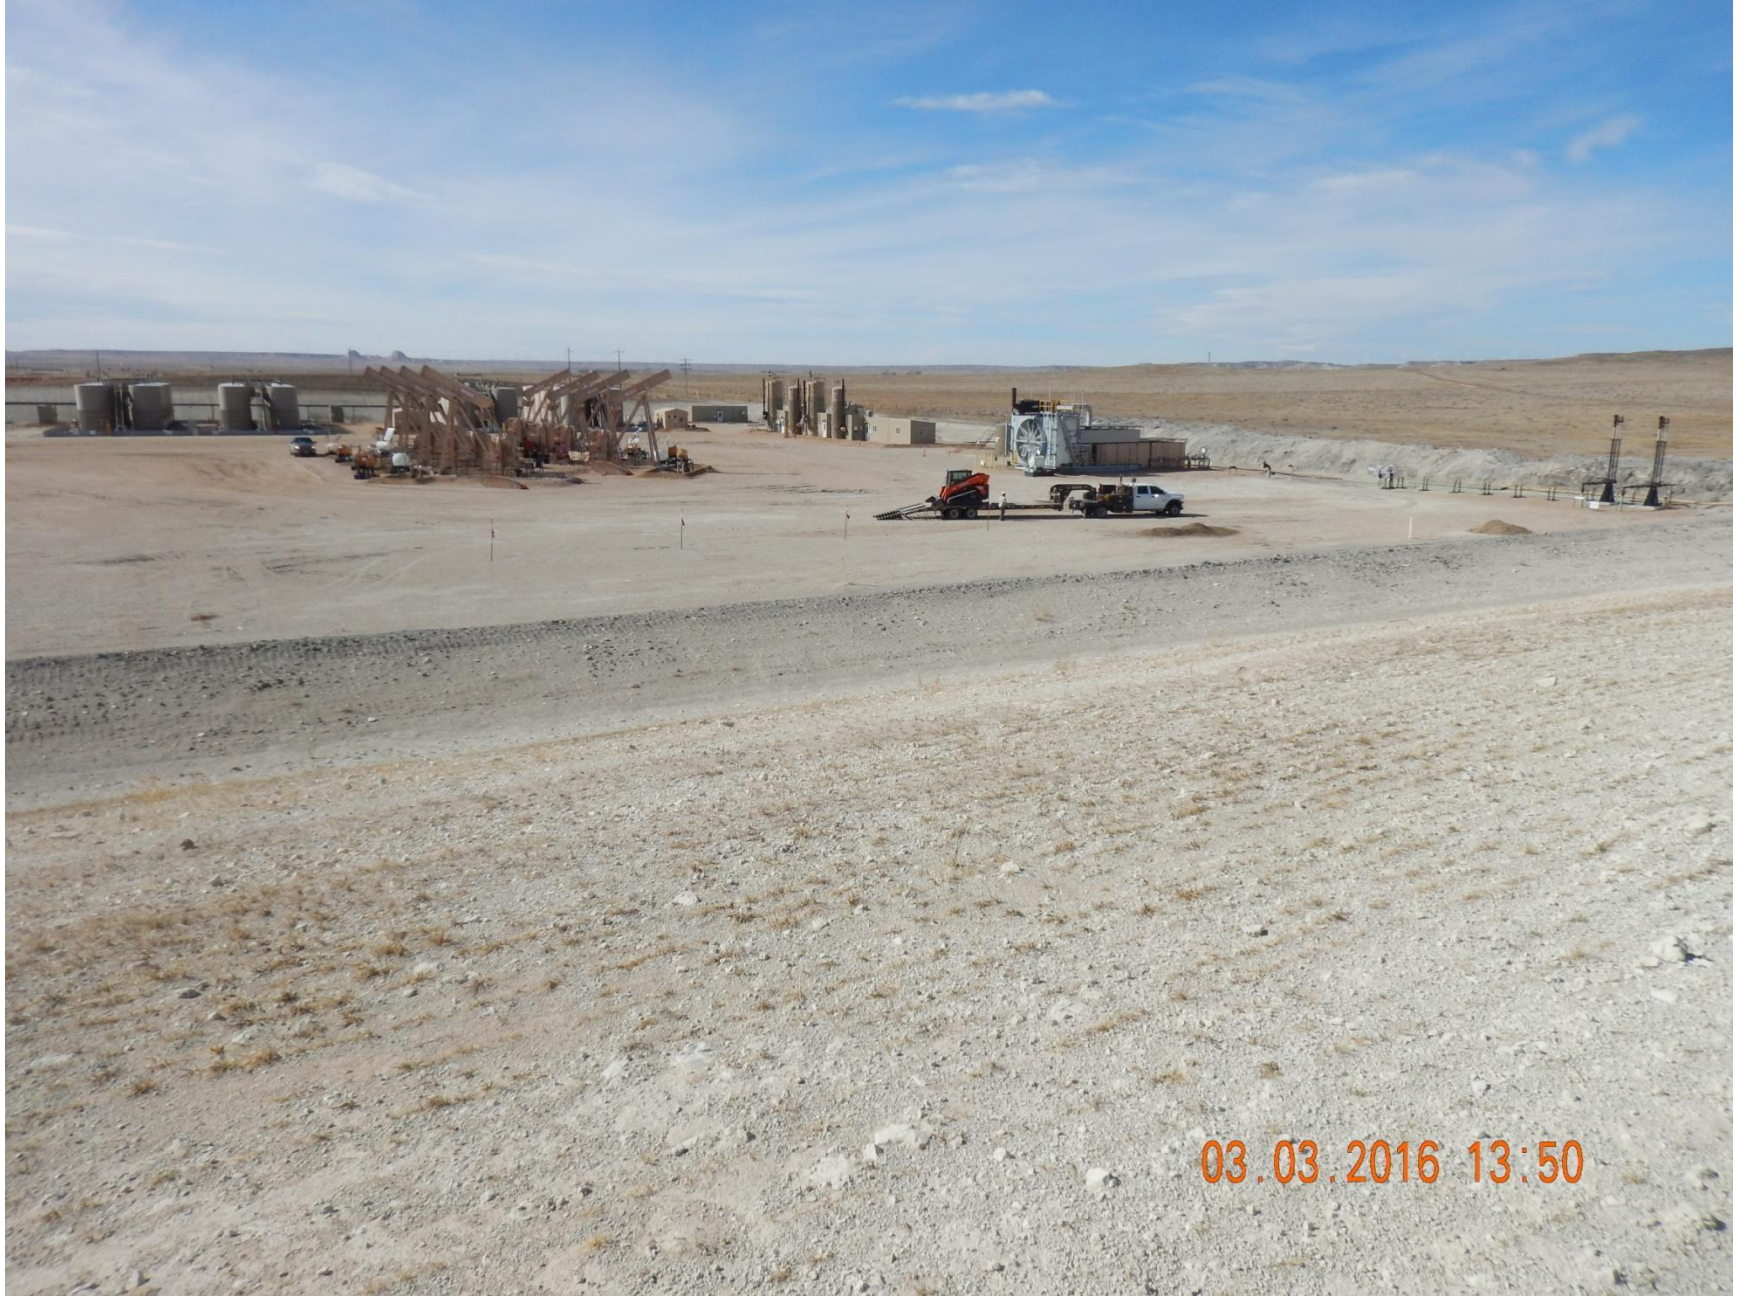
Figure 17: Photo taken from the spoils stockpile berm on the east end of the location, facing northwest. Photo shows interim and project areas.

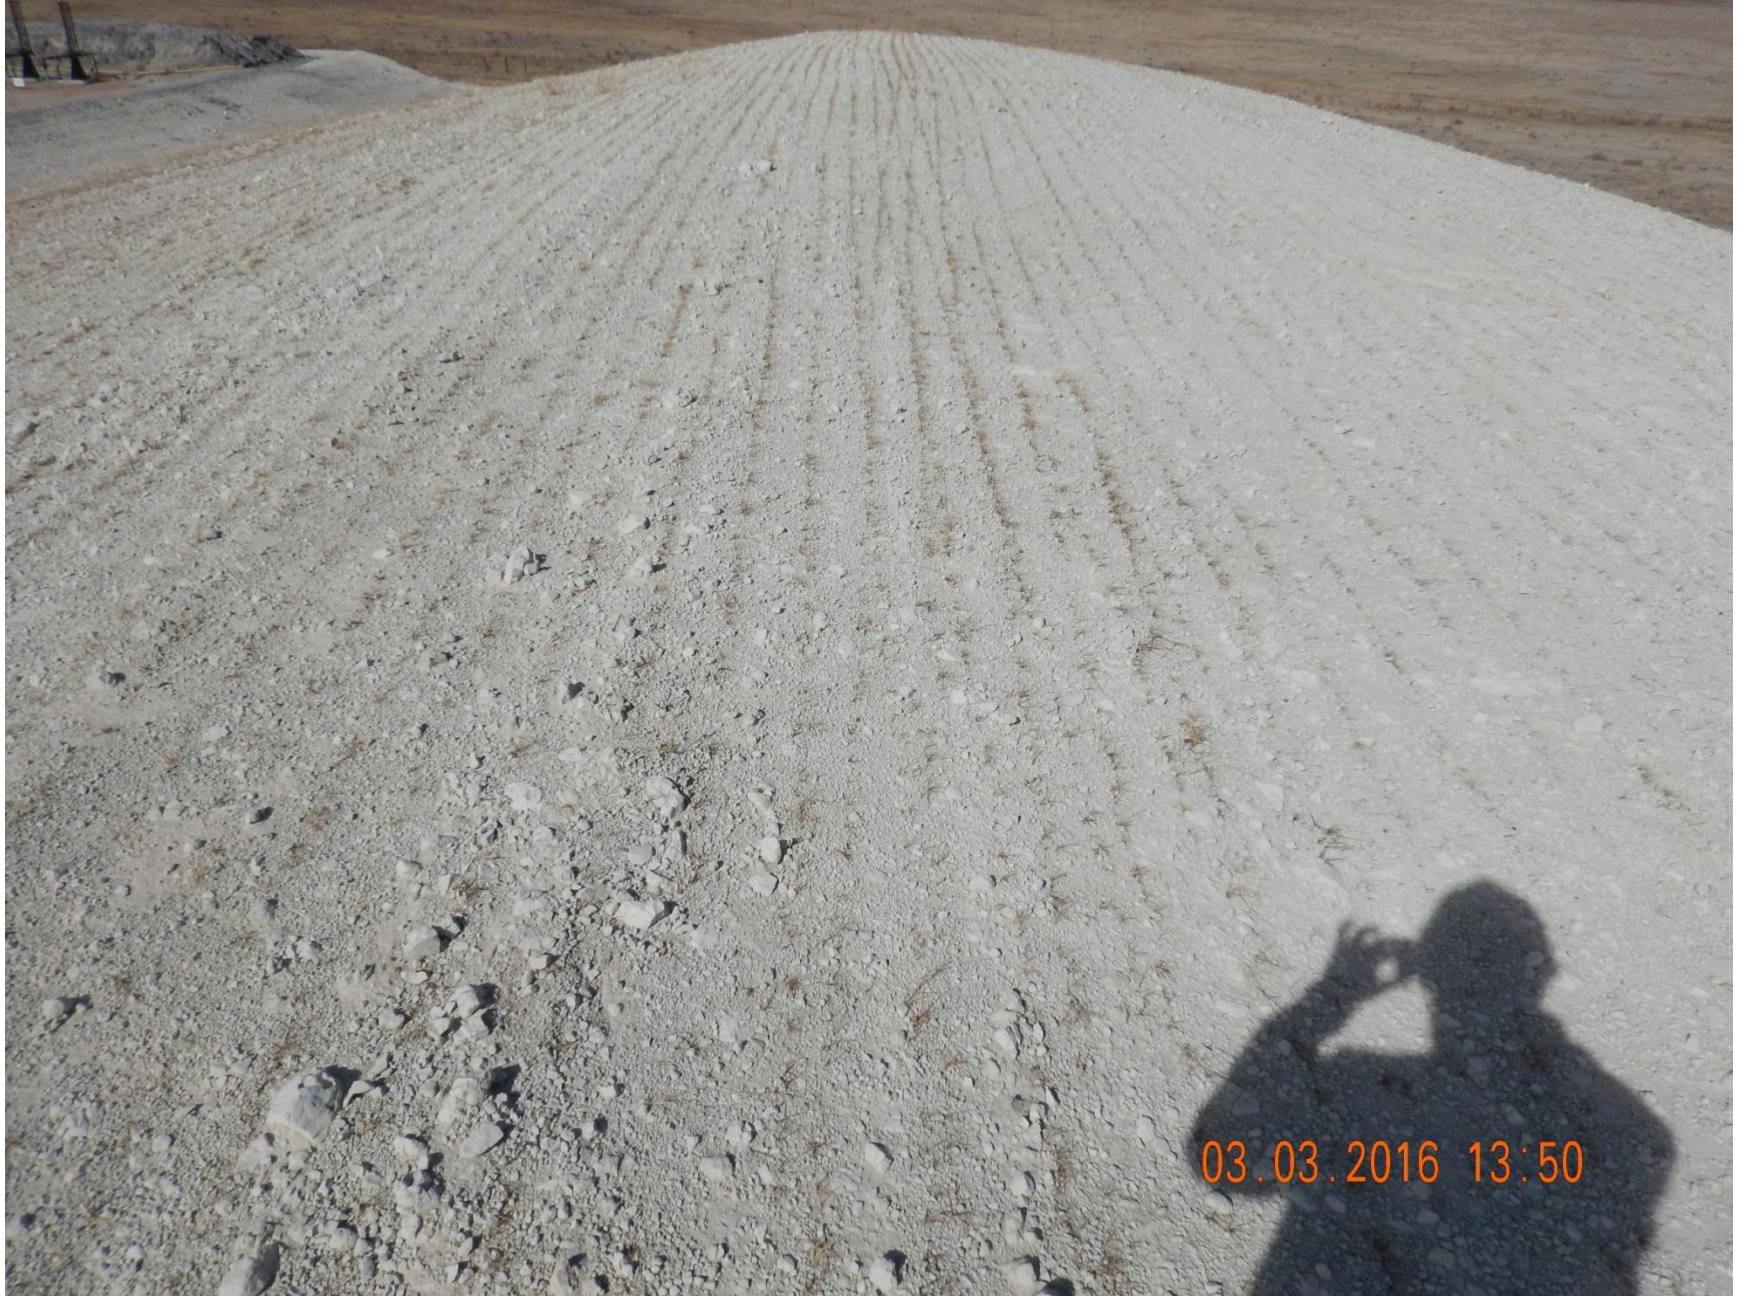
Figure 18: Photo taken from the spoils stockpile berm on the east end of the location, facing north. Photo shows soils on berm, and interim area.

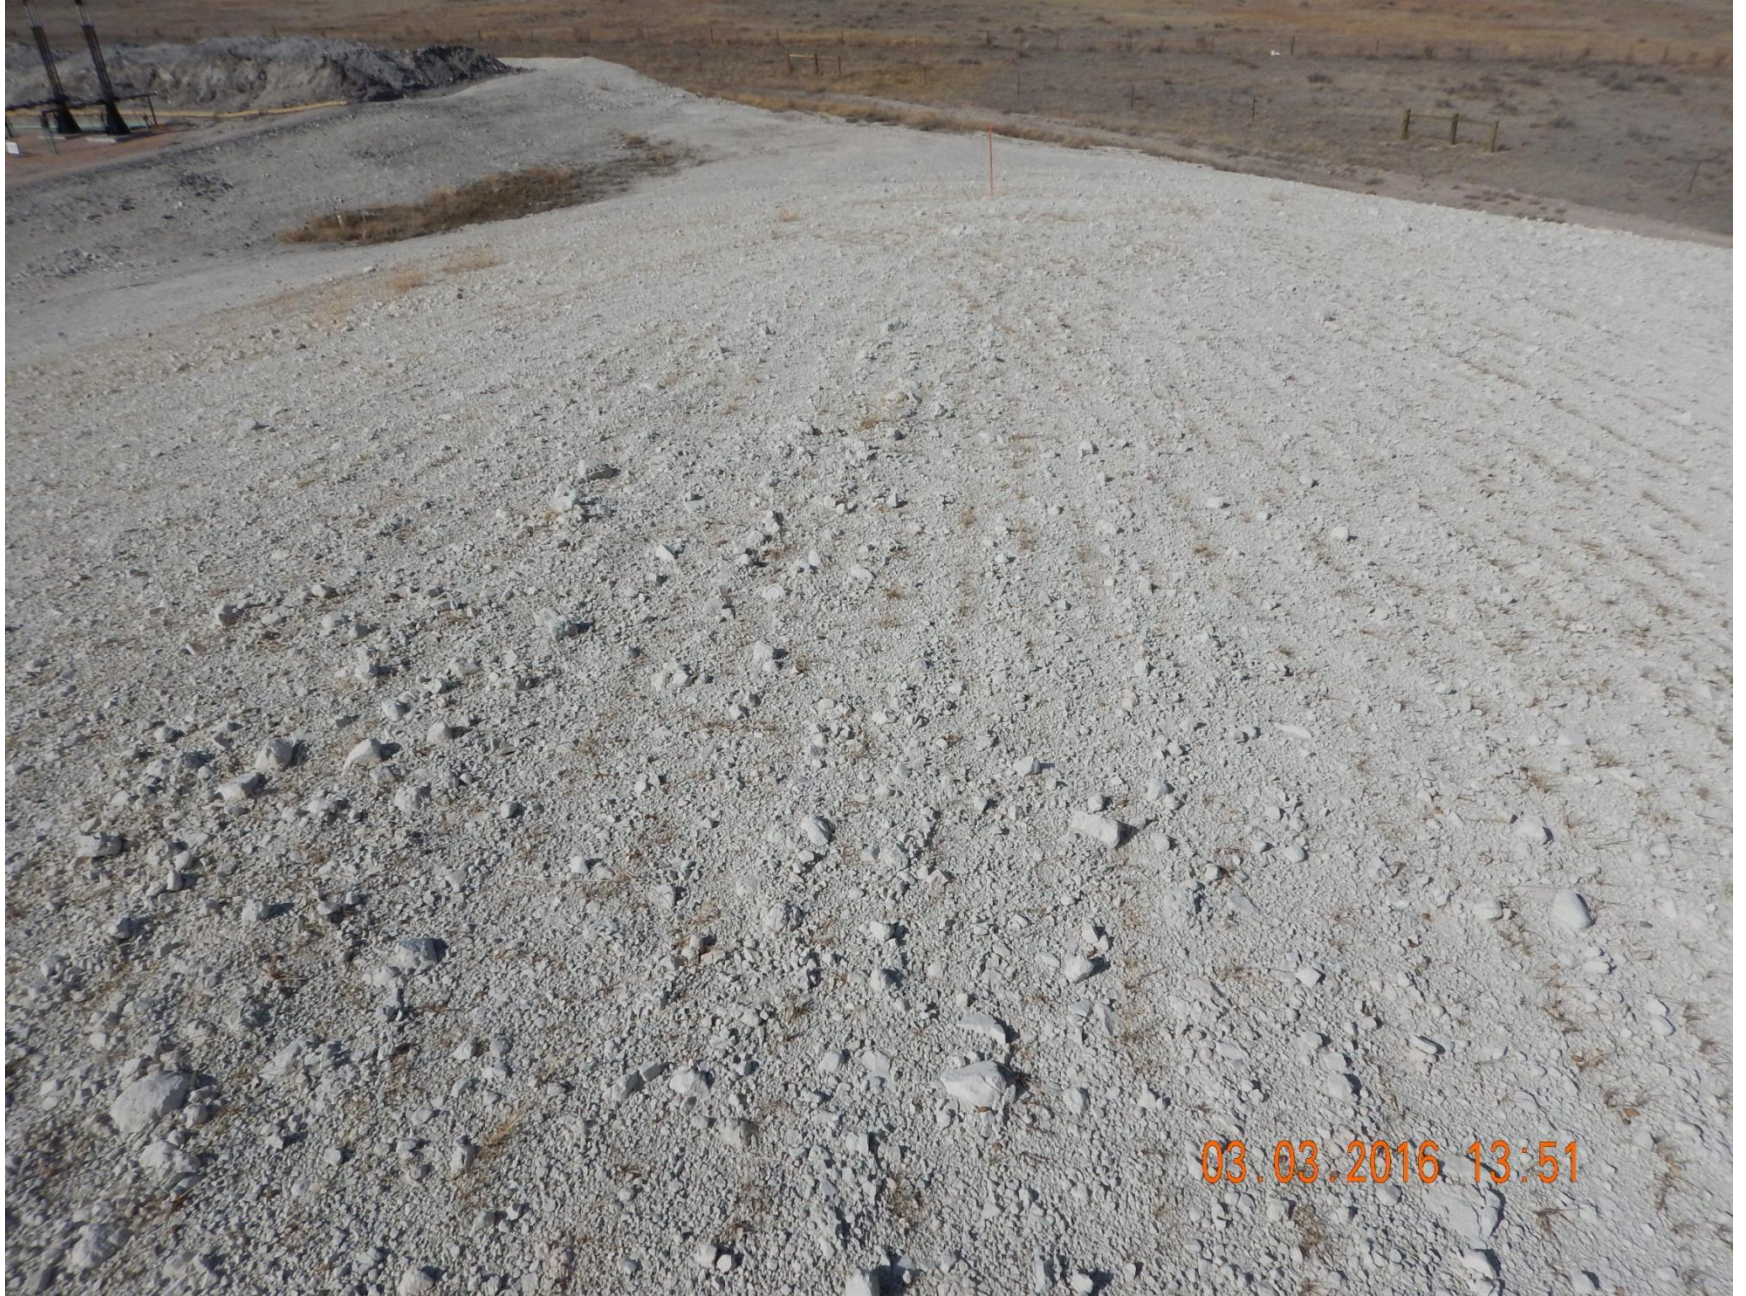
Figure 19: Photo taken from the spoils stockpile berm on the east end of the location, facing north. Photo shows soils on berm, and interim area.

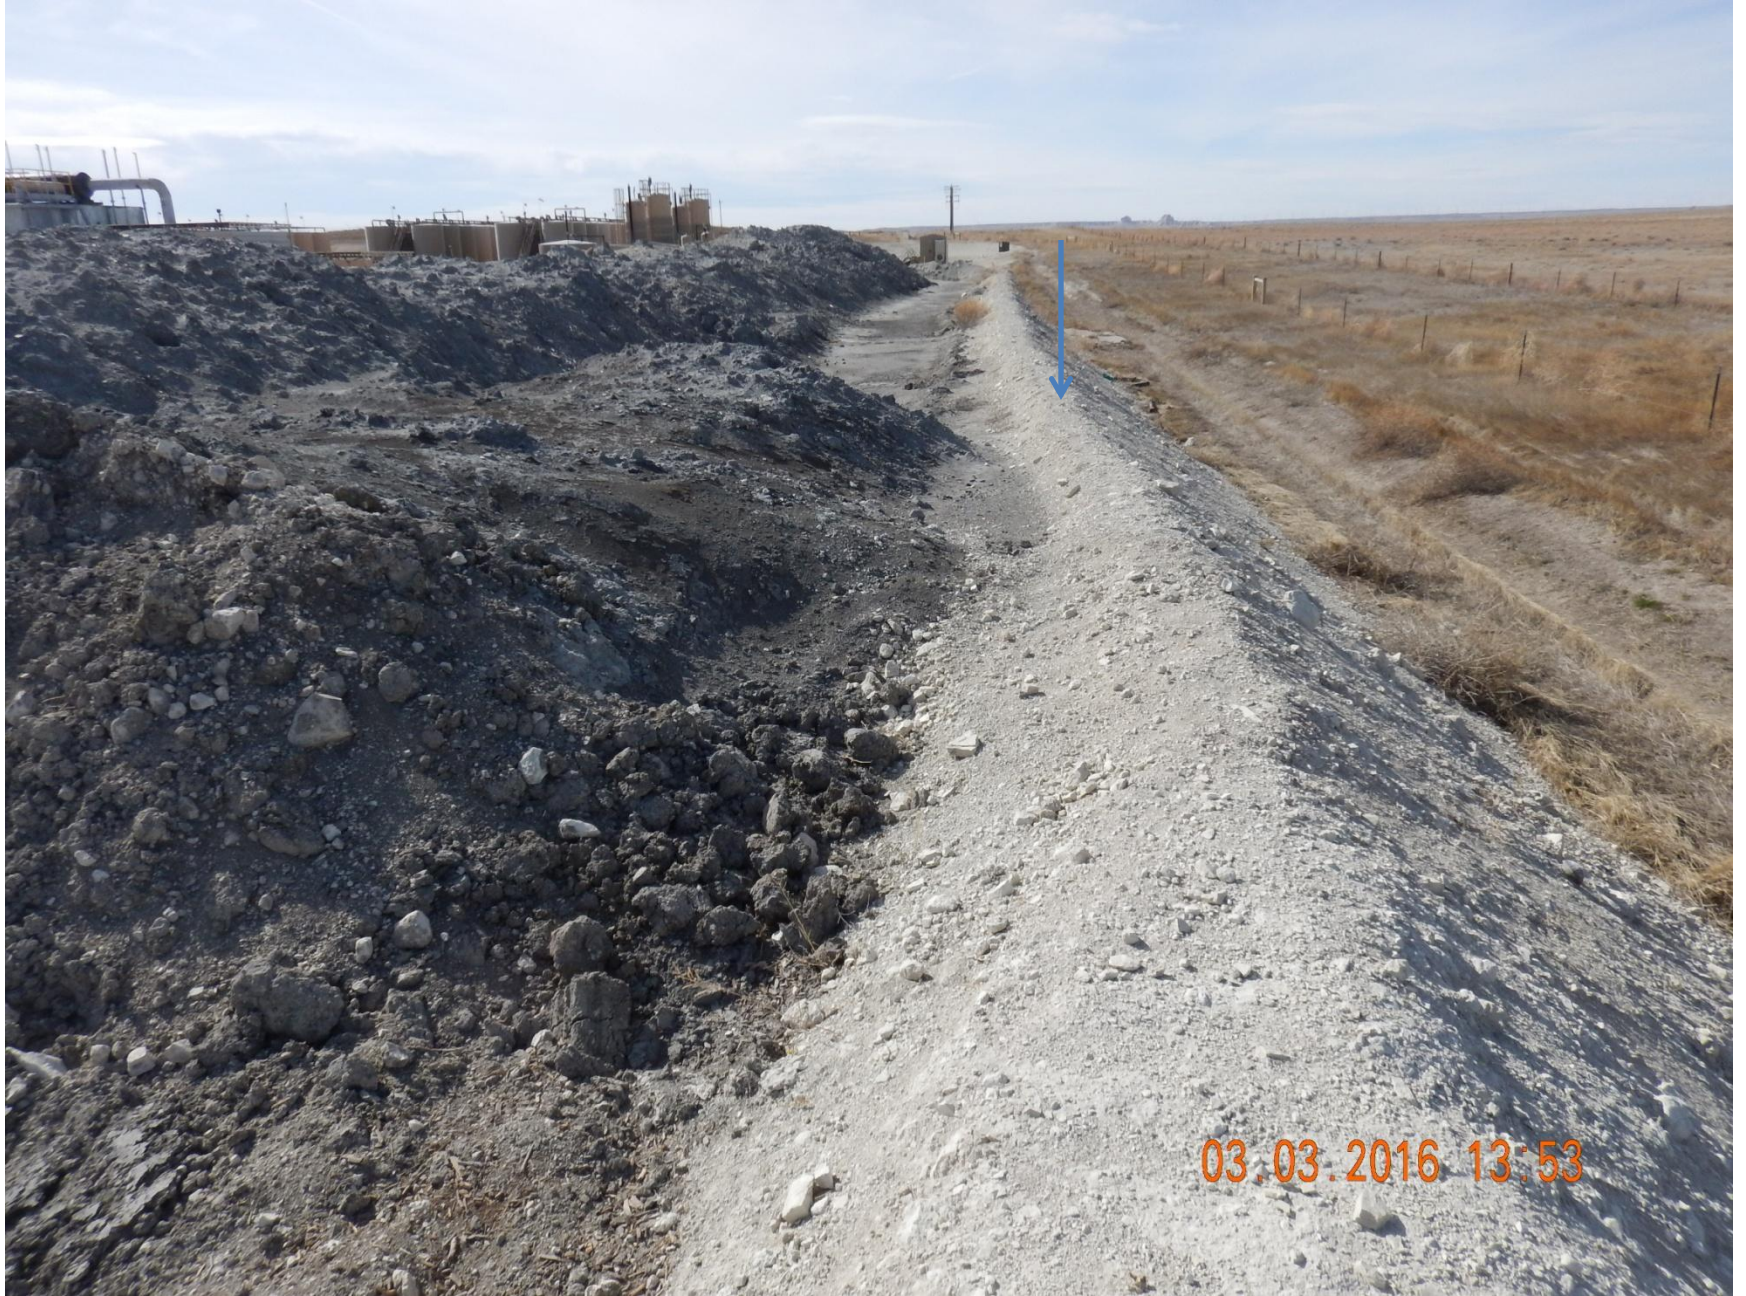
Figure 20: Photo taken from the northeast corner of the project area, facing west. Photo shows containment berm on the northern perimeter of the location, and the drill cuttings.
