Interim Reclamation Inspection

Operator: Whiting Oil and Gas

Location ID: 433999

Weld County, CO

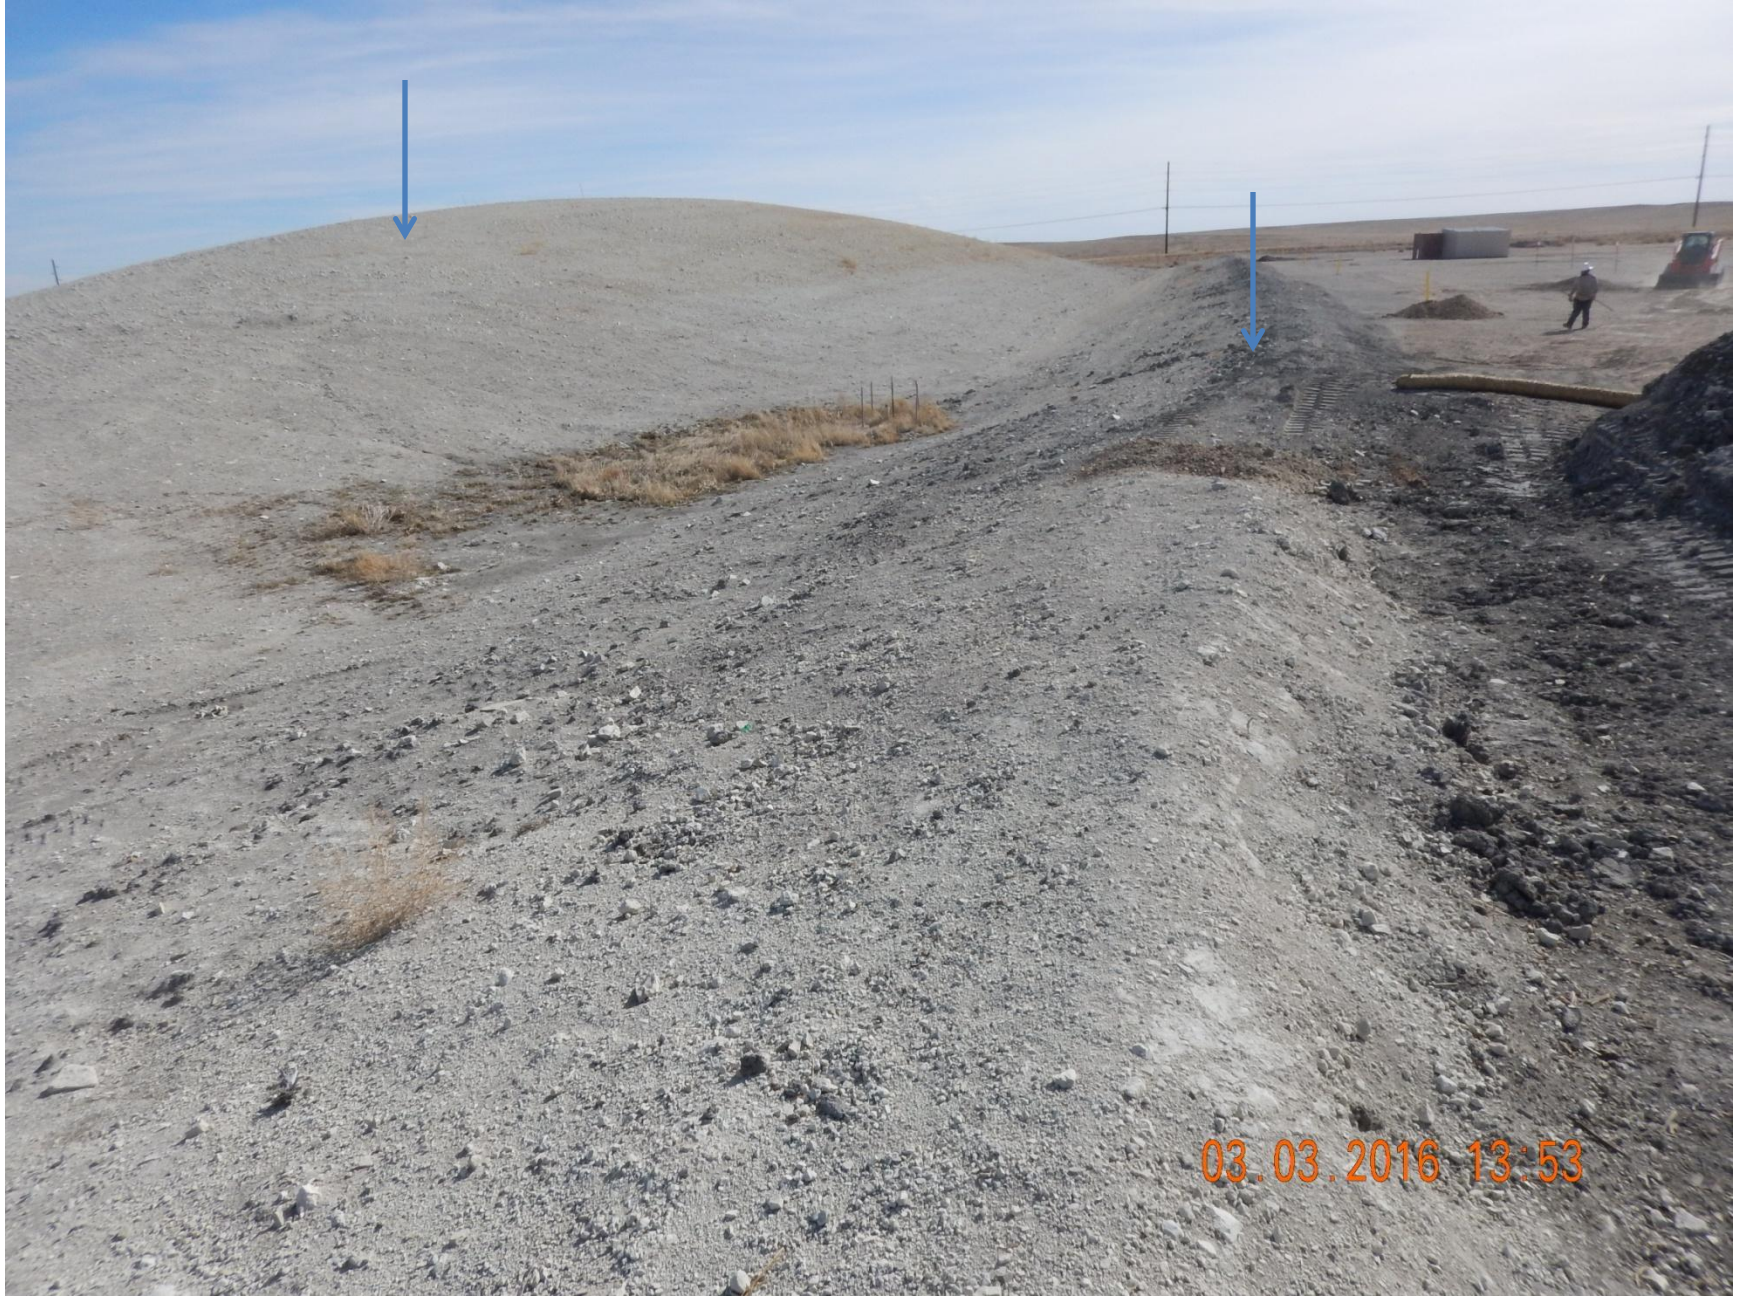
Figure 21: Photo taken from the northeast corner of the project area, facing west. Photo shows spoils stockpile to the left, and containment berm on the east perimeter of the project area.

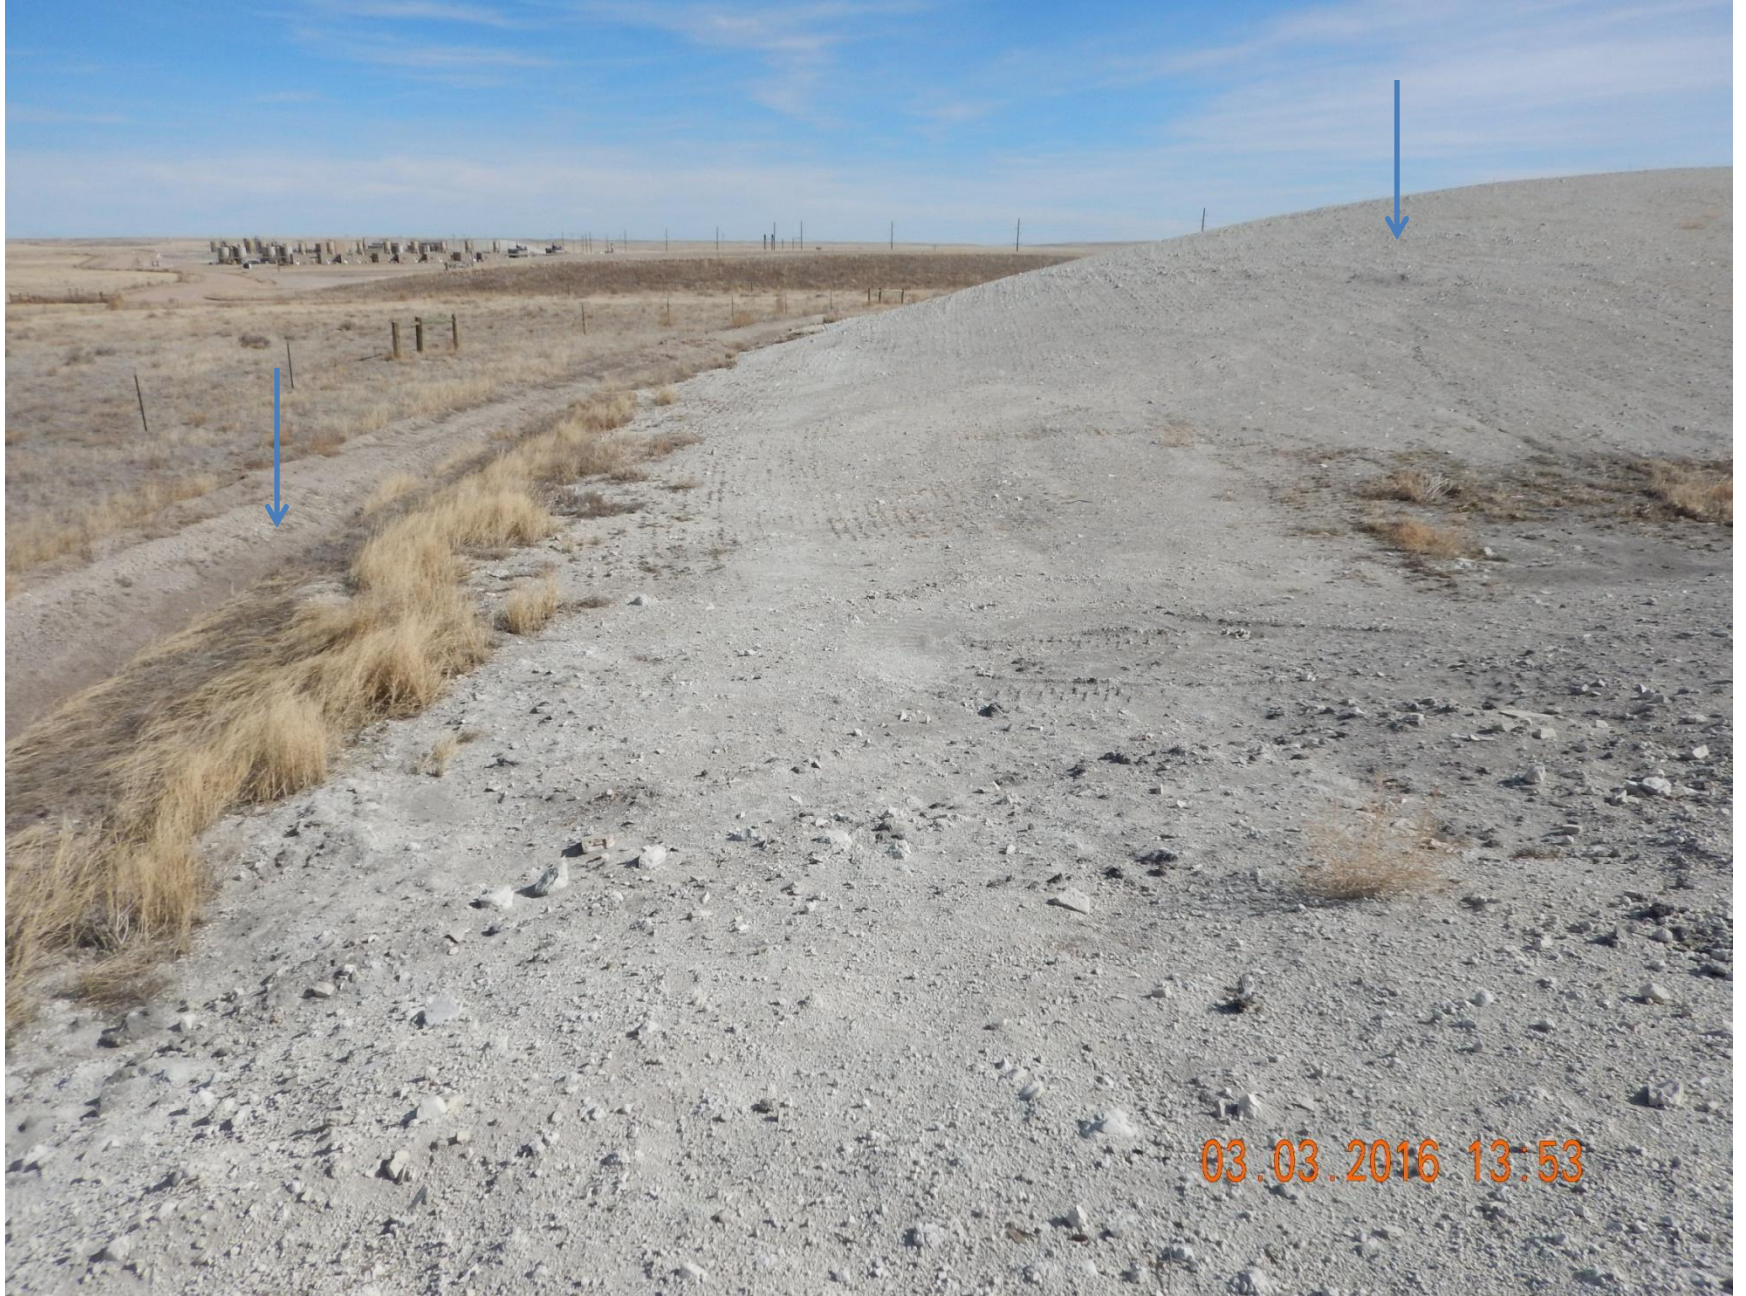
Figure 22: Photo taken from the northeast corner of the project area, facing east. Photo shows spoils stockpile on the right of the photo, and the stormwater diversion ditch on the left. .

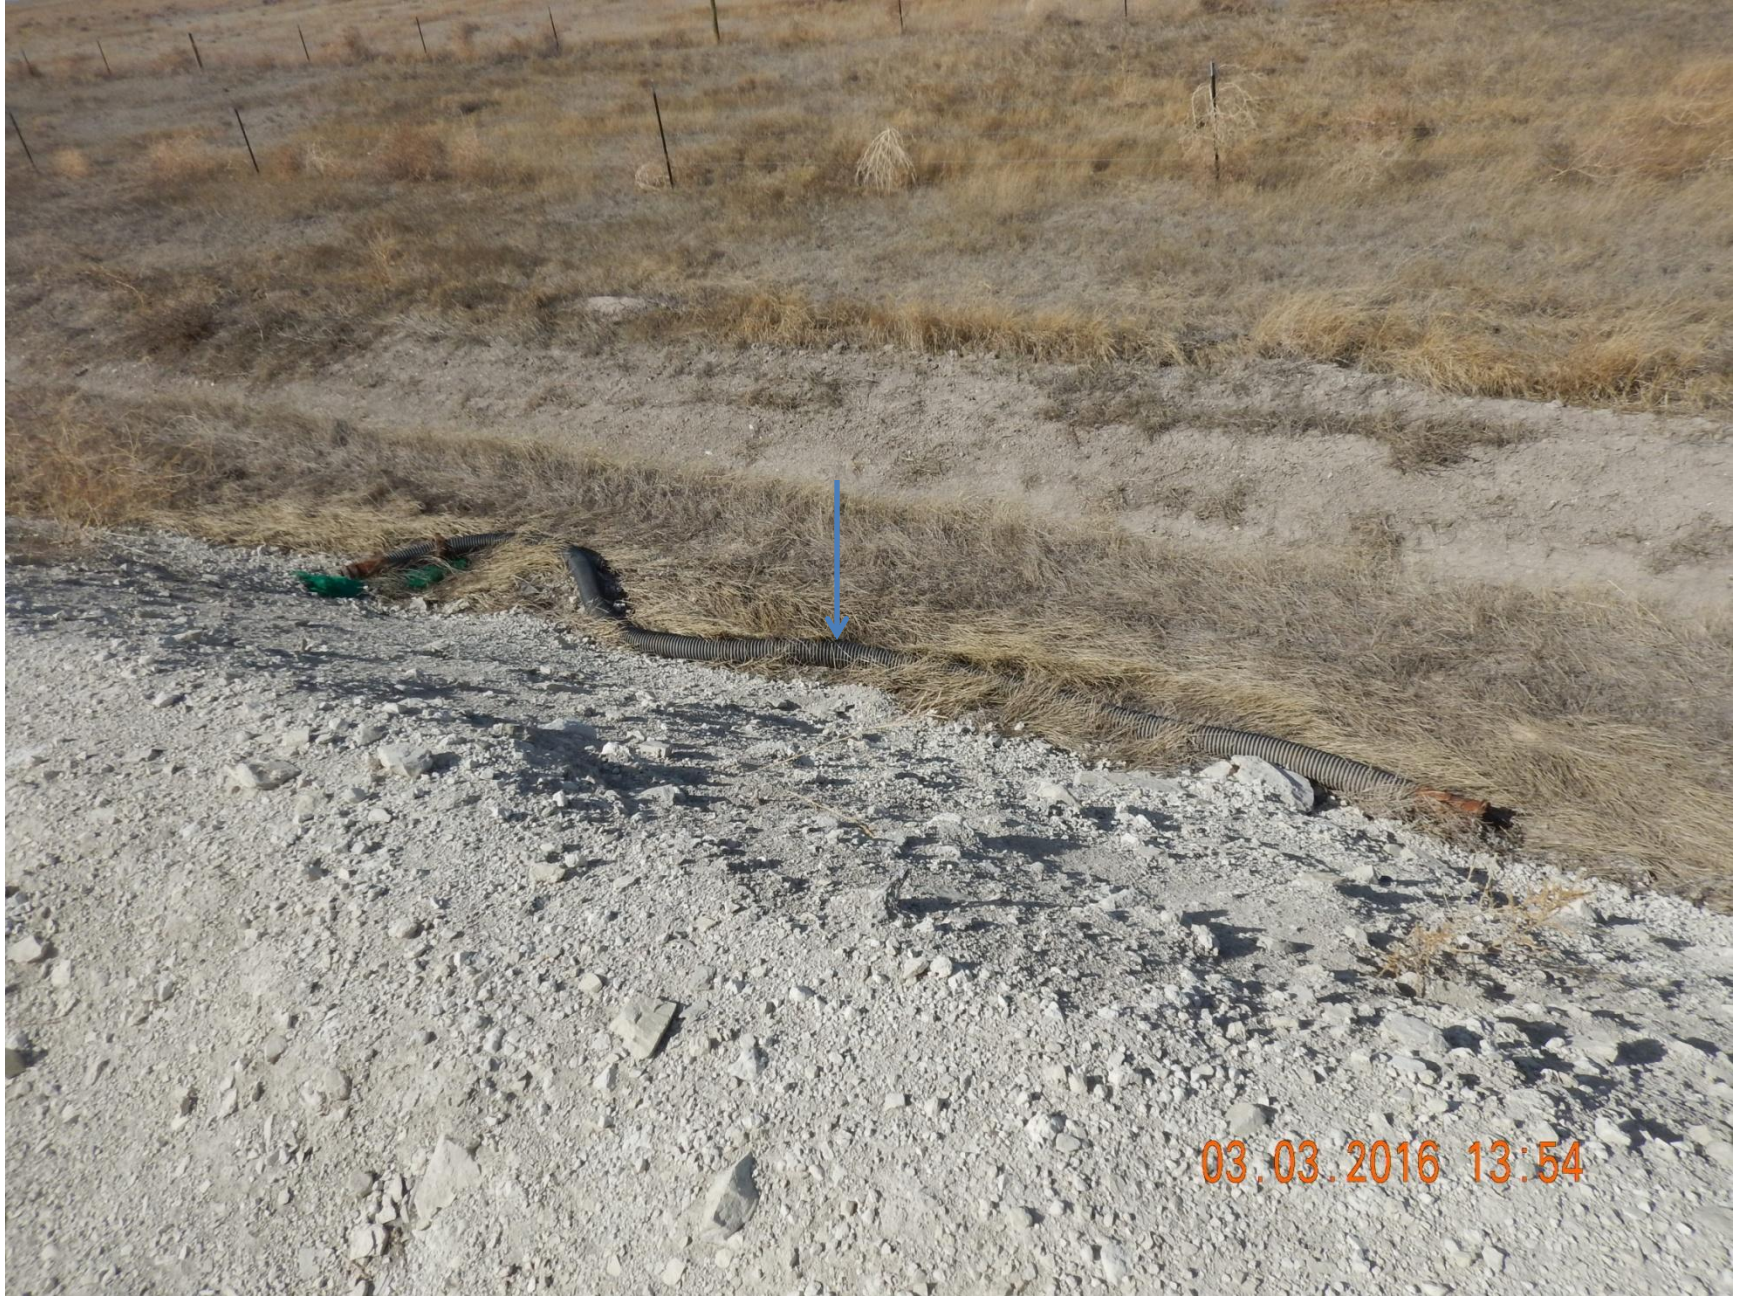
Figure 23: Photo taken from the north end of the project area, facing north. Photo of what appears to be ~15-20 feet of tubing equipment in the interim area.

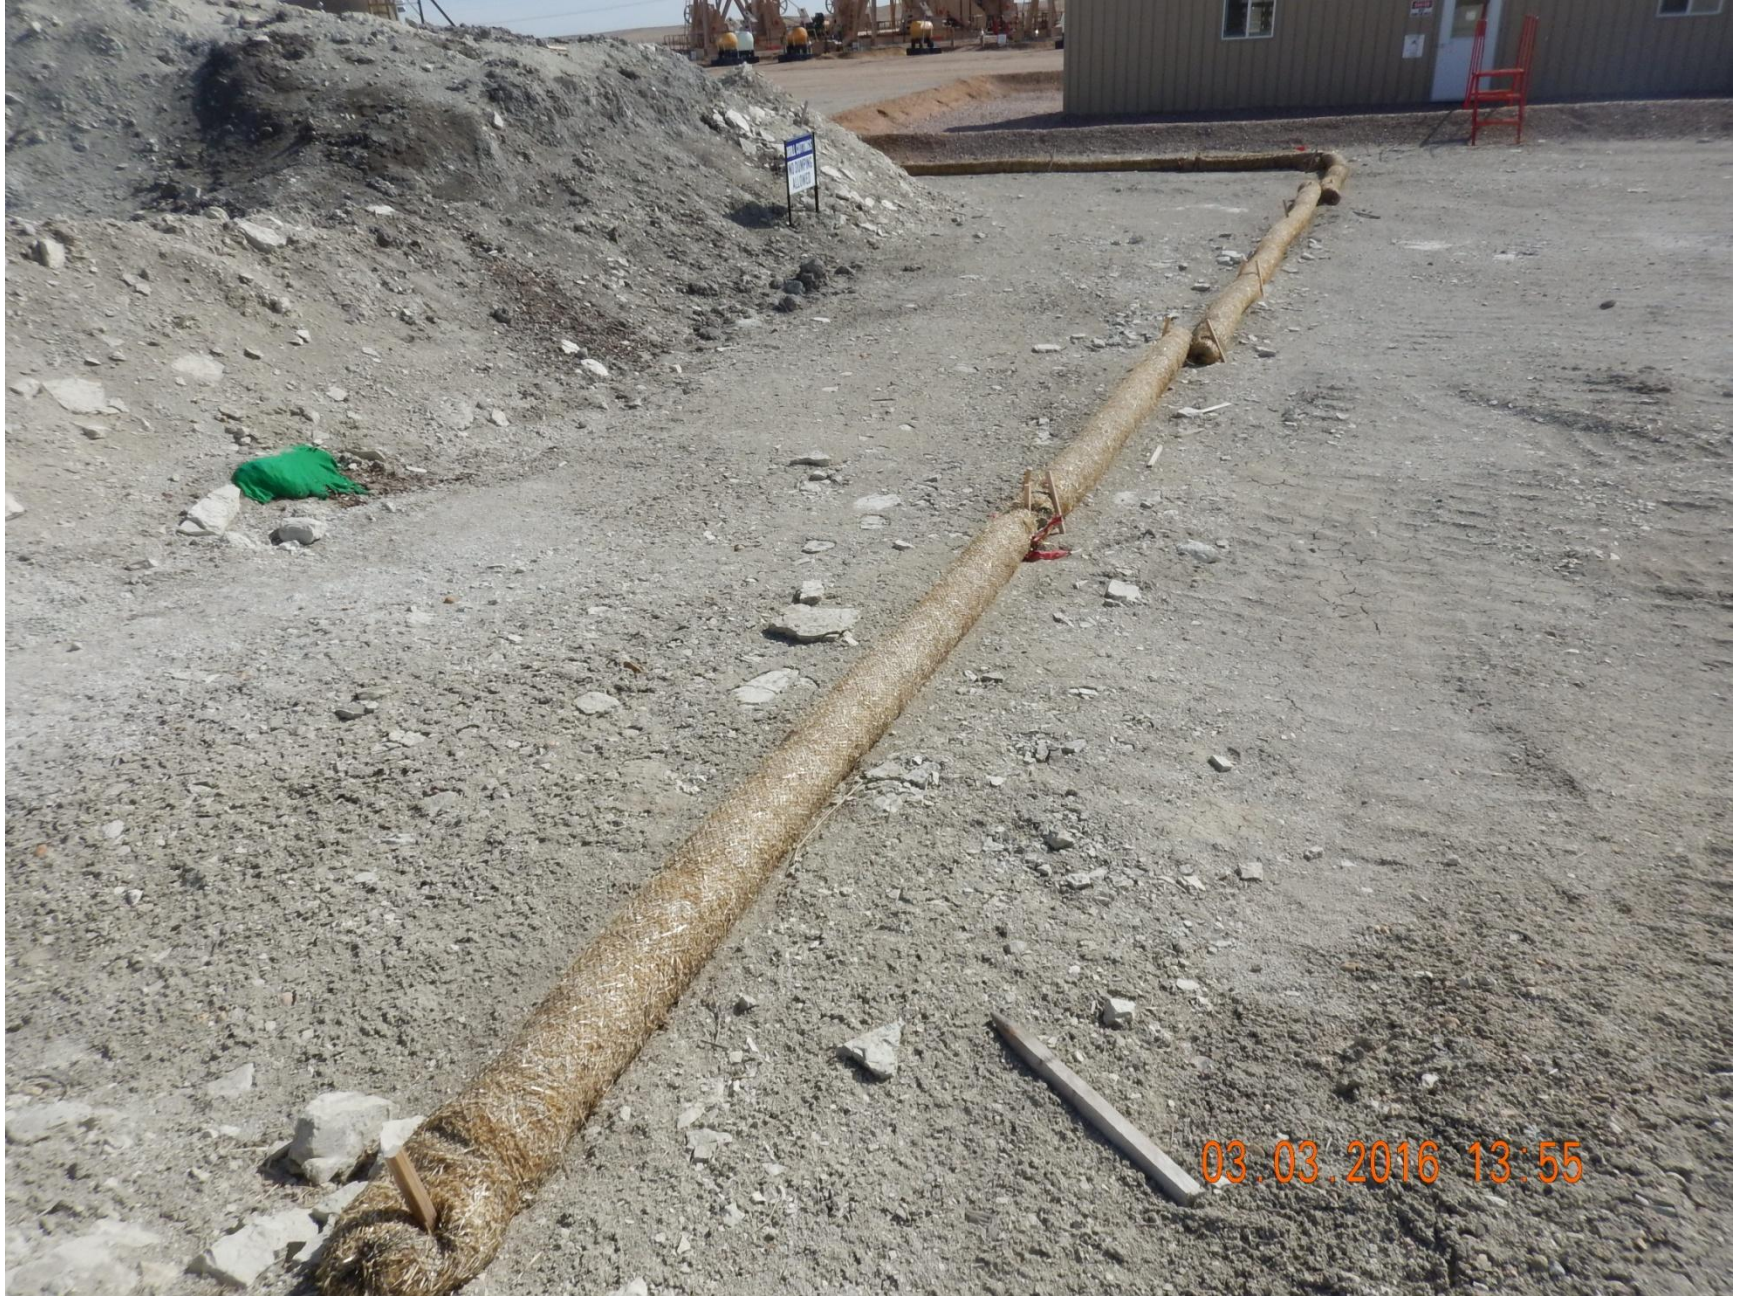
Figure 24: Photo taken from the northern end of the project area, west of the drill cuttings, facing south. Photo shows straw wattles used as a stormwater and sediment control BMP around cuttings.

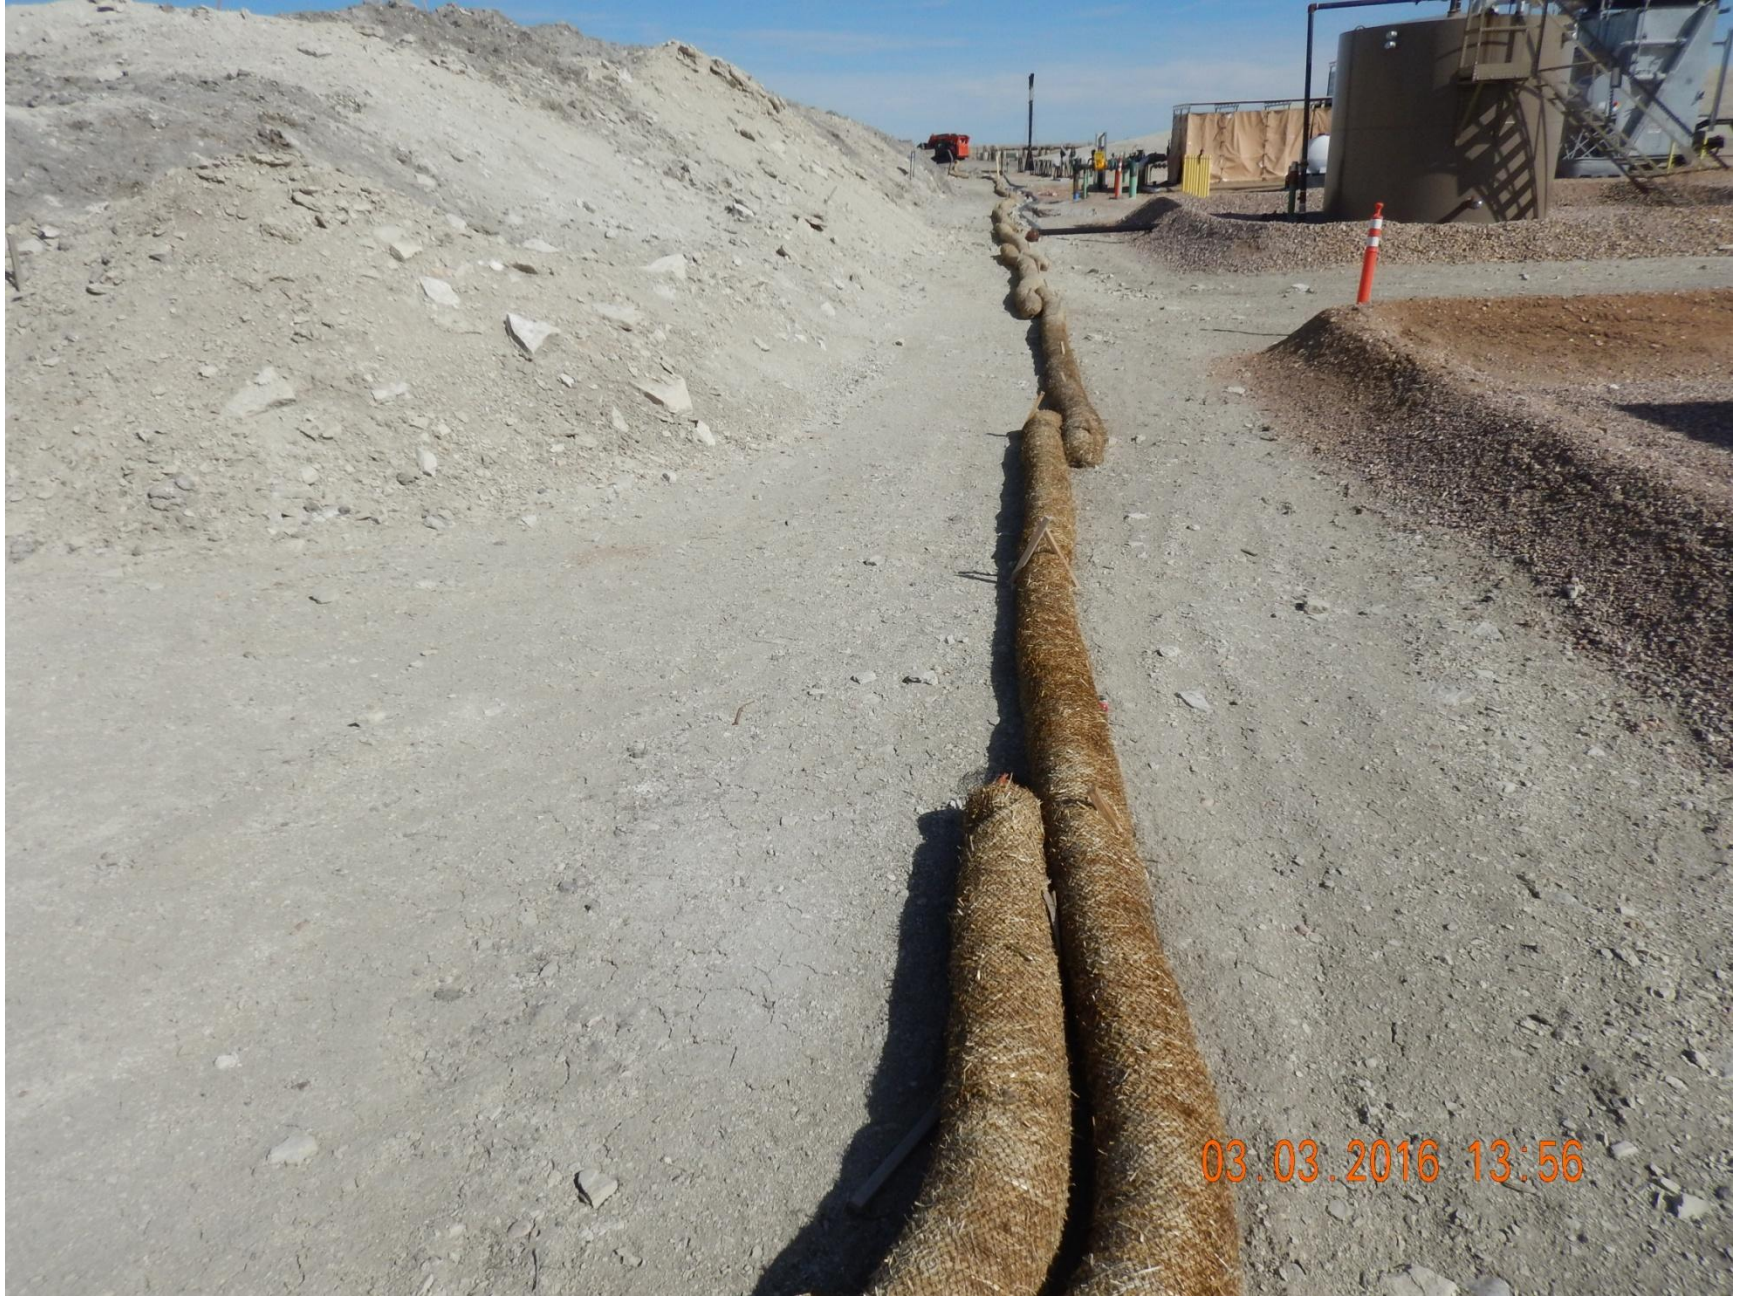
Figure 25: Photo taken from the northern end of the project area, west of the drill cuttings, facing east. Photo shows straw wattles used as a stormwater and sediment control BMP around cuttings

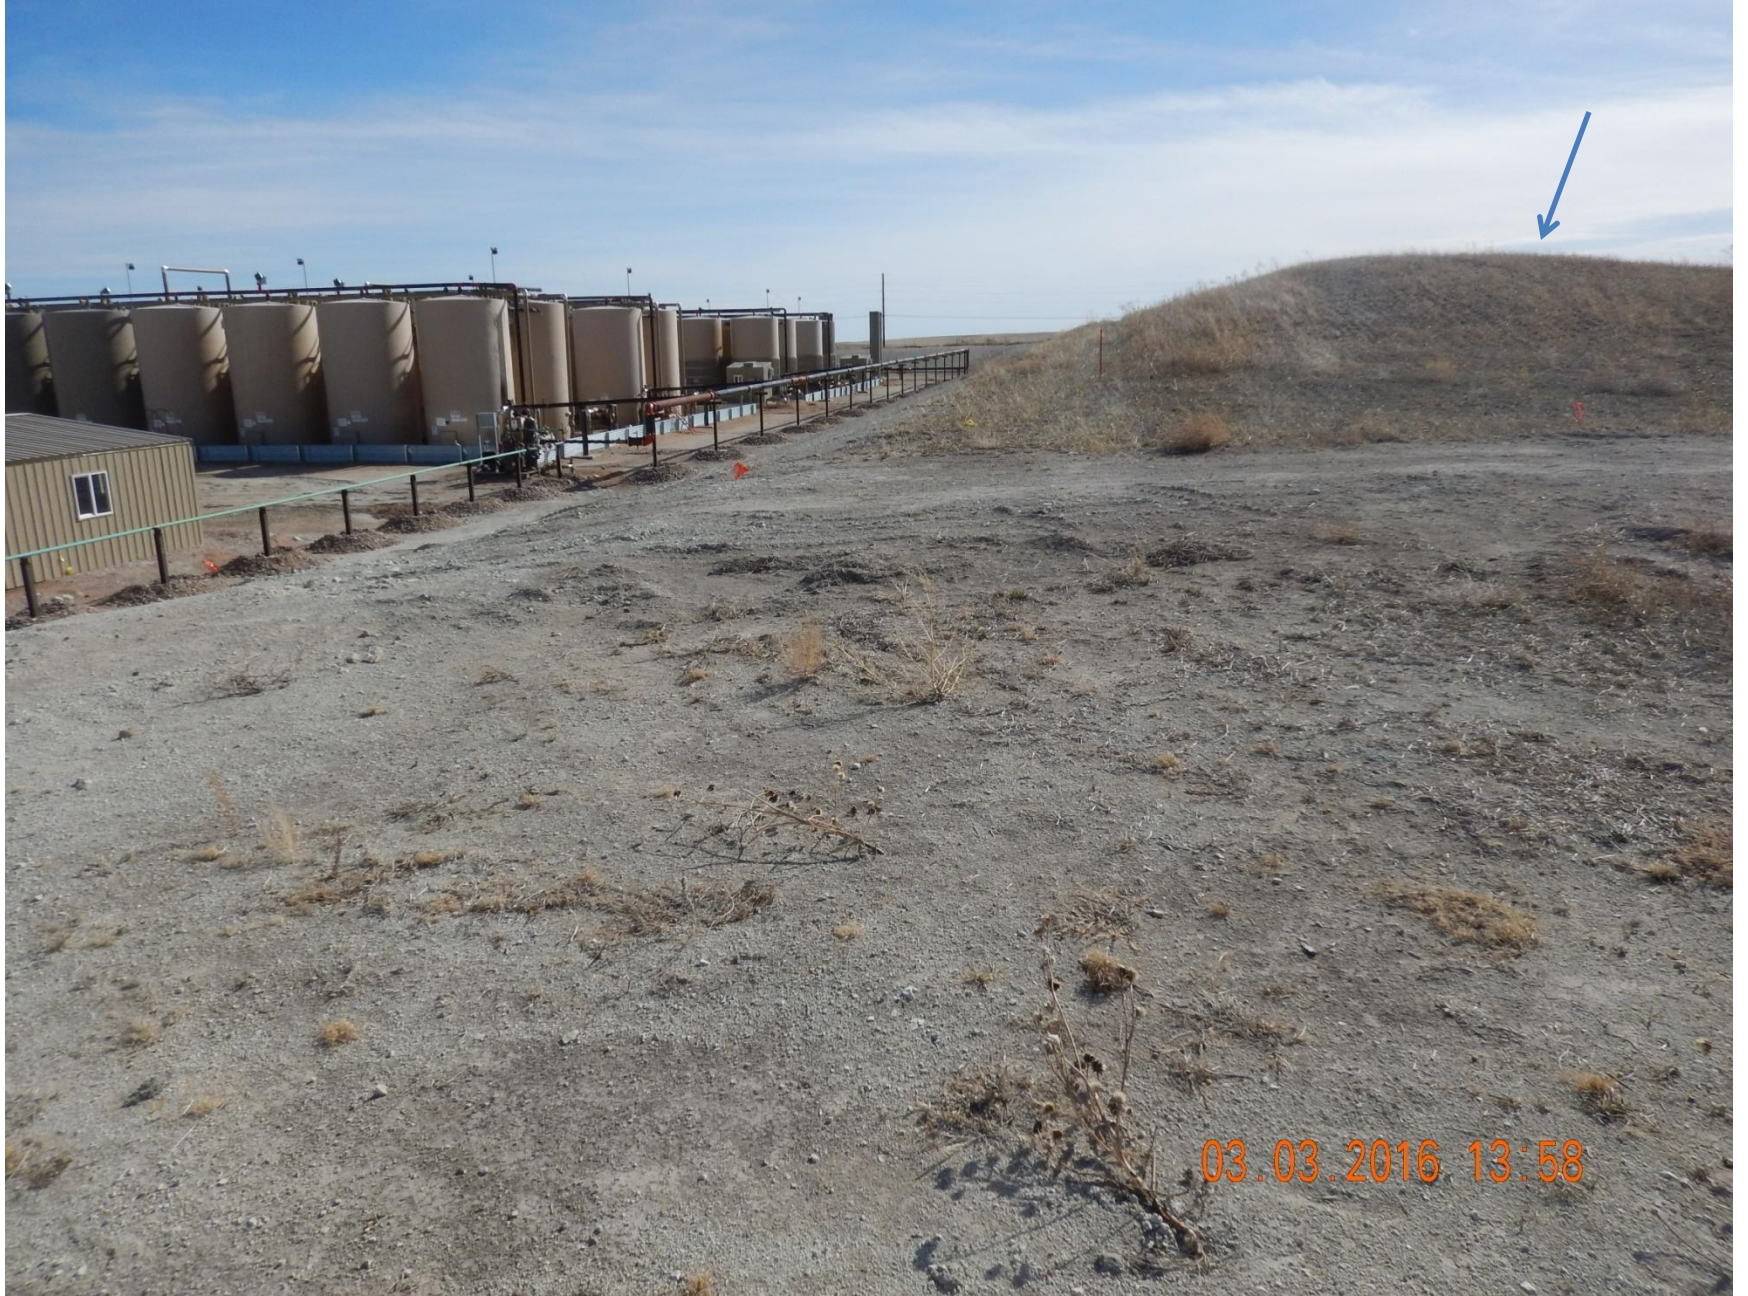
Figure 26: Photo taken from the northwest corner of the location, facing south. Photo shows project and interim areas. Note topsoil stockpile to the right of the photo.

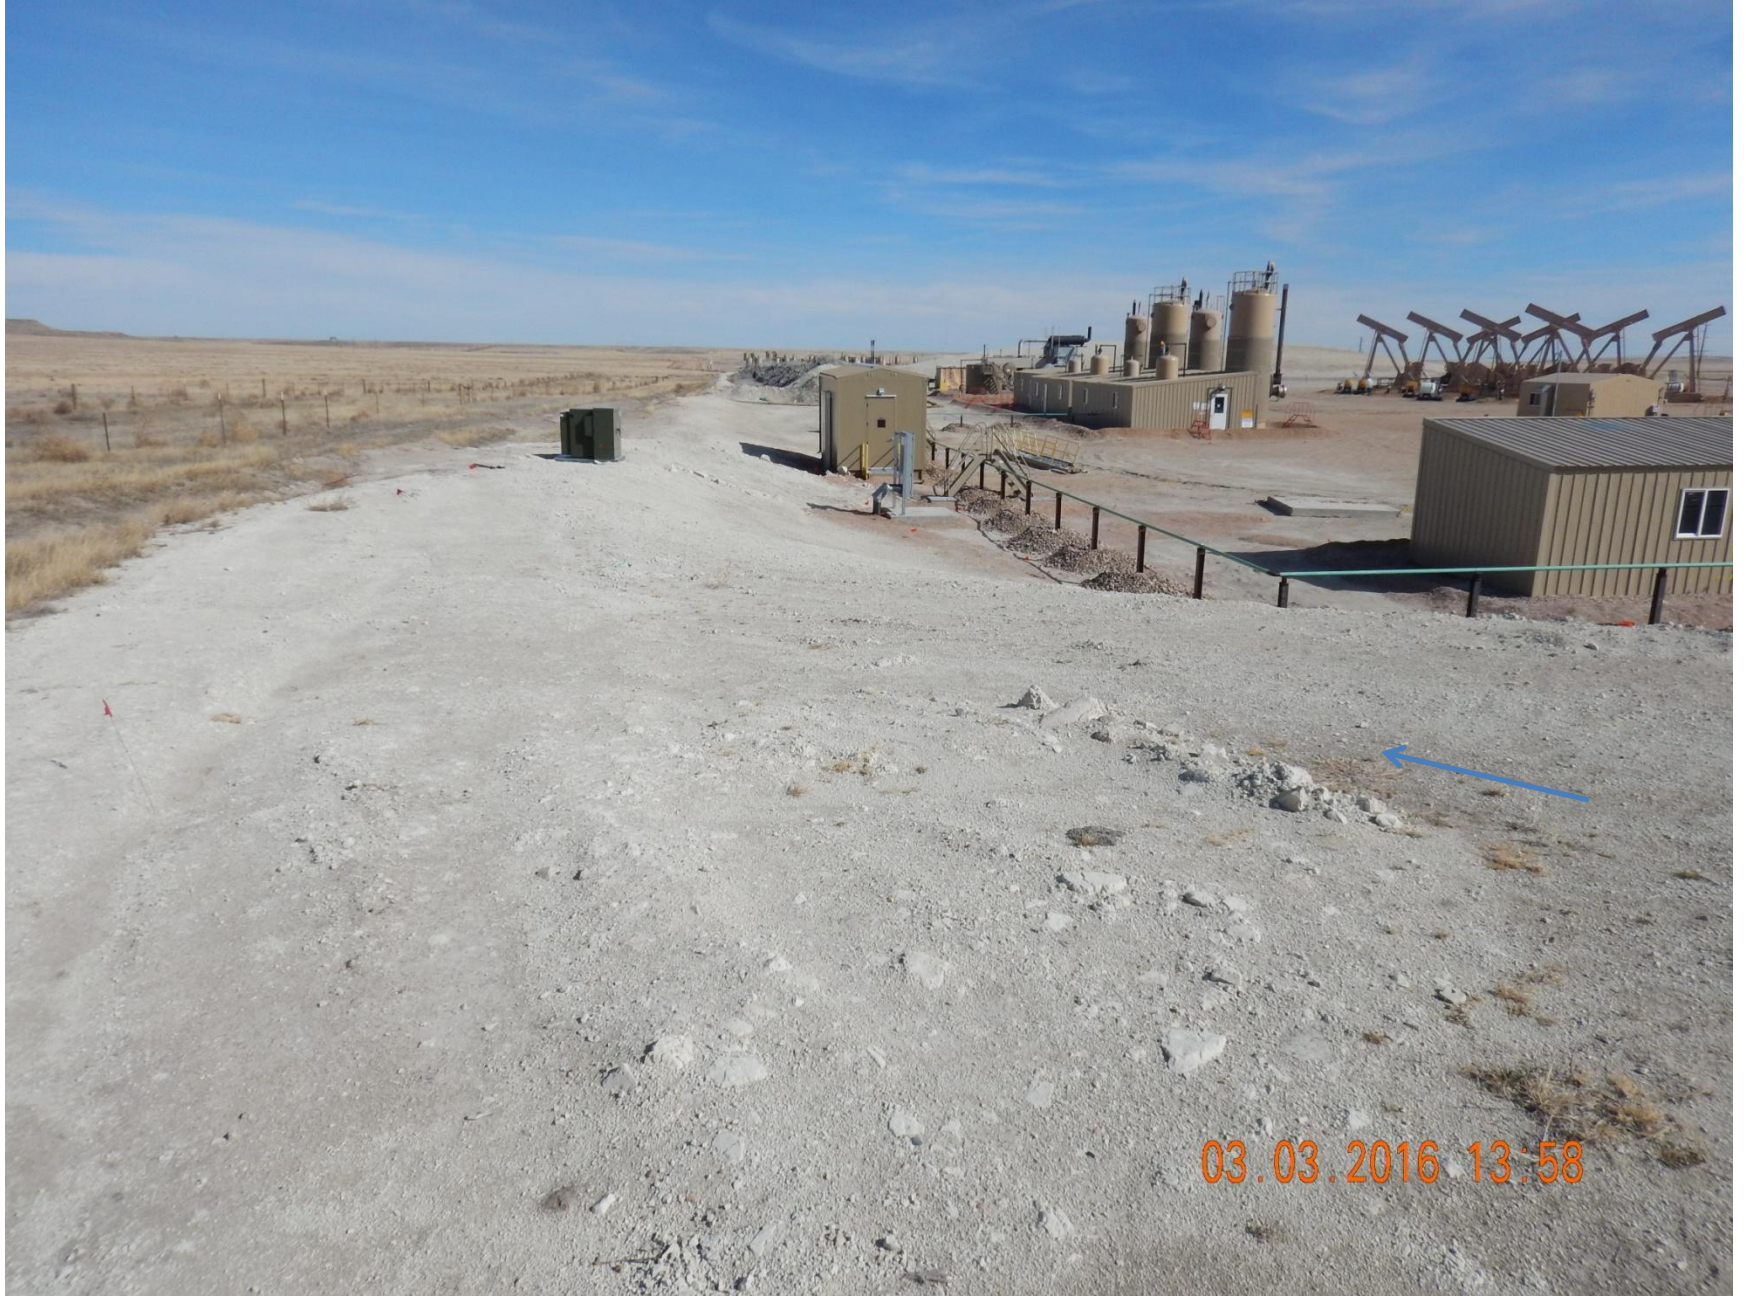
Figure 27: Photo taken from the northwest corner of the location, facing east. Photo shows project and interim areas, and stormwater diversion ditch.

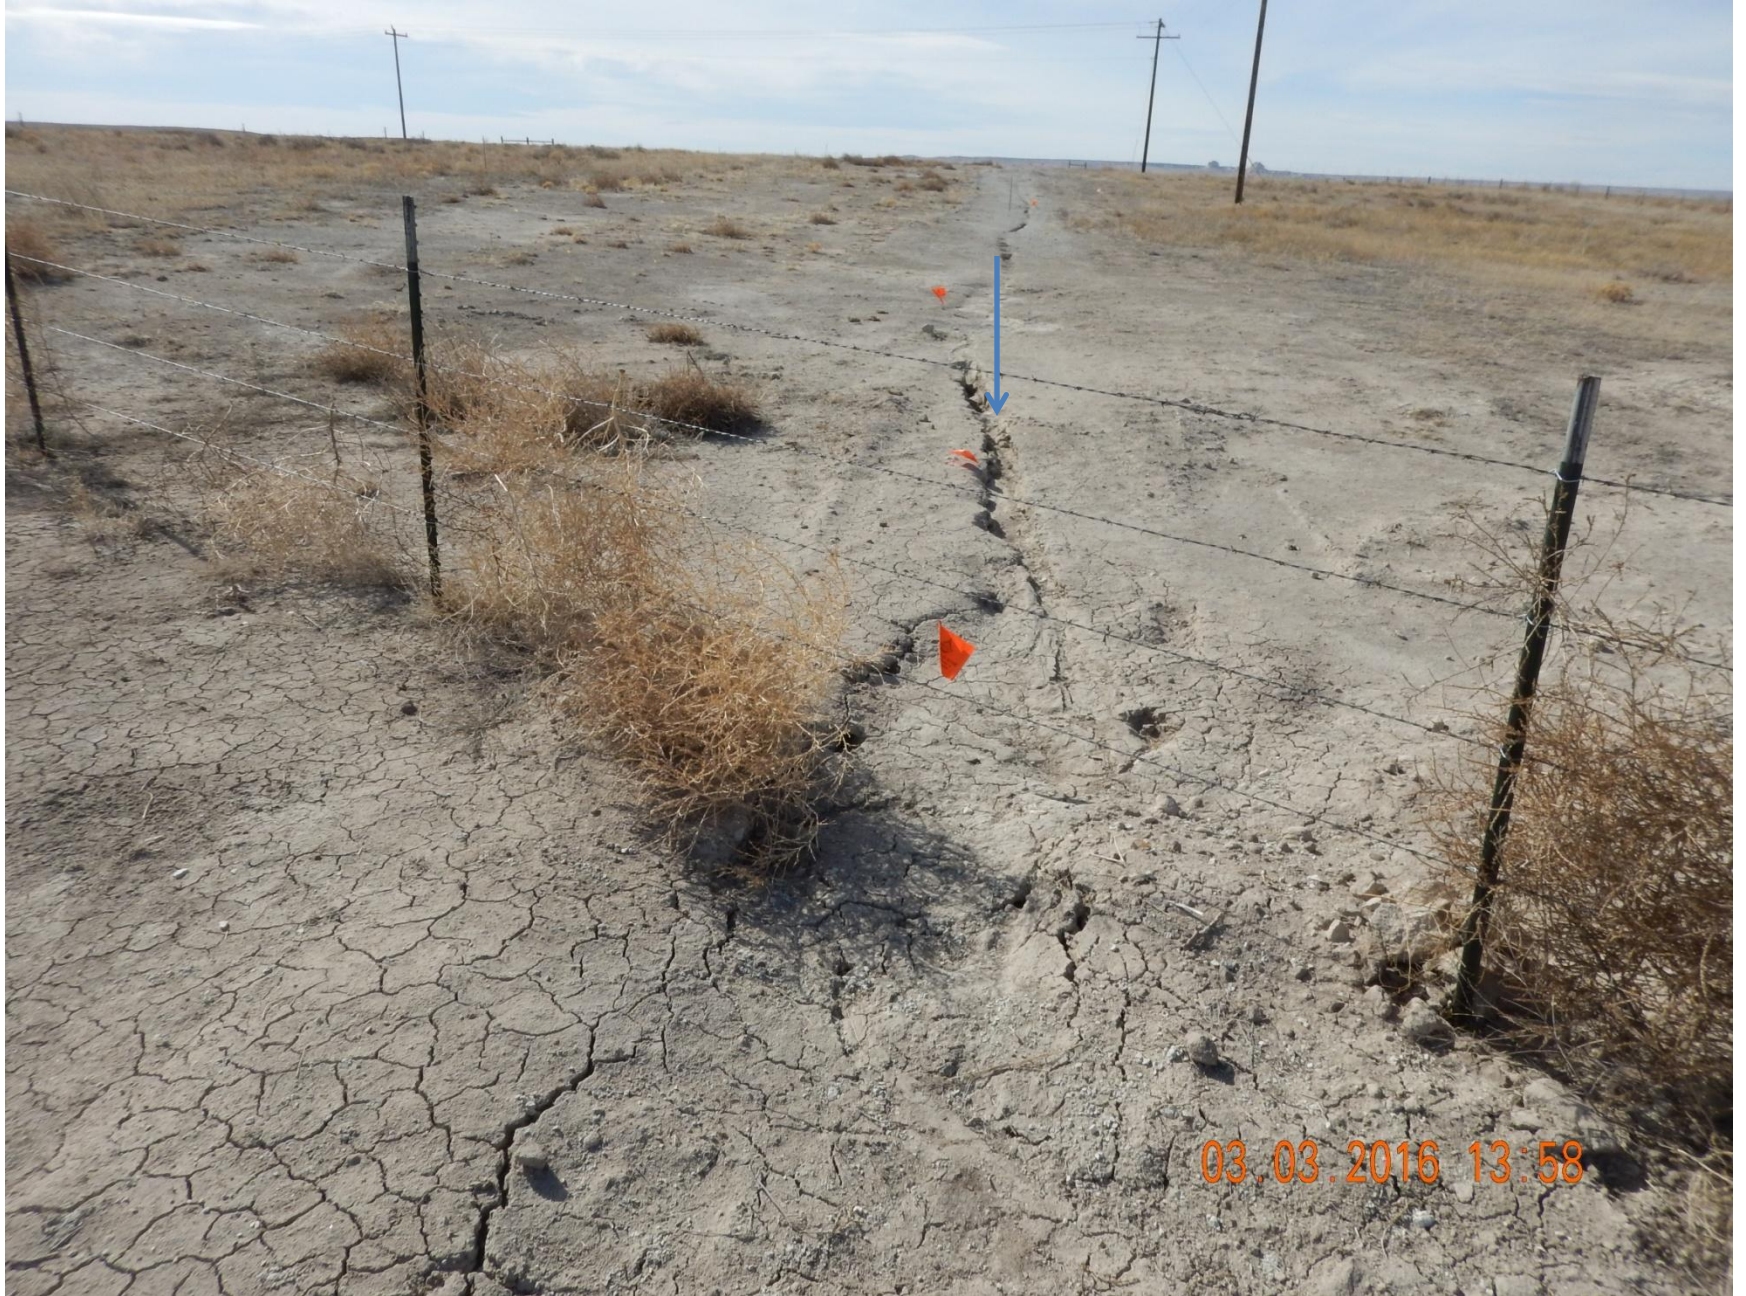
Figure 28: Photo taken from northwest corner of the location, facing west. Photo of pipeline. Photo shows stormwater erosion occurring onto pipeline flowing onto project location and into diversion ditch.

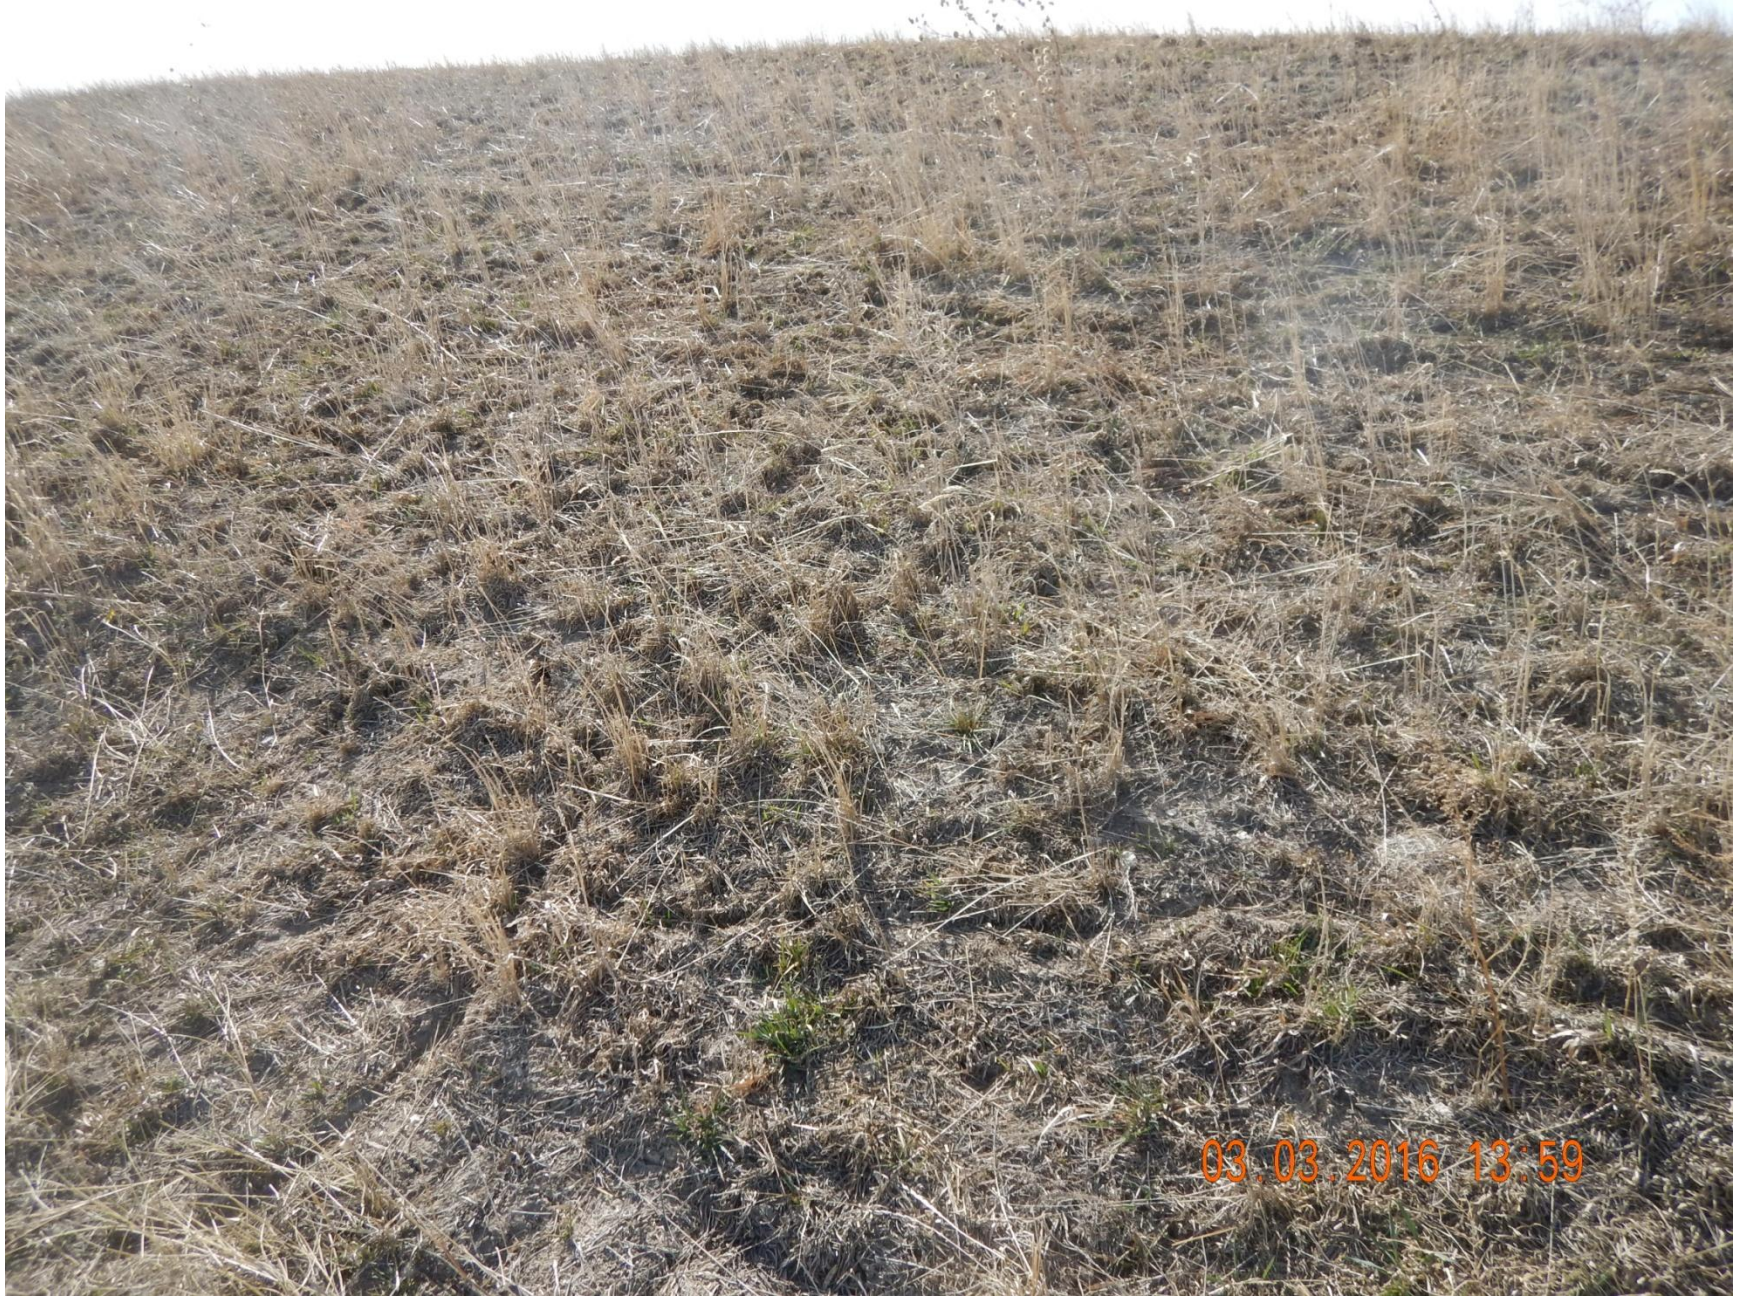
Figure 29: Photo taken from the topsoil stockpile on the west end of the location. Photo shows vegetation establishing on the interim area.

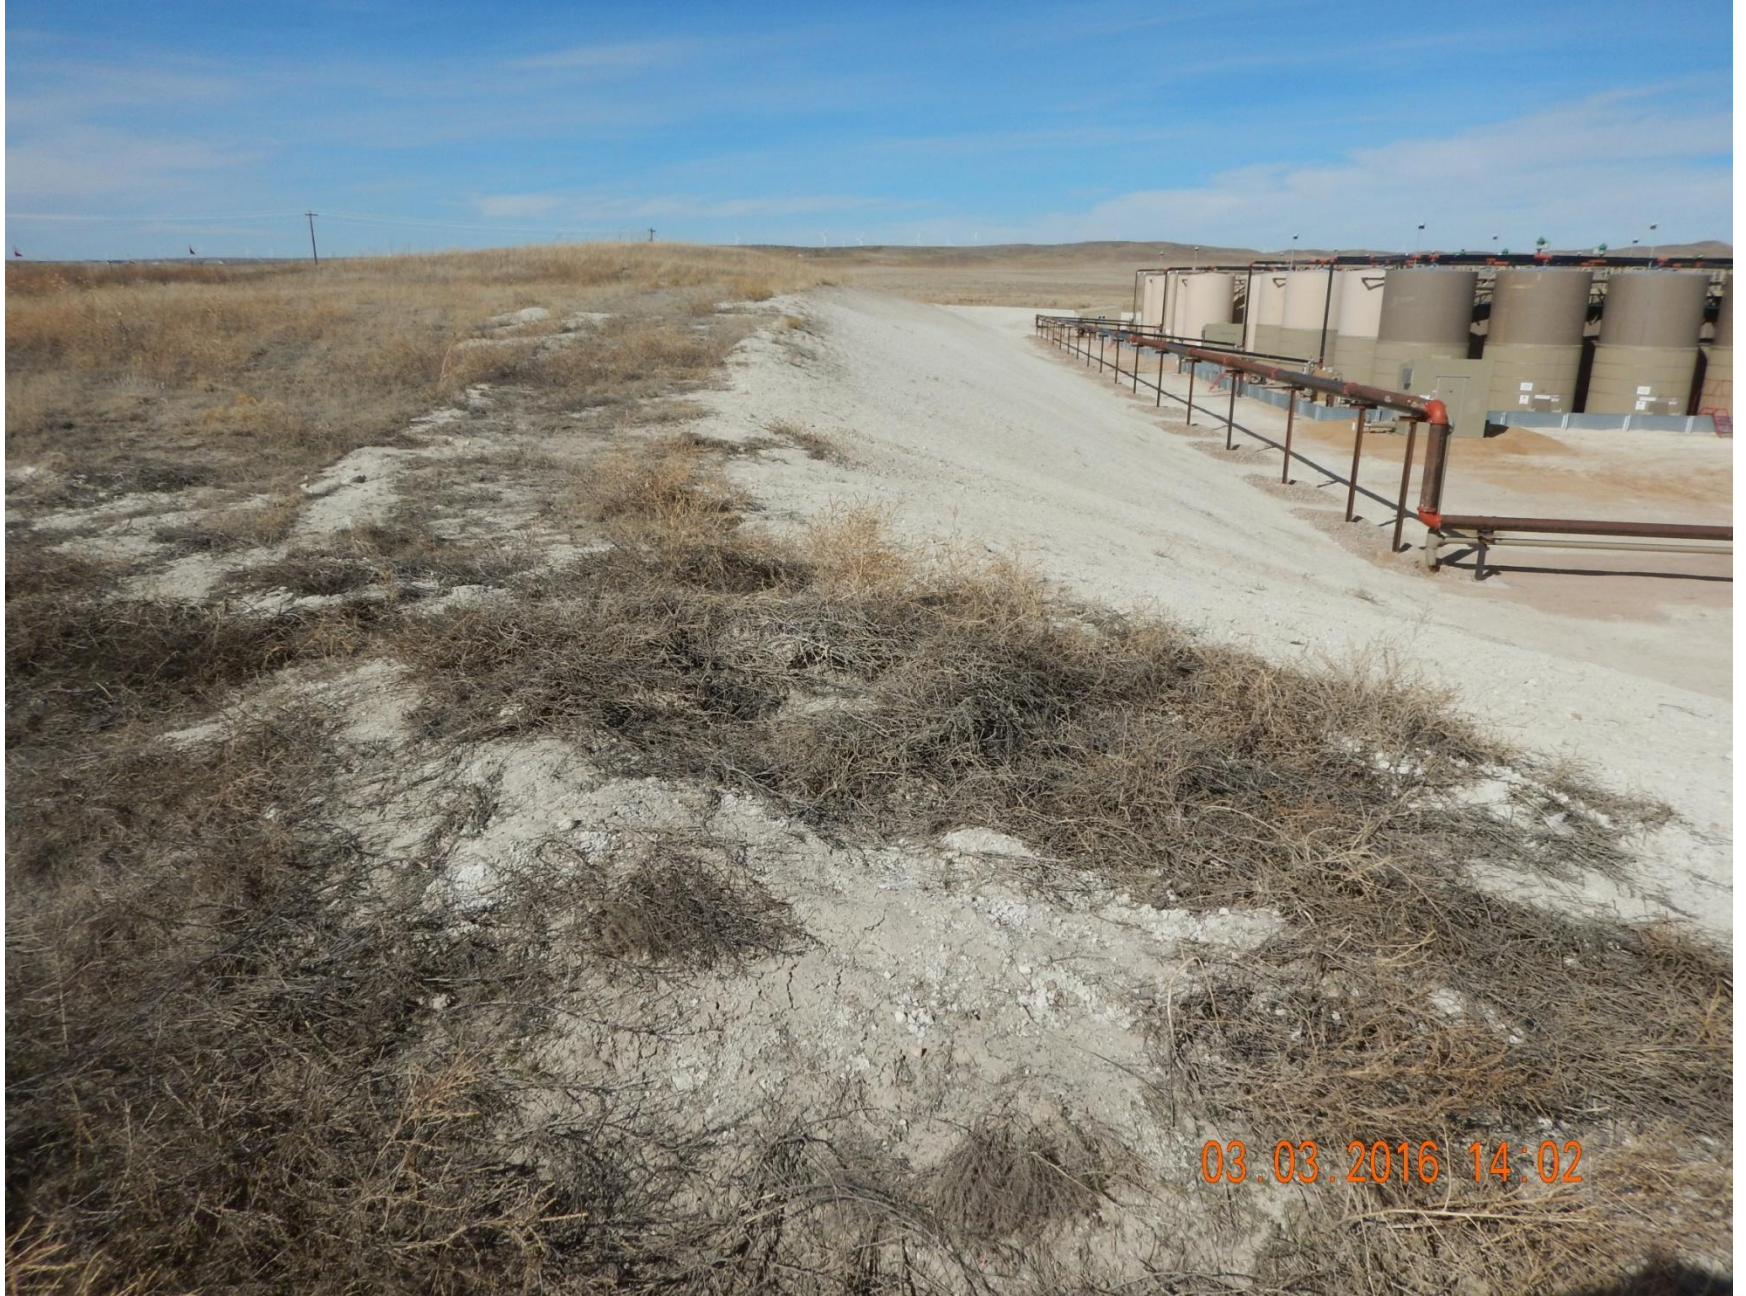
Figure 30: Photo taken from the southwest corner of the location, facing north. Photo shows interim and project areas. Note vegetation is predominantly undesirable weedy plant species.
