Interim Reclamation Inspection

Operator: Whiting Oil and Gas

Location ID: 433999

Weld County, CO

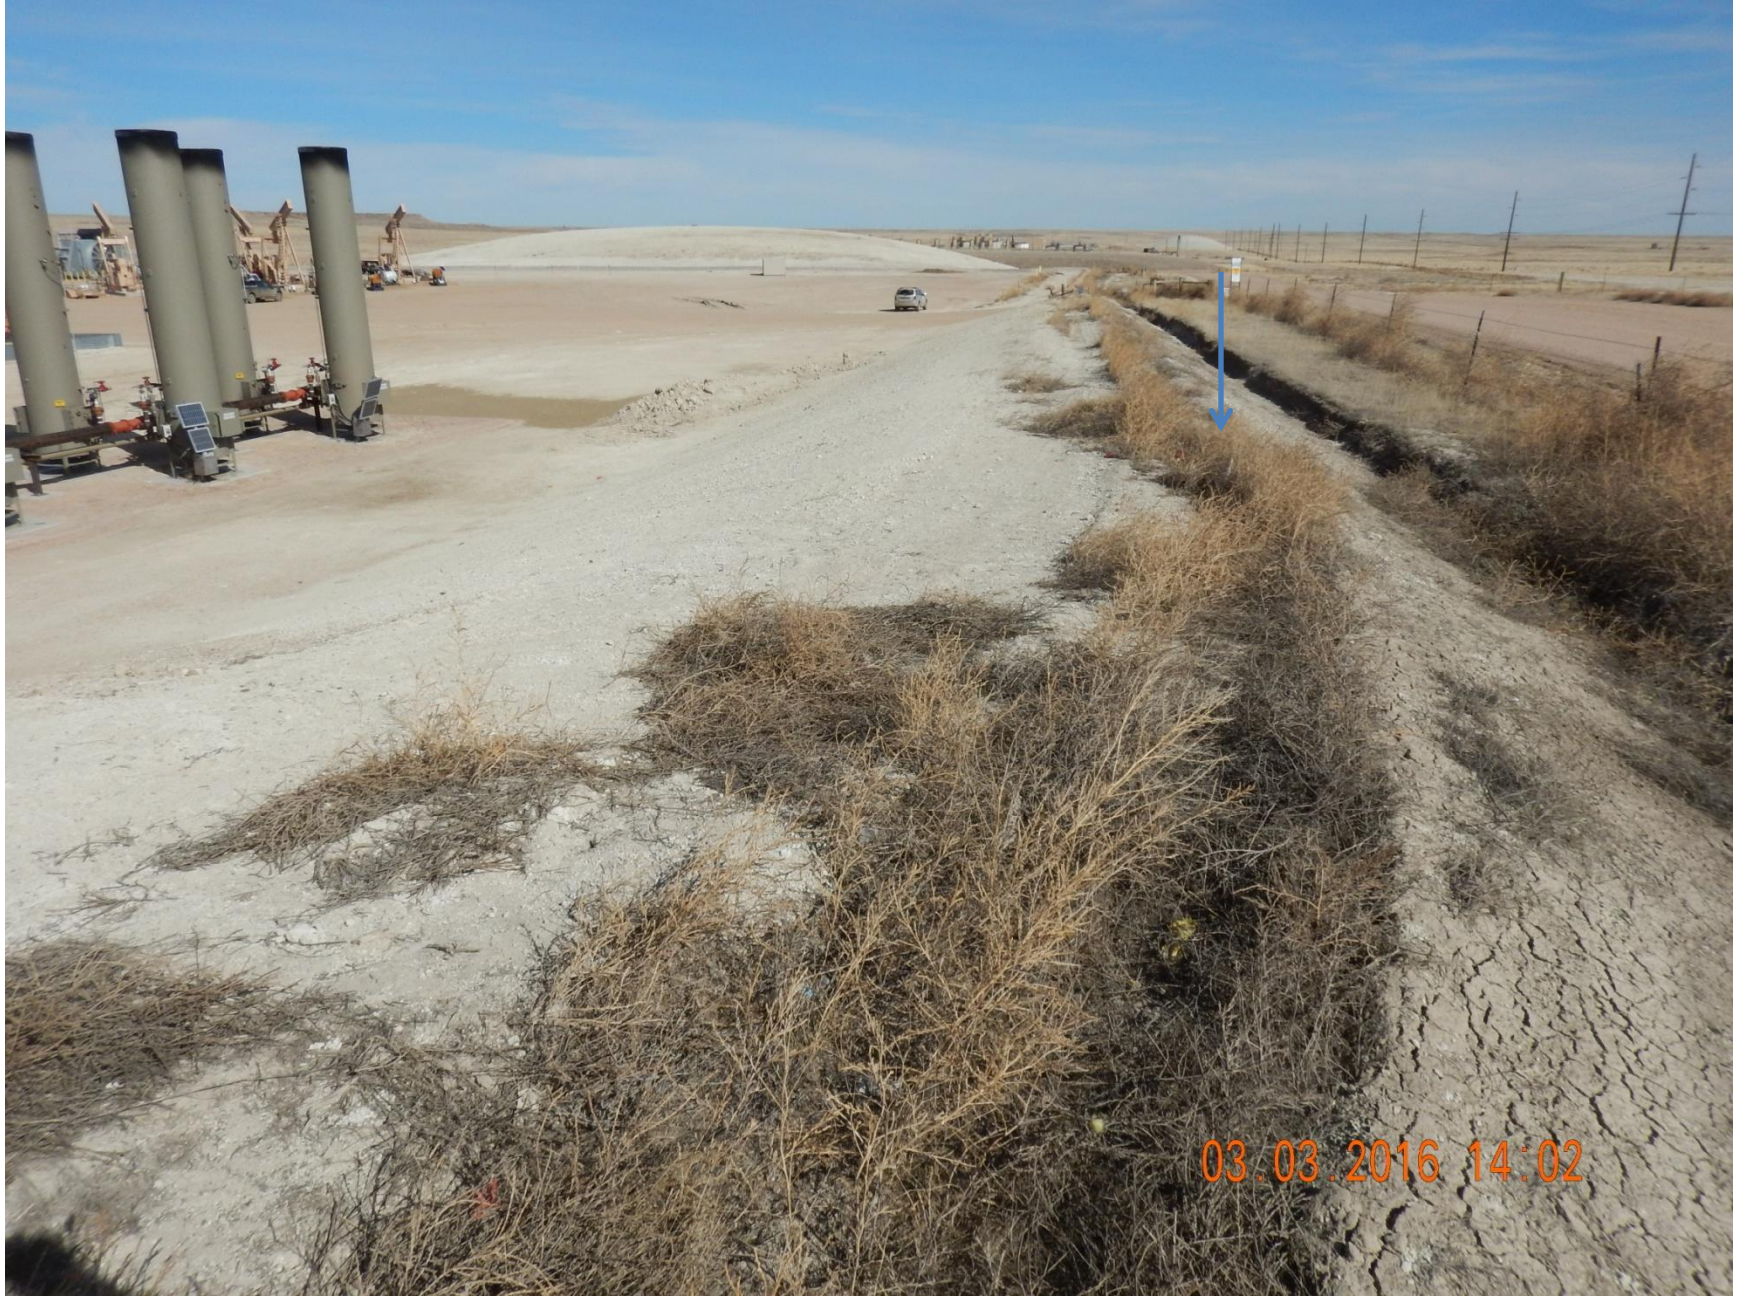
Figure 31: Photo taken from the southwest corner of the location, facing east. Photo shows project area and stormwater control dircth.

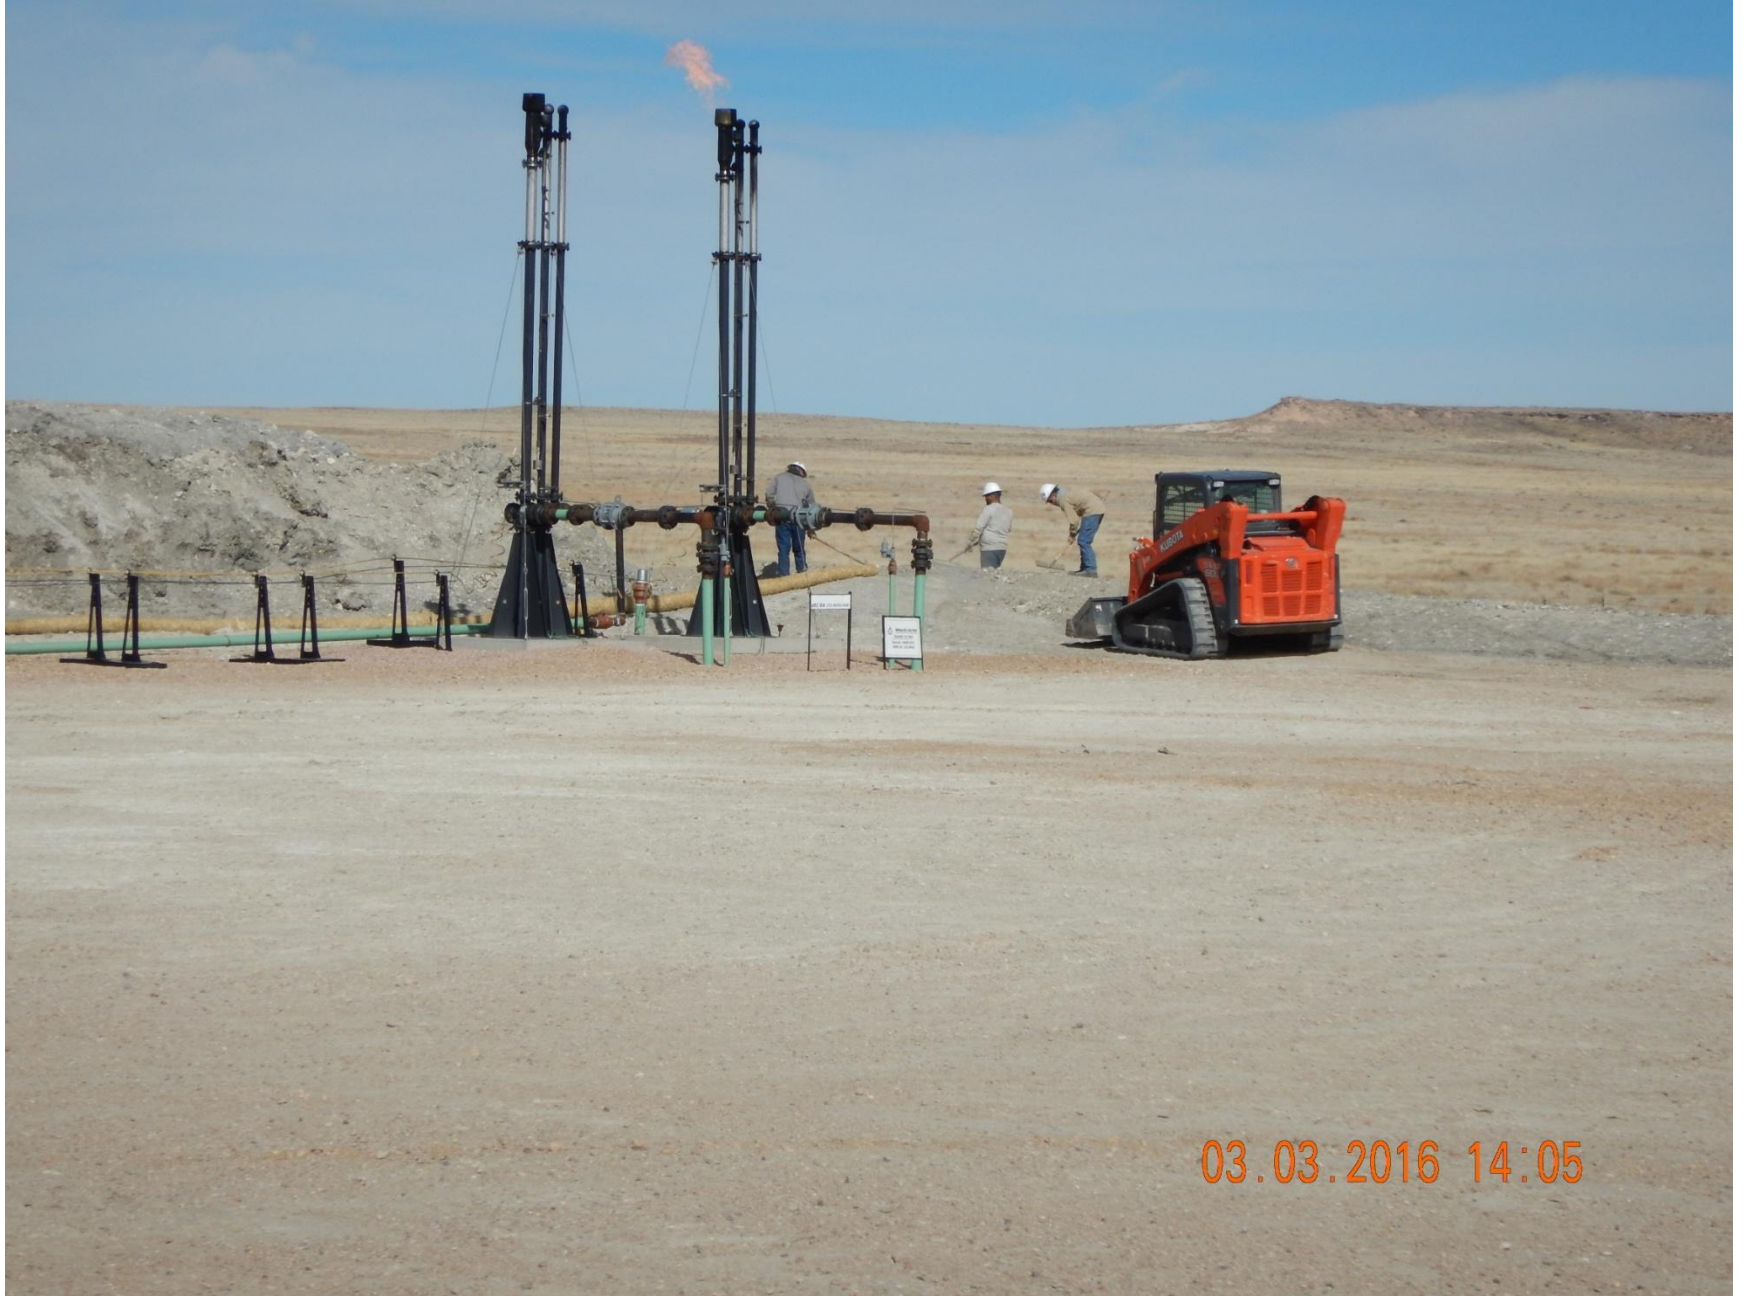
Figure 32: Photo taken from the center of the location, facing northeast. Photo shows workers repairing stormwater control BMPs.
