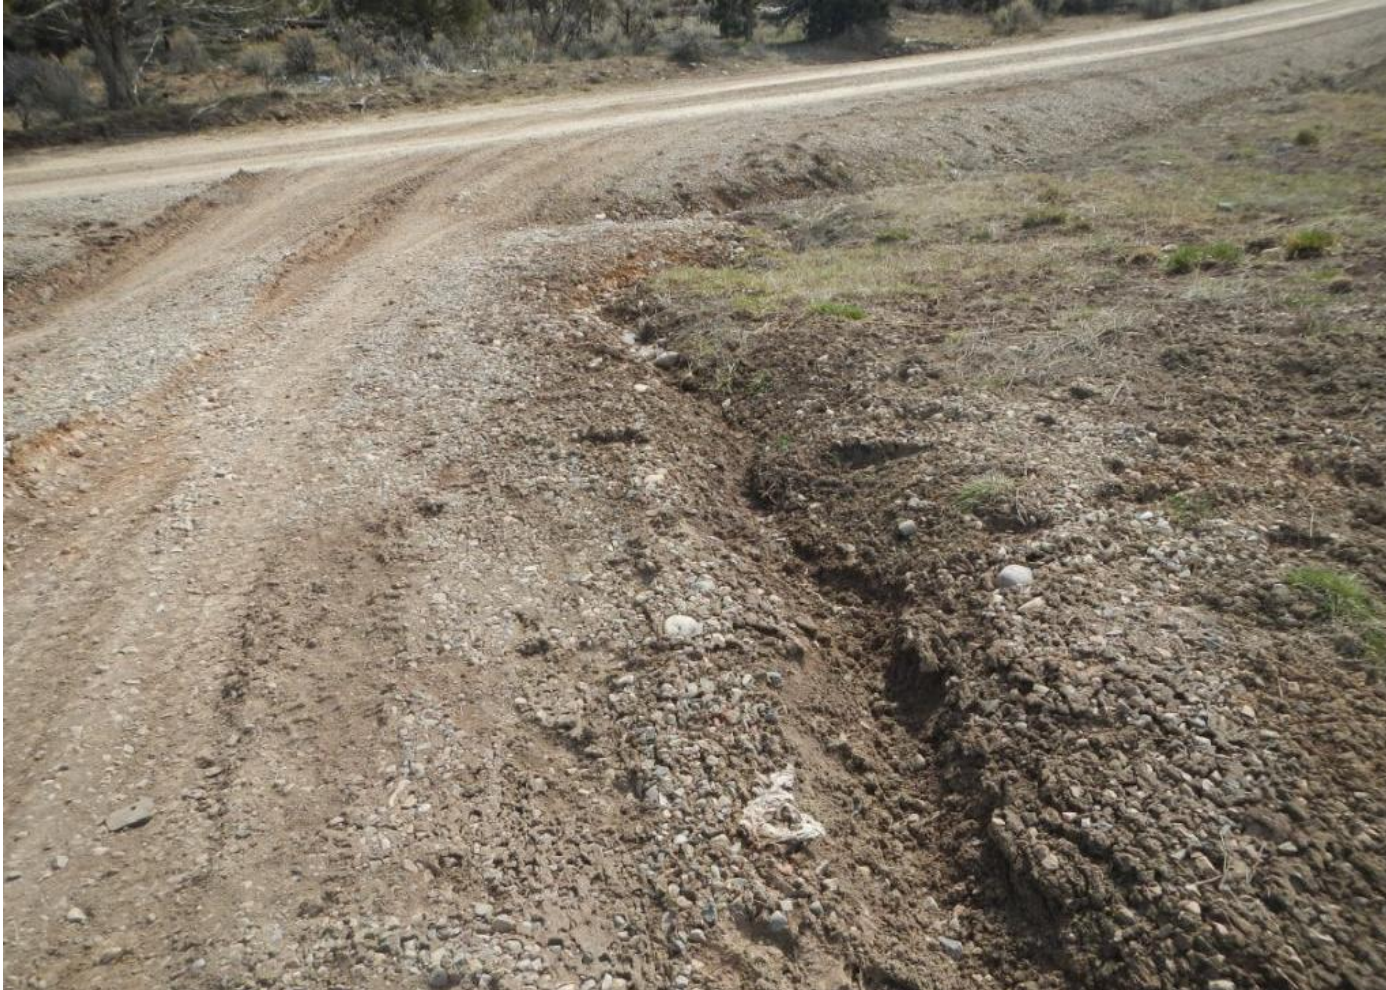
Photo 1. View of erosion occurring along the access road to the well pad. Erosional channel is approximately 18 inches wide and 15 inches deep.

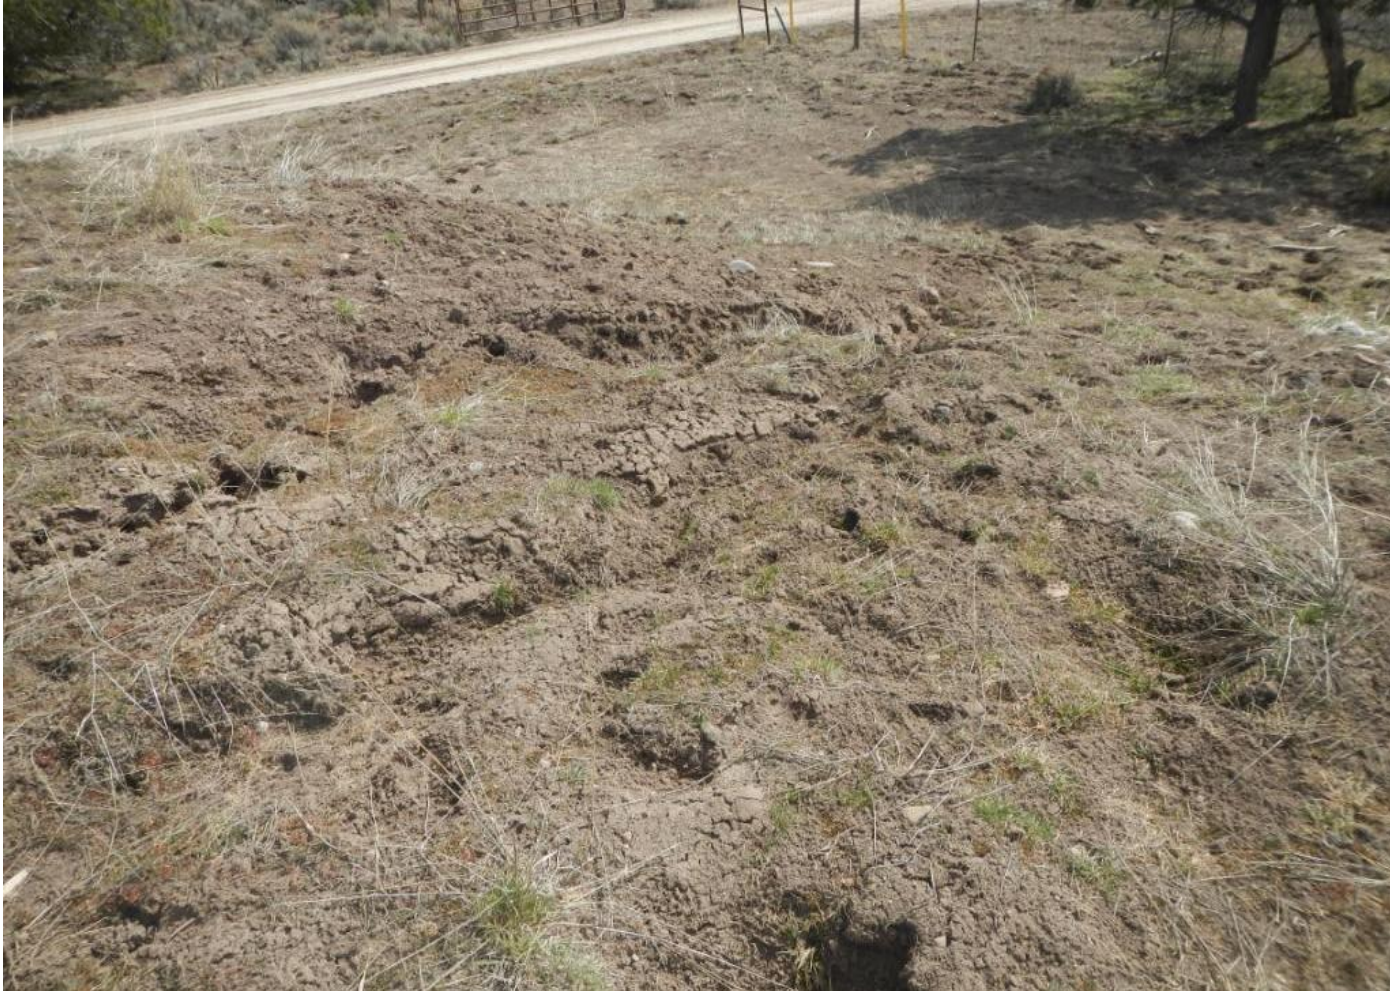
Photo 2. View of erosion occurring within the southeastern portion of the project area.

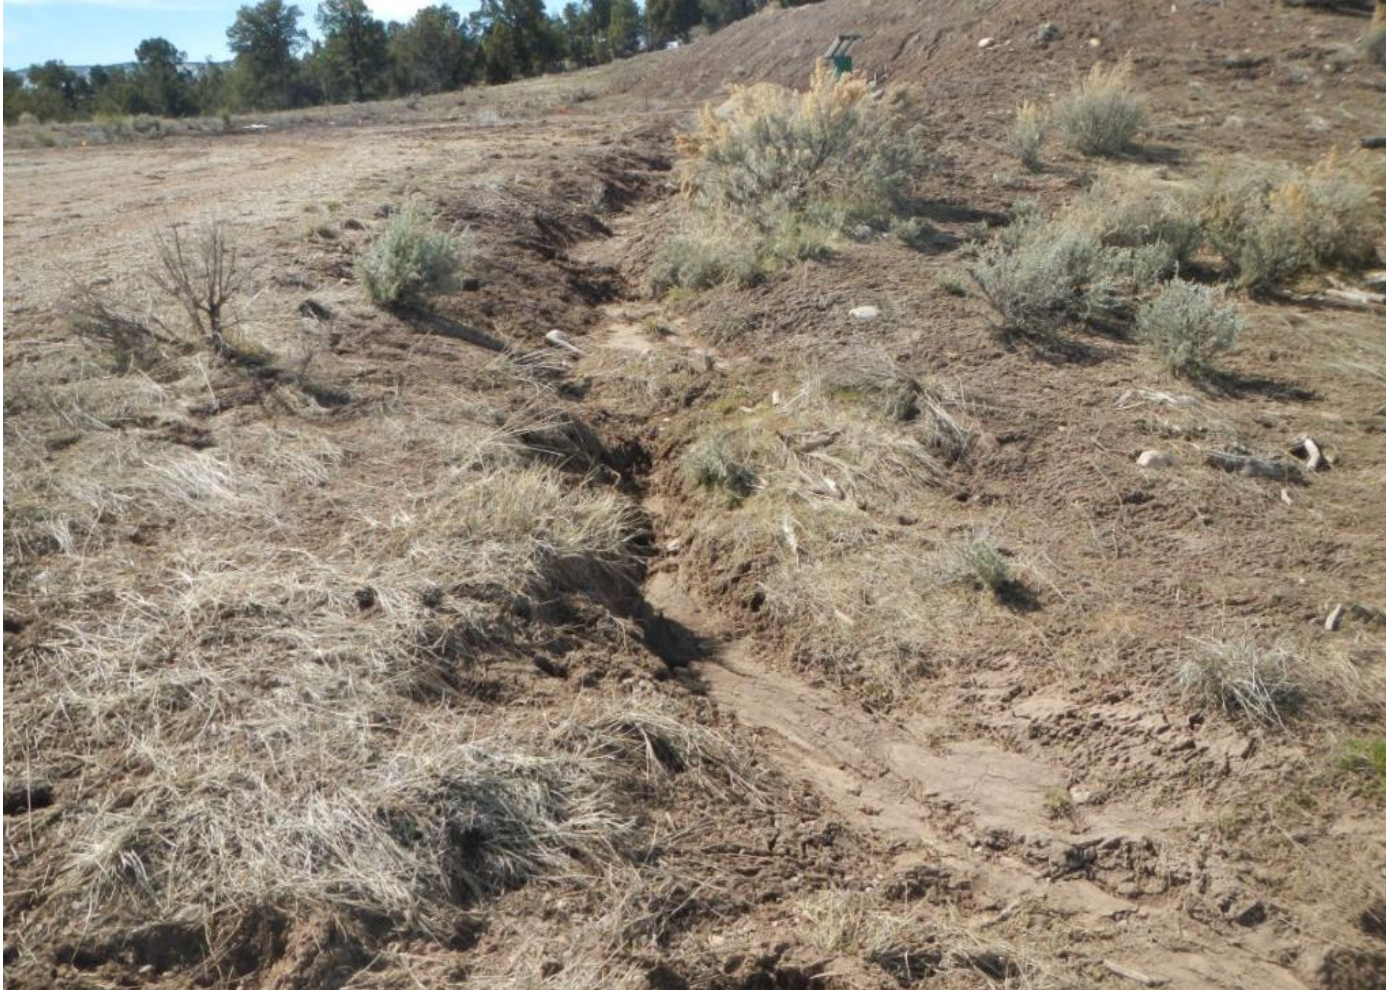
Photo 3. View of erosion occurring where stormwater flows off of the northeastern edge of the project area where it flows onto the adjacent well pad and then forms a gully (Photo 4).

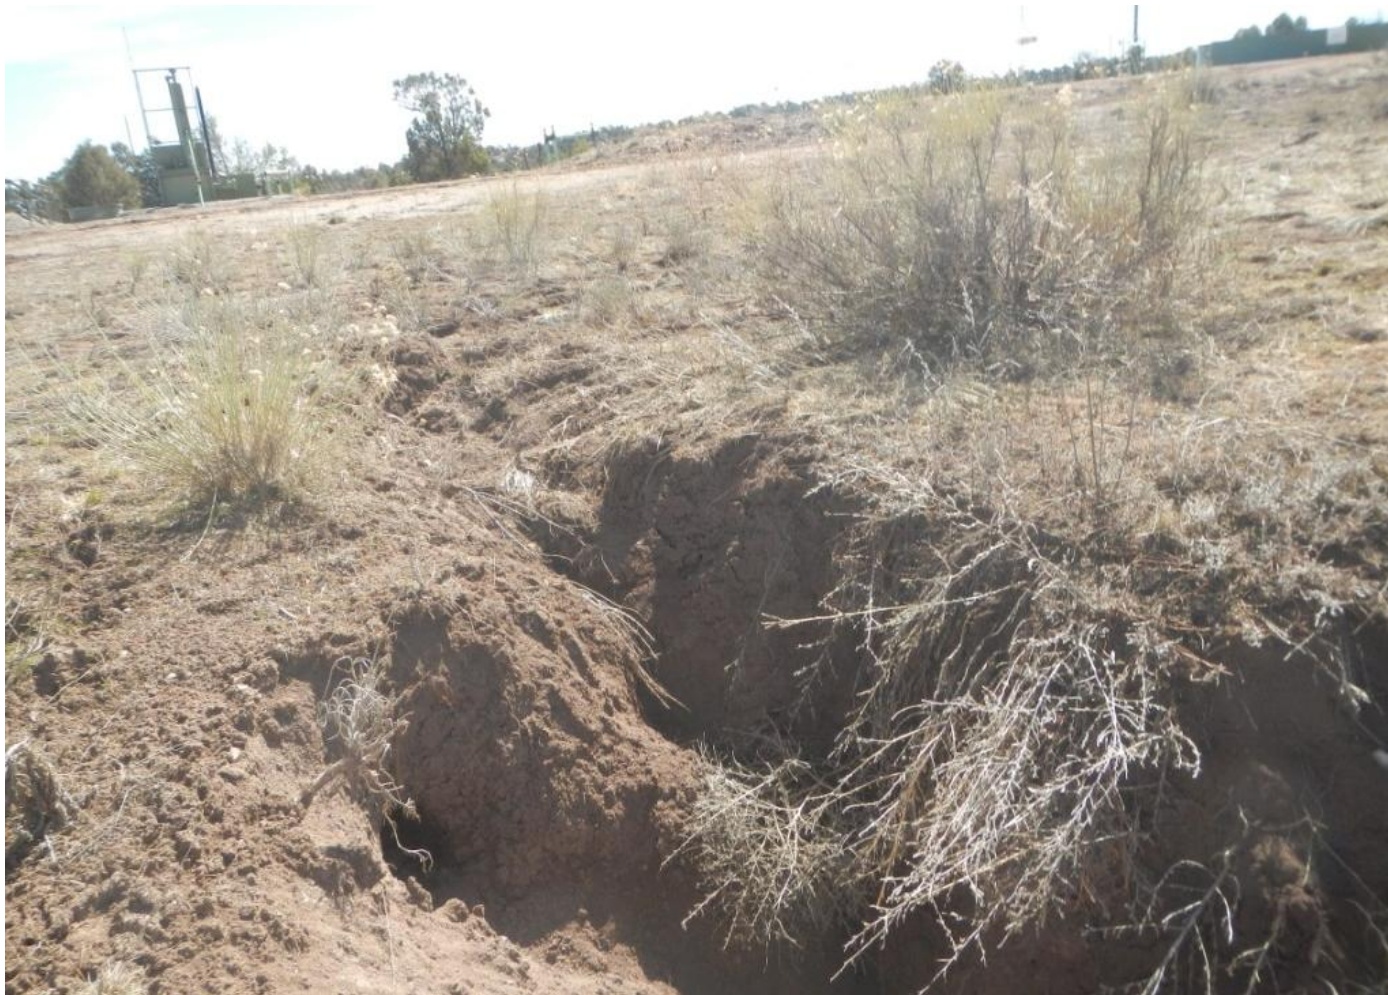
Photo 4. View of gully forming in northern edge of the adjacent well pad.

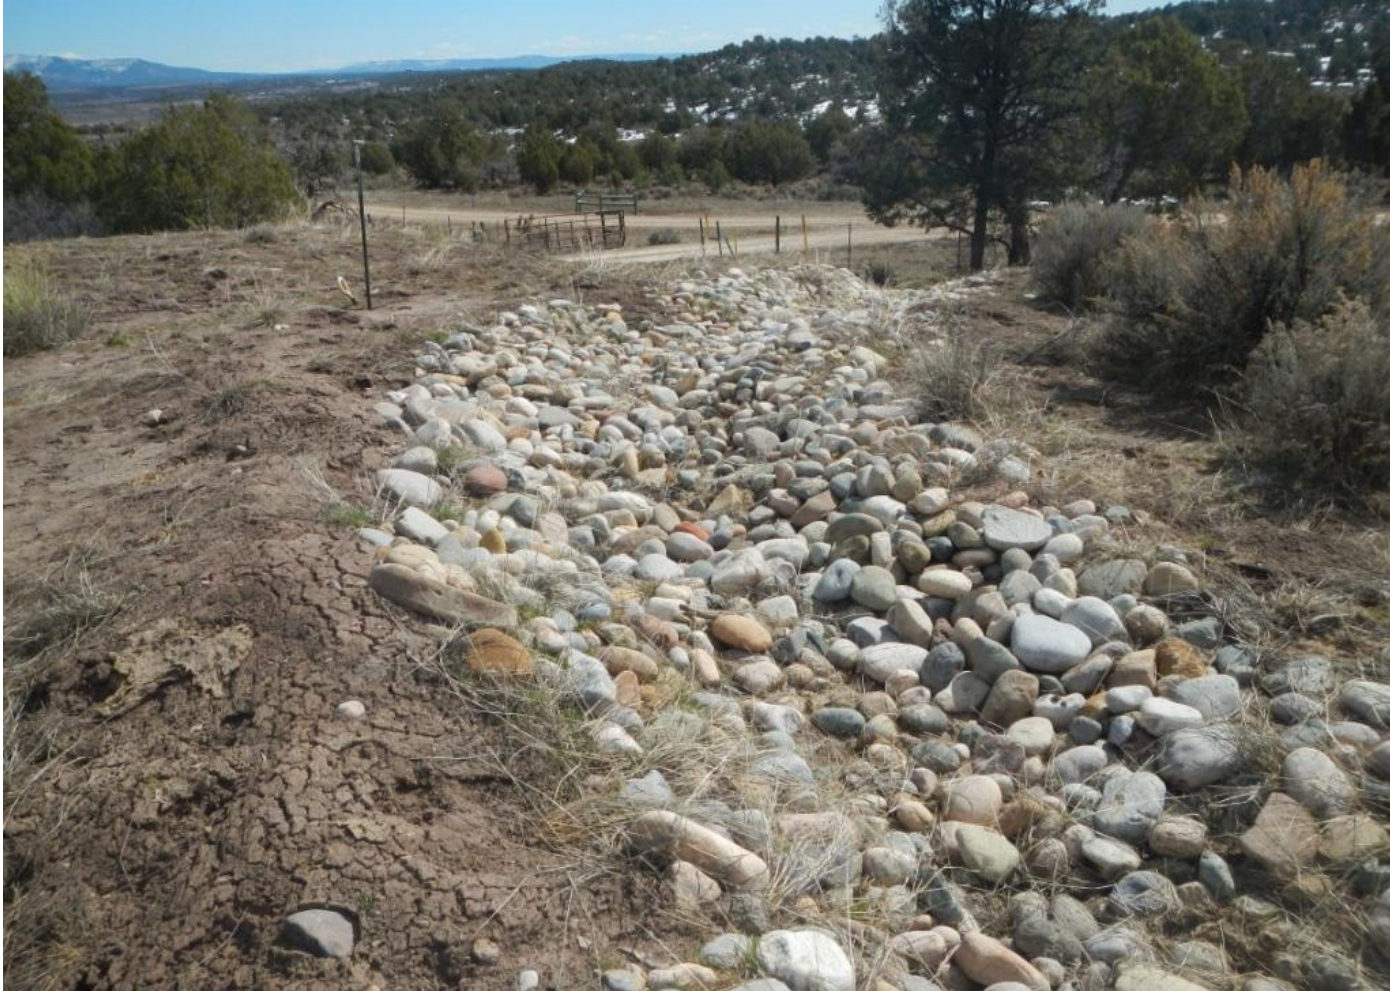
Photo 5. View of cobble BMP in the southern portion of the project area that appears to be functioning.

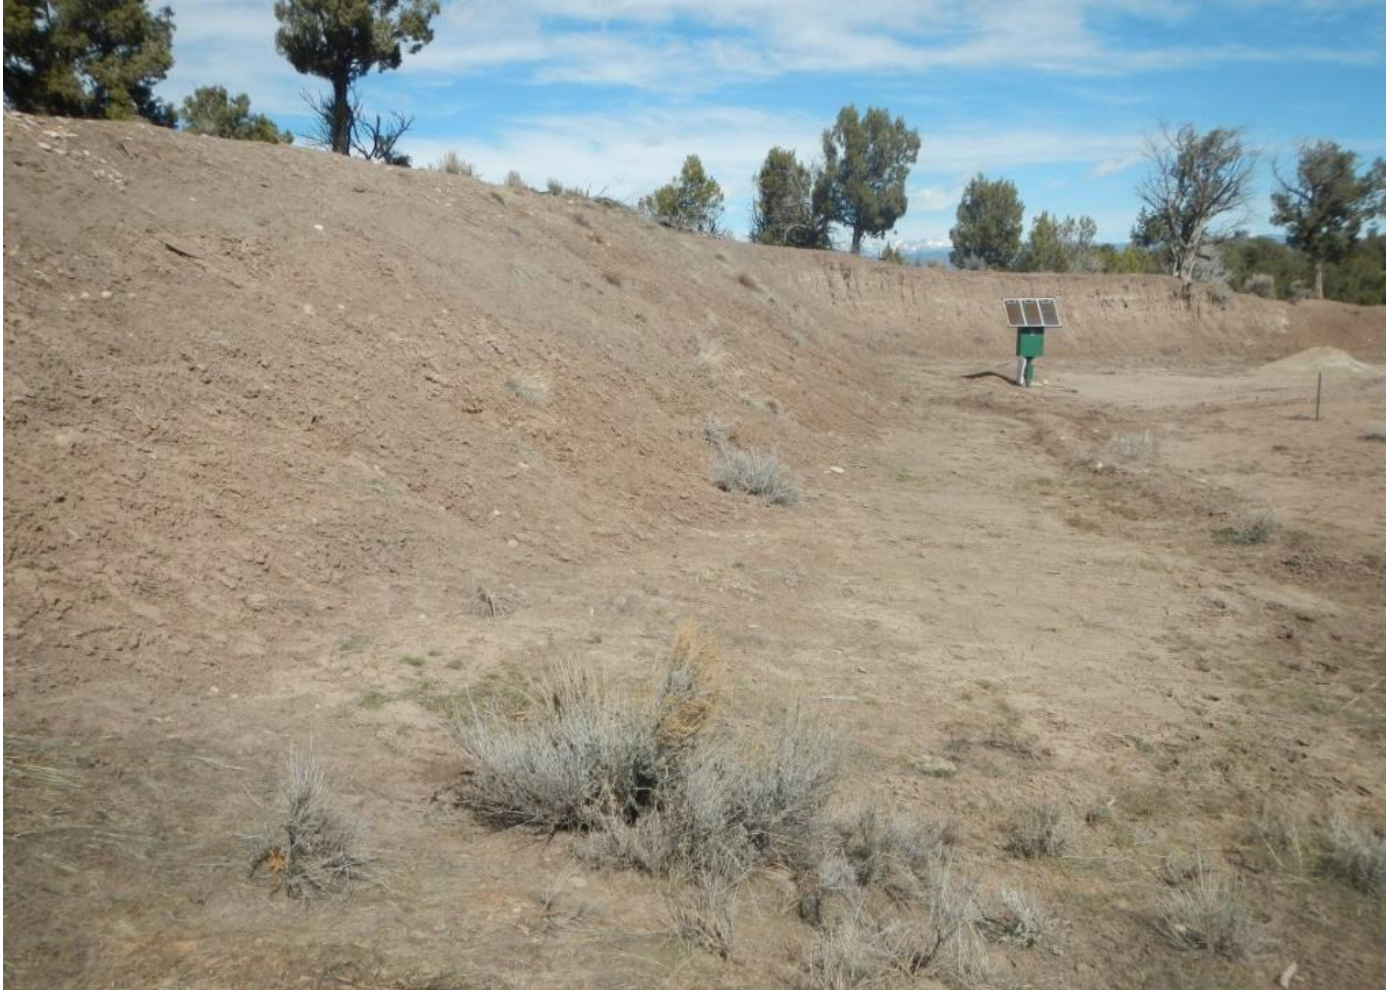
Photo 6. View of the western portion of the project area from the southwestern corner facing northward. Revegetation does not appear to be progressing on the slopes and revegetation may be needed.

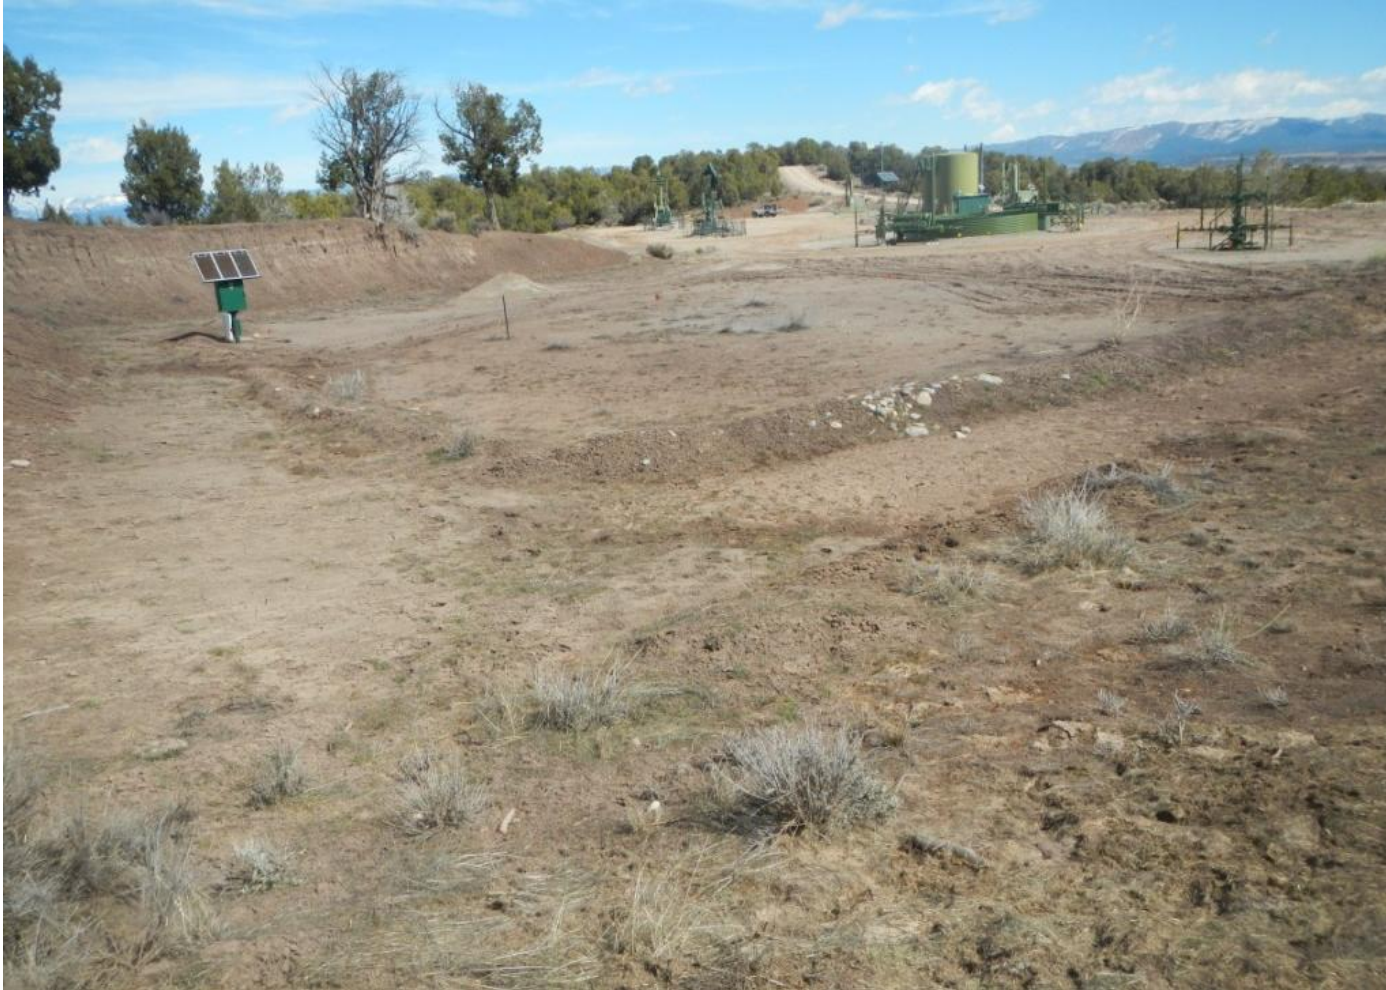
Photo 7. View of project area from the southeastern corner facing center. Poor revegetation in the western portion on flat areas that do not appear necessary for production operations. These areas should be revegetated in fall 2016 if vegetative cover does not increase during the growing season.

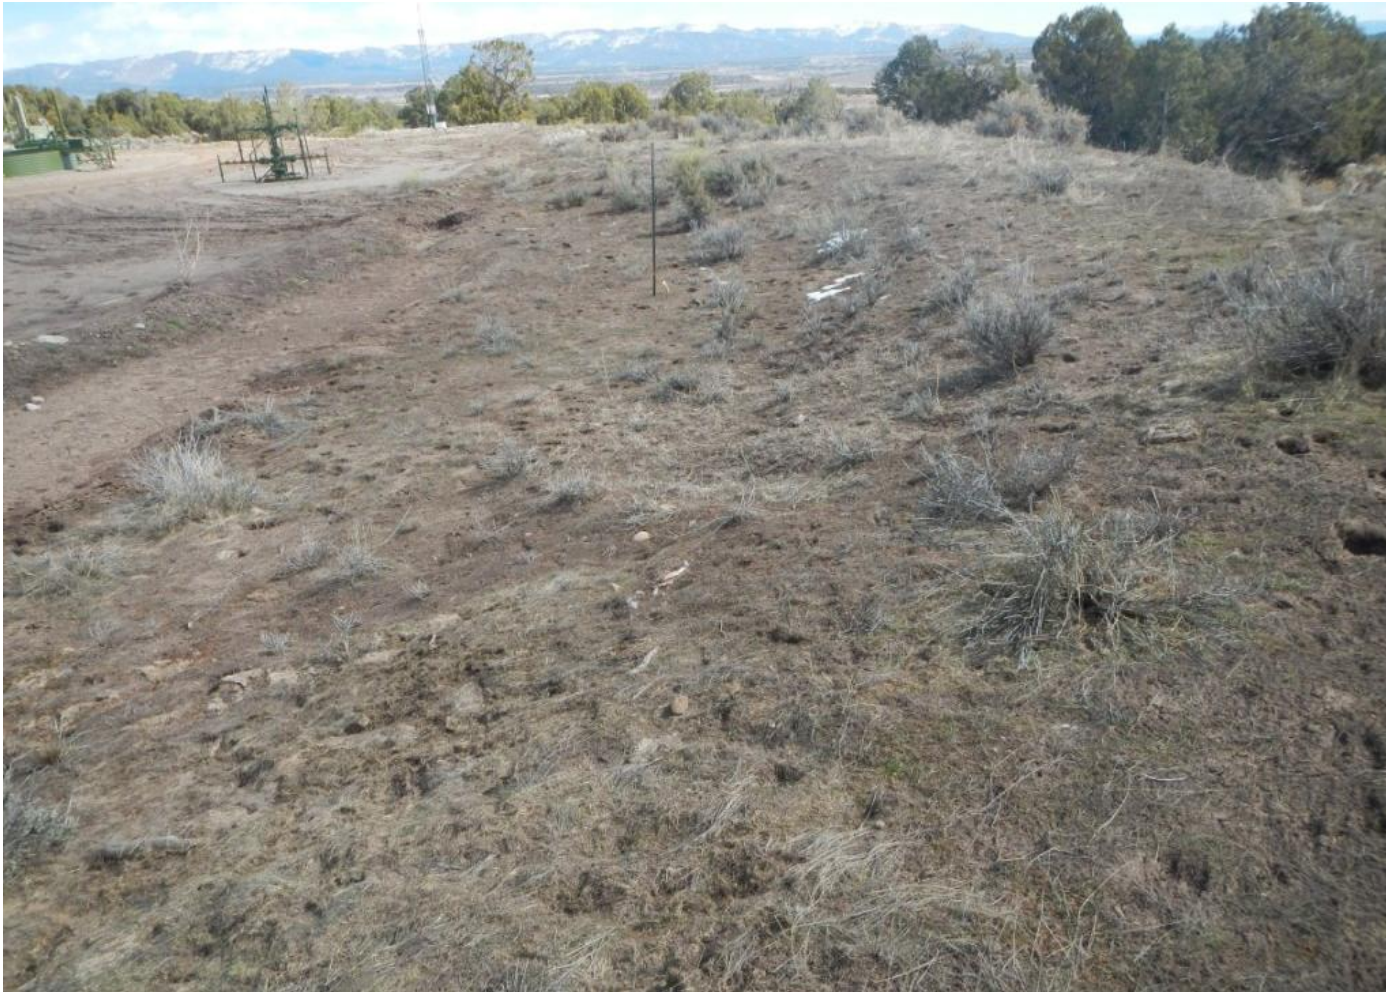
Photo 8. View of the southern portion of the project area from the southwestern corner facing eastward. Revegetation appears to be progressing here.
