Lindauer OO3 Facility

Inspection Doc# 675202590

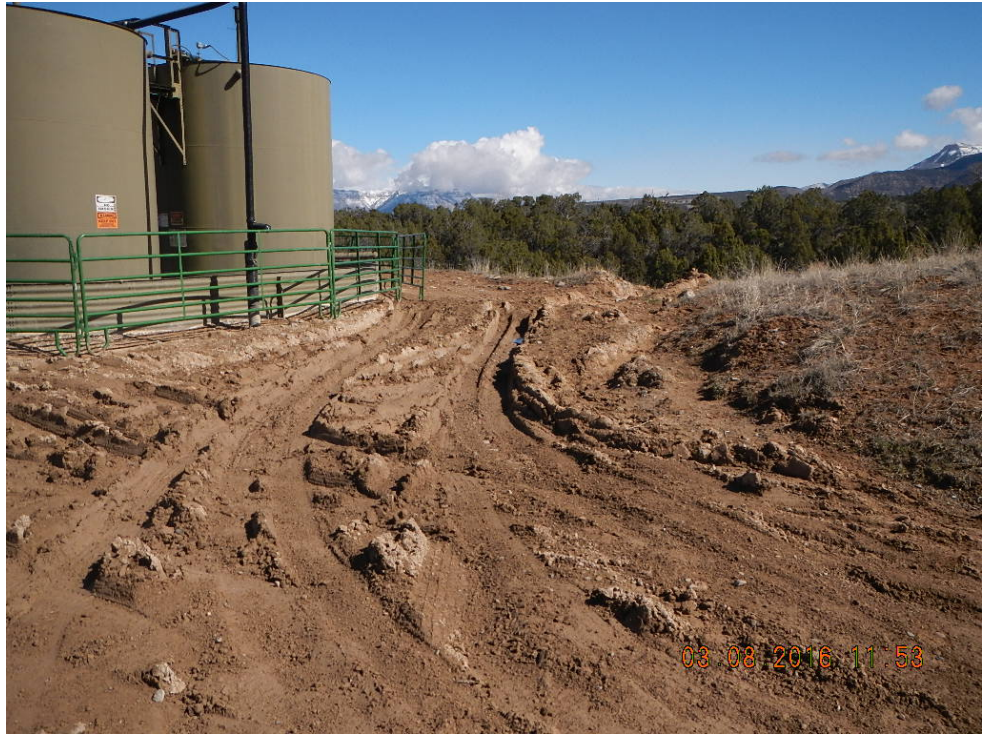
SE corner of location

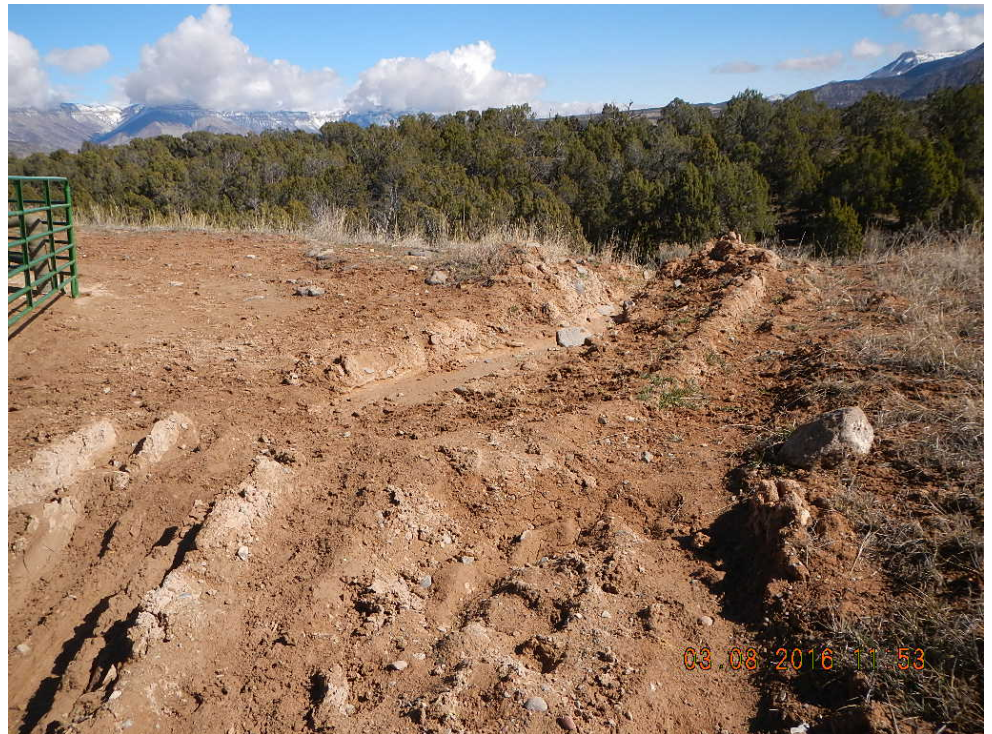
Area where stormwater is leaving location.

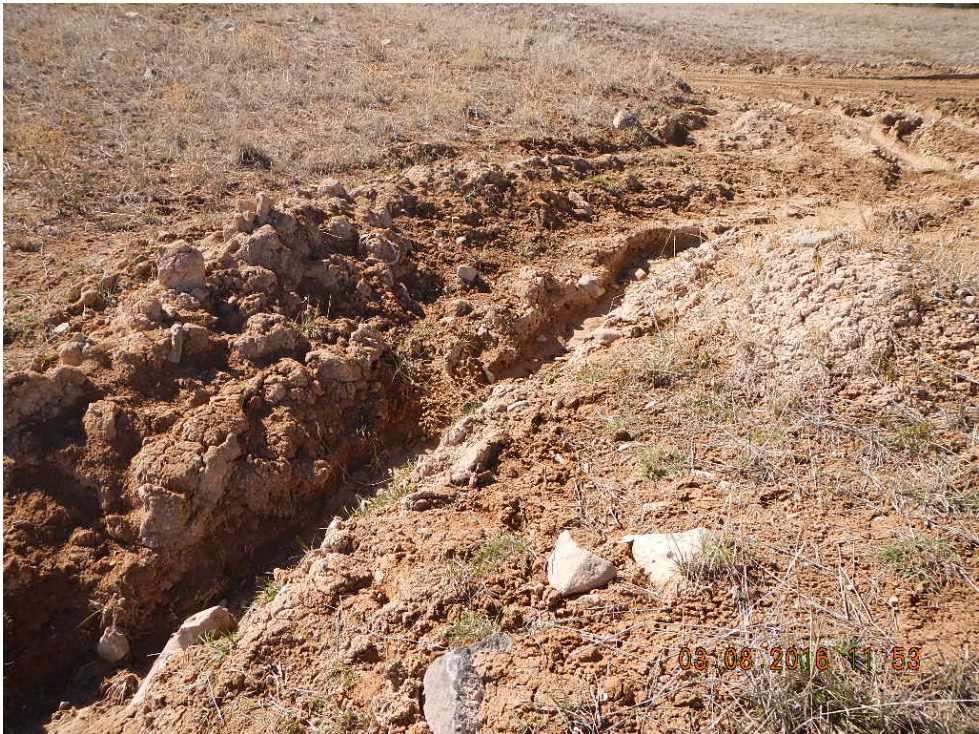
Erosion and run-off

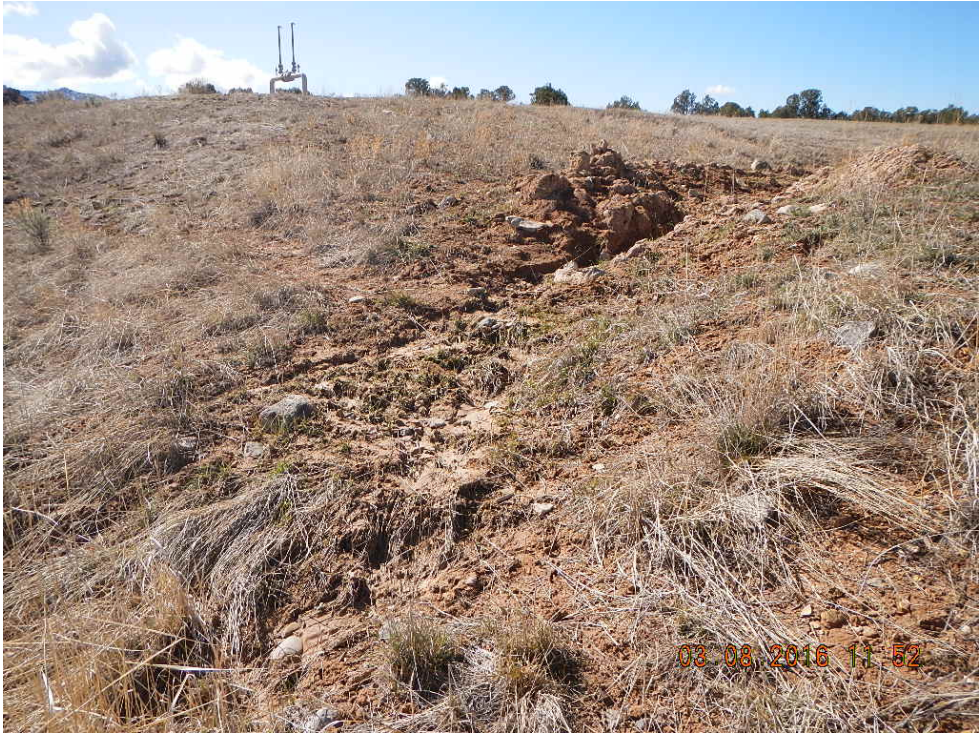
Erosion and sediment migration
