## Construction Inspection

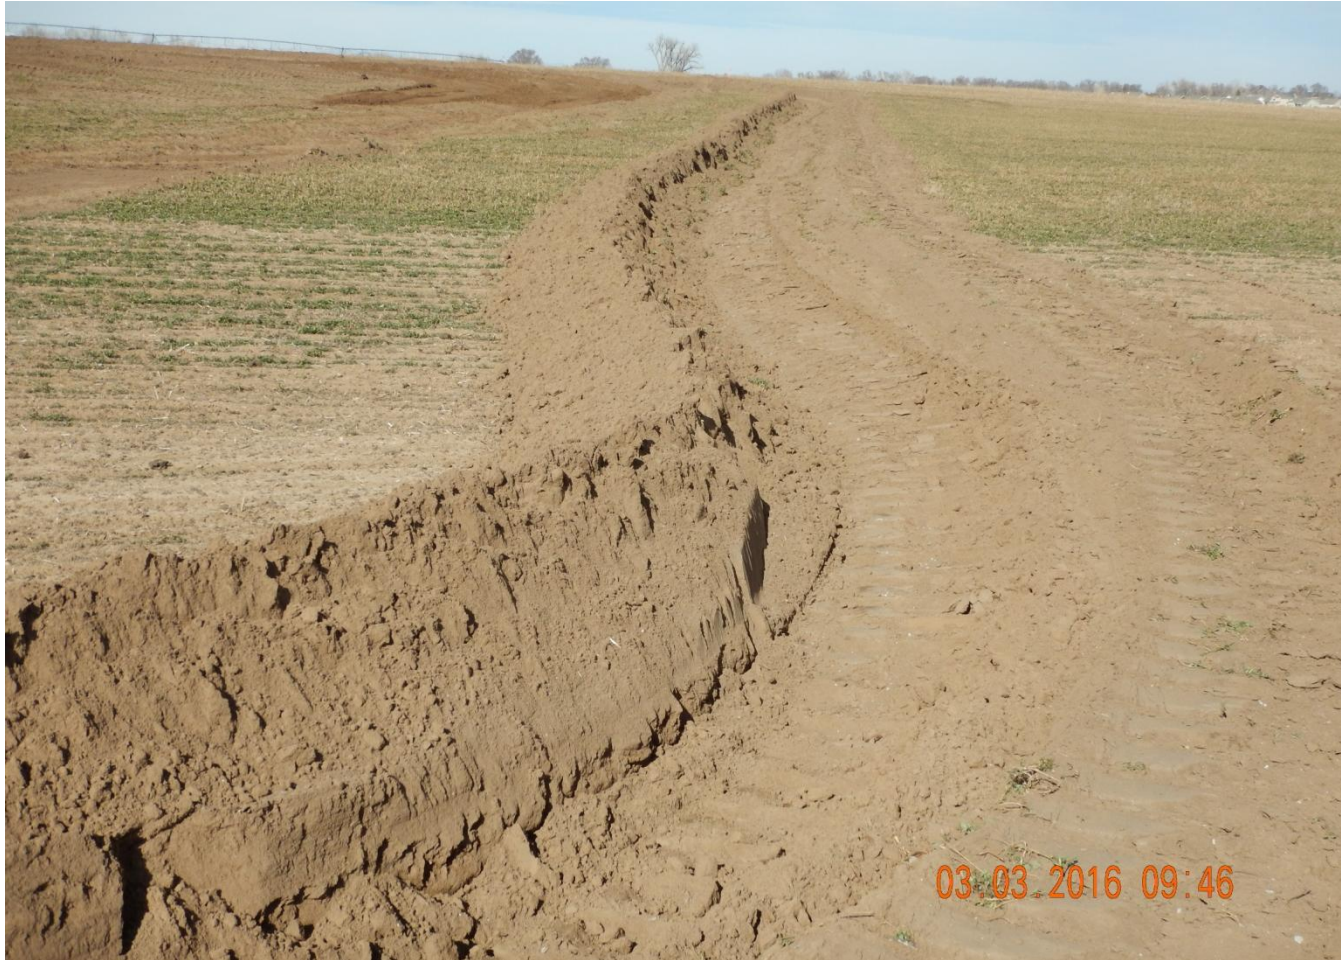
**Photo 1.** Photo taken from eastern location, facing North. Stormwater and sediment control BMPs installed in center of photo.

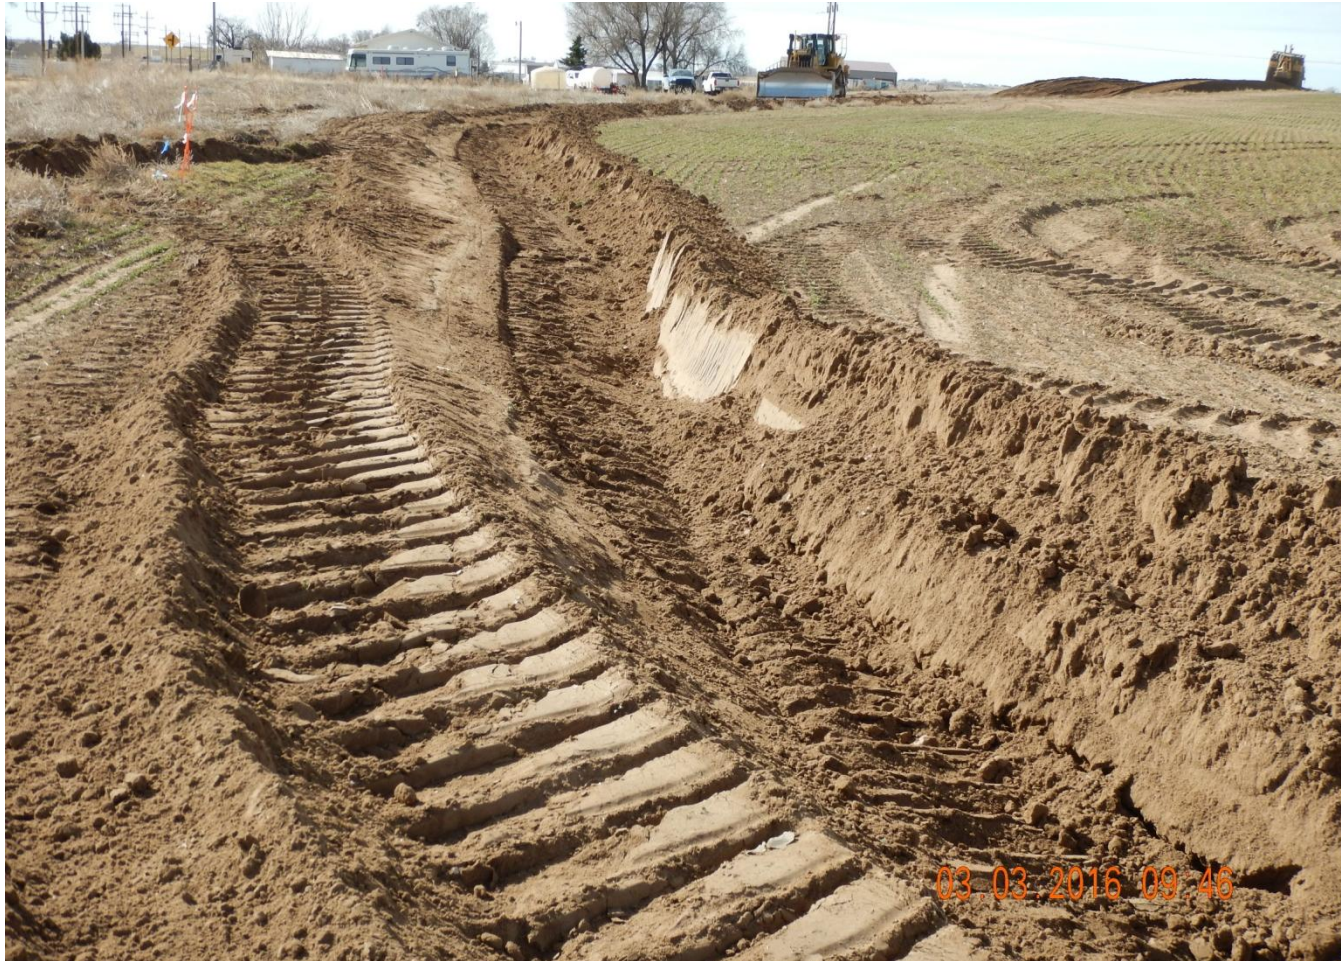
**Photo 2.** Photo taken from eastern location, facing South. Stormwater and sediment control BMPs installed in center of photo.

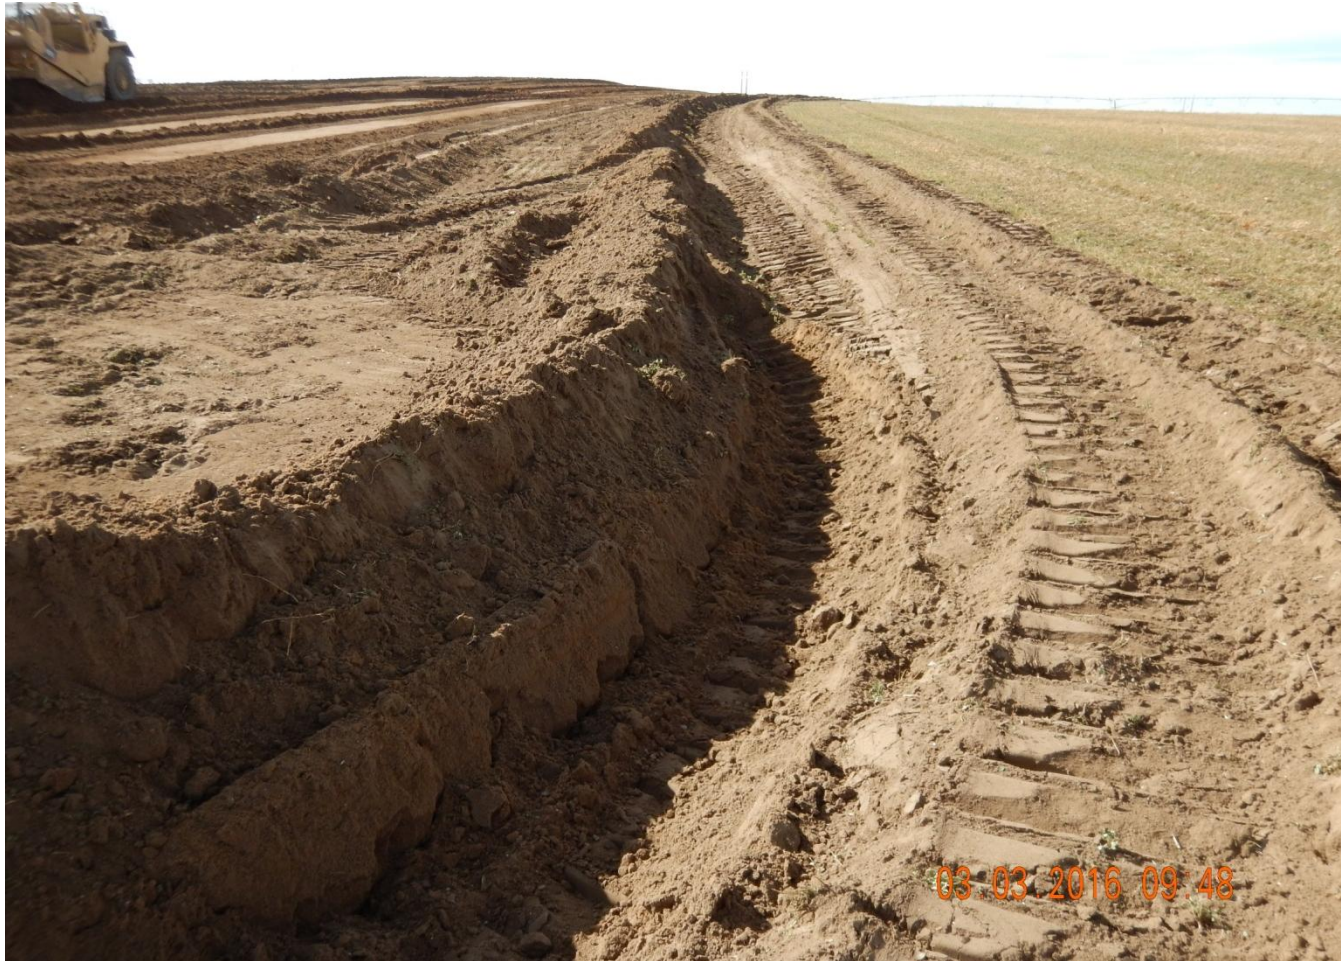
**Photo 3.** Photo taken from northeast location, facing West. Stormwater and sediment control BMPs installed in center of photo.

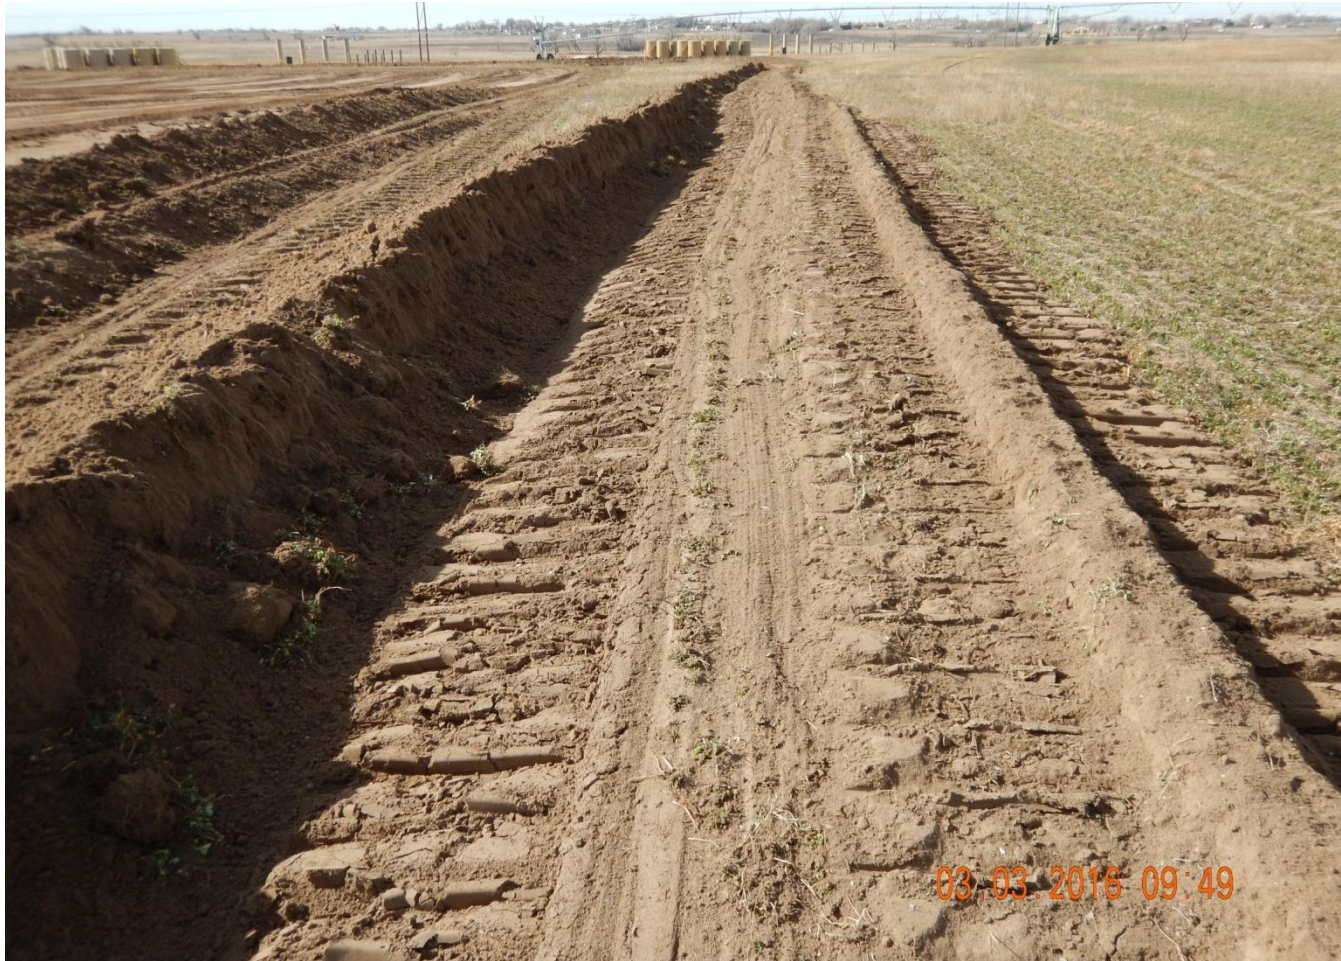
**Photo 4.** Photo taken from northwest location, facing South. Stormwater and sediment control BMPs installed in center of photo.

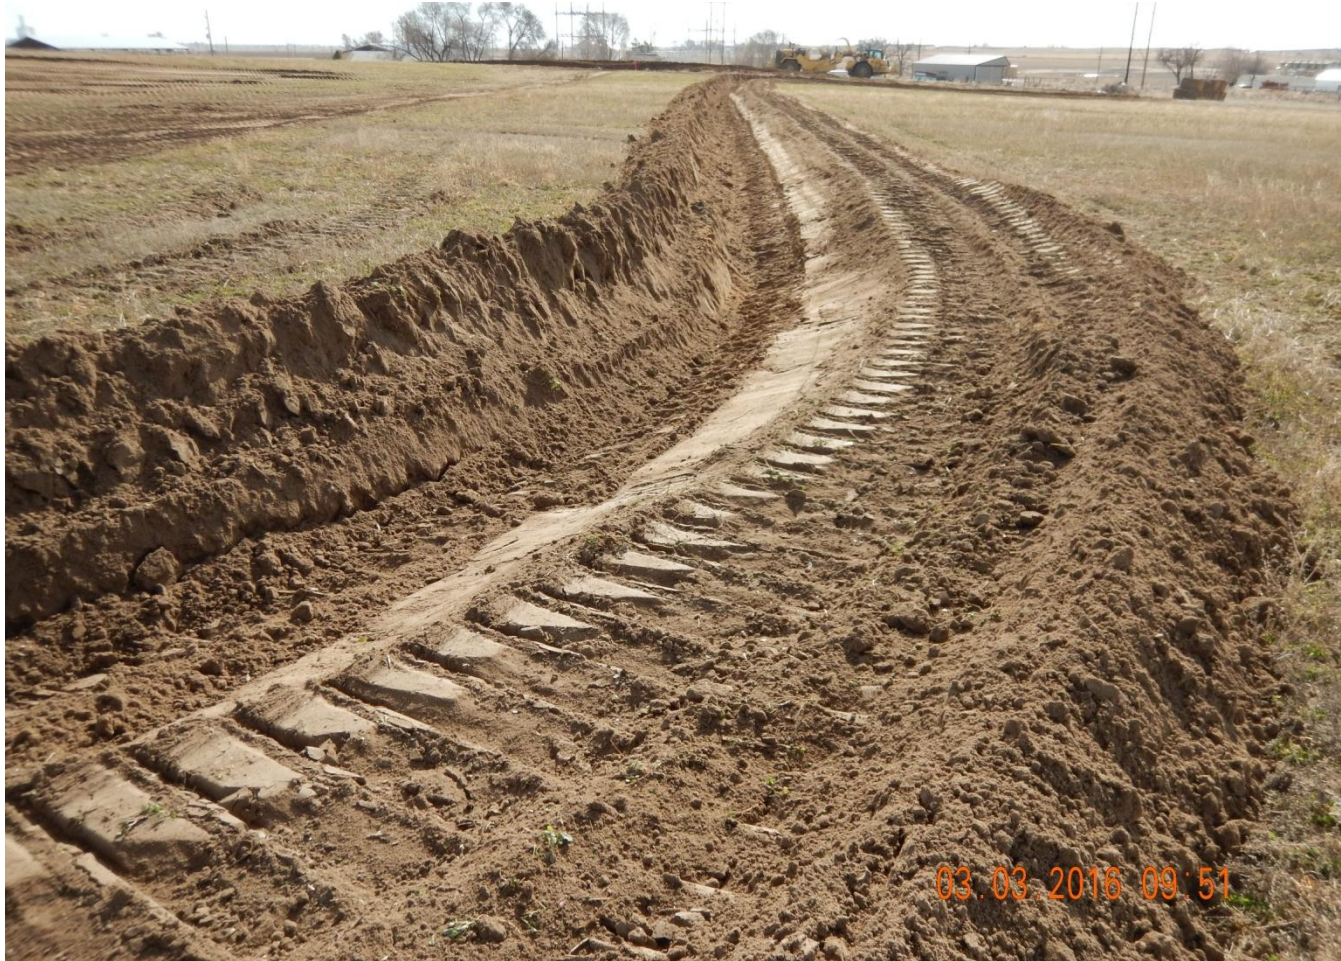
**Photo 5.** Photo taken from western location, facing East. Stormwater and sediment control BMPs installed in center of photo.

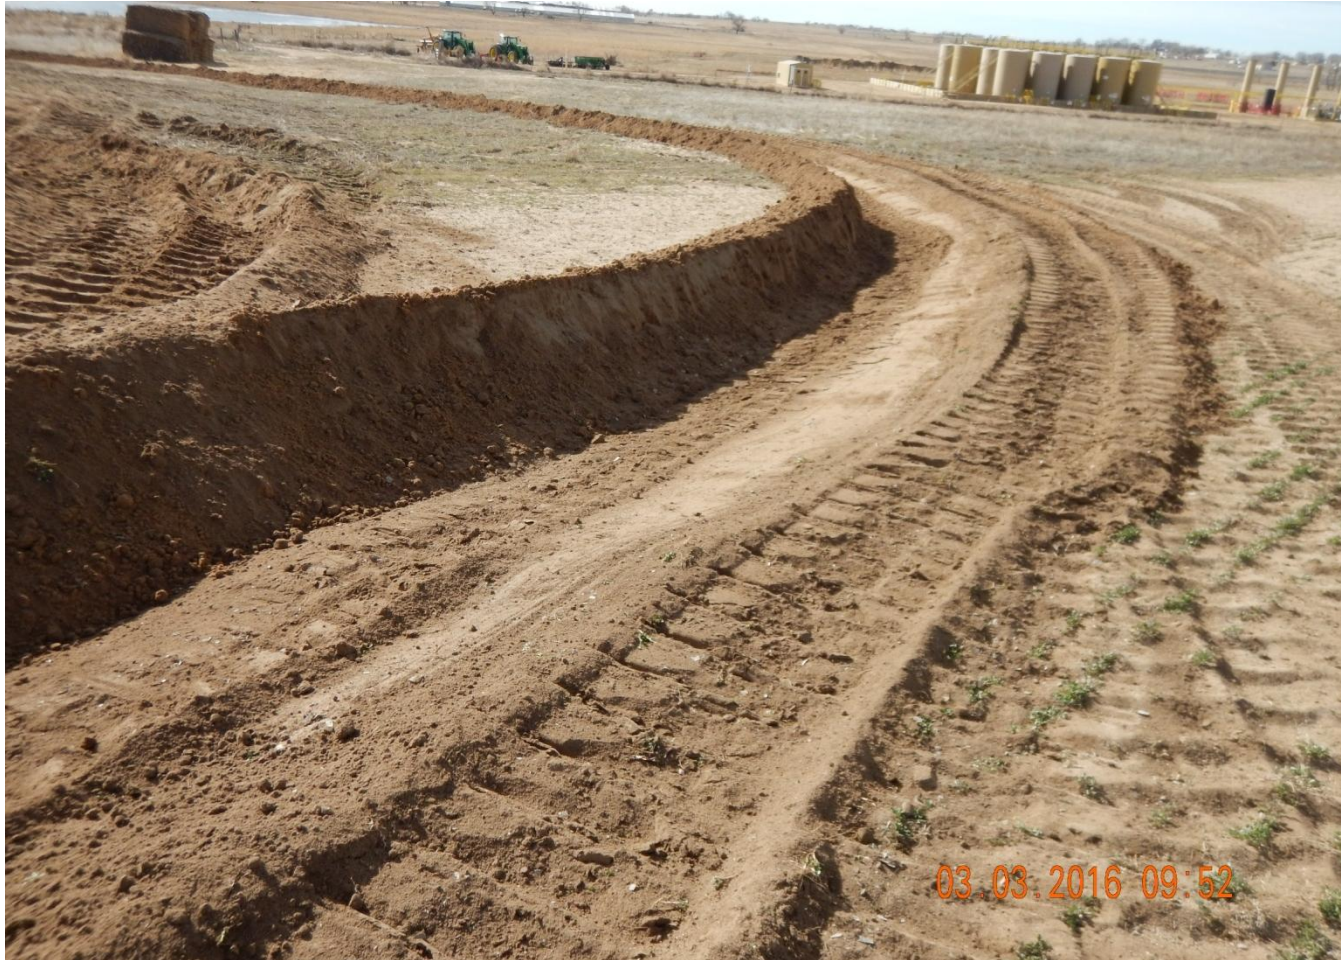
**Photo 6.** Photo taken from southwest location, facing South. Stormwater and sediment control BMPs installed in center of photo.

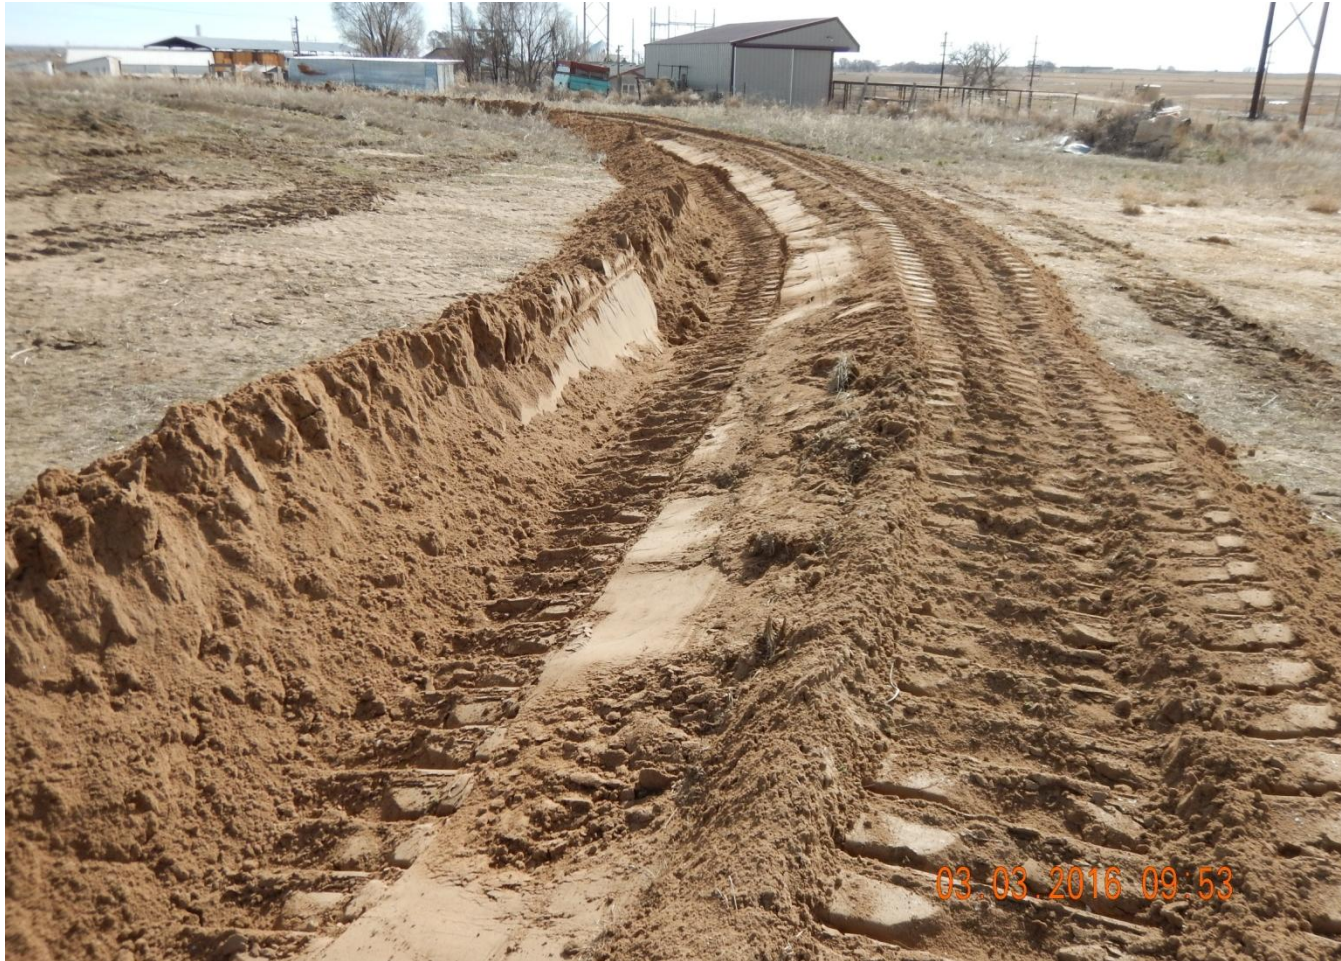
**Photo 7.** Photo taken from southwest location, facing East. Stormwater and sediment control BMPs installed in center of photo.

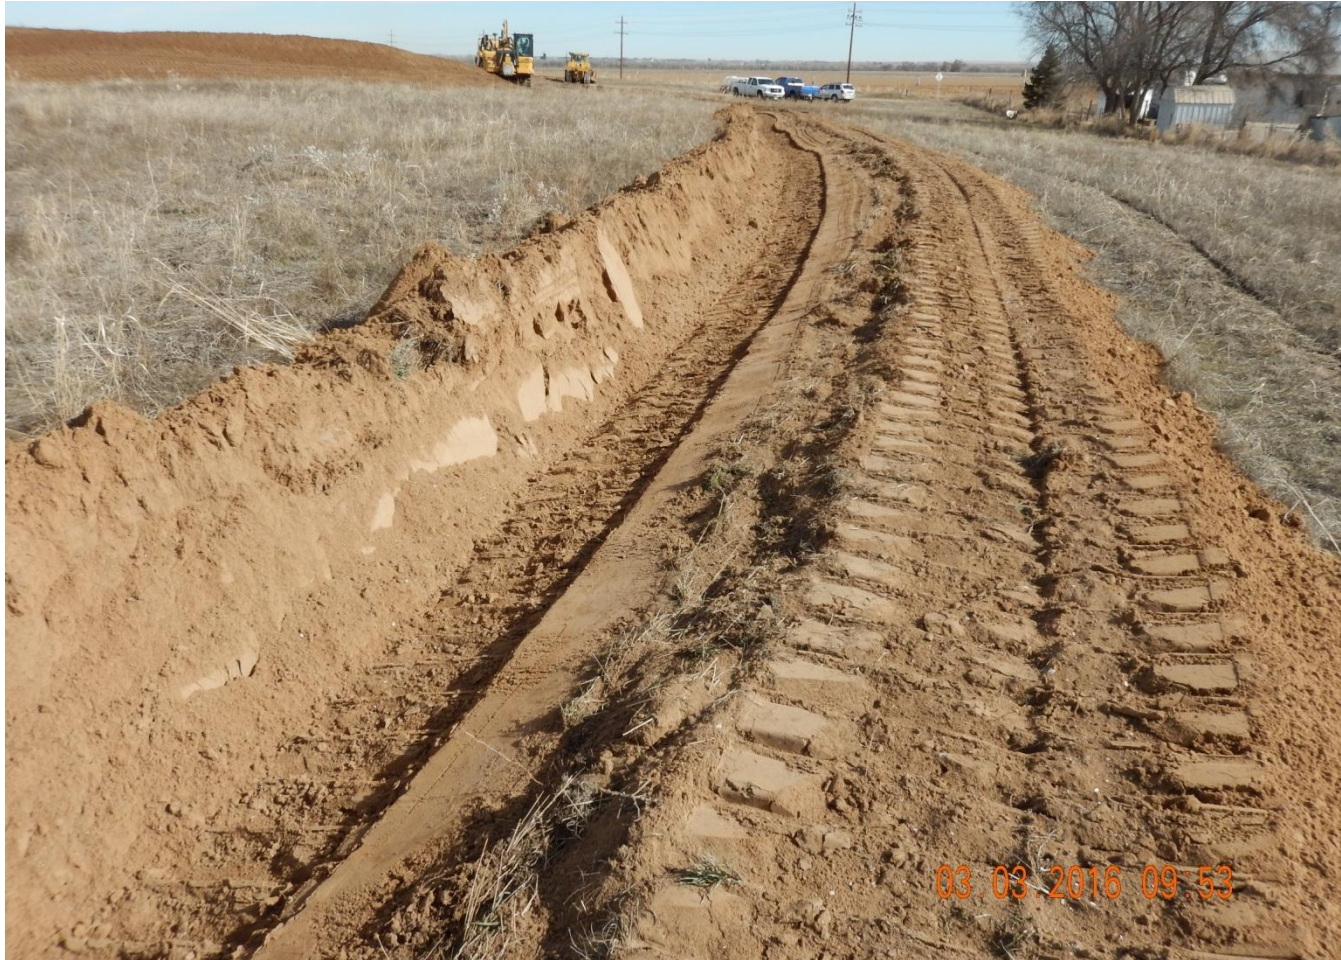
**Photo 8.** Photo taken from southern location, facing Northeast. Stormwater and sediment control BMPs installed in center of photo.

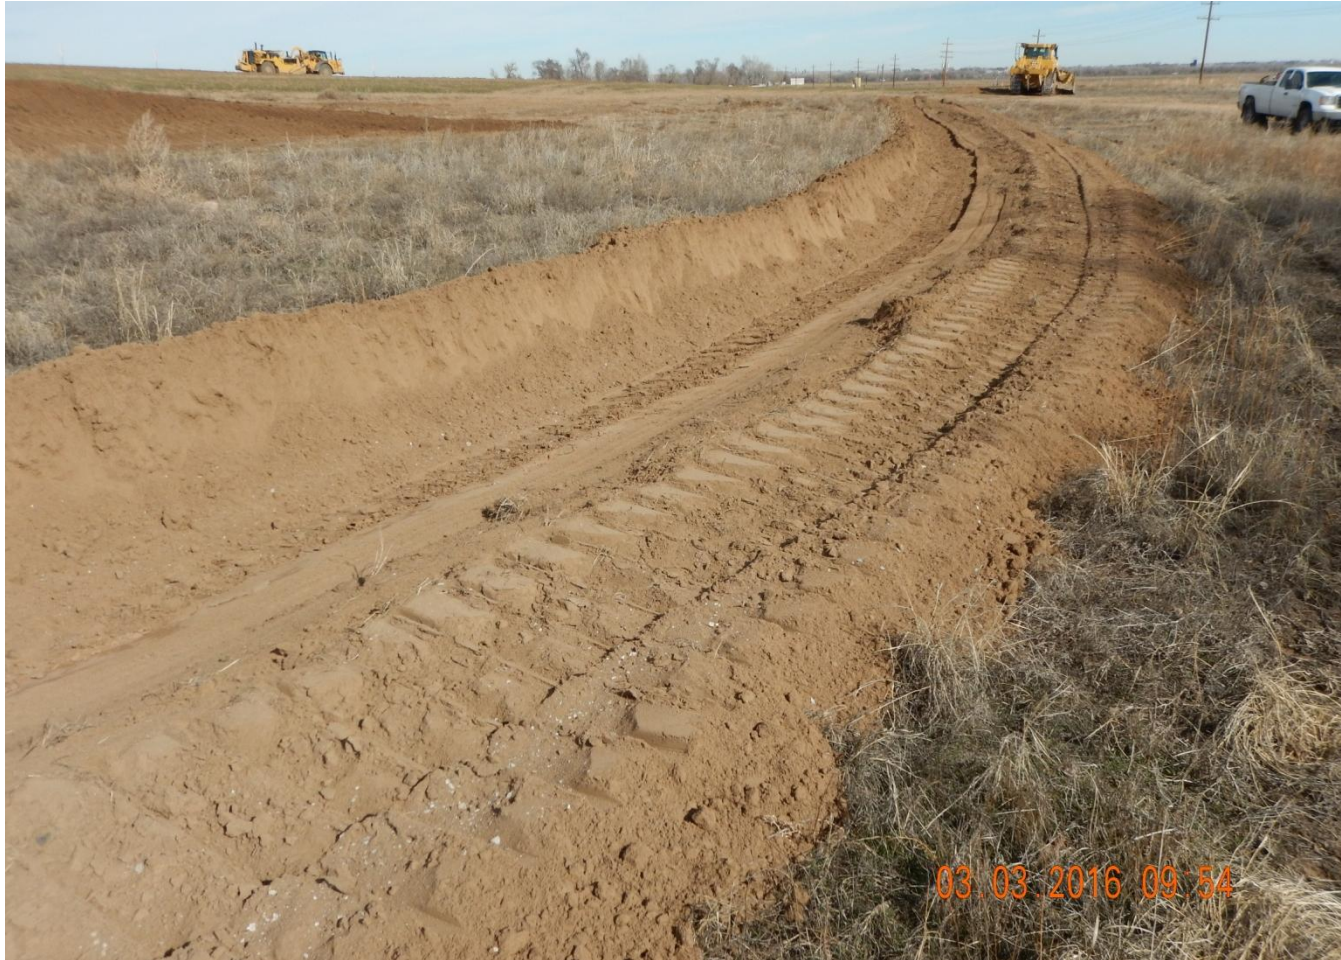
**Photo 9.** Photo taken from southeast location, facing North. Stormwater and sediment control BMPs installed in center of photo.

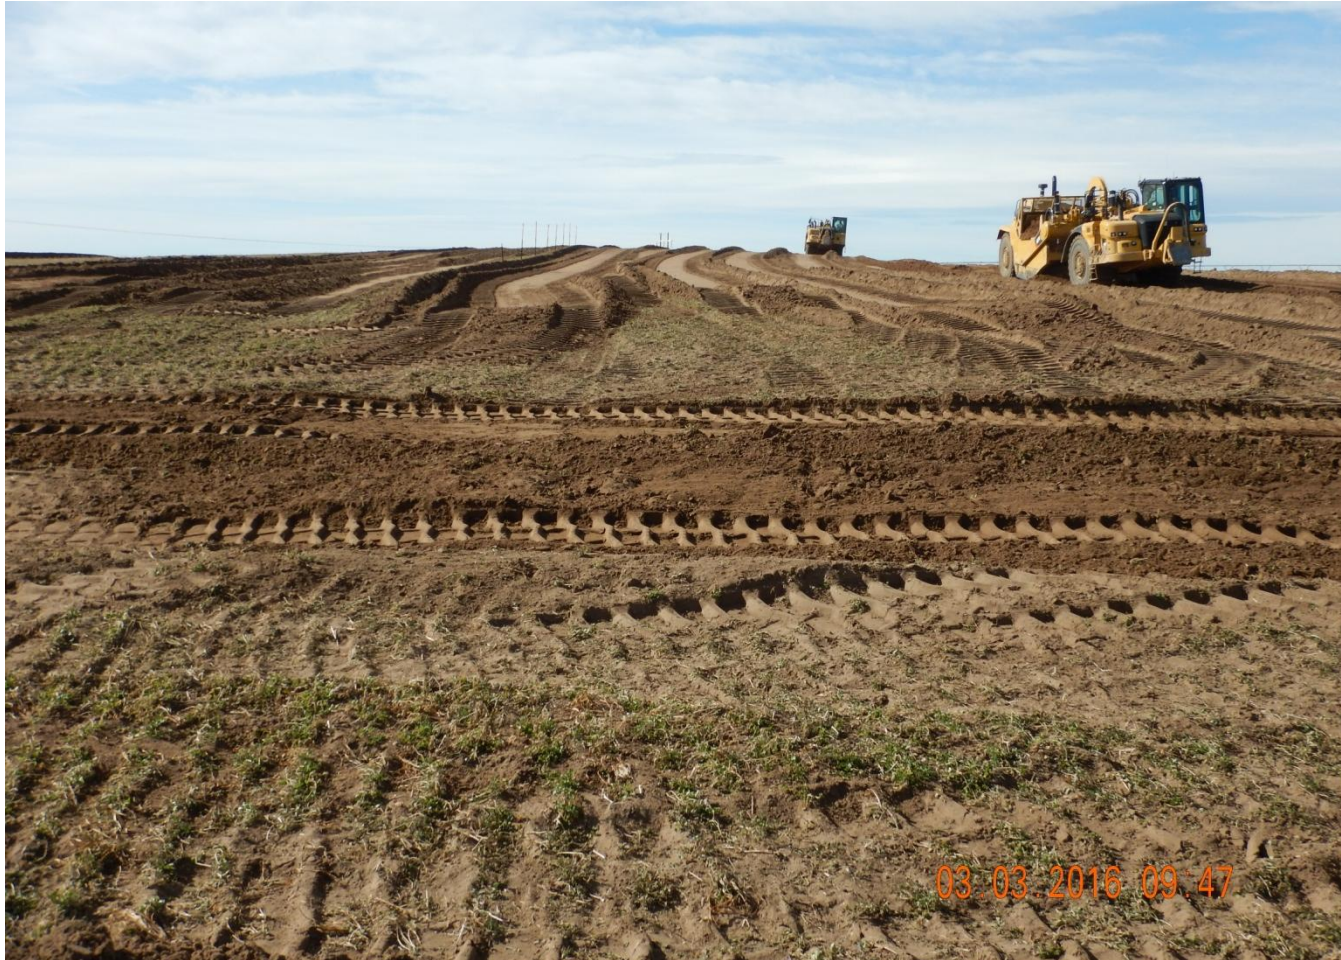
**Photo 10.** Photo taken from eastern location, facing West. Topsoil salvage in process.

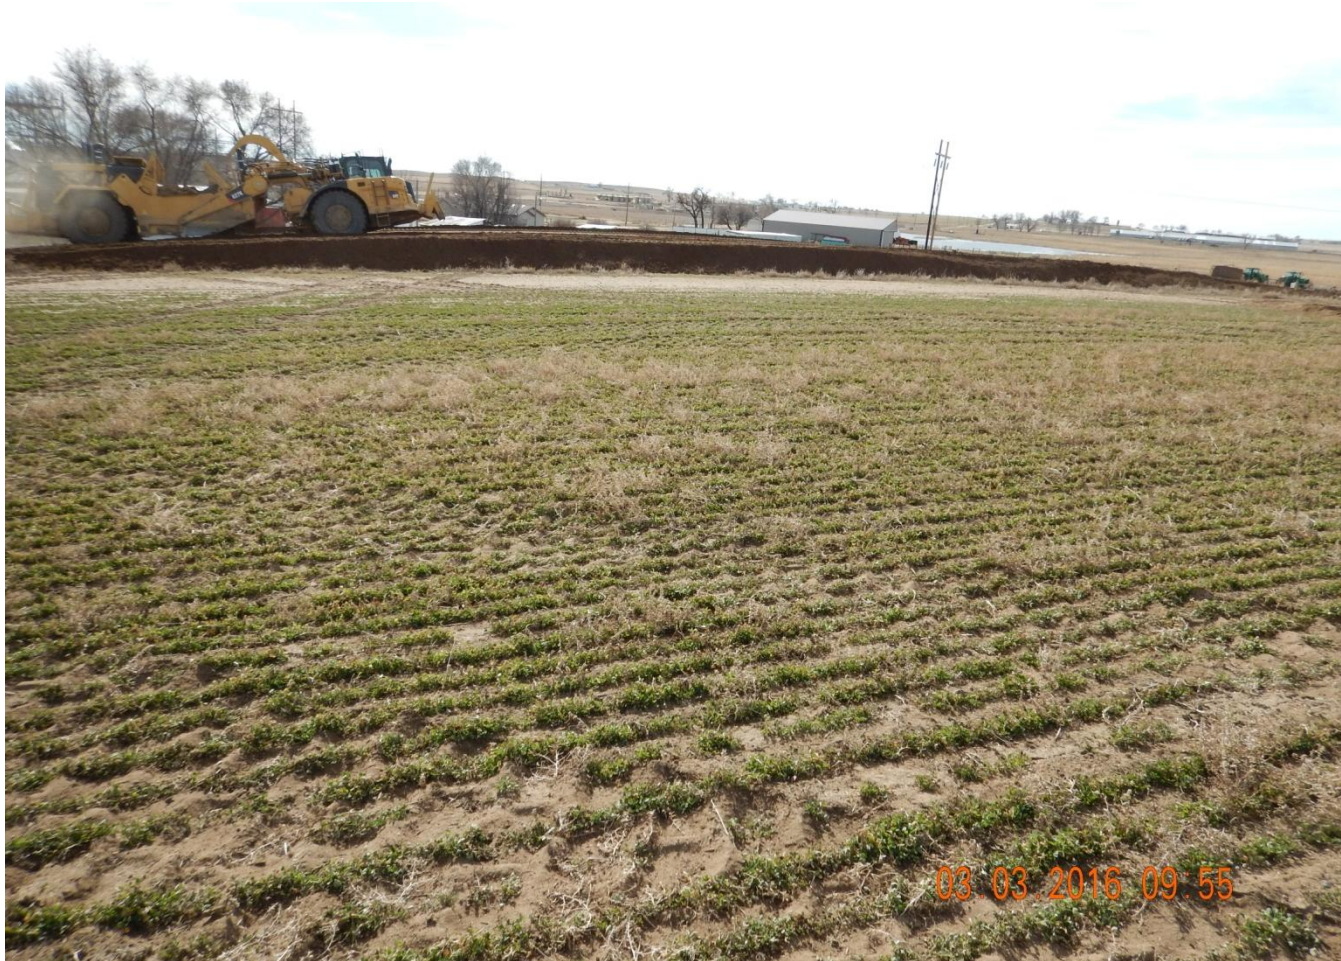
**Photo 11.** Photo taken from central location, facing towards topsoil salvage pile. Topsoil salvage in process.
