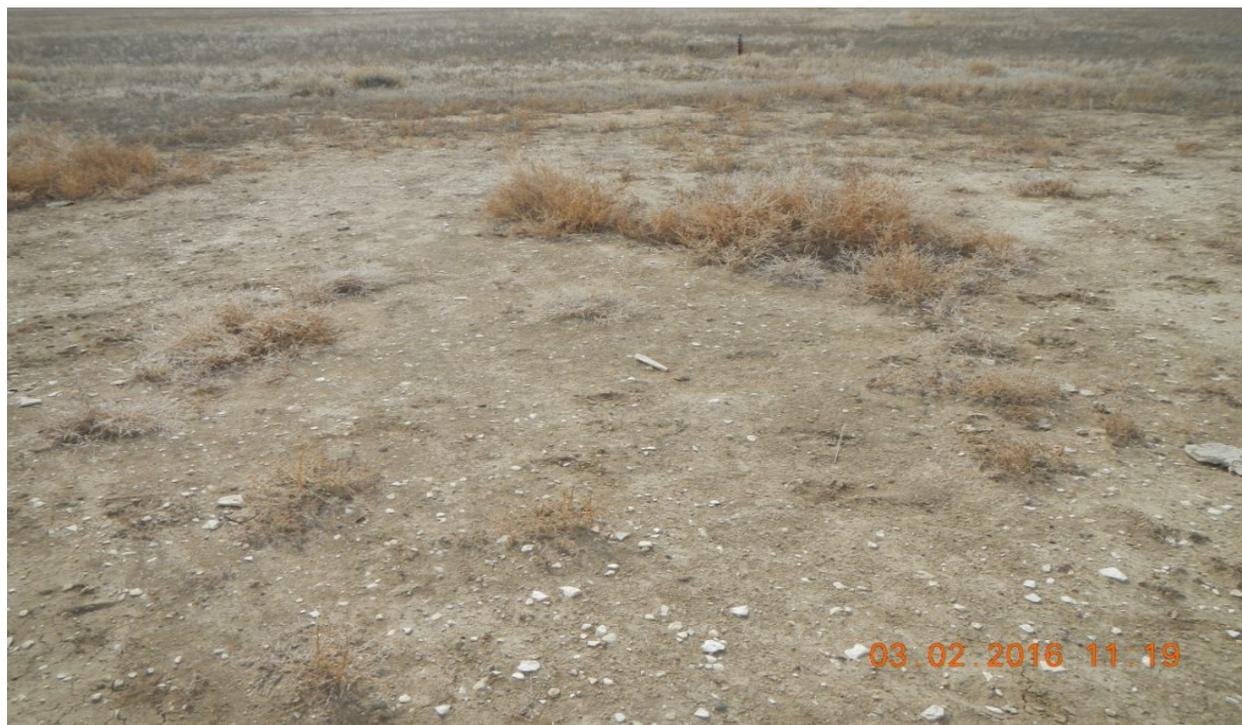
photo 3: Vegetation has not established at the disturbed area north of the location.

Lat/Long: 38.42183/-103.01434

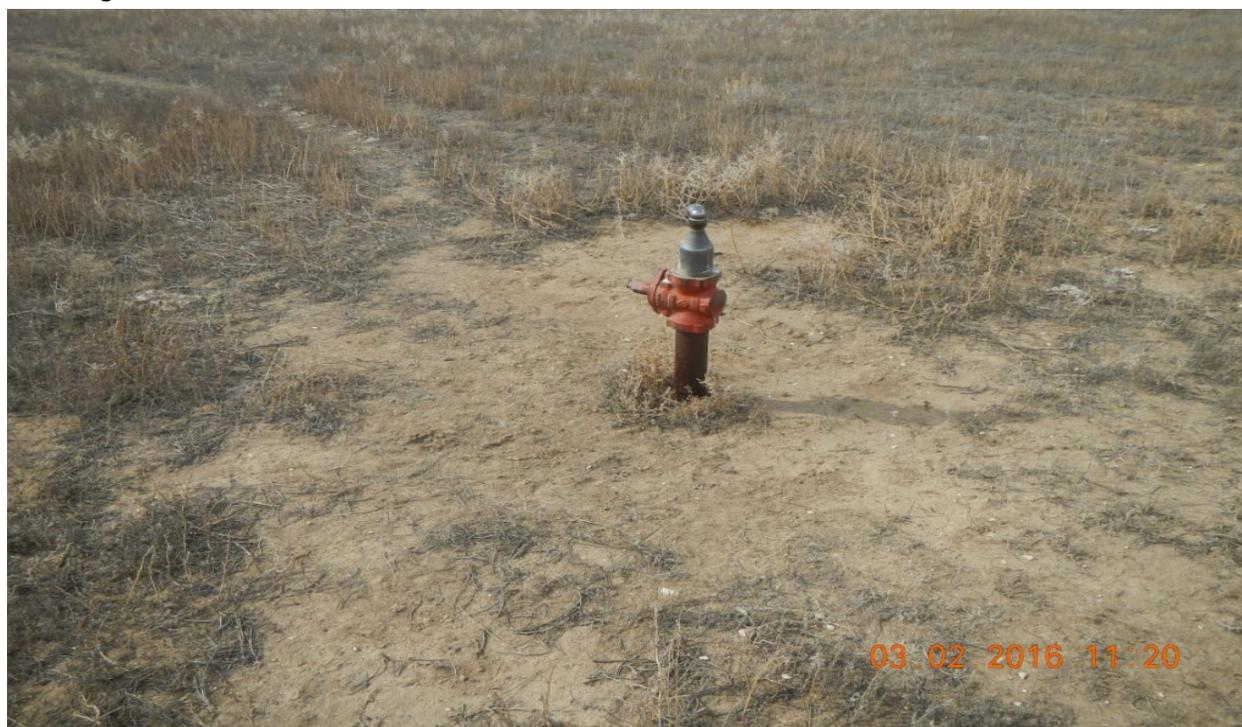
photo 4: Pipe riser remains north of the location. Lat/Long 38.42165/-103.01427

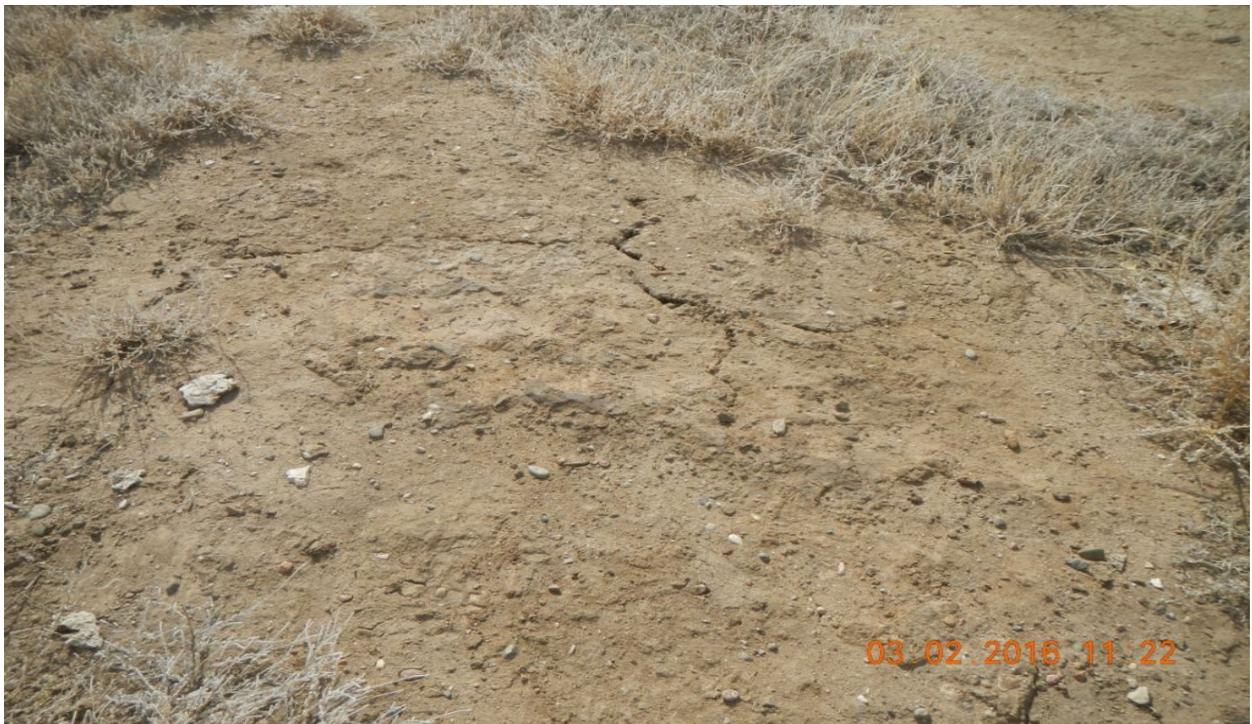
photo 6: Compacted, oil stained soil remains on location. Lat/Long:38.42056,-103.01367.

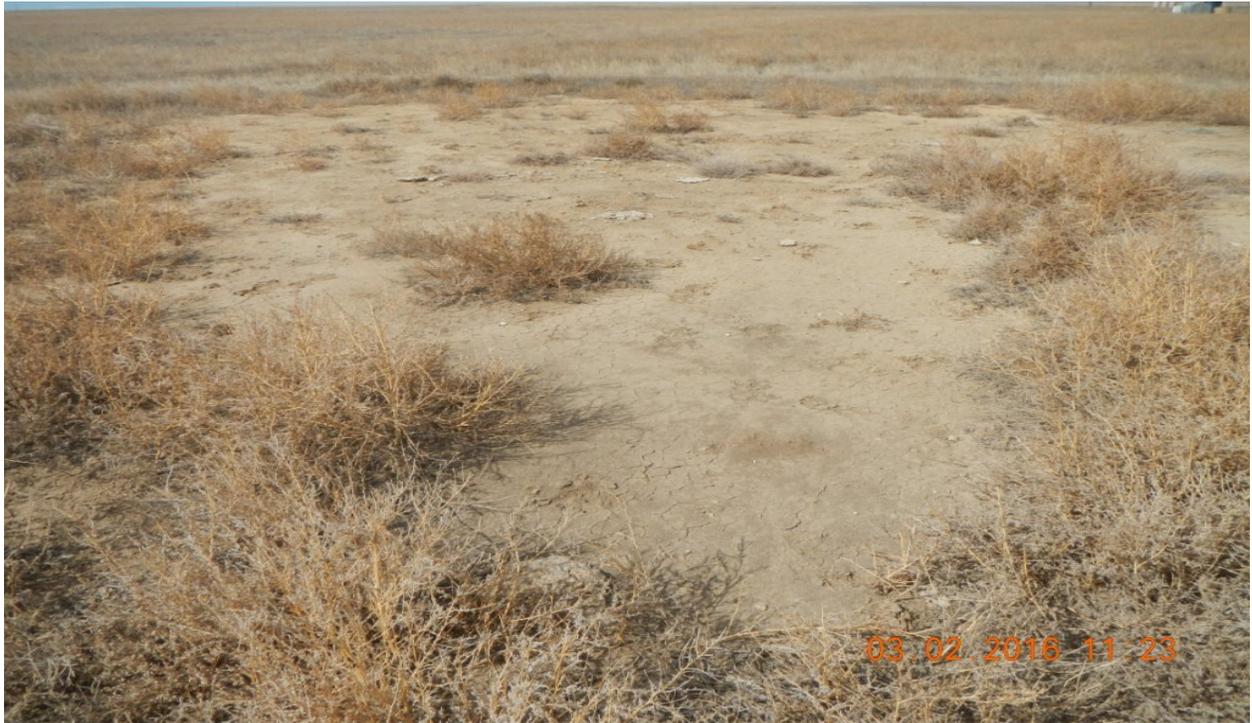
photo 7: Facing west toward the southwest side of the location. Vegetation has not established.

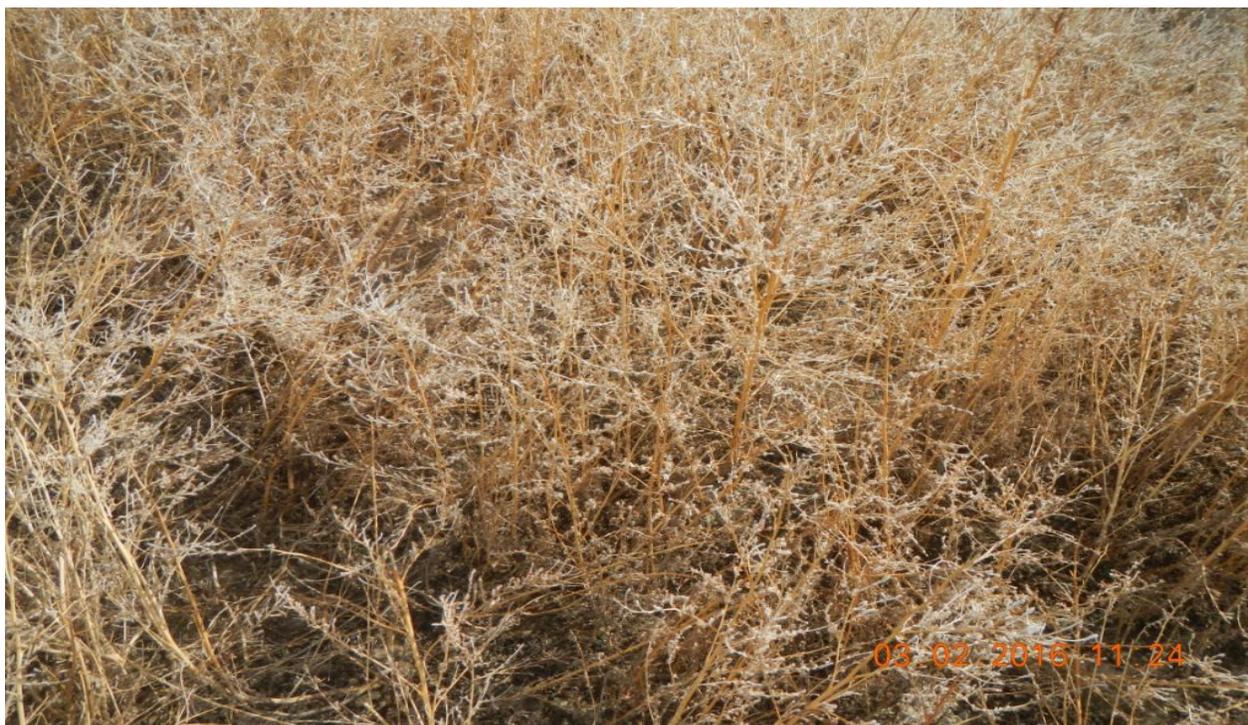
Photo 9: Weed debris was noticed throughout the location.
