**Bird State 32-1 Facility March 1, 2016 Environmental Inspection – S. Arauza**

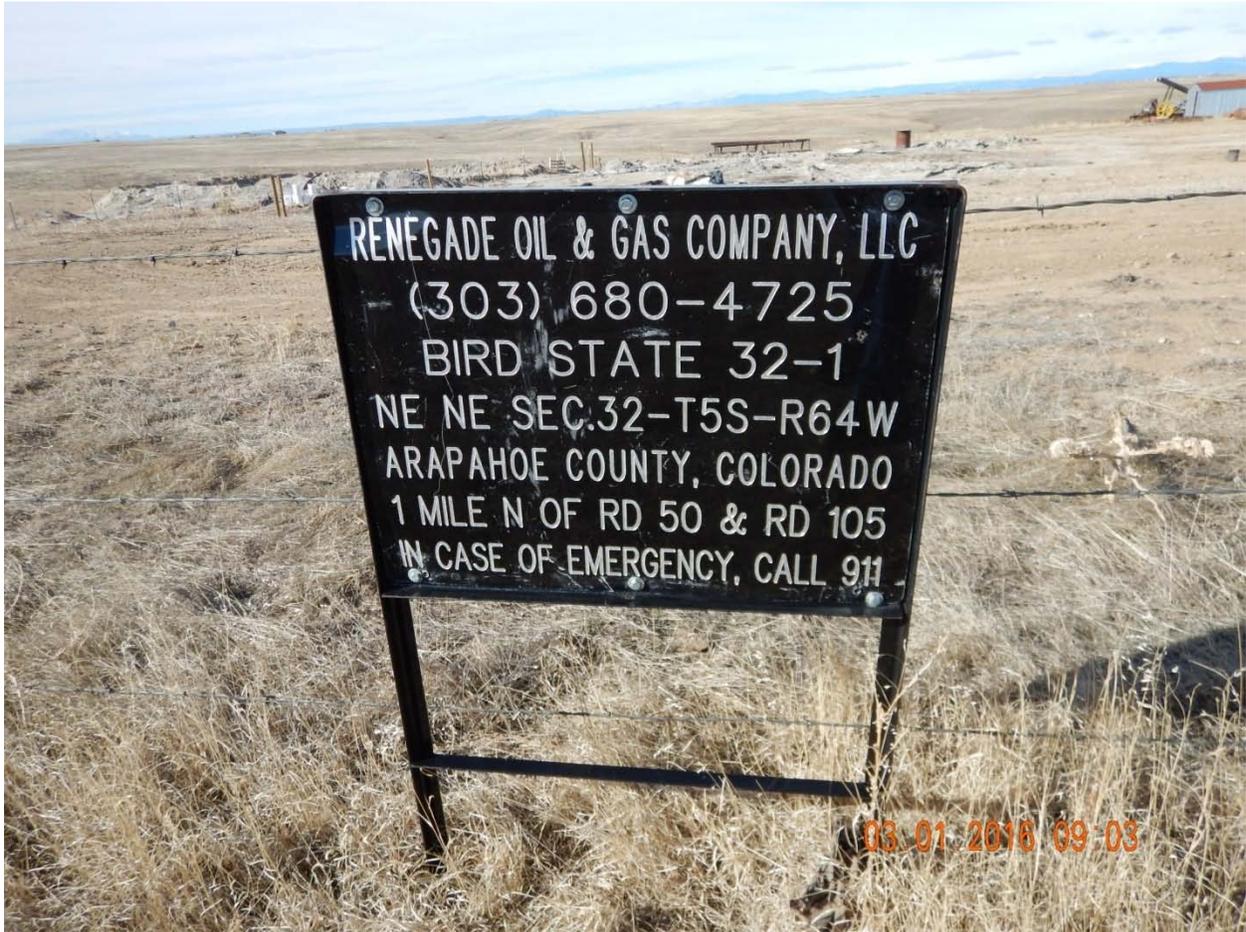
**Figure 1 - Well sign at entrance to location.**

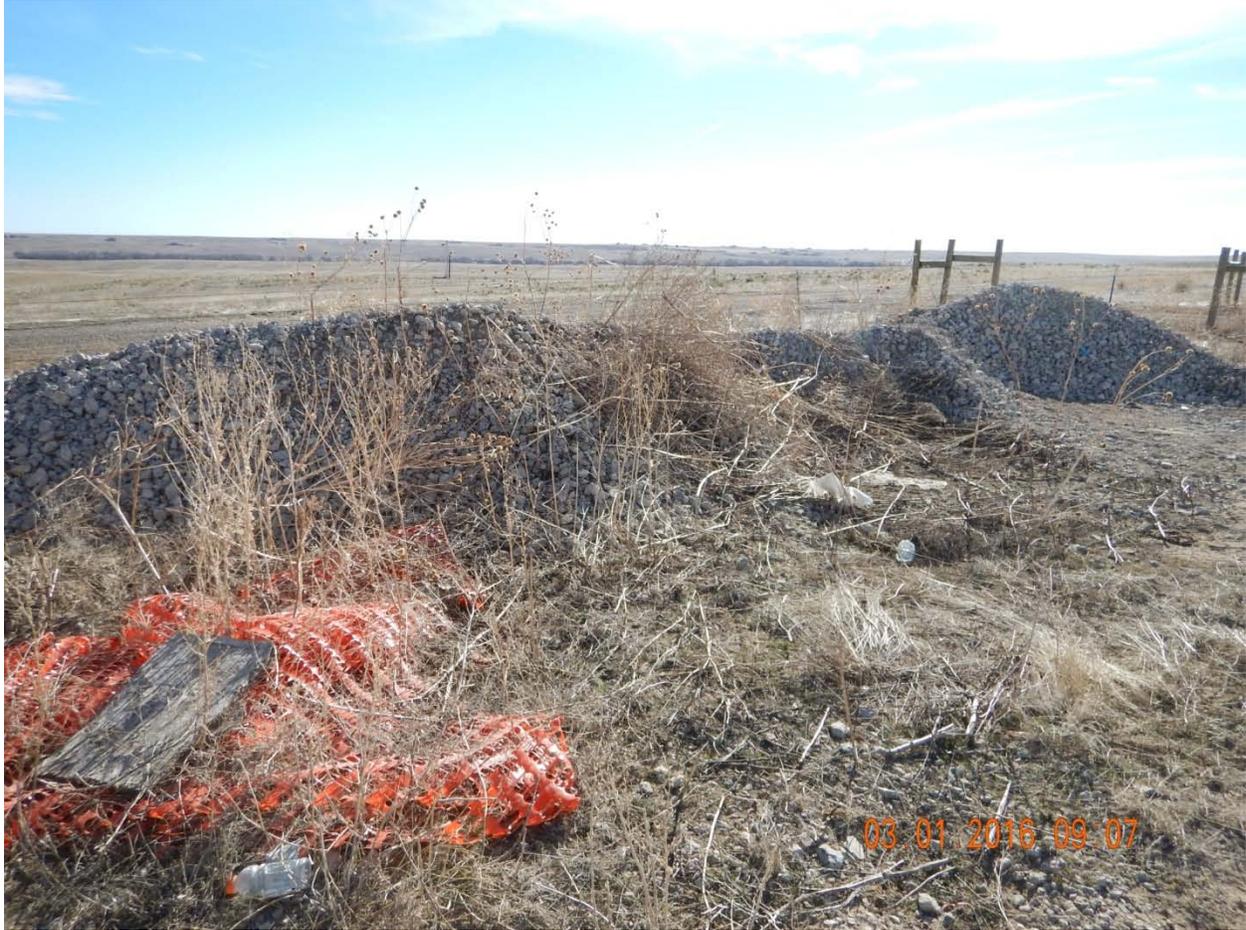
Figure 2 – Trash, weeds, and debris north of entrance to location.

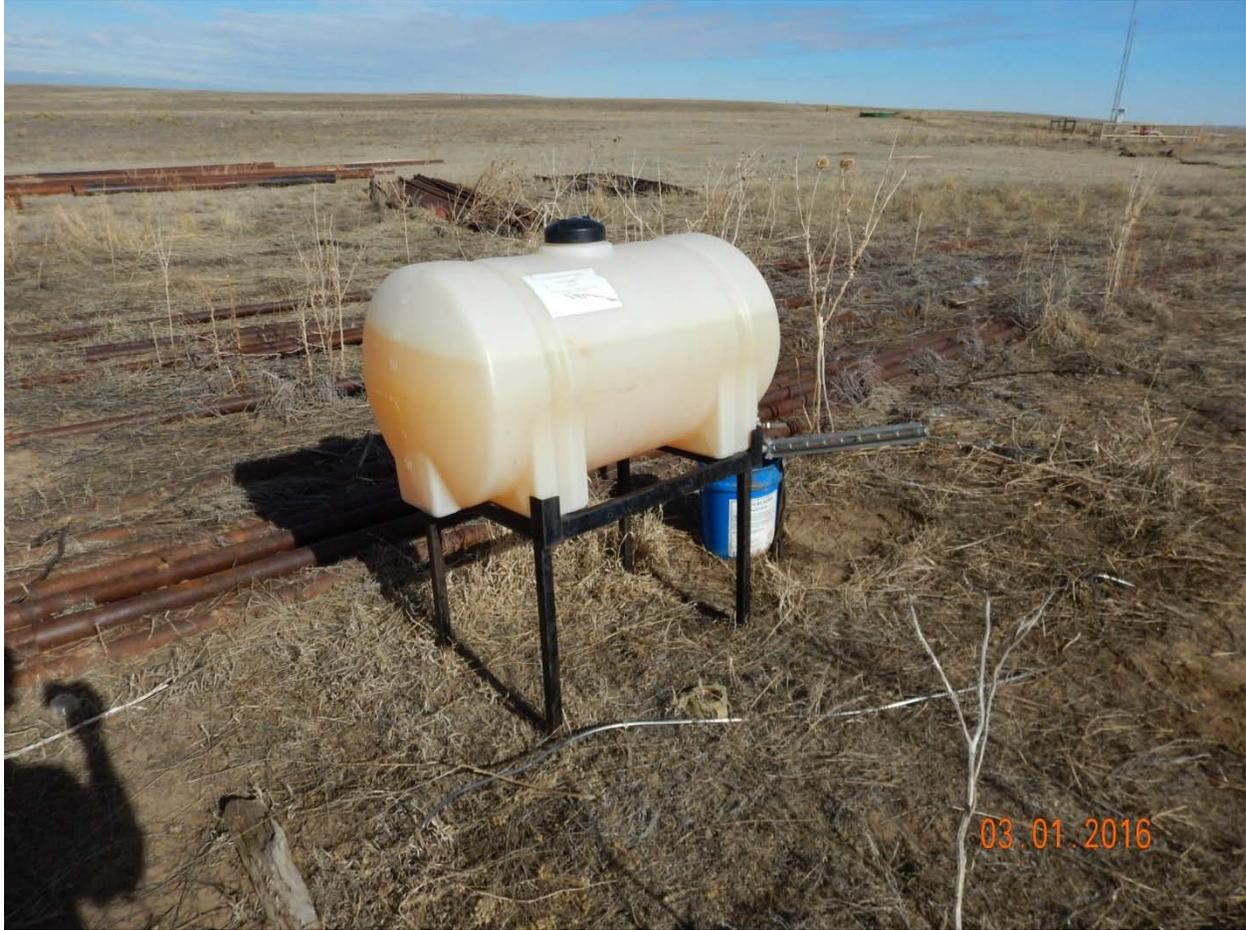
Figure 3 - Chemicals stored on-location lacking secondary containment.

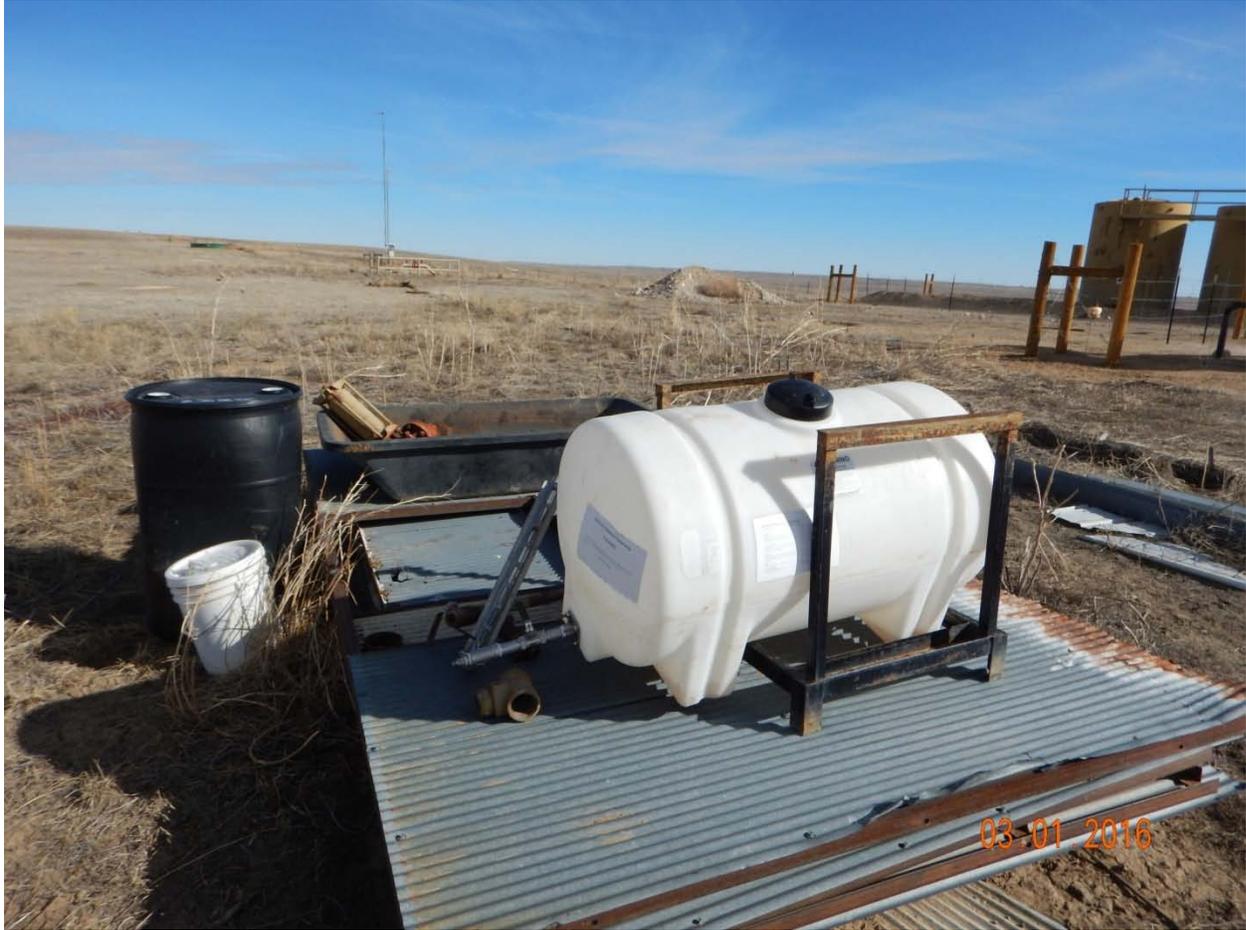
Figure 4 - Chemicals stored on-location (black 55 gallon drum and white 5 gallon bucket contained unknown material) lacking secondary containment

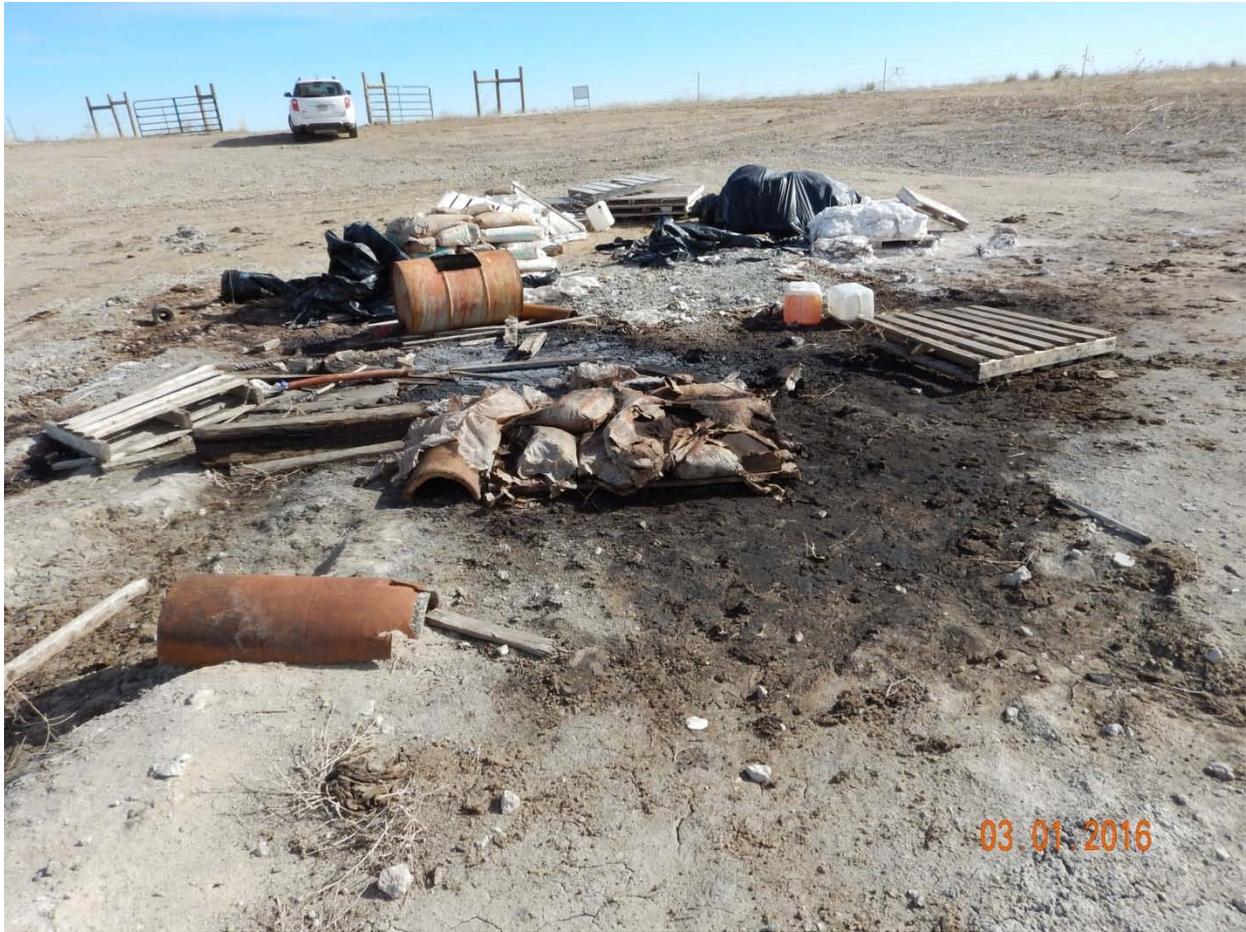
Figure 5 – Burn area with trash, debris, and unused chemicals northeast of unpermitted pit.

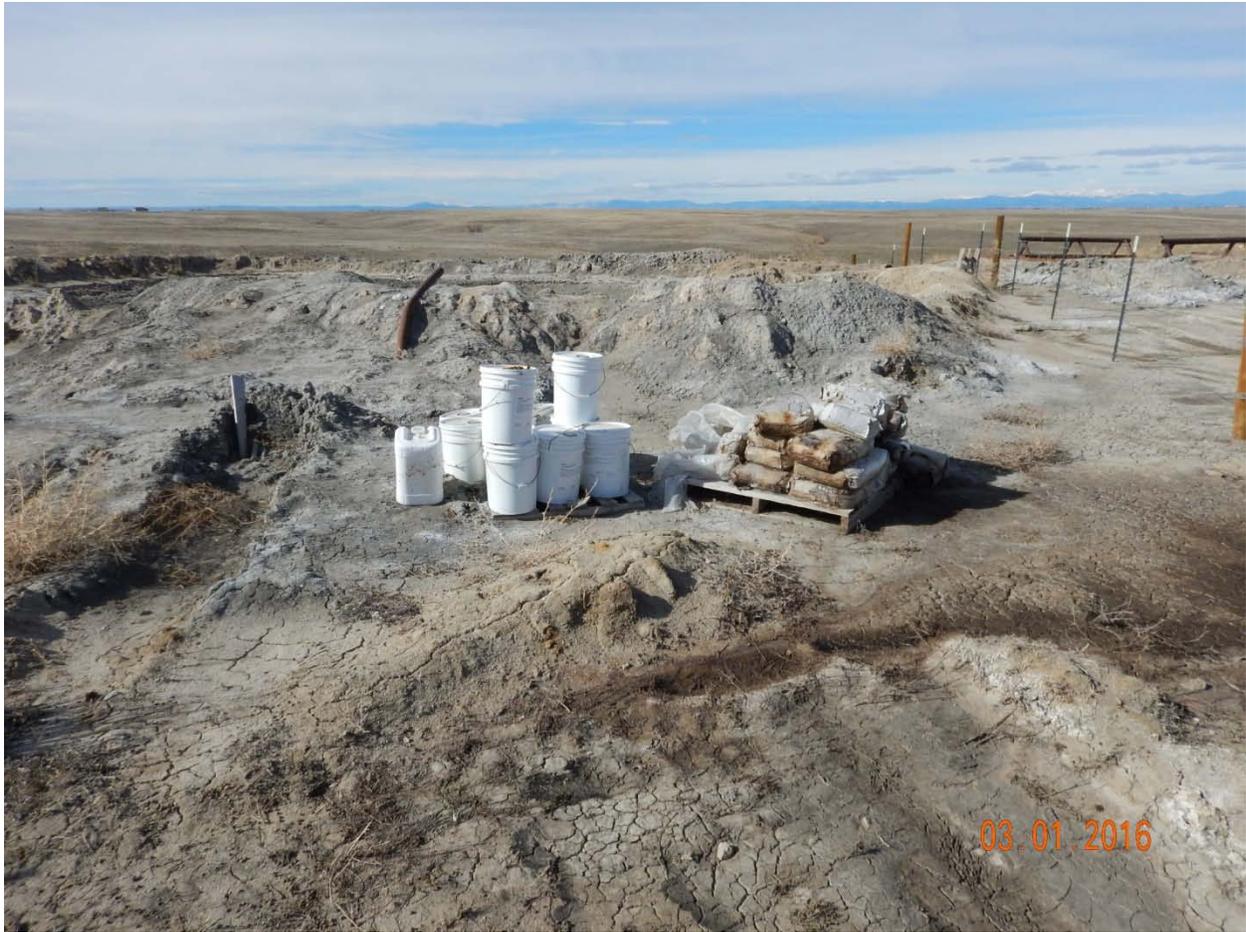
Figure 6 - Unused dry chemicals at northeast corner of fenced-in pit area. Note stained soil in foreground leads to puddle just north of fenced-in pit area.

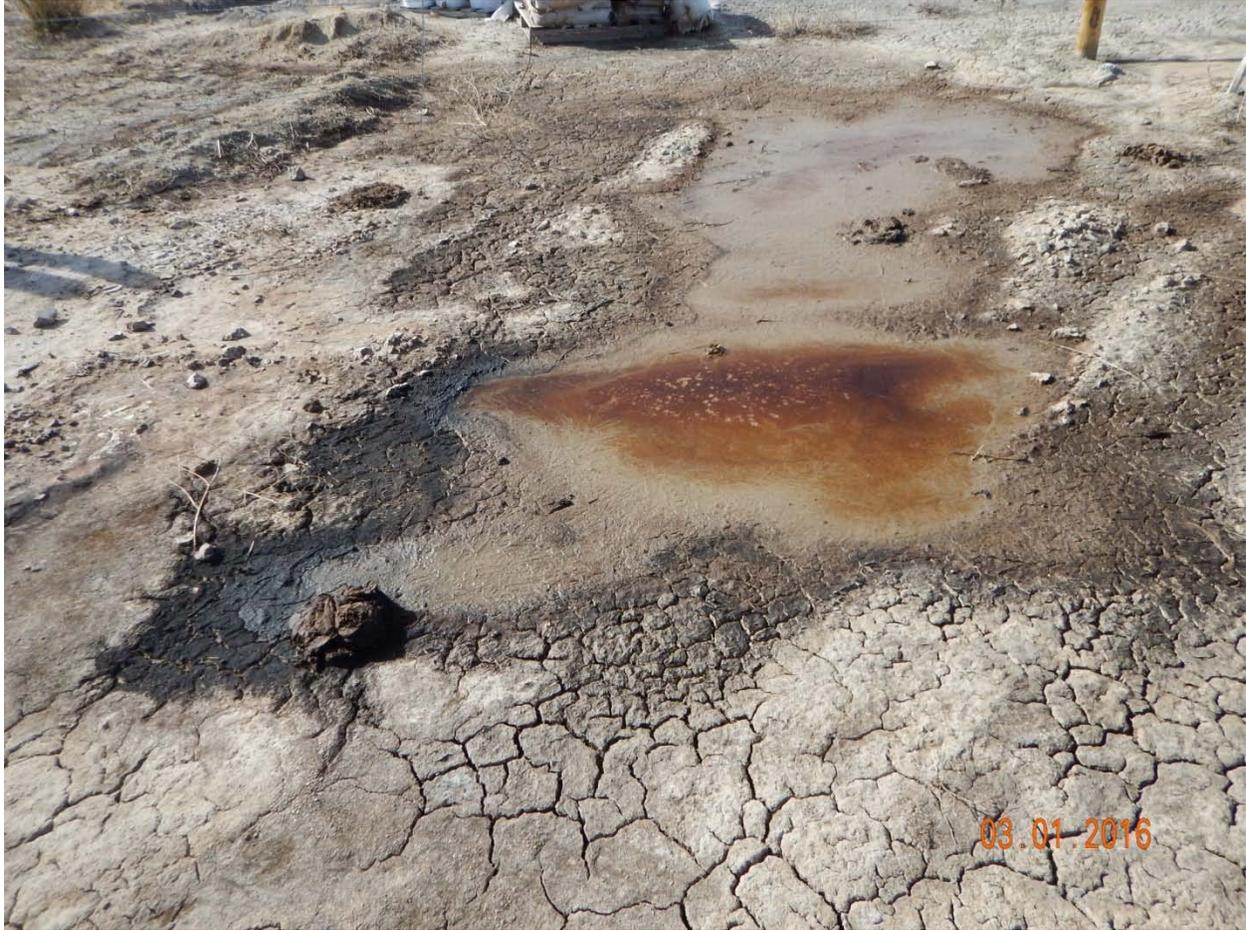
Figure 7 – Free fluid and oily waste north of pit area.

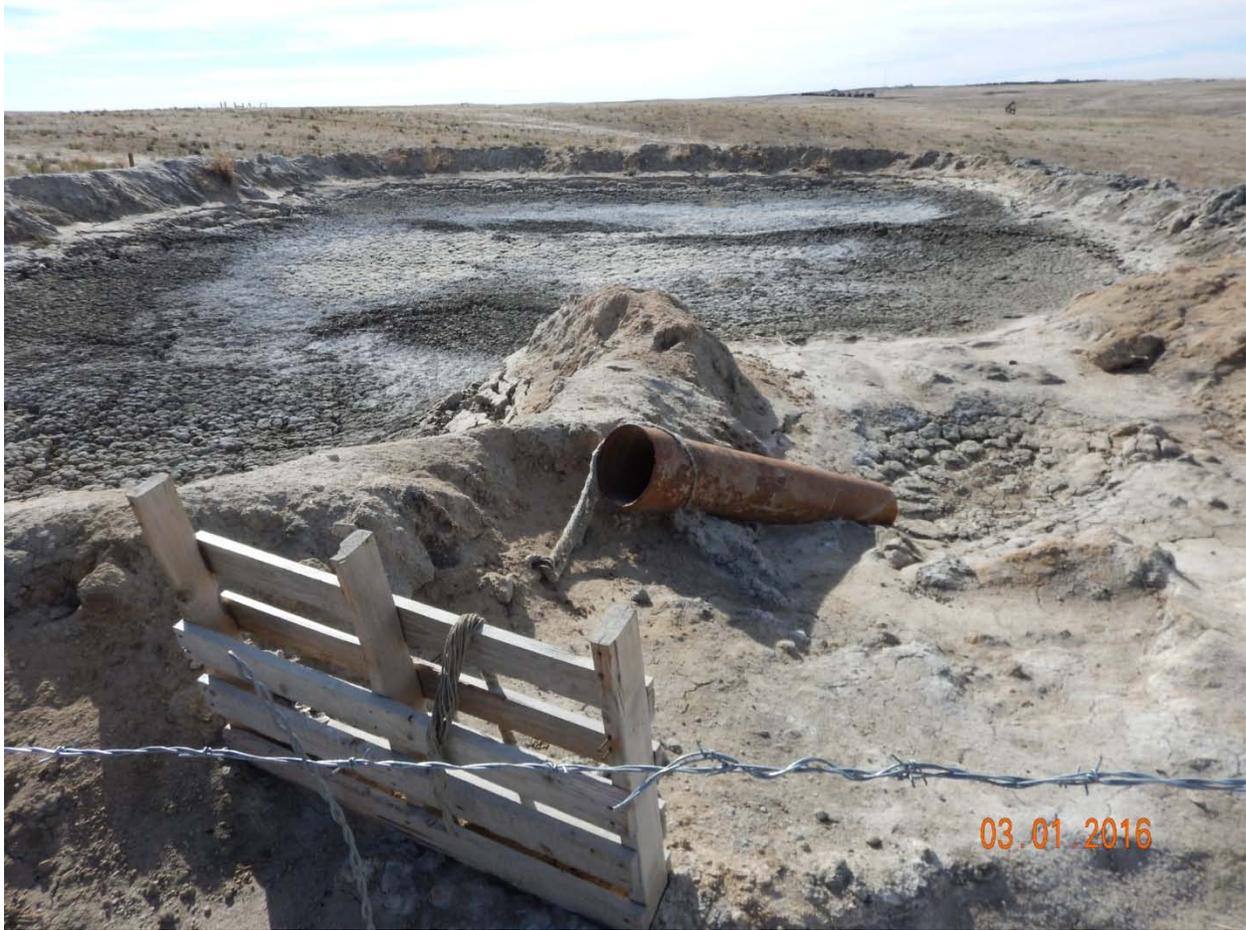
Figure 8 - View of unpermitted pit from the north, pit measured approximately 50'x50' and contained E&P waste. Southeast corner located at 39.577958 N, 104.568864 W.

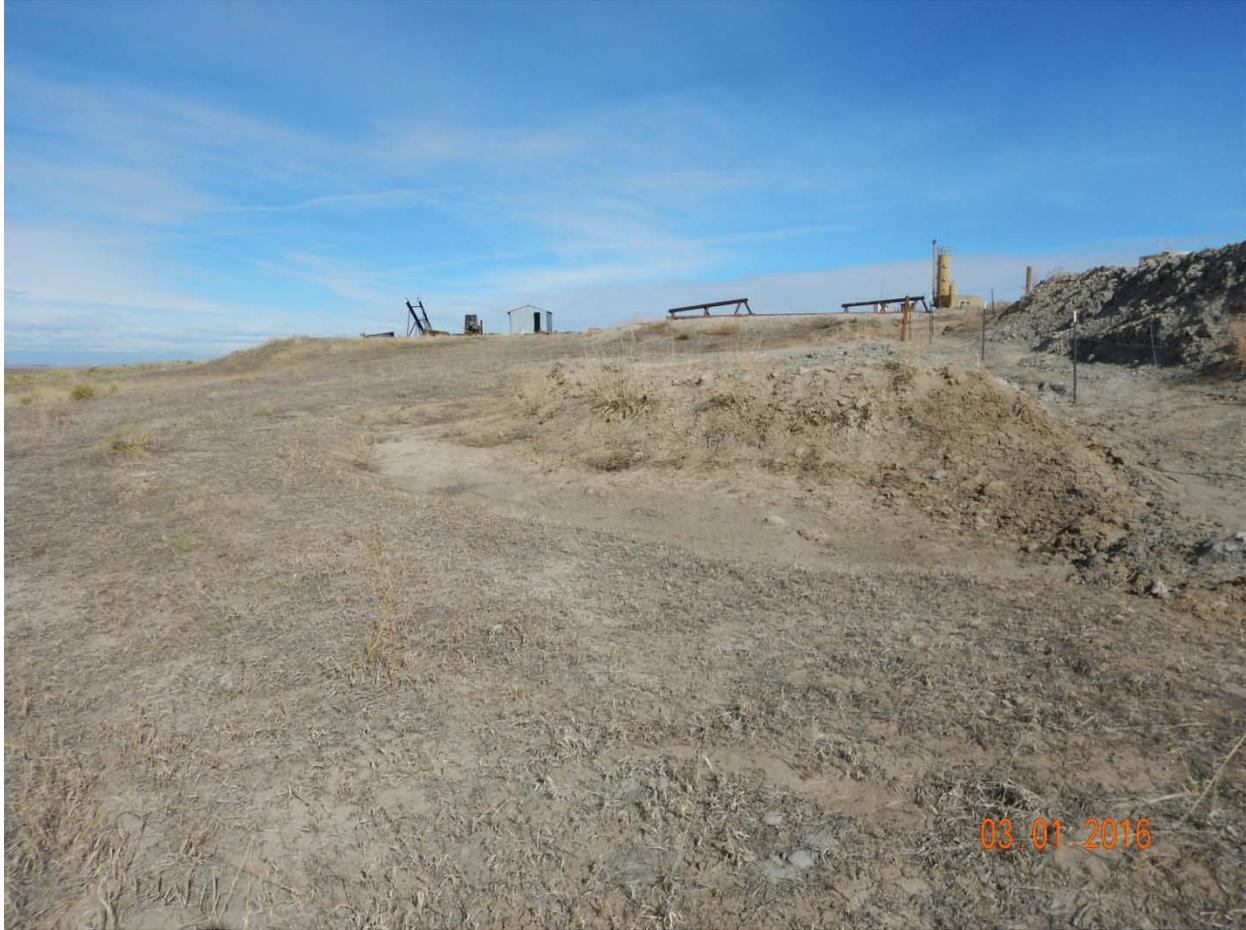
Figure 9 – Looking north at berm located at southwest corner of pit (visible in 10/6/2014 aerial photograph below).

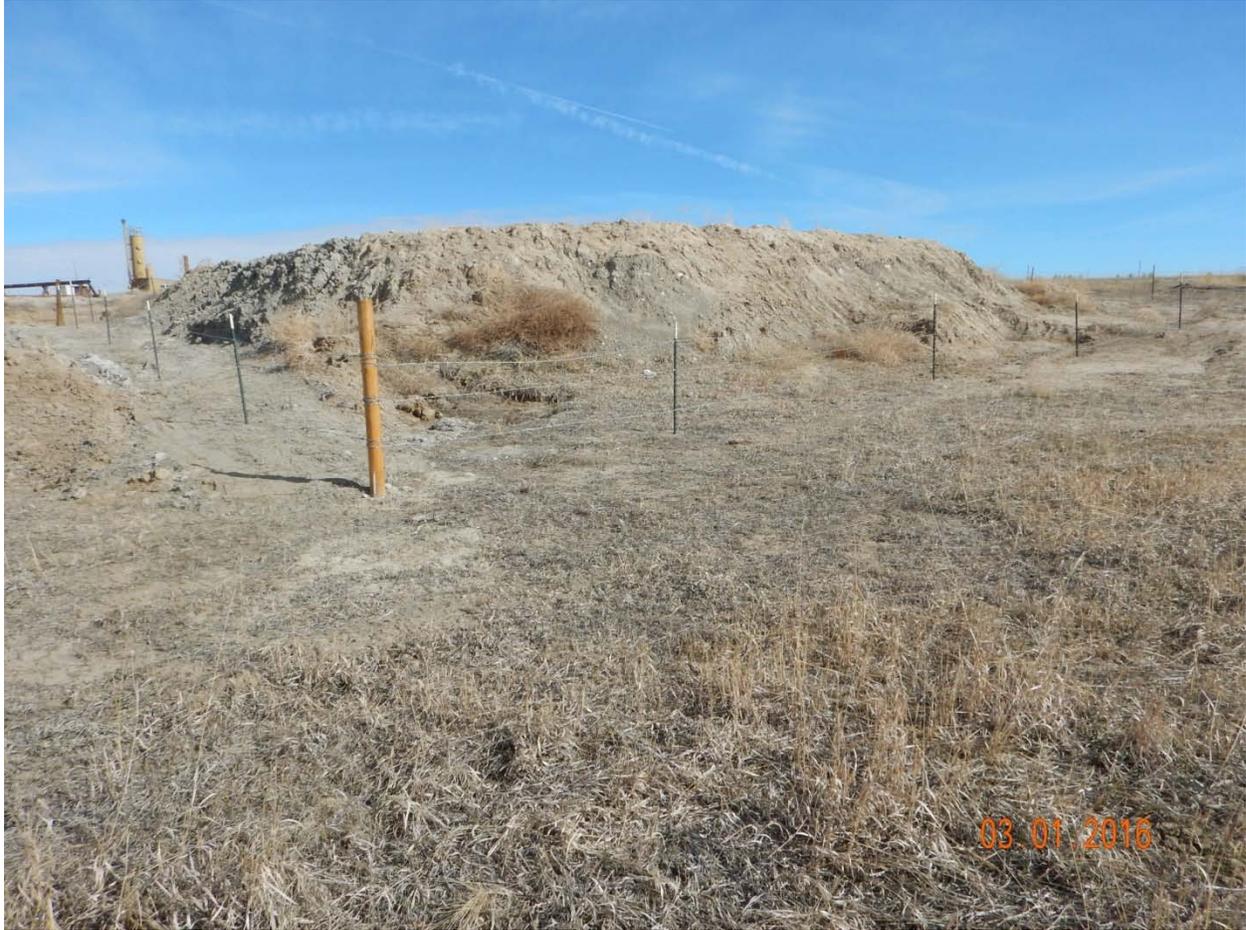
Figure 10 - View of southwest corner of the pit. Note sediment runoff and stressed vegetation outside of fenced-in area at southeast and southwest corners.

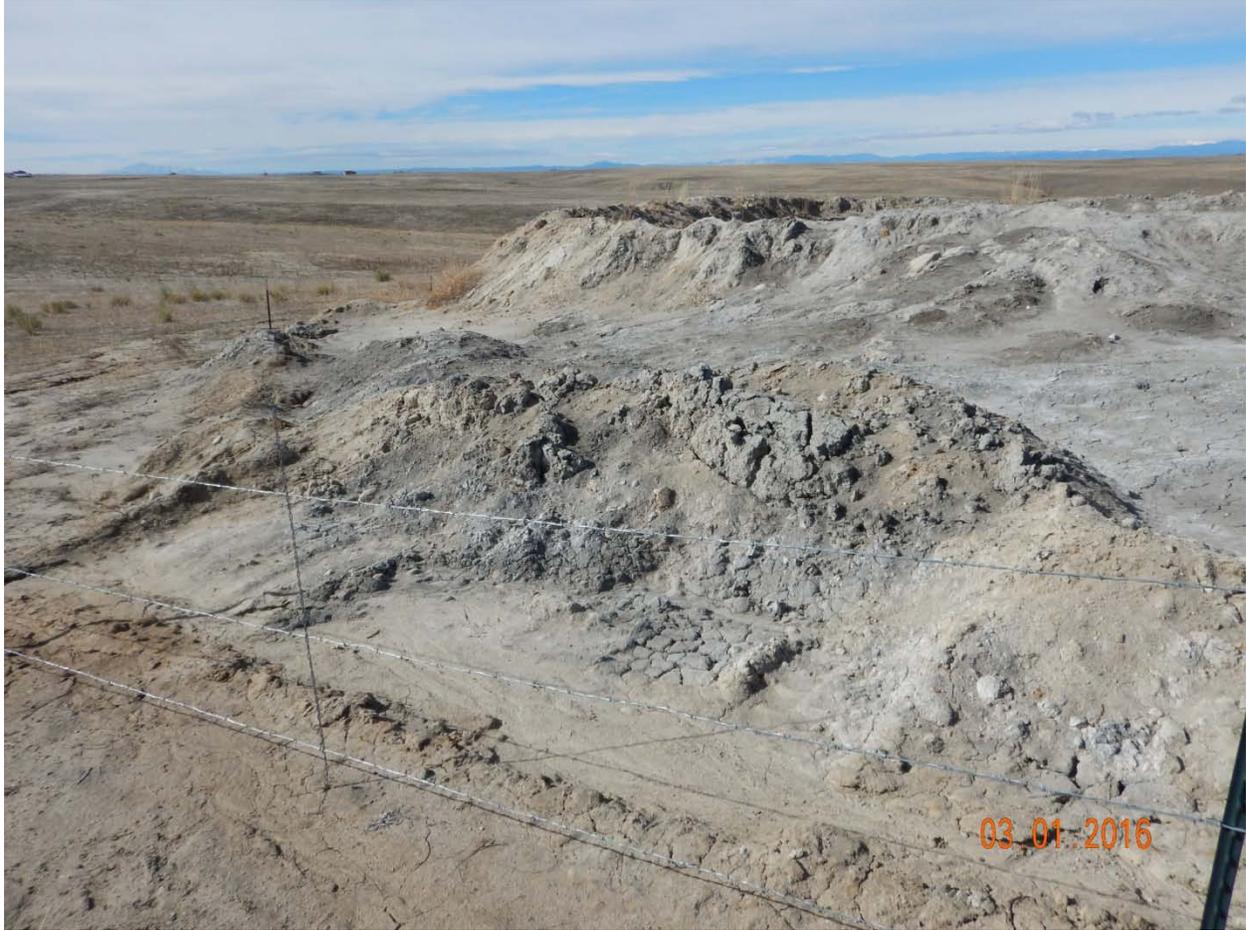
Figure 11 - View of pit from northeast corner.

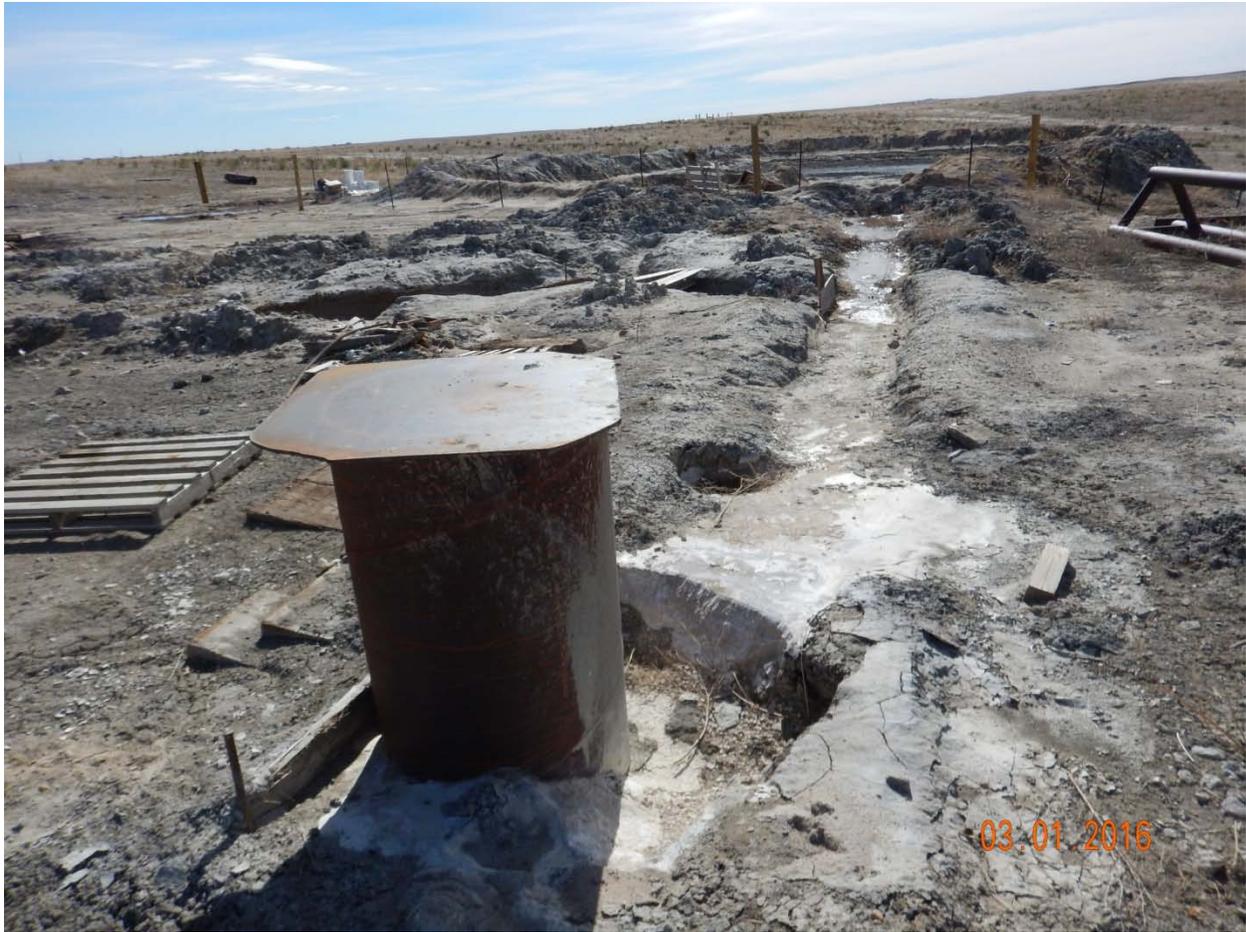
Figure 12 - Abandoned wellhead with ~2'x50' ditch leading to pit.

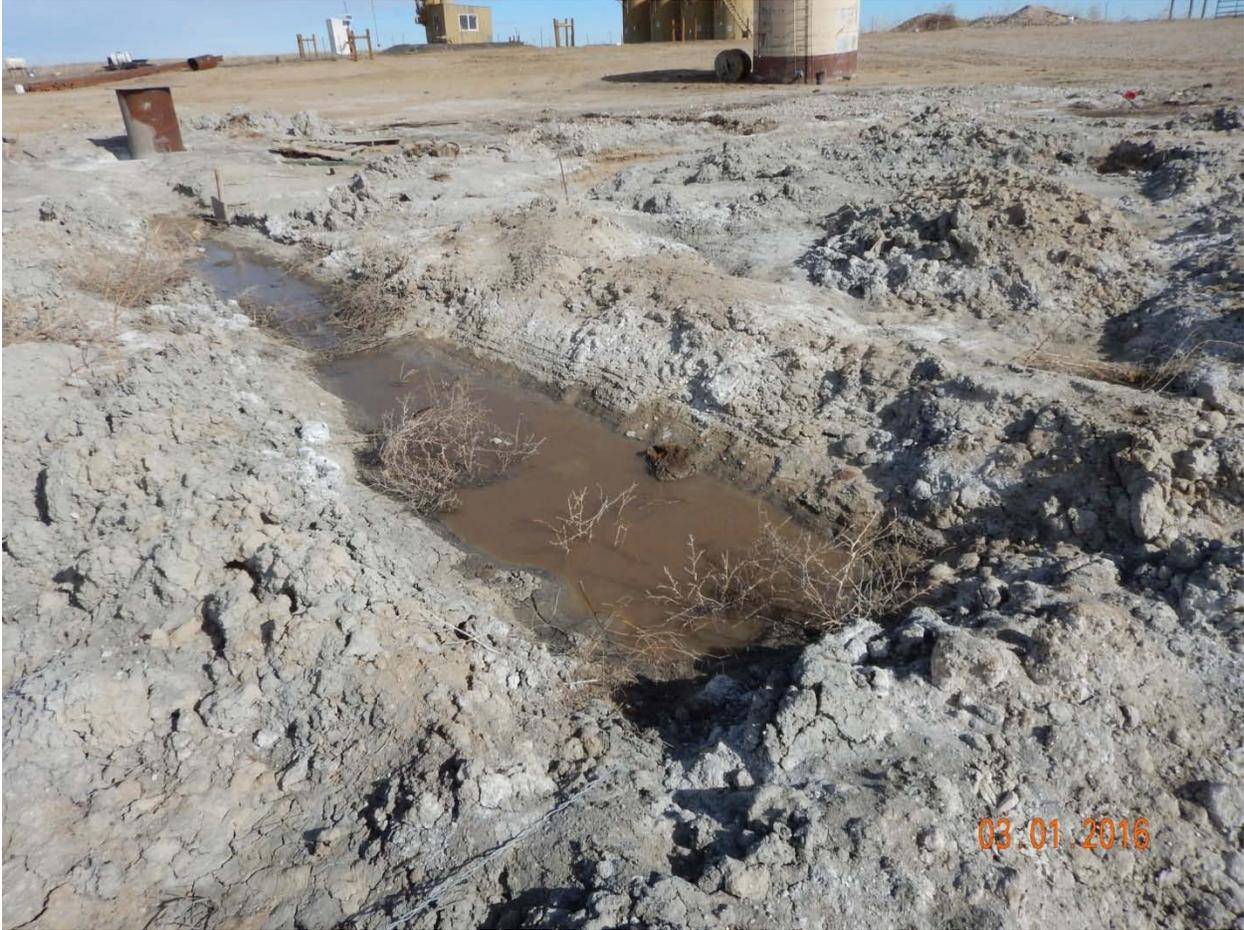
Figure 13 - View of ditch leading from abandoned wellhead to pit. Note presence of water and vegetation.
