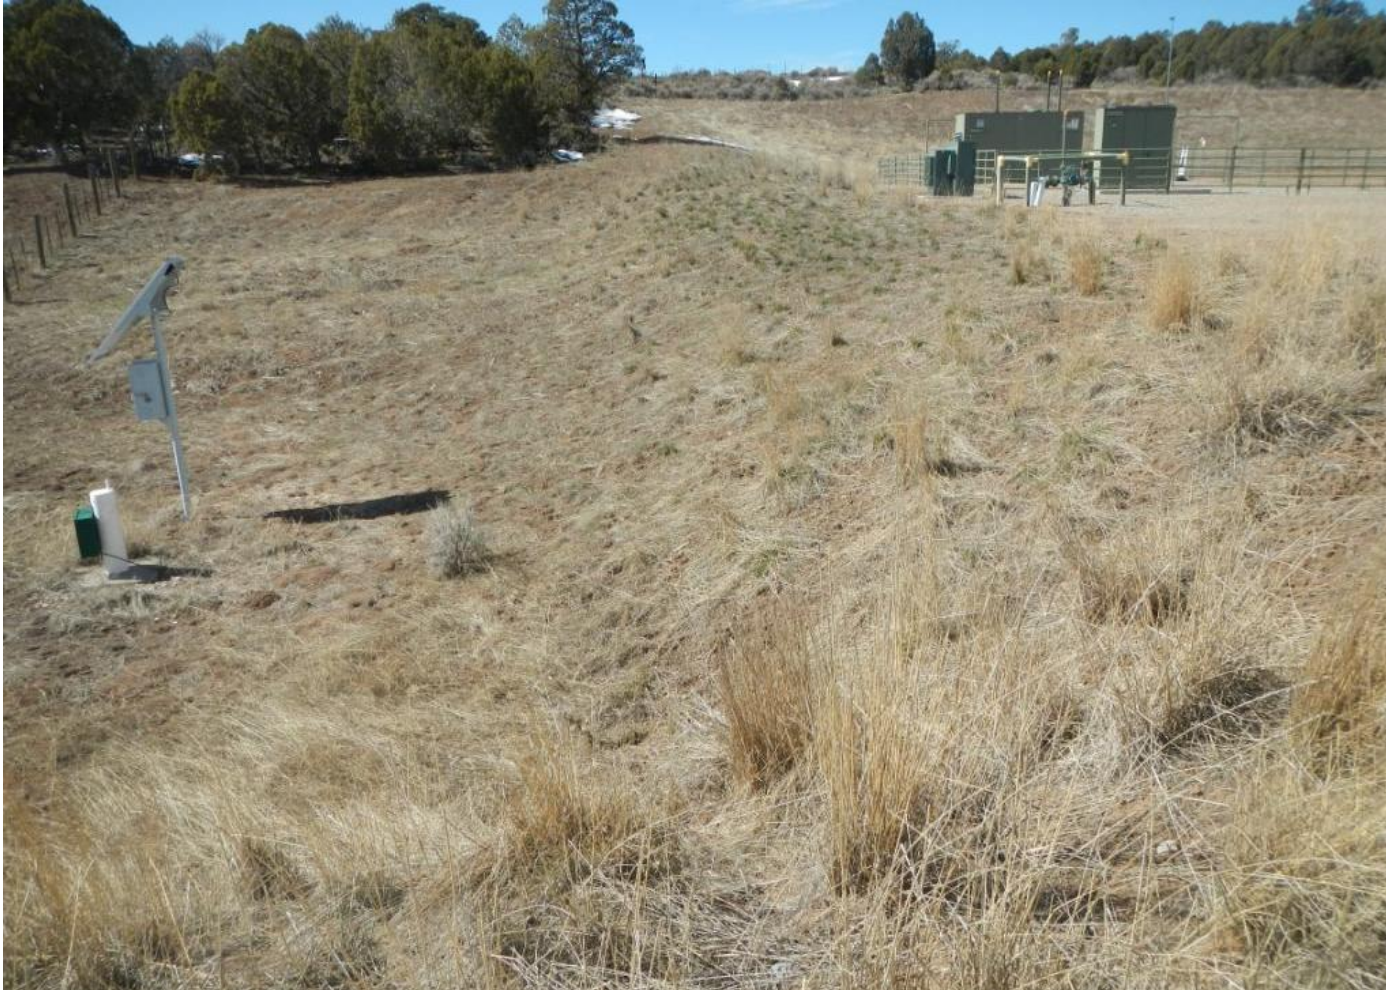
Photo 1. View of the western portion of the project area from the southwestern corner facing northward. Location is revegetating with grasses such as smooth brome (*Bromus inermis*), sand dropseed (*Sporobolus* sp.), and intermediate wheatgrass (*Thinopyron intermedium*).

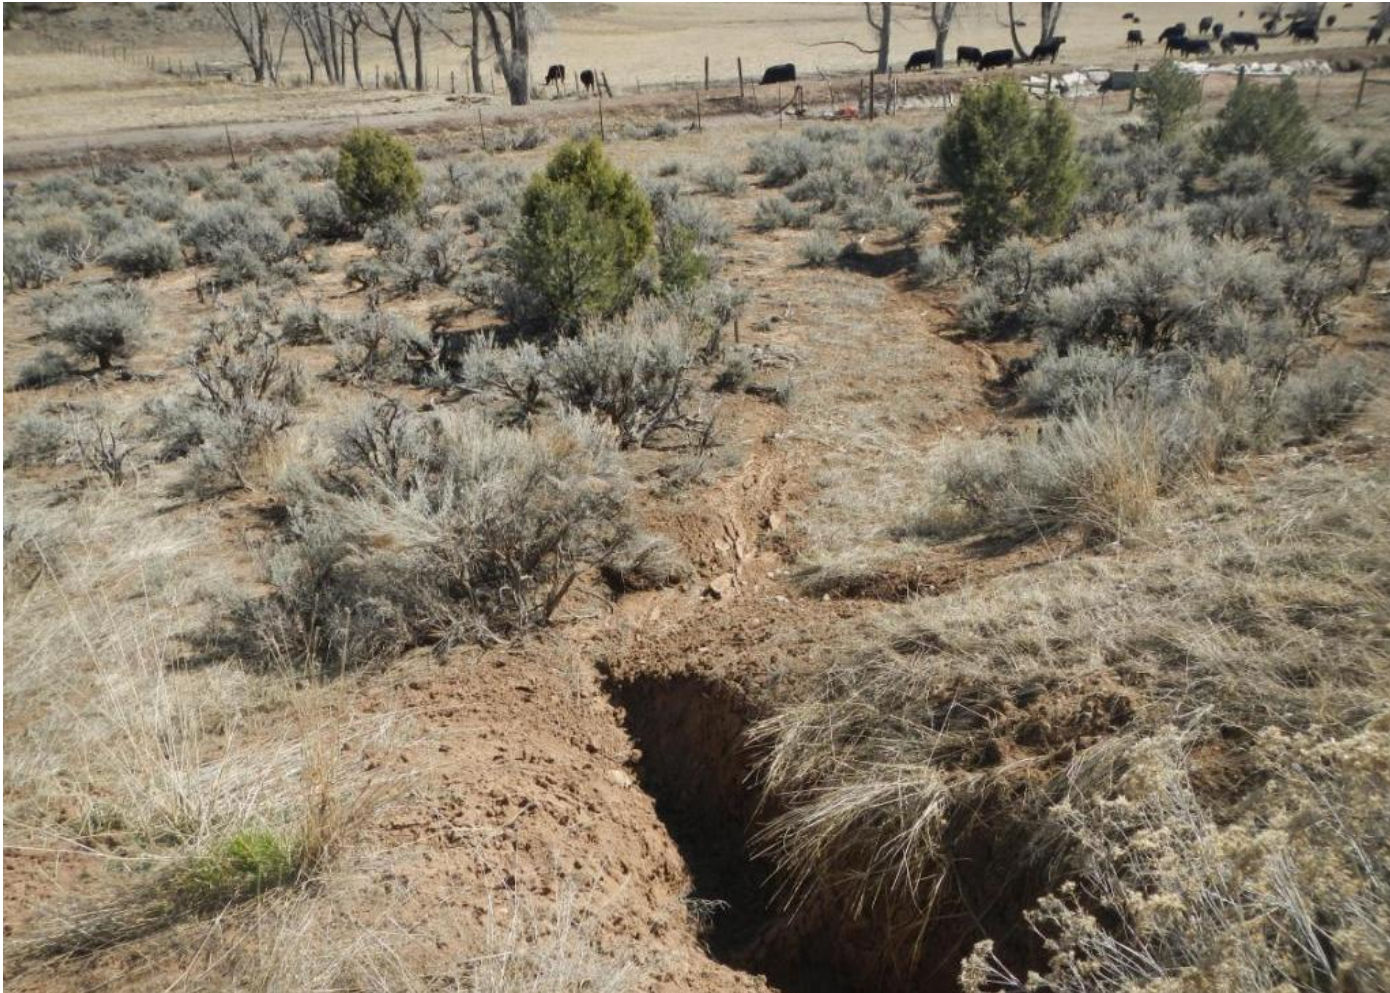
Photo 2. View of erosional channel approximately 6 feet deep and 3 feet wide in the eastern portion of the project area.

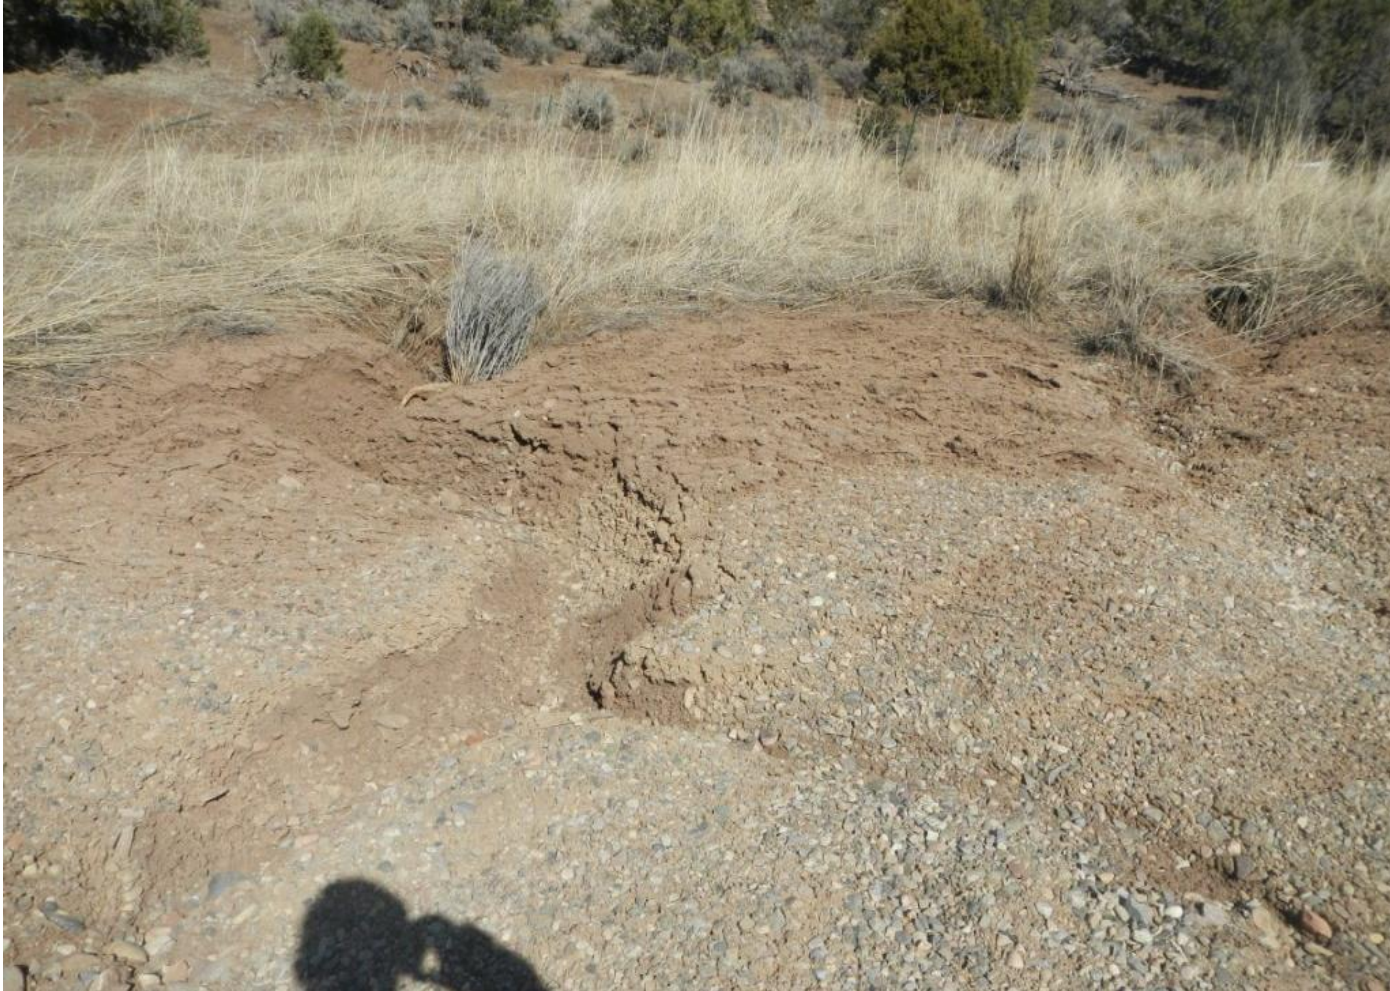
Photo 3. Stormwater erosional channel in the northeastern portion of the project area.

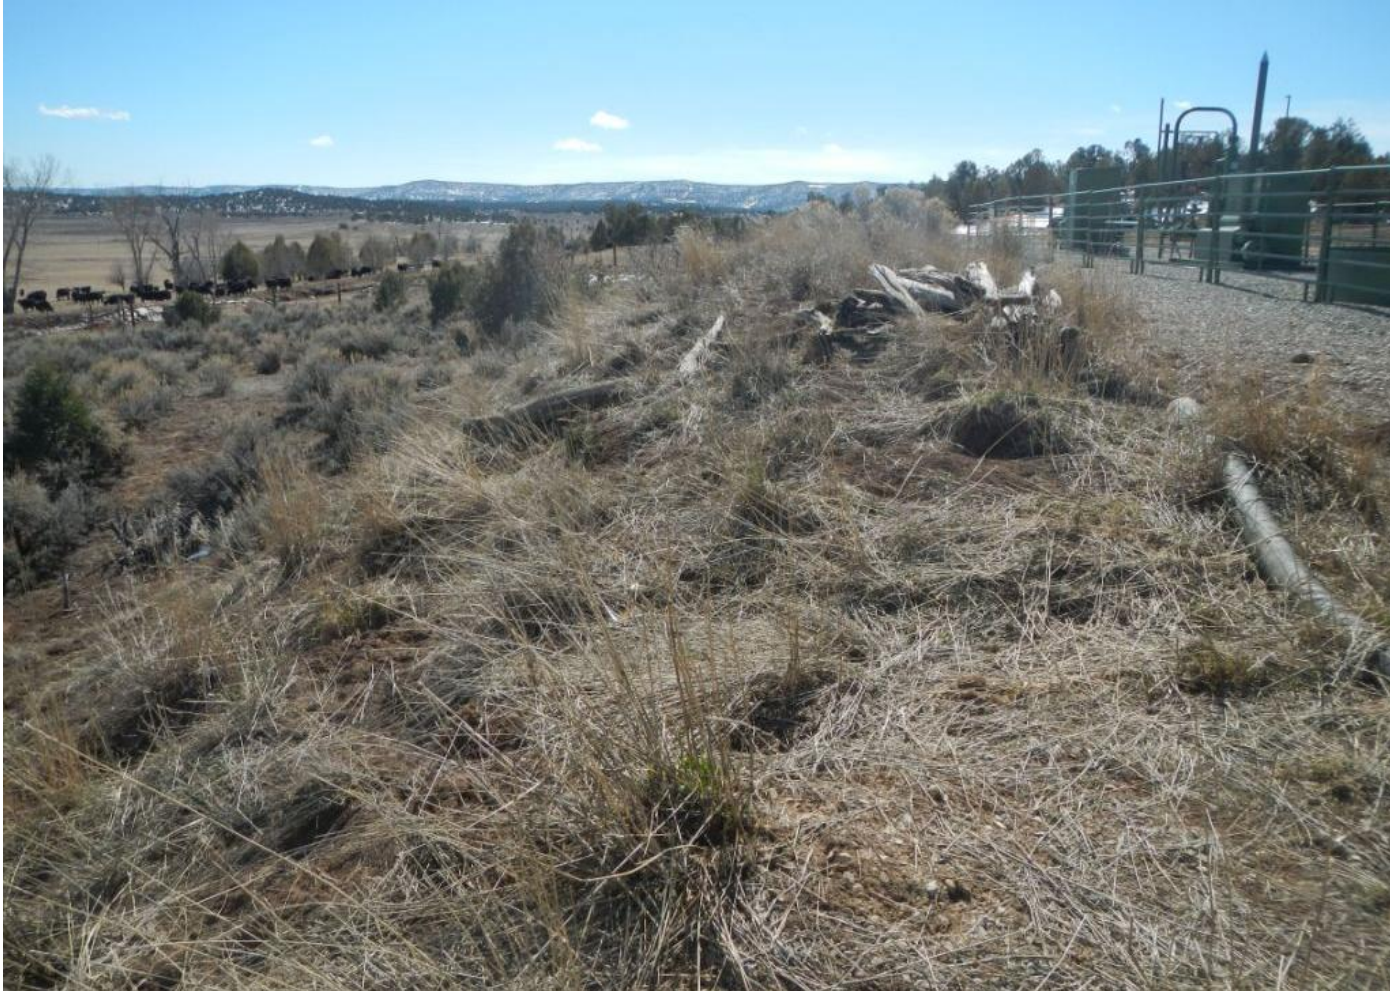
Photo 4. View of eastern portion of the project area from the northeastern corner facing southward.

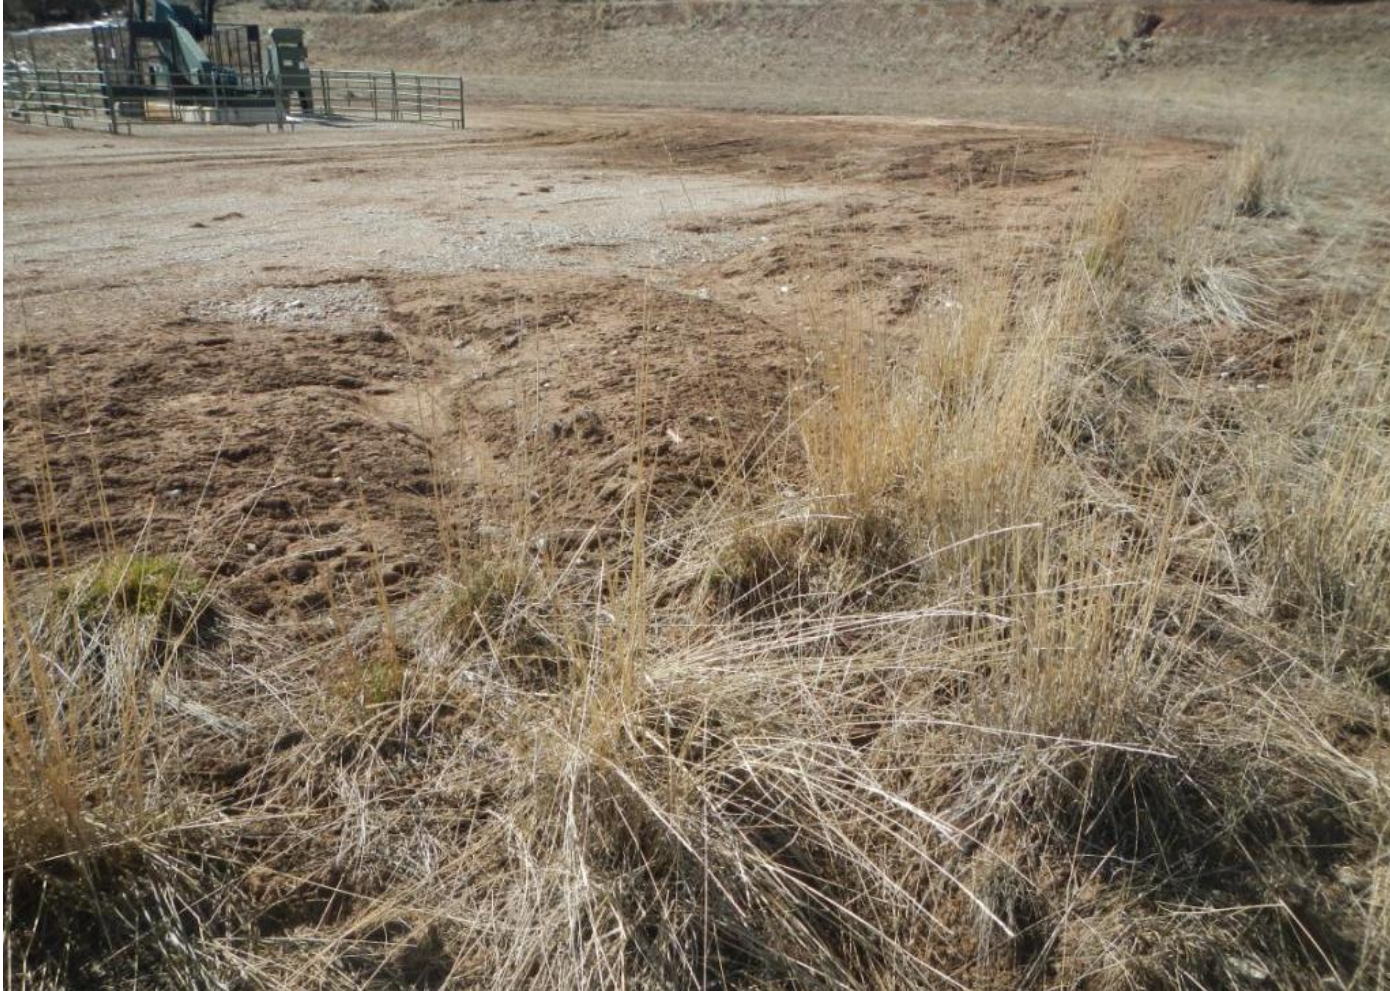
Photo 5. View of area along the northern edge of the well pad where concentrated stormwater flows appear to be exiting the well pad and eroding down the slope.

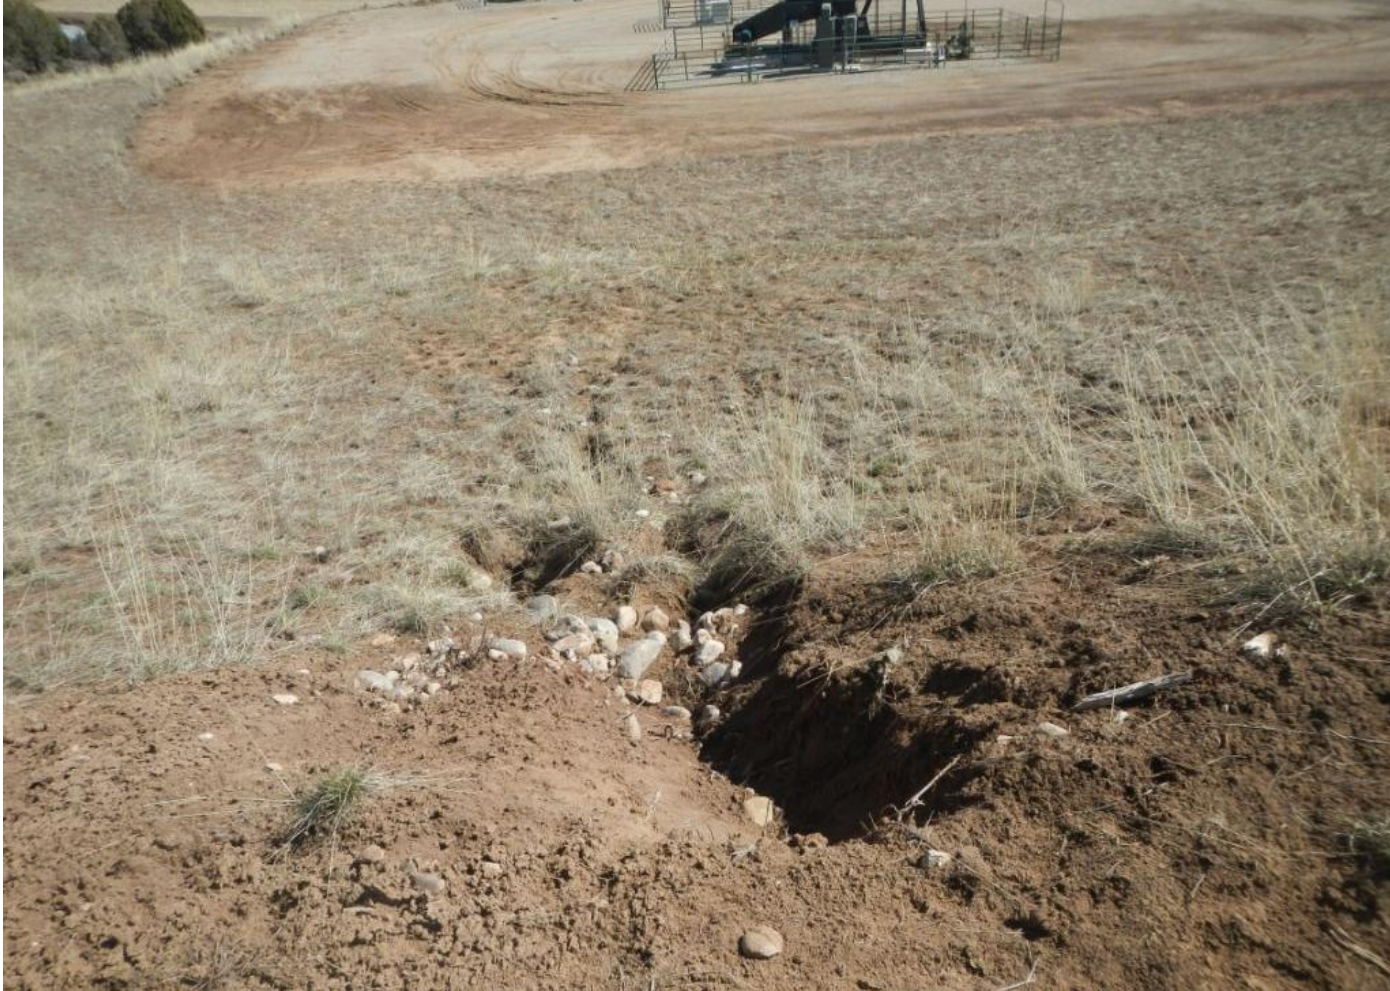
Photo 6. View of stormwater erosion in the western portion of the project area where it appears stormwater flows have breached a sedimented-in diversion channel and are eroding down-slope.

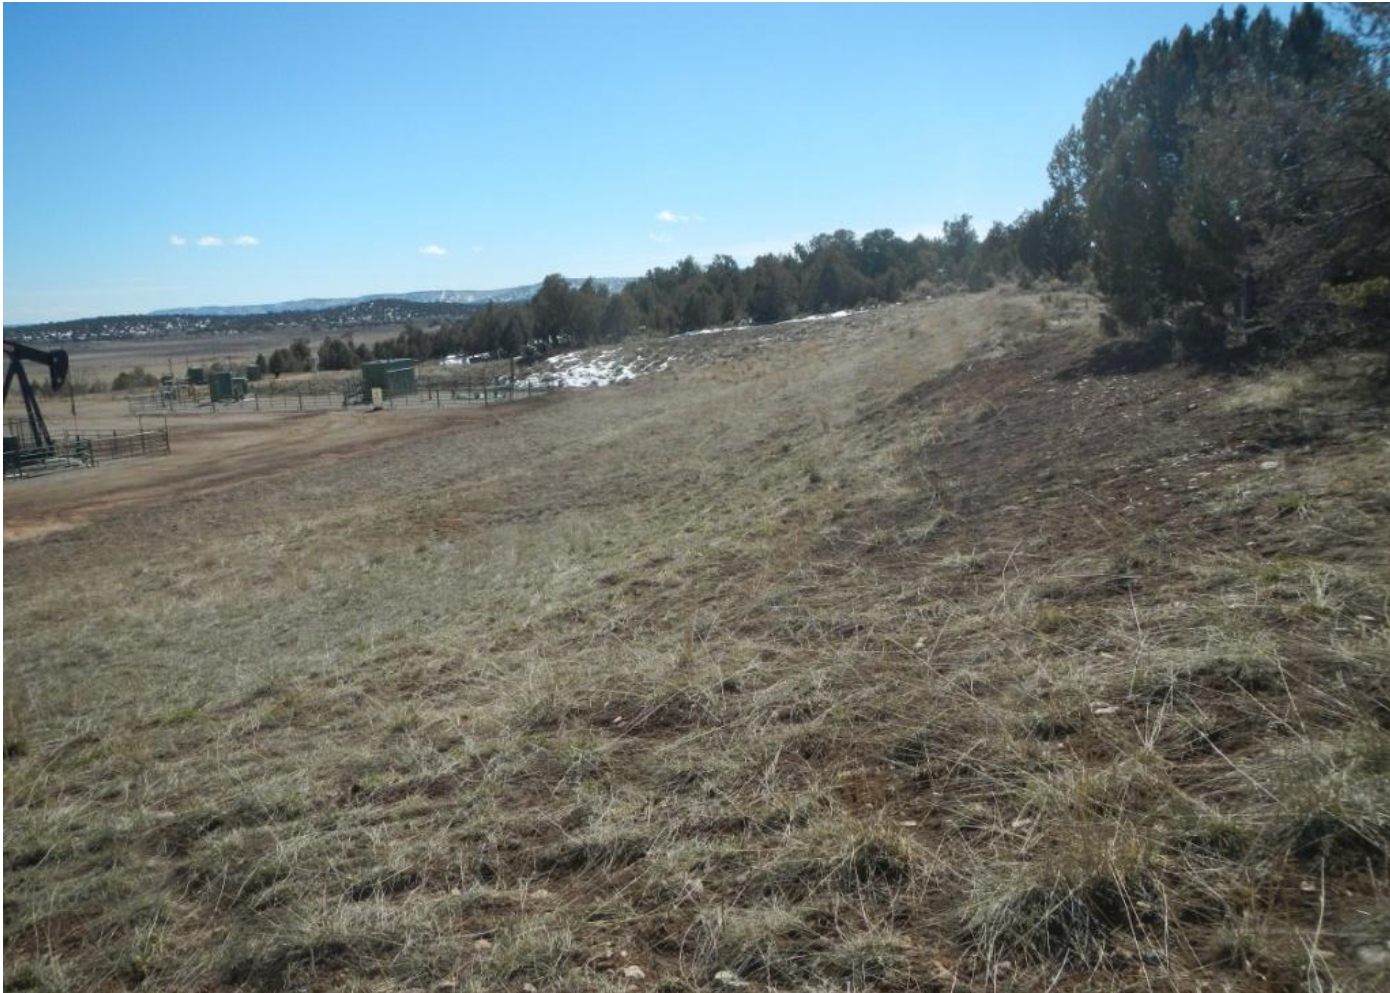
Photo 7. View of the western portion of the project area from the northwestern corner facing southward.

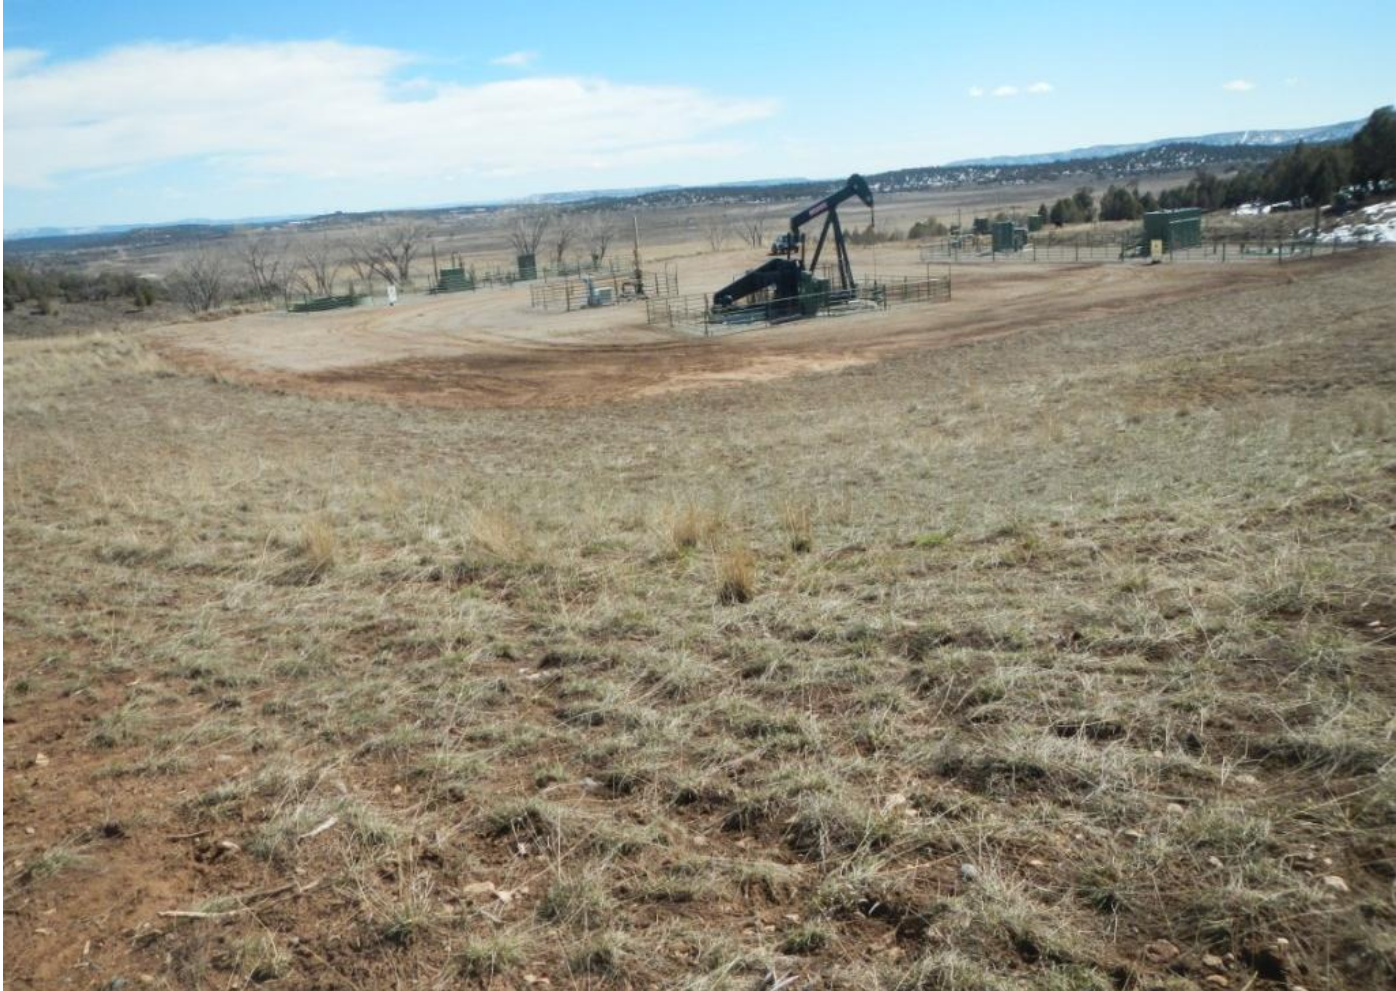
Photo 8. View of the Project area from the northwestern corner facing center.

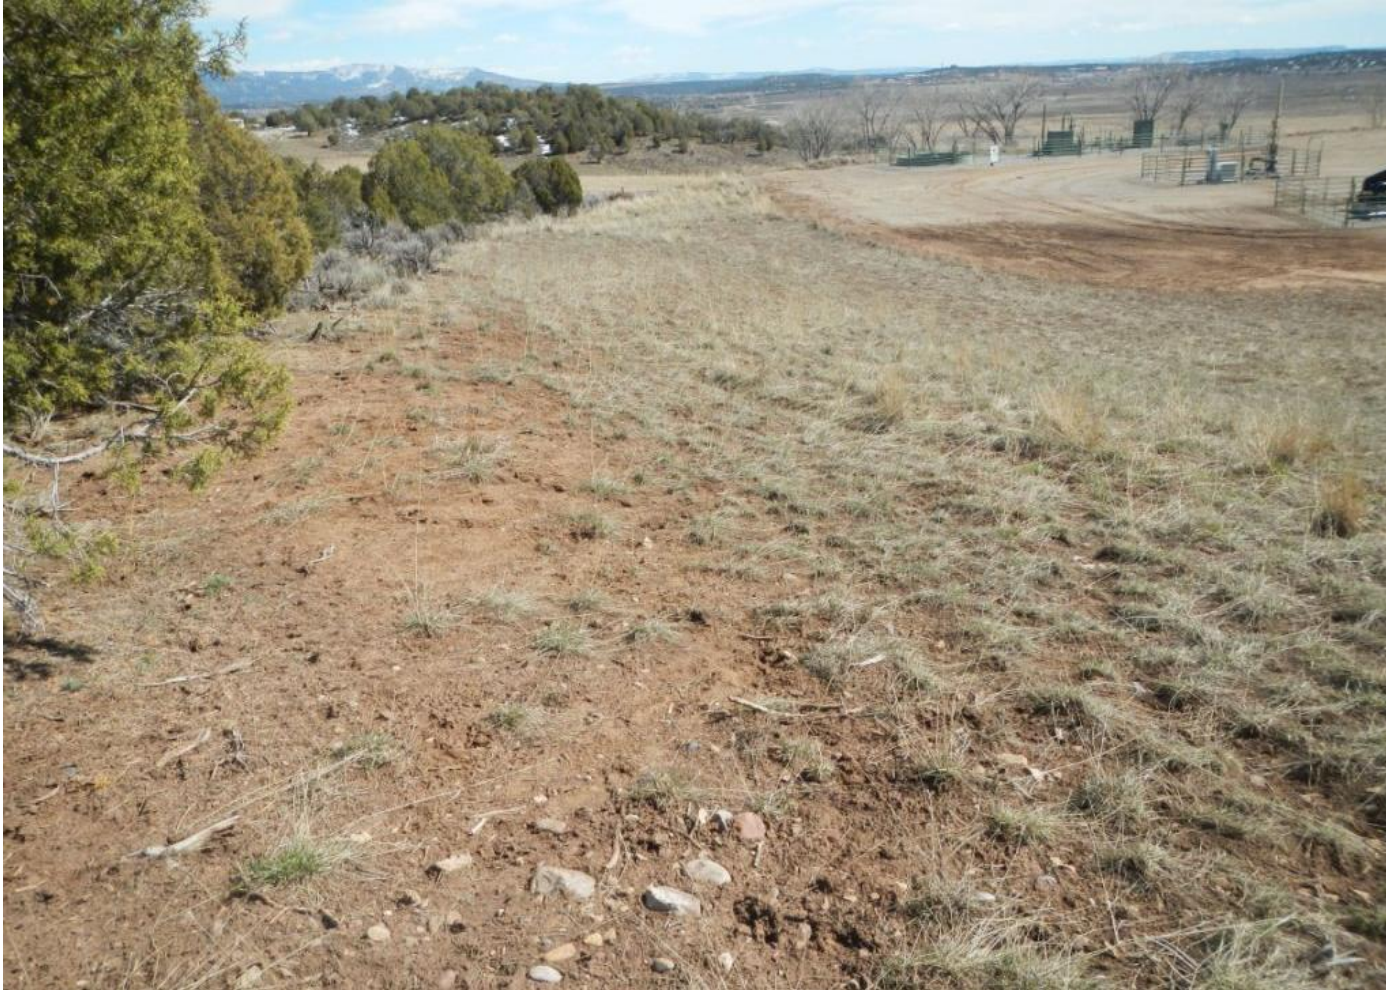
Photo 9. View of the northern portion of the project area from the northwestern corner facing eastward.

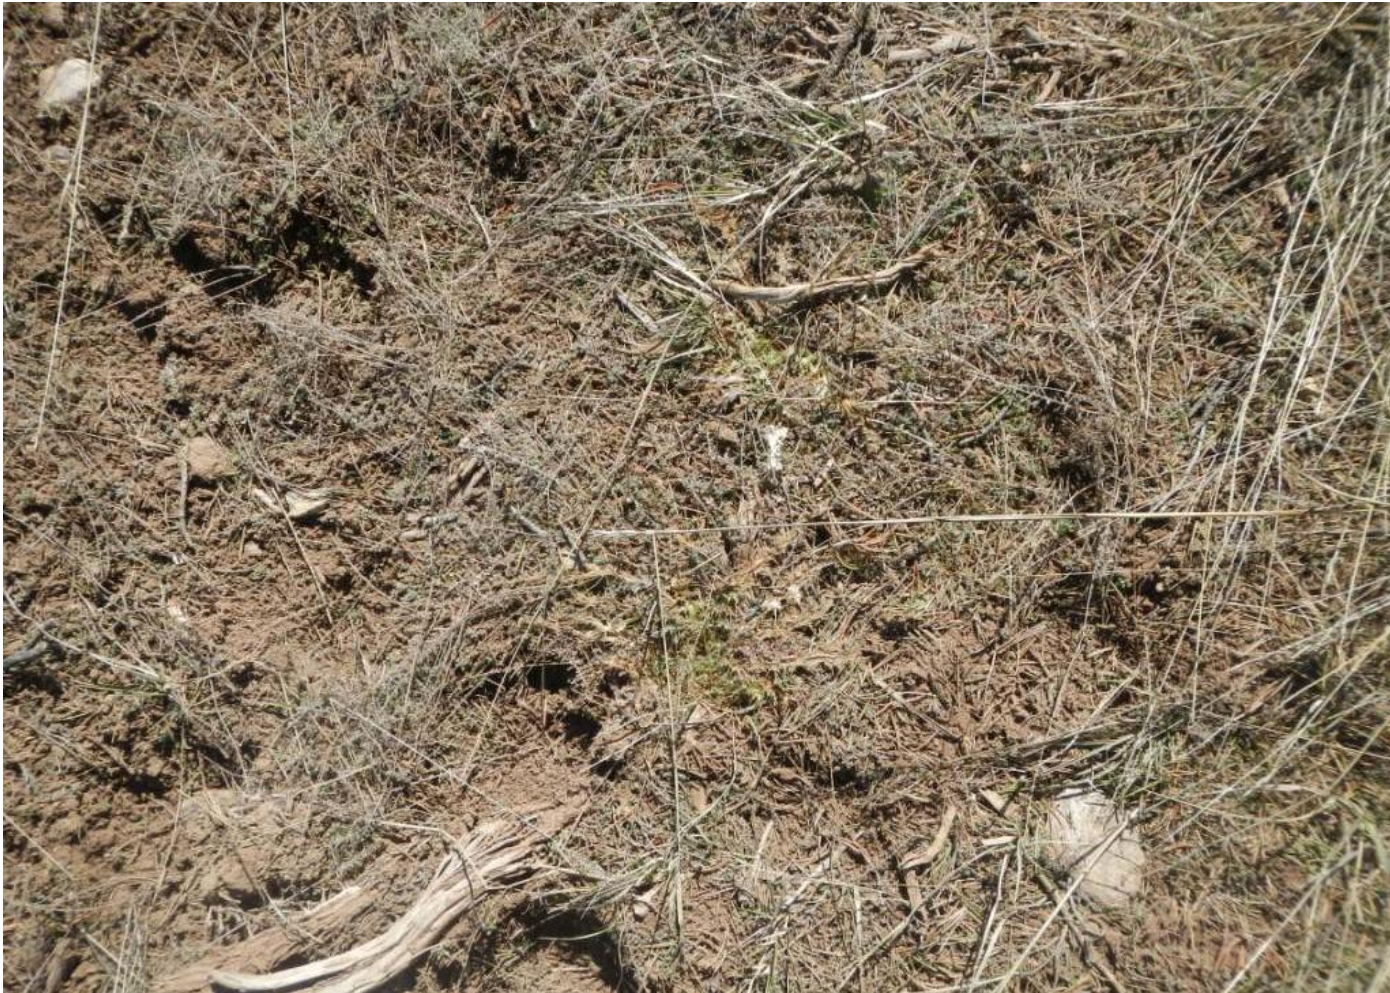
Photo 10. View of musk thistle rosettes within the western portion of the interim reclamation area.
