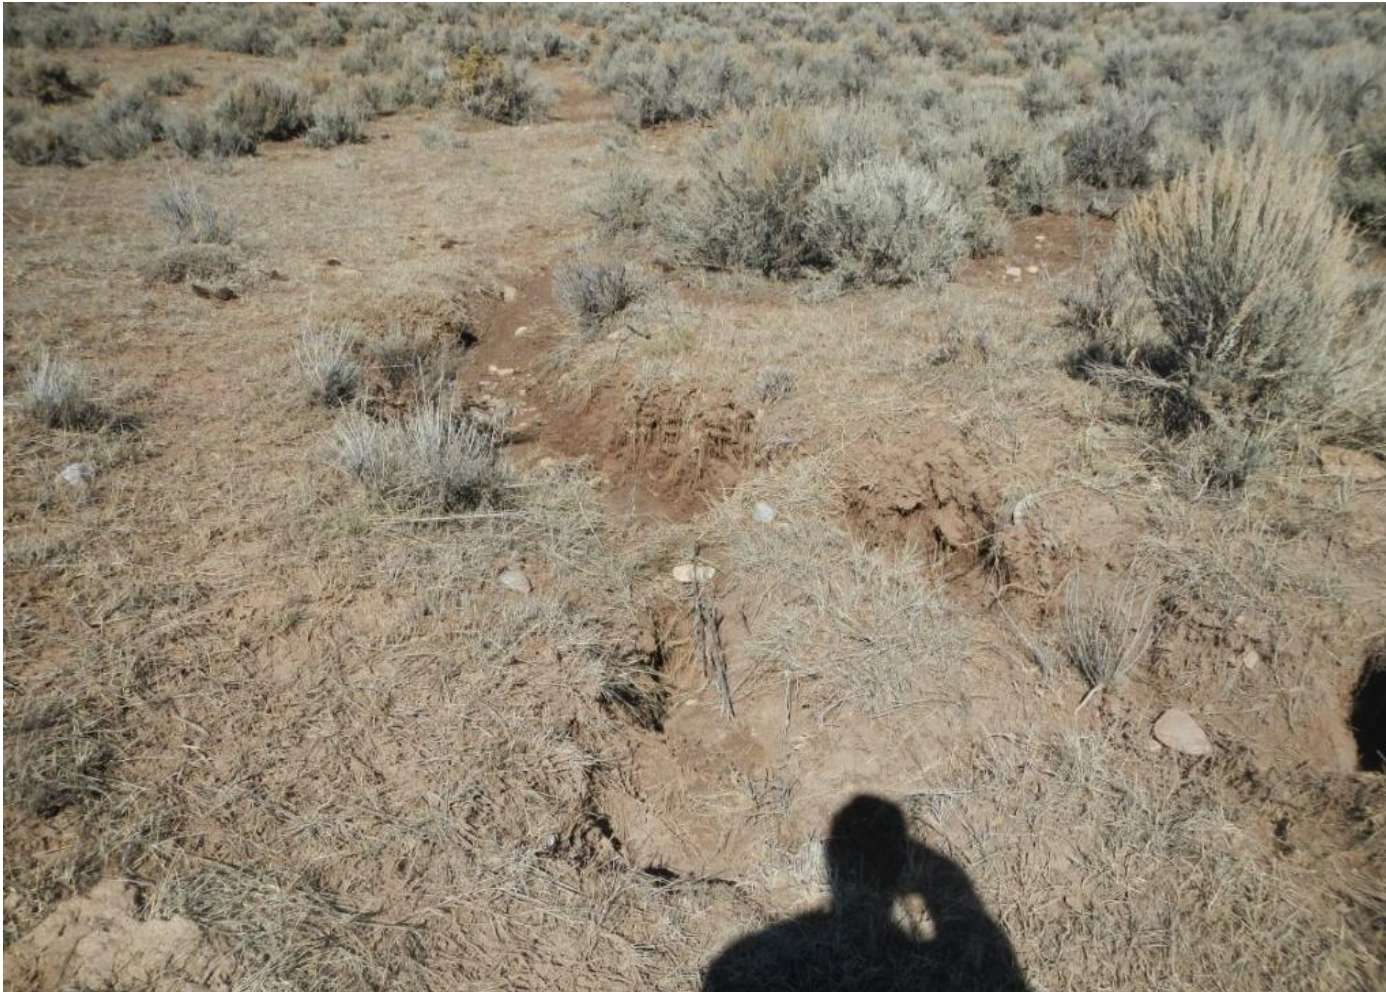
Photo 1. View of erosion channel that is approximately 3 feet wide and deep in the northeastern portion of the project area. This channel needs to be stabilized.

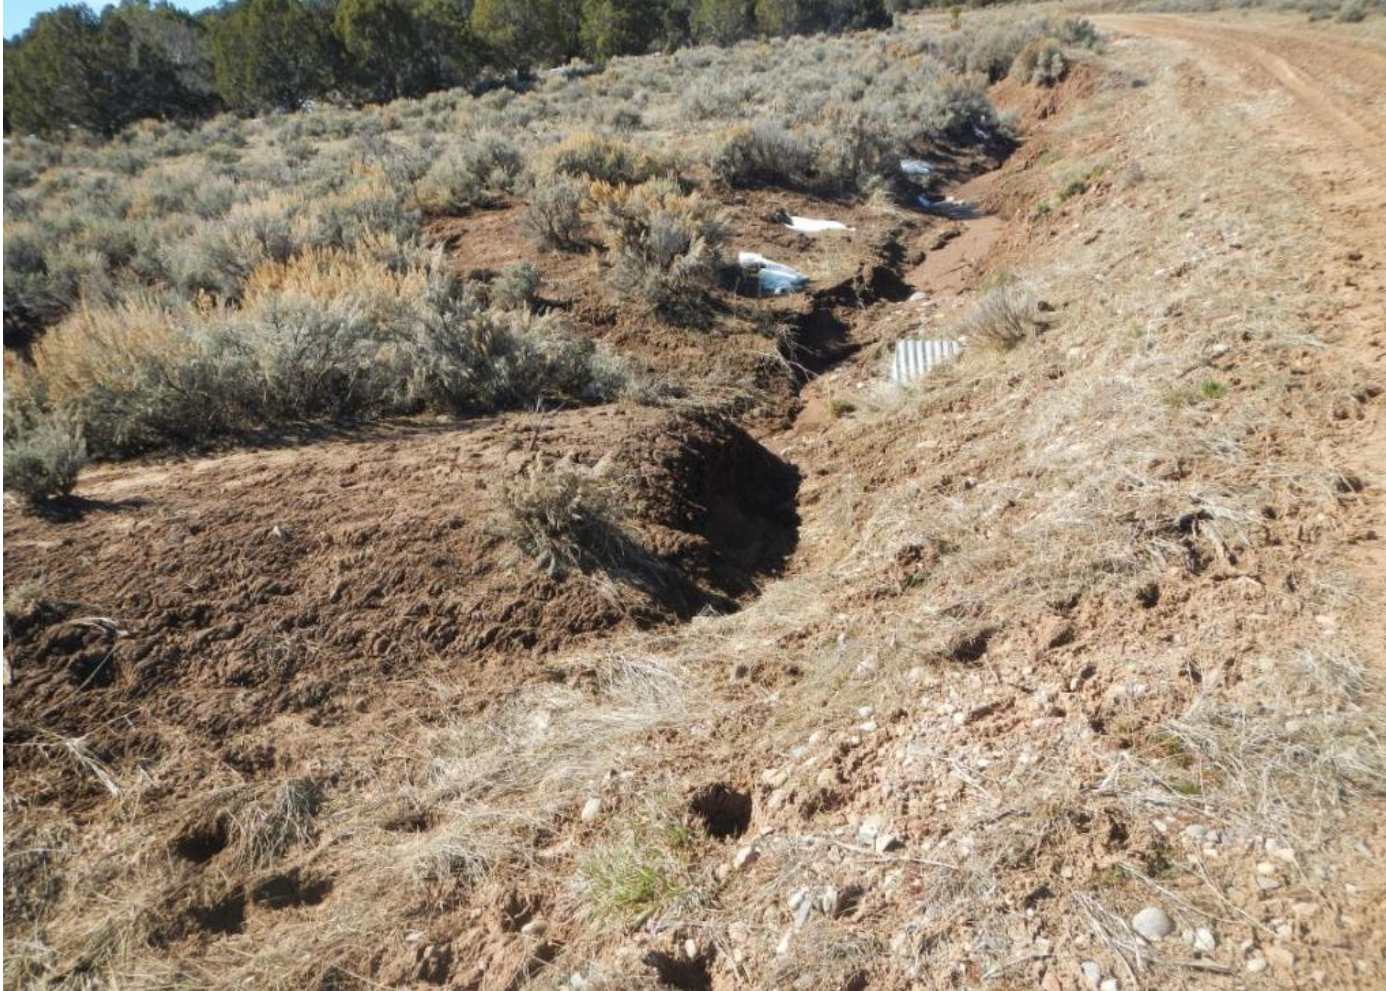
Photo 2. View of area near well pad entrance where stormwater flows off of the project area toward a culvert. Stormwater BMPs need to be installed here to prevent erosion and sediment discharge.

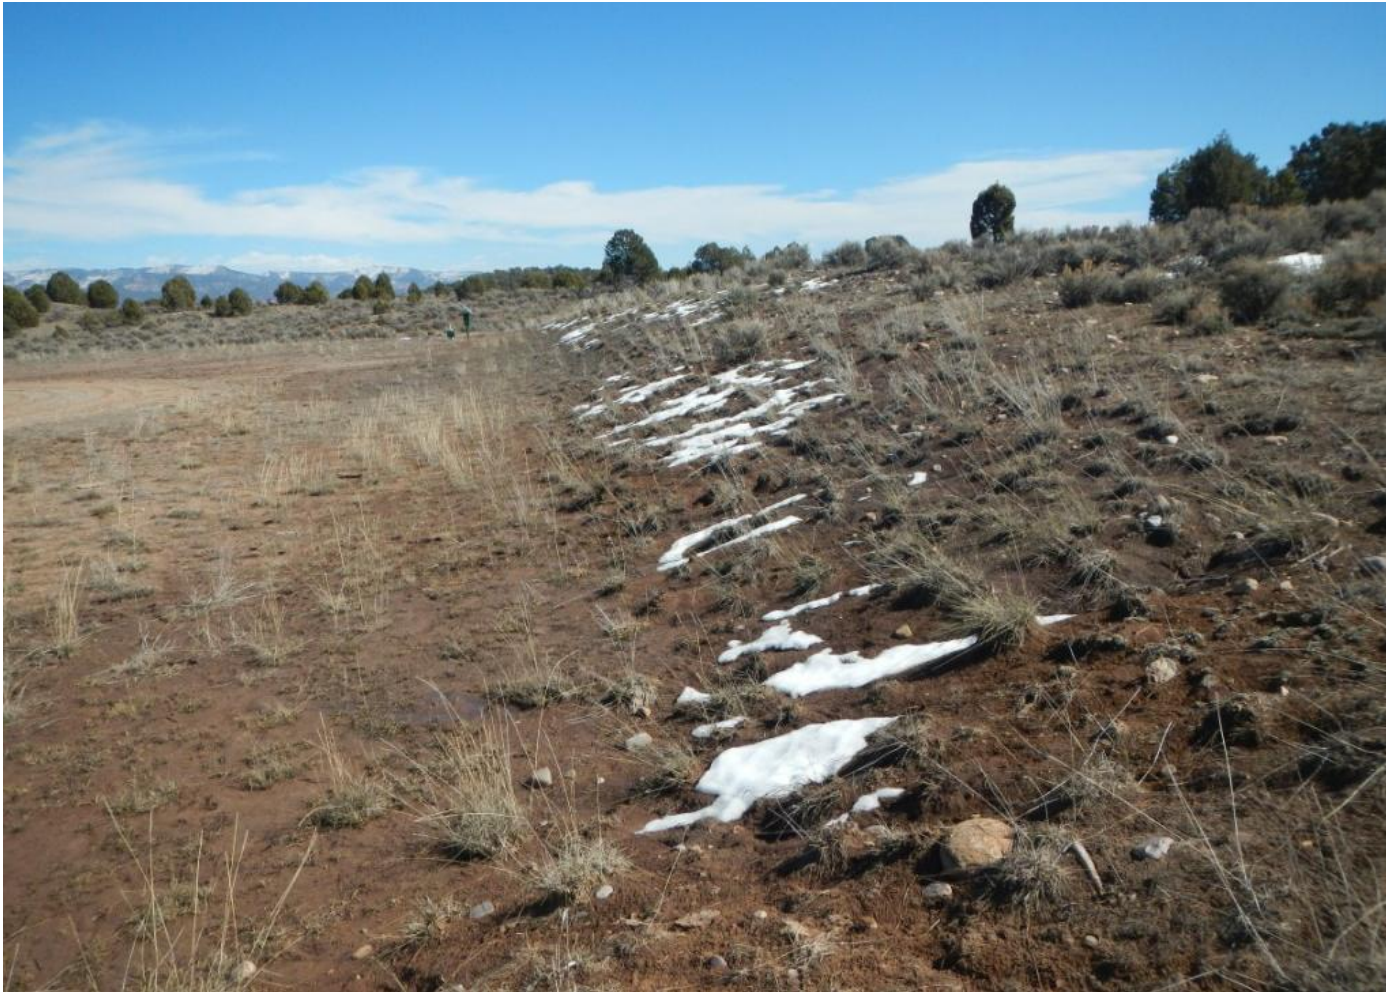
Photo 3. View of the southern portion of the project area from the southwestern corner facing eastward. Revegetation is progressing with grasses such as western wheatgrass (*Pascopyrum smithii*), blue grama (*Bouteloua gracilis*), and Indian ricegrass (*Achnatherum hymenoides*).
