# Interim Reclamation Inspection

3/10/2016

Operator: Carrizo

Location: 434923

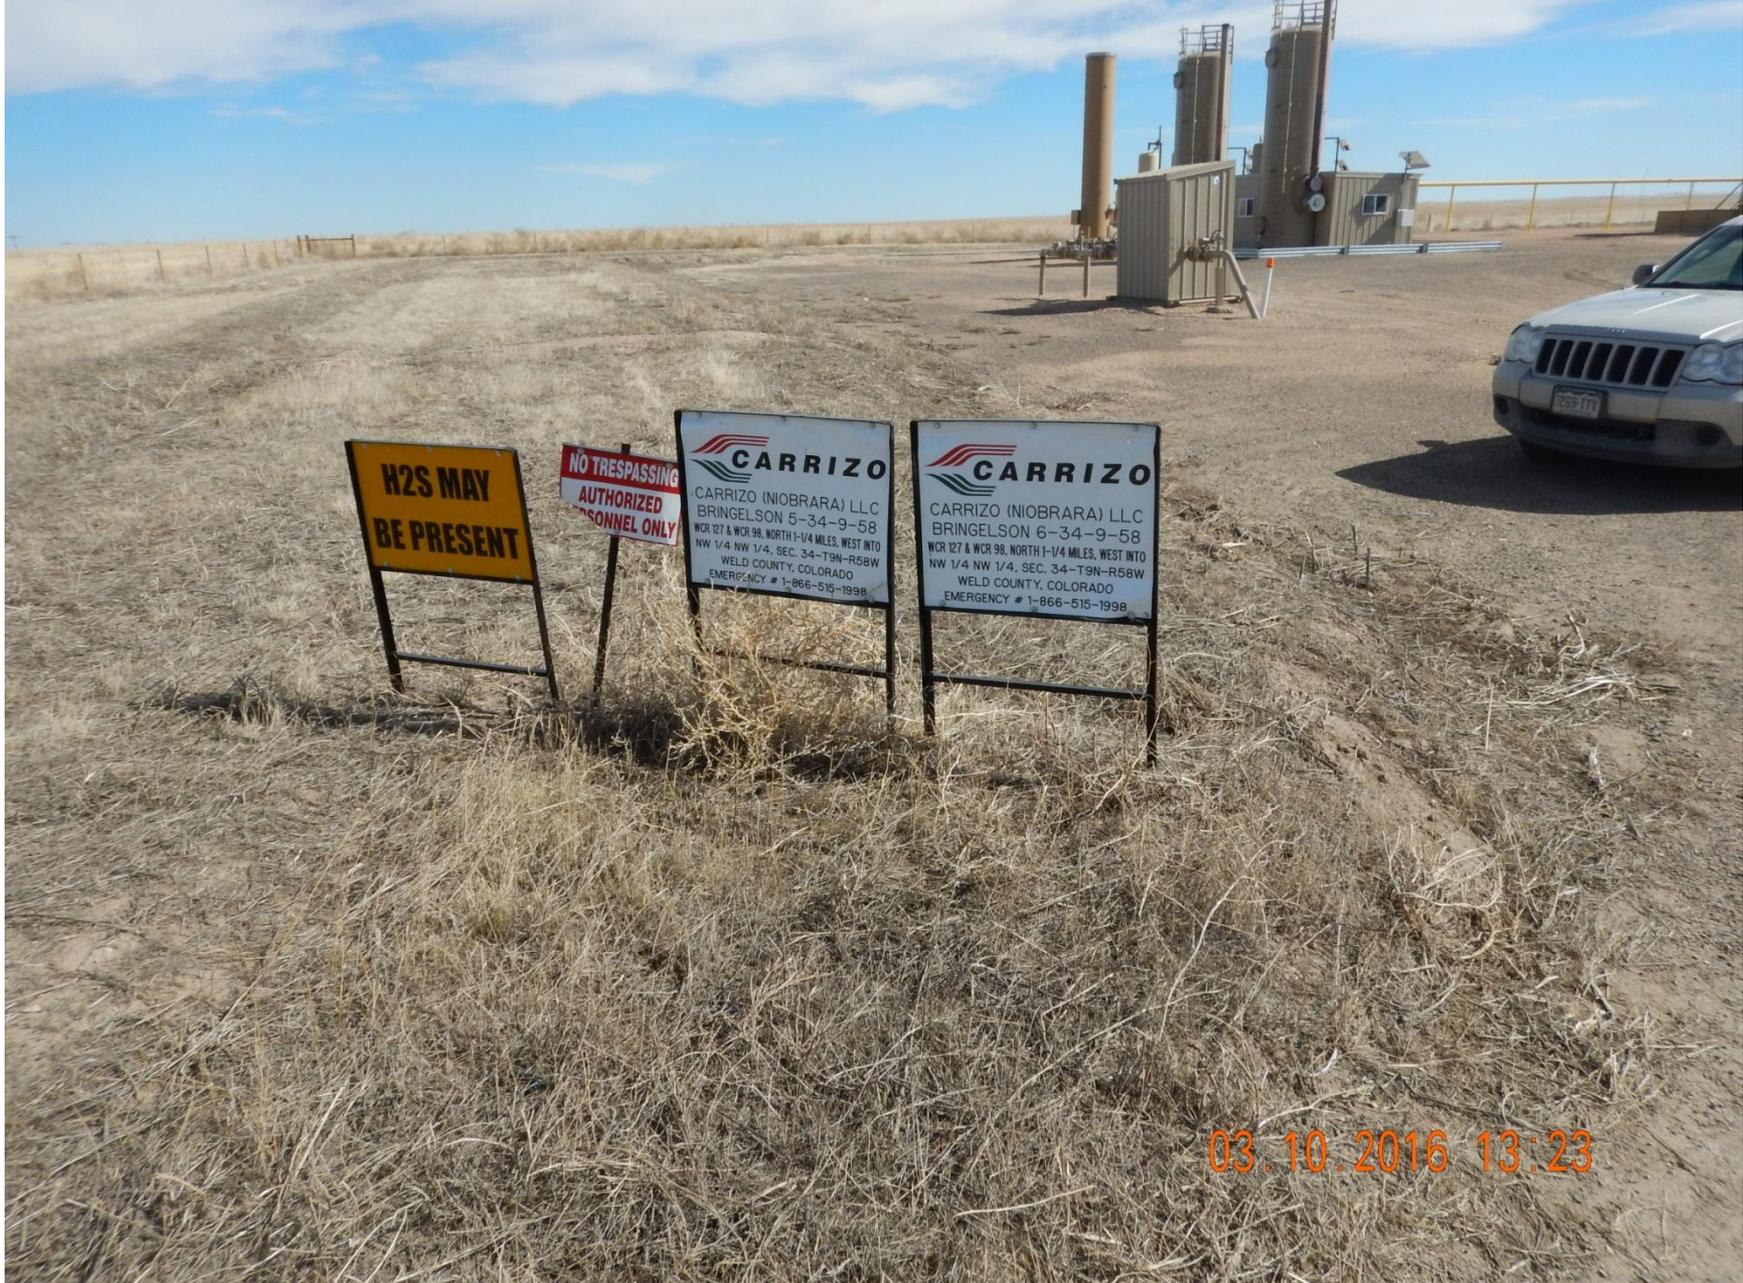
**Figure 1:** Photo taken from access road on the north end of the location, facing east. Photo shows location signs. .

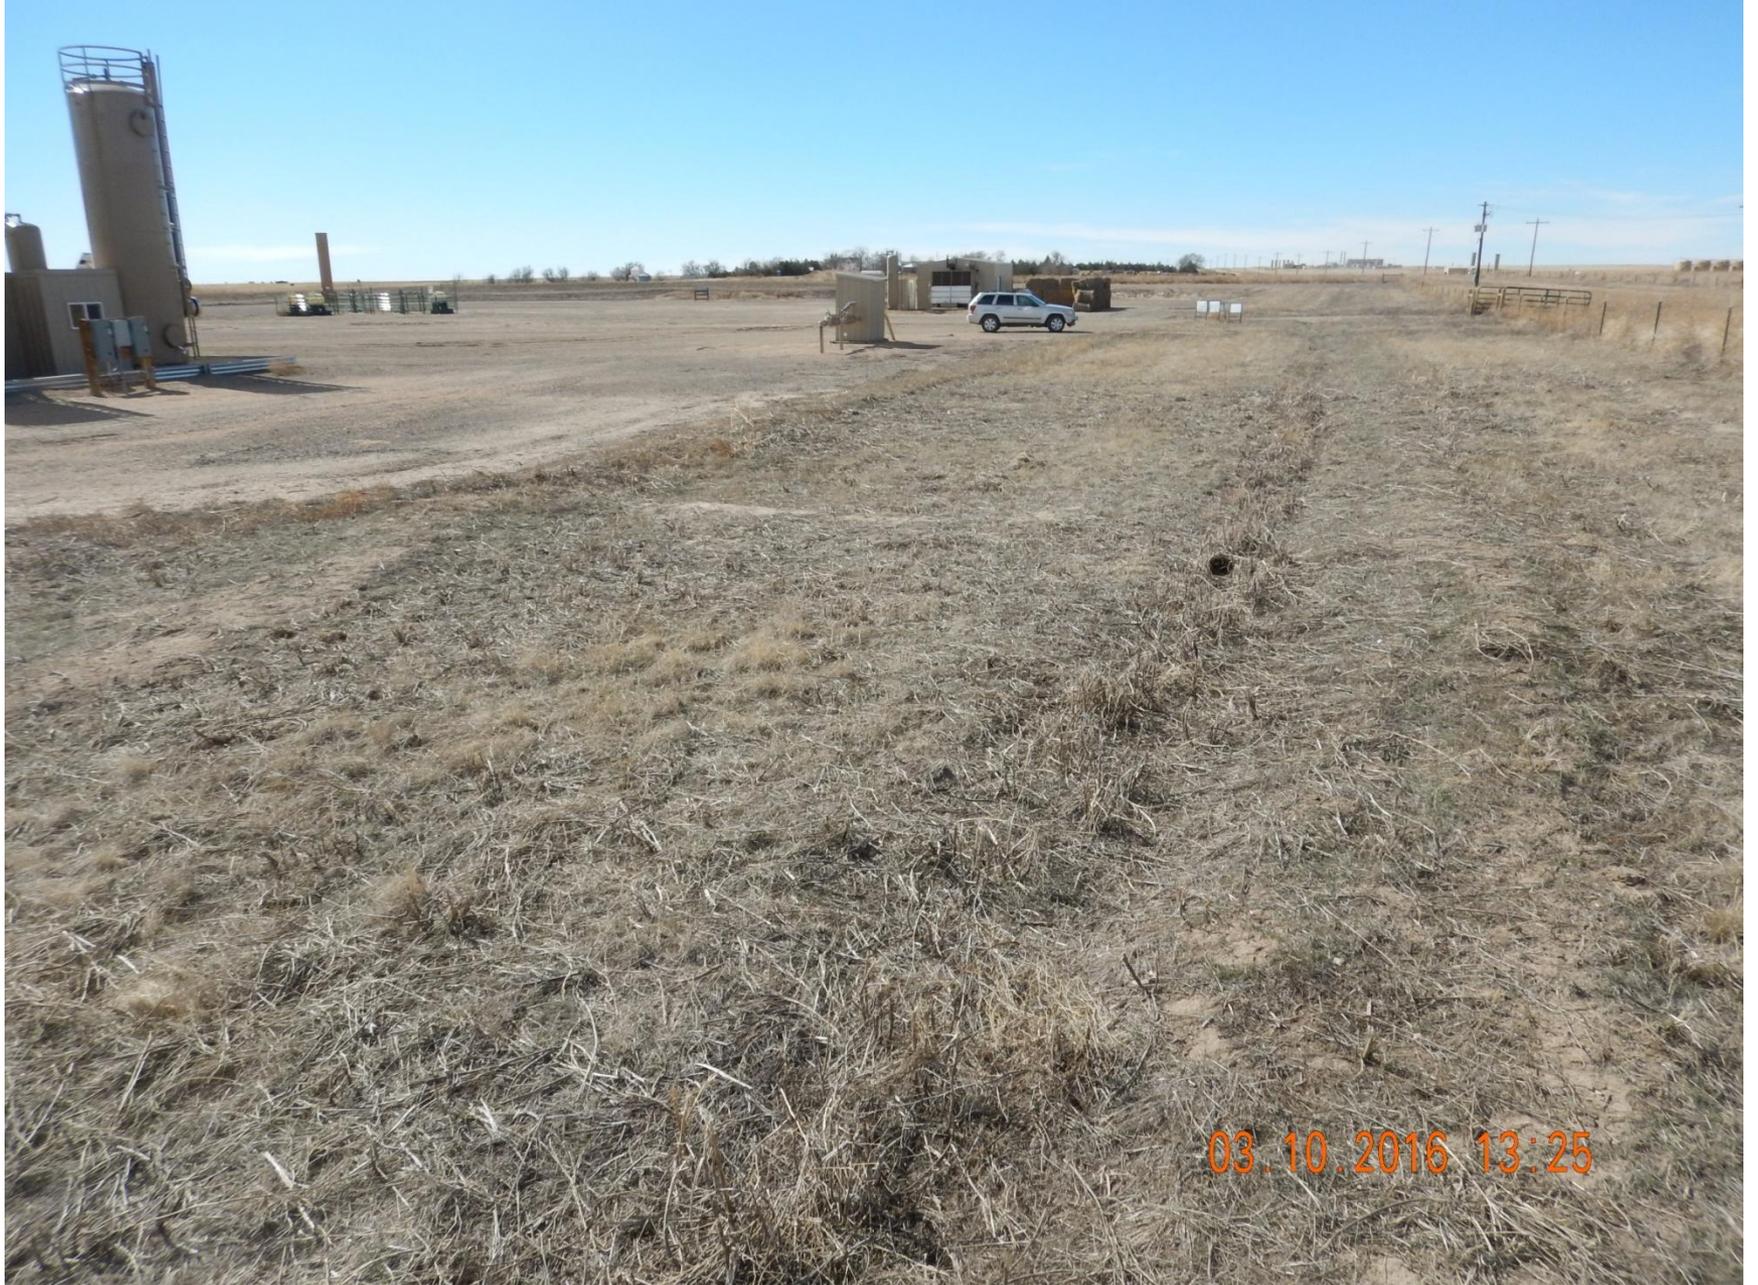
**Figure 2:** Photo taken from the northeast corner of the location, facing west. Photo shows interim and project areas, and stormwater control ditch.

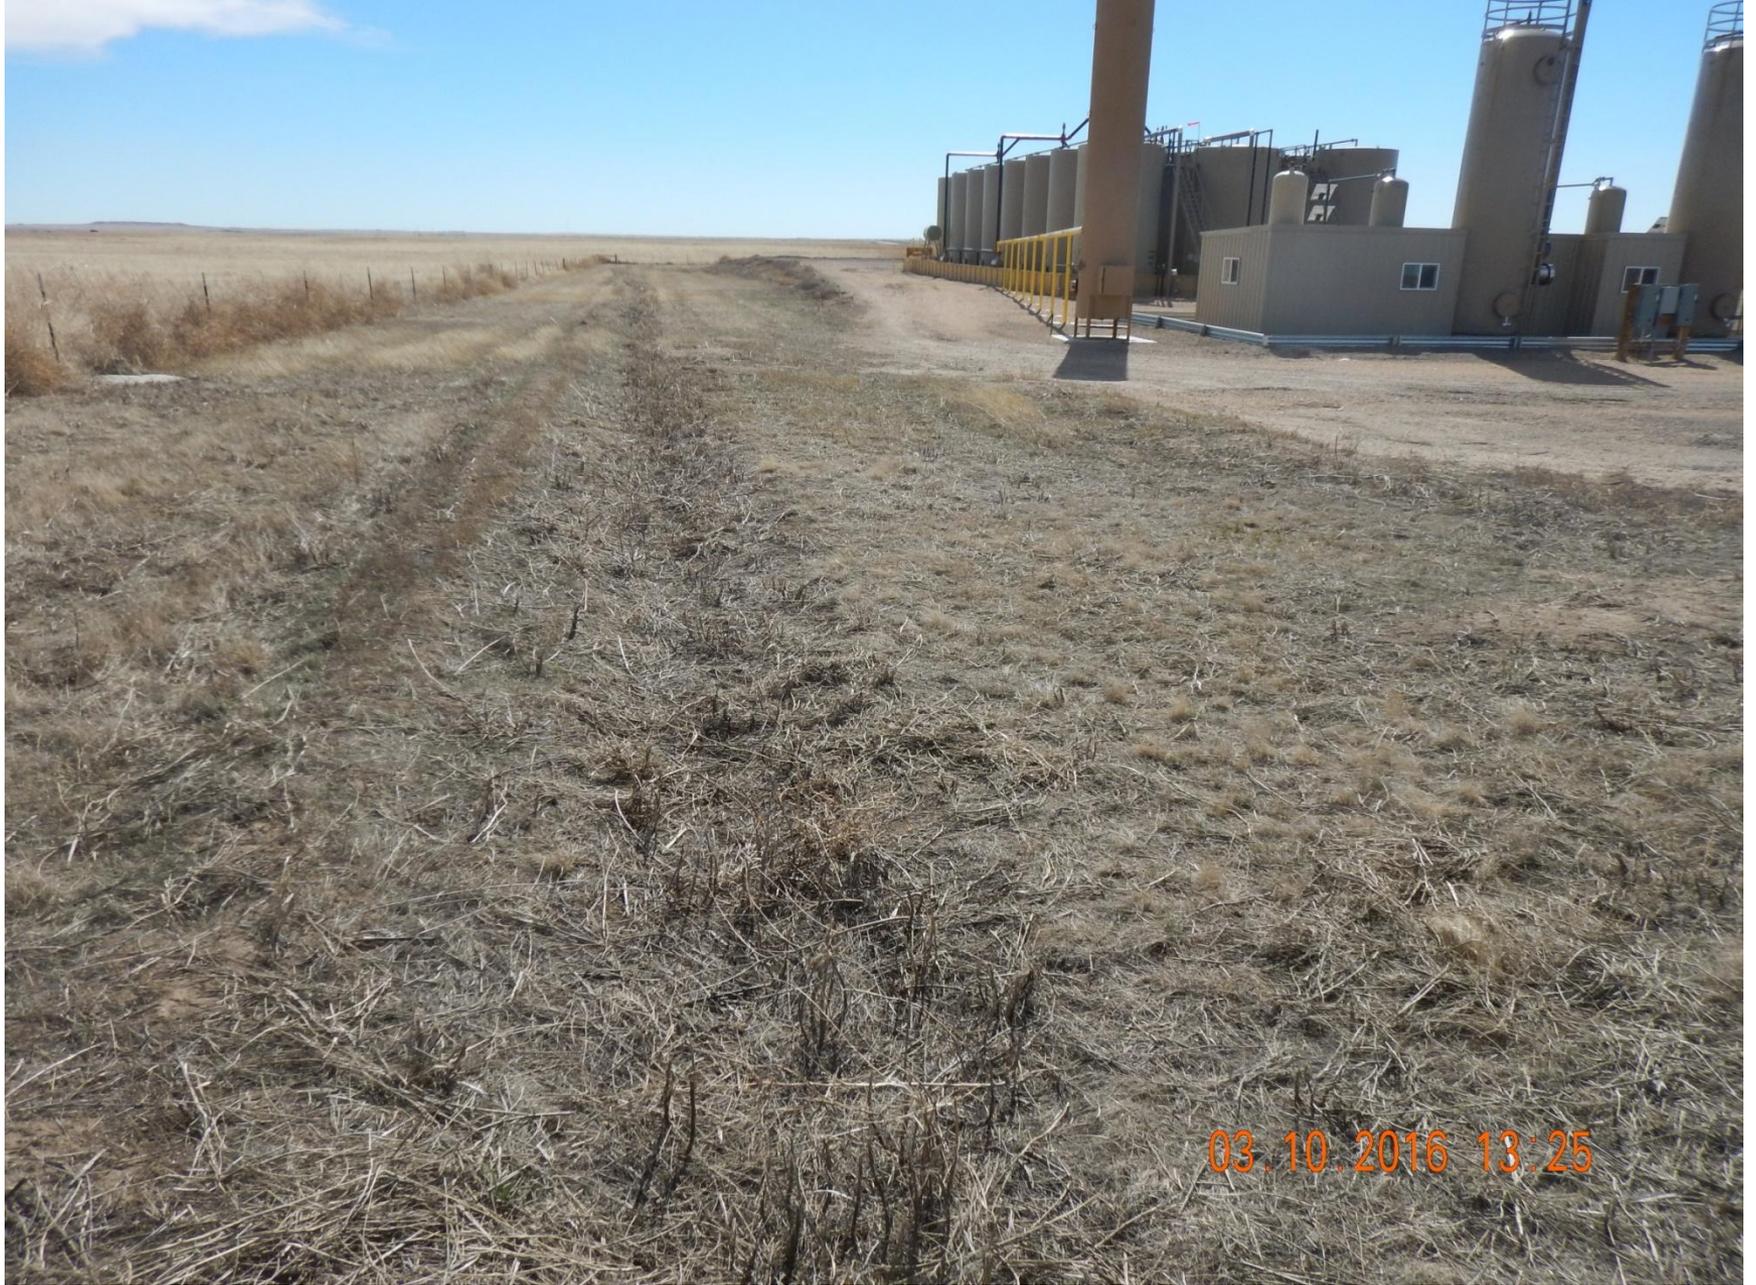
**Figure 3:** Photo taken from the northeast corner of the location, facing south. Photo shows interim and project areas, and stormwater control ditch.

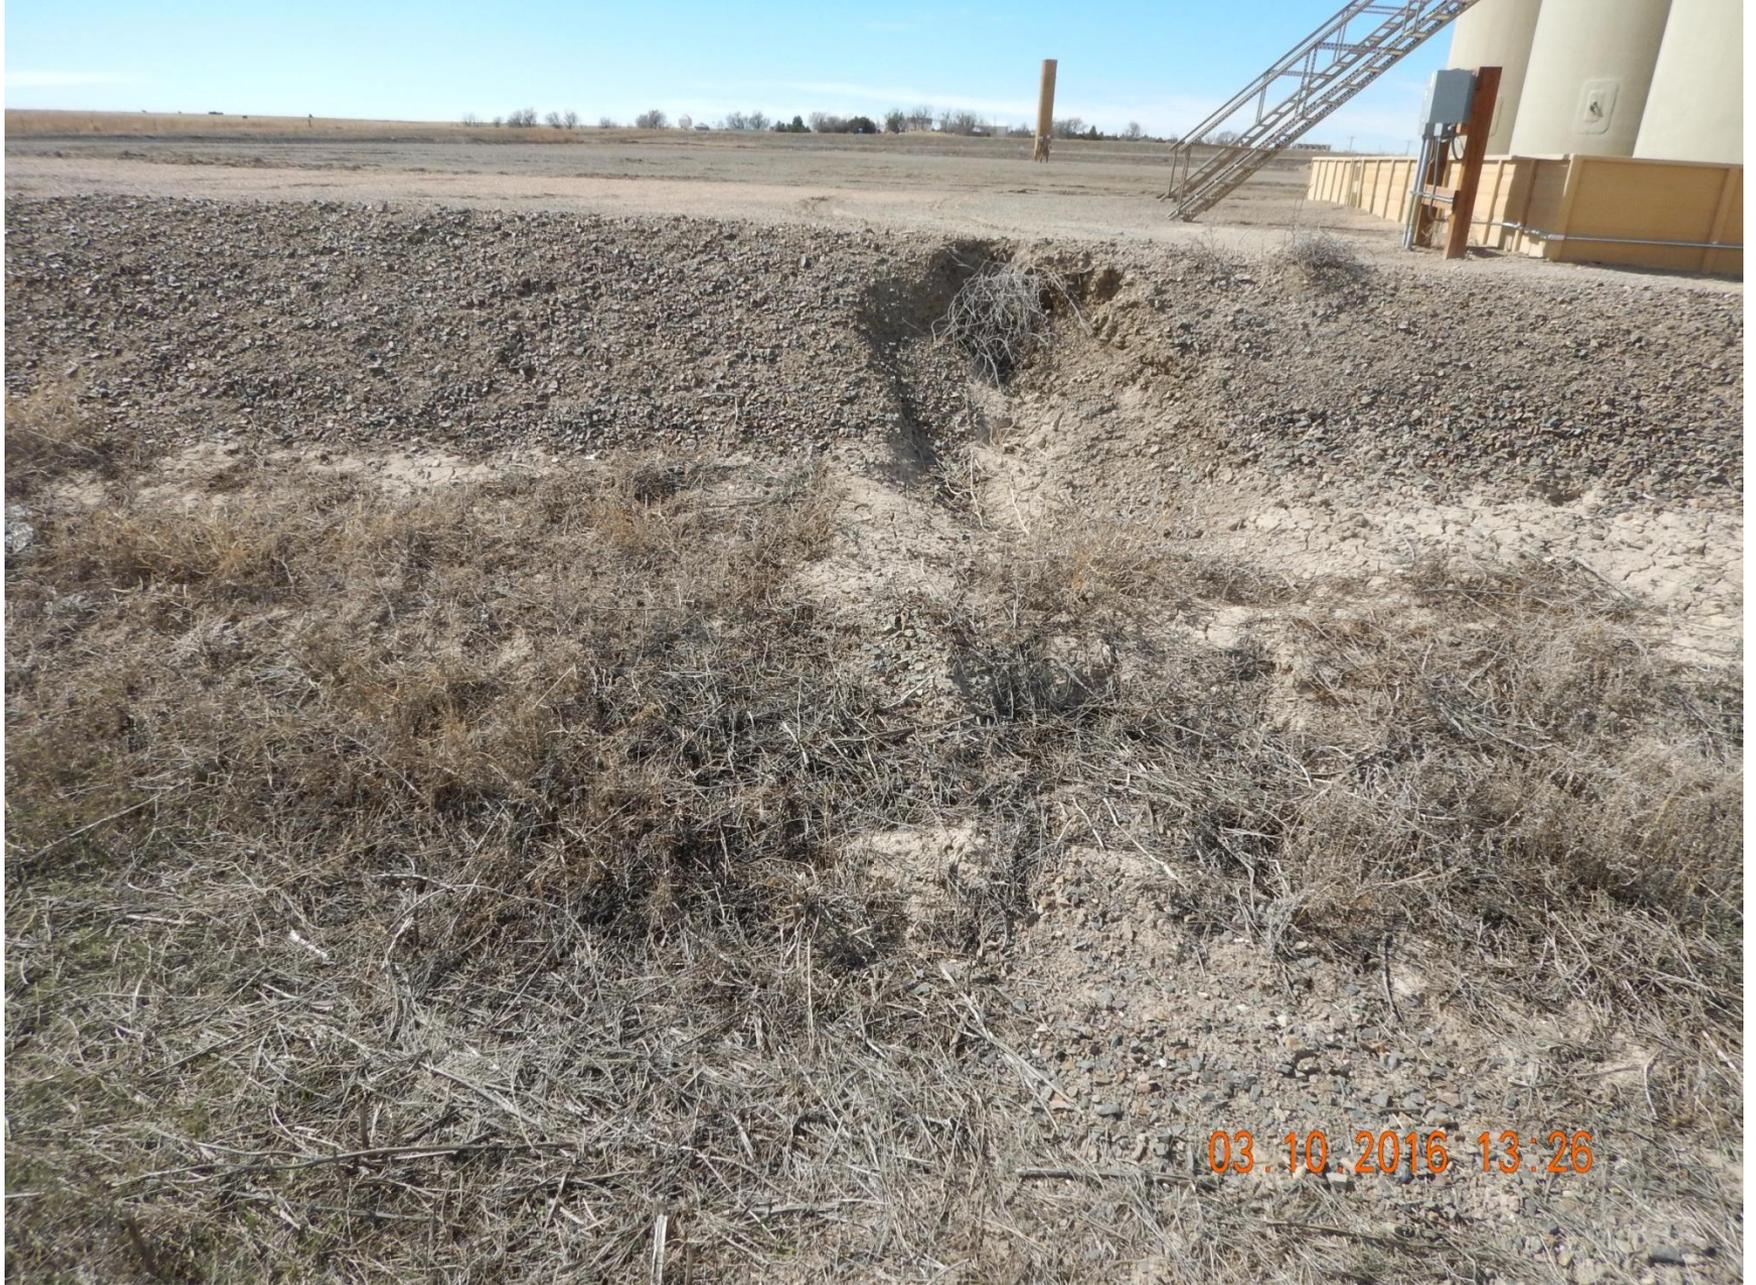
**Figure 4:** Photo taken from the east end of the location, facing west. Photo shows erosion occurring at perimeter control berm.

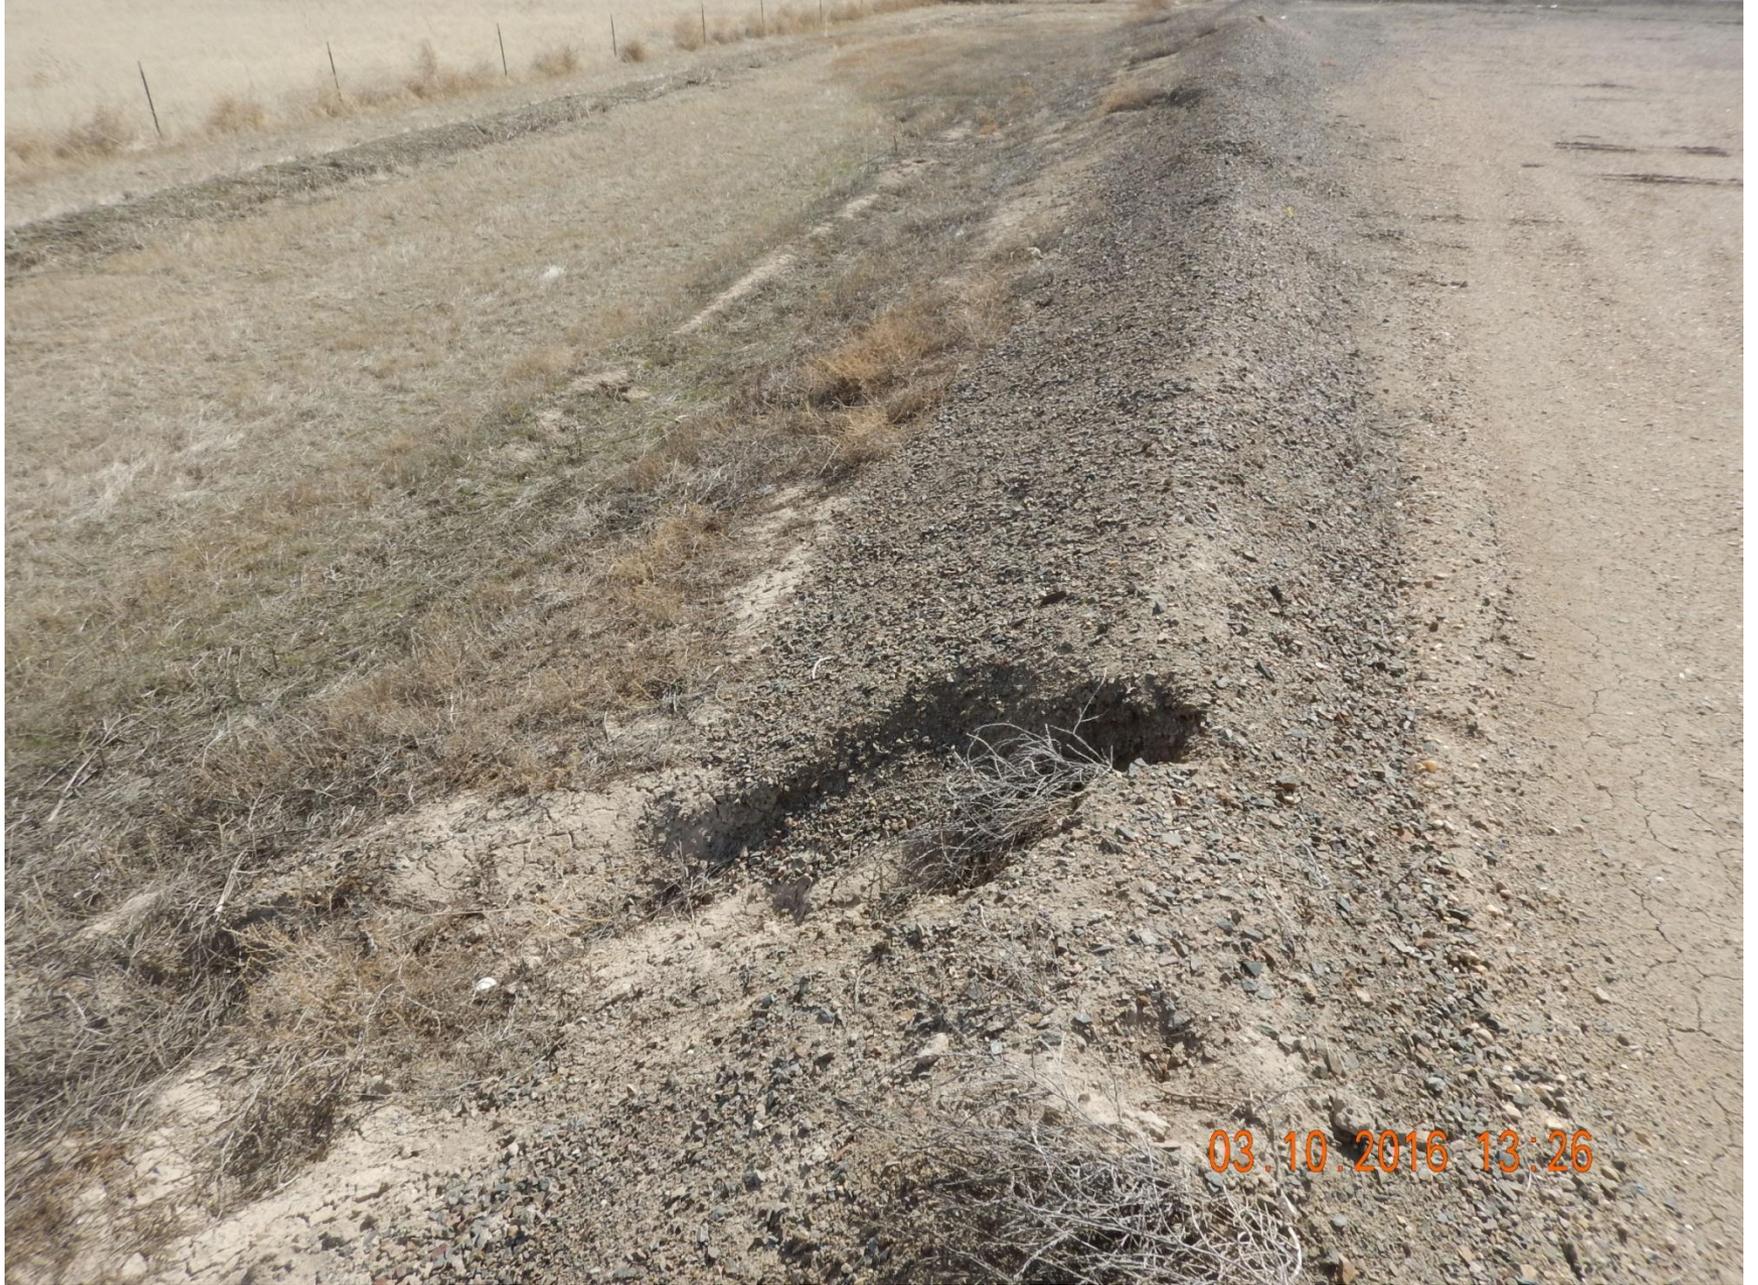
**Figure 5:** Photo taken from the east end of the location, facing south. Photo shows erosion occurring at perimeter control berm.

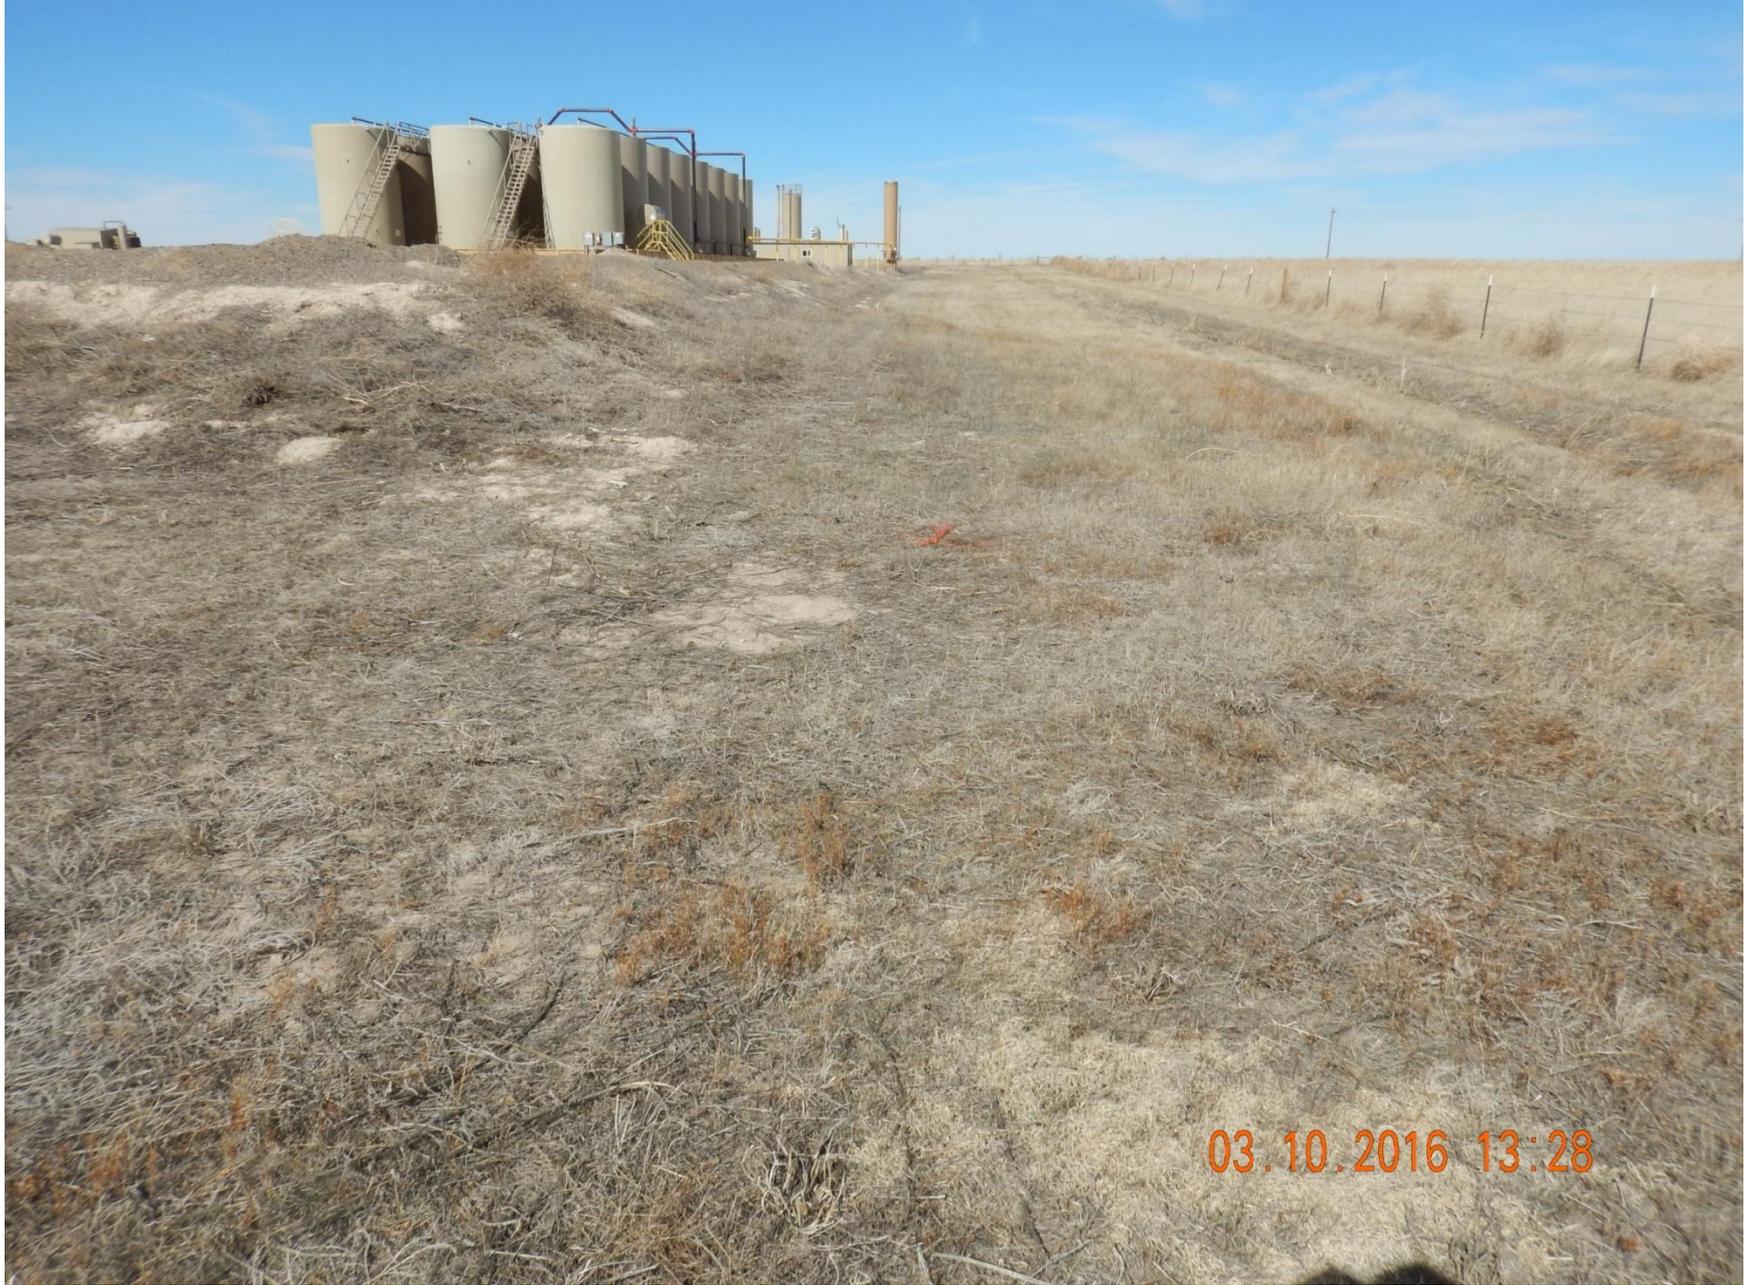
**Figure 6:** Photo taken from the southeast corner of the location, facing north. Photo shows interim and project areas, and stormwater control ditch. Note vegetation is predominantly undesirable weedy plant species.

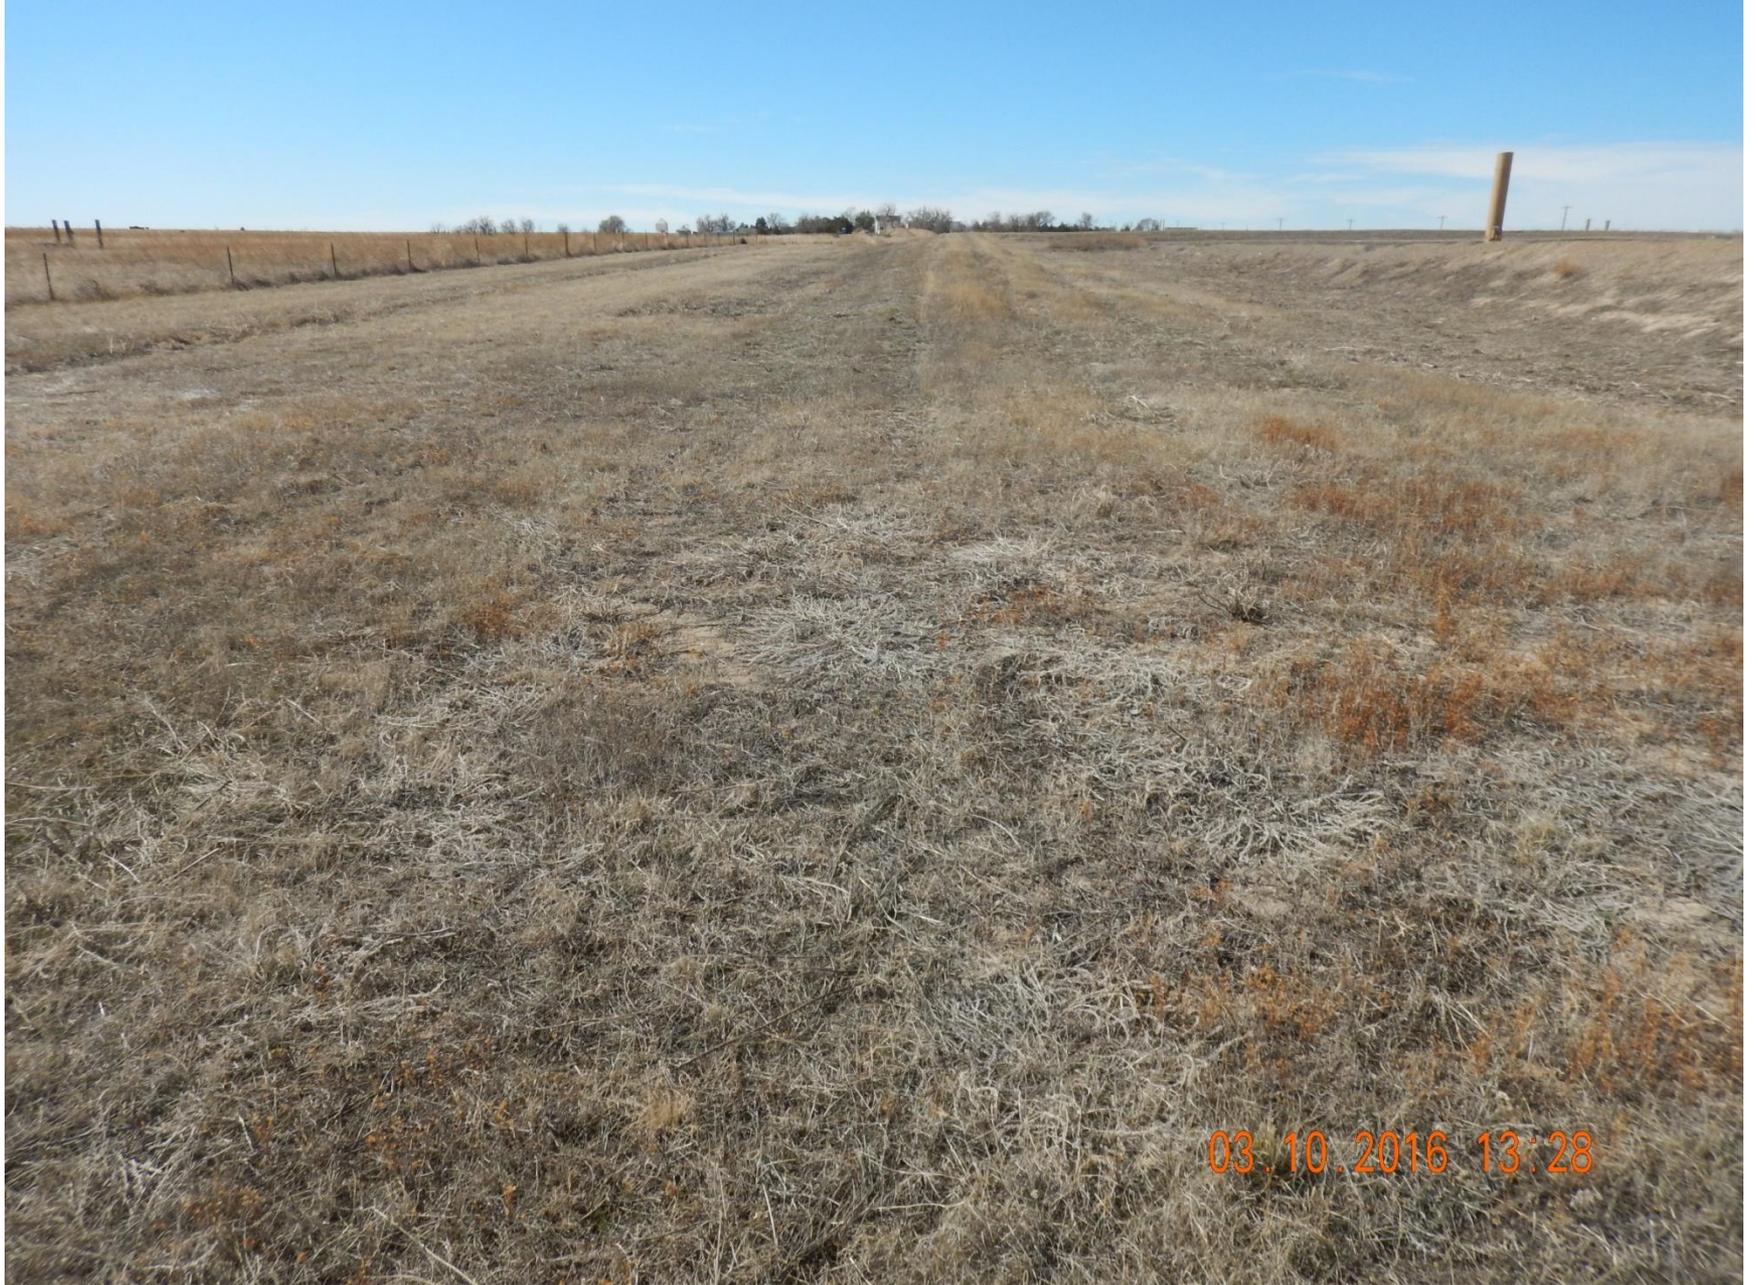
**Figure 7:** Photo taken from the southeast corner of the location, facing west. Photo shows interim and project areas.

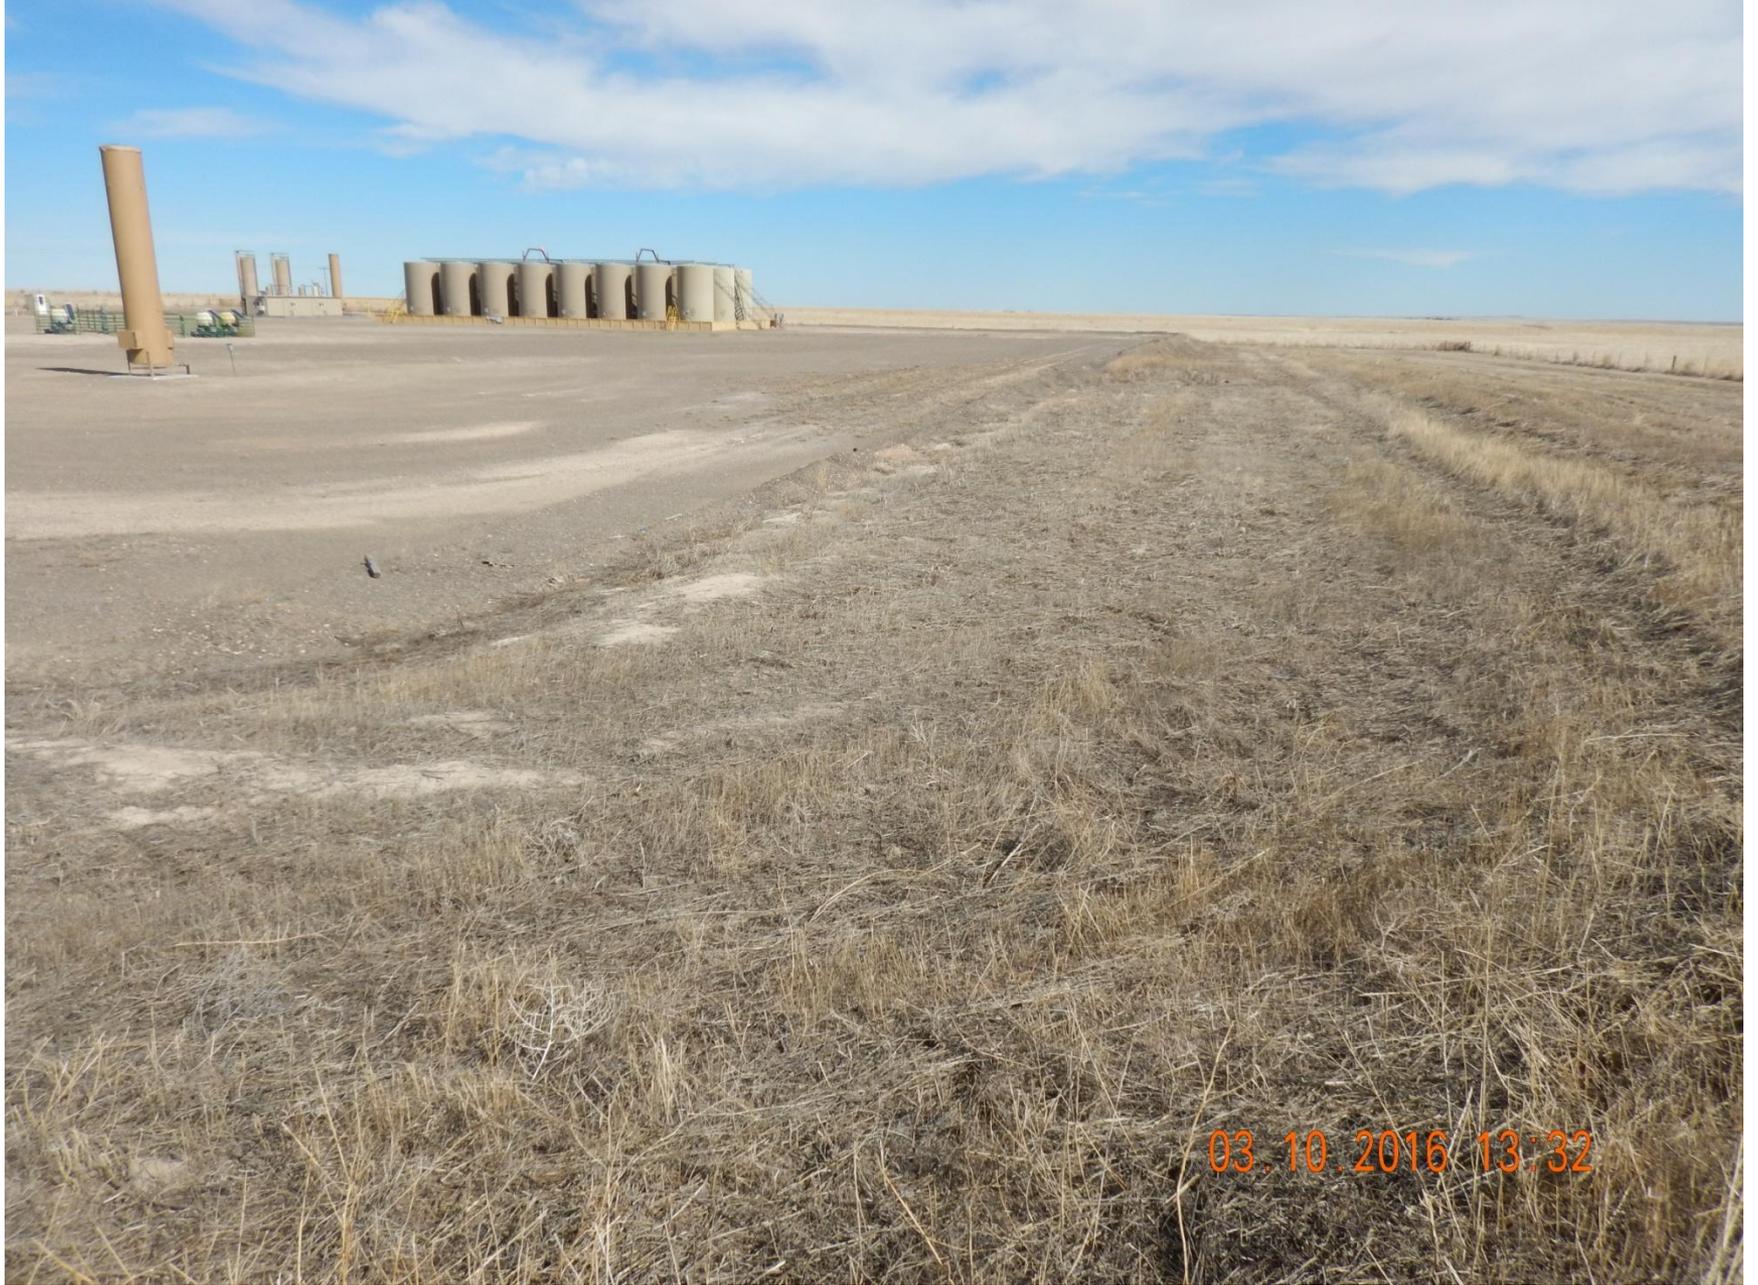
**Figure 8:** Photo taken from the southeast corner of the location, facing east. Photo shows interim and project areas.

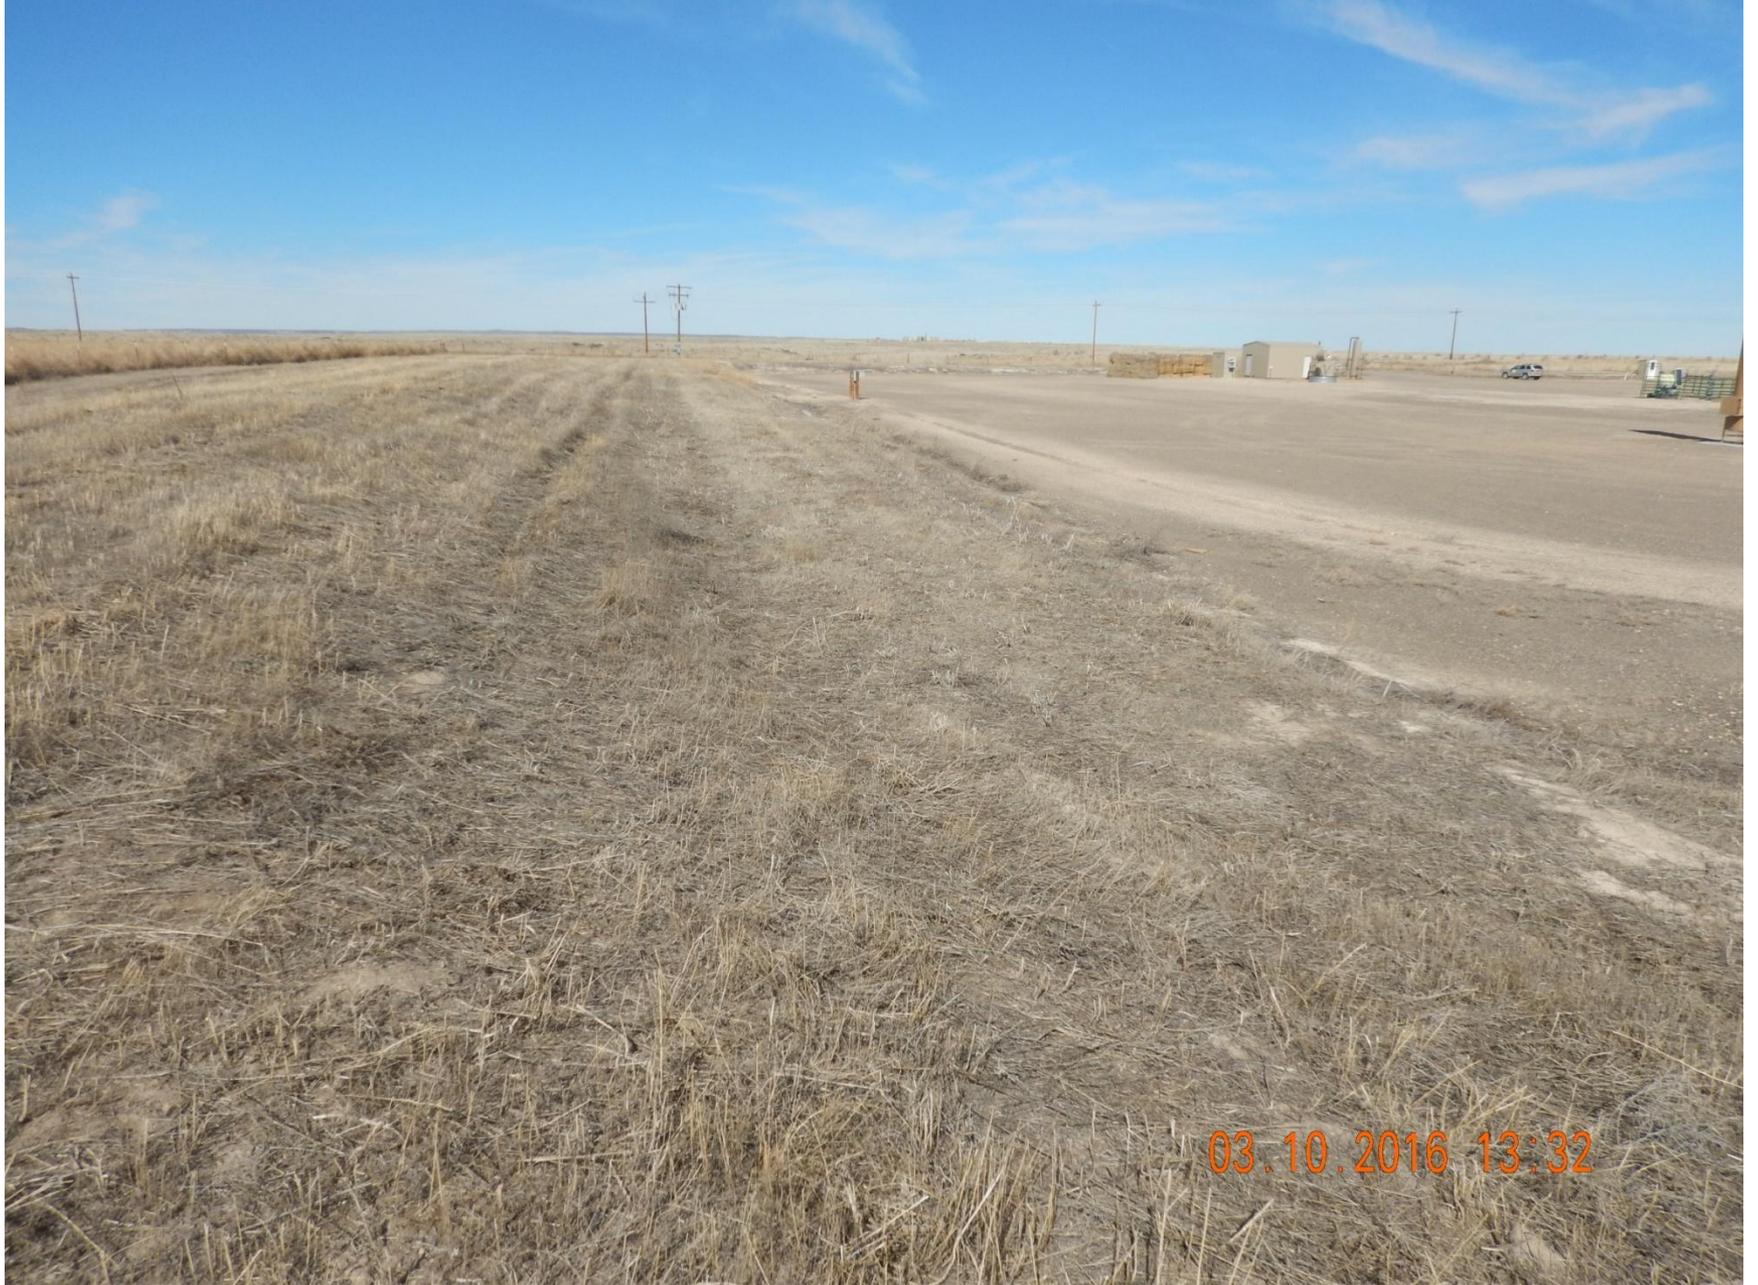
**Figure 9:** Photo taken from the southwest corner of the location, facing north. Photo shows interim and project areas.

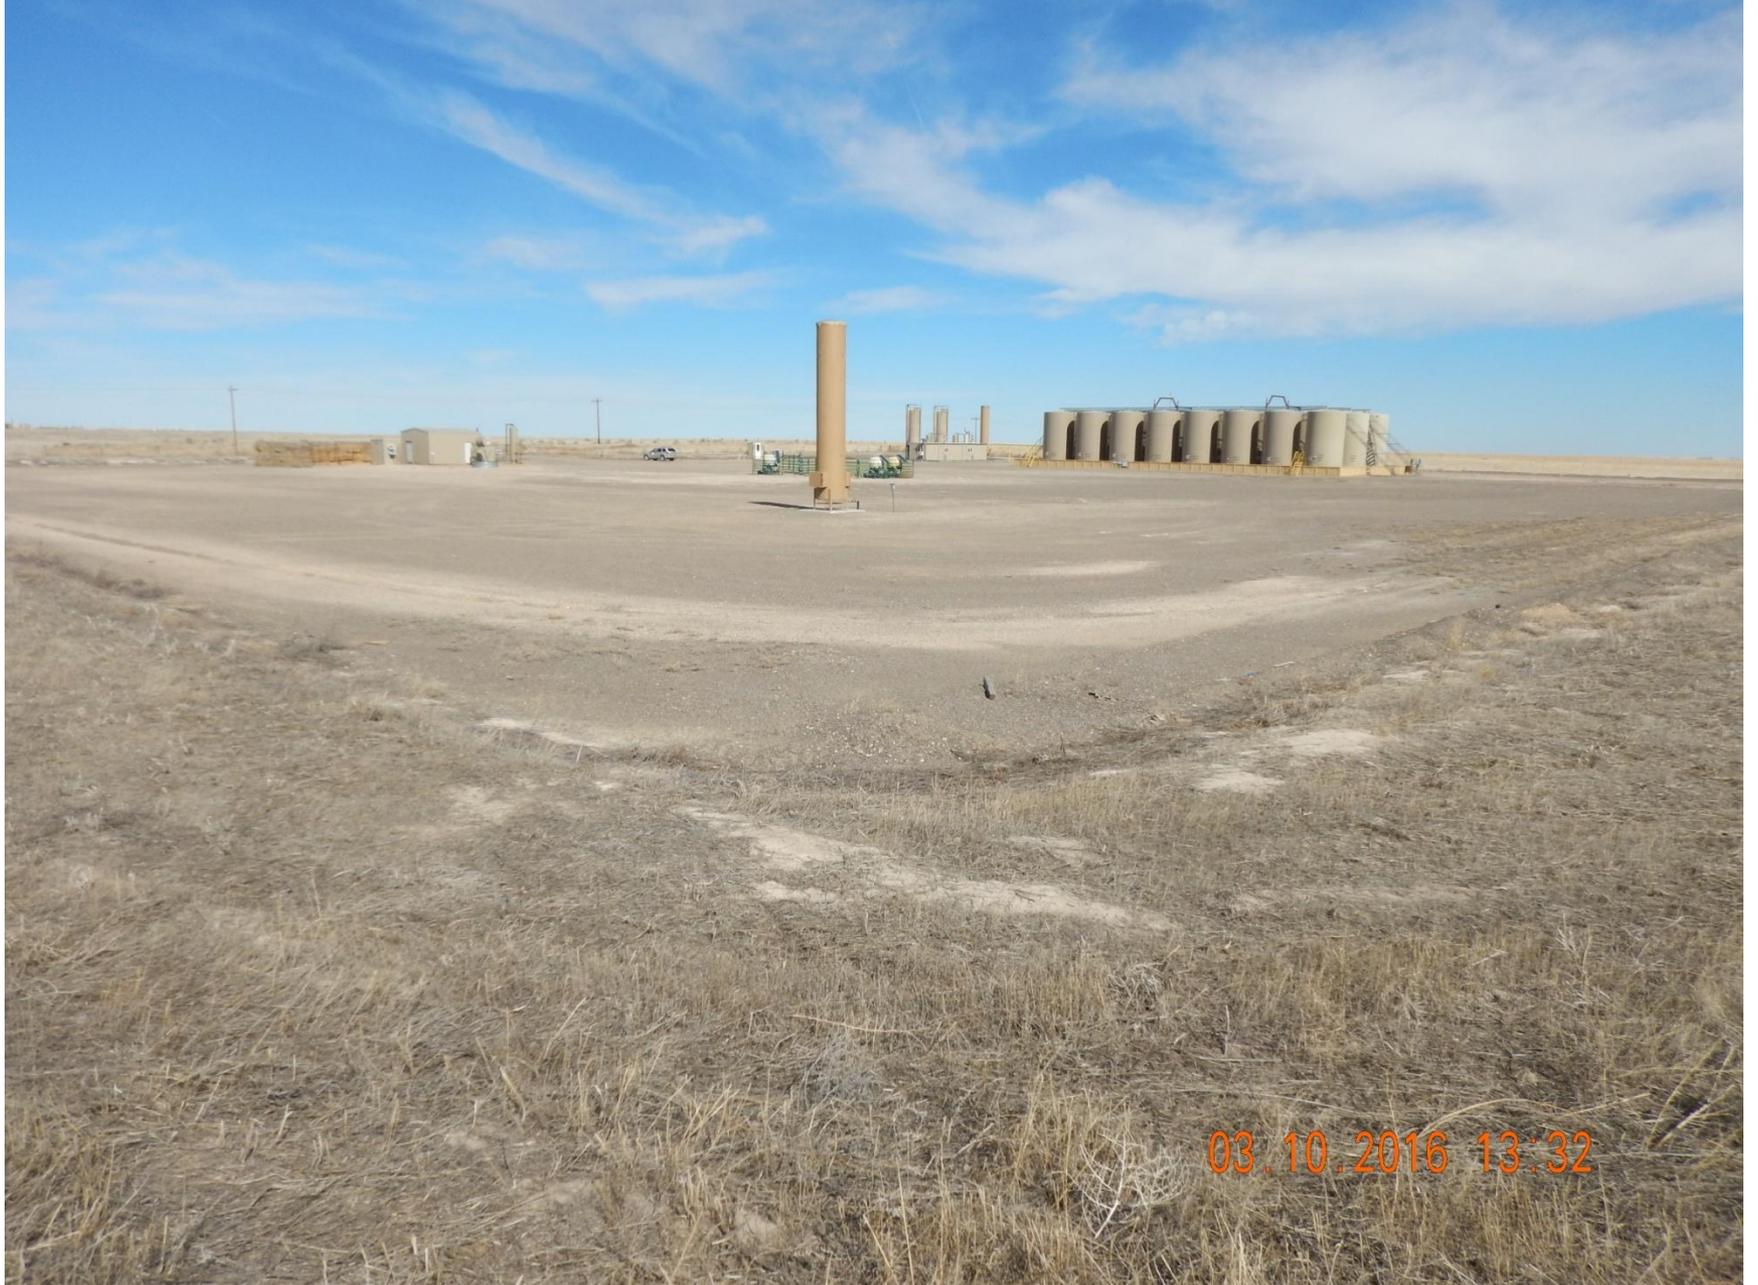
**Figure 10:** Photo taken from the southwest corner of the location, facing northeast. Photo shows project area.
