# Interim Reclamation Inspection

3/10/2016

Operator: Carrizo

Location: 434923

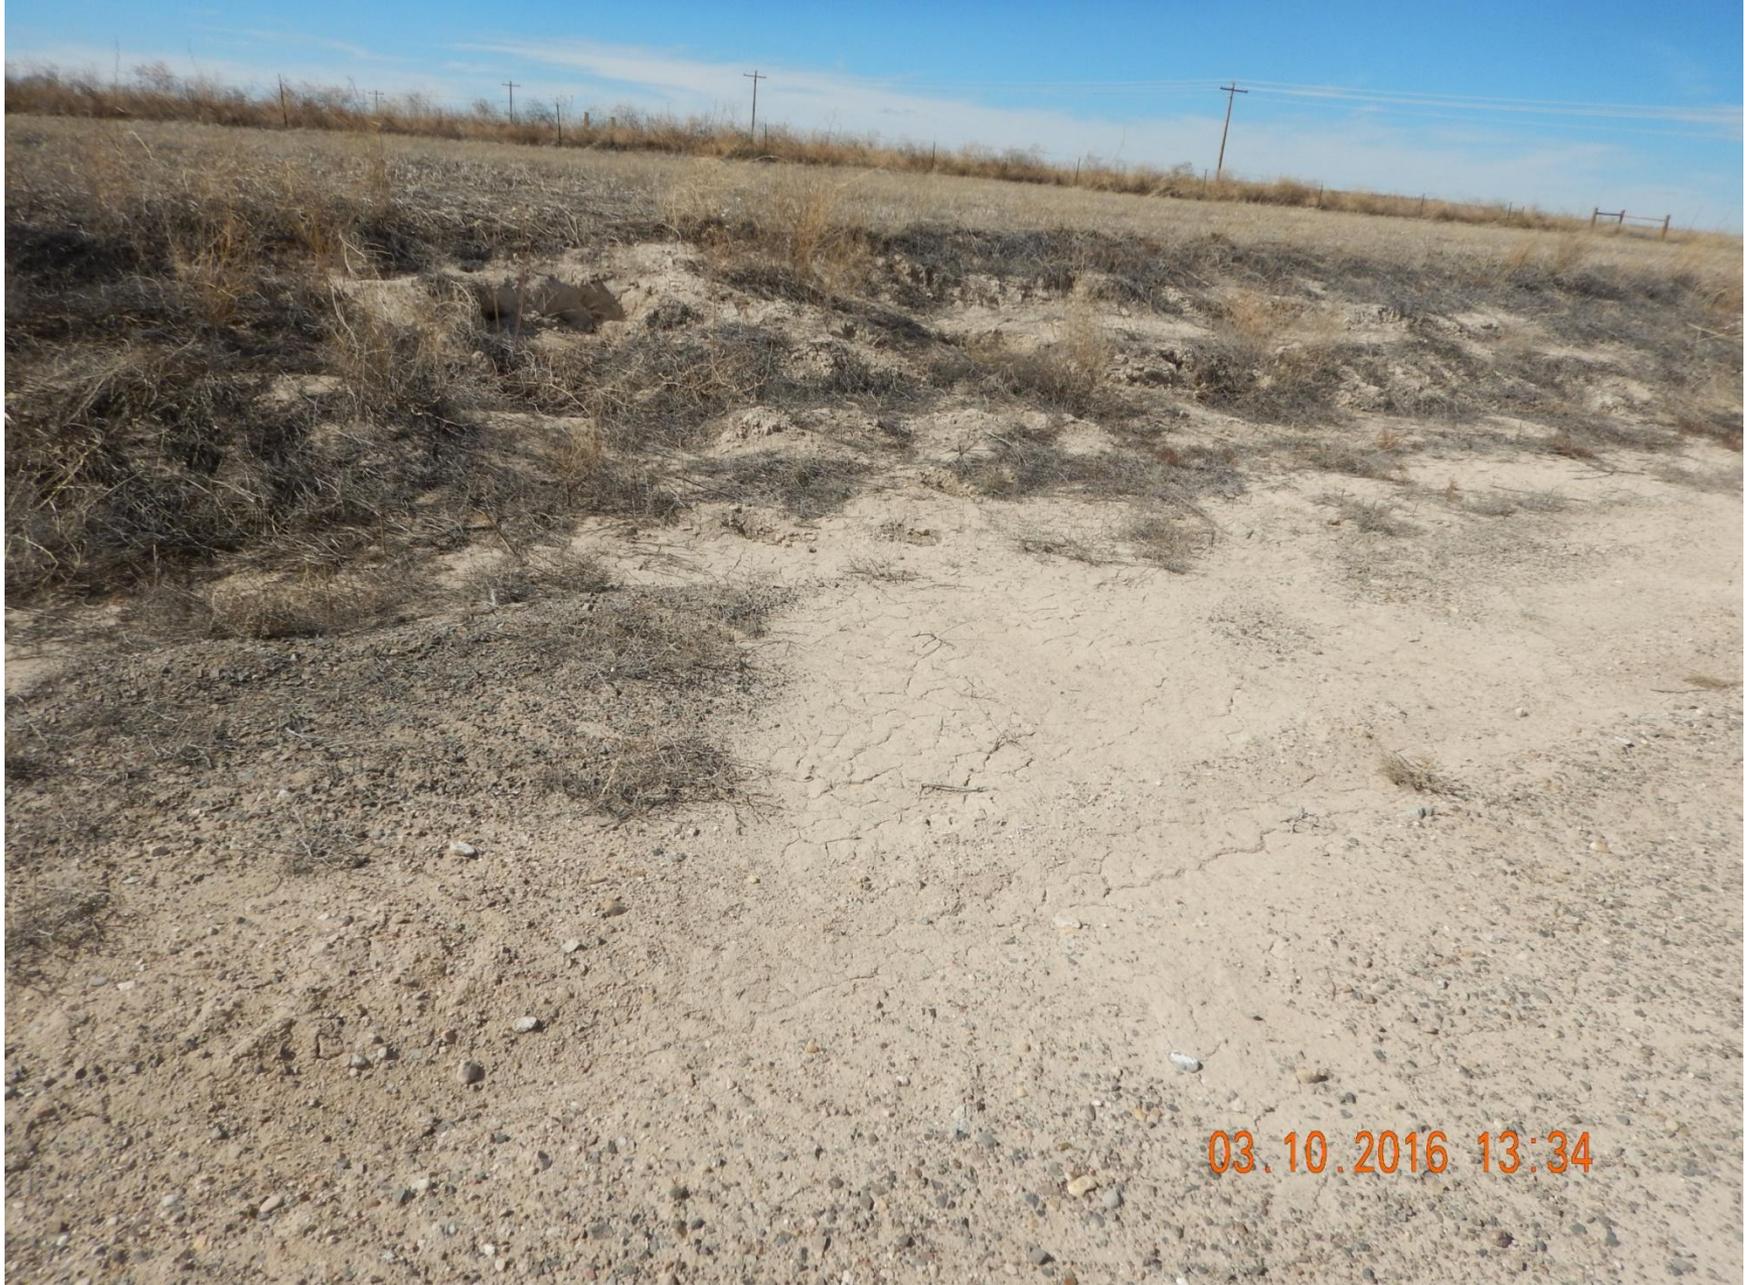
**Figure 11:** Photo taken from the western end of the project area, facing west. Photo shows erosion occurring on location.

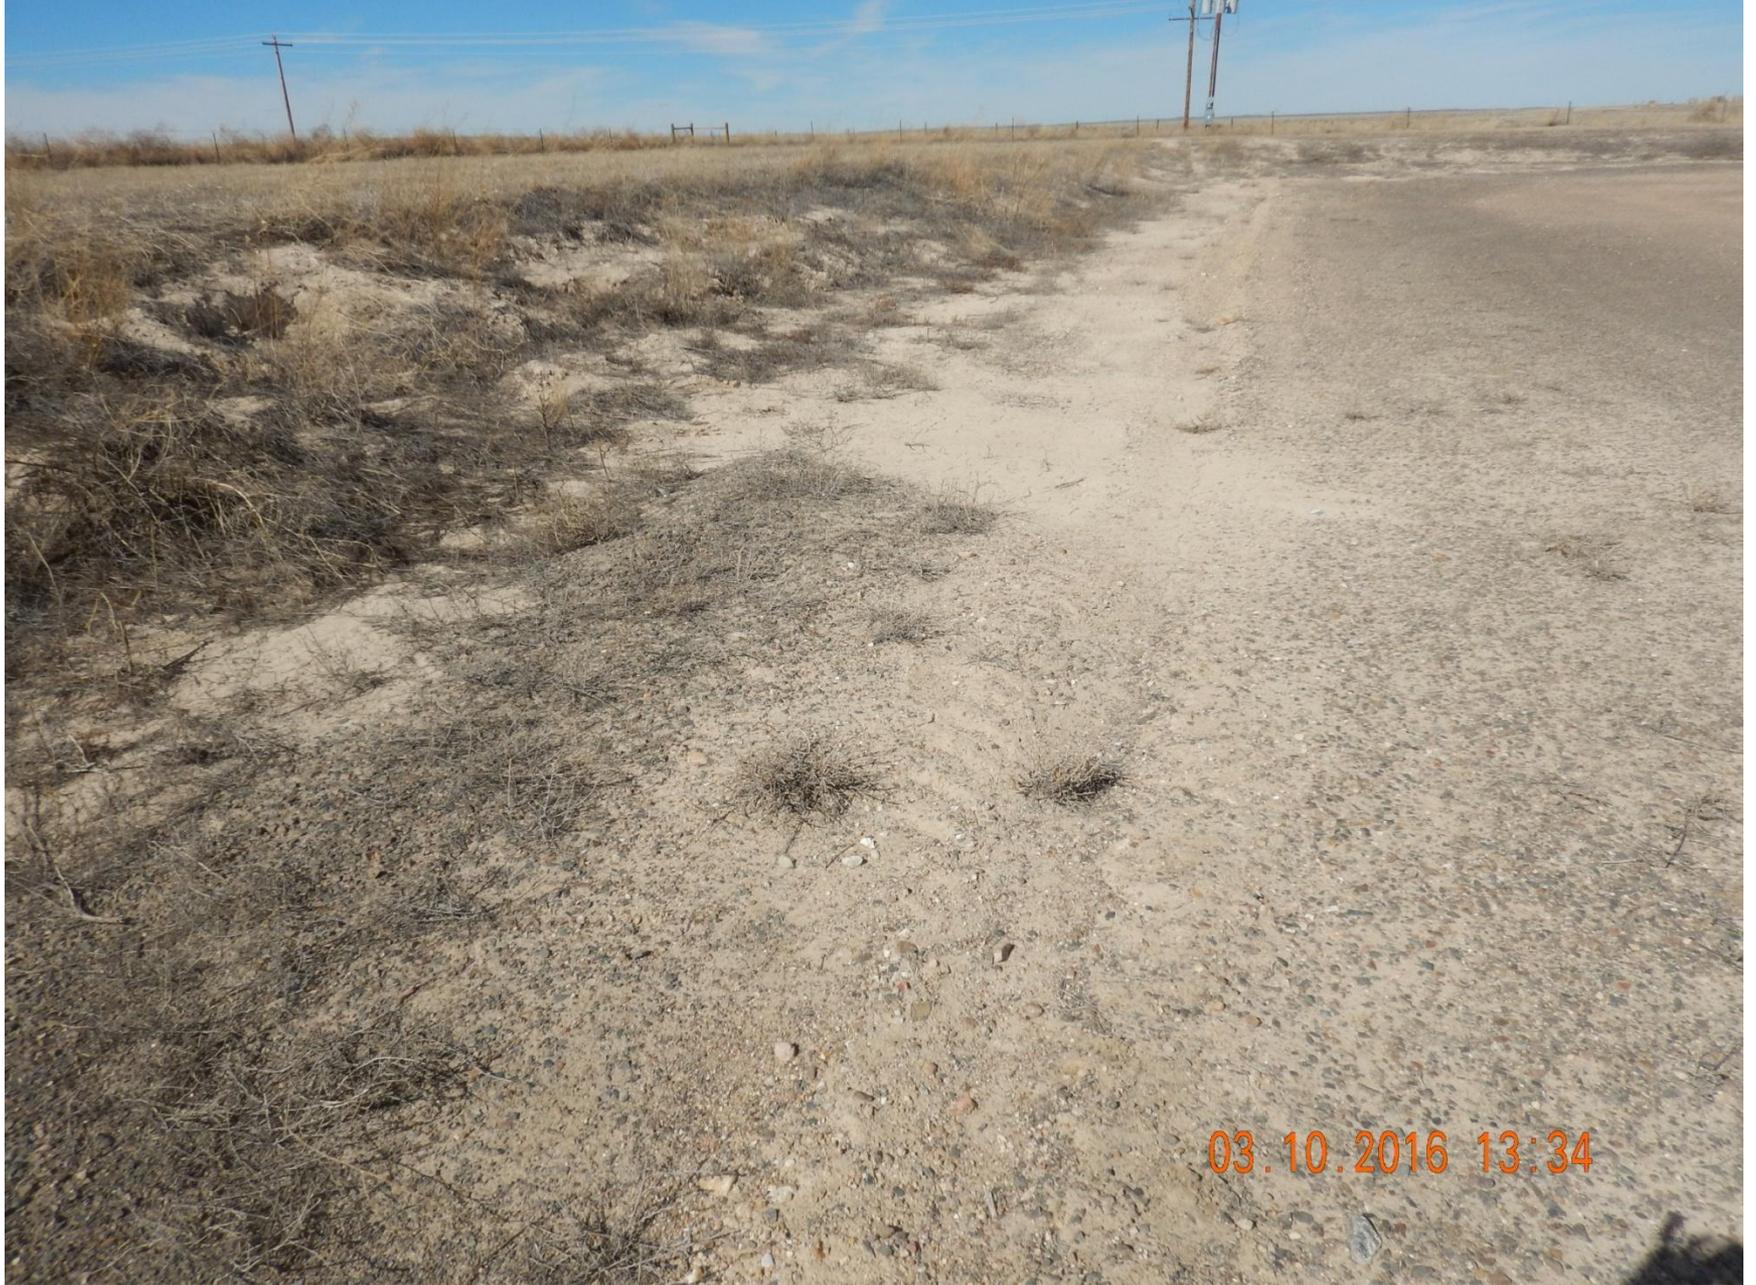
**Figure 12:** Photo taken from the western end of the project area, facing northwest. Photo shows erosion occurring on location.

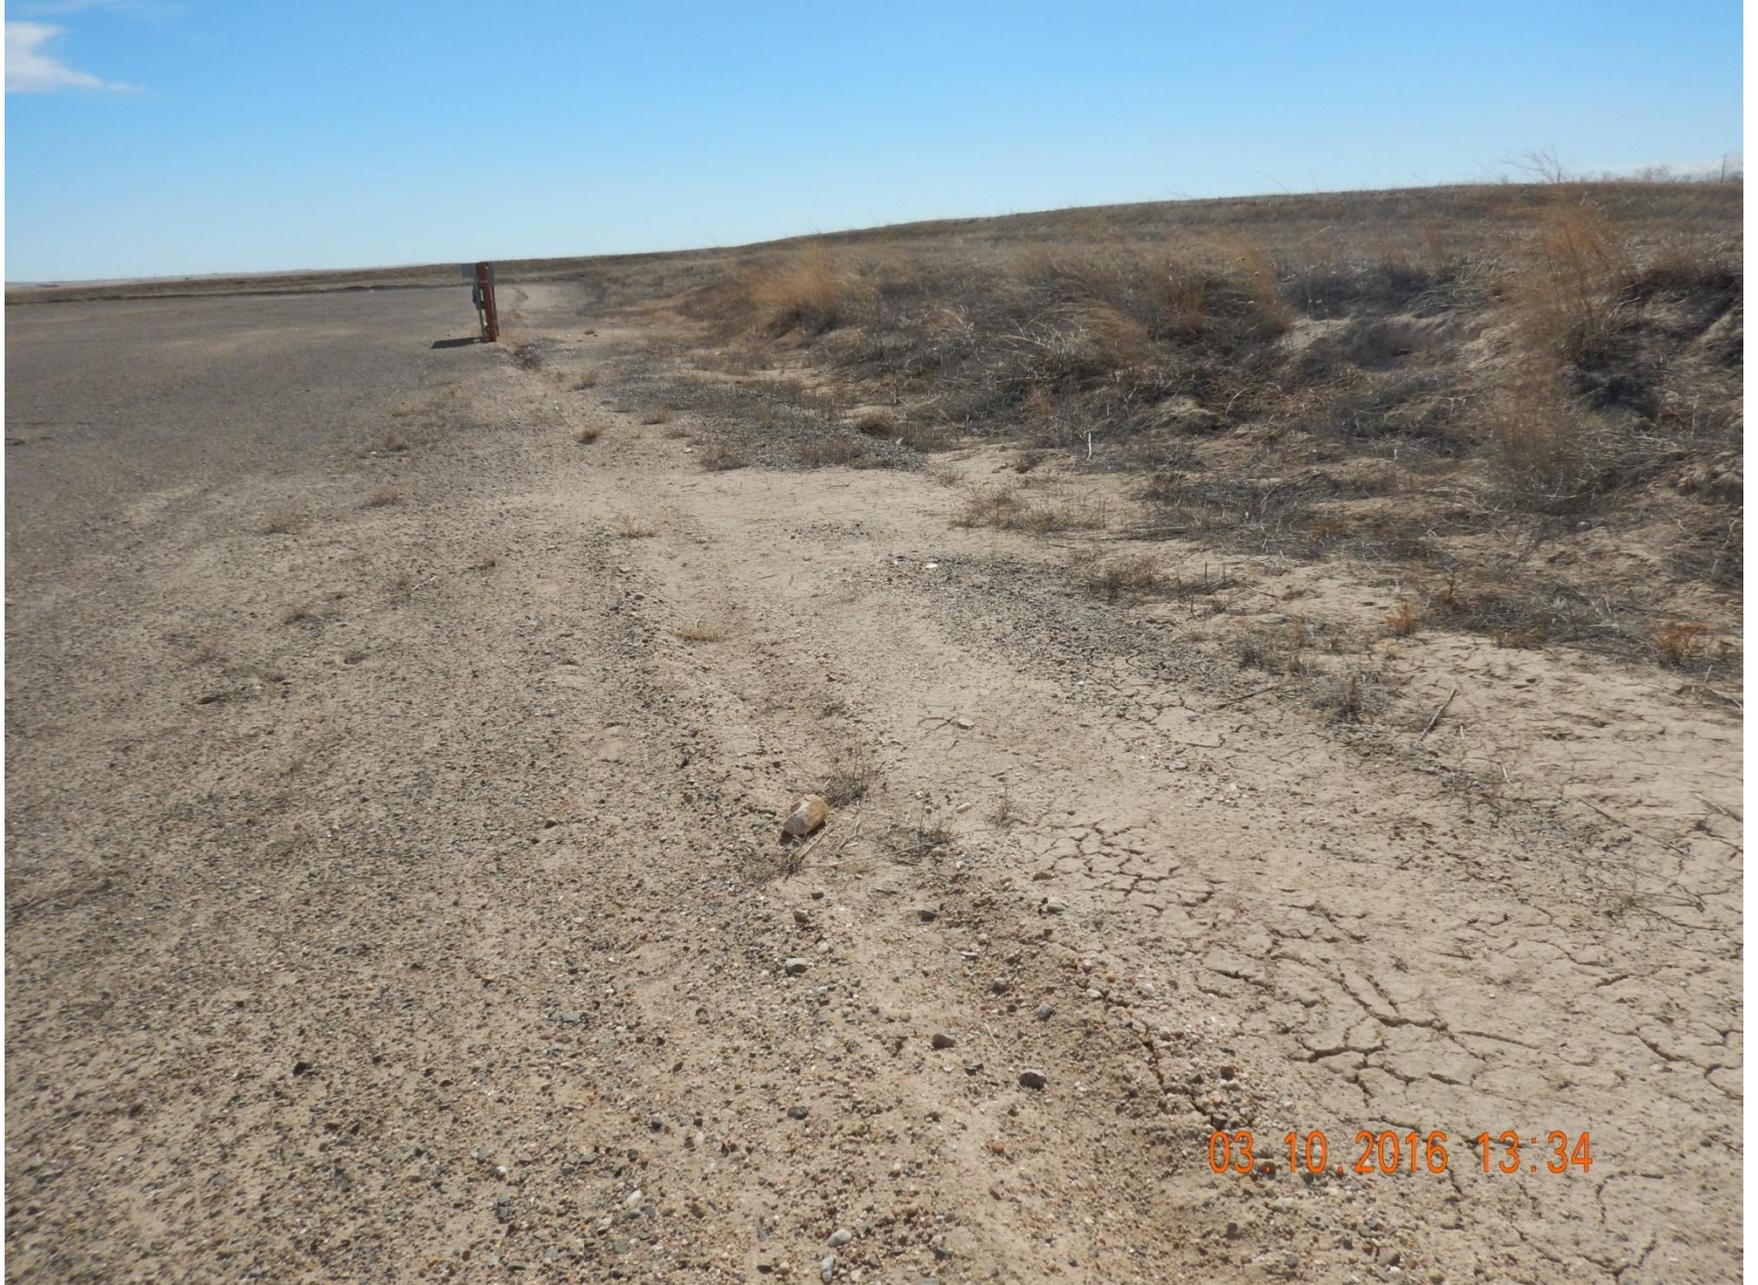
**Figure 13:** Photo taken from the western end of the project area, facing southwest. Photo shows erosion occurring on location.

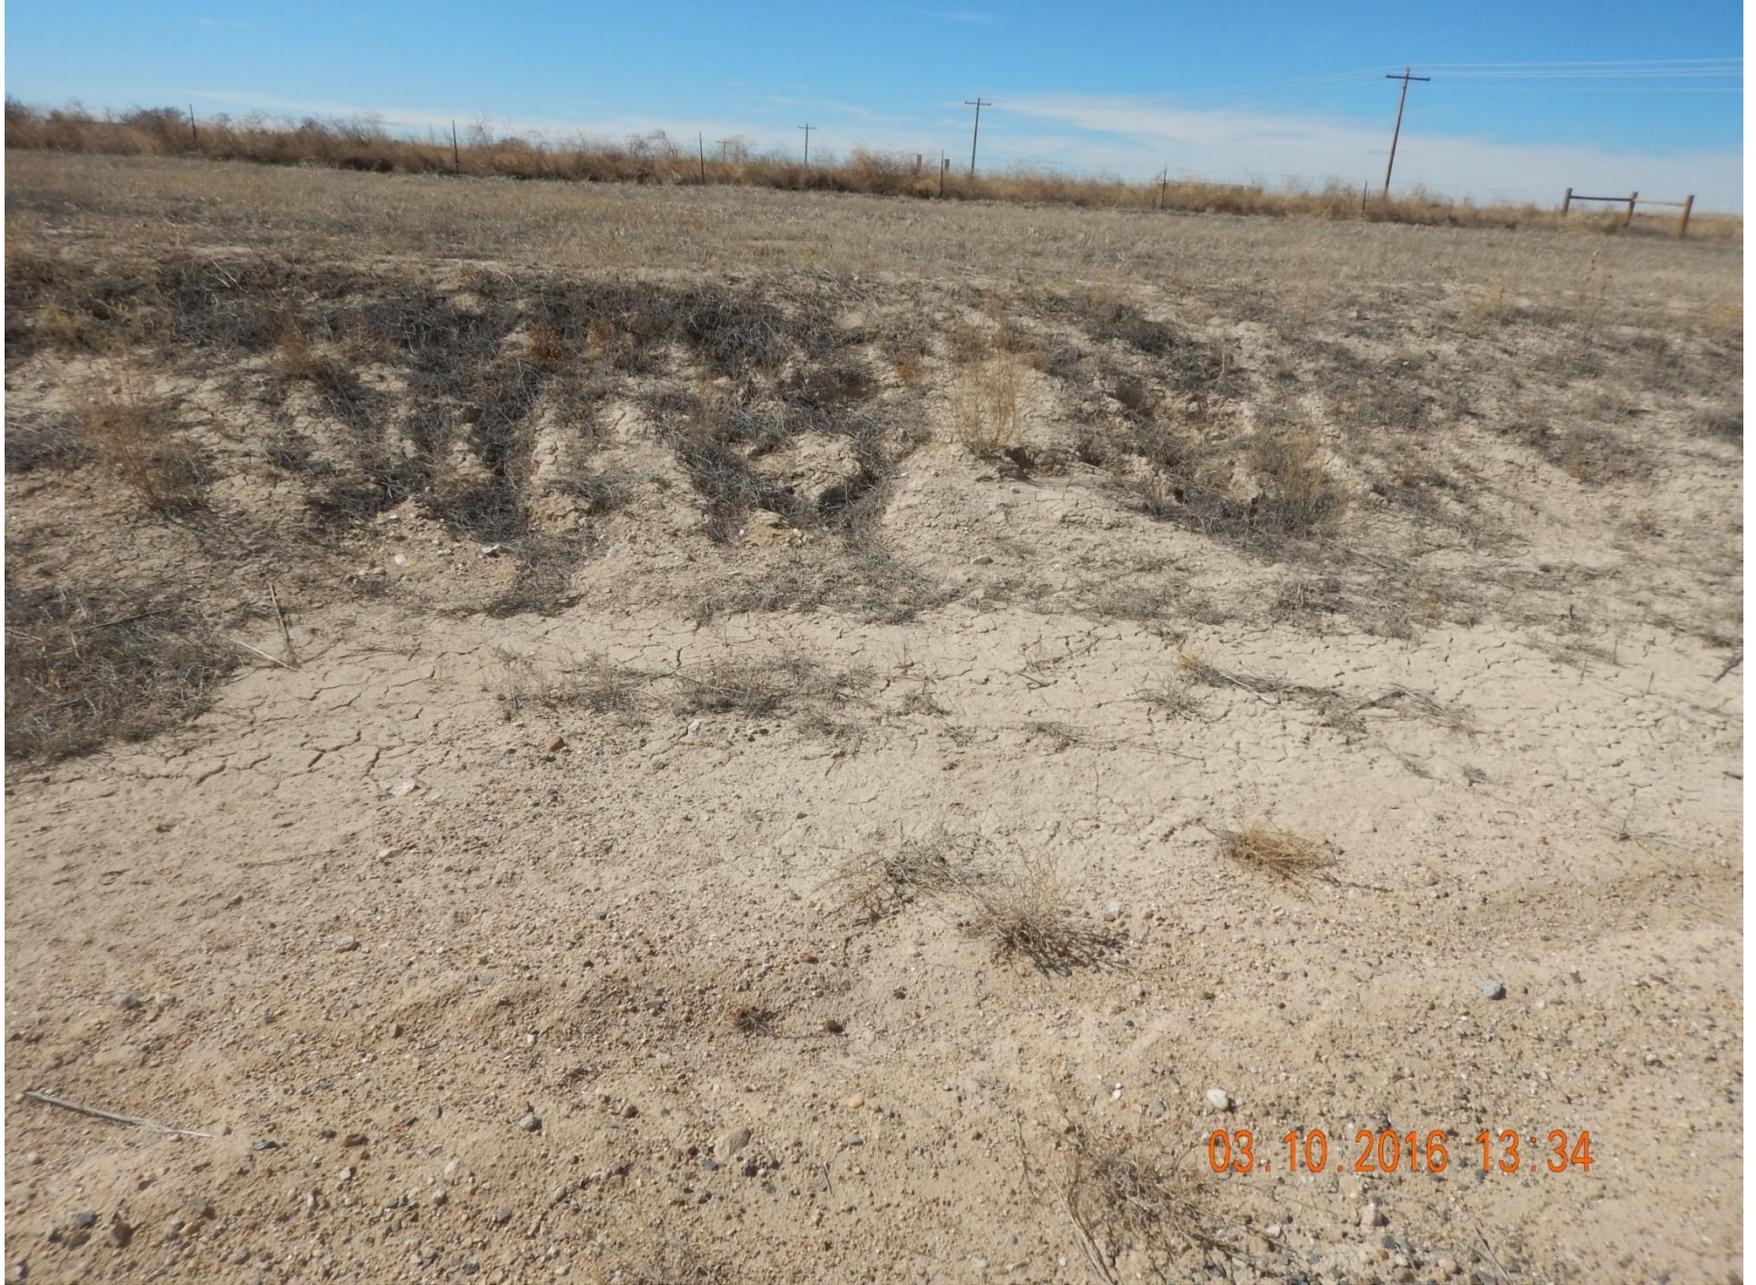
**Figure 14:** Photo taken from the western end of the project area, facing west. Photo shows erosion occurring on location.

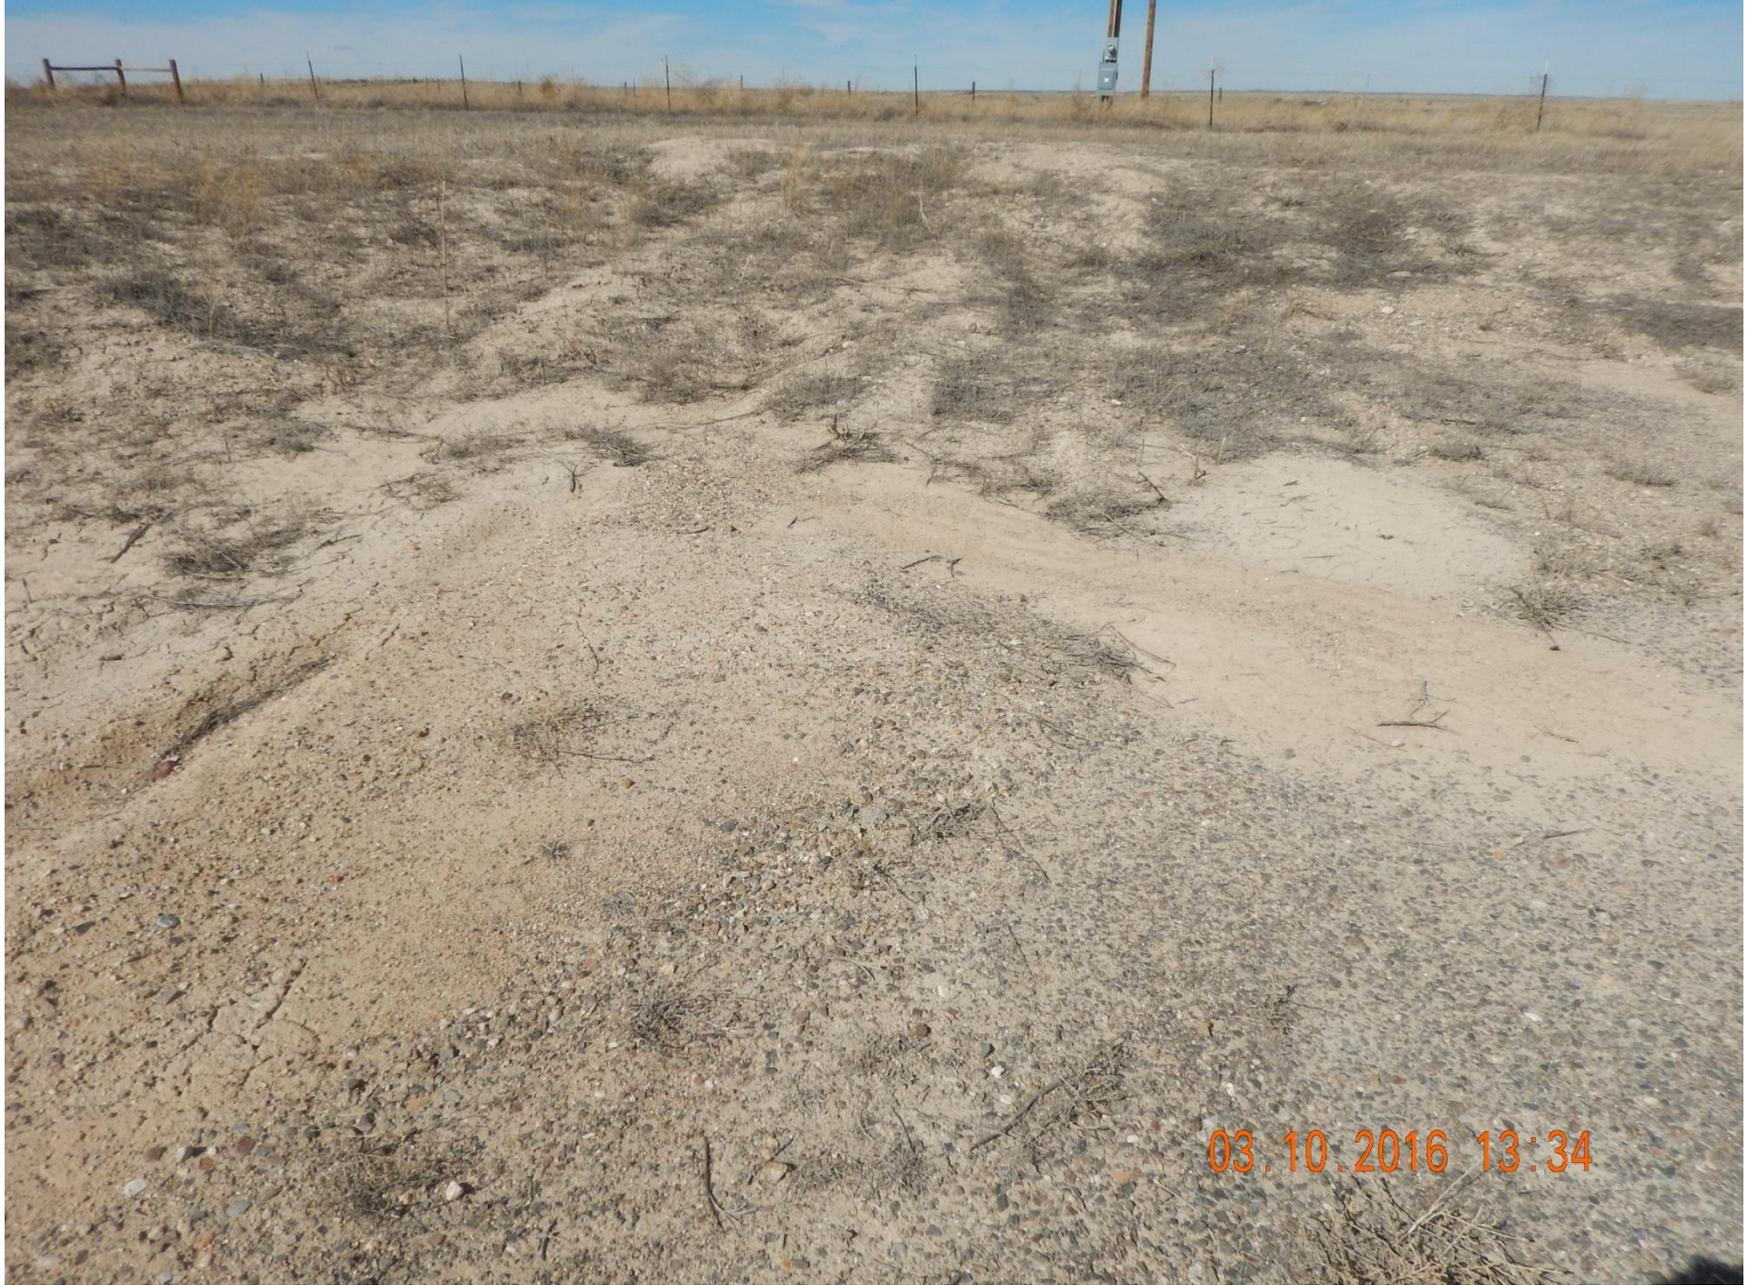
**Figure 15:** Photo taken from the northwest end of the project area, facing northwest. Photo shows erosion occurring on location.

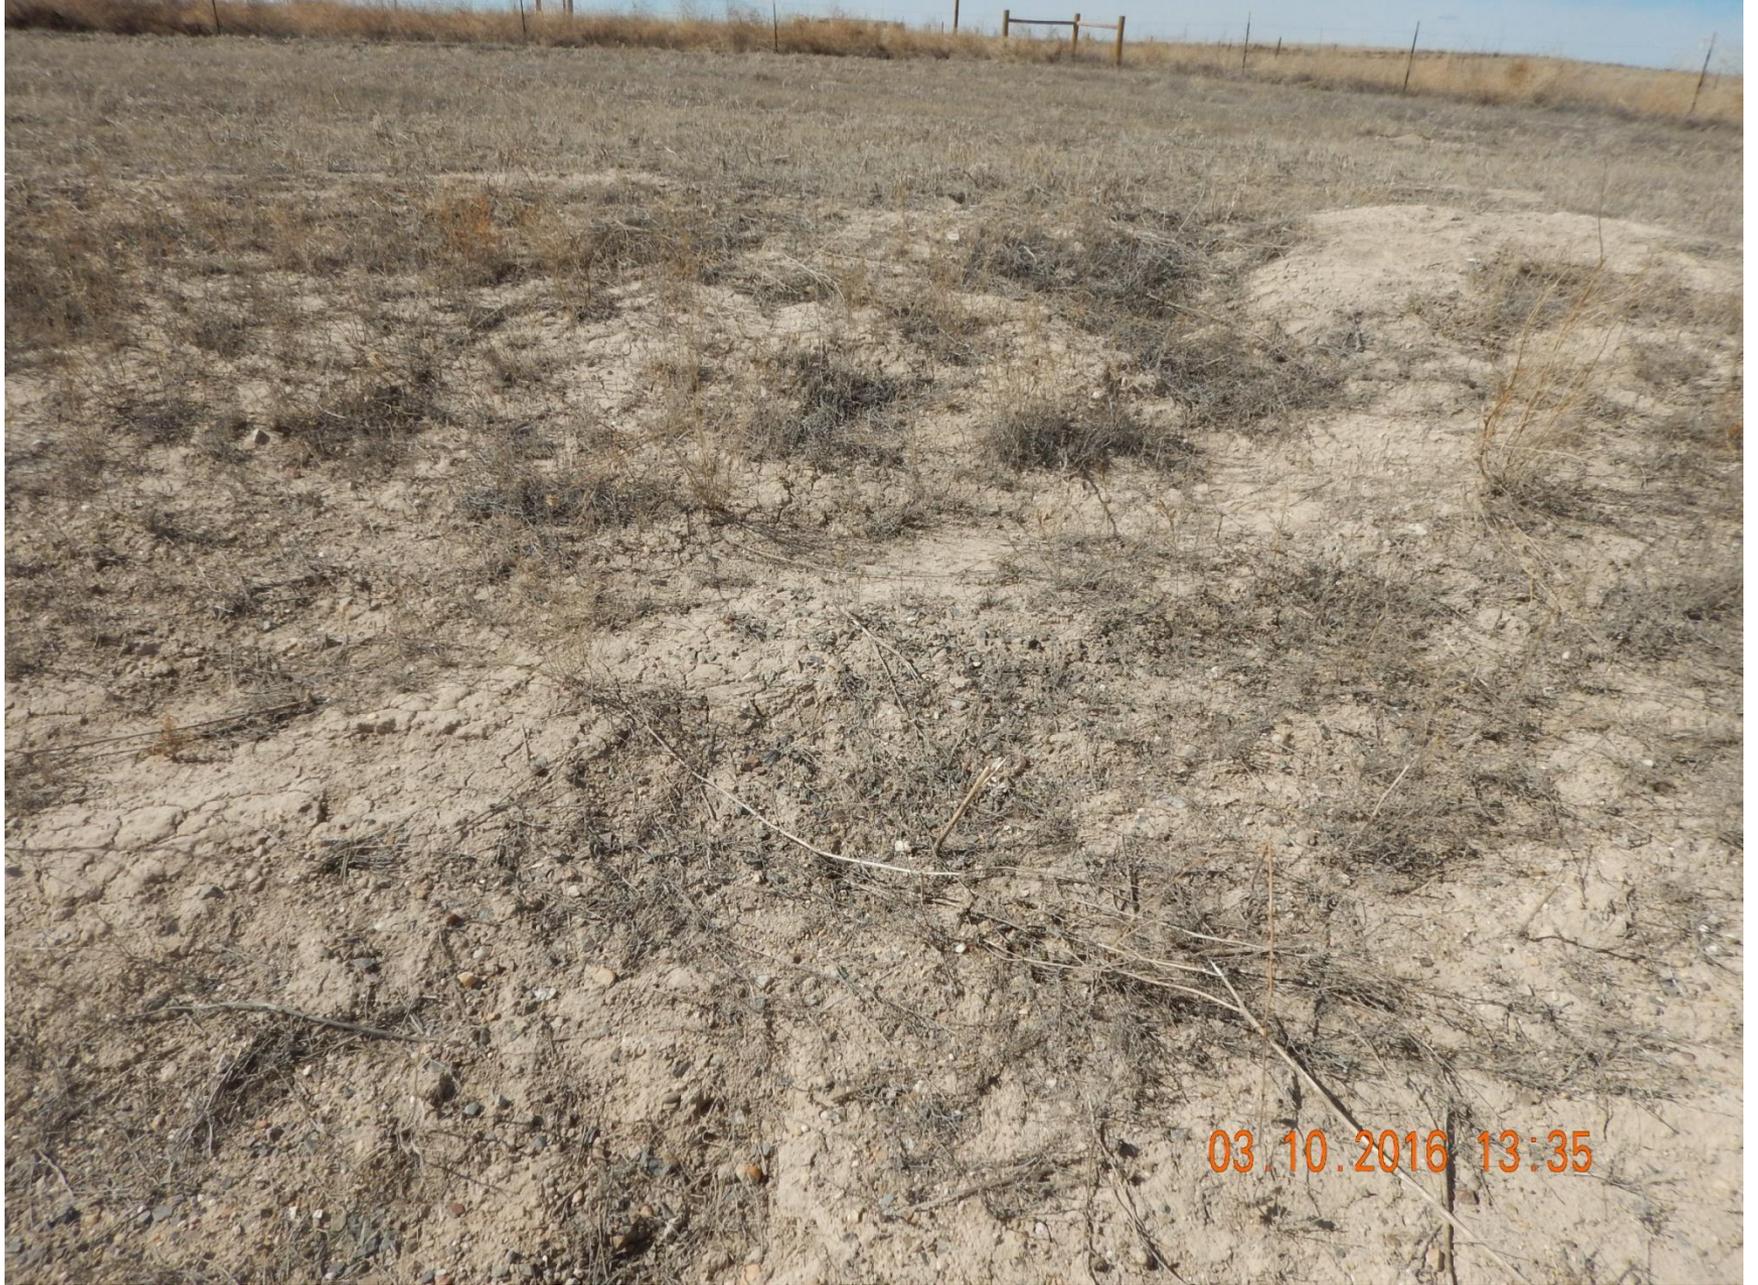
**Figure 16:** Photo taken from the northwest end of the project area, facing northwest. Photo shows erosion occurring on location.

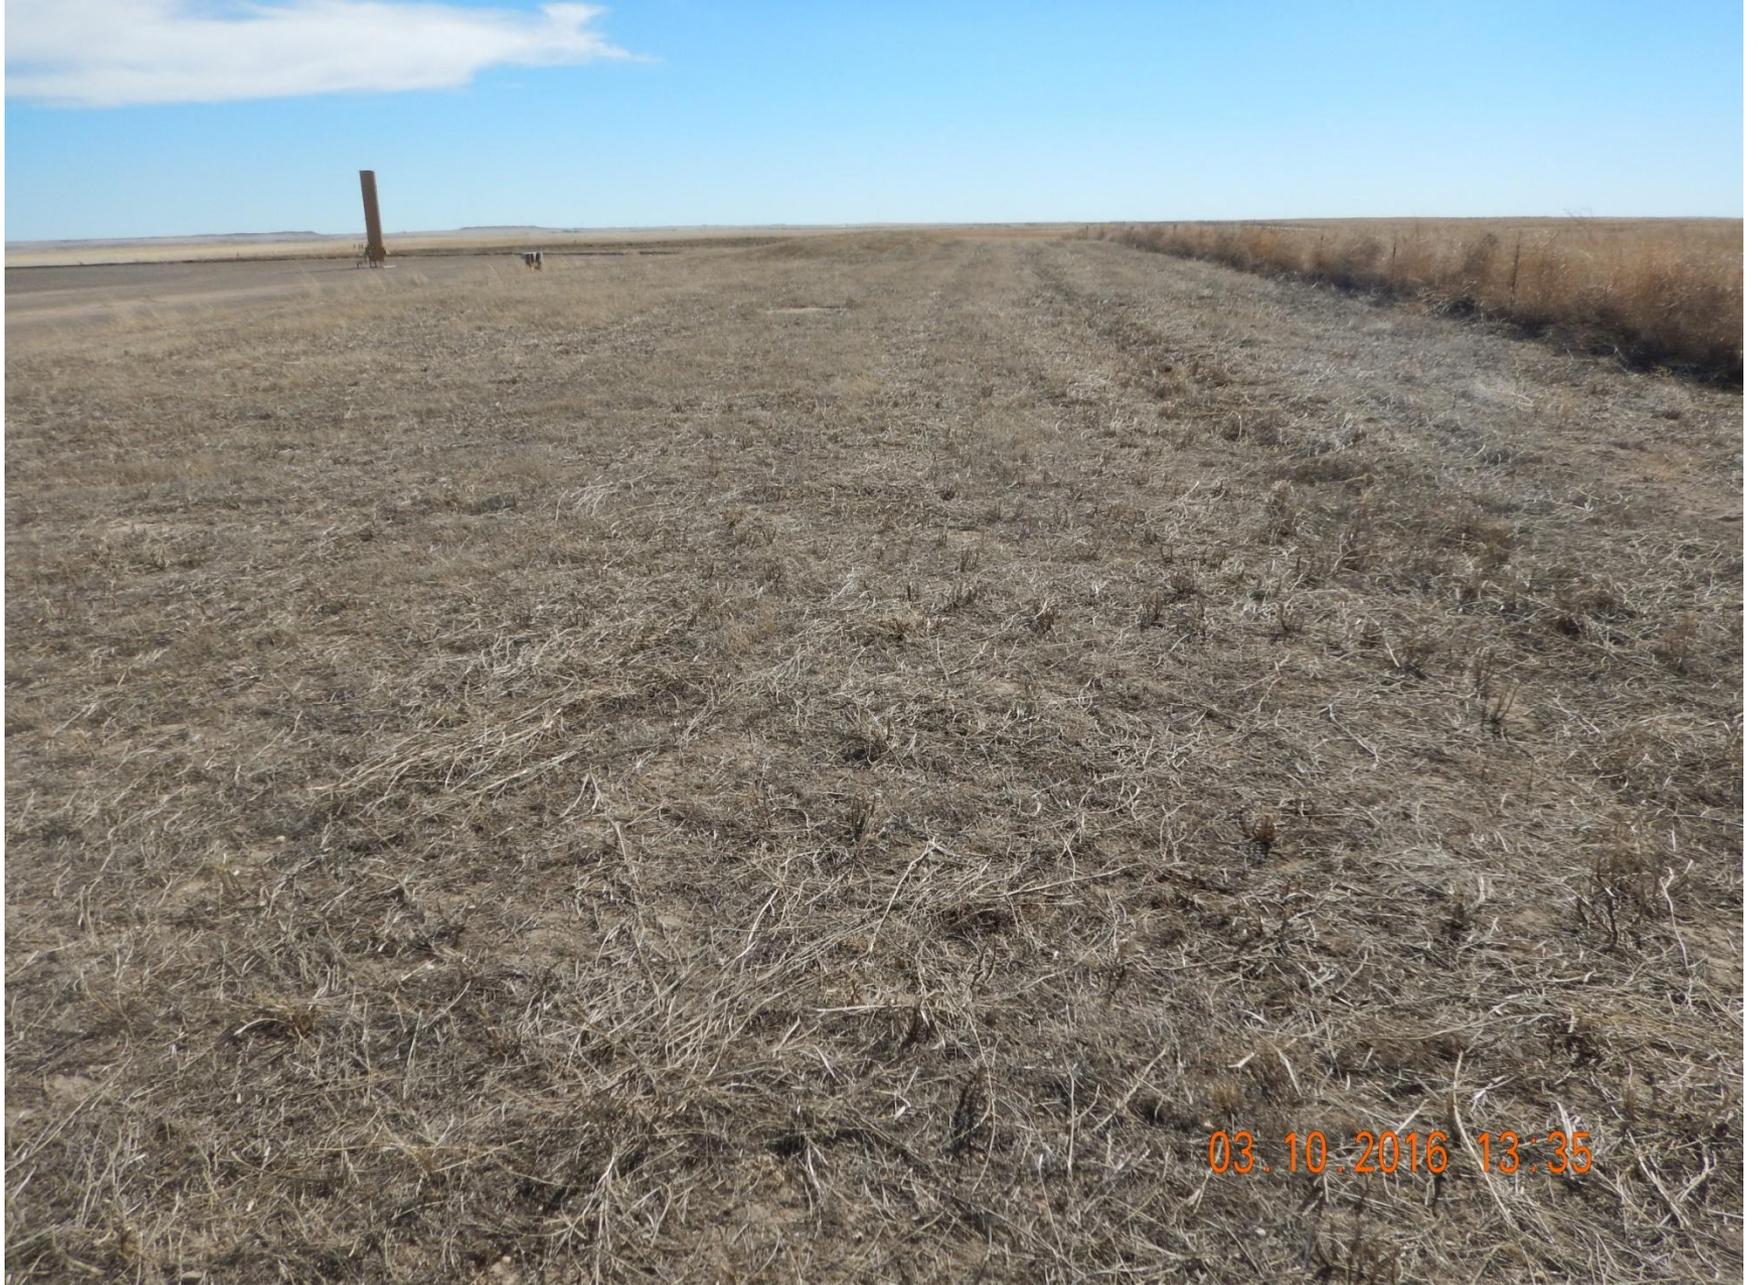
**Figure 17:** Photo taken from the northwest corner of the location, facing south. Photo shows vegetation on the current interim area. Note vegetation is predominantly undesirable weedy plant species.

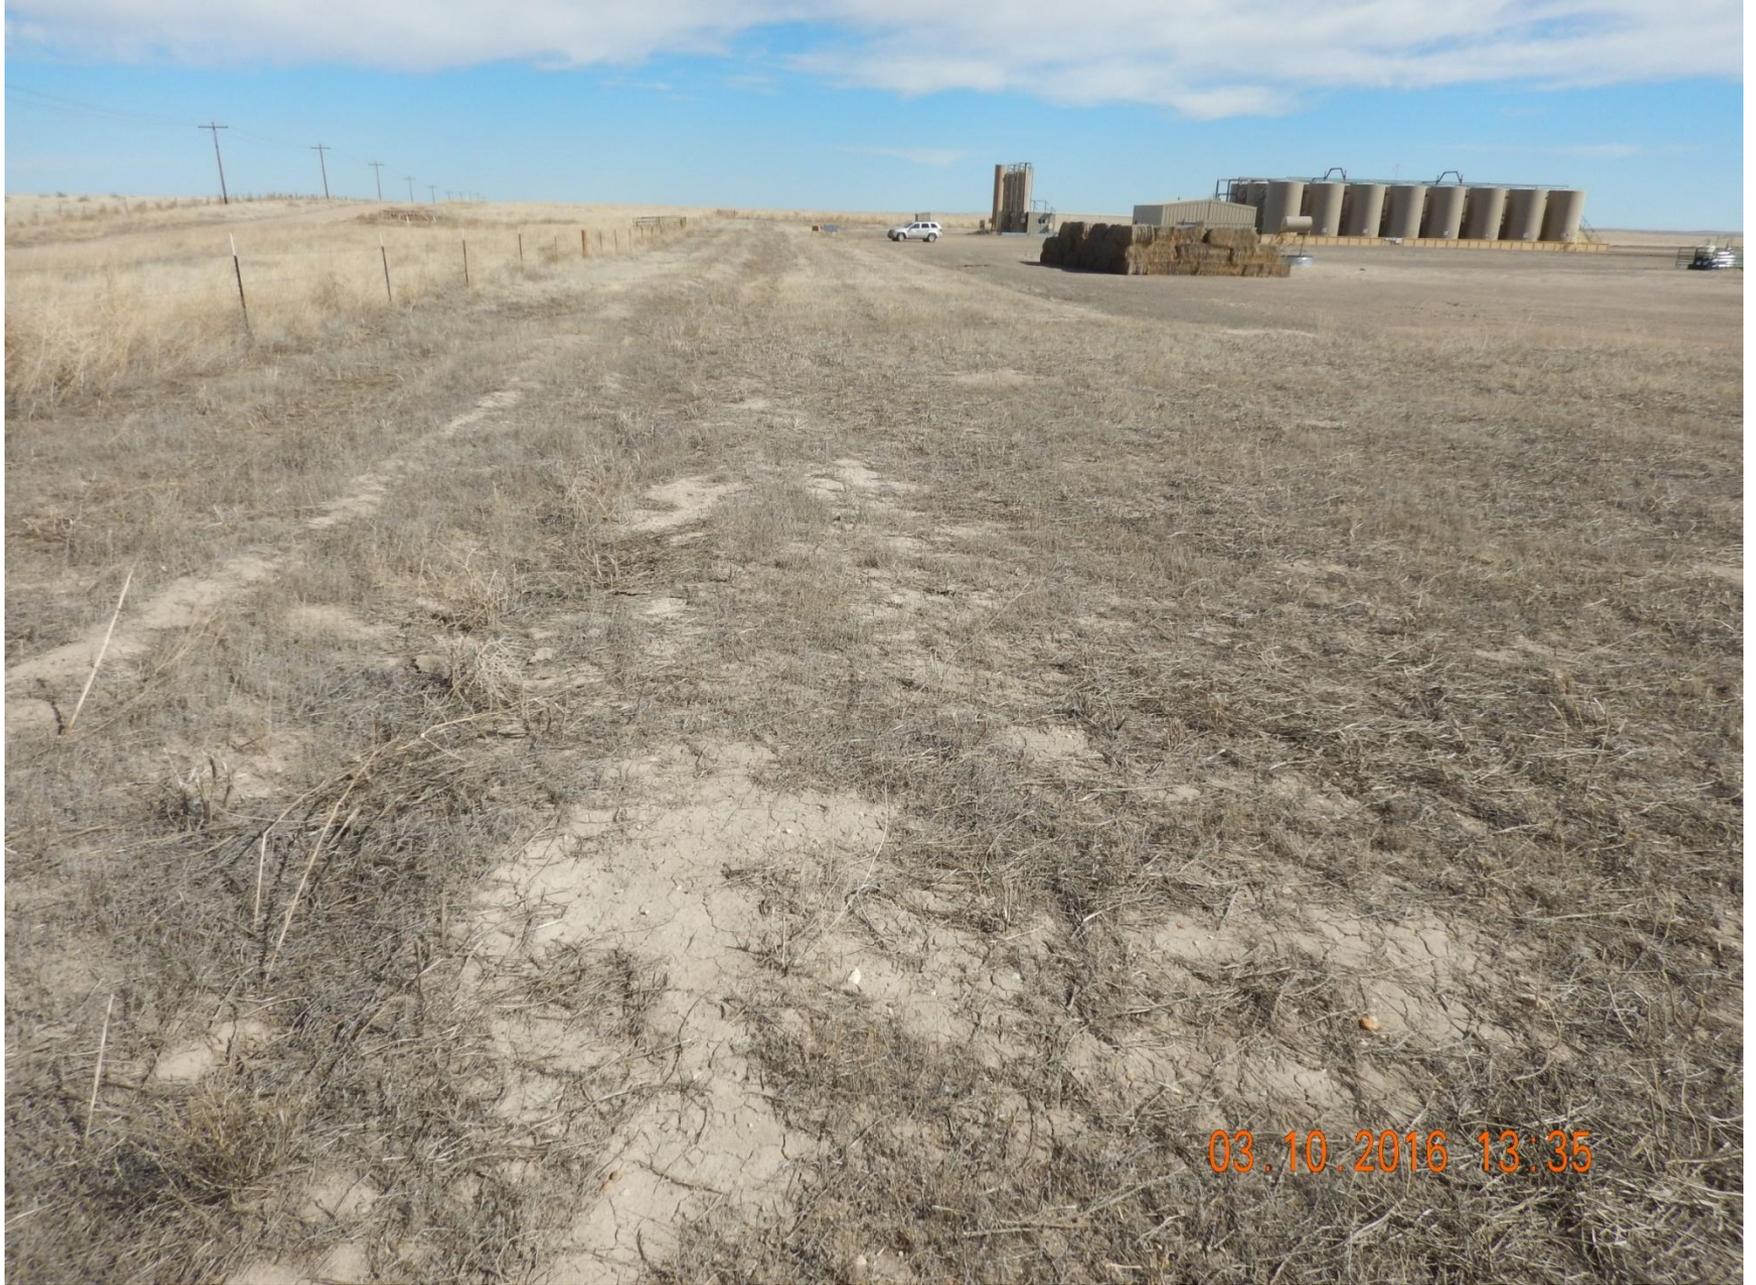
**Figure 18:** Photo taken from the northwest corner of the location, facing east. Photo shows vegetation on the current interim area. Note vegetation is predominantly undesirable weedy plant species.

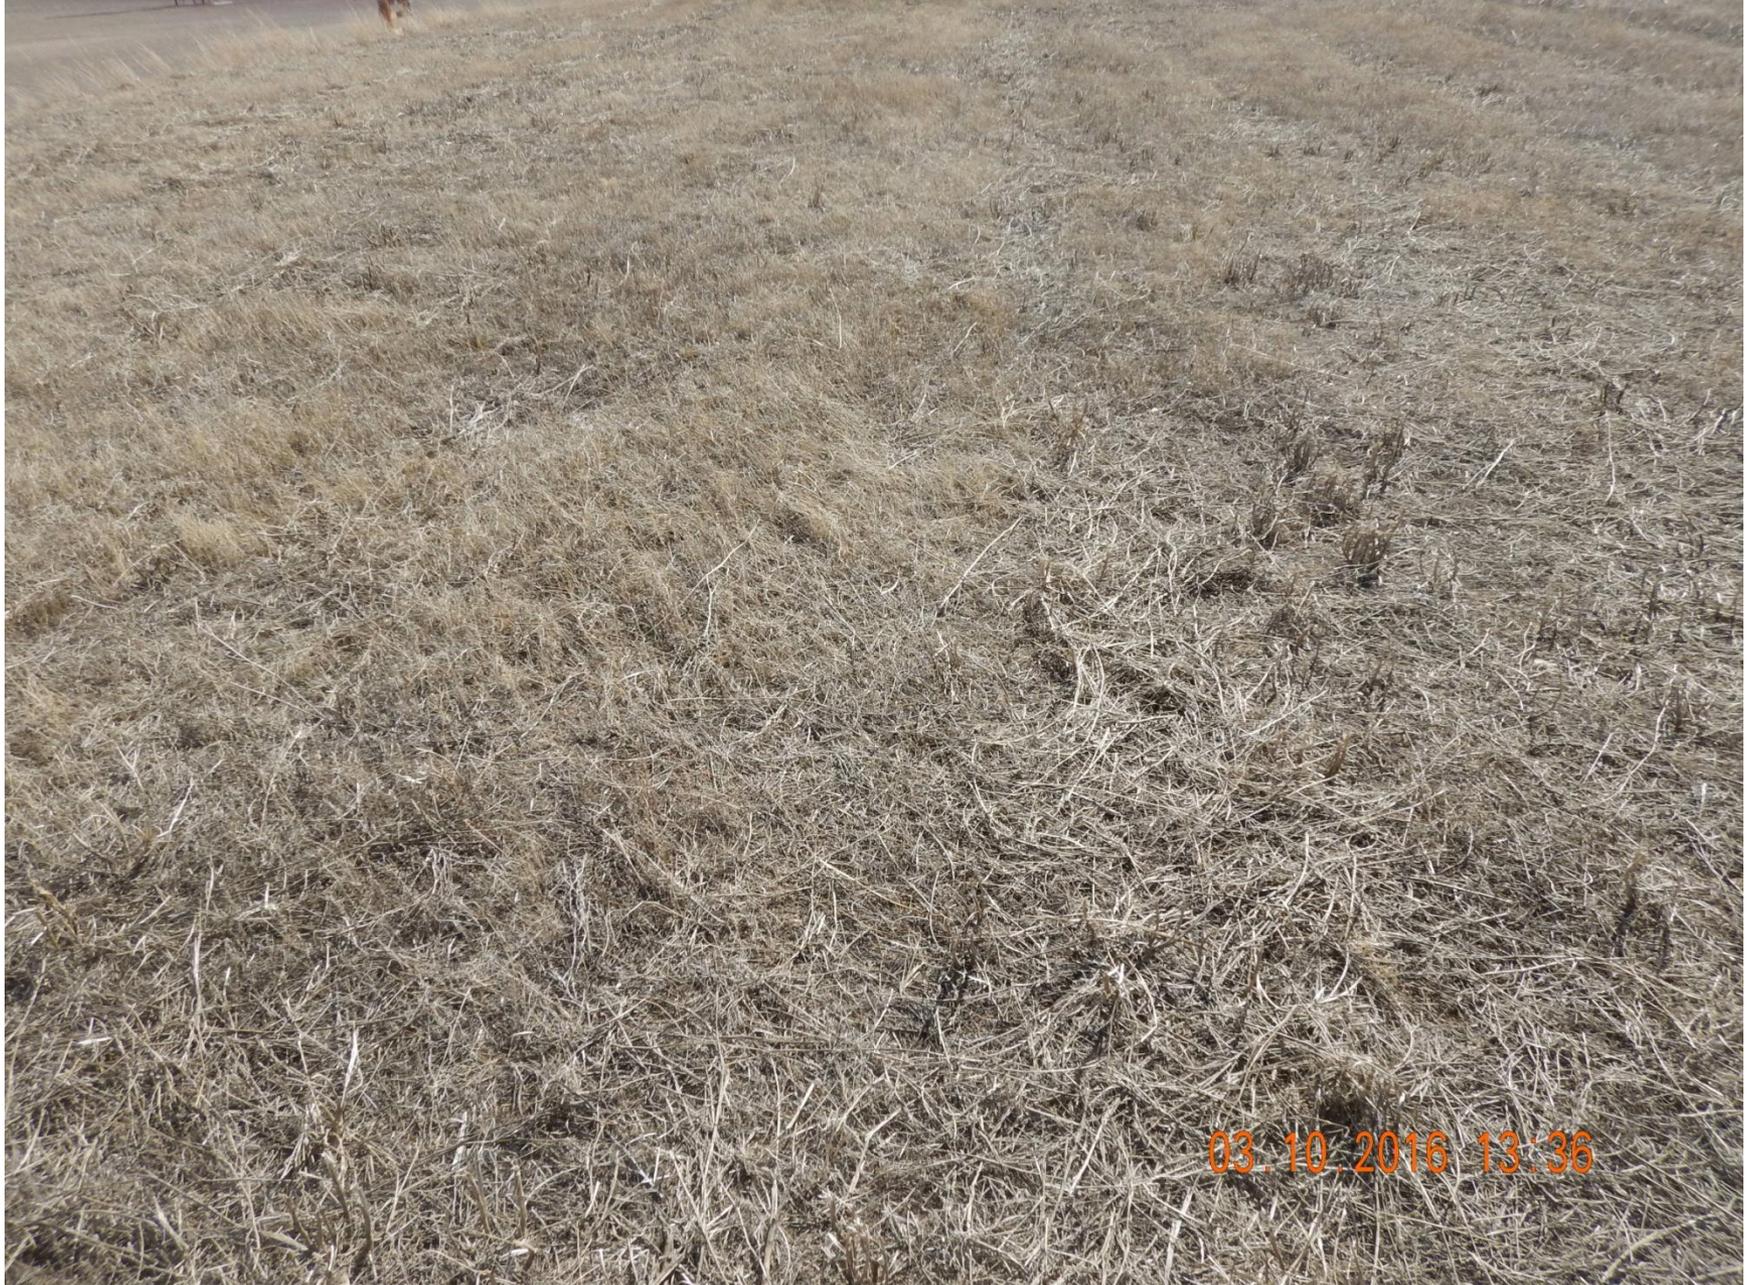
**Figure 19:** Photo taken from the northwest corner of the location. Photo shows vegetation on the current interim area. Note vegetation is predominantly undesirable weedy plant species.

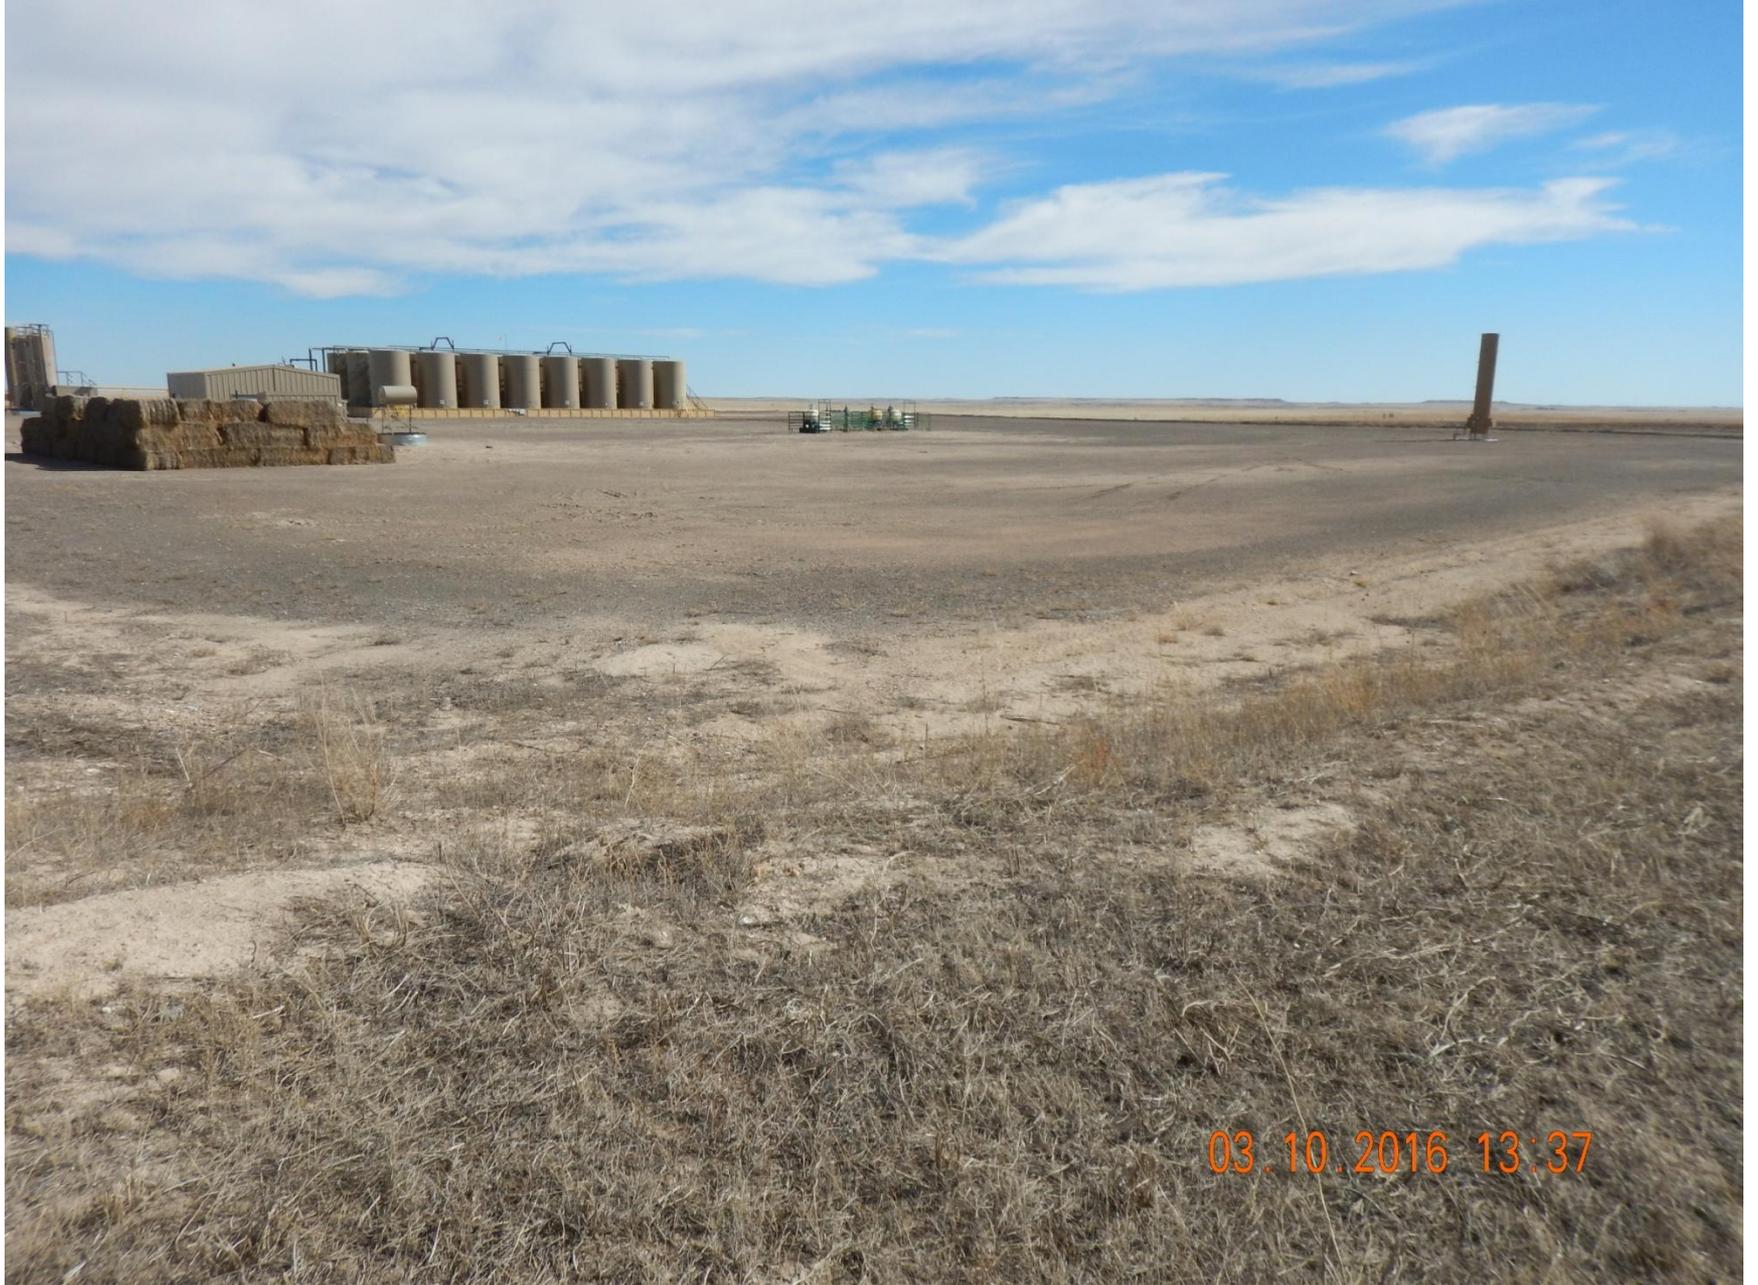
**Figure 20:** Photo taken from the northwest corner of the location, facing southeast. Photo shows project area.
