# Interim Reclamation Inspection

3/10/2016

Operator: Carrizo

Location: 434923

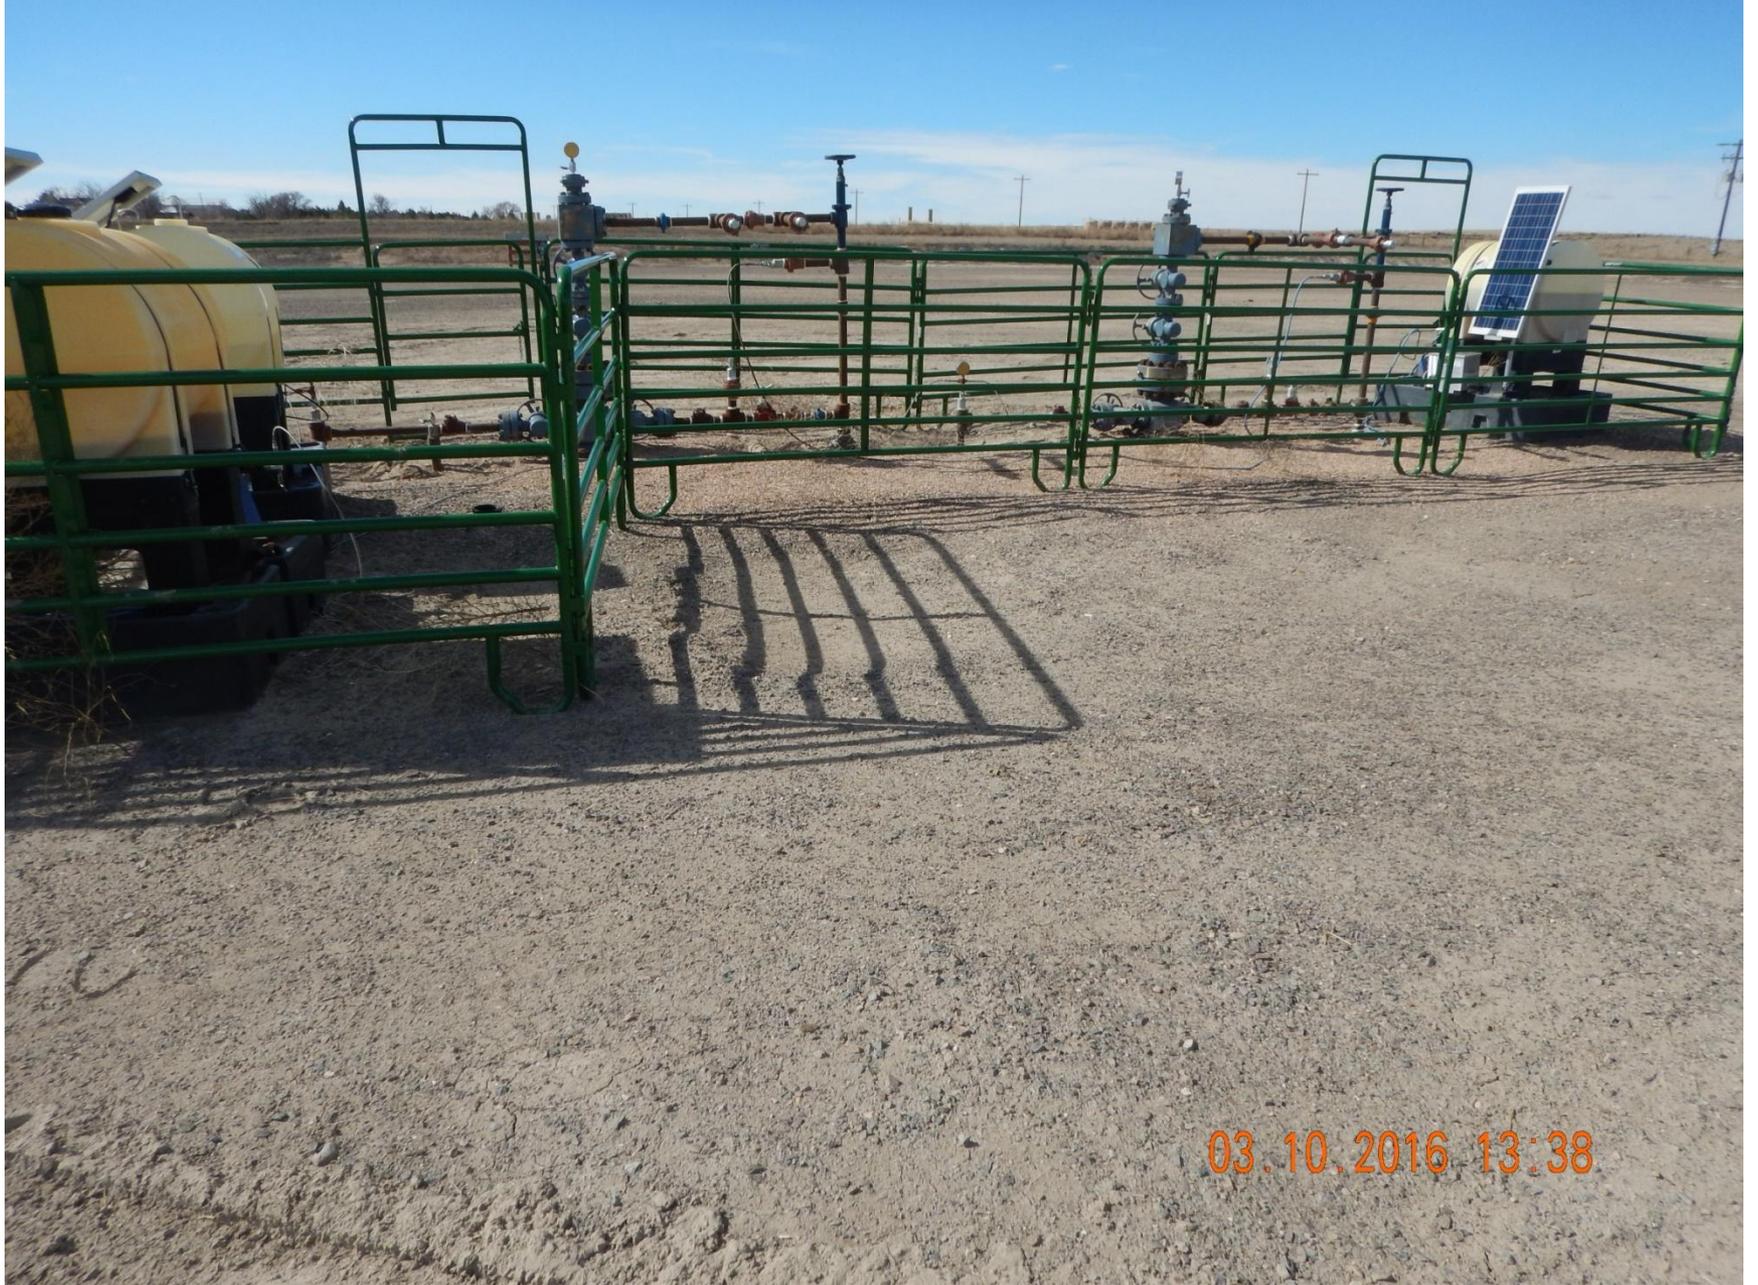
**Figure 21:** Photo taken from the producing wells, facing west. Photo shows signs missing from wells.

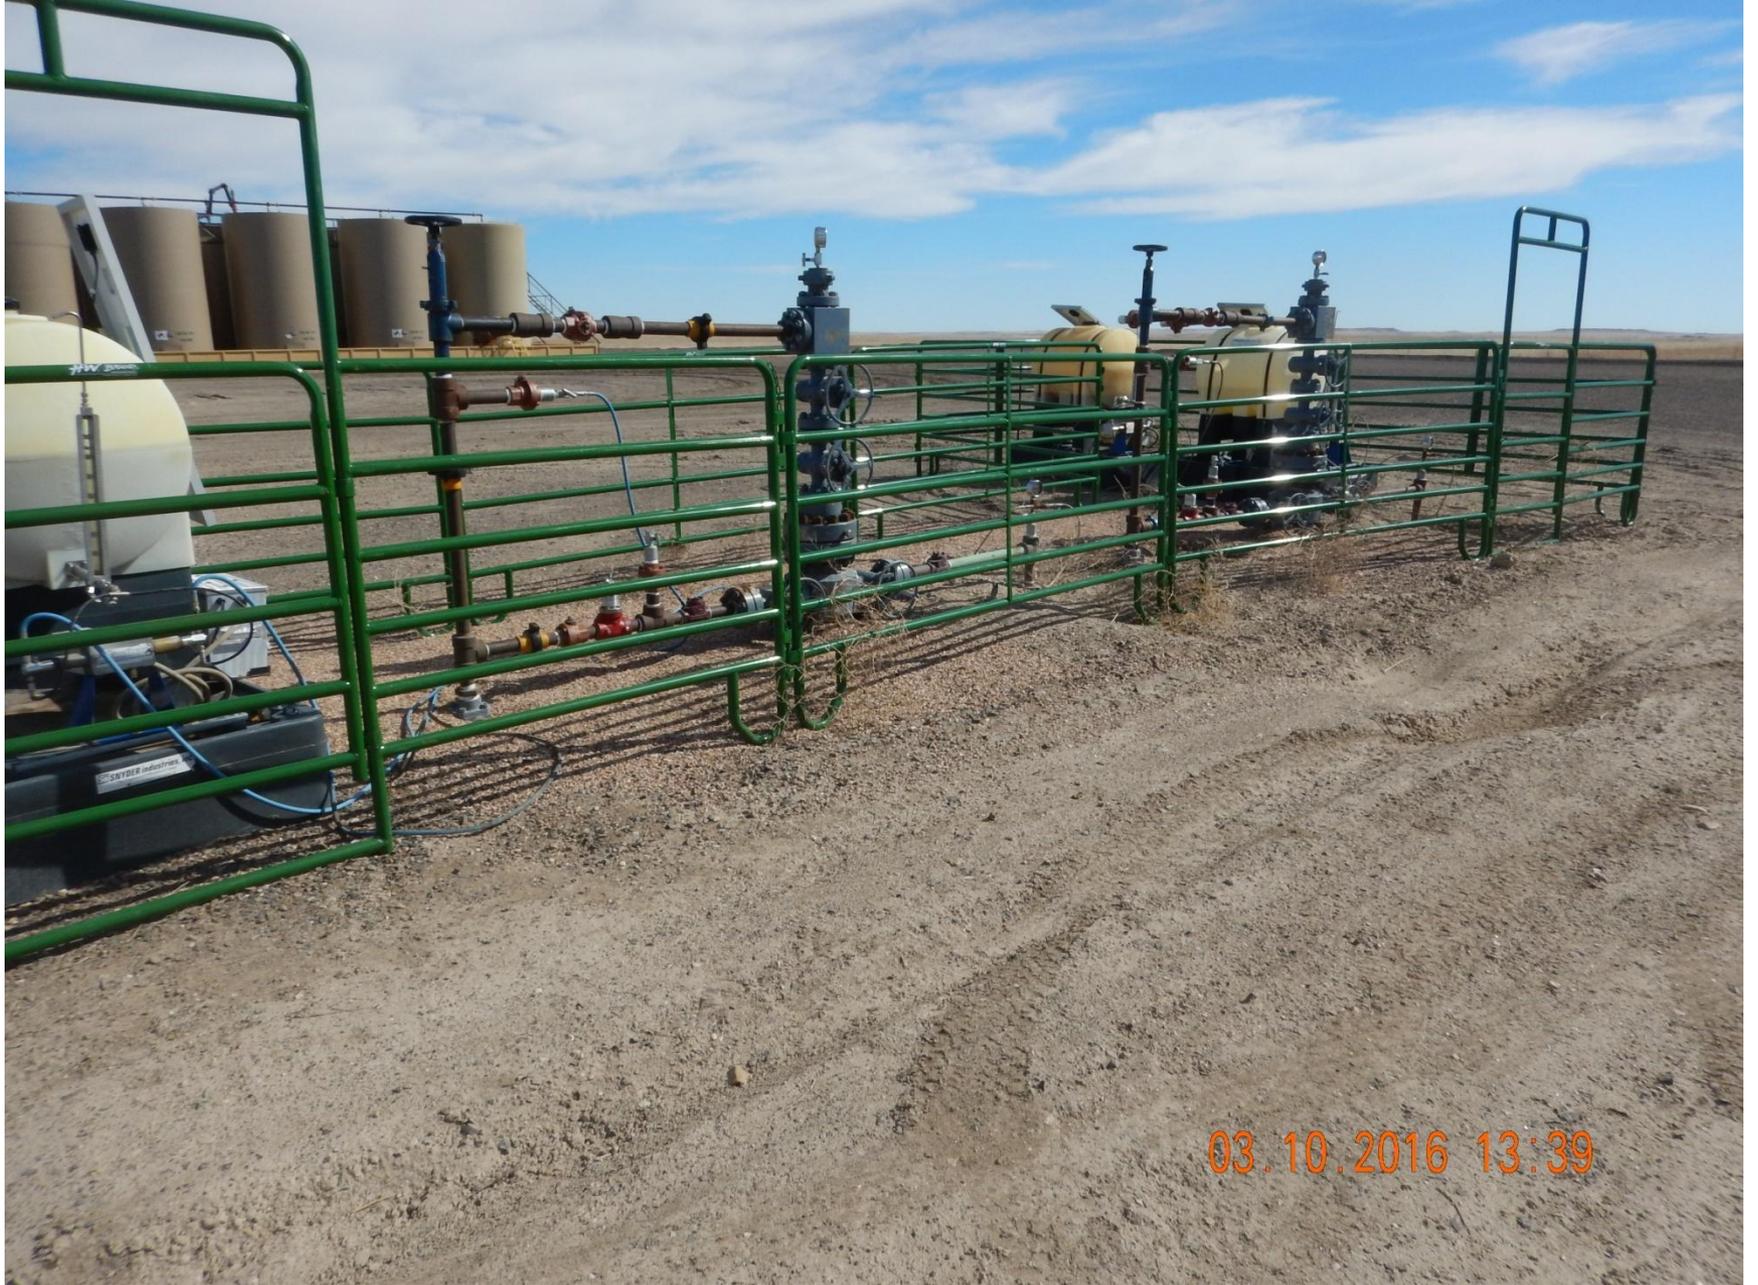
**Figure 22:** Photo taken from the producing wells, facing southeast. Photo shows signs missing from wells.

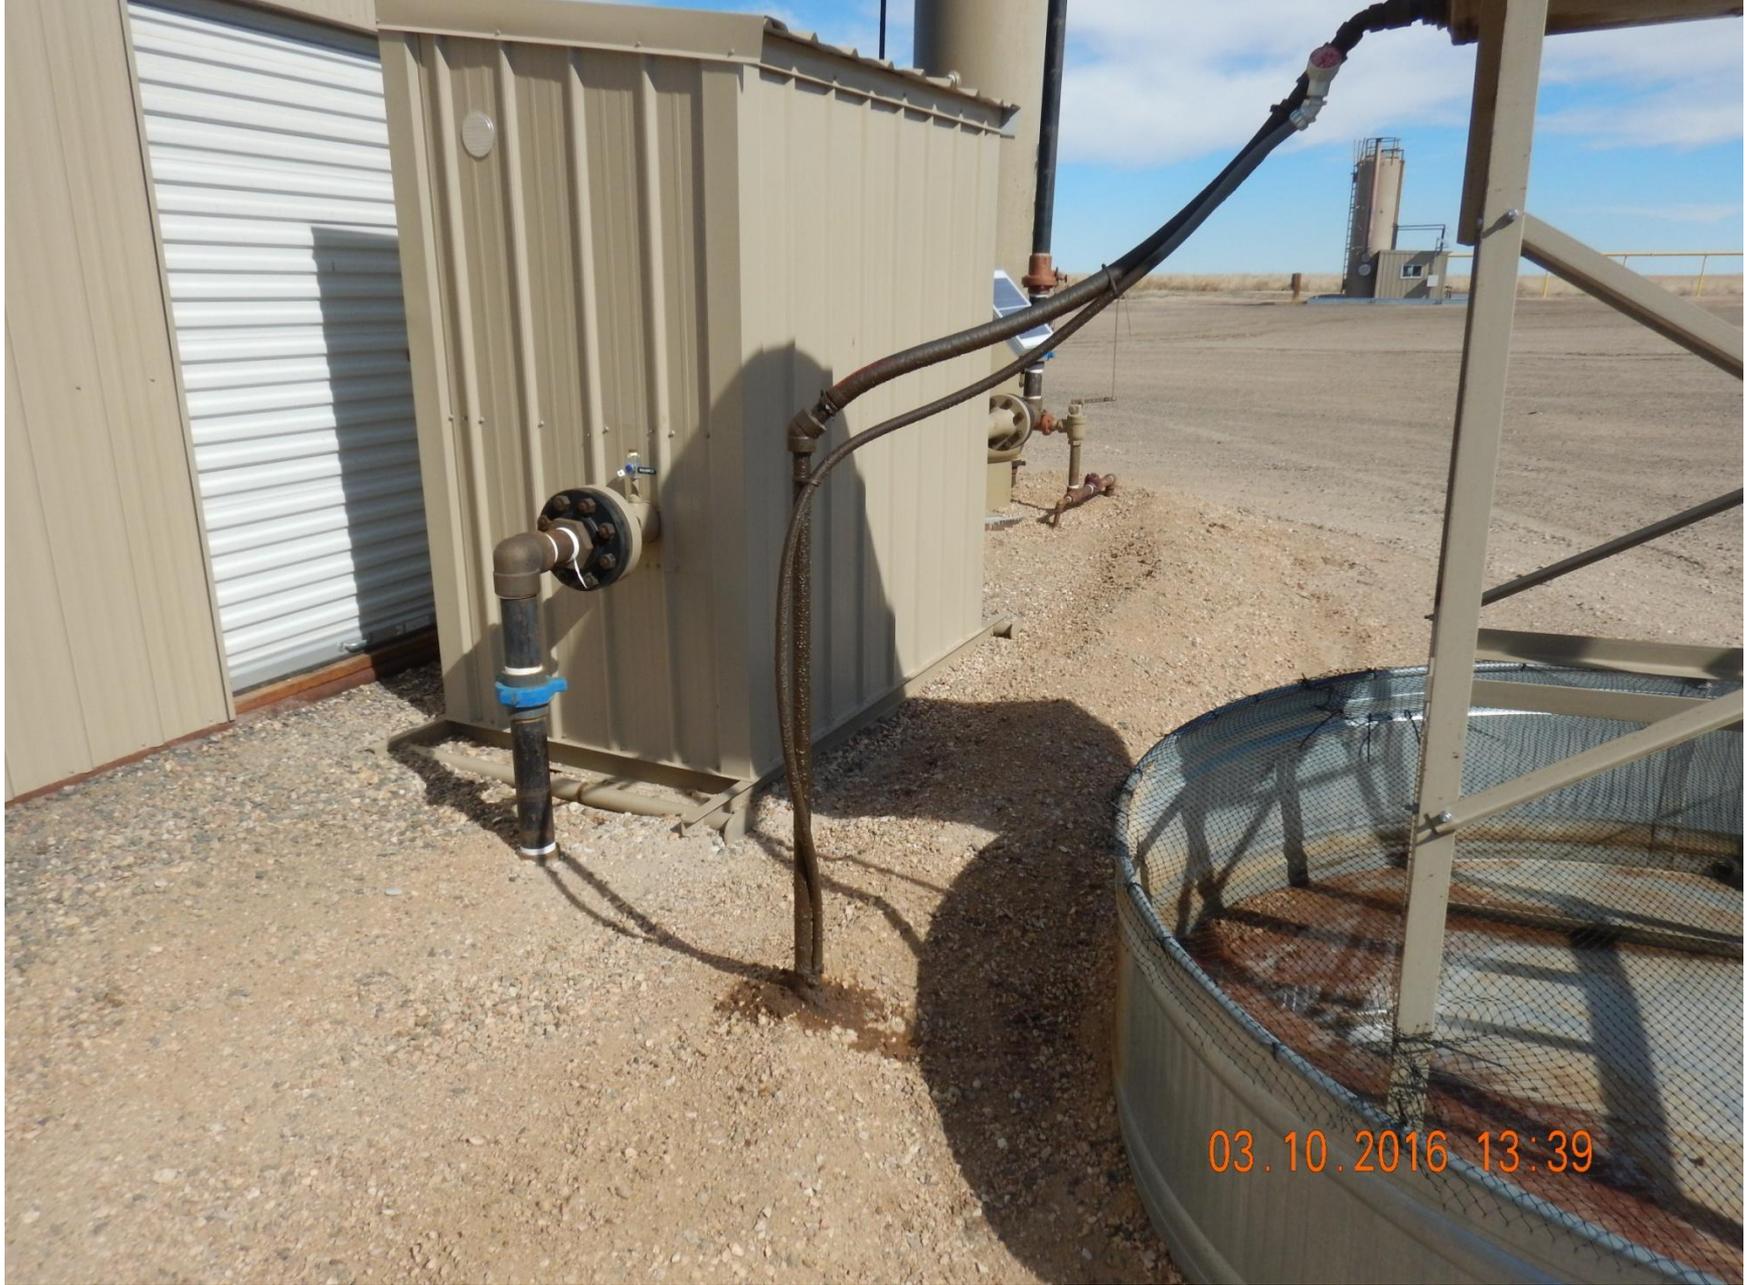
**Figure 24:** Photo taken from gas lift engine facility on the north end of the location. Photo shows pipe covered in oil, and stained soil.
