Construction Inspection

3/11/2016

Operator: Whiting

Location ID: 442408

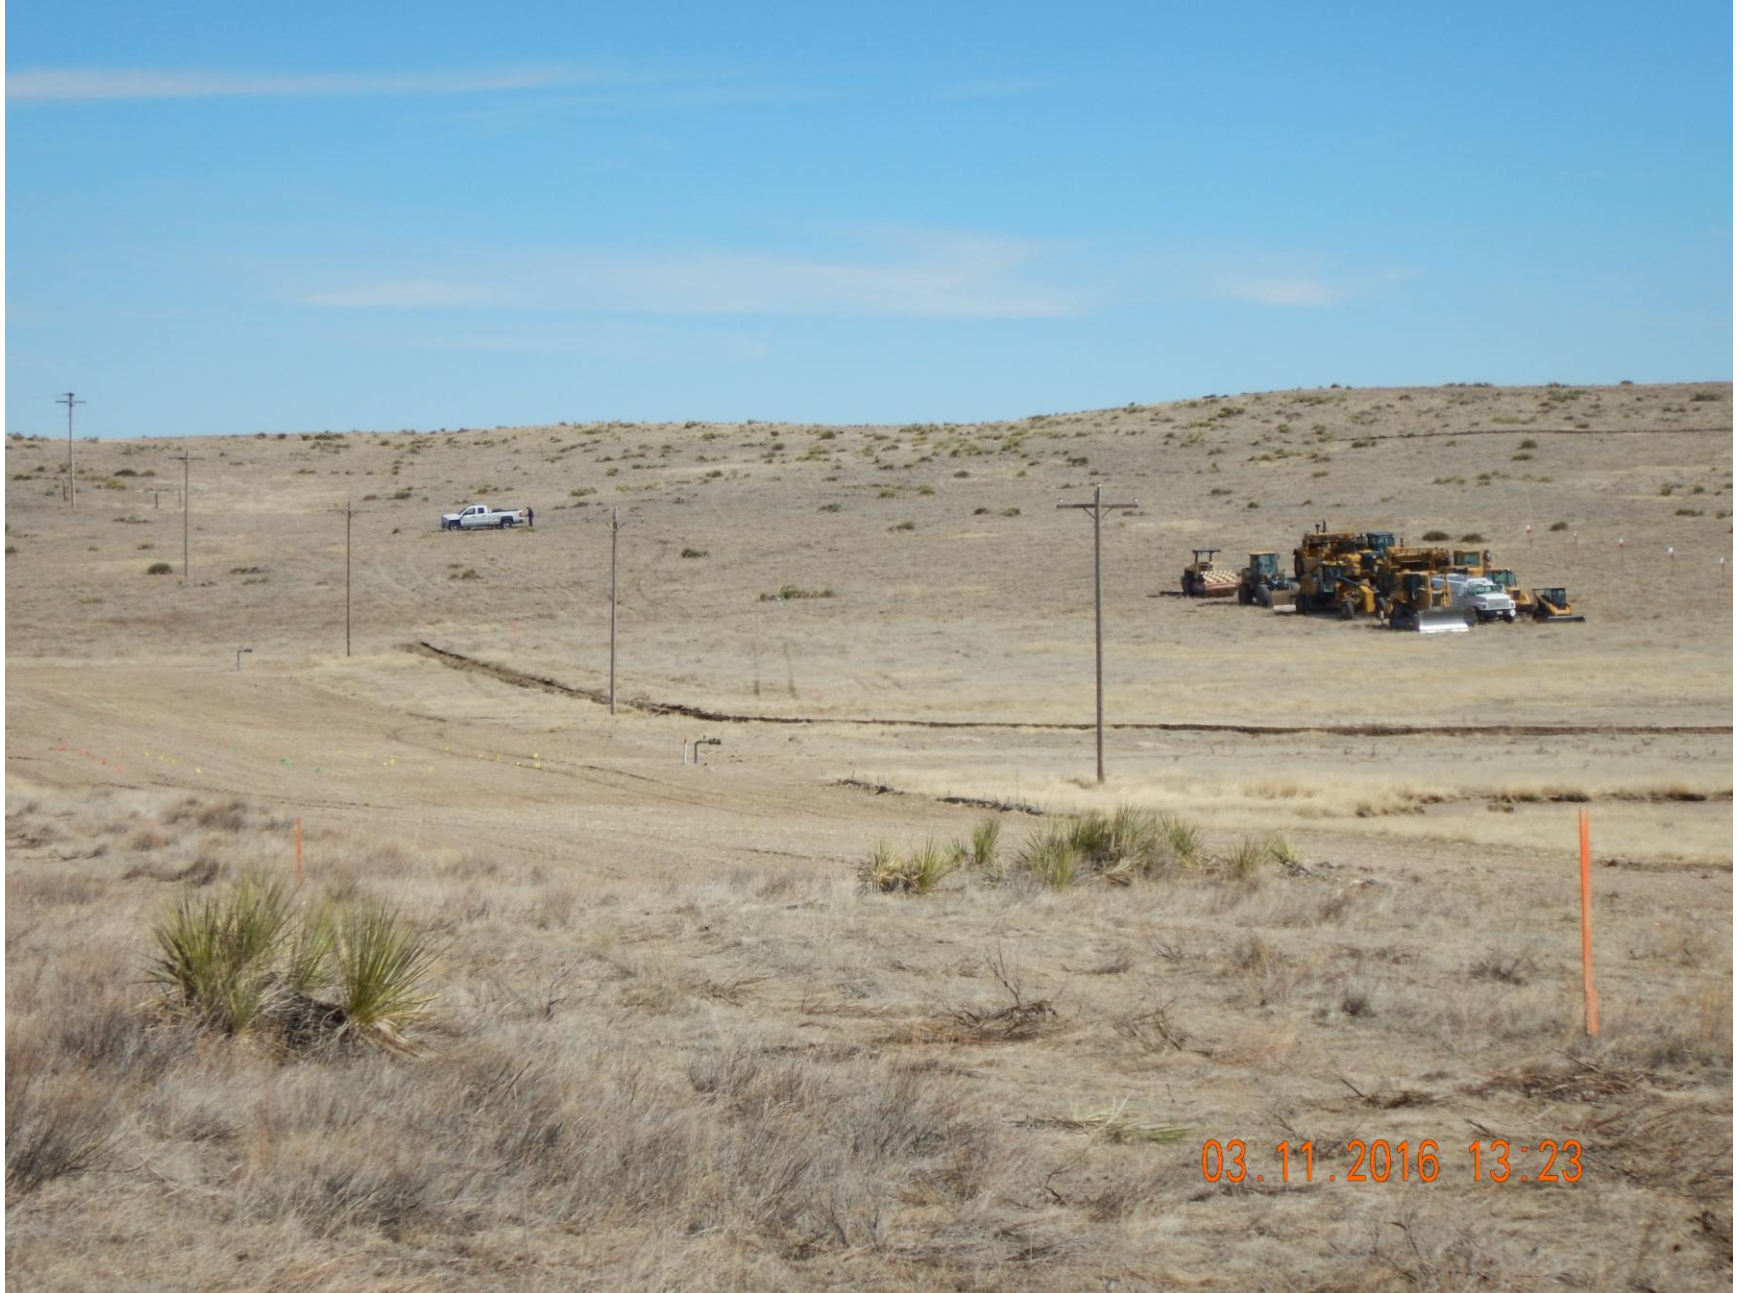
Figure 1: Photo taken from access road, northwest of location, facing east. Photo shows stormwater and sediment control ditch construction in process on perimeter of location.

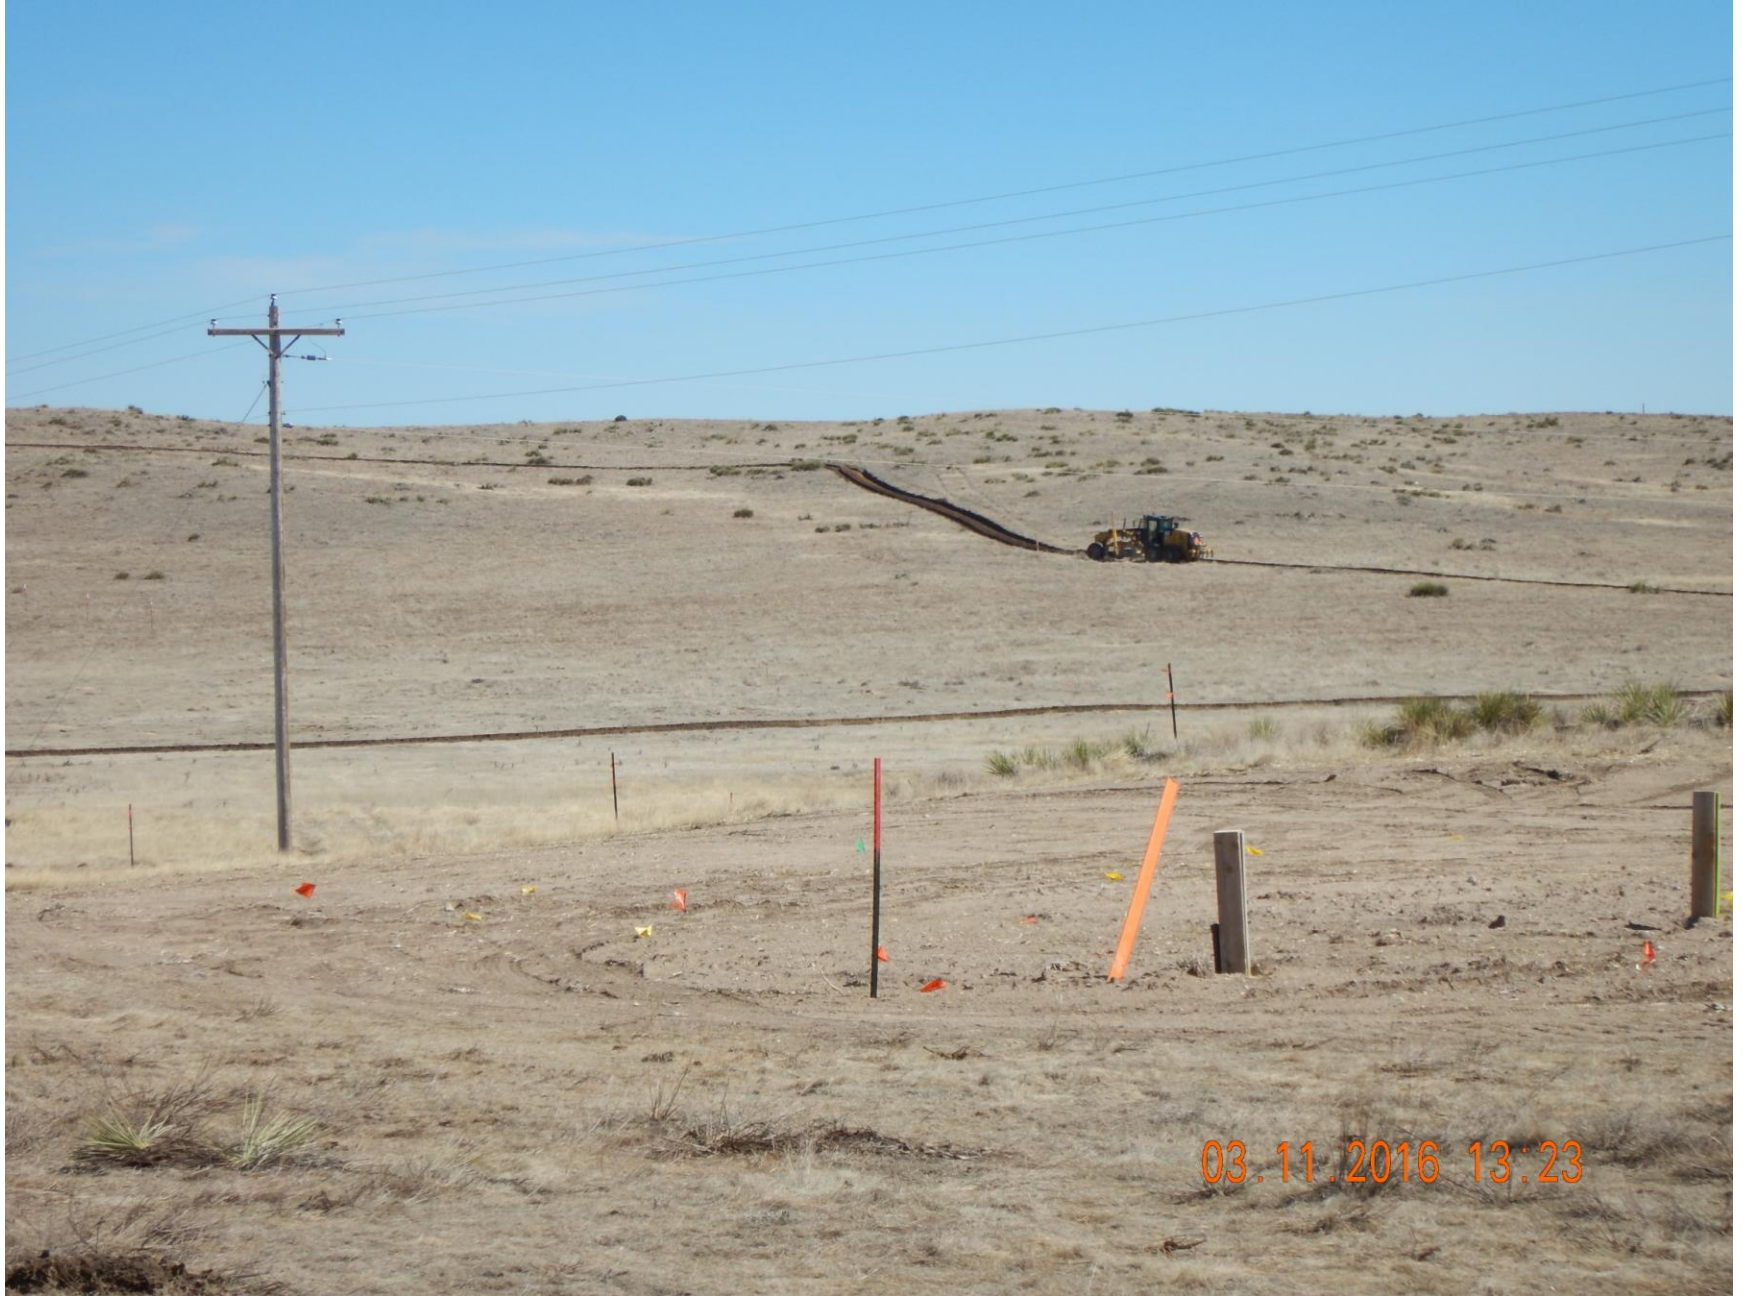
Figure 2: Photo taken from access road, northwest of location, facing southeast. Photo shows stormwater and sediment control ditch construction in process on perimeter of location.

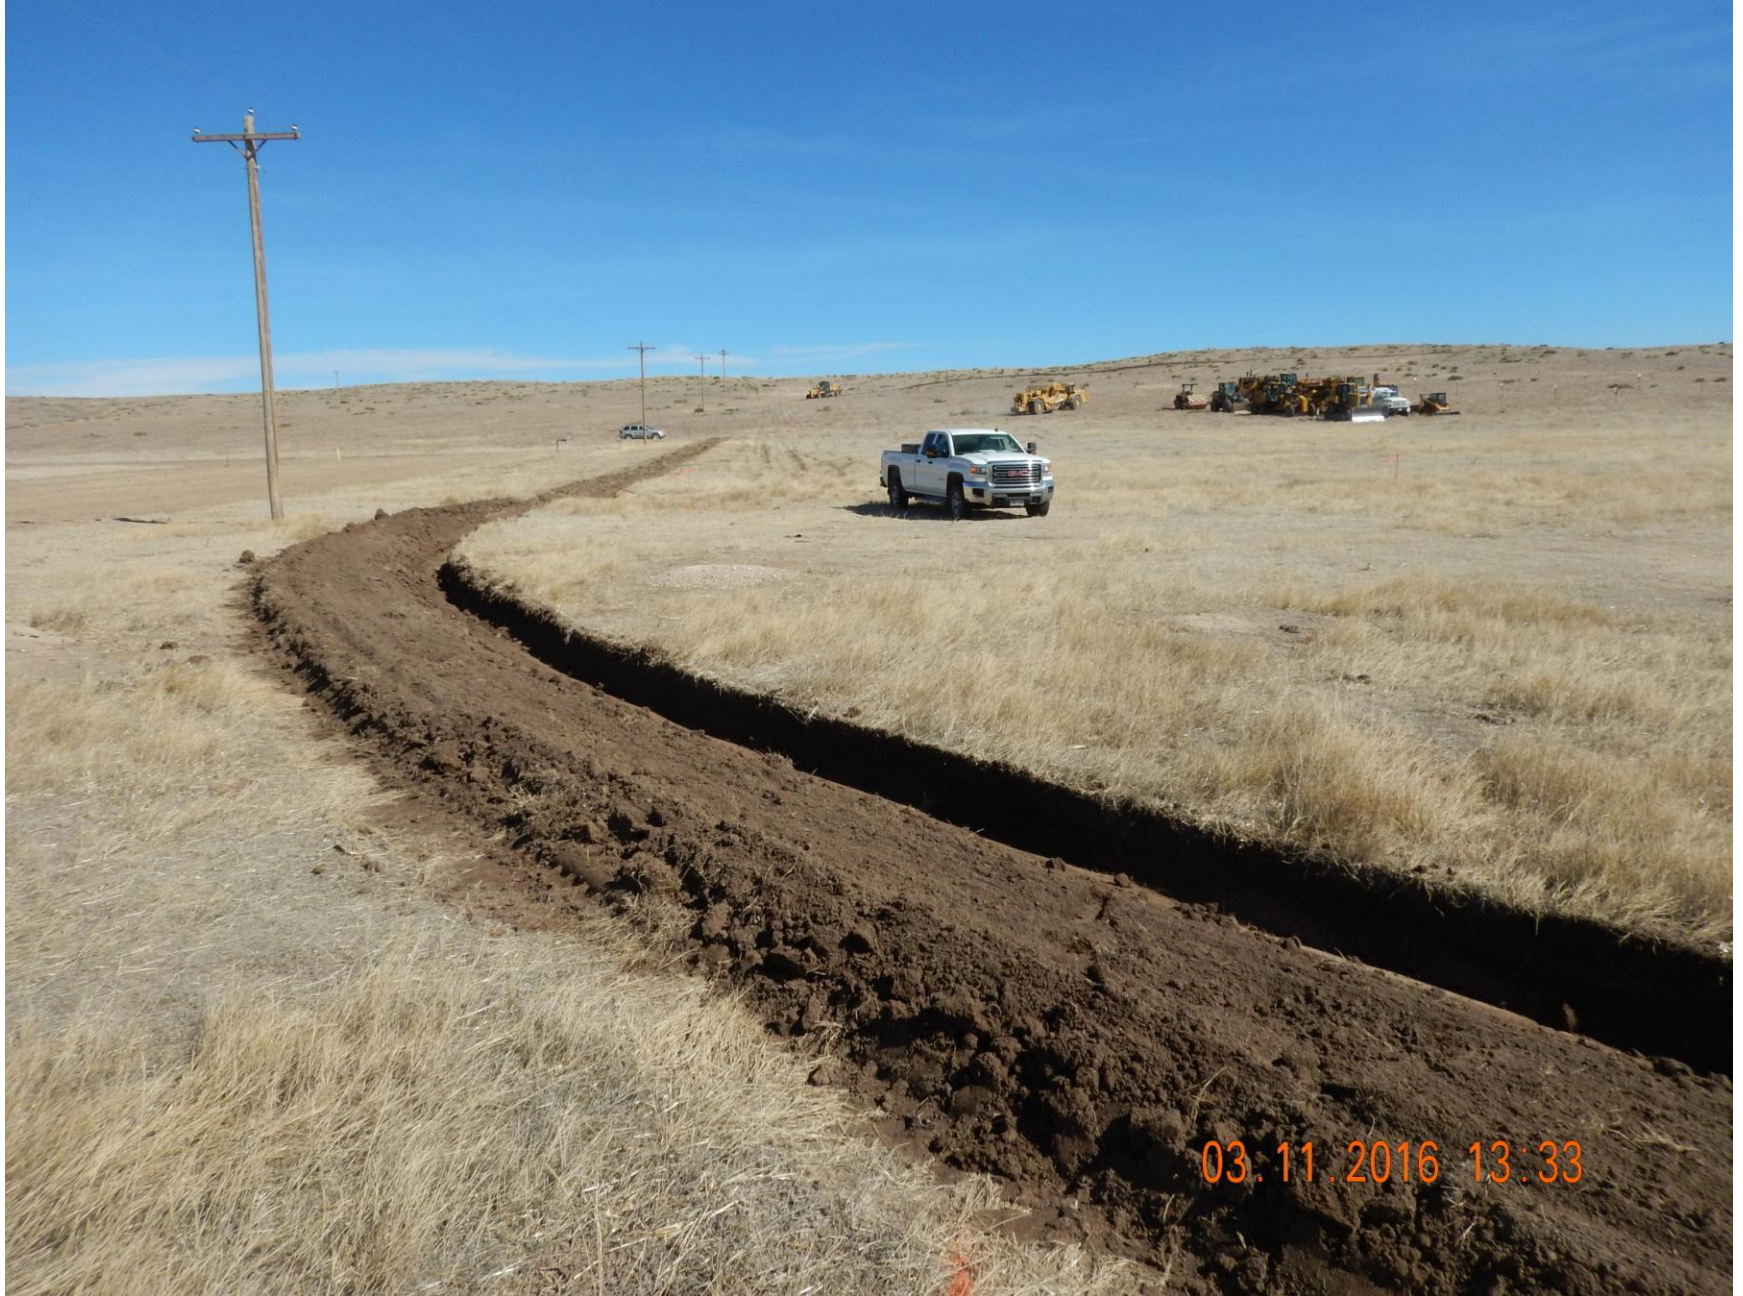
Figure 3: Photo taken from the northwest corner of the location, facing east. Photo shows stormwater control ditch BMP installation in process.

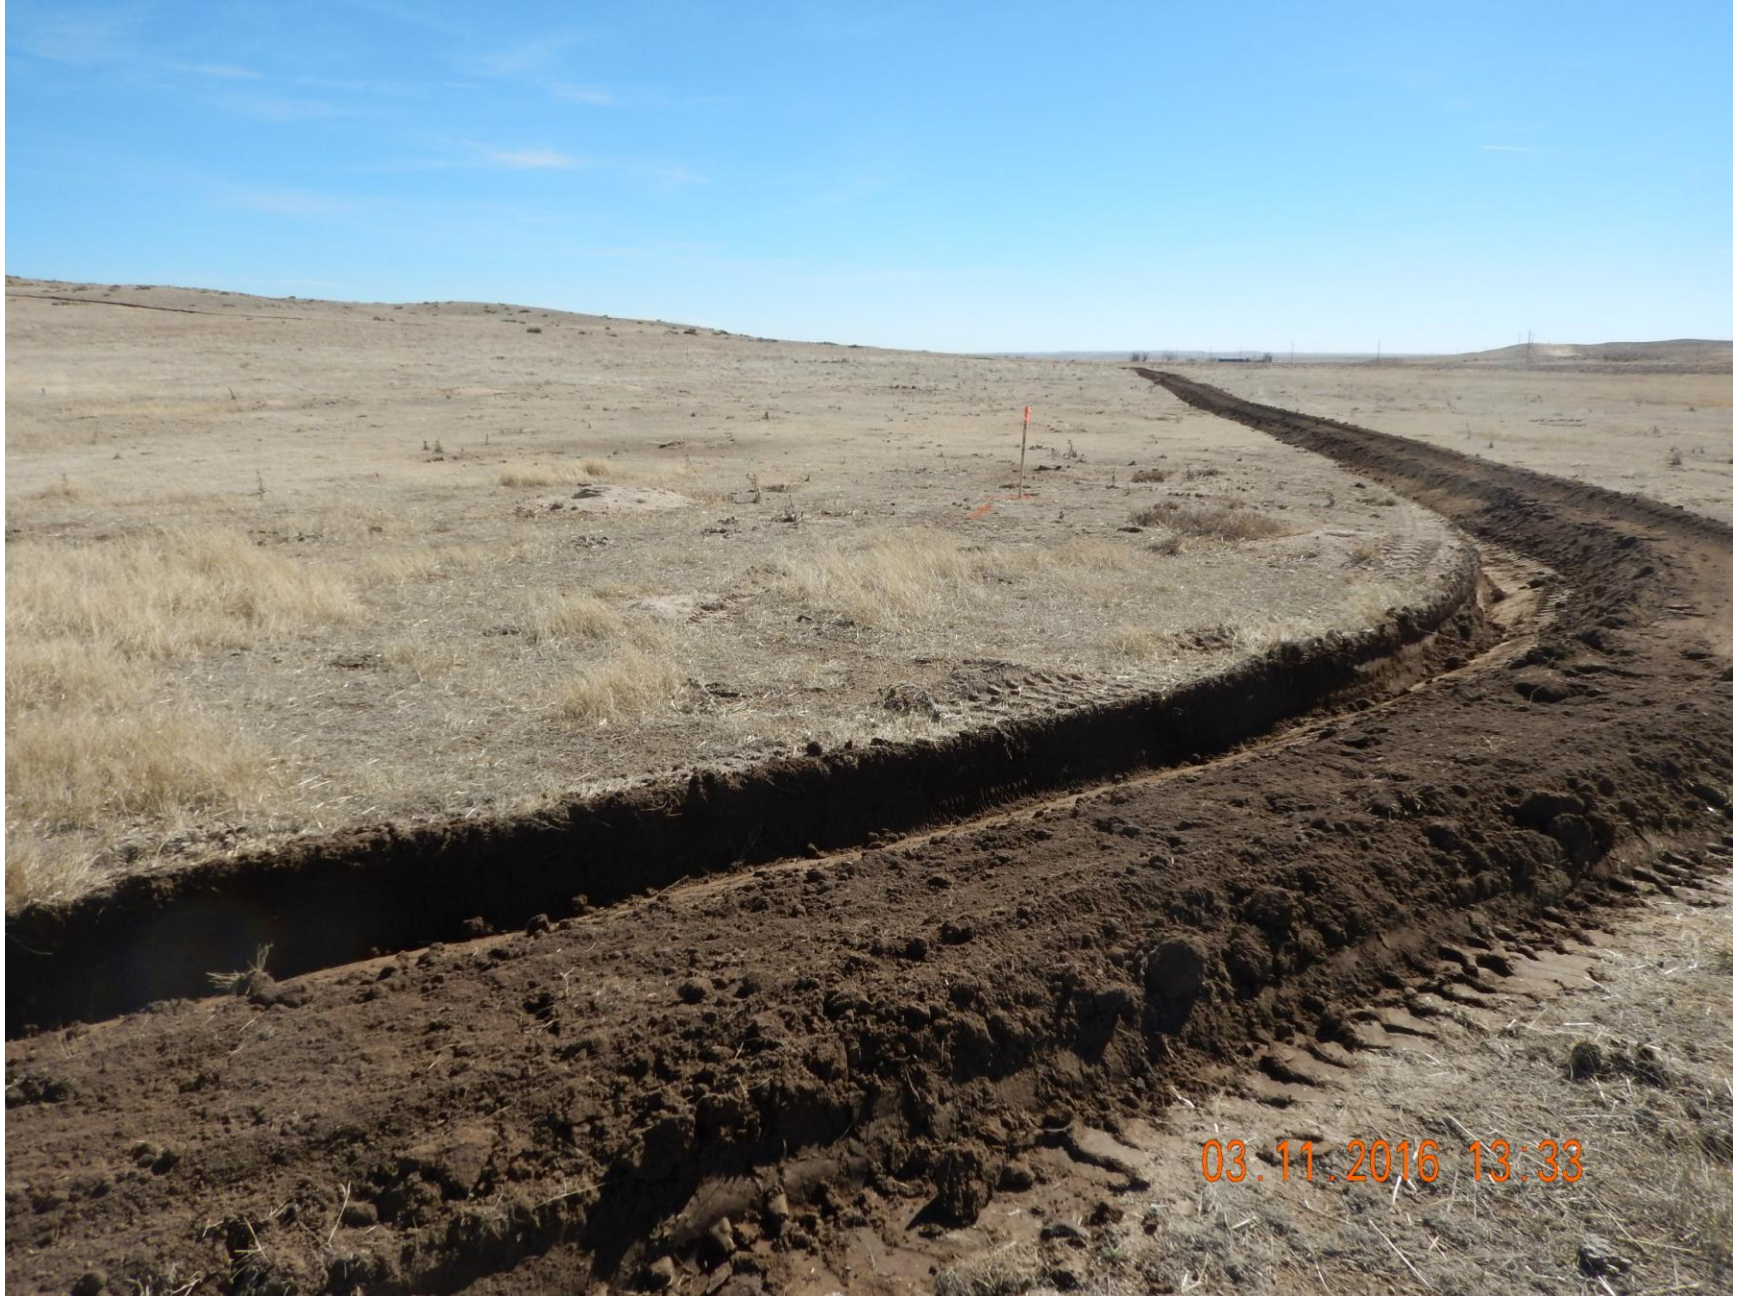
Figure 4: Photo taken from the northwest corner of the location, facing south. Photo shows stormwater control ditch BMP installed on perimeter of location.

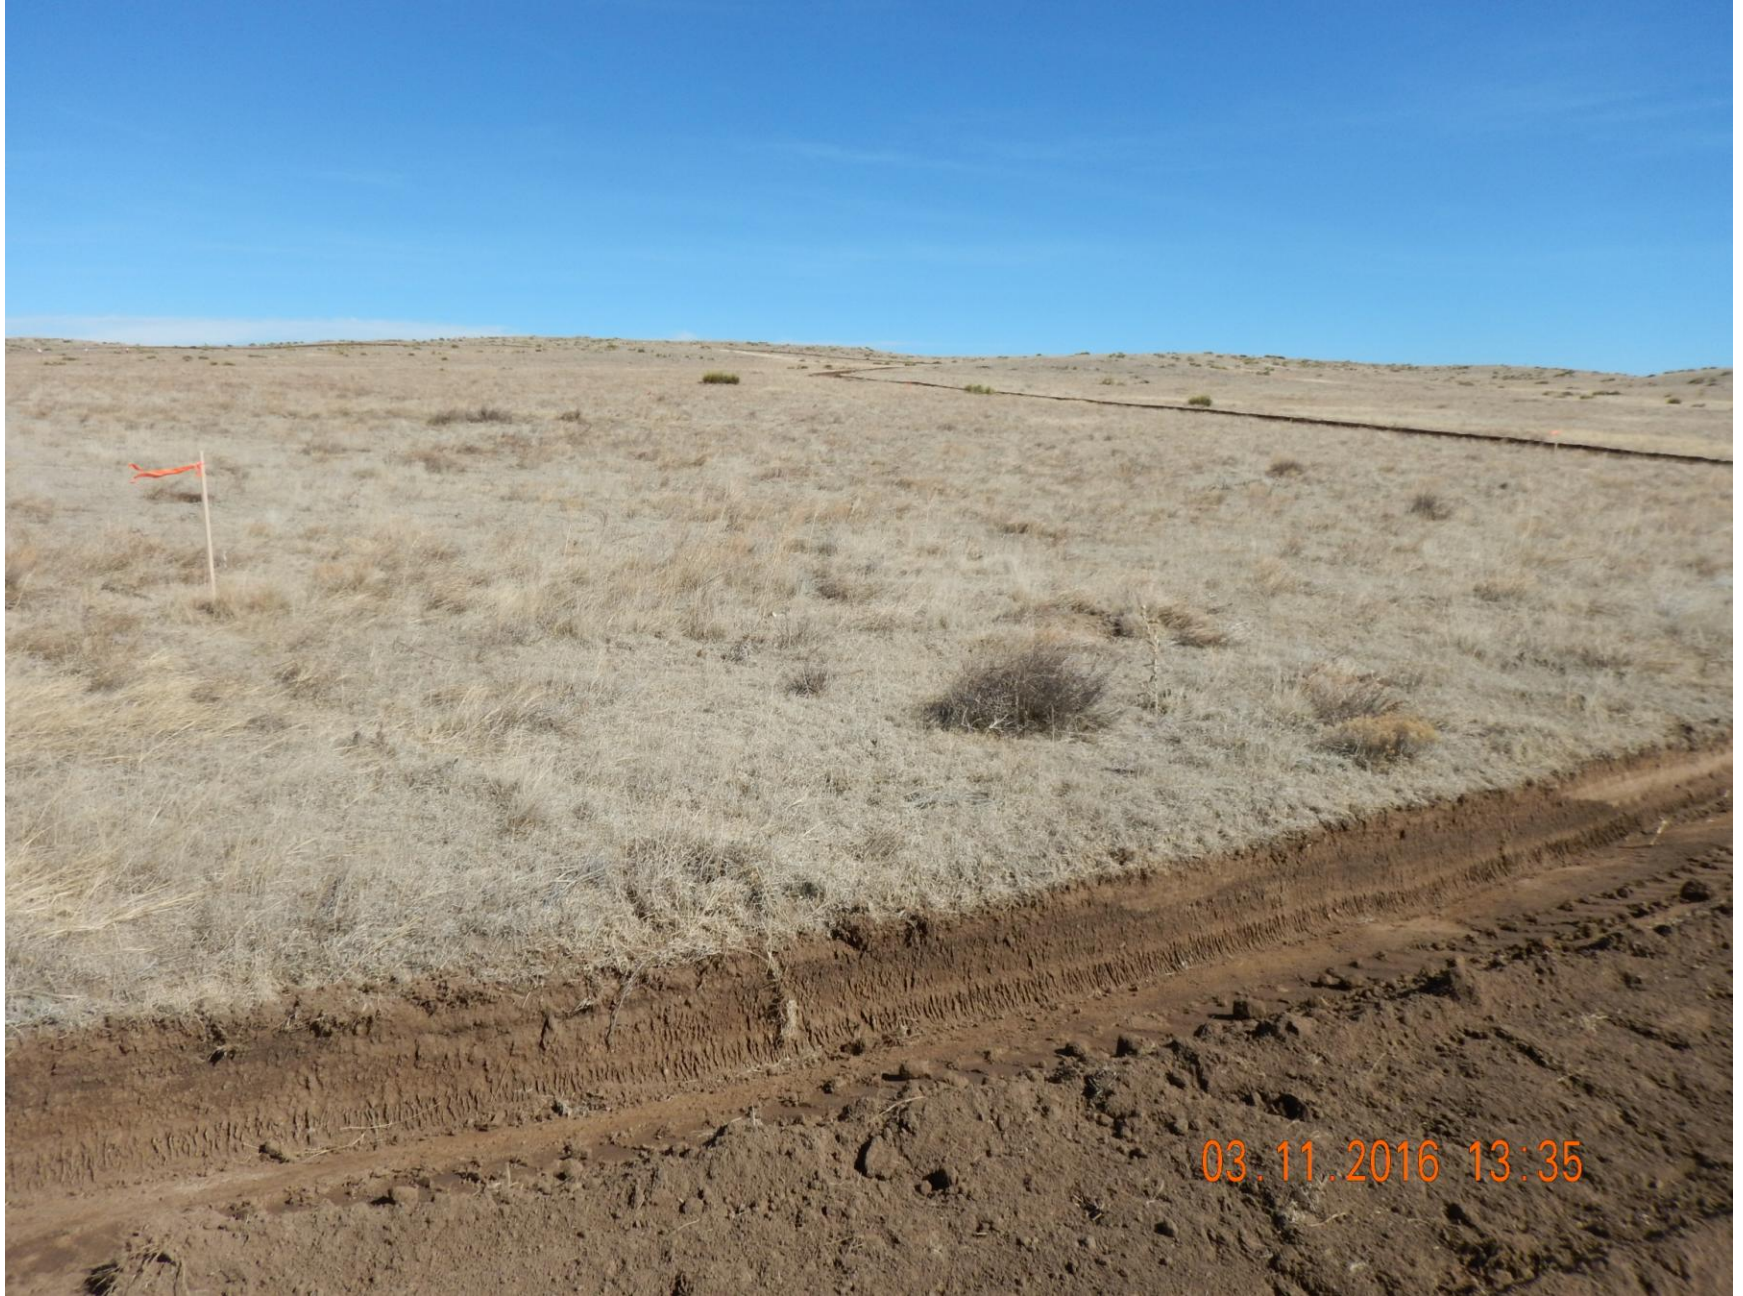
Figure 5: Photo taken from the southwest corner of the location, facing east. Photo shows stormwater control ditch BMP installed on perimeter of location.

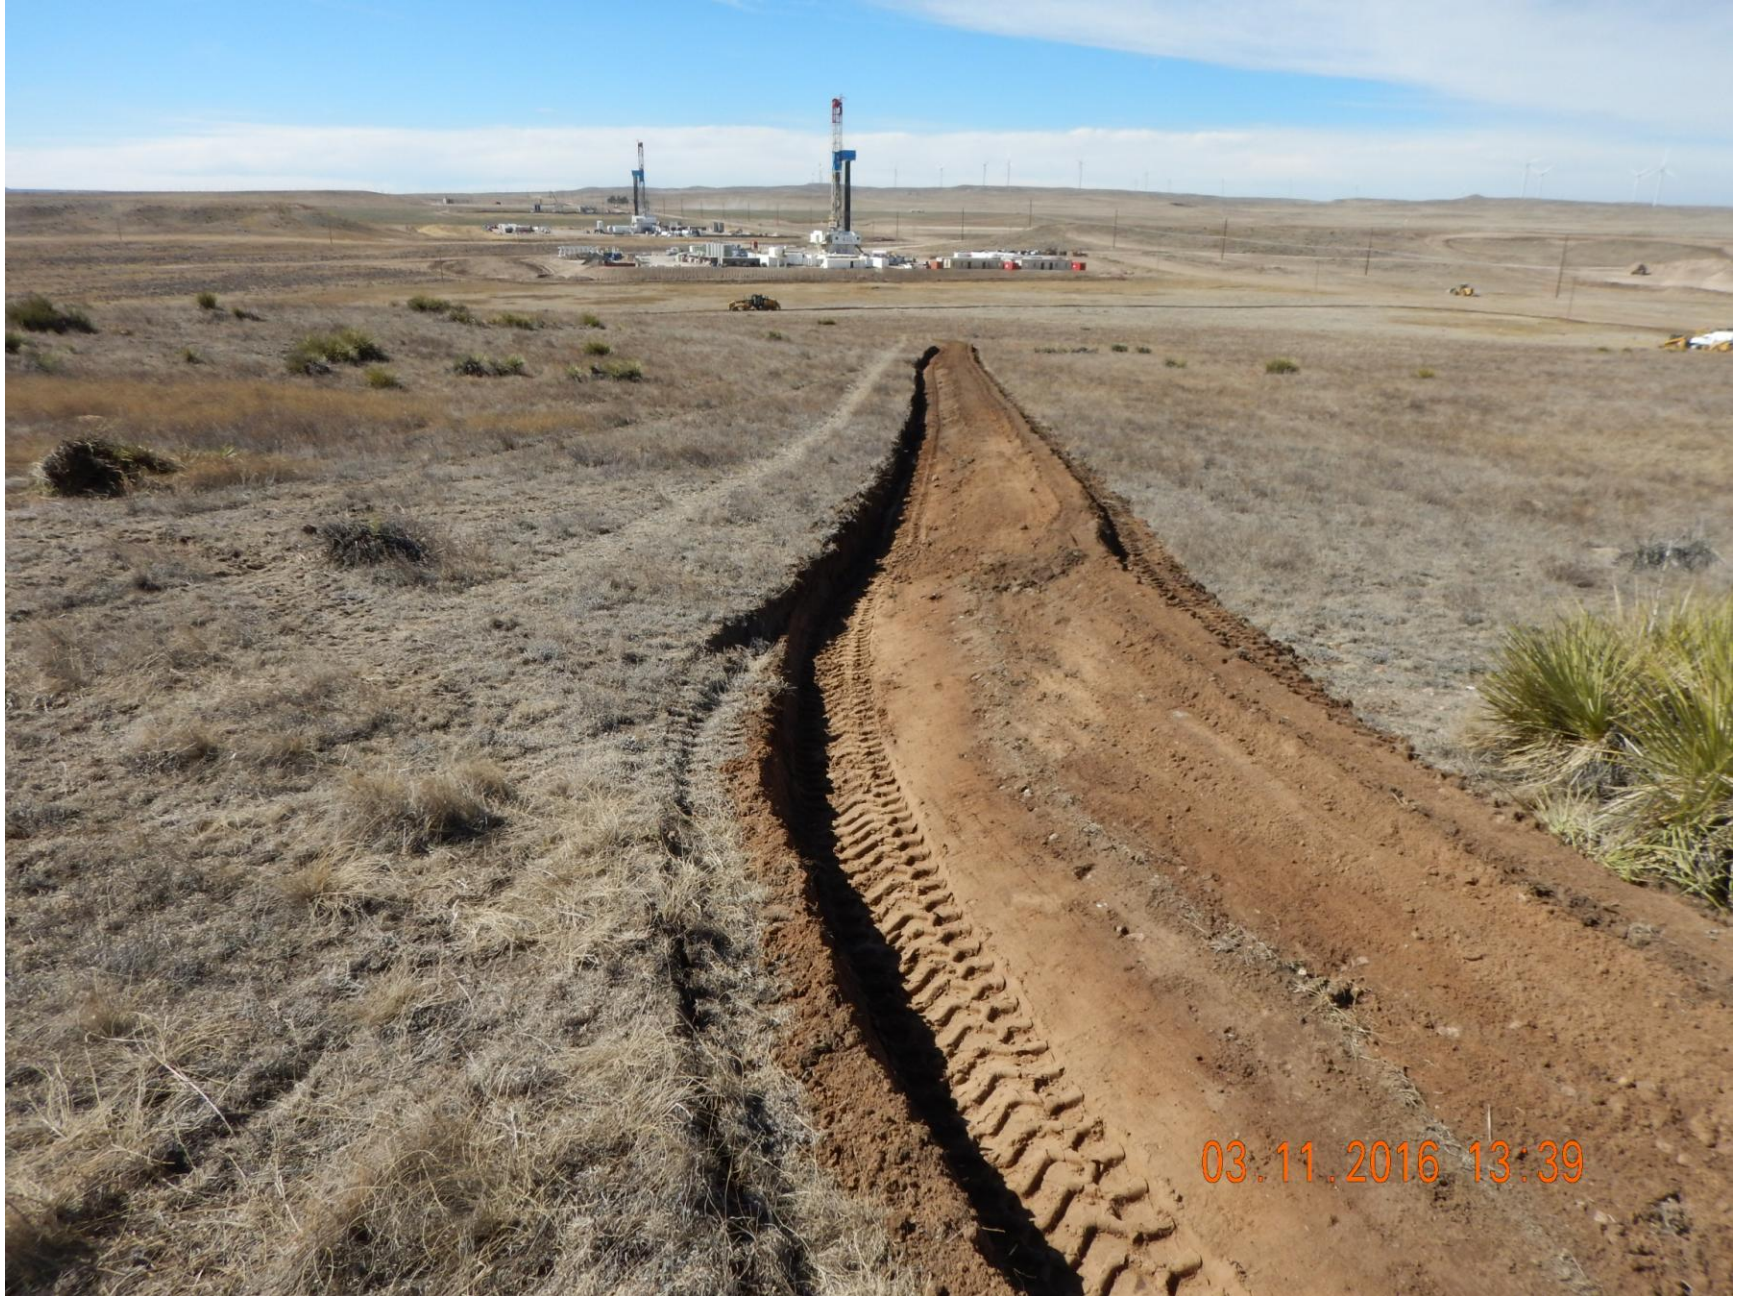
Figure 6: Photo taken from the southeast corner of the location, facing west. Photo shows stormwater control ditch BMP installed on perimeter of location. Note the grade of the slope, velocity checks are advised in areas with steeper grades.

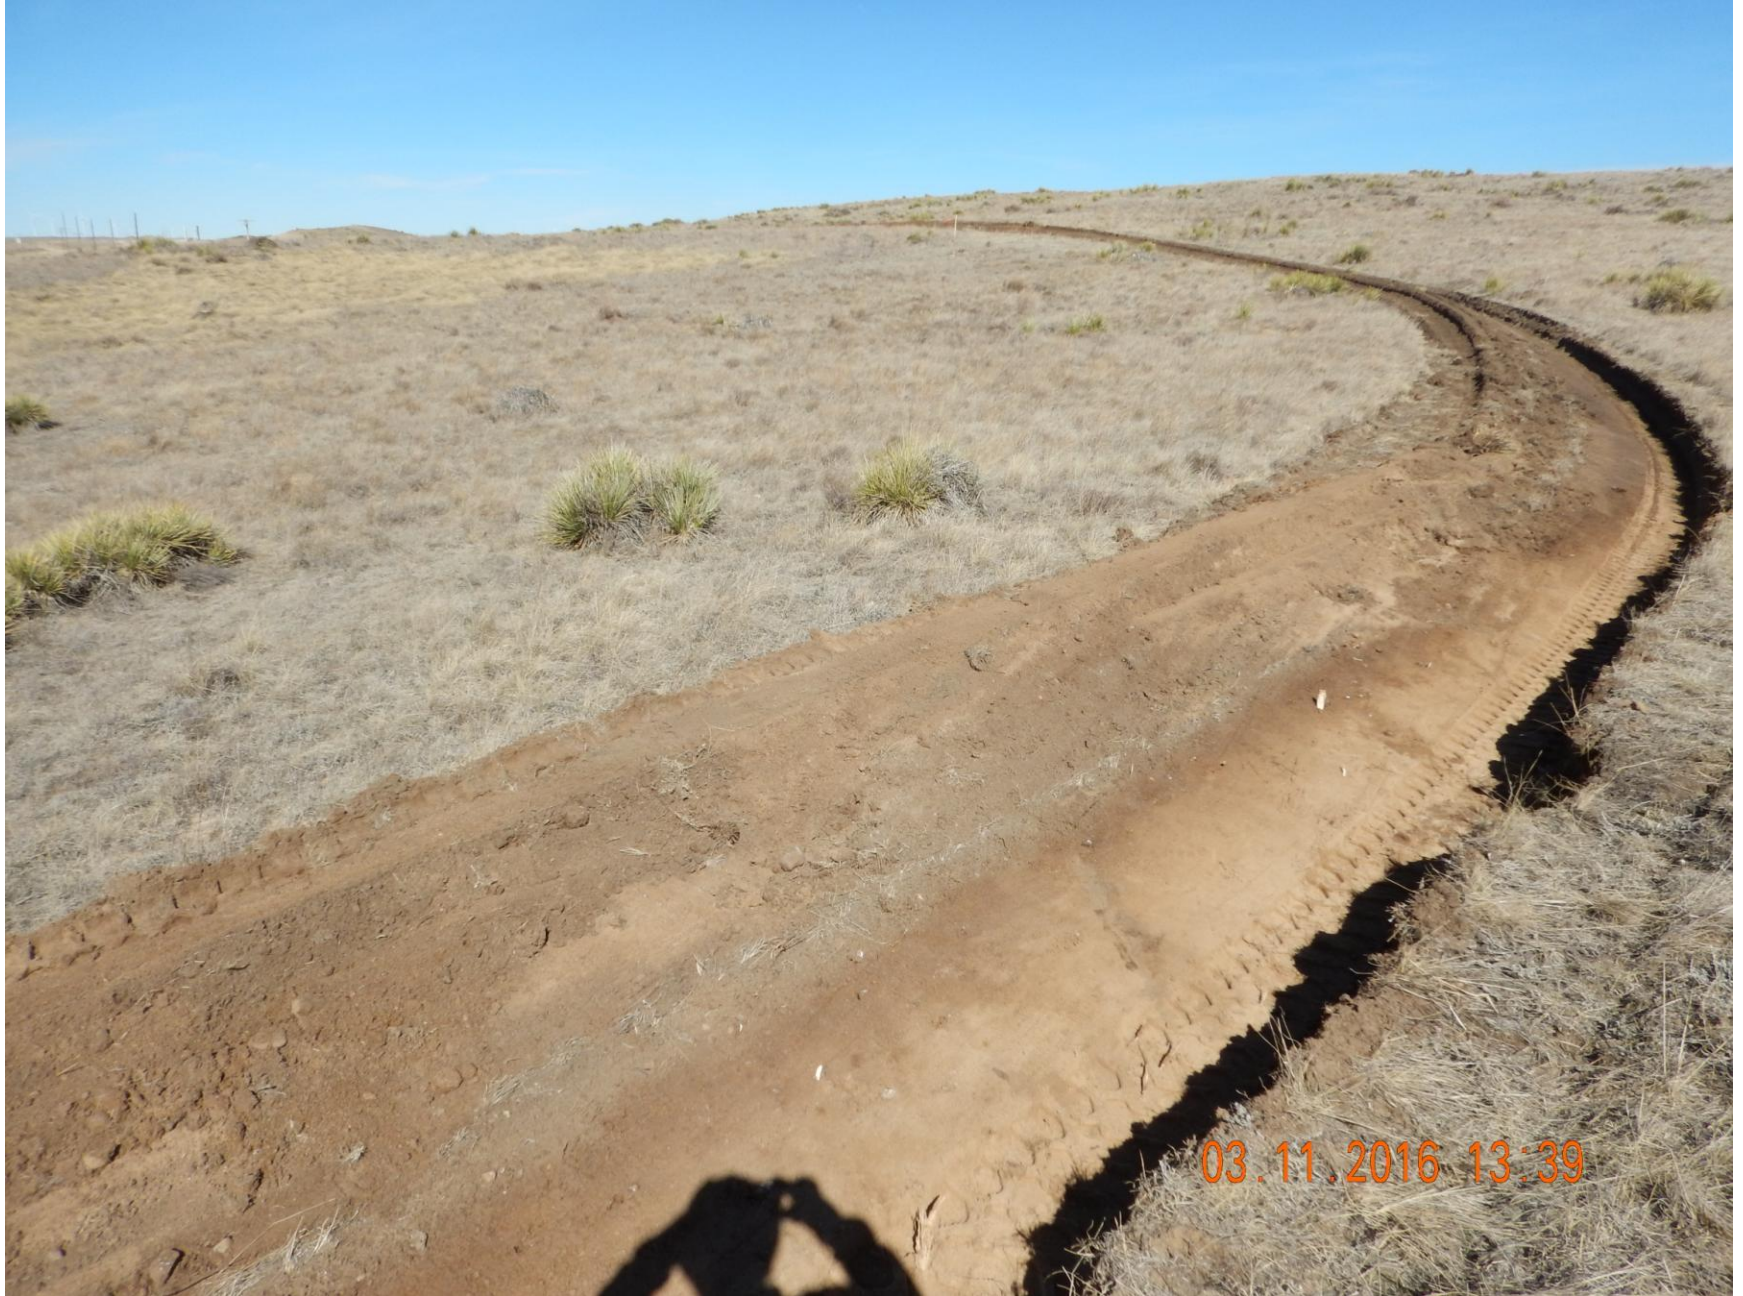
Figure 7: Photo taken from the southeast corner of the location, facing northeast. Photo shows stormwater control ditch BMP installed on perimeter of location. Note the grade of the slope, velocity checks are advised in areas with steeper grades.

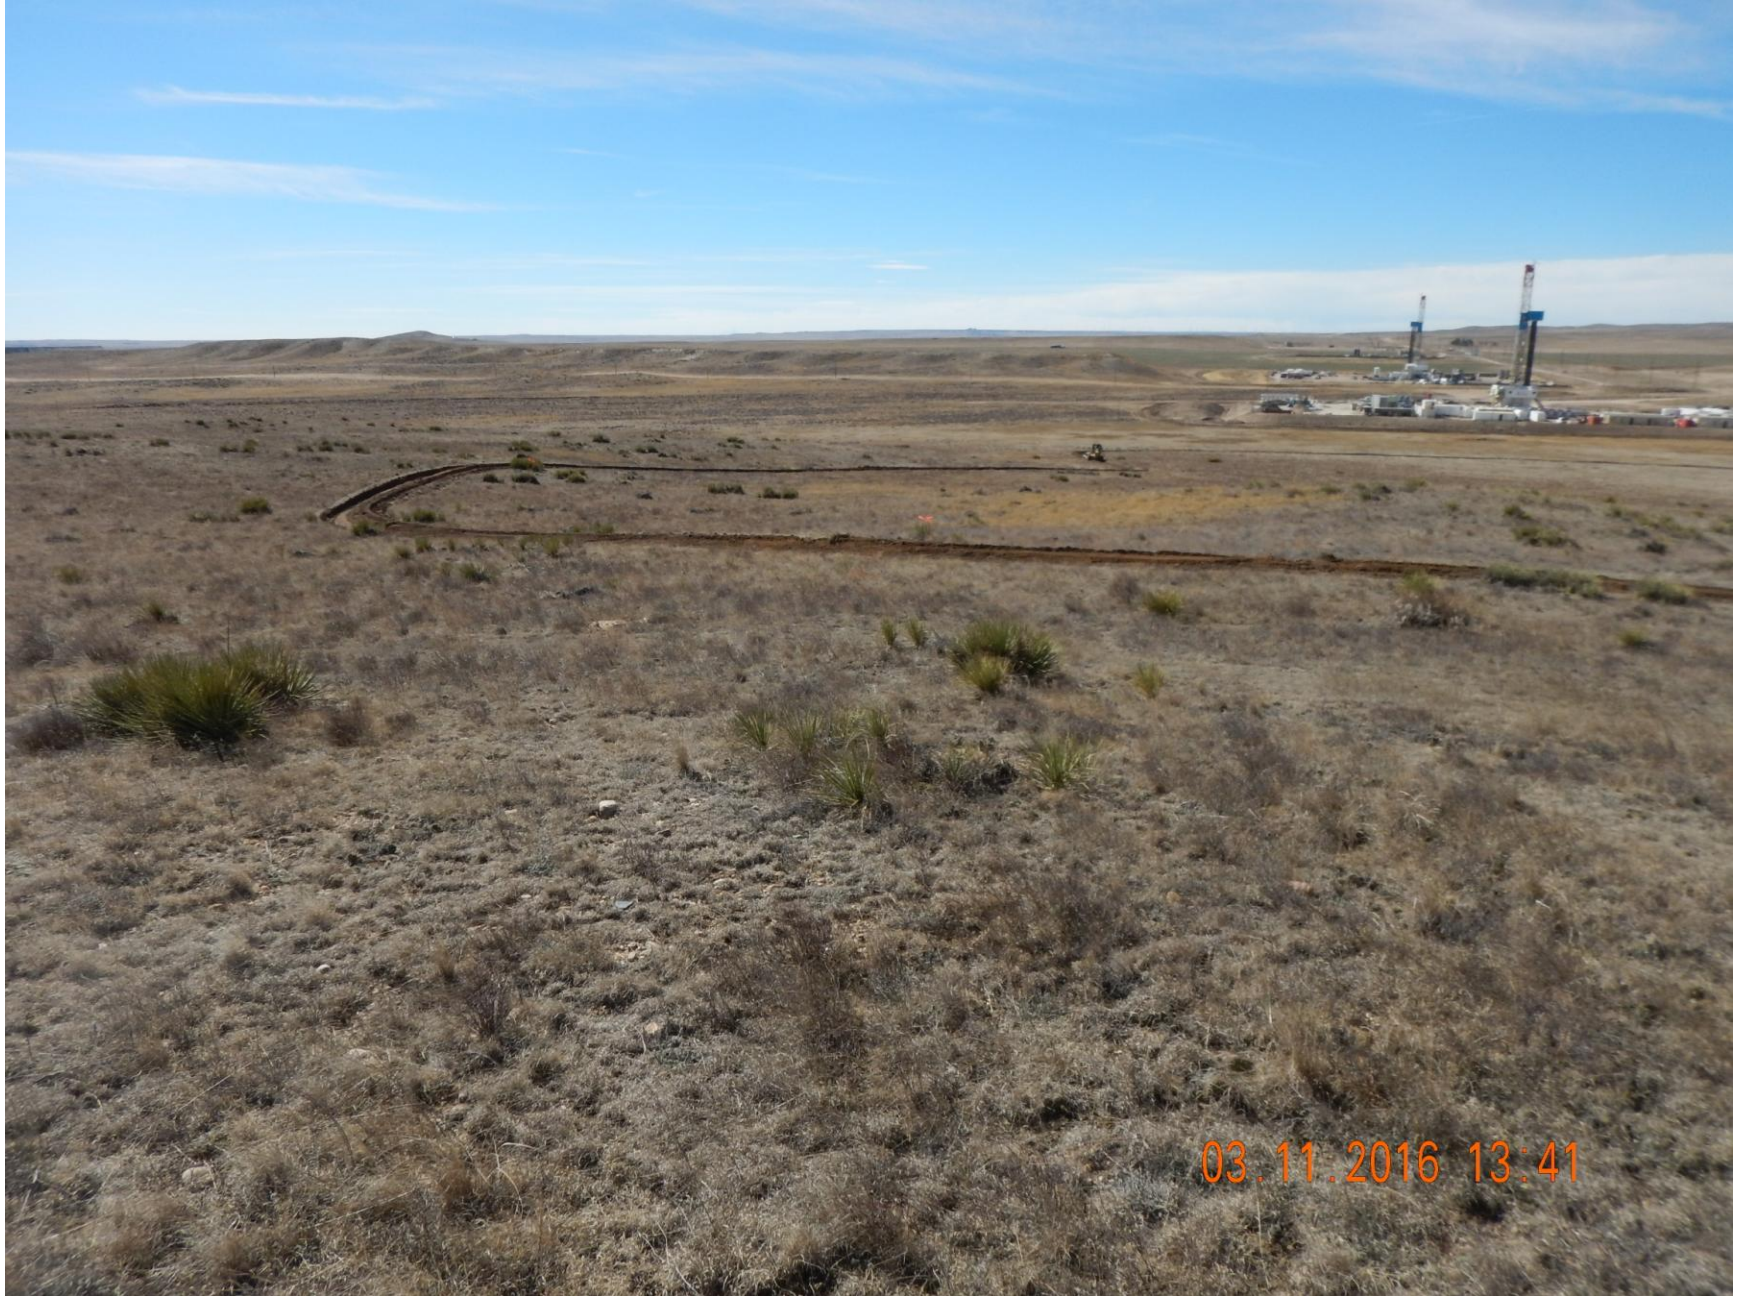
Figure 8: Photo taken from the east of the location, facing west. Photo shows location.

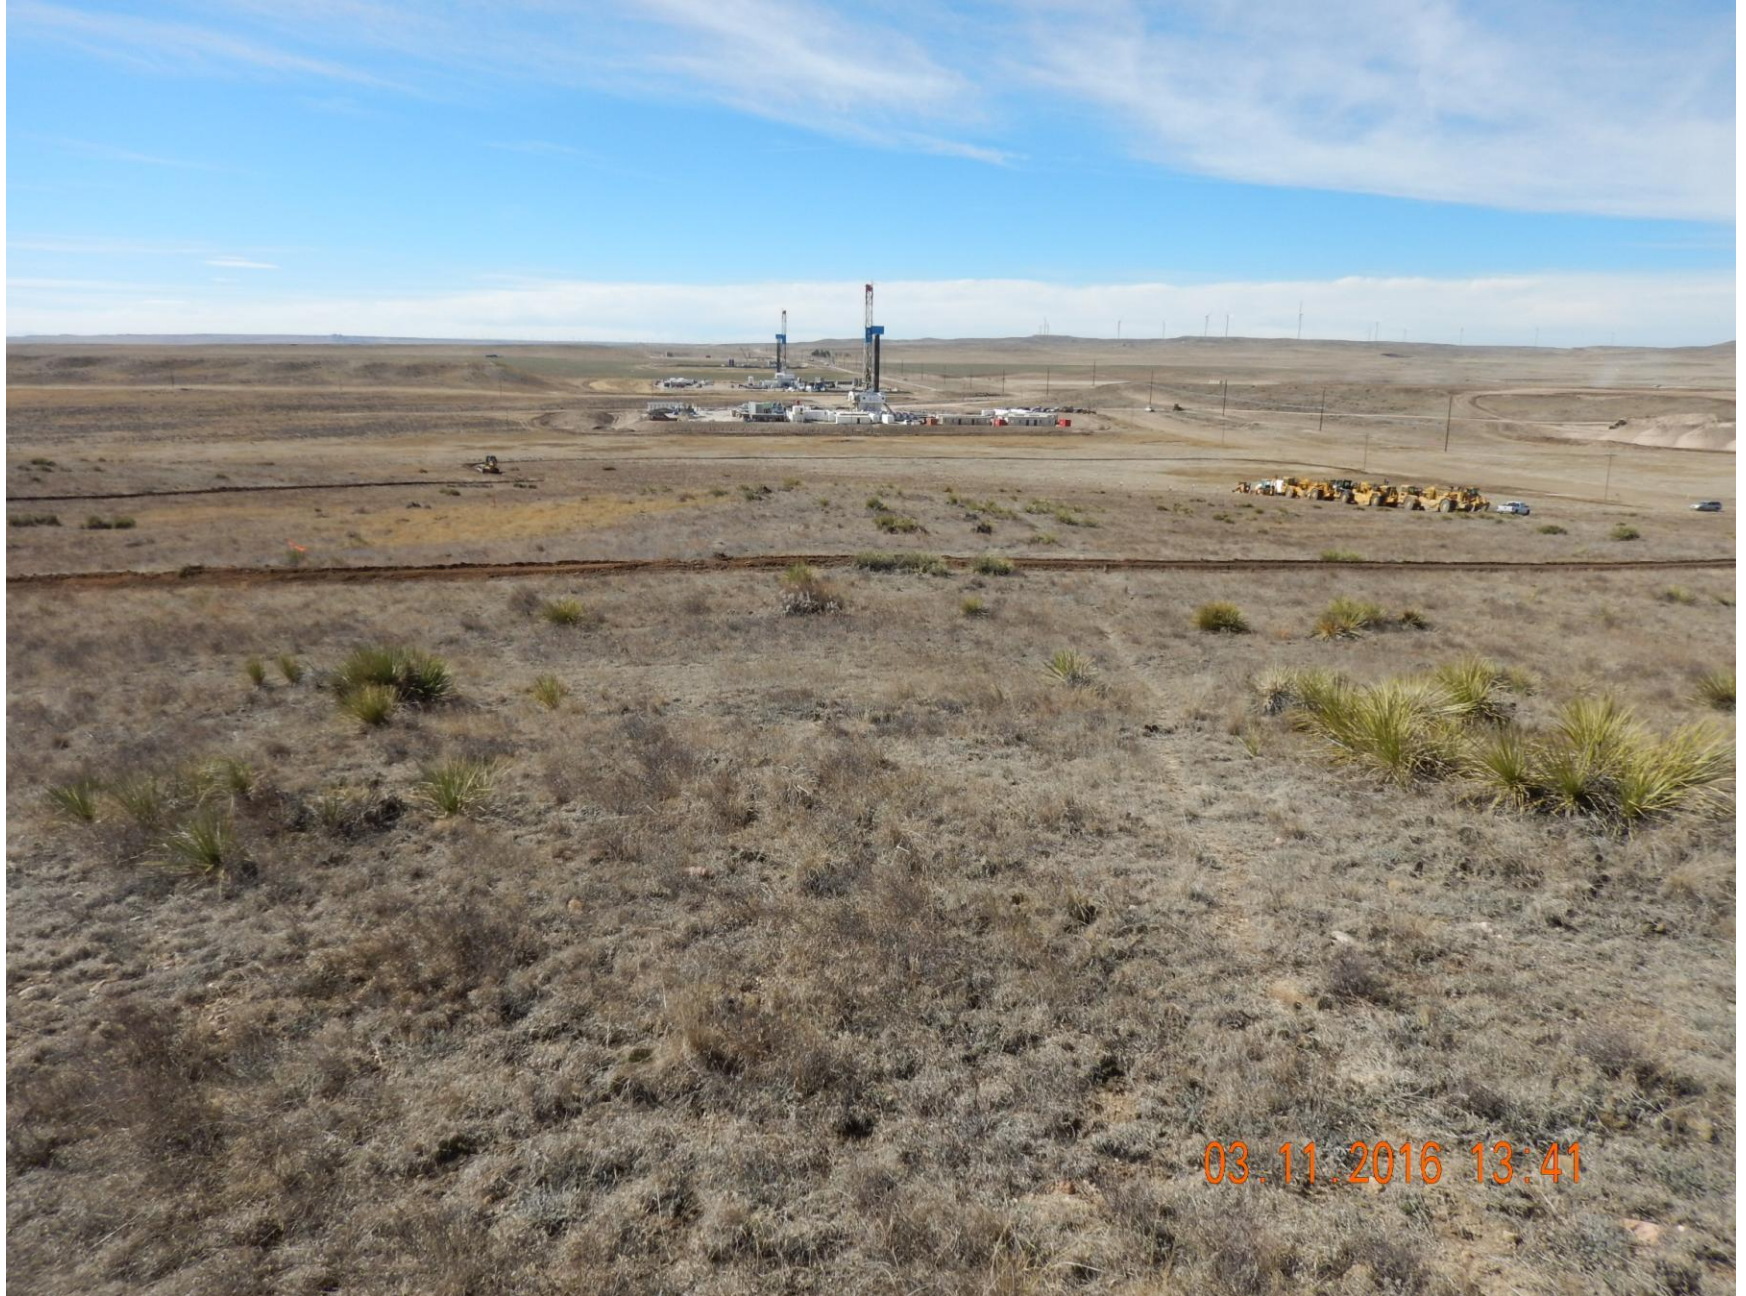
Figure 9: Photo taken from the east of the location, facing west. Photo shows location.

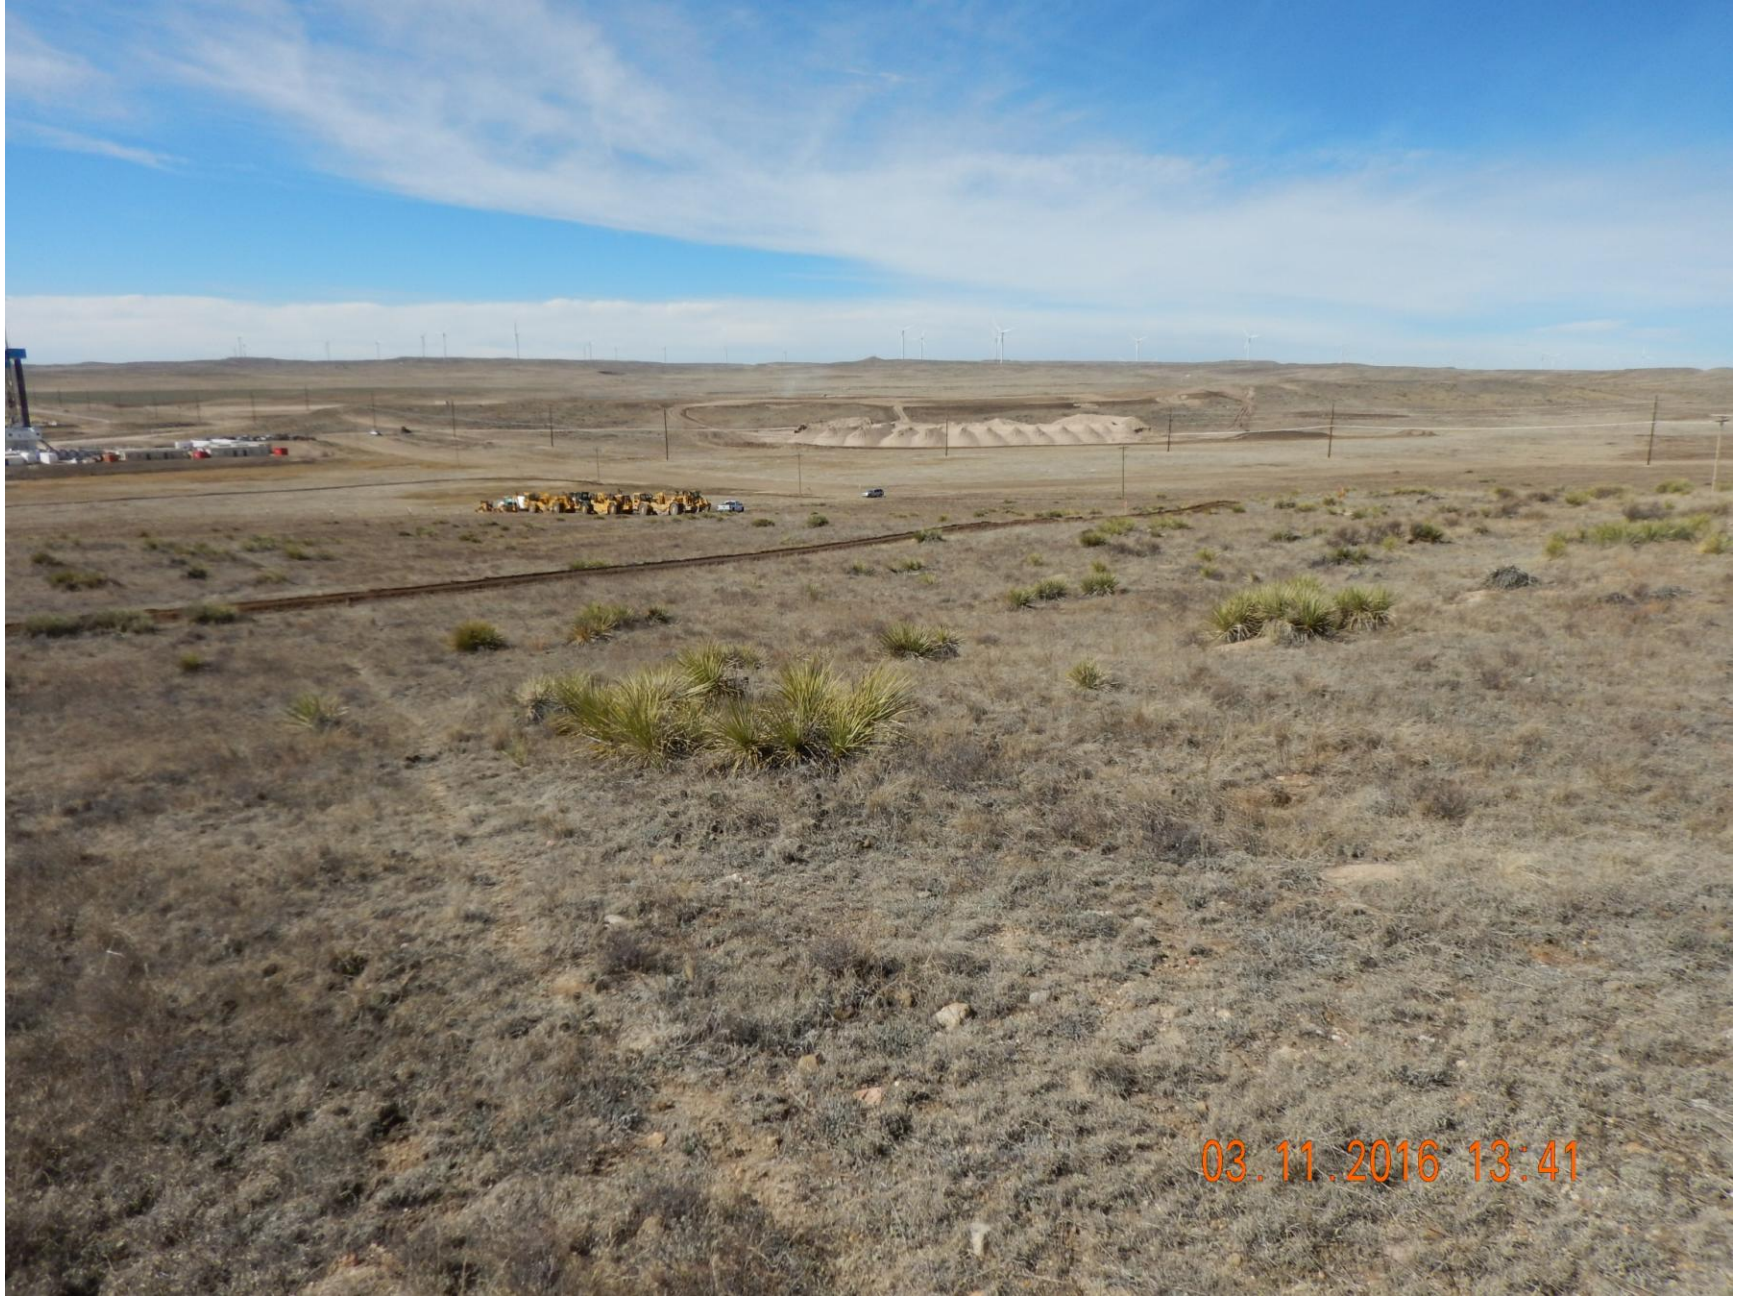
Figure 10: Photo taken from the east of the location, facing northwest. Photo shows location.
