Construction Inspection

3/11/2016

Operator: Whiting

Location ID: 442408

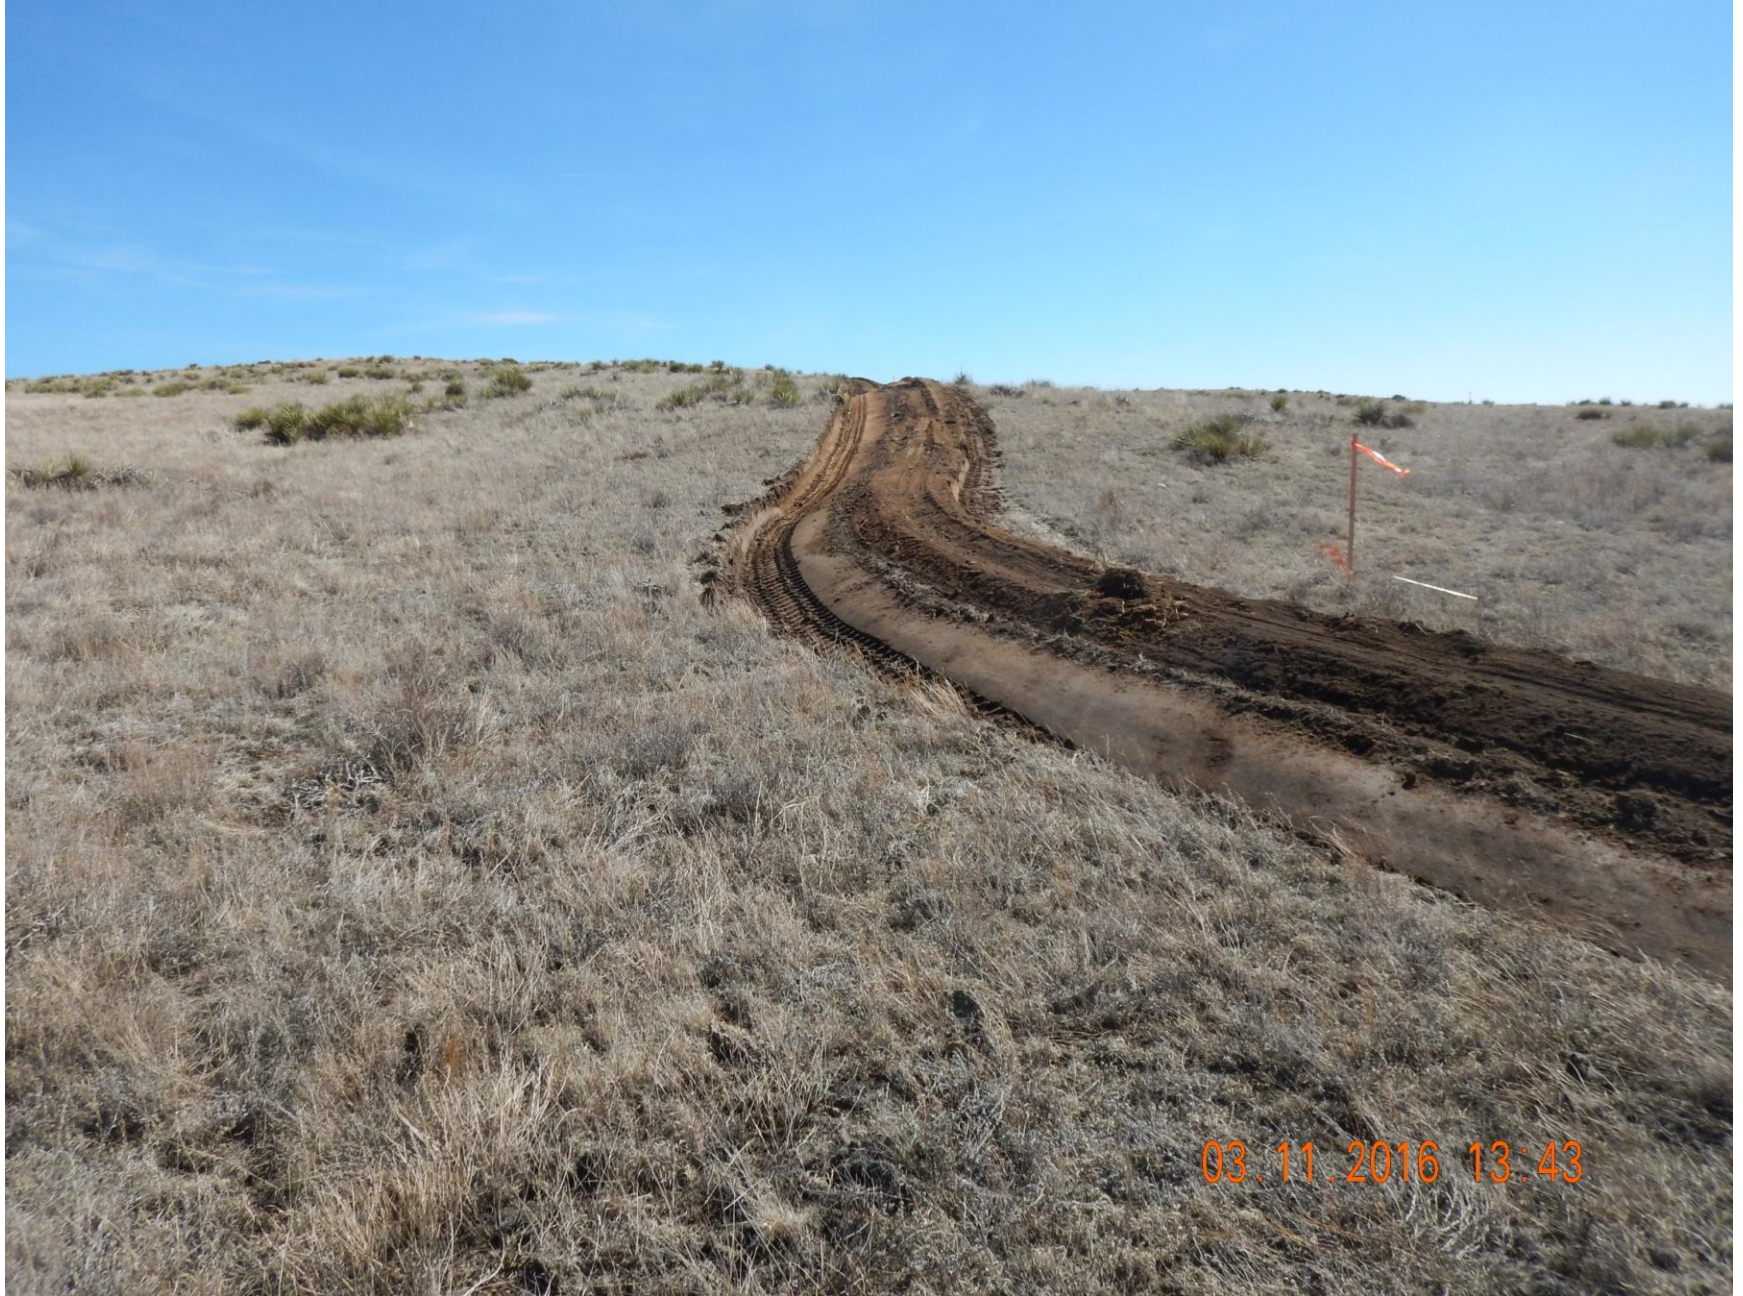
Figure 11: Photo taken from the northeast corner of the location, facing southeast. Photo shows stormwater control ditch BMP installed on perimeter of location. Note the grade of the slope, velocity checks are advised in areas with steeper grades.

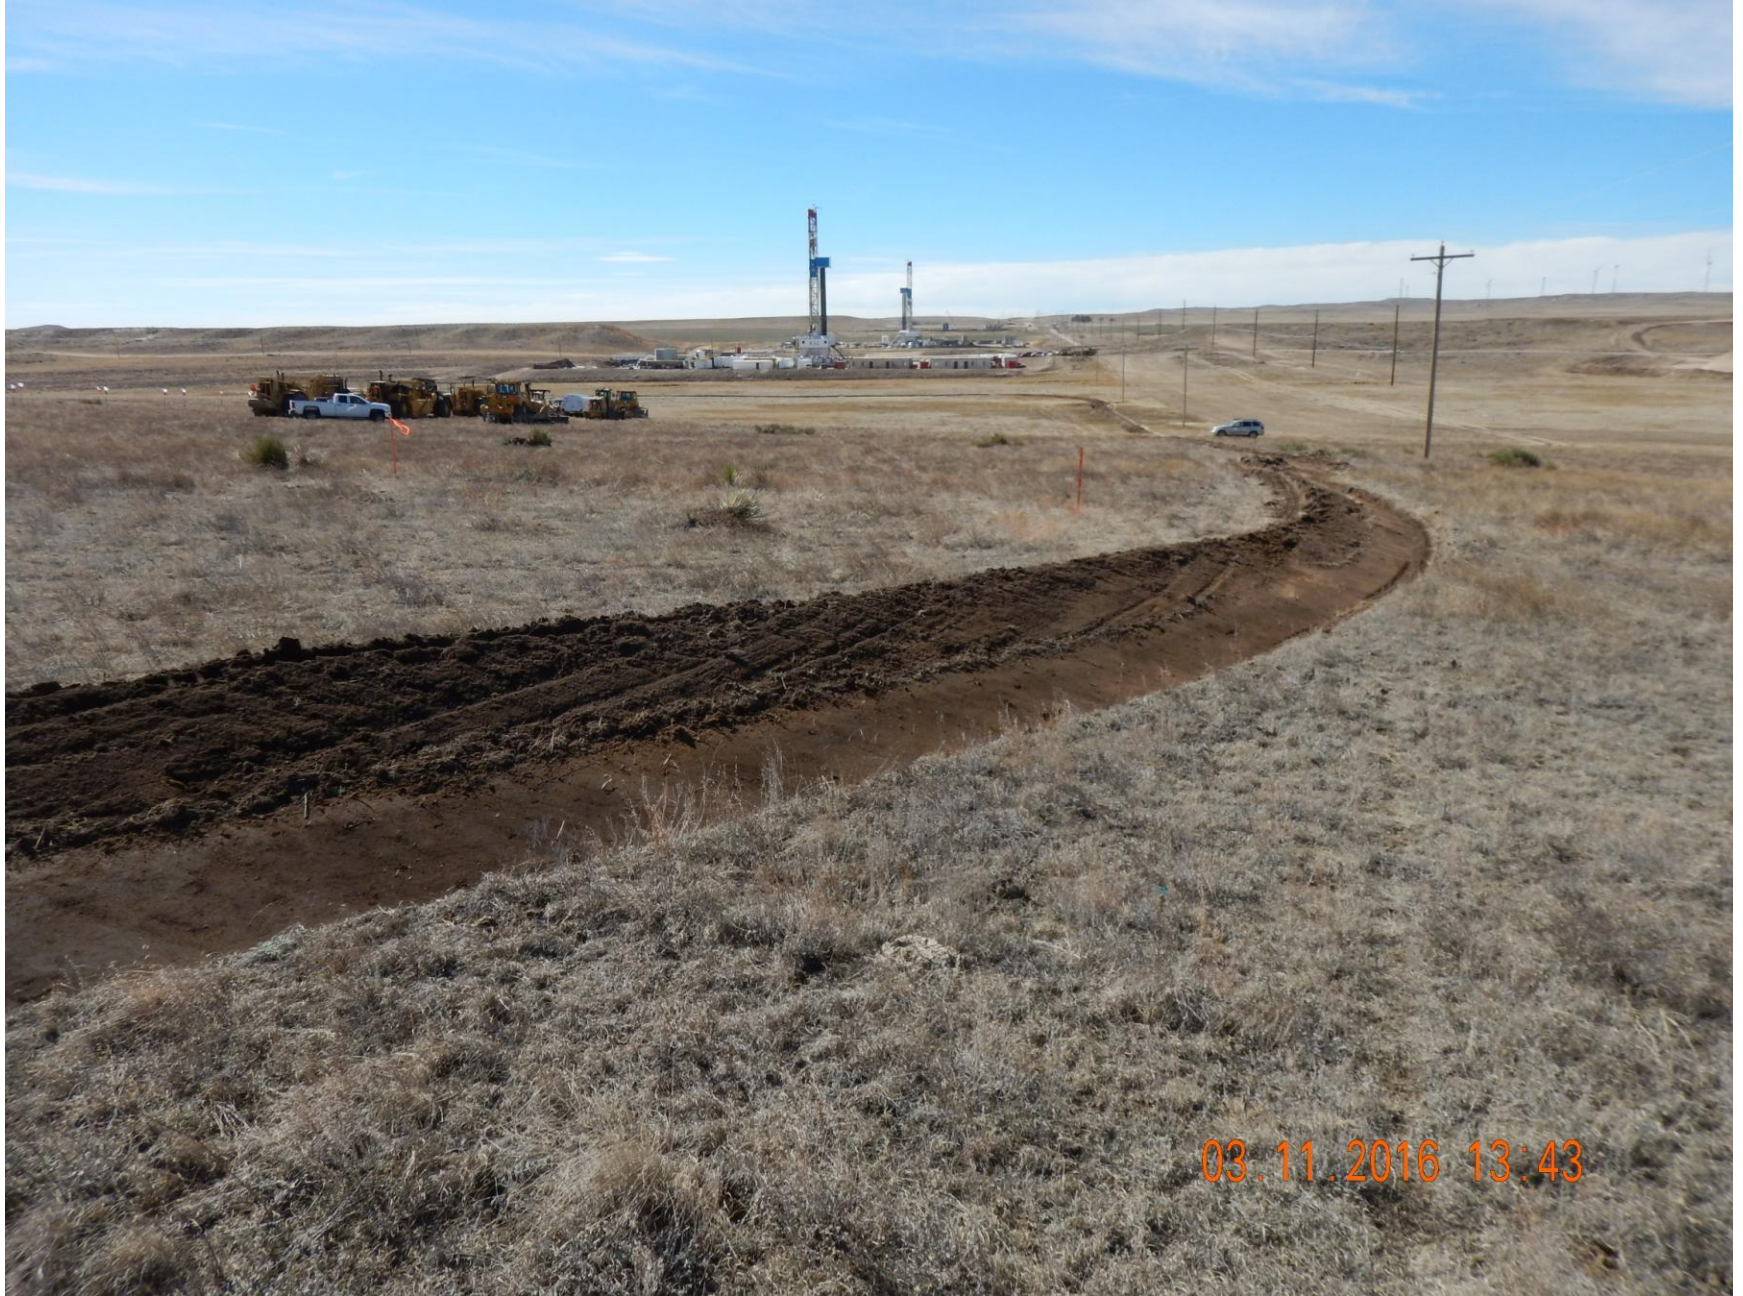
Figure 12: Photo taken from the northeast corner of the location, facing west. Photo shows stormwater control ditch BMP installed on perimeter of location.
