Final Reclamation Inspection

Operator: Noble Energy

Location ID: 327002

Weld County, CO

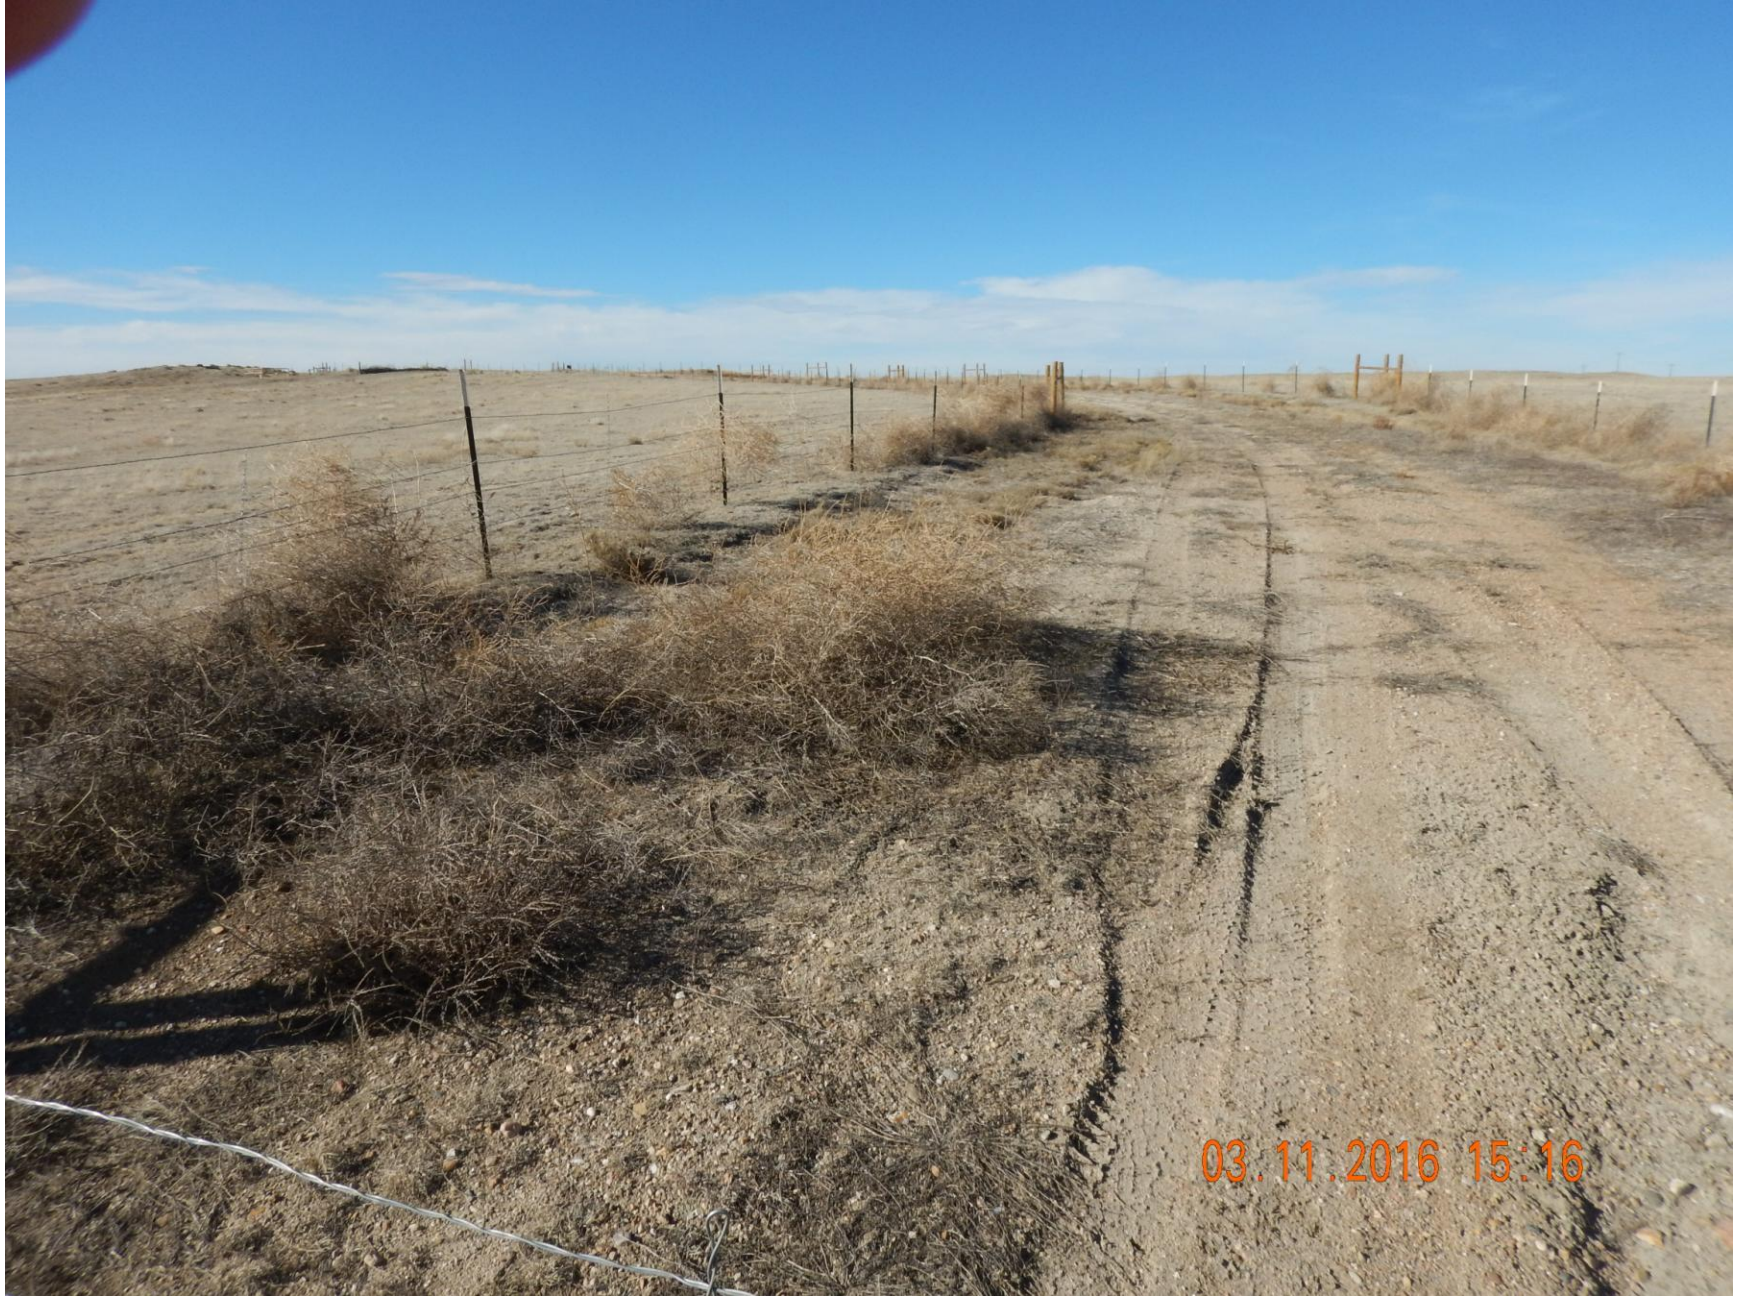
Figure 1: Photo taken from access road, southeast of location facing north.

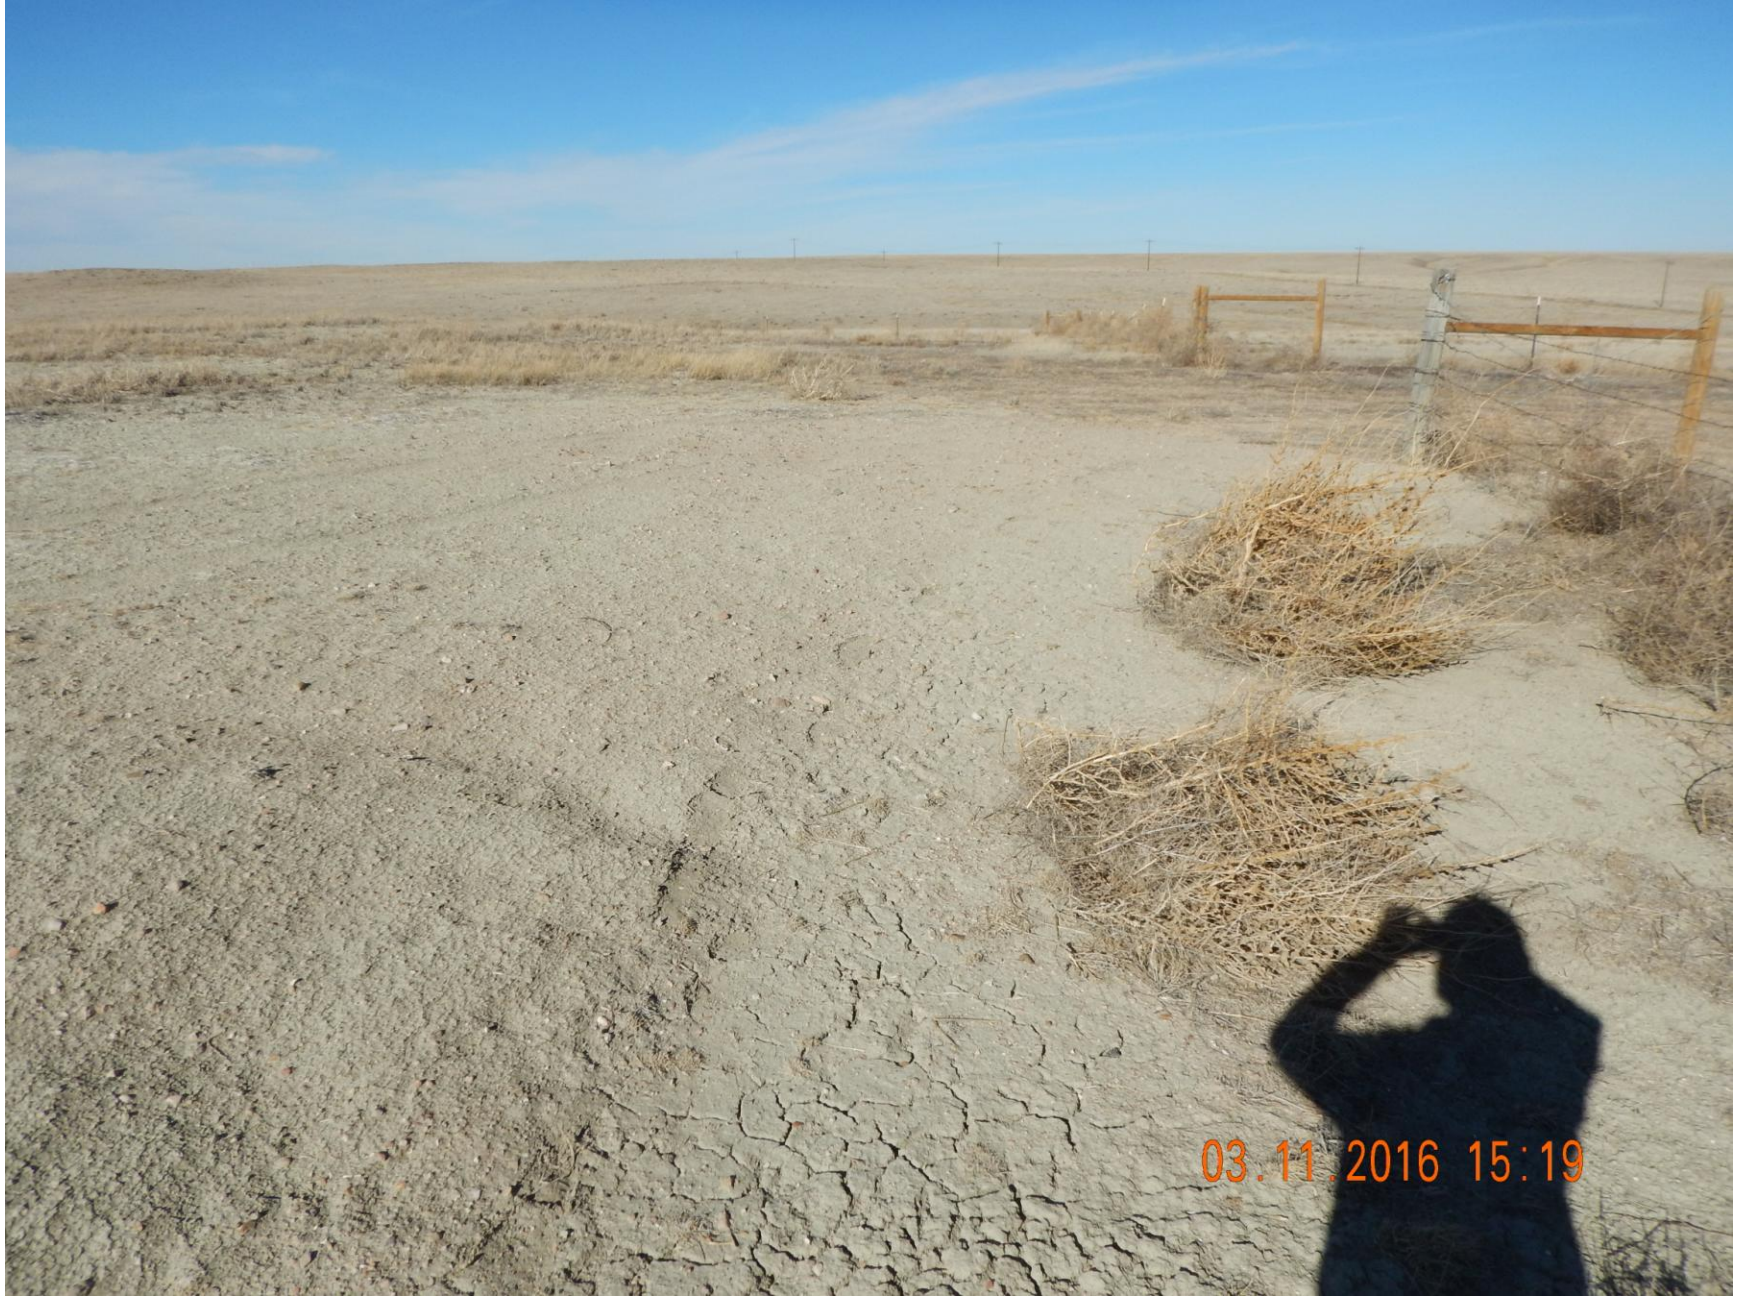
Figure 2: Photo taken from the southeast corner of the location, facing north. Photo shows location has not achieved uniform vegetation.

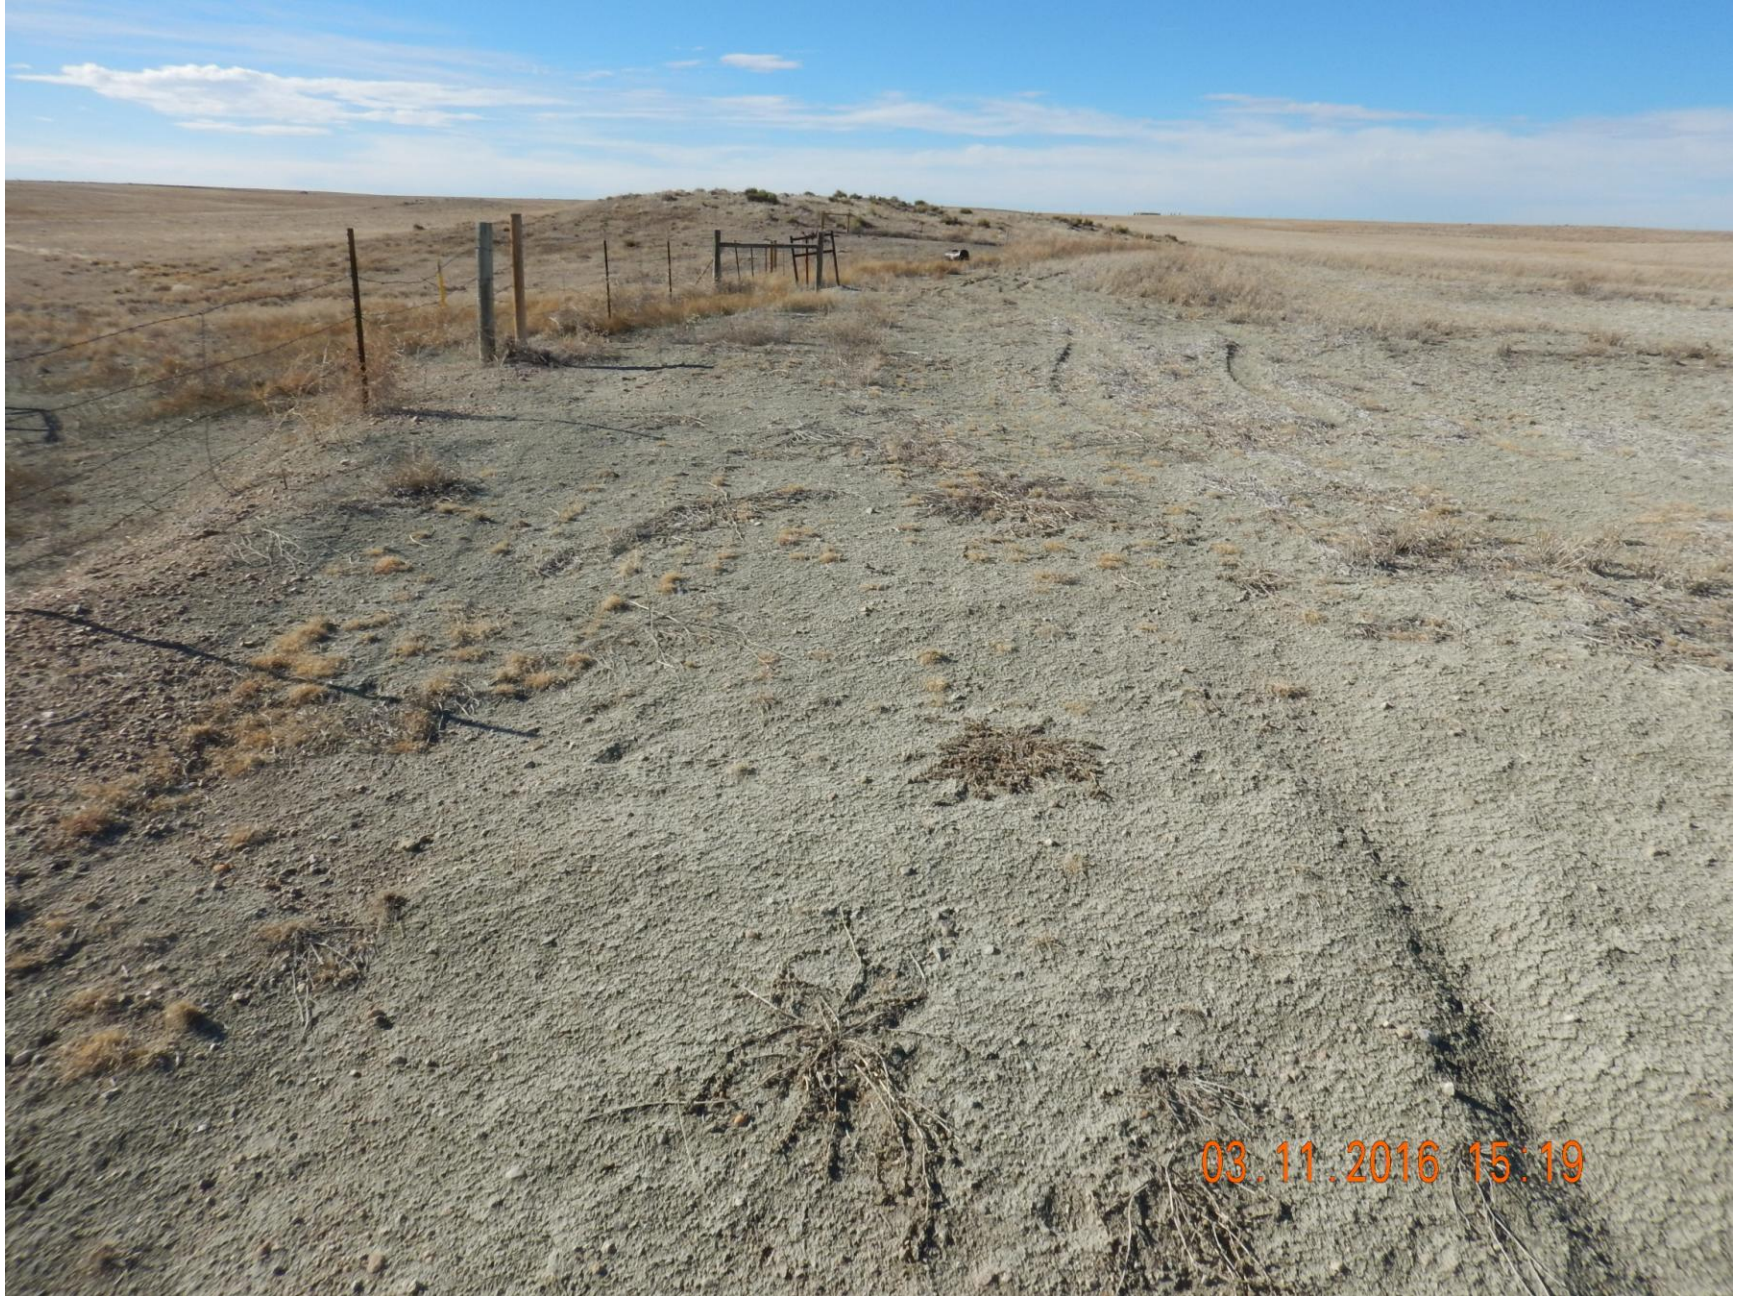
Figure 3: Photo taken from the southeast corner of the location, facing west. Photo shows location has not achieved uniform vegetation.

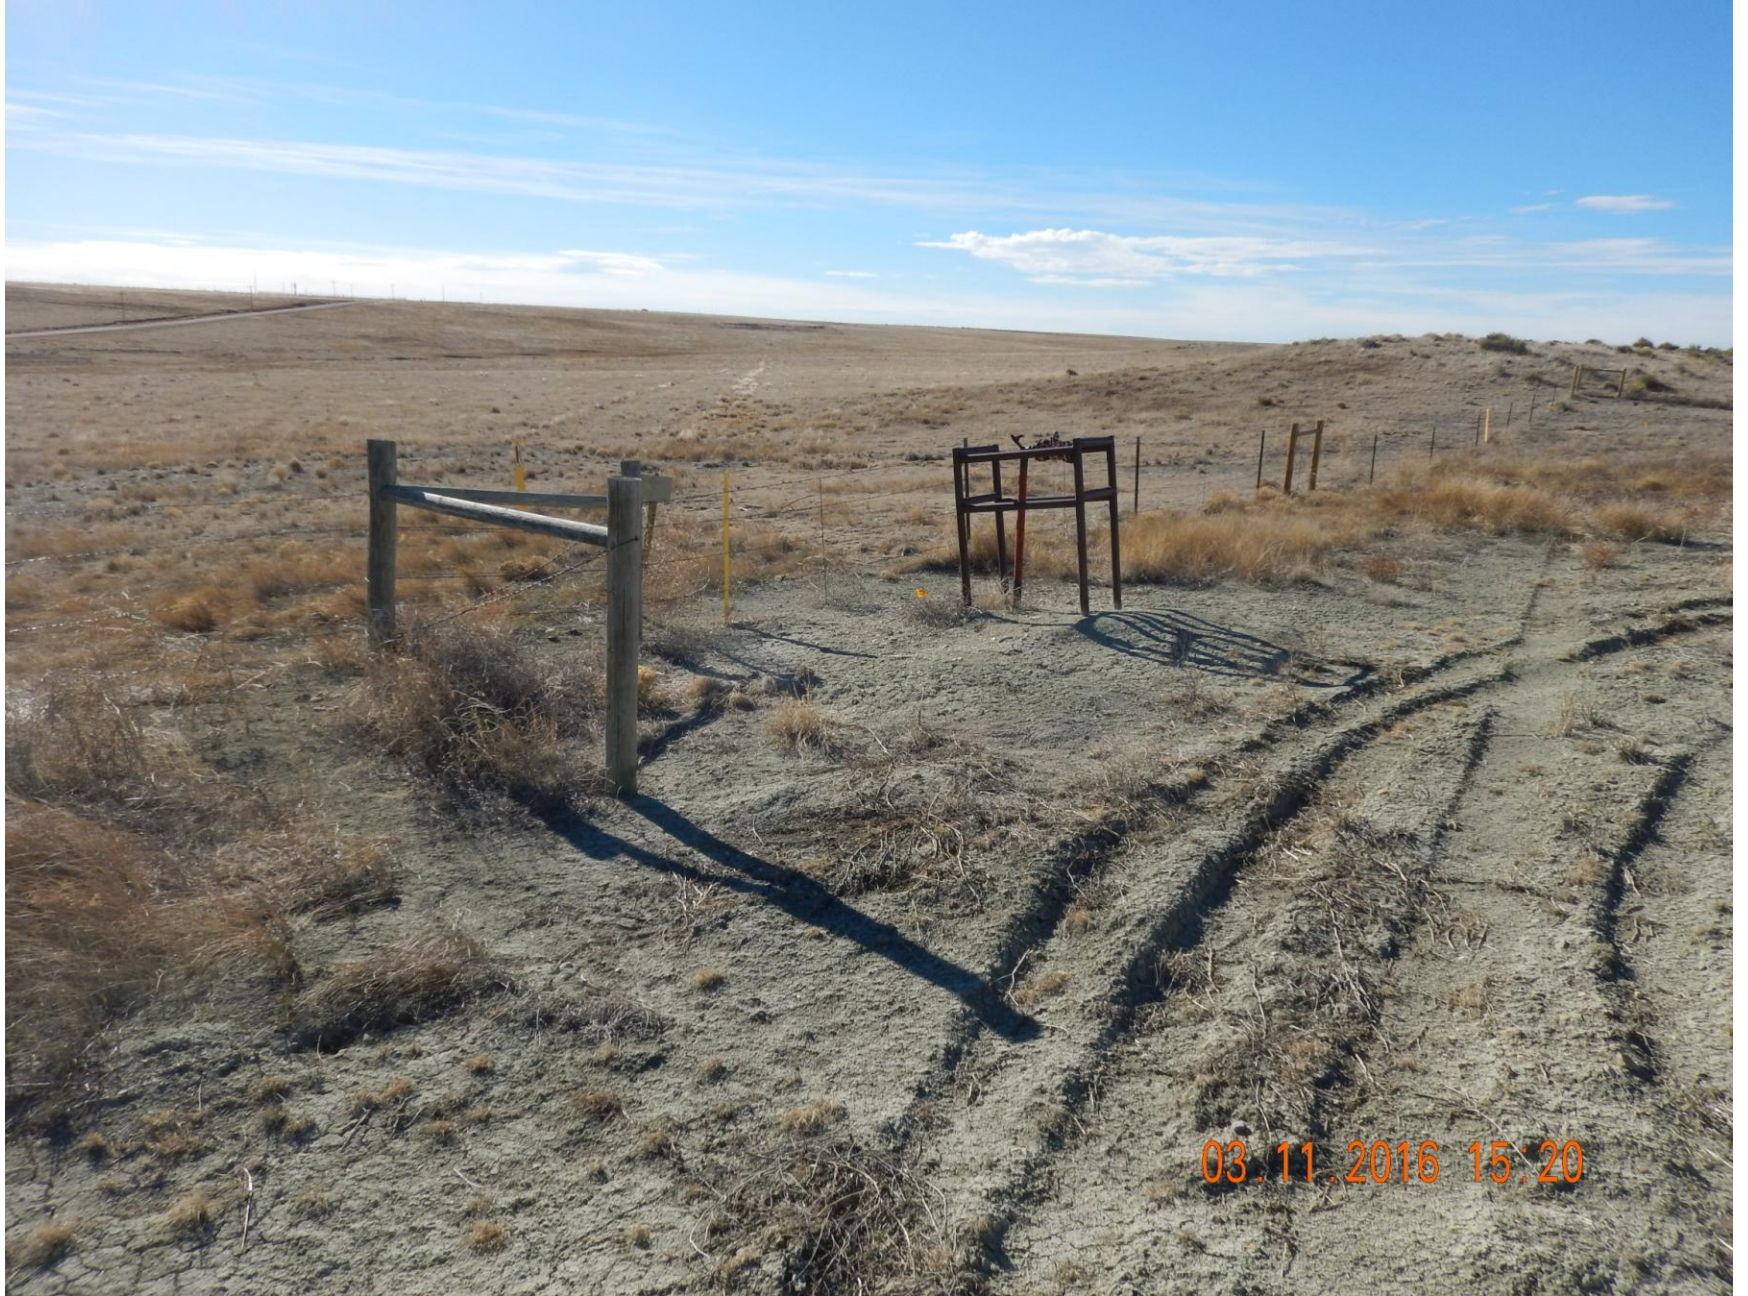
Figure 4: Photo taken from the south end of the location, facing southwest. Photo shows gathering riser remaining on location.

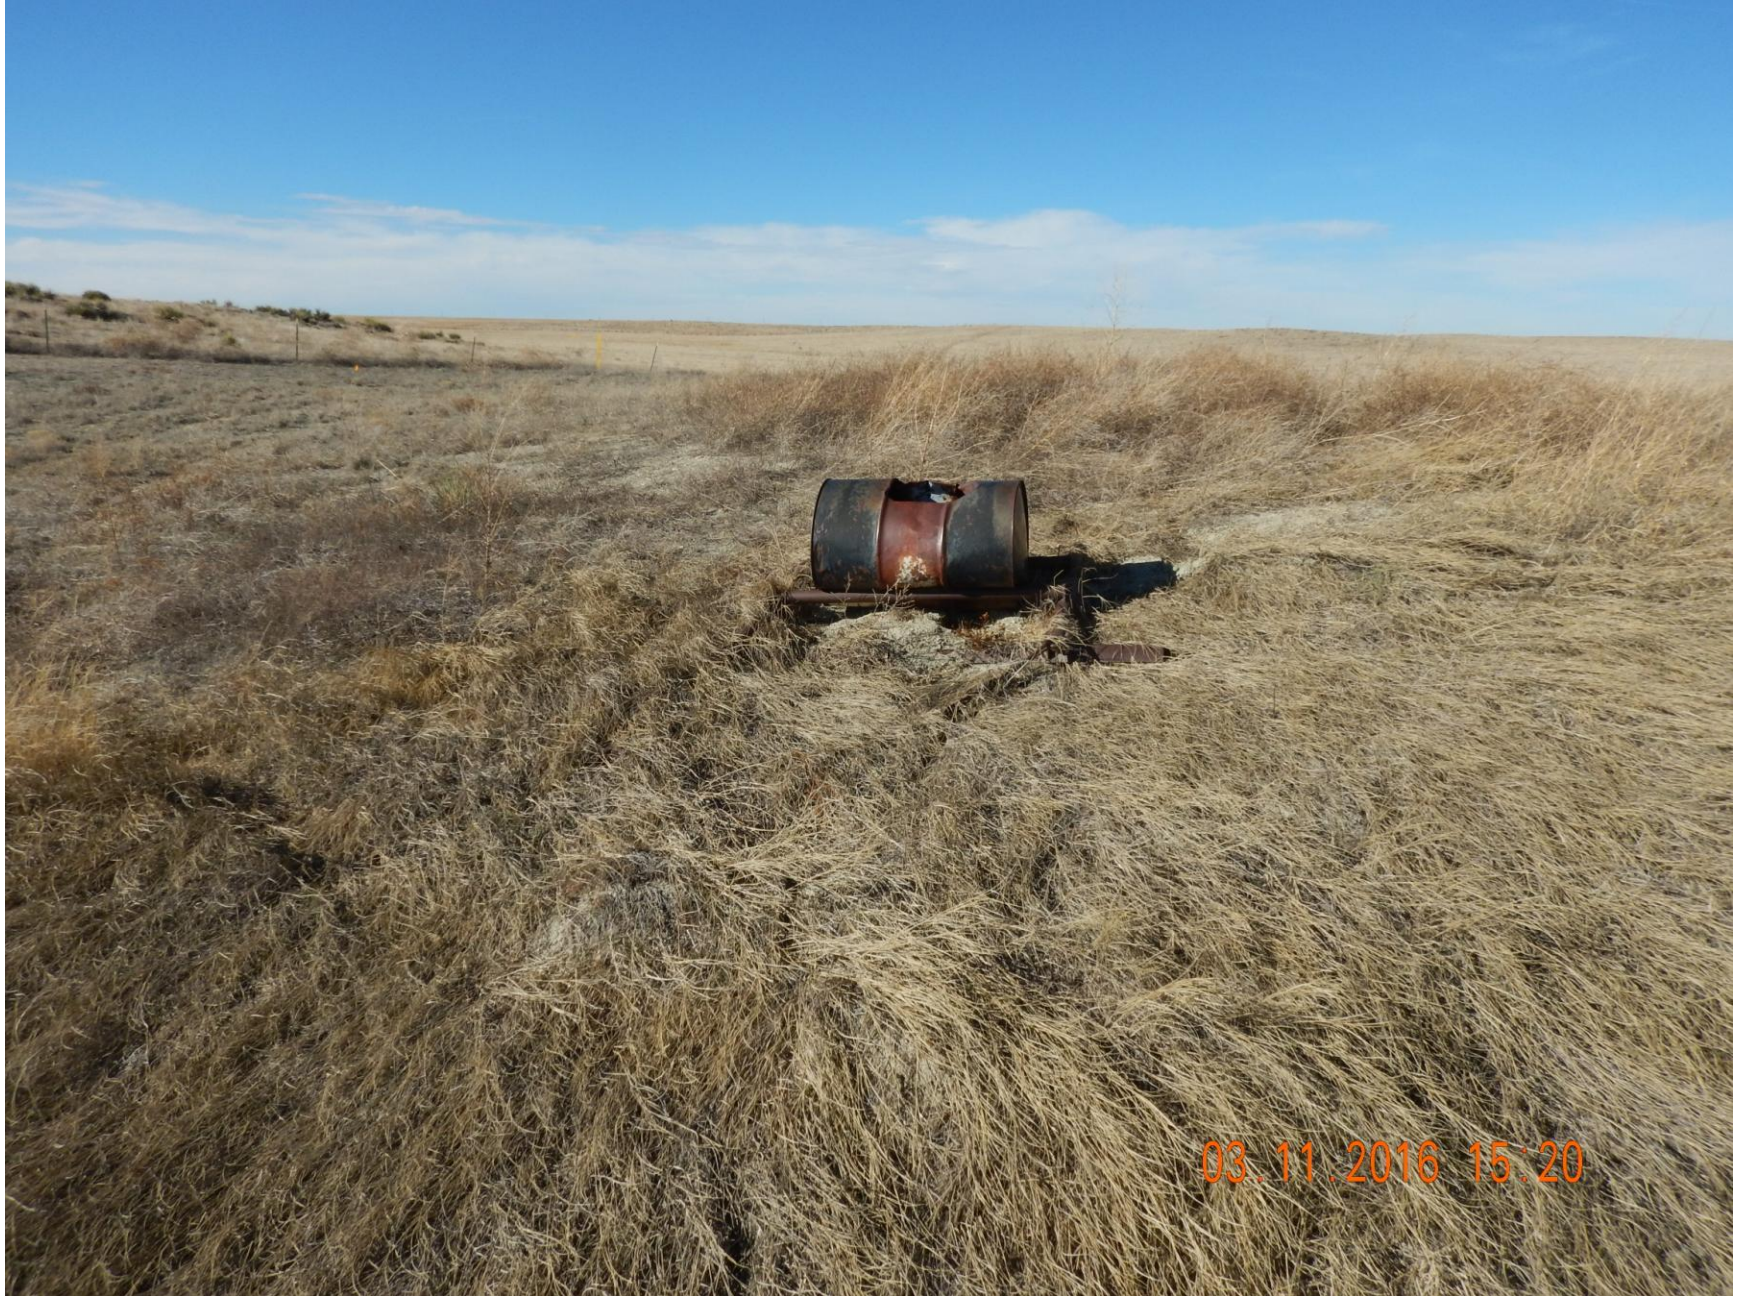
Figure 5: Photo taken from the south end of the location, facing north. Photo shows trash debris on location.

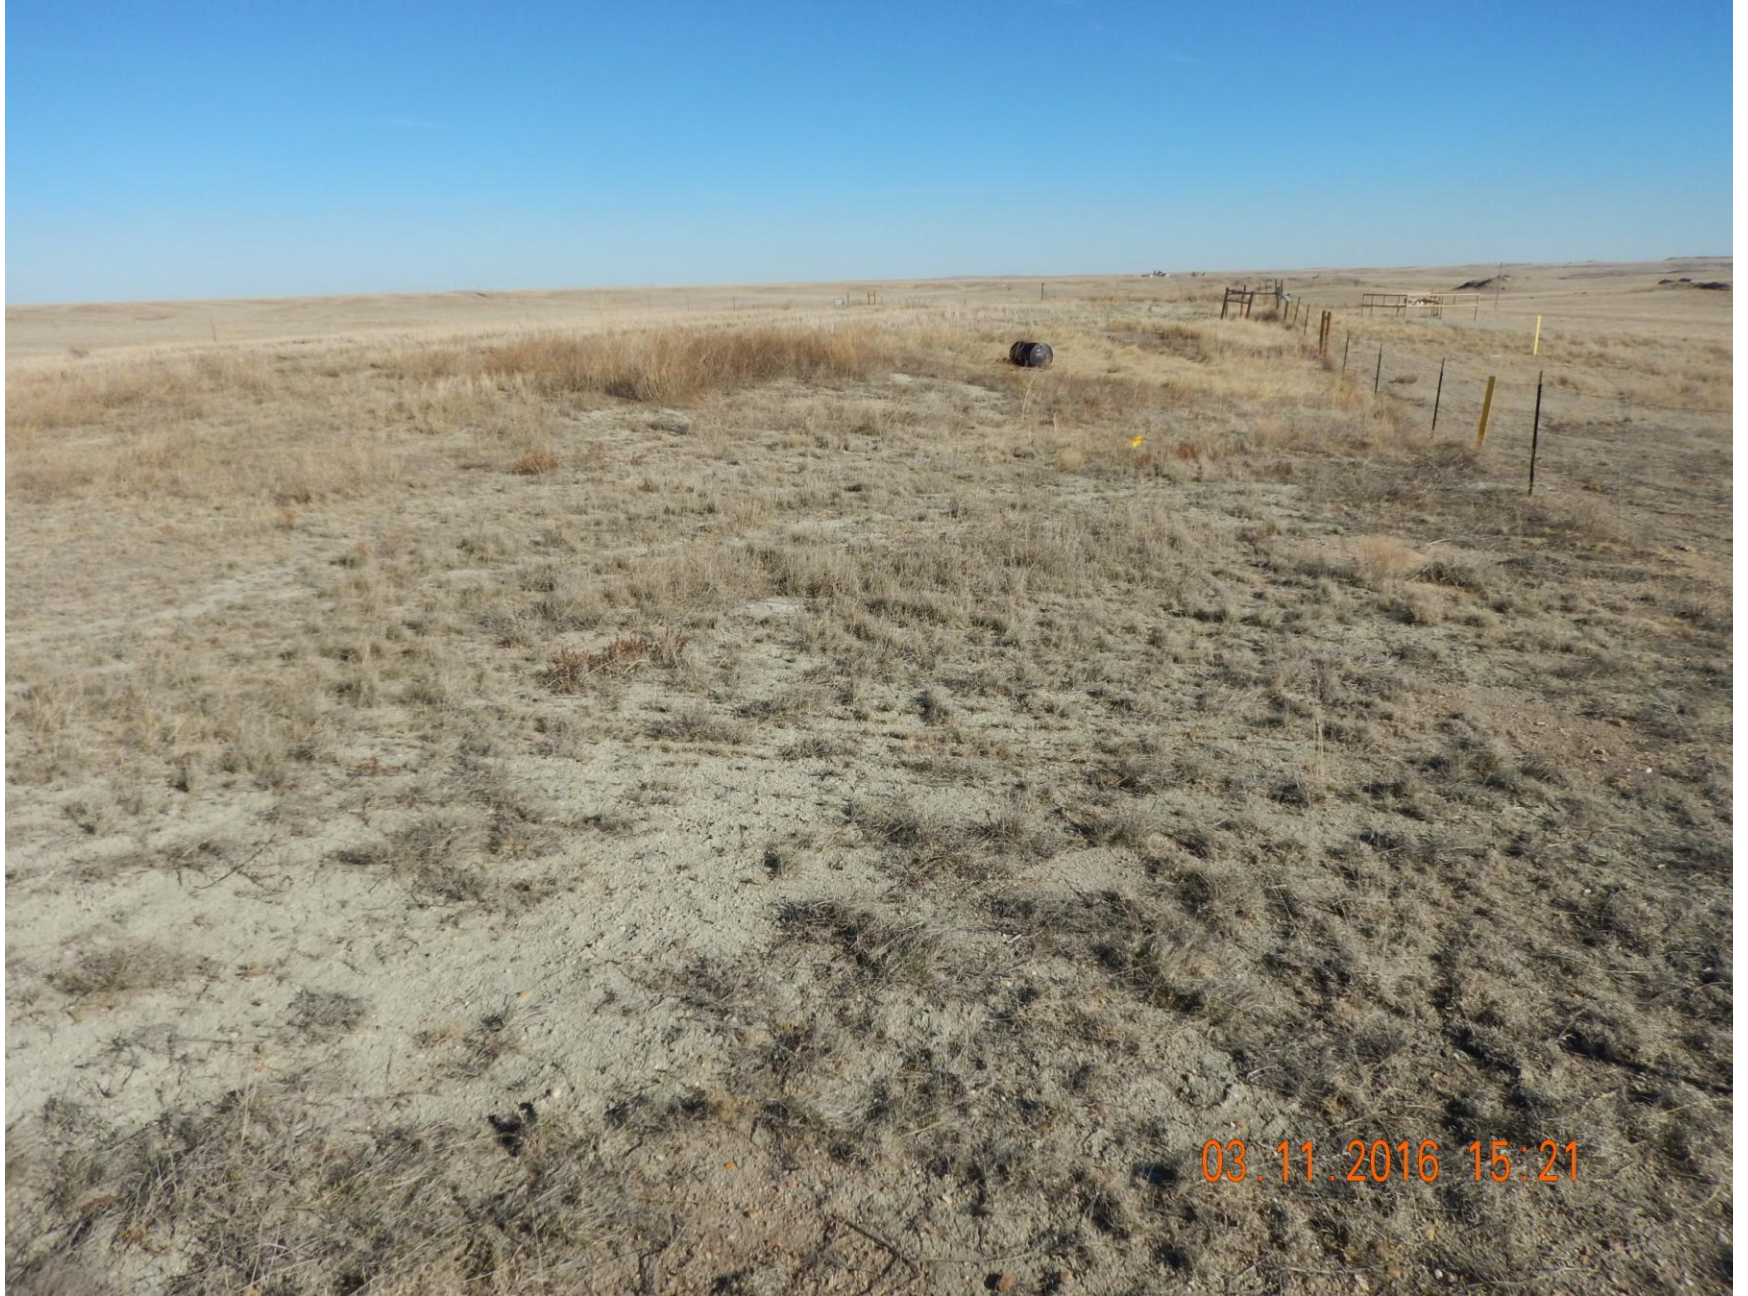
Figure 6: Photo taken from the southwest corner of the location, facing east. Photo shows location has not achieved uniform vegetative cover.

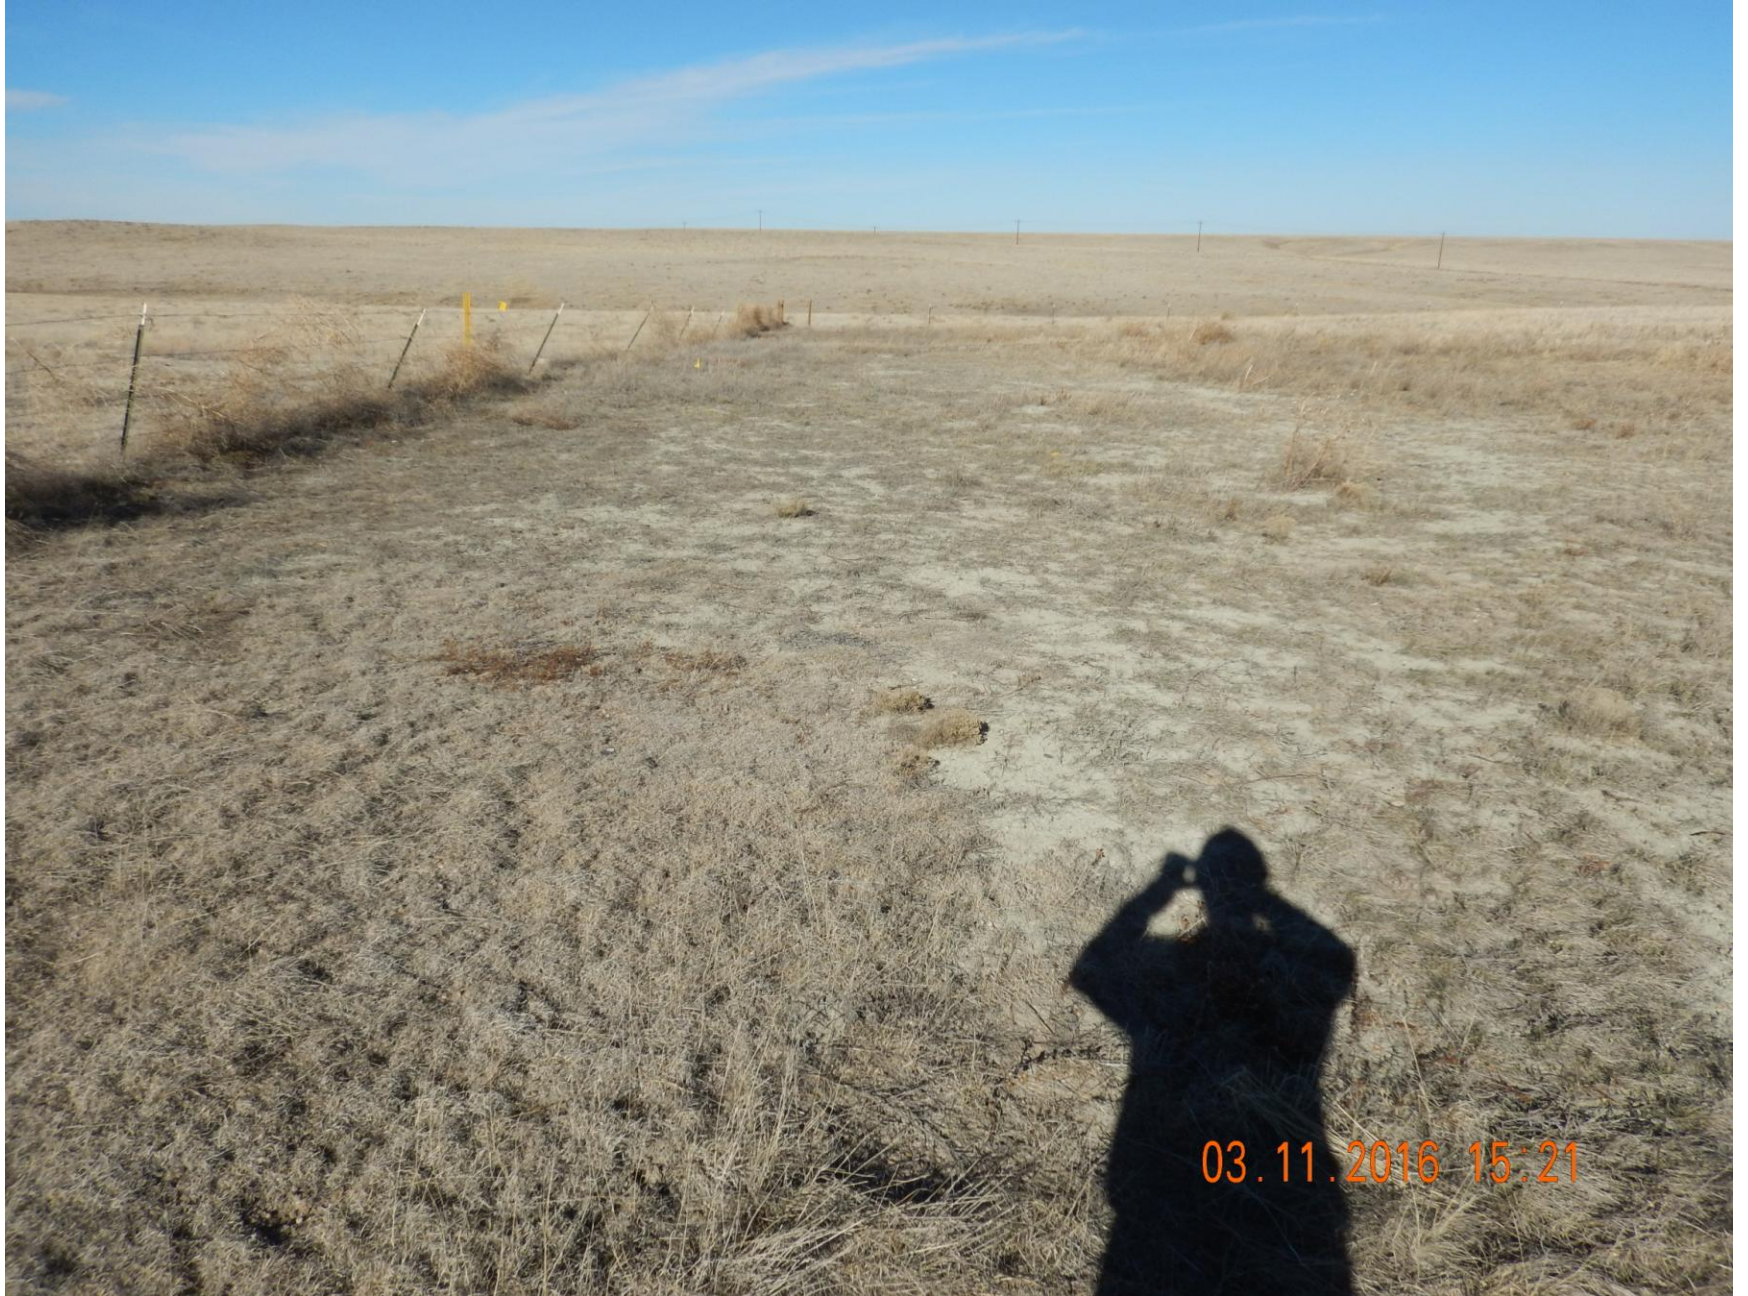
Figure 7: Photo taken from the southwest corner of the location, facing north. Photo shows location has not achieved uniform vegetative cover.

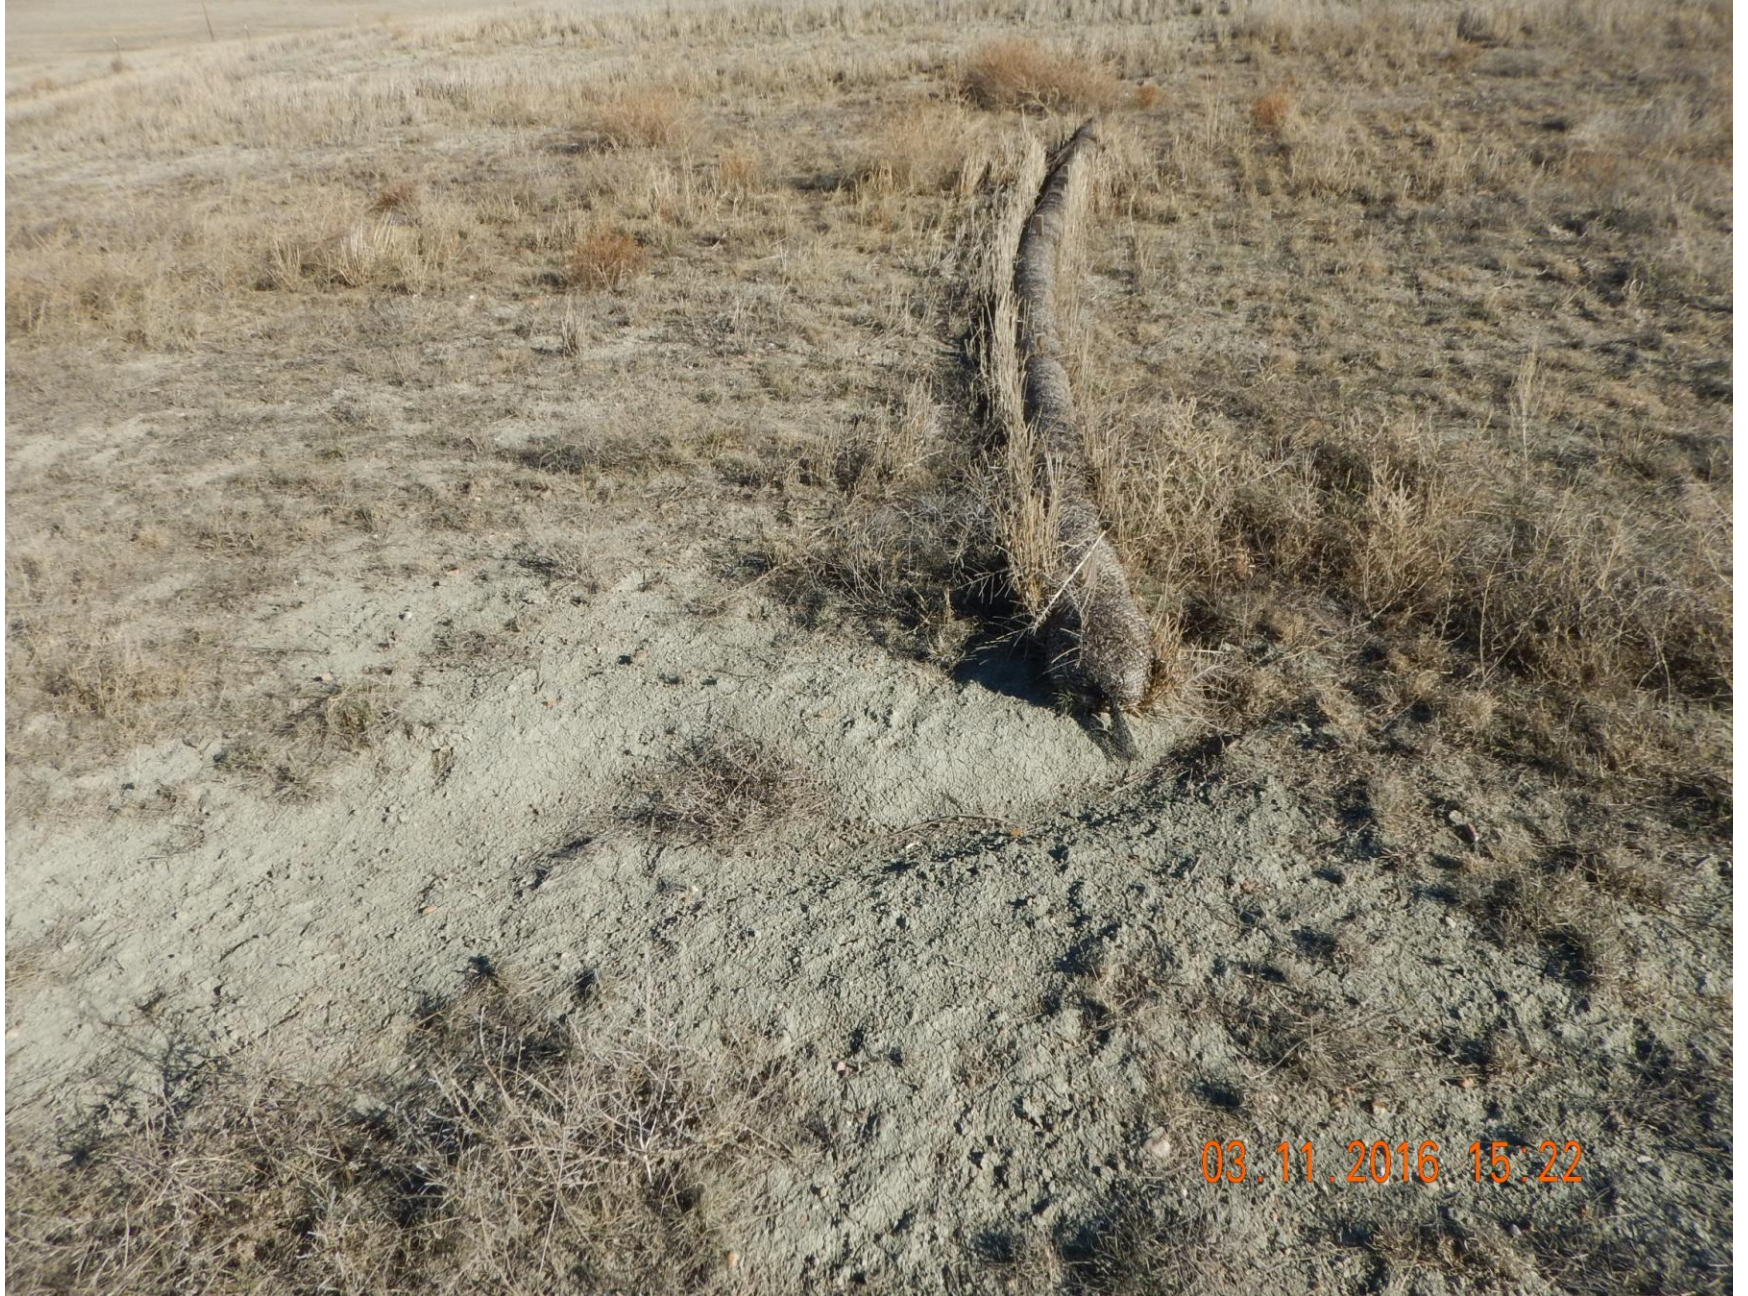
Figure 8: Photo taken from the west end of the location, facing east. Photo shows straw wattle BMP improperly maintained. Wattle is accelerating stormwater around, rather than pooling, causing erosion.

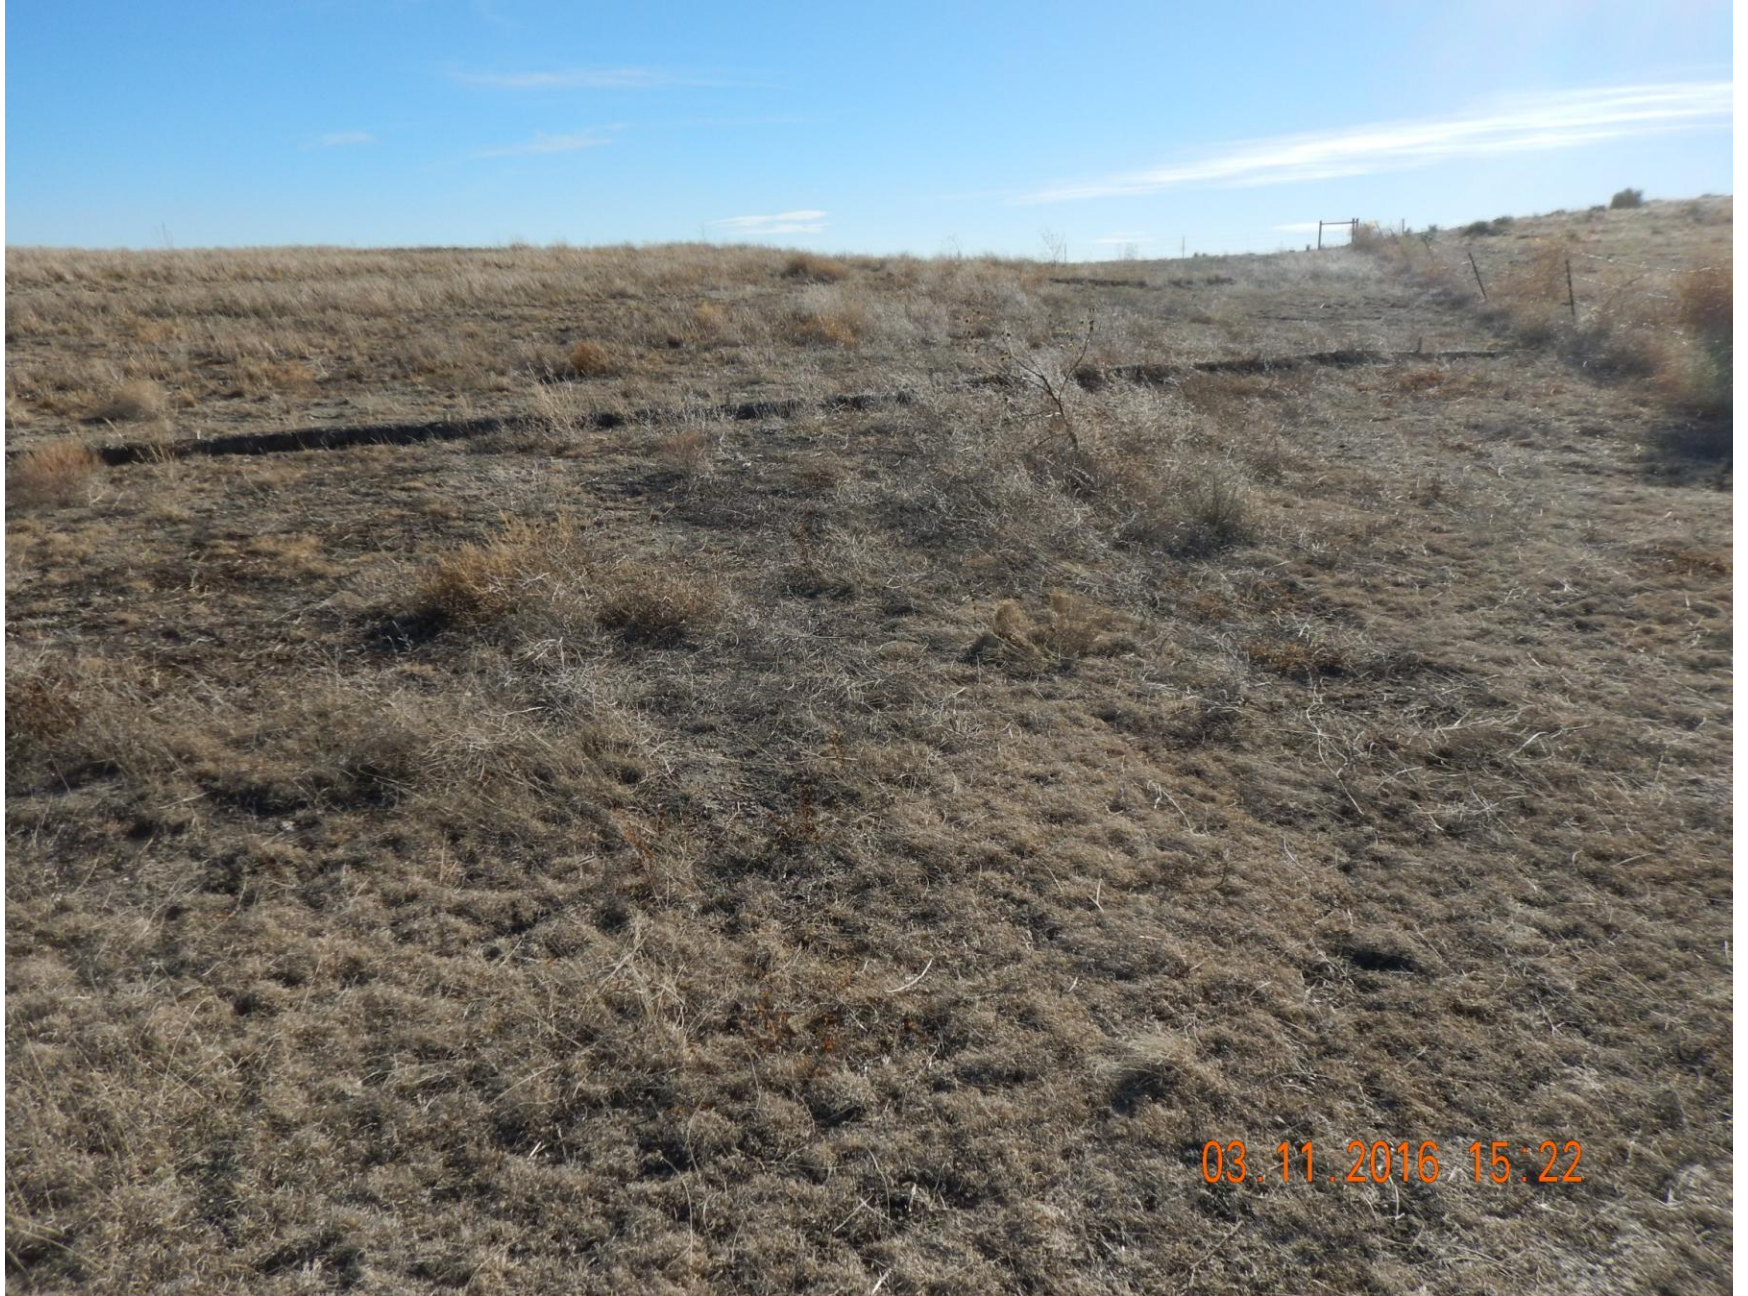
Figure 9: Photo taken from the northwest corner of the location, facing south. Photo shows vegetation on location.

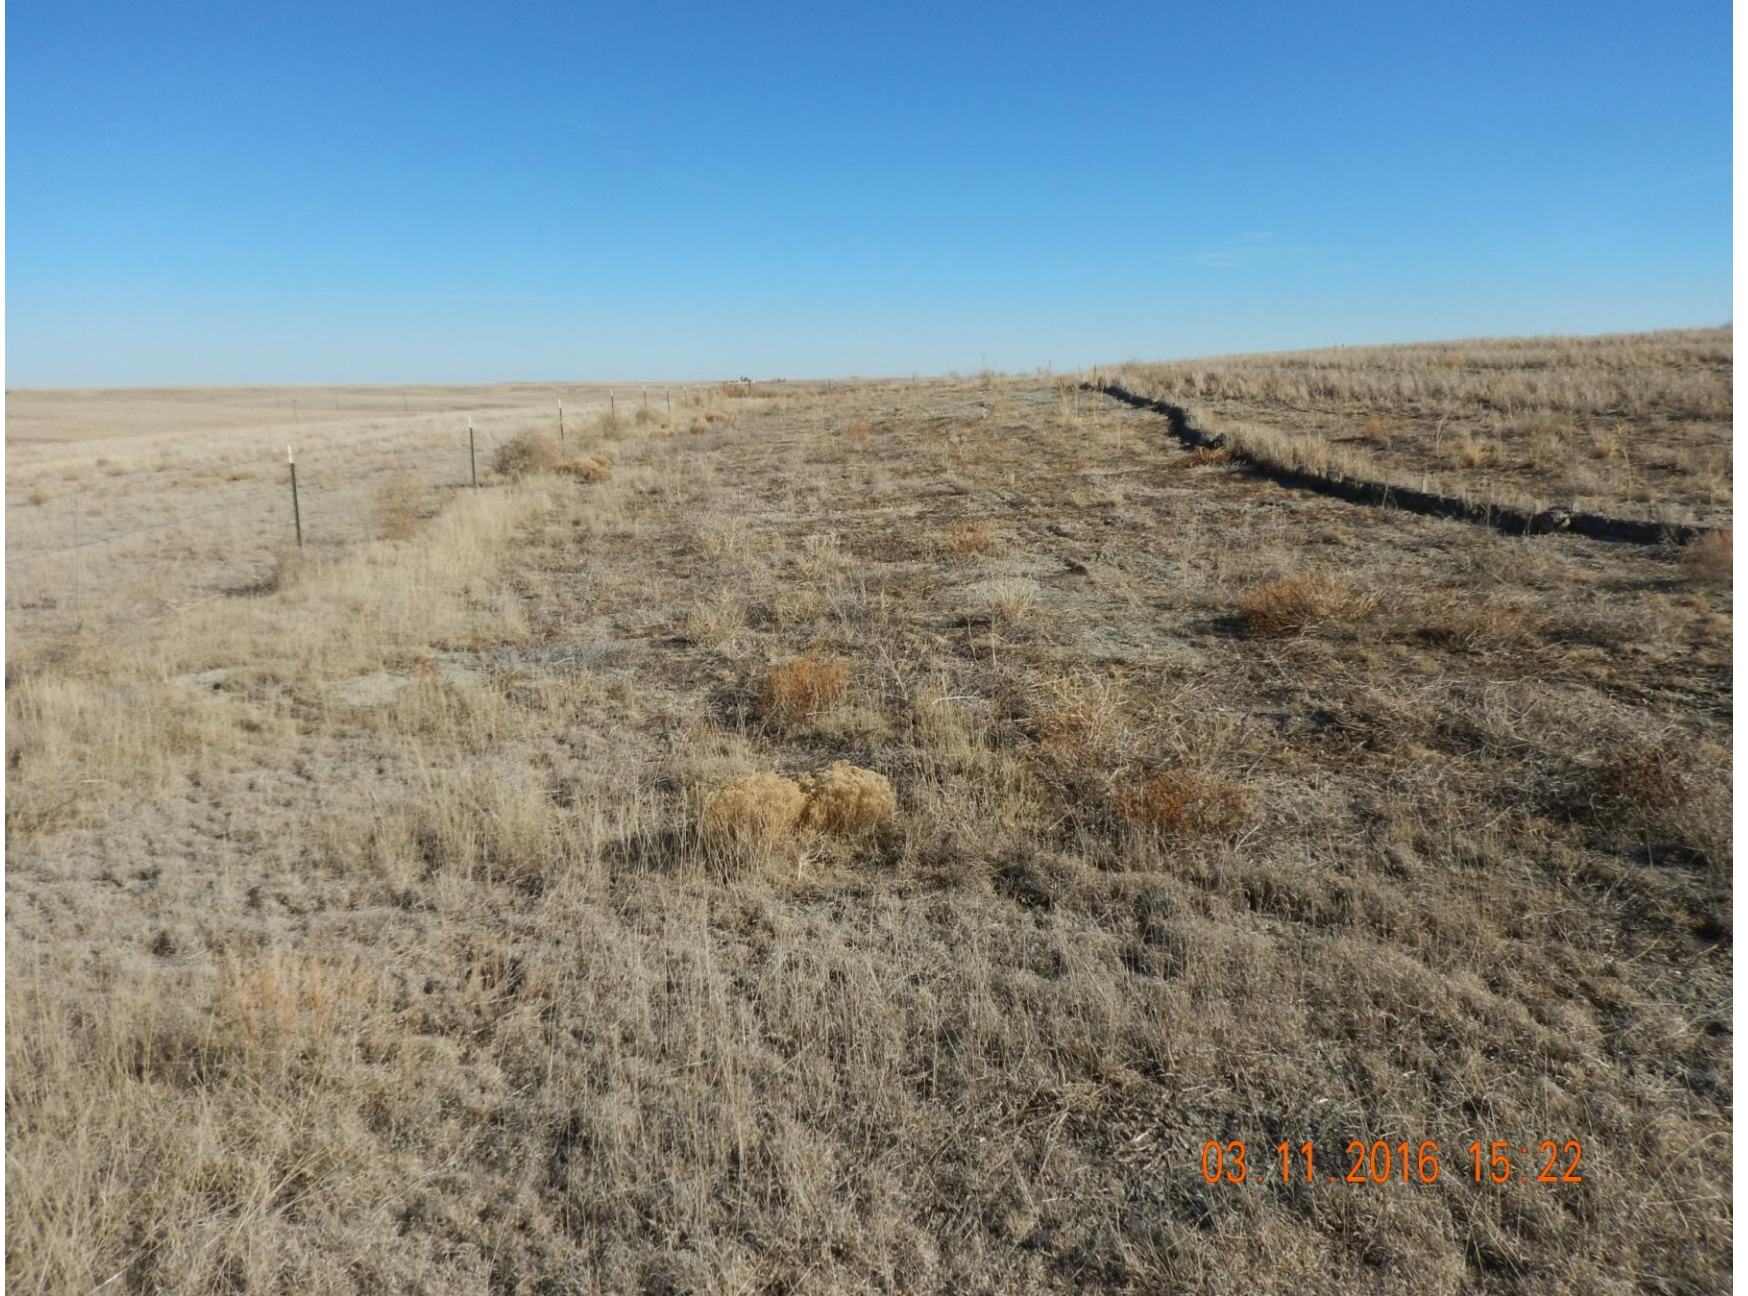
Figure 10: Photo taken from the northwest corner of the location, facing east. Photo shows vegetation on location.
